**GEOTECHNICAL REPORT
ARROYO GRANDE CREEK LEVEE IMPROVEMENTS
LOS BERROS CREEK TO OCEANO AIRPORT
SAN LUIS OBISPO COUNTY, CALIFORNIA**

October 5, 2012
Project No. 04.6212.0101

Subject: Geotechnical Report, Arroyo Grande Creek Levee Improvements, Los Berros
Creek to Oceano Airport, San Luis Obispo County, California

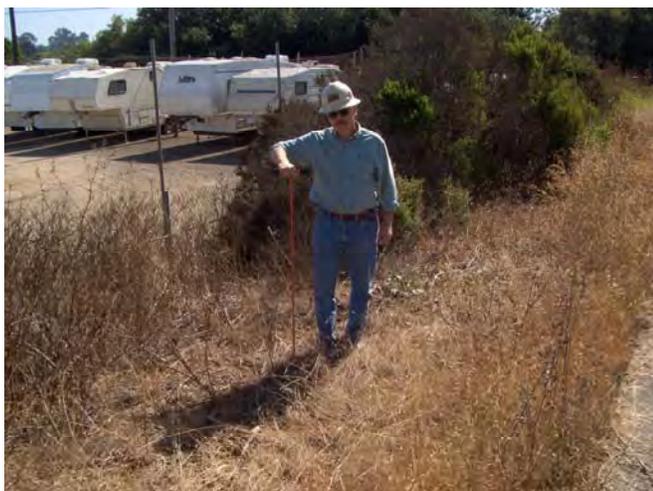
Varying degrees of rodent burrows, vegetation, and loose surface soil were commonly observed along the interior and exterior of the existing levee slopes. Photographs of rodent burrows and loose surface soil on levee slopes are shown on Plate 6. We understand the County actively manages vegetation and rodent activity on the levee, which is common maintenance practice for hydraulic earth structures.

Photo 1: Rodent burrows observed on exterior levee slope at about Station 71+50

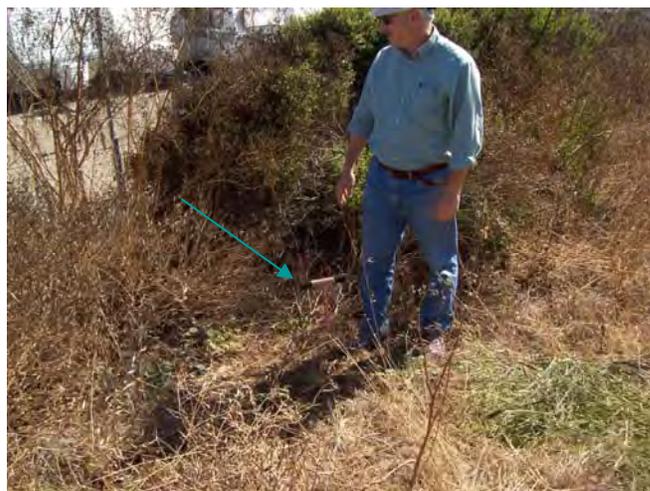
Photo 2: Depth of burrow approximately 2½ feet at about Station 71+50

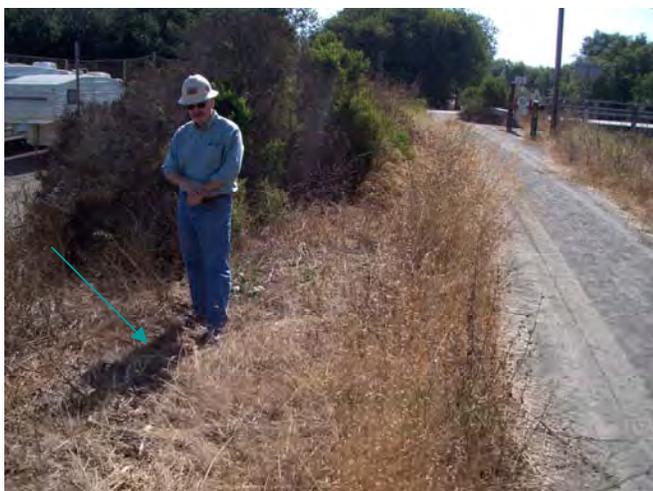
Photo 3: Depth of burrow approximately 4 feet at about Station 71+50 (only probe handle visible)

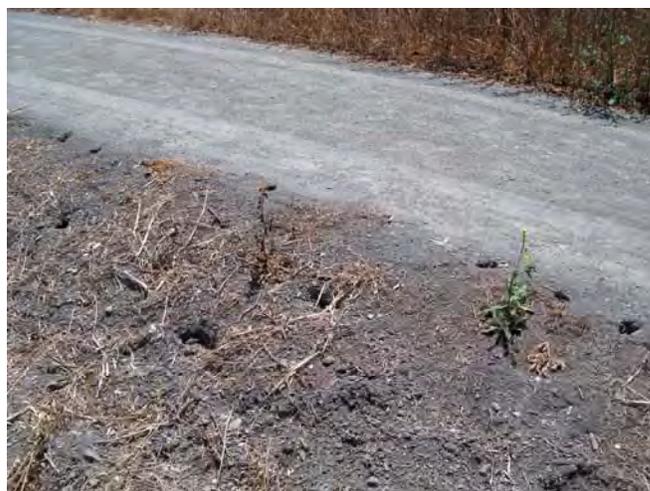
Photo 4: Rodent burrows observed on exterior levee slope at about Station 91+00
