January 22, 2013

**RE: Asbestos Building Inspection - 6555 Capistrano, Atascadero, California**

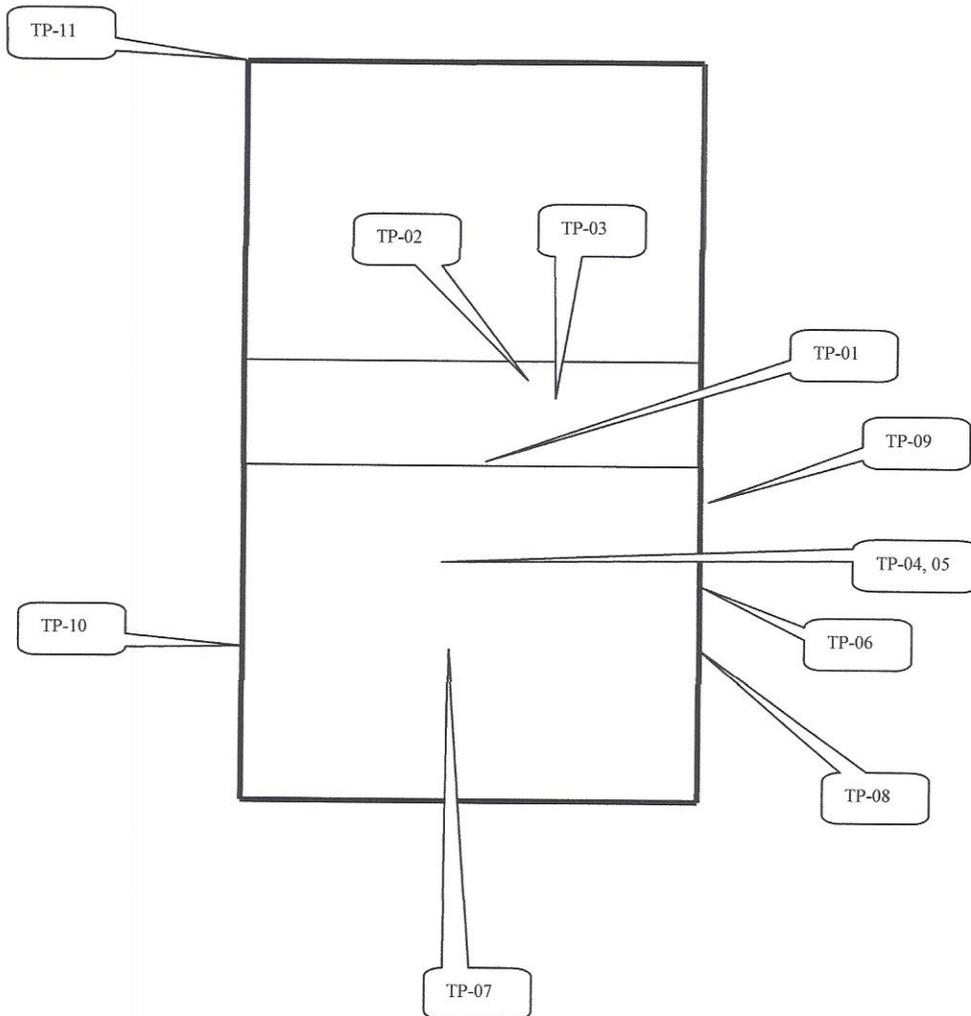
## SAMPLE LOCATION DIAGRAM

<u>Sample #</u>	<u>Material</u>	<u>Location</u>	<u>Asbestos Content</u>
TP-01	Drywall	2 <sup>nd</sup> Floor Wall	None Detected
TP-02	Drywall/Joint Compound	2 <sup>nd</sup> Floor Ceiling	None Detected
TP-03	Drywall/Joint Compound	2 <sup>nd</sup> Floor Ceiling	None Detected
TP-04	Rolled Shingle	Roof (top layer)	None Detected
TP-05	Felt	Roof (bottom layer)	None Detected
TP-06	Rolled Shingle	Roof Parapet	None Detected
TP-07	Putty	Roof Penetration	None Detected
TP-08	Putty	Roof Parapet Cap	None Detected
TP-09	Plaster	Exterior Wall	None Detected
TP-10	Plaster	Exterior Wall	None Detected
TP-12	Plaster	Exterior Wall	None Detected
