**SOILS ENGINEERING REPORT
VISTA DEL RIO ROAD REPAIR
VISTA DEL RIO ROAD AT HUTTON ROAD
NIPOMO, CALIFORNIA**

February 10, 2011

FILE NO.: SL-16142-SA

SUBJECT: Soils Engineering Report

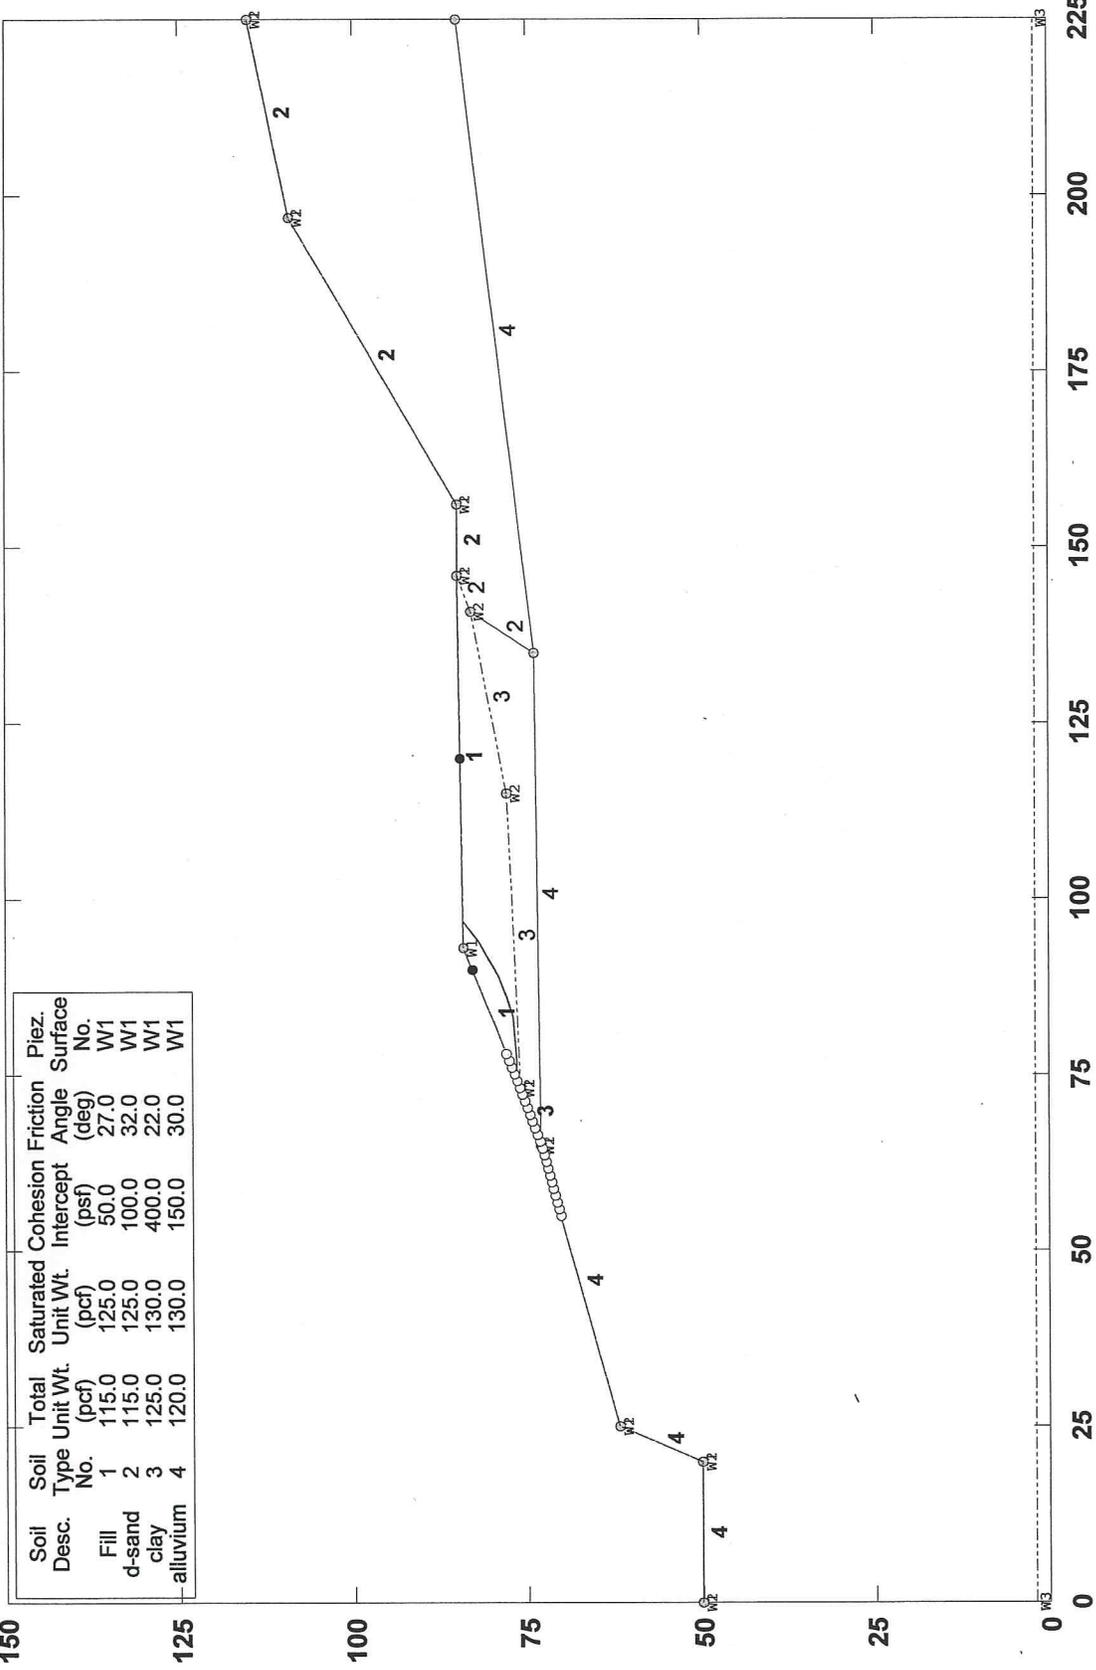
Vista Del Rio Slope Repair Local, Worst Water, Typical Soil

Under the local conditions analyzed, factor of safety ranged from 1.33 for the fully saturated state to 2.16 for moist fill soil overlying saturated native soils. Under global conditions the factors of safety varied from 1.43 for saturated conditions to 1.62 for moist fill and saturated native soils. These factors of safety indicate that instability is unlikely to be the cause of, or even a factor in, the distress seen in the road. The results of the analysis, presented as Surficial Slope Stability Plots, can be found in Appendix C.

PCSTABL5M/si FSmin=1.33

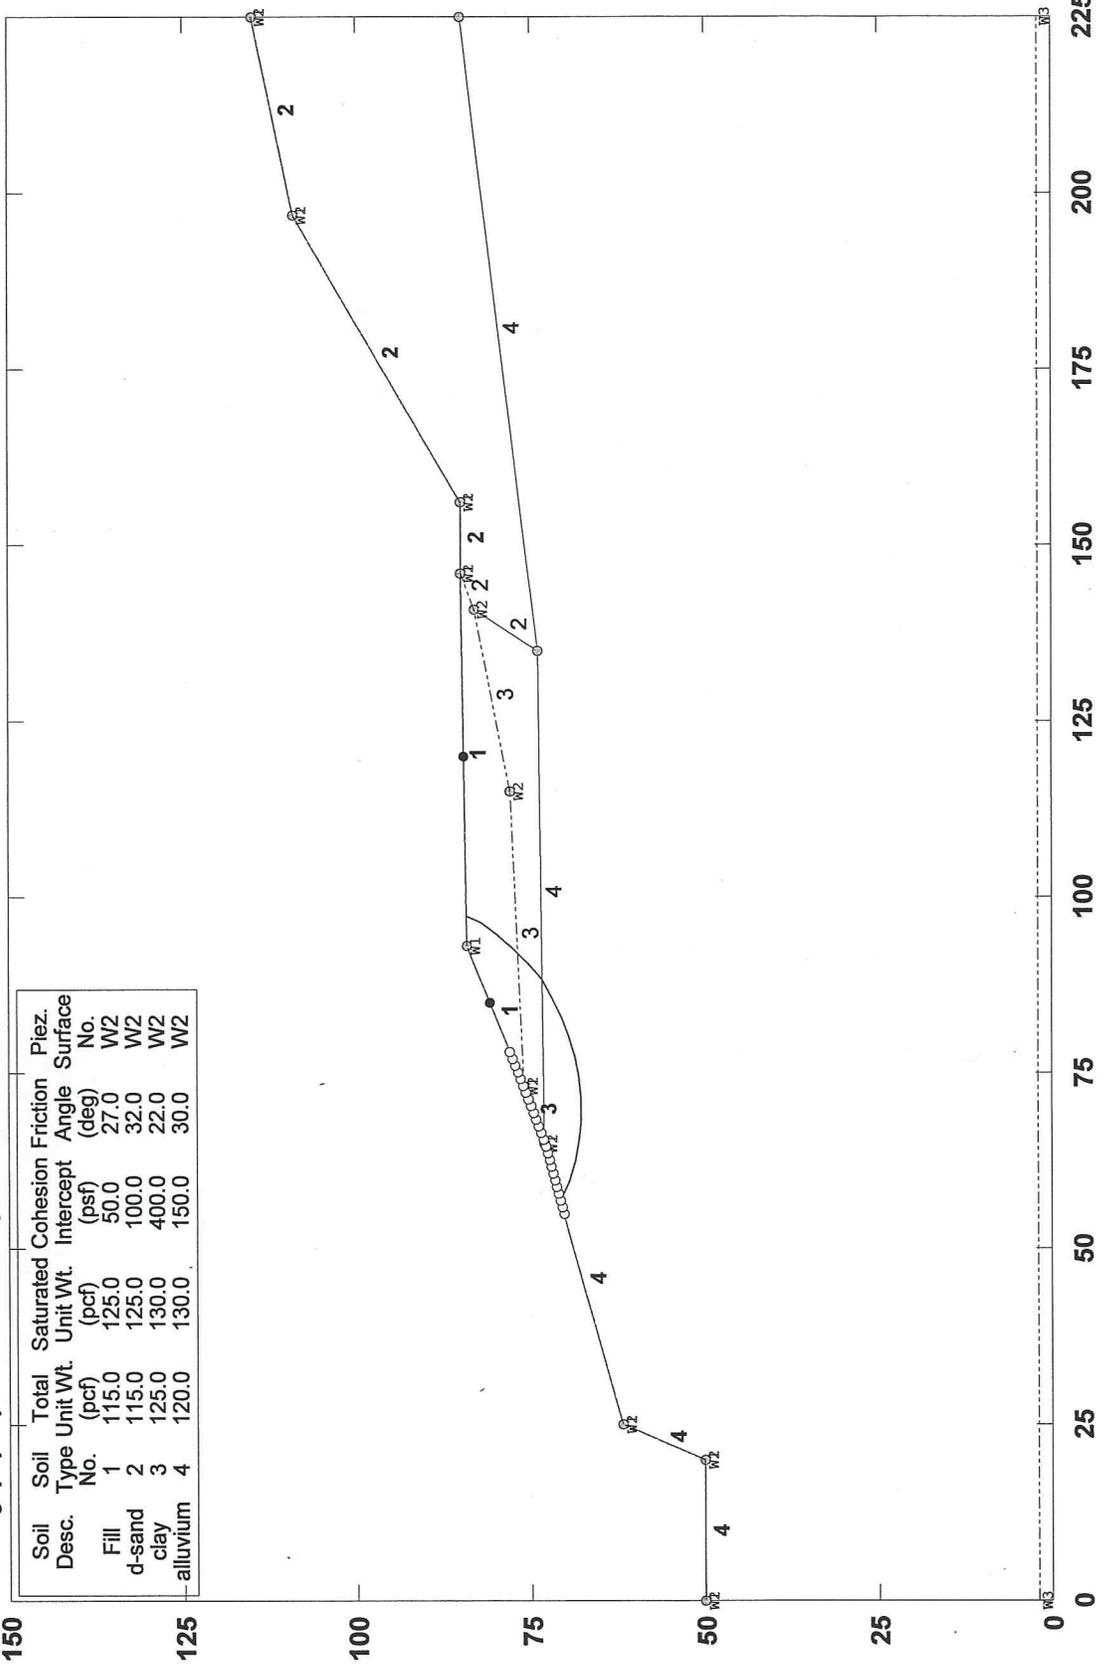
PCSTABL5M/si FSmin=2.16

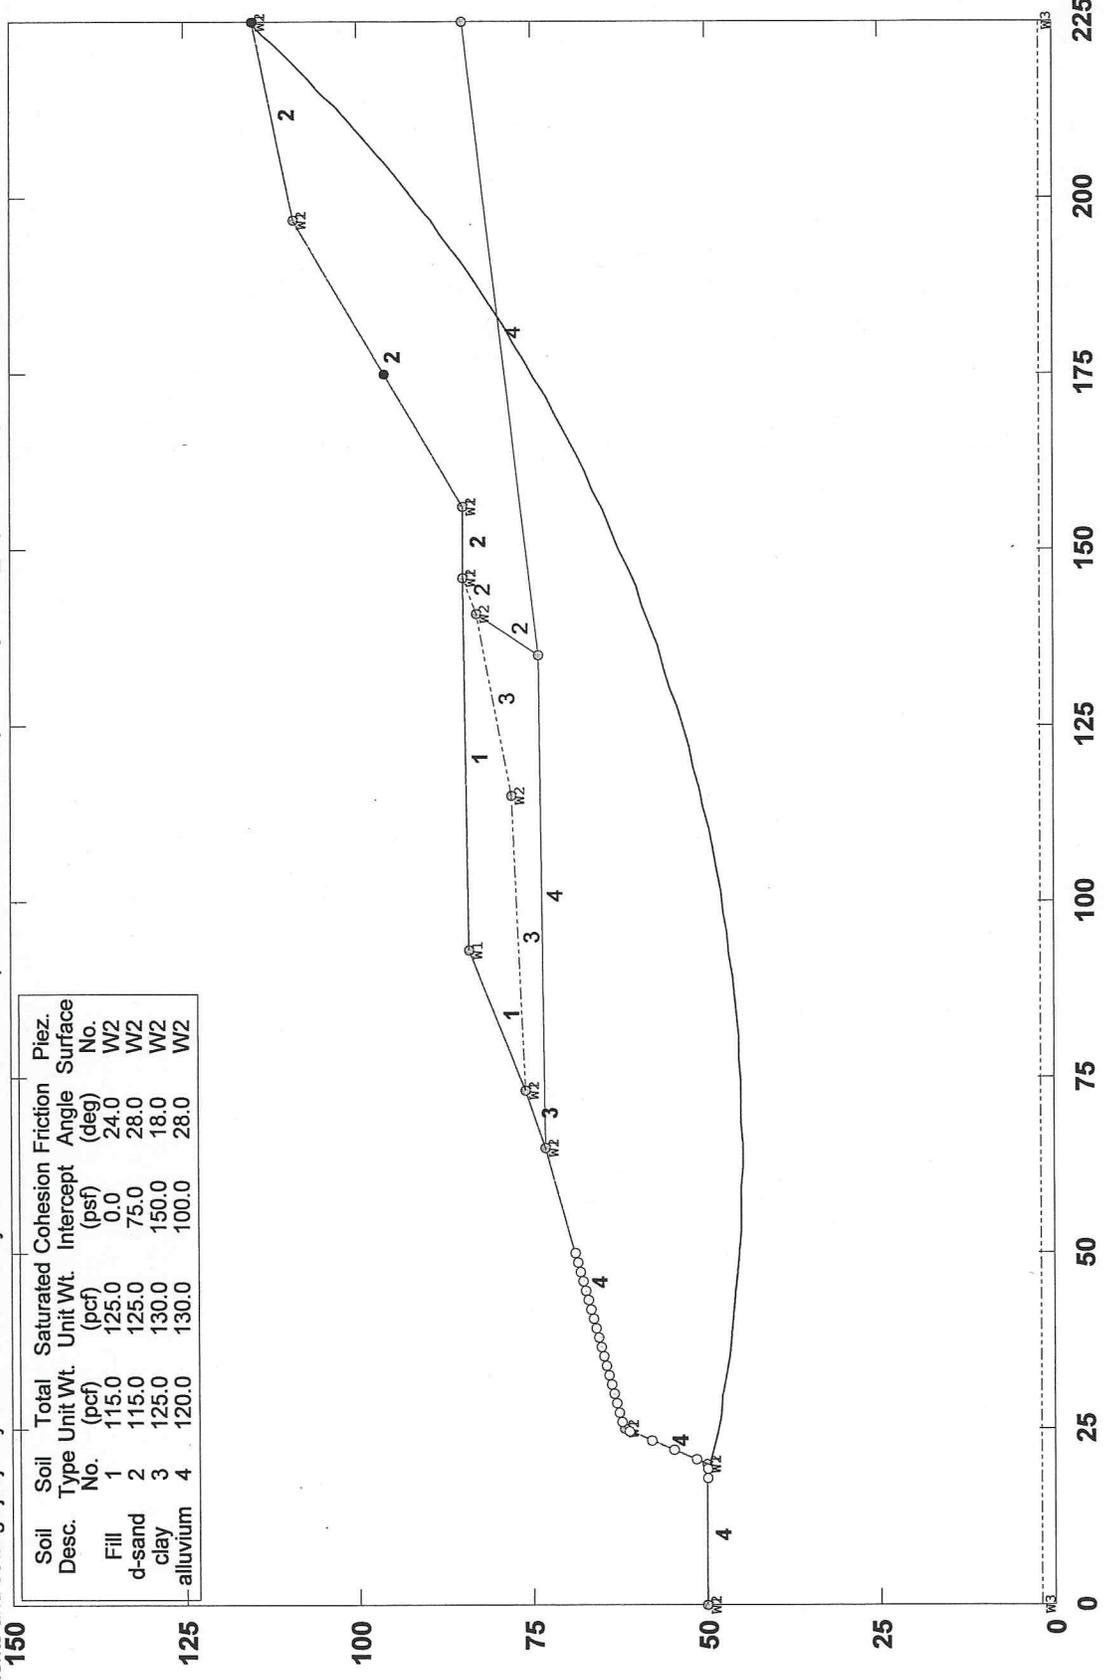
Vista Del Rio Slope Repair Global, Moderate Water, Worst Soil

PCSTABL5M/si FSmin=1.43

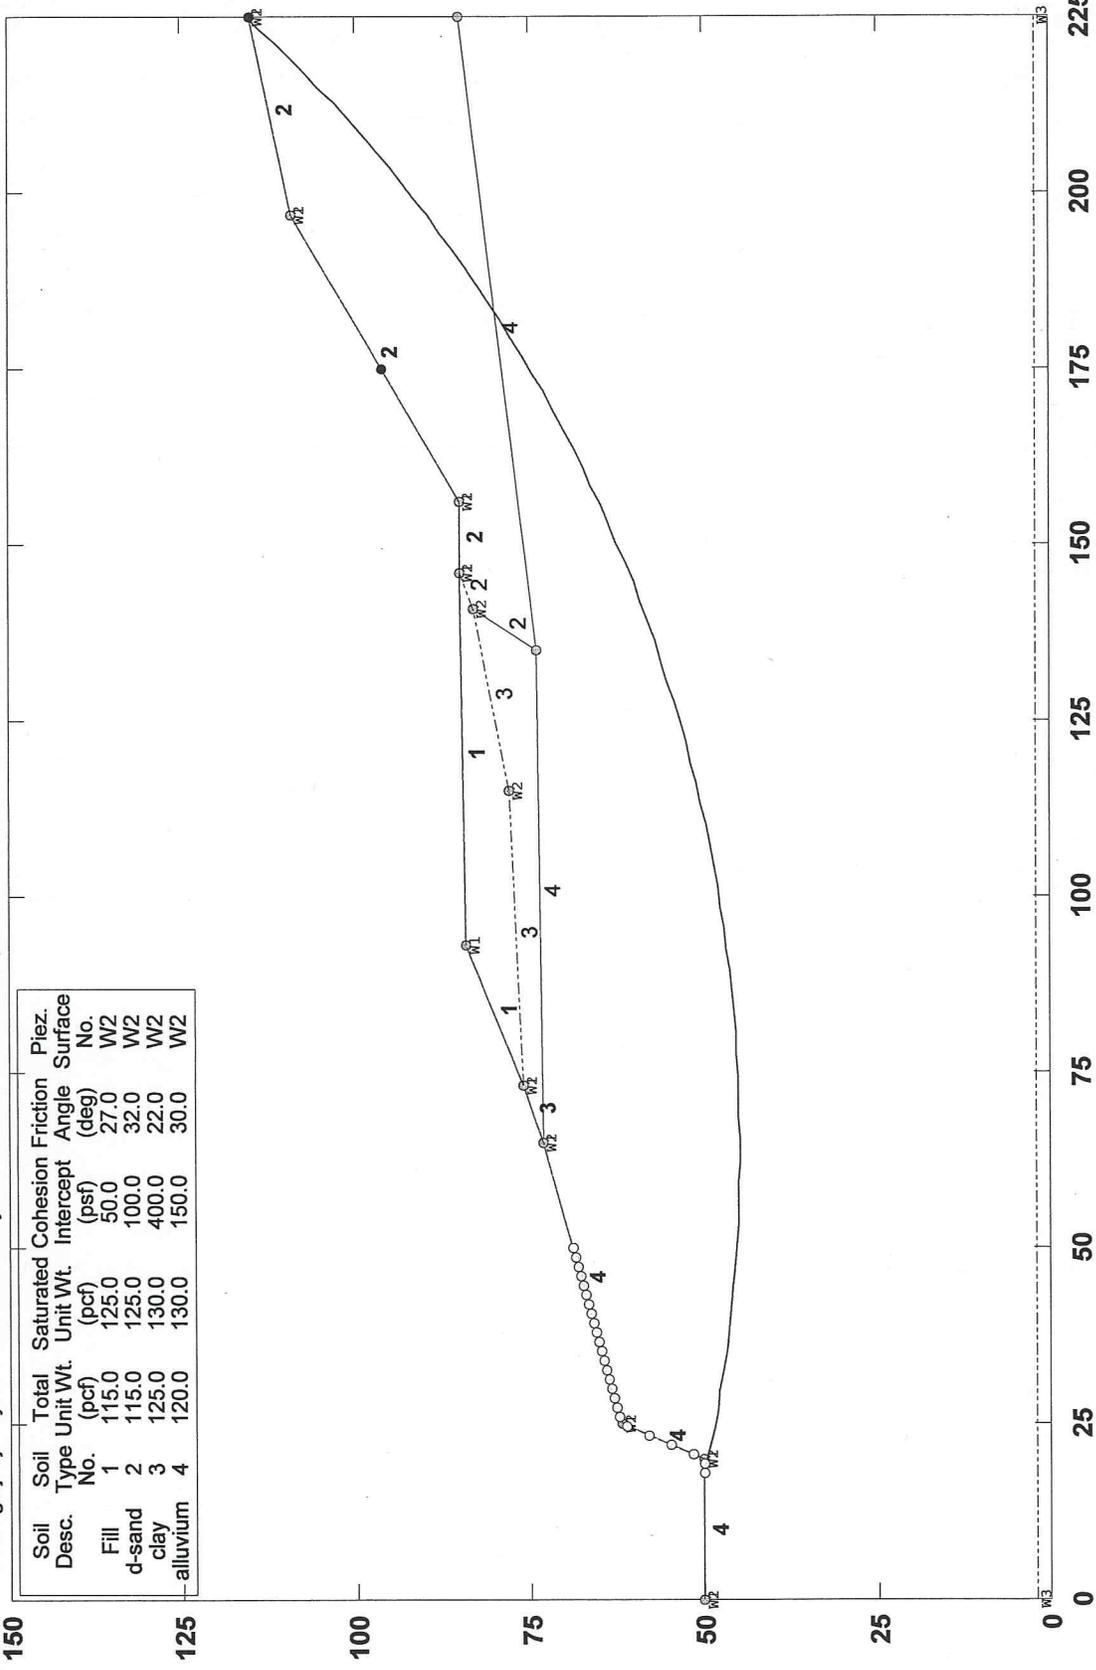
PCSTABL5M/si FSmin=1.62
