**GEOTECHNICAL REPORT
SANTA ROSA CREEK ROAD SLIP OUT
0.9 MILES WEST OF STATE ROUTE 46
SAN LUIS OBISPO COUNTY, CALIFORNIA**

Prepared for:
San Luis Obispo County

March 30, 2010

March 30, 2010
Project No. 3014.040

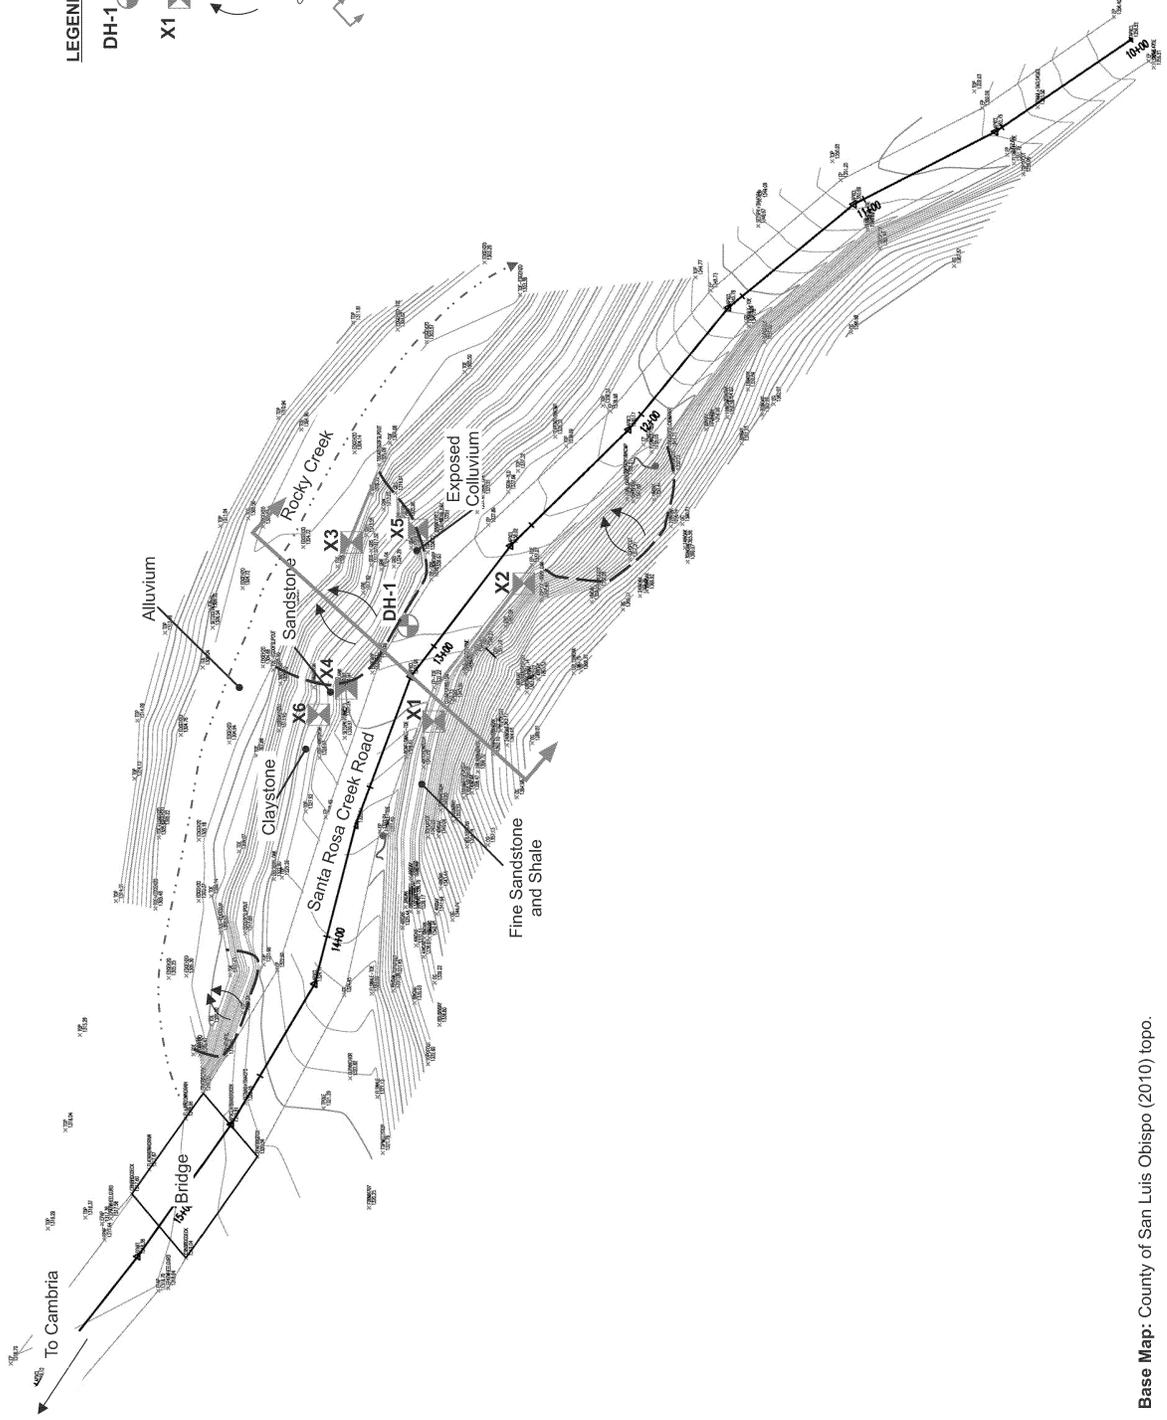
FIELD EXPLORATION PLAN
 Santa Rosa Creek Road
 0.9 miles north of Highway 46
 San Luis Obispo County, California

Approximately 1- to 2-inch wide tension cracks extending up to the edge of pavement were observed during our site visits. The cracks appear recent, and suggest that recent movement and likely extension of the instability of the slope has occurred in association with this winter's rain. The limits of the slide and observed instability were noted on the County (2010) topography (see Plate 2).

Landslide Deposits (Qls): The predominant areas of landsliding and slope instability are noted on Plate 2. The subject landslide is located on the relatively steep northeast facing slope below the northbound shoulder of Santa Rosa Creek Road. The landslide deposits are generally talus deposited at the base of the landslide that was composed of displaced material from the artificial fill, colluvium and Toro Formation. Tension cracks observed adjacent to the road were used to approximate the limits of the landslide. There also appears to be a landslide within the creek bank adjacent to the south abutment of the Rocky Creek Bridge.

Slope instability such as erosion, rock fall, and slumping of materials is also present along the cut slope that borders the southbound shoulder of Santa Rosa Creek Road. The predominant area of slope instability noted on Plate 2, appears to be associated with erosion and displaced over burden soil (colluvium) that has wasted downslope as a result of a daylighting spring and seepage conditions on the slope.

Bedding observed within the Toro Formation was observed within an outcrop adjacent to Rocky Creek. The bedding had a dip of approximately 42 degrees to the southwest, into the hillside, with a strike of N55W. A predominant set of joints was observed within the scarp of the upstream side of the landslide. The joint set appeared to be a controlling structure of the landslide feature and had a dip of approximately 56 degrees to the northeast, down slope, with a strike of N55W. A set of joints at the same location was observed to dip approximately 38 degrees southeast, into the hillside, with a strike of S65W. Our field measurements are shown on Plate 2.

Groundwater was not encountered in DH-1 prior to adding water to the hole at 20 feet deep to begin rock coring. As noted on Plate 2, springs were observed daylighting along the base of the slope and ditch along the southbound shoulder of the road. Water was flowing in Rocky Creek at the time of our March 2010 field exploration program. The approximate limits of the water surface are noted on County (2010) topographic map. Stream flow, groundwater and soil moisture conditions will vary seasonally due to changes in runoff, storm conditions, rainfall and other factors.

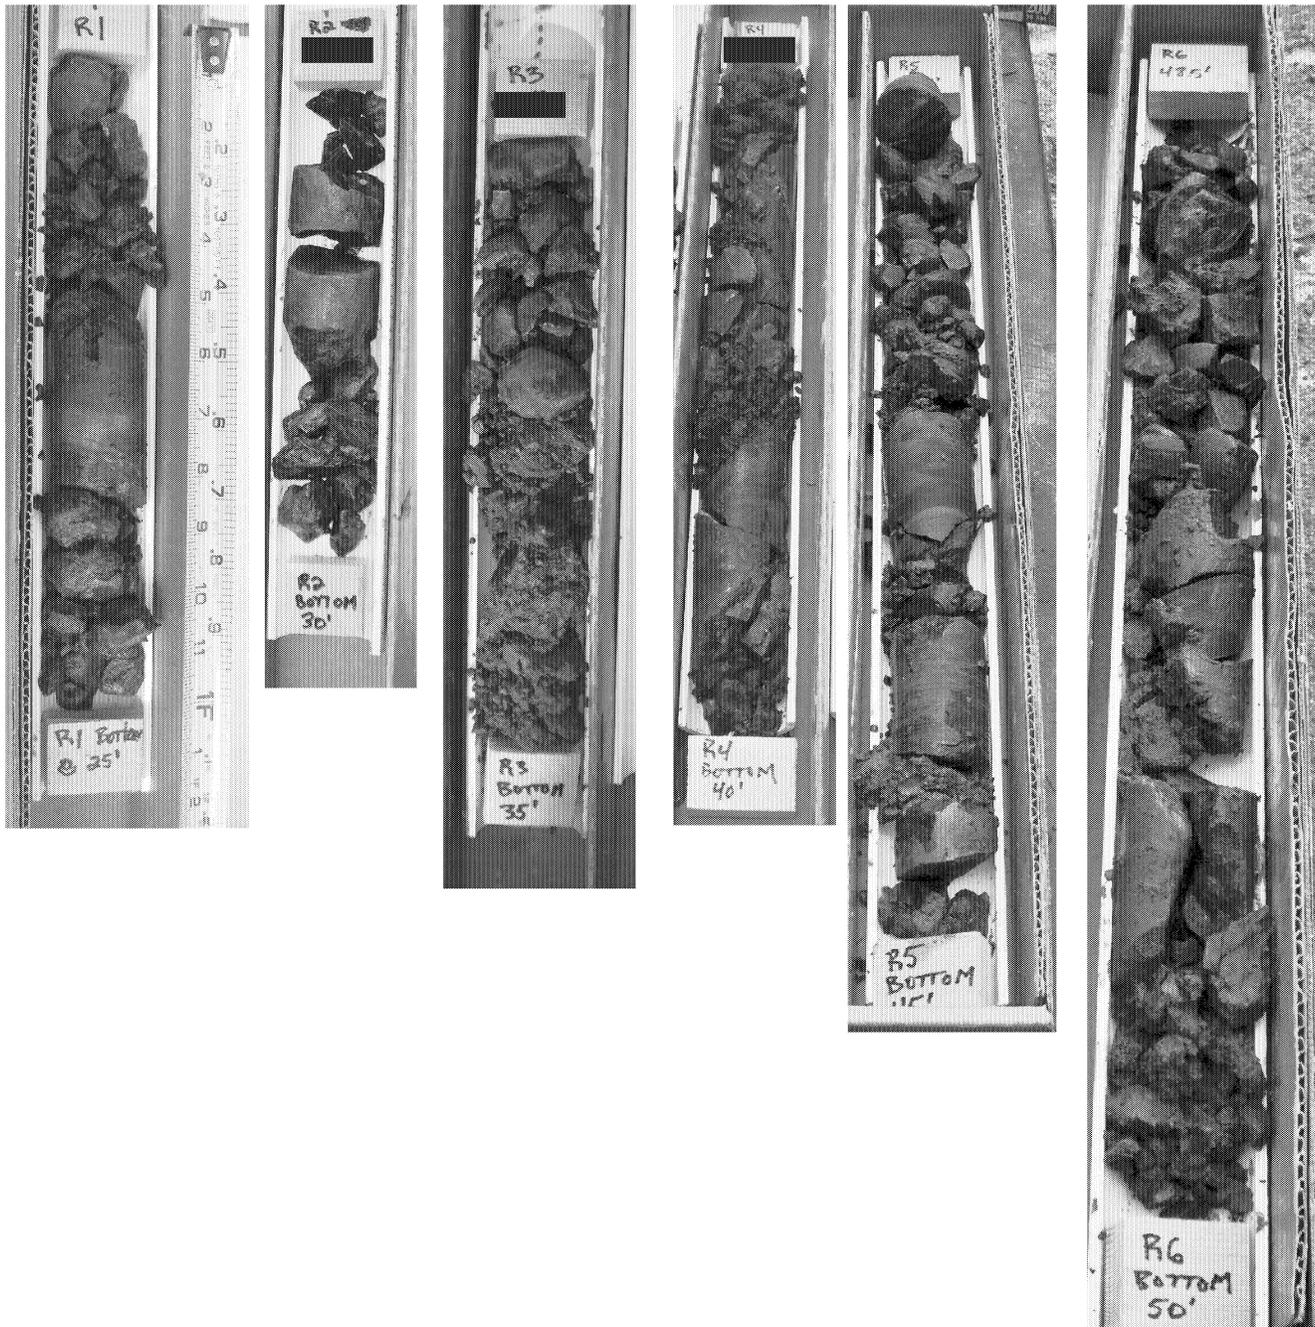
ROCK CORE PHOTOS for DH-01
Santa Rosa Creek Road Slipout
San Luis Obispo County, California

adjacent to Rocky Creek. The dark grey rock was generally very intensely to intensely fractured or sheared, moderately weathered, moderately hard claystone.

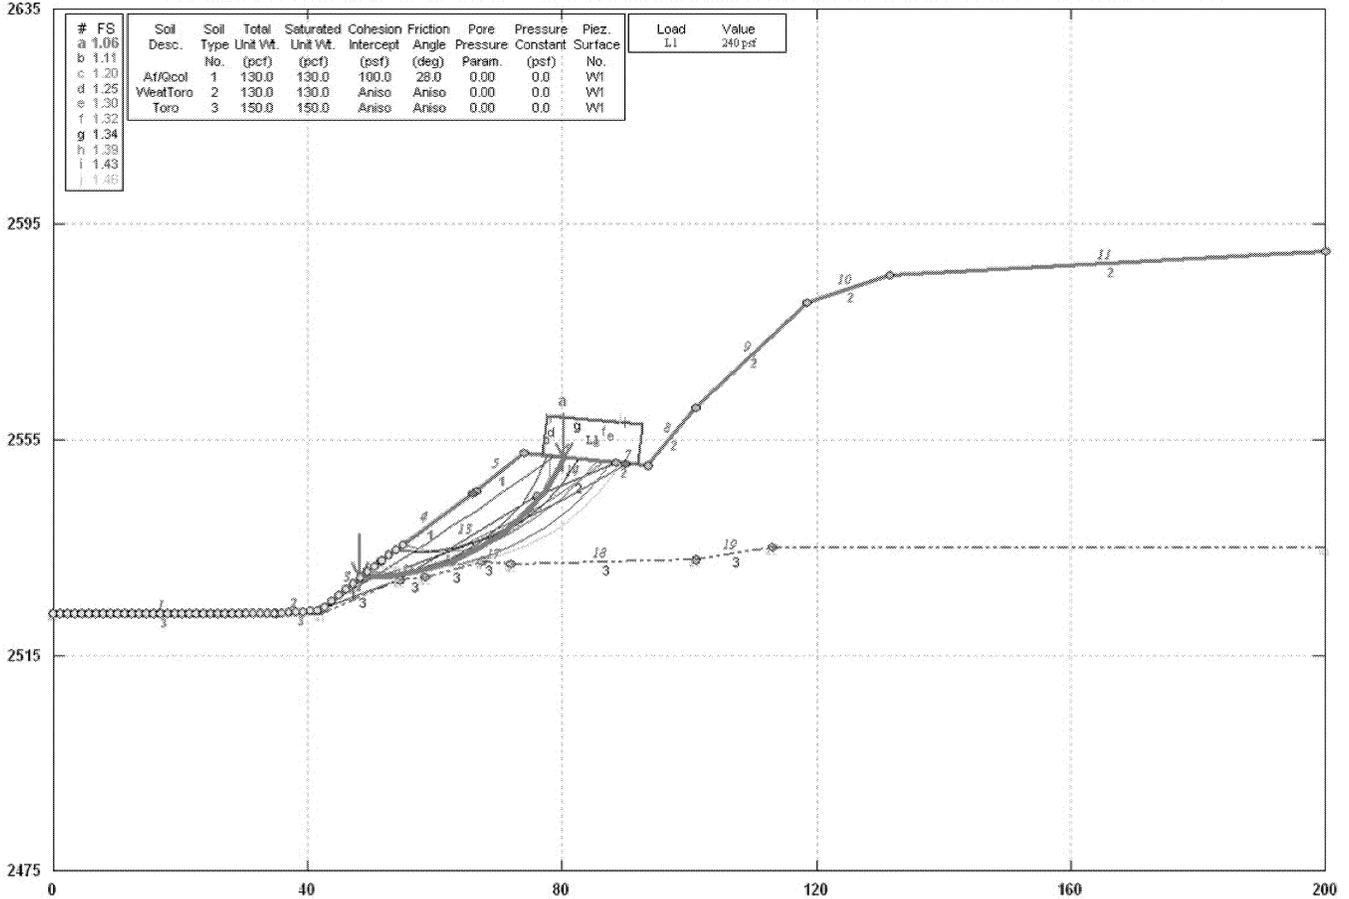
Santa Rosa Creek Road Existing Slope

The observed instability of the existing slope appears to be influenced by erosion of the toe of the slope along Rocky Creek, the presence of adversely oriented joint sets within the Toro

Formation that weaken the rock mass relative to slope stability, and potential groundwater seepage or increased moisture conditions within the rock. Additionally, the upper portion of the slope appears to have been inclined to about 1.1h:1v within the overlying artificial fill and colluvium soil units. The approximately 1h:1 inclination is generally too steep and potentially unstable for a soil slope. The estimated factor of safety is approximately 0.9 for the previous slope condition considered (with the slope assumed to be inclined to about 1.1 prior to the slope failure along the section analyzed). The estimated factor of safety for the existing slope condition is approximately 1.06 (with the slope inclined to about 0.5h:1v to 1:1h:v along the section analyzed). The existing slope is considered potentially unstable, and the estimated failure surfaces associated with instability of the slope would likely extend into Santa Rosa Creek Road.

GSTABL7 v.2 FSmin=1.06
Safety Factors Are Calculated By GLE (Spencer's) Method (0-1)

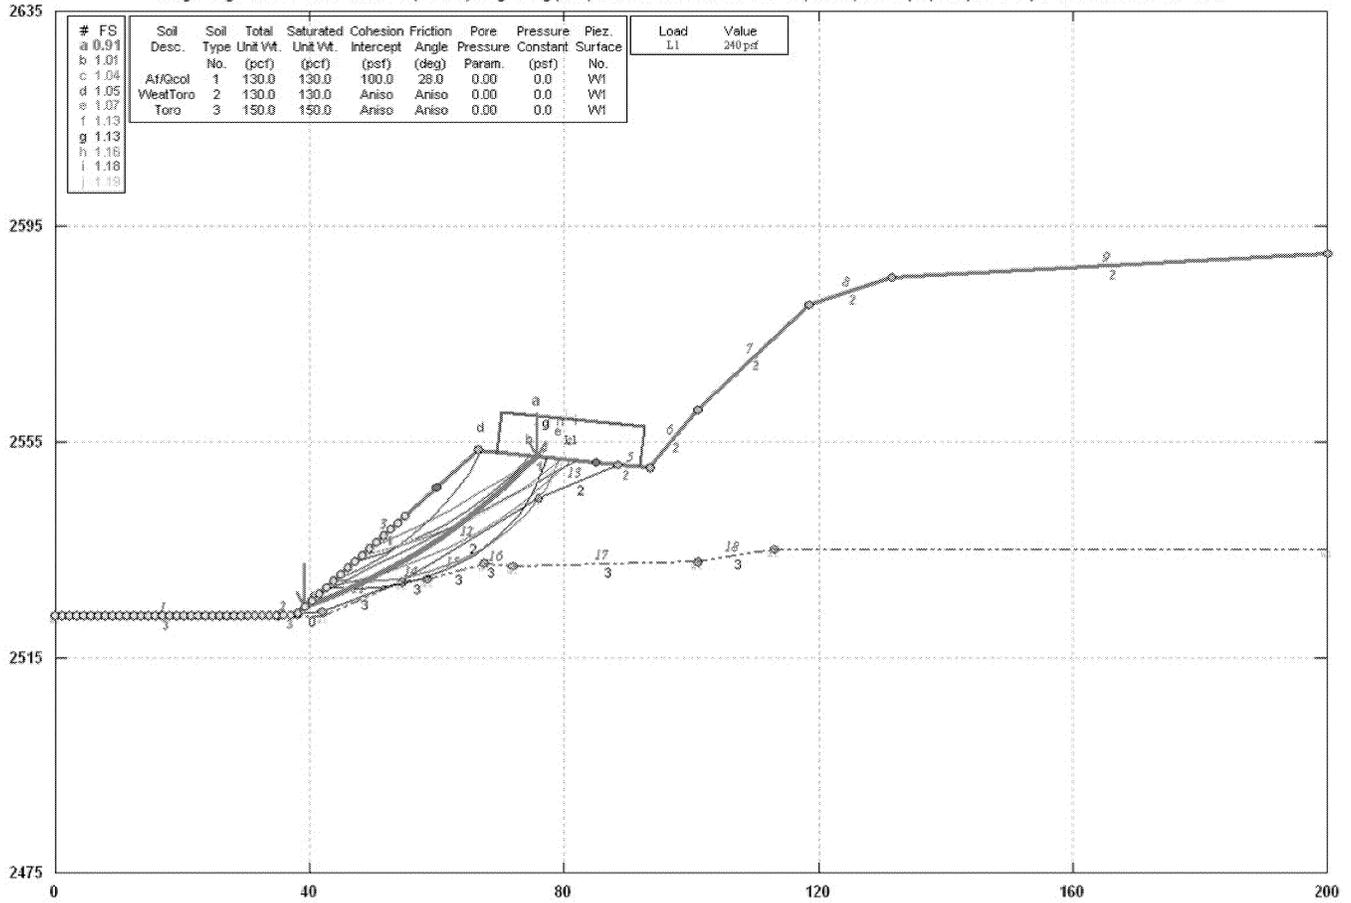
Santa Rosa Creek Road Previous Slope

GSTABL7 v.2 FSmin=0.91
Safety Factors Are Calculated By GLE (Spencer's) Method (0-1)

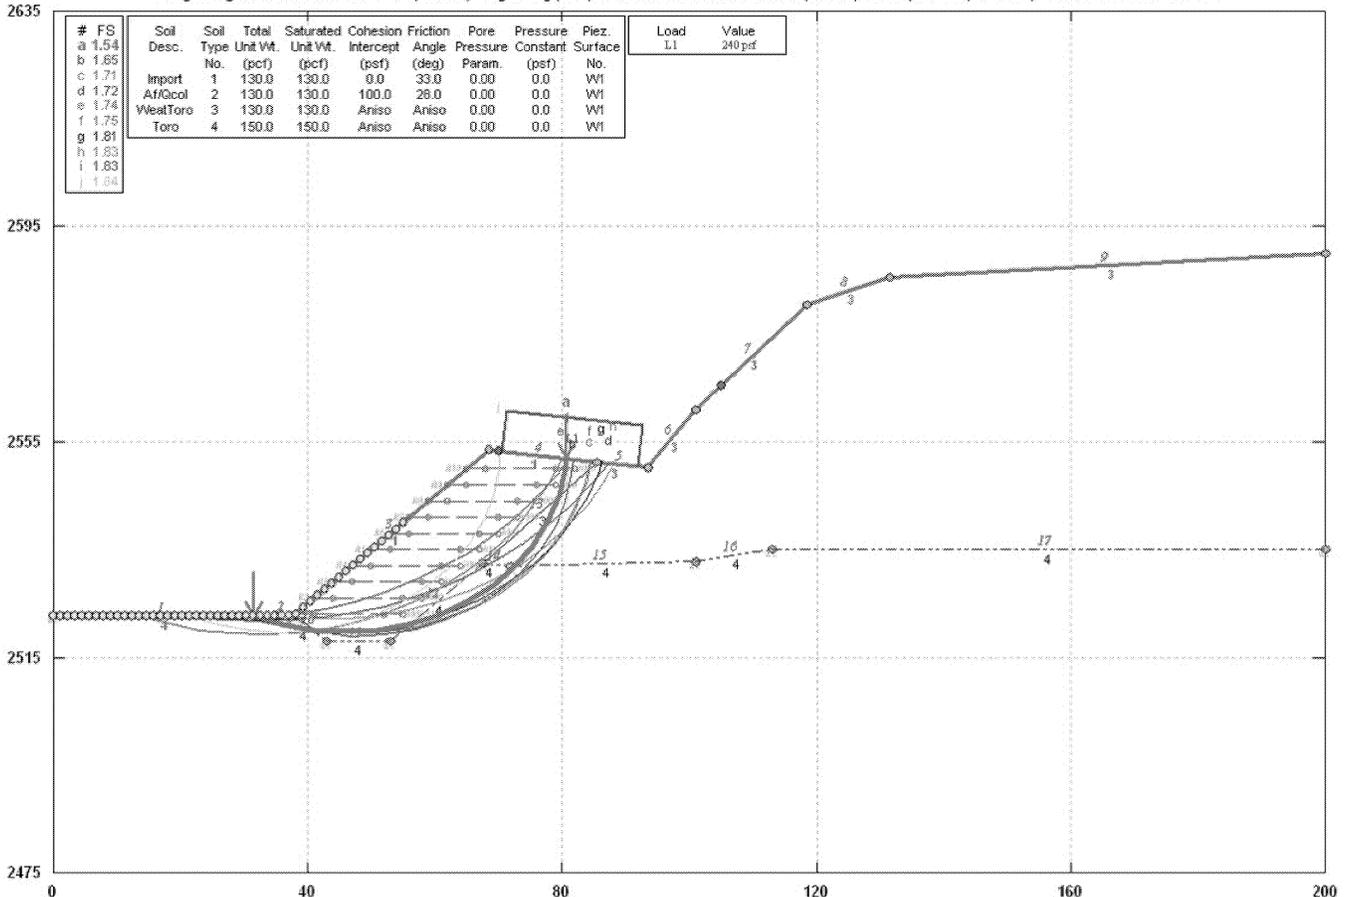
Santa Rosa Creek Road Geogrid Reinforced Slope -3' spacing, 17' length

GSTABL7 v.2 FSmin=1.54
Safety Factors Are Calculated By GLE (Spencer's) Method (0-1)

The slope can be restored to a relatively stable condition using geosynthetic reinforcement as recommended in this report. The analyses were used to estimate the reinforcement needed to construct a 1h:1v geosynthetic reinforced earth slope to support the roadway. Detailed recommendations (the strength, length, spacing, backfill) for the design and placement of the reinforcement are provided in the subsequent sections of this report. The recommendations provide for the minimum estimated factors of safety used to define stable slope conditions under static and pseudostatic loads. A summary of the slope stability analyses is provided below. The results of these analyses are presented in Appendix C.
