GEOLOGIC COASTAL BLUFF EVALUATION UPDATE
THE COTTAGES AT POINT SAN LUIS
APN: 076-174-009, AVILA BEACH AREA
SAN LUIS OBISPO COUNTY, CALIFORNIA

OCTOBER 6, 2016 (Rev. 1)

PROJECT NO. SL03926-7

GEO Solutions

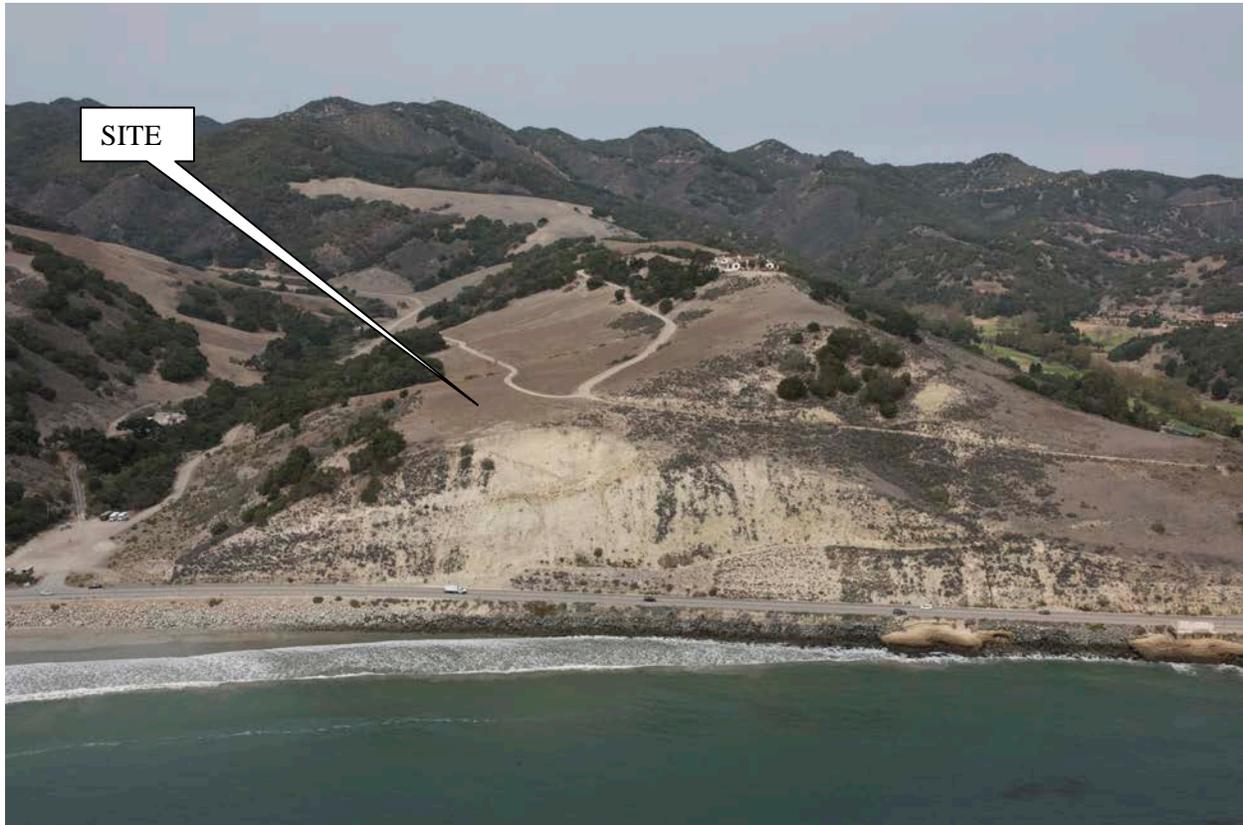
Figure 2: Photograph of the Site – 2015 (Adelman, 2002-2015)

In 2011, removal and re-grading of the bluff was performed by the County of San Luis Obispo due to slope failures from intense storms in 2010. Kane GeoTech, 2011 performed a visual assessment of the slope and resulted in the following conclusions “Approximately 1500-yds³ of material translated downslope in the two storm events as identified above and formed a debris fan at the base of the slope.” They also identified

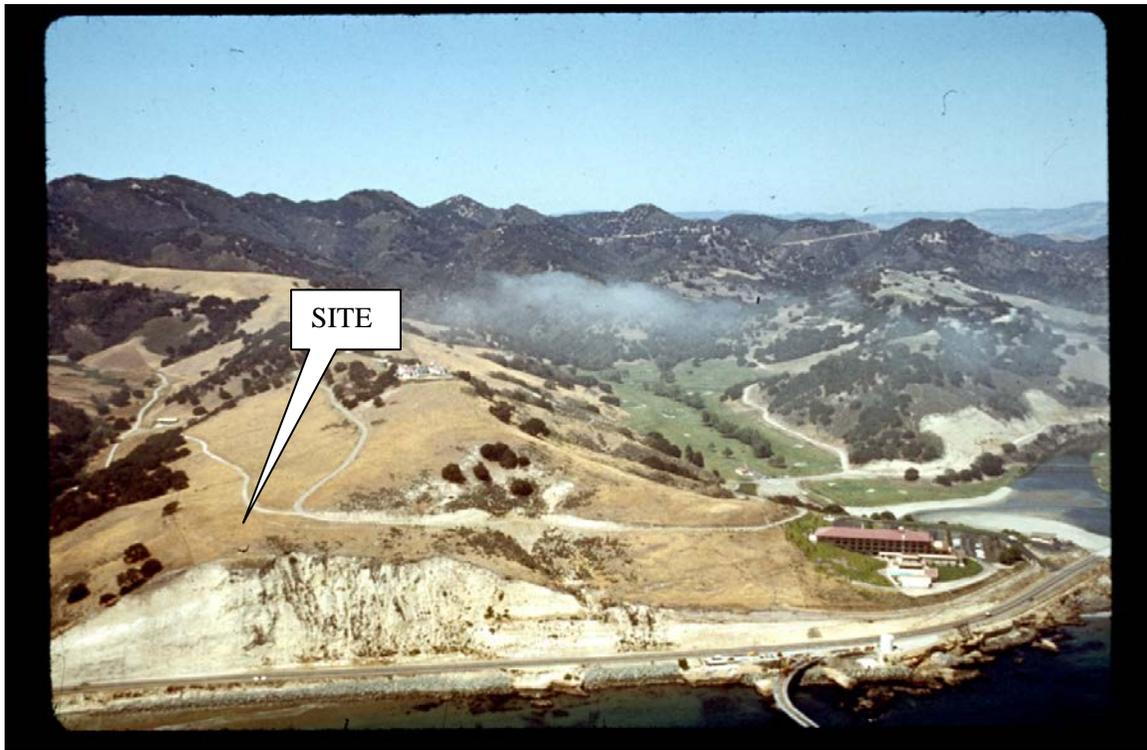
Figure 4: Photograph of the Site, 1972 (www.californiacoastline.org)

There appears to have been modifications to the existing bluff through time but the bluff appears to have been unmodified since 1970 Avila Beach Drive roadway improvements. Based on these improvements, a historical retreat rate (pre-1970) and a current retreat rate (post-1970) were determined along various locations of the bluff. Plate 3 depicts the location of the top of bluffs on

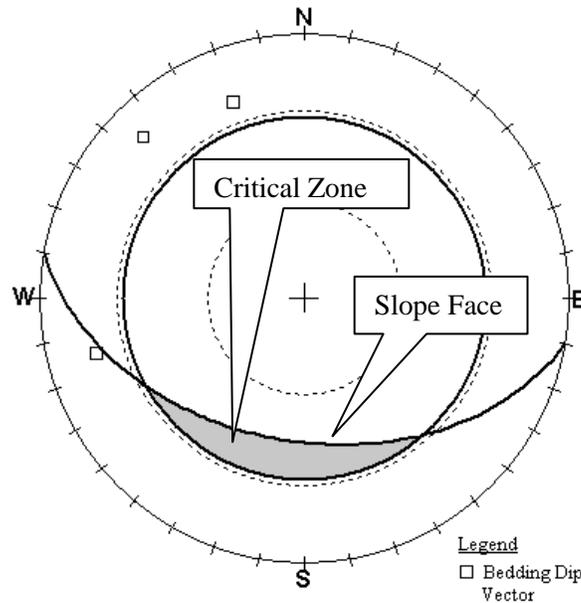
Figure 5: Kinetic Analysis

A stereographic analysis was performed for the cut slopes in the proposed enlarge reclamation plan. A representative of GeoSolutions, Inc. performed a site reconnaissance to obtain bedding orientations within the slope. It is understood that bedding data was obtained from surficial outcrop and that continuous fractures were not observed along the slope. Localized areas of highly fractured rock was observed and appeared to be friable and would result in a rotational failure. Using this surficial data, a stereographic analysis was performed to determine the potential for planar and wedge slope failures as per Norrish and Wyllie, 1996. Figure 5 represents the critical zone for slope failure to occur and the orientation of the slope face and fractures.

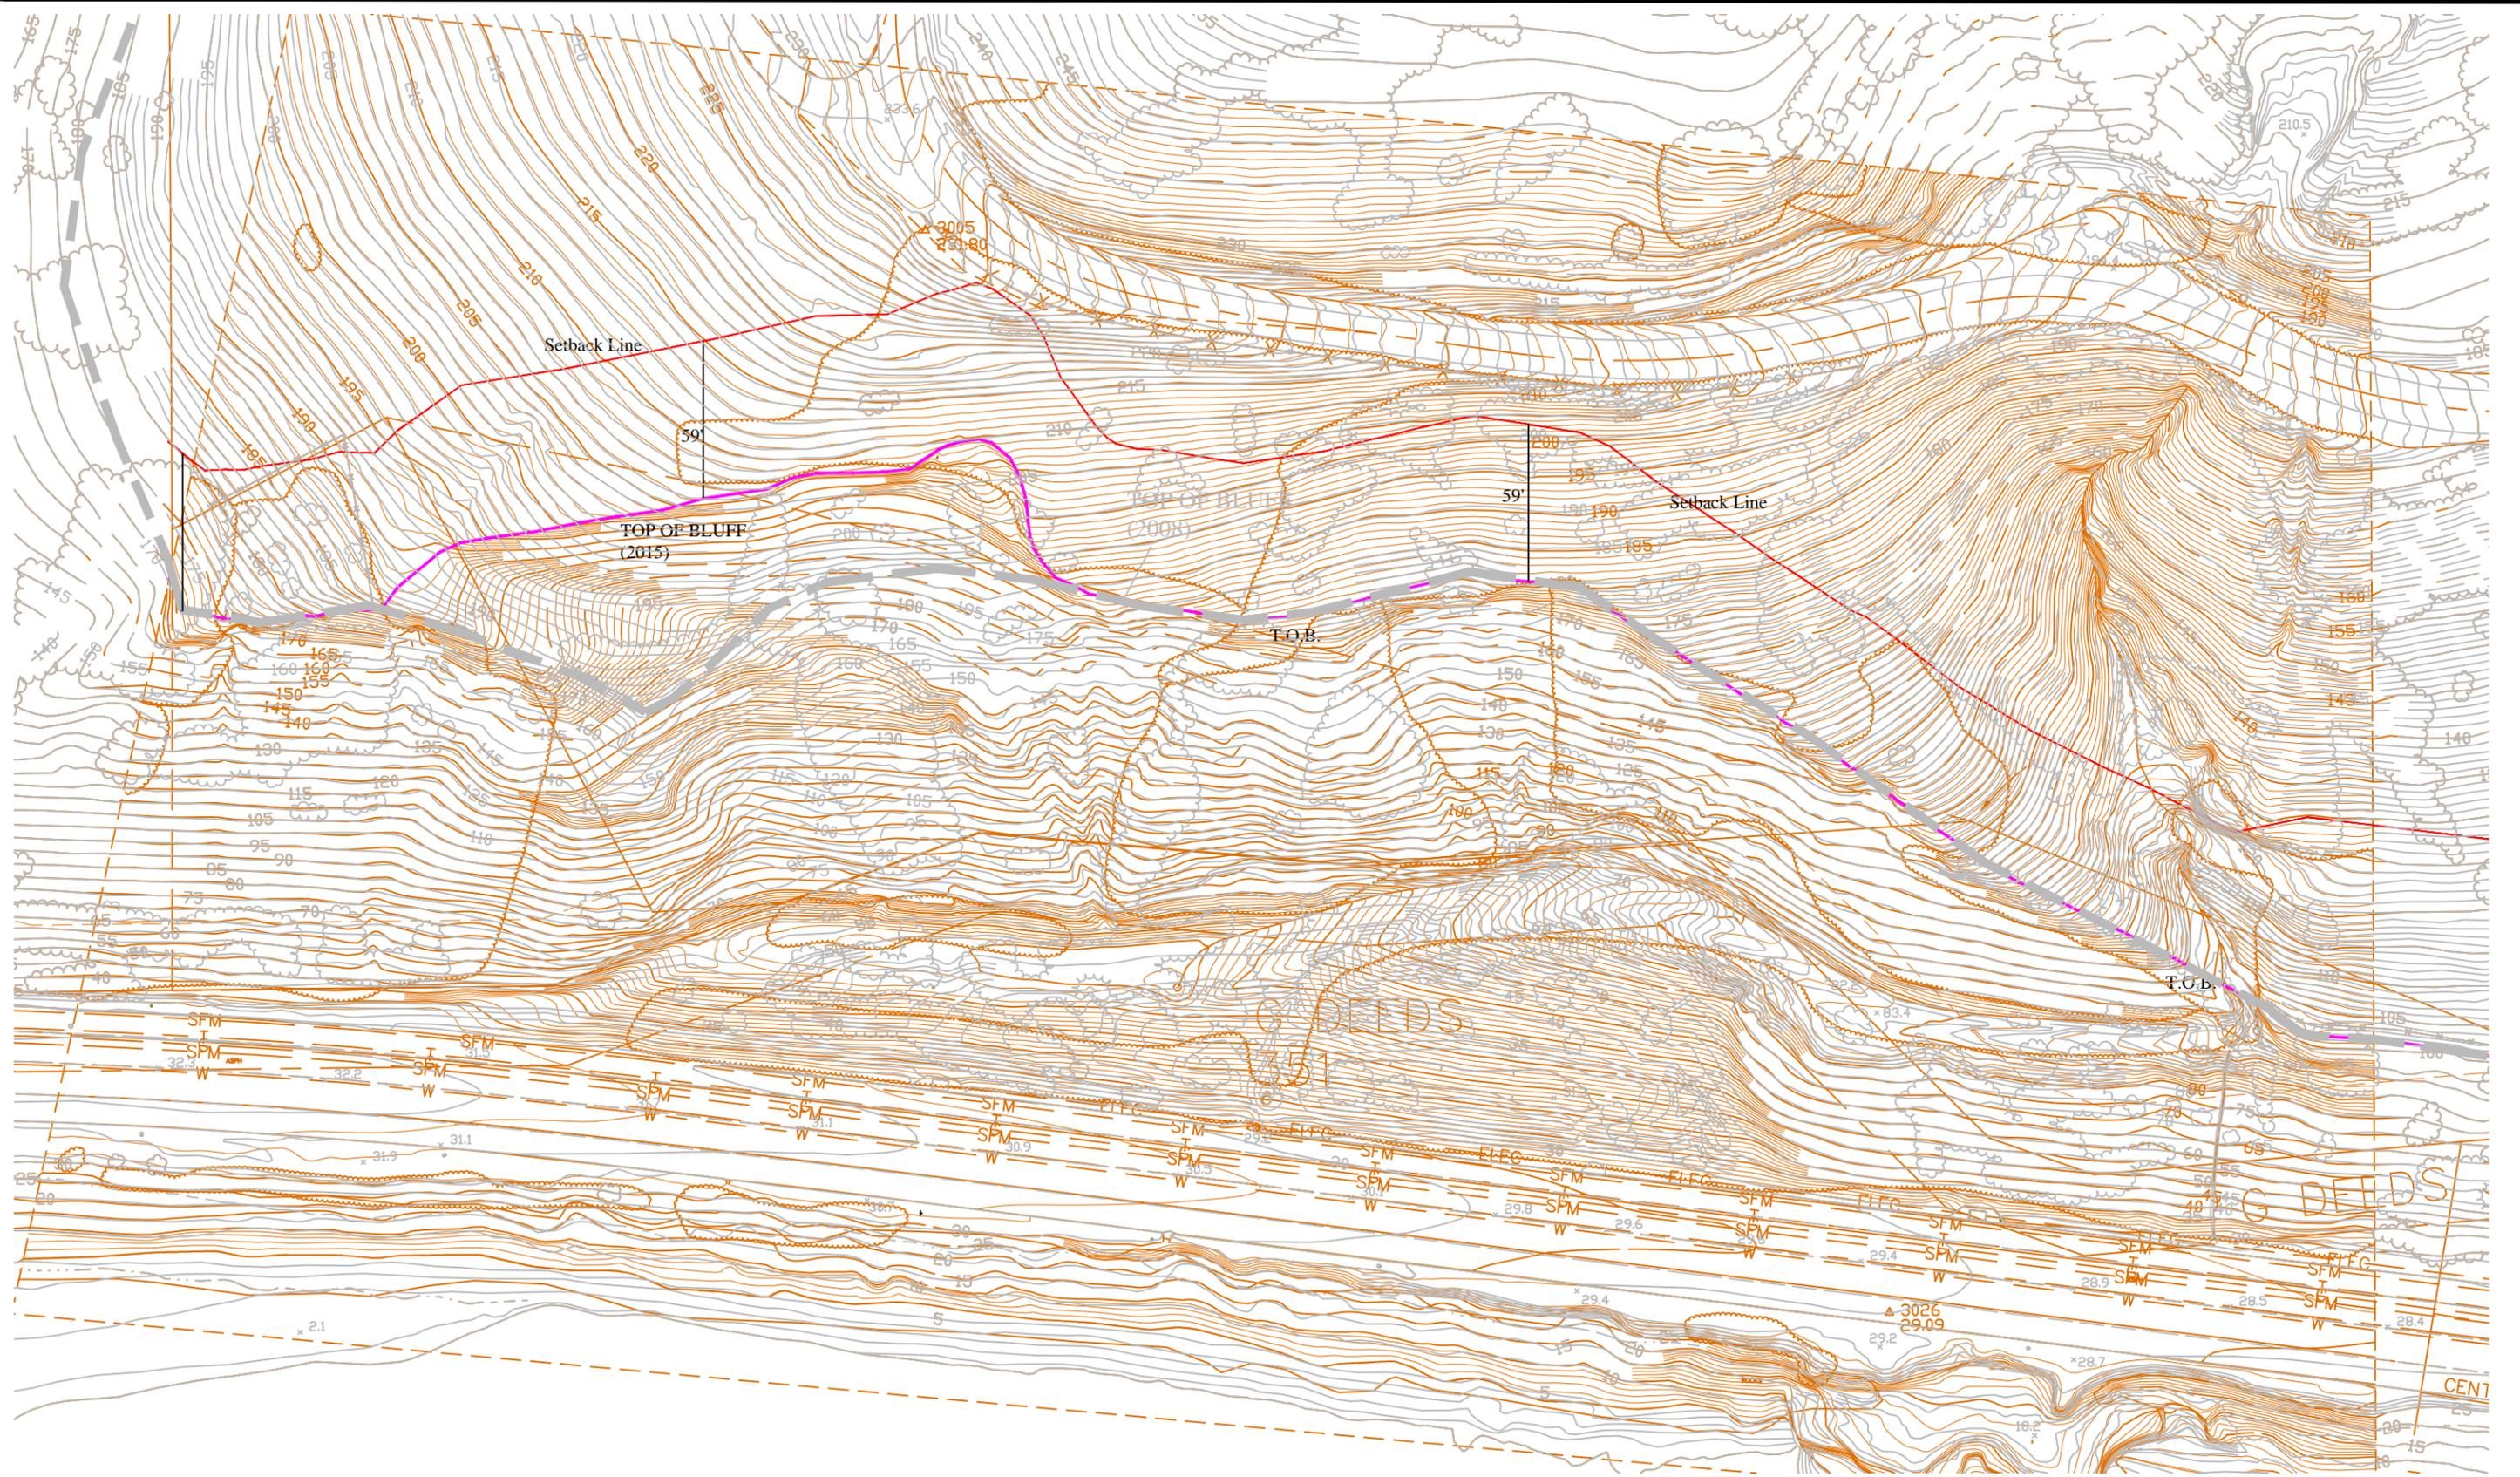
the topographic map and the bluff retreat locations. Table 5 presents the distance of retreat, time period of retreat, retreat rate and 100-year setback distance.

1. It is recommended that proposed development be setback the combined distance of the 100-year retreat rate with an additional buffer factor of 23-feet as measured from the existing bluff top. This would be a setback of 36 feet for the western portion and 59 feet for the eastern portion plus an additional 23-foot slope stability buffer for a resulting setback would be 59 and 82 feet (western portion and eastern portion respectively). Plate 1 and 3 depict the 100-year setback with the additional 23-foot slope stability buffer as measured from the top of bluff. This setback line should be established in the field as a series of stakes prior to initiation of construction and for layout of all structures.

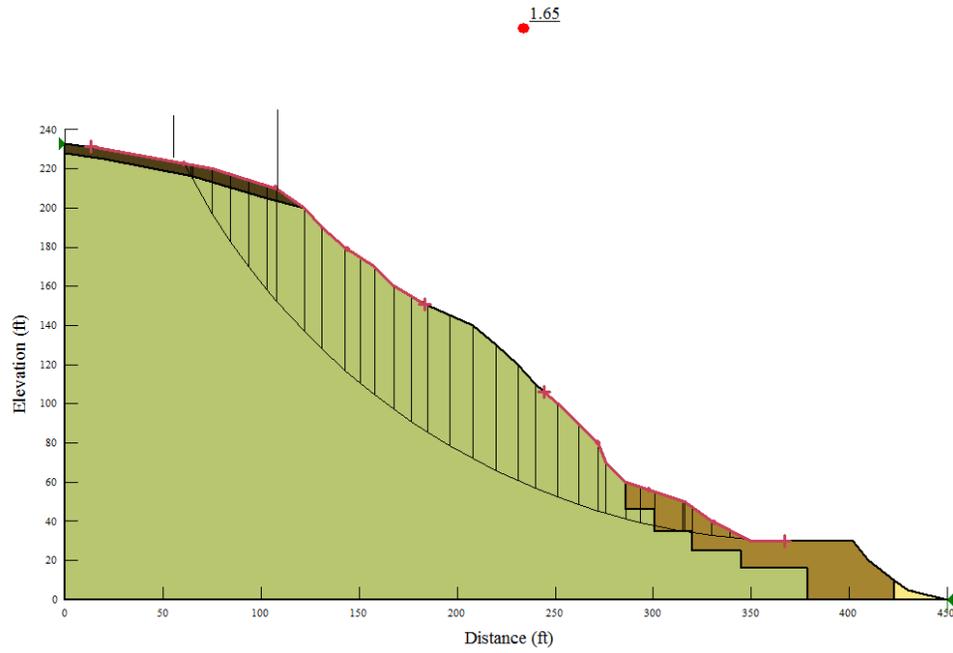
Figure C-7A: G-G' (Static Analysis)

An additional analysis was performed for this report along Section G-G' to verify the stability of the current bluff. As discussed in Section 1, a section of the bluff was graded in 2011 including the removal of material at the top of the slope and placement of fill at the base of the slope. The profile was determined from the current topographic map as presented on Plate 1. Laboratory results from Section C-2 was utilized in the analysis. The factor of safety values for Profile G (static and pseudo-static) are greater than the 1.5 and 1.1. The global stability of the bluff is observed to be stable at the current configuration, however if surface water is left uncontrolled surficial instability and erosion can occur. Figure C-7A and C-7B present the results of the slope stability analysis on Profile G.
