Waterway Management Program Hydraulic Performance Update

Public Works
Water Resources

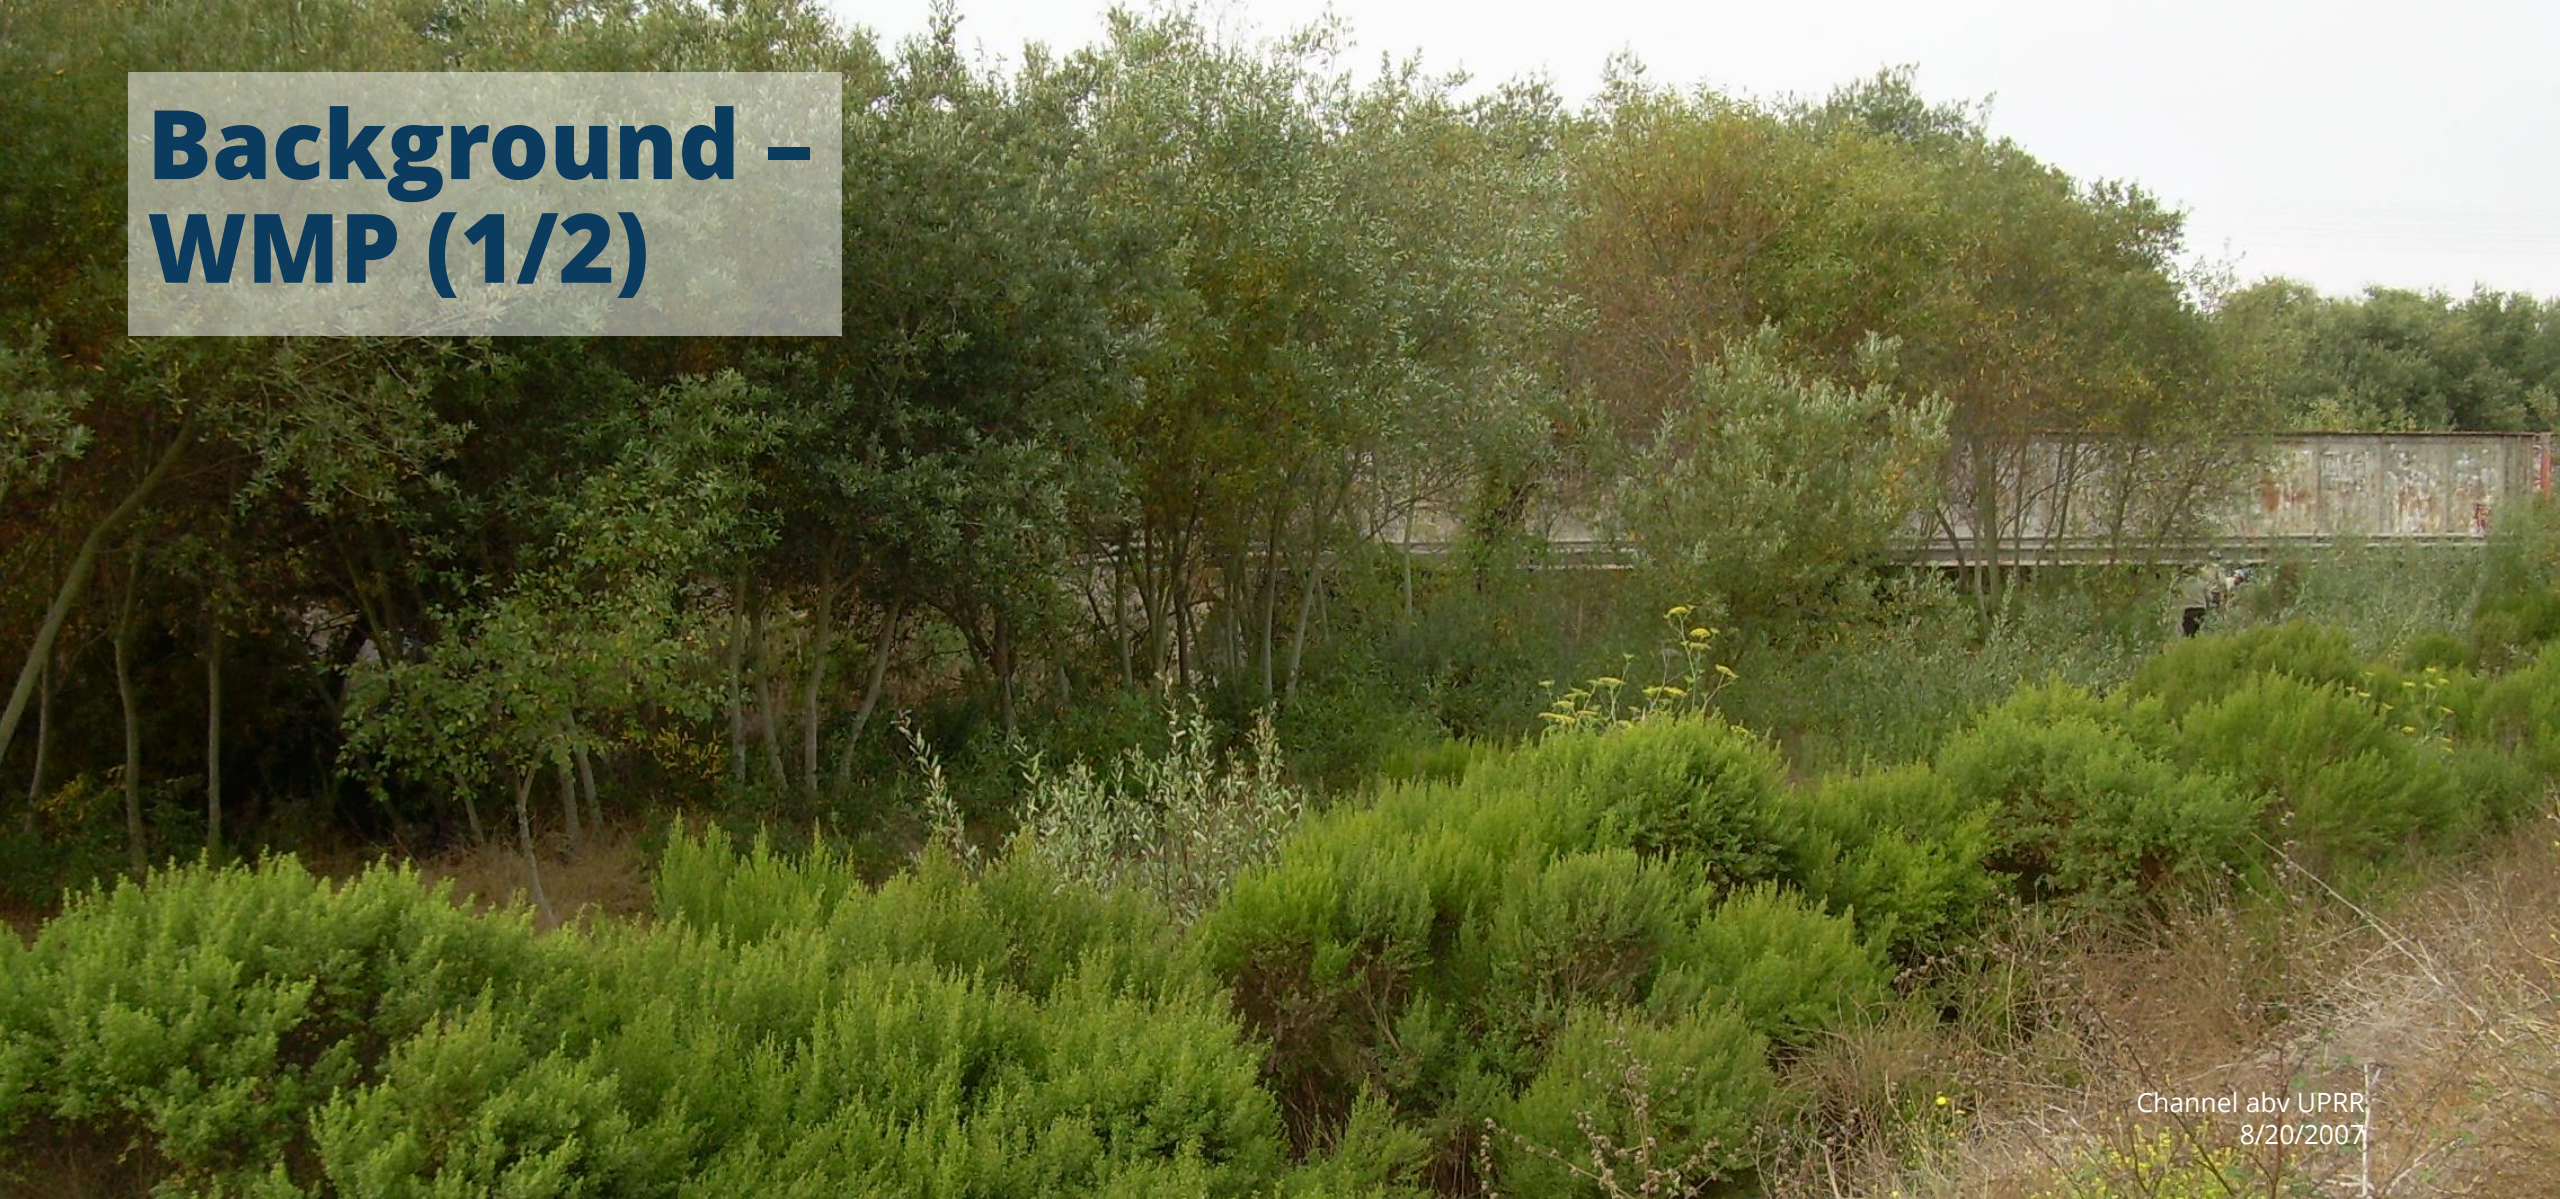
Channel abv UPRR
8/20/2007

1961 as-built (clear scraped) channel likely had 10- to 20-year flood capacity.

Sediment and vegetation accumulation reduced to 2- to 5-year capacity in 2006 (pre-WMP).

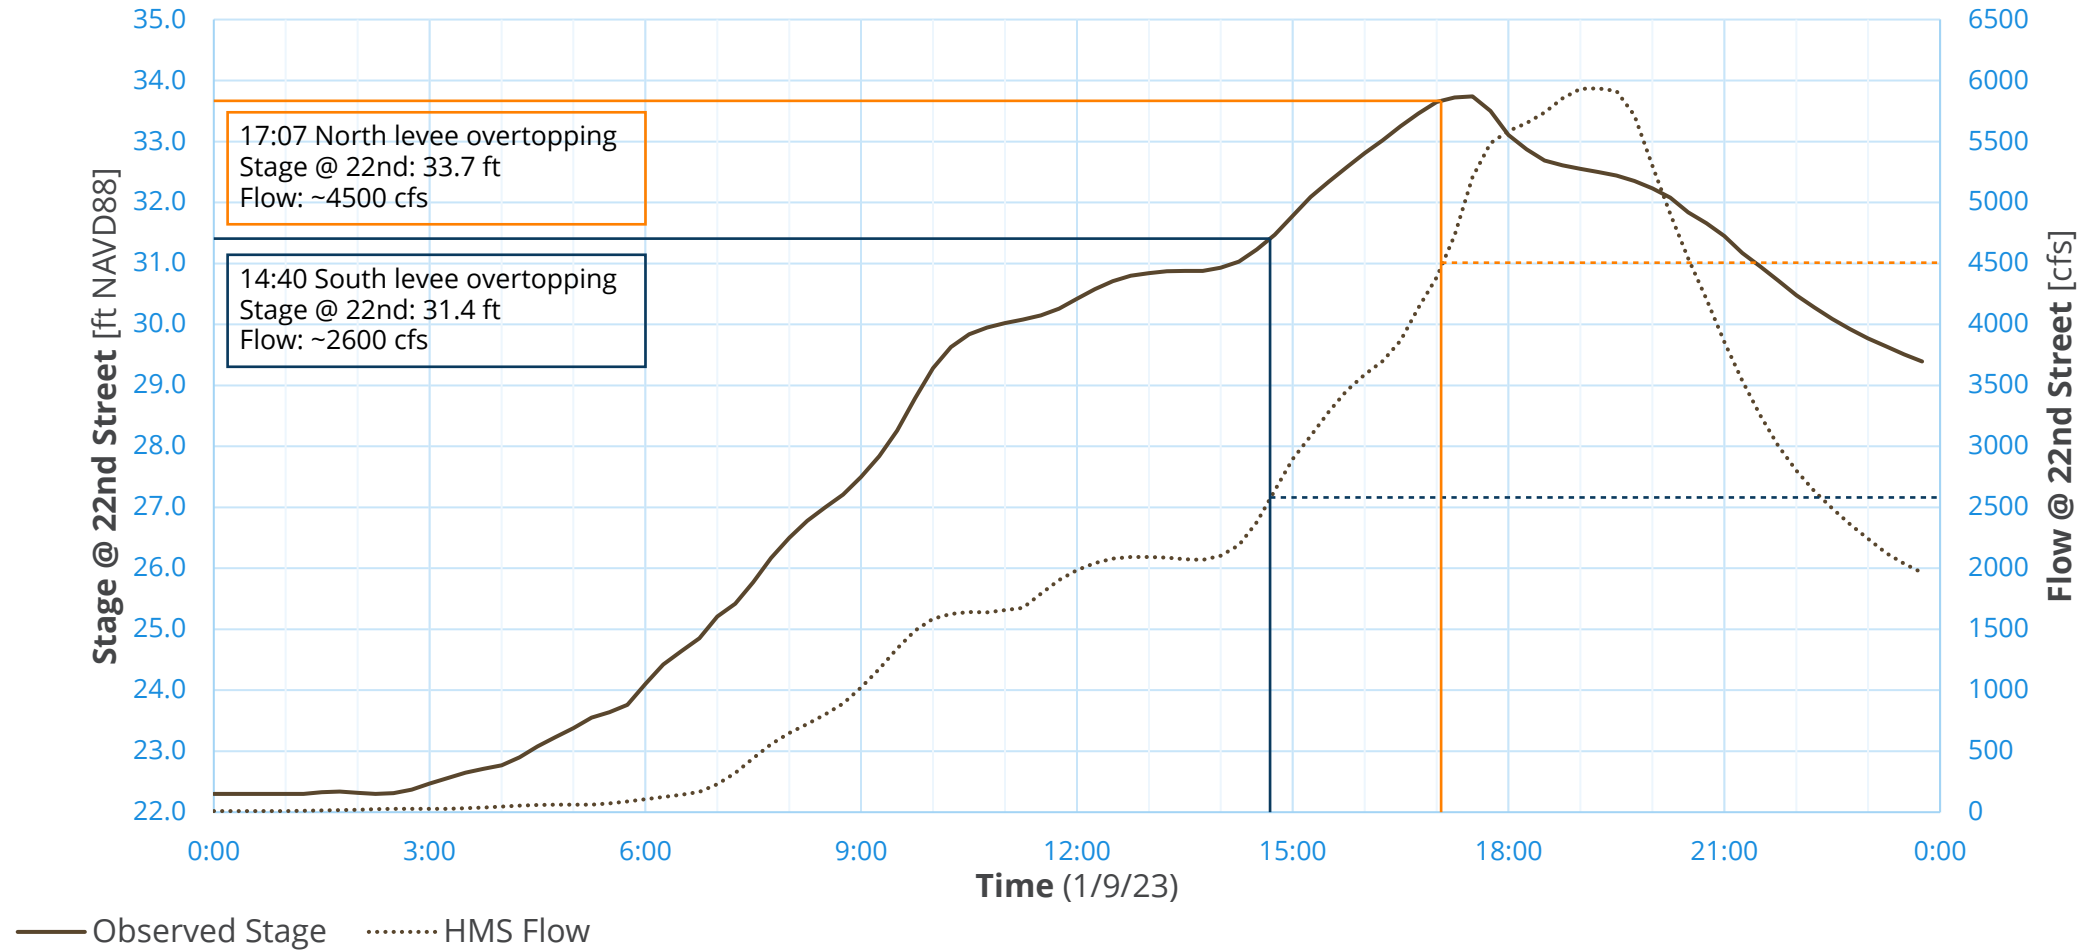
5-year recurrence flow = 2800 cfs
10-year recurrence flow = 5400 cfs
Peak >10-year, but levee failure at ~17:30 caused stage to drop prior to peak flow.

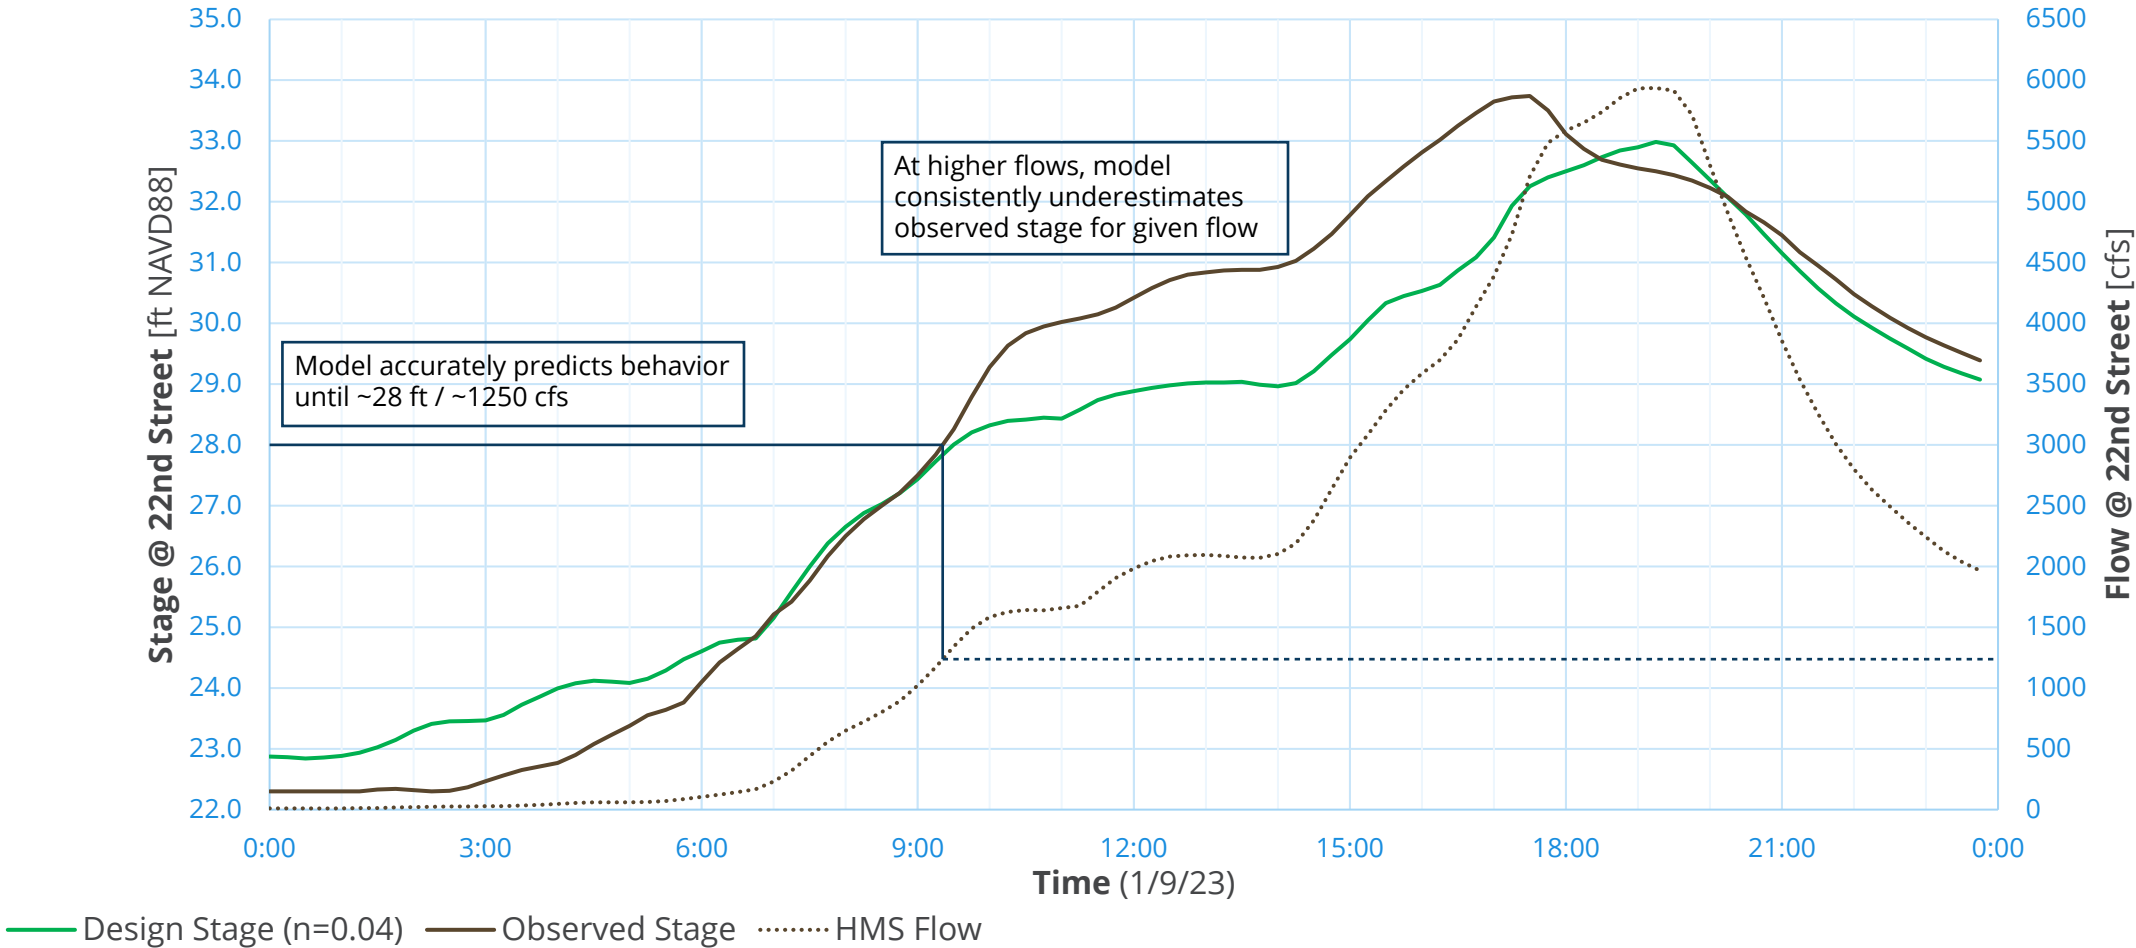
Notes:
Design Stage represents HMS hydrograph run through design hydraulic model.
Overprediction at <100s cfs expected – different hydraulics at low flows.
3/10/23 not shown but same pattern present.

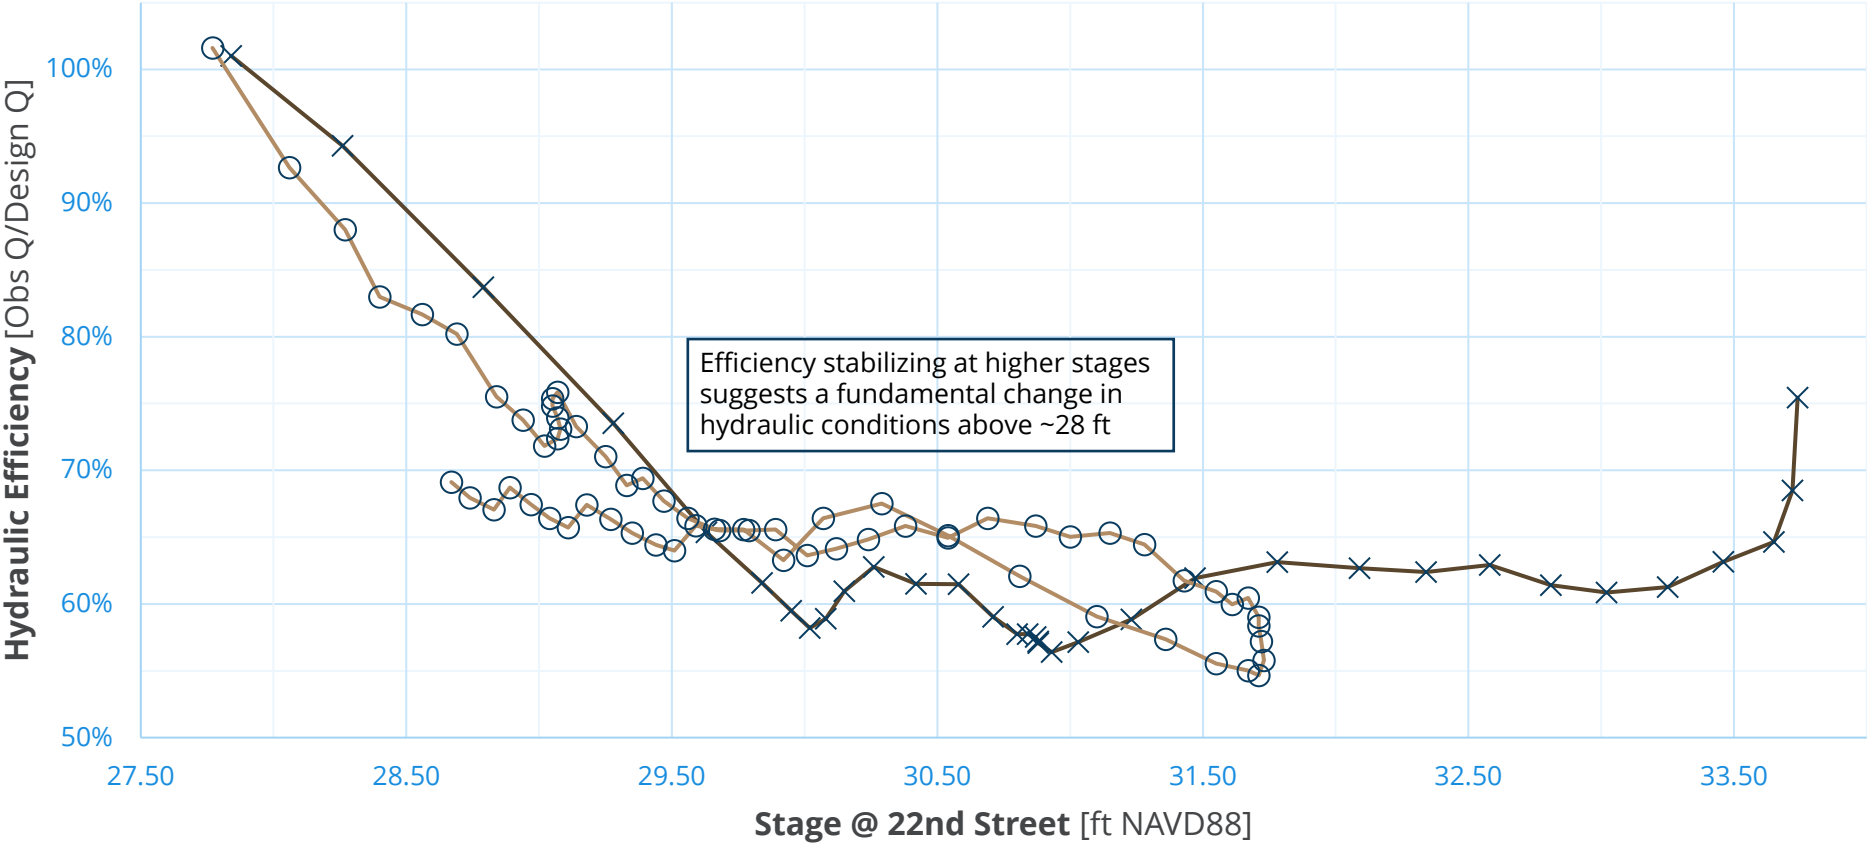
Notes:
1/9/23 values only include data points prior to levee failure.
Increase in apparent efficiency at stages >33 due to flow exiting channel.
3/10/23 values 'loop' back and differ at stages due to different hydraulics on rise and fall of hydrograph.

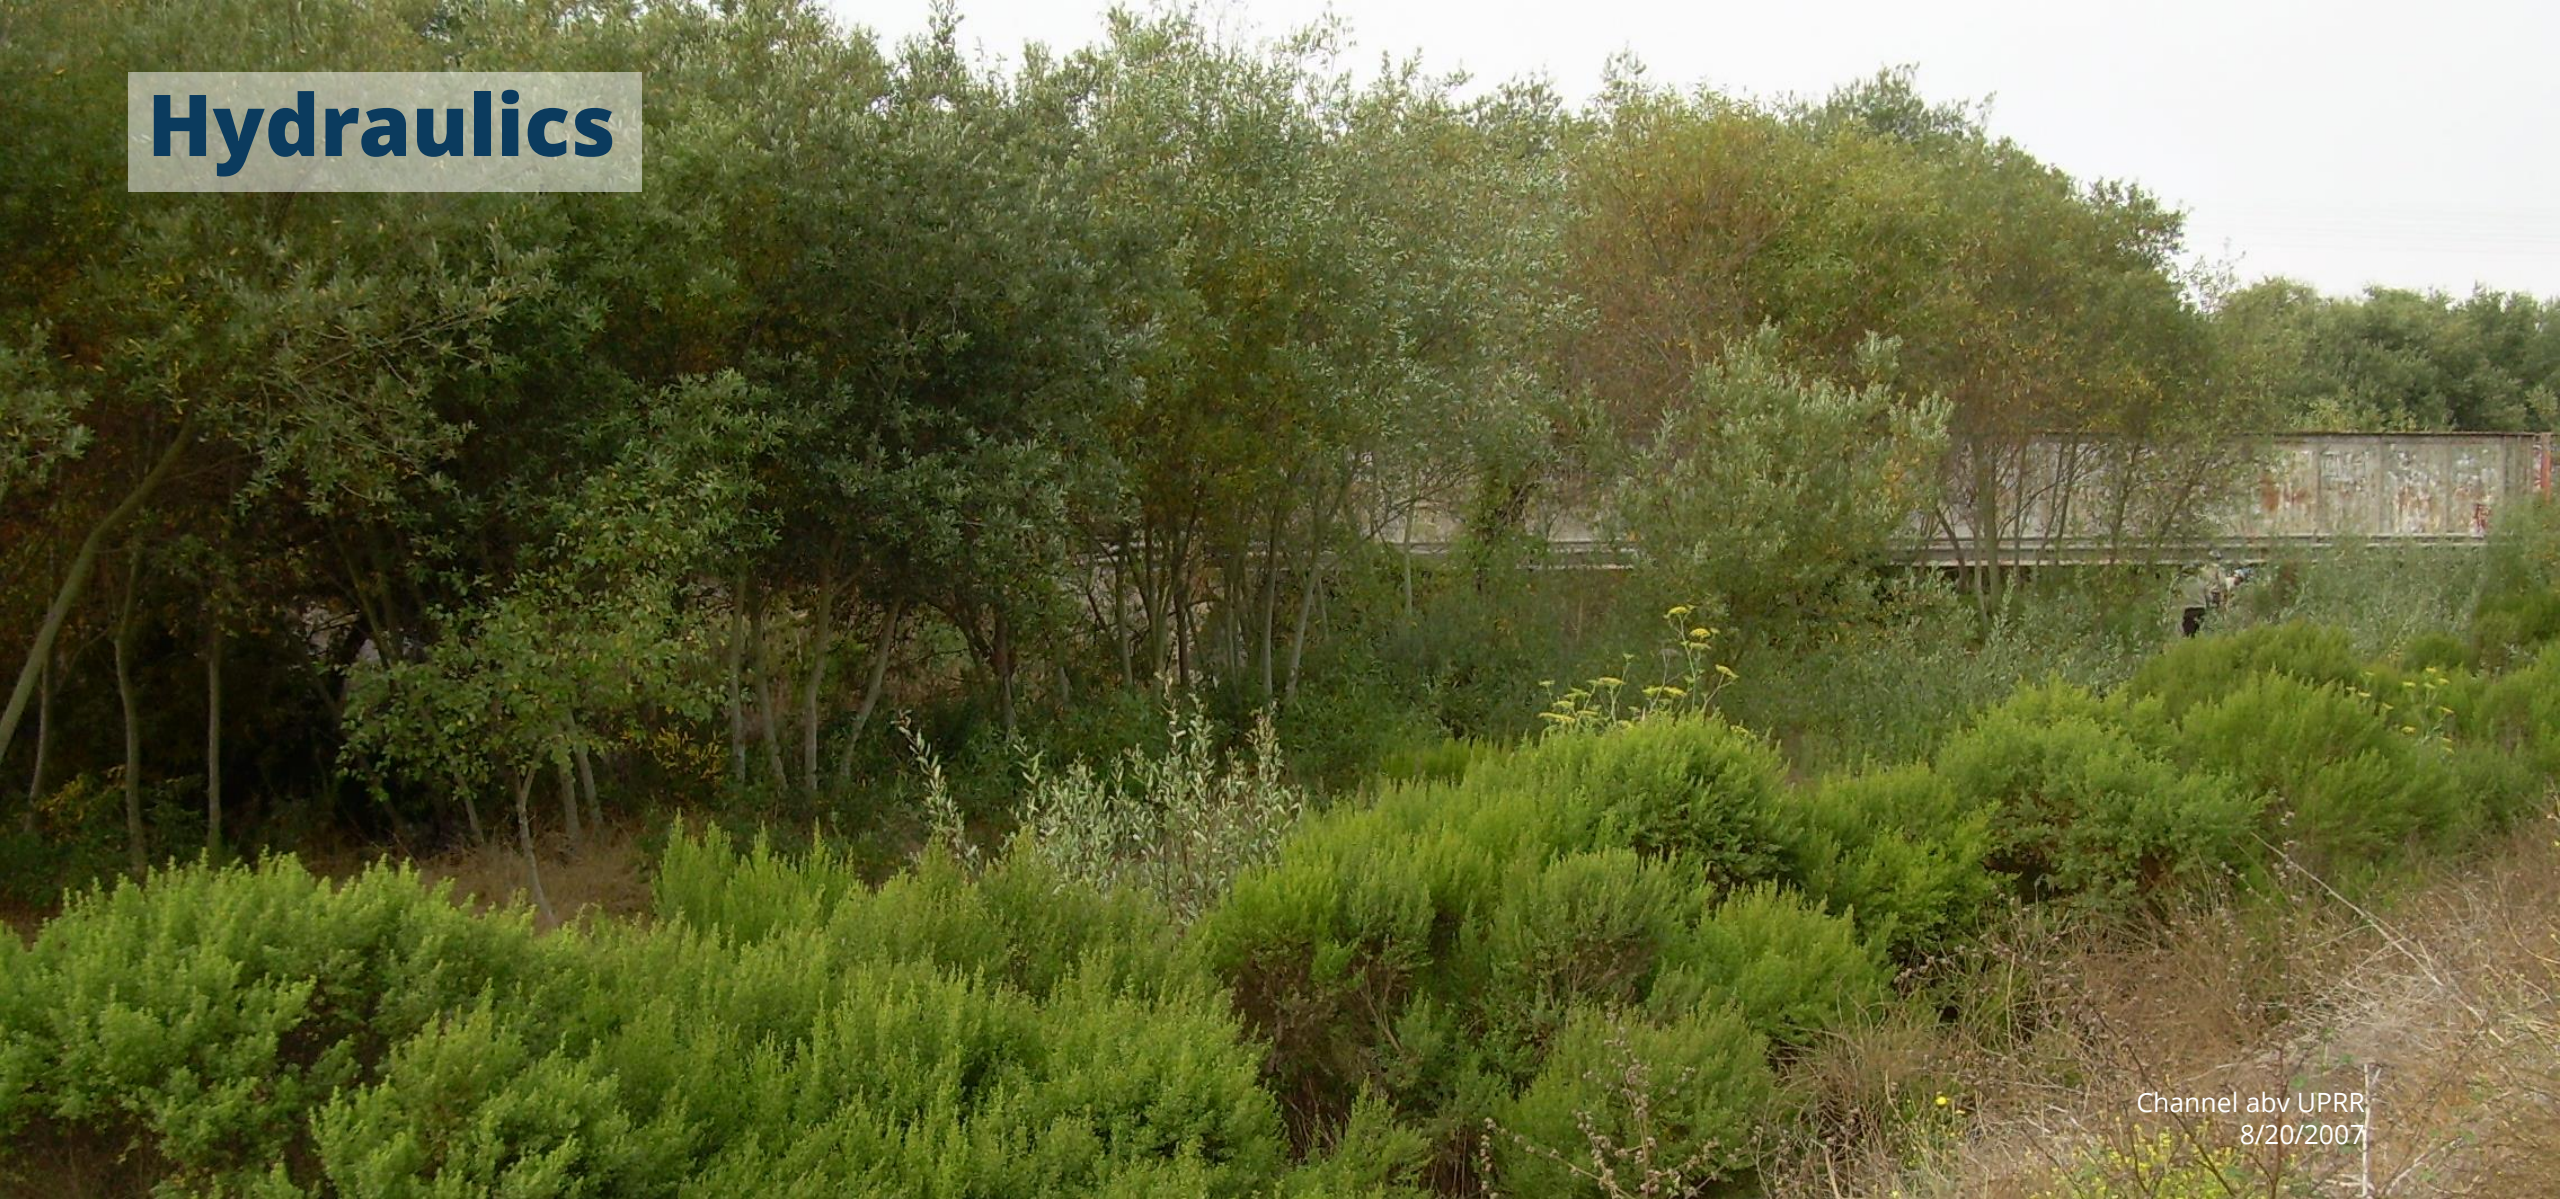
Channel abv UPRR
8/20/2007

Notes:
Compared to pre-WMP conditions, much lower roughness in lower channel elevations.
However, at high stages, tree canopy is more developed/rough.
Design engineer estimated roughness c. 2005 as $n=0.057$.
