**Project Name  
(as found on  
Certification):** Arroyo Grande Creek Channel Waterway Management  
Program

# Arroyo Grande Creek Channel Waterway Management Program

Regional Water Quality Control Board,  
Certification No. 34012WQ01 Annual Report

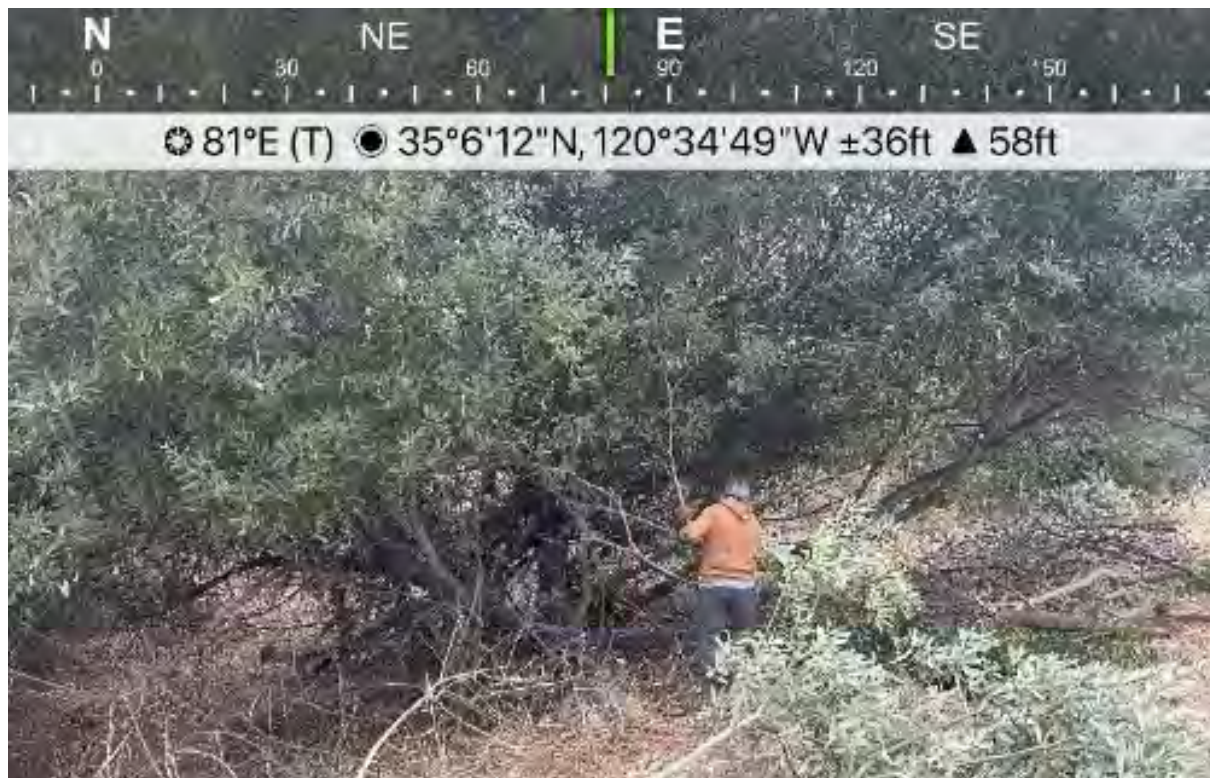
**Photograph 5.** Crew trimming woody vegetation along levee road south of Los Berros Creek, facing east. September 19, 2025.

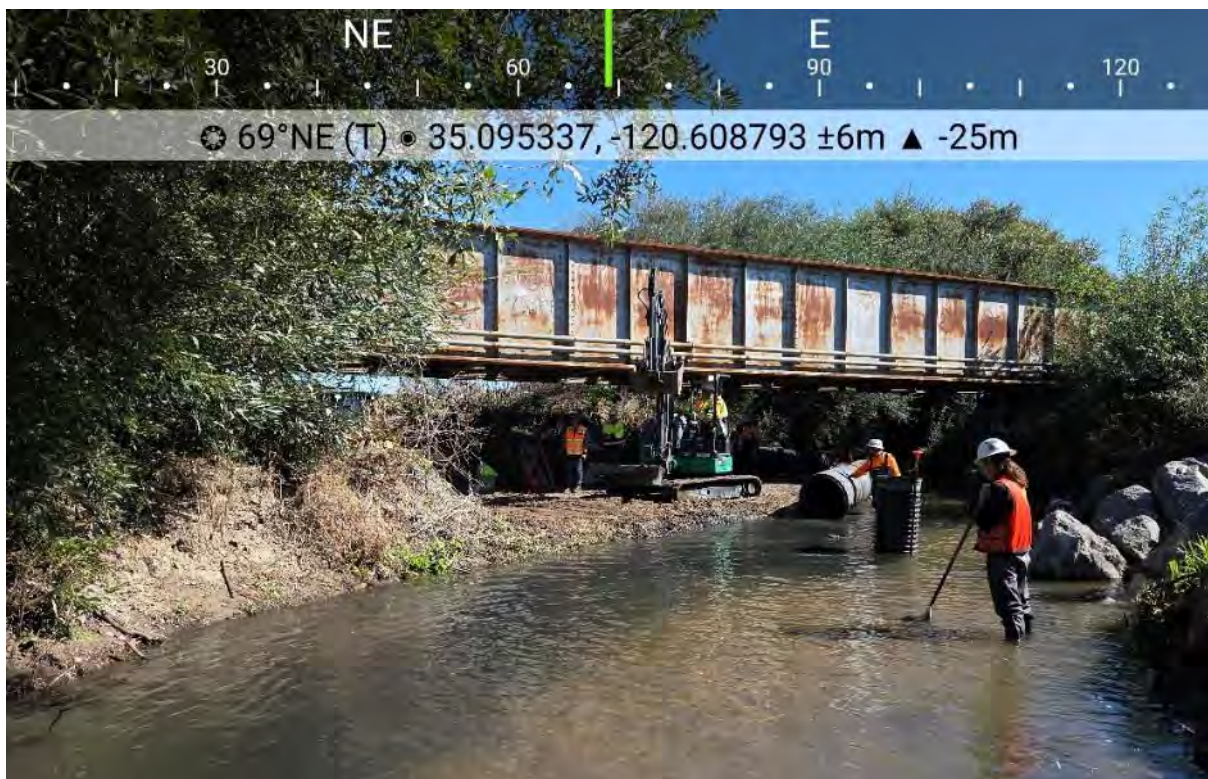
**Photograph 8.** Fish recovery and relocation during diversion of Arroyo Grande Creek at the Breach Site. October 16, 2025.

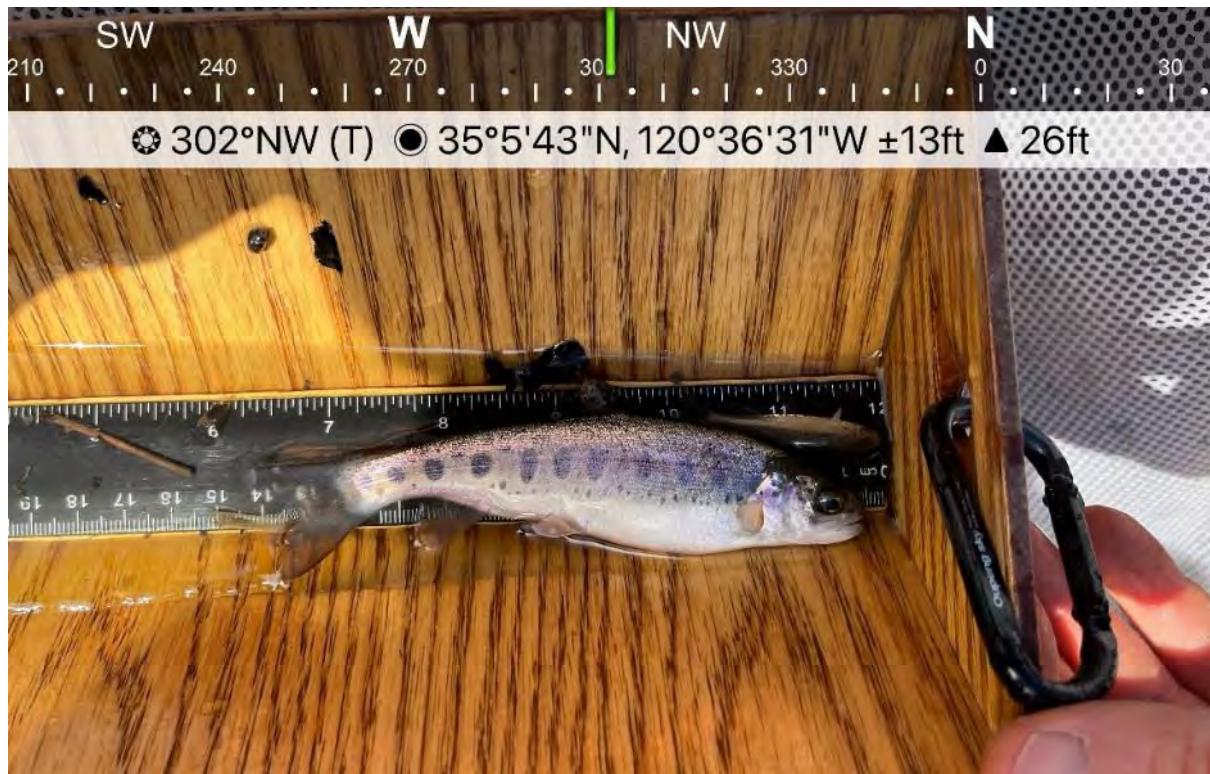
**Photograph 9.** SCCC steelhead recovered and relocated from the Breach Site. October 15, 2025.

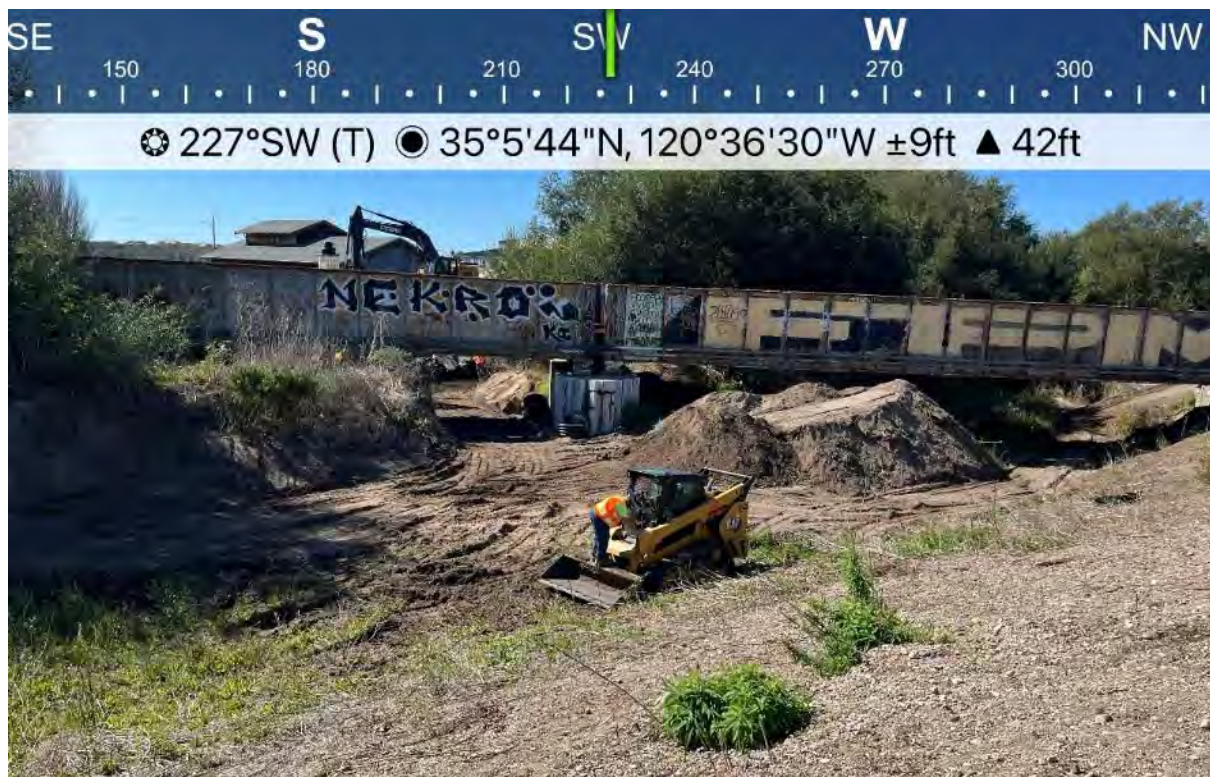
**Photograph 10.** Sediment removal at SMZ 7. October 16, 2025.

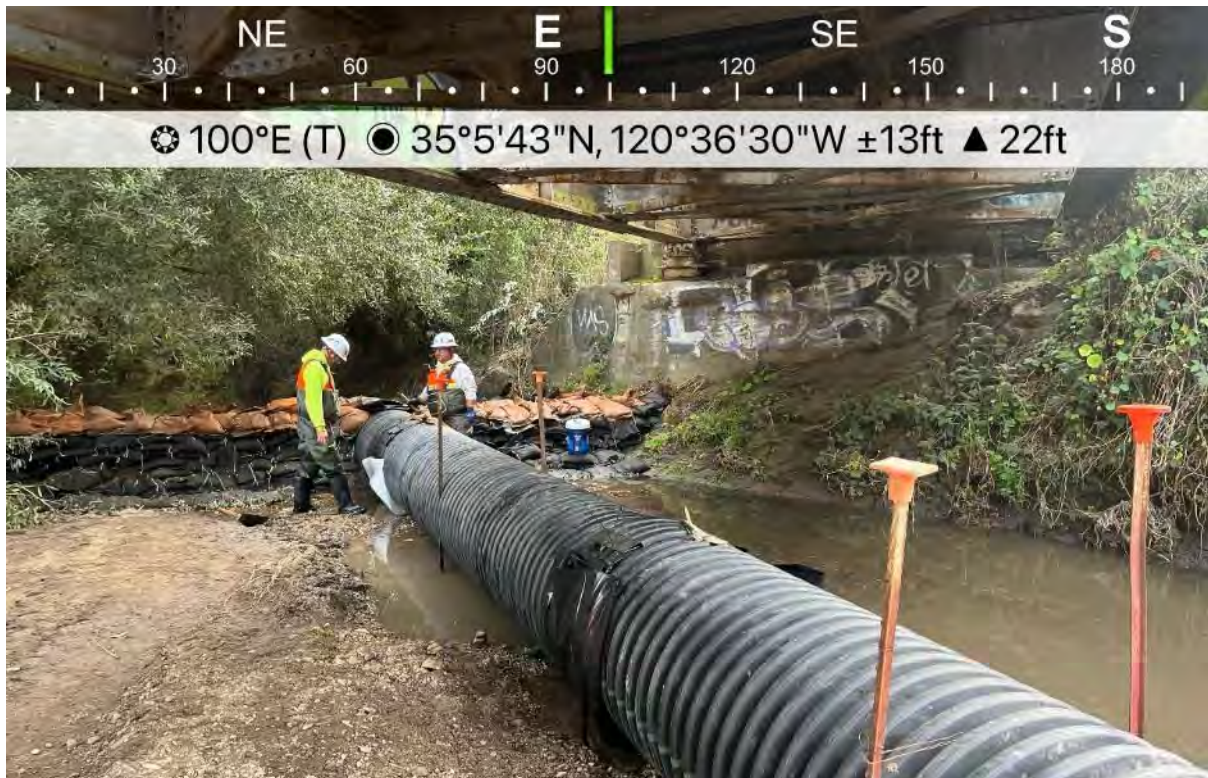
**Photograph 11.** Looking east at the upstream diversion dam and diversion pipe running under the UPRR Bridge. October 21, 2025.

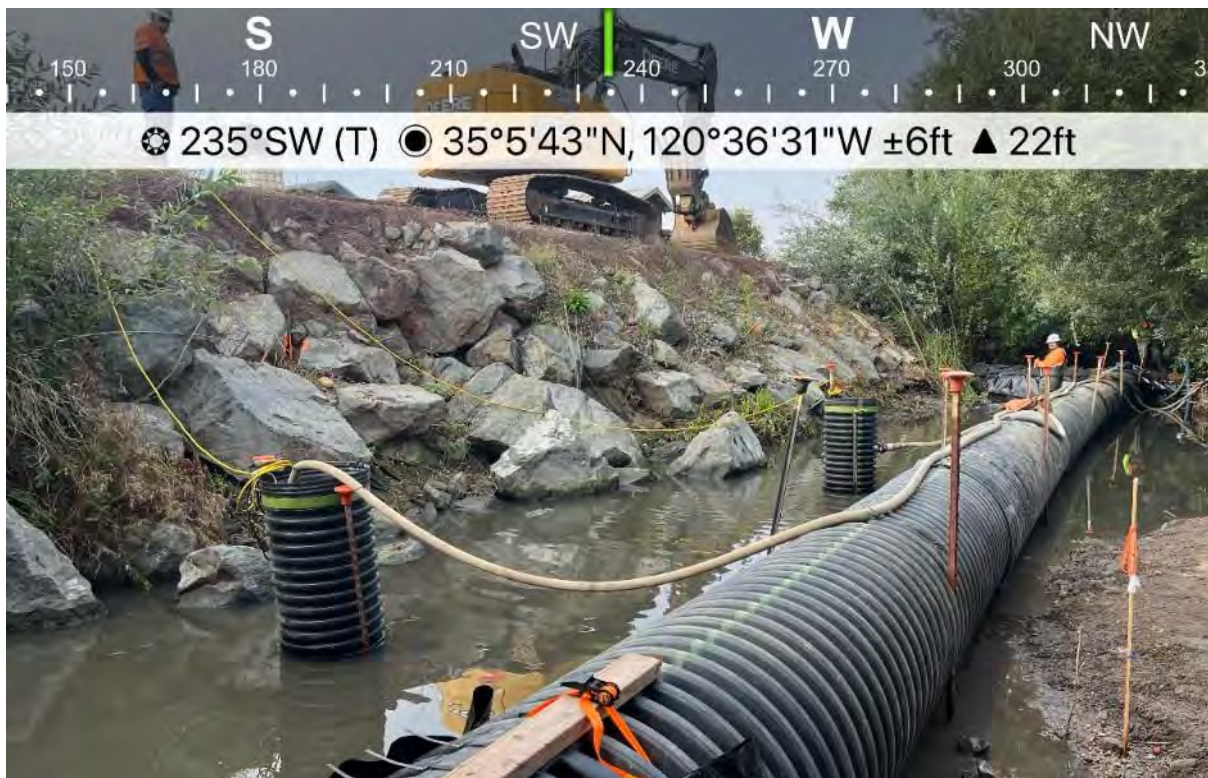
**Photograph 12.** Looking downstream (southwest) at the Breach Site with diversion pipe and dewatering wells in the foreground. October 21, 2025.

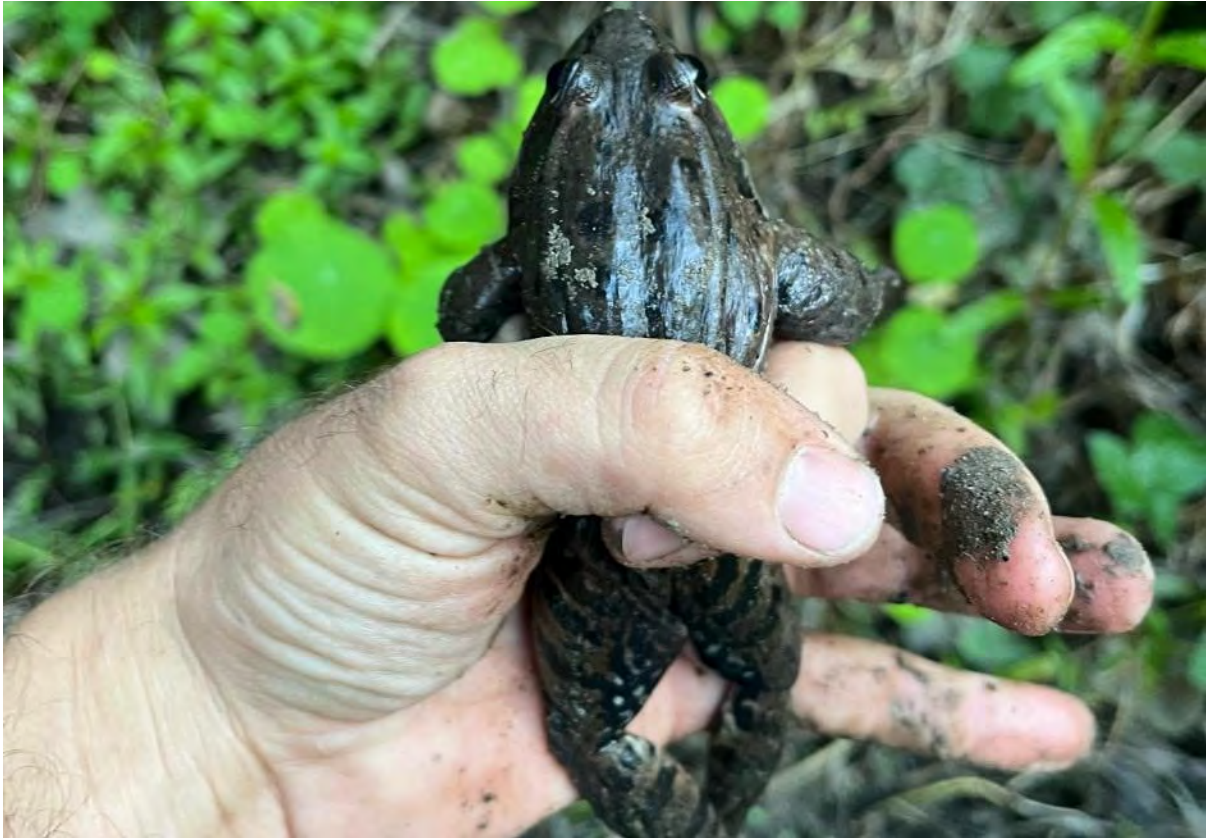
**Photograph 13.** Adult CRLF captured and relocated. October 22, 2025.

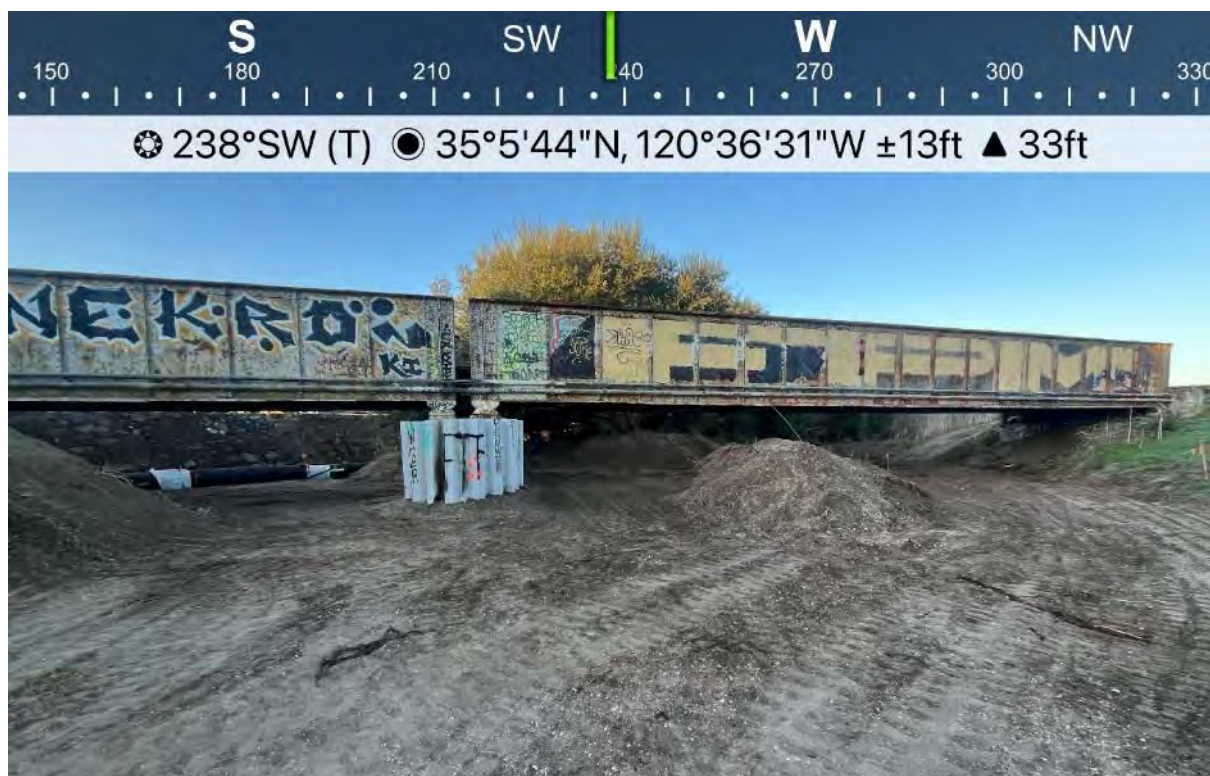
**Photograph 15.** Looking downstream (southwest) at the UPRR Bridge crossing the SMZ 7 secondary channel; Breach Site work area in background, photo left. October 27, 2025.

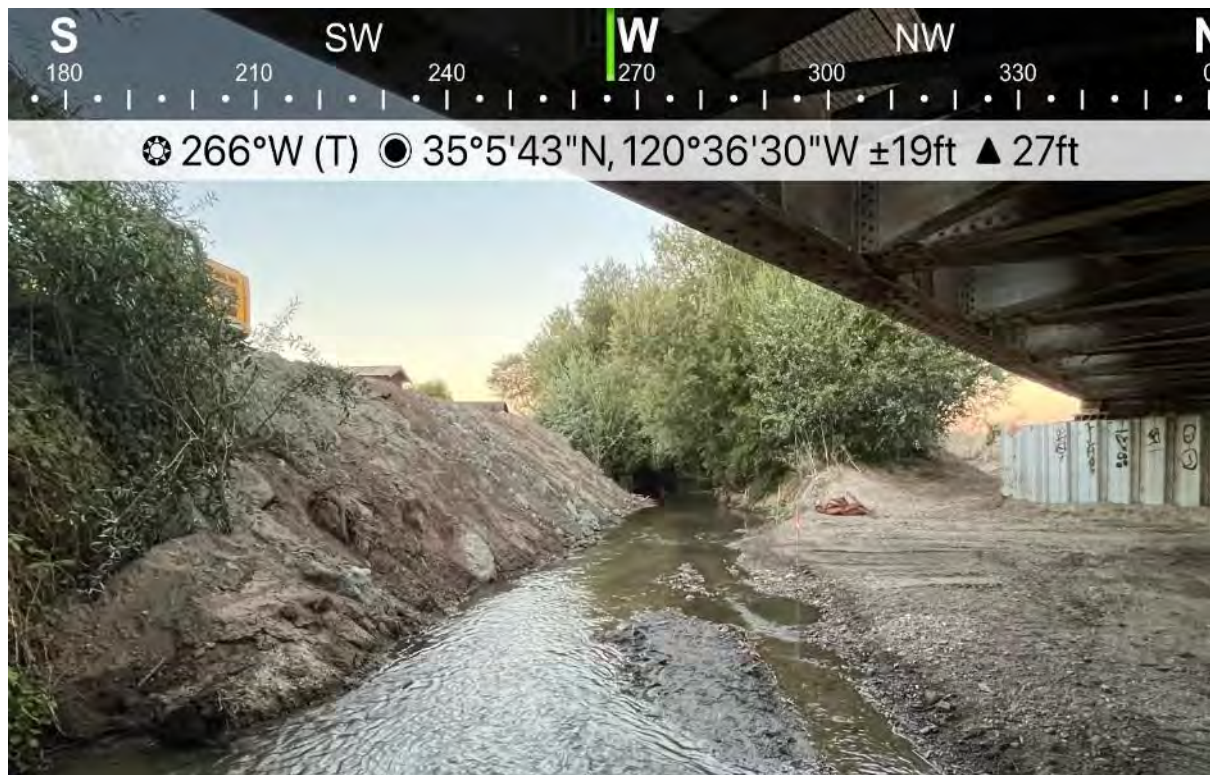
**Photograph 16.** Looking downstream (west) of Breach Site; levee bank has been stabilized, diversion removed, and streamflow returned to the primary channel. October 28, 2025.
