**INSPECTION REPORT FOR
SAN LUIS OBISPO COUNTY'S
CSA-7A LIFT STATION #3**

MARCH 9TH, 2023

**Advantage Technical Services, Inc.
www.ats-slo.com | License #96111**

STRUCTURAL CALCULATIONS FOR
San Luis Obispo Dept. of Public Works
Check Corroded Hoist Rail Beams

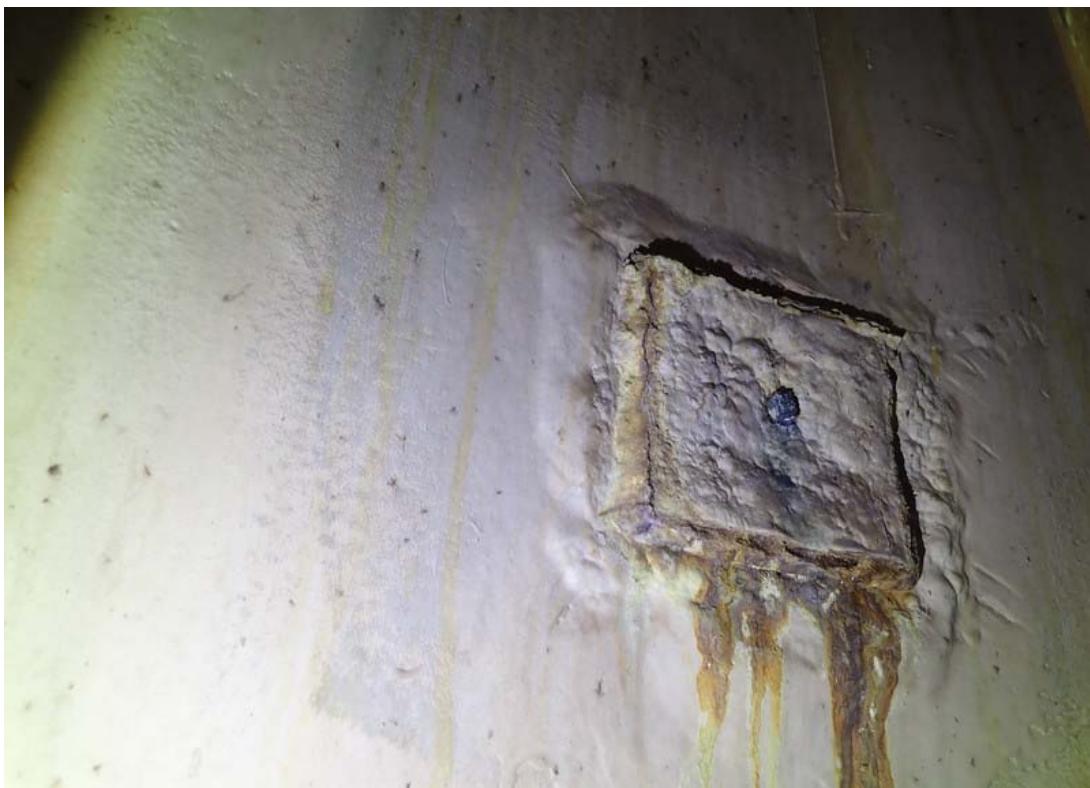
Typical corrosion at failed coatings in the access tube. Coating failures are present on most attachment point and joints in the shell of the access tube.

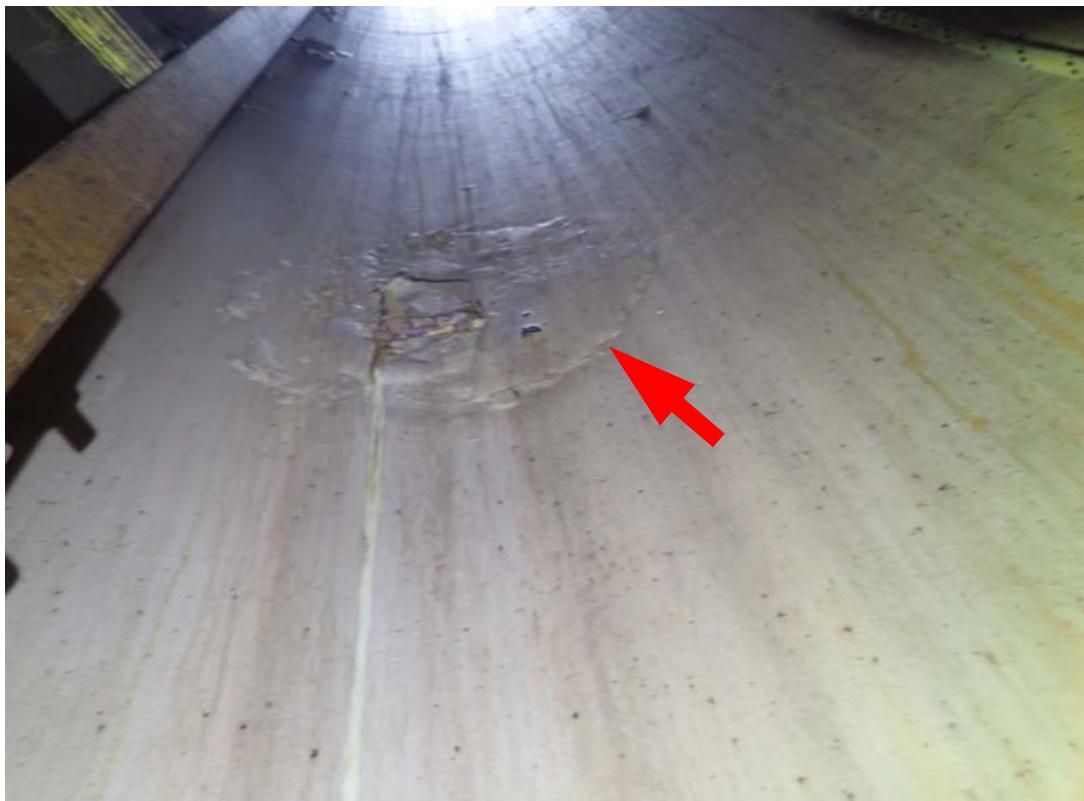
This view shows an area of the access tube. Damaged coating is visible at the arrow. Corrosion is present under the coating.

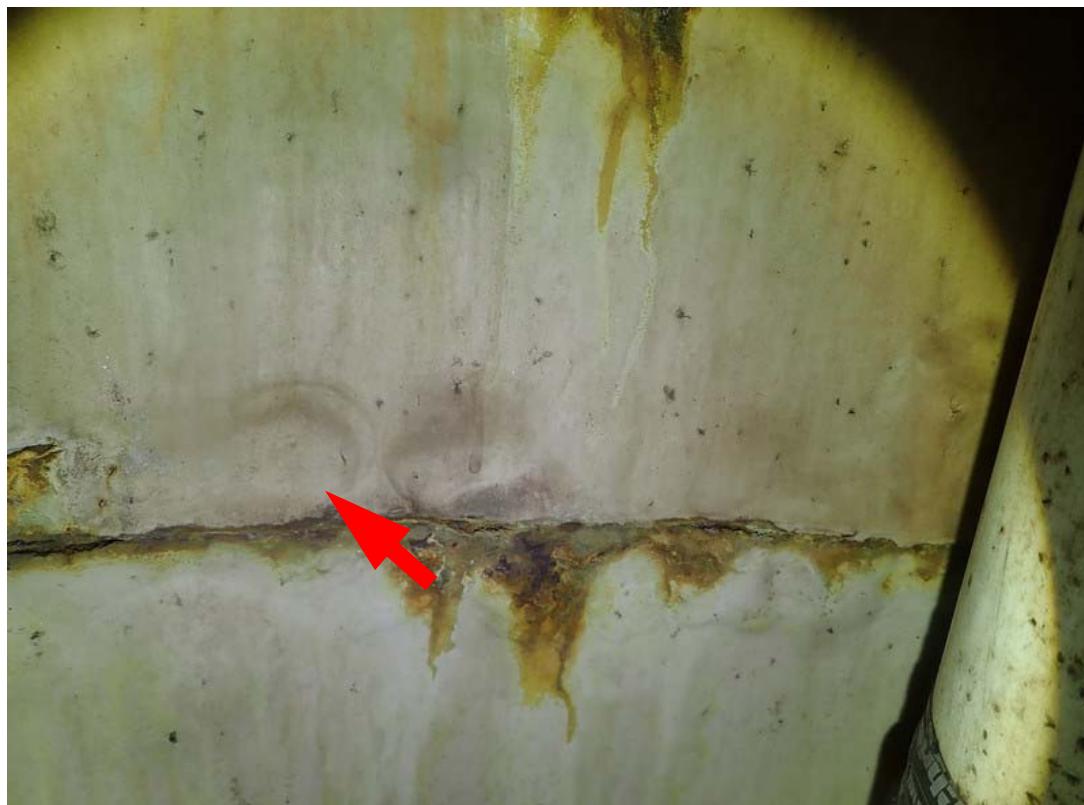
Access tube with corrosion at the joint between sections. Large blisters are visible at the arrow. The light wall PVC tube on the right appeared to be suspended only at the top.

6. Check the plastic piping that is hanging behind the ladder. Checks should include verification that the piping cannot swing into the required 7-inch clear area behind the ladder. Adequacy of the support system for the piping should also be verified. Redundancy in the attachment/hangers is likely appropriate for even light weight piping since failure could be hazardous for ladder users or personnel inside the lift station.

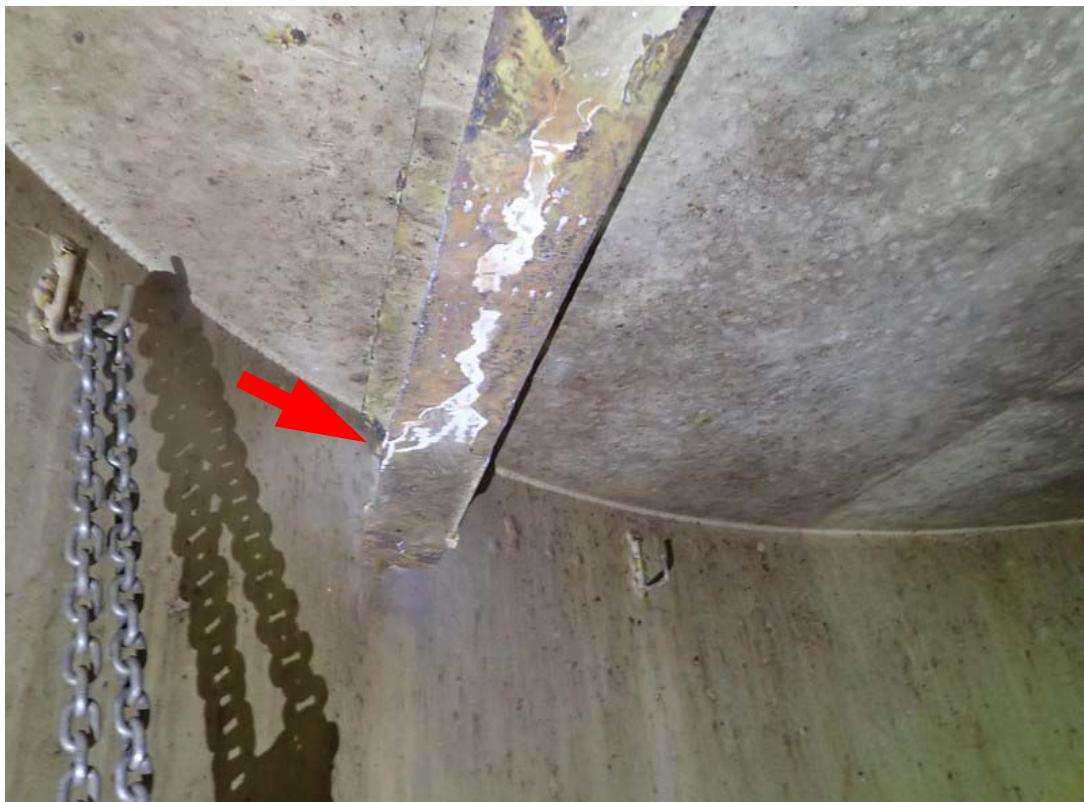
An additional view of some of the south end of the eastern beam from below. The arrow indicates the "outer" side of the hoist beam to shell connections that were inaccessible without abrasive blasting or similar cleaning methods.

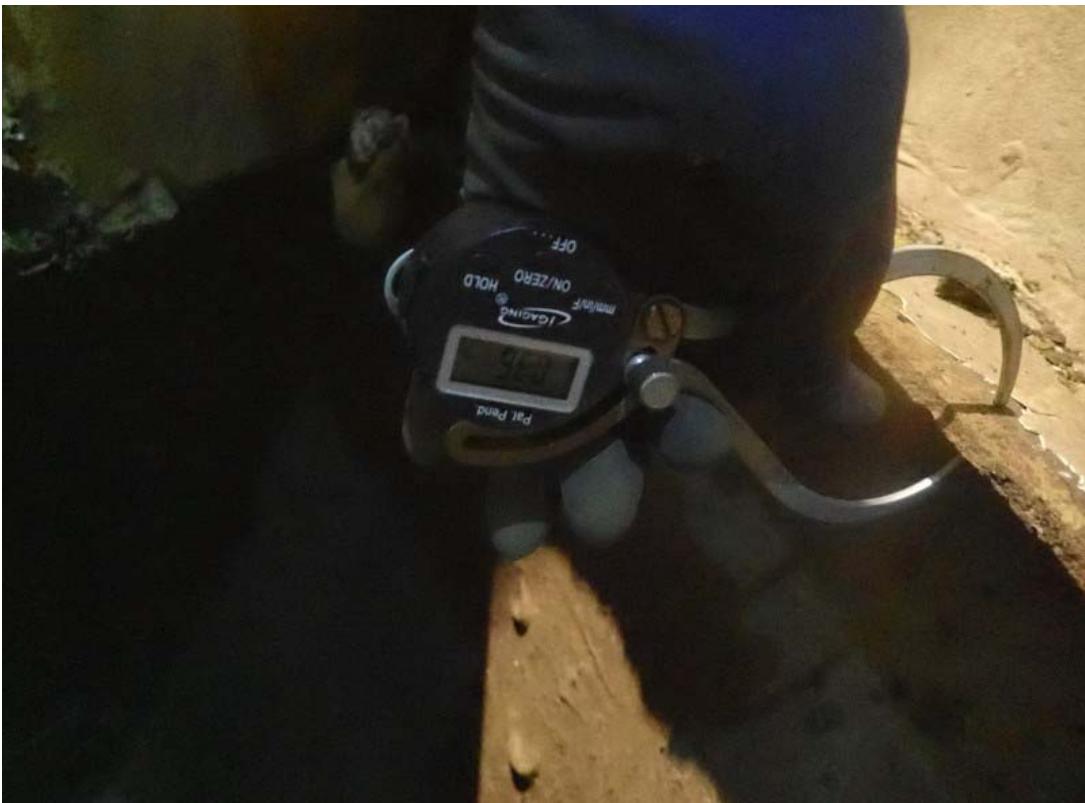
This view shows the top of a hoist rail lower flange. Corrosion damage on the hoist beam flanges was worst at the edges. This may be due, in part, by damage from the hoist trolley wheels riding on the coating.

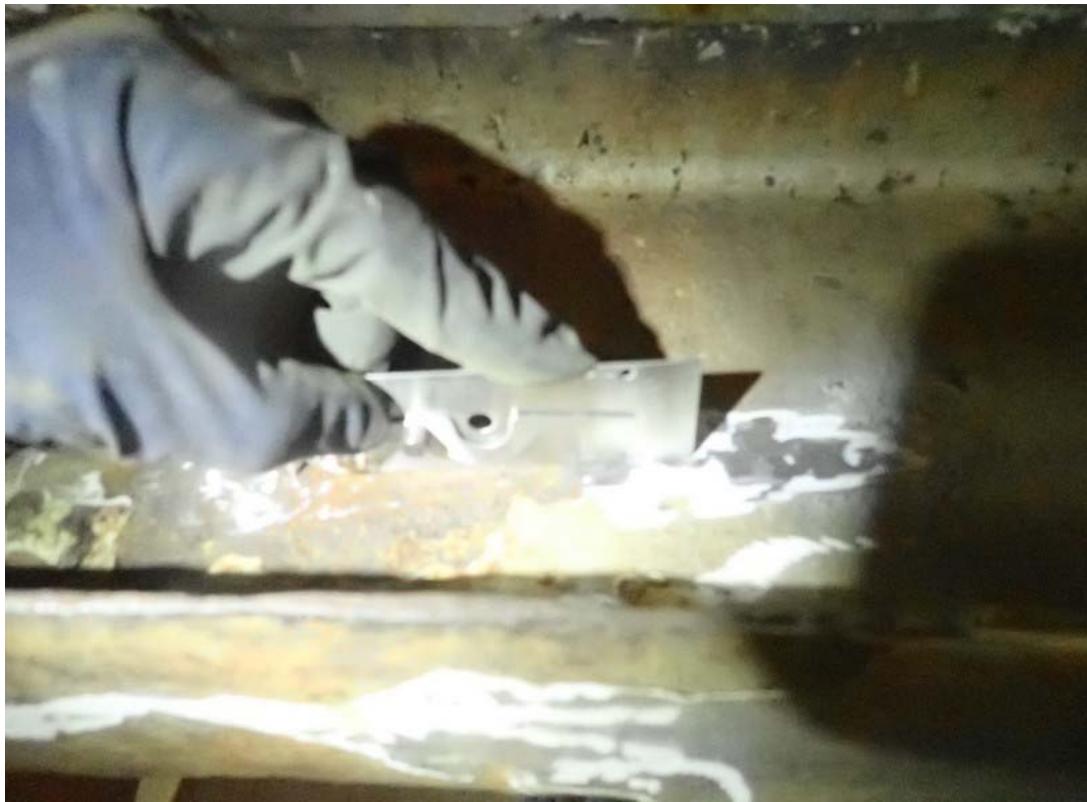
Measuring material loss on a sample area of the east hoist beam. Sound paint and metal are present adjacent to this area of localized corrosion that was checked.

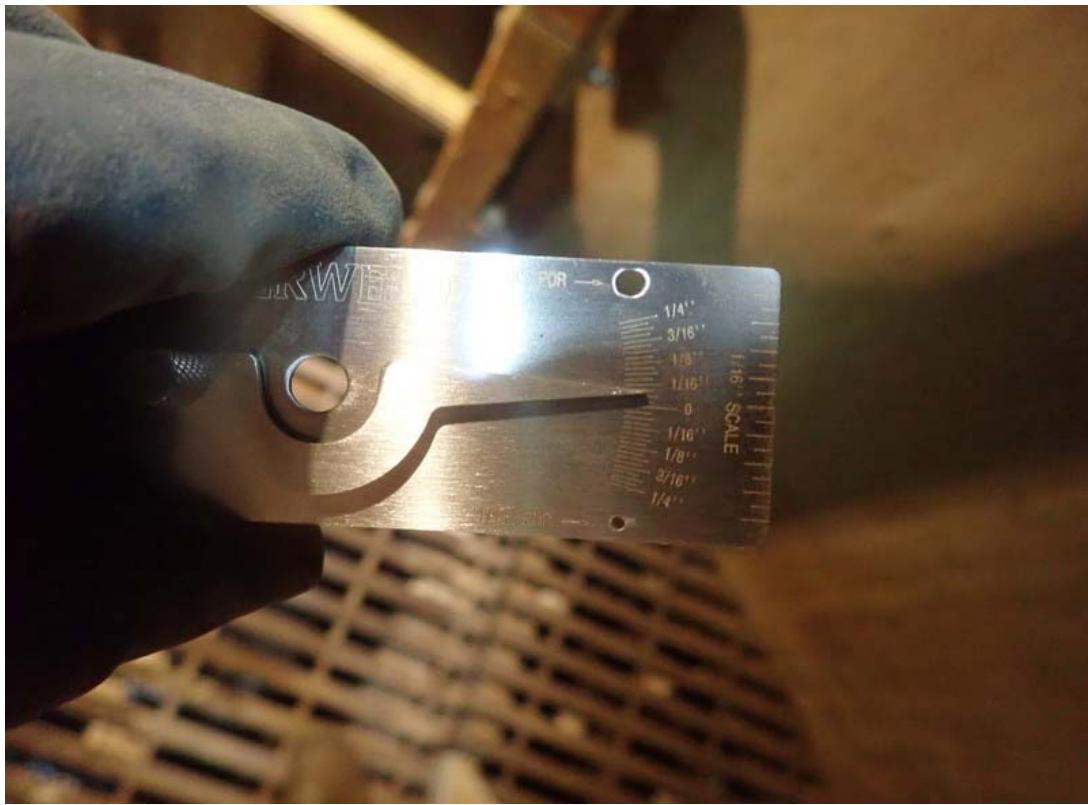
Calipers were used to measure the thickness of the bottom flanges of the beams in the sample areas. A “pit gauge” was used to measure material loss relative to adjacent uncorroded areas. Localized corrosion was measured on the web as 1/32”-3/64”.

Material loss was measured as $3/64"$ in the worst area of localized corrosion on the hoist beam web.

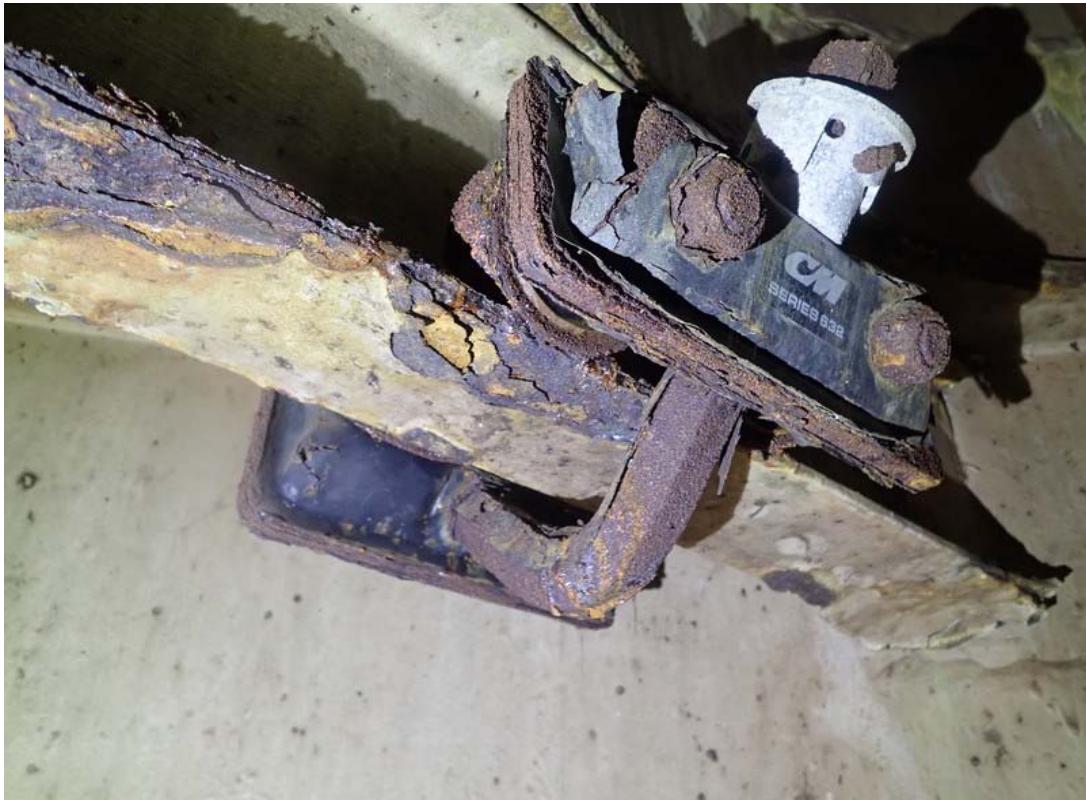
A beam trolley is in place on the eastern hoist rail. No trolley is present on the western hoist rail. The visible portions of the existing beam trolley are severely damaged by corrosion. It is likely that the wheel bearings and retainers are also damaged. This trolley should not be used.

Hoist trolley in place on the northern end of the west rail. The hoist trolley is severely corroded along with the beam. It is recommended that this trolley be taken out of service immediately.

4. Do not attempt to lift a pump with the existing beam trolley. If the rail end connections are rehabilitated for short term use or if new beams are installed, purchase a new beam trolley and store it outside of the lift station to help protect it from corrosion. The current corroded condition (roughening) of the top of the bottom flange of the hoist rails will impact how the trolley rolls along the rail. This will be most notable when the hoist is under load. Trolleys vary with wheel design. Some ride on the outermost edge of the beam flange while others have a bearing area that extends further toward the beam web. The wheel configuration of the trolley will

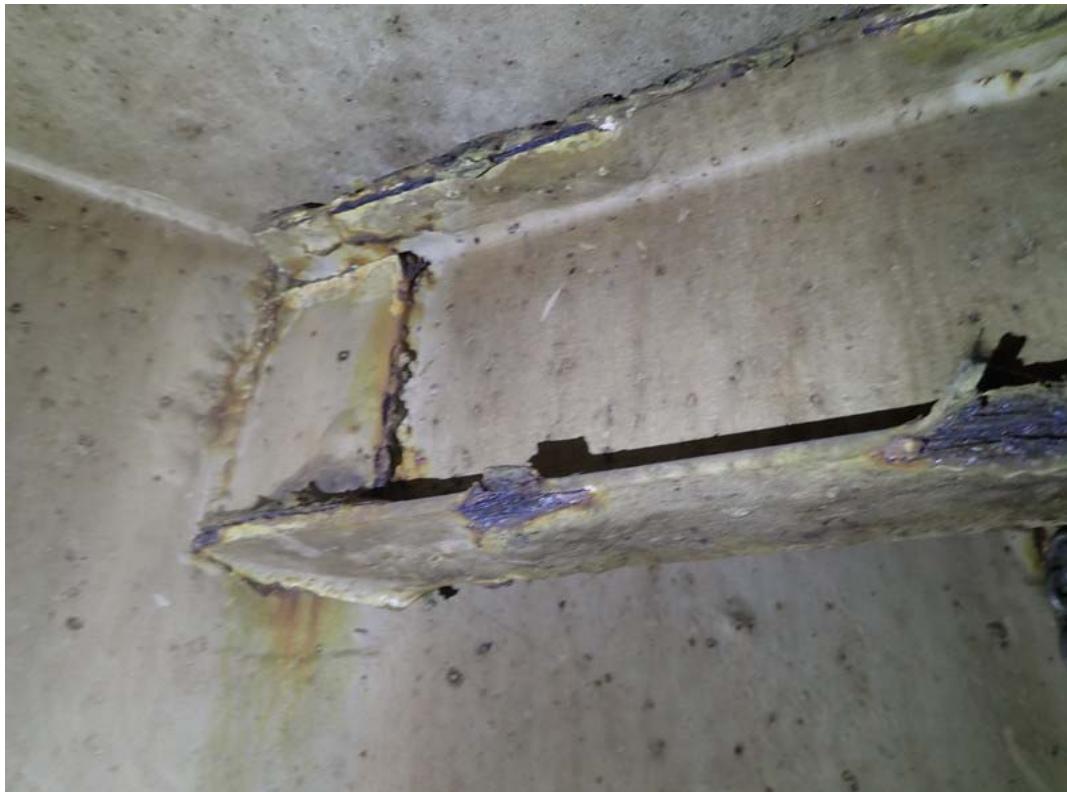
Hoist rail end connection. This view shows the typical condition of the beam rail to shell connection. The side shown is toward the center of the lift station.

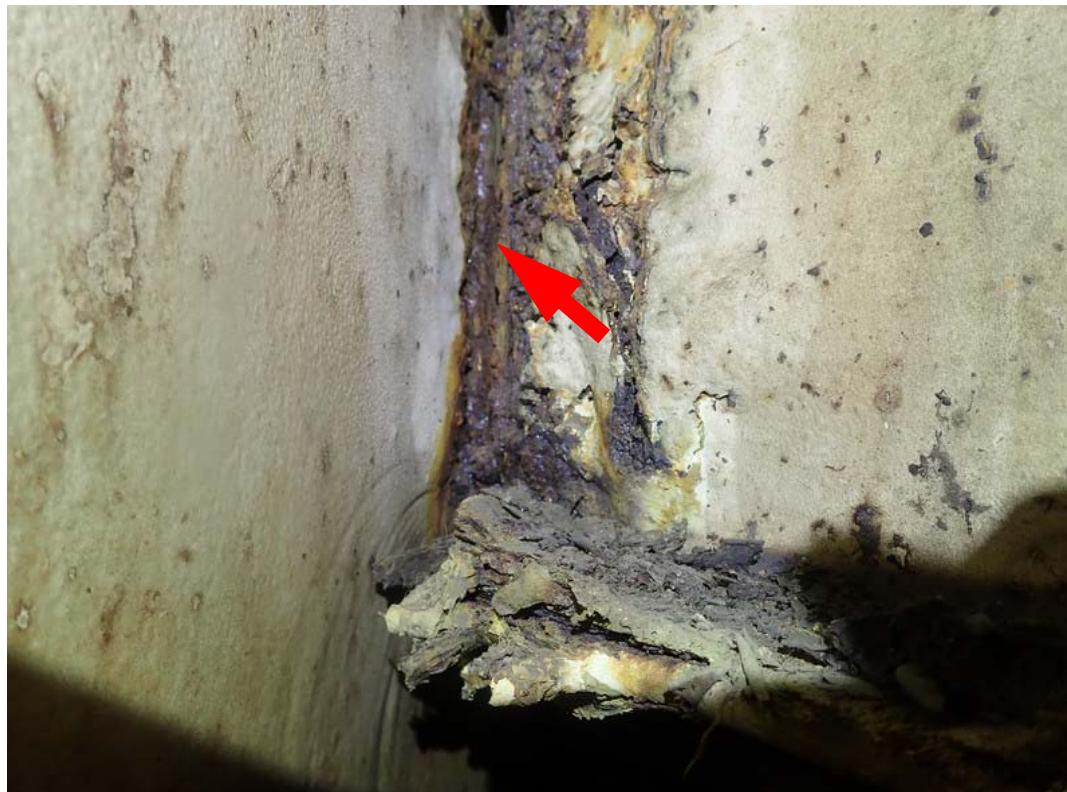
The inability to access, inspect and evaluate the structural components of the connections between the wet well shell and the hoist rails prevented a complete engineering evaluation. The end connections are a critical aspect of the design. Failure at either end connection of a beam under load will result in failure of the lifting system. The geometry that creates the challenging access existed during original construction. This poor access during construction adds questions relating to original weld and coating quality. Difficult of access during construction increases the potential that corrosion started early and that damage could exceed what was found at accessible locations on the beam. Additionally, the existing crevice conditions are often associated with accelerated corrosion.

This view shows the typical condition at the hoist rail to shell connections at the outer side of the rails (opposite side as shown in the top photo). The design detail has created a crevice at the connection (arrow). The critical area is inaccessible for inspection and maintenance.

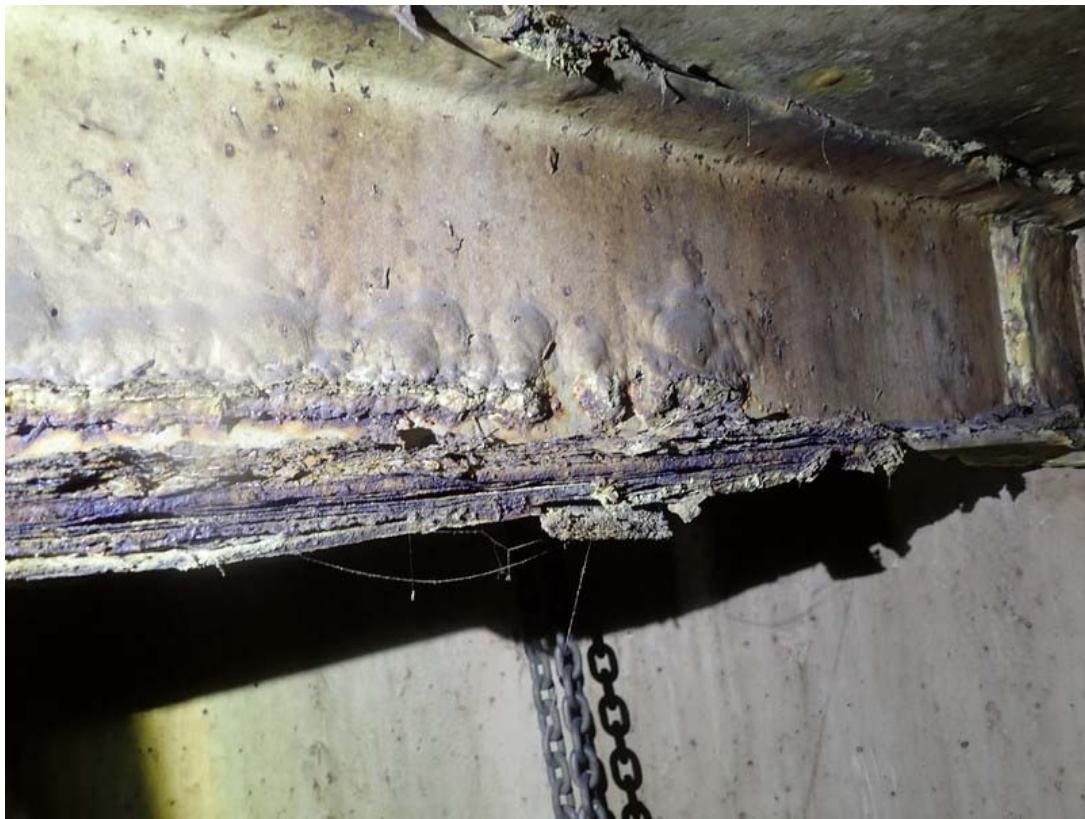
This view shows a hoist beam with what appeared to be some of the worst corrosion. This area was selected to be a sample area for rust removal, measurement and evaluation.

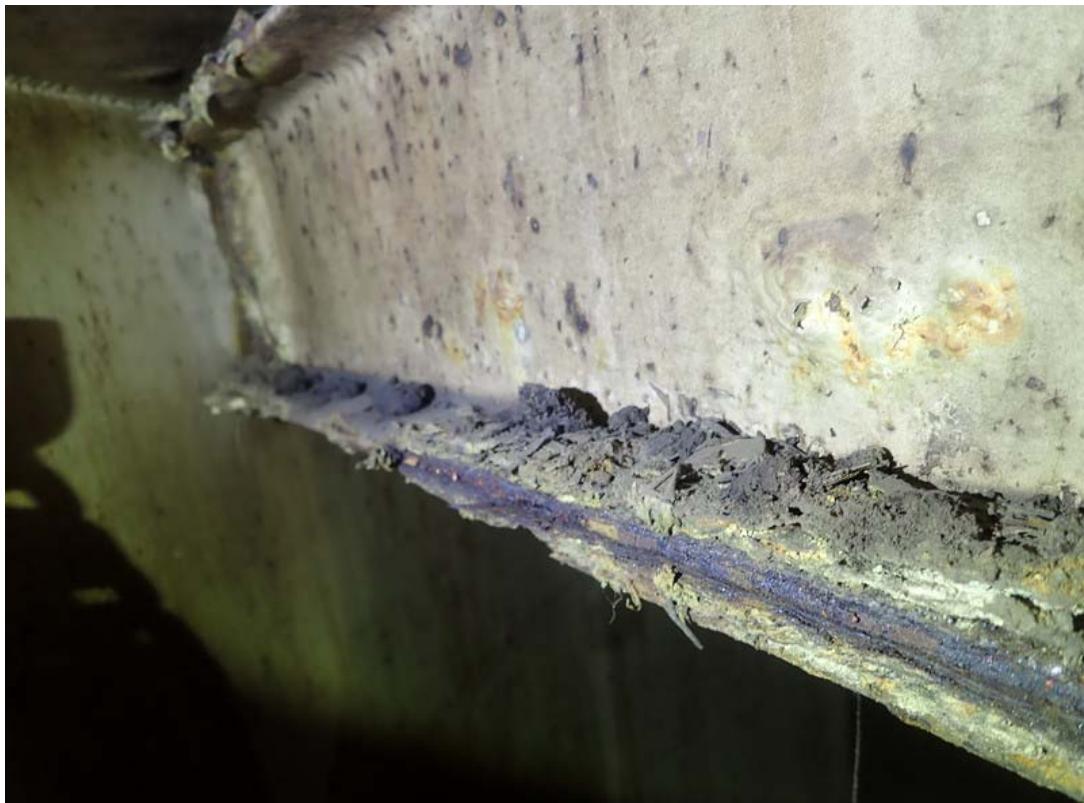
An additional view of some of the worst corrosion on the bottom flange of the hoist rails.

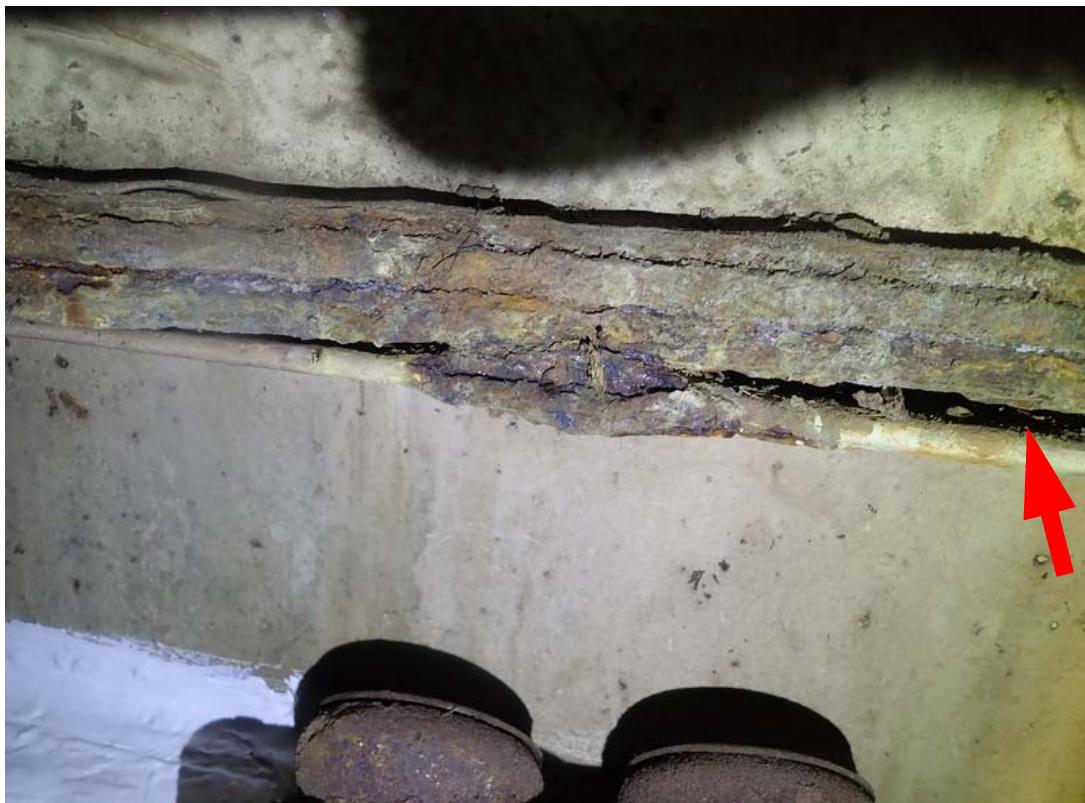
Additional challenges include the lack of space (approx. 1/4inch) between the top of the hoist beams and the ceiling. This causes the entire top of the hoist beams to be inaccessible for inspection and maintenance.

Top flange of hoist beam with inaccessible area above the beam.

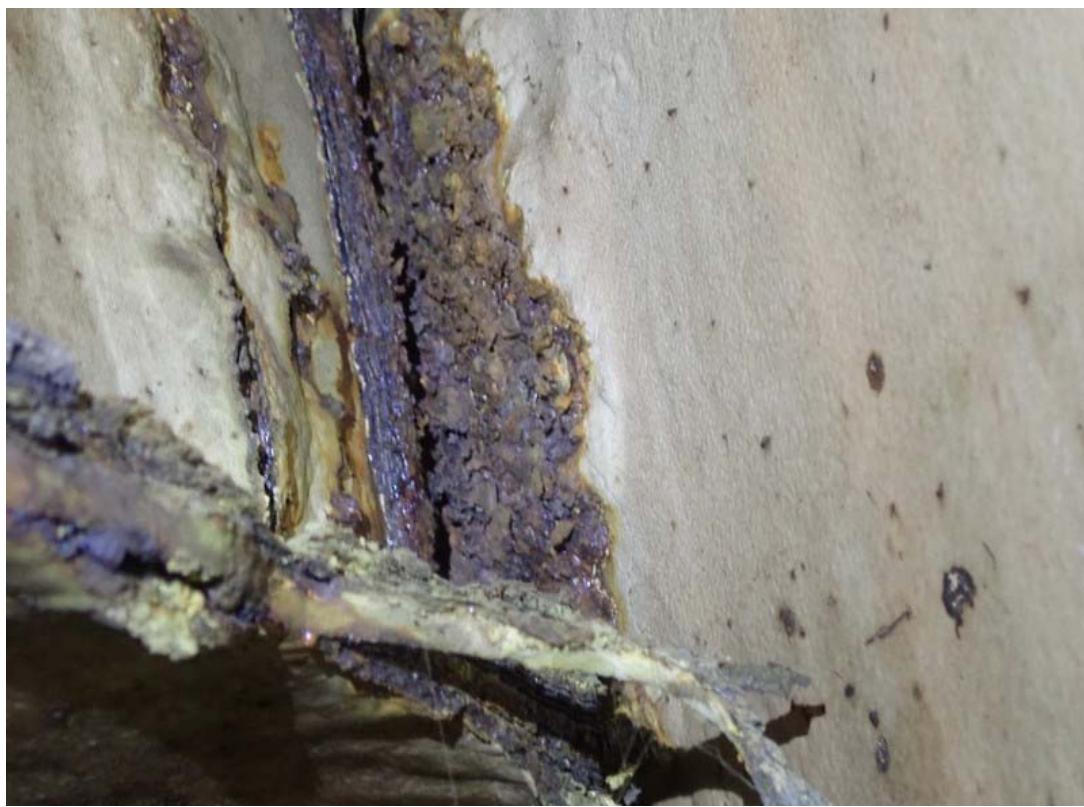
Inaccessible side of the eastern hoist rail at the shell connection. Severe corrosion is present. Measurement and evaluation of corrosion was not completed due to access restrictive geometry on the "outer" side of the attachments (shown).

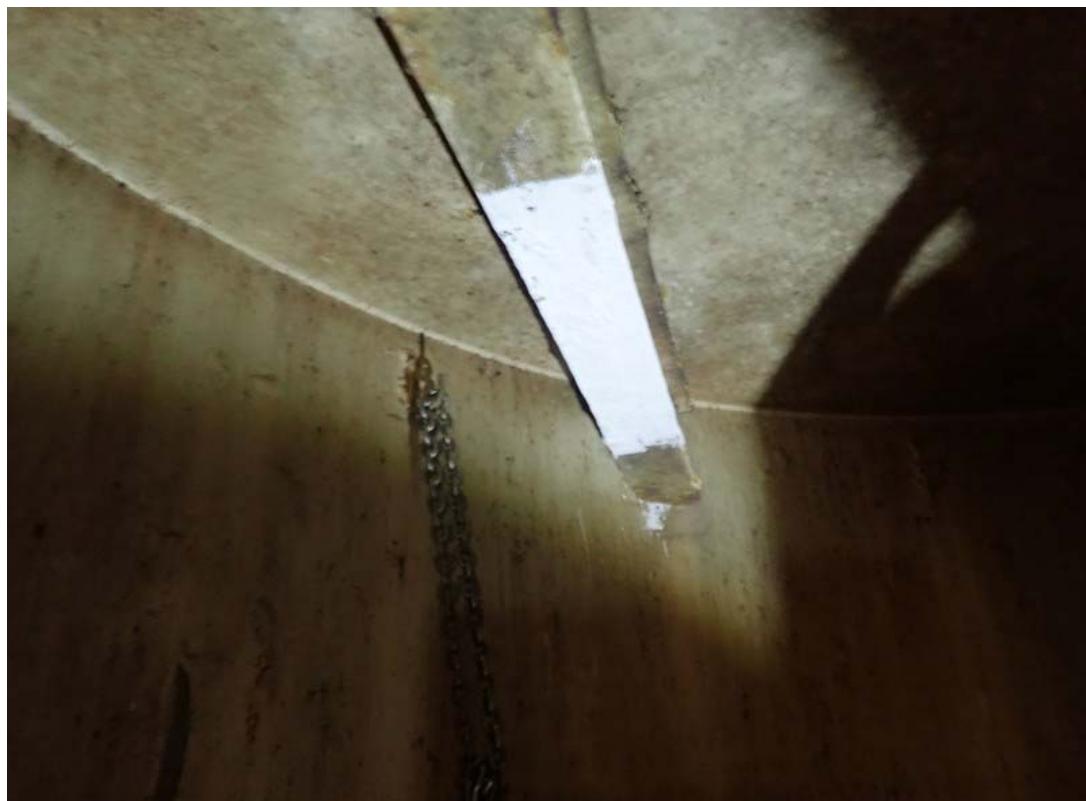
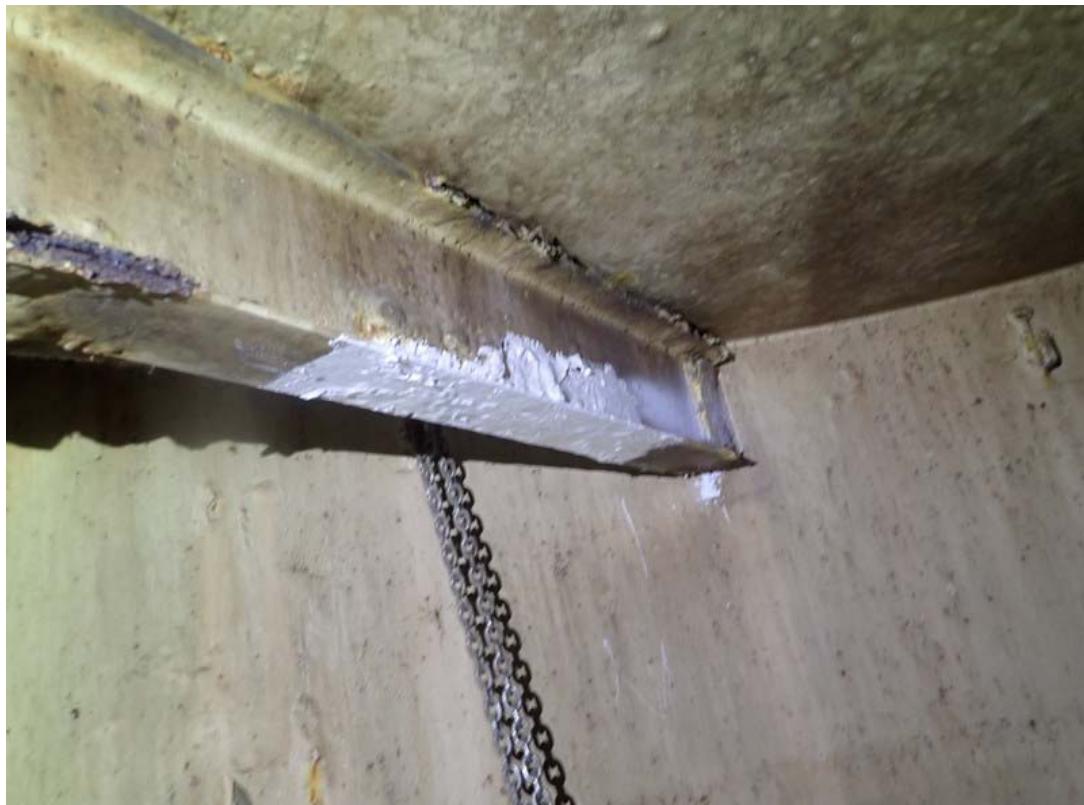
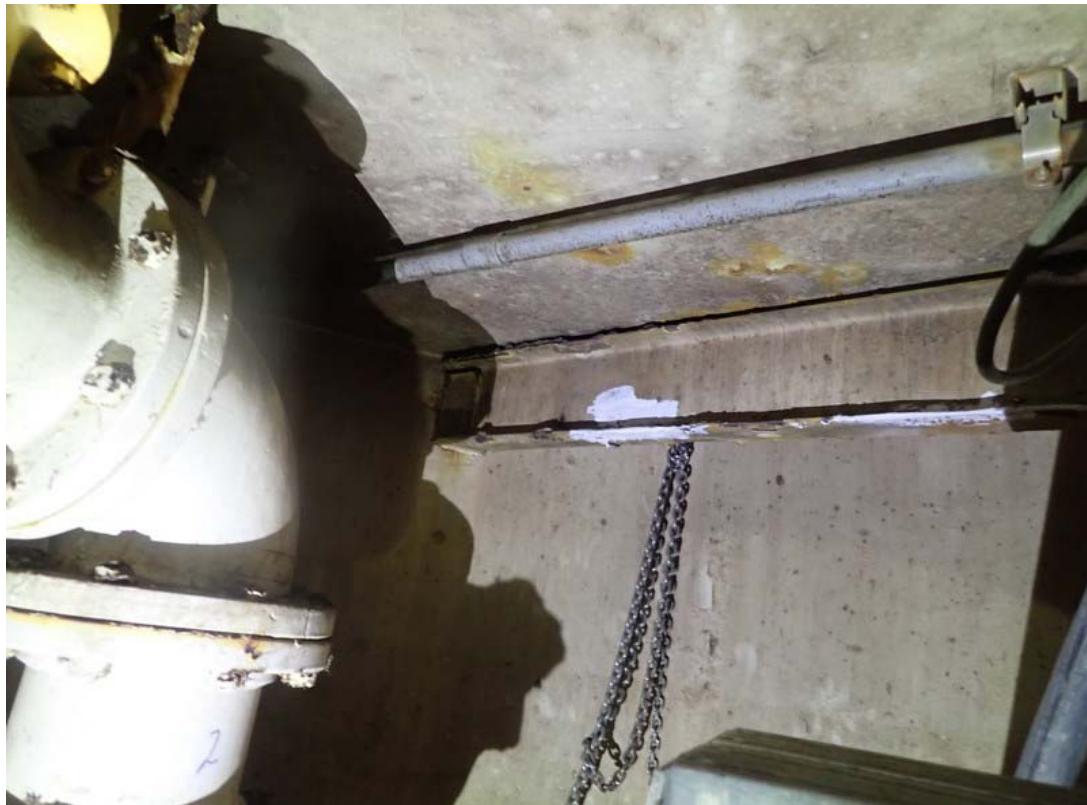
Underside of the east hoist rail after spot coating application was complete.

This view shows the spot coating application on a portion of the east beam. The coating was applied over the sample areas where loose materials were removed and the area surrounding the sample areas where loose coating remained.

This is an additional view of coating spot application. In this photo the west rail is shown.

Spot Coating Repair – Spot coating repairs were applied by ATS in the areas where corrosion and damaged coatings were removed to help slow additional corrosion. A 100% solids

epoxy (aquatapoxy) was used. The repairs were applied in conditions that do not meet the manufacturer's recommendations so they should be considered temporary/short term repairs.

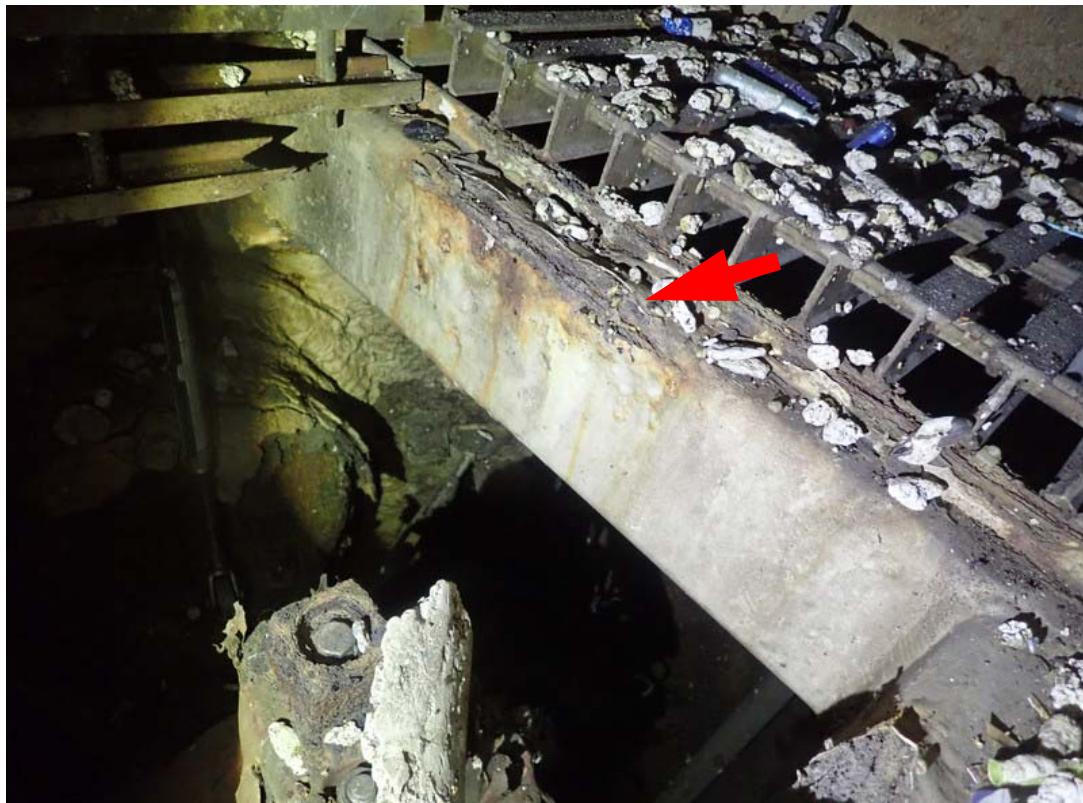
Significant localized corrosion is present on approximately 10% of the surface area of the support structure. The amount of corrosion product present appeared to be similar to what was present on the hoist rails where corrosion was measured to be approximately 1/16".

View with grating lifted to check conditions. Serious corrosion and significant metal loss are present in localized areas such as the grating support structure (arrow).

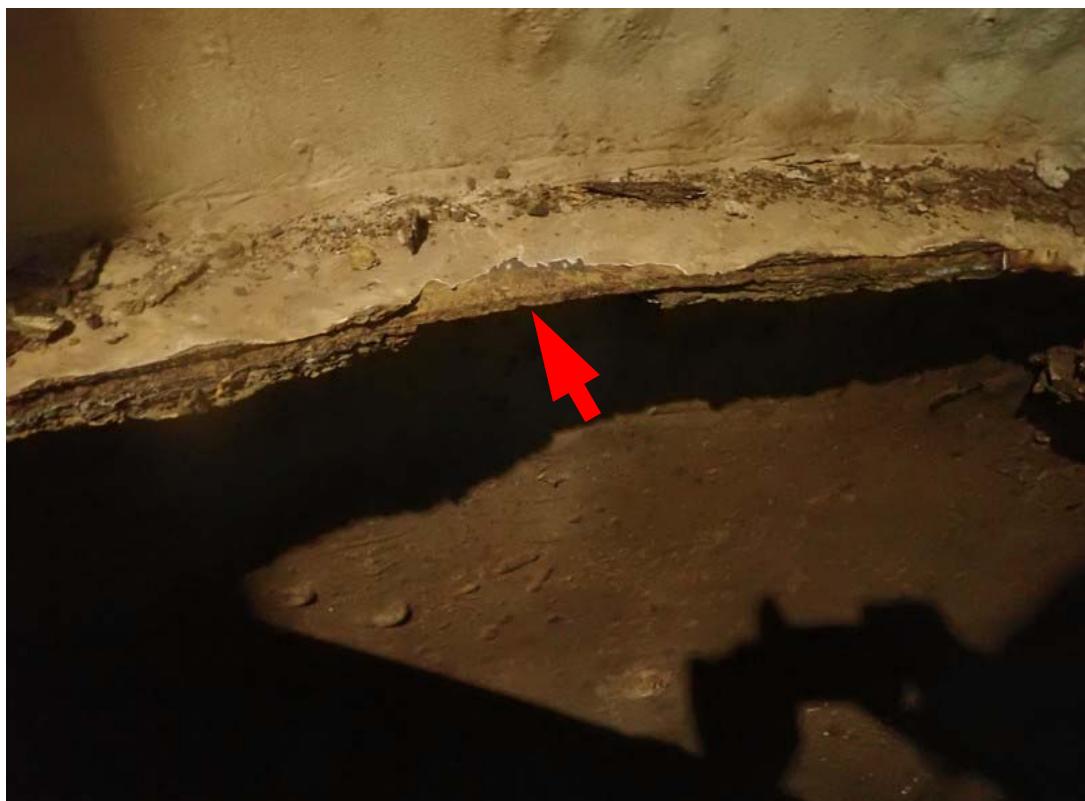
Perimeter "flange" (see top photo for location) after removal of oxides in a sample area (arrow). The corrosion appears to be similar to that found in other areas of the structure.

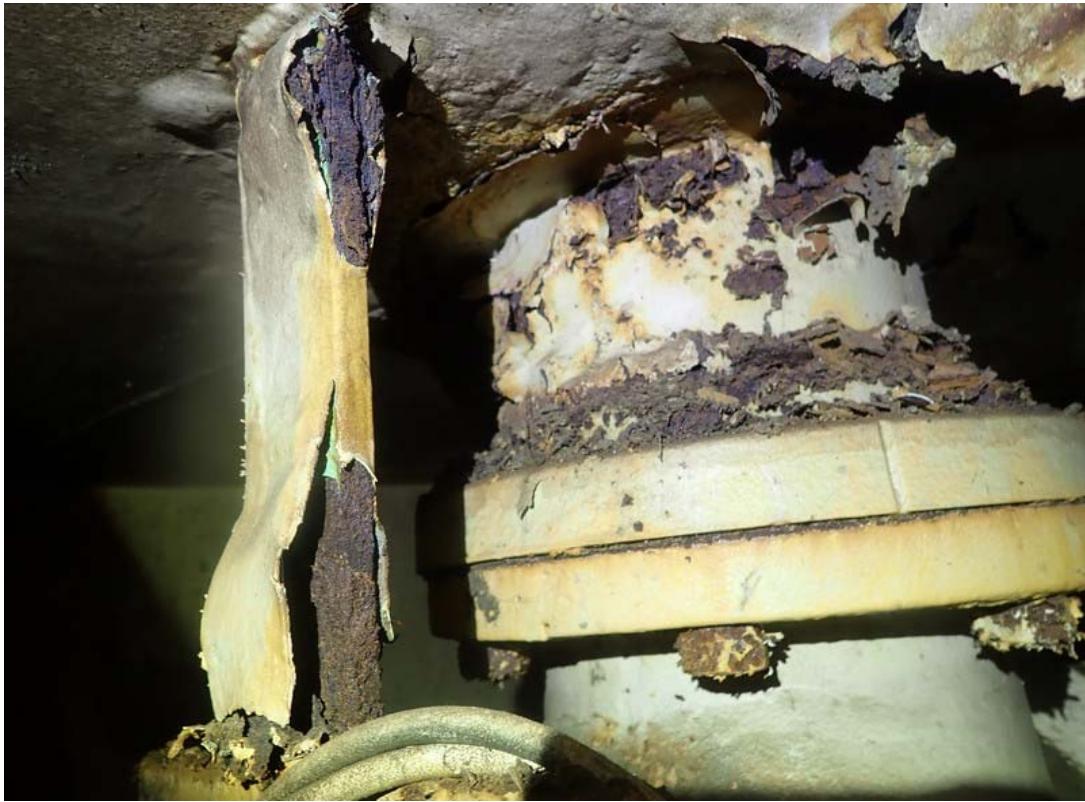
Pipe hanger on interior ceiling. Significant corrosion damage is present.

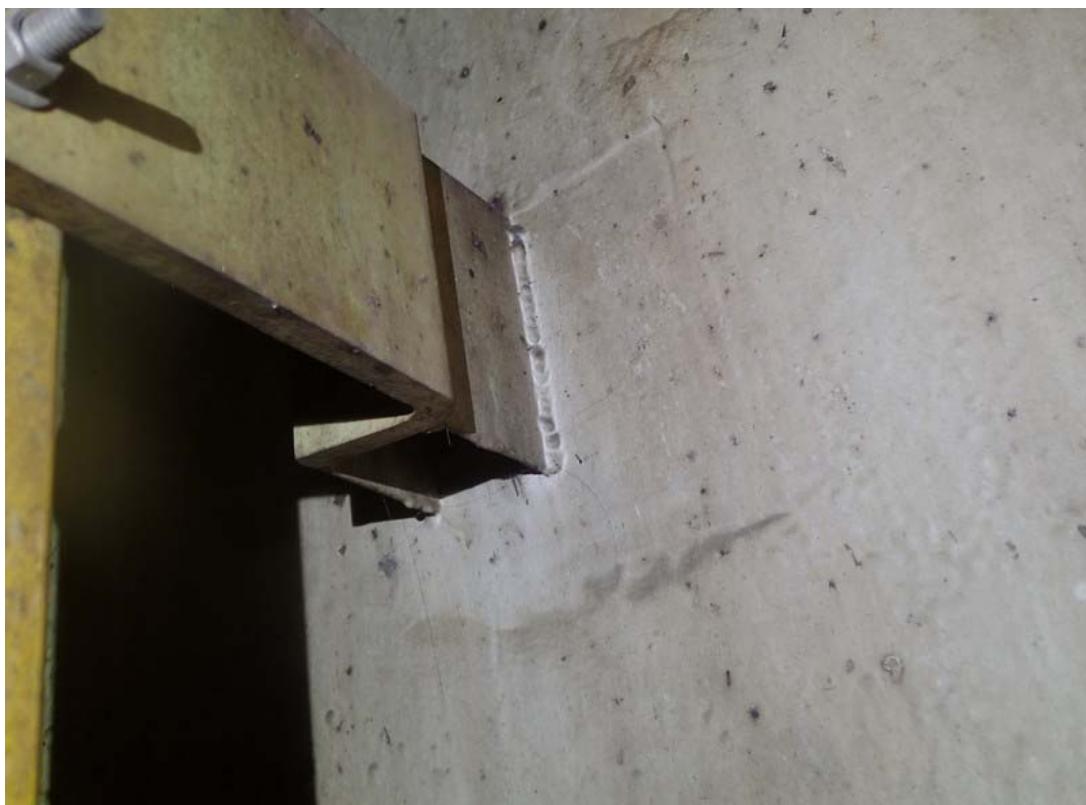
Typical ladder attachment. Ladder supports appear to be in good condition.
