MNS Engineers, Inc.

Risk Assessment Study on the Interceptor Sewerline System in County Service Area 7A, Oak Shores

County of San Luis Obispo
10/1/2015

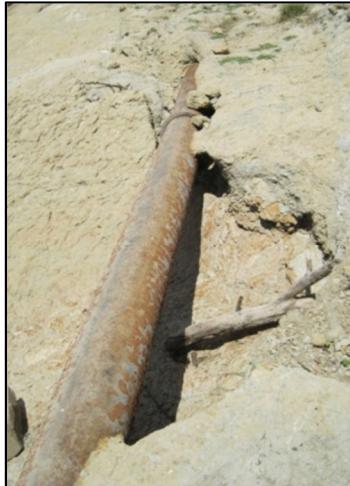
Exposed Interceptor Pipe IE-124 on the East Interceptor

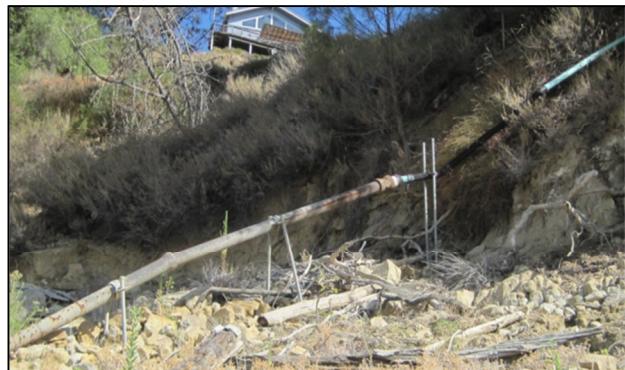
Exposed Lateral Repairs along Eroded Bank

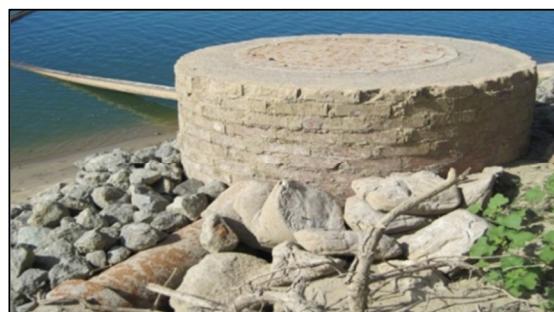
Manhole M93, Exposed Interceptor lower left

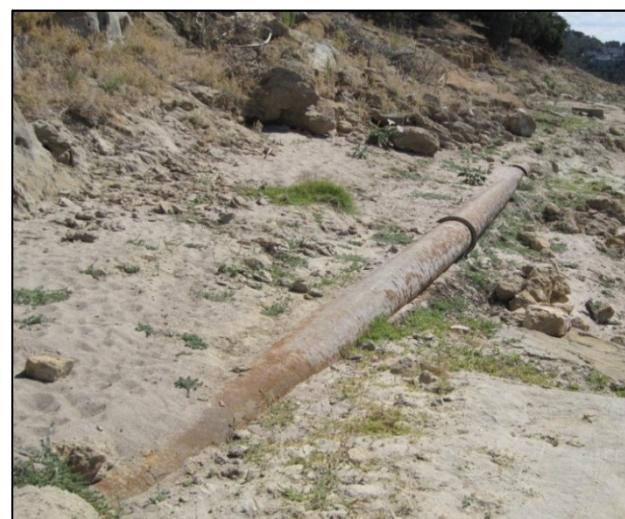
Exposed Interceptor IW-86 on the West Interceptor

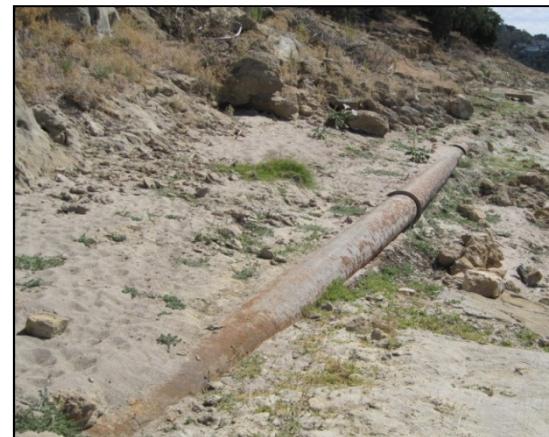
Figure 2.1: Exposed Interceptor IW-86 on the West Interceptor

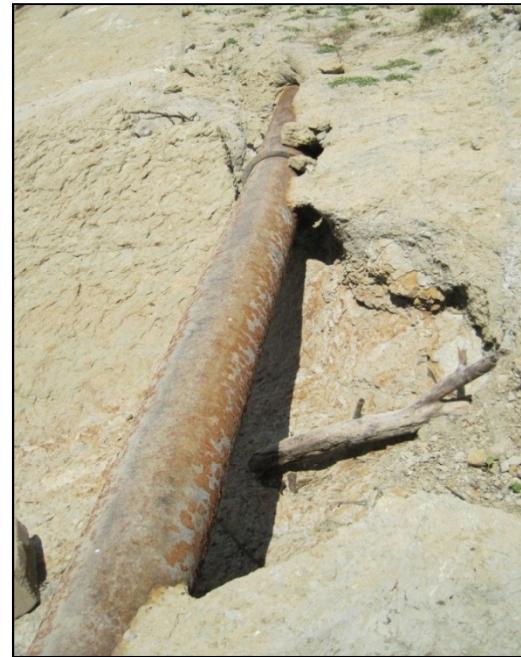
Figure 2.4: Exposed Interceptor Pipe IE-124 on the East Interceptor

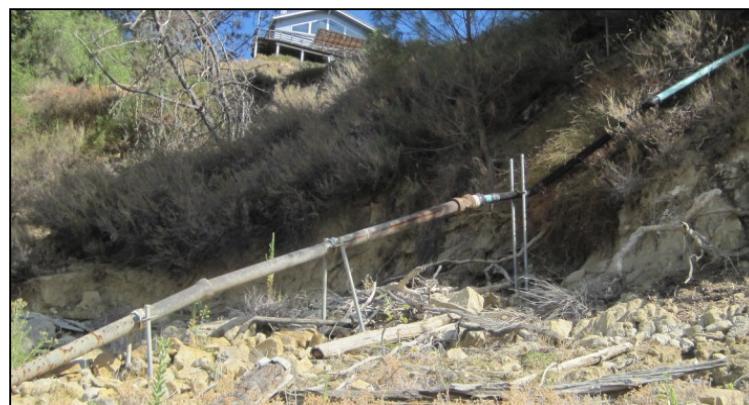
Figure 2.5: Exposed Feeder Composed of Different Materials

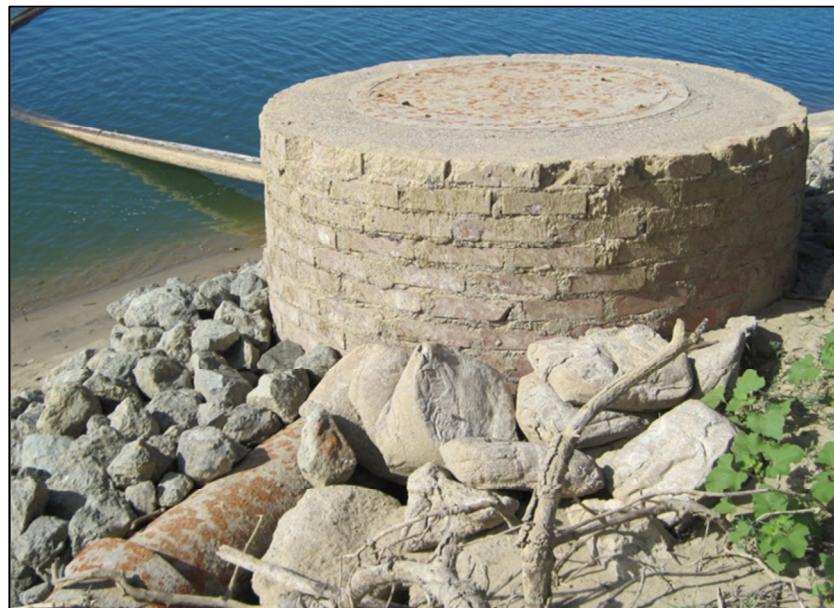
The manholes are sealed with rubber gaskets and they are bolted and calked to lower the risk of leaking. Due to the level of difficulty of opening and sealing the manholes covers, manholes are not often accessed. In the last 20 years, approximately 10 of the 49 manholes have been opened. In the past, manholes have become unsealed while the water levels were above the manholes^{2.12}. Several manholes are exposed and potentially vulnerable. 23 manholes were able to be located by survey. 26 manholes along the East and West interceptors are buried and could not be surveyed or accessed. Why they were installed this way is unknown.

Figure 2.6: Manhole M93, Exposed Interceptor, and Stabilization

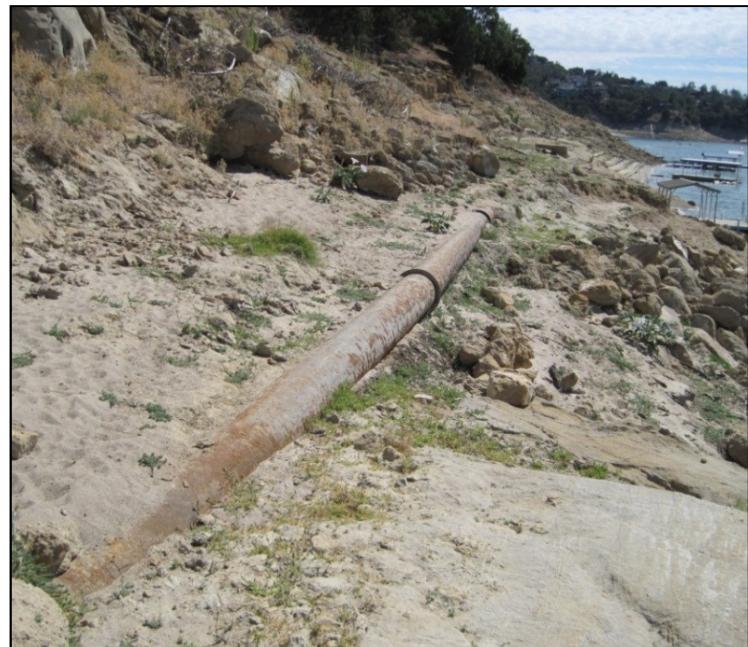
Interceptor lines and laterals which are exposed are at risk of damage from boats, with observations made by staff that on occasion boaters will tie their boats to the laterals.

The survey completed by MNS located sections of pipe where the main interceptor is exposed. On the East Interceptor, 11 locations are exposed totaling 102 linear feet of exposed

Figure 4.1: Exposed pipe along the West Interceptor between Manholes M86 and M87

pipeline. The West Interceptor has 8 locations exposed totaling approximately 231 linear feet of exposed pipeline. These exposed areas represent approximately 2% and 5% of the East and West Interceptors, respectively.

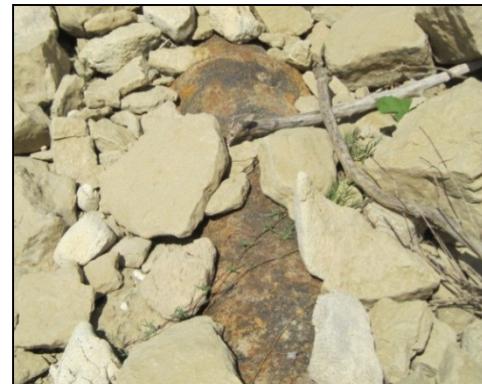
Figure 4.2: Corrosion of Interceptor

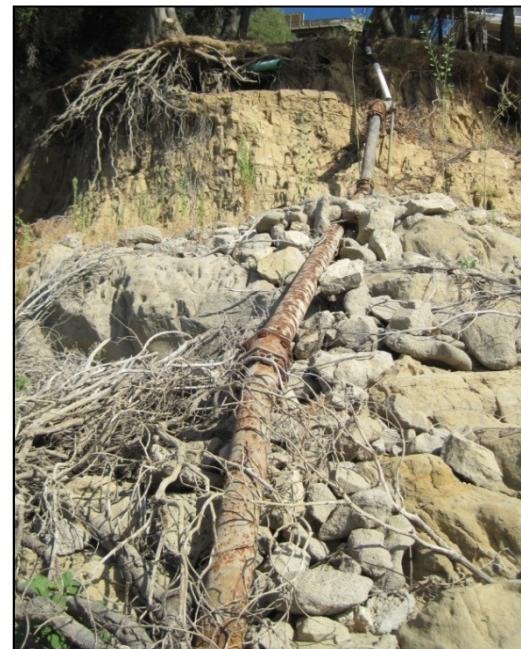
Figure 4.3: View of the Feeder Line at Parcel 201

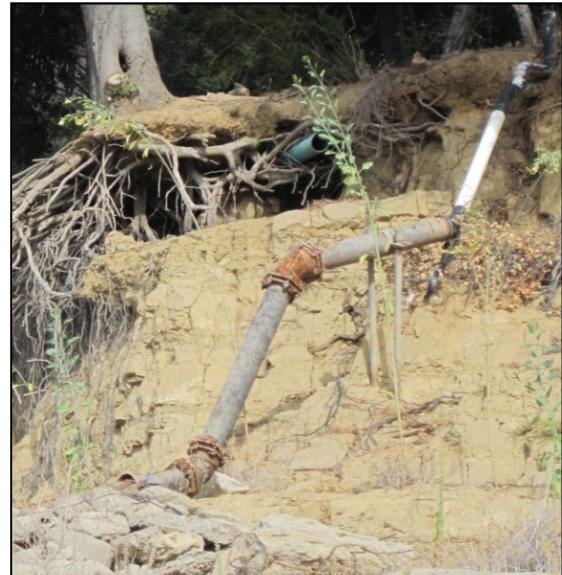
Figure 4.4: Feeder Line at Parcel 201

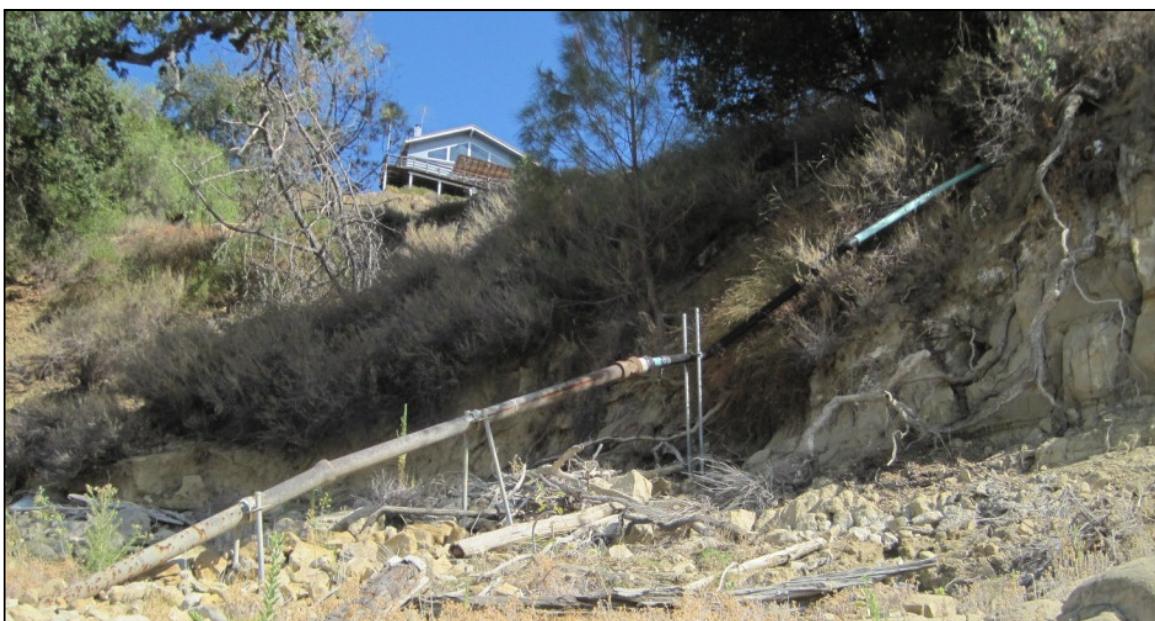
Figure 4.5: Feeder Pipe at Parcels 203 and 213

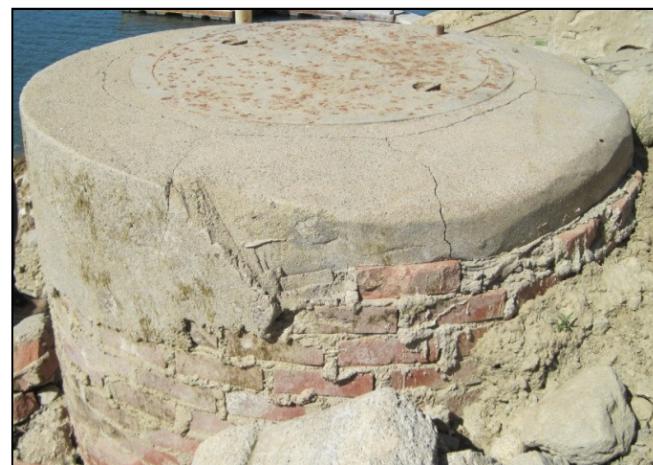
Figure 4.6: Manhole M91

Access to the manholes presents significant risk. The original manhole bolts break off when attempting to remove them. Lids weigh approximately 200 pounds and the original lifting rings and supports have broken off when attempting to access the manhole. When resealed, new rubber gaskets are used and a UV resistant sealer is used on the outside around the rim. There is currently no Standard Operating Procedure (SOP) in place for accessing the manholes. If the manhole is not sealed properly, a breach may occur, though it may not be noticed until the lake levels rise.

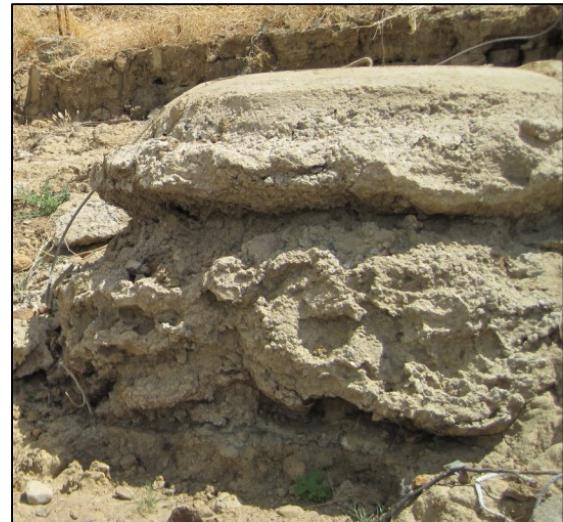
Figure 4.7: Manhole 126

Also, many manholes visible during the site visit had exterior cracking and some appeared as though they had

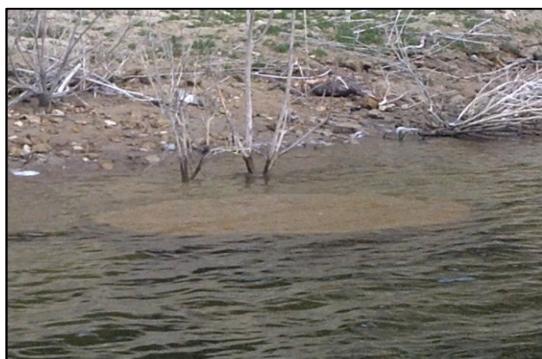
Figure 4.8: Underwater manhole.

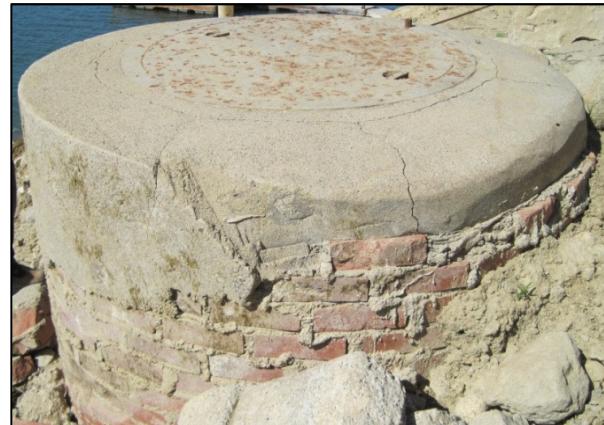
Figure 4.10: Manhole M86

been repaired after being hit. Figure 4.10 shows cracking on the exterior of a manhole along the west interceptor.

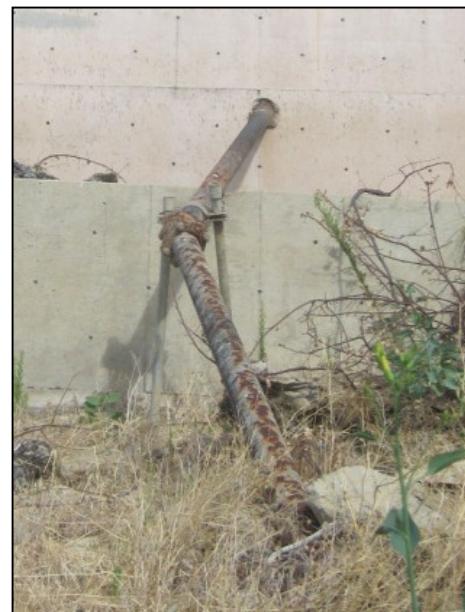
Some laterals traverse private property, presumably in public easements. The laterals have not been located with respect to easements created with the various tract maps. Without clarification of location of easements the reduction of risk is hampered by access uncertainty, as well as ownership uncertainty. The CSA 7A Sewer Use Ordinance speaks primarily to new connections and the associated permits and fees while the County Public Works Department's Procedural Memorandum O-2 establishes maintenance and operation of building sewers(aka house laterals). As a matter of expediency, the County currently repairs pipes as needed even if they may be the responsibility of the homeowners or are not in a

Figure 4.13: Lateral L-95.3 shown coming through a retaining wall.

public easement. These are policy and legal issues that need clarification because they put the County at risk for clear rights to access for maintenance or in an emergency.

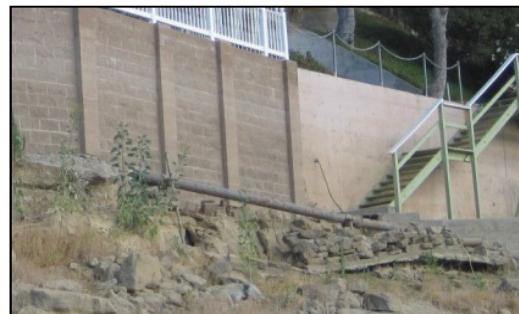
1. These walls were built over and around the lateral lines without modification, lowering, or repair of these exposed lines.
2. The District's participation in the review process of these improvements should be considered.
3. Assessments or conditions of approval may apply, or current policy regarding building sewer connections lateral sewers.
4. The County's current procedures regarding coordination between the Planning/Building Department and Public Works with respect to new or enlarged houses and installation of sewer laterals should have caught these inconsistencies..

Figure 4.14: Retaining wall built over Feeder
F-95
