Original: September 16, 2015
Updated: March 7, 2018
2nd Update: September 21, 2018

Subject: The Cottages at Point San Luis Project: Tree Inventory Report

Figure 3: Tree Survey Map – Original Survey Area

Figure 4: Tree Survey Map – Supplemental Survey Area

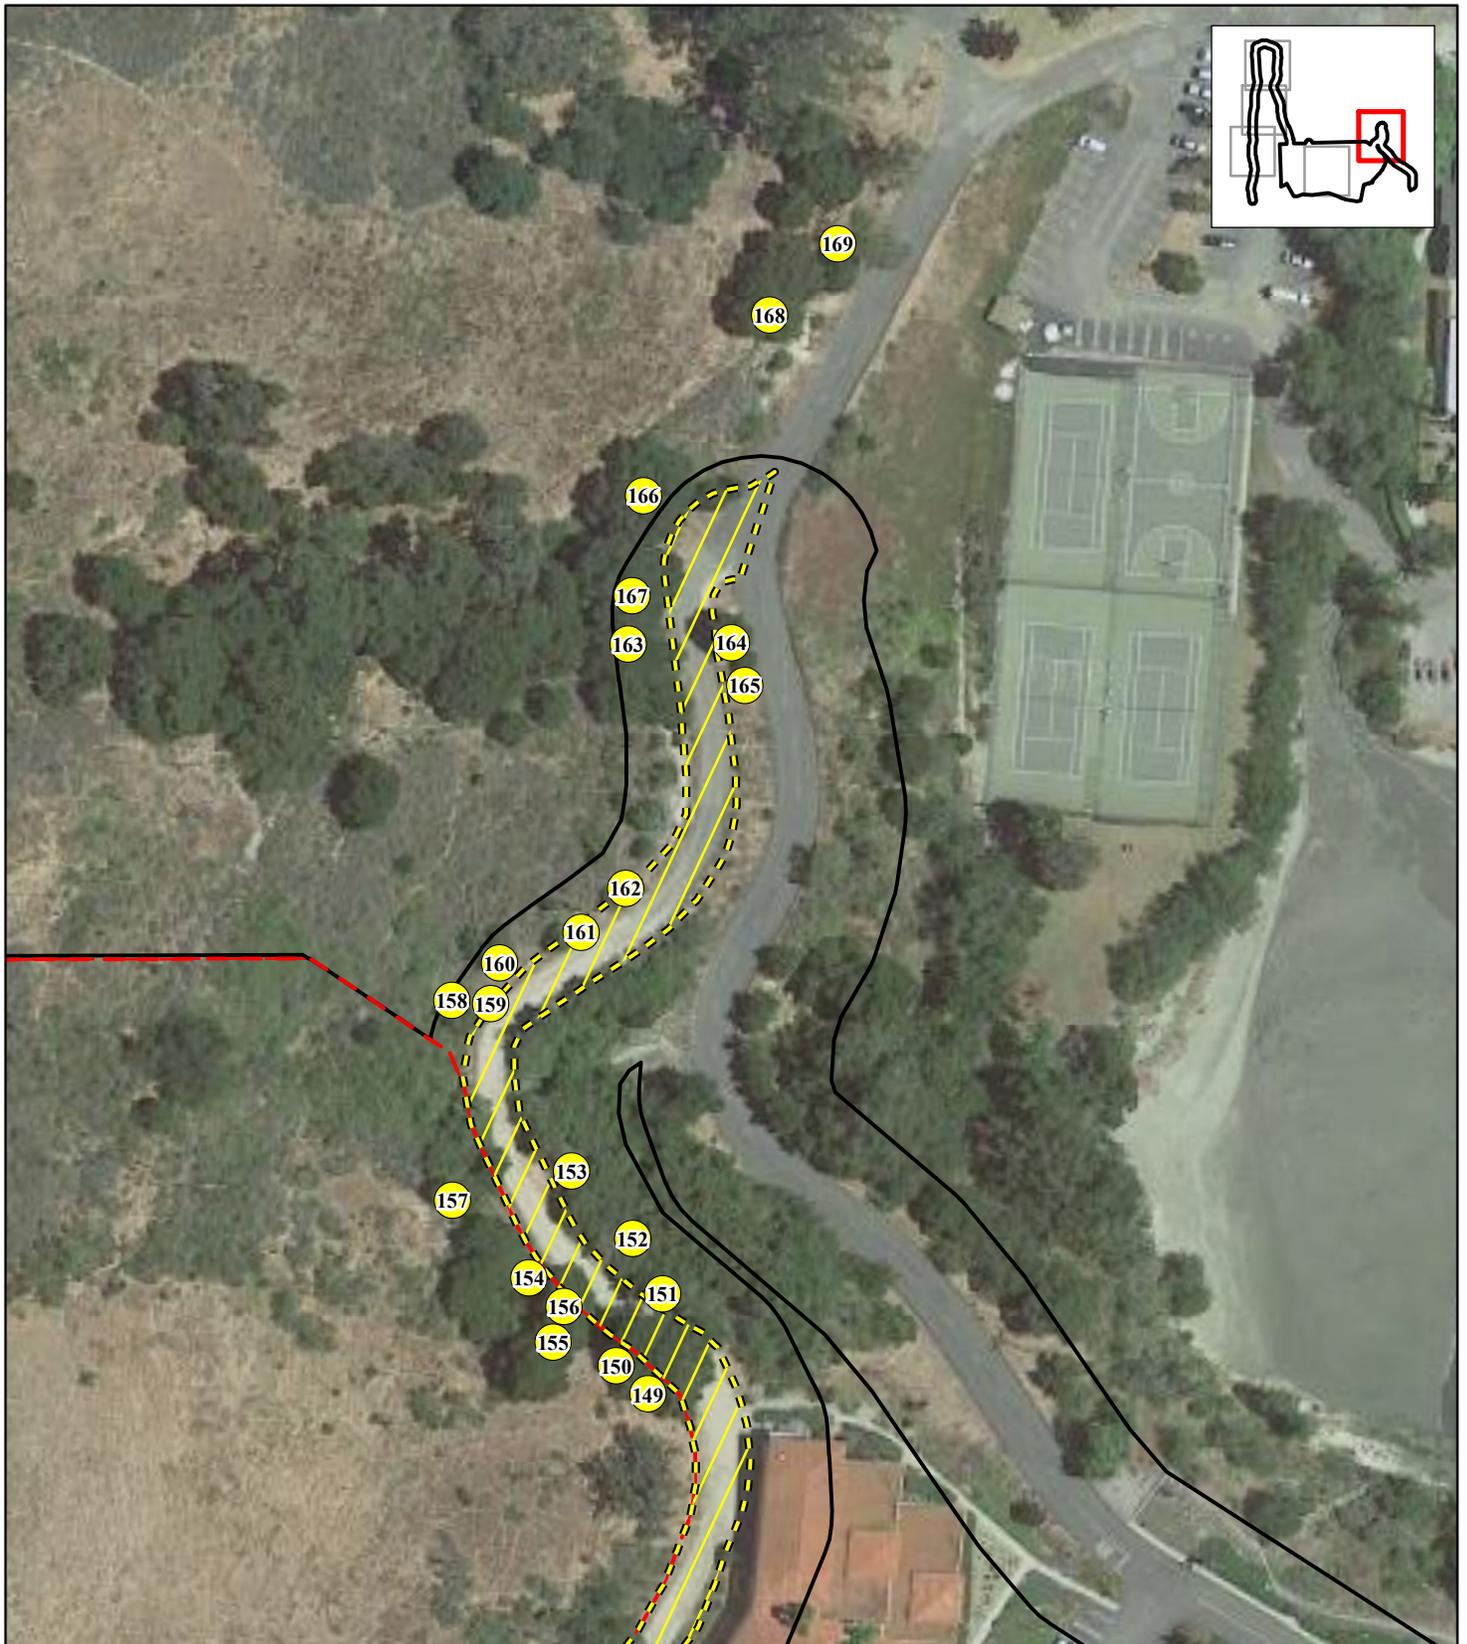
FIGURE 3D

Approximately 17 trees were identified to have probable impacts related to the access road (refer to Figure 3D and Table B-1), and approximately 6 trees have potential to be removed within the development limits (refer to Figure 3E and Table B-1). Trees along the access road may be impacted in order to provide fire apparatus clearance as mandated by County fire regulations (minimum road width of 24 feet with a 10 foot fuel modification zone on each side of the road, and unobstructed vertical clearance of 13 feet 6 inches). These impacts are exempt from County tree removal permit requirements. Depending on the size of construction related equipment (i.e., scrapers, dump trucks, etc.) and the final development limits, several trees will likely require additional trimming or removal beyond the County fire code regulations.

The removal of one or more individual trees may be needed to accommodate required access road improvements for the proposed project, and up to 6 trees will likely be removed within the development limits based on the current site plans. The proposed project will likely require a tree

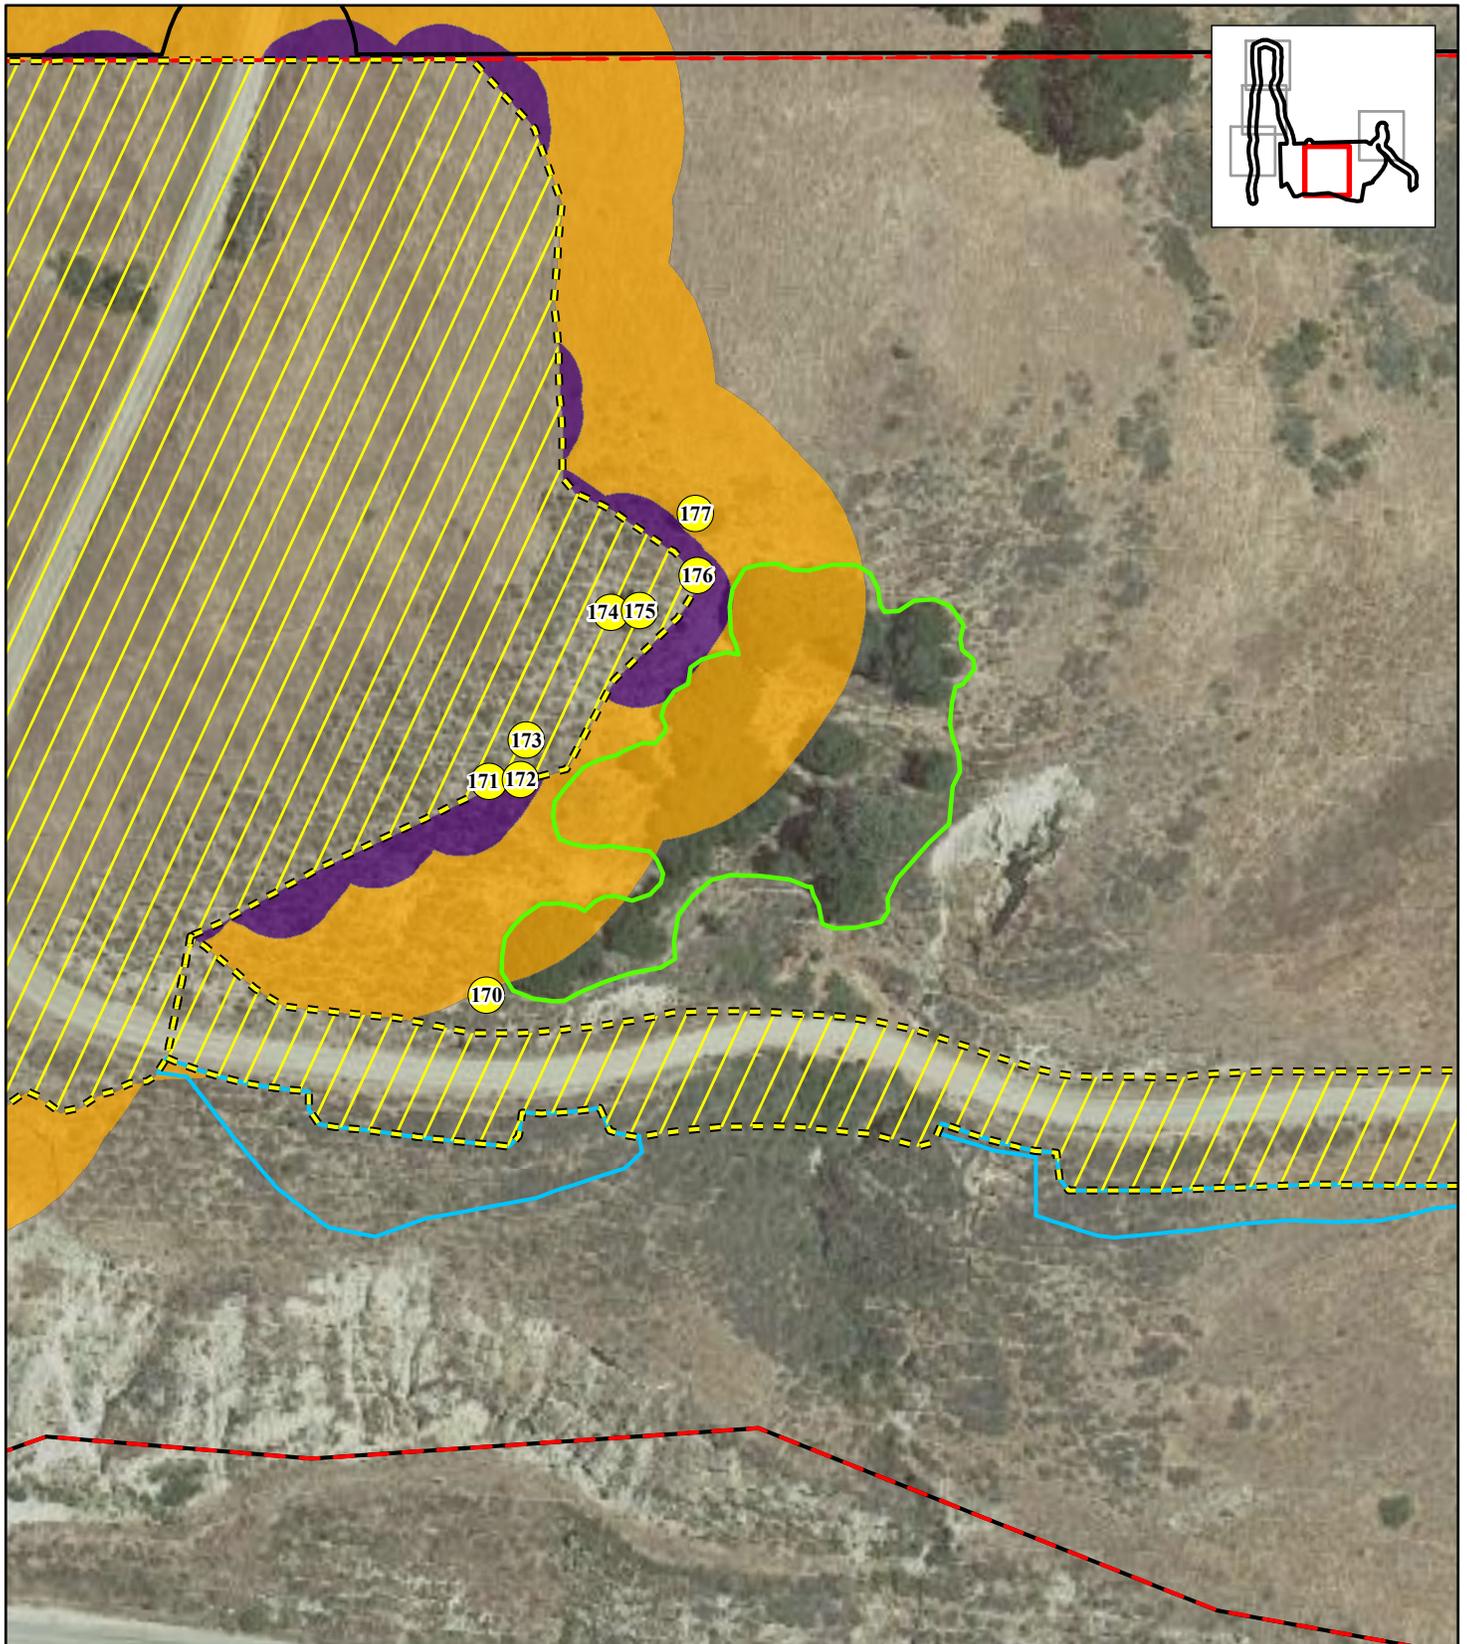
FIGURE 3E

A stand of coast live oak woodland is present within the central survey area just north of the proposed access road. The limit of the wooded area is designated by an outline of the canopy on Figure 3E. These trees are not planned to be impacted and should be protected as outlined in the section below, titled *Tree Protection Measures*.

proposed project plans should incorporate placement of tree protection fencing outside of the drip line of protected trees (as depicted on Figure 3E). Preserved trees on the project site should be avoided during the construction phase by following best management practices as outlined in the following paragraphs.

Tree Protection Fencing. Prior to the start of construction, Tree Protection Fencing (TPF) should be installed around the stands of coast live oak woodland and individual oak trees in proximity to ground disturbance areas. The TPF should be maintained during the entire development process to prevent direct damage to trees and their growing environment. The TPF should consist of blaze orange barrier fencing supported by metal “T bar” fence posts. The TPF should be placed at a distance that is at or outside of the drip lines of avoided trees. The TPF should be installed as part of the site preparation before construction or tree removal/trimming begins and should be installed under the supervision of a qualified arborist. The TPF should not be altered in any way that would increase the encroachment on the avoided trees during construction activities.

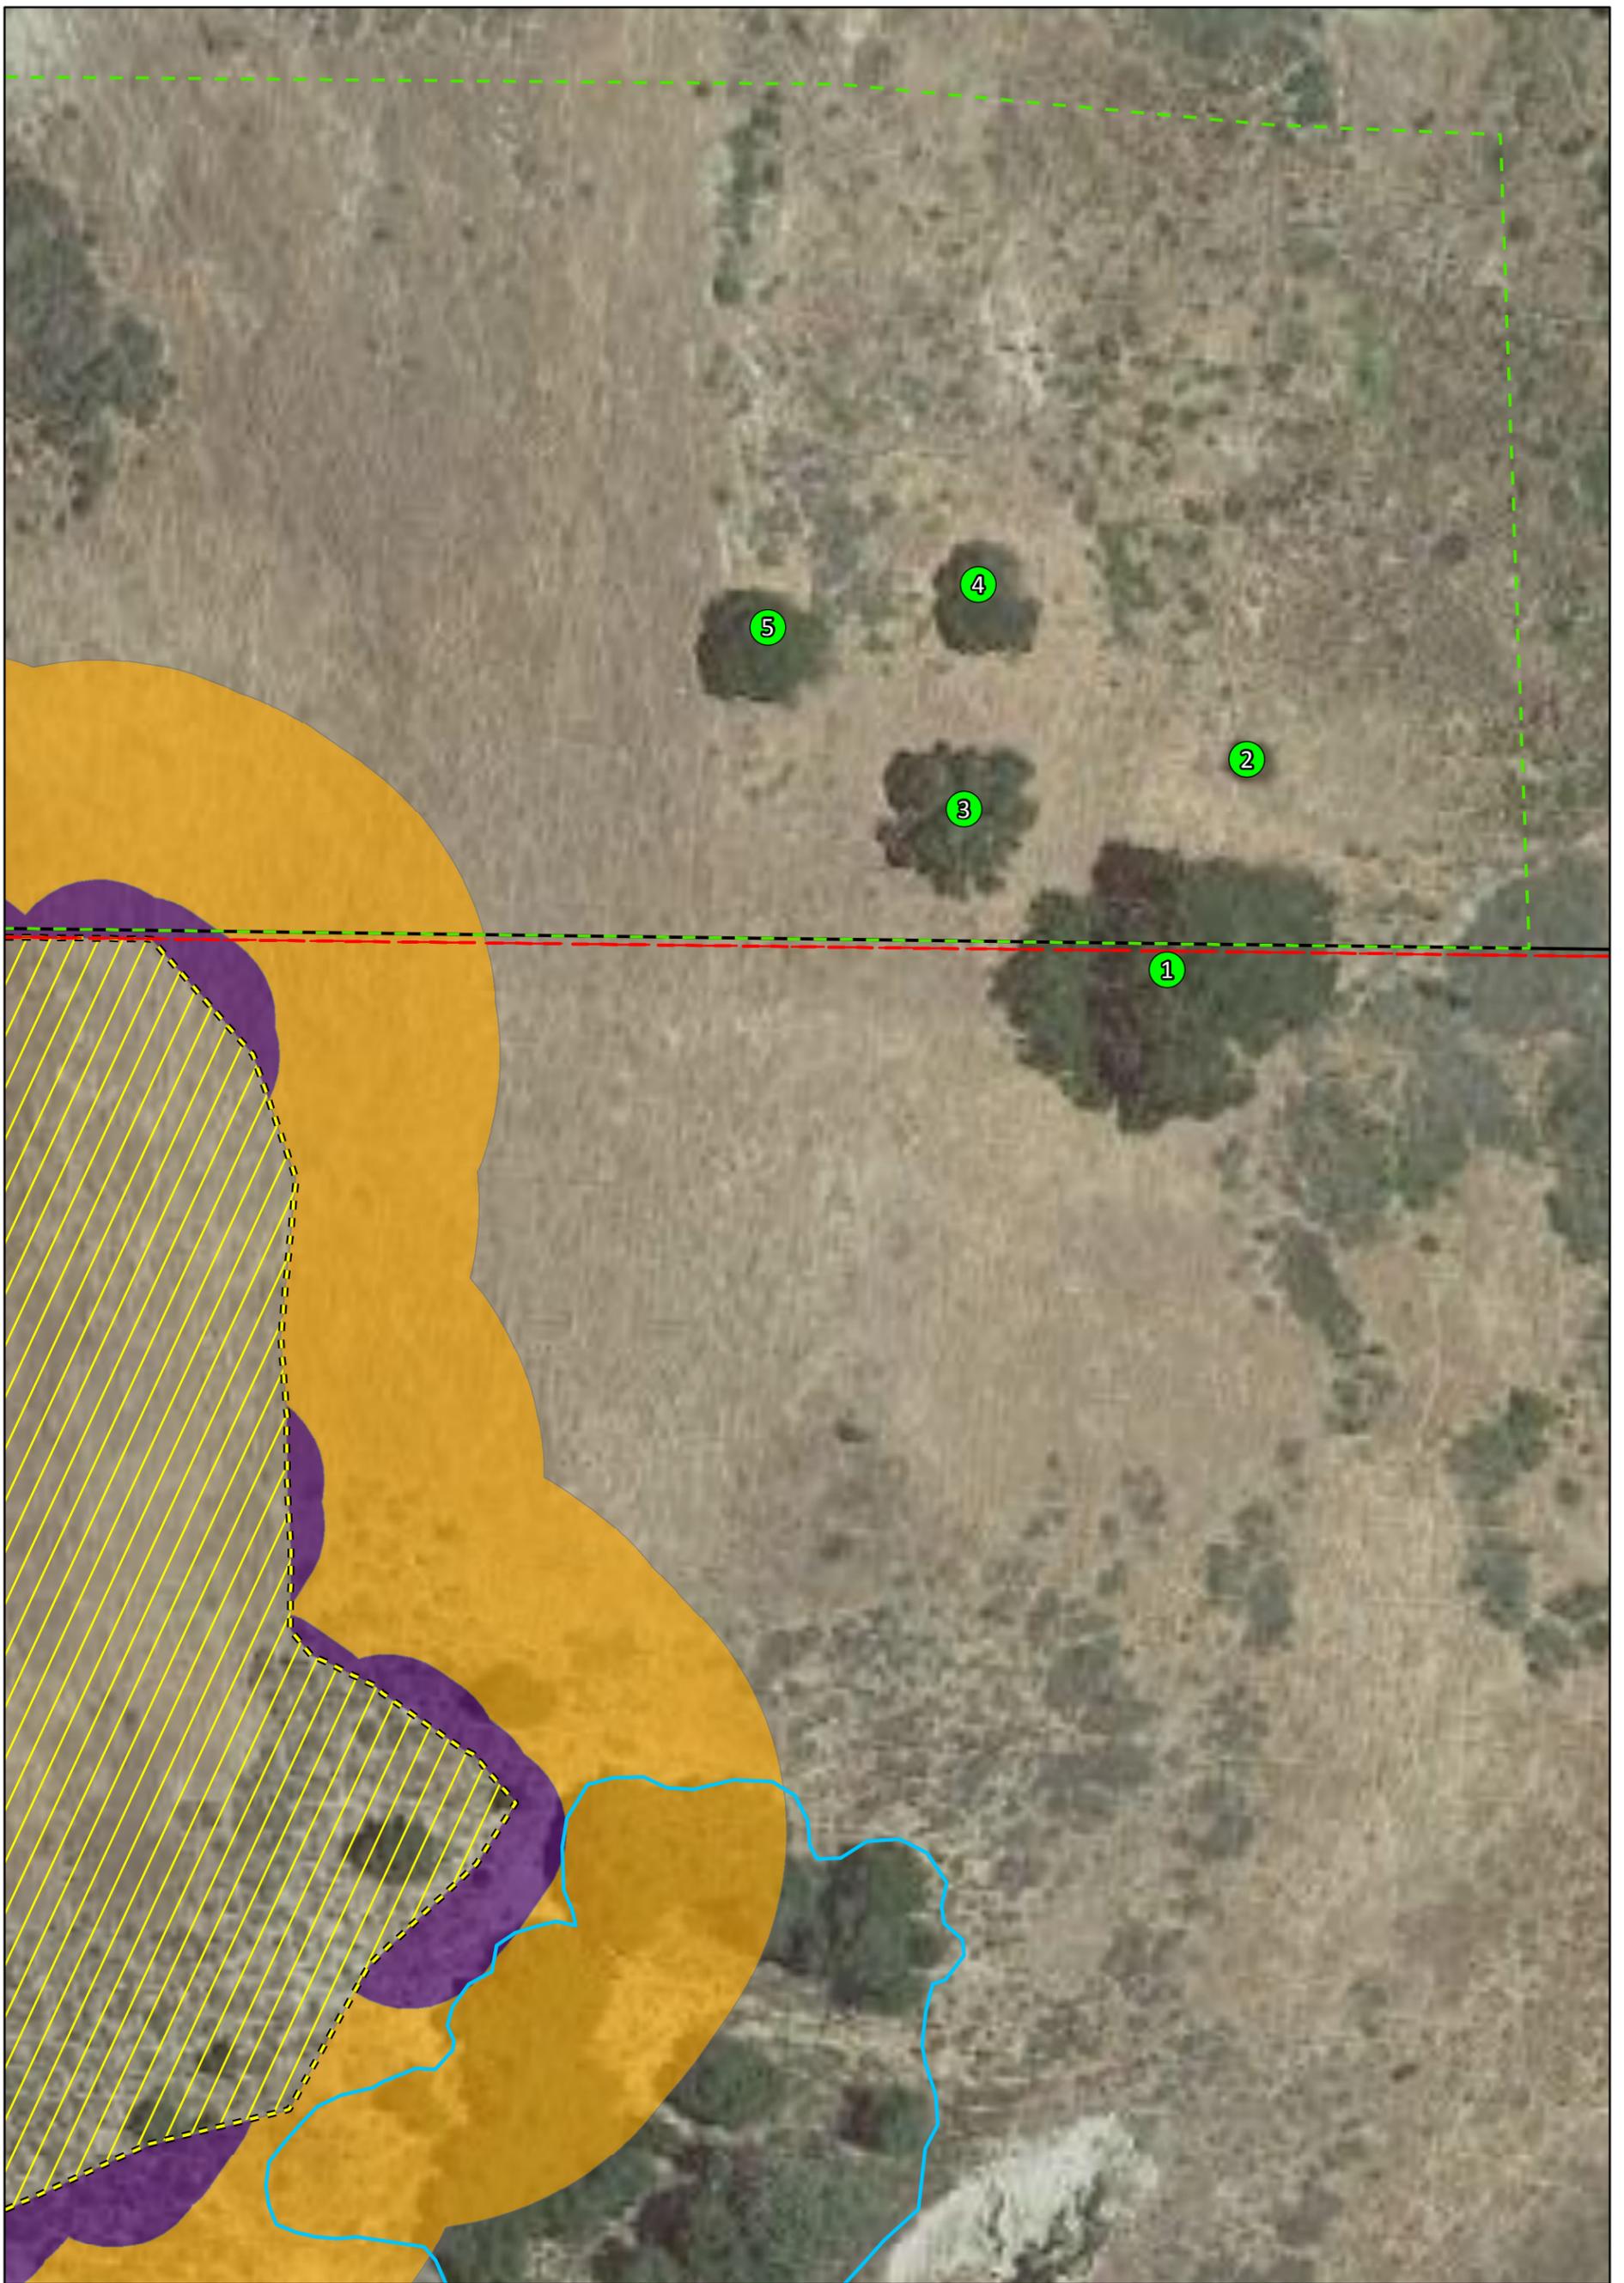
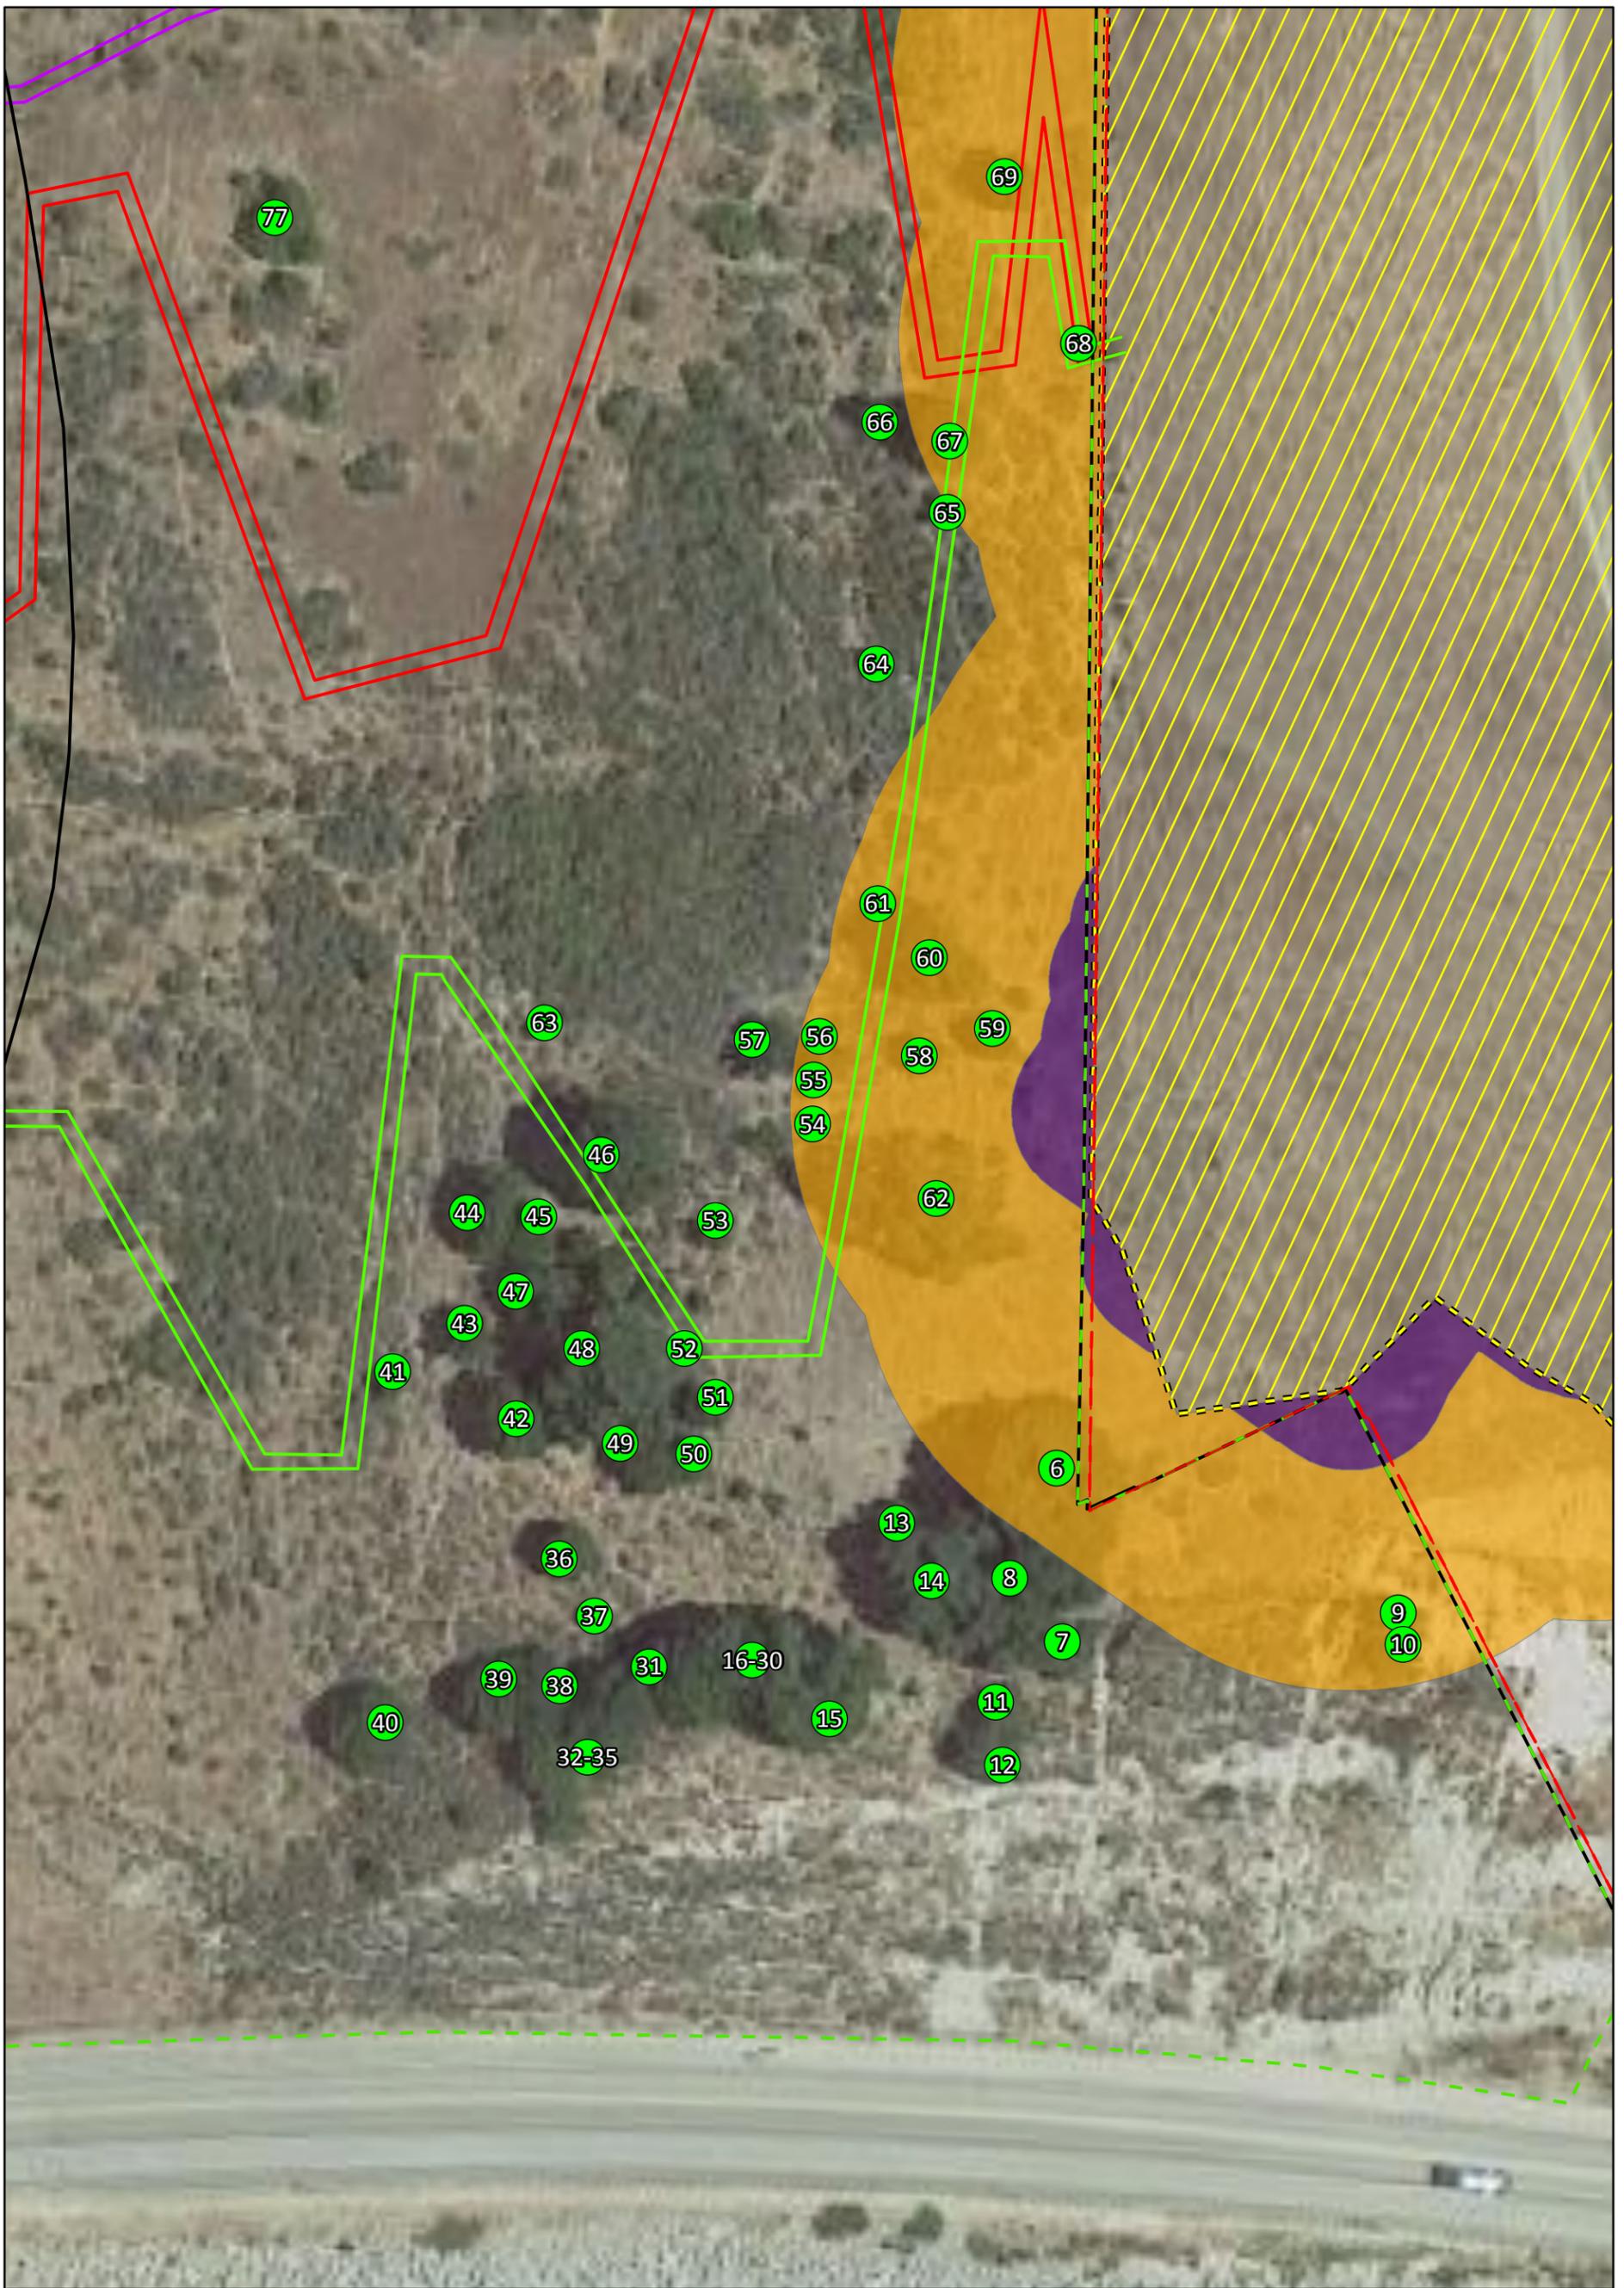
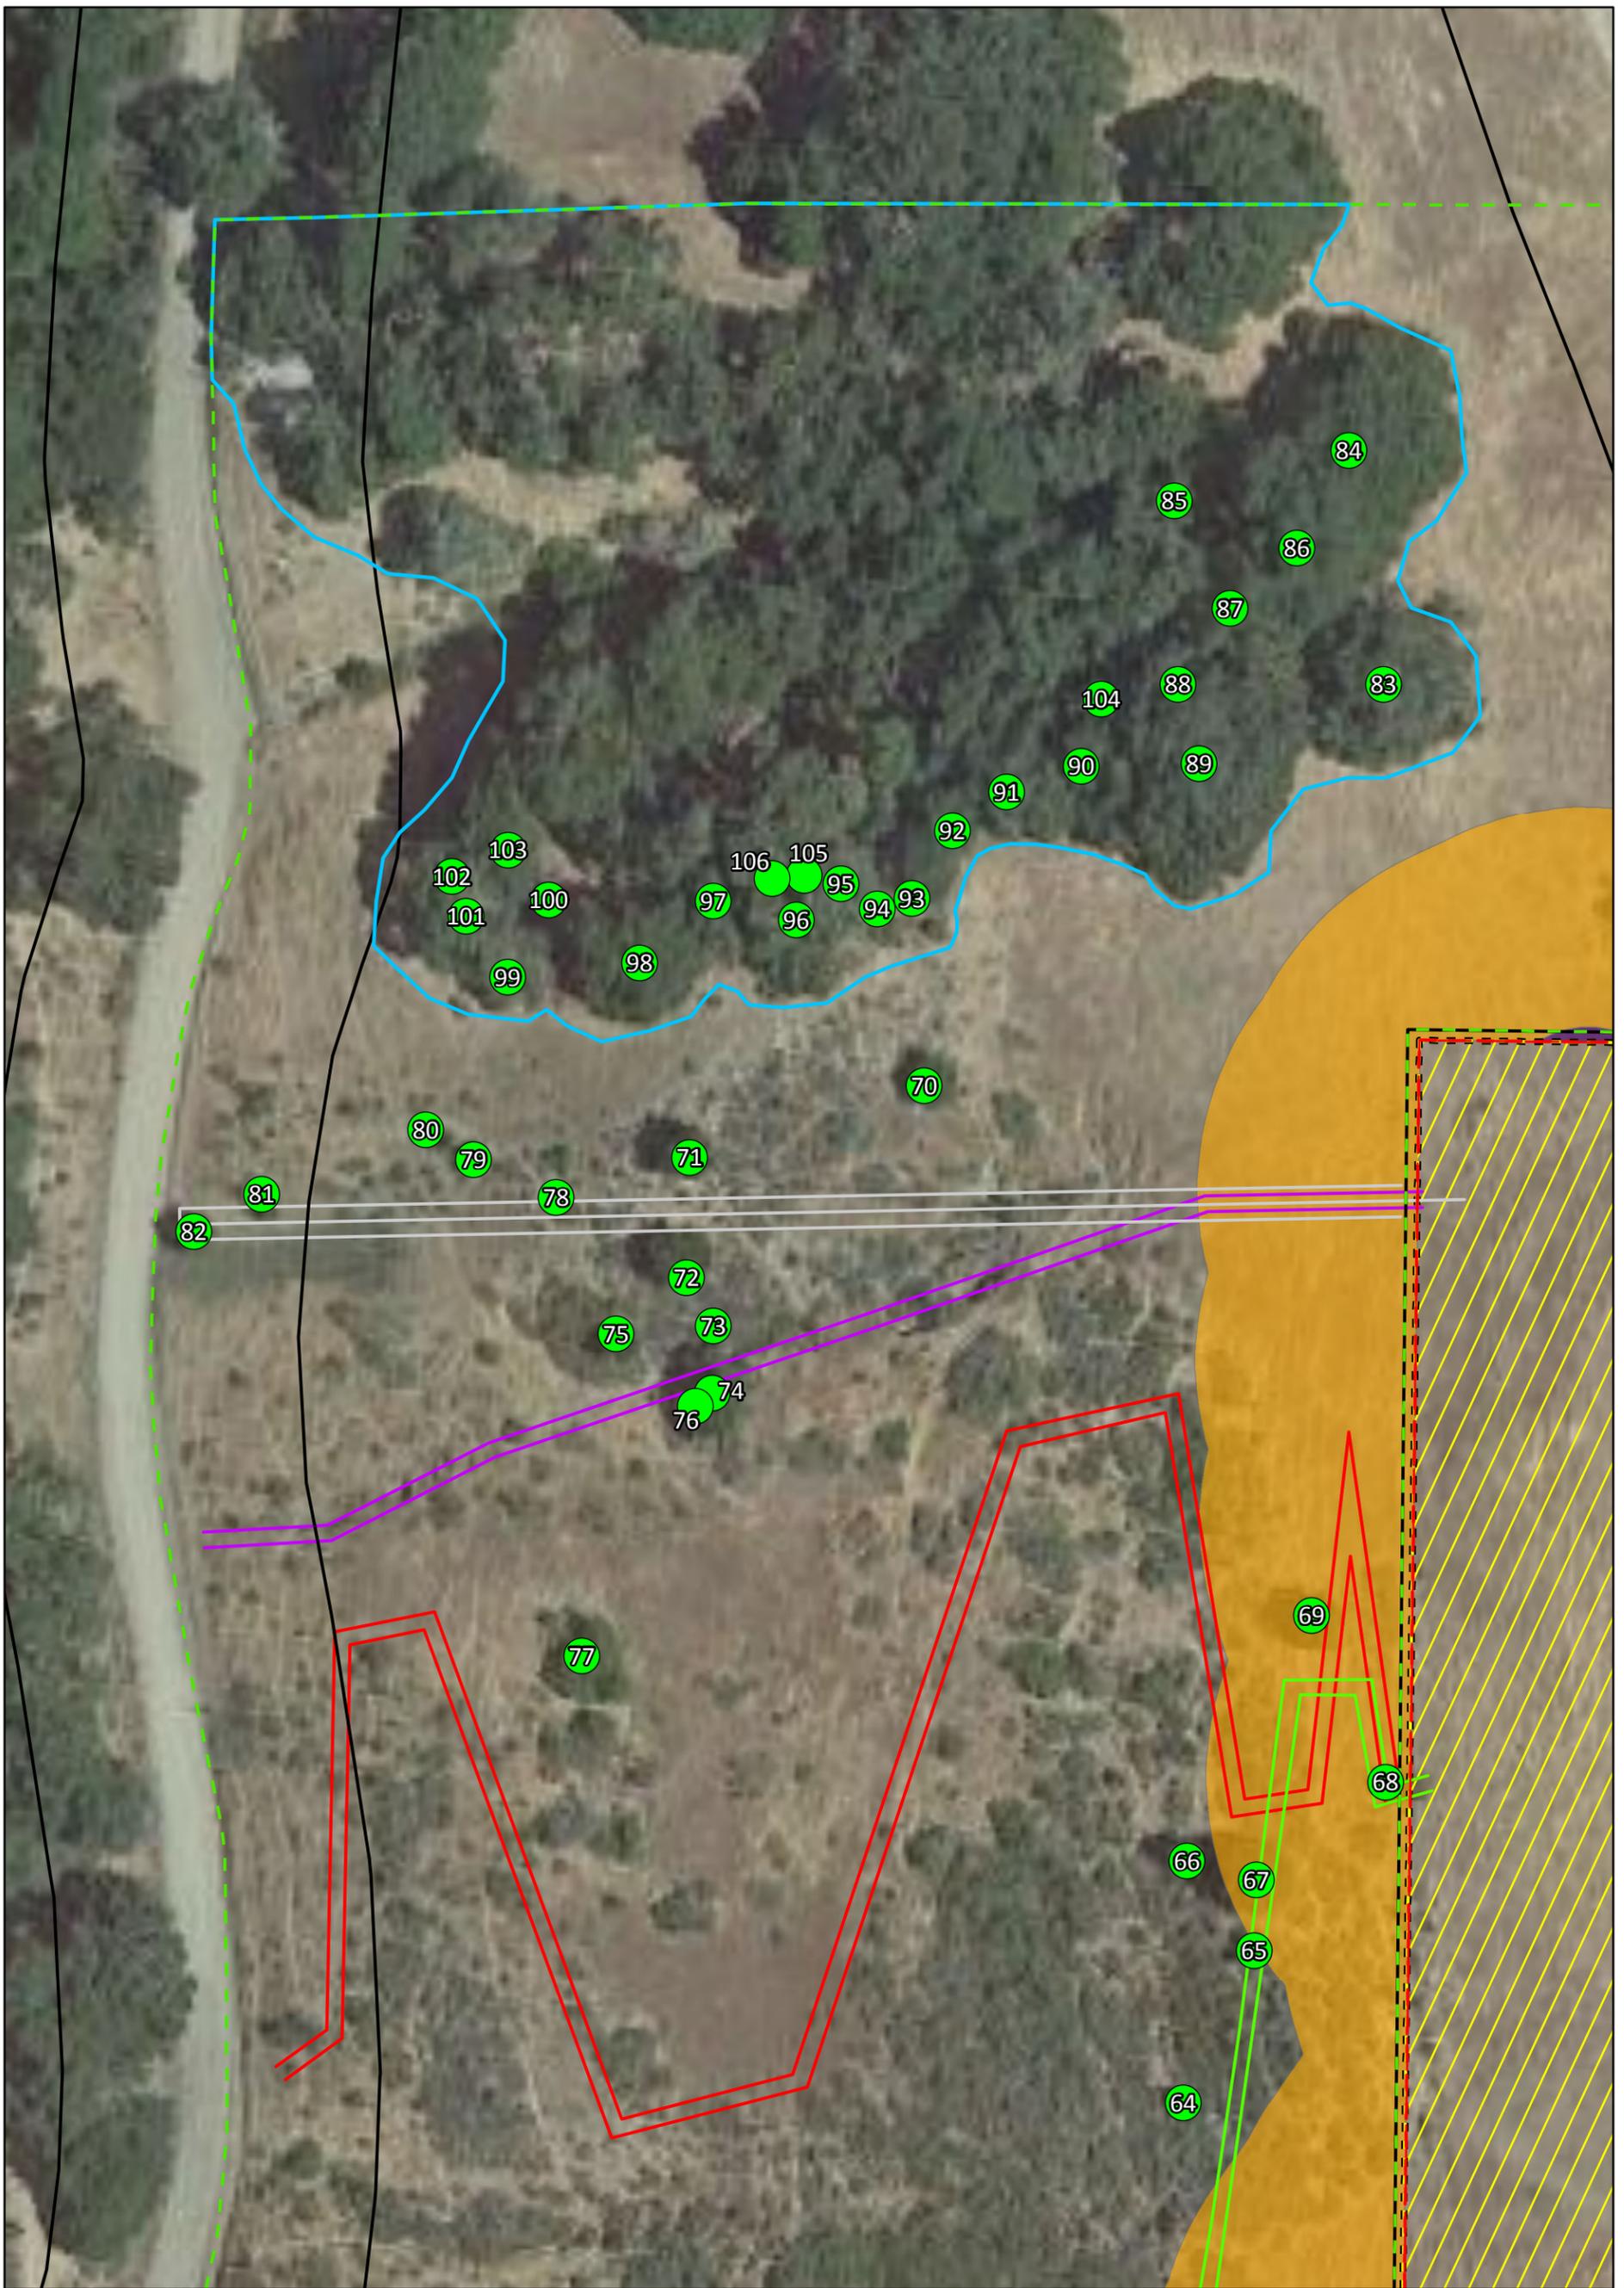
FIGURE 4
Page 2 of 3

A total of 106 coast live oak trees were surveyed within the supplemental survey area, as summarized in Table 2 and depicted on Figure 4. In addition to a small grove of oak trees to the northeast of the building footprint and the oak trees between the proposed building footprint and Wild Cherry Canyon, a woodland consisting of mature coast live oak trees is present to the northwest of the proposed building footprint. This stand contains many mature heritage oak tree specimens and was identified as a collective resource; not all trees were assessed individually as they will be protected in place. No other native or nonnative trees were observed in the supplemental survey area.

Between 7 and 18 mapped coast live oak trees were identified to have probable impacts related to the preliminary storm drain alignment and each identified pathway alternative. Trees within these impact areas may be affected by direct trimming or removal, or construction activities (e.g., trenching, excavation, or slope contouring) within the root zones. A total of five trees are located within the identified storm drain alignment, so between 2 and 13 of the trees within the proposed impact limits are associated with the pathway alternatives.

A woodland consisting of mature coast live oak trees is present to the northwest of the proposed building footprint. This stand contains many mature heritage oak tree specimens and was identified as a collective resource; not all trees were assessed individually as they will be protected in place (refer to Figure 4, sheet 3, trees 83-106). In addition, coast live oak trees that fall outside of the final storm drain and pathway alignments should be protected as outlined in the section below titled *Tree Protection Measures*.
