Arroyo Grande Creek Channel Waterway Management Program

National Marine Fisheries Service
Biological Opinion Annual Report

January 2026

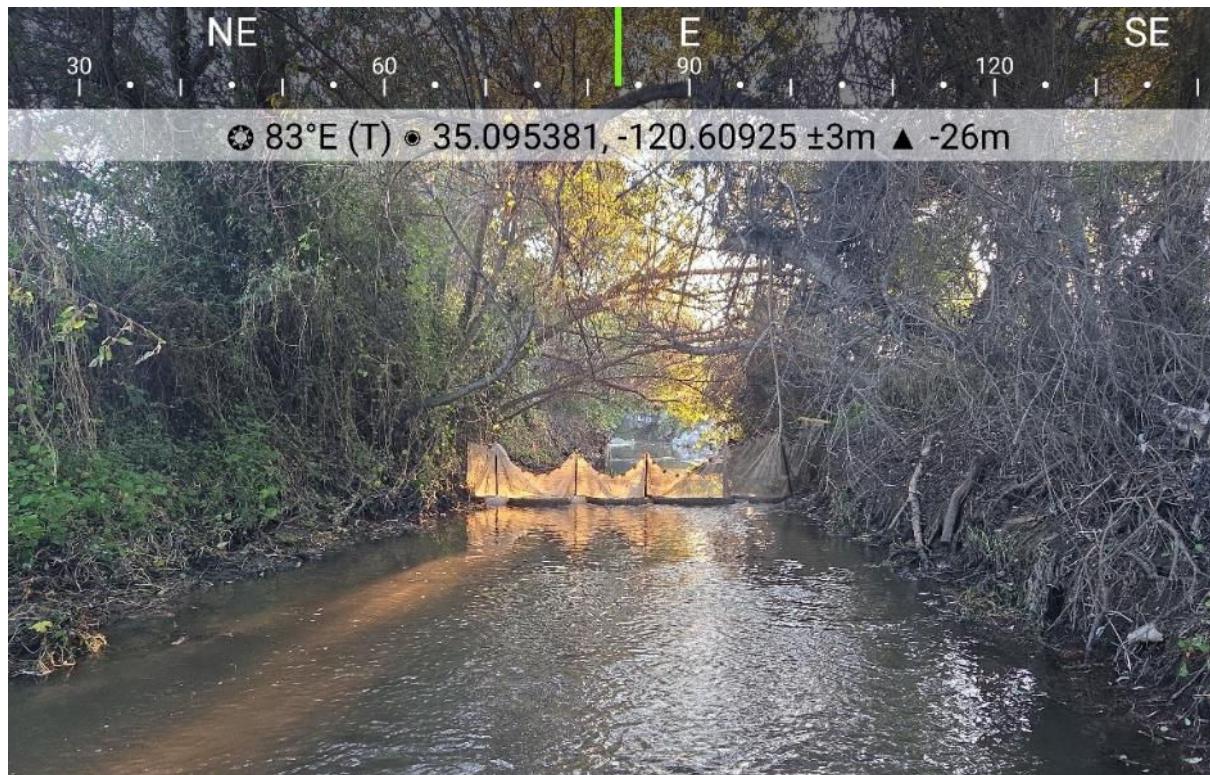
Photograph 7. Looking east at the upstream block at the Breach Site. October 16, 2025.

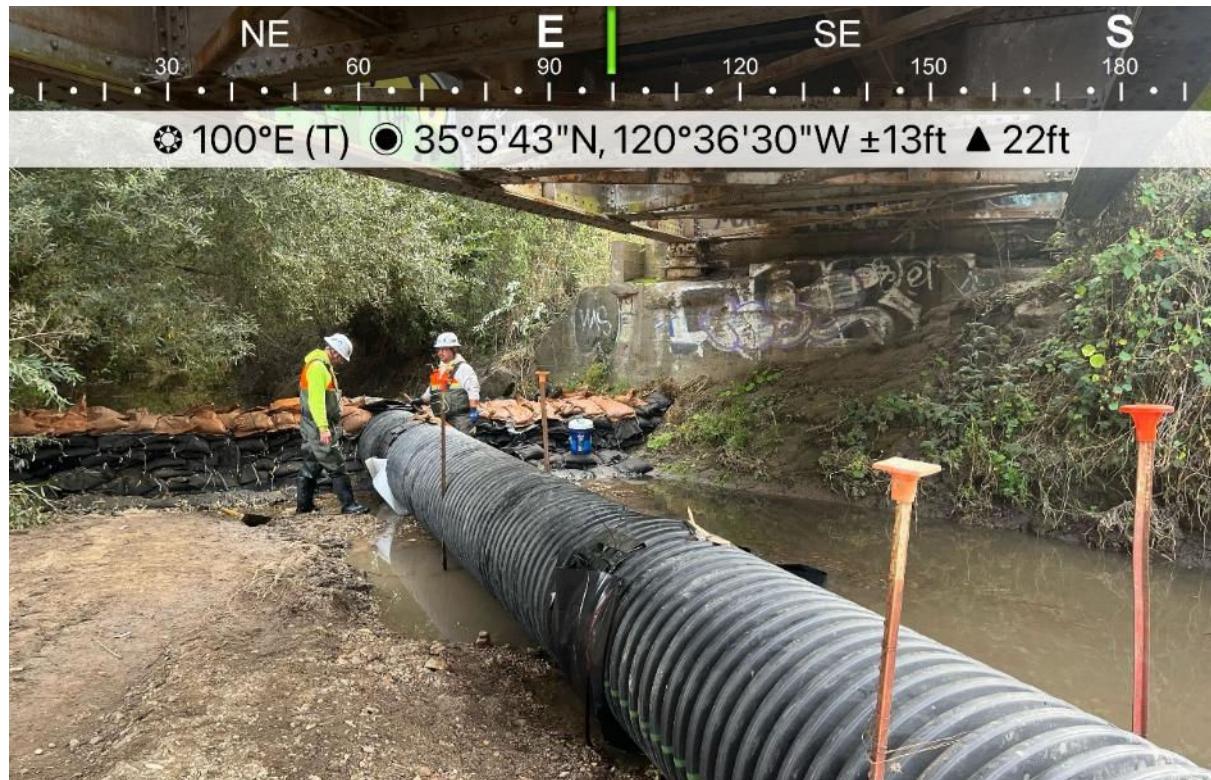
Photograph 11. Looking east at the upstream diversion dam and diversion pipe running under the UPRR Bridge. October 21, 2025.

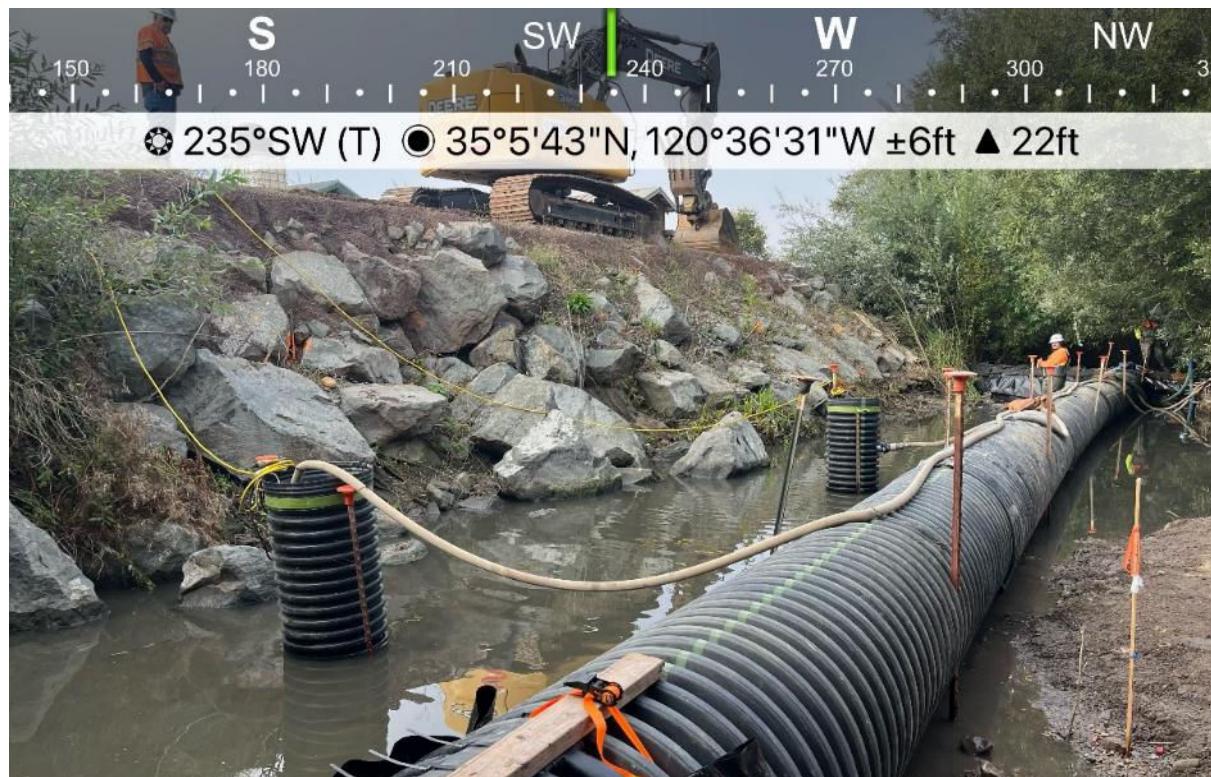
Photograph 12. Looking downstream (southwest) at the Breach Site with diversion pipe and dewatering wells in the foreground. October 21, 2025.

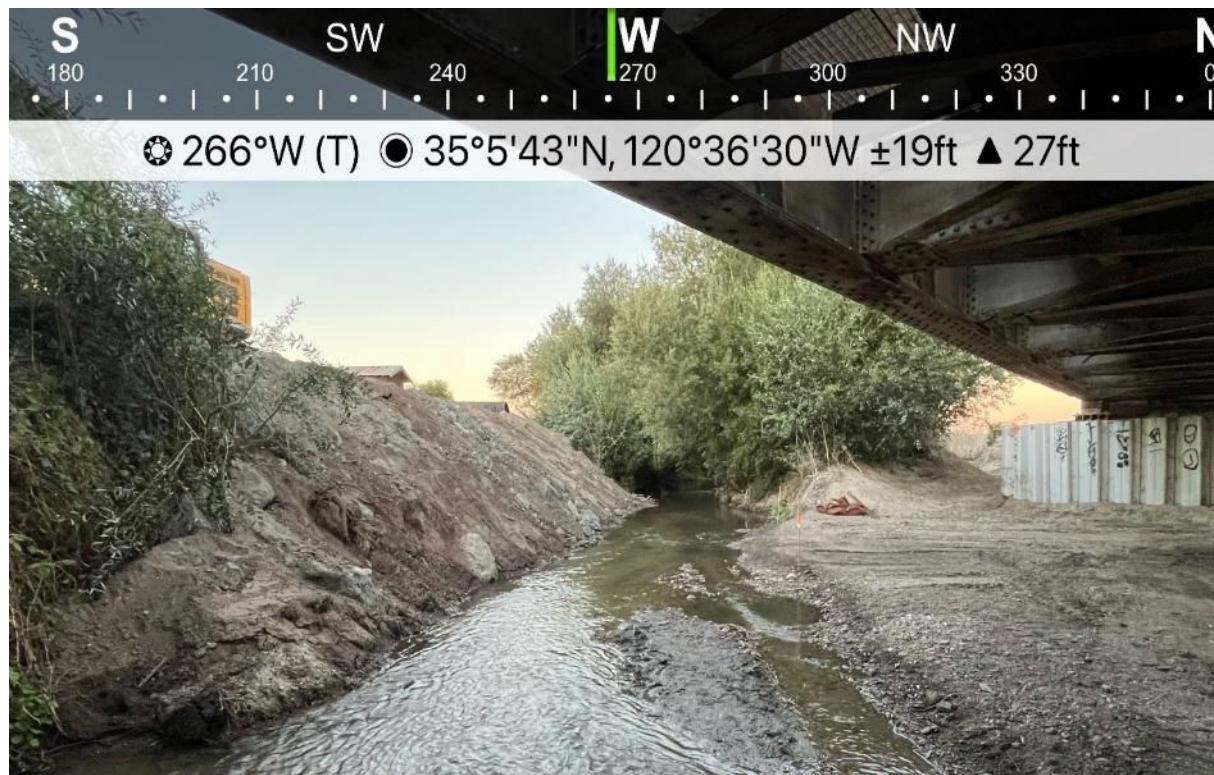
Photograph 16. Looking downstream (west) of Breach Site; levee bank has been stabilized, diversion removed, and streamflow returned to the primary channel. October 28, 2025.

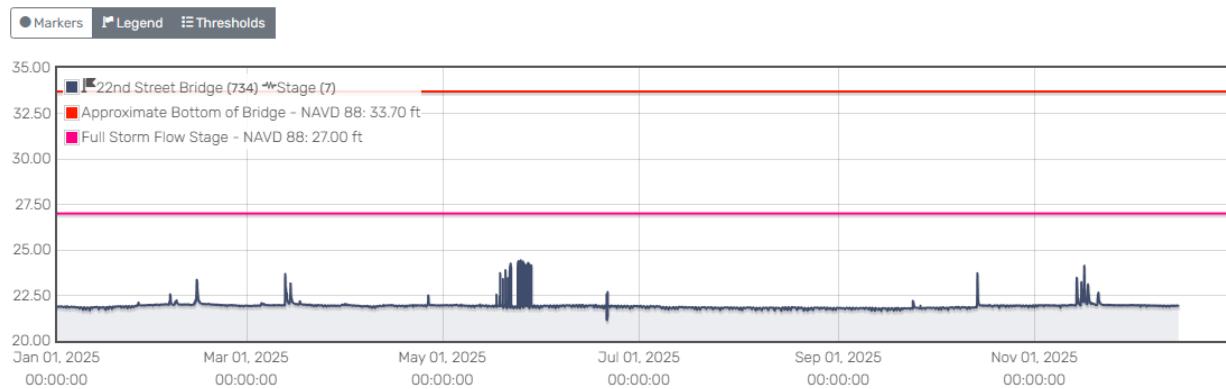
Figure 1. 22nd Street Bridge Gage Stage Data 2025

Conditions remained relatively unchanged since the fall 2024 inspection, which followed sediment and debris removal activities completed throughout most of the project reach. Refer to the 2024 report for locations where maintenance occurred. Storm flows during 2025 were similar to those in 2024, if not lower. The creek did not experience any high-flow events exceeding full storm flow stage at the 22nd Street Bridge gage (County of San Luis Obispo Public Works Department, 2025). Figure 1 includes a graph showing flow stage at 22nd Street Bridge during 2025.

Few secondary channels appeared to have been activated during 2025, and of those activated, all but Secondary Channel 15 have swapped from their primary channels to the secondary permanently. Table 1 summarizes the secondary channels activated during each winter since monitoring began in Water Year 2020.
