Arroyo Grande Creek Waterway Management Program

Update to 2025 Vegetation Management and Sediment Removal Work Plan

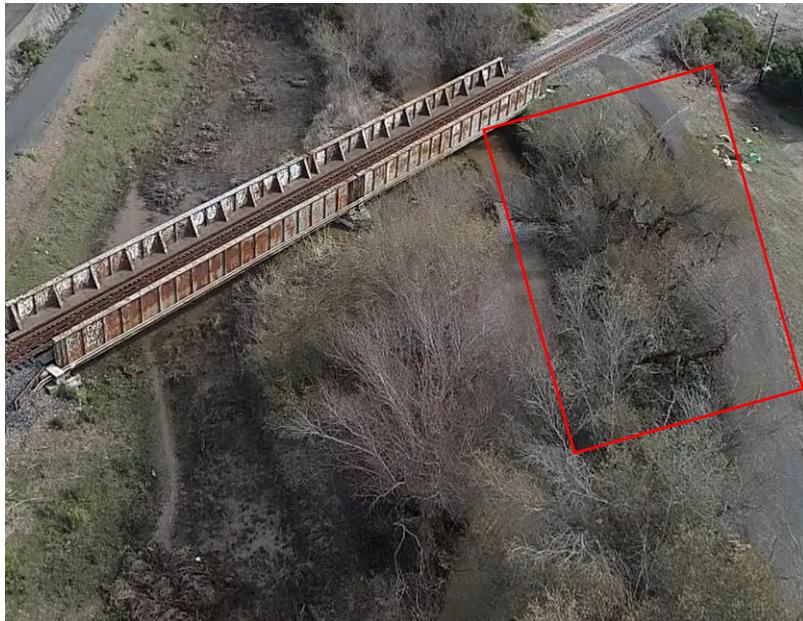
Figure 1: Breach Site Location with Intact Riparian Buffer (January 2021)

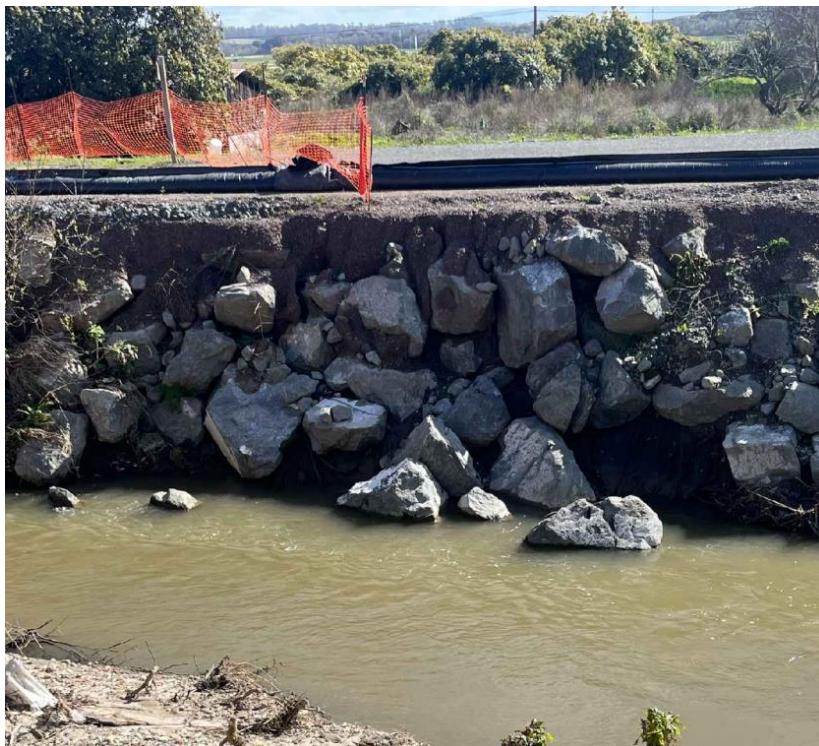
In 2024, the District observed that the breach site repair had become destabilized and that new scour and erosion along the repair site had resulted in the displacement of RSP along the toe of the levee slope. The District's engineers determined that the condition of the breach site repair was unstable and vulnerable to failure. On June 19, 2024, the District prepared a letter initiating the discussion on the need for stabilization of the breach site by repairing the eroded levee slope.

The existing condition of the 2023 breach site is a steep and unstable armored levee slope that does not support riparian vegetation along the channel bank. In its current state, the breach site does not support the ecological function of the riparian buffer zone as intended throughout the

Figure 2: Existing Levee Breach Site, Looking South (Cannon, Spring 2024)

integrity of the levee and the riparian buffer by anchoring approximately 205 cubic yards (115-linear feet) of 18-inch to 36-inch diameter RSP along the base of the existing RSP from the 2023 emergency repair within the inner levee slope.

Stabilization of the levee slope at this location will facilitate restoration of the riparian buffer, which was lost during the 2023 flood condition that initiated the emergency repair activity. RSP voids will be soil-filled and a final layer of soil will be placed over the top of the RSP. Native creek bank and creek bed material excavated for the rock placement will be used to fill voids, and additional soil will be brought to the project area as needed to supplement the native material. Approximately 130 cubic yards of soil will be placed, with approximately 20 cubic yards placed within the RSP voids below the assumed OHWM. The graded surface will be hydroseeded and cottonwood cuttings will be placed within the RSP along the toe of the slope. The vegetated RSP is expected to restore the ecological value provided by the riparian buffer that was lost at this location as a result of the levee breach.

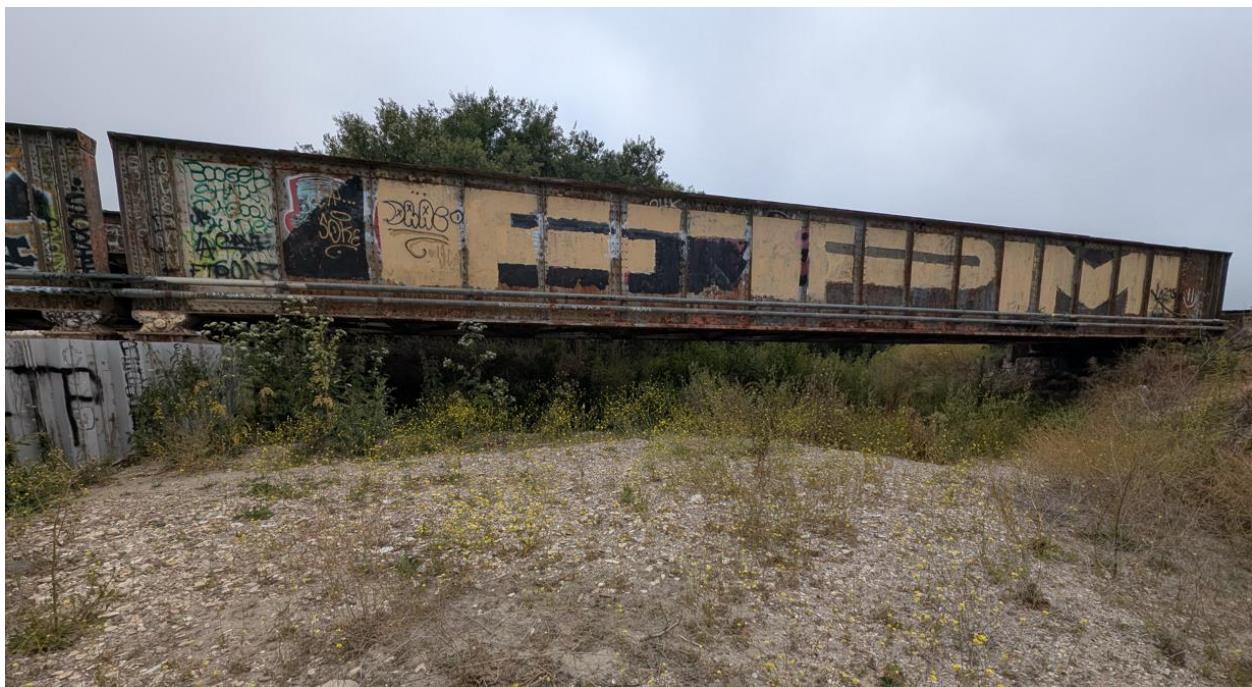
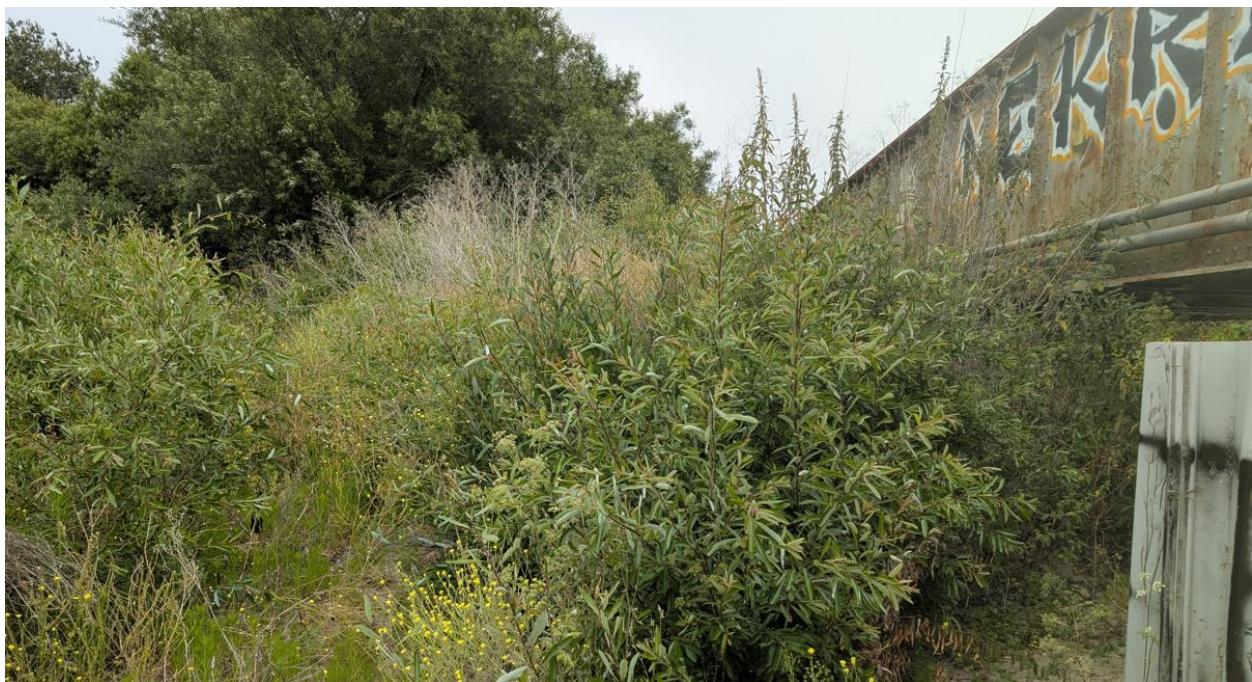
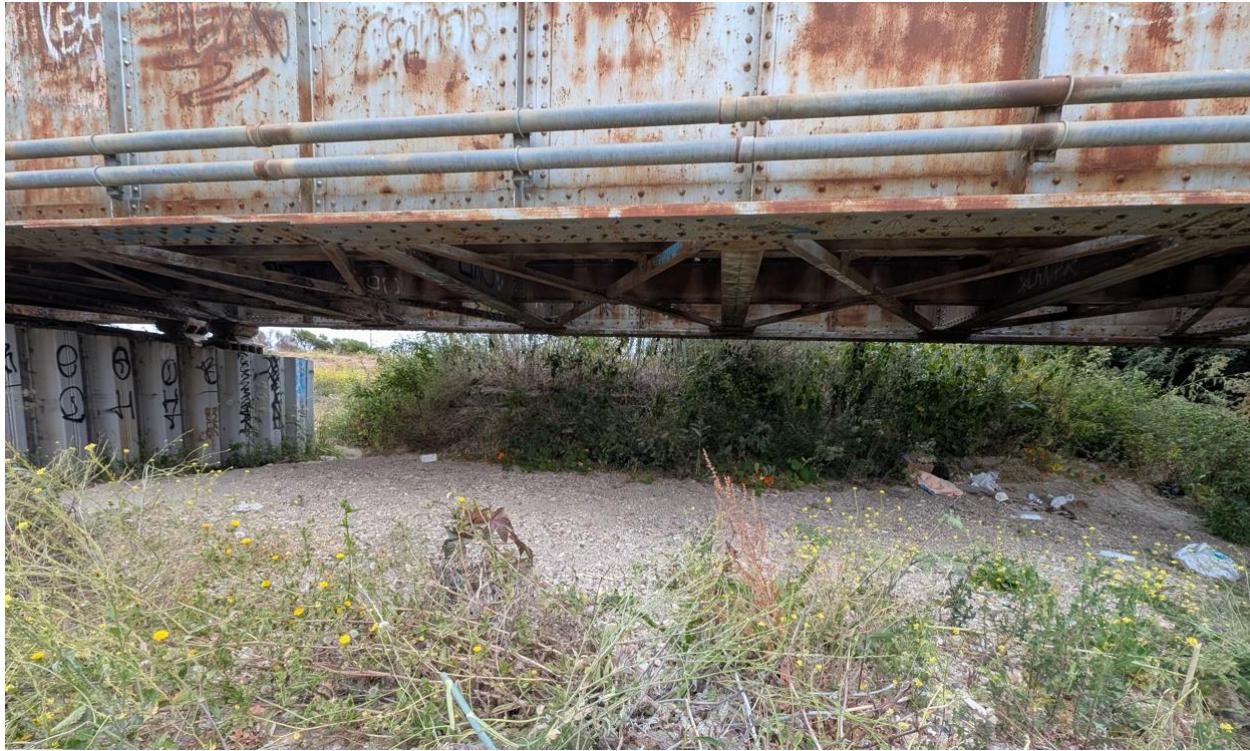
Sediment has accumulated within the secondary creek channel of SMZ 7, both underneath and adjacent to the UPRR bridge, as well as within the discontinuous segment of the riparian buffer 20-feet upstream and downstream of the UPRR bridge. In the existing condition, the sediment bar has widened and lengthened forming an impediment to flow contiguous with the bridge center pier. The existing condition is shown in Figures 3 through 5 below.

Figure 33: Sediment Accumulation in SMZ 7, Looking Downstream (Wallace Group, June 2025)

Figure 4: Vegetation at Upstream UPRR Bridge Face (Wallace Group, June 2025)

Figure 5: Sediment and Vegetation Blocking the UPRR Bridge Opening, SMZ 7 Looking Downstream (Wallace Group, June 2025)

Approximately 300 CY of sediment along 190 LF of the secondary channel is necessary for SMZ 7, which is proposed to occur at the same time the breach site stabilization work and necessary stream diversion is in place at this location. In accordance with permit conditions, vegetation removal will occur only as necessary and is restricted to within 20-feet upstream and downstream of the bridge in order to clear sediment underneath and adjacent to the bridge.

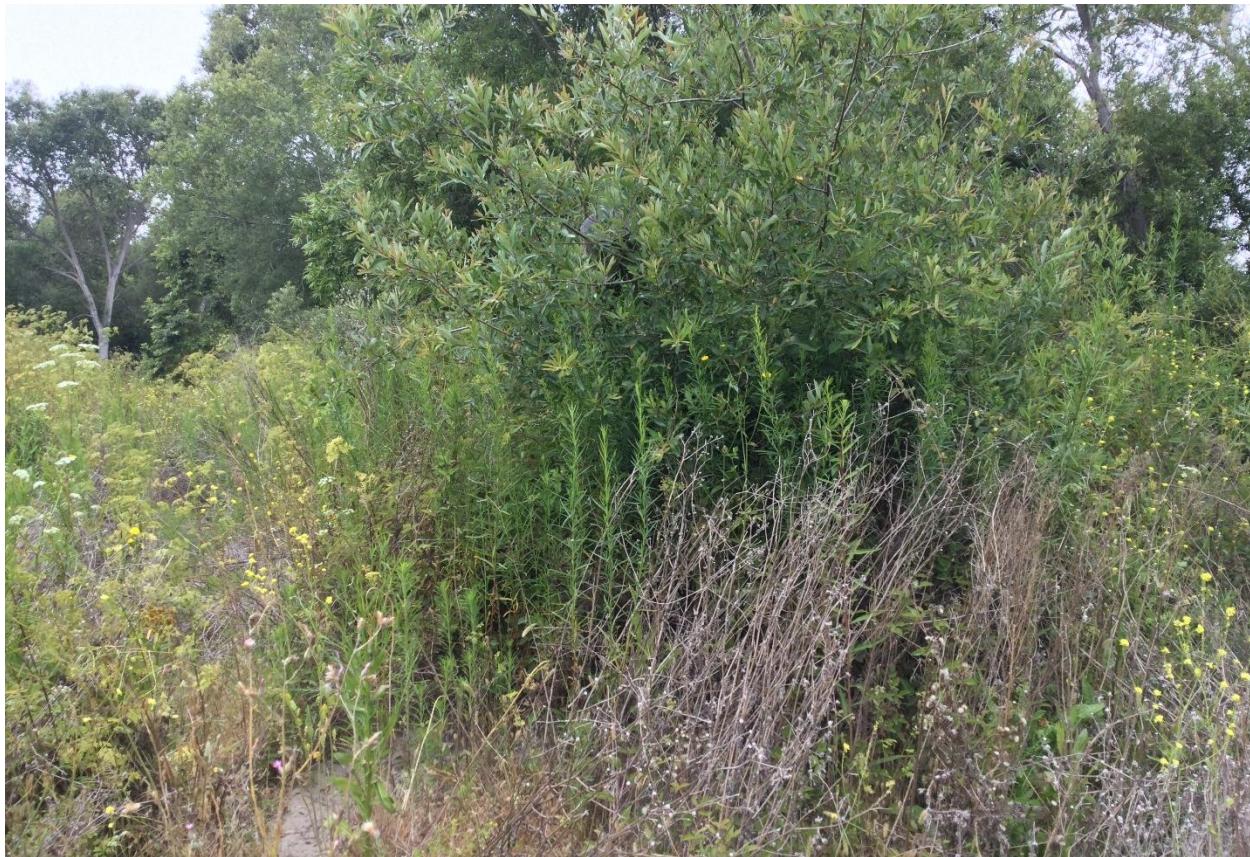
The HEC-RAS model indicates that under existing conditions the creek has more than 2 feet of freeboard along the length of SMZ 1. Sediment removal is anticipated to be limited to restoration of the log structure at this time.

Figure 66: Sediment and Vegetation Covering Log Structure 1A, Looking Downstream (Wallace Group, June 2025)

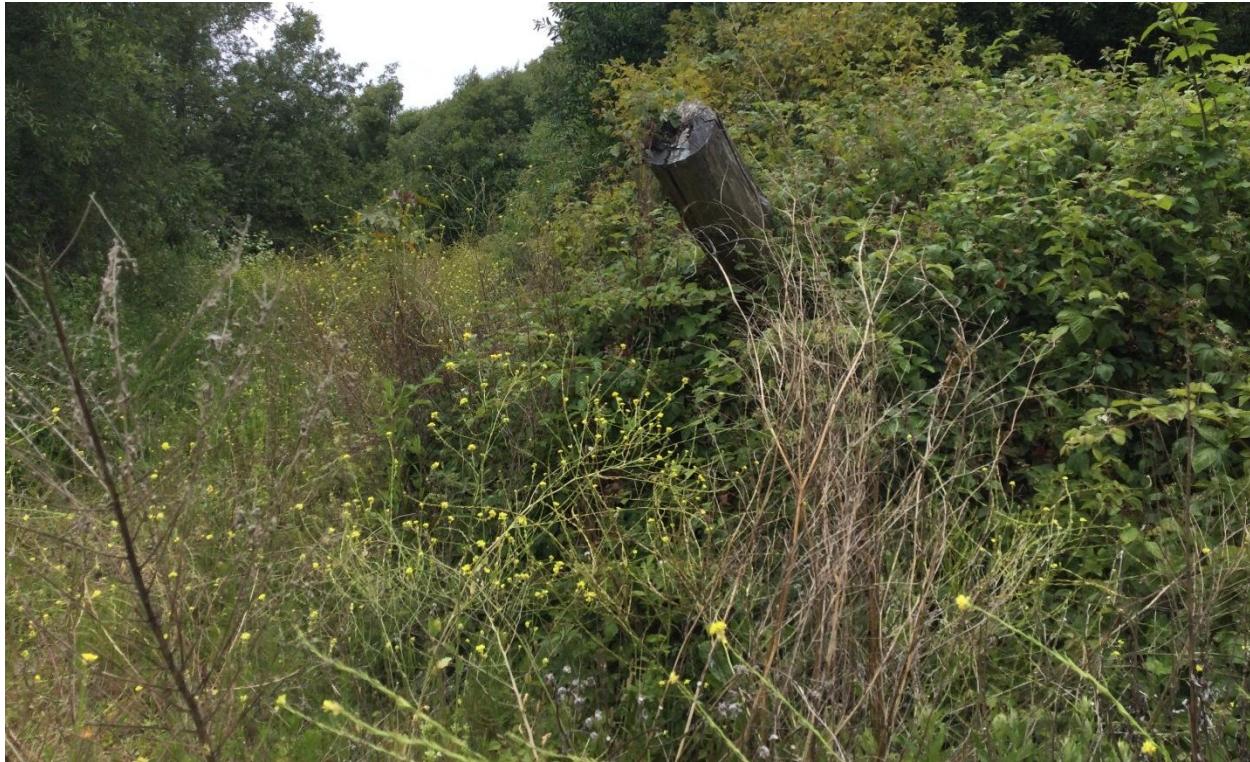
Figure 7: Log Structure 2A, Looking Downstream (Wallace Group, June 2025)

The HEC-RAS model indicates that under existing conditions the creek has less than 1-foot of freeboard along the upstream half of SMZ 2, and less than 2-feet of freeboard along the lower half of SMZ 2. The model will be used to evaluate the extents of sediment removal required to restore design capacity in this location. The initial estimate of sediment removal quantities and lengths assumes that sediment removal will be limited to the area in and around Log Structure 2A.

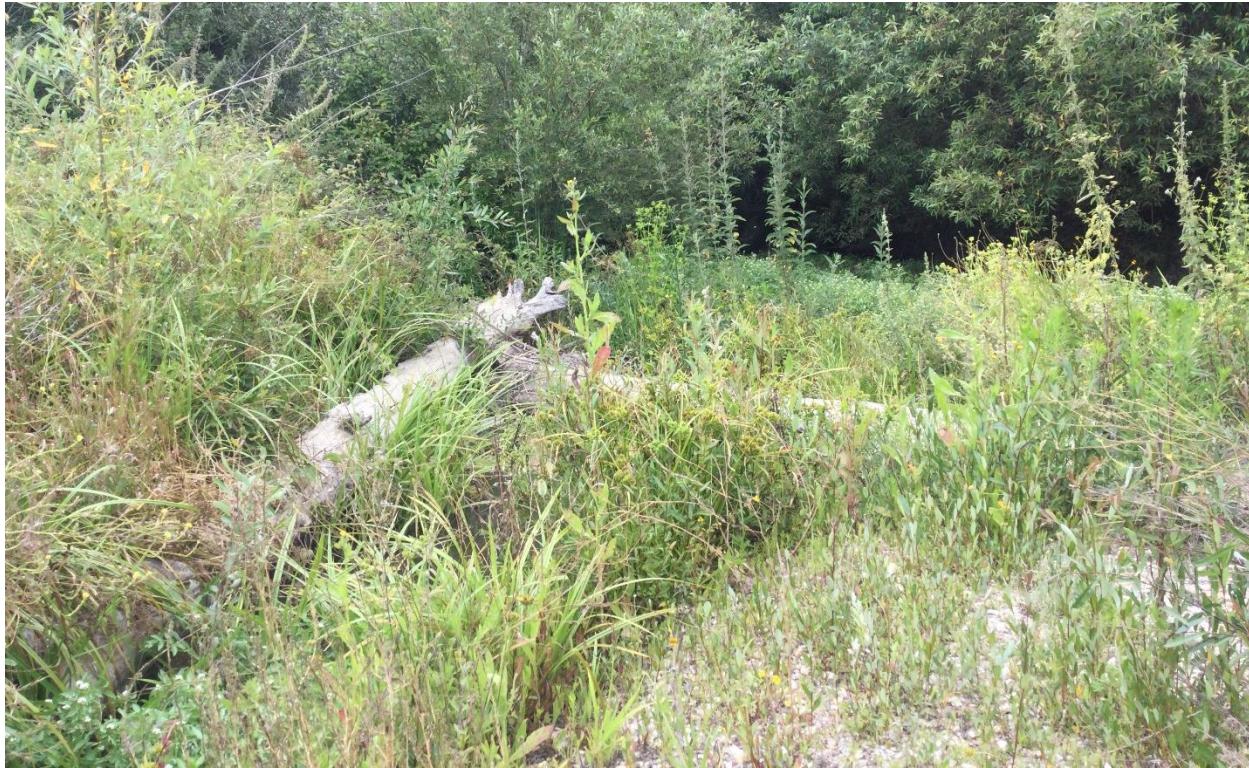
Figure 8: Log Structure 3B, Looking Downstream (Wallace Group, June 2025)

The HEC-RAS model indicates that under existing conditions the creek will overtop the southern levee in a 10-year storm, along the upstream and downstream ends of SMZ 3. The model will be used to evaluate the extents of sediment removal required to restore design capacity in this location. The initial estimate of sediment removal quantities and lengths assumes that sediment removal is required along the upstream half of SMZ 3.

The potential need for backfill at Log Structure 3B for erosion stabilization will be balanced with the existing loss of freeboard and likely need for sediment removal at this location. A grading strategy to meet flood risk and habitat objectives will be further developed for this location.

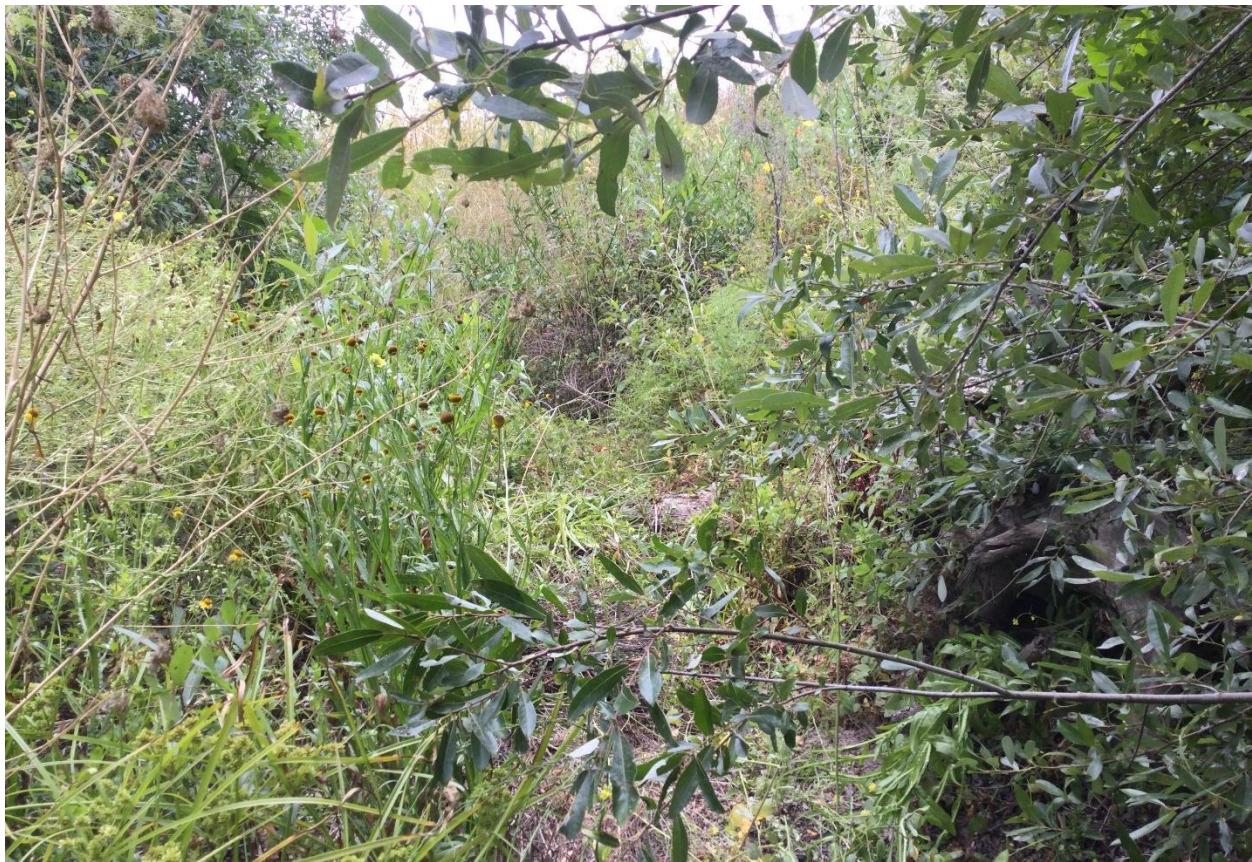
Sediment has accumulated within the secondary channel throughout SMZ 5. The riparian buffer is densely overgrown and visually appears to be a significant barrier to flow during storm events. Recommendations for this area include sediment removal throughout the secondary channel and confirmation of the existing riparian buffer width with additional topographic survey. Based on visual inspection it appears that the mid-channel buffer width has increased due to sediment accumulation followed by vegetation growth. Lidar mapping indicates that the mid channel bar is upwards of 30-feet wide in this location. Sediment removal along the bar may be warranted to re-establish the mid-channel bar to design conditions.

The HEC-RAS model indicates that under existing conditions the creek will overtop the southern levee in a 10-year storm, along the full length of SMZ 5 and extending upstream towards SMZ 6 and downstream through SMZ 3. The model will be used to evaluate the extents of sediment removal required to restore design capacity in this location. The initial estimate of sediment removal quantities and lengths assumes that sediment removal is required along the full length of SMZ 5.

Figure 9: Sediment and Vegetation at Log Structure 5B, Looking Upstream (Wallace Group, June 2025)

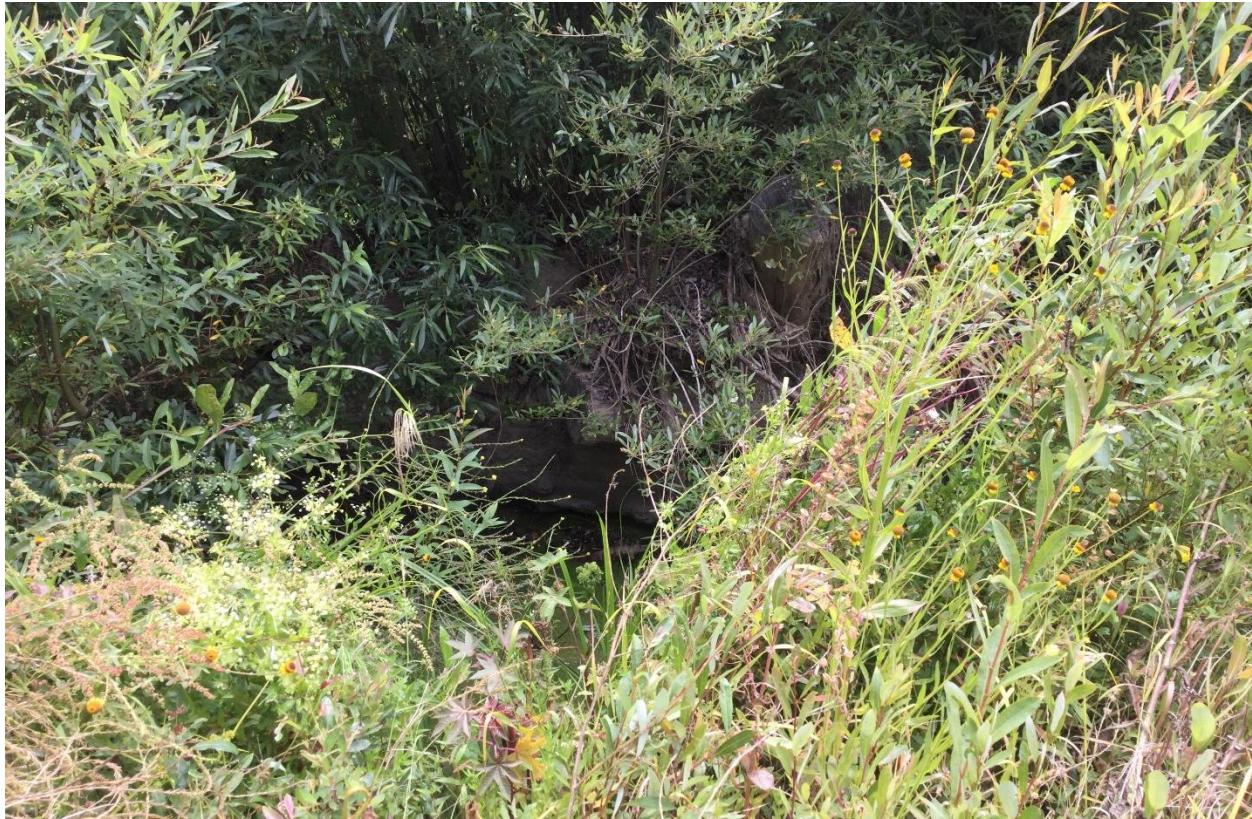
The HEC-RAS model indicates that under existing conditions the freeboard along SMZ 8 is less than 2-feet along the northern levee, and less than 1-foot along the southern levee. The model will be used to evaluate the extents of sediment removal required to restore design capacity in this location. The initial estimate of sediment removal quantities and lengths assumes that sediment removal is required along the upstream half of SMZ 8.

Figure 11: Sediment and Vegetation Covering Log Structure 8A, Looking Downstream (Wallace Group, June 2025)

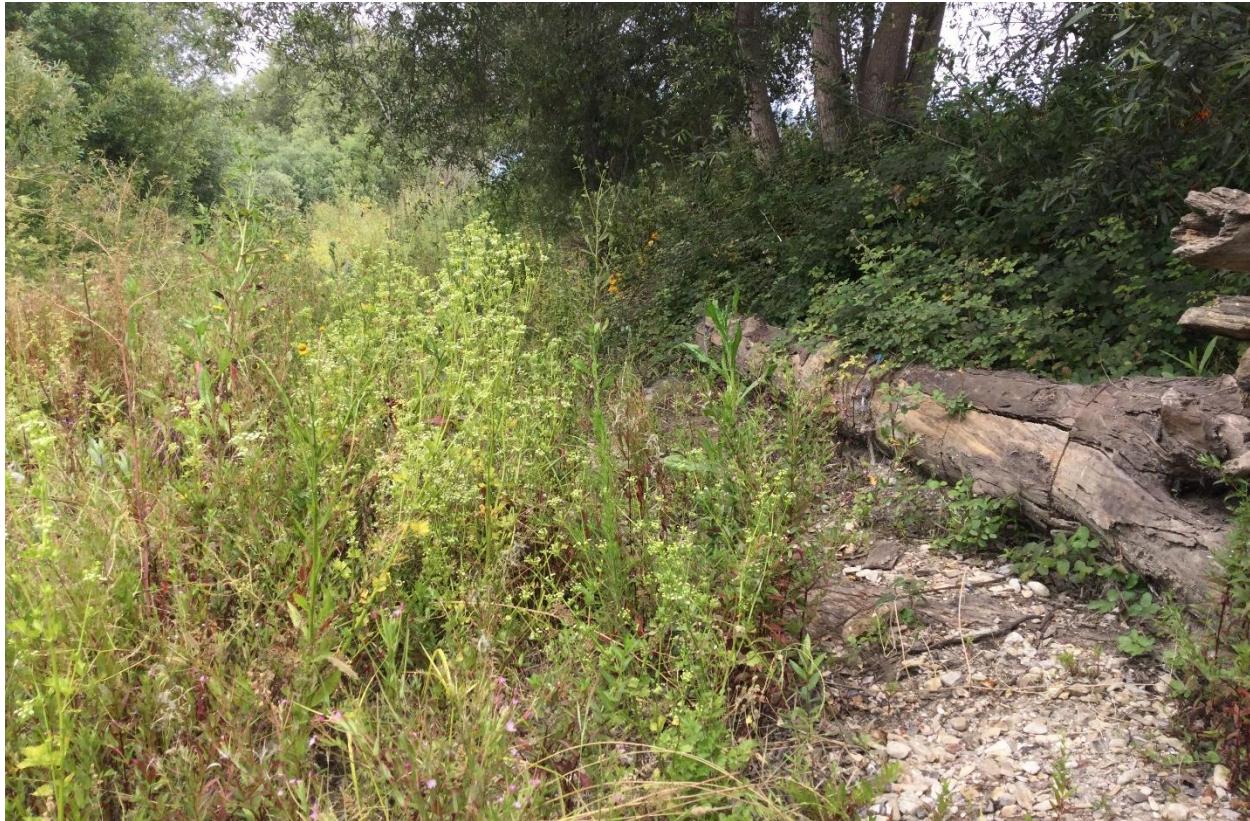
The HEC-RAS model indicates that under existing conditions the freeboard is less than 1-foot along the southern levee for the full length of SMZ 9. The model will be used to evaluate the extents of sediment removal required to restore design capacity in this location. The initial estimate of sediment removal quantities and lengths assumes that sediment removal is required along the full length of SMZ 9.

Figure 12: Sediment and Vegetation in Secondary Sediment Channel at Log Structure 9B, Looking Downstream (Wallace Group, June 2025)

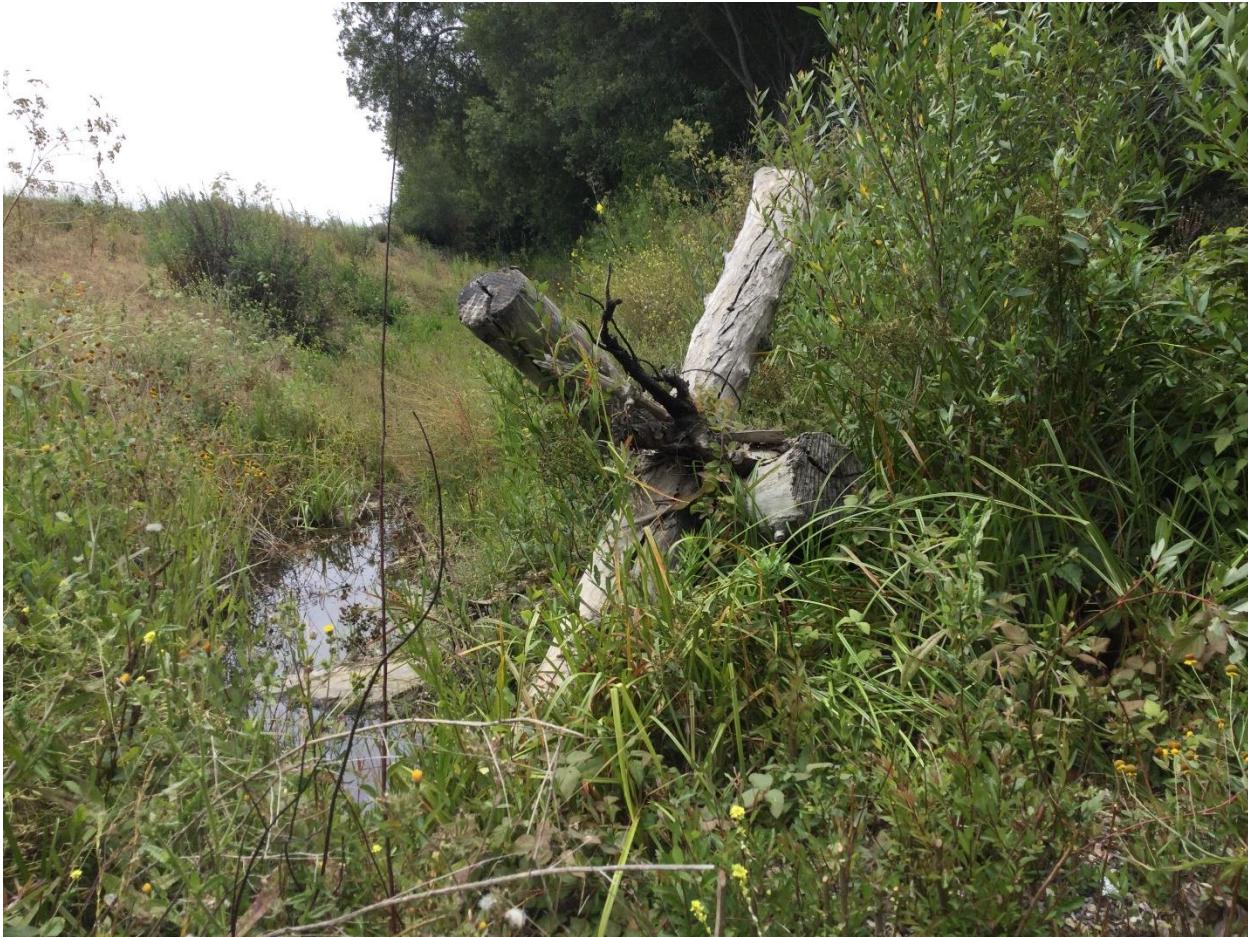
The HEC-RAS model indicates that under existing conditions the freeboard is less than 1-foot along the southern levee for the full length of SMZ 11. The model will be used to evaluate the extents of sediment removal required to restore design capacity in this location, and additional topographic data will be collected in the primary flow channel to better define the potential sediment accumulation. The initial estimate of sediment removal quantities and lengths assumes that sediment removal is required along the full length of SMZ 11.

Figure 13: Sediment and Vegetation at Log Structure 11A, Looking Downstream (Wallace Group, June 2025)

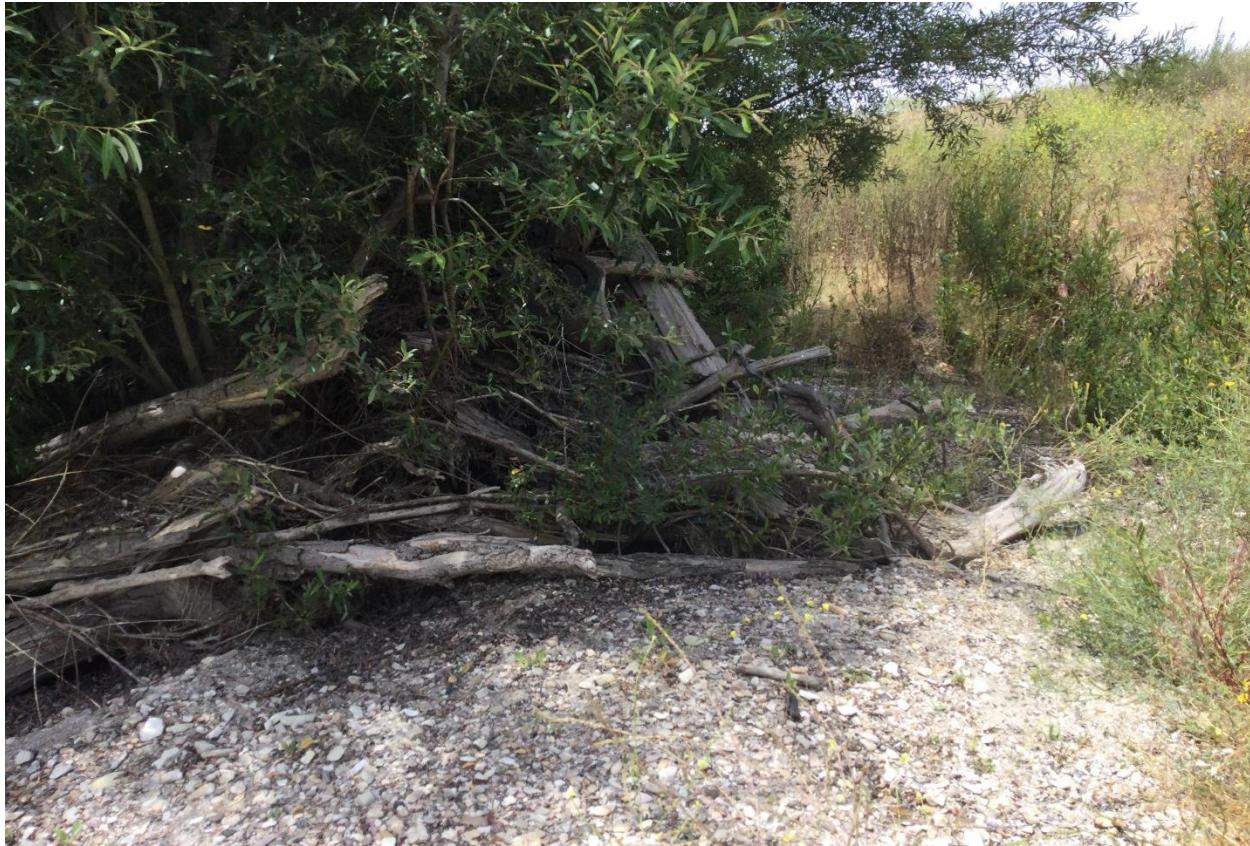
The HEC-RAS model indicates that under existing conditions the freeboard is less than 1-foot along the southern levee for the majority of SMZ 11, and less than 2-feet along the northern levee with isolated areas of freeboard above 2-feet at the northern levee. The model will be used to evaluate the extents of sediment removal required to restore design capacity in this location. The initial estimate of sediment removal quantities and lengths is based on the maximum allowable length of 500-feet in one year, at the upstream end of the SMZ where freeboard is currently the lowest.

Figure 14: Sediment and Vegetation Buildup at Log Structure 12/13A, Looking Downstream (Wallace Group, June 2025)

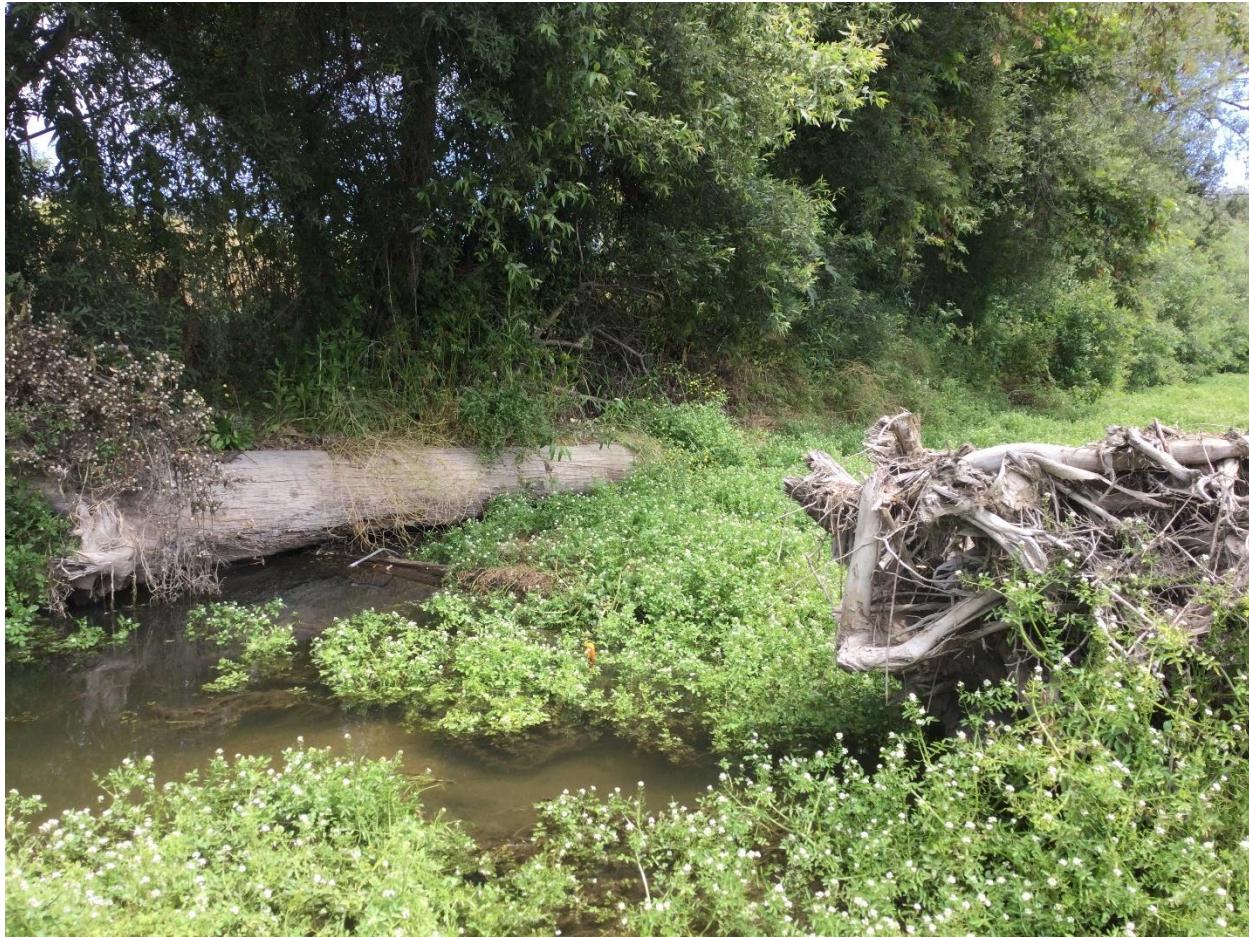
Log Structure 14B has experienced erosion. The two root wads are both fully exposed, and the footer log appears to be exposed but this could not be confirmed because it was submerged at the last inspection (June 2025). This location may require backfill upstream of the footer logs. Based on log structure monitoring observations, the log structure does not currently provide the original design intent of grade control in this location but does provide habitat value with pool formation and cover in the secondary channel. Proposed work around the log structure will be confirmed with subsequent log structure monitoring prior to planned work in 2026.

Figure 15: Exposed Log Structure and Root Wads at 14B, Looking Upstream (Wallace Group, June 2025)

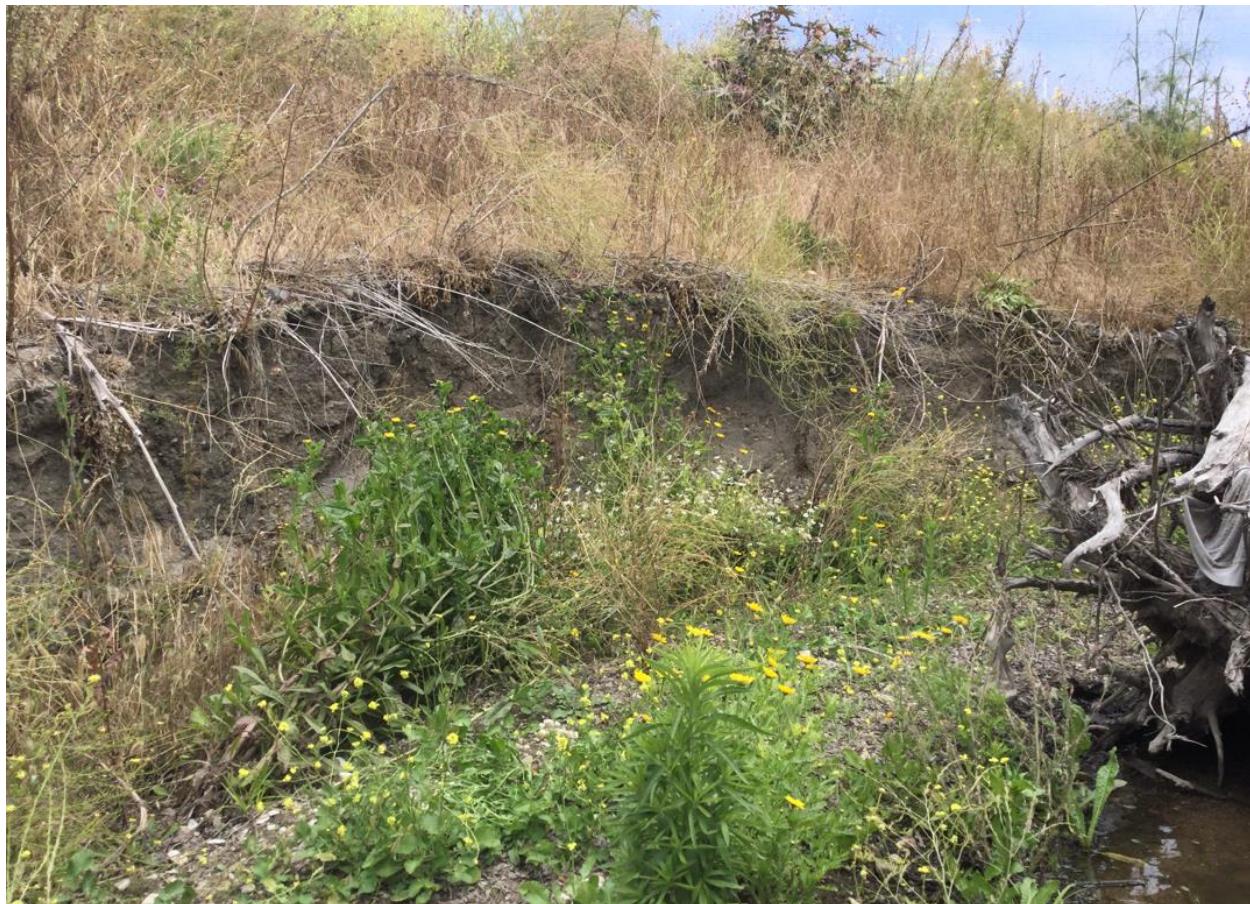
Figure 16: Bank Erosion at 15A, River Right Bank looking upstream (Wallace Group, June 2025)

stabilization would be considered a permanent impact not discussed as a typical component of the AGWMP, this activity would require additional agency coordination prior to implementing.

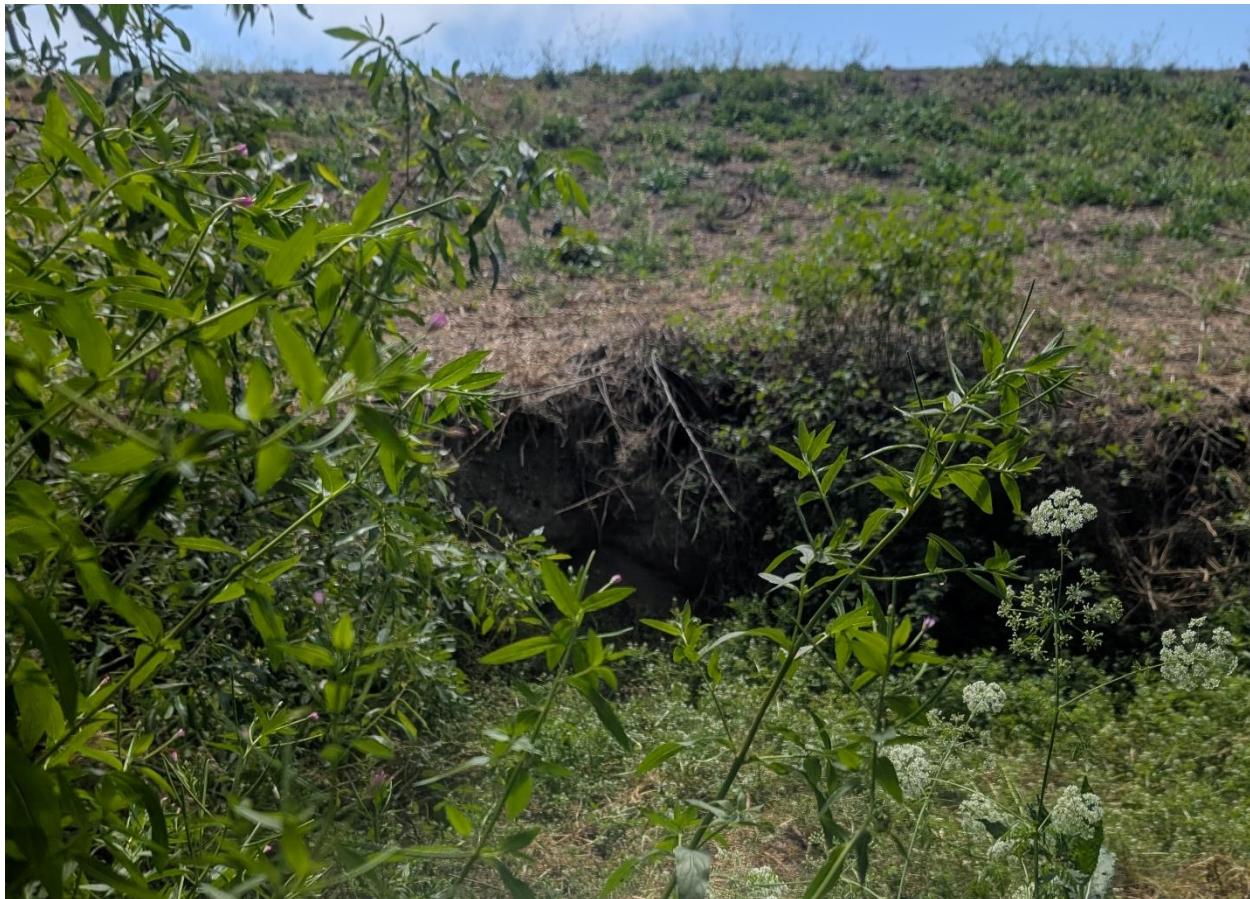
Figure 17: Bank Erosion at 16A, River Right Bank looking upstream (Wallace Group, June 2025)

vegetated rock (RSP). If warranted, RSP would be placed along the stabilized bank and adjacent to the log structure as needed to restore grade. RSP voids would be filled with soil to promote revegetation. As use of RSP for bank stabilization would be considered a permanent impact not discussed as a typical component of the AGWMP, this activity would require additional agency coordination prior to implementing.

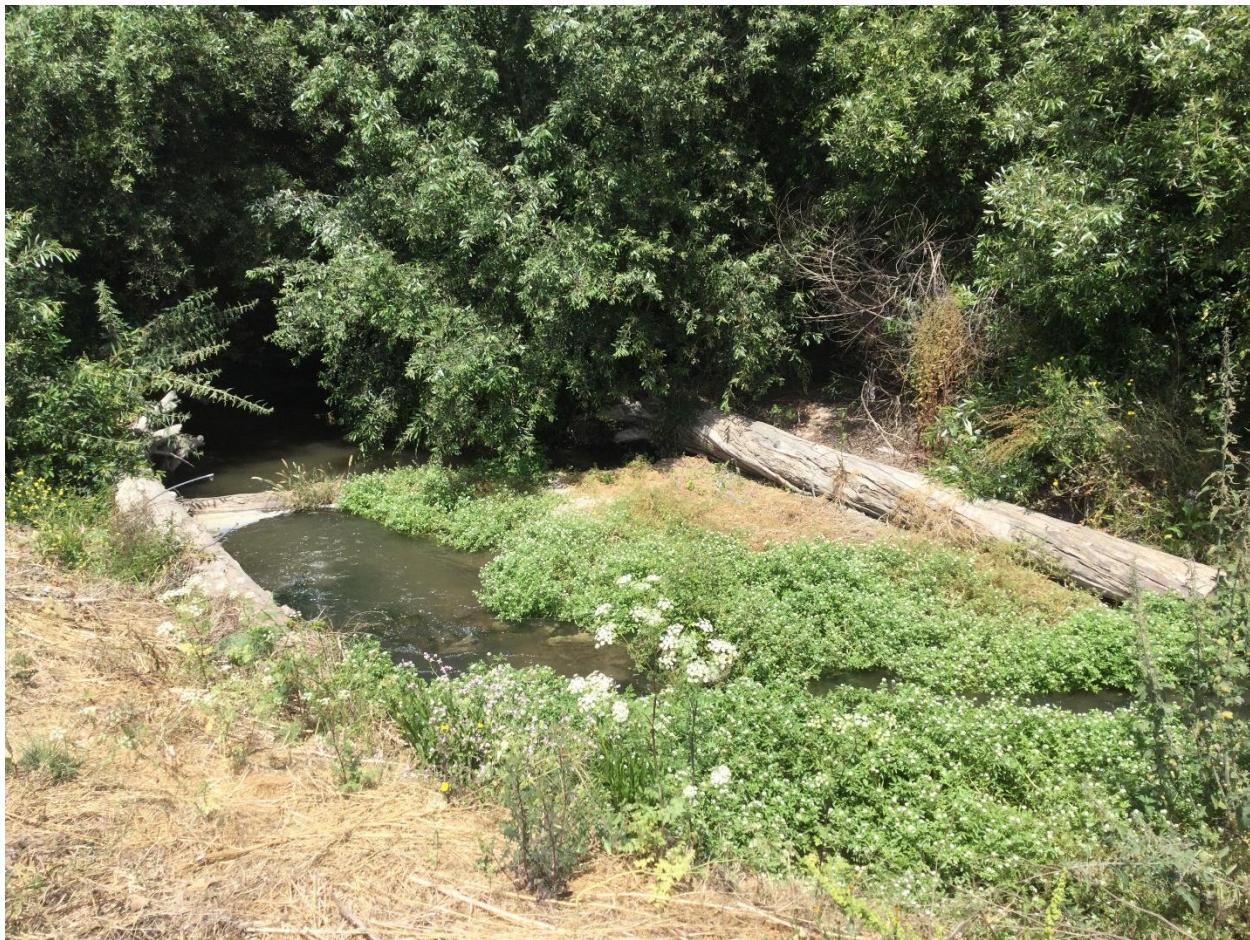
Figure 18: Log Structure 16B, Looking Downstream (Wallace Group, June 2025)

At the downstream end of SMZ 16 the creek has breached the riparian buffer and is flowing through the secondary channel. The footer logs of Log Structure 16B are undermined, and the creek is flowing underneath the logs. To re-establish the primary channel, sediment will be removed in the primary channel, the mid-channel bar will be re-established, and the grade in the secondary channel upstream of Log Structure 16B will be re-established with fill. Re-establishment of the mid-channel bar will provide an opportunity to establish cottonwood cuttings in the riparian buffer.

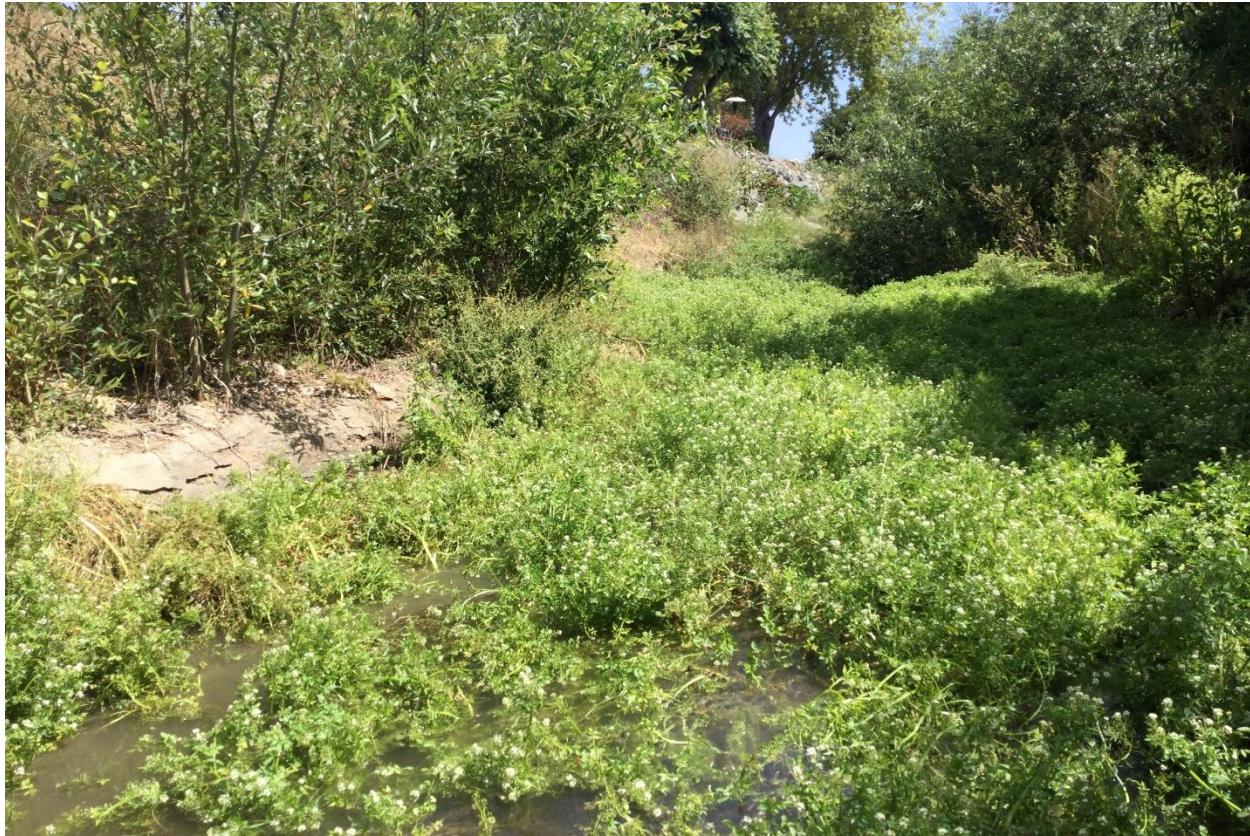
Figure 19: Log Structure 17B, Looking Upstream (Wallace Group, June 2025)

The creek has breached the SMZ 17 mid-channel bar in multiple locations and is actively flowing in both the primary and secondary channels. Grading and placement of fill will be required to repair the mid-channel bar and re-establish the primary channel. The graded area of the mid-channel bar repair will provide an opportunity to establish cottonwood cuttings in the riparian buffer. Reestablishing the primary channel and the adjacent riparian habitat is beneficial to maintaining steelhead habitat within the reach of Arroyo Grande Creek.

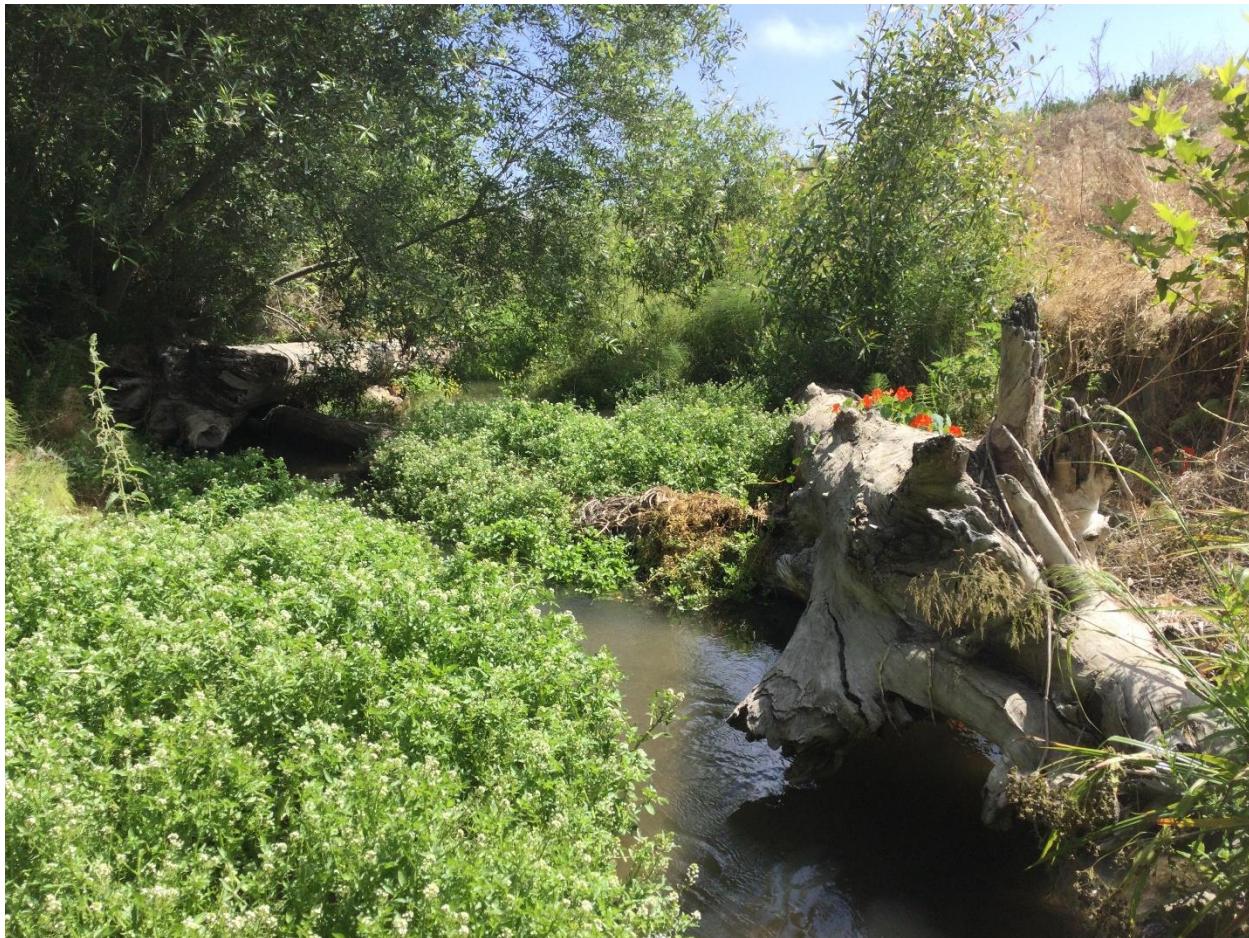
Figure 20: Log Structure 18B, Looking Upstream (Wallace Group, June 2025)

The HEC-RAS model indicates that under existing conditions the freeboard is 2-feet or more through nearly all of SMZ 18, with a small area of the southern (east) levee having less than 2-feet freeboard.

The realignment of the creek to the primary channel and repair of the scoured mid-channel bar would improve habitat value by reconnecting creek flow to the mature riparian canopy beneficial to maintaining steelhead habitat within the reach of Arroyo Grande Creek. Compared to the current thalweg, the designed primary channel's broader width and mature, well-established riparian vegetation provides superior cover and water temperatures for steelhead.
