Arroyo Grande Creek Waterway Management Program

Update to 2025 Vegetation Management and Sediment Removal Work Plan

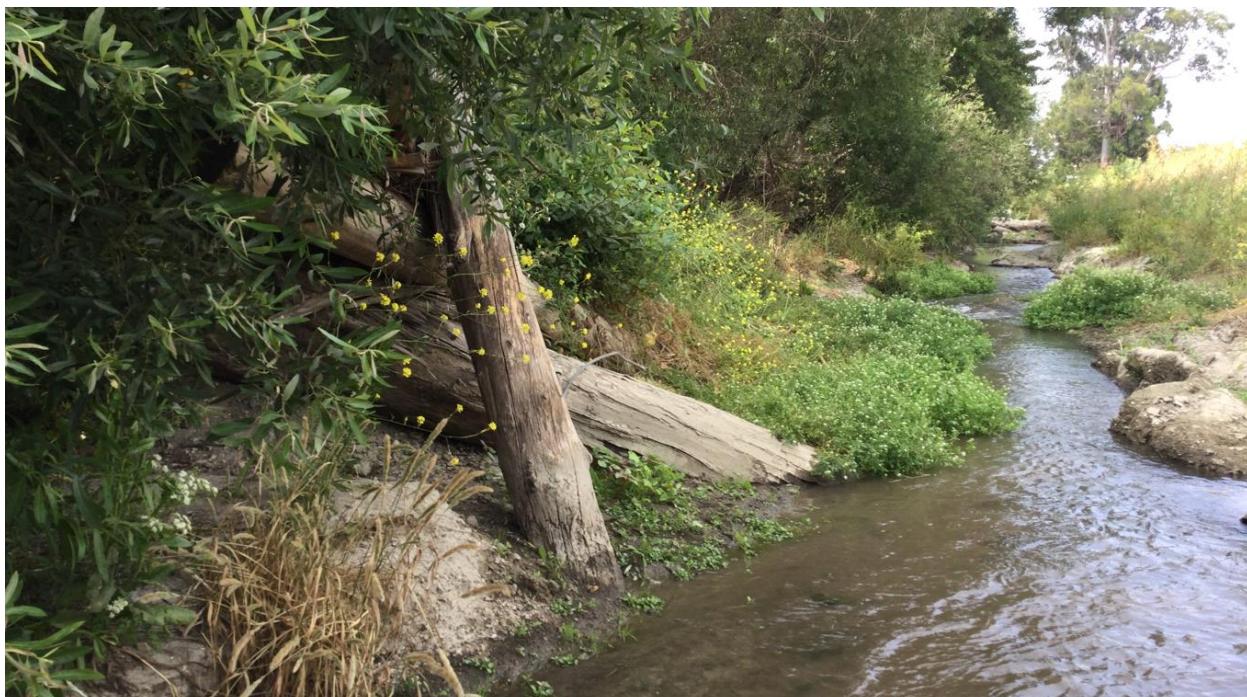
Log structure 19A is perched above the current thalweg and sediment has accumulated within the log structure, up to the interior top of the structure where the logs are anchored together. To minimize disruption to the log structure and the riparian buffer, minimal sediment will be removed from immediately underneath the log structure. The intent is that the removal of excess sediment will allow accumulated sediment within the log structure to naturally mobilize during a subsequent storm event.

Figure 21: 19A Log Structure and Secondary Flow Channel, Looking Downstream (Wallace Group, June 2025)

A phased approach is recommended at SMZ 19 to remove sediment in the designed primary channel first, then divert the creek back into the primary channel. Following successful diversion, the backfill work would be performed in the secondary channel.

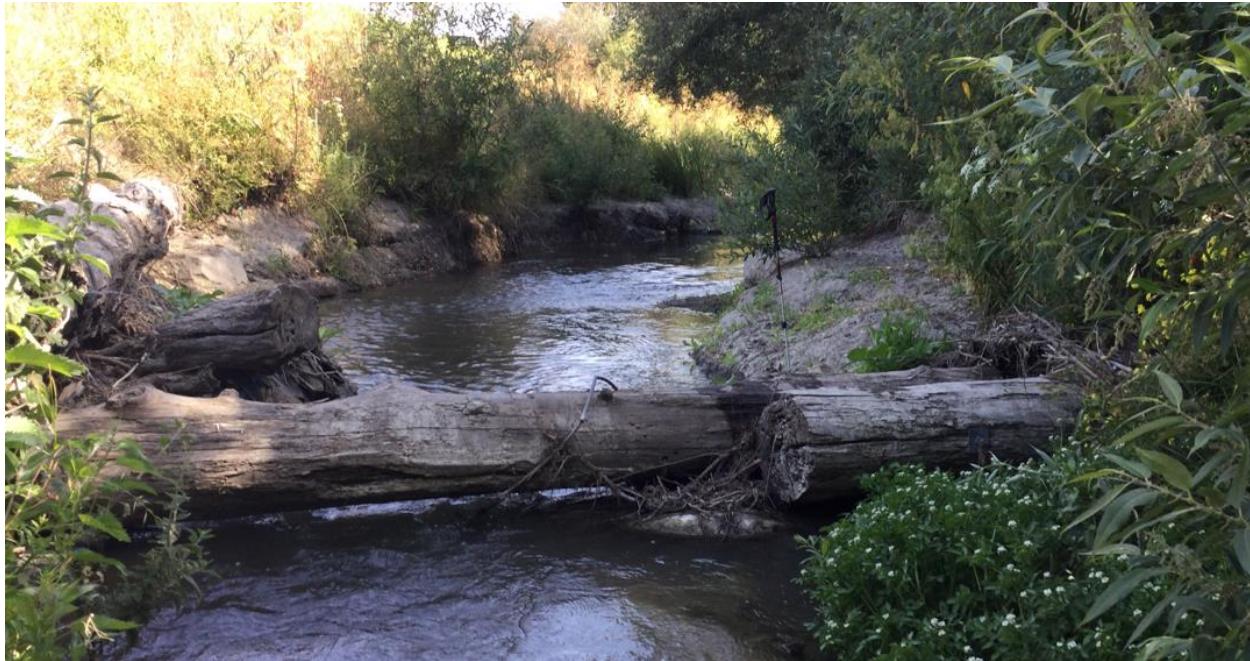
Log structure 19B is undermined and requires backfill to restore its intended function of grade control in the upstream secondary channel. Backfill alternatives will be carefully reviewed for this location. Given the depth of undercutting below the structure more significant backfill may be necessary. One alternative is boulders placed on the upstream side of the footer logs to encourage aggradation in the secondary channel. If rock is used at this location, voids between rocks would be filled with soil to promote vegetation.

Figure 22: 19B Log Structure, Looking Upstream (Wallace Group, June 2025)

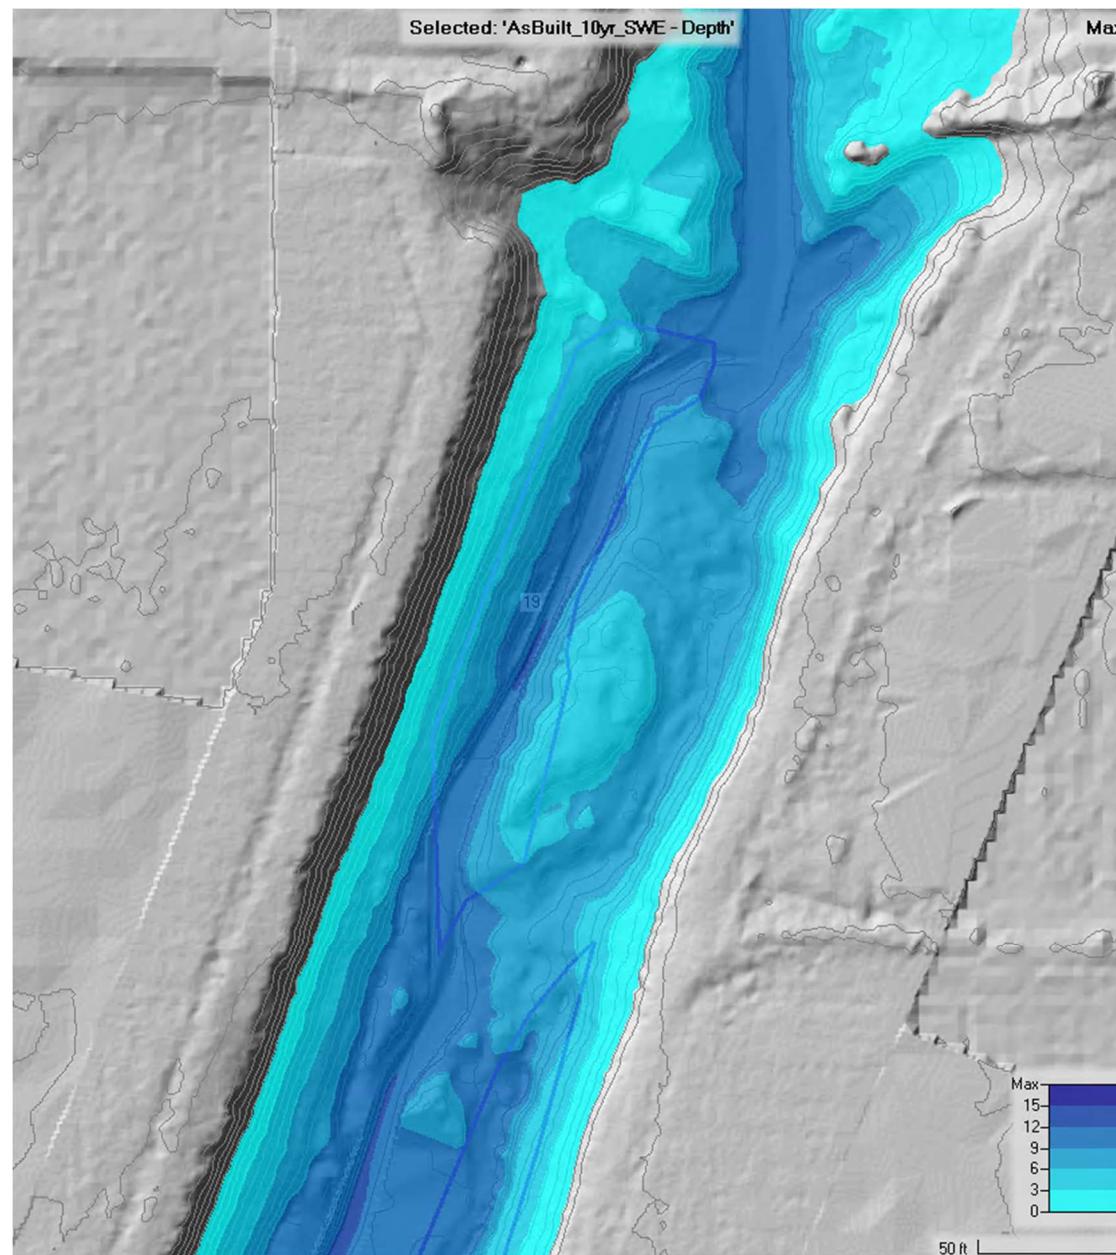
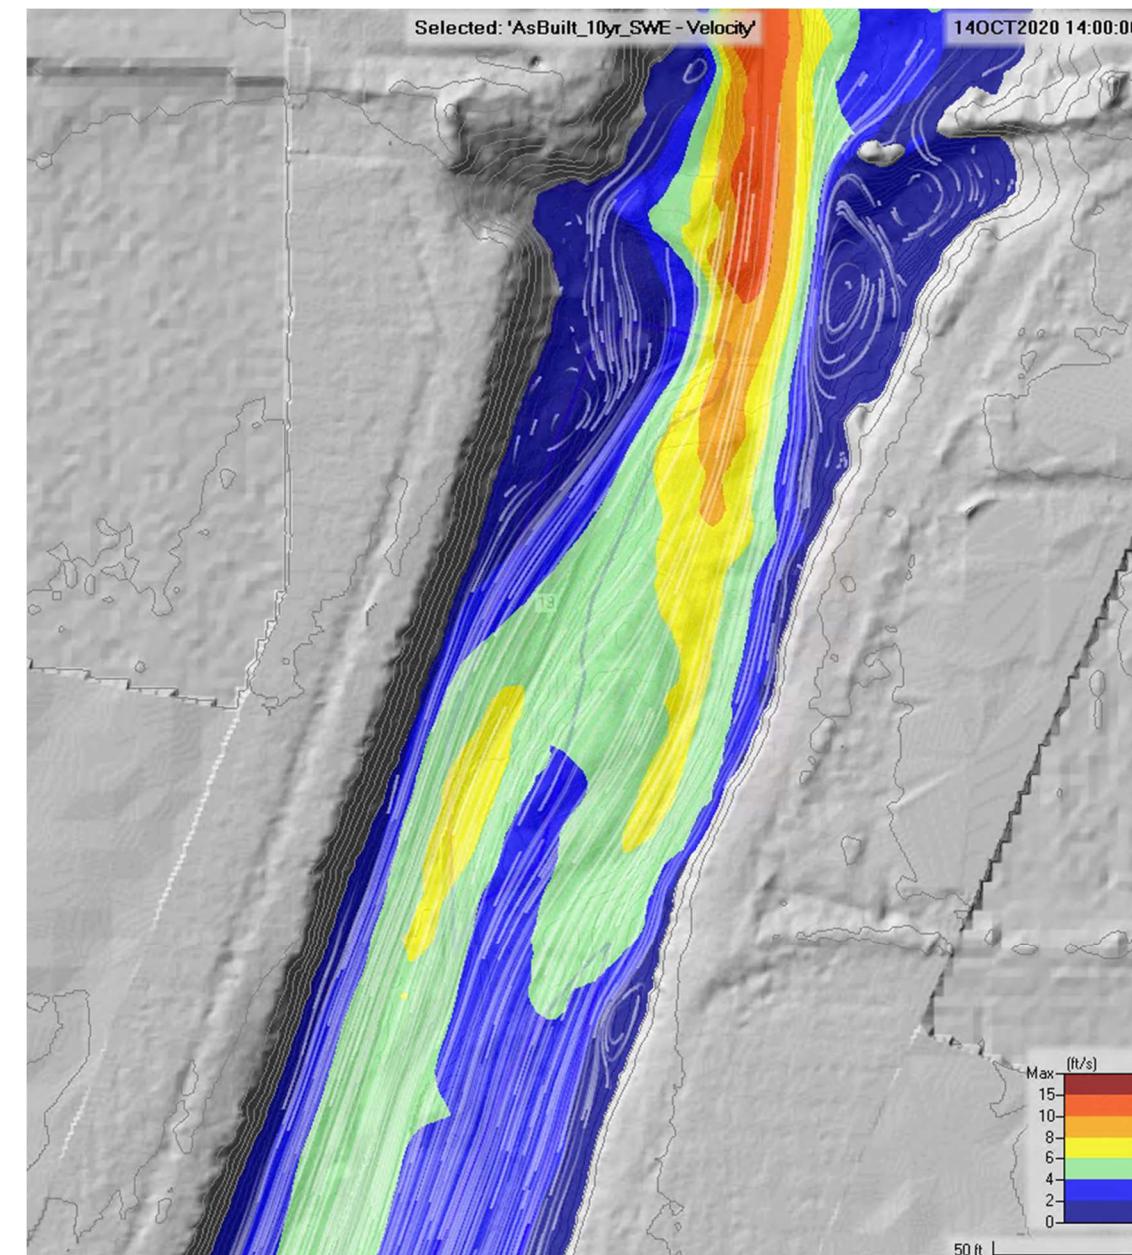
SMZ 19:

Notes: model indicates decrease in velocity at upstream end of SMZ 19 in location of low water crossing

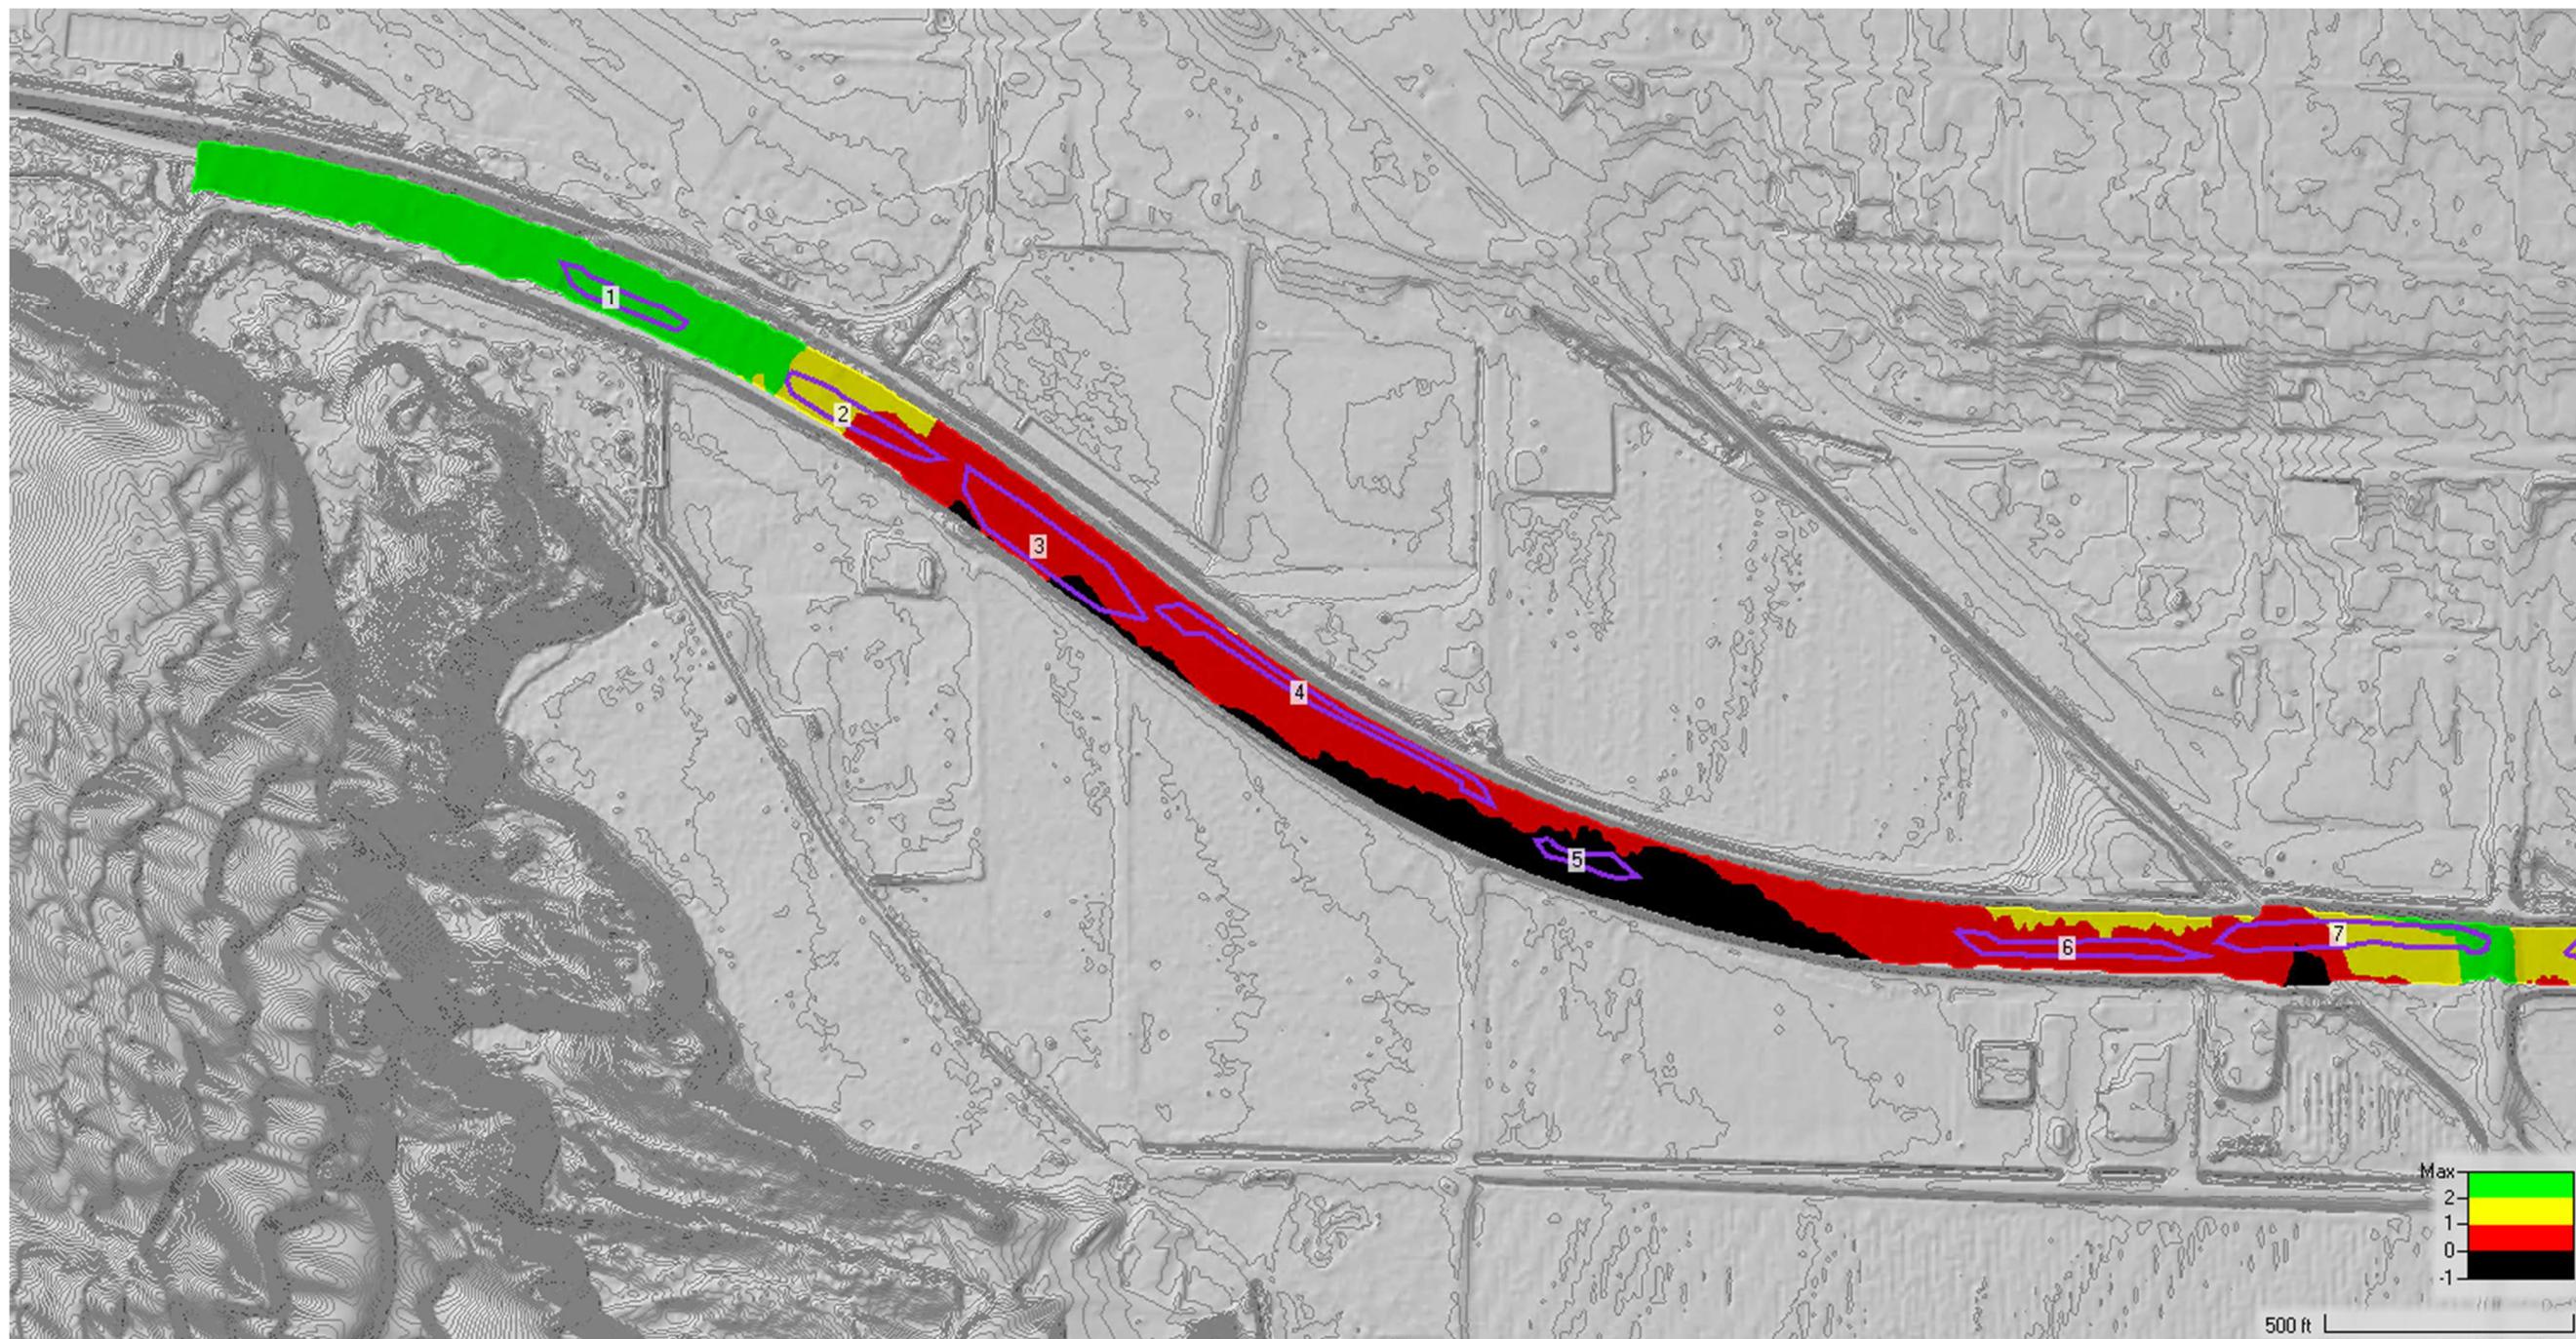
10-year Existing Conditions Freeboard, SMZ 1 to SMZ 7 (ft):

Notes: Black shading indicates locations of overtopping

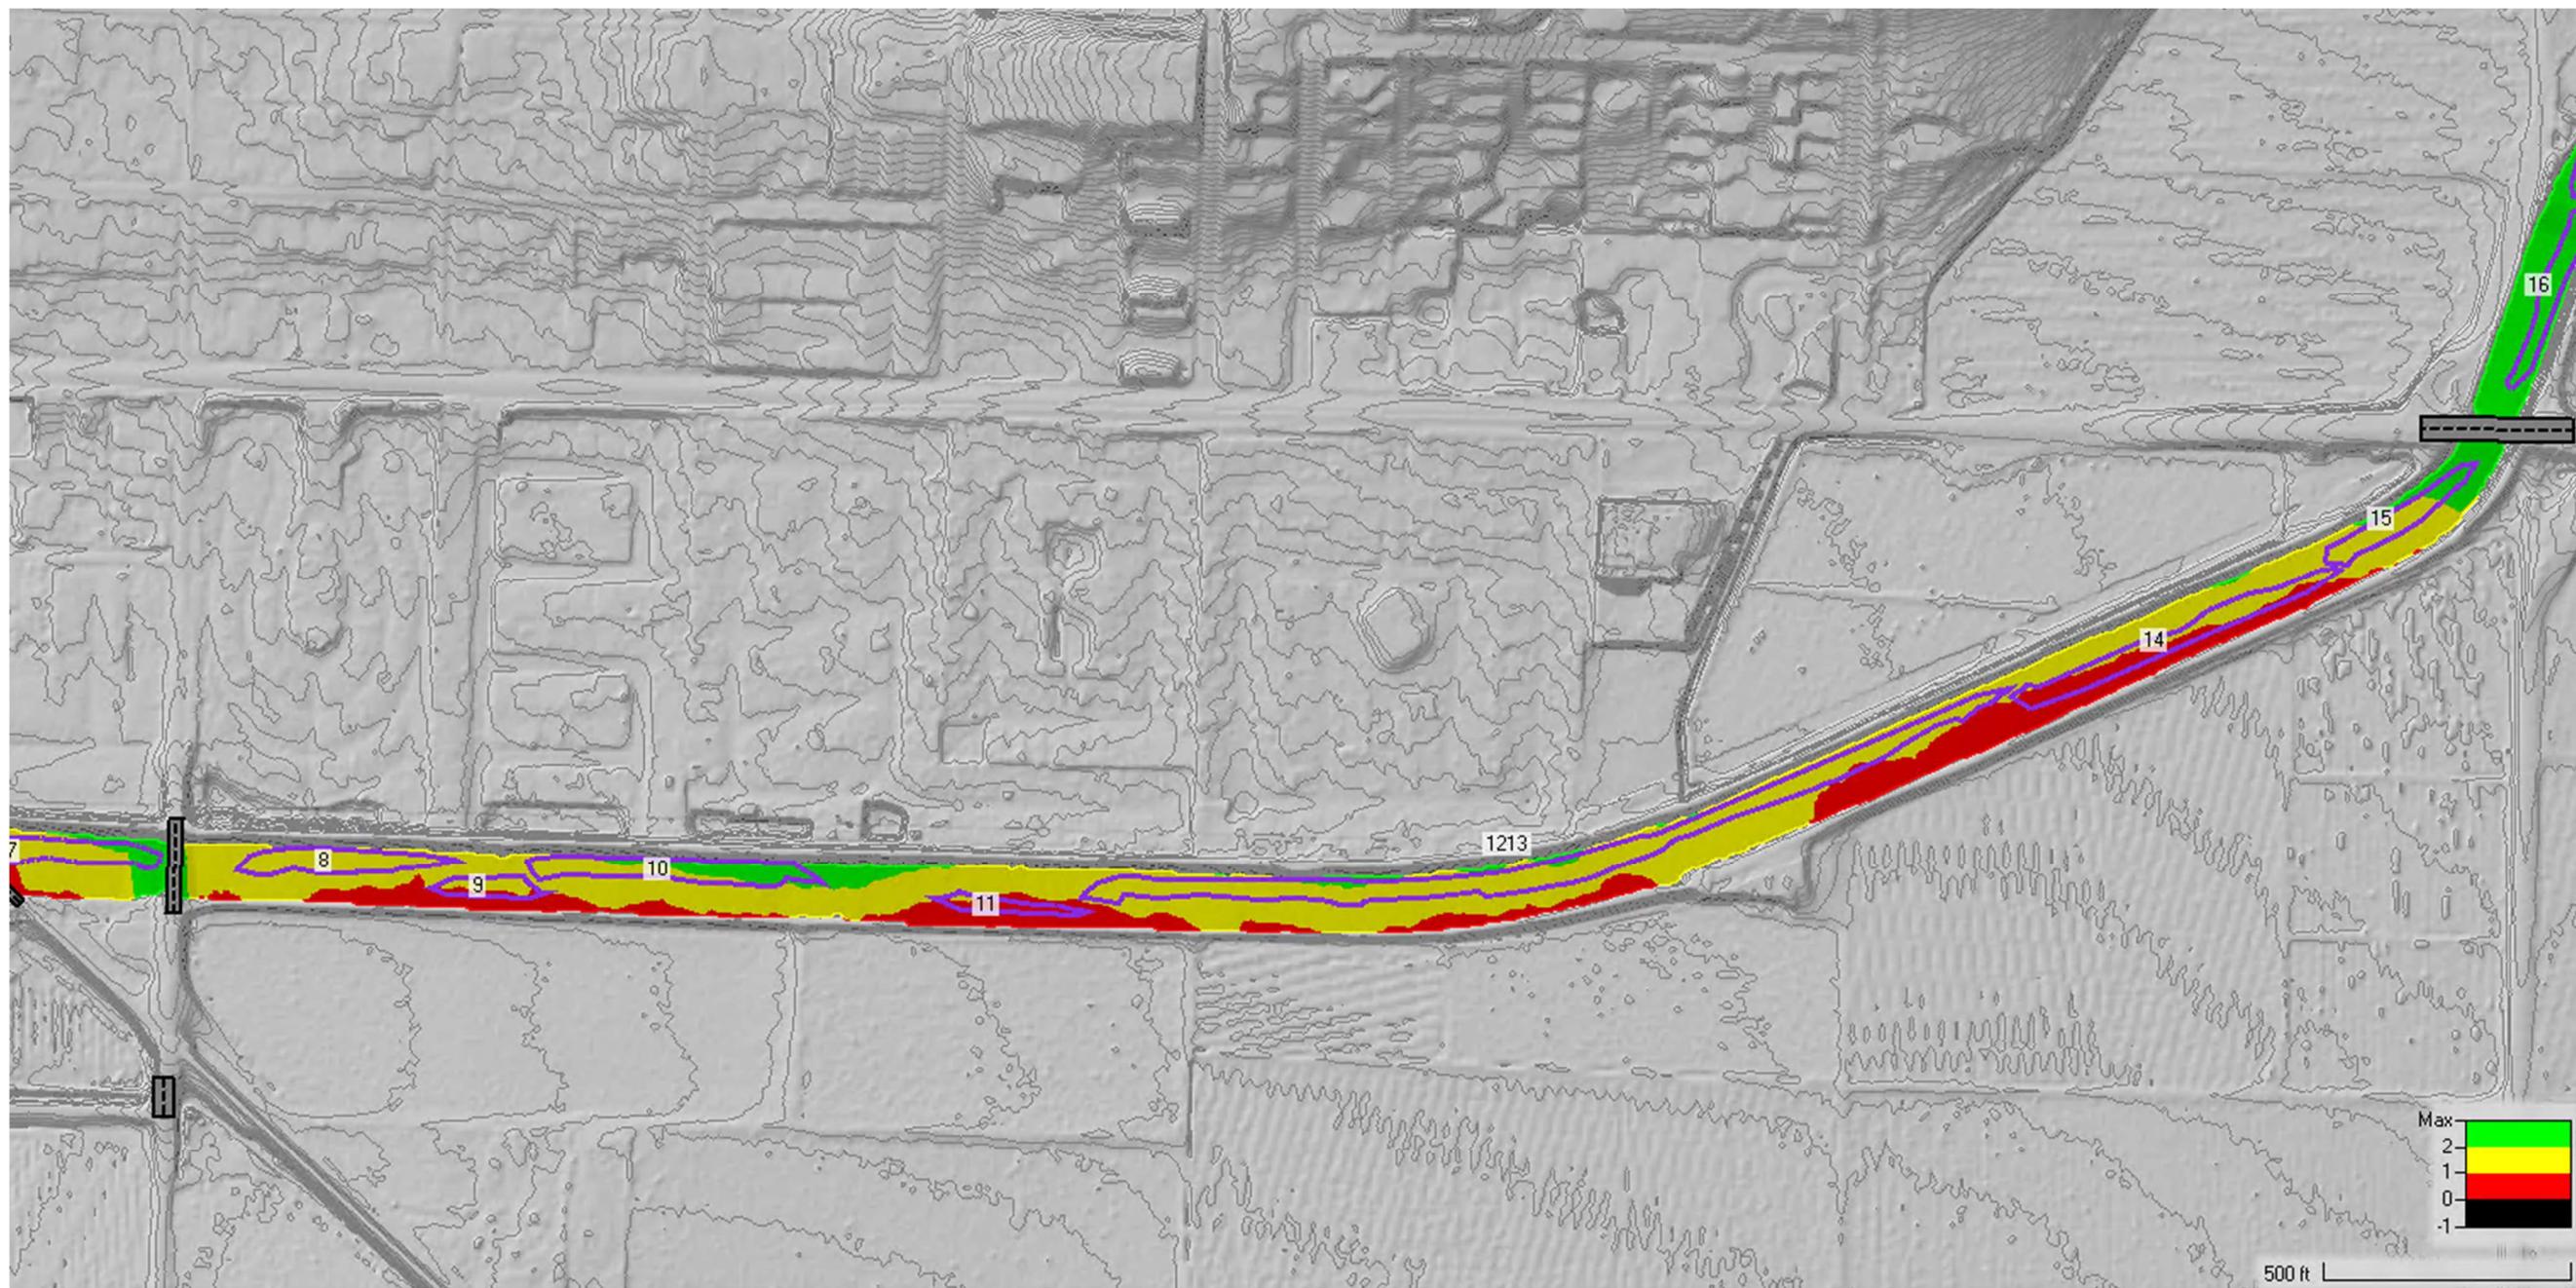
10-year Existing Conditions Freeboard, SMZ 8 to SMZ 15 (ft):

Notes: Black shading indicates locations of overtopping

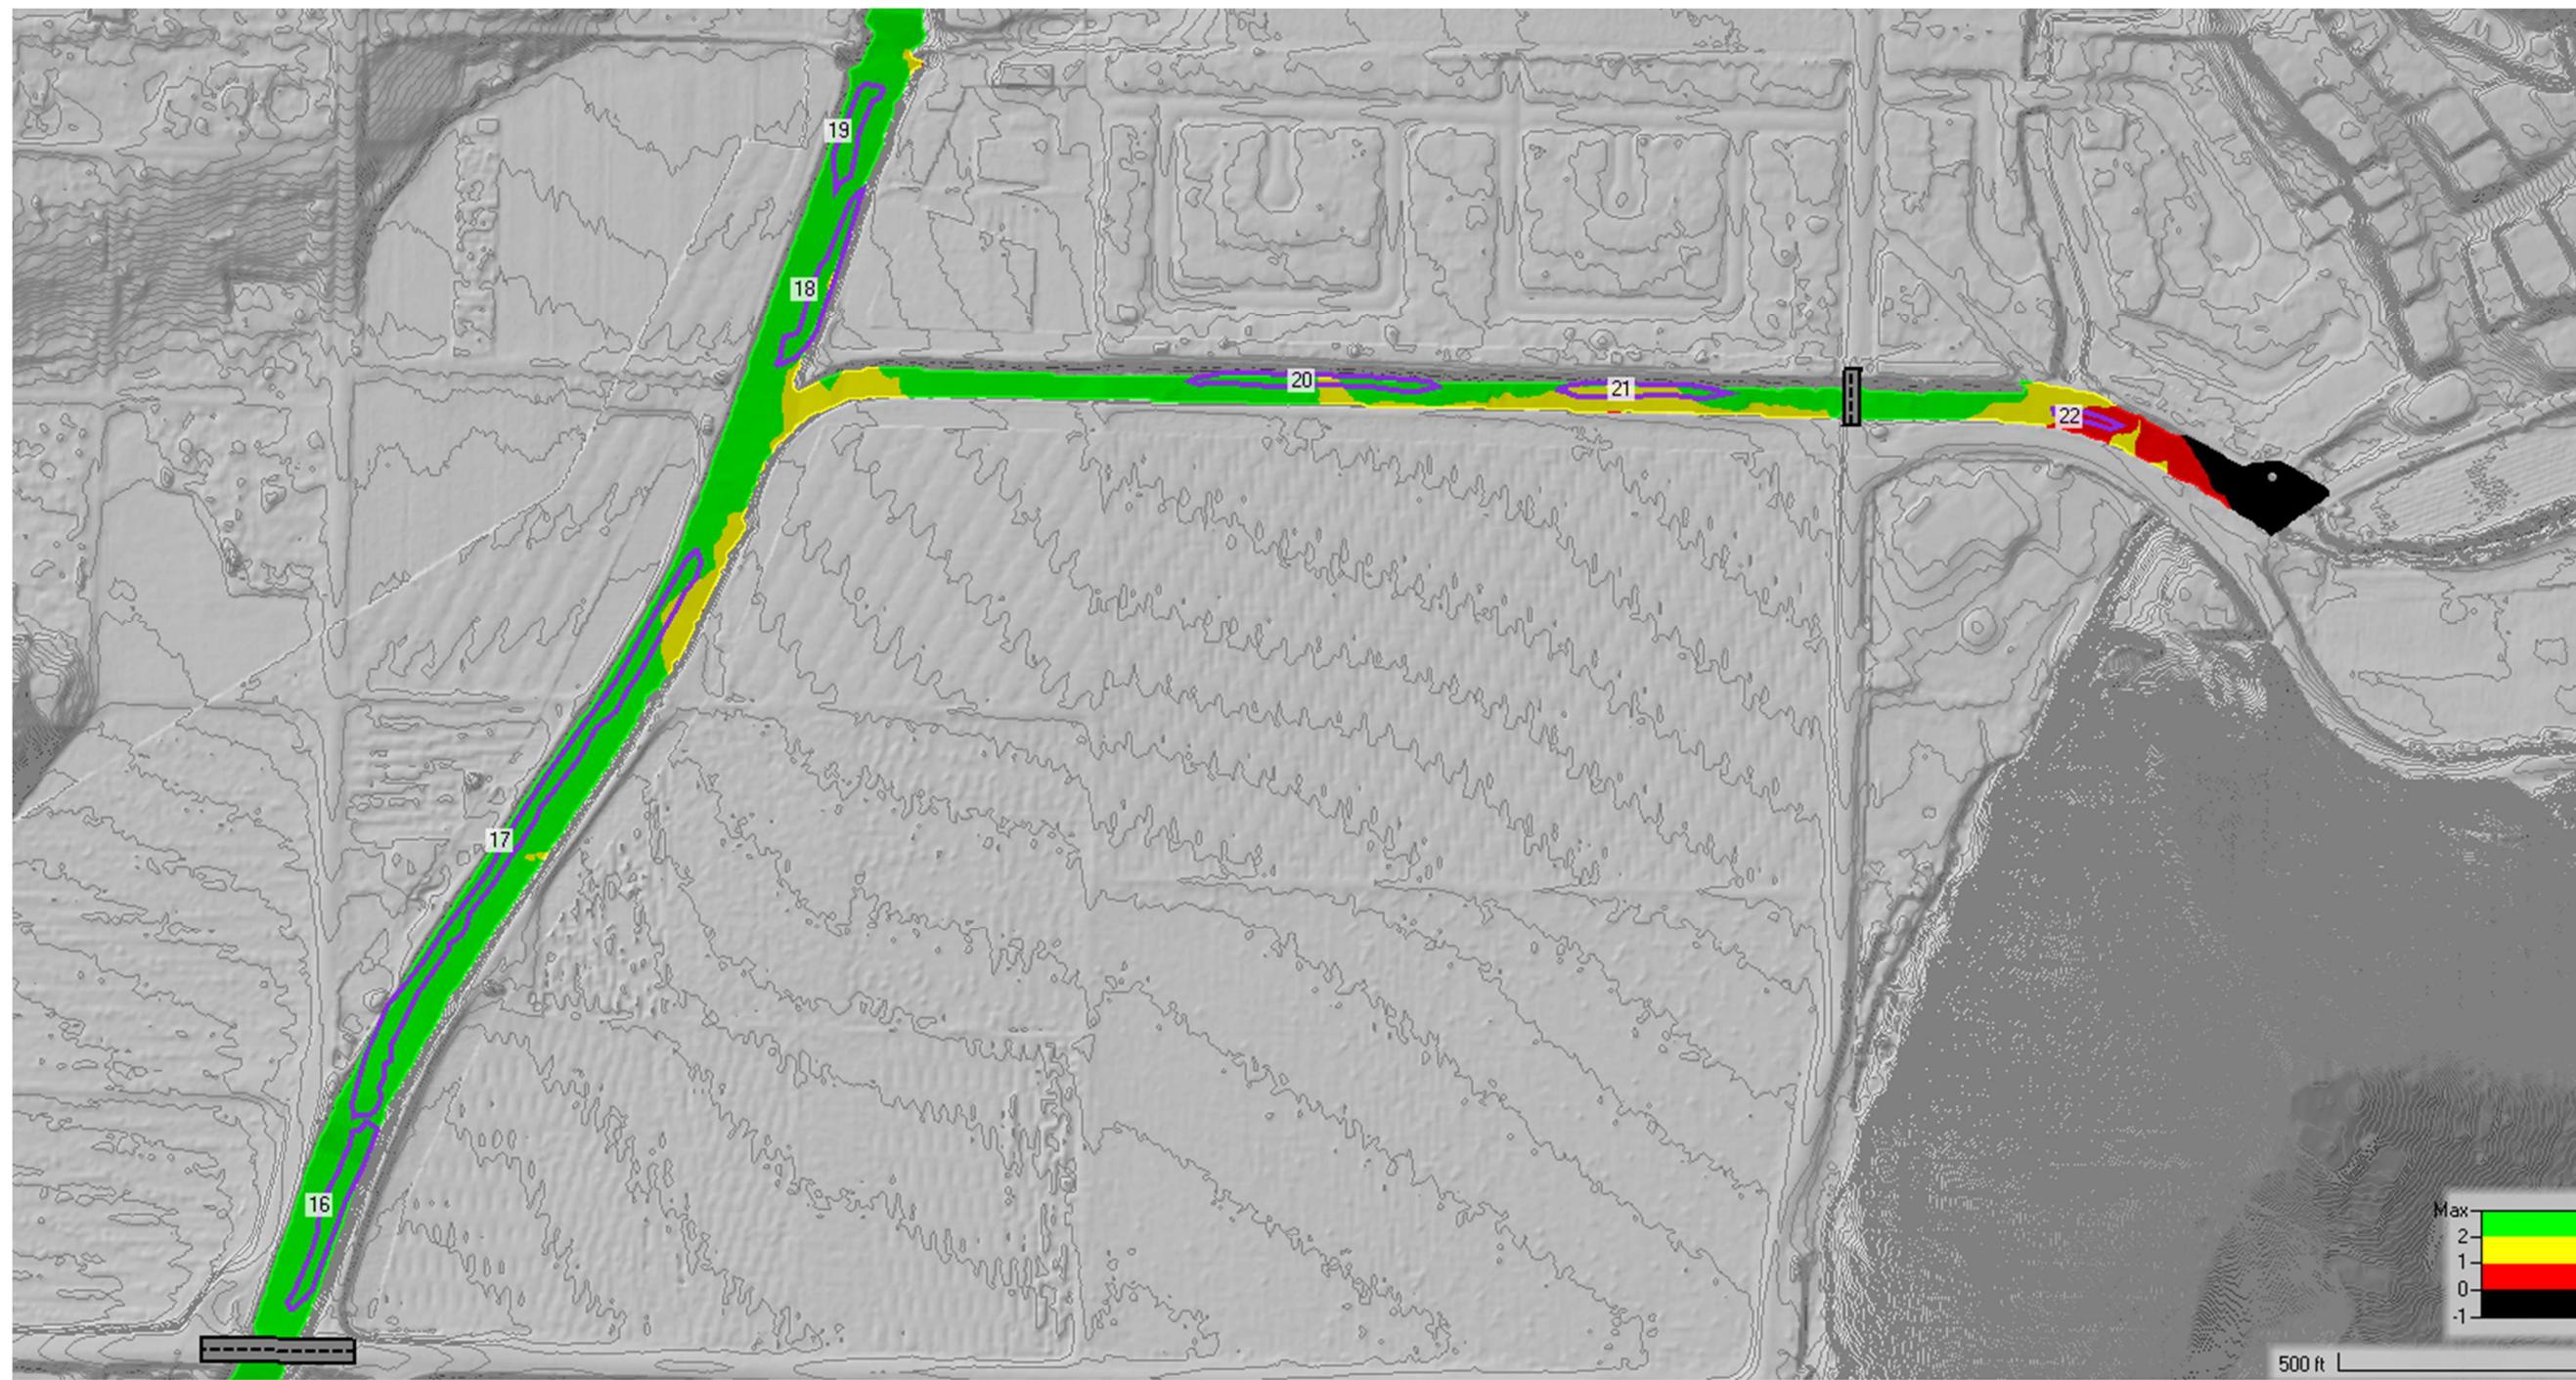
10-year Existing Conditions Freeboard, SMZ 16 to SMZ 22 (ft):

Notes. Black shading indicates locations of overtopping
