Biological Report

Cold Canyon Landfill: Proposed Expansion

2268 Carpenter Canyon Road

August 2006

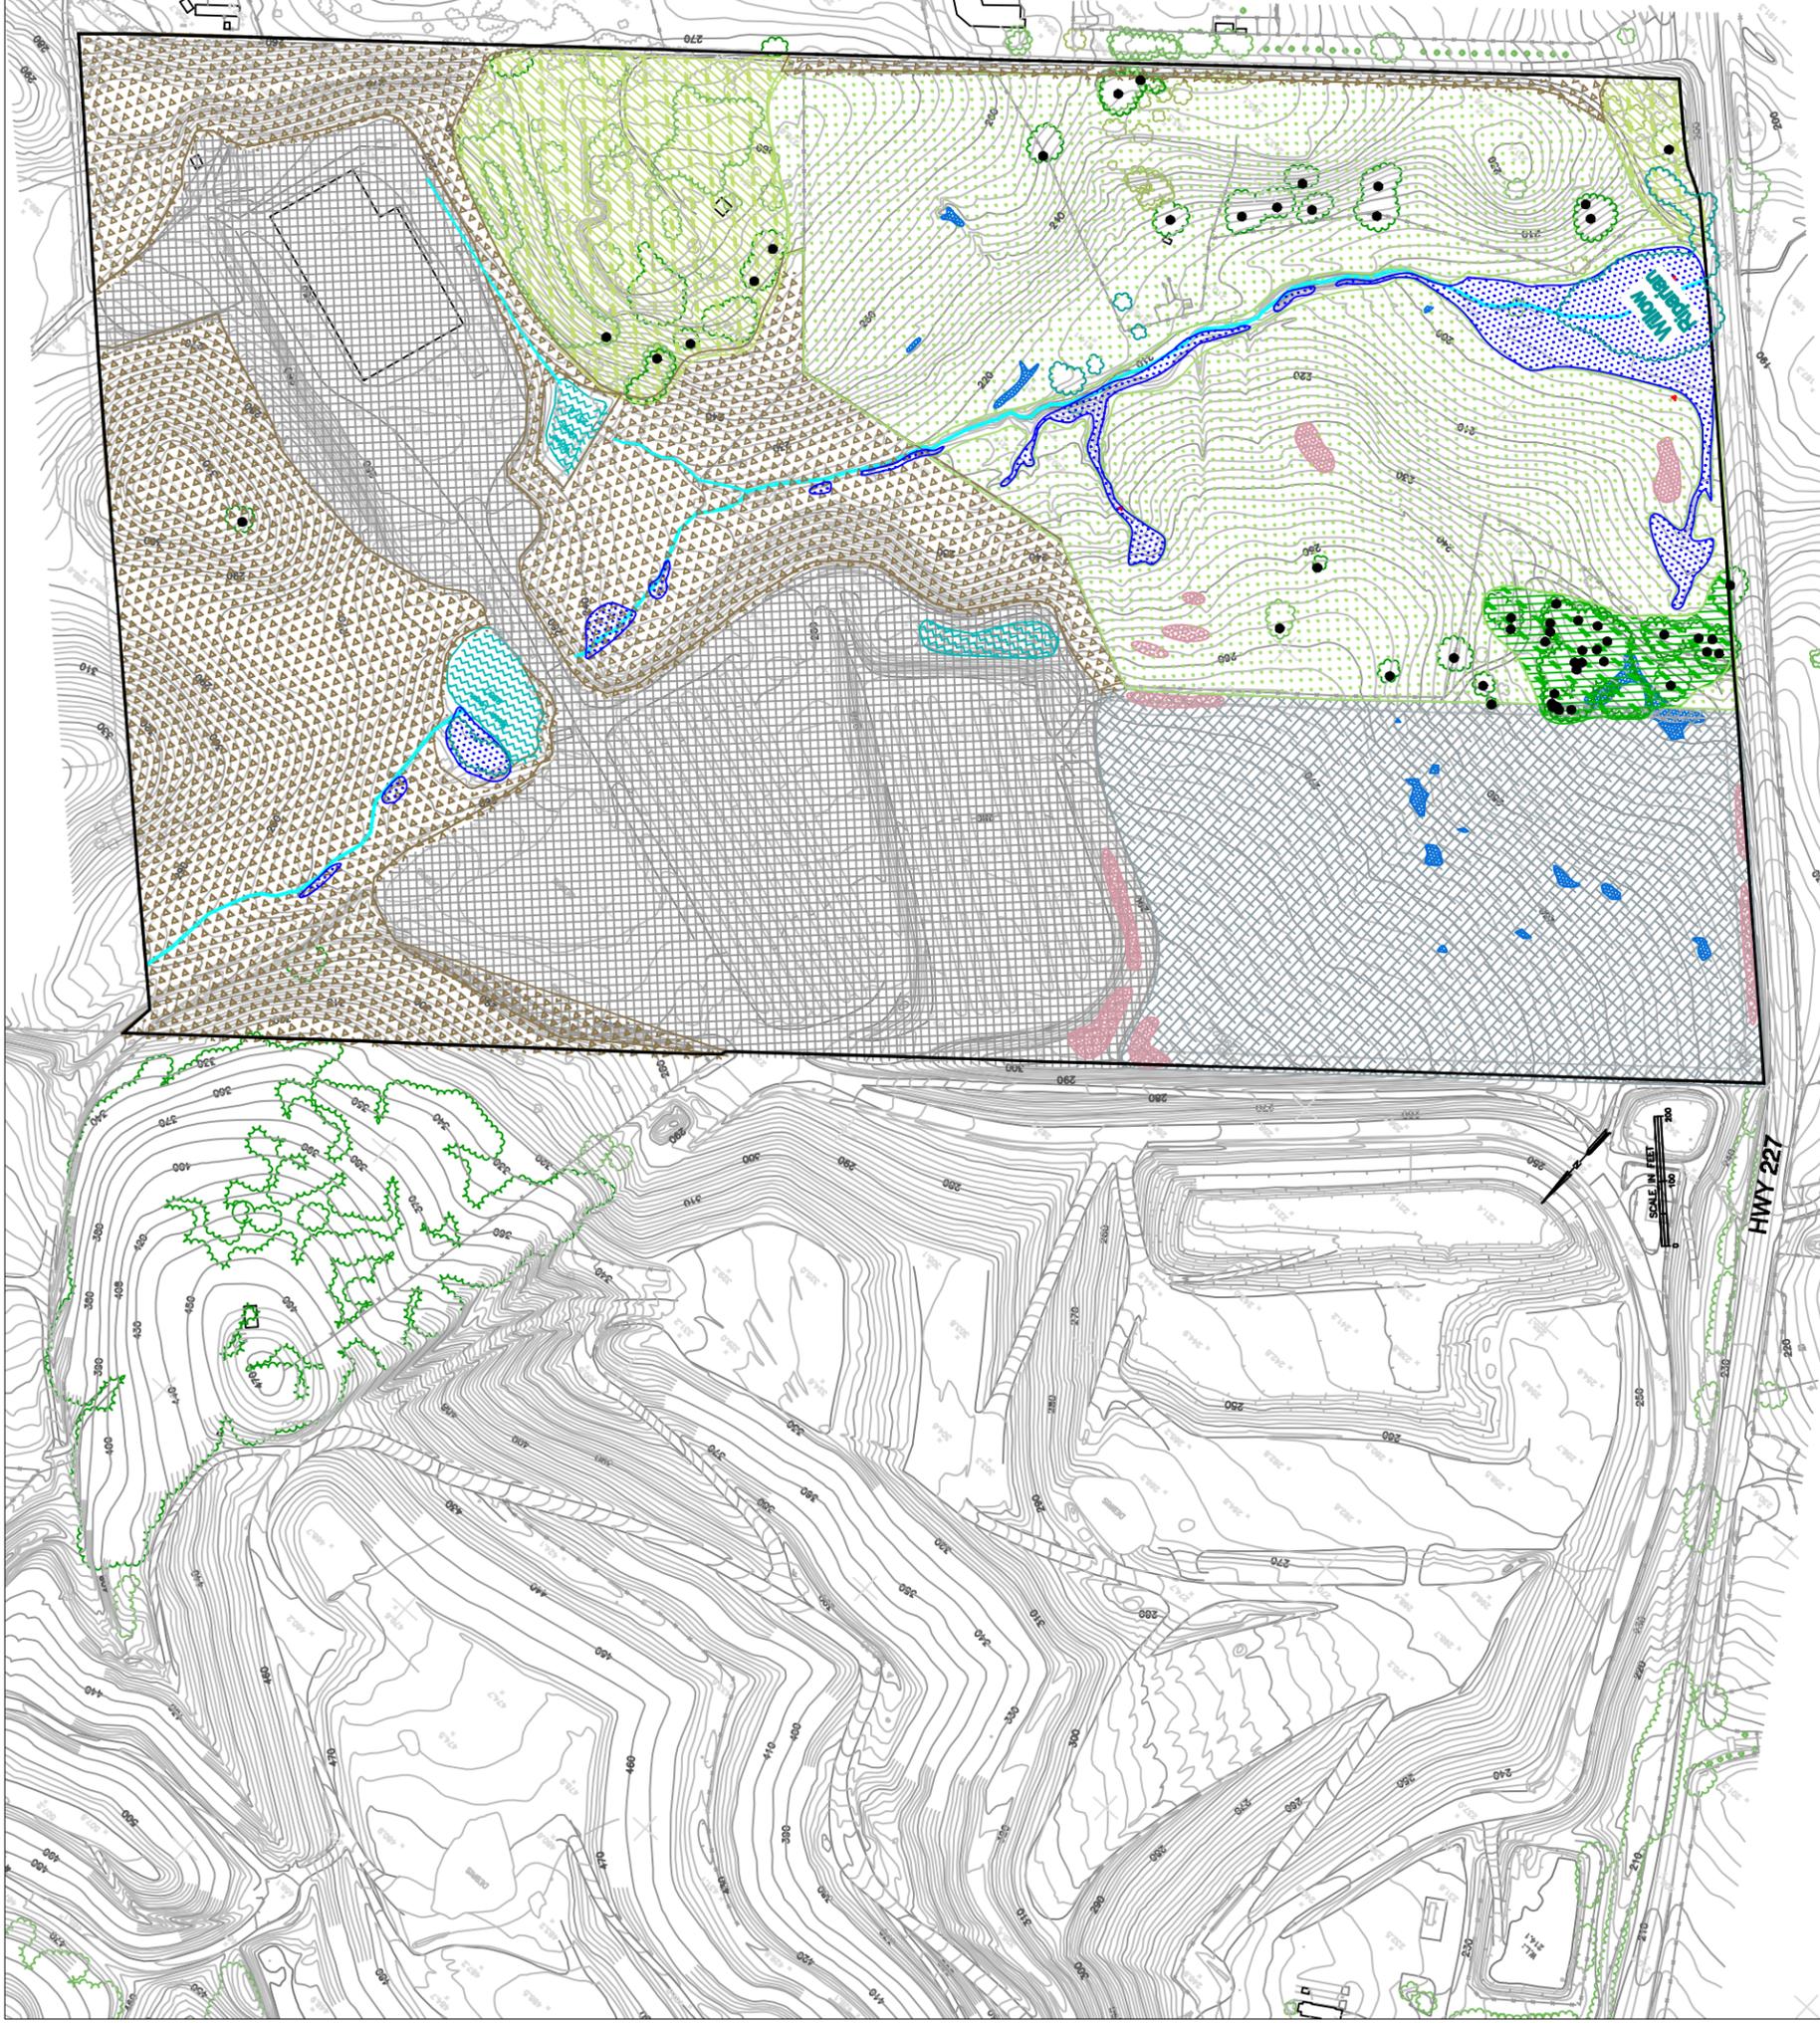
Impact Map

Limits of 2006 Biological Surveys by Althouse and Meade, Inc.		Epithermal stream, centerline
	Agrestial habitat (~12.76 acres)		Channel wetlands—federal (~2.23 acres)
	Anthropogenic habitat (~22.78 acres)		Slope Wetlands – state (~0.25 acre)
	Annual grassland (~22.84 acres)		Reservoirs and detention basins (~0.79 acre)
	Coast live oak woodland (~1.29 acres)		Tagged oak trees
	Mixed woodland (~5.39 acres)		Willow Canopy
	Obispo Indian Paritruush (~1000 individuals in 2006)		Canopy
	Ruderal habitat (~20.95 acres)

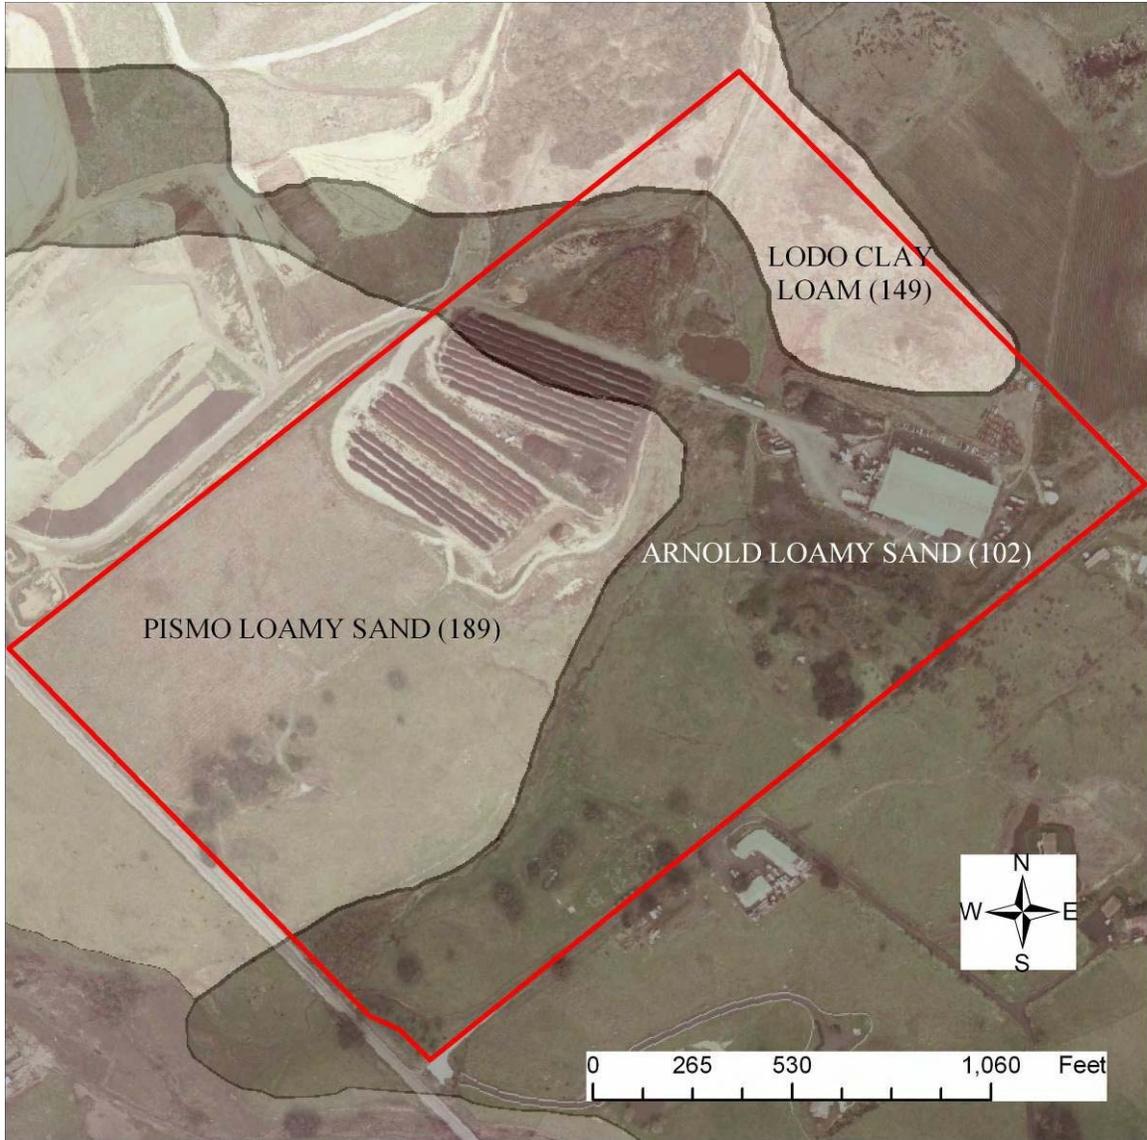
FIGURE 3. SOILS MAP. The approximate property boundaries of the subject property are outlined above. Map units are from the USDA Soil Survey of the San Luis Obispo County Coastal Part (1984). Three map units, Pismo loamy sand, 9 to 30 percent slopes (#189); Arnold loamy sand, 5 to 15 percent slopes (#102); and Lodo clay loam, 30 to 50 percent slopes (#149) are delineated on the property. The base layer of this map is a 2006 aerial photo by the NRCS.

Soil conditions observed onsite are generally consistent with mapped soils, except where disturbed by recent human activities, including grading for composting operations and construction of recycling sort facilities. Also, the range of slope gradients observed is broader than slopes described by the mapped units.

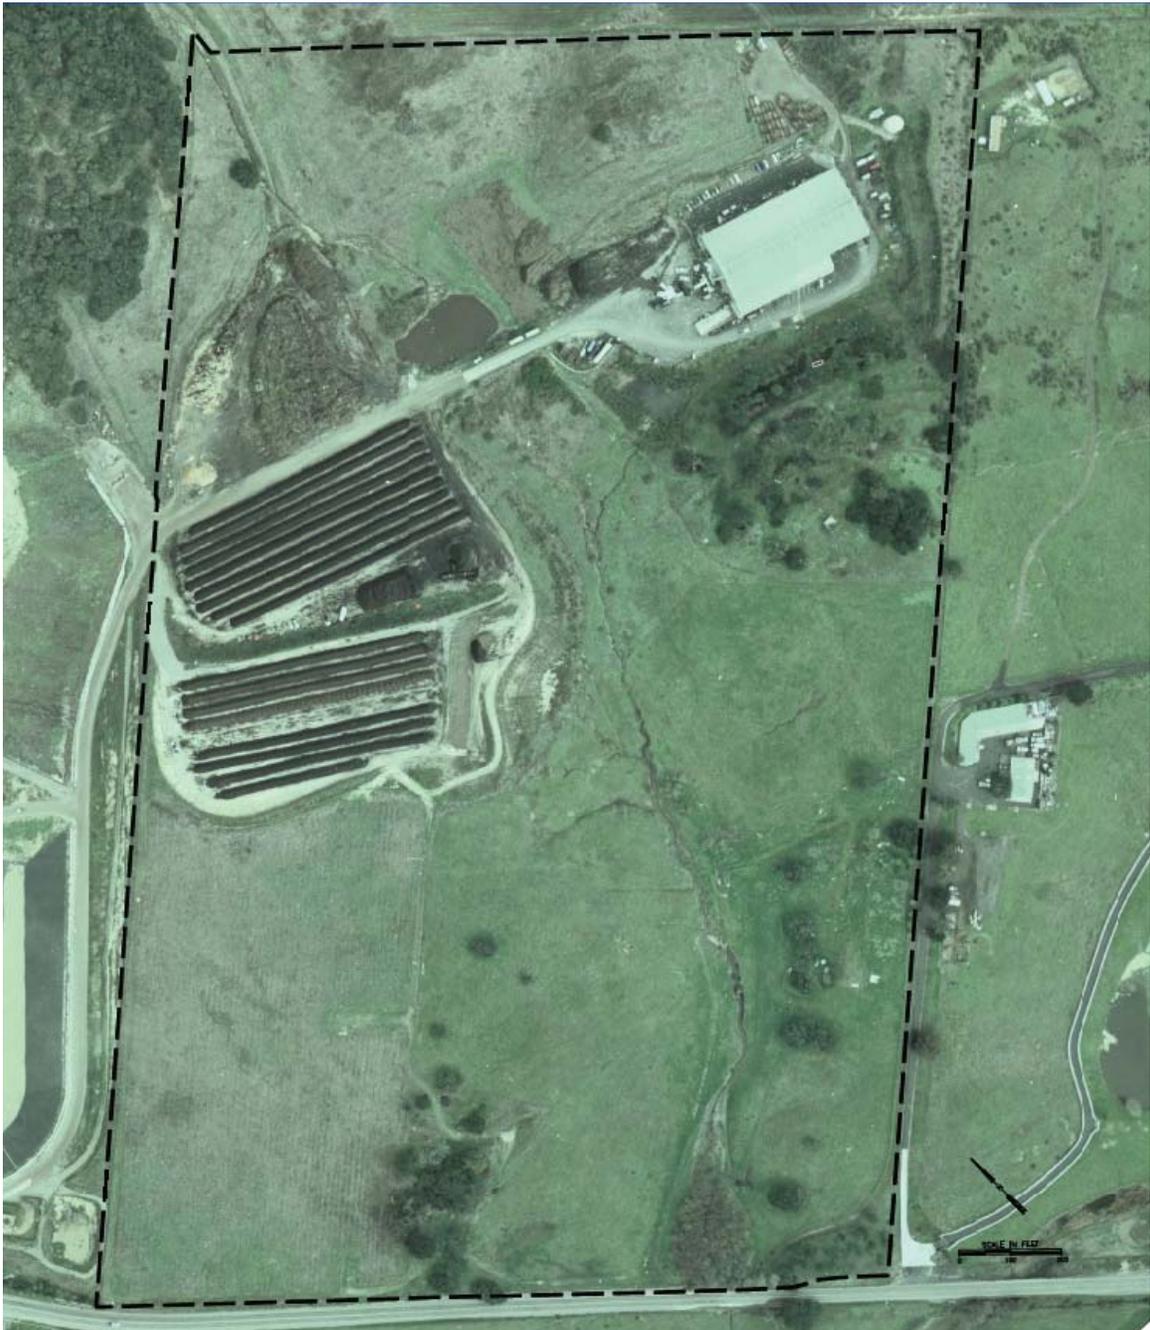
FIGURE 4 . AERIAL PHOTO. The approximate boundaries of the proposed expansion property are outlined above. Aerial photo by Golden State Aerial Surveys, flight date January 3, 2006.

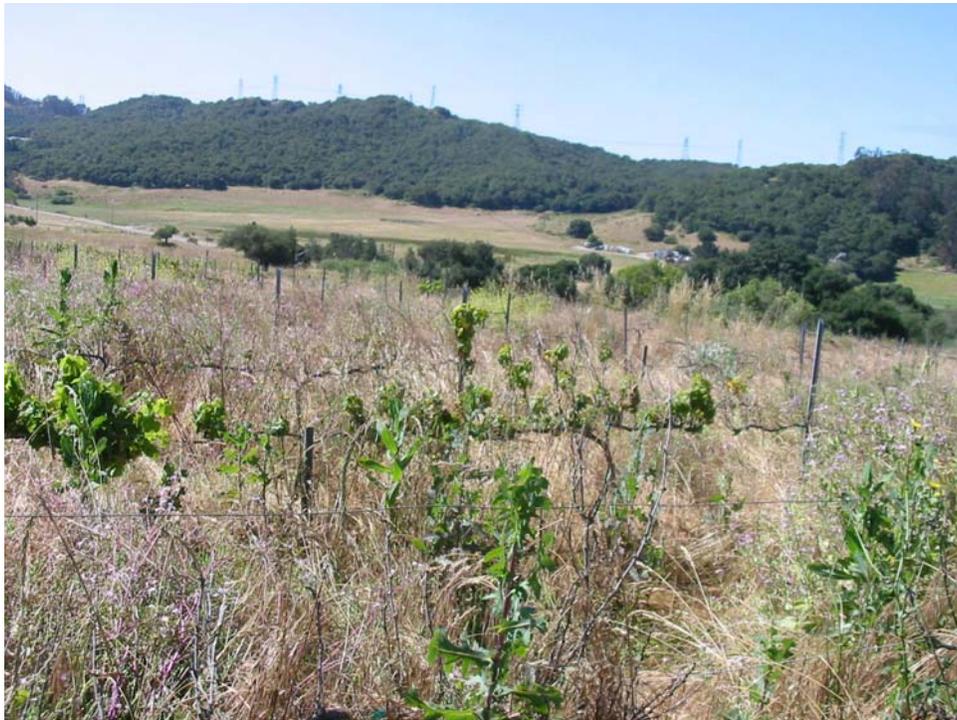
Photo 1. Agrestal habitat on the property consisted of an abandoned vineyard. Grape vines (*Vitis vinifera*) were still alive during initial site surveys in 2006. Between rows of vines, common weeds such as prickly lettuce, black mustard, and ripgut brome were dominant. Grape vines were removed in early 2007.

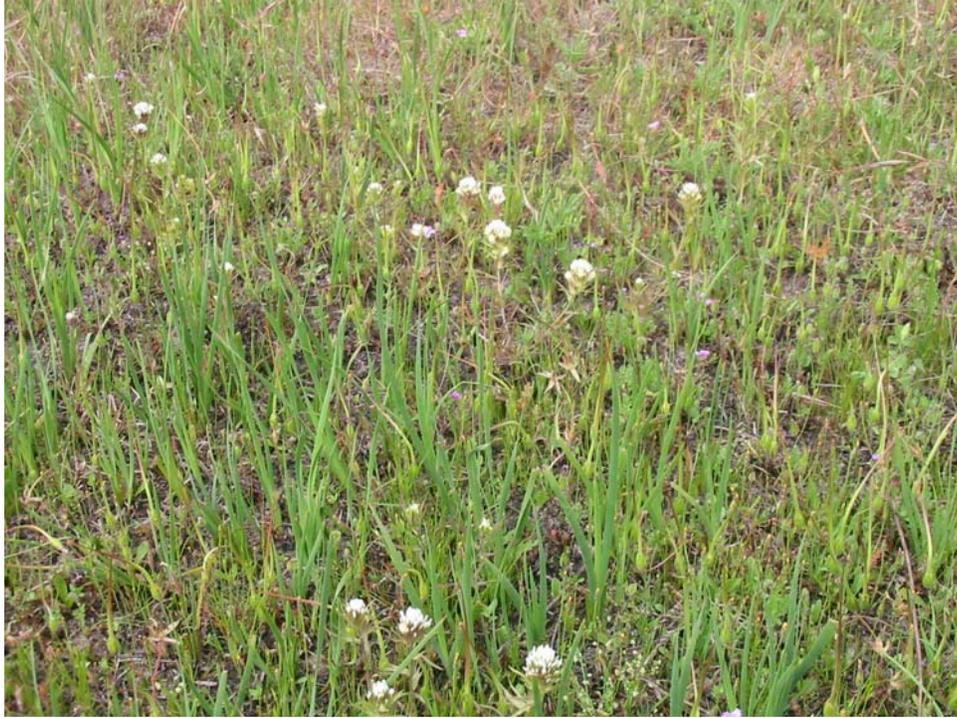
Photo 2. Obispo Indian paintbrush was observed in bloom on May 15, 2006 in grazed annual grassland, along the perimeters of the abandoned vineyard, and along unpaved roads. Vegetation was less dense in these areas, and weed competition was less vigorous than in other areas of the property.

The perimeter of the vineyard contains one rare plants, Obispo Indian paintbrush (*Castilleja densiflora* ssp. *obispoensis*). Obispo Indian paintbrush was observed among shorter grasses and annual herbs at the margins of the vineyard in 2006 and 2007 (Photos 2 and 3). This special status plant is also present in annual grassland.

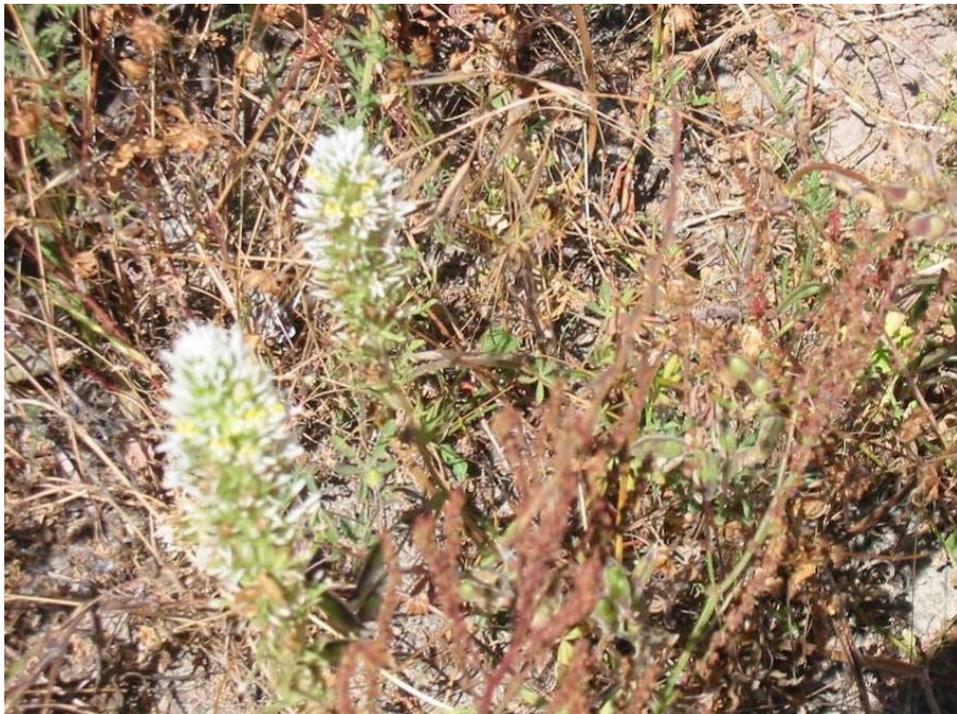
Photo 3. Closeup photo of Obispo Indian paintbrush along margin of vineyard.

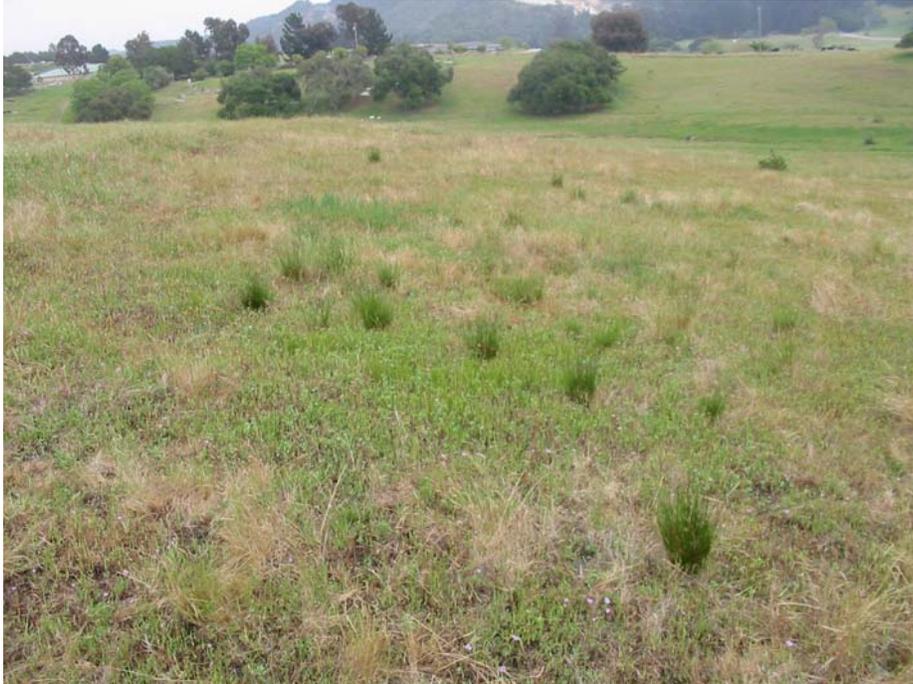
Photo 4. Annual grassland occurs on moderately sloped hills on the subject site. Although non-native annual species are dominant, native bunchgrass and rushes, such as *Nassella cernua* and *Juncus tenuis*, are also present. Some individual coast live oaks are scattered across grassland onsite.

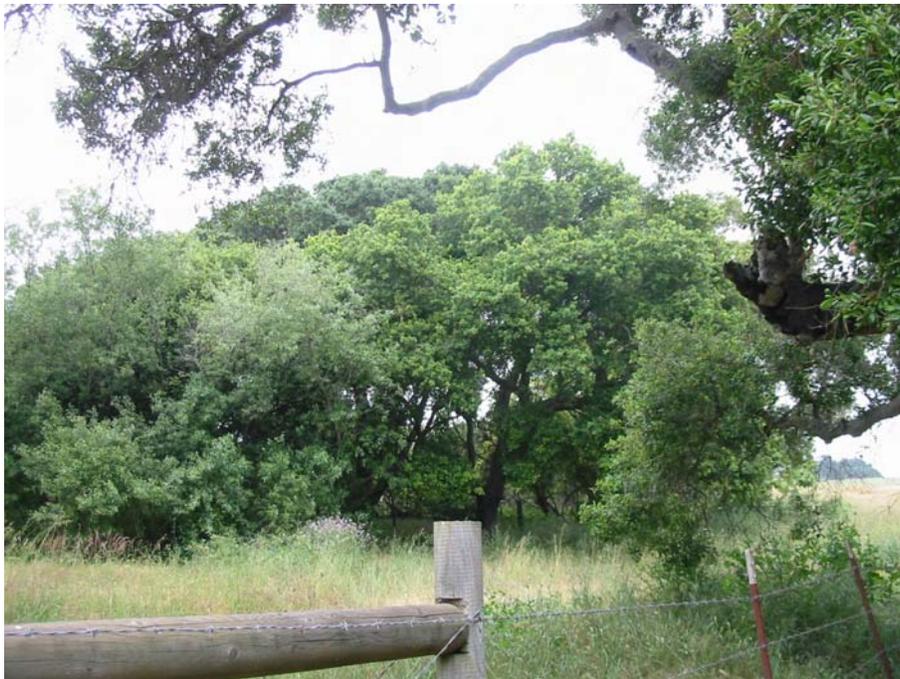
Photo 5. A small oak woodland is present in the southwest corner of the property. Over 35 mature oaks occupy 1.3 acres; arroyo willows and several ornamental and horticultural trees are also present.

An area of coast live oak woodland adjacent to the abandoned vineyard includes over 30 coast live oak trees averaging 16 inches diameter at breast height. These trees range from 6 to 73 inches sum dbh (that is, dbh of all main trunks added together) with a mean sum dbh of 25 inches. Coast live oak woodland occupies approximately 1.3 acres. Multiple mature coast live oaks, in good condition, also grow in small stands scattered about the property. In some areas, these stands of trees function as woodland; in other locations, individual oaks persist in open savanna.

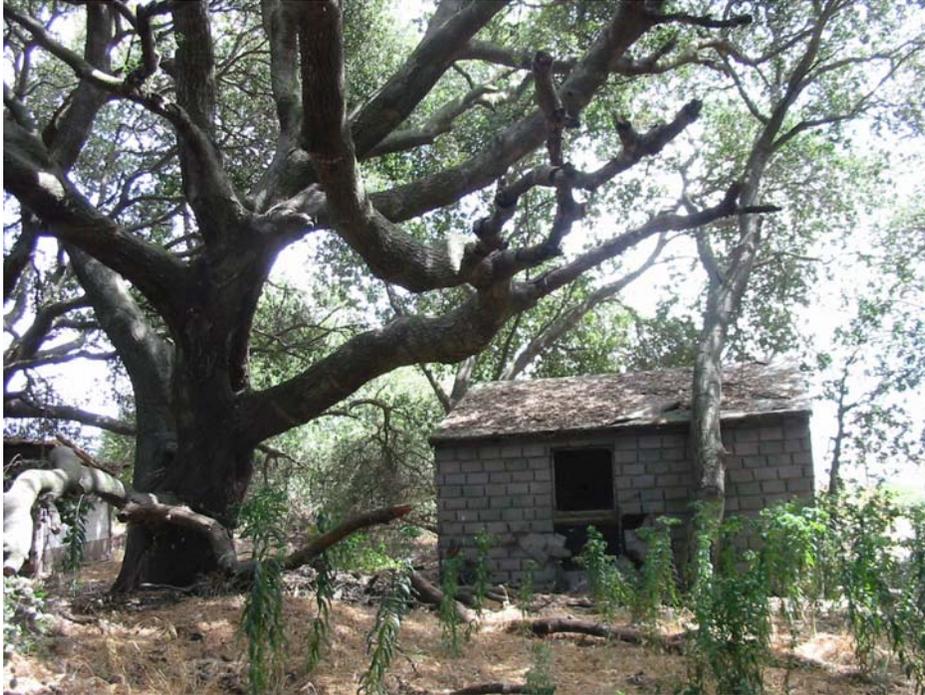
Photo 6. Oaks occur with landscape trees, such as *Pittosporum undulatum*, in mixed woodland on a knoll south of the existing sort facility. Old abandoned structures are scattered among the trees. This area would not be removed by the proposed landfill expansion.

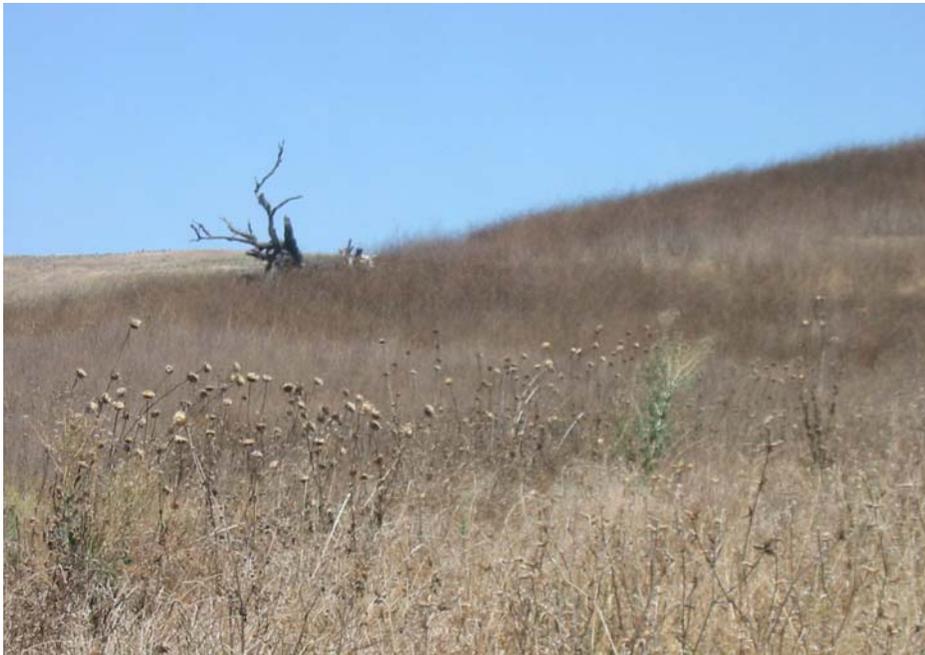
Photo 7. Weed-choked northeastern portion of property. This ruderal habitat is dominated by common weeds, including Italian thistle (*Carduus pycnocephalus*), wild radish (*Raphanus sativus*), black mustard (*Brassica nigra*), and prickly lettuce (*Lactuca serriola*). Photo taken July 31, 2006.

(*Bromus diandrus*), Italian thistle (*Carduus pycnocephalus*), perennial mustard (*Hirschfeldia incana*), prickly lettuce (*Lactuca serriola*), bristly ox-tongue (*Picris echioides*), wild radish (*Raphanus sativus*), and milk thistle (*Silybum marianum*). Past and ongoing disturbances, including an abandoned unpaved road, stockpiling of raw greenwaste, and compost operations have probably contributed to conditions favoring a ruderal community at this location.

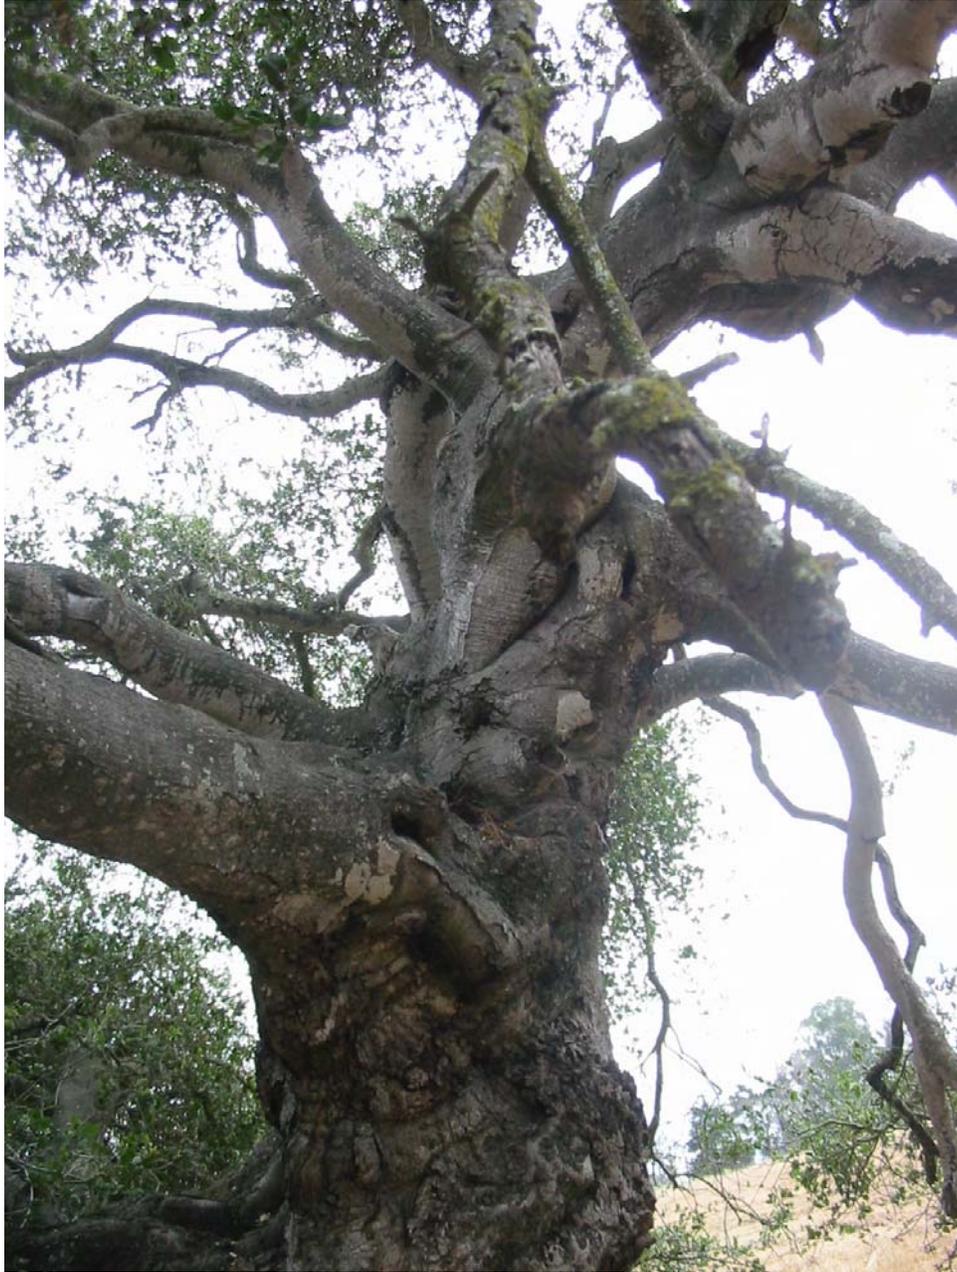
Photo 8. Large coast live oak (tree # 9) in moderate condition, located east of the drainage. This tree is expected to remain intact.

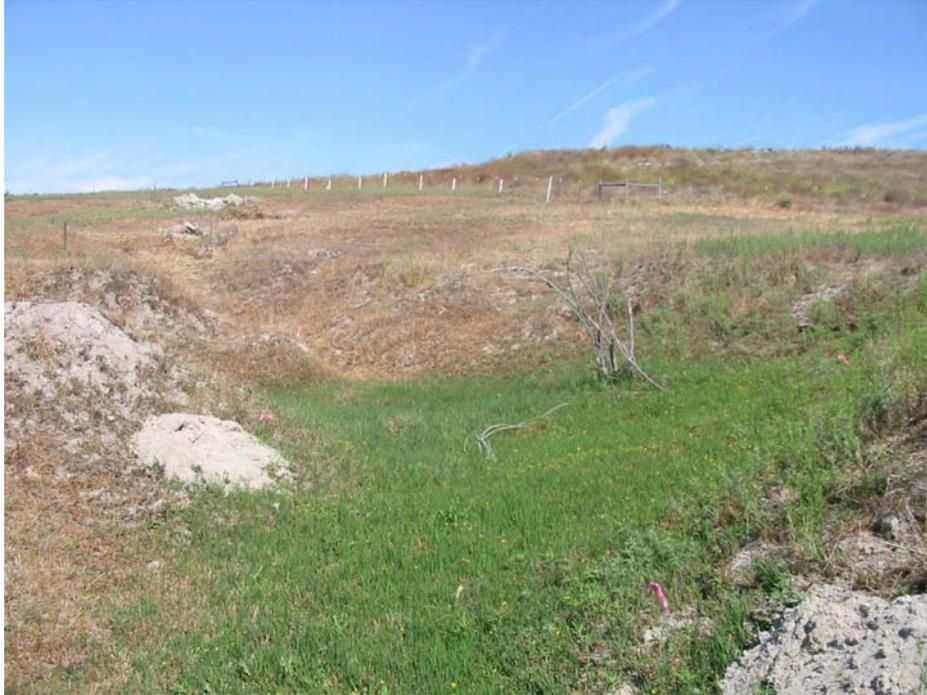
Photo 9. Seasonal wetland in a swale that drains into an ephemeral stream on the property. The USACE verbally stated in 2007 that this wetland is under their jurisdiction.

Slope wetlands are present on approximately 0.25 acres of the property, in shallow depressions and from saturated return flow seeps along lower hillsides. In these isolated shallow depressions and seeps, wetland vegetation is composed of primarily flat-stem rush (*Juncus phaeocephalus*), with occasional individuals of Mediterranean barley (*Hordeum marinum* ssp. *gussoneanum*), toad rush (*Juncus bufonius*), and loosestrife (*Lythrum hyssopifolium*). Non-native annual grasses and herbs, including soft chess (*Bromus hordeaceus*), ripgut brome (*Bromus diandrus*), and wild radish (*Raphanus sativus*) form a dense ring of vegetation around these isolated patches of seasonal wetland.

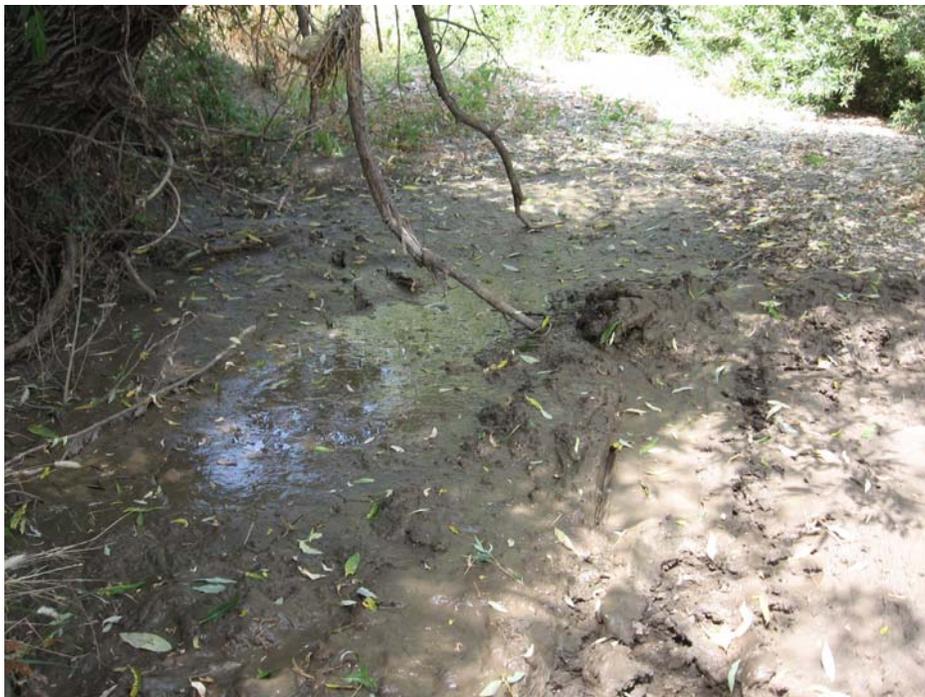
Photo 10. Recently deposited sediment within the ephemeral drainage masks wetland soil conditions beneath willow canopy (near Highway 227). However, this area is a jurisdictional wetland, as verified by the Corps. Photo taken June 13, 2006.

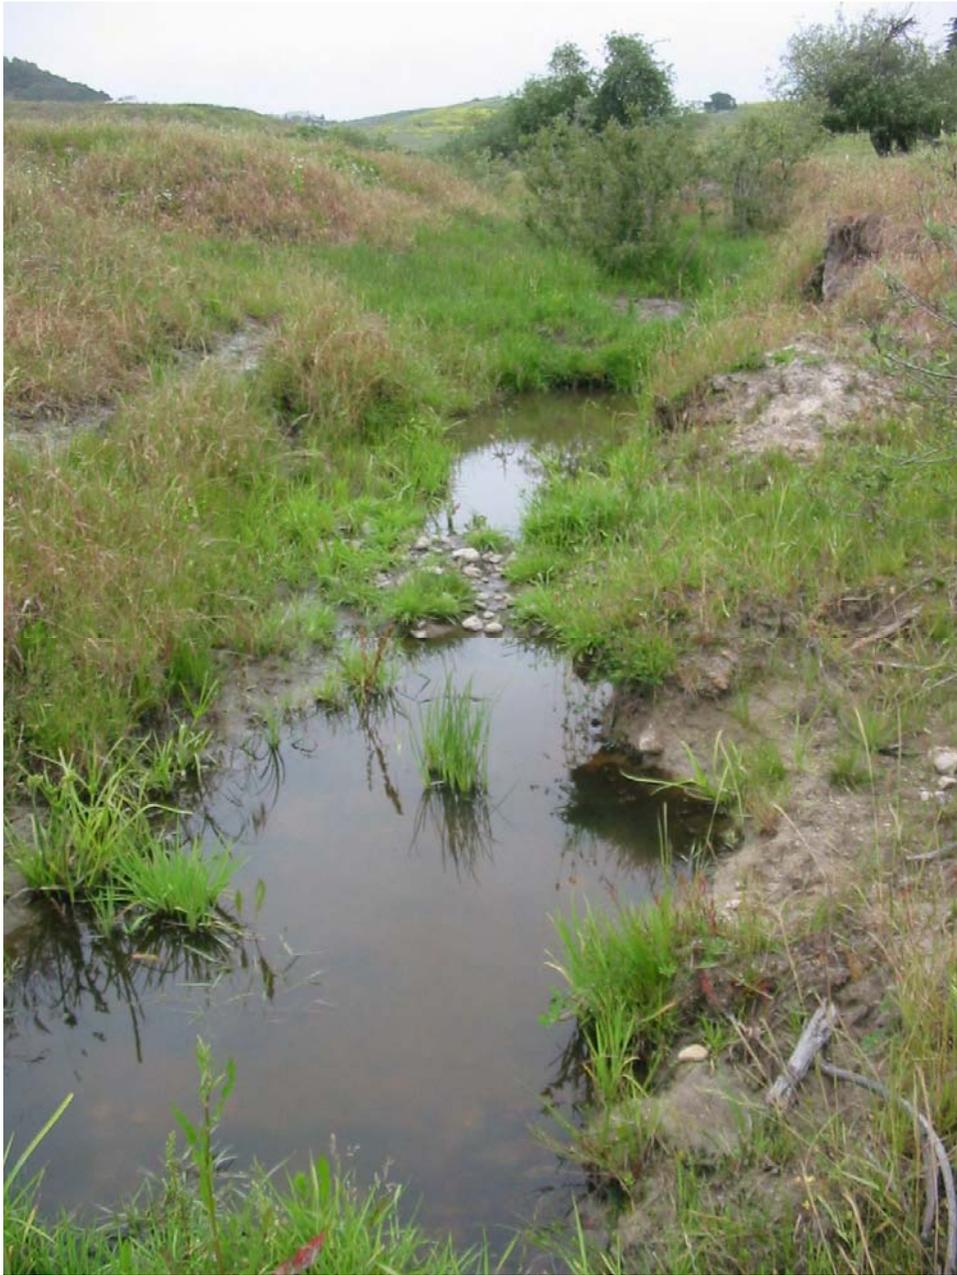
Photo 11. Seasonal pools persist within the ephemeral drainage in wet years. This reach of the drainage includes jurisdictional wetlands of the U.S. Note emergent wetland vegetation along pool margins and lower banks. Photo taken May 15, 2006.

Approximately 2.2 acres of wetlands along and within the stream channel are more diverse and provide higher-quality habitat than slope wetlands on the subject property. A mixture of annual and perennial species, including willows (*Salix lasiolepis*), sedges (*Carex* sp.), spikerush (*Eleocharis macrostachya*), flat-stem rush (*Juncus phaeocephalus*), rabbit's-foot grass (*Polypogon monspeliensis*) and curly dock (*Rumex crispus*) are present in channels and adjacent wetland, forming multiple layers of vegetation in some locations.

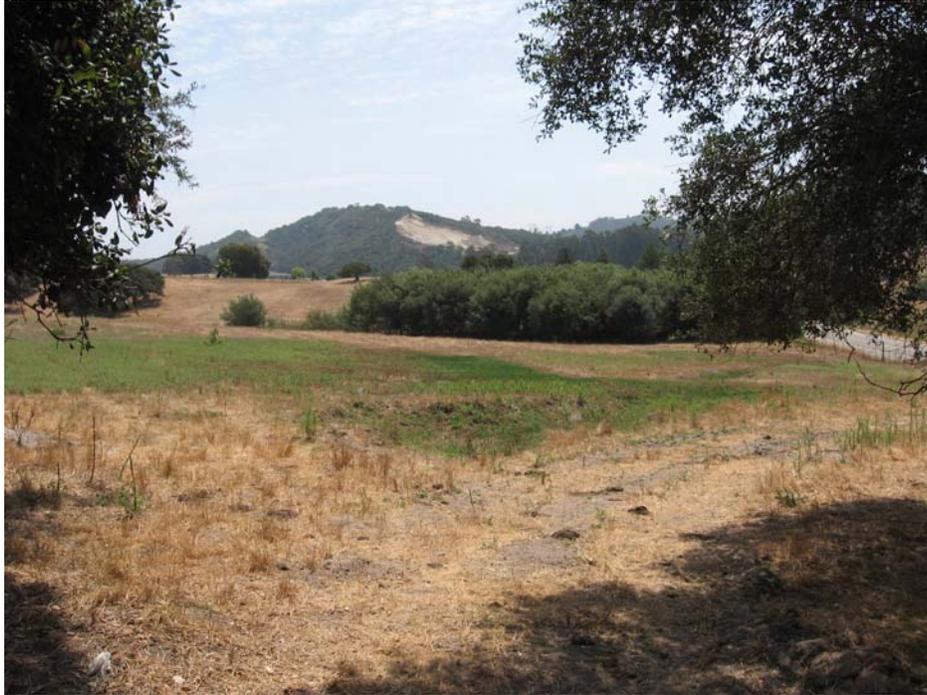
Photo 12. Arroyo willow riparian occurs in the floodplain of an ephemeral drainage on the property. Individual willows are also present near the drainage and seasonal wetlands. This photo was taken from a small oak woodland near Highway 227, facing southeast, in July 2006.

Arroyo willow shrubs and small trees are present in and along the drainage, forming a dense canopy on the flood plain near the southwest edge of the property. Although surface water dries in late spring, soils remain moist into July in this approximately 0.85-acre thicket of mature Arroyo willows. The willow thicket provides excellent nesting habitat for many bird species, including robins and towhees, which were nesting in willows on the property in 2006.

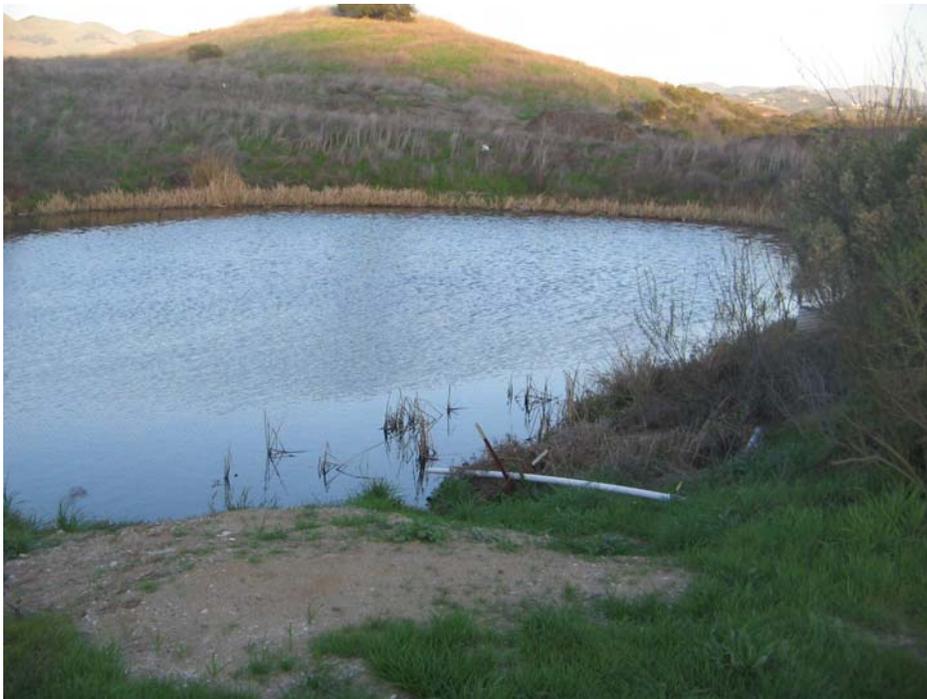
Photo 13. Existing reservoir within the drainage. This reservoir will remain in place.

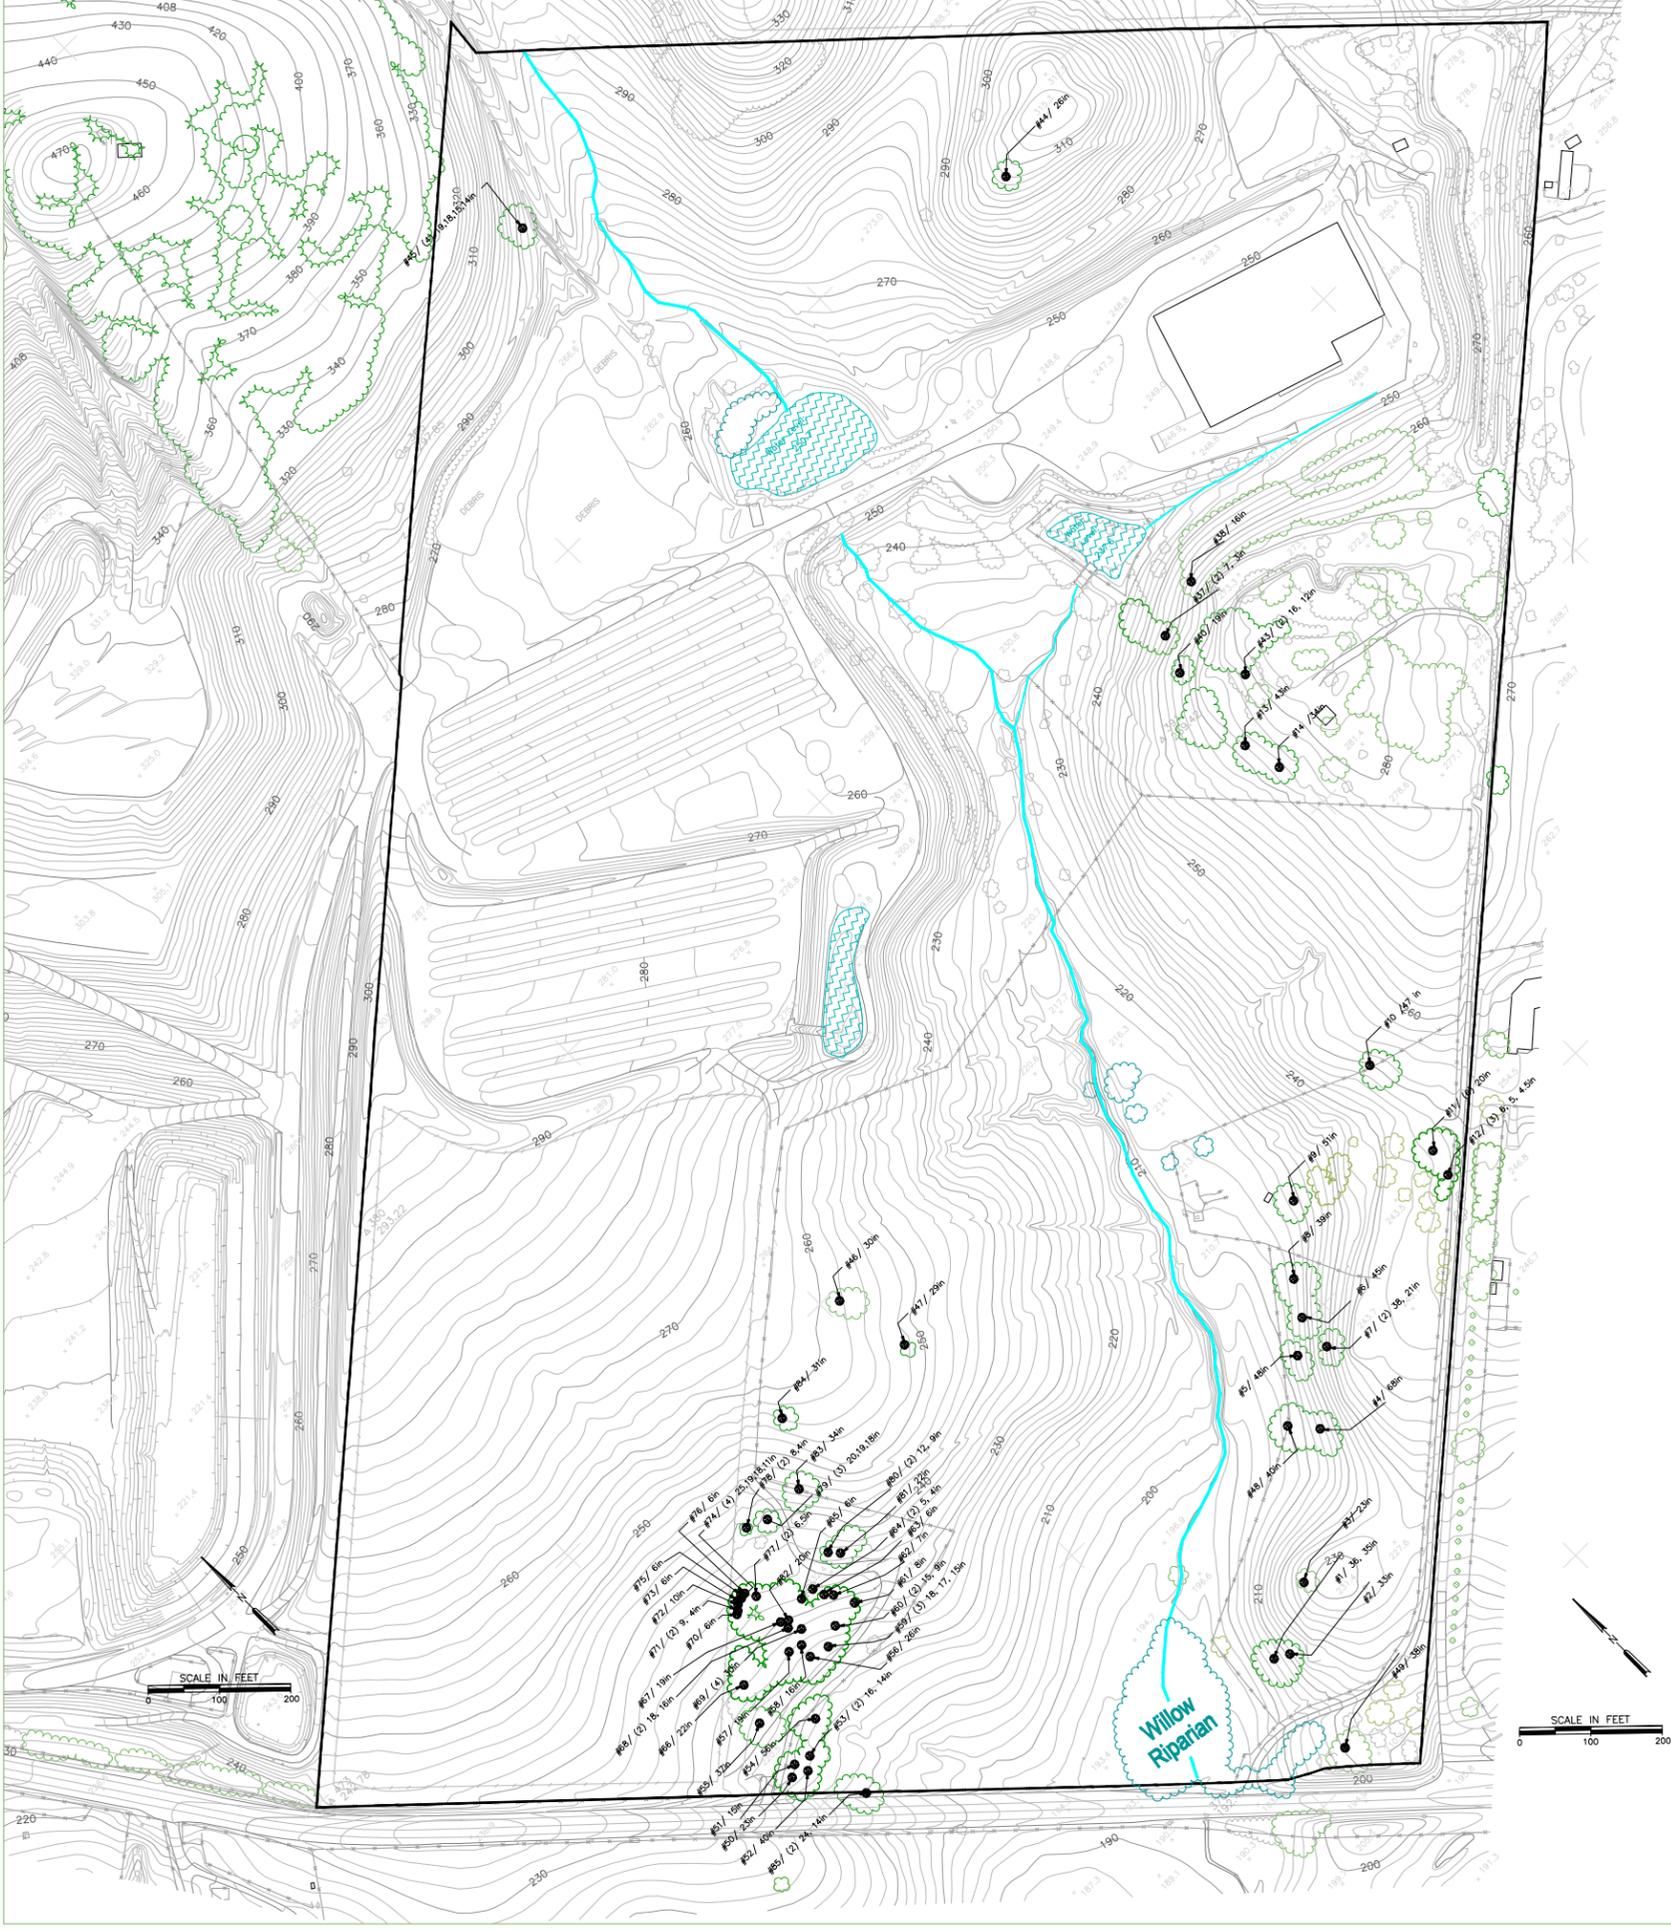
Tree Impact Map

= trunk location of coast live oak tree
