Biological Report

Cold Canyon Landfill: Proposed Expansion

2268 Carpenter Canyon Road

August 2006

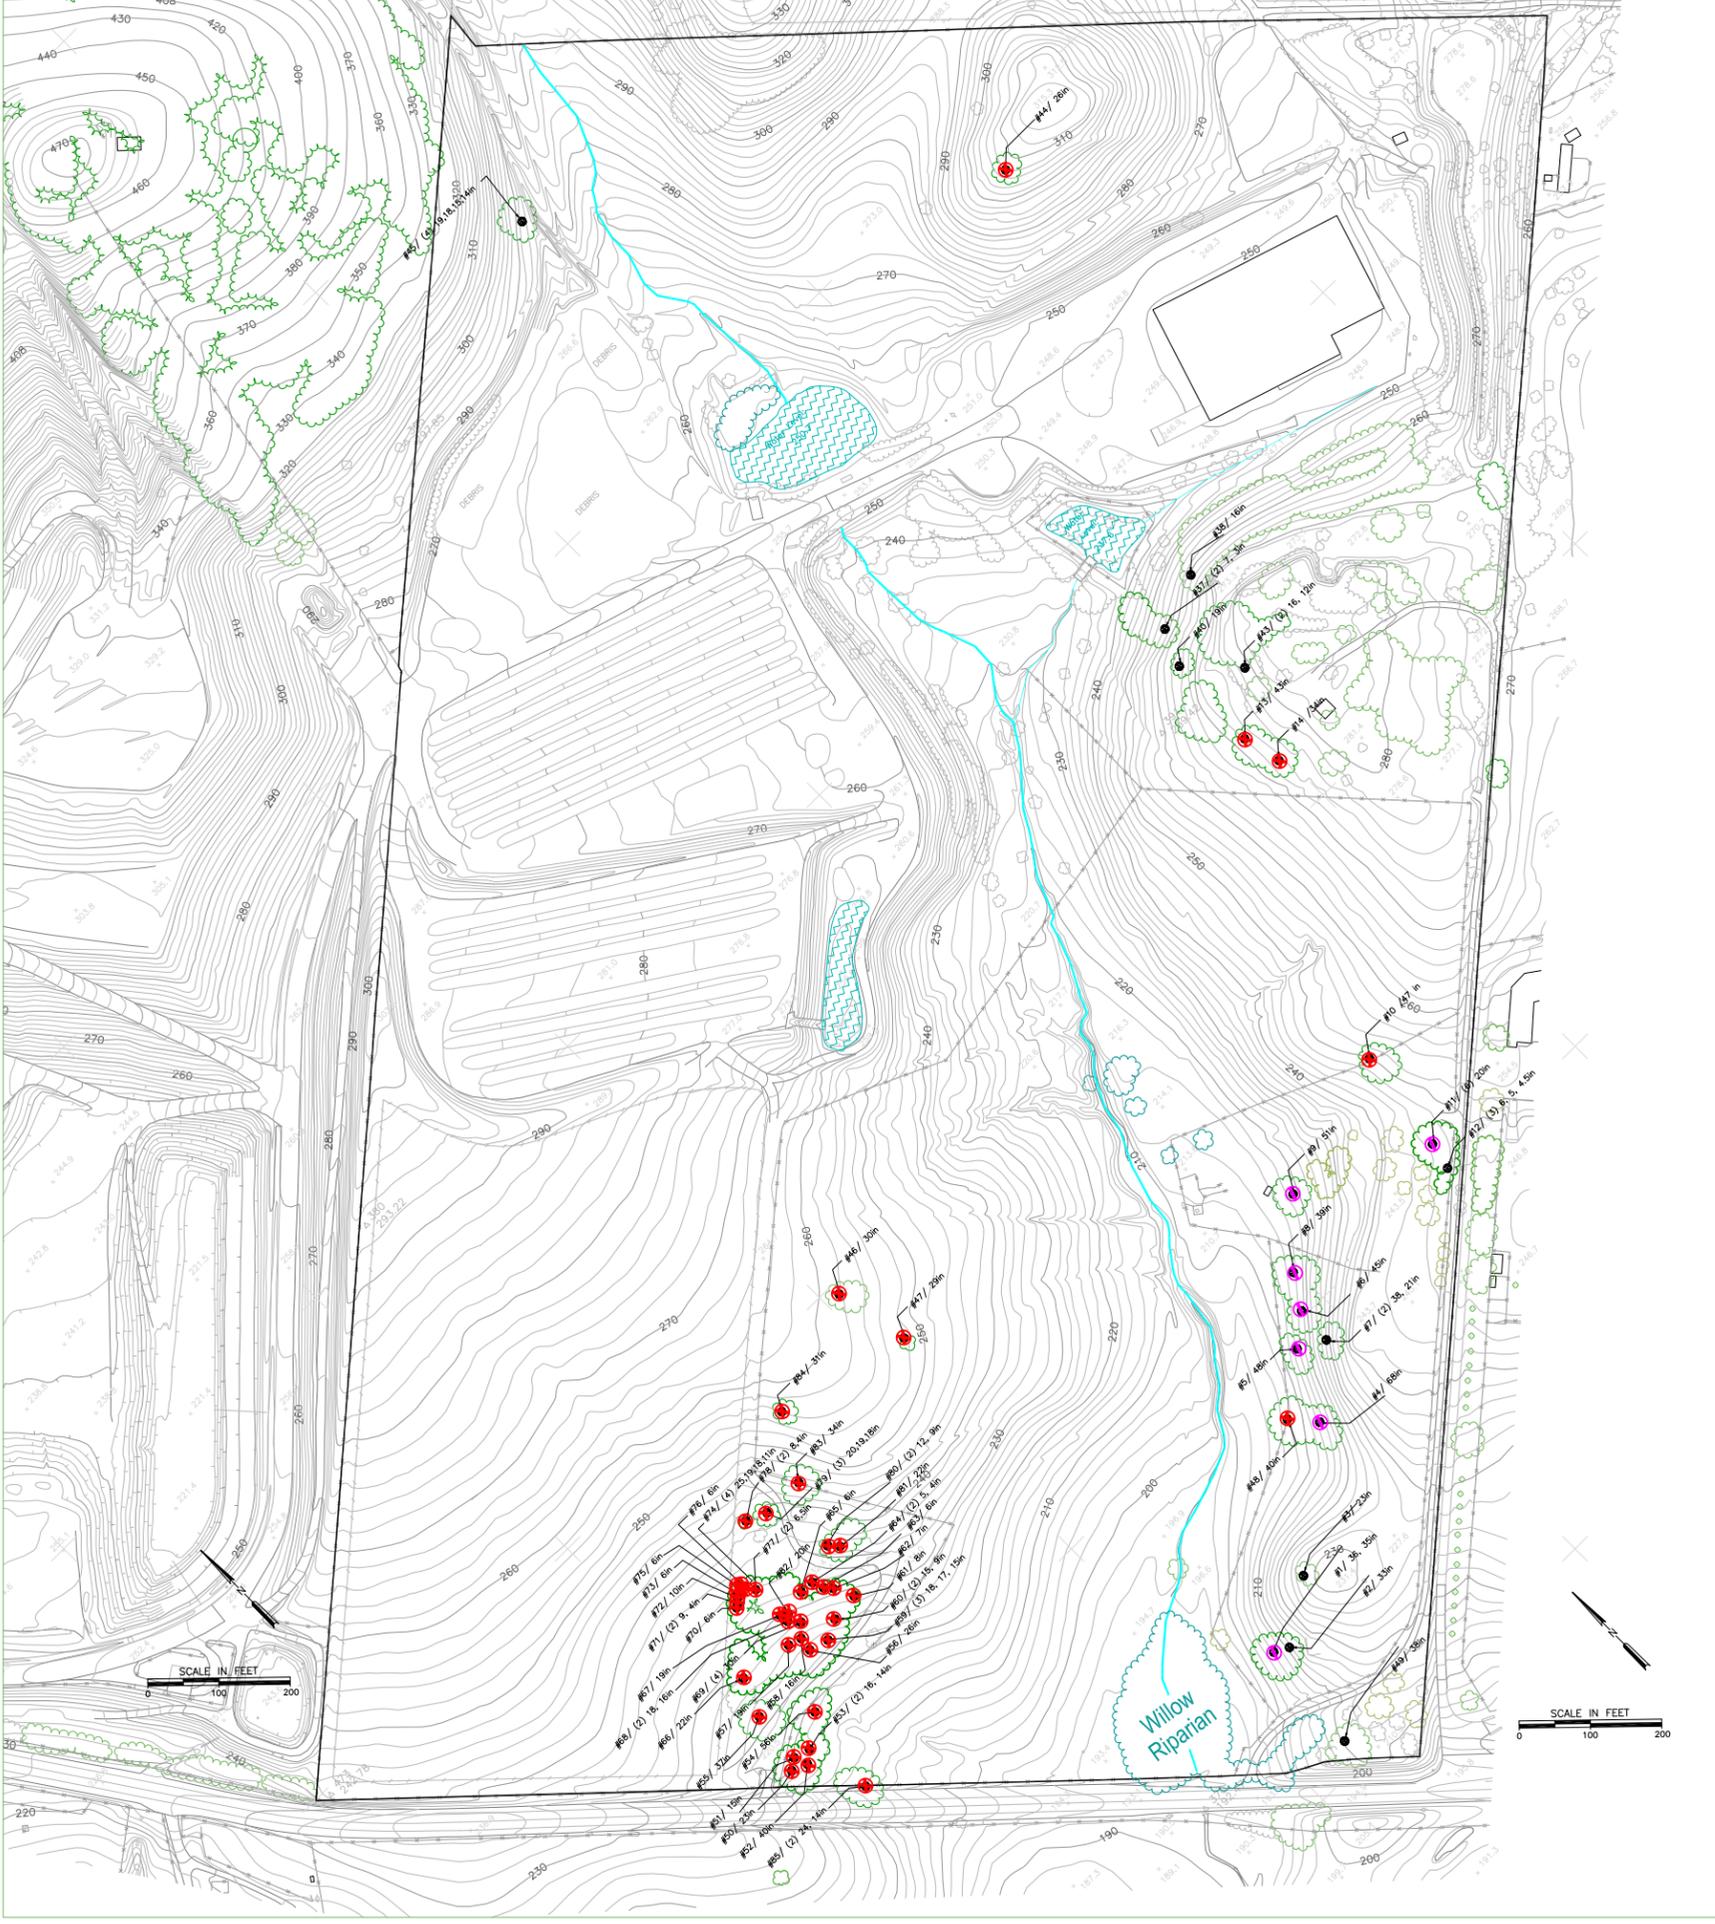
Tree Impact Map

= coast live oak tree to be impacted
