**BOB JONES CITY TO SEA TRAIL  
ENGINEERING FEASIBILITY STUDY**  
COUNTY OF SAN LUIS OBISPO

**PREFERRED TRAIL ALIGNMENT**  
SAN LUIS OBISPO, CALIFORNIA

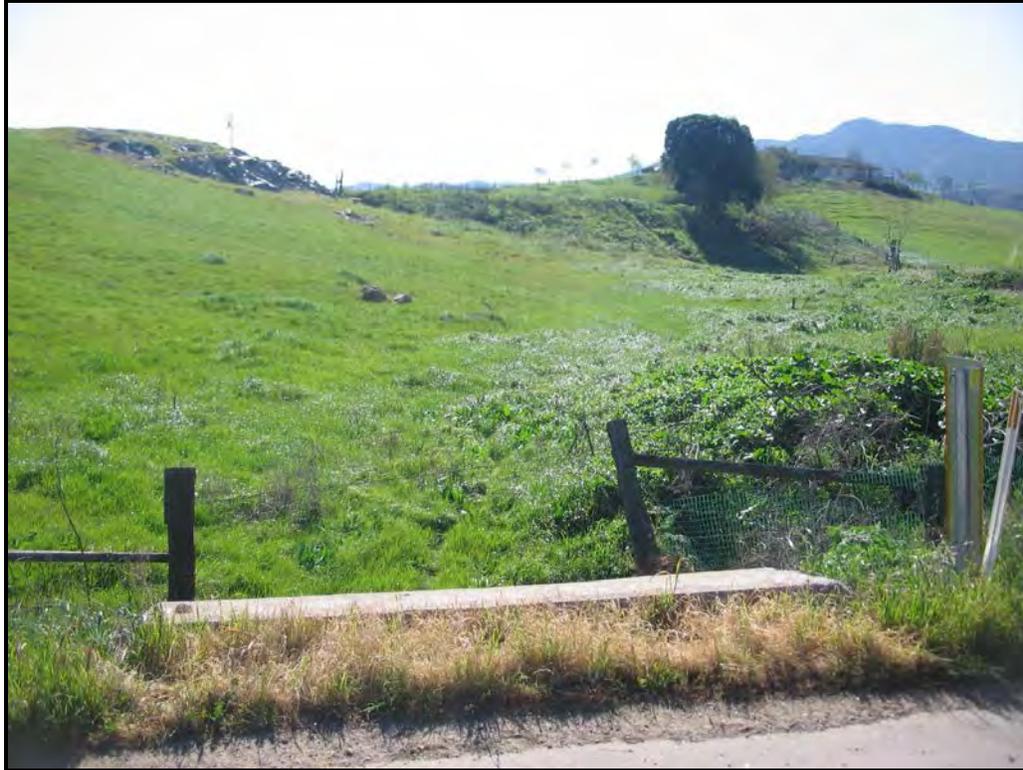
**Photo 1:**

East view of Habitat Assessment (HA) Site #1, just east of South Higuera Street. A box culvert directs runoff from a swale traversing annual grassland, continuing under the road to a stream on the opposite side of the road.

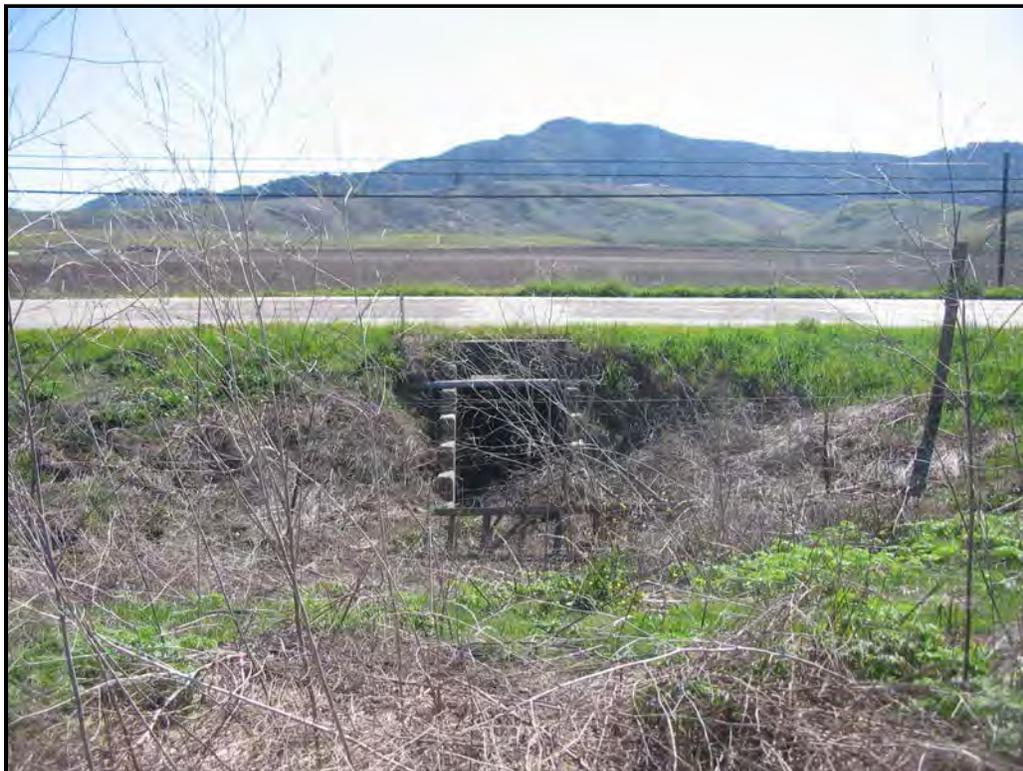
**Photo 2:**

East view of HA Site #2, just west of South Higuera Street. A box culvert conveys runoff into an agricultural drainage ditch and under the road.

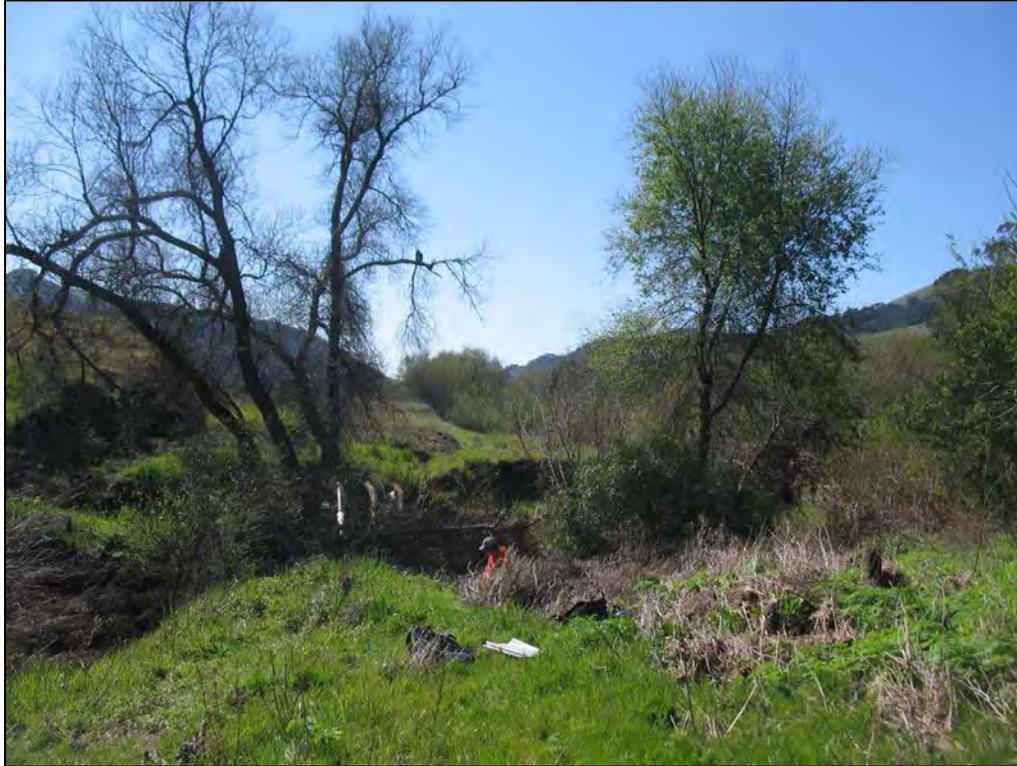
**Photo 3:**

South view of general vicinity of HA Site #3 at confluence of San Luis Obispo Creek with its East Fork. Site has overhanging arroyo willow cover with some emergent vegetation. One of three crossing options proposed at this location.

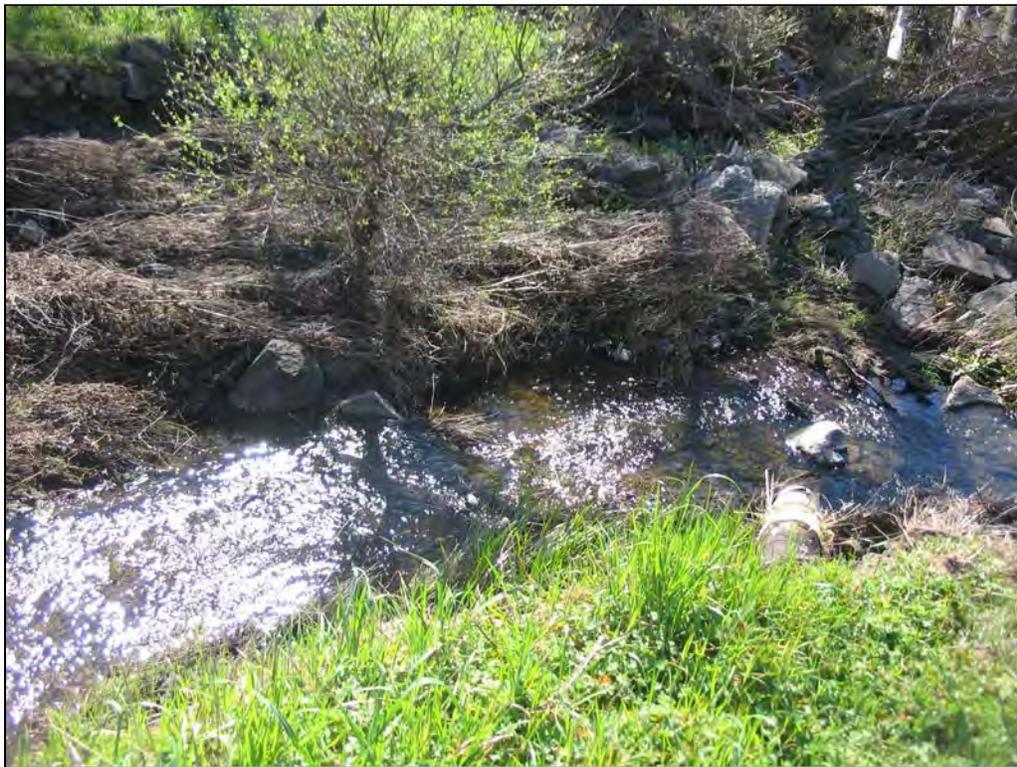
**Photo 4:**

Southeast view of flow conditions of SLO Creek just upstream of HA Site #3.

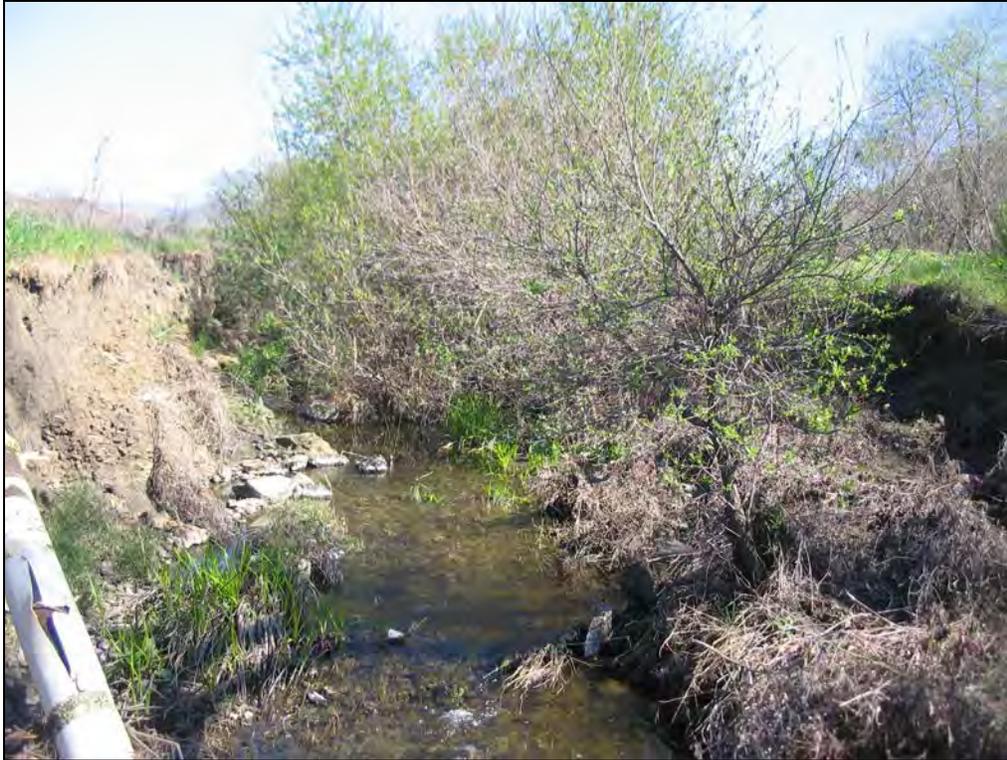
**Photo 5:**

North view of HA Site #3, showing overhanging willow cover and some emergent vegetation of SLO Creek

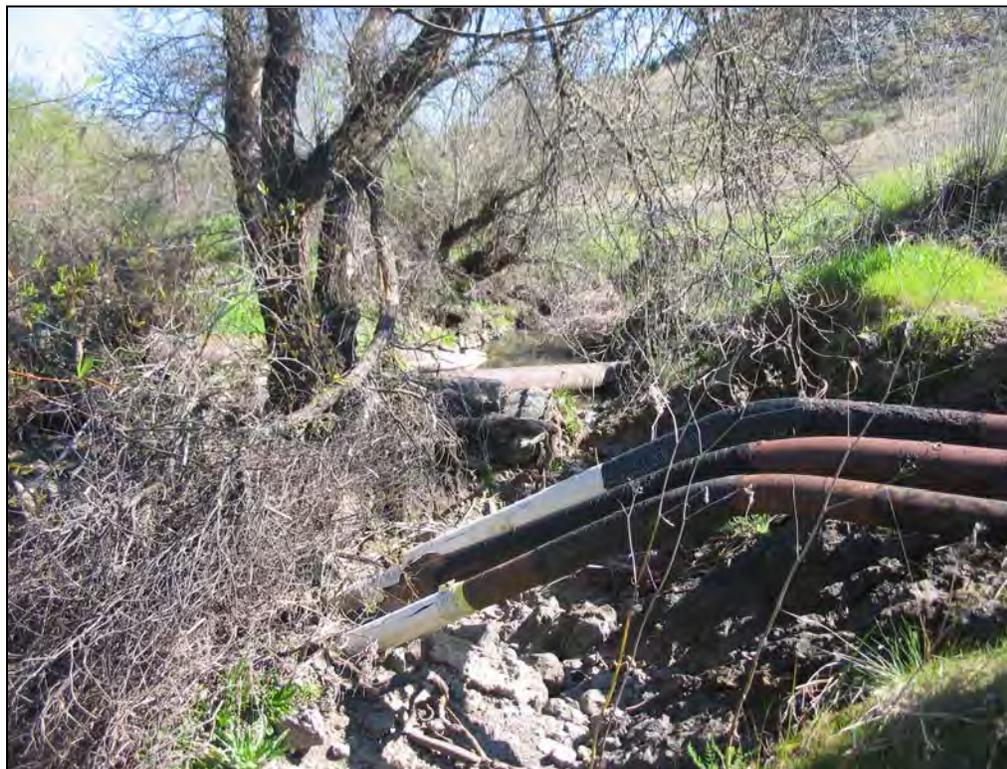
**Photo 6:**

Northeast view of East Fork of SLO Creek at HA Site #3, where significant erosion has occurred and pipes are exposed. There was some backwater pooling in this area at the time of the site assessment.

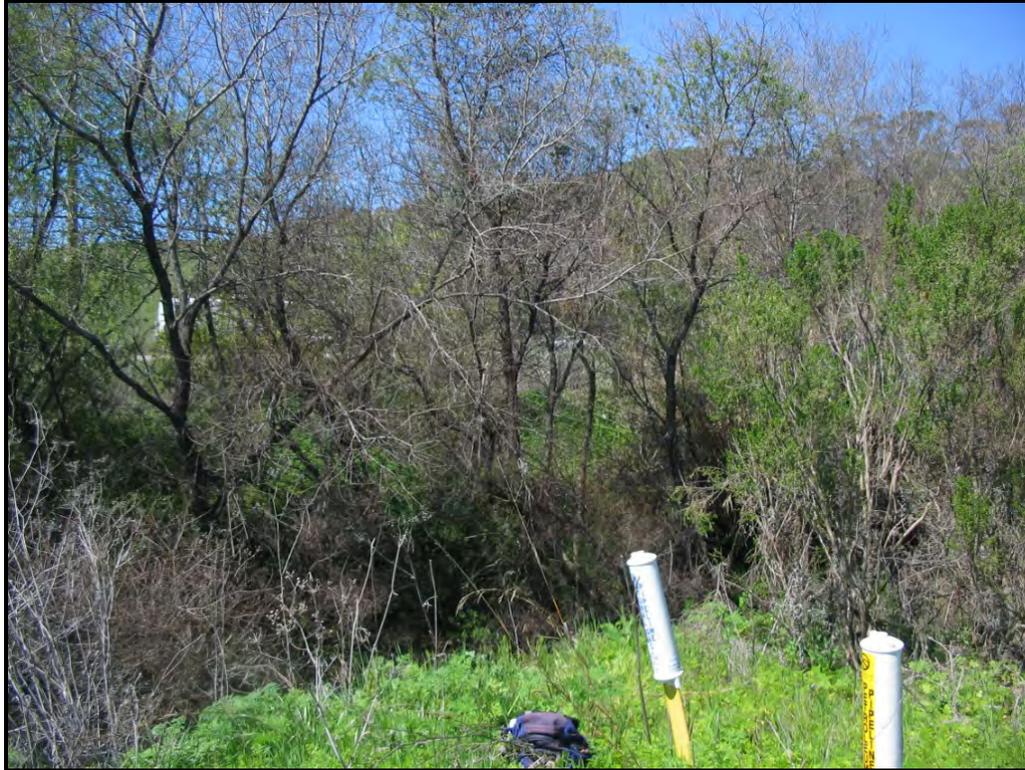
**Photo 7:**

West view of HA Site #4 proposed crossing, from the east side of SLO Creek a few hundred feet south of the Filipponi Reserve. Willows and walnut trees provide the overstory.

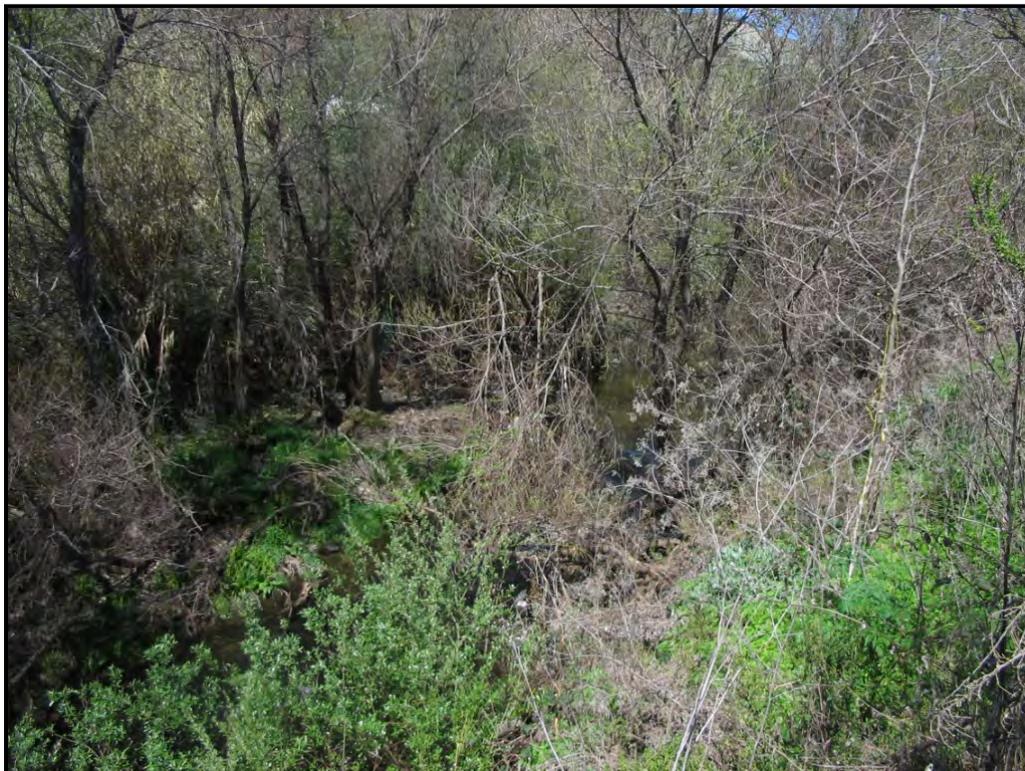
**Photo 8:**

Northwest view of upstream conditions at HA Site #4. Dense vegetation grows along the banks and there is no emergent vegetation in the wetted portion of the stream channel.

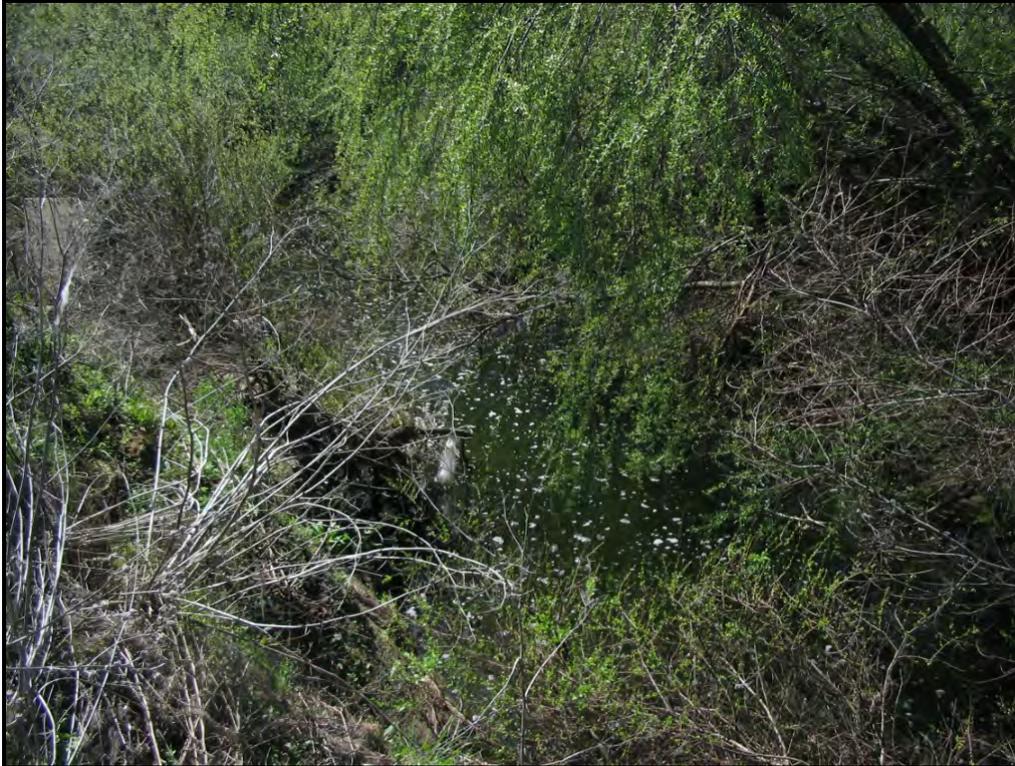
**Photo 9:**

Southwest view of flow conditions through HA Site #4. Note dense vegetative cover along the banks but no emergent vegetation.

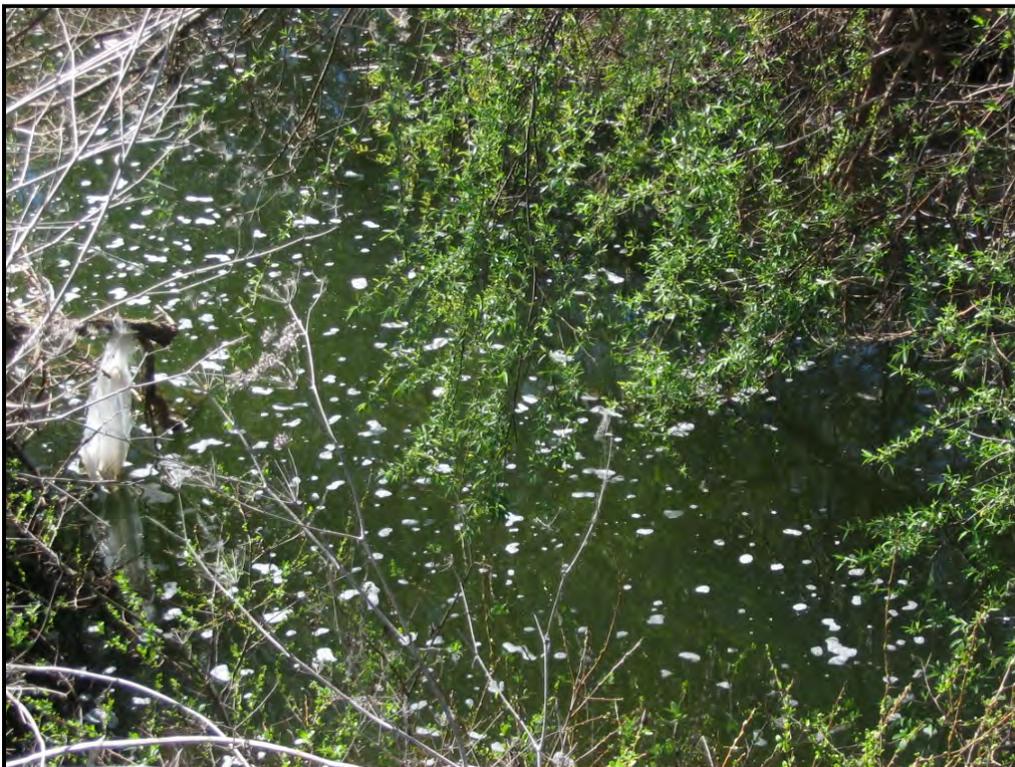
**Photo 10:**

Close-up at wetted channel at HA Site #4. Water is still to slow-moving at this location with depths of 4 to 5 feet.

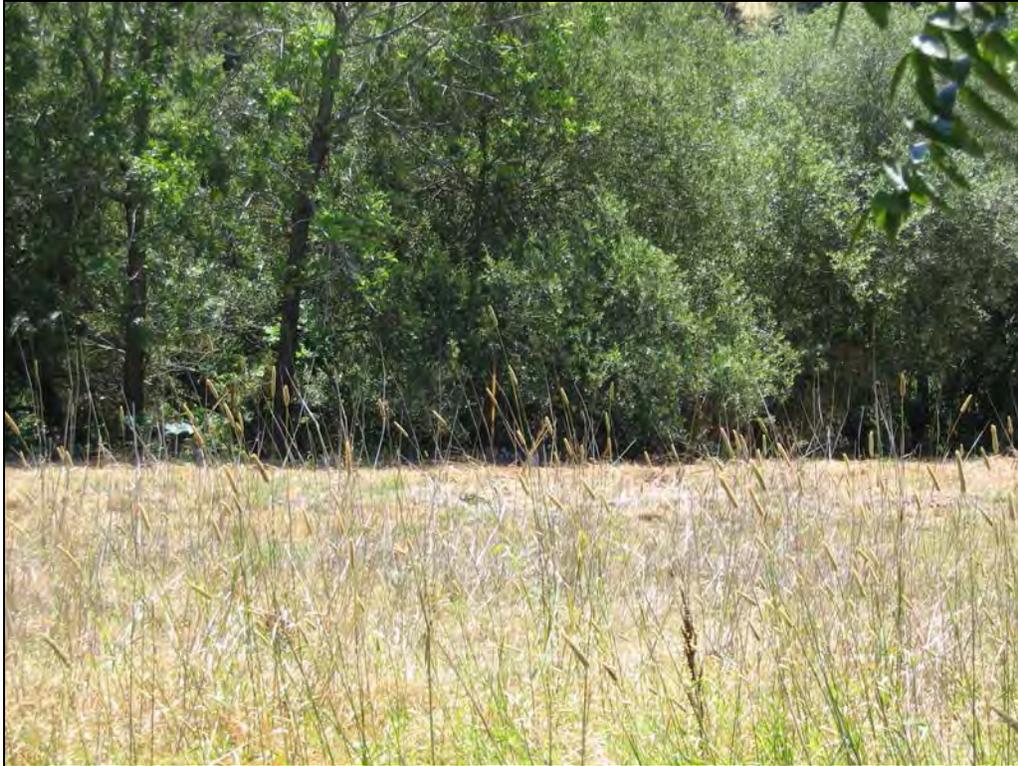
**Photo 11:**

East view of HA Site #5, which is the northernmost proposed crossing of SLO Creek on the Bunnell property.

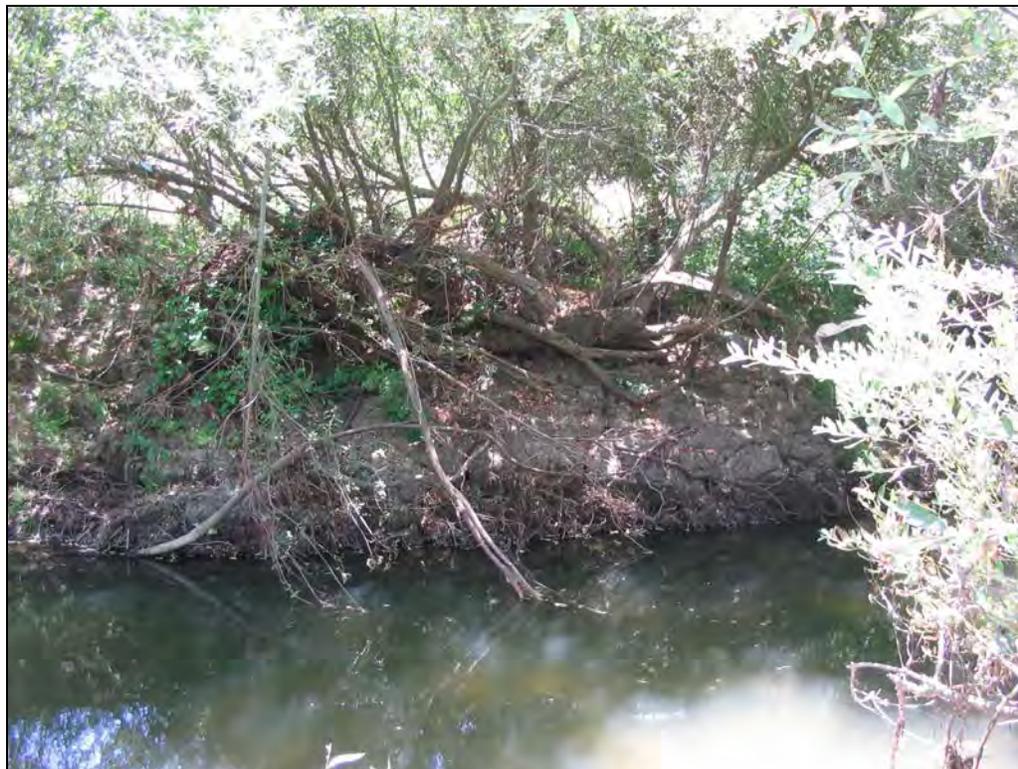
**Photo 12:**

East view of HA Site #5. Note slow flow conditions, lack of emergent vegetation, willow cover, and rootwads along the east bank.

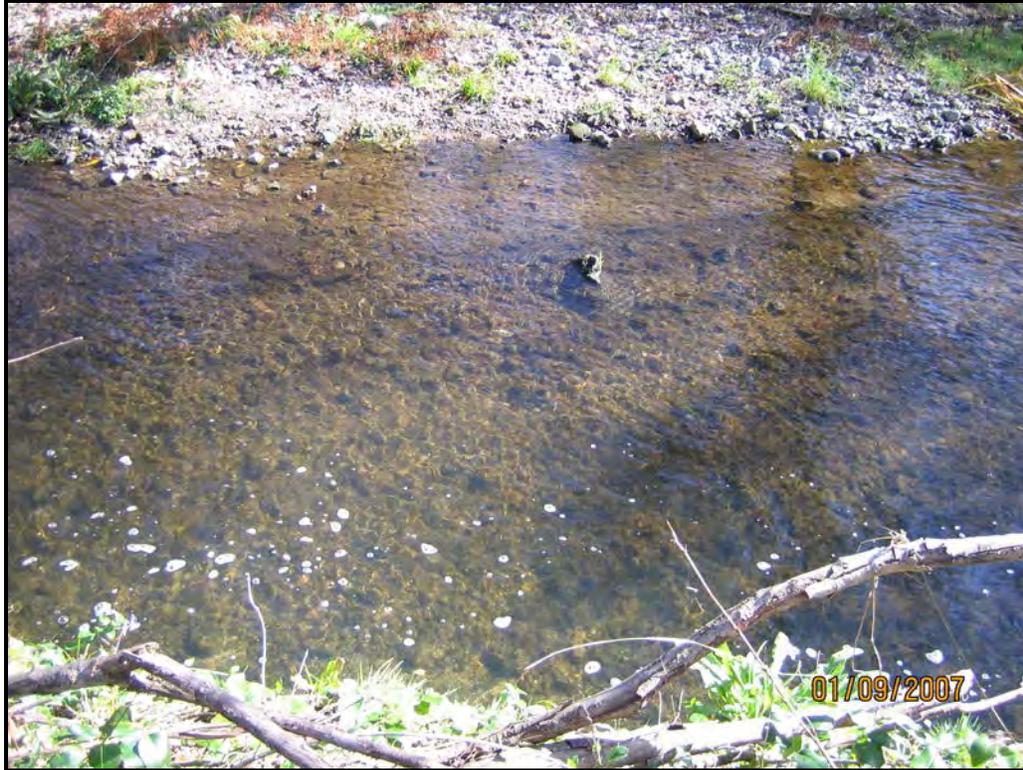
**Photo 13:**

East view of in-stream conditions of HA Site #6, near the southern boundary of the Bunnell property. Note glide conditions and gravel and cobble substrate.

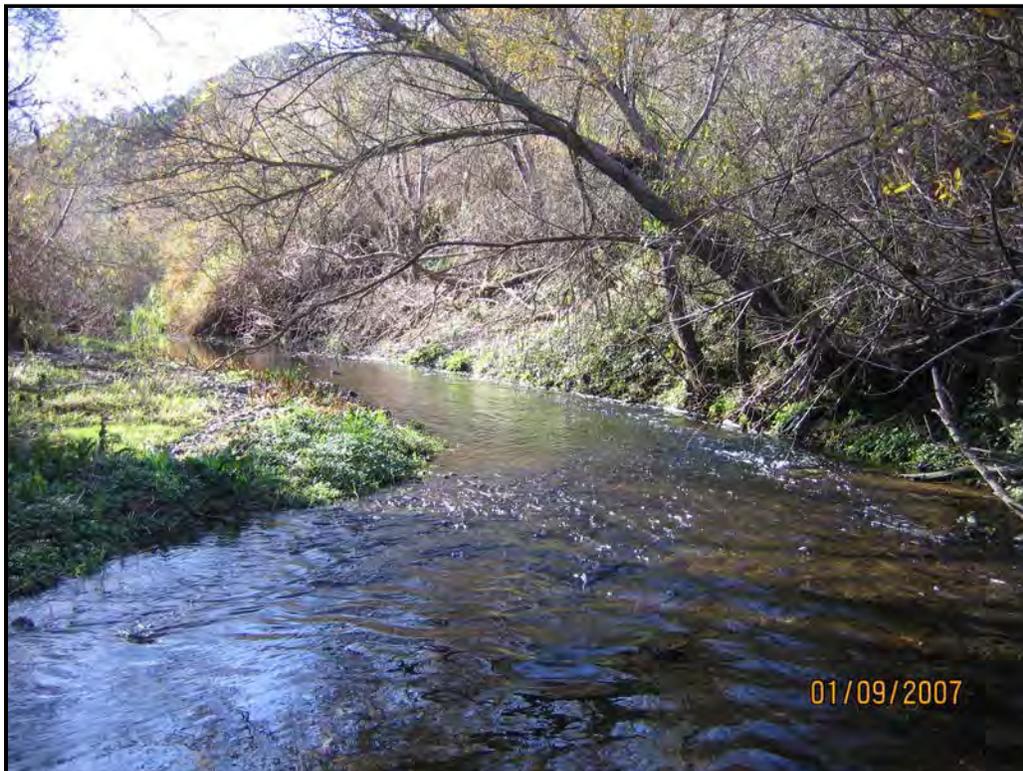
**Photo 14:**

Southeast view of downstream conditions at HA Site #6. Note lack of emergent vegetation with some overhanging willow cover.

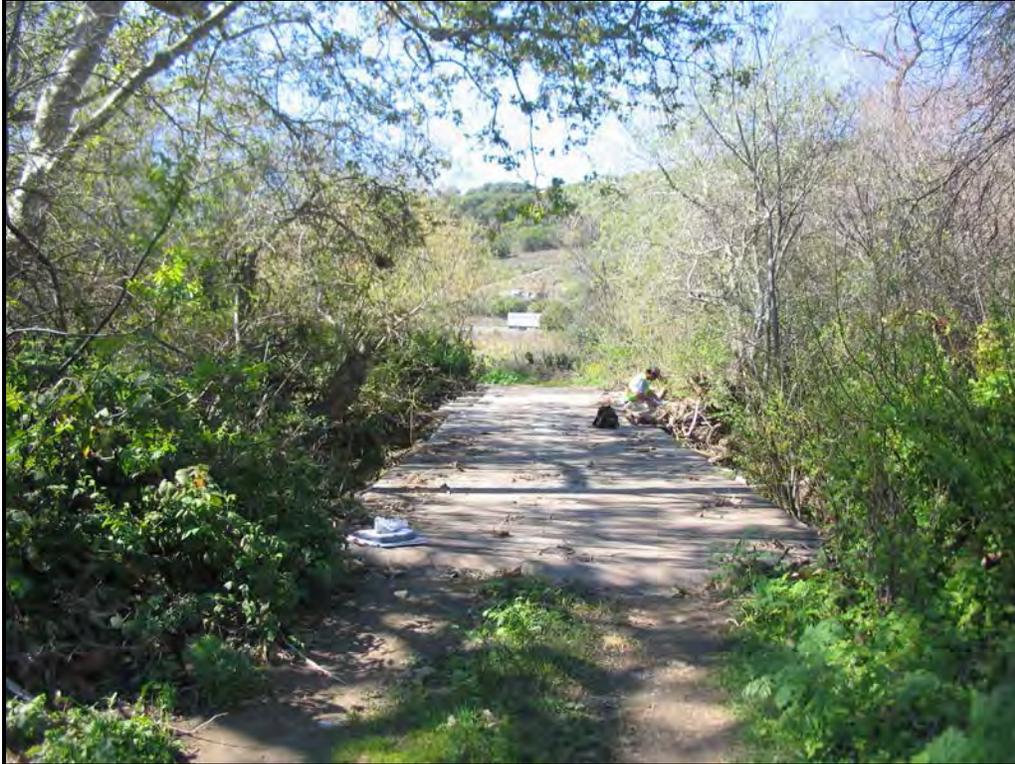
**Photo 15:**

West view of HA Site #7 – bridge over SLO Creek near Monte Road.

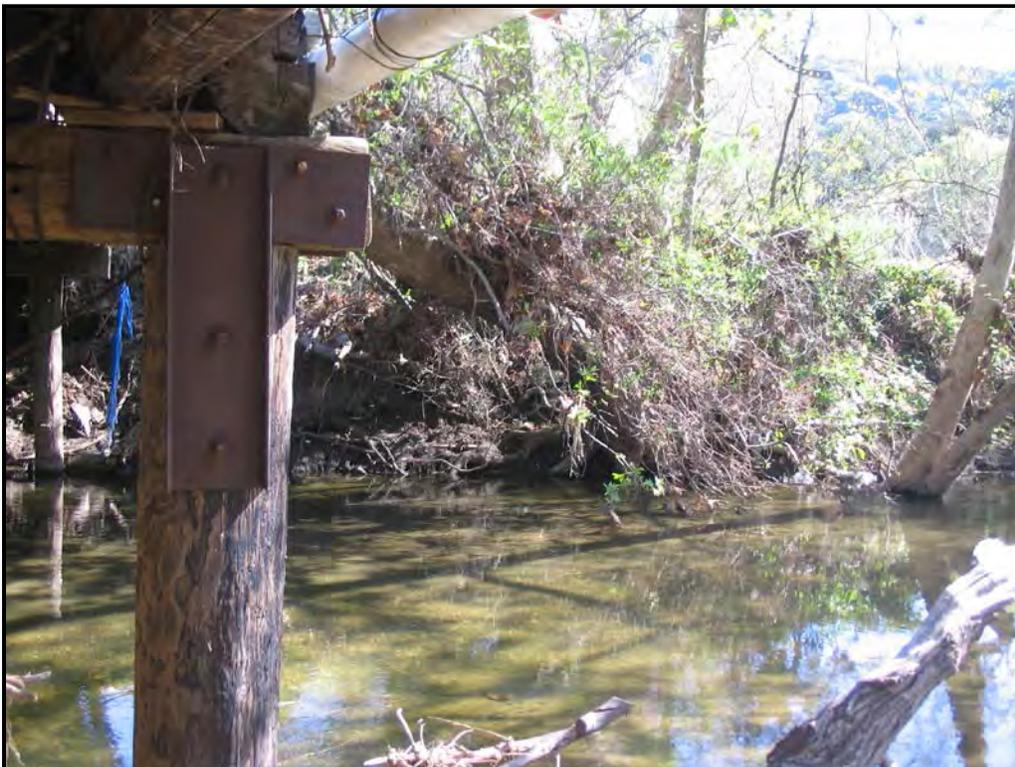
**Photo 16:**

Southeast view of undercut banks and in-stream conditions just downstream of HA Site #7 bridge.

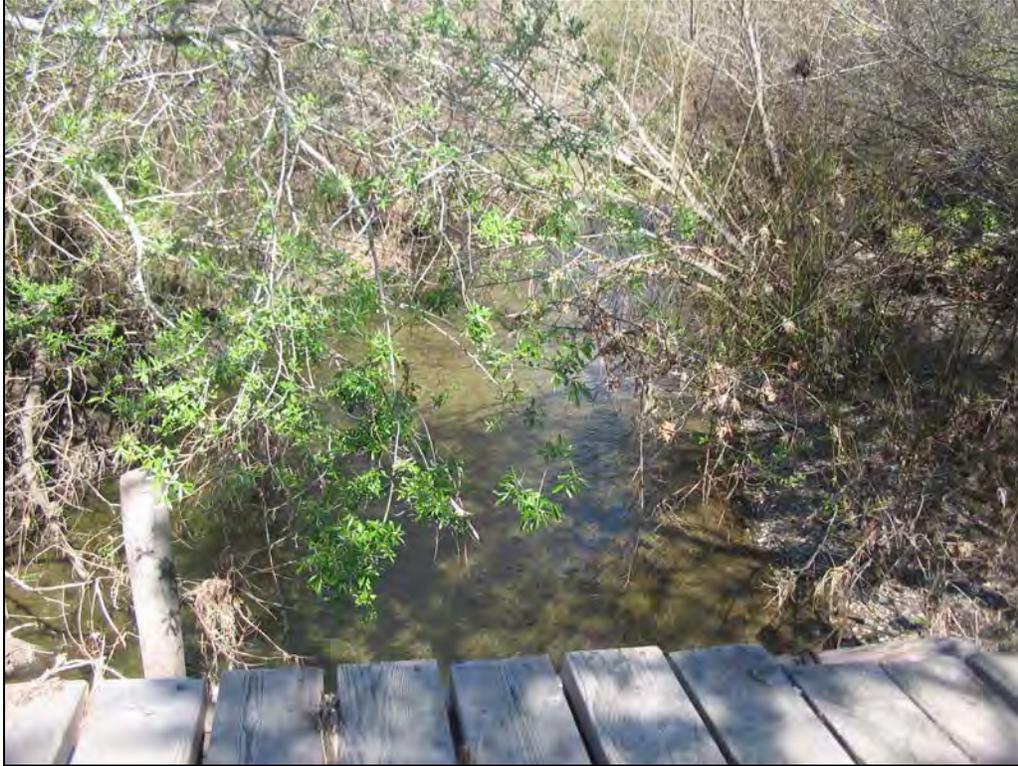
**Photo 17:**

Upstream view of SLO Creek from HA Site #7 bridge.

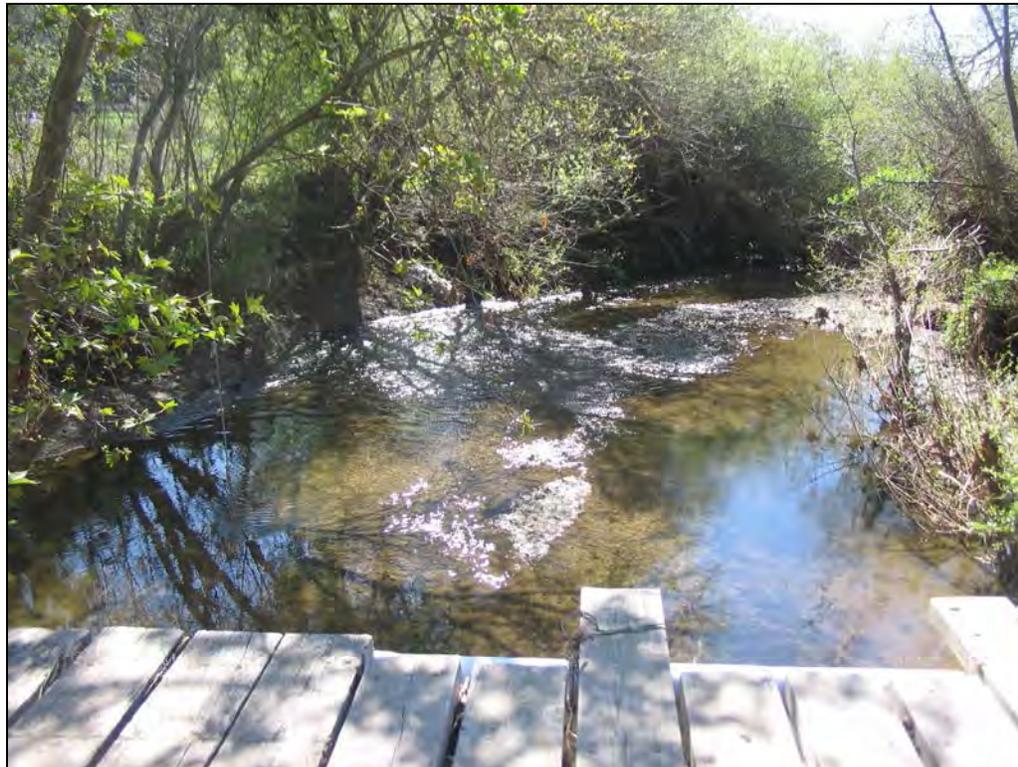
**Photo 18:**

Downstream view of SLO Creek from HA Site #7 bridge.

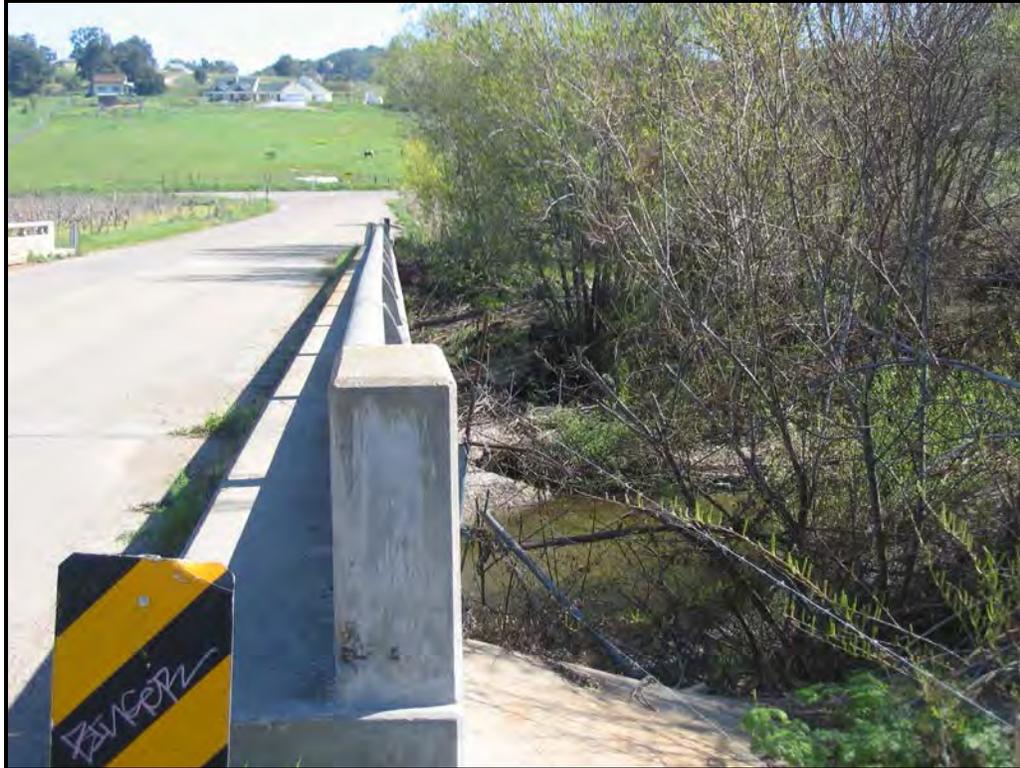
**Photo 19:**

East view of south side of San Luis Bay Drive Bridge over SLO Creek, at HA Site #8. Note dense willow vegetation in this area..

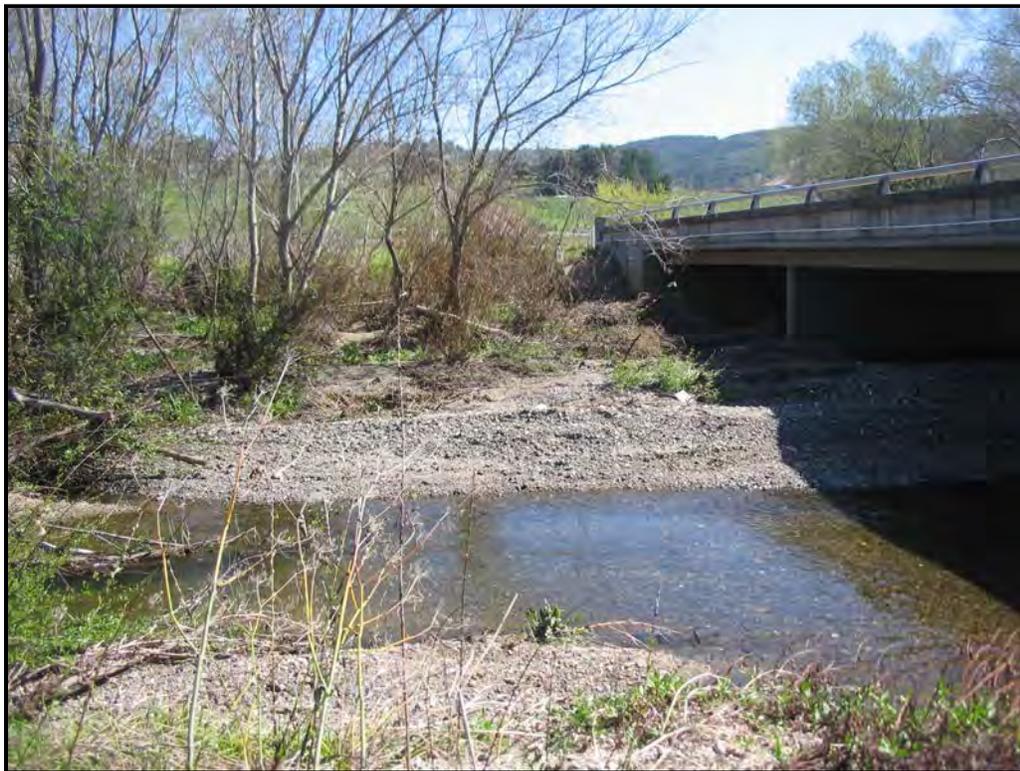
**Photo 20:**

Conditions upstream from HA Site #8, on the north (opposite) side of San Luis Bay Drive Bridge over SLO Creek.

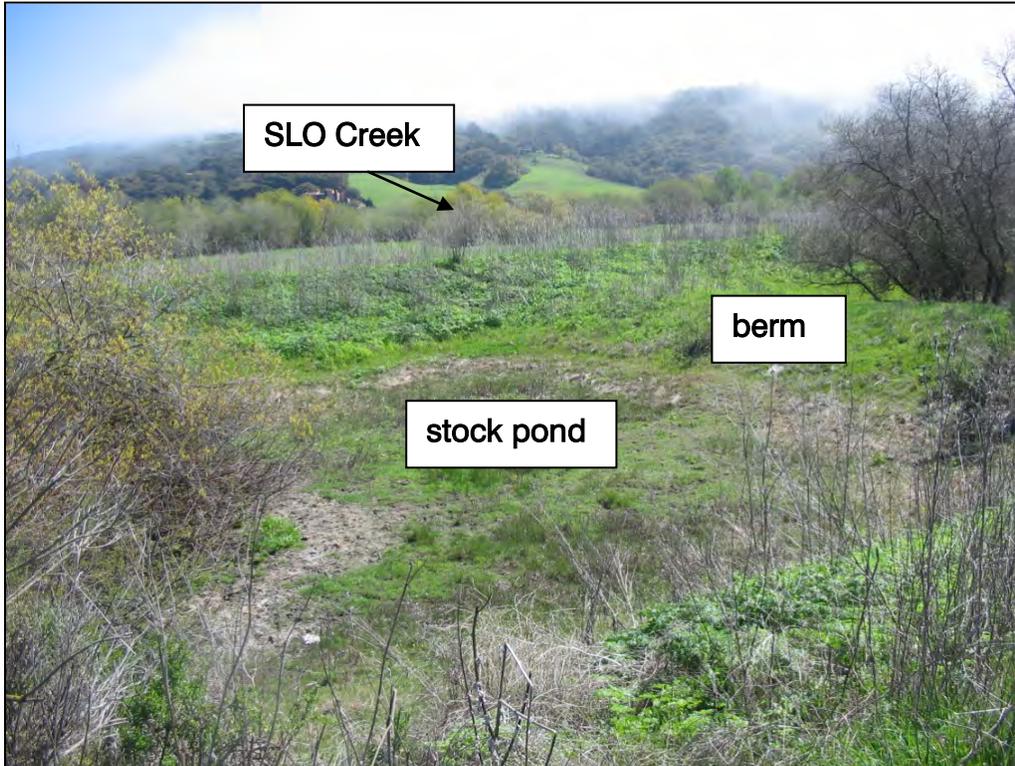
**Photo 21:**

Southeast view of northernmost stock pond (dry) at HA Site #9. The SLO Creek corridor is in the background, located about 600 feet away.

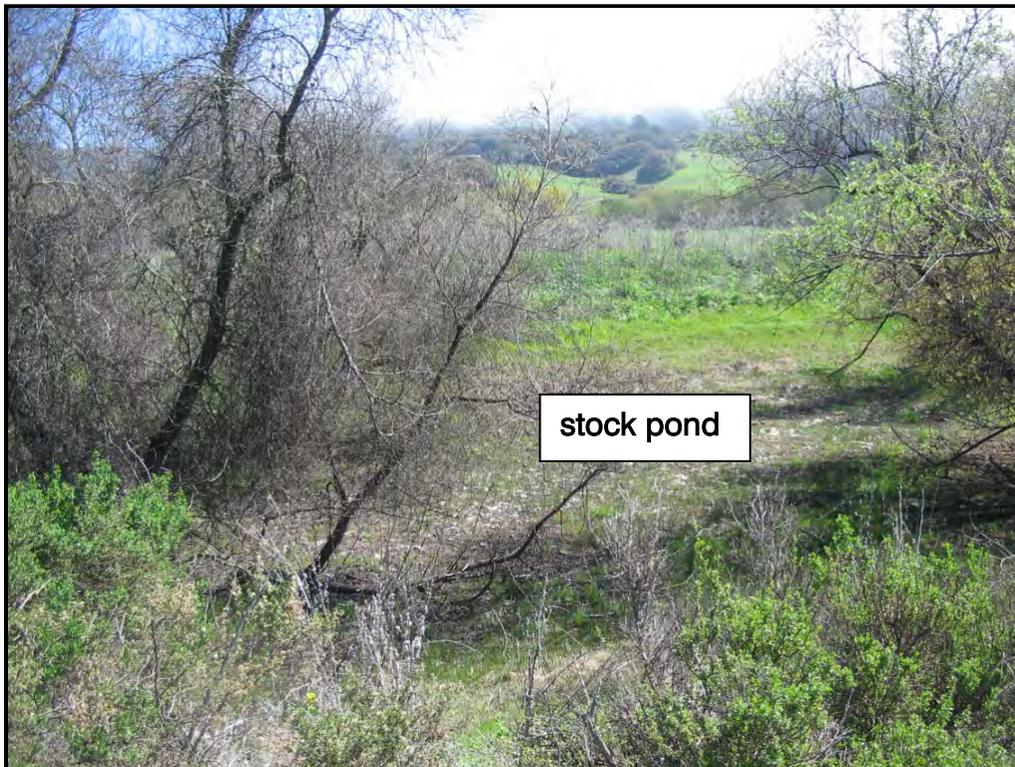
**Photo 22:**

Southeast view of central stock pond (dry) at HA Site #9. Note willow and shrub cover, but no emergent vegetation.

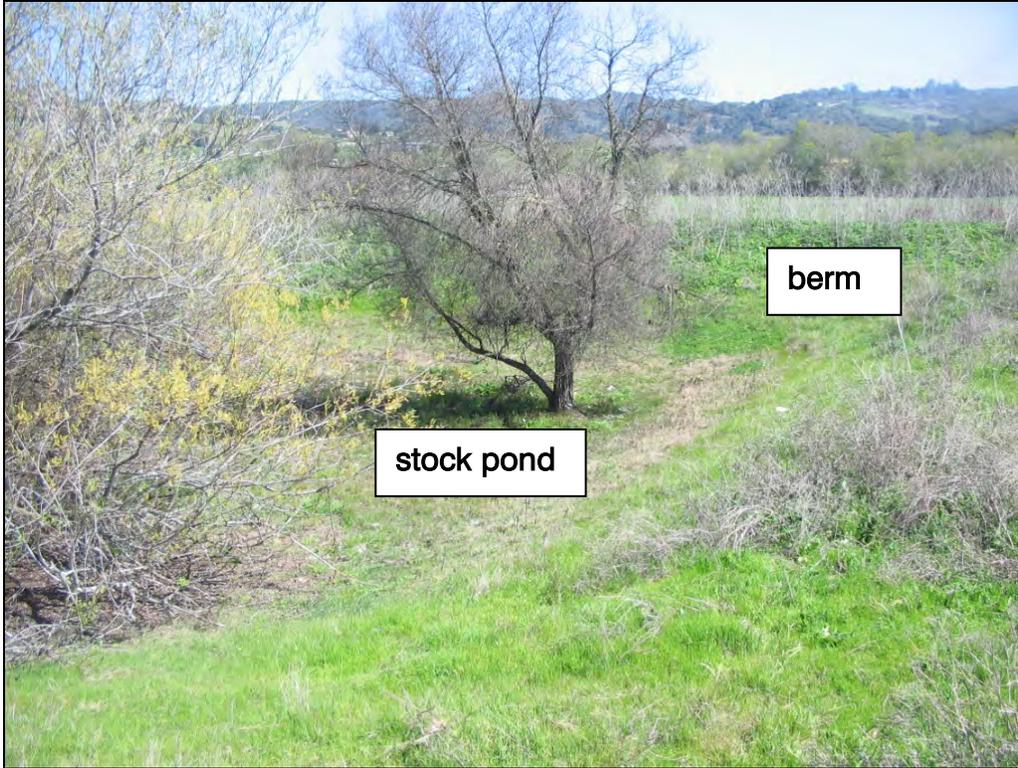
**Photo 23:**

Northeast view of southernmost stock pond (dry) at HA Site #9. The SLO Creek corridor is in the background.

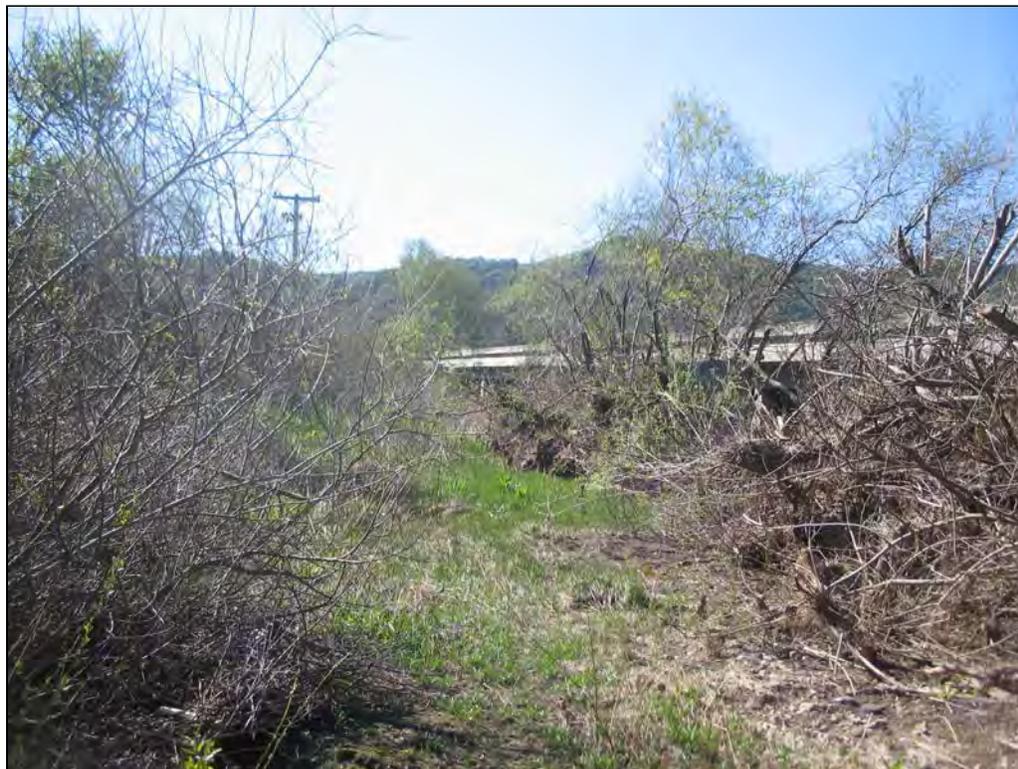
**Photo 24:**

South view of SLO Creek floodplain in the vicinity of HA Site #10. Arroyo willow cover and some spikerush occur in this area. This area was dry at the time of the site assessment
