**Attachment D:
Photo Documentation**

Bob Jones Pathway – San Luis Obispo to Ontario Road Conceptual Habitat Mitigation and Monitoring Plan

SWCA Environmental Consultants

February 29, 2012 (Revised March 5, 2013)

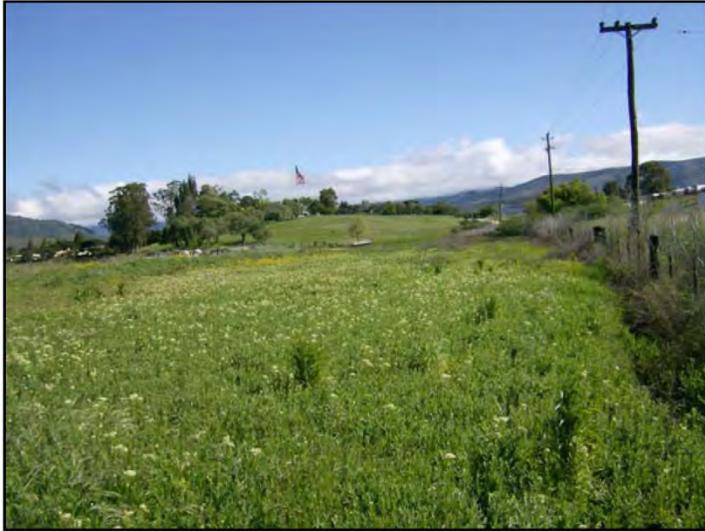
Photo 1:

Northeast view of field adjacent to drainage ditch with hydrological connectivity to SLO Creek. The drainage ditch is parallel to the fenceline at the far right edge of the photo.

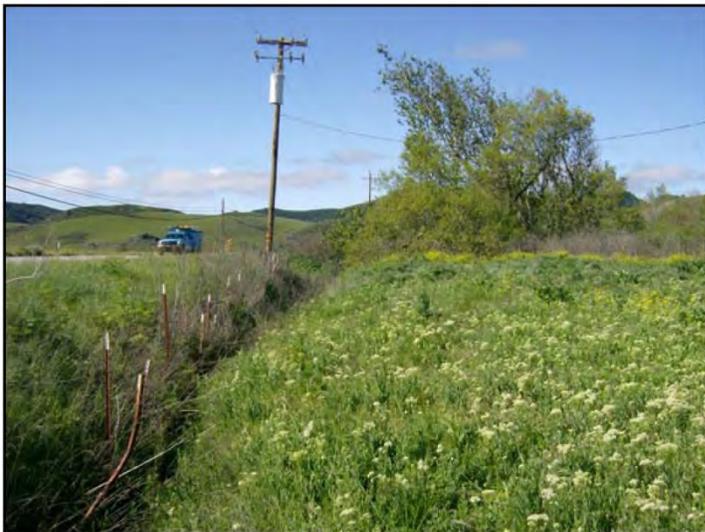
Photo 2:

Southwest view of field adjacent to drainage ditch with hydrological connectivity to SLO Creek. The drainage ditch is the dark area along the fenceline toward the left side of the photo.

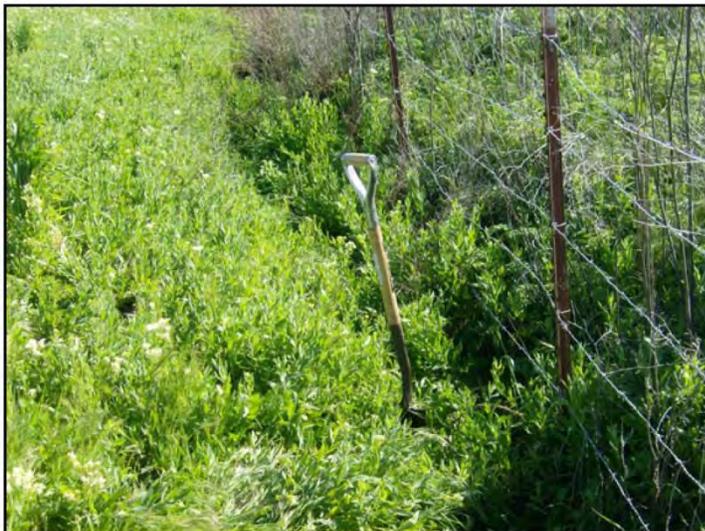
Photo 3:

Location of Soil Test Pit #1 in drainage ditch. This ditch was determined to be jurisdictional other waters.

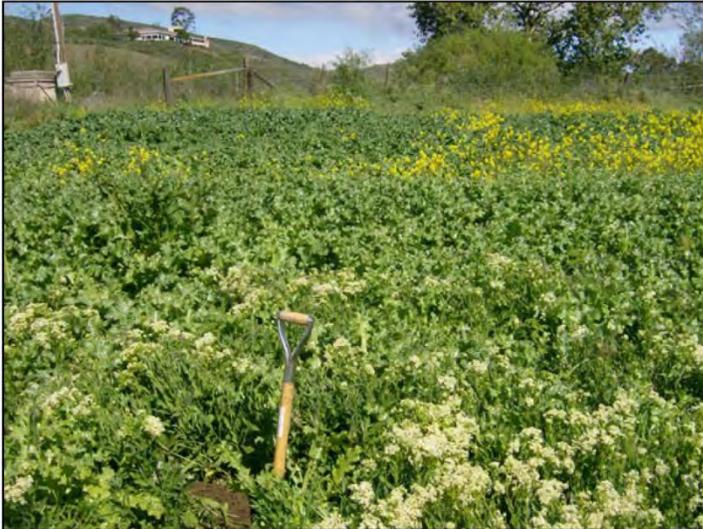
Photo 4:

Location of Soil Test Pit #2 in field proposed as a construction staging area. This area was determined to be non-wetlands (uplands).

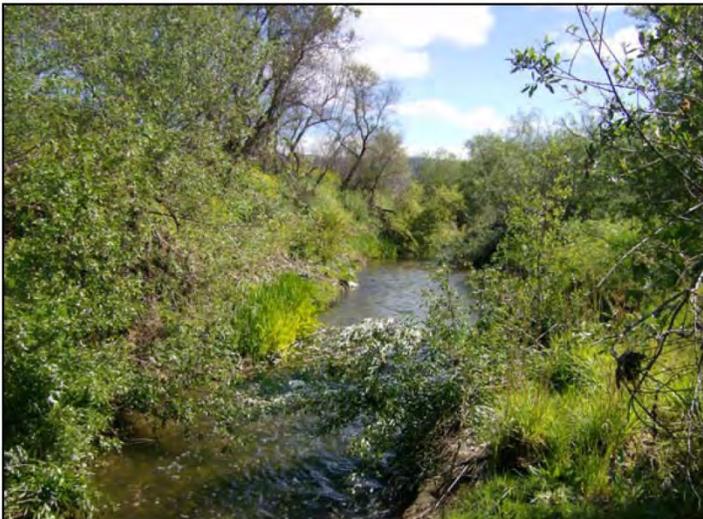
Photo 5:

Northeast view of SLO Creek riparian corridor at a location west of South Higuera Street.

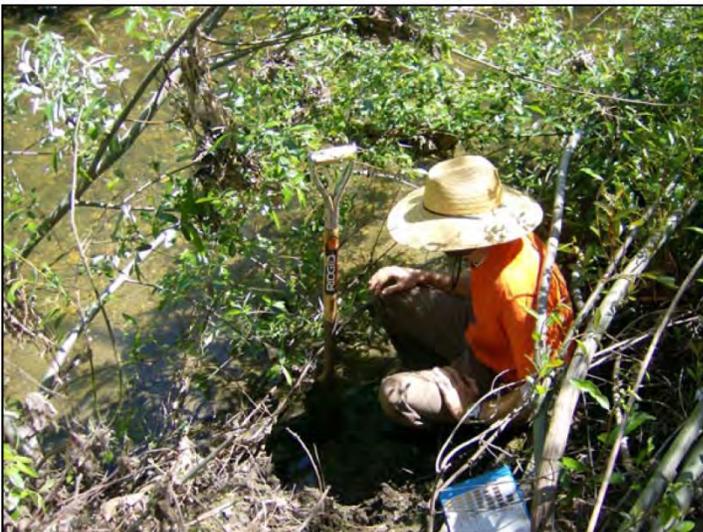
Photo 6:

Location of Soil Test Pit #3 in the streambed of SLO Creek at the vicinity of a proposed bridge crossing. SLO Creek was determined to be jurisdictional wetlands.

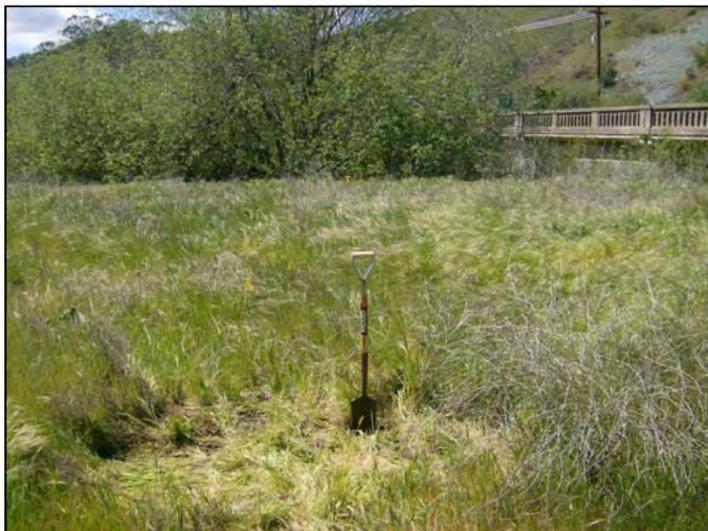
Photo 7:

Location of Soil Test Pit #4 in a grassy field outside of the SLO Creek riparian corridor. This area was determined to be non-wetlands (uplands).

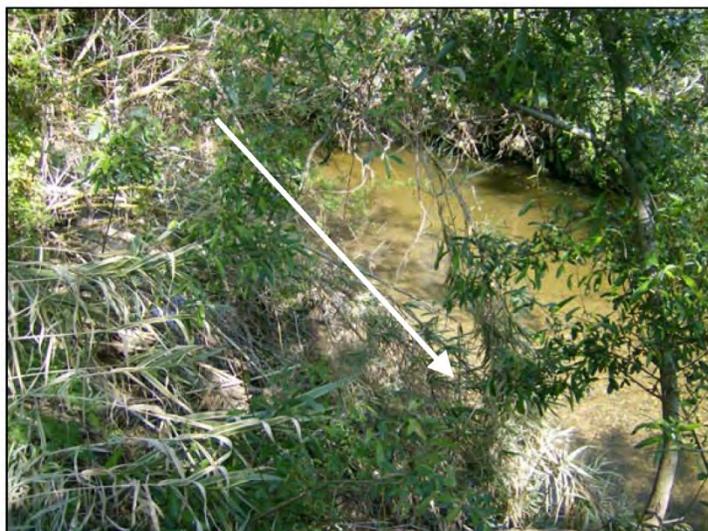
Photo 8:

Arrow demarcates approximate location of Soil Test Pit #5 in the streambed of SLO Creek at the vicinity of a proposed bridge crossing. SLO Creek was determined to be jurisdictional wetlands.

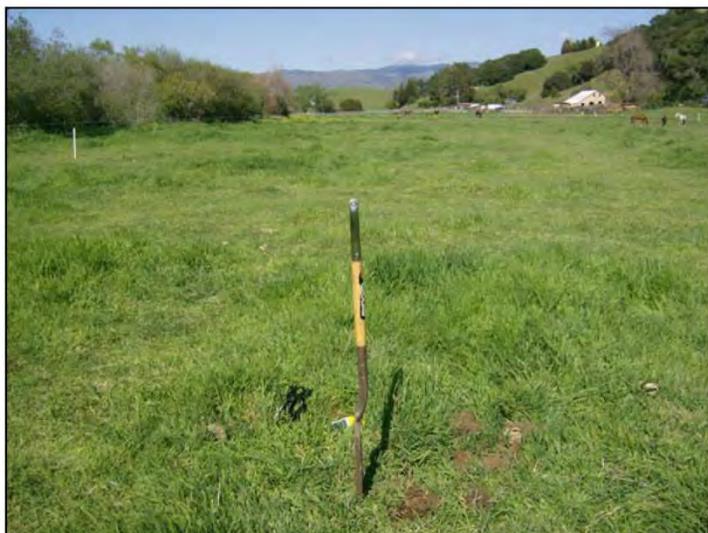
Photo 9:

Location of Soil Test Pit #6 in a pasture proposed as a staging area outside of the SLO Creek riparian corridor. This area was determined to be non-wetlands (uplands).

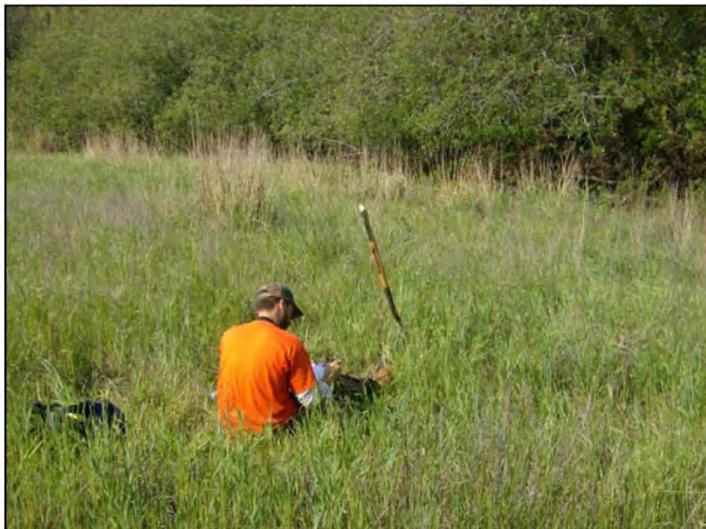
Photo 10:

Location of Soil Test Pit #7 in a grassy field proposed as a staging area outside of the SLO Creek riparian corridor, which occurs in the background. This area was determined to be non-wetlands (uplands).

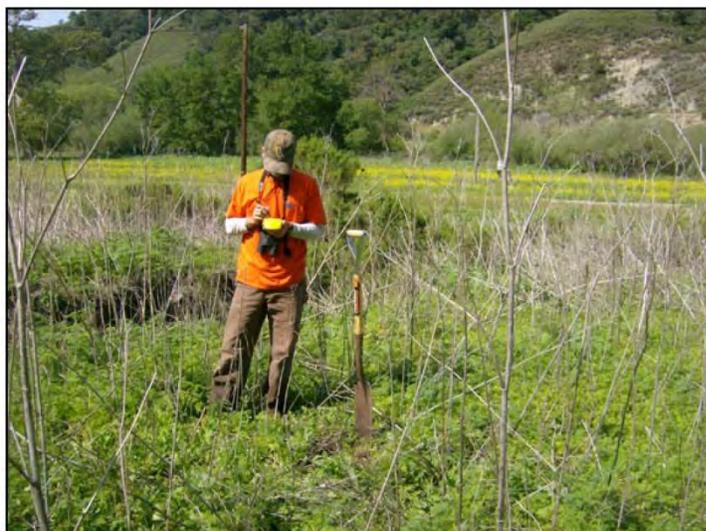
Photo 11:

Location of Soil Test Pit #8 in a seasonal wetland area that the proposed route would pass through. This area is vegetated with poison hemlock, which is a weedy yet facultative wetland species, but is not considered a jurisdictional wetland due to a lack of wetland hydrology and wetland soils.

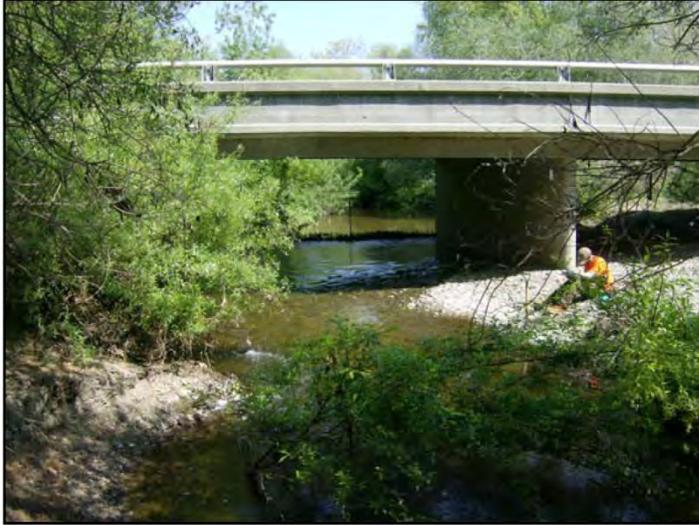
Photo 13:

North view of SLO Creek at the existing San Luis Bay Drive Bridge. A new bridge for the pathway is proposed to be constructed just south of the existing bridge.

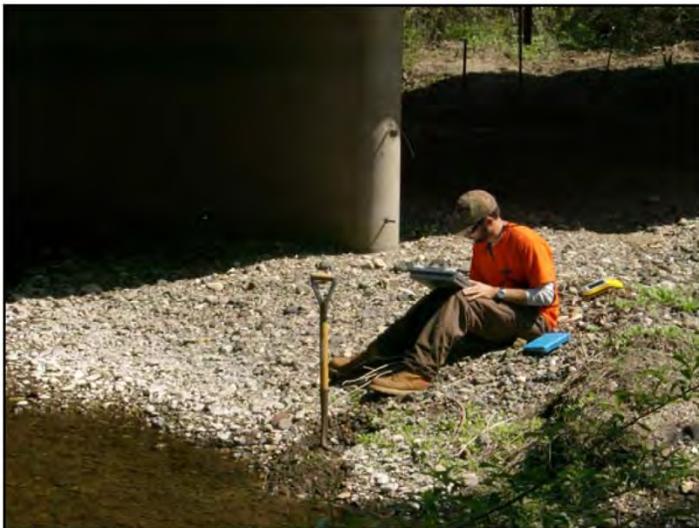
Photo 14:

Location of Soil Test Pit #9 in the streambed of SLO Creek at the vicinity of the new proposed San Luis Bay Drive crossing. SLO Creek was determined to be jurisdictional wetlands. Hydric riverwash soils occur along the streambed.

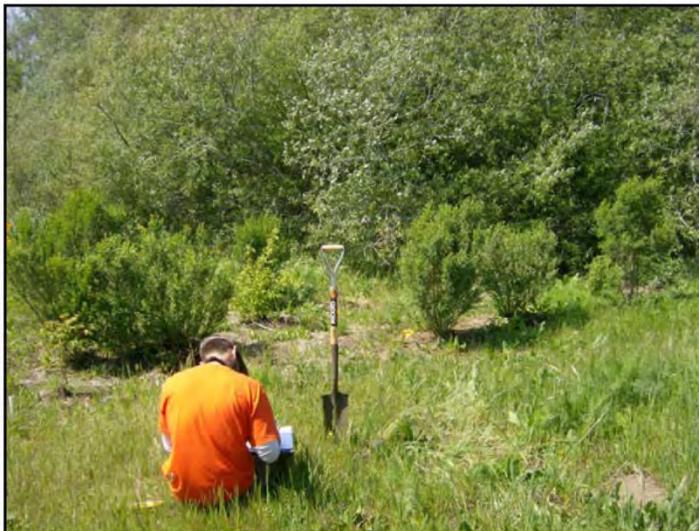
Photo 15:

Location of Soil Test Pit #10 in a grassy agricultural field outside of the SLO Creek riparian corridor. This area was determined to be non-wetlands (uplands).

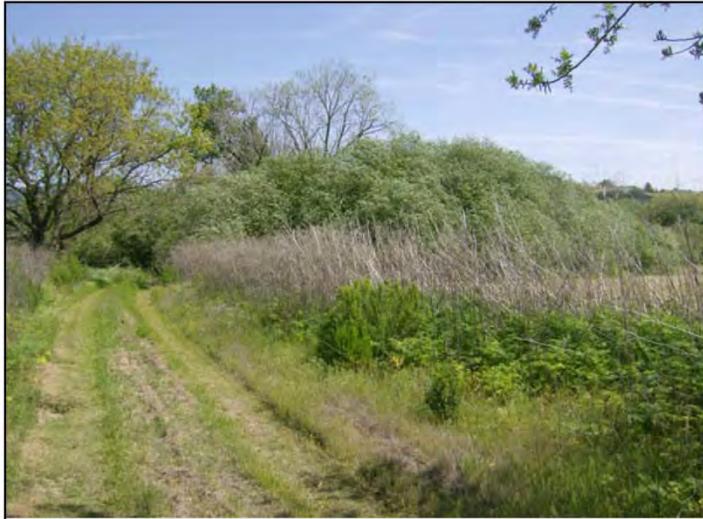
Photo 16:

North view of an existing agricultural access road south of San Luis Bay Drive where a section of the new pathway is proposed. Non-jurisdictional willow scrub outside of the SLO Creek corridor occurs along this access road in some sections.

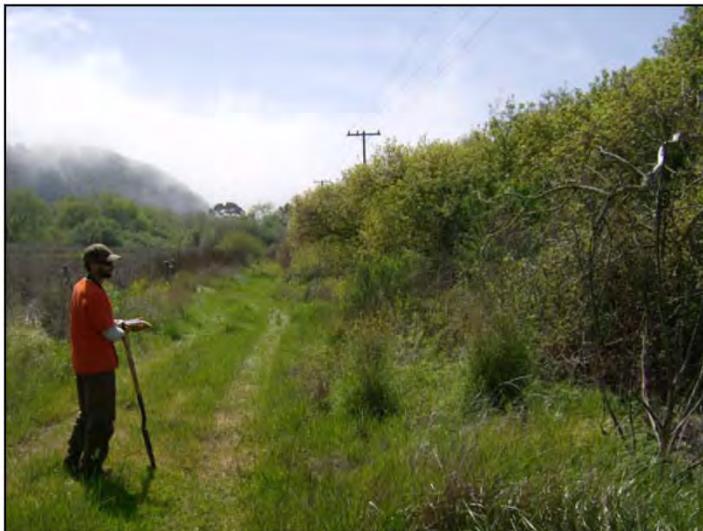
Photo 17:

South view of the existing agricultural access road south of San Luis Bay Drive where a section of the new pathway is proposed. Here is a representative view of some of the non-jurisdictional willow scrub outside of the SLO Creek corridor that may need to be trimmed to create space for construction equipment to construct the new path.

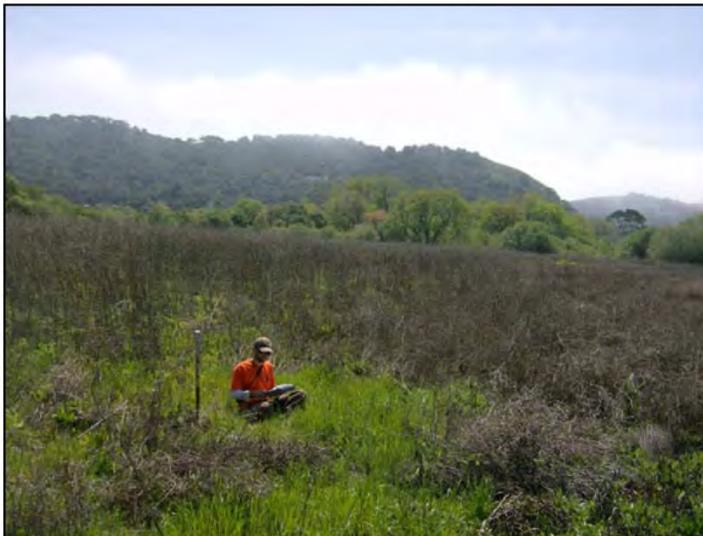
Photo 18:

Location of Soil Test Pit #11 in a disturbed field adjacent to the proposed pathway where a staging area is proposed. This area was determined to be non-wetlands (uplands).

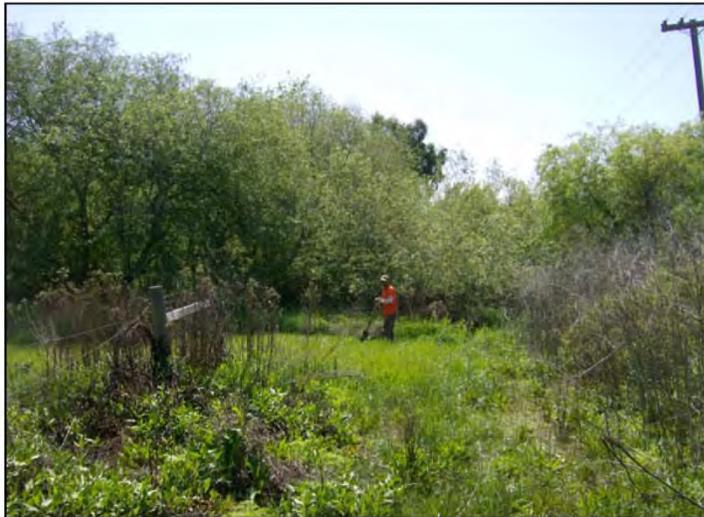
Photo 19:

South view of the proposed terminus of the new pathway before it crosses over Highway 101 to the west (right). The floodplain of SLO Creek with its expansive willow riparian vegetation is visible in the background. The proposed pathway and overcrossing would avoid impacting this vegetation.

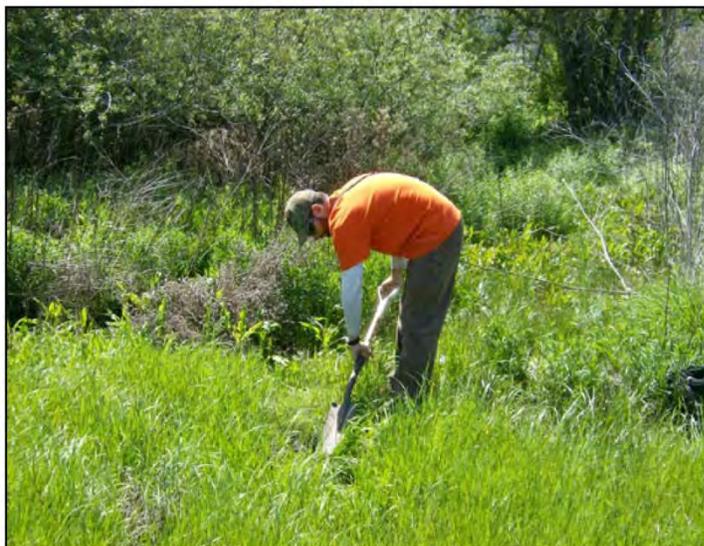
Photo 21:

Location of Soil Test Pit #12 adjacent to the SLO Creek floodplain at the vicinity of the new proposed Highway 101 overcrossing. Although hydrophytic species occurred at this location, this area was determined to be non-wetlands (uplands) due to lack of hydric soils and wetland hydrology.
