Wetland Delineation

For the proposed
Righetti Agricultural Cluster Development
APN 044-051-028
San Luis Obispo County
California

August 2005
Revised December 2008

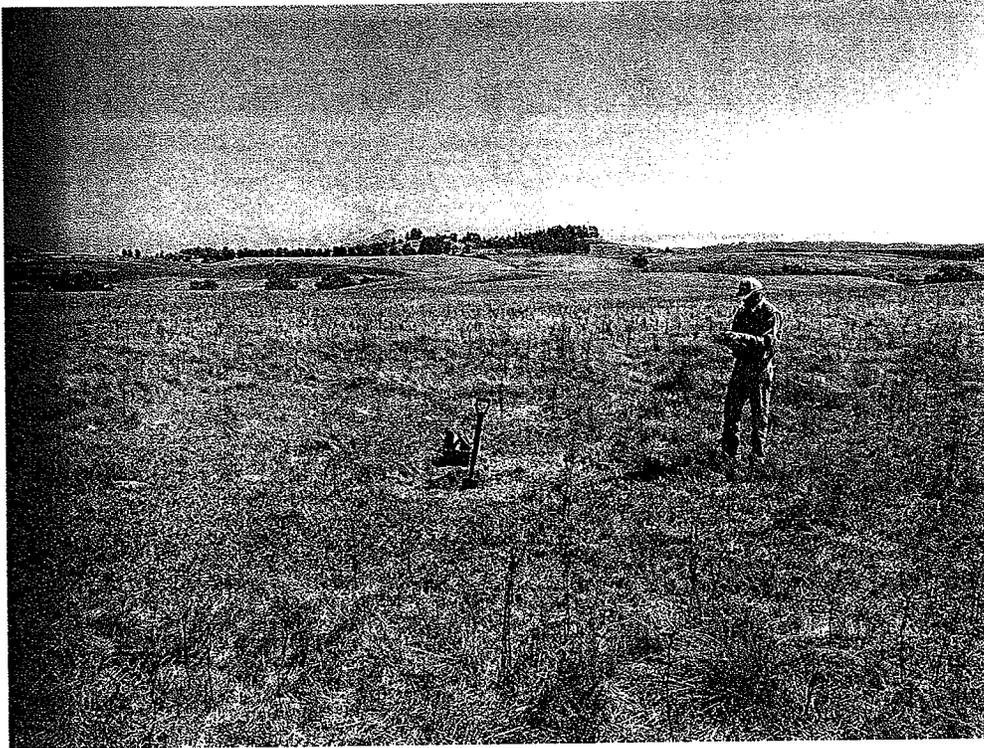
Photo 1. View southeast of sample site 1. This site qualifies as a state wetland, but does not meet the criteria for federal wetland.

This sample site was located in the northwestern portion of the property in an area of hydrophytic vegetation within a grassland dominated by medusahead (*Taeniatherum caput-medusae*). The dominant plant species recorded at this site were: *Juncus phaeocephalus* (FACW¹), *Hordeum marinum* (FAC+²), *Rumex pulcher* (FAC+), and *Lolium perenne* (FAC*). Hydrophytic vegetation covered 95% of the area around the pit. The soil was a sandy loam. Manganese concretions and redoximorphic features were present. The site is a seep with no indication of surface flow off-site. There is no channel, drift lines, or other indication of direct hydrologic connectivity with the western drainage. **This site does not meet the criteria for federal wetland because the site does not satisfy the criteria for wetland hydrology. This site meets the criteria for state wetland.**

Project/Site: Righetti Applicant/Owner: Investigator(s): Meade, Dart	Date: 8-1-05 County: SLO State: CA
Do Normal Circumstances exist on the site? yes Is the site significantly disturbed (Atypical Situation)? No Is the area a potential Problem Area? (If needed, explain on reverse.)	Community ID: Transect ID: Plot ID: 1

Dominant Plant Species	Stratum	Indicator
1.	Juncus phaeocephalus	Herb	FACW
2.	Hordeum marinum	Grass	FAC+
3.	Calamagrostis perenne	Grass	FAC+
4.	Rumex crispus	Herb	FAC+
5.			
6.			
Percent of Dominant Species that are OBL, FACW or FAC (excluding FAC-).		95%	
Remarks: Distinct Juncus patch in medusahead grassland.

Hydrology Remarks: Seep, no indication of flow offsite on surface

Depth (inches)	Horizon	Matrix Colors (Munsell Moist)	Mottle Colors (Munsell Moist)	Mottle Abundance/ Size/Contrast	Texture, Concretions Structure, etc
0-5	A1	10YR 3/2	7.5YR 4/6	Many / med / good	Sandy loam, sub ang.
5-18	A2	10YR 4/2	7.5YR 4/6 + 10YR 5/4	Few / small	Sandy loam ^{slightly} damp

Hydrophytic Vegetation Present? <i>Yes</i>	Is this Sampling Point Within a Wetland? <i>State Yes</i>
Wetland Hydrology Present? <i>No</i>	
Hydric Soils Present? <i>Yes</i>	
Remarks: <i>Federal No.</i>

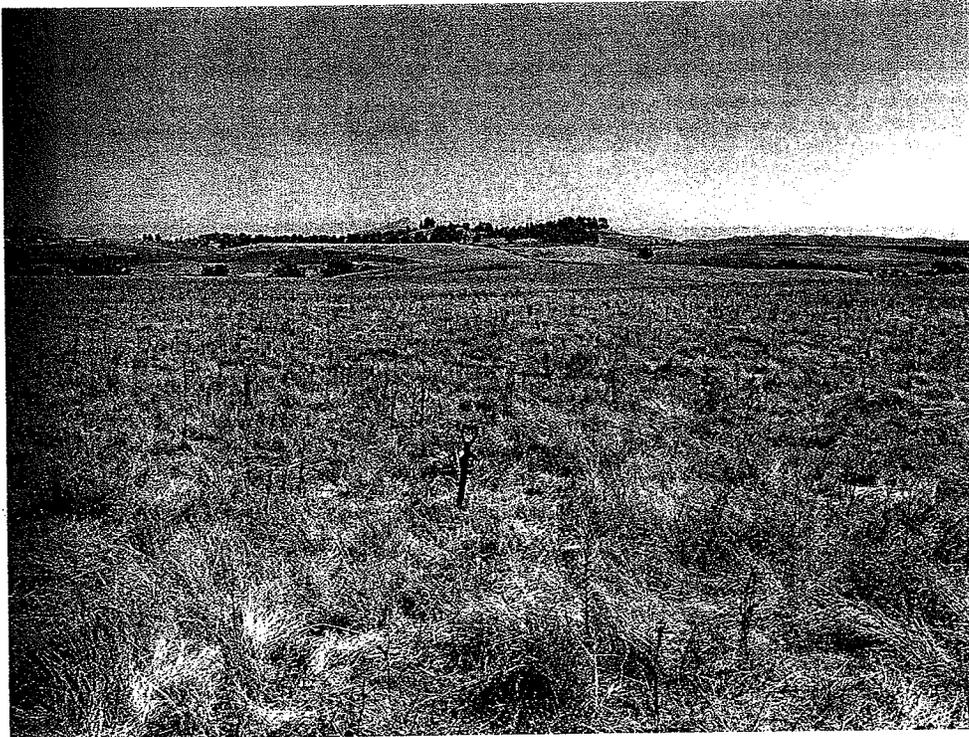
Photo 2. View southeast of sample site 2. The dominant vegetation is an exotic upland grass species called medusahead. This site is not a wetland.

This sample site was located 87 feet NW of Site 1. The dominant plant species recorded at this site was *Taeniatherum caput-medusae* (not listed), with 90% cover. Additional species recorded were *Lolium perenne* (FAC*), with 10% cover. The soil in the upper horizon (0-17 inches) was sandy loam. Soil deeper than 17 inches transitioned from a sandy loam to a clay sand. Some redoximorphic features appeared in the upper inch of the clay layer. No wetland hydrology was present. Strong hydric soil indicators were present only below seventeen inches. Hydrophytic vegetation was not present. **This site does not meet the criteria for federal or state wetland.**

VEGETATION		Stratum	Indicator
	Dominant Plant Species		
1.	<i>Taeniatherum caput-medusae</i>	grass	
2.	<i>Lolium multiflorum</i>	grass	
3.			
4.			
5.			
6.			
Percent of Dominant Species that are OBL, FACW or FAC (excluding FAC-).		<i>0%</i>	
Remarks: <i>90% medusaehead</i>

Hydrology Remarks: <i>Sloping ground, no indicators</i>

Depth (inches)	Horizon	Matrix Colors (Munsell Moist)	Mottle Colors (Munsell Moist)	Mottle Abundance/ Size/Contrast	Texture, Concretions Structure, etc
0-17	A1	10YR 3/2	10YR 4/6	very few / fine /	Sandy loam
17-18	A2	10YR 4/4	5YR 5/6 + 10YR 3/2	Common / large /	loamy sand → clay sand

Remarks: Redox appears above & in upper inch of clay layer

Hydrophytic Vegetation Present? No.	Is this Sampling Point Within a Wetland? No.
Wetland Hydrology Present? No	
Hydric Soils Present? Yes (deep)	
Remarks:

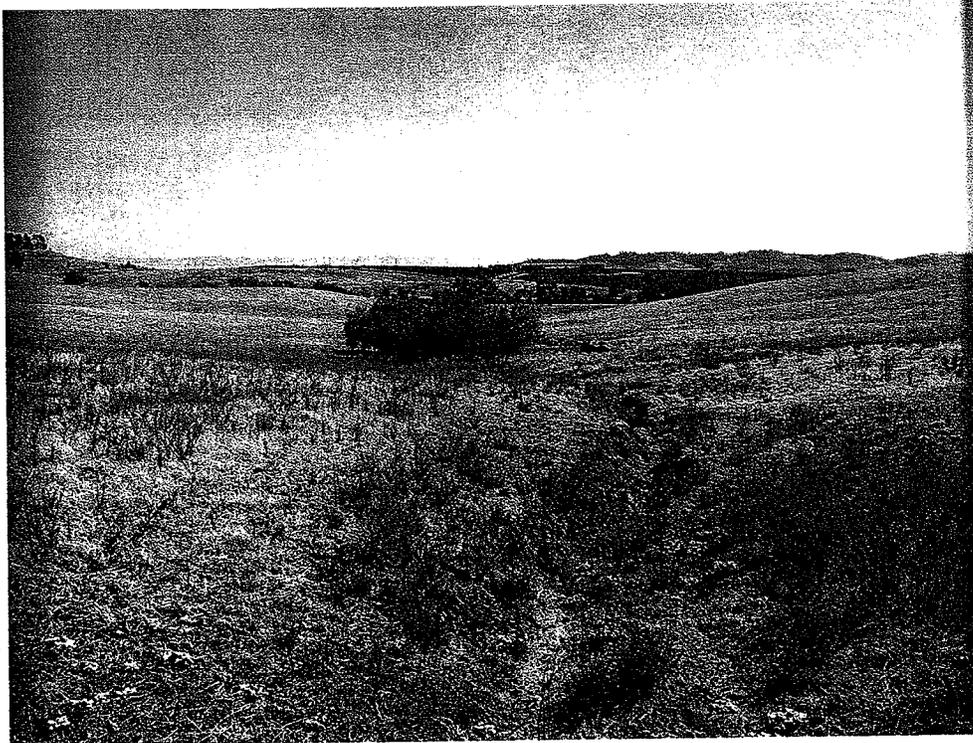
Photo 3. View south of the western drainage (flow is to the south). The channel in the foreground qualifies as waters of the United States, with wetland conditions beginning at the willow patch in the background.

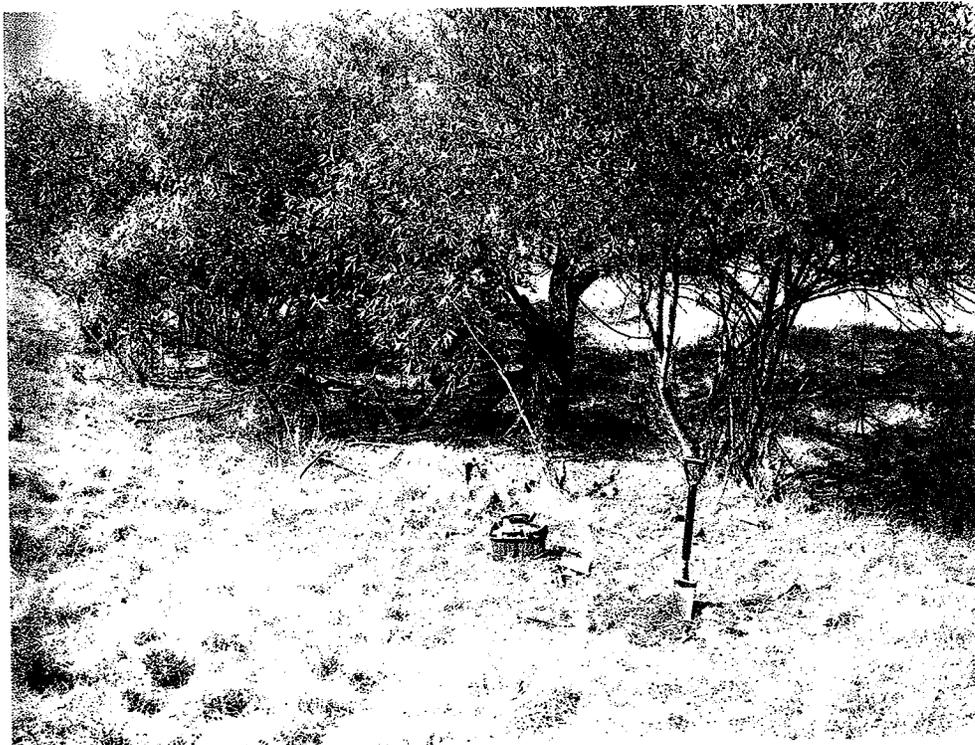
Photo 4. View north of sample site 3. Hydrophytic vegetation, hydric soils, and wetland hydrology were noted at this site.

This sample site was located in the channel bottom of the western drainage in an area of hydrophytic vegetation. The three dominant plant species recorded at this site were: *Eleocharis macrostachya* (OBL³), *Salix lasiolepis* (FACW), and *Rumex pulcher* (FAC+). Hydric soil indicators observed at this site included gleyed soil and an aquic moisture regime. Redoximorphic features were present. Wetland hydrology was observed (drift lines). **This site meets the criteria for federal and state wetland.**

Dominant Plant Species	Stratum	Indicator
1.	Elychnis	Herb	OBL
2.	Salix lasiolepis	Canopy	FACW
3.	Rumex pulcher	Herb	FAC+
4.			
5.			
6.

Hydrology Remarks: In channel bottom

Depth (inches)	Horizon	Matrix Colors (Munsell Moist)	Mottle Colors (Munsell Moist)	Mottle Abundance/ Size/Contrast	Texture, Concretions Structure, etc
0-4		10YR 3/2	7.5YR 5/8	Many / small	Subangular, gravels 1/2 in., sand clay
4-10		10YR 2/1	7.5YR 5/8	Many / mod.	Sandy loam with some gravel

Hydrophytic Vegetation Present? <i>Yes</i> Wetland Hydrology Present? <i>Yes</i> Hydric Soils Present? <i>Yes</i>	Is this Sampling Point Within a Wetland? <i>Yes</i> <i>State and Federal.</i>
Remarks: _____

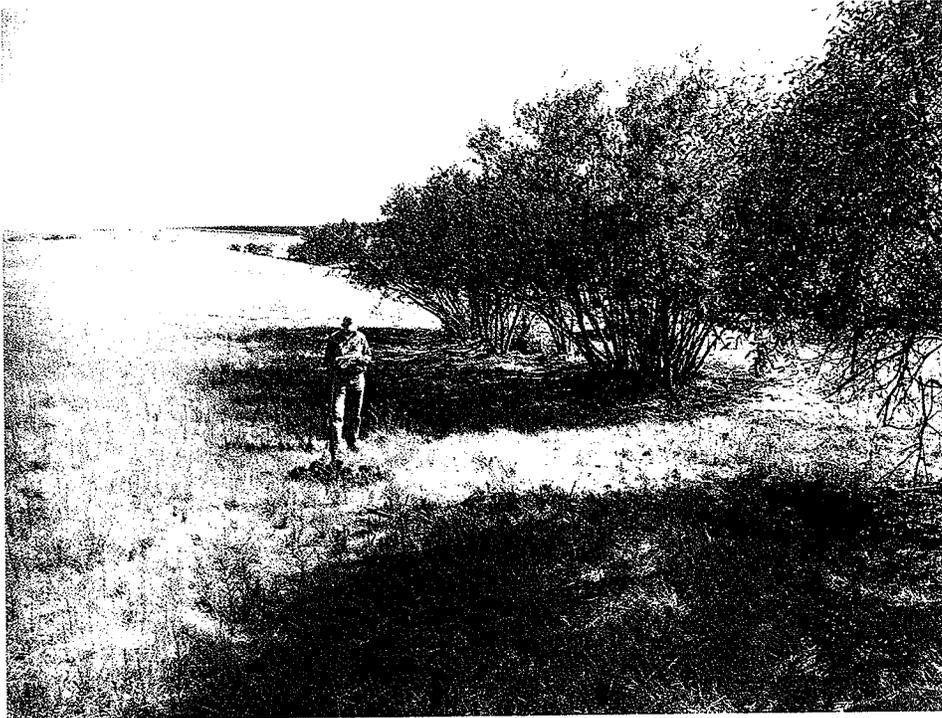
Photo 5. View south of sample site 4. The dominant vegetation at this site consisted of upland species. This site does not qualify as a wetland. The wetland boundary is between this test pit and the willows.

This sample site was located on the east side of the western drainage, outside the top of bank in an area of upland vegetation adjacent to the willow patch. The three dominant plant species recorded at this site were: *Lolium multiflorum* (not listed), *Hemizonia congesta* ssp. *luzulifolia* (not listed), and *Taeniatherum caput-medusae* (not listed). These species do not qualify as hydrophytic vegetation. Soils at this site were massive clay. No wetland hydrology was present. No redoximorphic features were observed. While low-chroma colors were observed, hydric soil was not present at this site. **This site does not meet the criteria for federal or state wetland.**

Dominant Plant Species	Stratum	Indicator
1.	<i>Taeniatherum caput-medusae medusa head</i>	<i>Grass</i>	<i>—</i>
2.	<i>Polium multiflorum</i>	<i>Grass</i>	<i>—</i>
3.	<i>Hemizonia congesta</i>	<i>Herb</i>	<i>—</i>
4.			
5.			
6.			
Percent of Dominant Species that are OBL, FACW or FAC (excluding FAC-).		<i>0%</i>	
Remarks:

Hydrology Remarks: <i>On slope above drainage. No indicators.</i>

Depth (inches)	Horizon	Matrix Colors (Munsell Moist)	Mottle Colors (Munsell Moist)	Mottle Abundance/ Size/Contrast	Texture, Concretions Structure, etc
0-18	A	10YR 3/1	—		Massive Clay

Remarks: No redox. low chroma

Hydrophytic Vegetation Present? No	Is this Sampling Point Within a Wetland? No.
Wetland Hydrology Present? No	
Hydric Soils Present? No	
Remarks:

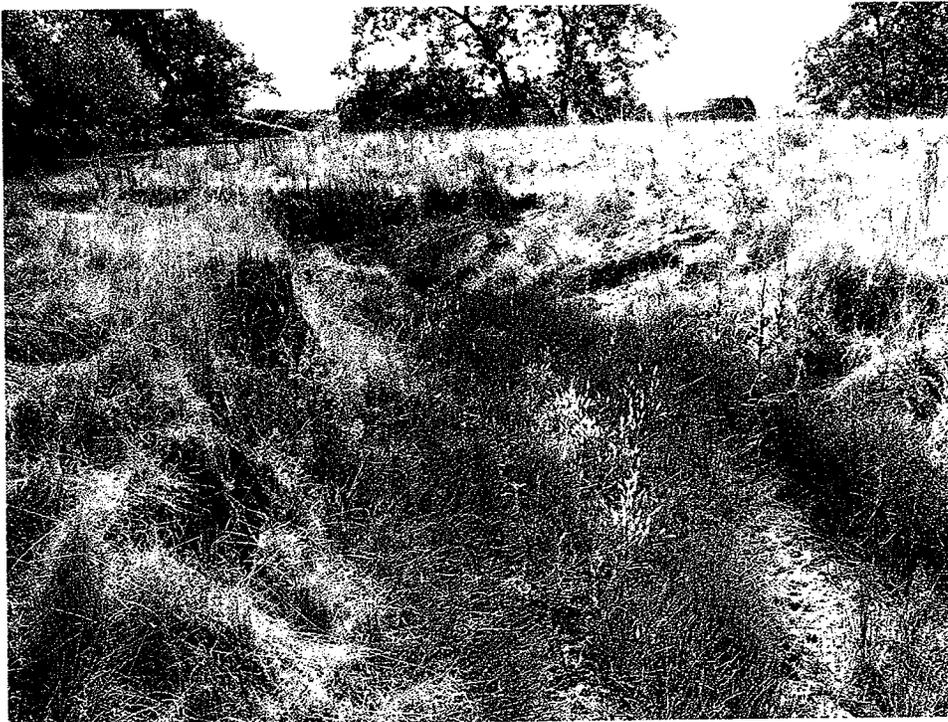
Photo 6. The channel bottom of the main riparian drainage is wetland through-out its length on the property.

A riparian corridor along the southeastern edge of the project site is dominated by a tall canopy of mature Western sycamore (*Platanus racemosa*) trees. The corridor supports seasonal surface flows that typically dry up in early summer. Bedrock outcrops are dispersed throughout the drainage, creating pool habitat suitable for amphibians and fish in years with above average rainfall such as 2005.
