*Nacimientto Water Project  
Watershed Sanitary Survey  
Five-Year Update (2021-2025)*

<b>SWRCB-DDW System No.:</b>	CA4010080
<b>System Name:</b>	San Luis Obispo County – Nacimiento Water Project
<b>Survey Period:</b>	January 1, 2021 through December 31, 2025
<b>Initial Survey Completed:</b>	2011
<b>Updates Completed:</b>	2016, 2021, 2026
<b>Name of Agency and Address:</b>	County of San Luis Obispo Public Work Department County Government Center, Room 206 San Luis Obispo, CA 93408
<b>Name of Watershed:</b>	Nacimiento Reservoir (aka Lake Nacimiento)
<b>Infrastructure:</b>	Multi-port intake structure, 45-mile-long transmission main, three pump stations, three raw water storage reservoirs, and a SCADA system
<b>Total Watershed Size in acres:</b>	208,060 acres
<b>Watershed Capacity:</b>	377,900 acre-feet
<b>Location:</b>	San Luis Obispo County and Monterey County

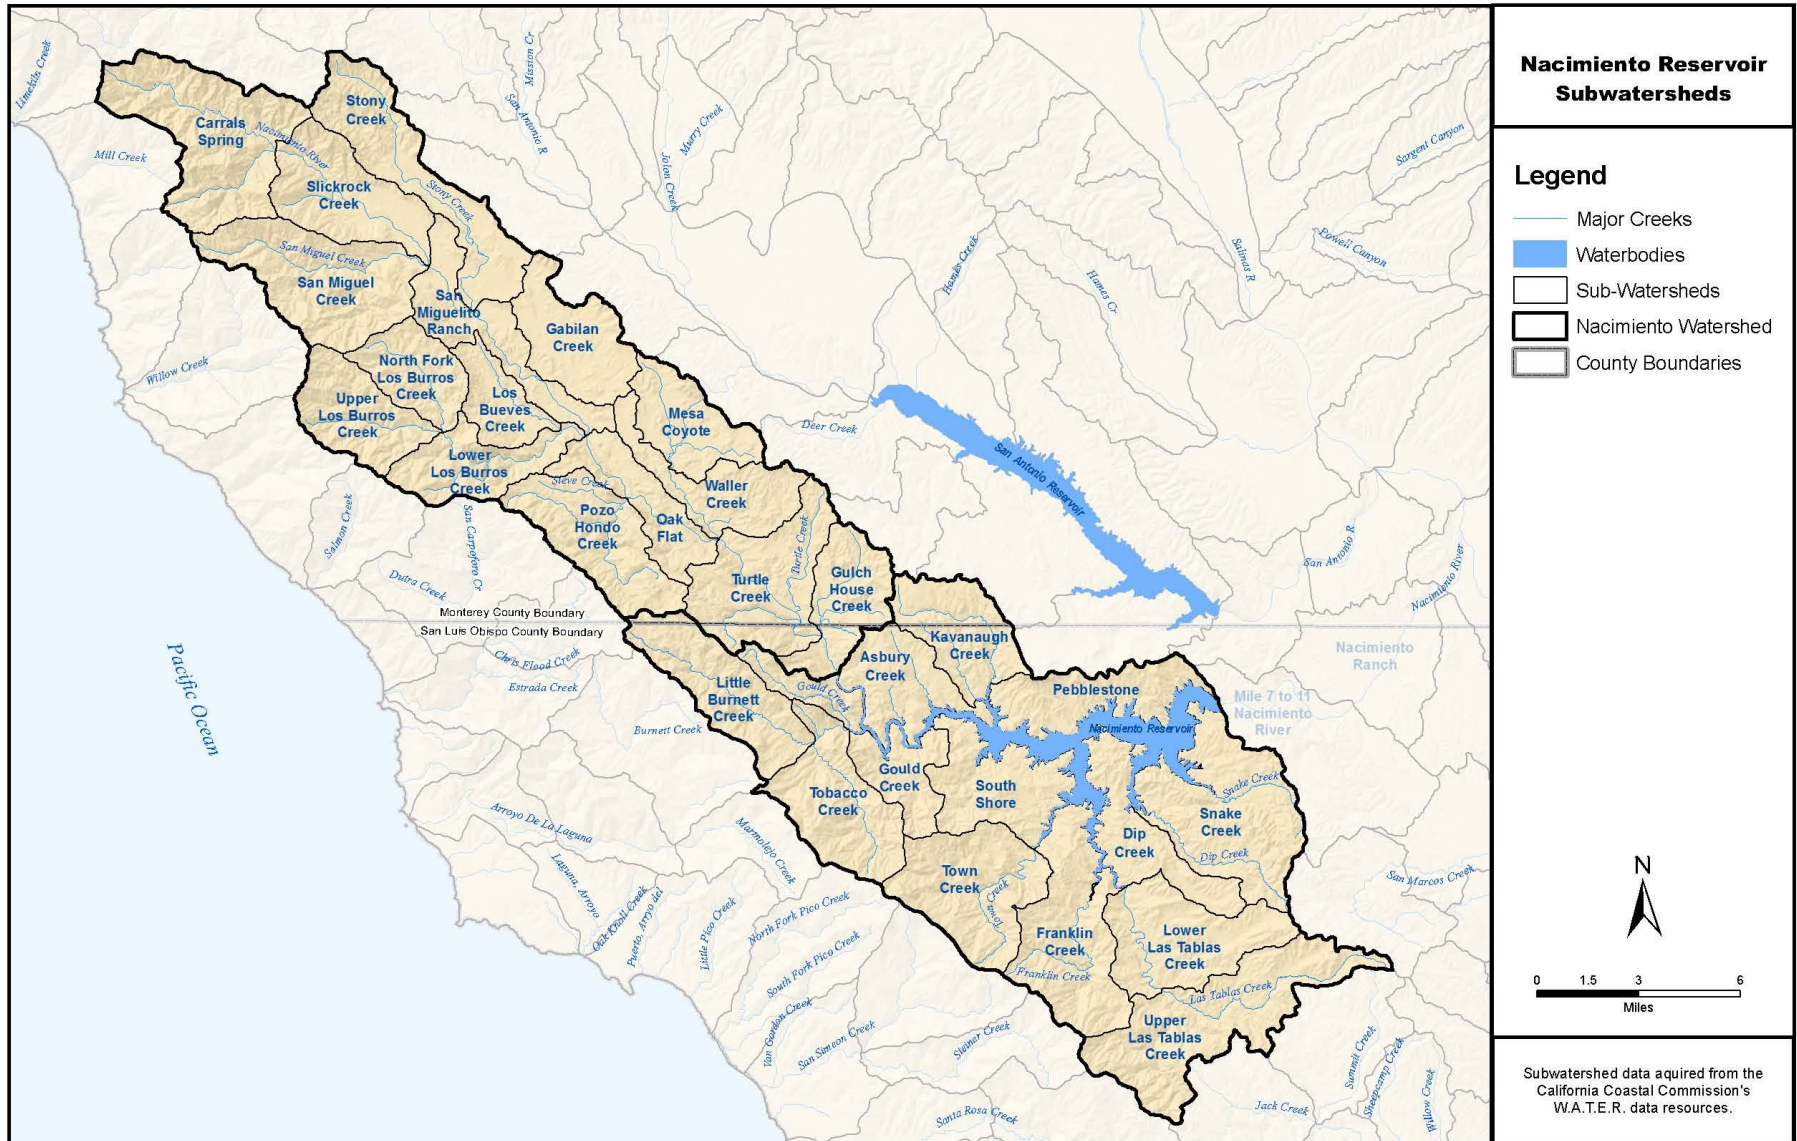
Figure 1: Nacimiento Reservoir Watershed

Nacimiento Reservoir is an 18-mile-long reservoir with 165 miles of shoreline in the southern Santa Lucia Range. At full capacity, it covers 5,727 acres, reaches depths of up to 190 feet, and holds 377,900 acre-feet of water. The surrounding 208,060-acre<sup>1</sup> watershed (325 square miles) is nearly equally split between Monterey County (104,480 acres) to the north and San Luis Obispo County (103,580 acres) to the south (see Figure 1).

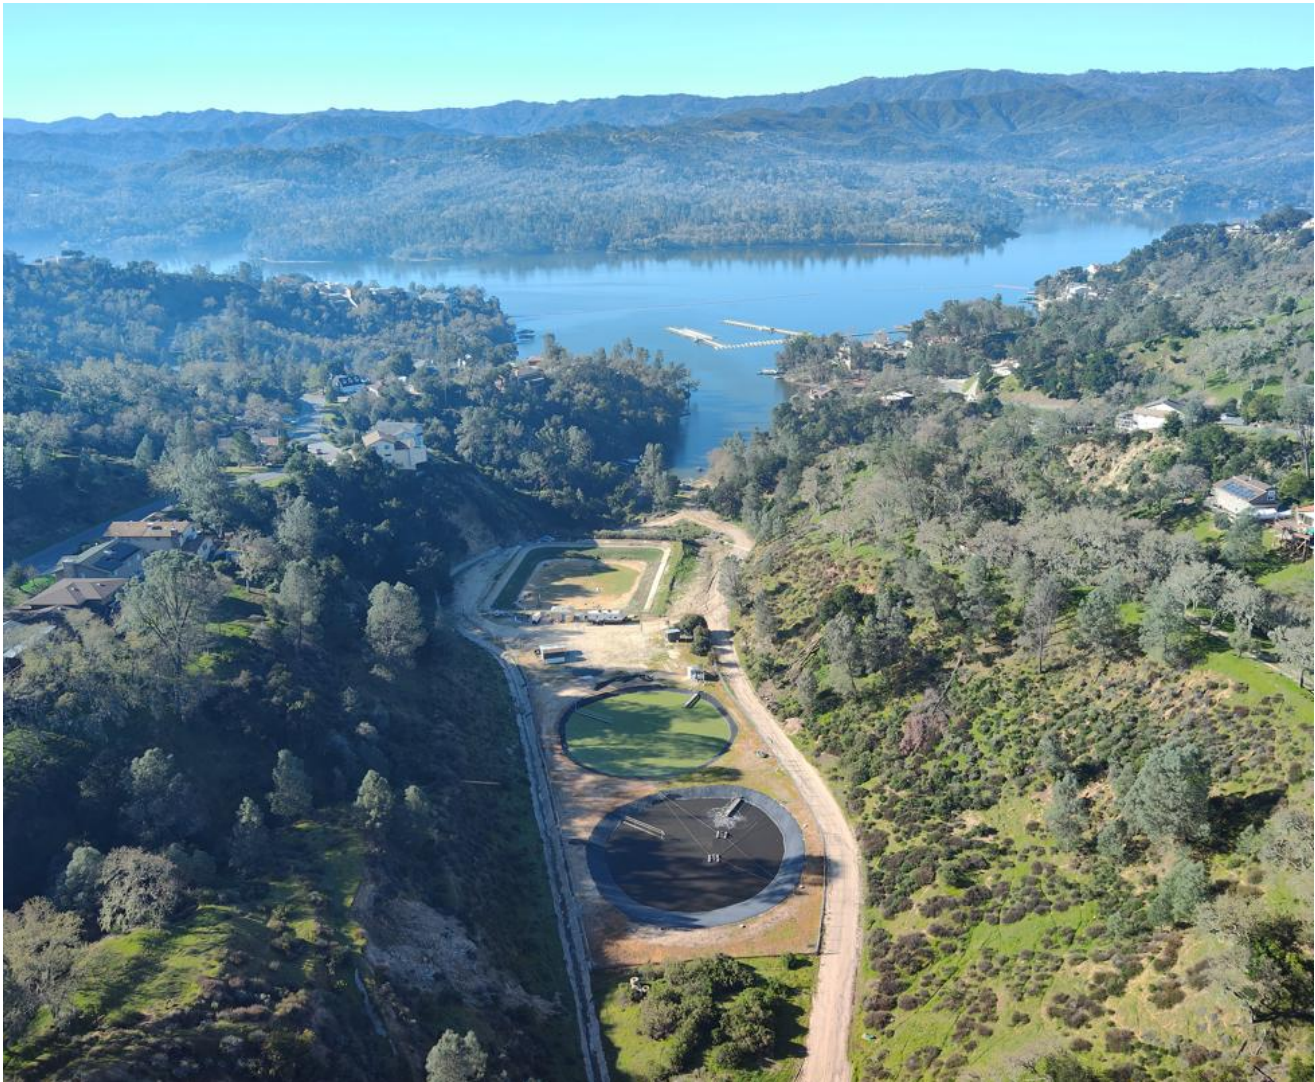
**Figure 4: CSA 7A Oak Shores Wastewater Treatment Facility**

Between 2021 and 2025, five SSOs occurred in the CSA 7A wastewater collection system. One was classified as Category 1 on April 6, 2021. This spill originated from manhole overflow and entered a storm drain culvert to a dry creek bed where it was absorbed into the soil and did not enter the reservoir. The remaining four were Category 3 under 1,000 gallons that did not reach surface water.

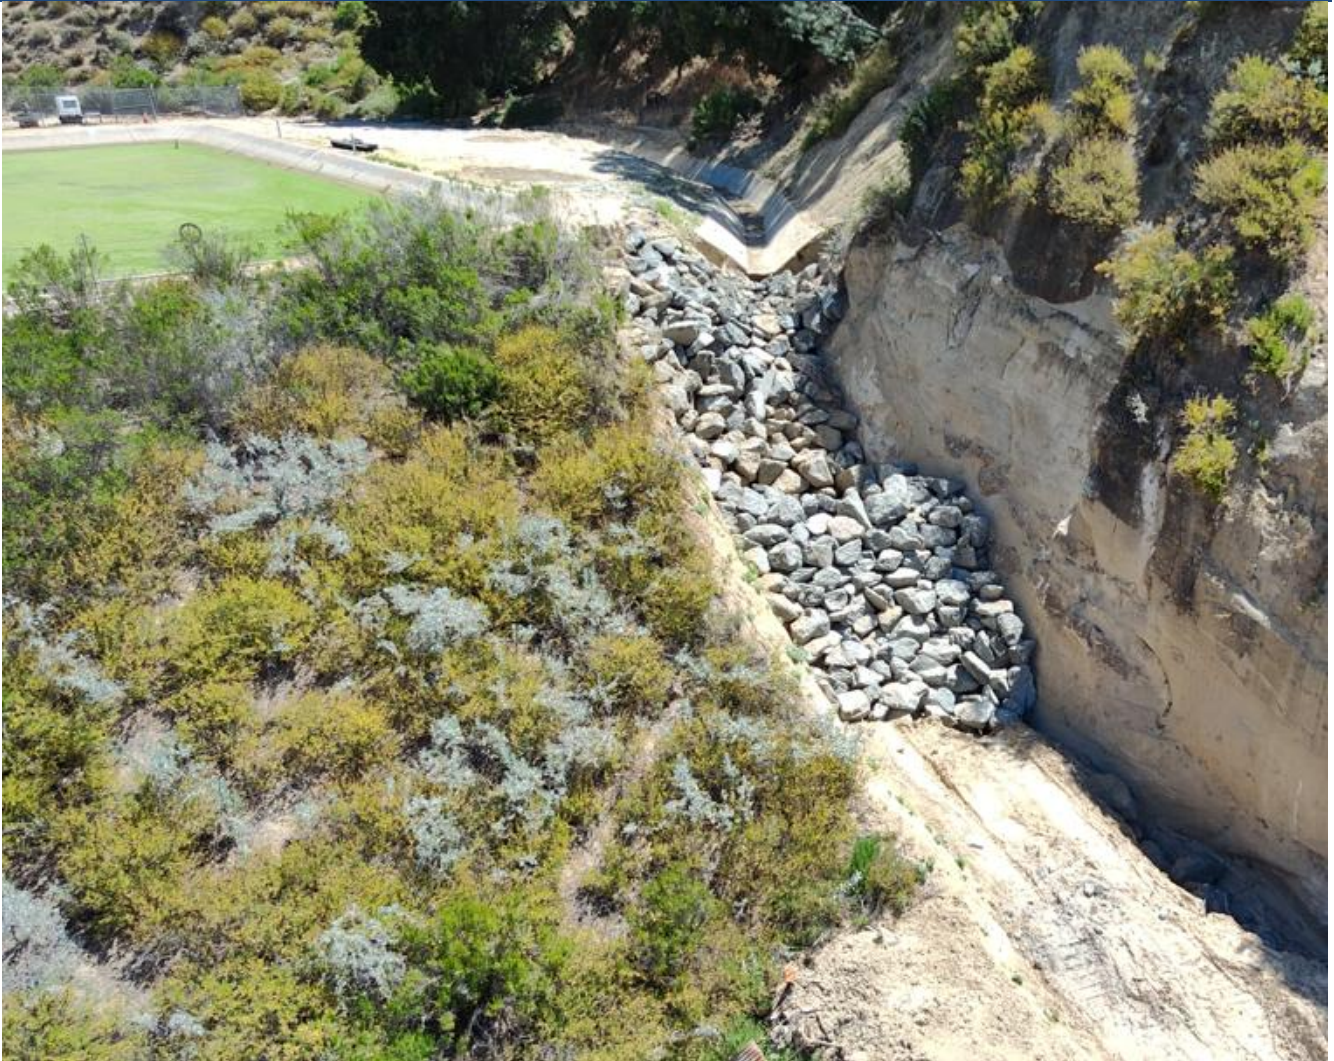
**Figure 5: Interim Storm Repair at CSA 7A**

In 2023, heavy rainstorms caused significant erosion near the County Service Area 7A – Oak Shores wastewater treatment facility (CSA 7A), undermining the structural integrity of the embankment and creating a high-risk situation in which wastewater could enter the Nacimiento Reservoir if the embankment collapses. The County installed an interim boulder reinforcement while permanent repairs are designed and constructed. To further reduce the risk of discharge, CSA 7A modified its treatment operations and removed nearby ponds from service and will continue operating under this configuration until long-term stabilization is complete.

The 2023 storm events intensified these challenges by causing severe hillside erosion near CSA 7A, creating a significant contamination risk to the watershed. In response, facility operations were modified to prevent any sewage discharge into Nacimiento Reservoir. The County completed the embankment repair design and will commence construction June 2026.

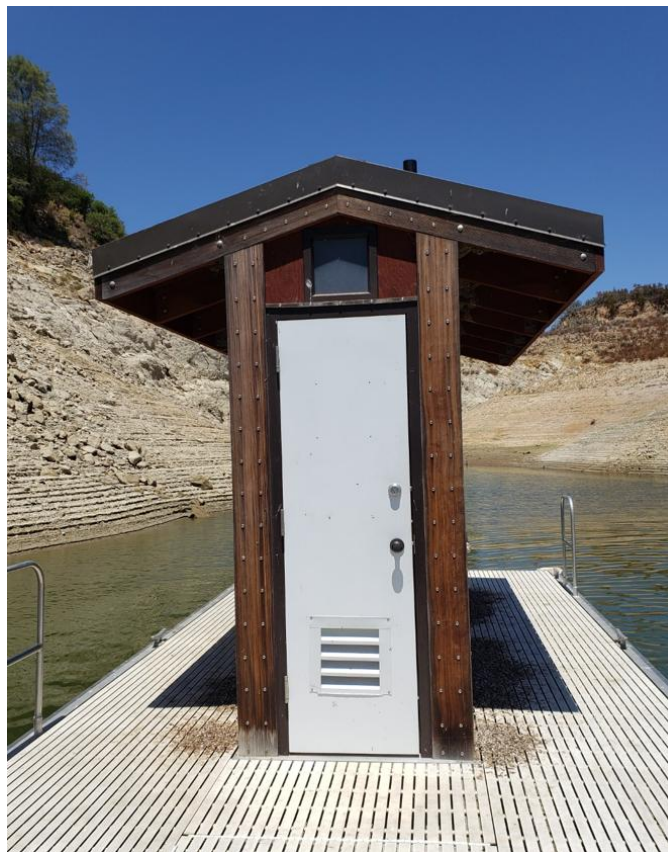
**Figure 6: Example of a Nacimiento Reservoir Floating Toilet**

Replacing FTs with onshore chemical toilets has been considered, but maintenance and access challenges make this difficult. Most shoreline property is privately owned, and servicing land-based units would require extensive agreements and coordination. The State provides grant funding for FTs to encourage boaters to use them rather than discharging waste into the lake, and Monterey County staff prefer maintaining FTs over not having facilities available.

Further evaluation is needed because the draft *Guidelines for Evaluating Applications for Recreational Use Permits at Domestic Water Supply Reservoirs* (November 15, 2020) state that floating restrooms should be prohibited unless special approval is obtained from California Department of Public Health (CDPH).

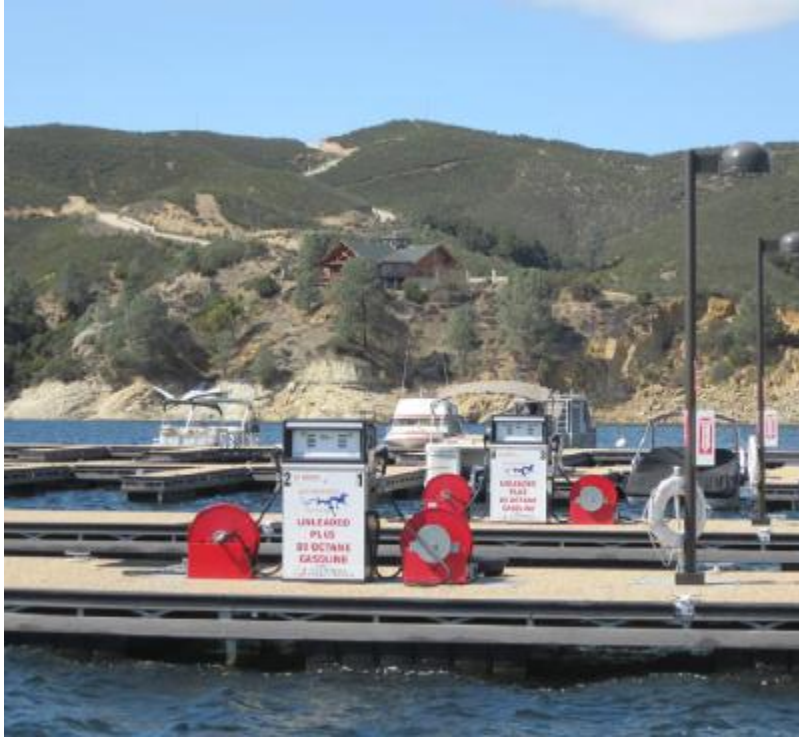
**Figure 8: Fuel pumps on Lake Nacimiento Resort docks**

The Lake Nacimiento Resort public recreation area has a fueling station for boats located on the reservoir. Two fuel pumps are located on the docks at the resort marina (Figure 8). Two double-walled 12,000 gallon underground storage tanks that service these pumps are located beneath the marina parking lot (Figure 9). A double-walled pipeline runs underground from the storage tanks for approximately 100 yards to a junction box. A flexible triple-walled fuel line runs above ground from the junction box along the shore to the fuel pumps on the dock (Figure 10, Figure 11).

The distance from the junction box to the pumps varies as the lake elevation changes; it can range from less than 25 yards to approximately 400 yards. The lines are inspected at least daily, and the entire system is inspected monthly. Boaters fill their vessels over open water.

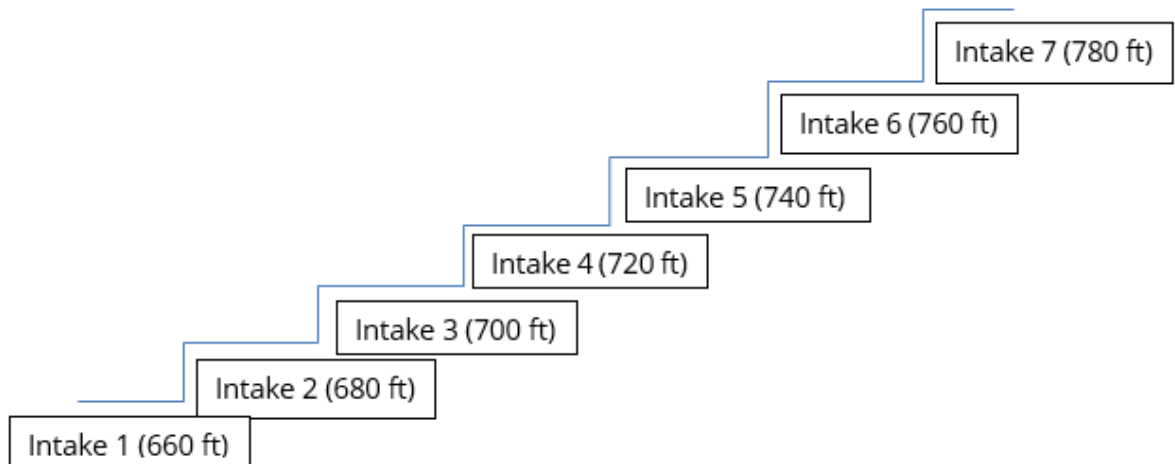
**Figure 18: Nacimiento Reservoir Intake Elevations**

The sample locations include the raw water from the Intake Pumping Station (Nacimiento Reservoir Inlet), the elevation intakes collected at twenty-foot intervals (780' – 660', see Figure 18) from the reservoir log boom, and six watershed tributaries in the Nacimiento watershed (Dip Creek, Las Tablas Creek, Narrows, Snake Creek, Town Creek, and Kavanaugh Creek). Since the inflows are seasonal, analytical data for some of the elevation intakes and the tributaries may not be available for all sampling events. For Monitoring Locations, see Figure 19.

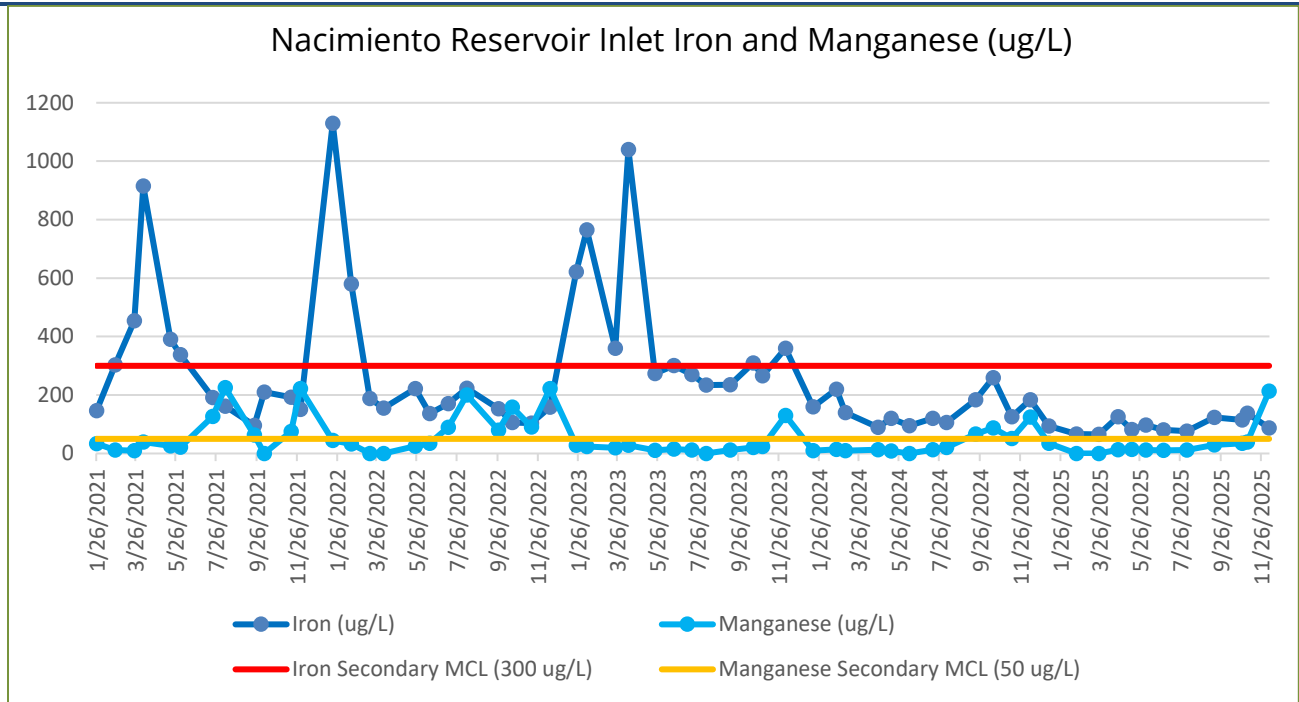
**Figure 26: Nacimiento Reservoir Inlet Iron and Manganese**

The Drinking Water Secondary MCL for Iron is 300 µg/L and for Manganese is 50 µg/L. The Drinking Water Primary MCL for Aluminum is 1,000 µg/L and Secondary MCL is 200 µg/L. See Figure 26 and Figure 27 for graphs of the Nacimiento Reservoir Inlet compared to the primary and secondary MCLs.

At greater depths, oxygen depleted, and the concentration of iron and manganese increased. On average, aluminum, iron and manganese at the Nacimiento Reservoir Inlet met the secondary limits, with manganese at the maximum limit. In general, higher levels of aluminum are present in the winter months and at less depths. Elevated aluminum, iron and manganese levels were a result of stormwater runoff. The optimal water quality on average for aluminum, iron and manganese were between intake elevations 720 feet to 780 feet. A Summary of aluminum, iron and manganese can be found in Table 14.

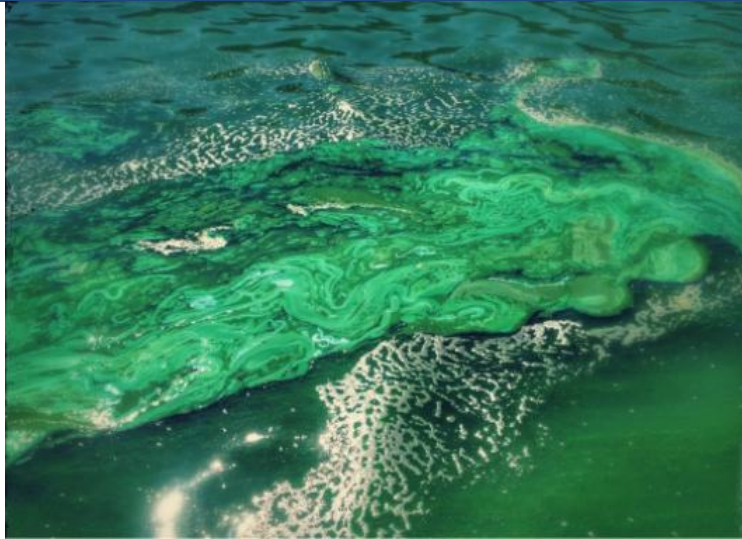
**Figure 30: Example Blue-Green Algae Bloom**

Based on cyanotoxin testing results and or visual indicators confirming the presence of HABs, the State requires each body of water to post an advisory level, CAUTION, WARNING or DANGER (Figure 29 and Figure 30).

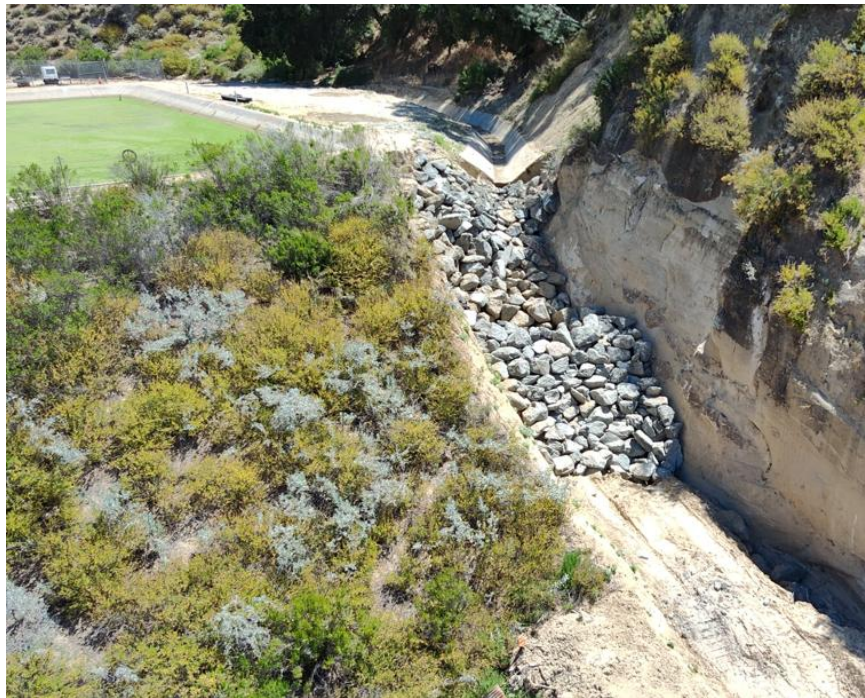
**Figure 31: Drainage Channel Blowout and Stabilization of Embankment**

In 2023, severe storm erosion undermined the structural integrity of the treatment pond adjacent to CSA 7A (Figure 31, Figure 32). The storm damage created a potential pathway for effluent or partially treated wastewater to reach the Nacimiento Reservoir in the event of slope failure. The County implemented immediate slope stabilization measures using interim boulder buildup. To further mitigate discharge risk, CSA 7A modified its treatment operations by taking the ponds nearest the compromised slope offline and will continue modified operations until the permanent repair is finished. Design is complete and construction will commence June 2026.

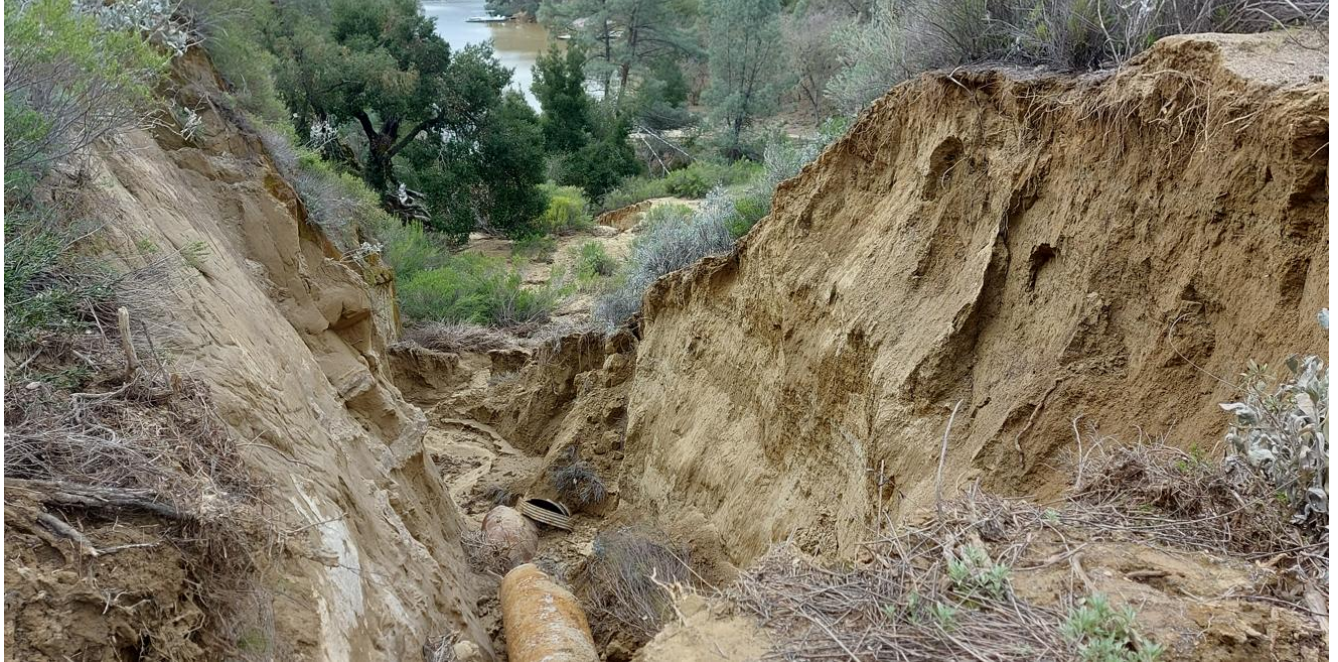
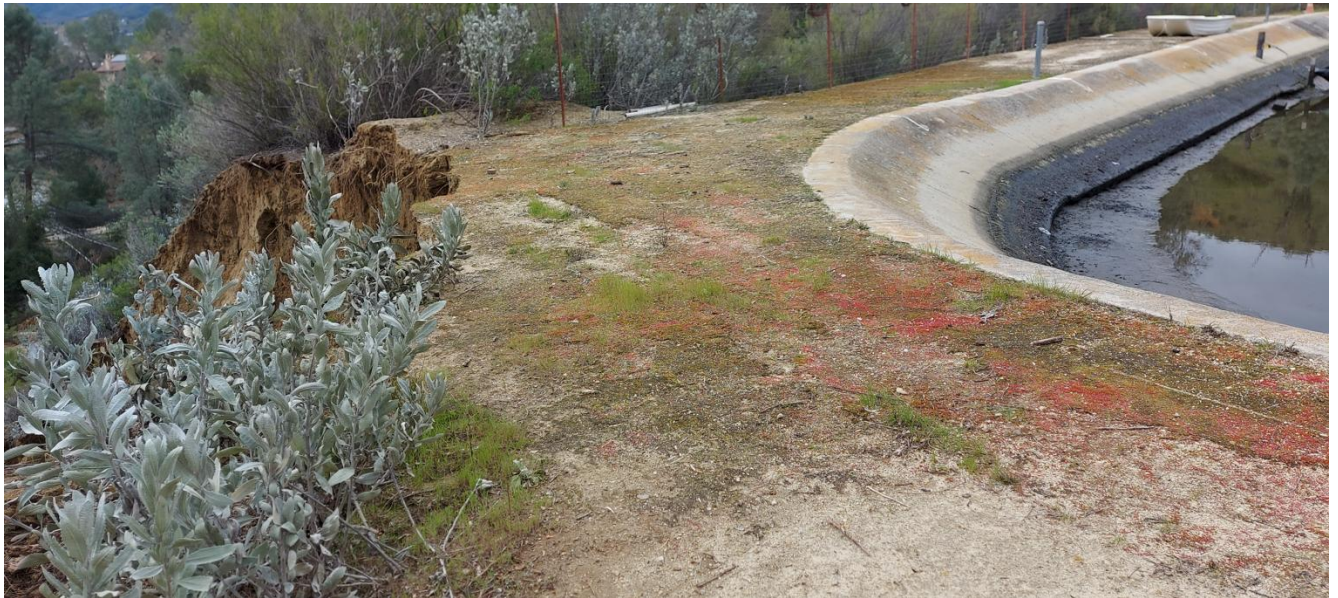
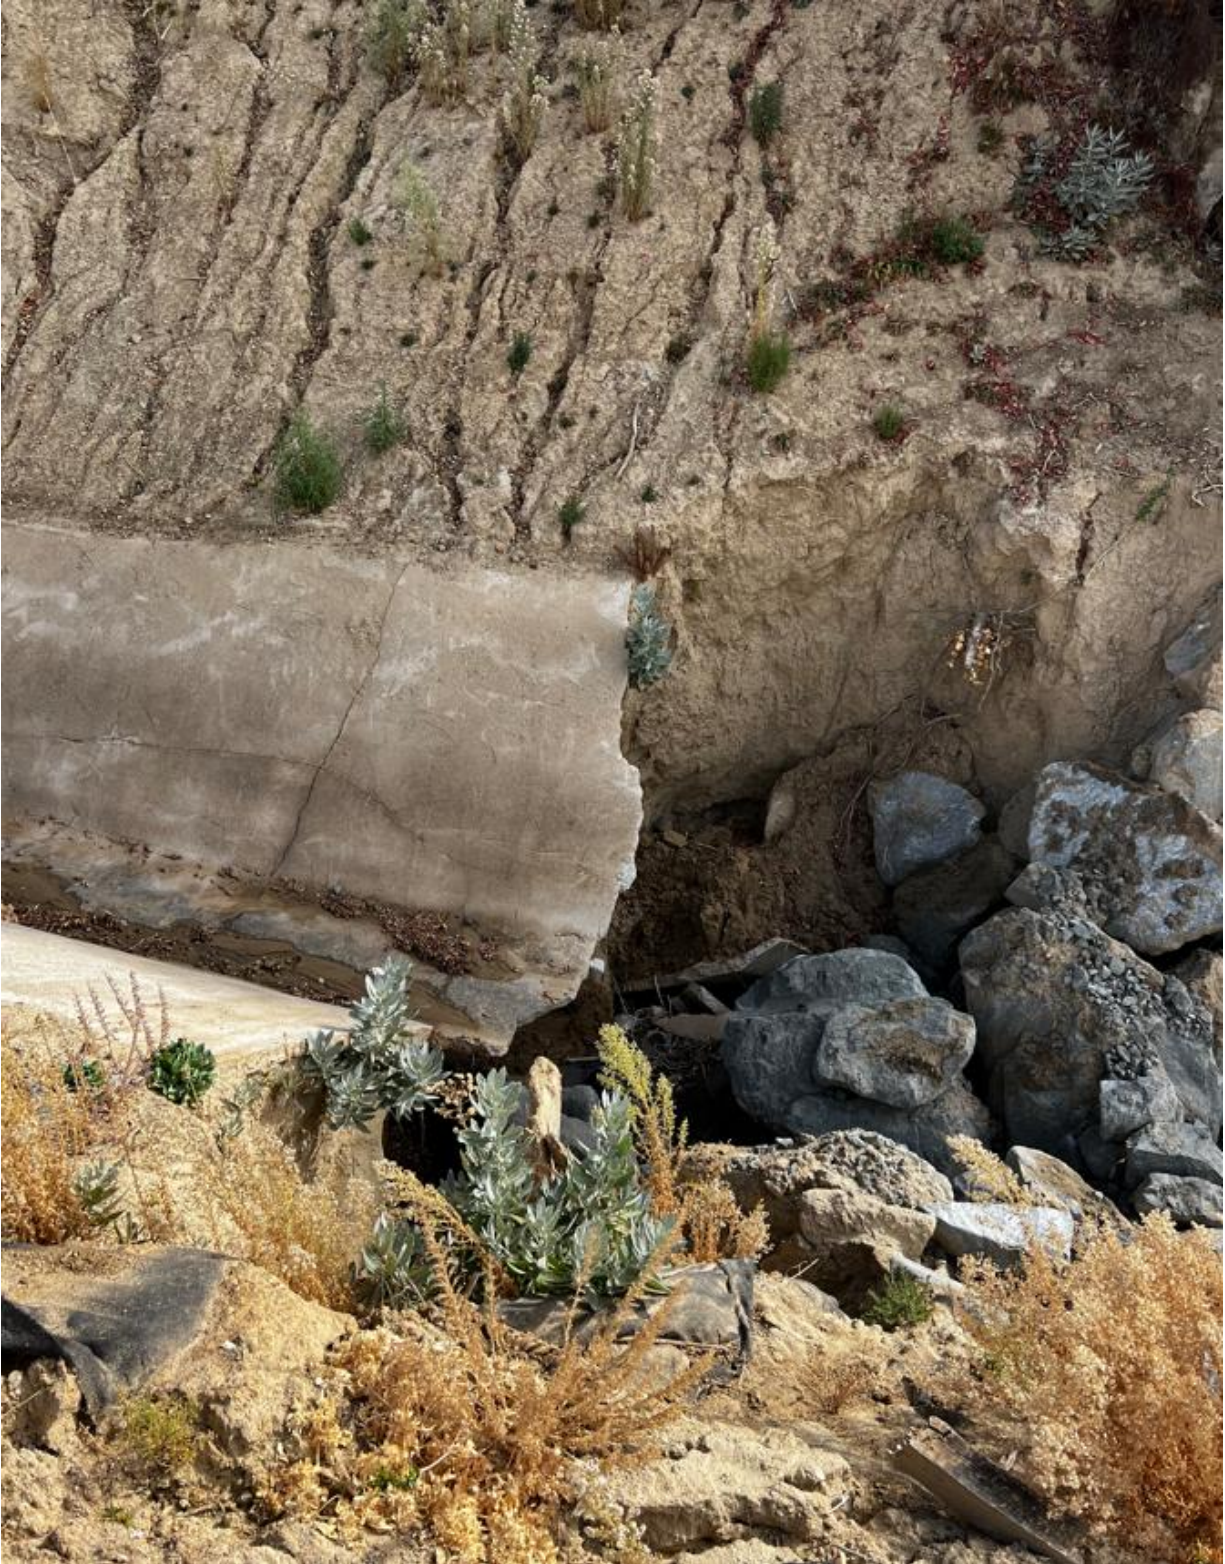
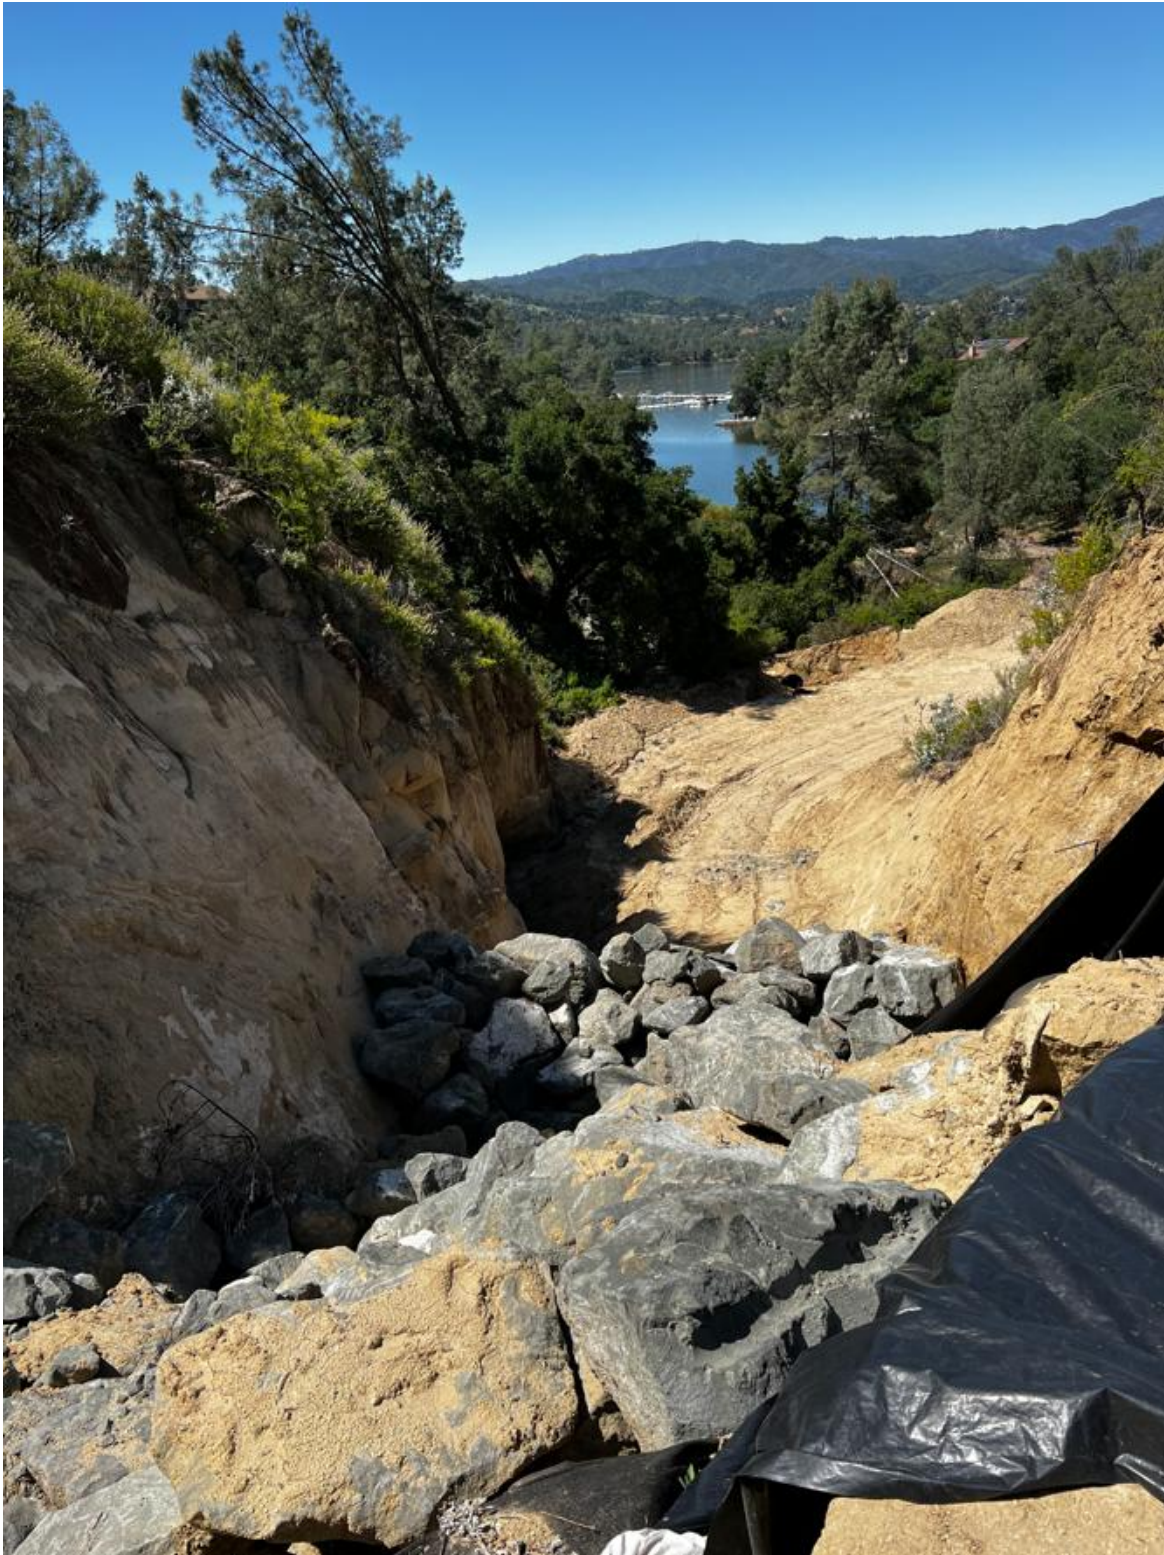
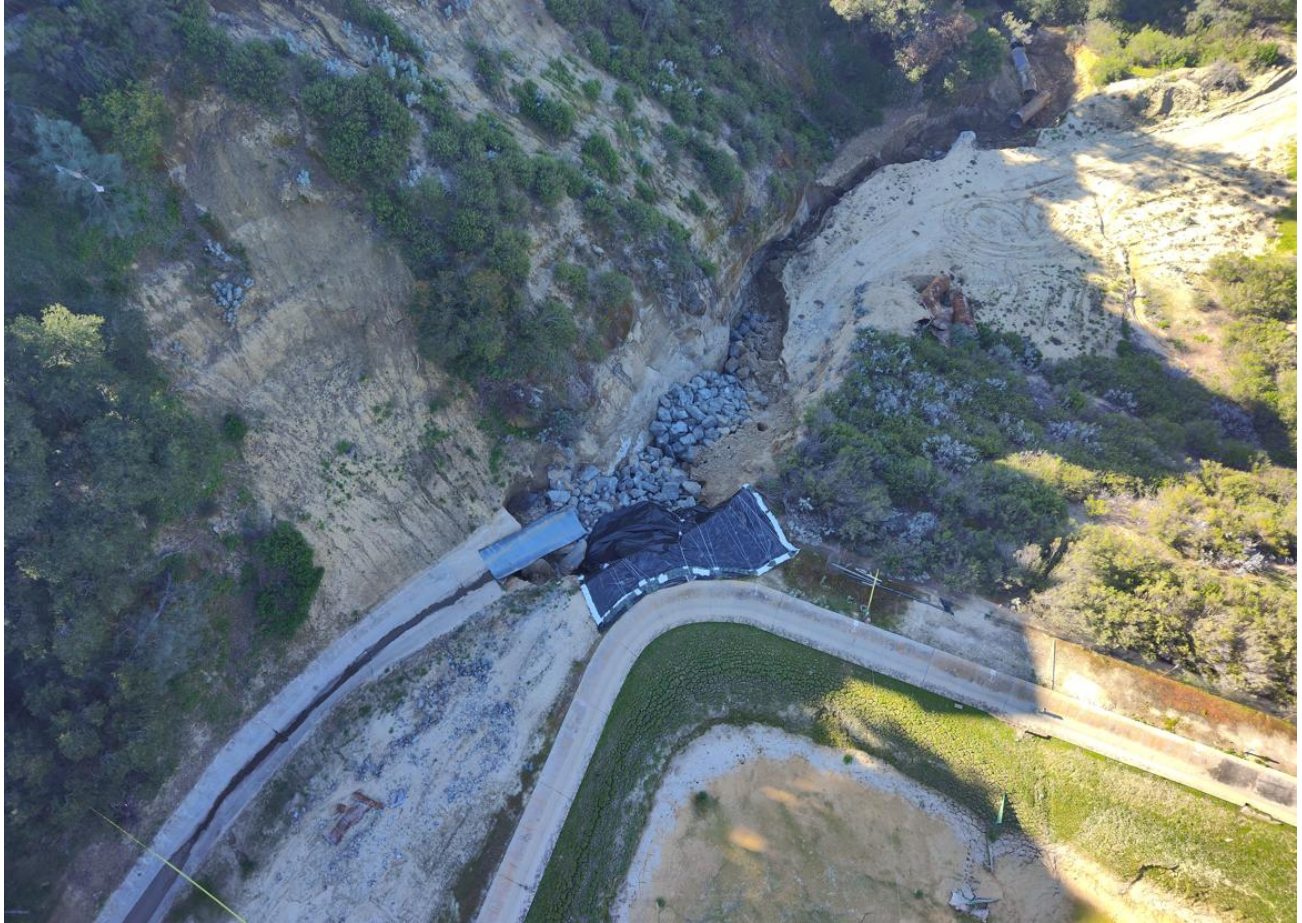
## APPENDIX A: Photos of 2023 Storm Erosion and Interim Repair

Interim Boulder Stabilization
