MEMORANDUM

Re: Interconnected Surface Water Assessment, Paso Robles Basin GSP

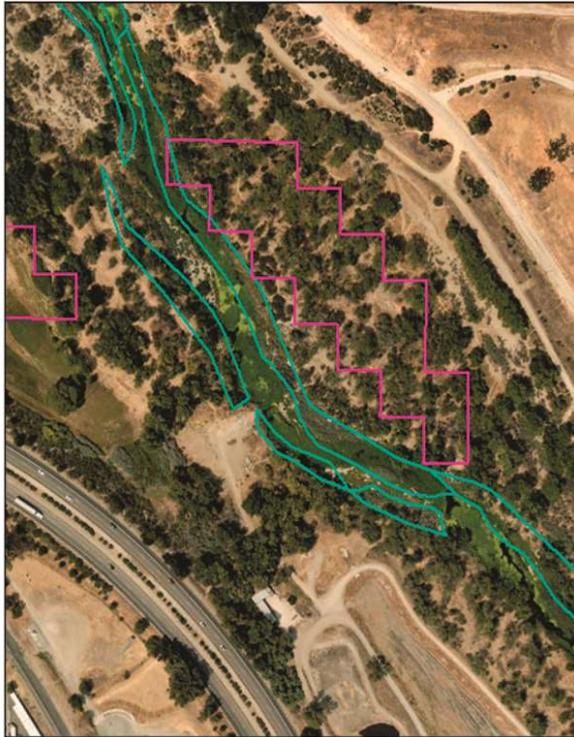
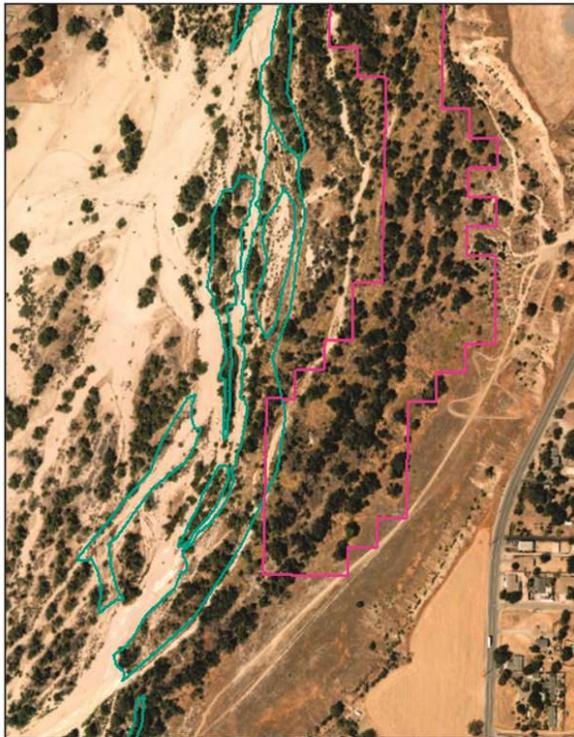
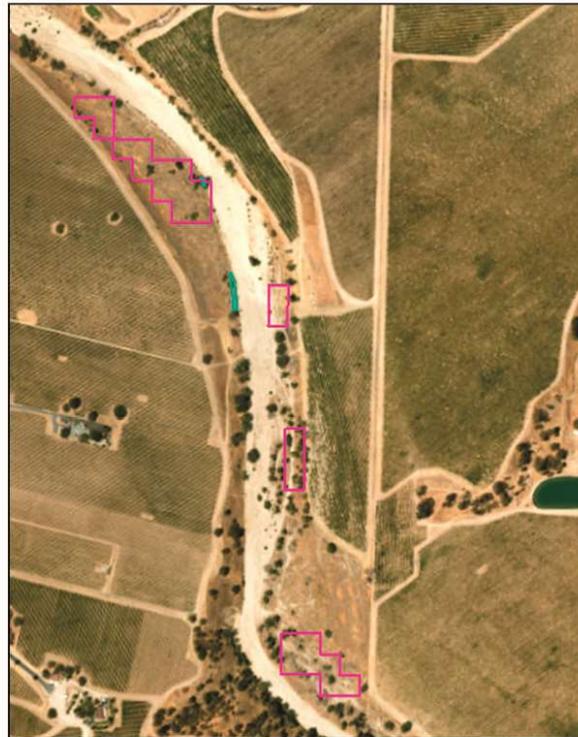
A comparison of the NCCAG maps with aerial photographs revealed that the accuracy of the NCCAG vegetation delineations is poor in the Subbasin. This is illustrated in Figure 6, which shows NCCAG vegetation polygons overlain on aerial photographs at four locations along the Salinas and Estrella Rivers. The riparian vegetation polygons clearly miss many areas of vegetation that is denser and more likely phreatophytic than the vegetation in the polygons or simply cover areas with little vegetation at all. The wetland polygons along the river channels were mapped in greater detail but do not consistently correspond to a particular type of vegetation visible in the photograph. In particular, wetlands within the river channels are commonly present as long, narrow ribbons along the low-flow channel. Slight shifting in the low-flow channel location or small errors in georeferencing the data can place the mapped polygon over the incorrect type of vegetation.

Figure 6. NCCAG Vegetation Polygon Accuracy Along the Salinas and Estrella Rivers

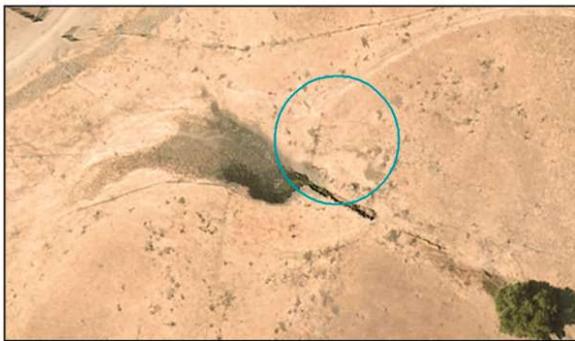
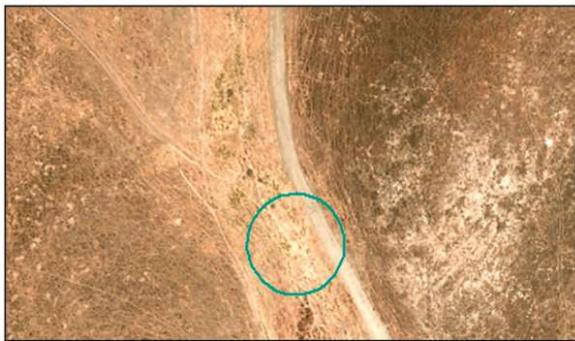
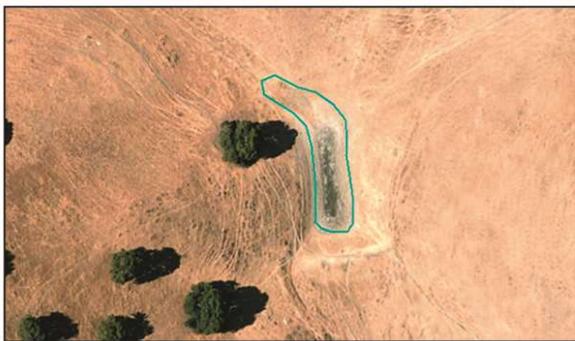
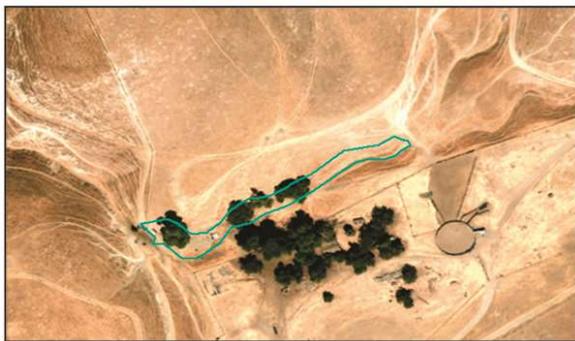
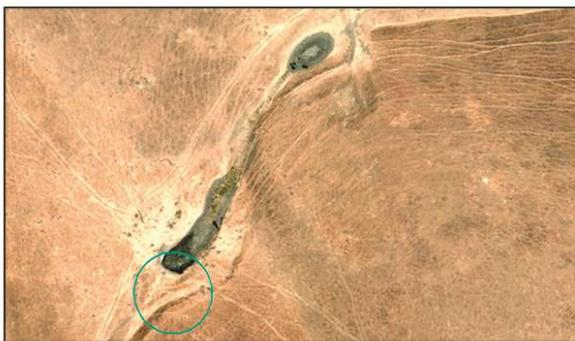
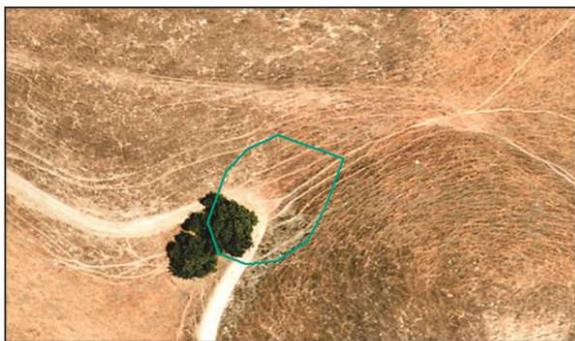
The NCCAG wetland map also includes numerous off-channel vegetation patches mapped as springs or seeps. Mapping accuracy for these features was also uneven, as shown in Figure 7.

Figure 7. NCCAG Wetland Map Accuracy within Paso Robles Subbasin

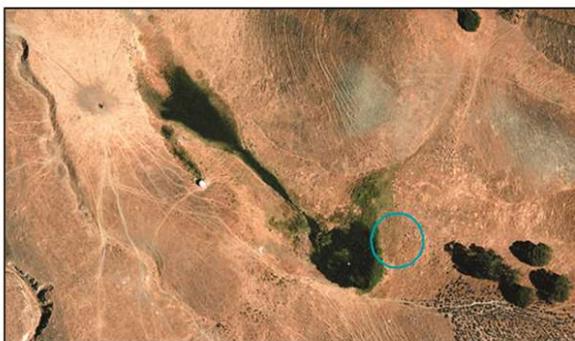
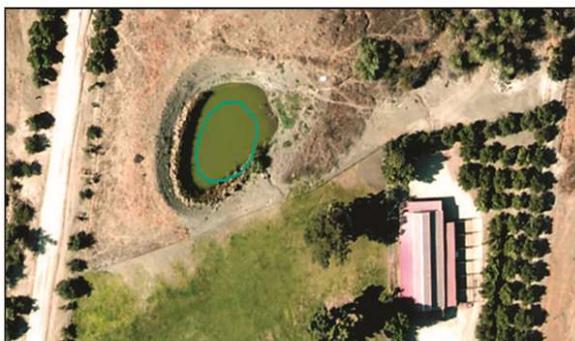
NCCAG Wetland Vegetation

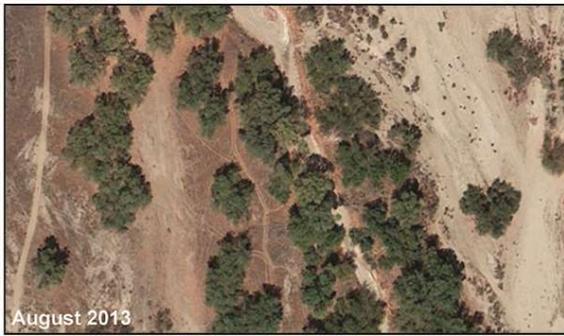
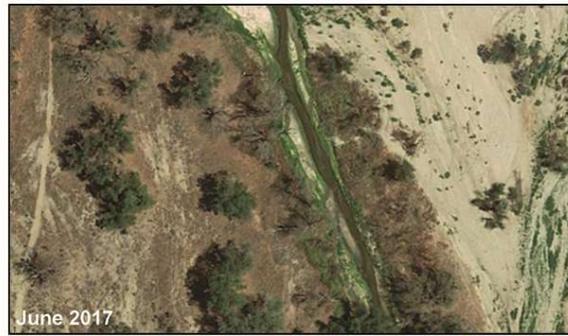
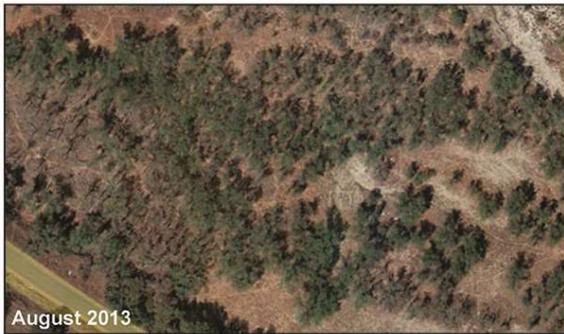
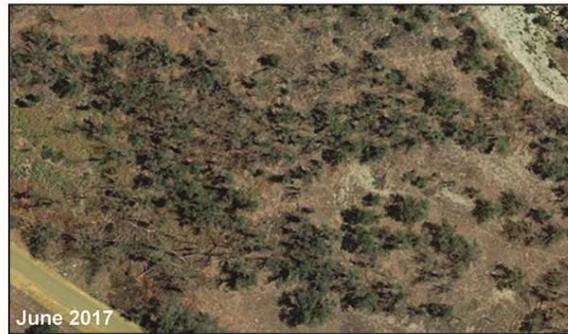
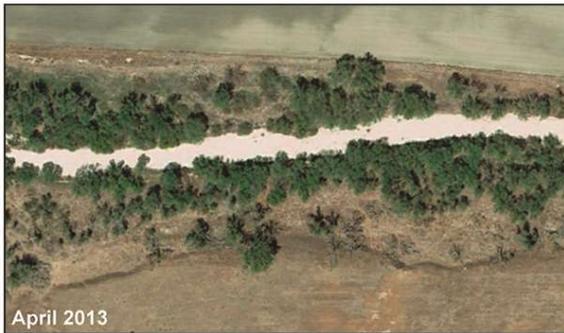
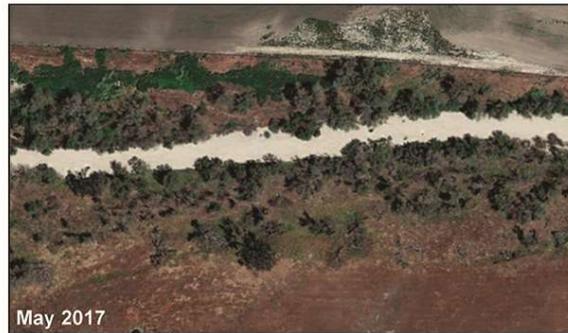
The resolution of recent historical aerial photographs on Google Earth© is sufficiently high that the death of individual trees or groups of trees can be readily detected by comparing photographs before and after the mortality event. The 2012-2016 drought caused noticeable riparian tree mortality in a number of locations. Aerial photographs bracketing the drought (2013 and 2017) were systematically compared to map locations of significant tree mortality. Pairs of photographs illustrating tree mortality are shown in Figure 10, and a map showing the locations and percent canopy reduction where mortality was observed is shown in Figure 11.

Figure 10. Riparian Vegetation Mortality between 2013 and 2017

Mortality occurred along the Salinas and Estrella Rivers. The number of locations and extent of mortality was less for the Salinas River. Along the Salinas River, groundwater levels declined 12-18 feet during the drought as a result of insufficient surface flow to maintain the normal high water table. This indicates that for trees accustomed to shallow depths to water (less than 20 feet), water-level declines of 12-18 feet can be fatal. The situation along the Estrella River is more complex. Tree mortality was concentrated during the 2012-2016 period even though Paso Robles Formation groundwater levels had been declining for years before the drought. Like the presence of emergent flow and relatively dense riparian vegetation along the middle segment of the Estrella River prior to 2012, the delayed mortality of trees along the river might indicate the presence of a water table normally shallower than the water levels in nearby Paso Robles Formation wells.

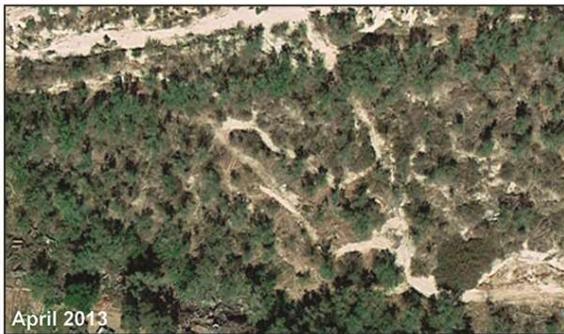
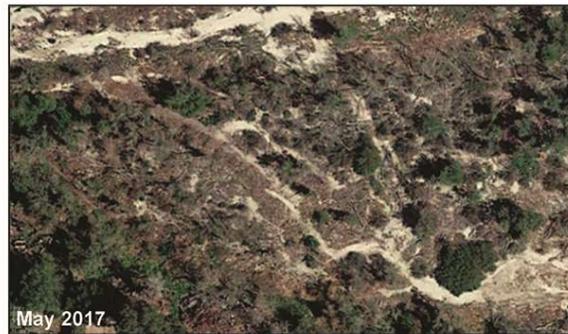
Estrella River at Shandon
