**COUNTY OF SAN LUIS OBISPO**  
**Department of Public Works**  
**John Diodati, Director**

**Re: Arroyo Grande Creek Channel Waterway Management Program – 2025 Annual Vegetation Management and Sediment Removal Work Plan**

**ATTACHMENT A**

**Representative Site Photographs**

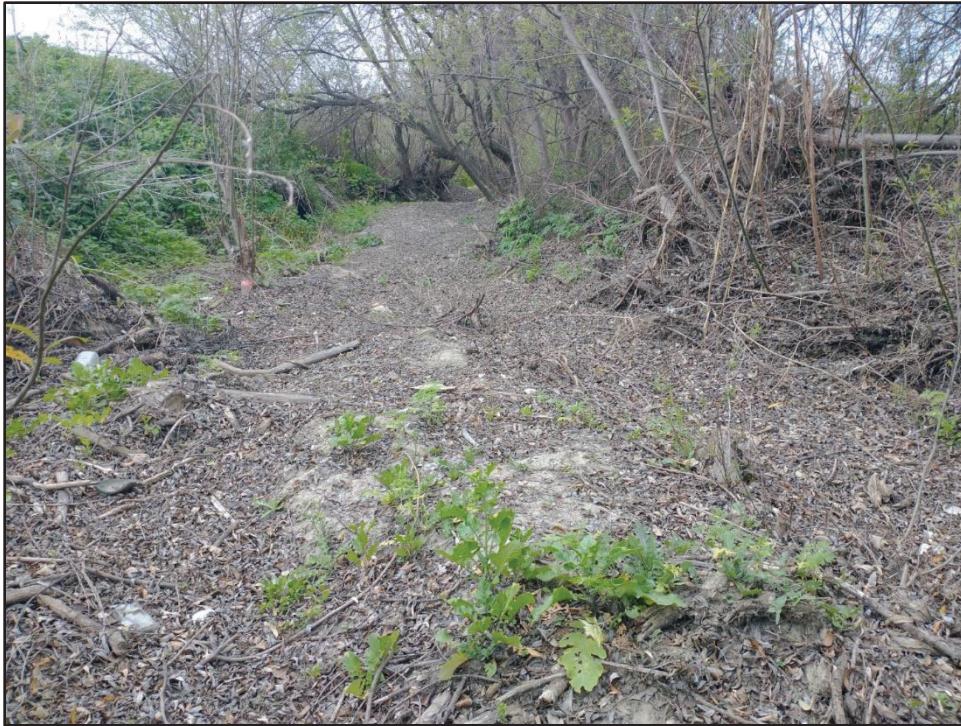
**Photo 1.** View south of sediment deposition and lack of water flow within the former main channel adjacent to SMZ 19 (February 28, 2025).

Areas identified as Priority 1 were determined based on both observed and modeled conditions that show less flood conveyance occurring downstream of the 22<sup>nd</sup> Street Bridge relative to areas upstream of Highway 1. This is especially true of Sites 18 and 19 which are located upstream of the Los Berros Creek confluence. Construction methods including identification of disposal areas will be provided in the secondary 2025 work plan. Existing alcoves in SMZ 2 and SMZ 8 would be excavated concurrent with sediment management activity. To limit impacts to flowing waters, sediment removal occurring within former main channels and alcoves would maintain a 3-foot buffer between excavation areas and actively flowing water within Arroyo Grande Creek to the maximum extent feasible. However, in-stream work requiring diversion/dewatering may be necessary in areas of significant sediment deposition up to the edge of the active channel. Where streambed substrate is recommended to address undercutting or flanking of Type B (downstream) log structures, a gradation is recommended based on hydraulic parameter output from the HEC-RAS model (e.g. velocity, shear) and composed primarily of rounded river rock, to the extent feasible.

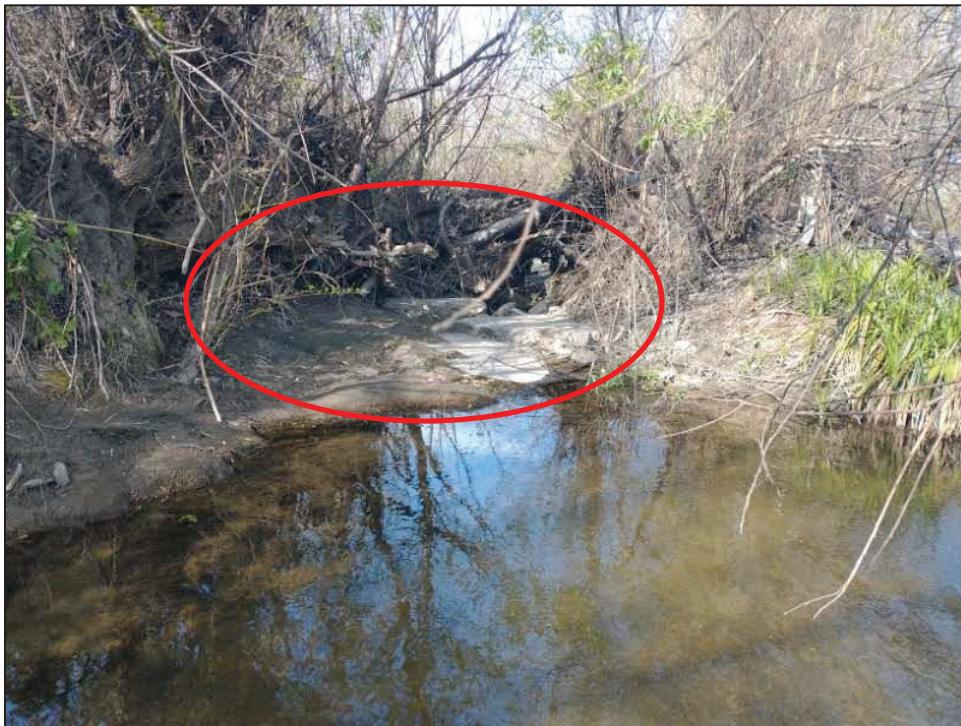
**Photo 2.** View north of sediment deposition within a portion of the main channel adjacent to SMZ 16 (February 21, 2025).

SMZ ID	Length (ft)	Volume (cy)	Priority	Alcove	Log Structure	Notes
8	350	~160	1	Yes	No	~60CY at alcove; ~100CY in SMZ8
16	375	~300	2	No	Yes	~300CY at downstream extent of former primary channel to re-engage primary flow path; Stream substrate at Structure 16B to address undermining and flanking
18	325	~800	2	No	No	~800CY along extent of former primary channel to re-engage primary flow path
19	200	~120	2	No	No	~120CY where debris jam removed at upstream end of former primary channel
<b>Total</b>	<b>2,225</b>	<b>3,020</b>

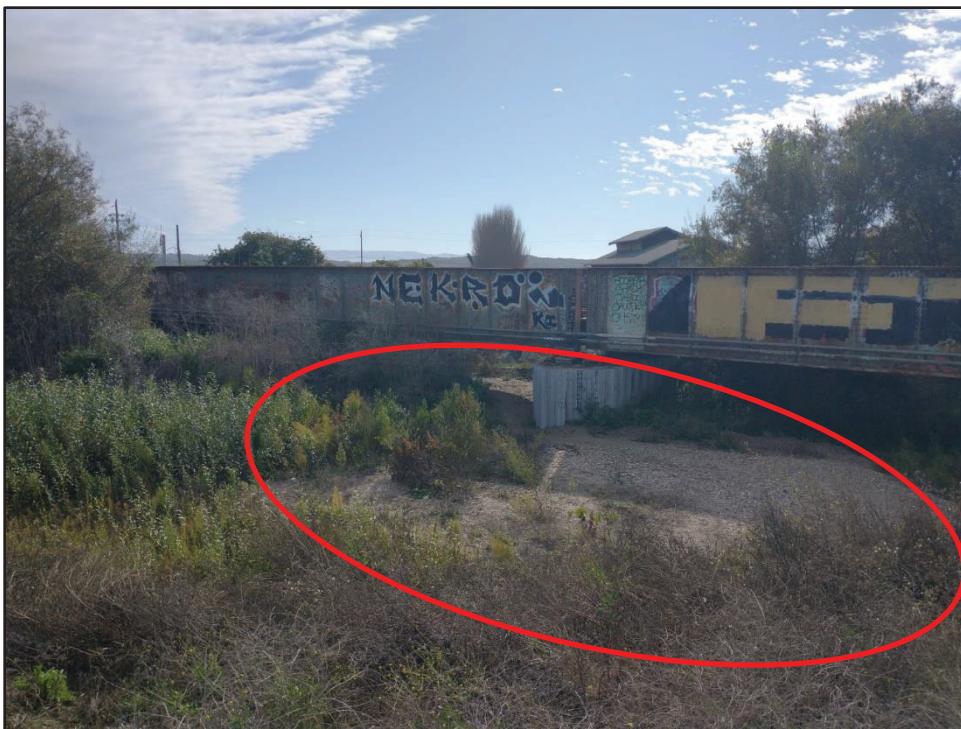
**Photo 3.** View south of sediment deposition under the Union Pacific Railroad Bridge with SMZ 7 in the foreground and the main channel in the background (December 5, 2024).

SMZ ID	Length (ft)	Volume (cy)	Priority	Alcove	Log Structure	Notes
2	300	~320	1	Yes	Yes – 2B	~70CY at alcove; ~250 CY in SMZ2; Stream substrate at Structure 2B to prevent undermining of footer log
5	175	~120	1	No	No	~120CY in SMZ5 at upstream end
7	500	~1,200	1	No	No	~1,200CY along entire SMZ including under the UPRR Bridge

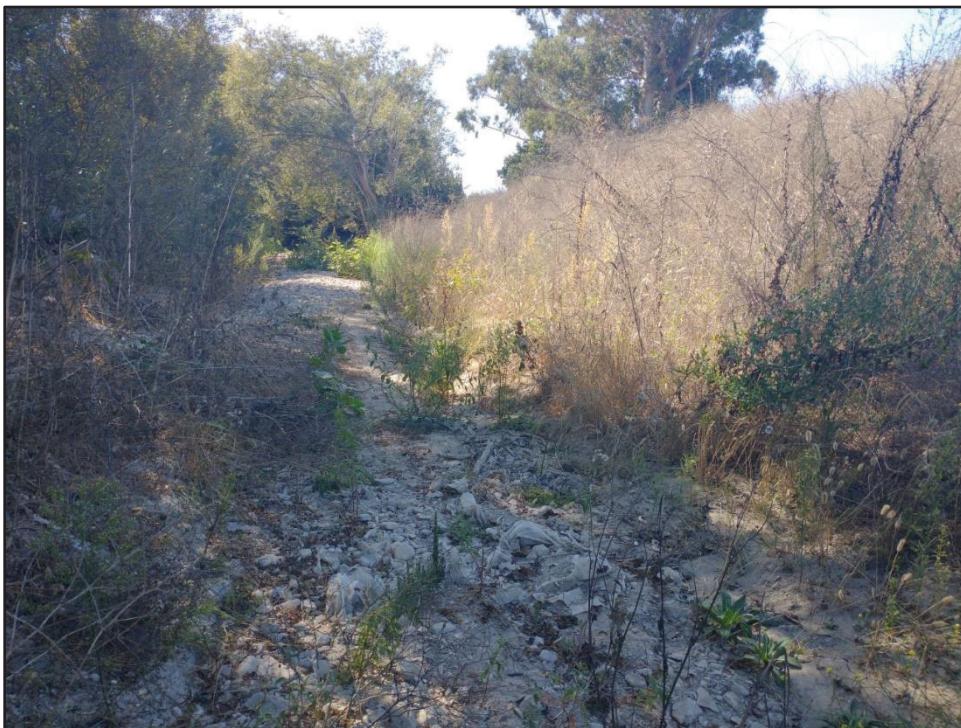
**Photo 4.** View south of sediment deposition and lack of water flow within the former main channel adjacent to SMZ 19 (October 22, 2024).

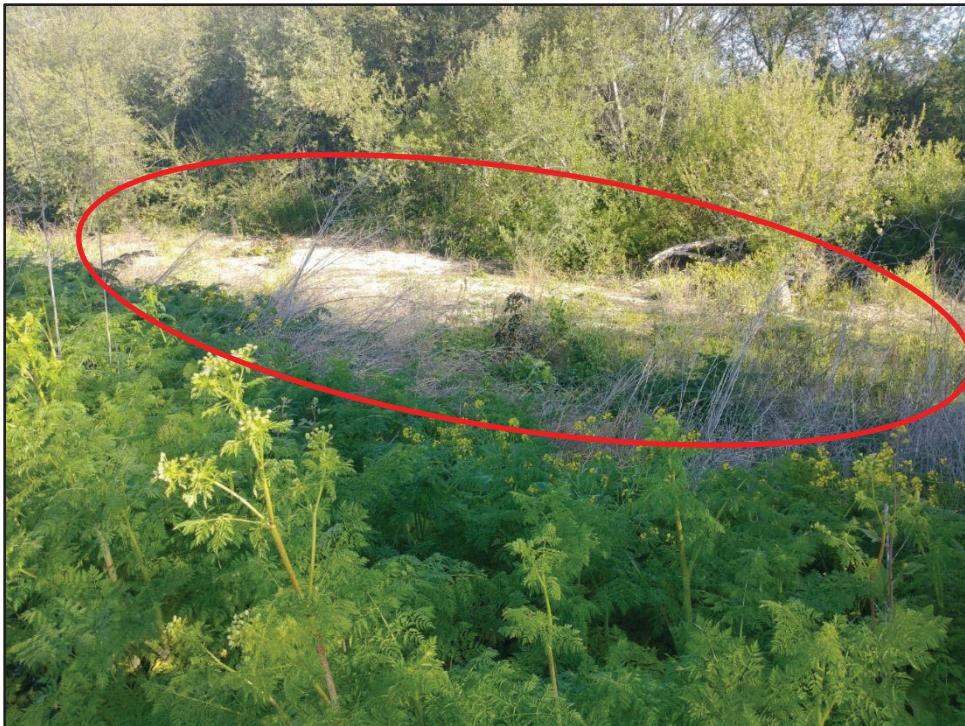
**Photo 5.** View northwest of sediment deposition within SMZ 5 (April 11, 2025).

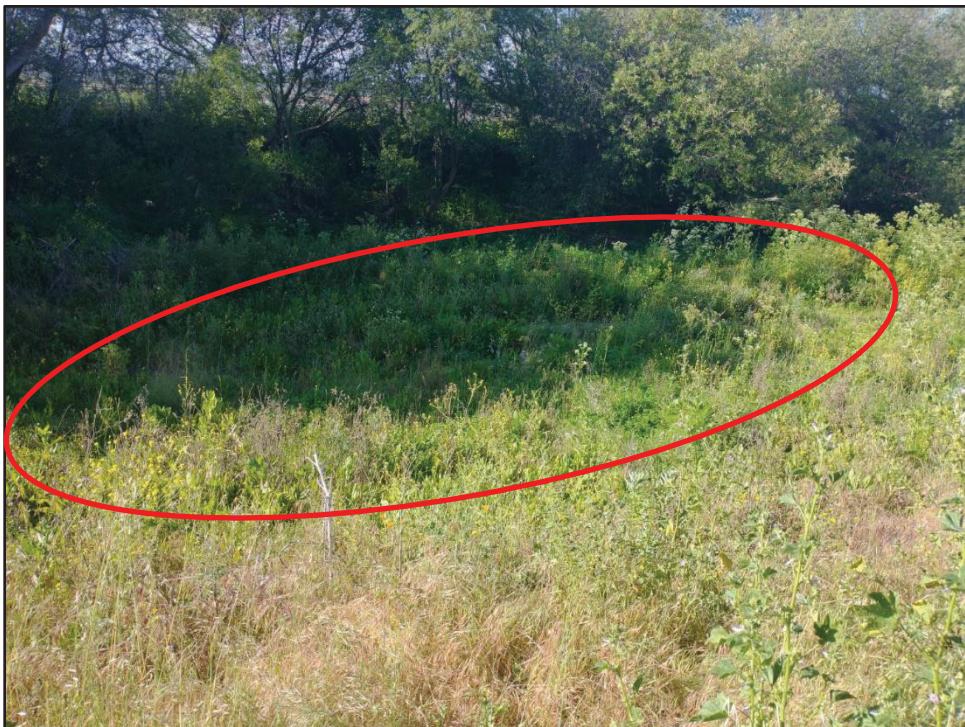
**Photo 6.** View southwest of sediment deposition within the alcove of SMZ 8. The downstream log structure is just out of frame to the left (April 11, 2025).

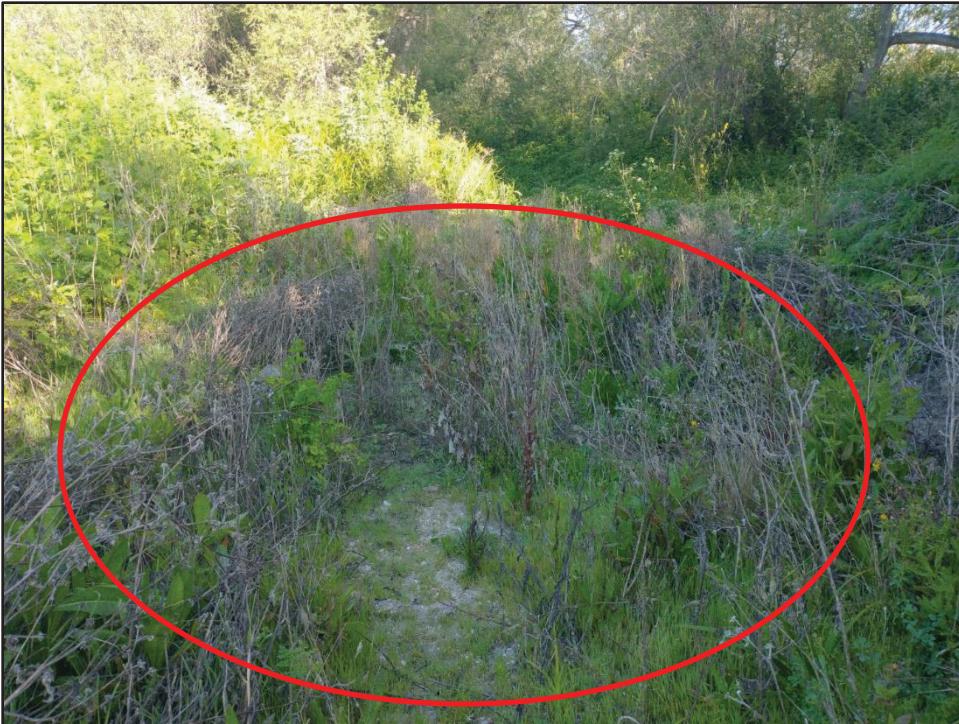
**Photo 7.** View northwest of sediment deposition within the alcove of SMZ 3 (April 11, 2025).

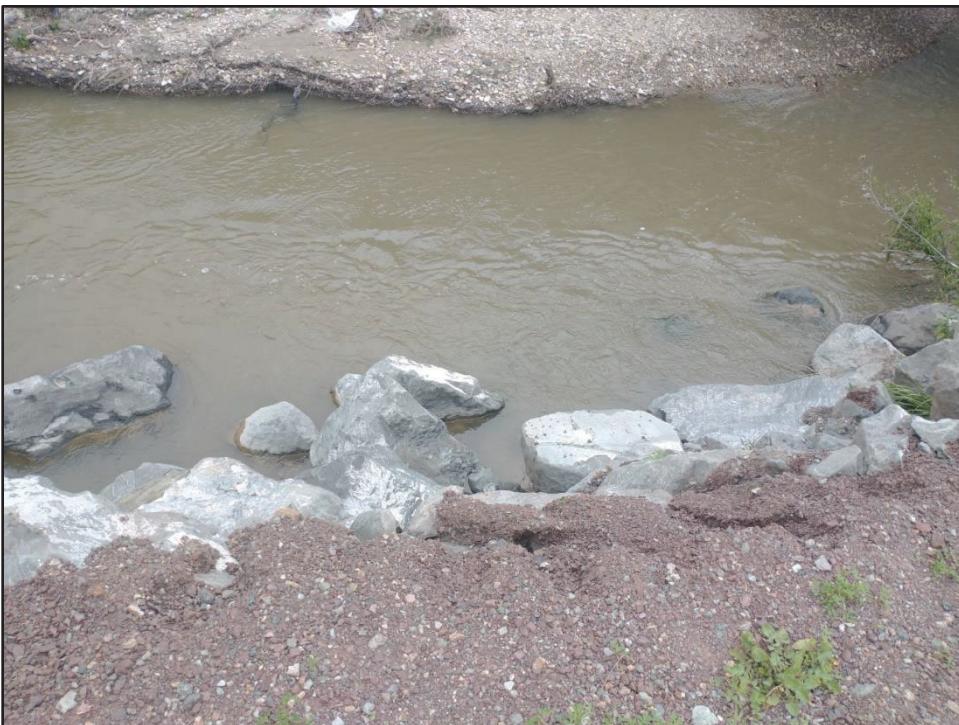
The District provided a letter dated June 19, 2024, detailing that upon inspection of the south levee breach site that occurred downstream of the UPRR bridge on January 9, 2023, bank erosion was discovered within the area of rock slope protection used to rebuild the levee at the breach site. The District determined that in its current condition the site presents an increased risk for failure at flows below the design capacity of the levee, therefore adaptive management is necessary to address the vulnerability at this location.

The existing condition of the project site is comprised of a steep and unstable armored levee slope devoid of riparian vegetation where existing RSP boulders have been displaced along the toe of the slope undermining the stability of the levee. The proposed project will consist of placing approximately 205 cubic yards of 18-inch to 36-inch diameter RSP along the base of 115-linear feet of existing RSP within the inner levee slope. The purpose of the new RSP is to rebuild the toe of the levee slope to anchor the existing RSP and to create a more stable slope angle. The stabilization of the levee slope at this location will provide an opportunity to also restore the riparian buffer by incorporating vegetation within RSP voids.

**Photo 8.** View looking down from the top of the south levee at the breach site repair instability just west of the UPRR (April 3, 2024).

The proposed design incorporates filling RSP voids with topsoil to support vegetation regrowth. Following construction of the repair, the District intends to plant native riparian species using the list of appropriate species discussed in the Revegetation section of this Annual Work Plan. This includes installing container stock, hydroseeding, and installing cottonwood stakes between RSP voids to establish riparian vegetation. The vegetated RSP is expected to restore the ecological value provided by the riparian buffer throughout the WMP that was lost at this location as a result of the levee breach.

Construction of the proposed project would be conducted by equipment operating from the top of the levee, and is anticipated to last 8 working days and is proposed to occur from October 22nd through October 31st, 2025. Stream diversion and dewatering to temporarily dewater the channel during construction is anticipated to be necessary based on current conditions. A proposed project plan set and stream diversion and dewatering plan will be provided for your review and to support ongoing permit compliance correspondence. This project will be further detailed in a secondary 2025 work plan to be provided on or before August 1st, 2025 that reflects appropriate permit authorizations.
