April 9, 2026
Rincon Project No: 24-17044

**Subject: Arroyo Grande Creek Channel Waterway Management Program
2026 Annual Vegetation Management and Sediment Removal Work Plan**

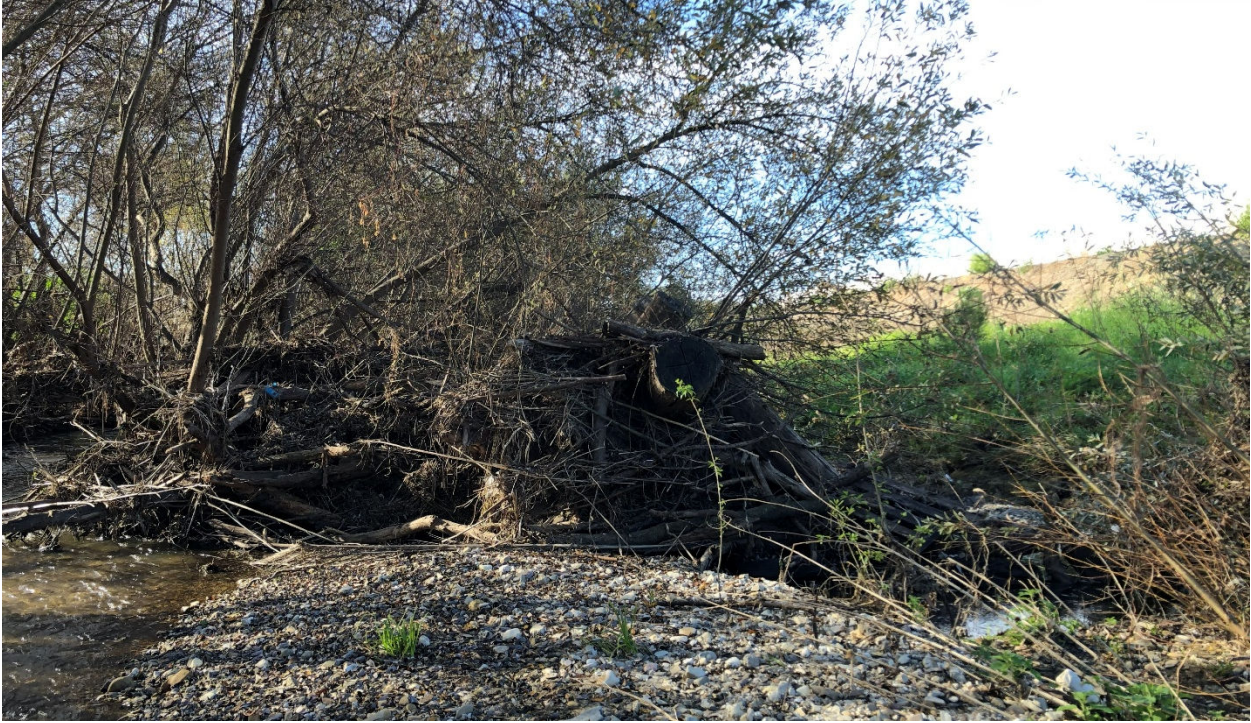
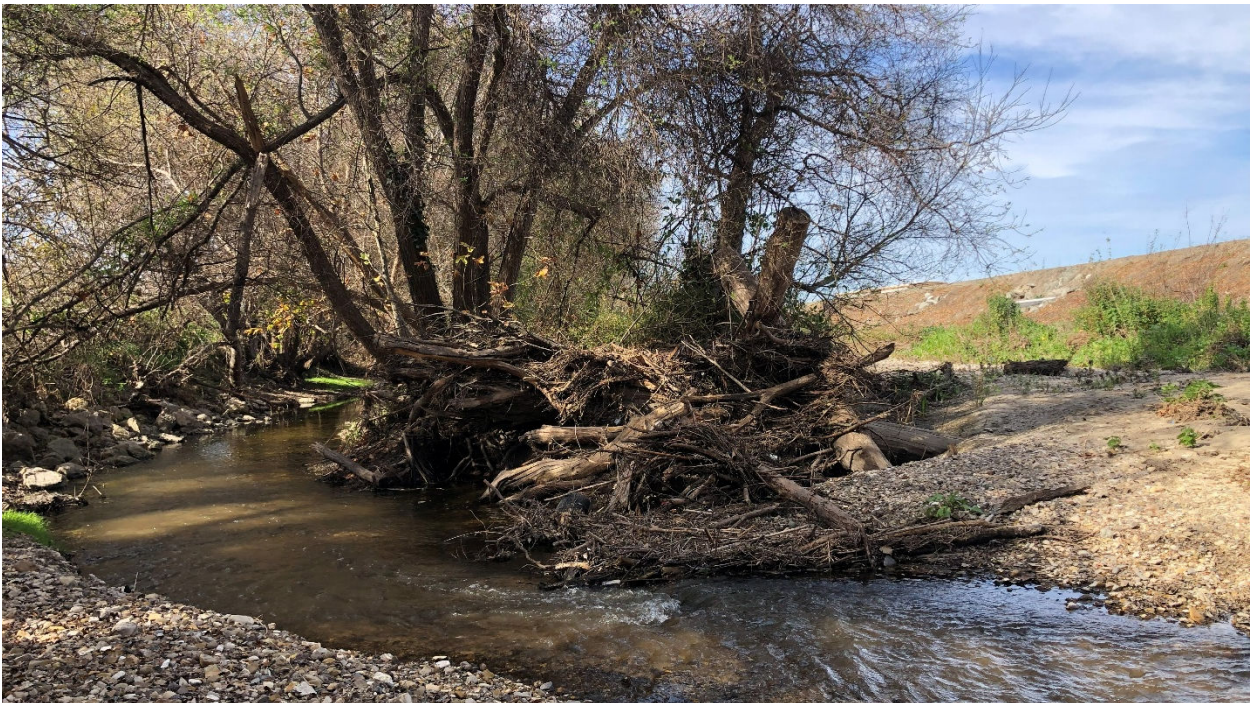
Photos 1 and 2. Many Type A log structures are heavily laden with woody debris but remain intact and functional. Commonly observed instream habitat included small scour pools at the base of Type A structures. Woody debris on log structures will be removed where it is identified as reducing channel capacity.

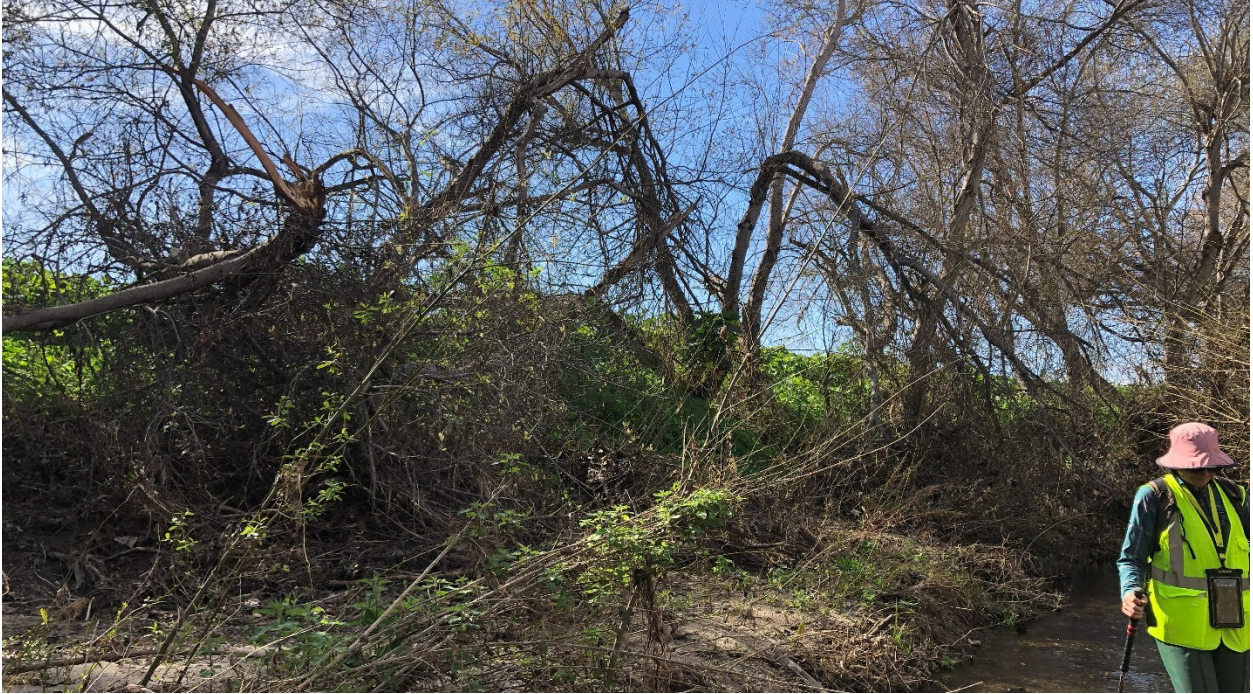
Photo 3. Over-mature arroyo willow trees are prone to branch failure, broken tops, etc. Hazard trees will be identified, prioritized, and proactively removed to help prevent incorporation of these branches into the instream large wood and debris load.

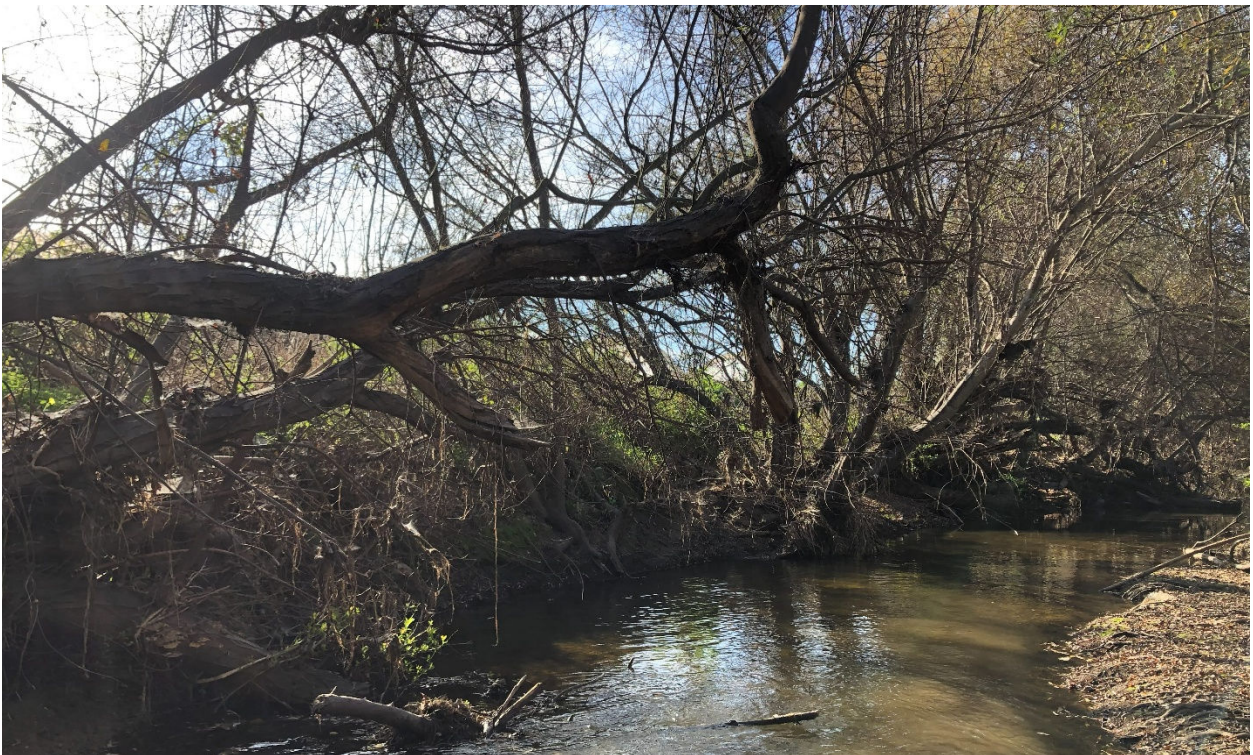
Photo 4. Overhanging branches and dense woody vegetation have the potential to trap large wood and other debris during high flow events. Vegetation will be removed in compliance with permit requirements.

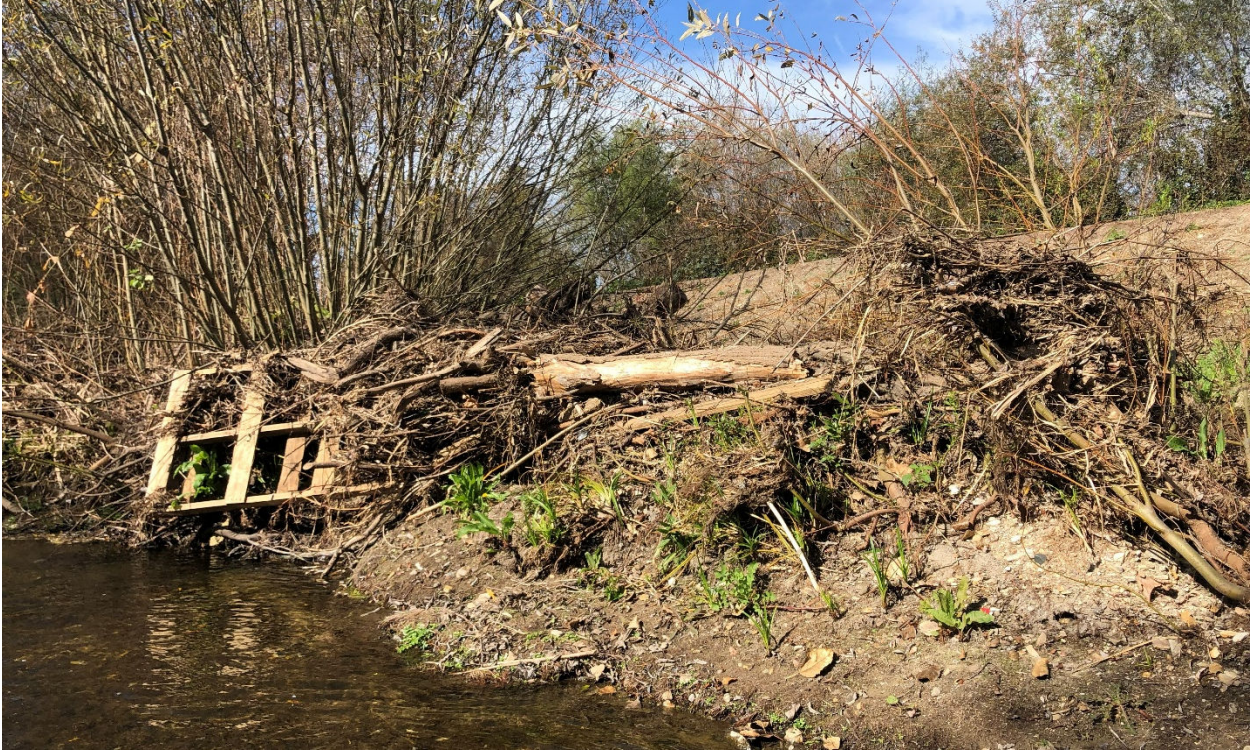
Photo 5. Large debris jams reduce channel capacity and can cause damage to live vegetation. Debris jams are more labor-intensive and costly to remove as compared to branches within the riparian canopy.

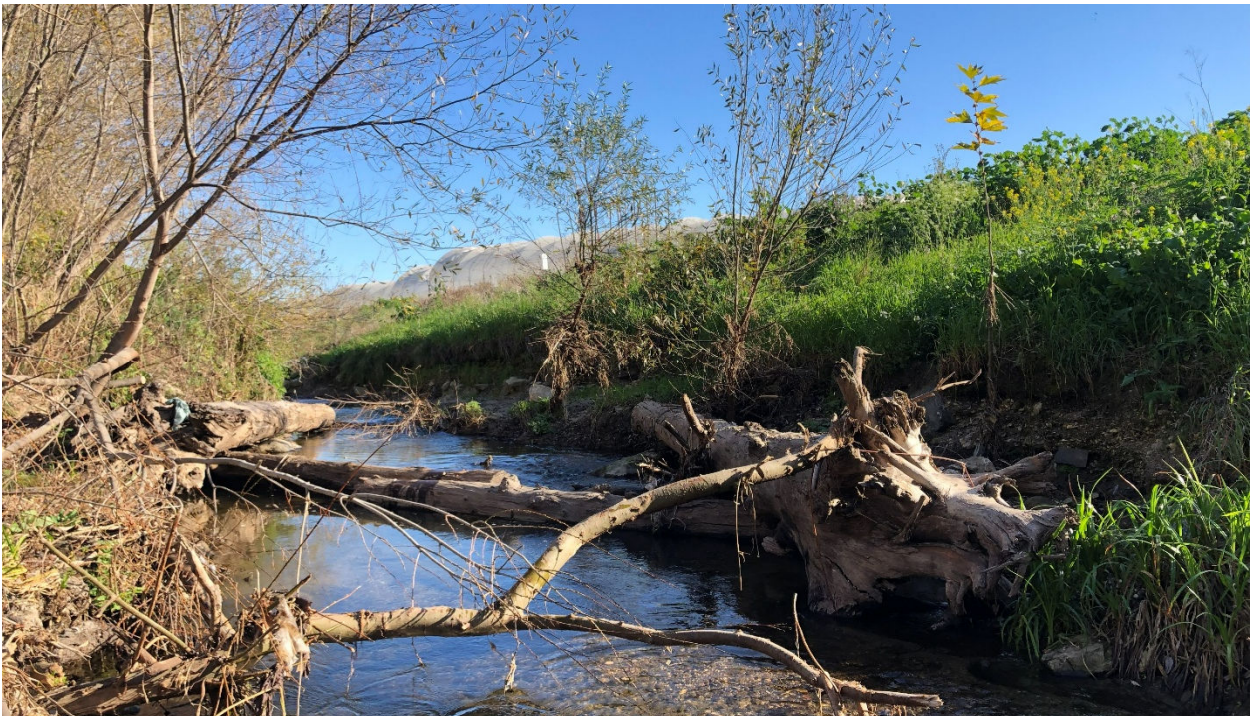
Photo 6. Existing California sycamore seedling growing adjacent to a Type B log structure will provide increased stability and instream habitat improvements at maturity. Additional locations will be identified for tree plantings adjacent to Type B structures.
