Salinas Reservoir

Water Quality Monitoring Report

Water Year 2024 (October 2023 – September 2024)

San Luis Obispo County
Flood Control and
Water Conservation District

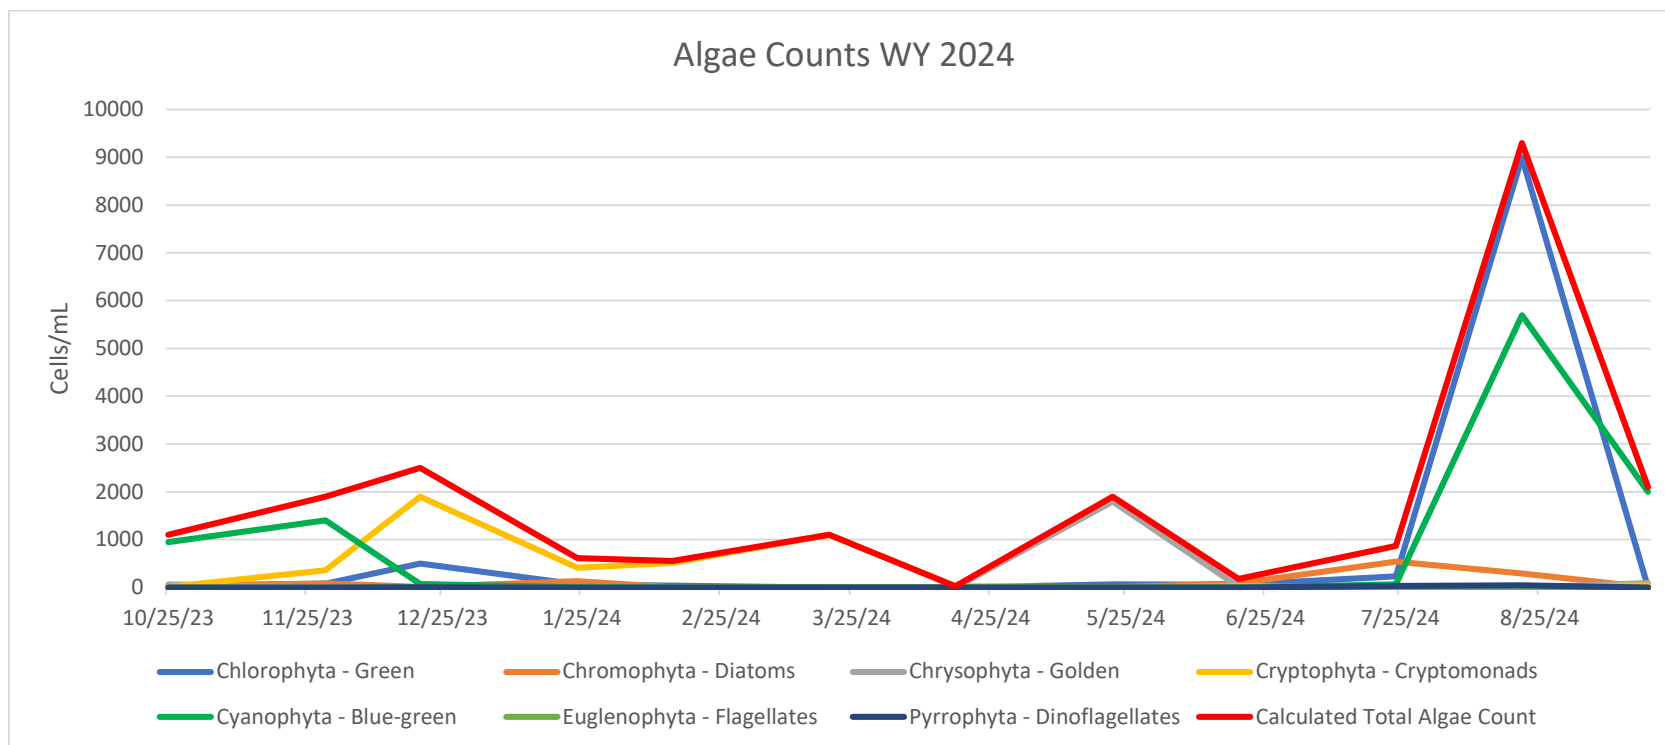
8.3 Algae Data at Intake in Use

Algae counts vary from year to year and often have a spike in the warmer summer/fall months. For example, the total algae count in August 2024 spiked at 9,300 cells/mL including 5,700 cells/mL of blue-green algae. Total alga counts reached a minimum in April 2024 with 29 cells/mL.
