# **Salinas Reservoir**

## **Water Quality Monitoring Report**

### **Water Year 2025 (October 2024 – September 2025)**

San Luis Obispo County  
Flood Control and  
Water Conservation District

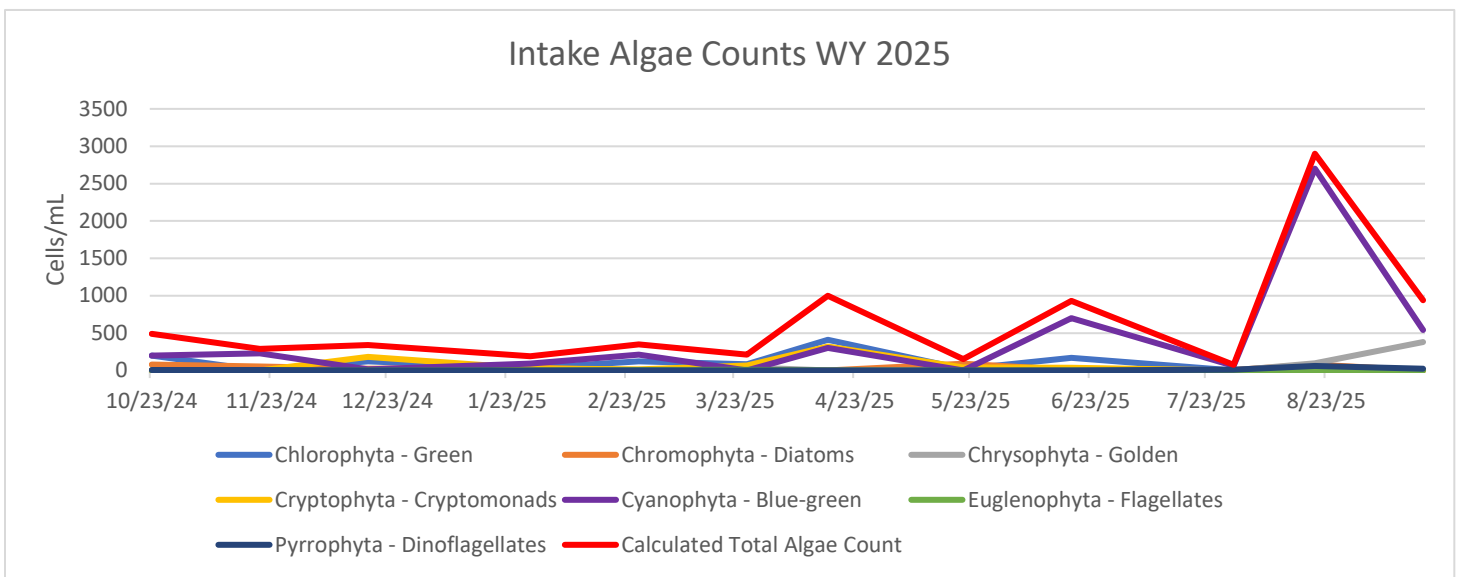
Figure 5: Algae Counts at Intake

The WQL monitors and identifies seven major algal groups: cyanobacteria (blue-green algae), cryptomonads, diatoms, dinoflagellates, flagellates, golden algae, and green algae. Identification at the genus level helps assess their potential impacts on water quality. Common taxa observed in SALR include *Raphidiopsis raciborskii* (formerly *Cylindrospermopsis raciborskii*), *Oscillatoria*, as well as various cryptomonads and diatoms.

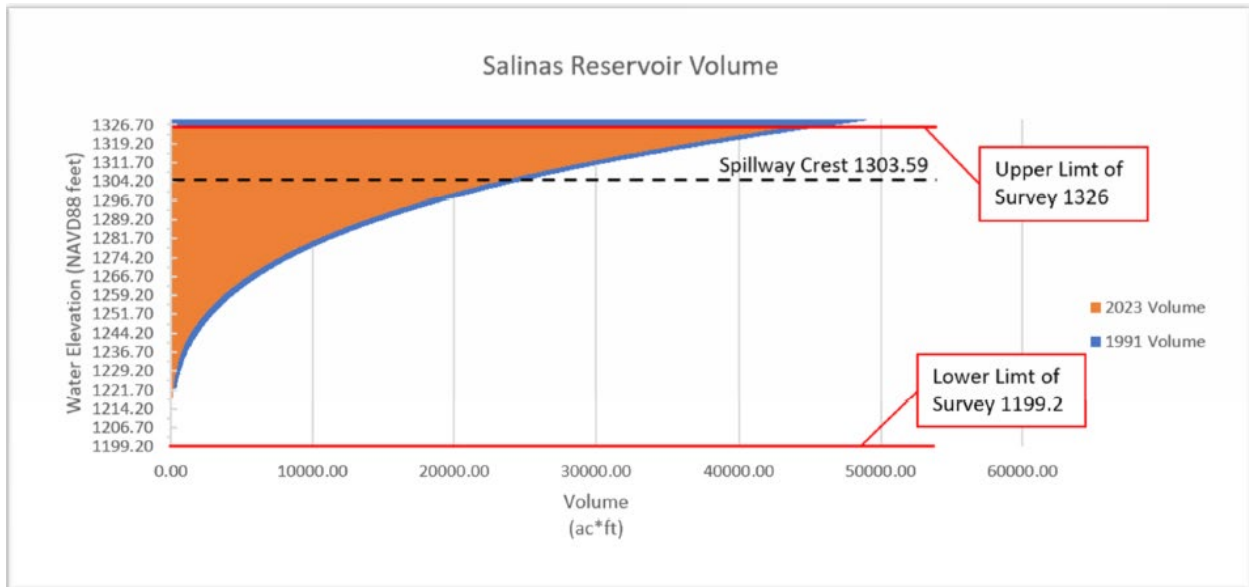
Figure 10: Cumulative Reservoir Capacity (Reese, 2024)

The original 1941 capacity curves for Salinas Reservoir did not account for storage below the lowest dam intake elevation of 1222.85 feet. Although later surveys identified the true reservoir floor at 1199.2 feet, this additional depth contributes little to overall capacity since pumping ceases below the intake level.

The findings of the report indicate SALR has lost 1,522 acre-ft since 1991 with a relative mean siltation rate of 0.19% per year. Thus, the revised total calculated capacity of SALR is 22,320 acre-ft. Comparative analysis indicates that SALR experiences roughly twice the relative siltation rate of Lopez Reservoir, despite similar annual sediment deposition volumes. This difference is attributed to variations in watershed size, geology, reservoir geometry, and climate, with Salinas' broad, shallow morphology and warmer conditions promoting greater organic accumulation and self-siltation. Figure 10 illustrates trends in capacity reductions.

A bathymetric survey completed in 2025, using depth data collected in 2023 when the reservoir was at full capacity, indicated a capacity loss of 1,590 acre-feet over the past 32 years. Additional details are provided in the Bathymetric Survey section.
