*Lopez Lake and Lopez Terminal
Watershed Sanitary Survey
Five-Year Update (2021-2025)*

Prepared By:
County of San Luis Obispo
Department of Public Works
Water Quality Division

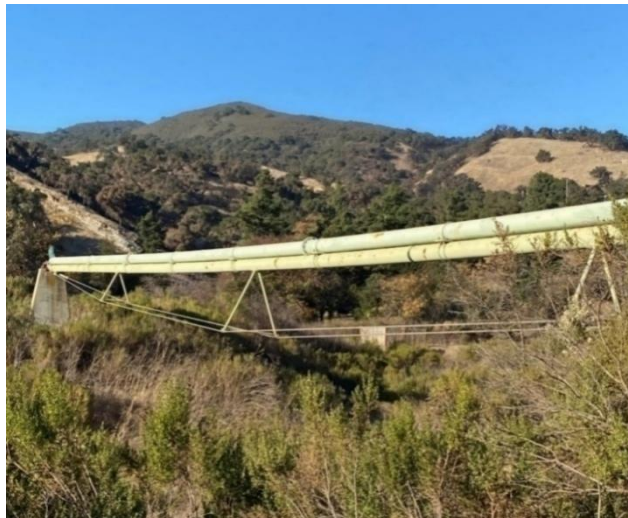
Figure 6: Wittenberg Crossing

The wastewater plant has a pipe crossing that crosses over the Wittenberg arm. Quarterly, the crossing and all four wastewater percolation ponds are inspected by District Staff (Figures 6-8). The ponds are located on the back side of Lopez Lake, across from Wittenberg Creek Arm.

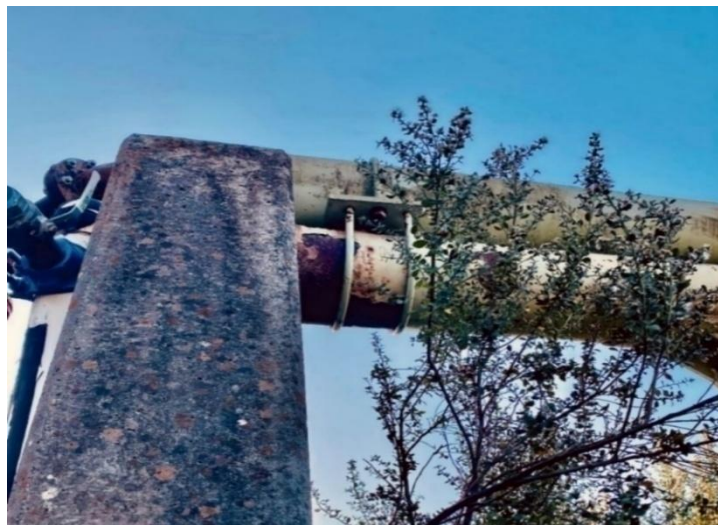
Figure 8: Sewer Force Main Wear or Corrosion

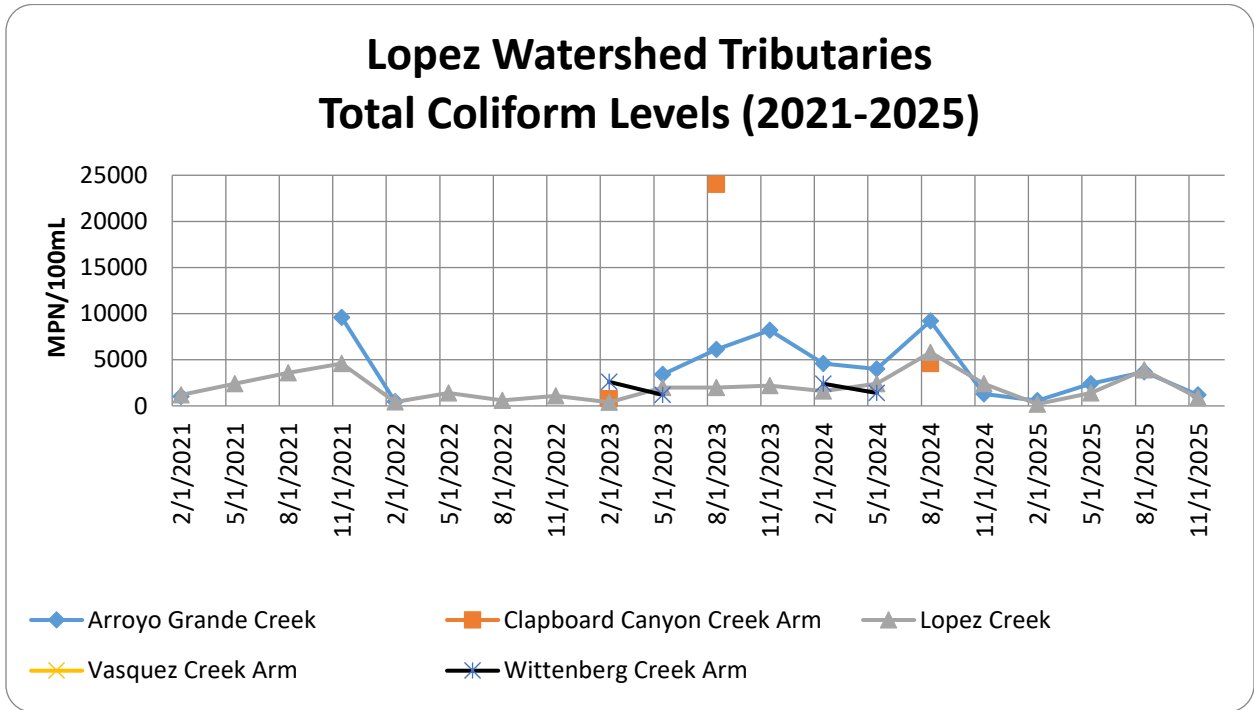
While wildlife, grazing animals, and agricultural activity have been observed upstream of the sampling locations in all the monitored creeks, Arroyo Grande Creek is believed to have the greatest number of grazing animals and the most agricultural activity.

During the period covered by this survey update, coliform and *E. coli* levels seem to vary with the time of year. However, Arroyo Grande Creek seems to be holding steady from one year to the next, which may have to do with drought conditions. Monitoring of the creeks for pathogens or pathogen indicator species should continue, as wild and domestic animals can be significant sources of microbial pathogens like *Giardia* and *Cryptosporidium*.

Figure 12: Comparison of Total Coliform levels between Lopez Lake tributaries

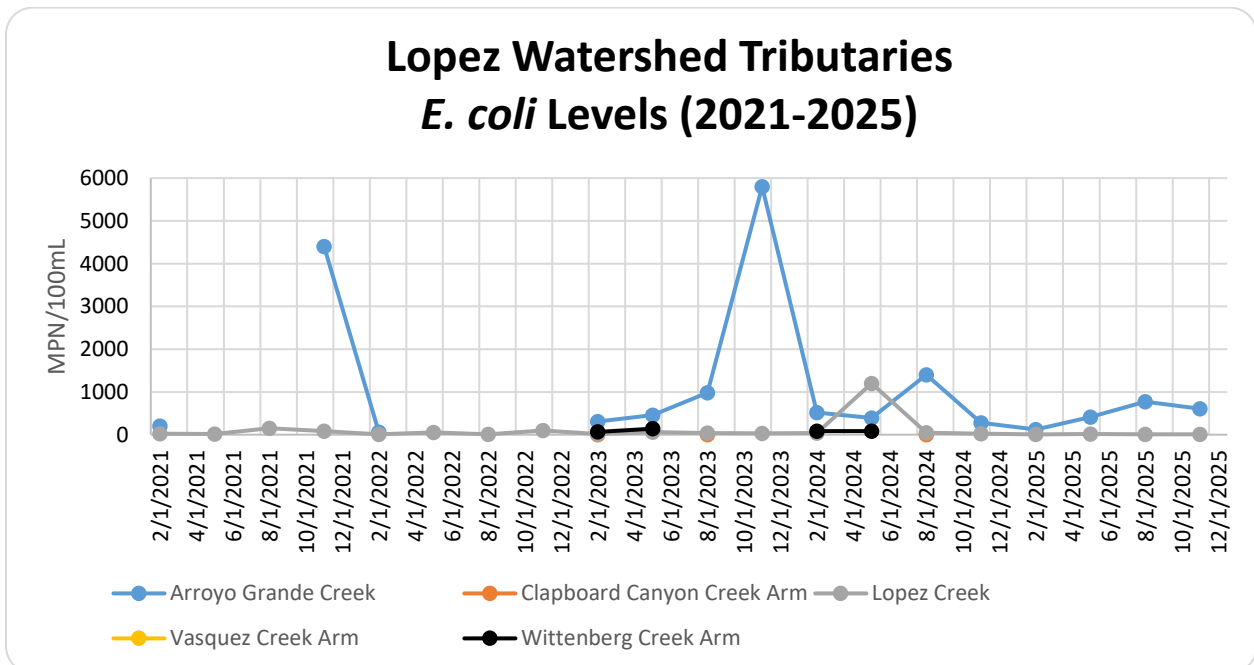
Figure 13: Comparison of *E. coli* levels between Lopez Lake tributaries

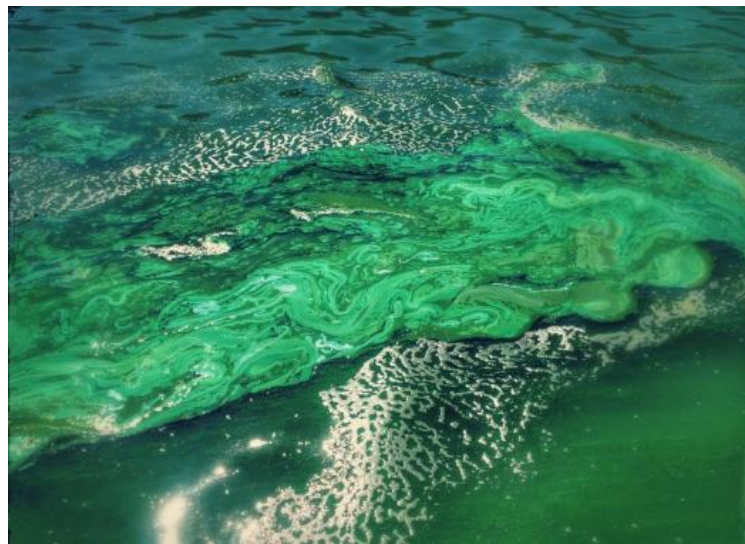
Figure 21: Blue-green Algal Bloom at Lopez Lake (Section H)

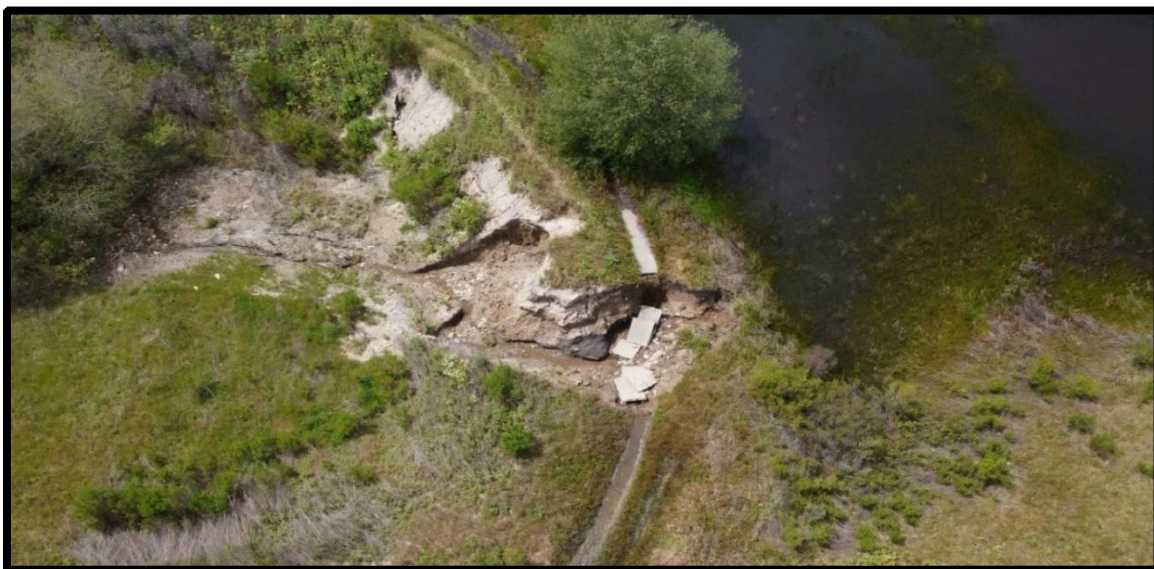
Figure 22: Perimeter Channel Breach on North Side of Terminal Reservoir

The perimeter channel repairs required coordination with the Department of Water Resources, because the State Water Project pipeline runs under and adjacent to the repair site. The repair was completed in the fall of 2024 after resolving DWR concerns about potential impacts from repair activities to the State Water Project pipeline.

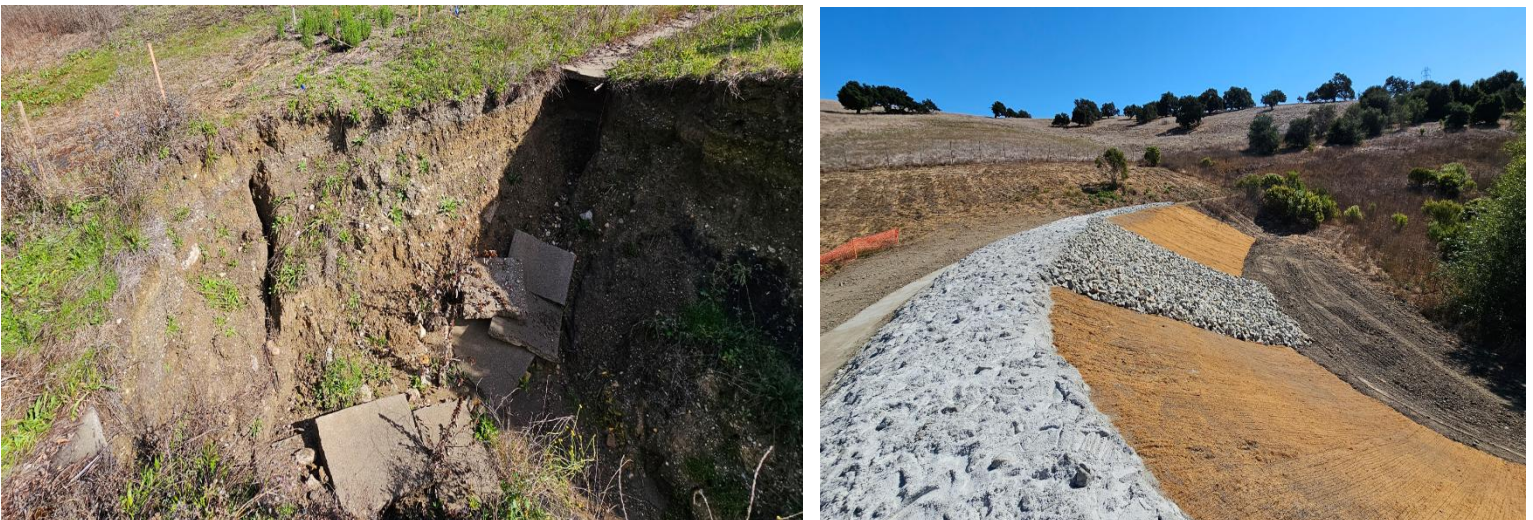
Figure 24: Perimeter Channel Breach Before Repairs vs Perimeter Channel After Repaired

A perimeter channel breach can also affect a system's risk category under the Surface Water Treatment Rule by altering the quality and stability of source water delivered to the LWTP. A breach may allow uncontrolled runoff, sediment, and debris to enter the conveyance system, increasing vulnerability to waterborne pathogens and potentially requiring additional treatment. It is critical to make repairs to a channel breach and reduce these risks. The repaired channel is shown in Figure 24.

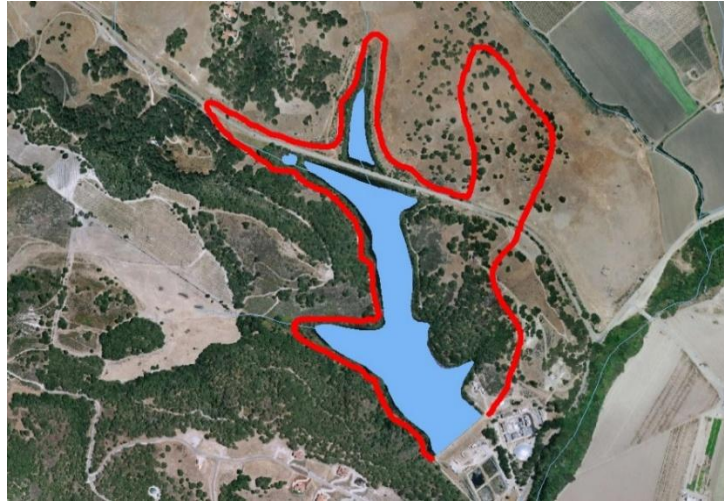
Figure 25: Lopez Terminal Reservoir Watershed Boundary

Figure 25 illustrates the Terminal Reservoir watershed. The red line represents the watershed boundary.

A small section at the northeast corner of the watershed, east of Orcutt Road, is not protected by the Perimeter Channel. Following sustained heavy rains, this section has the potential for draining onto Orcutt Road. Orcutt Road drainage continues to be a potential problem, with runoff making its way into the Terminal Reservoir.

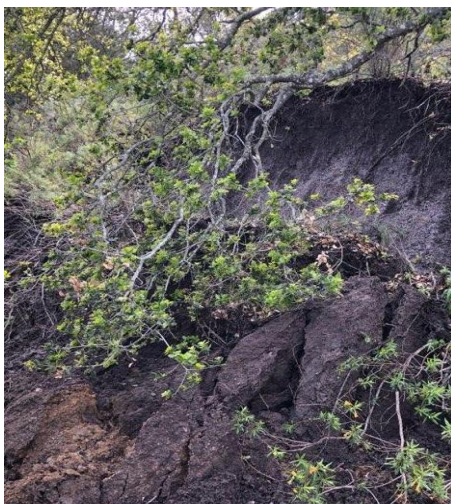
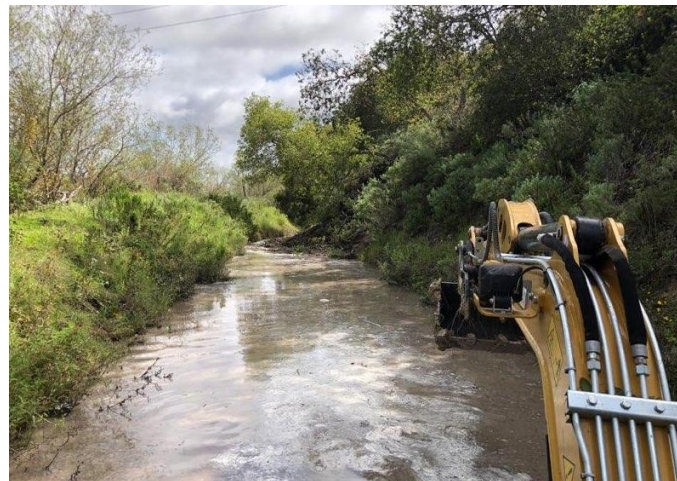
During the rain event, localized slope failures occurred along the south side of the diversion channel due to increased stormwater flows. There was no evidence of water overtopping or breaching into the terminal facility. Water Operations crews performed debris removal and channel stabilization activities to restore full conveyance capacity in advance of the next rainy season. See Figure 26 and 27 below.

Figure 26: Lopez Terminal Reservoir Diversion Channel Landslide damage

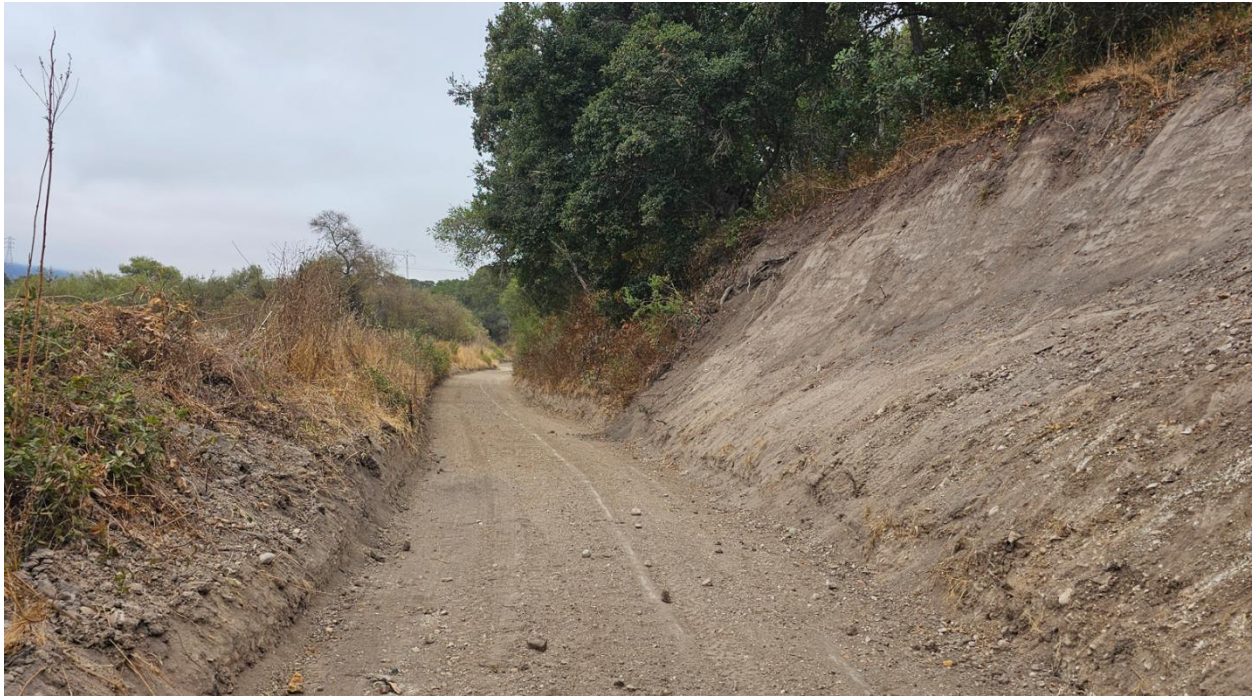
Figure 27: Diversion Channel repair

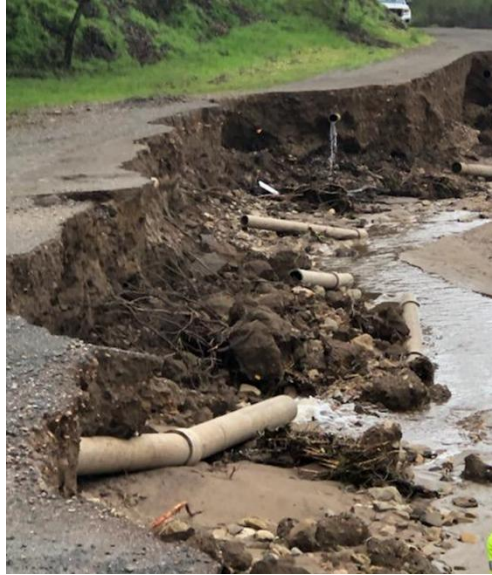
In January 2023, a force main at the Lopez Recreation Area carrying treated effluent collapsed, resulting in the release of approximately 168 gallons of treated wastewater into Lopez Lake. Road conditions and creek flooding made it difficult to fully assess the extent of the damage at the time. Boat-based sampling and drone monitoring were conducted to evaluate the affected area and confirm that the spill did not impact reservoir water quality. San Luis Obispo County Parks responded promptly, repairing the damaged pipe and rerouting it beneath the road to help prevent a similar failure in the future. See Figure 28.

Figure 28: Lopez Lake Treated Effluent Line Break

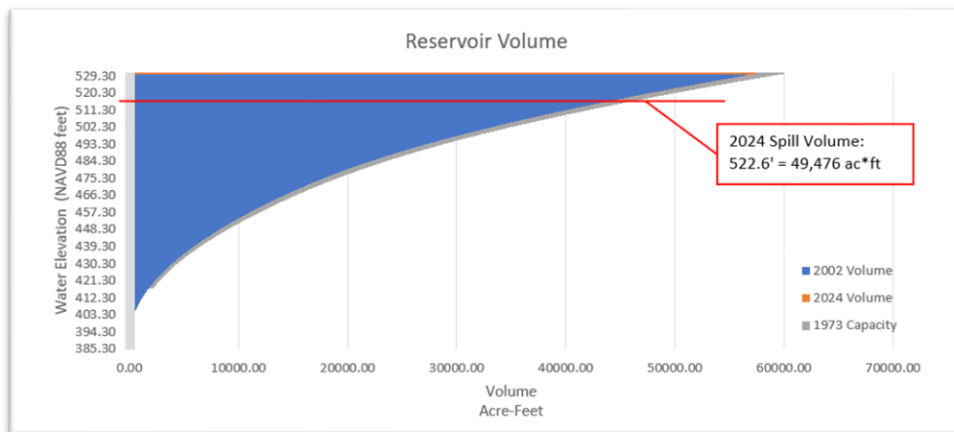
Although differences in the technologies used for the 1973, 2002, and 2023 models partially obscure the comparison, Figure 28 suggests that the period from 2002 to 2024 departs from the reservoir’s typical siltation patterns. The comparison curve shows a less consistent slope, indicating relatively minor sediment accumulation. This likely reflects reduced sedimentation rates during drought conditions compared to non-drought periods. Because the reservoir did not spill between 2002 and 2023, spill events provide a useful benchmark for distinguishing typical from atypical conditions when evaluating the reservoir.

Figure 30: Cumulative Reservoir Capacity from 1973,2002 and 2024 (Reese, 2024)

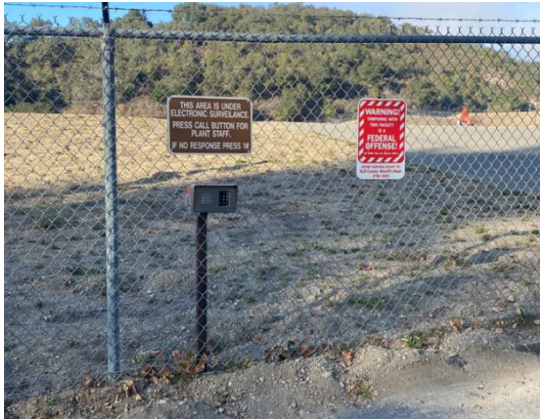
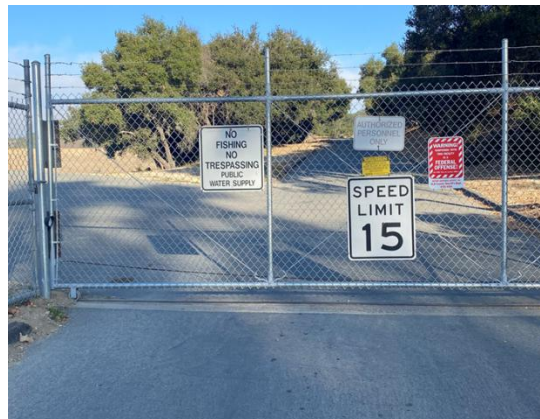
Access to the treatment facility is controlled through a locked, passcode-protected gate that is monitored during regular working hours, and all visitors are required to check in at the office upon arrival. Entry through adjacent private property is strictly prohibited. The most visible areas of the Terminal Reservoir watershed are secured with chain-link fencing topped with barbed wire, while the remaining perimeter is enclosed with barbed wire fencing. Although fencing alone cannot prevent access by a determined intruder, extending the chain-link fencing with barbed wire around the watershed has significantly reduced casual trespassing. In addition, the District provides on-site housing for two Water Treatment Plant employees, which enhances watershed security during non-working hours.

Figure 31: Key Pad coded lock to get into Lopez Terminal and WTP

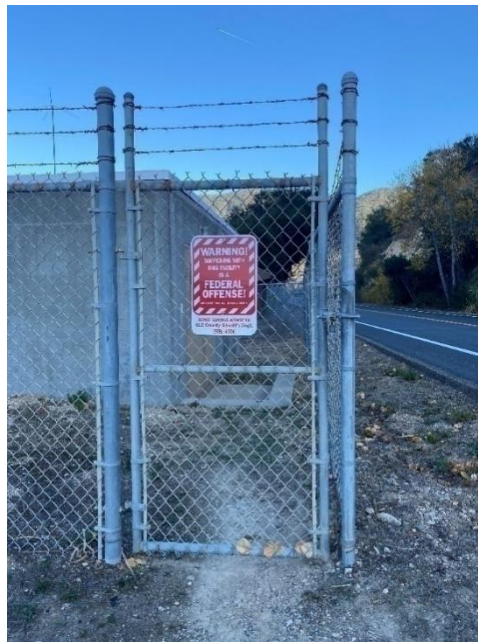
Security at a lake intake building is critical to protect both water quality and the infrastructure that delivers safe drinking water. Unauthorized access or tampering could introduce contaminants, damage equipment, or disrupt water delivery, posing risks to public health. Maintaining controlled access, fencing, surveillance, and on-site personnel helps prevent vandalism and trespassing, ensuring that the intake operates reliably and the water supply remains safe for the community. See figure 32.

Figure 32: Locked gate at Intake structure.

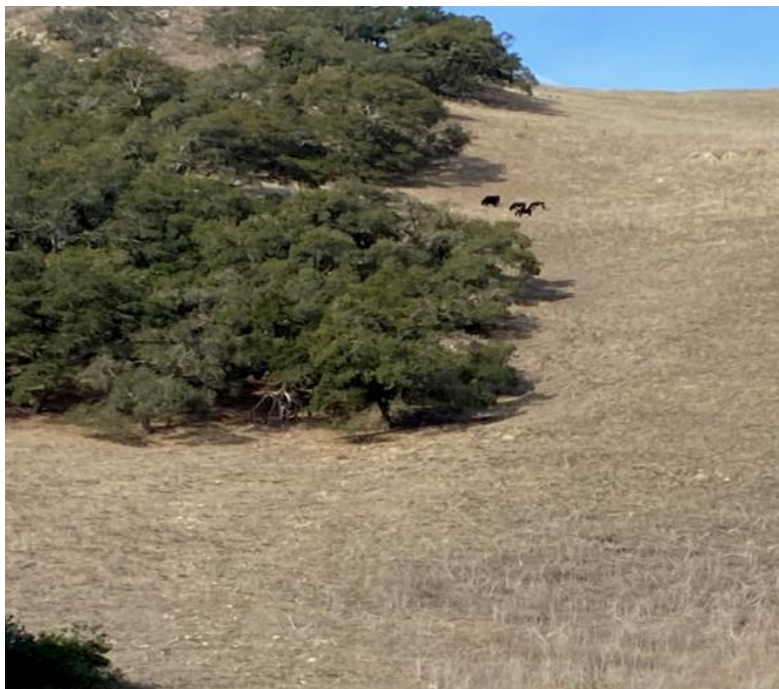
Figure 33: Cattle on hillside near Sections F and G

Several deer and bear can be found along the edge of the lake throughout the year in these sections. Sections E, F, and G, are the most popular for recreational vessels and water skiers. Occasionally cattle from a nearby ranch are found near the water's edge in section F (Figure 33). These areas tend to be very windy in the afternoon.

increasing the risk of harmful algal growth and contamination. This can make it more difficult for treatment plants to remove pathogens and impurities, requiring additional treatment and increasing operational costs. Preventing livestock access helps maintain cleaner source water, supporting safer, more efficient surface water treatment and a reliable drinking water supply

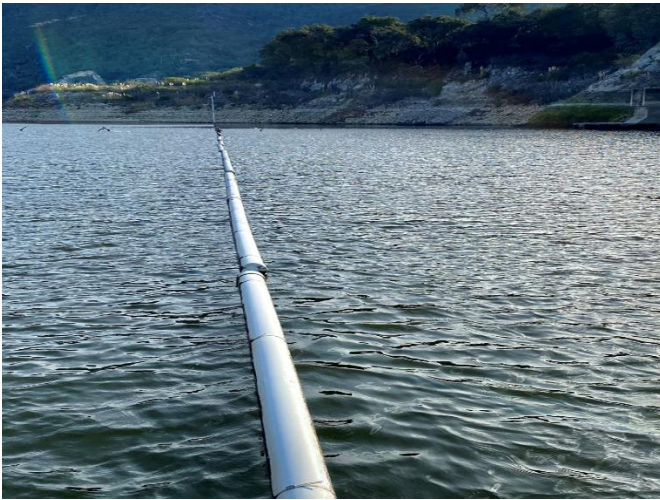
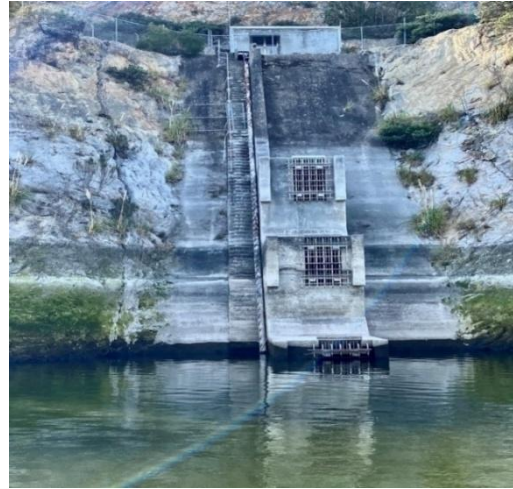
conduct regular field measurements on a weekly or monthly basis. Water samples are also collected weekly at both the Influent to Terminal and Influent to Plant points. A log boom is installed to protect the intake structure from recreational users and large debris. Figures 34 show the log boom and accumulated debris that could potentially interfere with water delivery or release, and a view of Lopez Lake's intake structure

Figure 34: Lopez Lake Log Boom and Intake Building

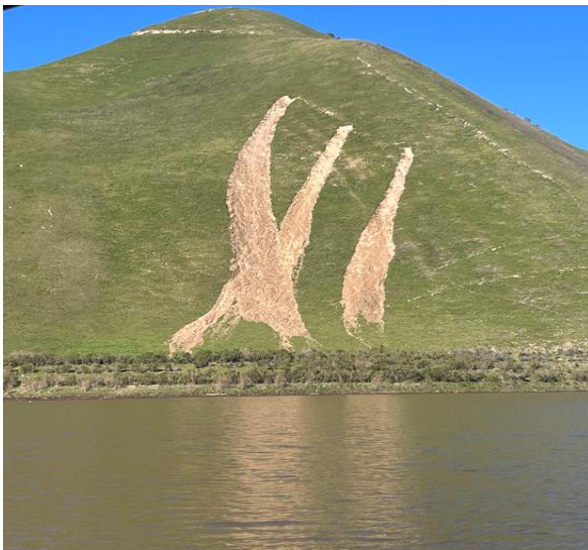
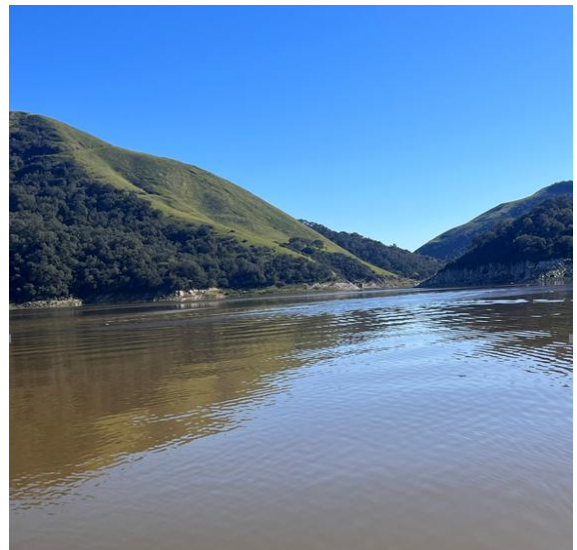
In 2023, heavy rains significantly impacted Lopez Lake by increasing inflows and raising water levels, as seen in Figure 35. The elevated runoff carried sediments and organic material into the reservoir, temporarily reducing water clarity and potentially increasing nutrient loads. Rising water levels also tested the reservoir's intake structures and spillway operations, requiring careful monitoring to maintain water quality and ensure safe water delivery downstream.

Figure 35: Lake inspection photos after the 2023 storms
