Whale Rock Reservoir

County Service Area (CSA) 10 - Cayucos

Watershed Sanitary Survey Five-Year Update (2021-2025)

Prepared By:
County of San Luis Obispo
Department of Public Works
Water Quality Division

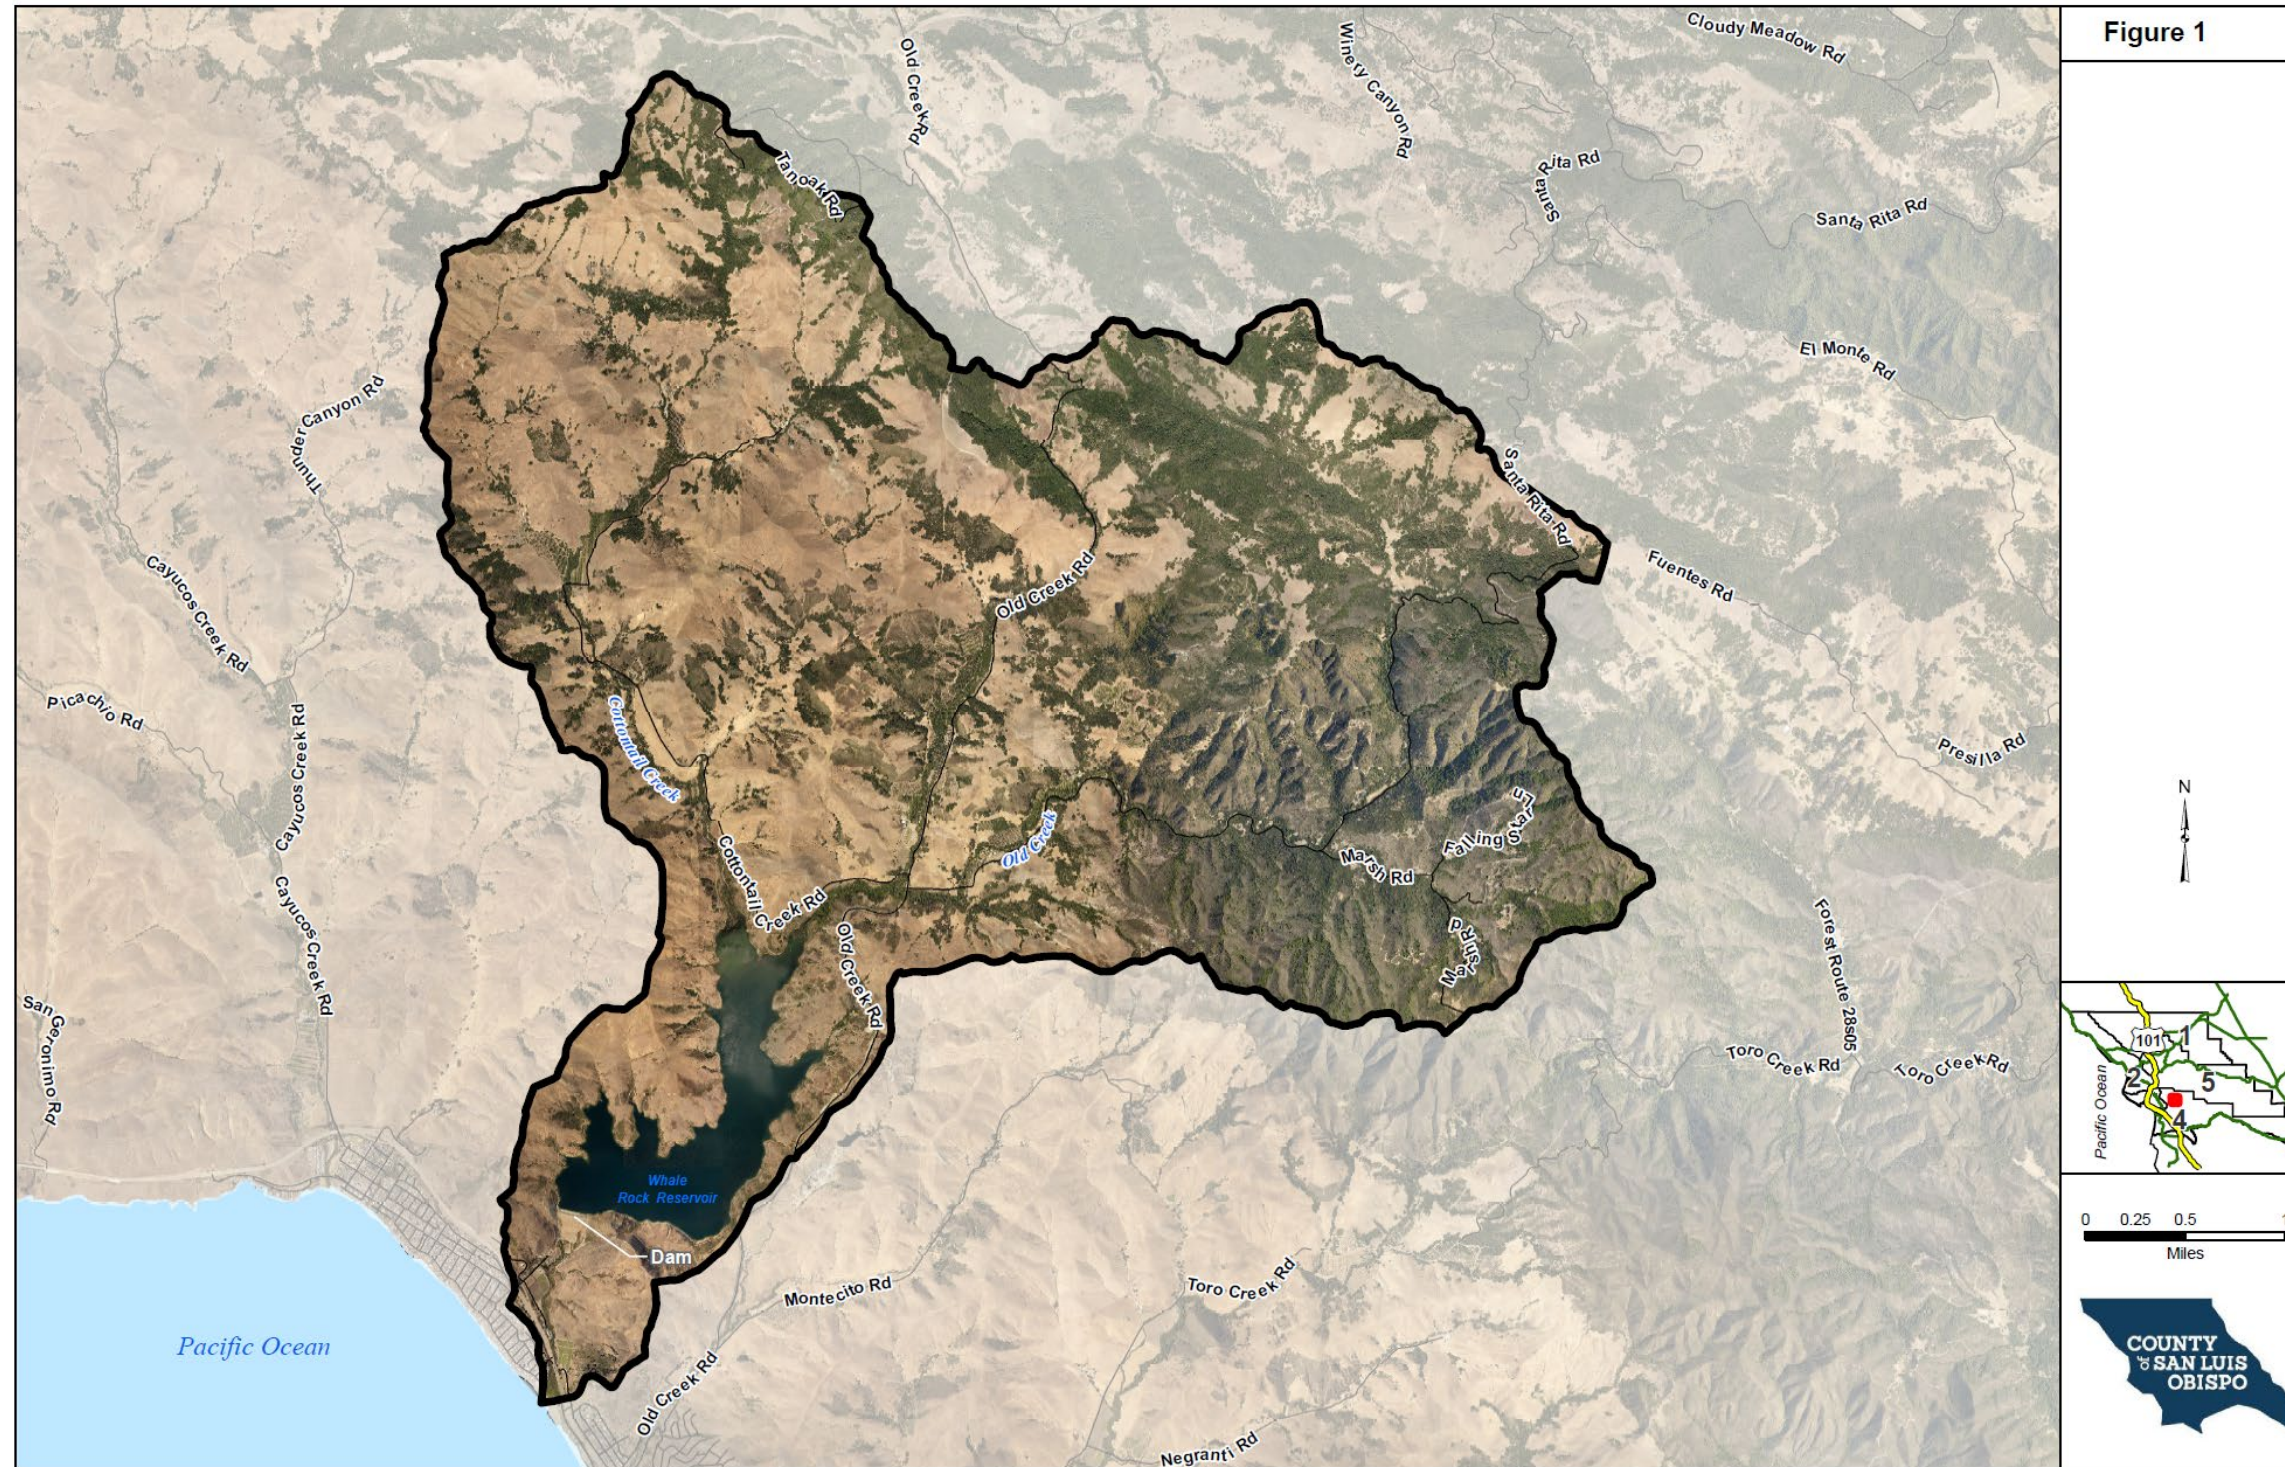
Figure 1

The Whale Rock Reservoir (see Figure 1) is located on Old Creek Road, about half a mile east of Cayucos. The State Department of Water Resources began planning, designing, and constructing the Whale Rock Dam in 1958, completing it in 1961 to supply water to the City, the California Men’s Colony, and California Polytechnic State University, San Luis Obispo. Together, these three agencies form the Whale Rock Commission.

The reservoir is part of the Old Creek Watershed, which spans approximately 13,000 acres (20.6 square miles) within the Santa Lucia Range and the County’s Planning Area (NOAA, 2013; SLO County, 2021). The watershed is physically bisected by the Whale Rock Dam, creating two distinct hydrological environments.

Figure 1: Whale Rock Reservoir Watershed)

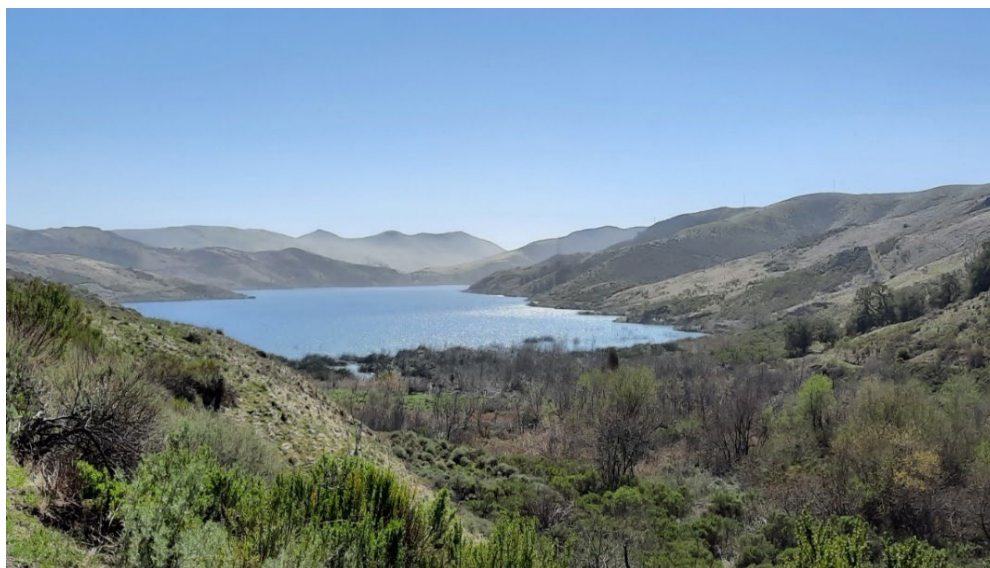
The area above the dam serves as the primary collection basin. The headwaters rise in the upper elevations approximately 5 miles northeast of the dam. Old Creek and its unnamed tributaries drain the east half of the watershed, while Cottontail Creek (see Figure 2) drains the west half.

Figure 2: Cottontail Creek entering Whale Rock Reservoir

Water quality data is lacking on the main inlets to the Whale Rock Reservoir, Cottontail and Old Creek. Coordination with the City and landowners in the area is needed to create a regular sampling schedule for the creeks; with physical, bacteriological, nutrient, and organic analyses recommended.

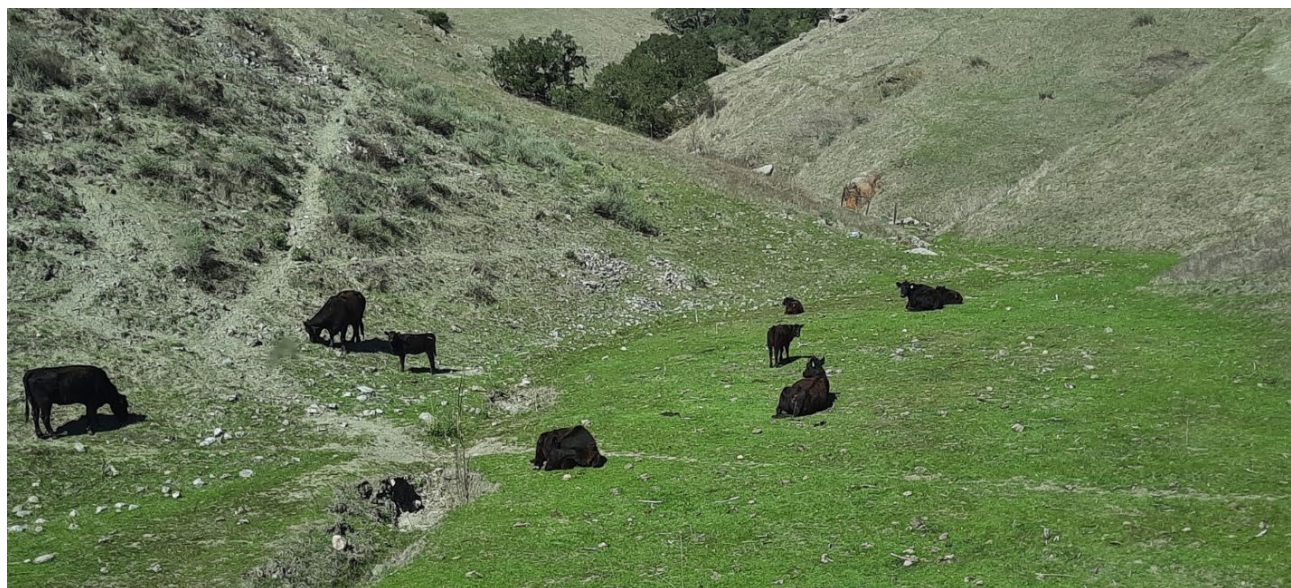
Cattle grazing occurs throughout the watershed (see Figure 3). However, fencing prevents direct access to the reservoir. Most grazing areas are further separated from the reservoir by public and private roads. Cattle grazing can significantly contribute to coliform levels; however, while total coliform levels are sometimes elevated seasonally, *Escherichia coli* (*E. coli*) levels in raw water have generally remained low. Higher rainfall correlates with increased coliform bacteria levels. See the [Bacteriology](#) section for further discussion.

Figure 3: Cattle grazing within the watershed.

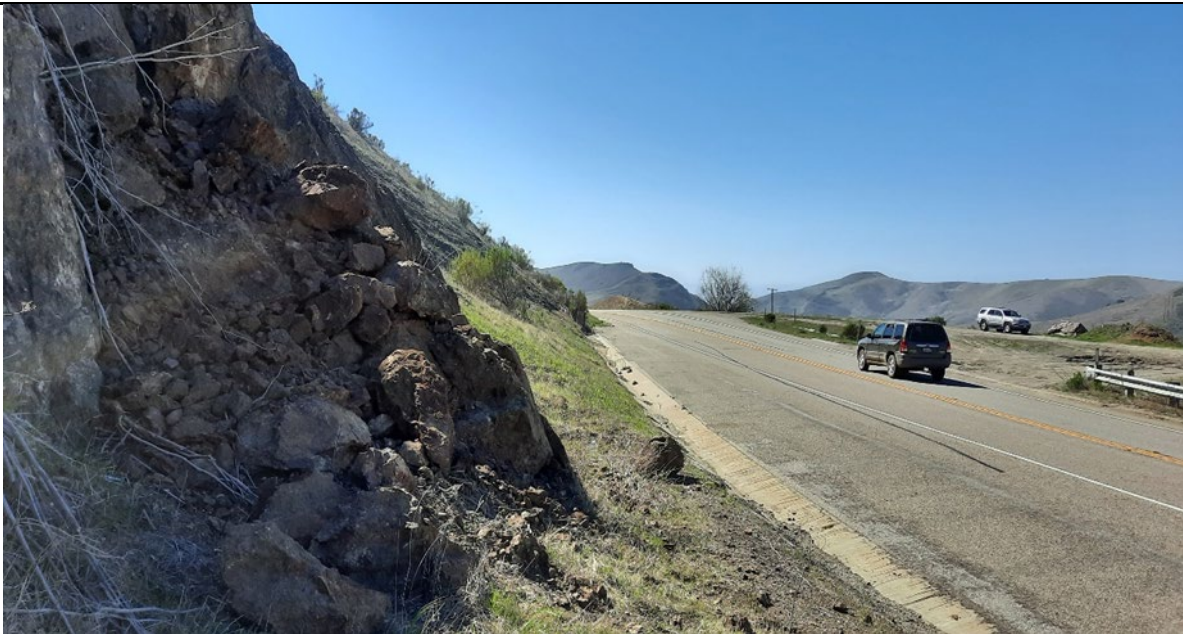
Transportation corridors in the Whale Rock watershed consist of several improved and unimproved County roads. The major roads include Old Creek Road, Santa Rita Road, and Cottontail Creek Road. During extreme precipitation events, severe erosion can occur in portions of these roads (see Figure 4). These roads are not considered primary routes for carrying hazardous materials. There are no railroad tracks present within the watershed.

Figure 4: Landslide on Old Creek Road

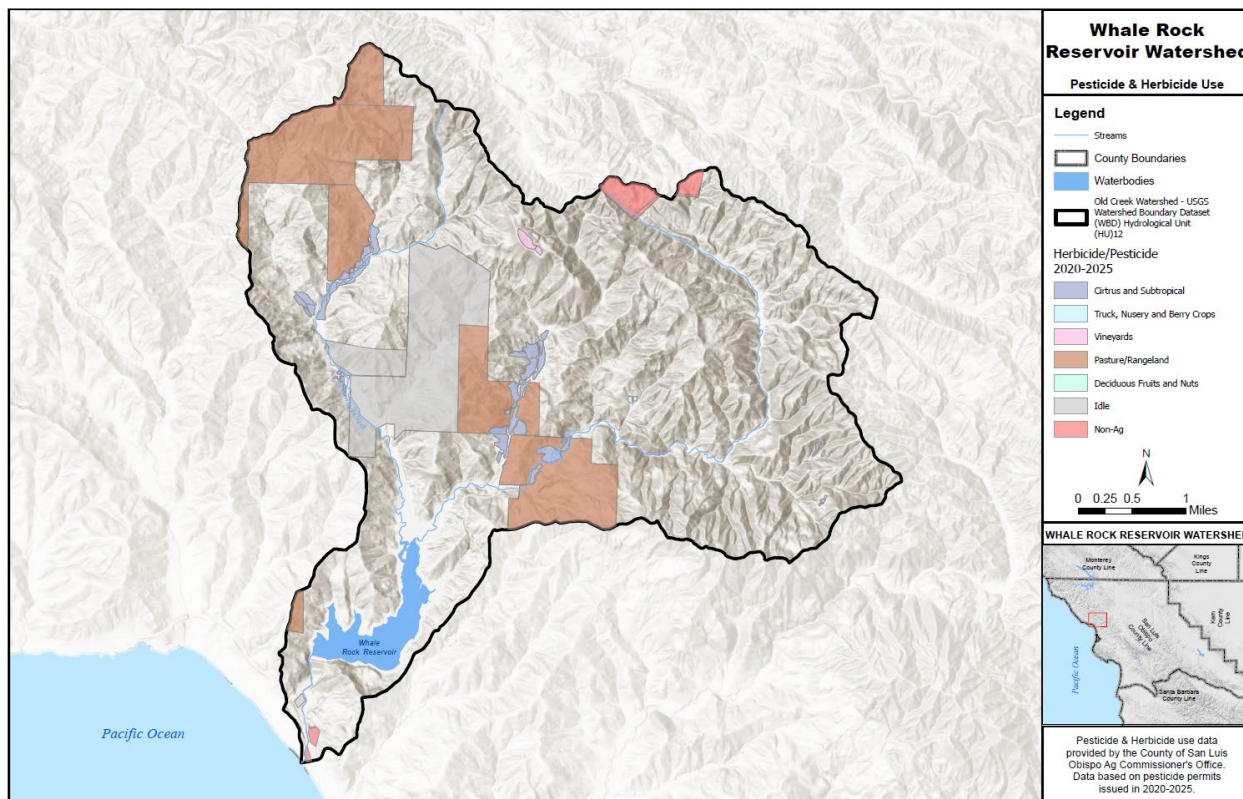
Pesticide and herbicide usage in the watershed is required to be reported to the County of San Luis Obispo Agriculture Commissioner’s Office. An annual summary of this usage can be seen in Table 2. On average, approximately 7.5% of the watershed was treated each year between 2021-2025. Figure 5 illustrates the areas and categories of land use that have been affected by pesticide and herbicide use. The impact of these chemicals on tributary water quality has not been fully evaluated; however, no pesticides or herbicides have been detected by the County in the Whale Rock Reservoir itself.

Figure 5: Pesticide and Herbicide Usage

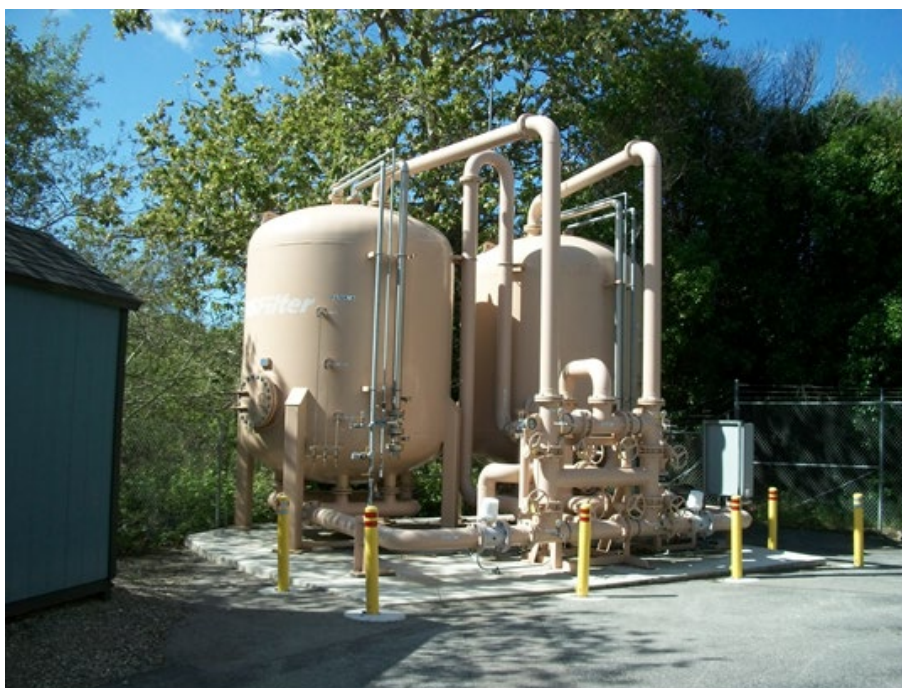
To ensure compliance with the Stage 1 Disinfectant/Disinfection Byproduct Rule) CWTP utilizes two 20,000-pound GAC filters (see Figure 6). The GAC filters provide TOC reduction and taste and odor control. CWTP monitors TTHMs and HAA5 quarterly for delivered water.

Figure 6: Granular Activated Carbon Filters

The CWTP and distribution system continue to operate in compliance with state and federal drinking water regulations, with no major operational issues during the study period. GAC filtration continues to effectively reduce TOC and control disinfection by-product formation (TTHMs and HAA5), while also maintaining taste and odor control. No taste or odor complaints were reported during this period, and no major system upgrades are currently scheduled or recommended.

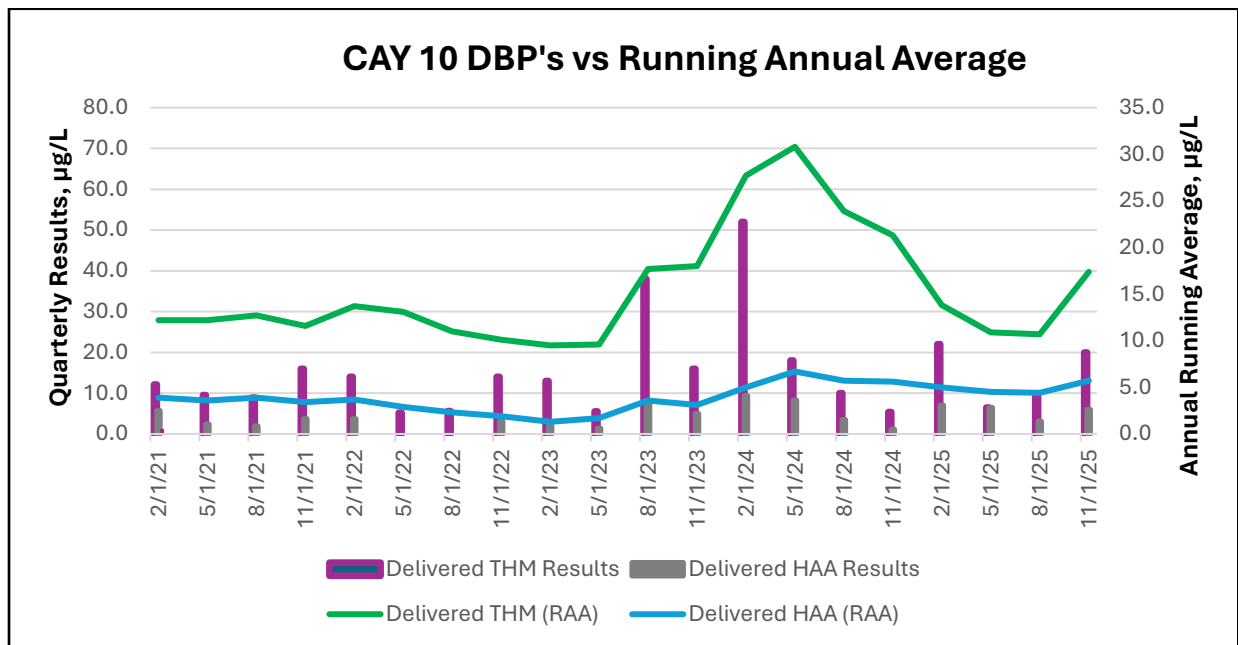
Compliance with the Stage 2 DBPR is based on TTHM and HAA5 locational running annual averages (LRAA) calculated at each monitoring site. All samples met the MCL requirements.

Quarterly monitoring is required and ongoing. DBP trends are shown in the following graph, Figure 7.

Figure 7: 2021 - 2025 TTHM/HAA5 Quarterly Results vs Running Annual Average

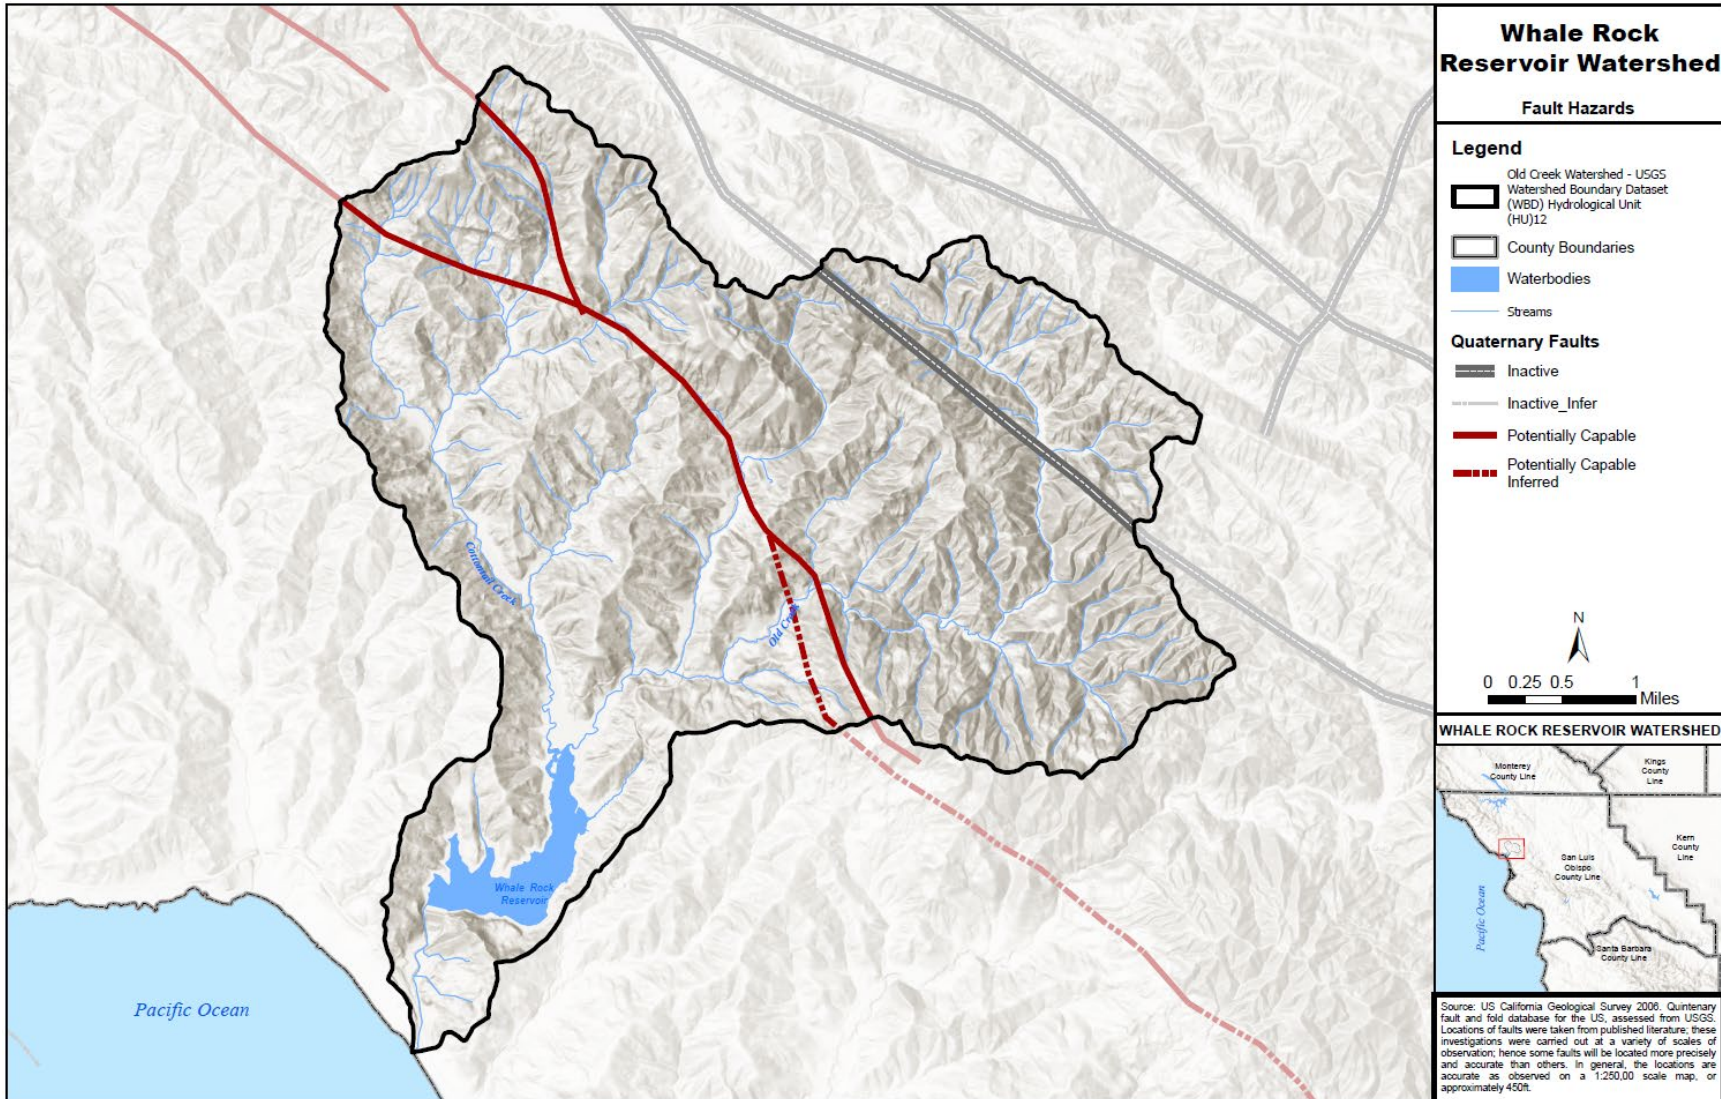
Appendix B: Fault Hazards

According to the United States Geological Survey, the watershed region is crossed by many active and potentially active earthquake faults as shown in Appendix B. Faults to the vicinity, such as the San Andreas Rift Zone on the east to the Hosgri and Santa Lucia Banks faults to the west, can cause severe ground motion within the watershed. Potential impacts to the watershed include damage to the water supply system.

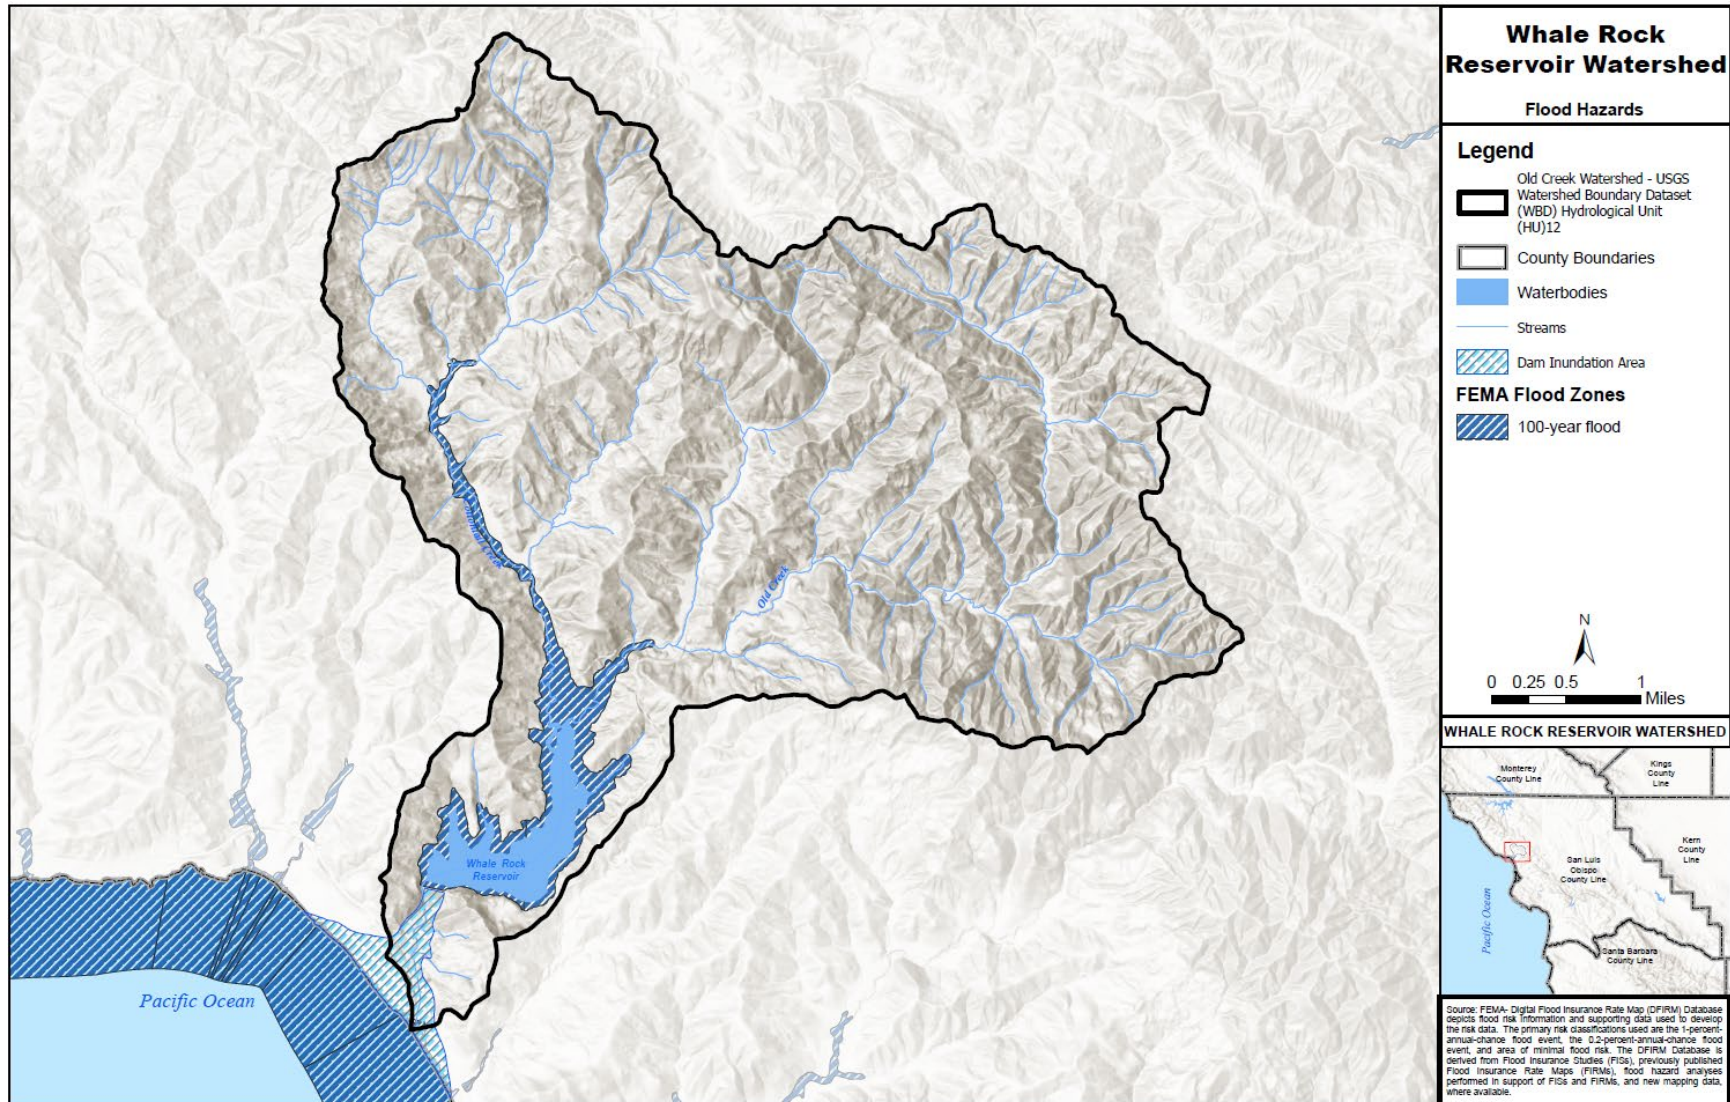
Appendix C: Watershed Planning Area Flood Map

Flood hazards exist for Old Creek, Cottontail Creek, and their tributaries during significant precipitation events. Floodplains occur in both steep, narrow stream channels and in flatter watershed areas where channels widen. Flooding can increase turbidity, suspended solids, chemical contamination, and disrupt raw water delivery. A failure of the Whale Rock Reservoir Dam could inundate the CWTP as shown in the maps in Appendix C, impairing its ability to produce potable water from primary and secondary sources. Due to its coastal location, the plant is also vulnerable to severe tsunami events.
