El Camino Real Bridge Replacement Project BA

Biological Assessment

El Camino Real at Santa Margarita Creek Bridge Replacement,
San Luis Obispo County, California

District 5
Existing Bridge No. 49C0310
BRLS-5949 (131)

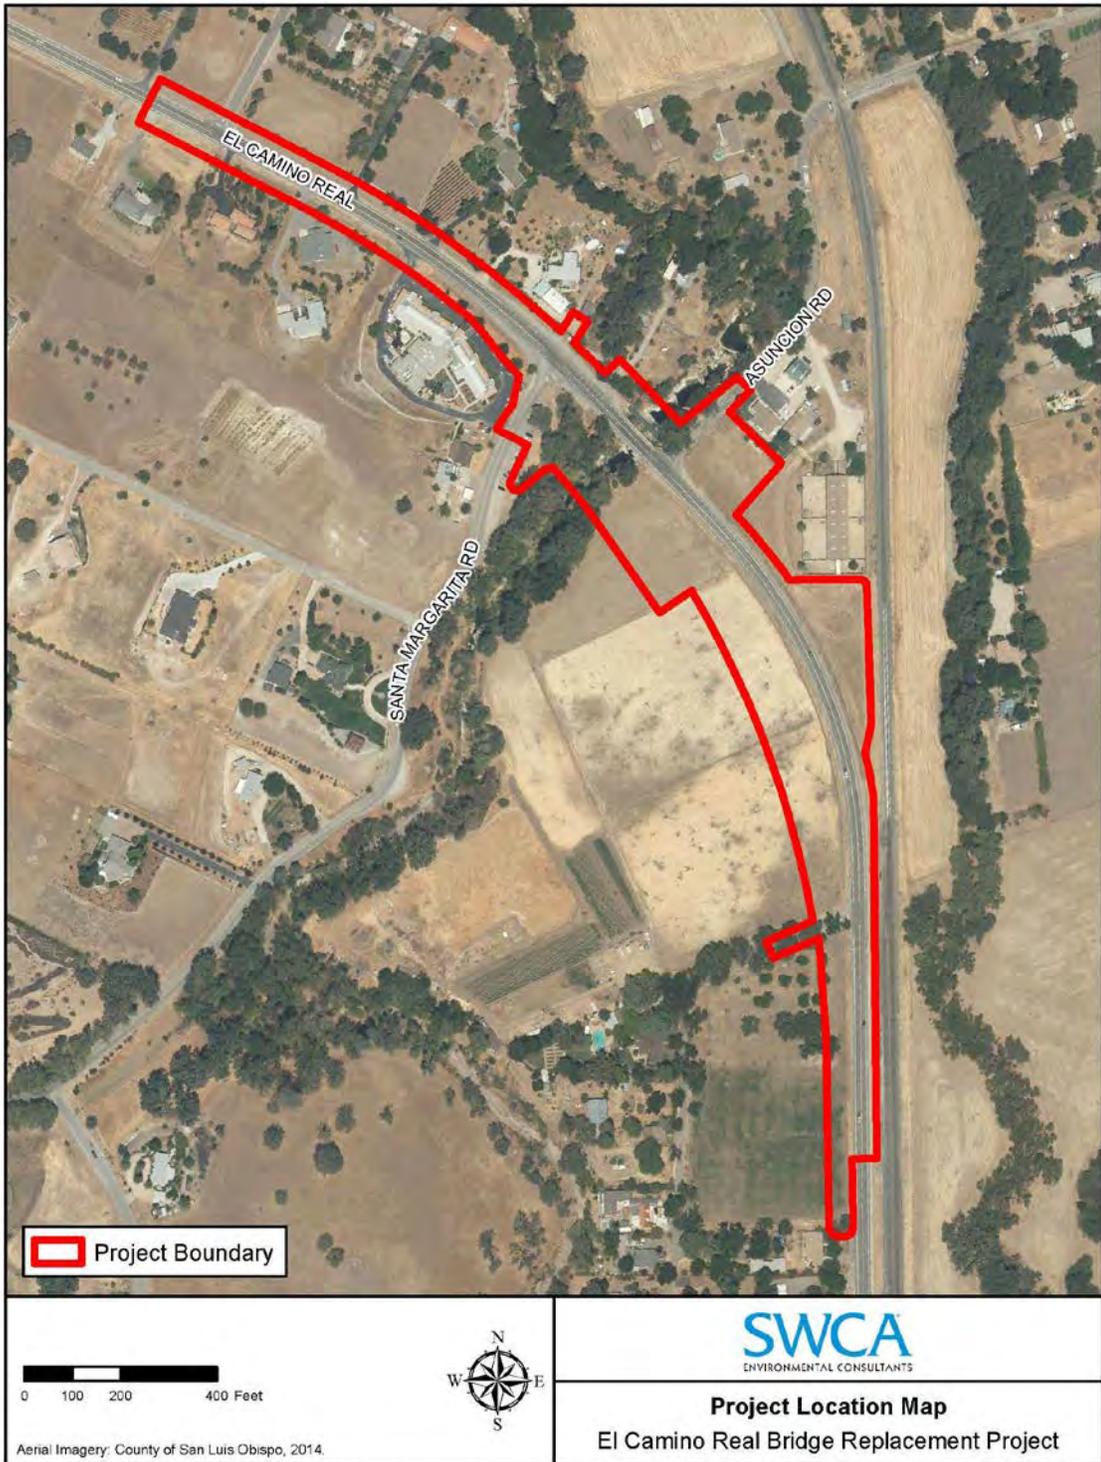
Figure 2: Project Location Map

For the purposes of this report, the BSA includes all areas that could be potentially impacted by the project, plus a buffer to accommodate any changes to the project limits and design that may occur during project development (refer to Figure 2). For the purposes of this report, the BSA includes an approximately 0.5-mile section of roadway along El Camino Real Road, between Santa Margarita Road and Asuncion Road. The BSA limits along the roadway are consistent with the County right-of-way (ROW), which is 100 feet wide along El Camino Real and includes portions of an agricultural parcel that would be acquired for the proposed curve correction. The BSA also includes areas beyond the County ROW at the bridge location and around intersections and driveways that connect with El Camino Real within the outer project limits. Adjacent parcels are owned by private farmers, a private convalescent hospital, and private residences. Biological observations within these portions of the BSA were made from the County ROW because permission to access these properties was not obtained or deemed necessary for the purposes of this study.

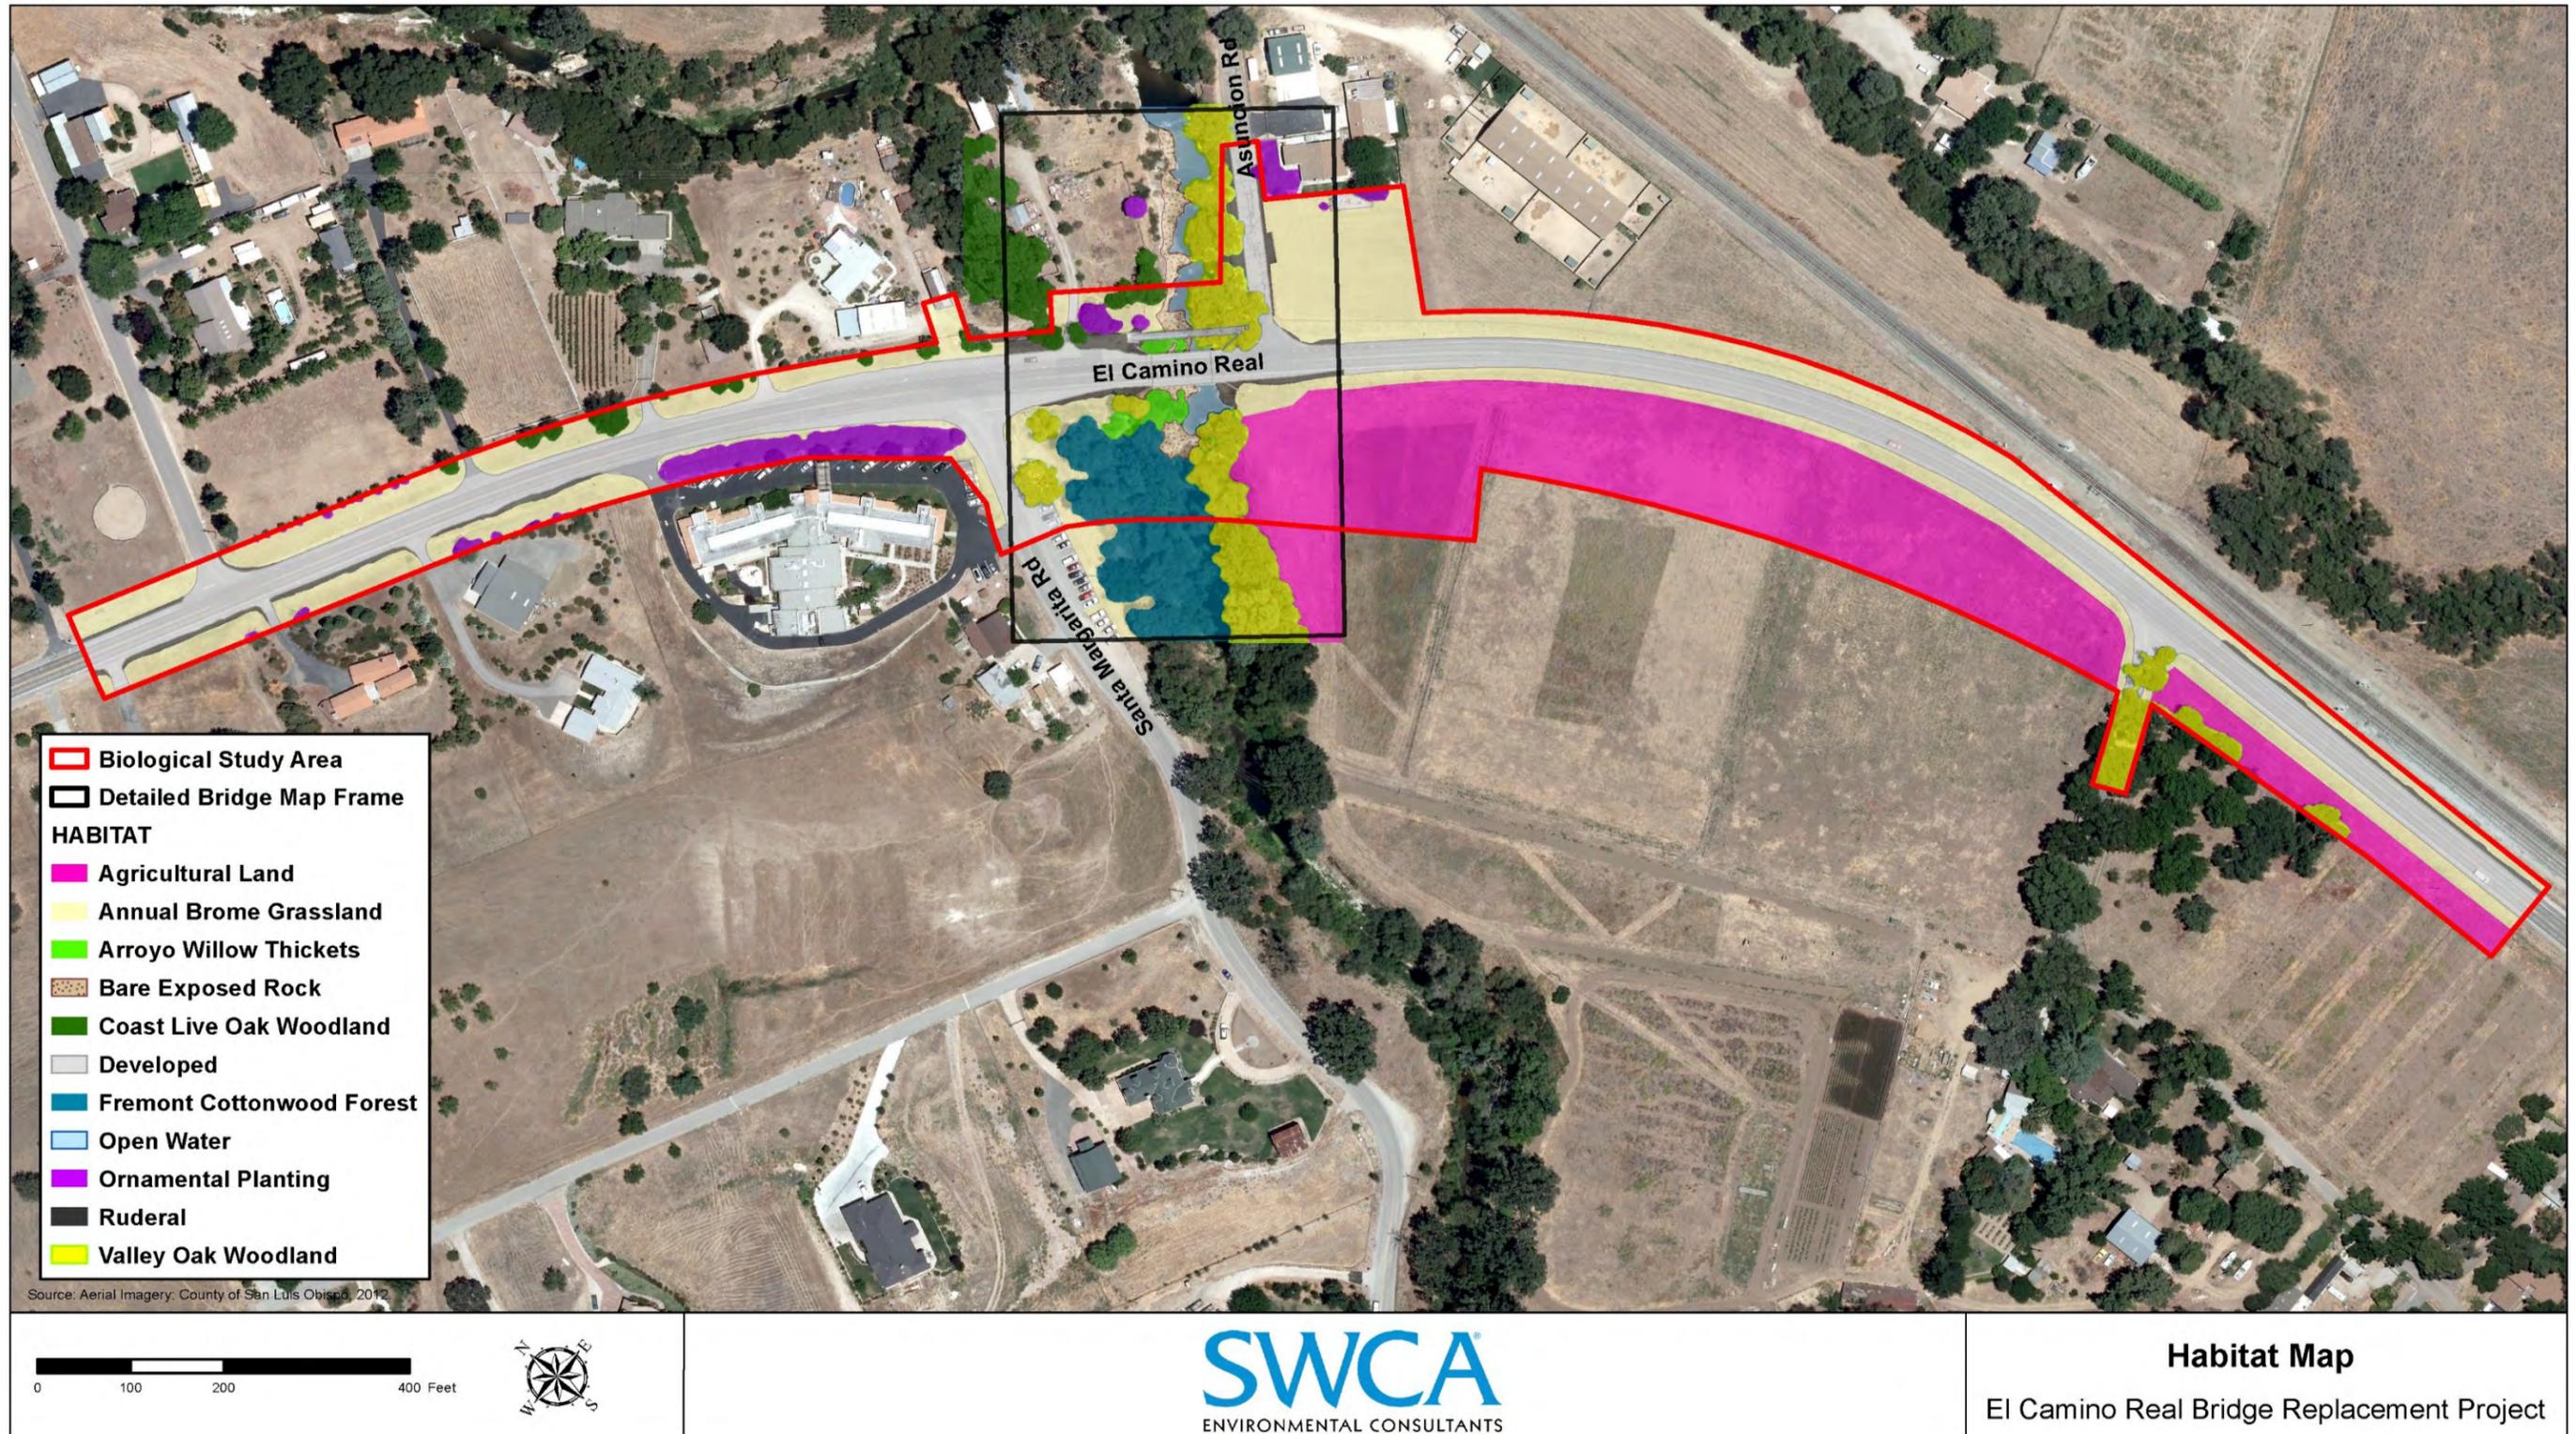
Figure 3: Habitat Map

The BSA is approximately 11.6 acres in size. The dominant natural communities within the BSA were characterized using the California Manual of Vegetation (Sawyer et al. 2009). The natural community classification was cross referenced with the CNDDDB to determine which natural communities are recognized as sensitive by CDFW. The vegetation communities observed within the BSA include: ruderal/developed, annual brome grassland, coast live oak woodland, valley oak woodland, arroyo willow thicket, and Fremont cottonwood forest (refer to Figure 3).

Approximately 0.41 acre of riparian habitat (classified as either arroyo willow thicket or Fremont cottonwood forest) and approximately 0.71 acre of oak woodlands (classified as coast live oak woodland and valley oak woodland) adjacent to the riparian areas were mapped within the BSA. Appendix D includes representative photos of the BSA.

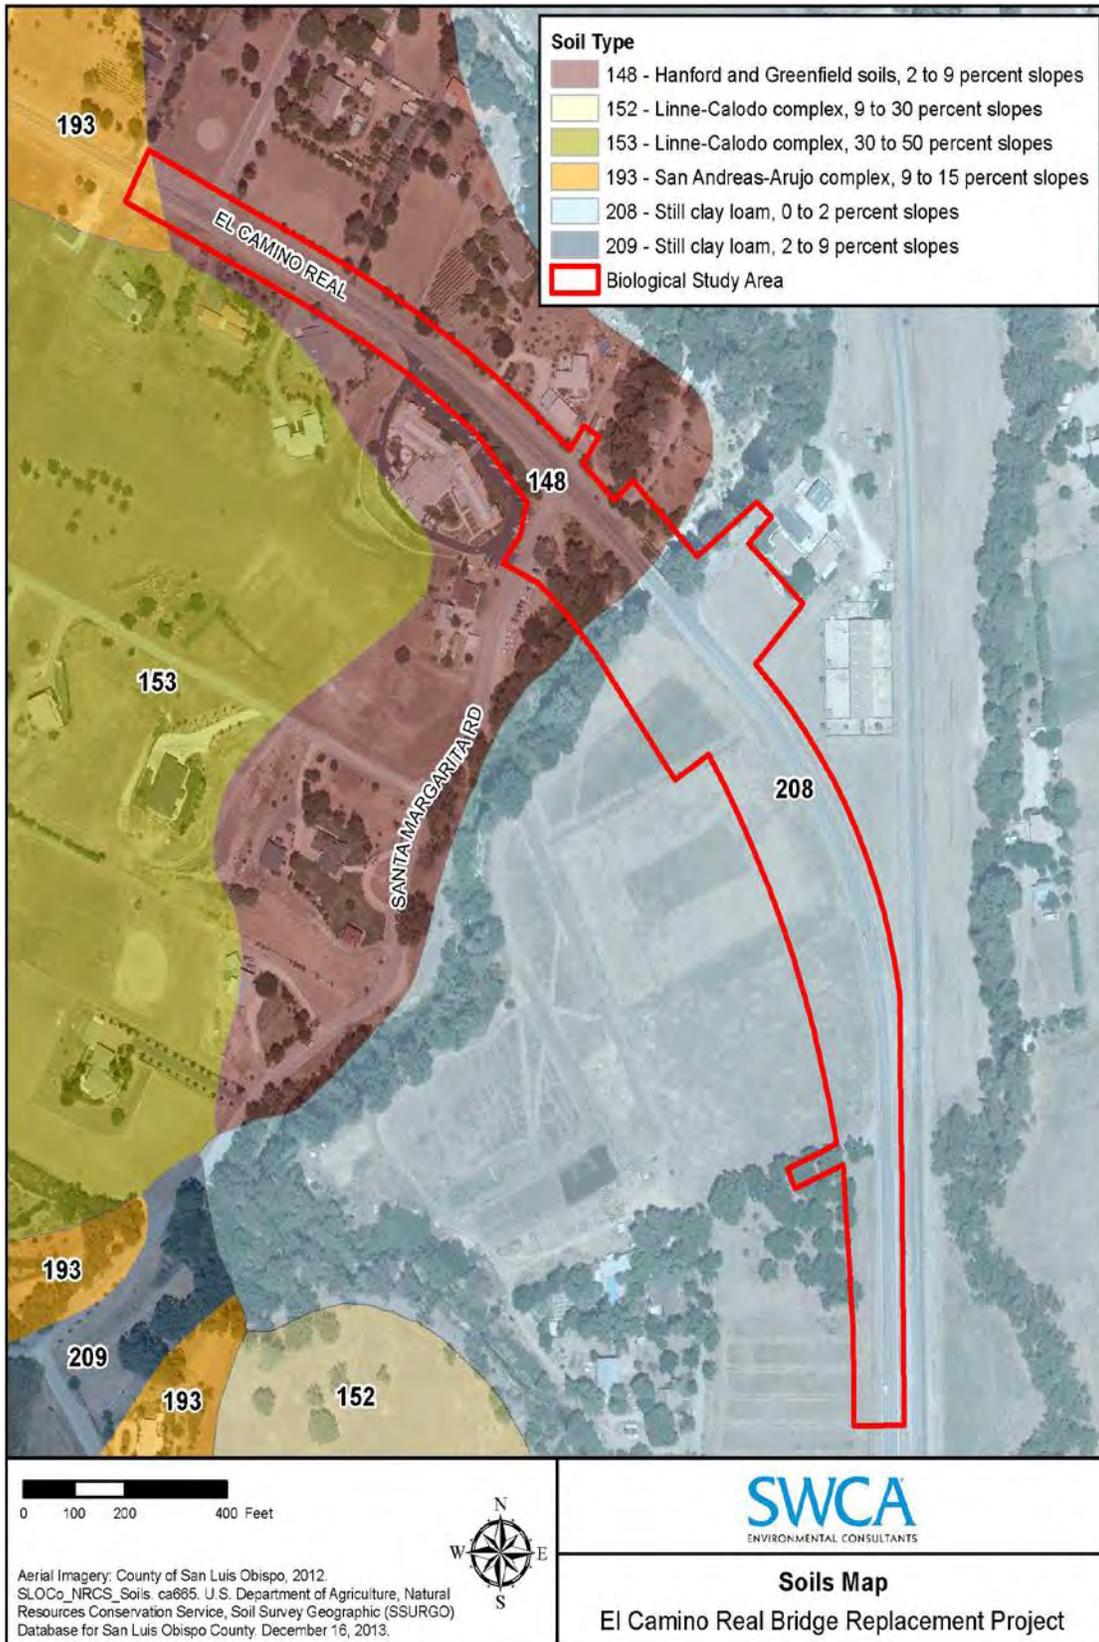
Figure 4: Soil Mapping Units Within and Adjacent to the BSA

- **Hanford and Greenfield fine sandy loams (Mapping Unit 148)** is mapped on the terrace to the northwest of the creek. This map unit is an undifferentiated unit that can include soils from the Hanford or Greenfield soil series. Soils in the Hanford series tend to be gently sloping, deep, well drained, and formed on stream bottoms, floodplains, and alluvial fans. These soils have low erodibility and low shrink-swell characteristics. Soils in the Greenfield series tend to be steeply to very steeply sloping and moderately drained. Greenfield soils are coarse textured alluvium derived from granitic and mixed rock sources and have low erodibility and low shrink-swell characteristics.

- **Still clay loam (0 to 2 percent slopes; Mapping Unit 208)** is mapped on the terrace to the southeast of Santa Margarita Creek. Still clay loam is a deep, nearly level soil that is well drained. Still clay loam is formed in alluvium derived from sedimentary rocks. The soil has moderate erodibility and moderate shrink-swell characteristics.
- **San Andreas-Arujo complex (9 to 15 percent slopes; Mapping Unit 193)** is mapped along El Camino Real in the northern portion of the BSA. The San Andreas-Arujo complex consists of well-drained, moderately deep soils that formed from weathered, soft sandstone and igneous and metamorphic rock. San Andreas and Arujo soils are found on uplands, hills, and mountainous uplands and have slopes of nine to 75 percent.

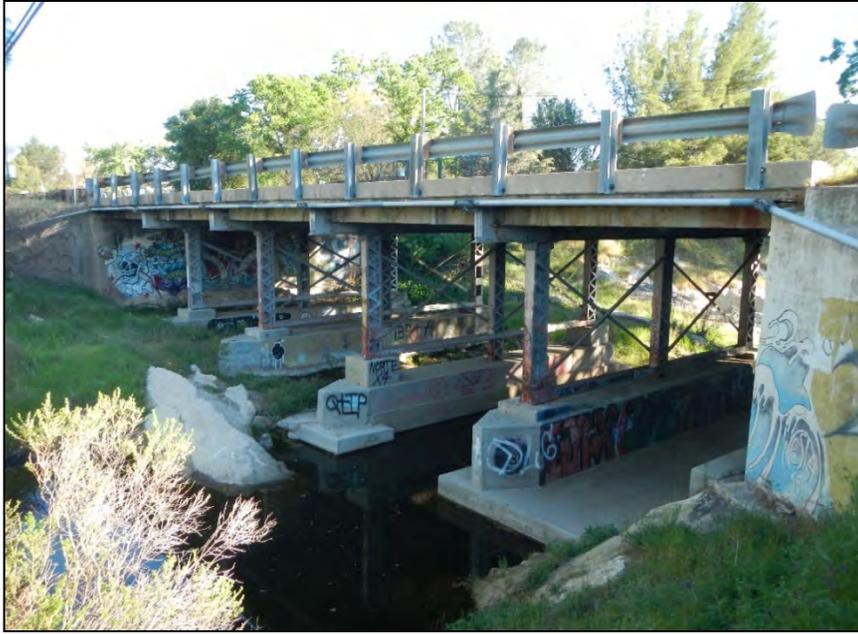
PHOTO 1:
View north of the existing El Camino Real Bridge. Note perennial pool in foreground.

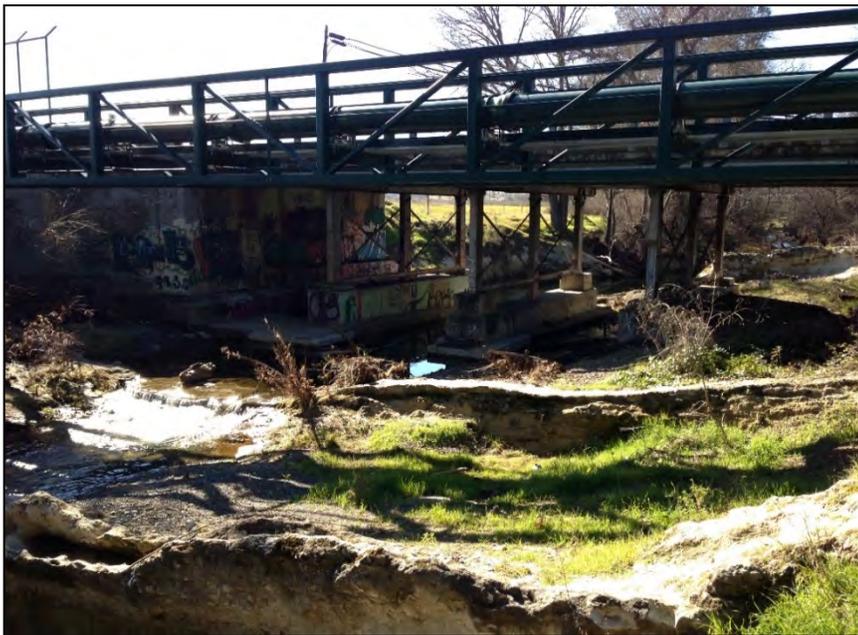
PHOTO 2:
View southwest of El Camino Real Bridge and the Nacimiento waterline span.

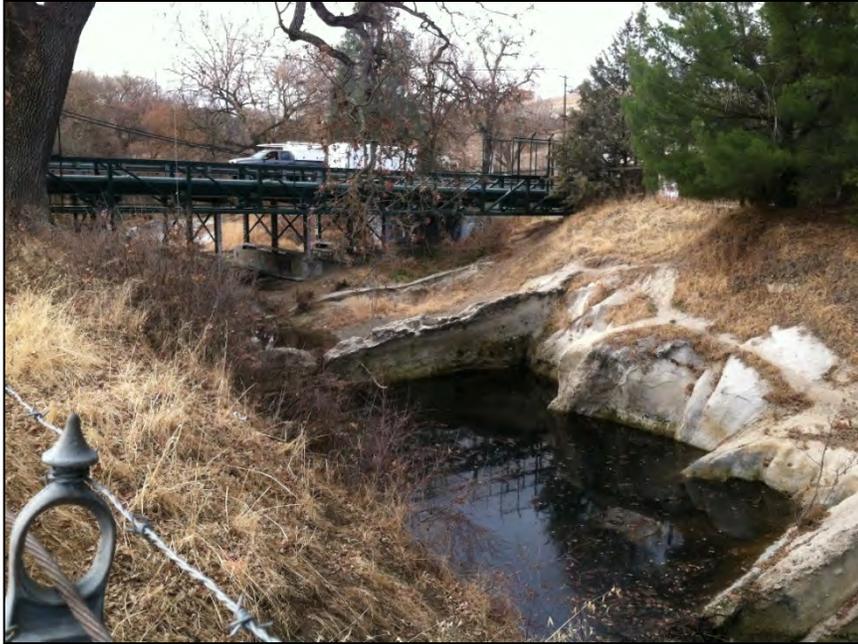
PHOTO 3:

View northwest of existing El Camino Real Bridge. Note parallel utility bridge spanning across Santa Margarita Creek.

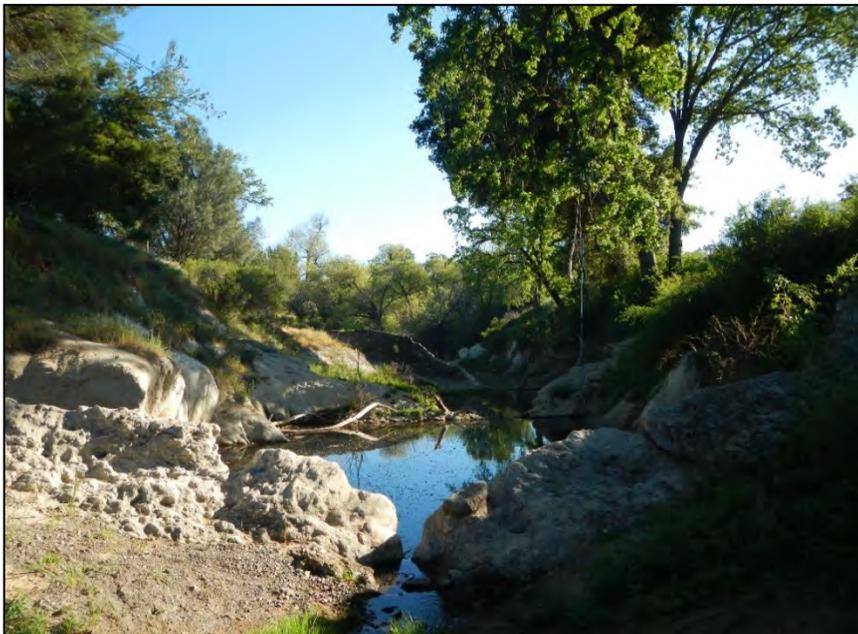
PHOTO 4:

View west looking up stream from El Camino Real Bridge.

Downstream of the bridge, the channel continues to flow into several additional plunge pools. The riparian corridor narrows to a width of approximately 100 feet and the channel becomes more incised. The first downstream pool is approximately 100 feet wide and 6.5 feet deep and flanked by steep, narrow banks. Exposed sandstone bedrock is also visible along the pool margins and at the footings of the bridge (refer to Appendix D, Photo 6). Continuing downstream there are two more pools with similar vegetative characteristics and structure, both approximately 70 feet wide and roughly four feet deep (refer to Appendix D, Photo 4).

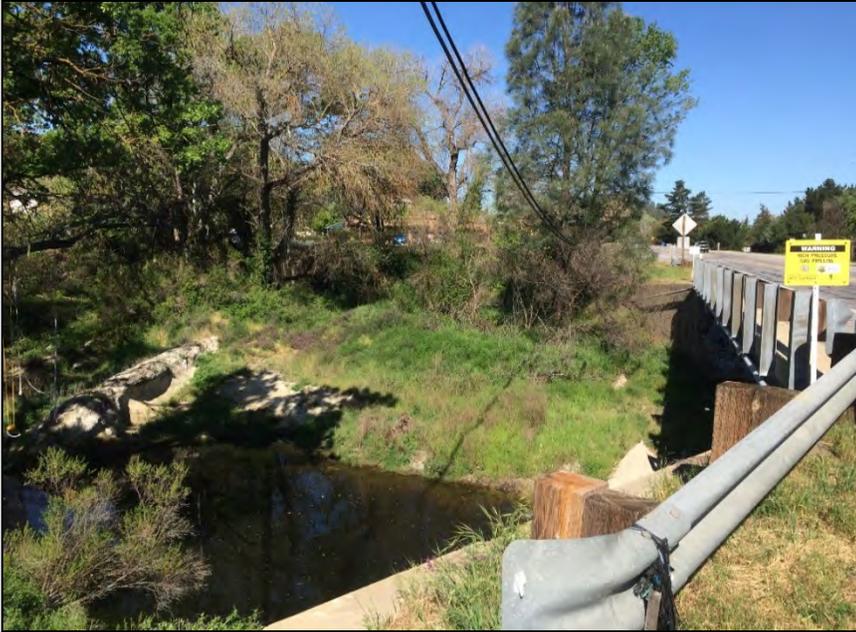
PHOTO 5:

View north of El Camino Real Bridge. Note foothill pine that falls within the proposed bridge footprint.

The riparian corridor on the upstream side of the bridge is less confined and has a more developed vegetation community. While the south bank upstream was not much wider than the south bank downstream of the bridge, it supported more trees and a thicker understory (refer to Appendix D, Photo 5). The most expansive portion of riparian vegetation was present along the upstream northern bank.

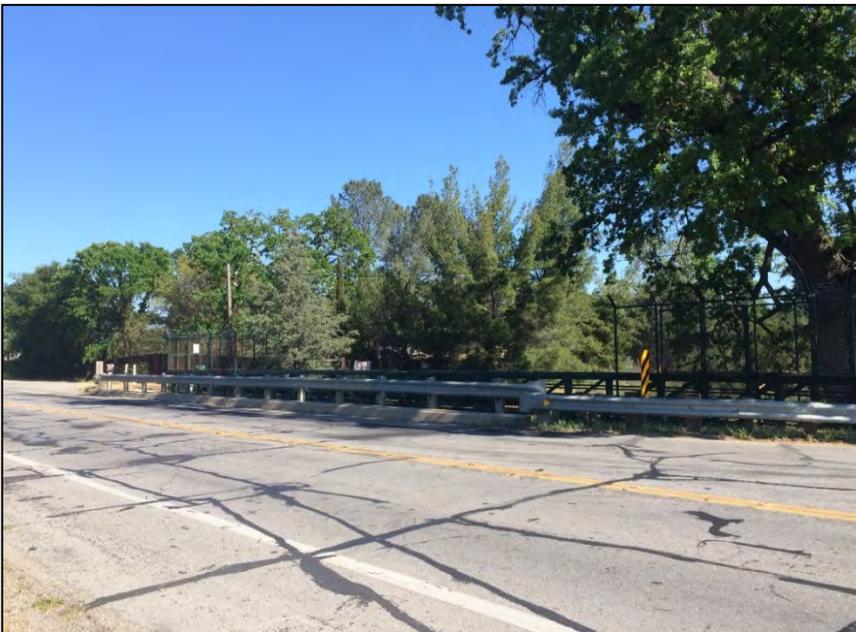
PHOTO 6:

View north along El Camino Real of Santa Margarita Bridge. Note utility bridge and large valley oak tree to the east of the bridge.

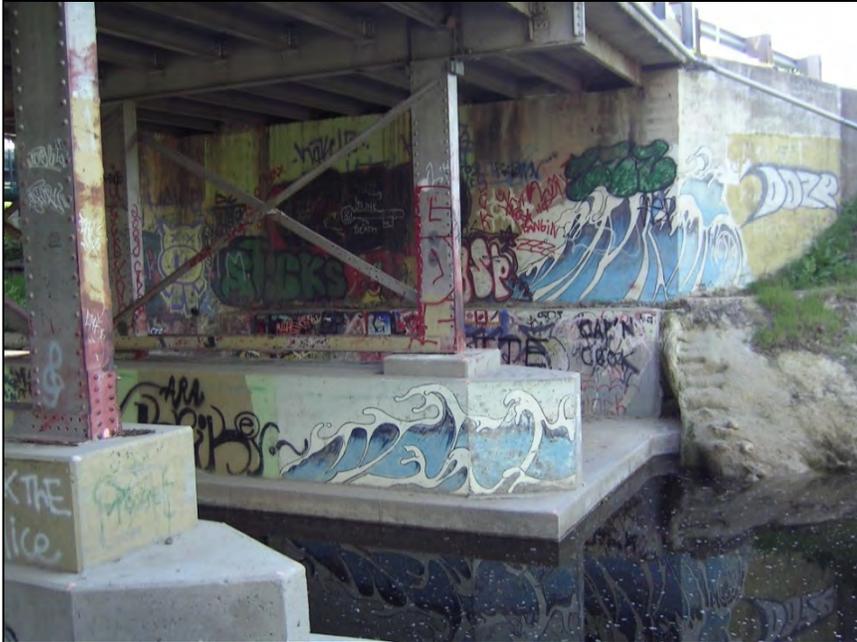
PHOTO 7:
View south of existing El Camino Real Bridge. Note large amount of concrete to be removed from the Santa Margarita Creek Channel.

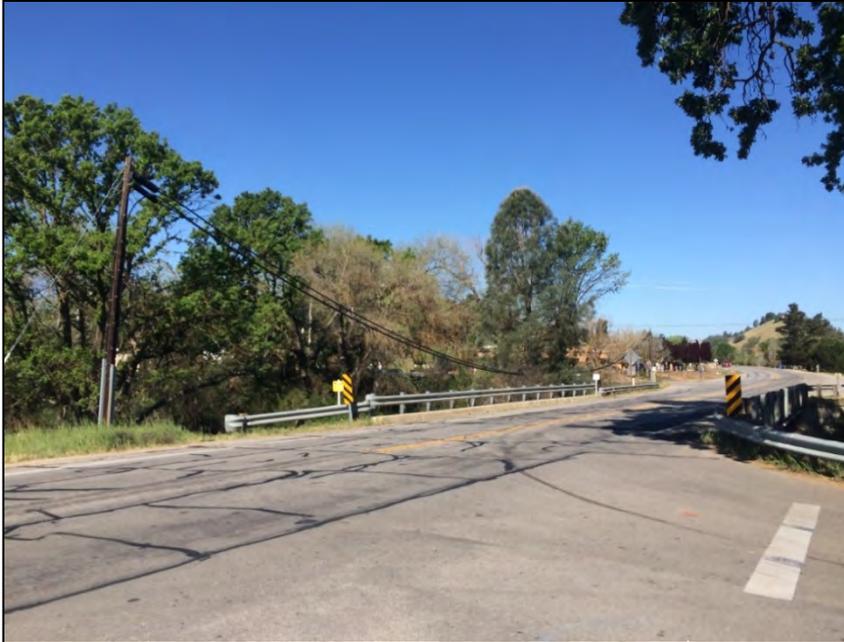
PHOTO 9:
View north of
existing El
Camino Real
Bridge from
the
intersection at
Asuncion
Road.

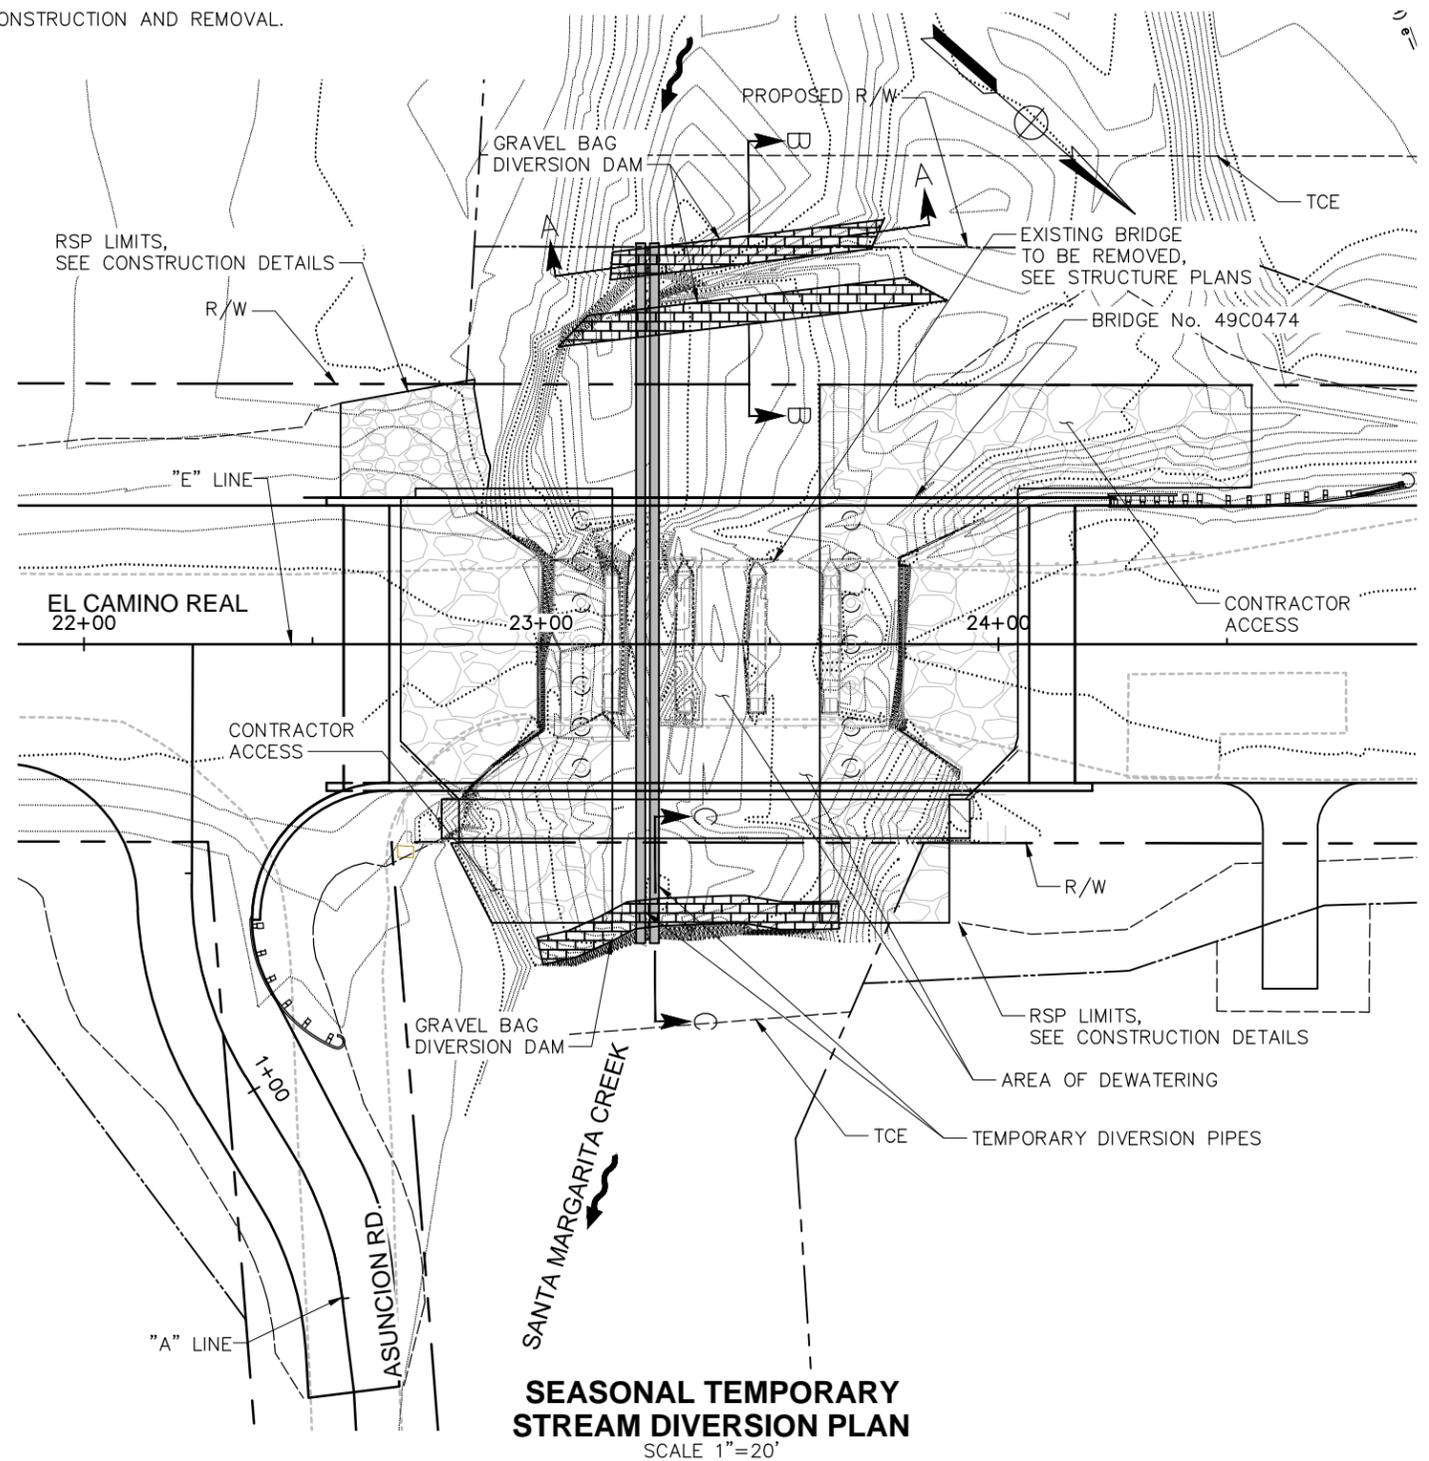
- ⊙ INDICATES 48" CIDH PILE
- ⌊ INDICATES EXISTING FOOTINGS TO BE REMOVED

SEASONAL TEMPORARY STREAM DIVERSION PLAN
SCALE 1"=20'

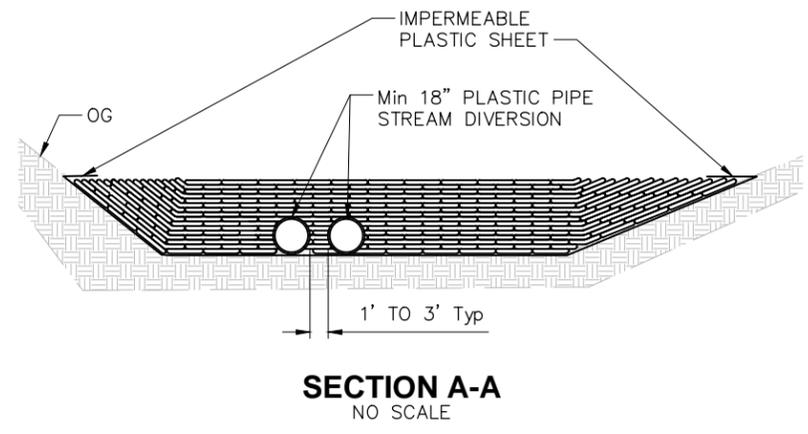
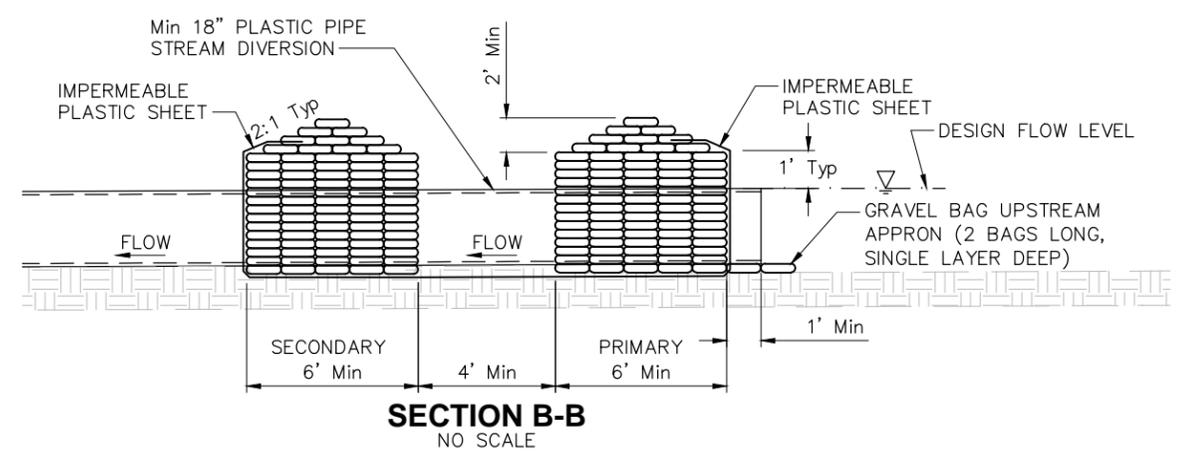
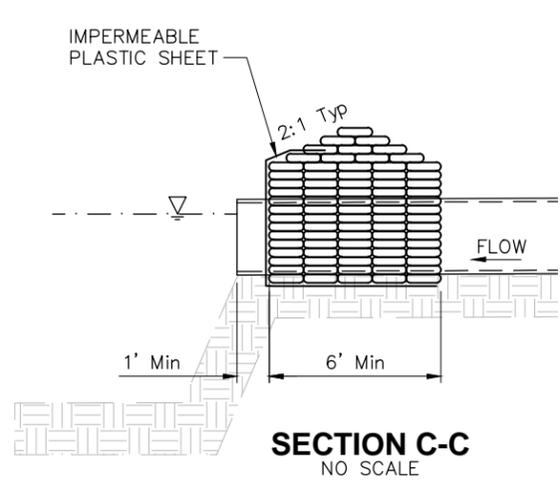
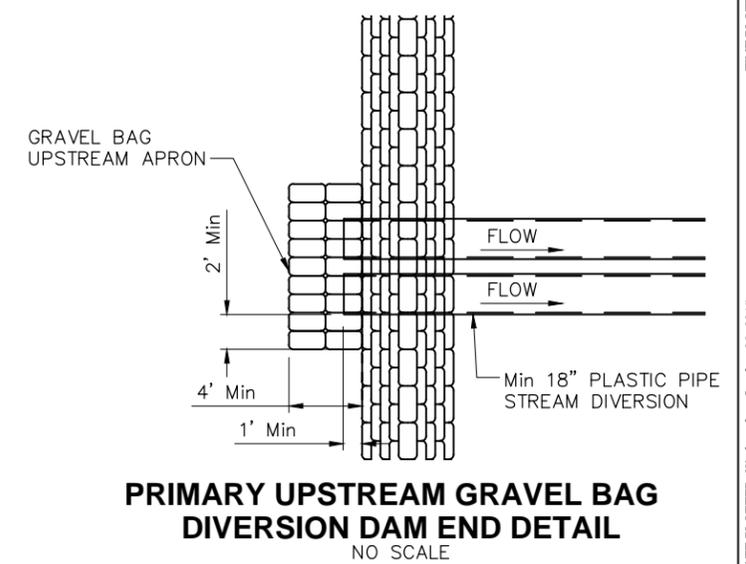
SEASONAL TEMPORARY STREAM DIVERSION
SCALE: AS SHOWN

Temporary berms will be constructed both upstream and downstream of the bridge. The berms will be constructed using clean gravel or sand bags with clean crushed rock or sand and will be used to divert summer flows away from the work area and downstream. The berms will have an impervious membrane made up of visqueen polyethylene film to keep water from seeping into the work area and downstream away from the project site. The berms will be stacked bags and are expected to be at least 4 feet tall. The berms will be a minimum of 6' wide.

Temporary culverts, consisting of approximately two 18-inch pipes, will be used to divert summer flows away from the work area and downstream. The pipes will be approximately 150' long and will be installed through the upstream and downstream berms running parallel to the direction of flow.

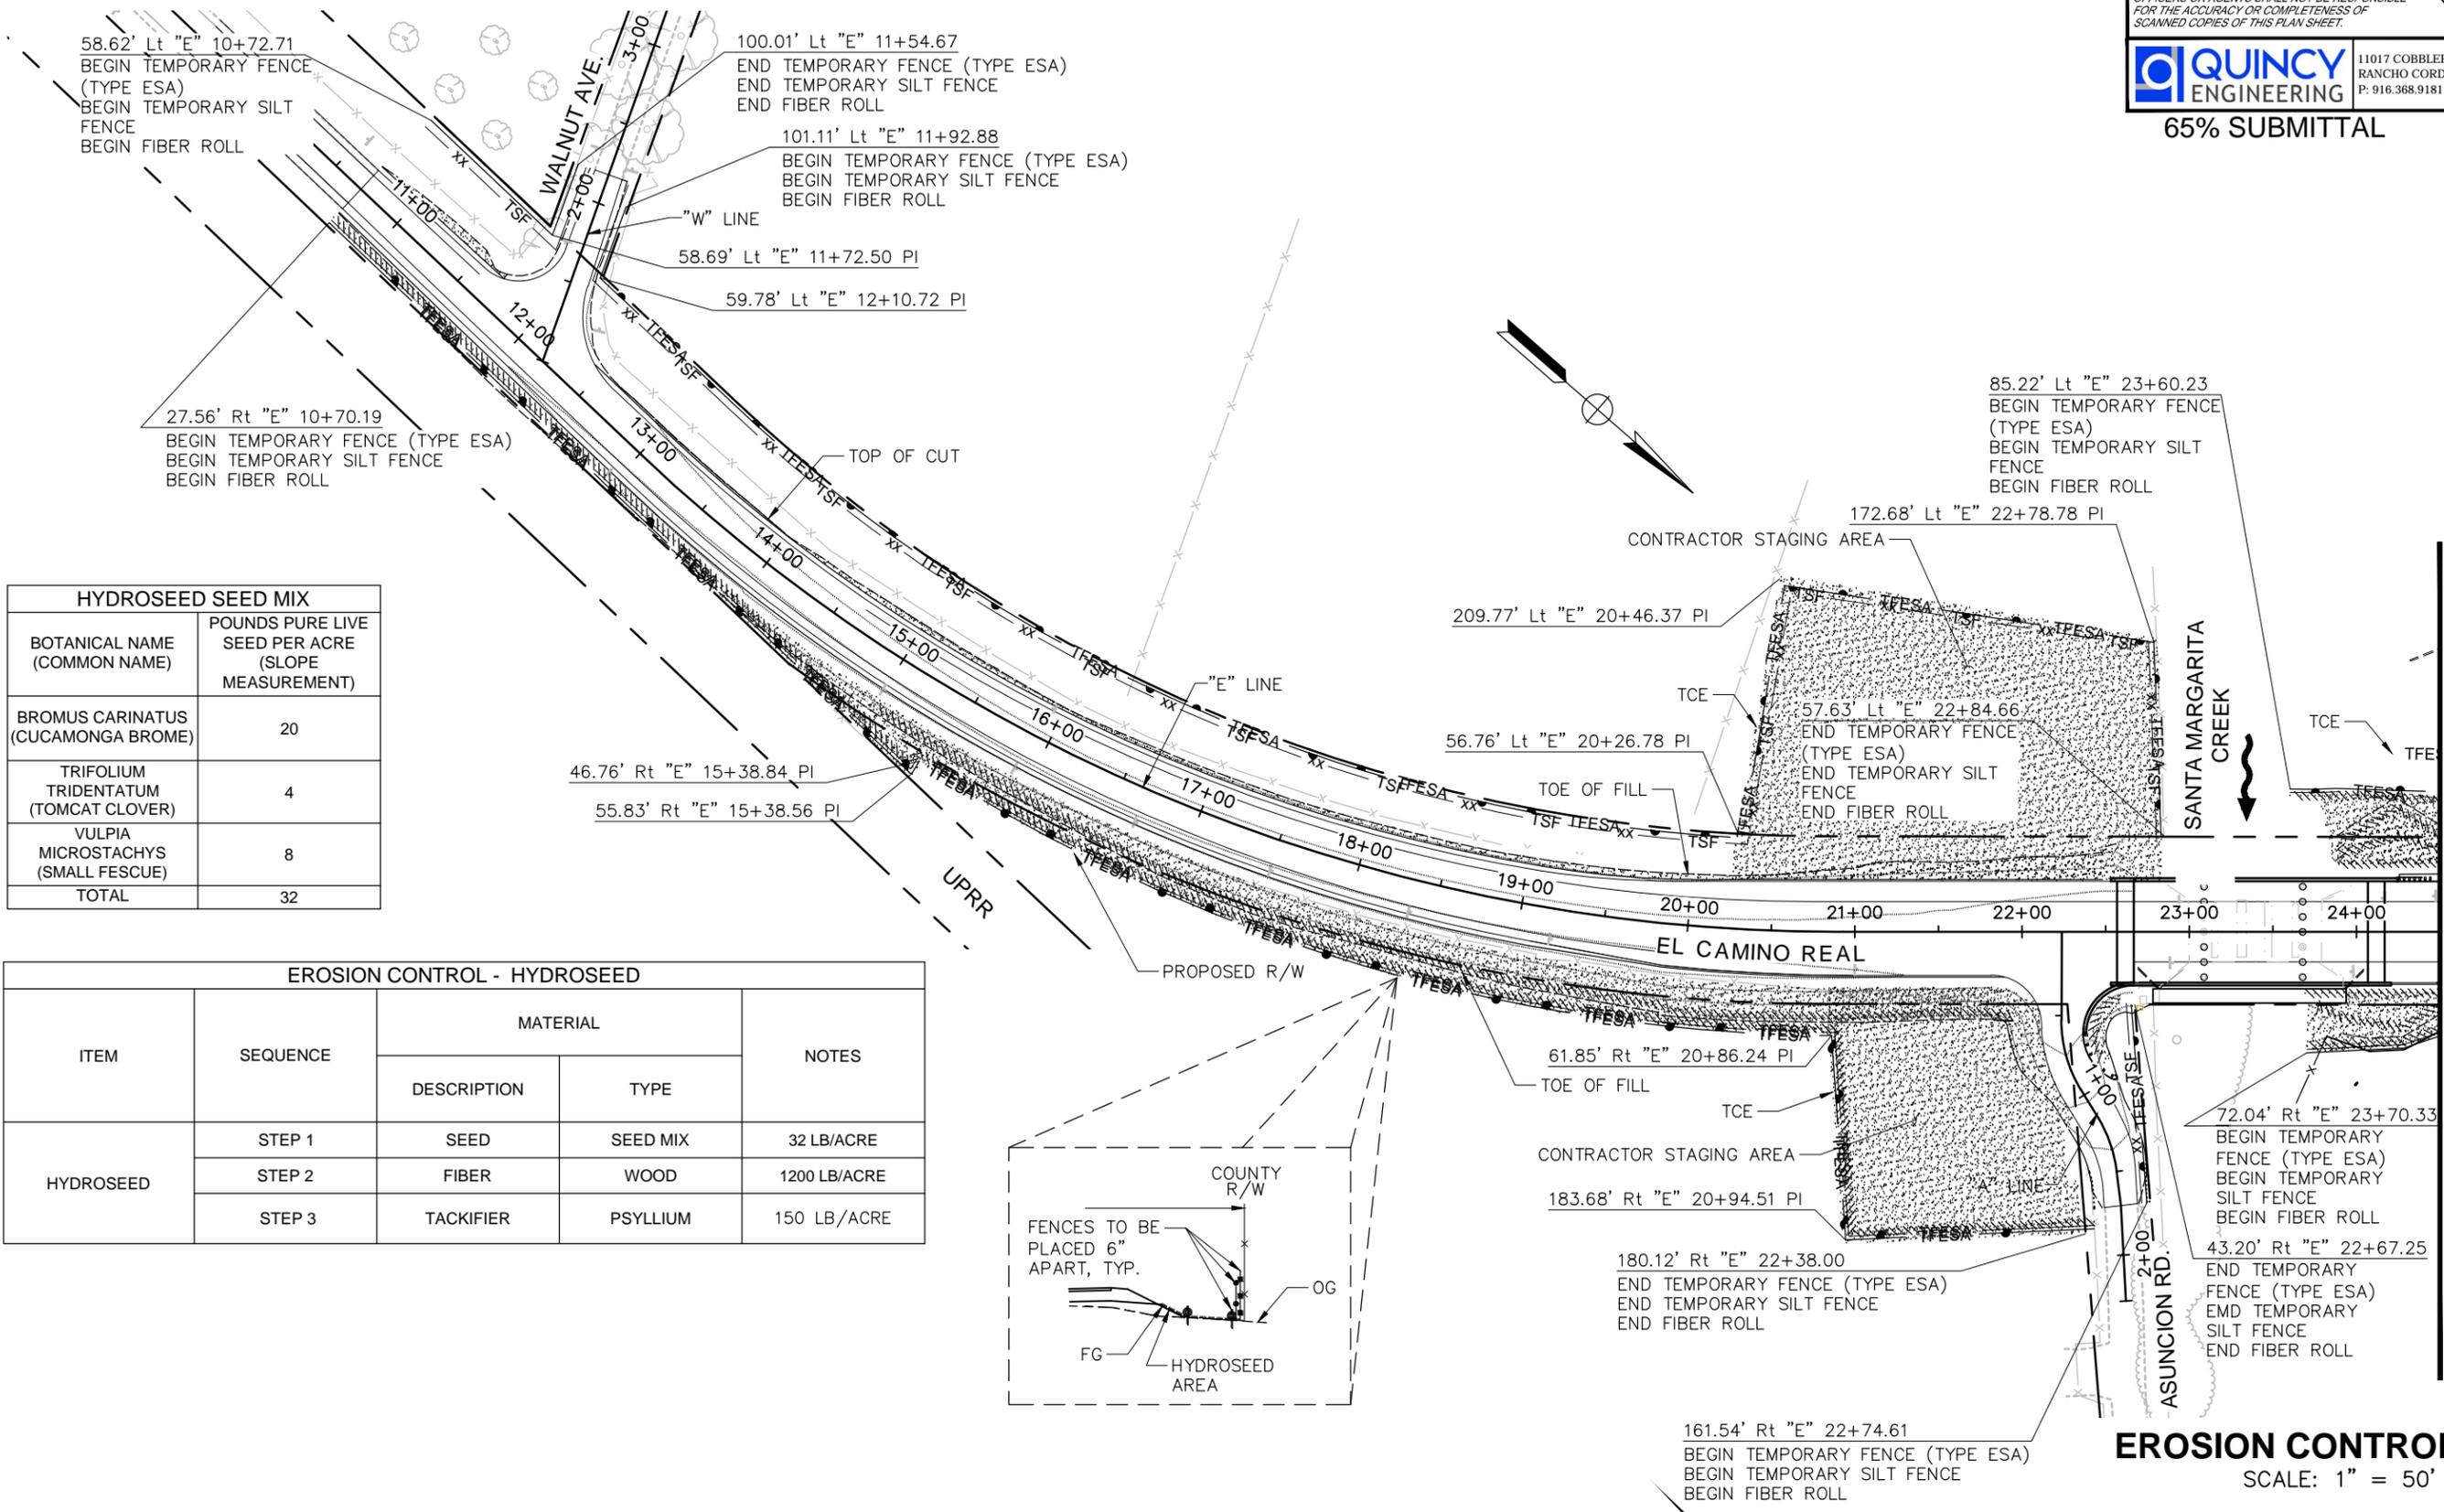
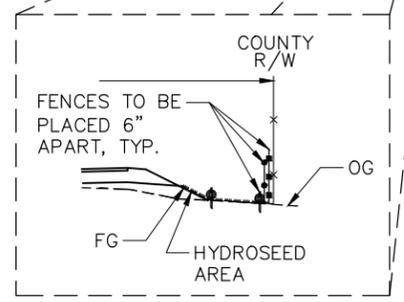
HYDROSEED SEED MIX	
BOTANICAL NAME (COMMON NAME)	POUNDS PURE LIVE SEED PER ACRE (SLOPE MEASUREMENT)
BROMUS CARINATUS (CUCAMONGA BROME)	20
TRIFOLIUM TRIDENTATUM (TOMCAT CLOVER)	4
VULPIA MICROSTACHYS (SMALL FESCUE)	8
TOTAL	32

EROSION CONTROL - HYDROSEED				
ITEM	SEQUENCE	MATERIAL		NOTES
		DESCRIPTION	TYPE	
HYDROSEED	STEP 1	SEED	SEED MIX	32 LB/ACRE
	STEP 2	FIBER	WOOD	1200 LB/ACRE
	STEP 3	TACKIFIER	PSYLLIUM	150 LB/ACRE

EROSION CONTROL PLAN
SCALE: 1" = 50'

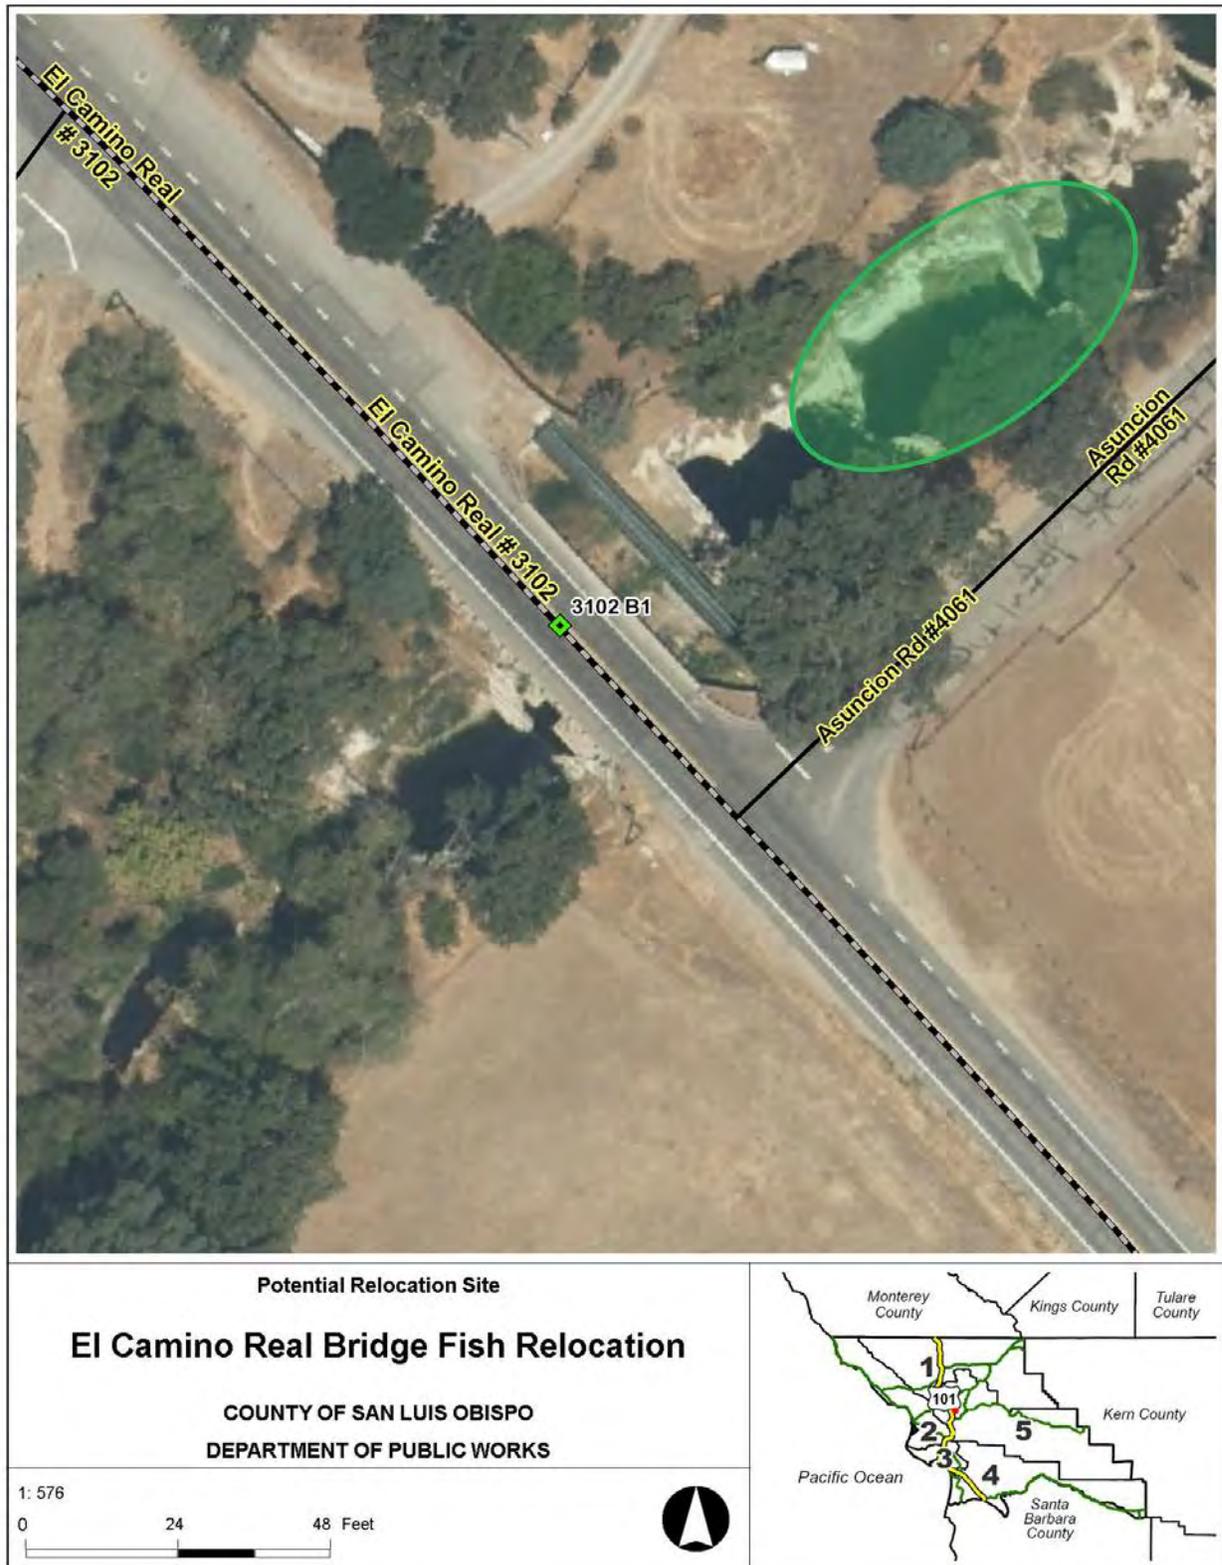
Figure 2: Potential Relocation Site

Fish will be relocated to the next available suitable habitat for their respective size class and life stage, downstream of the temporary berms and culverts. A potential relocation site, pending Section 7 & Agency approvals is located just downstream in the same creek (refer to Figure 2).
