El Camino Real Bridge Replacement Project BA

Biological Assessment

El Camino Real at Santa Margarita Creek Bridge Replacement,
San Luis Obispo County, California

District 5
Existing Bridge No. 49C0310
BRLS-5949 (131)

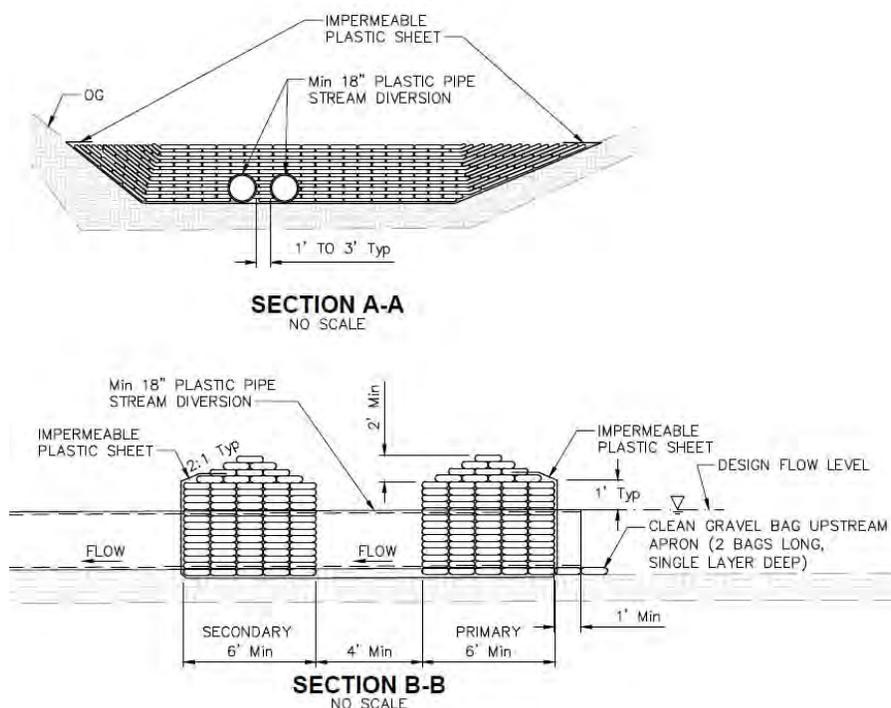
Temporary berms will be constructed both upstream and downstream of the bridge. The berms will be constructed using clean gravel or sand bags with clean crushed rock or sand and will be used to divert summer flows away from the work area and downstream. The berms will have an impervious membrane made up of visqueen polyethylene film to keep water from seeping into the work area and downstream away from the project site. The berms will be stacked bags and are expected to be at least 4 feet tall. The berms will be a minimum of 6' wide.

Temporary culverts, consisting of approximately two 18-inch pipes, will be used to divert summer flows away from the work area and downstream. The pipes will be approximately 150' long and will be installed through the upstream and downstream berms running parallel to the direction of flow.

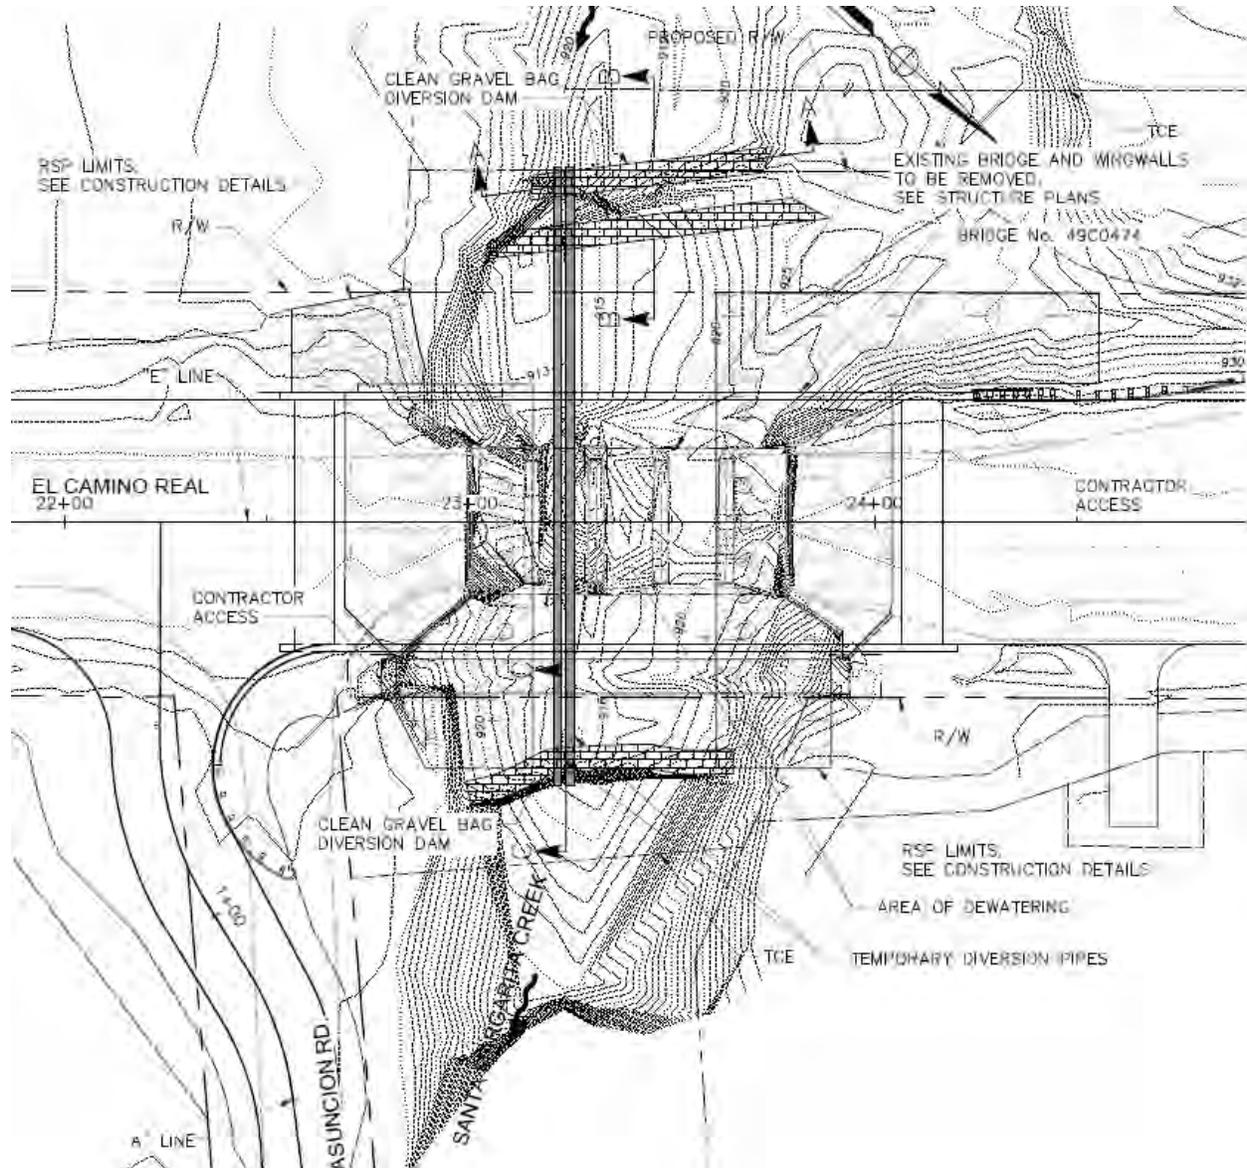
berms will completely block the normal flow of the creek, keeping water out of the work area, allowing only the flow that enters the diversion pipes to pass under the bridge. All diversion/dewatering activities will adhere to Caltrans Standard Specifications.
