GEOTECHNICAL REPORT
SANTA ROSA CREEK ROAD SLIP OUT
0.9 MILES WEST OF STATE ROUTE 46
SAN LUIS OBISPO COUNTY, CALIFORNIA

Prepared for:
San Luis Obispo County

March 30, 2010

Subject: Geotechnical Report, Santa Rosa Creek Road, Slip out 0.9 miles north of State Route 46, San Luis Obispo County, California

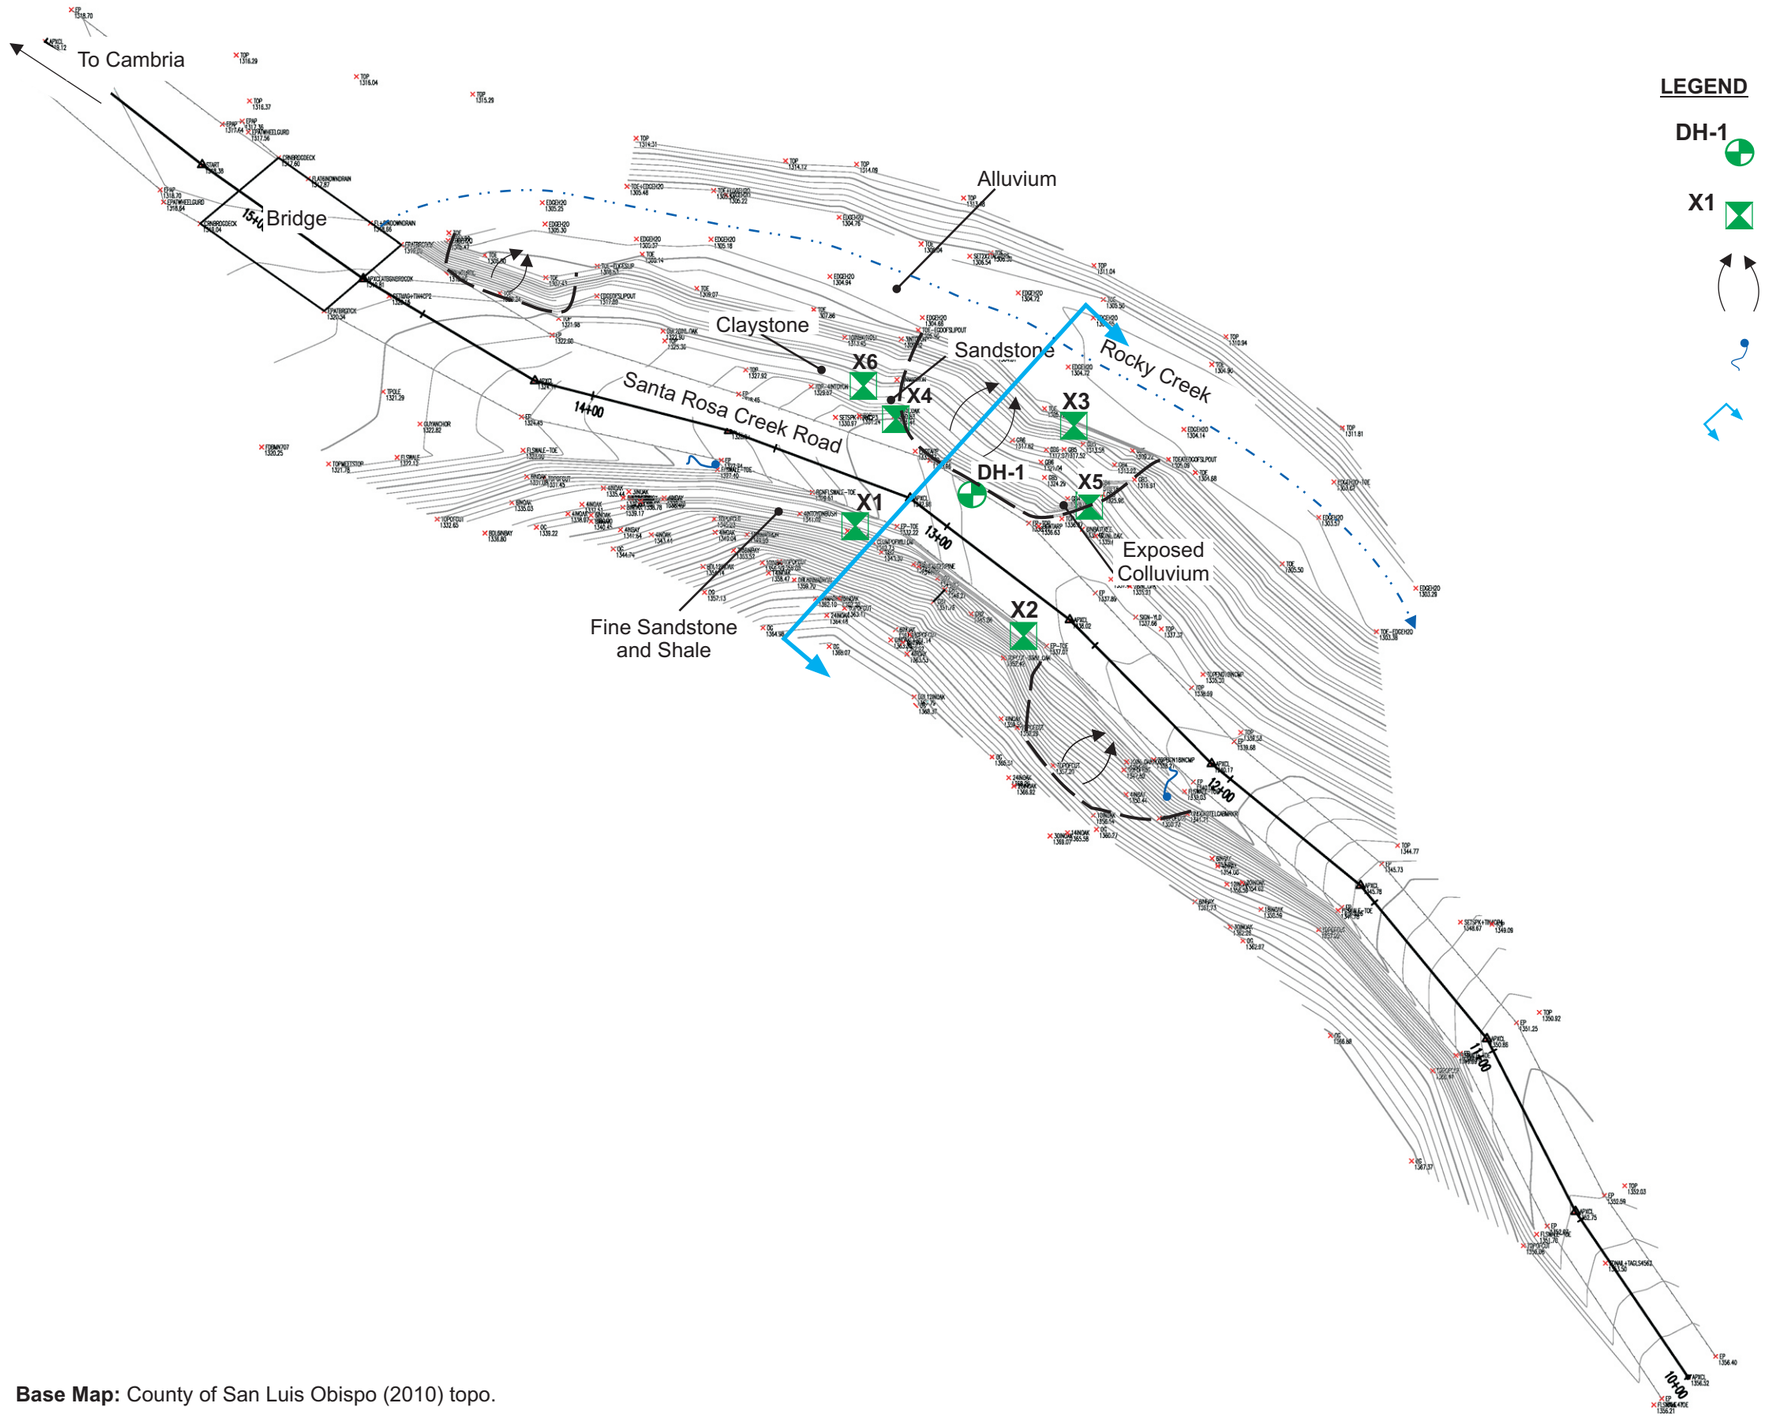
FIELD EXPLORATION PLAN
Santa Rosa Creek Road
0.9 miles north of Highway 46
San Luis Obispo County, California

Approximately 1- to 2-inch wide tension cracks extending up to the edge of pavement were observed during our site visits. The cracks appear recent, and suggest that recent movement and likely extension of the instability of the slope has occurred in association with this winter's rain. The limits of the slide and observed instability were noted on the County (2010) topography (see Plate 2).

Landslide Deposits (Qls): The predominant areas of landsliding and slope instability are noted on Plate 2. The subject landslide is located on the relatively steep northeast facing slope below the northbound shoulder of Santa Rosa Creek Road. The landslide deposits are generally talus deposited at the base of the landslide that was composed of displaced material from the artificial fill, colluvium and Toro Formation. Tension cracks observed adjacent to the road were used to approximate the limits of the landslide. There also appears to be a landslide within the creek bank adjacent to the south abutment of the Rocky Creek Bridge.

Slope instability such as erosion, rock fall, and slumping of materials is also present along the cut slope that borders the southbound shoulder of Santa Rosa Creek Road. The predominant area of slope instability noted on Plate 2, appears to be associated with erosion and displaced over burden soil (colluvium) that has wasted downslope as a result of a daylighting spring and seepage conditions on the slope.

Bedding observed within the Toro Formation was observed within an outcrop adjacent to Rocky Creek. The bedding had a dip of approximately 42 degrees to the southwest, into the hillside, with a strike of N55W. A predominant set of joints was observed within the scarp of the upstream side of the landslide. The joint set appeared to be a controlling structure of the landslide feature and had a dip of approximately 56 degrees to the northeast, down slope, with a strike of N55W. A set of joints at the same location was observed to dip approximately 38 degrees southeast, into the hillside, with a strike of S65W. Our field measurements are shown on Plate 2.

Groundwater was not encountered in DH-1 prior to adding water to the hole at 20 feet deep to begin rock coring. As noted on Plate 2, springs were observed daylighting along the base of the slope and ditch along the southbound shoulder of the road. Water was flowing in Rocky Creek at the time of our March 2010 field exploration program. The approximate limits of the water surface are noted on County (2010) topographic map. Stream flow, groundwater and soil moisture conditions will vary seasonally due to changes in runoff, storm conditions, rainfall and other factors.

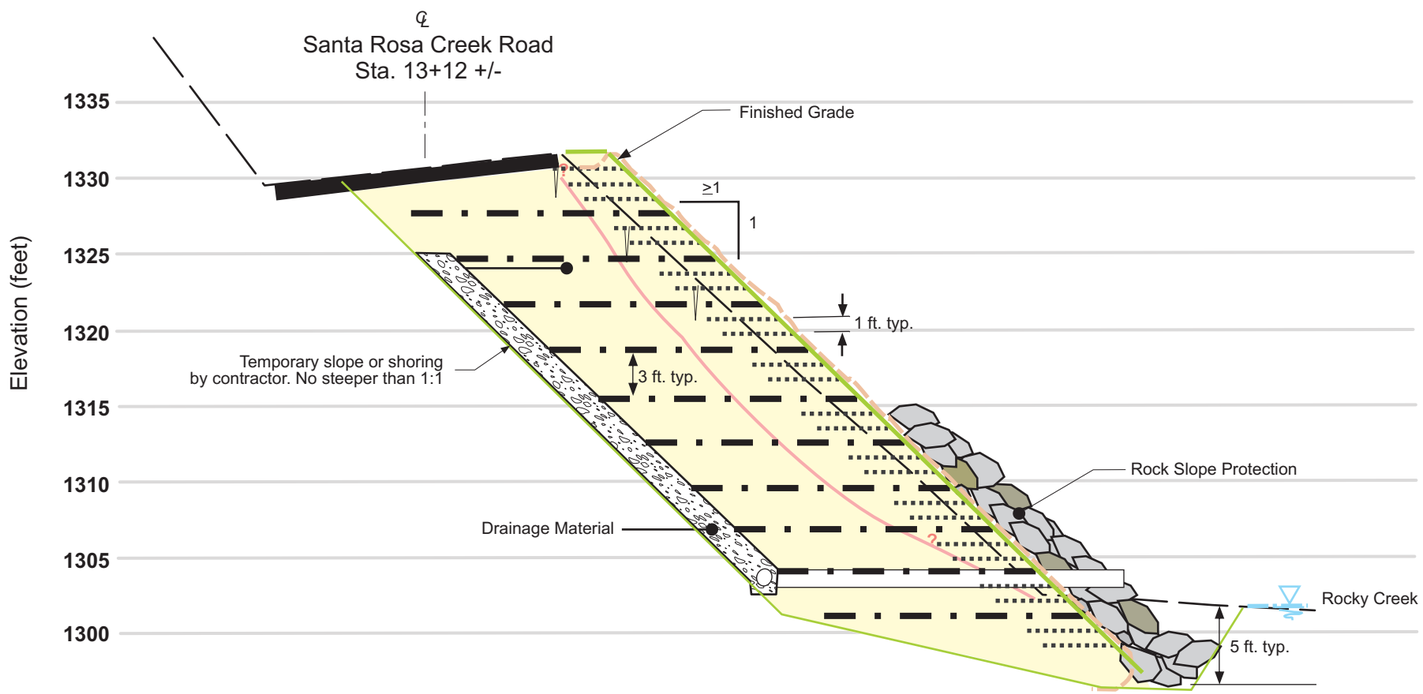
GEOSYNTHETIC REINFORCED EMBANKMENT DETAIL
Santa Rosa Creek Road
0.9 miles north of Highway 46
San Luis Obispo County, California
PLATE 3a

Legend:
- Finished grade
- Assumed temporary slope
- Existing grade
- 17-foot long primary geogrid reinforcement
- 4-foot long Intermediate geogrid reinforcement
- Erosion control matting
- Drainage material
- Structure backfill
- Topsoil or onsite materials
- Assumed slide plane to be removed

- The slope can be restored to a relatively stable condition using geosynthetic reinforcement as recommended in this report. We have provided recommendations to design the slope to an inclination of 1h:1v using geosynthetic reinforced earth to support the roadway. That face of the slope should be covered with erosion control matting to assist in establishing vegetation on the slope. Rock should be placed along the base of the slope help protect the slope from stream bank erosion. Detailed recommendations for the design and placement of the reinforcement are provided in the subsequent sections of this report.

suggest that the temporary backslope for the GRE be cut no steeper than 1:1, which is similar to the existing slope inclinations downslope of Santa Rosa Creek Road. The geologic conditions exposed by the excavation should be reviewed by the contractor and geotechnical professional during construction to further evaluate the stability and characteristics of the rock once it is exposed.

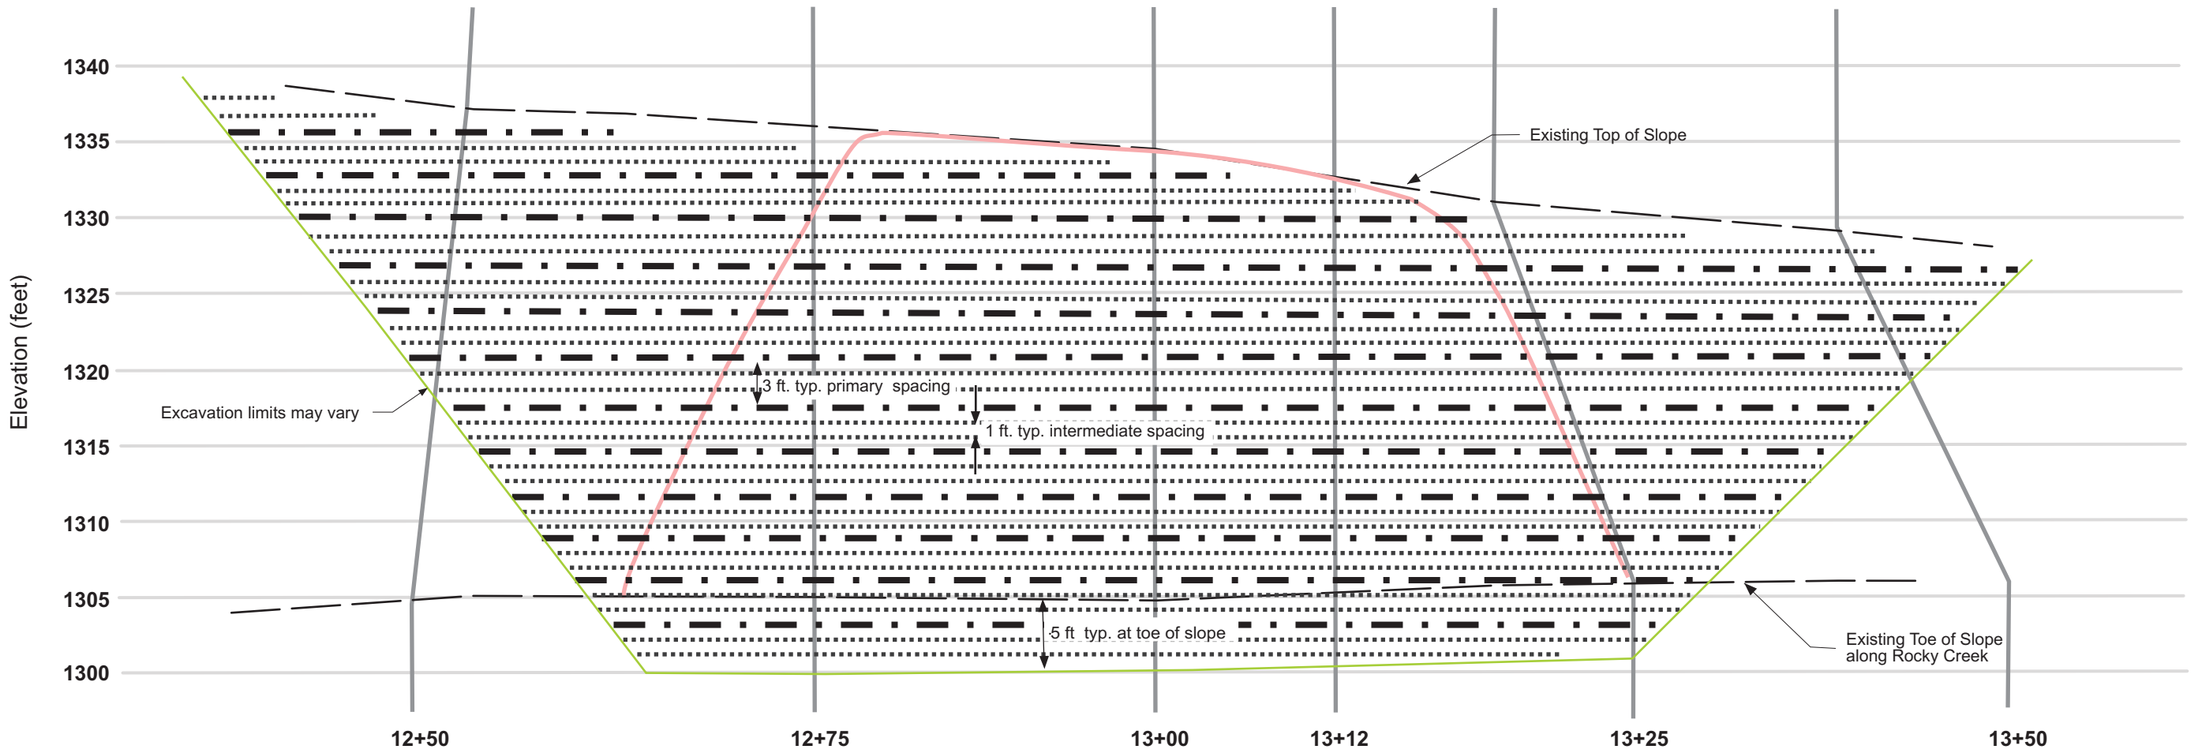
GEOSYNTHETIC REINFORCED EMBANKMENT DETAIL
Santa Rosa Creek Road
0.9 miles north of Highway 46
San Luis Obispo County, California
PLATE 3b

A typical section and typical profile summarizing our recommendations for design of the GRE is presented on Plates 3a and 3b – Geosynthetic Reinforced Embankment Detail. To provide an estimated factor of safety of at least 1.5, we recommend that the slope be designed to a slope inclination of 1h:1v or flatter. The toe of the slope should catch on the existing embankment slope. The recommended reinforcement should be continued through the entire limits of the slope restoration.

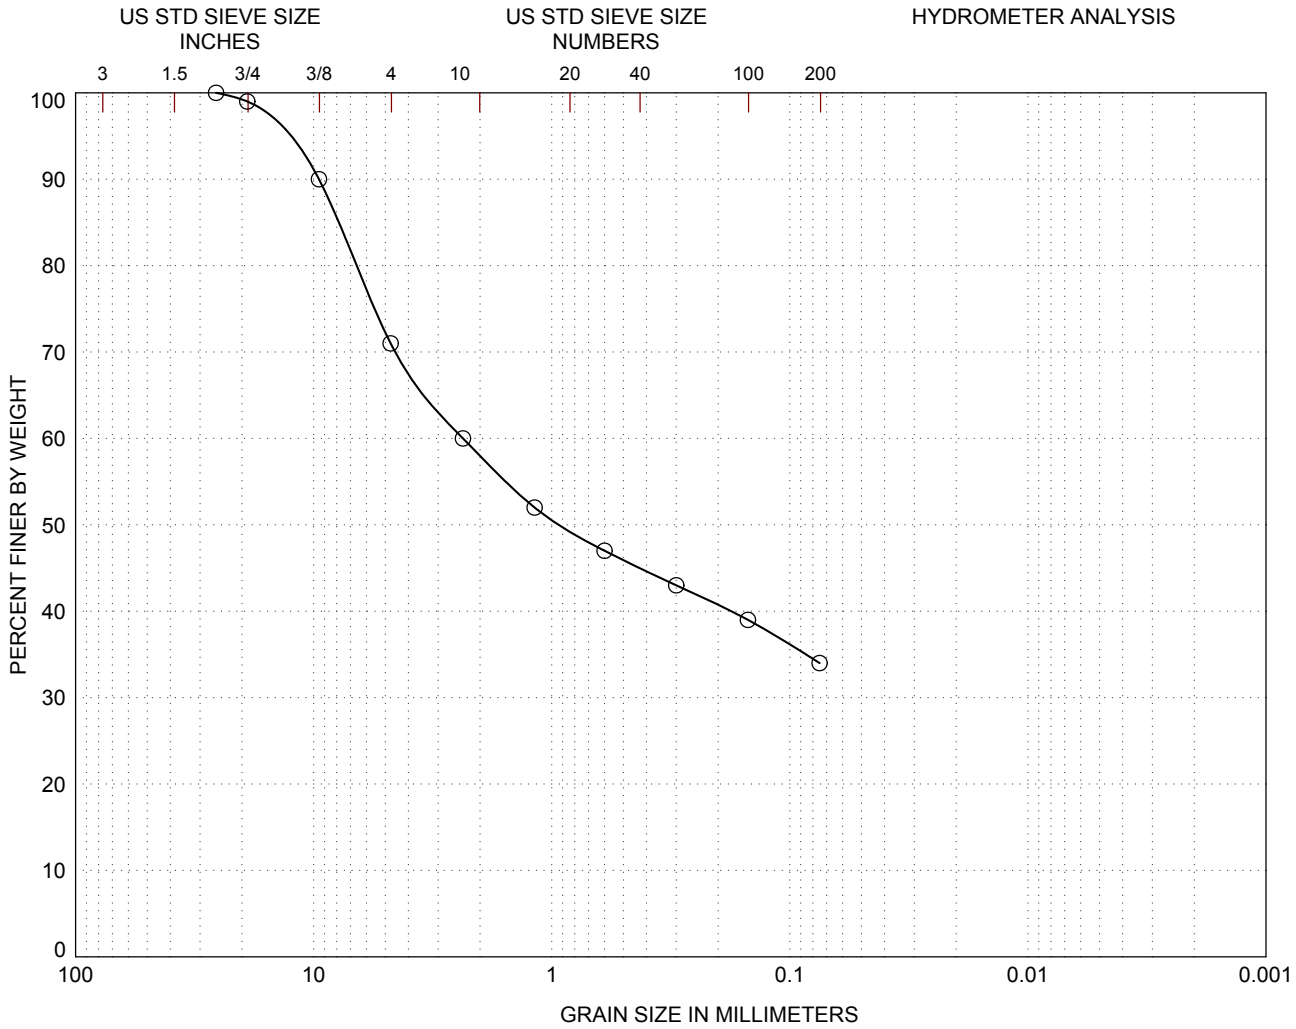
PLATE B-1

LEGEND	(location)	(depth,ft)	CLASSIFICATION	Cc	Cu
○	DH-1	0.0	Clayey SAND with gravel (SC)

GRAIN SIZE CURVES
Santa Rosa Creek Road Slipout
San Luis Obispo County, California

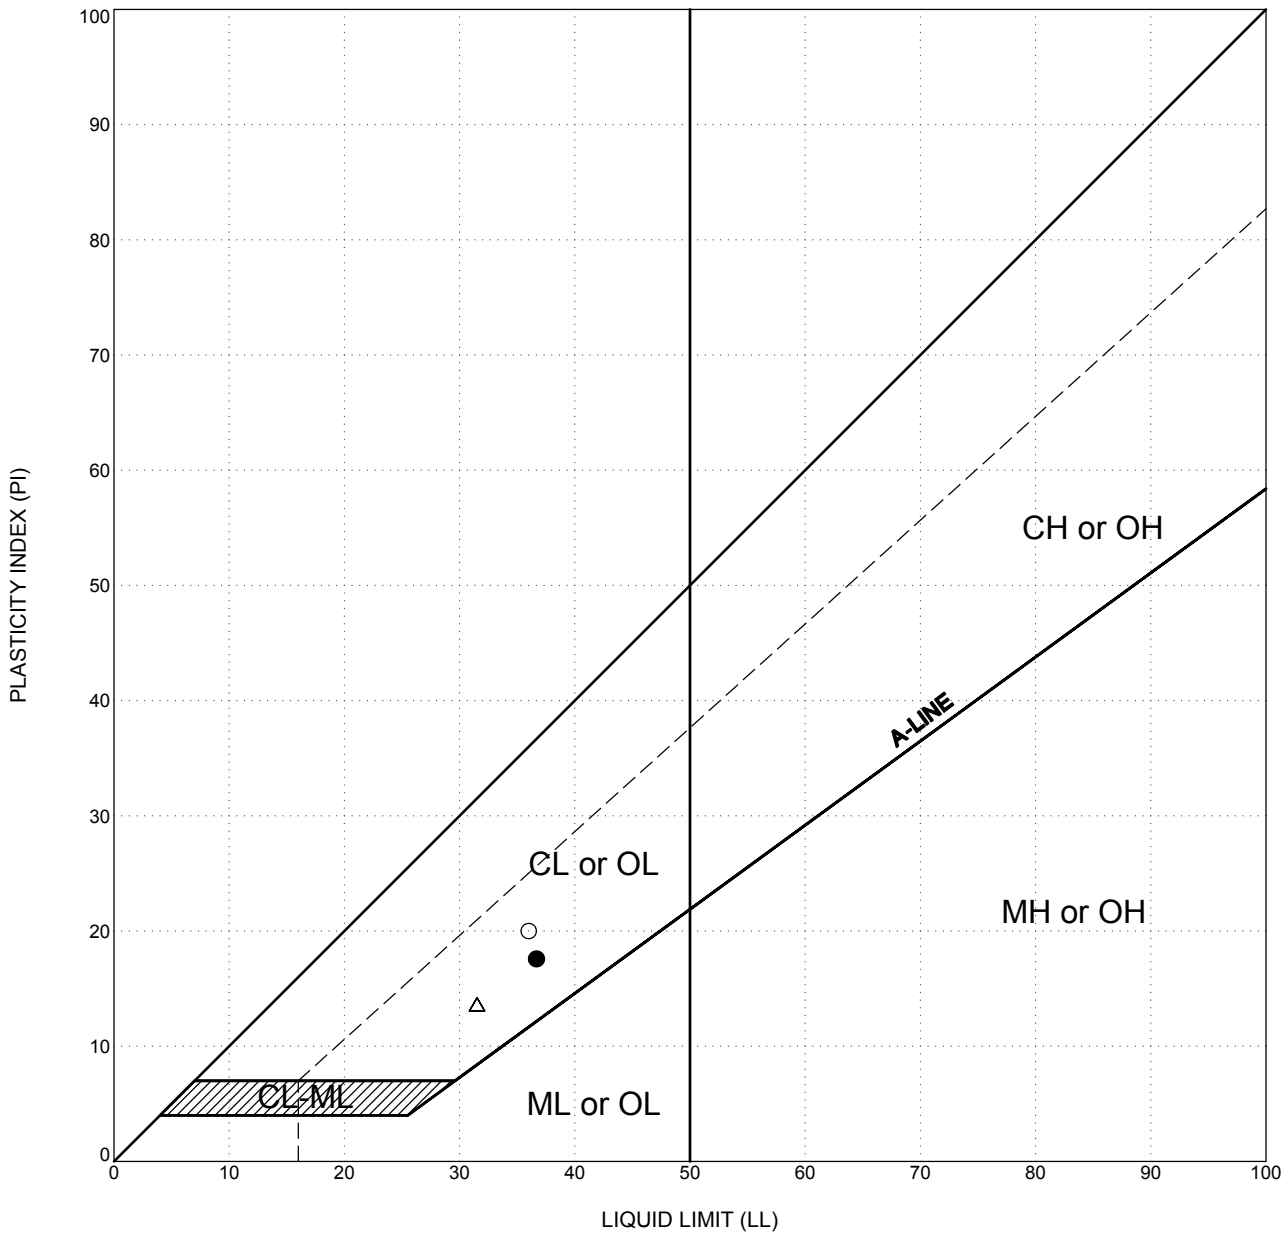
PLATE B-2

LEGEND	location	depth, ft	CLASSIFICATION	ATTERBERG LIMITS TEST RESULTS LIQUID LIMIT(LL)	PLASTIC LIMIT(PL)	PLASTICITY INDEX (PI)
○	DH-1	0.0	Clayey SAND with gravel (SC)	36	16	20
●	DH-1	5.0	Lean CLAY (CL)	37	19	18
△	DH-1	23.0	CLAYSTONE (Cx), "Lean CLAY (CL)"	32	18	14

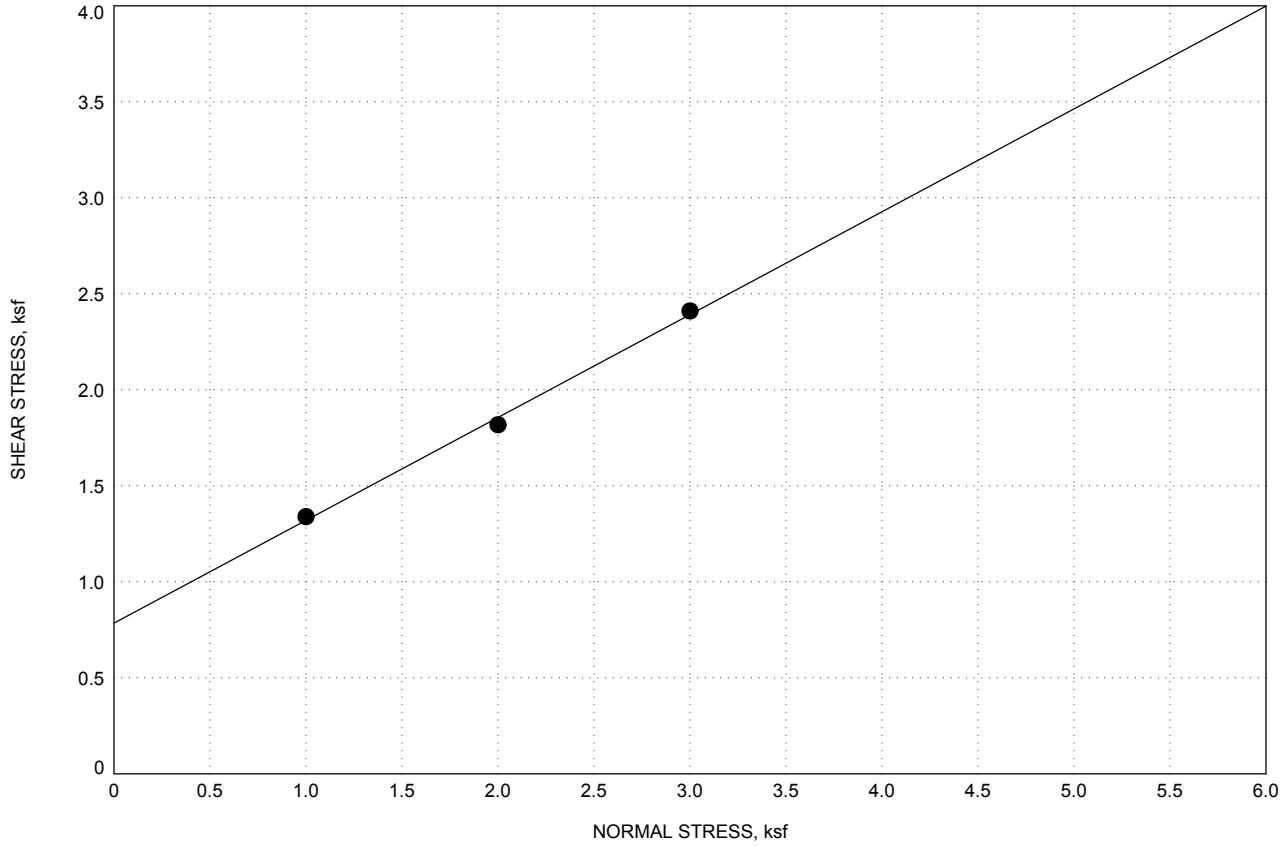
PLATE B-3a

COHESION, ksf	0.8
ANGLE OF INTERNAL FRICTION, deg	28

LOCATION	DH-1
DEPTH, ft	0
MOISTURE CONTENT, %	11
UNIT DRY WEIGHT, pcf	120
MATERIAL DESCRIPTION	Clayey SAND with gravel (SC)
SAMPLE CONDITION	Remold

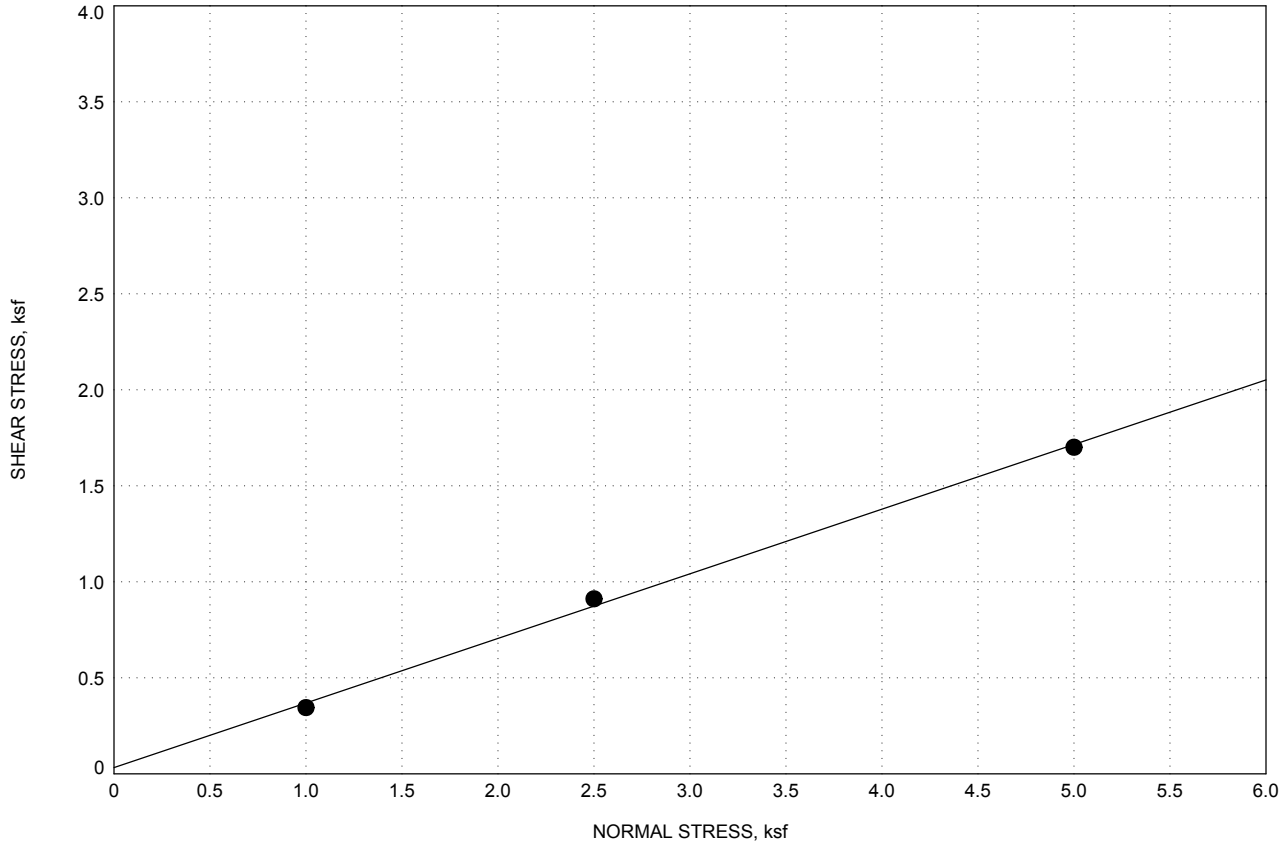
PLATE B-3b

COHESION, ksf	0.0
ANGLE OF INTERNAL FRICTION, deg	19
LOCATION	DH-1
DEPTH, ft	10
MOISTURE CONTENT, %	6
UNIT DRY WEIGHT, pcf	120
MATERIAL DESCRIPTION	CLAYSTONE (Cx), "Lean CLAY (CL)"
SAMPLE CONDITION	Ring - Precut shear plane

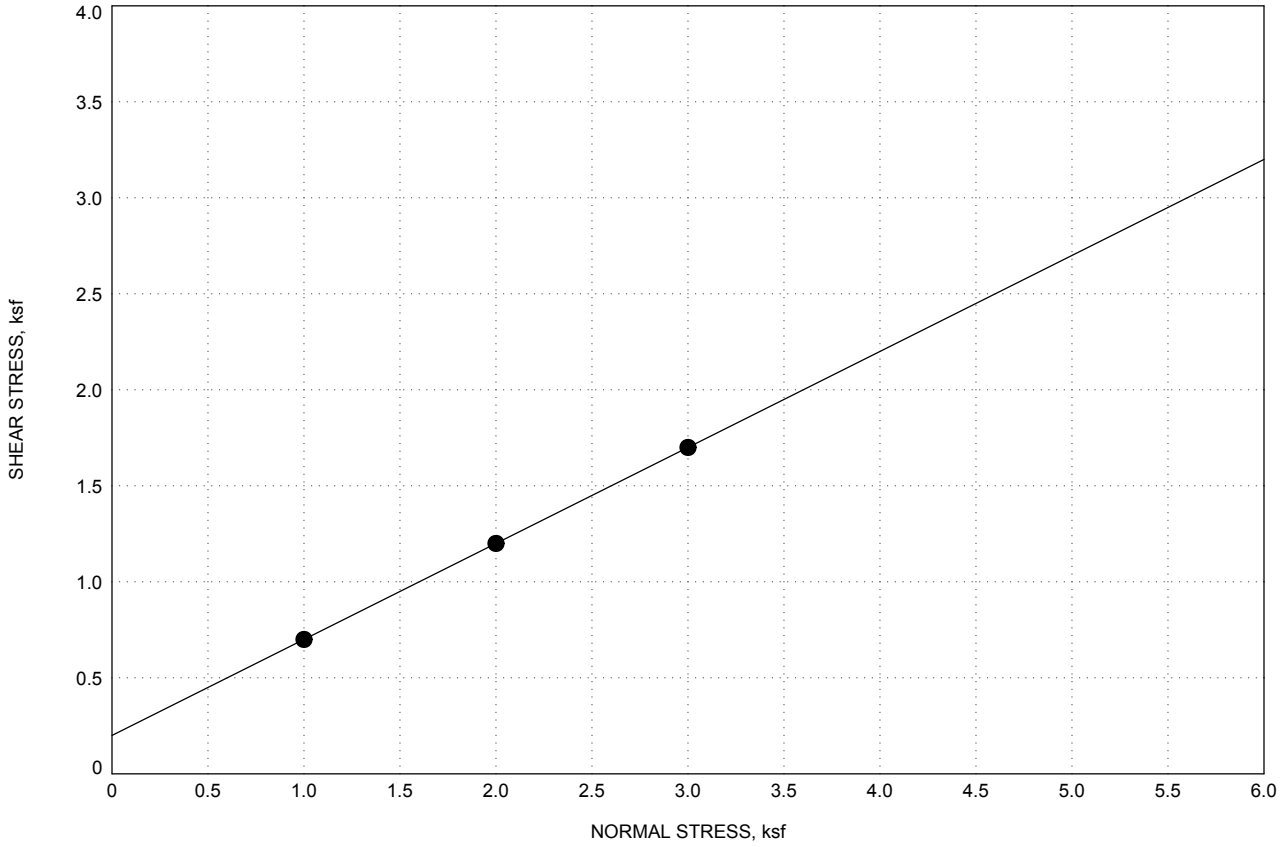
PLATE B-3c

COHESION, ksf	0.2
ANGLE OF INTERNAL FRICTION, deg	27
LOCATION	DH-1
DEPTH, ft	43
MOISTURE CONTENT, %	
UNIT DRY WEIGHT, pcf	
MATERIAL DESCRIPTION	CLAYSTONE (Cx), "Lean CLAY (CL)"
SAMPLE CONDITION	Ring Sample

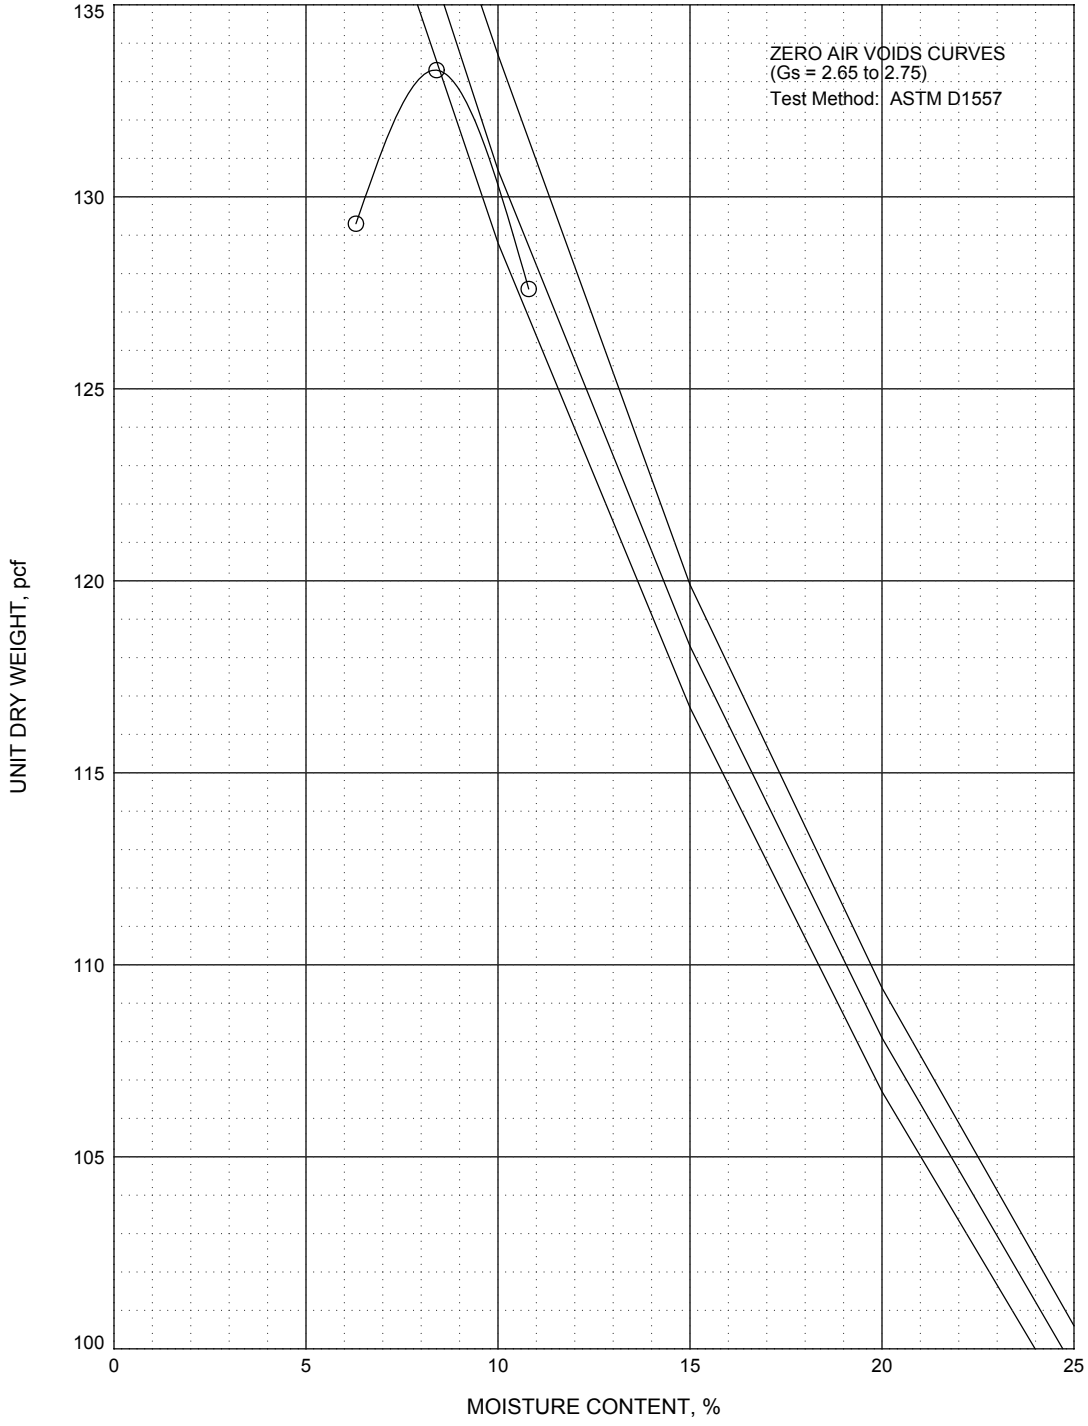
LEGEND	(location)	(depth), ft	CLASSIFICATION	MAXIMUM UNIT DRY WEIGHT, pcf	OPTIMUM WATER CONTENT, %
○	DH-1	0.0	Clayey SAND with gravel (SC)	133.3	8.4

COMPACTION TEST RESULTS
Santa Rosa Creek Road Slipout
San Luis Obispo County, California

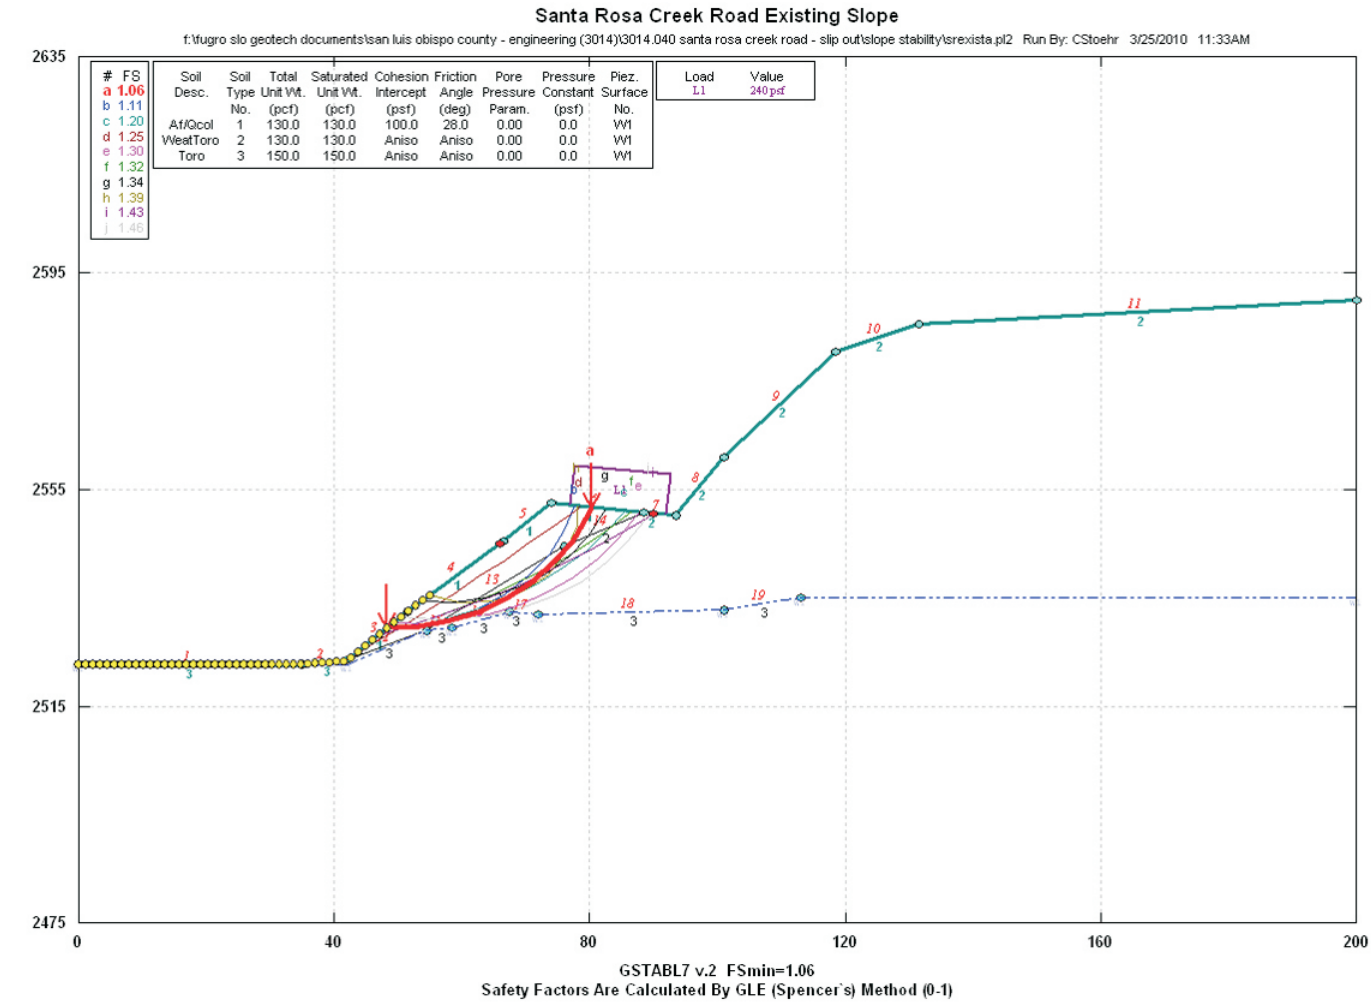
PLATE C-2

The observed instability of the existing slope appears to be influenced by erosion of the toe of the slope along Rocky Creek, the presence of adversely oriented joint sets within the Toro

Formation that weaken the rock mass relative to slope stability, and potential groundwater seepage or increased moisture conditions within the rock. Additionally, the upper portion of the slope appears to have been inclined to about 1.1h:1v within the overlying artificial fill and colluvium soil units. The approximately 1h:1 inclination is generally too steep and potentially unstable for a soil slope. The estimated factor of safety is approximately 0.9 for the previous slope condition considered (with the slope assumed to be inclined to about 1.1 prior to the slope failure along the section analyzed). The estimated factor of safety for the existing slope condition is approximately 1.06 (with the slope inclined to about 0.5h:1v to 1:1h:v along the section analyzed). The existing slope is considered potentially unstable, and the estimated failure surfaces associated with instability of the slope would likely extend into Santa Rosa Creek Road.

Static Loading Condition: 1.06

SLOPE STABILITY PLOT - EXISTING SLOPE
Santa Rosa Creek Road Slipout
San Luis Obispo County, California

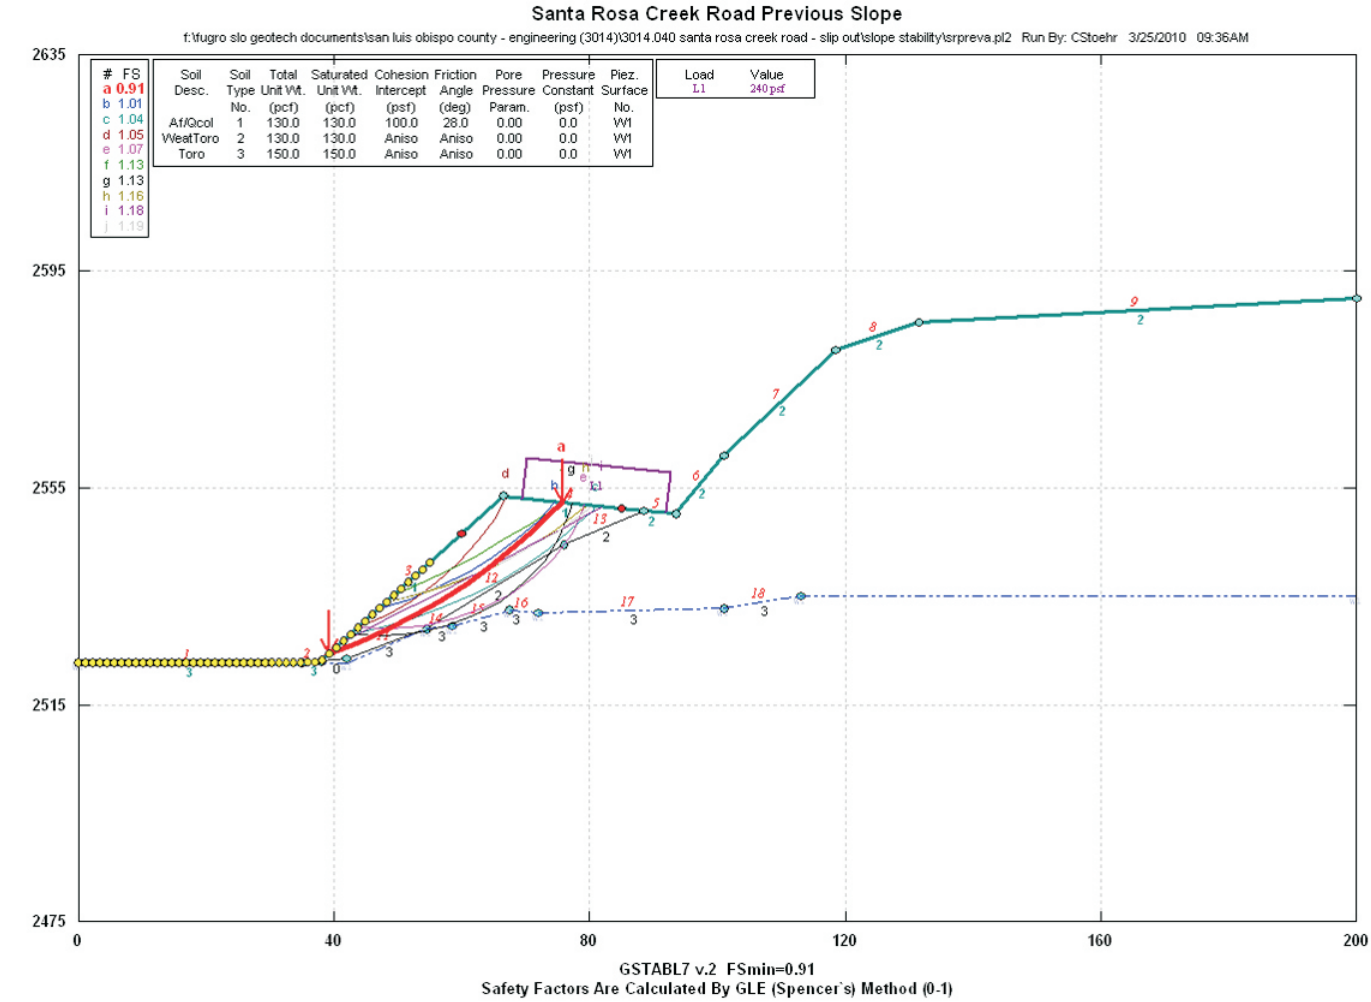
PLATE C-3

SLOPE STABILITY PLOT - PREVIOUS SLOPE CONDITION
Santa Rosa Creek Road Slipout
San Luis Obispo County, California
