GEOLOGIC COASTAL BLUFF EVALUATION UPDATE
THE COTTAGES AT POINT SAN LUIS
APN: 076-174-009, AVILA BEACH AREA
SAN LUIS OBISPO COUNTY, CALIFORNIA

OCTOBER 6, 2016 (Rev. 1)

PROJECT NO. SL03926-7

GEO Solutions

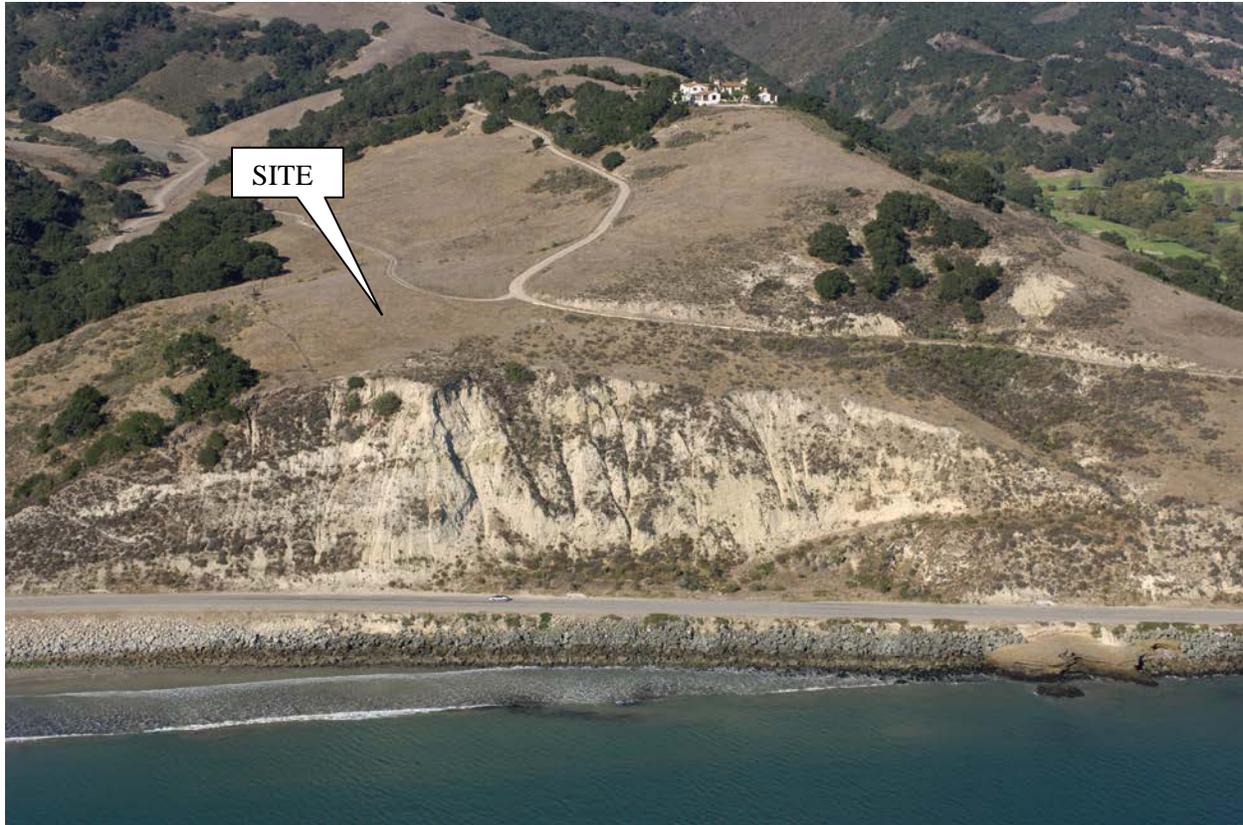
Figure 3: Photograph of the Site – 2005 (Adelman, 2002-2015)

“A marginally stable mass estimated to be approximately 2600-yds³ remain near the top of the slope. The mass is over-steepened and unsupported and will likely fail in the near future.” Grading was performed by the County of San Luis Obispo including removal of the marginally stable mass at the top of bluff and constructing a 1:1 buttress fill slope along the base of the slope. Documentation of the work performed was not available at the time of this report. Figure 2 and 3 shows a photograph of the site before and after grading (Adelman, 2002-2015).

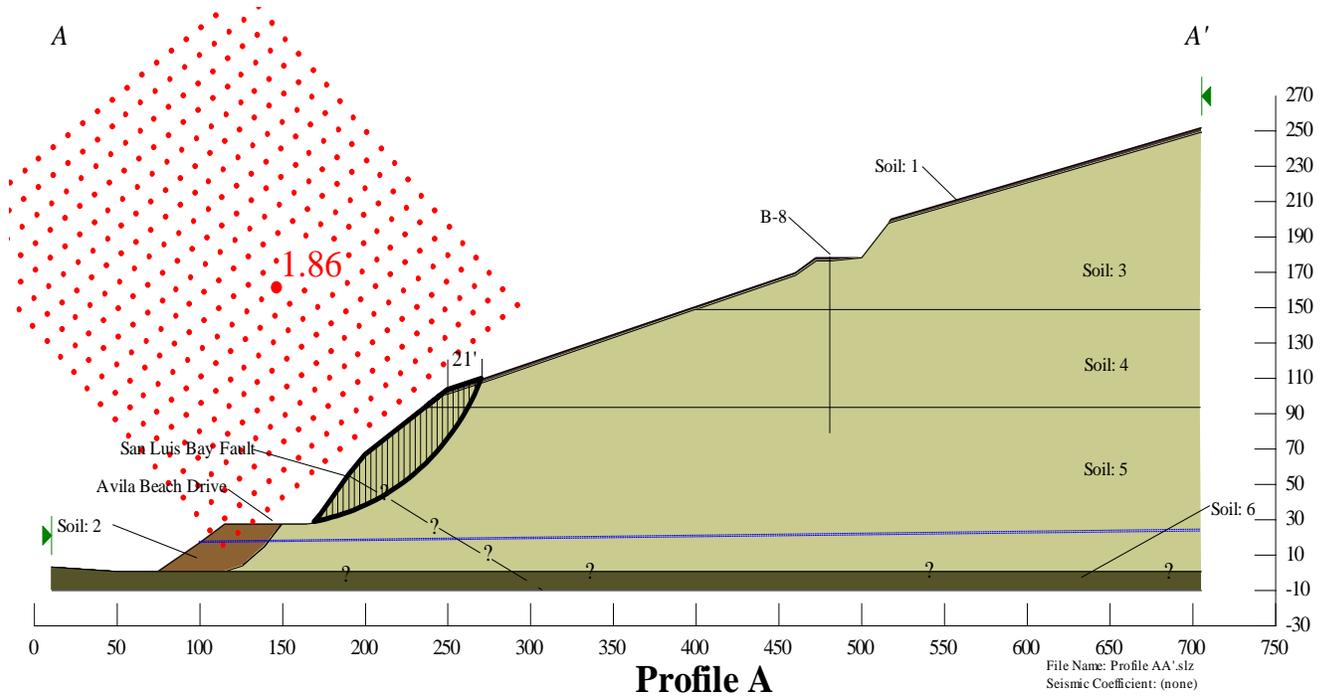
Figure CA-1A: Profile A-A' (Static Analysis)

distance from the top of the bluff to the back of the potential slip surface varying from 13 to 27 feet. The psuedo-static analysis resulted in a varying factor of safety of 1.1 to 1.8 with a horizontal distance from the top of the bluff to the back of the potential slip surface varying from 12 to 27 feet. The horizontal distance for Profiles A through F from the top of bluff to the potential critical slip surface, as well as the respective factor of safety values are presented in Table C-2. Figures C-1 through C-6 illustrate Profiles A through F with the potential slip surfaces and their respective horizontal distances for static and psuedo-static conditions.

The factor of safety values for Profile A (static and pseudo-static), Profile D (static and pseudo-static), and Profiles E and F (static and pseudo-static) are greater than the 1.5 and 1.1 required for determining the horizontal distance for setback from the bluff top. However, these values represent the critical factor of safety and therefore factors of safety 1.5 and 1.1 for static and pseudo-static analysis, respectfully, are exceeded with the modeling conditions utilized. The horizontal distances for these cases were determined from the potential slip surfaces associated with the critical factor of safety.

1. It is recommended that proposed development be setback the combined distance of the 100-year retreat rate with an additional buffer factor of 23-feet as measured from the existing bluff top. This would be a setback of 36 feet for the western portion and 59 feet for the eastern portion plus an additional 23-foot slope stability buffer for a resulting setback would be 59 and 82 feet (western portion and eastern portion respectively). Plate 1 and 3 depict the 100-year setback with the additional 23-foot slope stability buffer as measured from the top of bluff. This setback line should be established in the field as a series of stakes prior to initiation of construction and for layout of all structures.
