Waterway Management Program Hydraulic Performance Update

Public Works
Water Resources

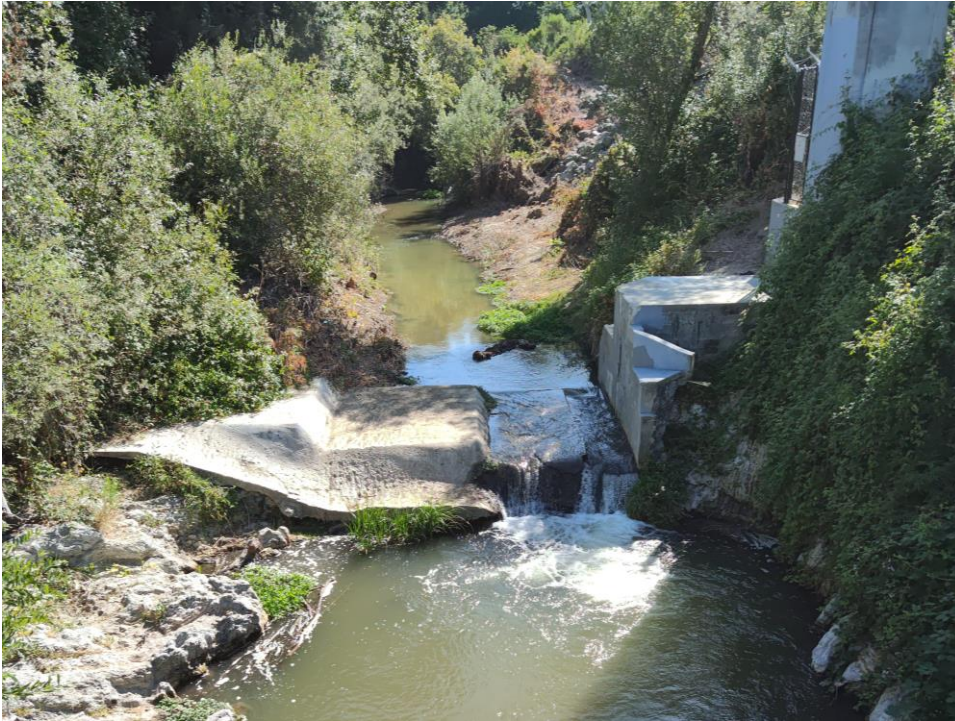
Arroyo Grande Creek Gage

Entire analysis relies on calibration to rating curve-derived discharge estimates at these two stations.

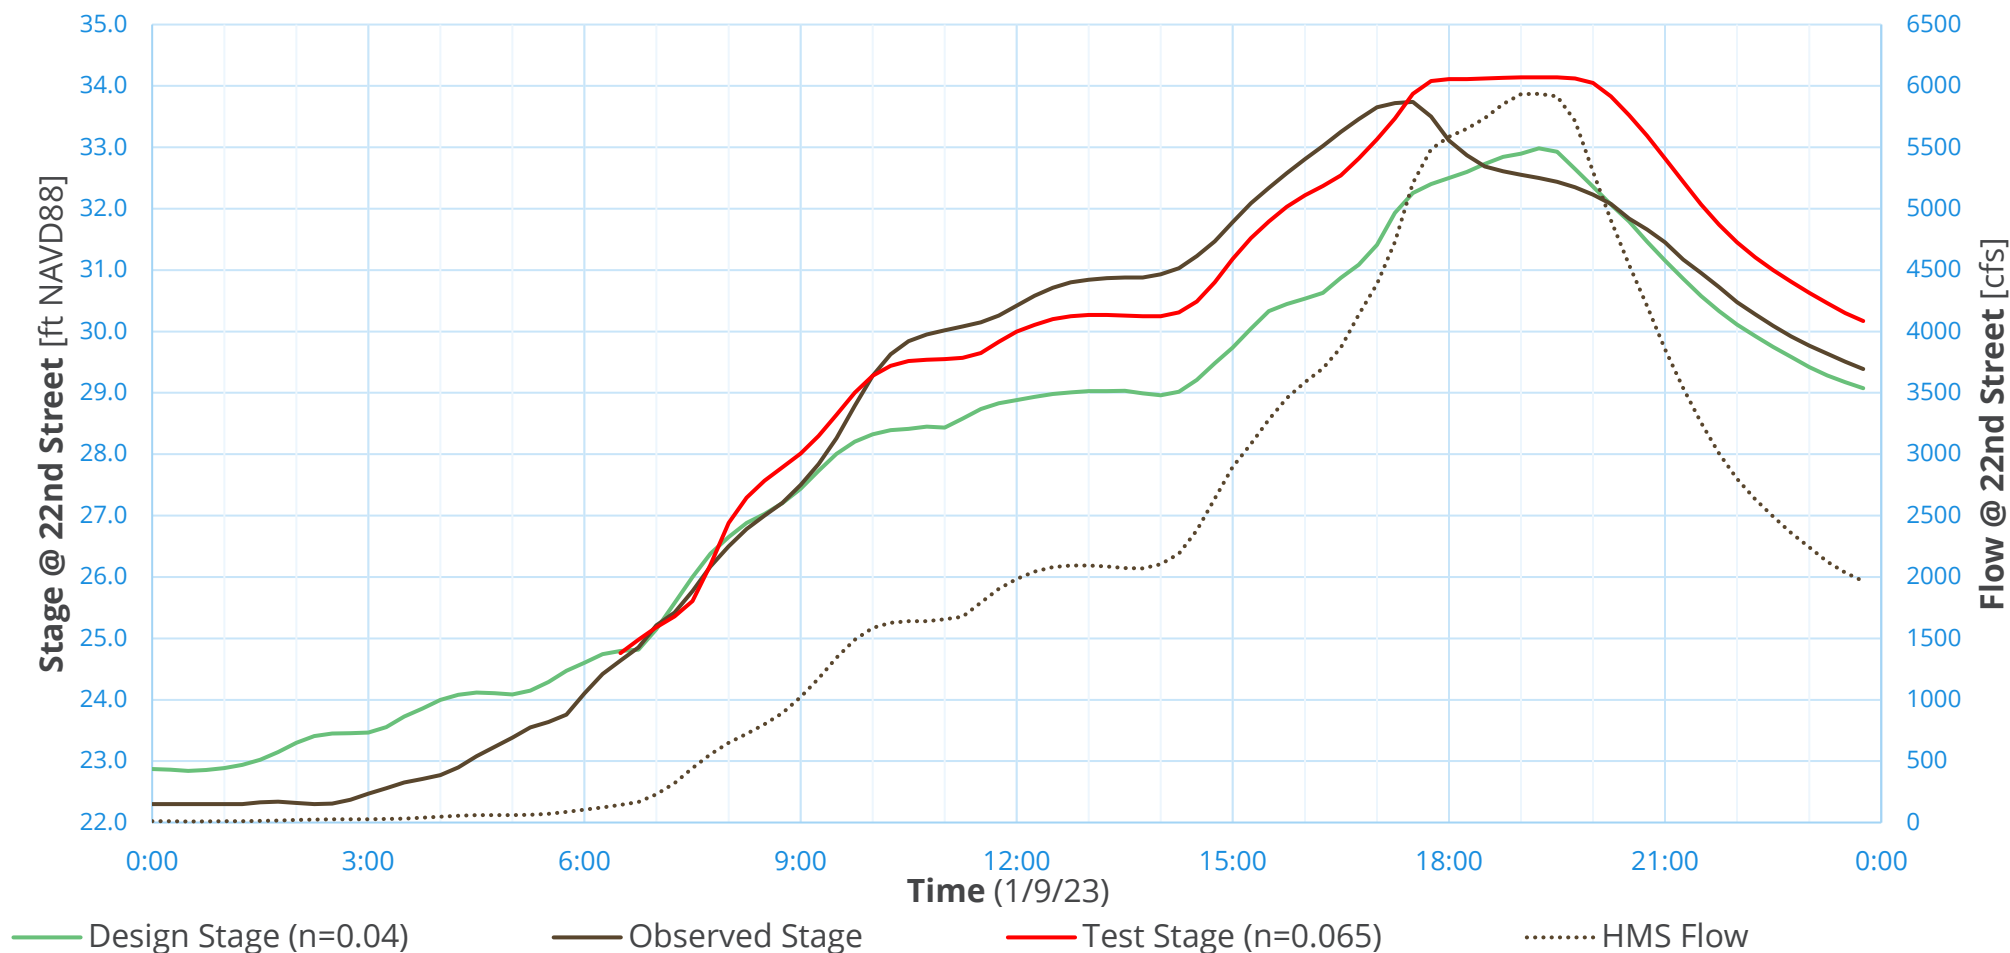
- Sediment removal and levee raise beneficial
- Permitted vegetation maintenance not in accordance with design assumptions
- Assumed performance
 - North: 10-year / 10% annual chance (from 20-year / 5%)
 - South: 5-year / 20% annual chance (from 10-year / 10%)
