**Project Name  
(as found on  
Certification):** Arroyo Grande Creek Channel Waterway Management  
Program

# Arroyo Grande Creek Channel Waterway Management Program

Regional Water Quality Control Board,  
Certification No. 34012WQ01 Annual Report

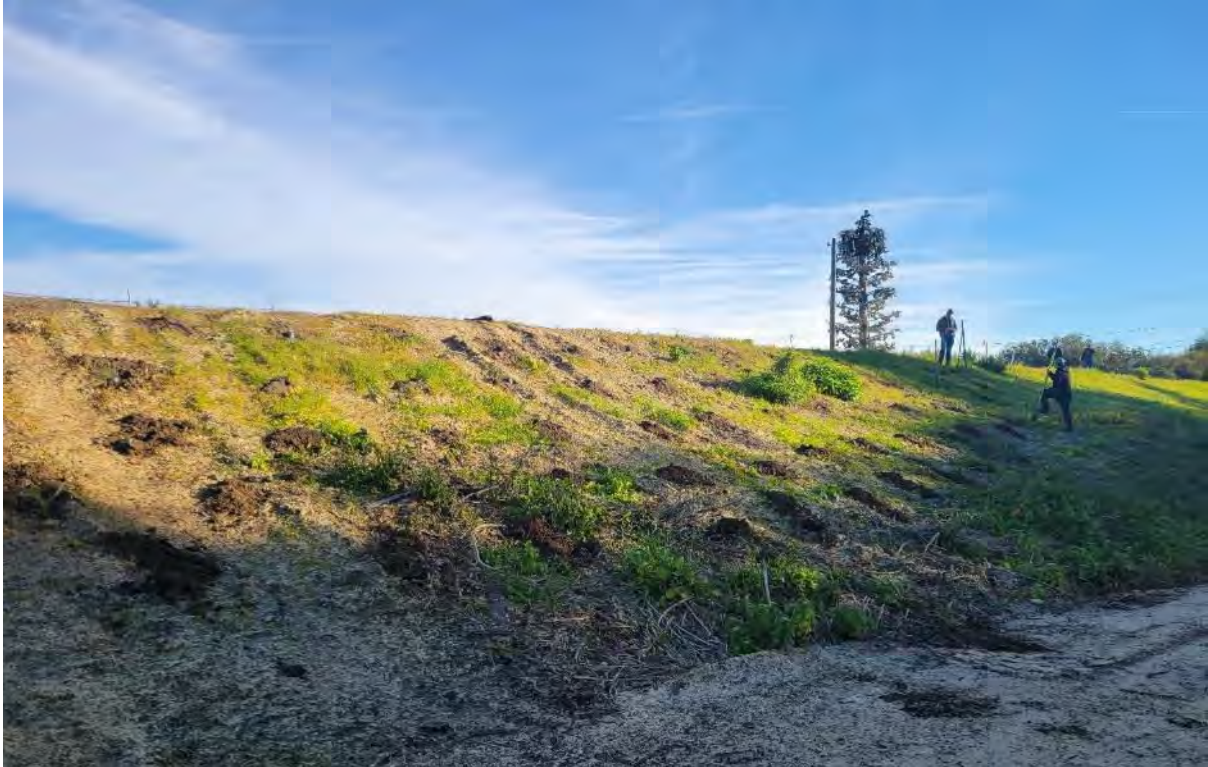
**Photograph 17.** Planting container plants at SMZ 7. December 2, 2025.

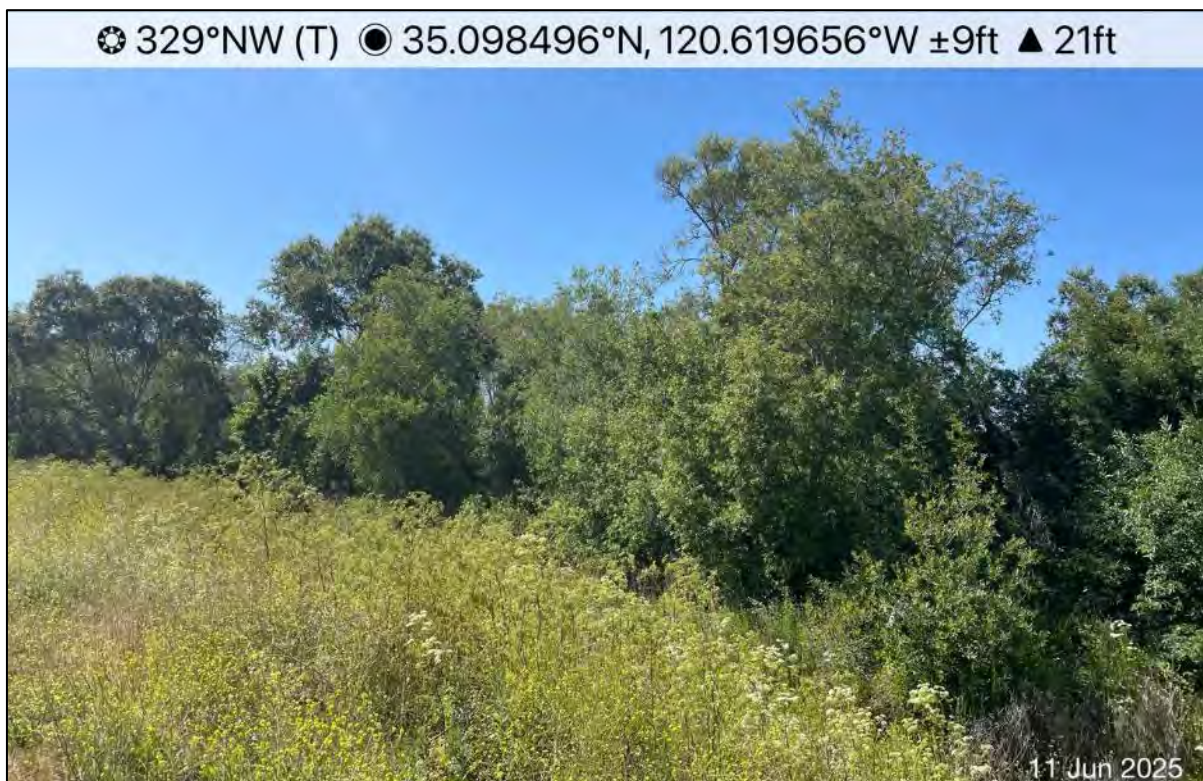
**Photograph 2.** View of SMZ 1, facing northwest. June 11, 2025.

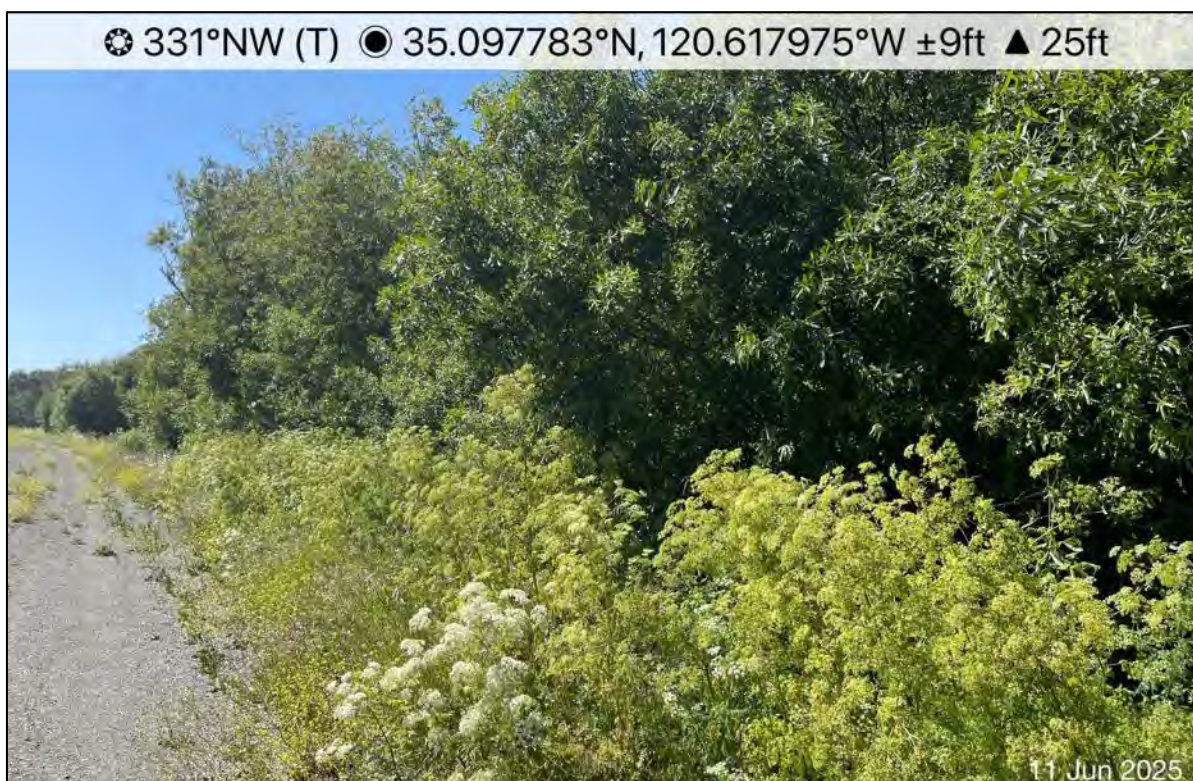
**Photograph 4.** View of SMZ 2, facing northwest. June 11, 2025.

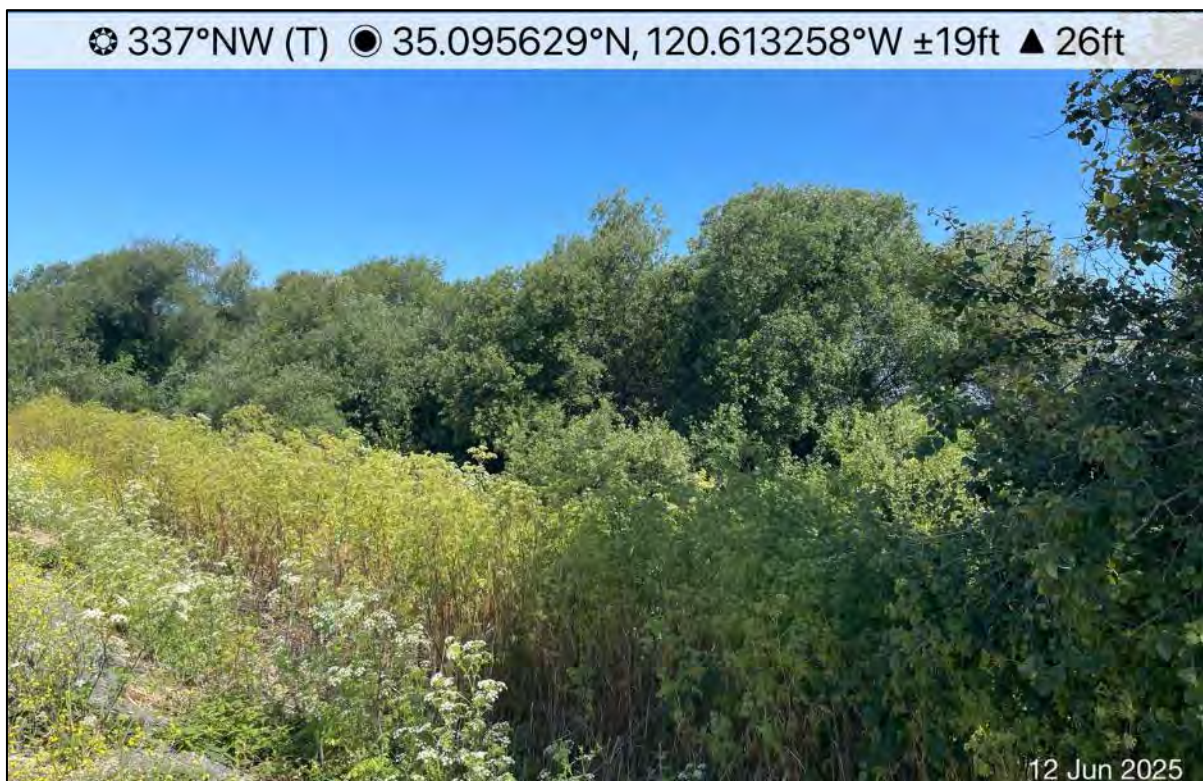
**Photograph 10.** View of SMZ 5, facing northwest. June 12, 2025.

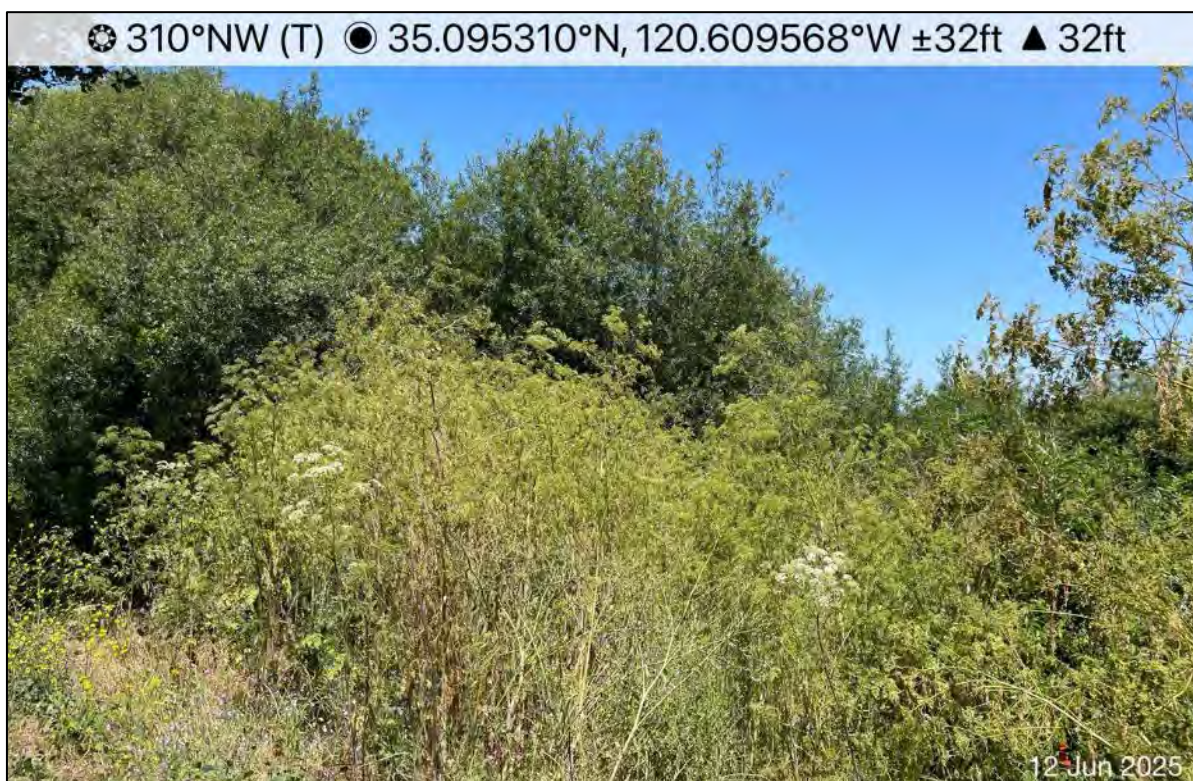
**Photograph 12.** View of SMZ 6, facing northwest. June 12, 2025.

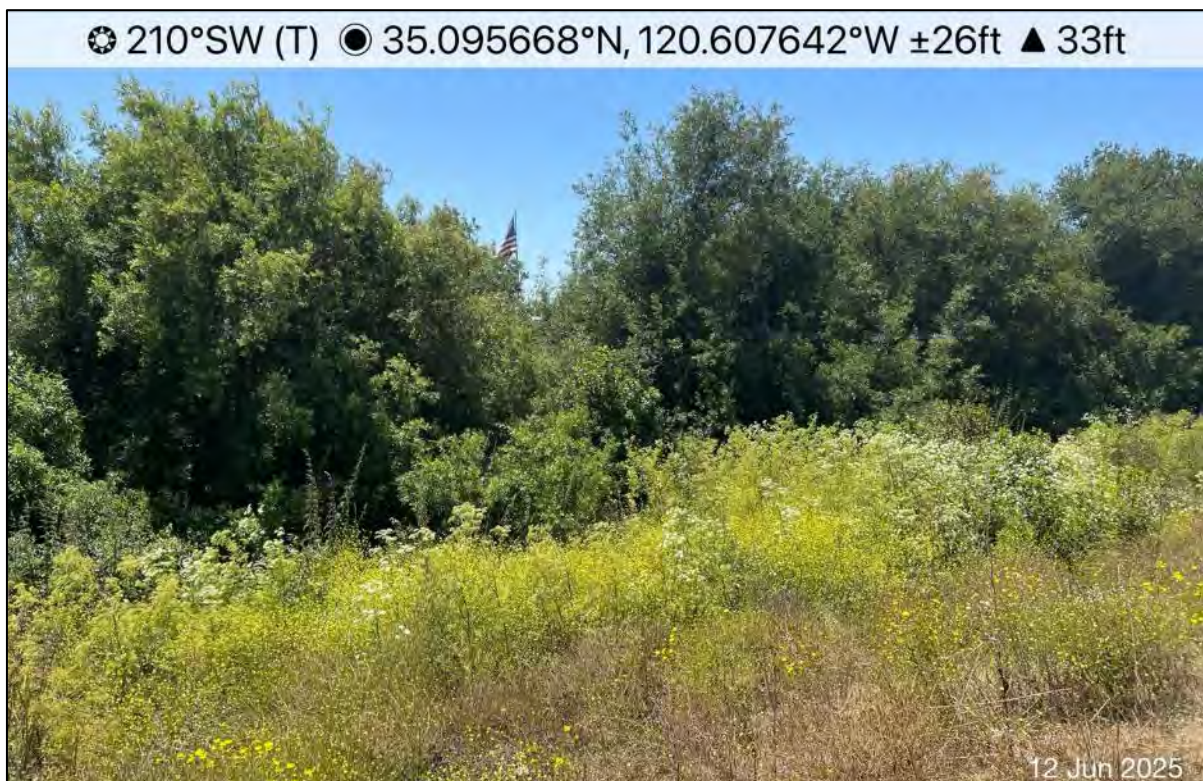
**Photograph 14.** View of SMZ 7, facing southwest. June 12, 2025.

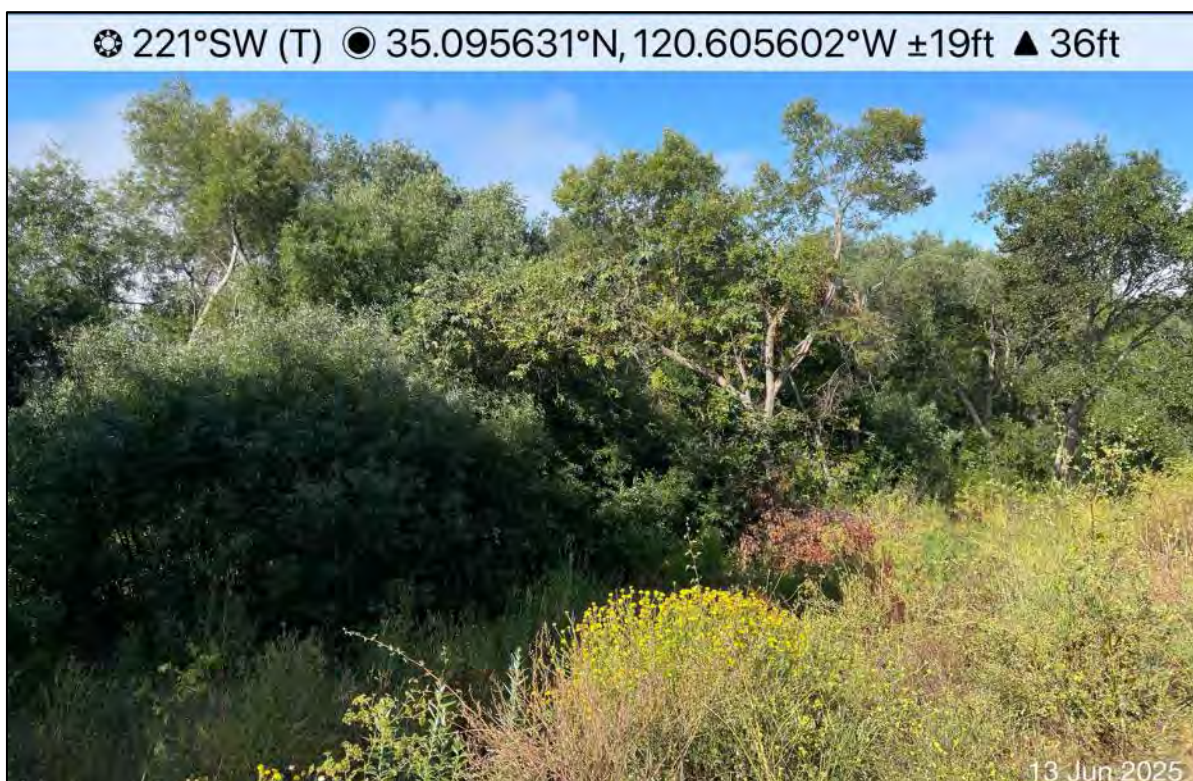
**Photograph 16.** View of SMZ 8, facing southwest. June 13, 2025.

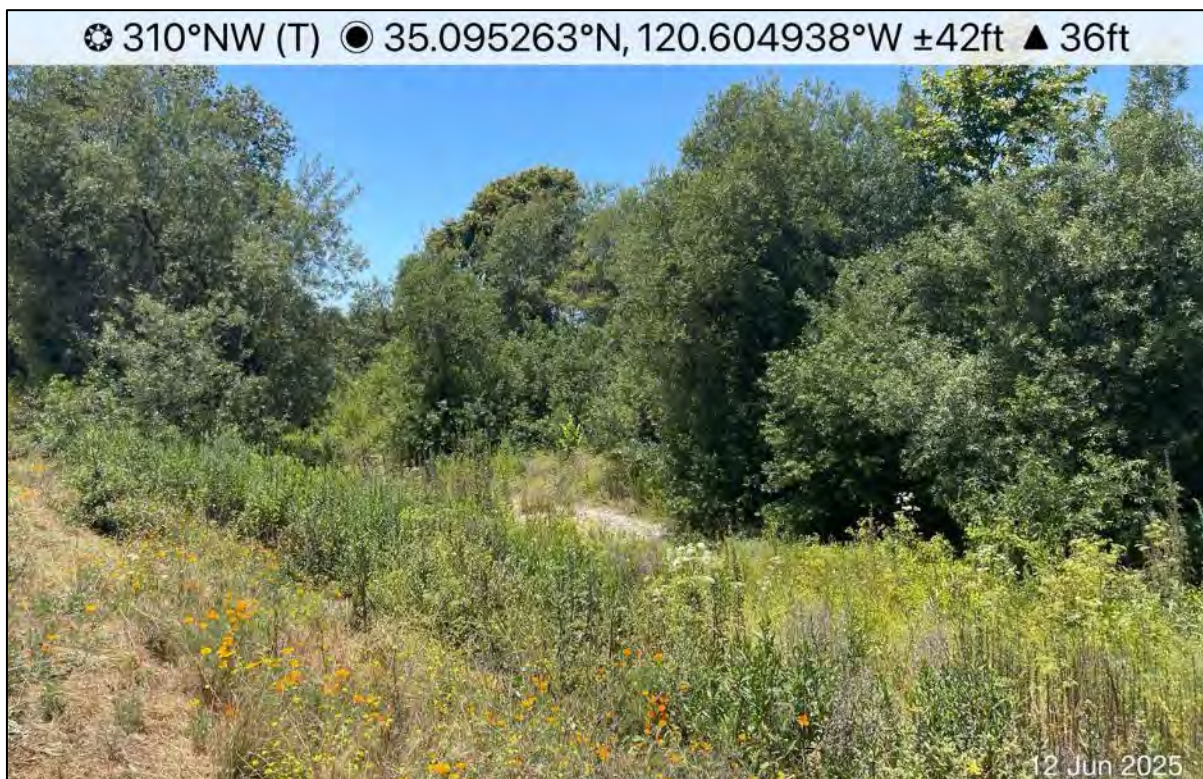
**Photograph 17.** View of SMZ 9, facing northeast. June 12, 2025.

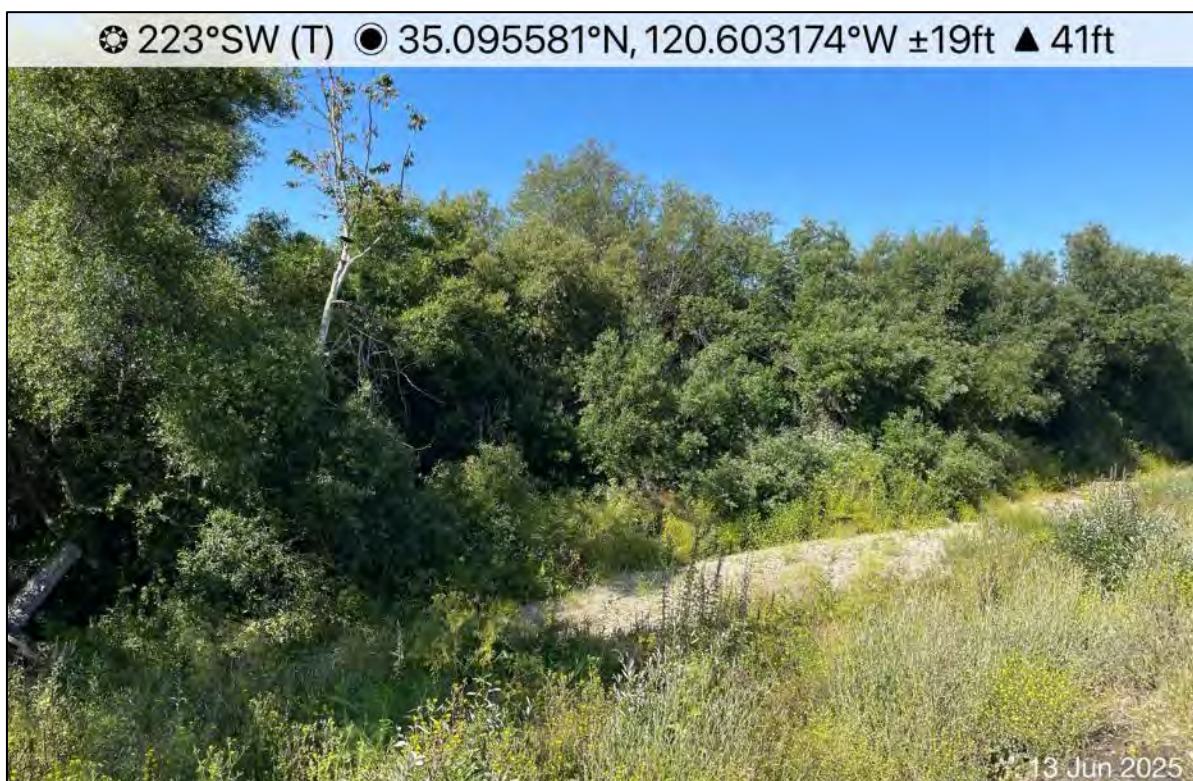
**Photograph 19.** View of SMZ 10, facing southeast. June 13, 2025.

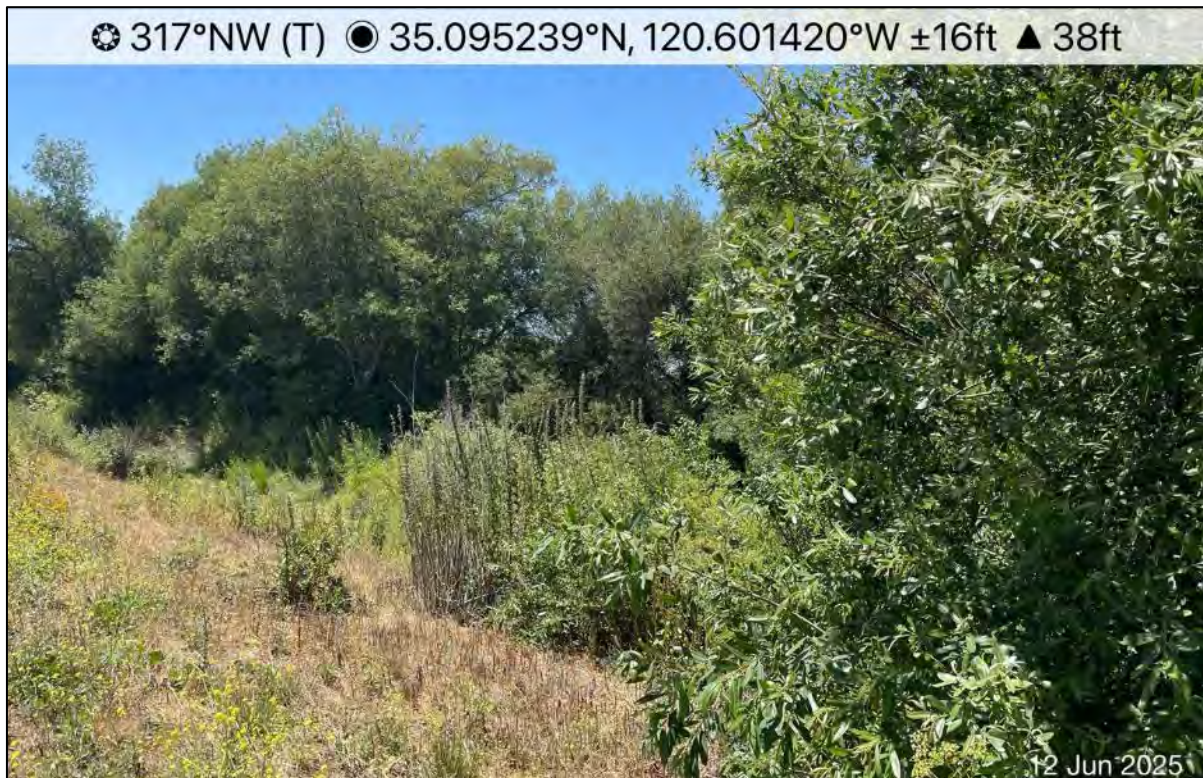
**Photograph 21.** View of SMZ 11, facing northeast. June 12, 2025.

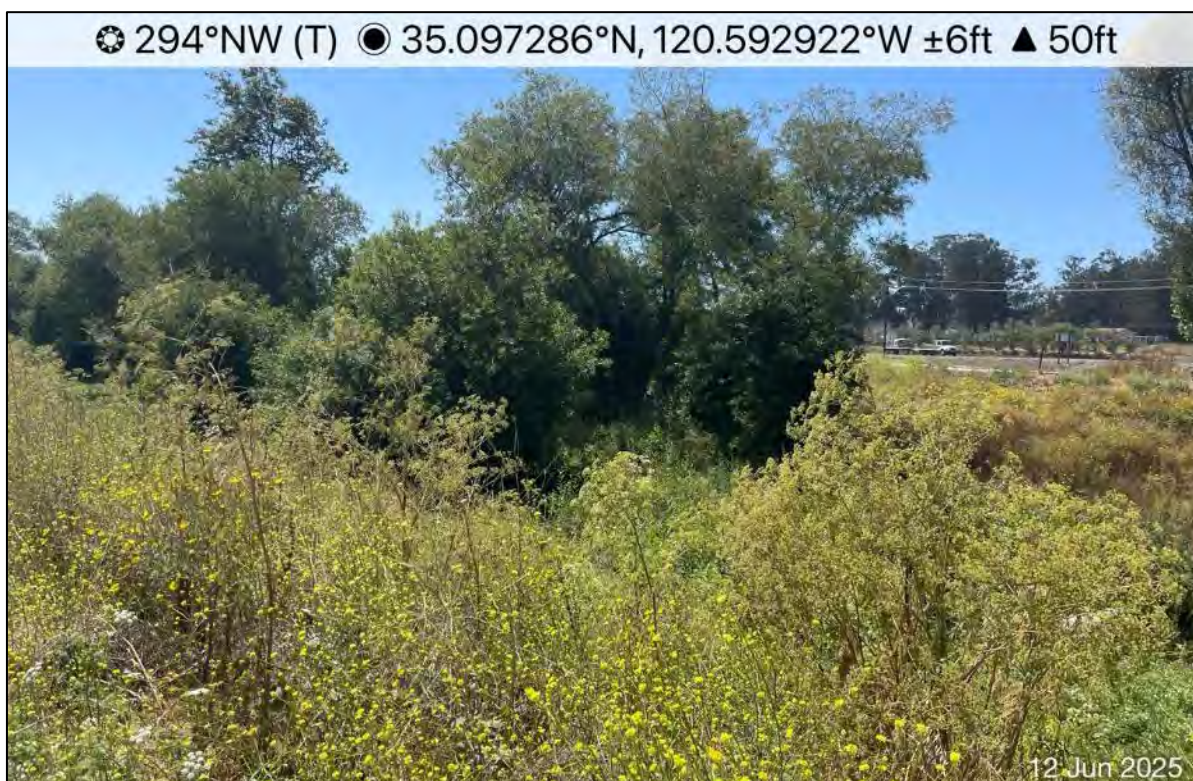
**Photograph 27.** View of SMZ 14, facing north. June 12, 2025.

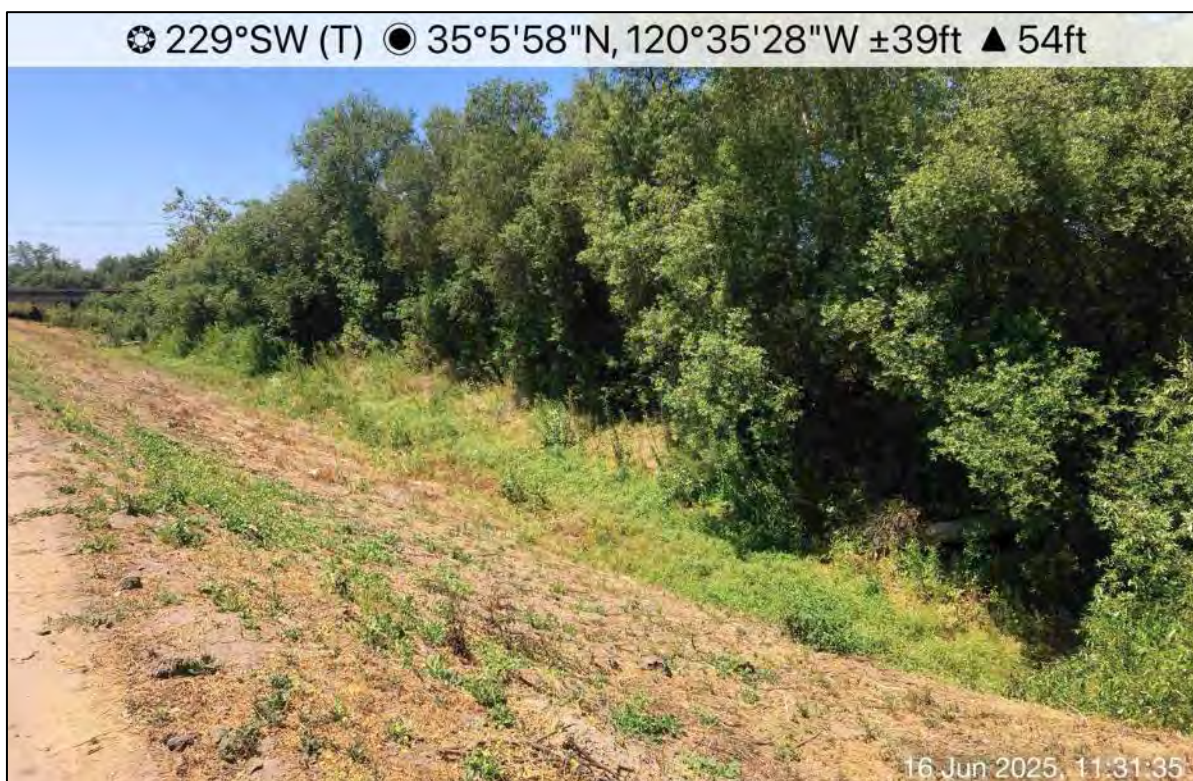
**Photograph 31.** View of SMZ 16, facing north. June 16, 2025.

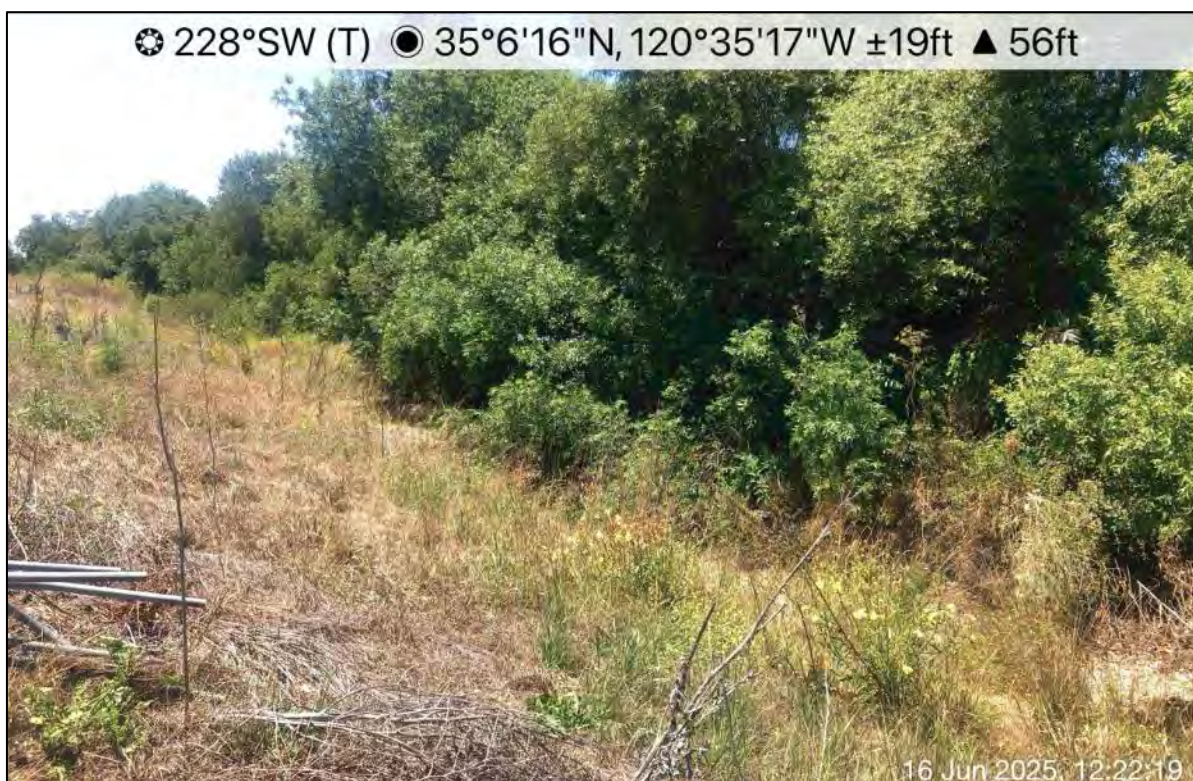
**Photograph 35.** View of SMZ 18, facing north. June 16, 2025.

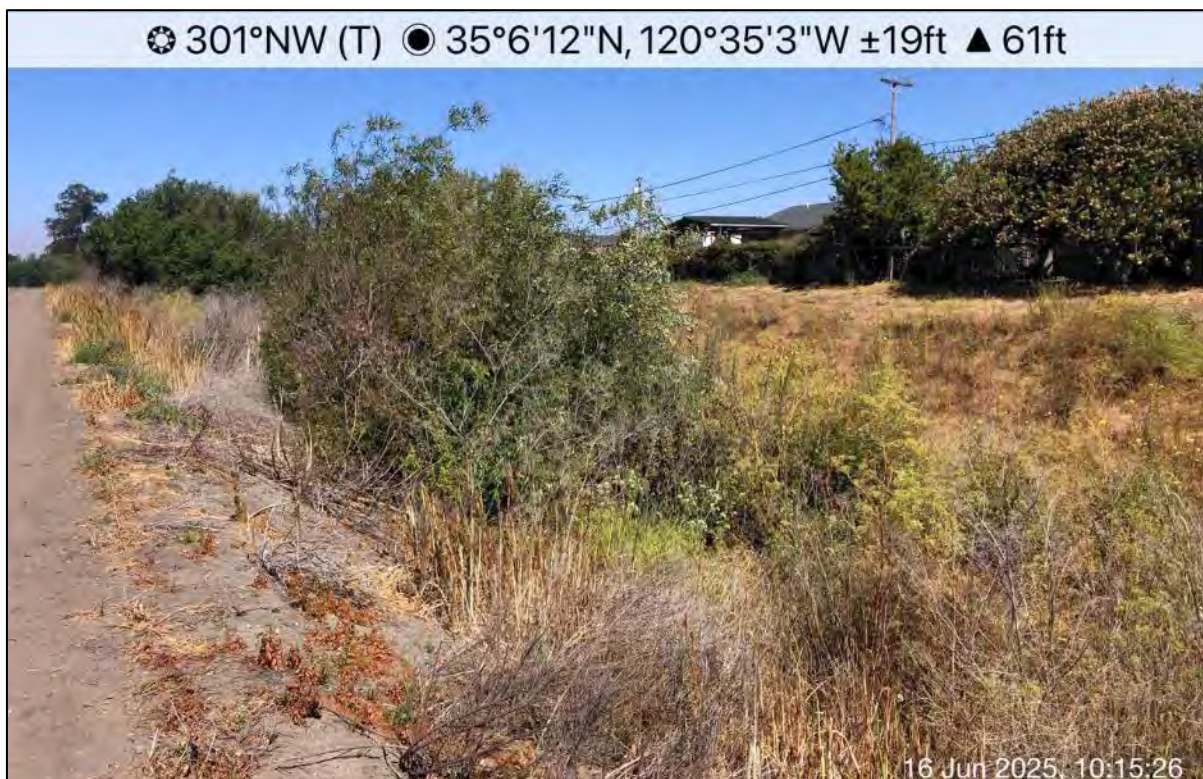
**Photograph 39.** View of SMZ 20, facing northeast. June 16, 2025.

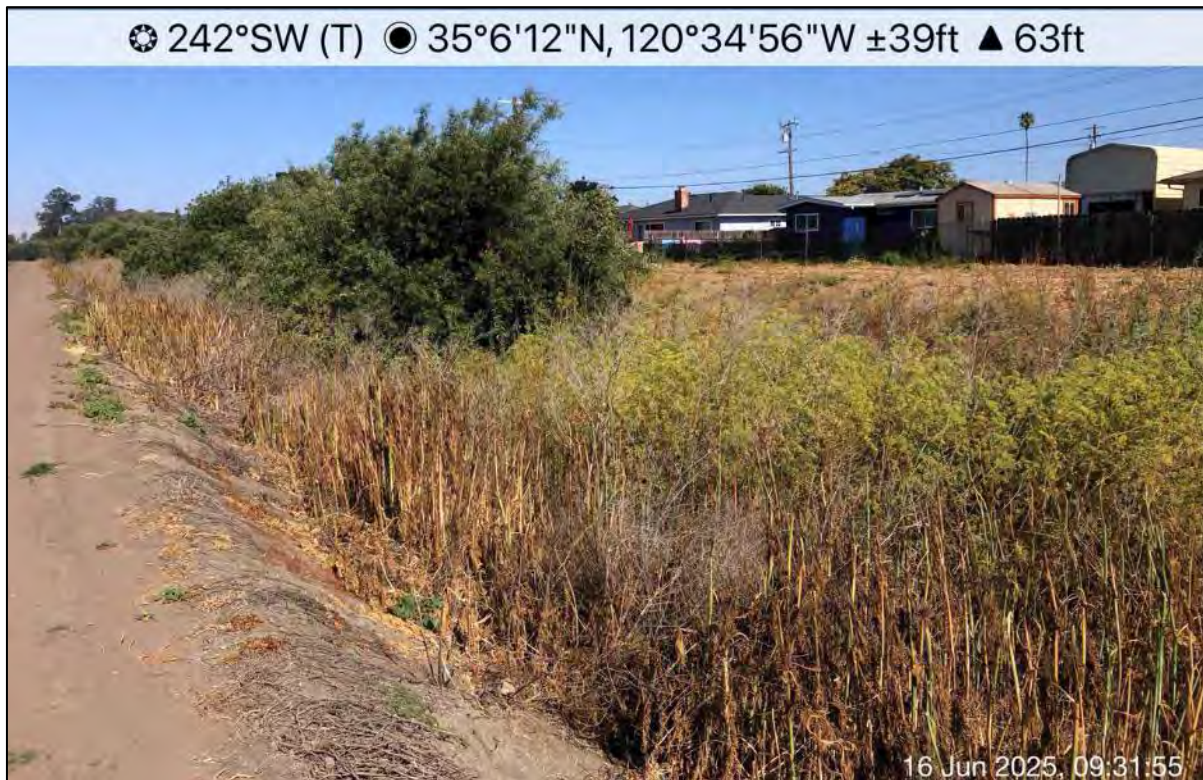
**Photograph 41.** View of SMZ 21, facing northeast. June 16, 2025.

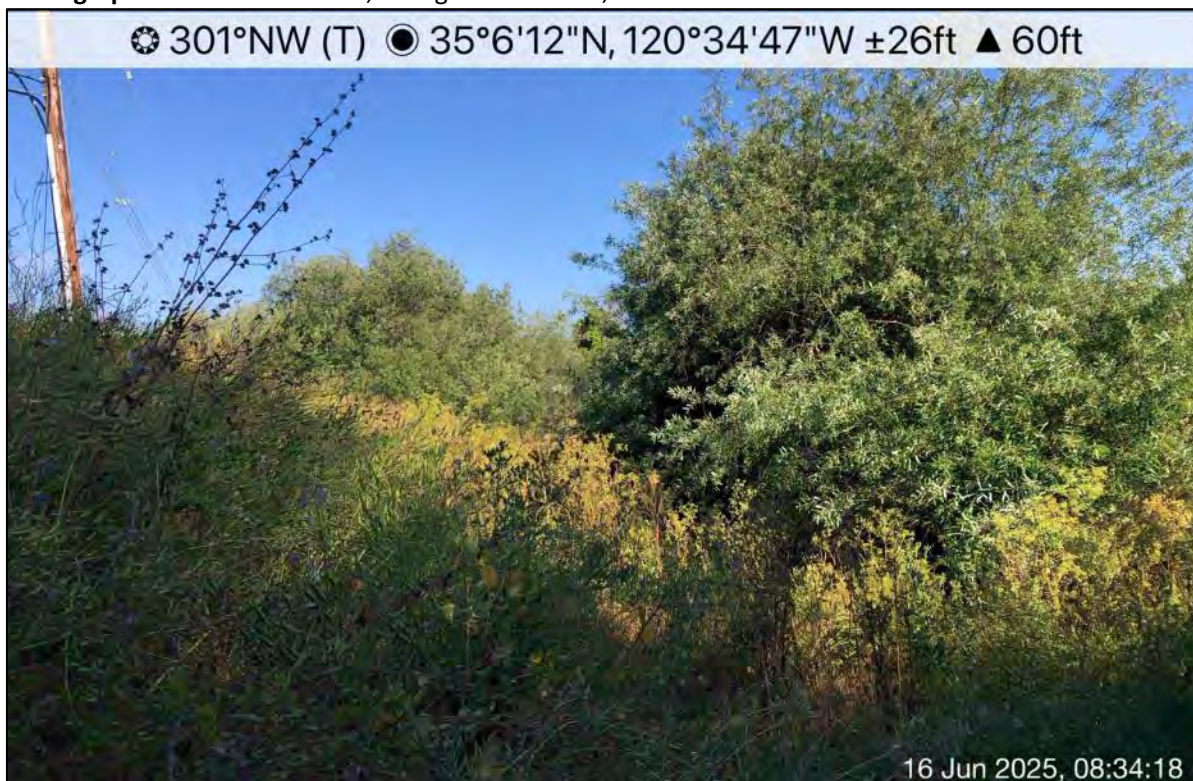
**Photograph 43.** View of SMZ 22, facing east. June 16, 2025.

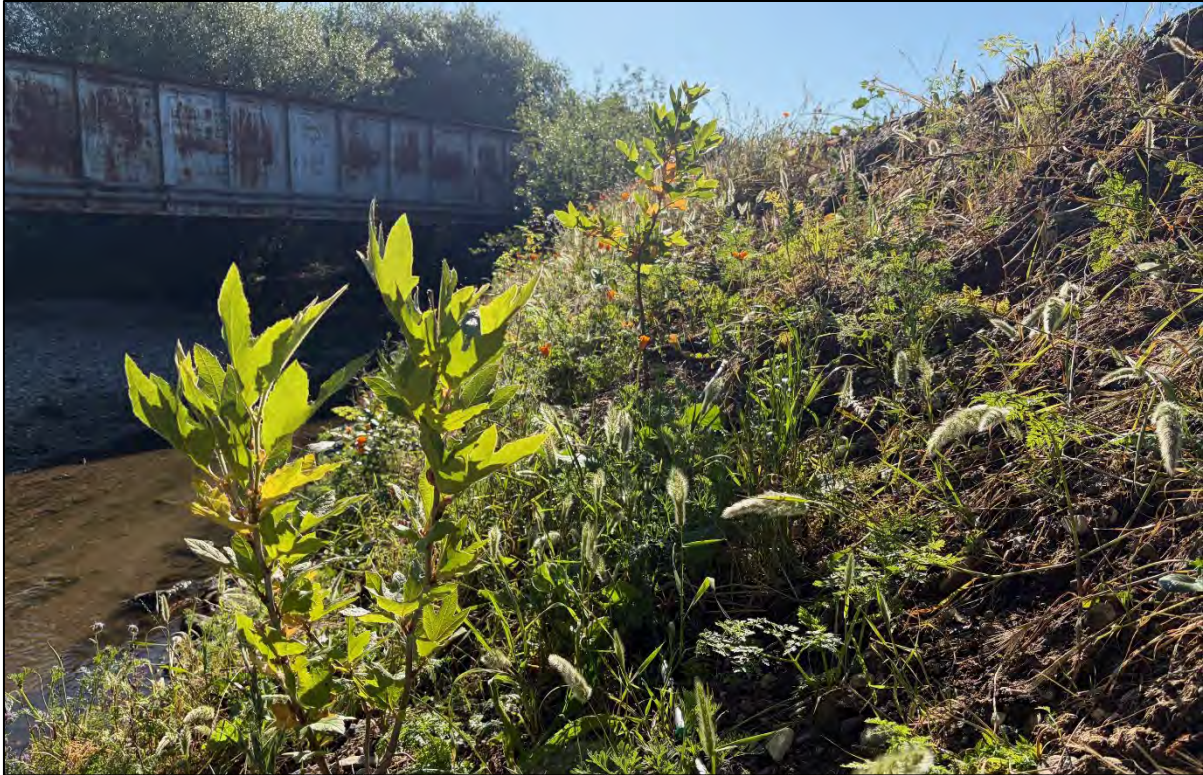
**Photograph 44.** View of SMZ 22, facing northwest. June 16, 2025.

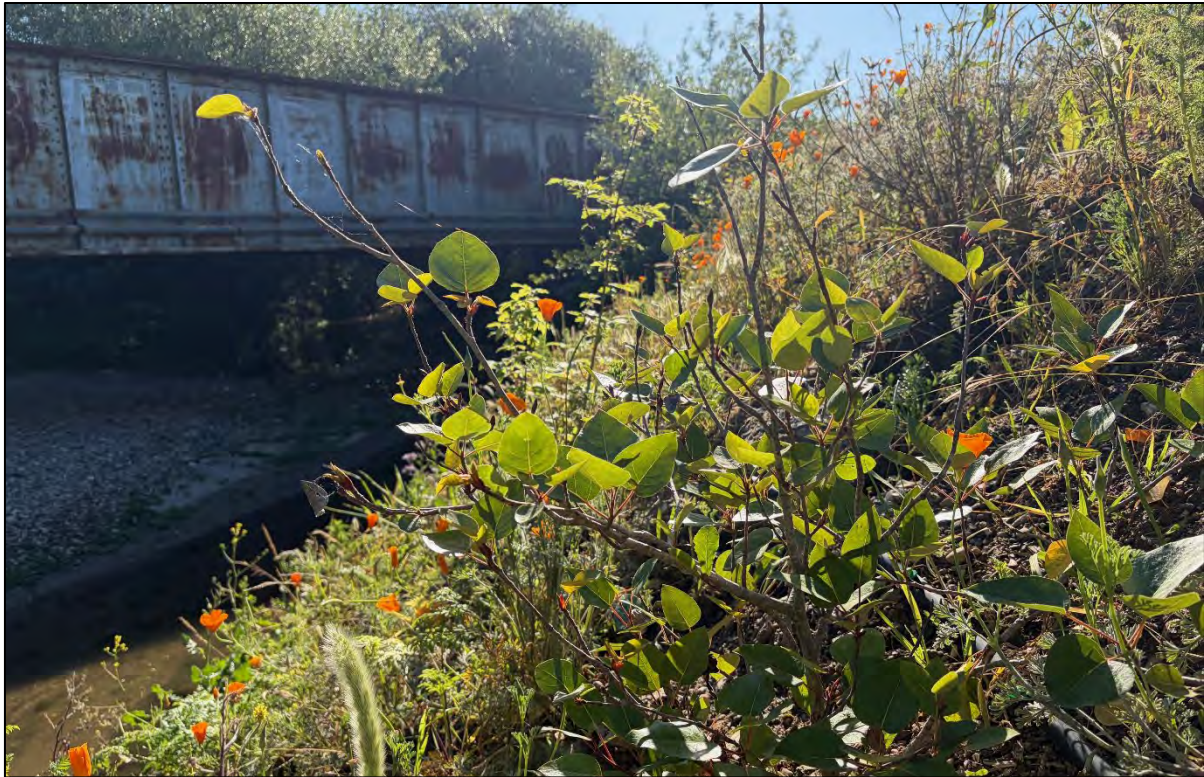
**Photograph 46.** White alder at the Breach Site planting area, facing west. April 14, 2026.
