**PRELIMINARY GEOTECHNICAL REPORT
ARROYO GRANDE CREEK WATERWAYS
MANAGEMENT PLAN
LOS BERROS CREEK TO NEAR OCEANO AIRPORT
SAN LUIS OBISPO COUNTY, CALIFORNIA**

Prepared for:
County of San Luis Obispo
Department of Public Works

April 22, 2009

April 22, 2009
Project No. 3014.029

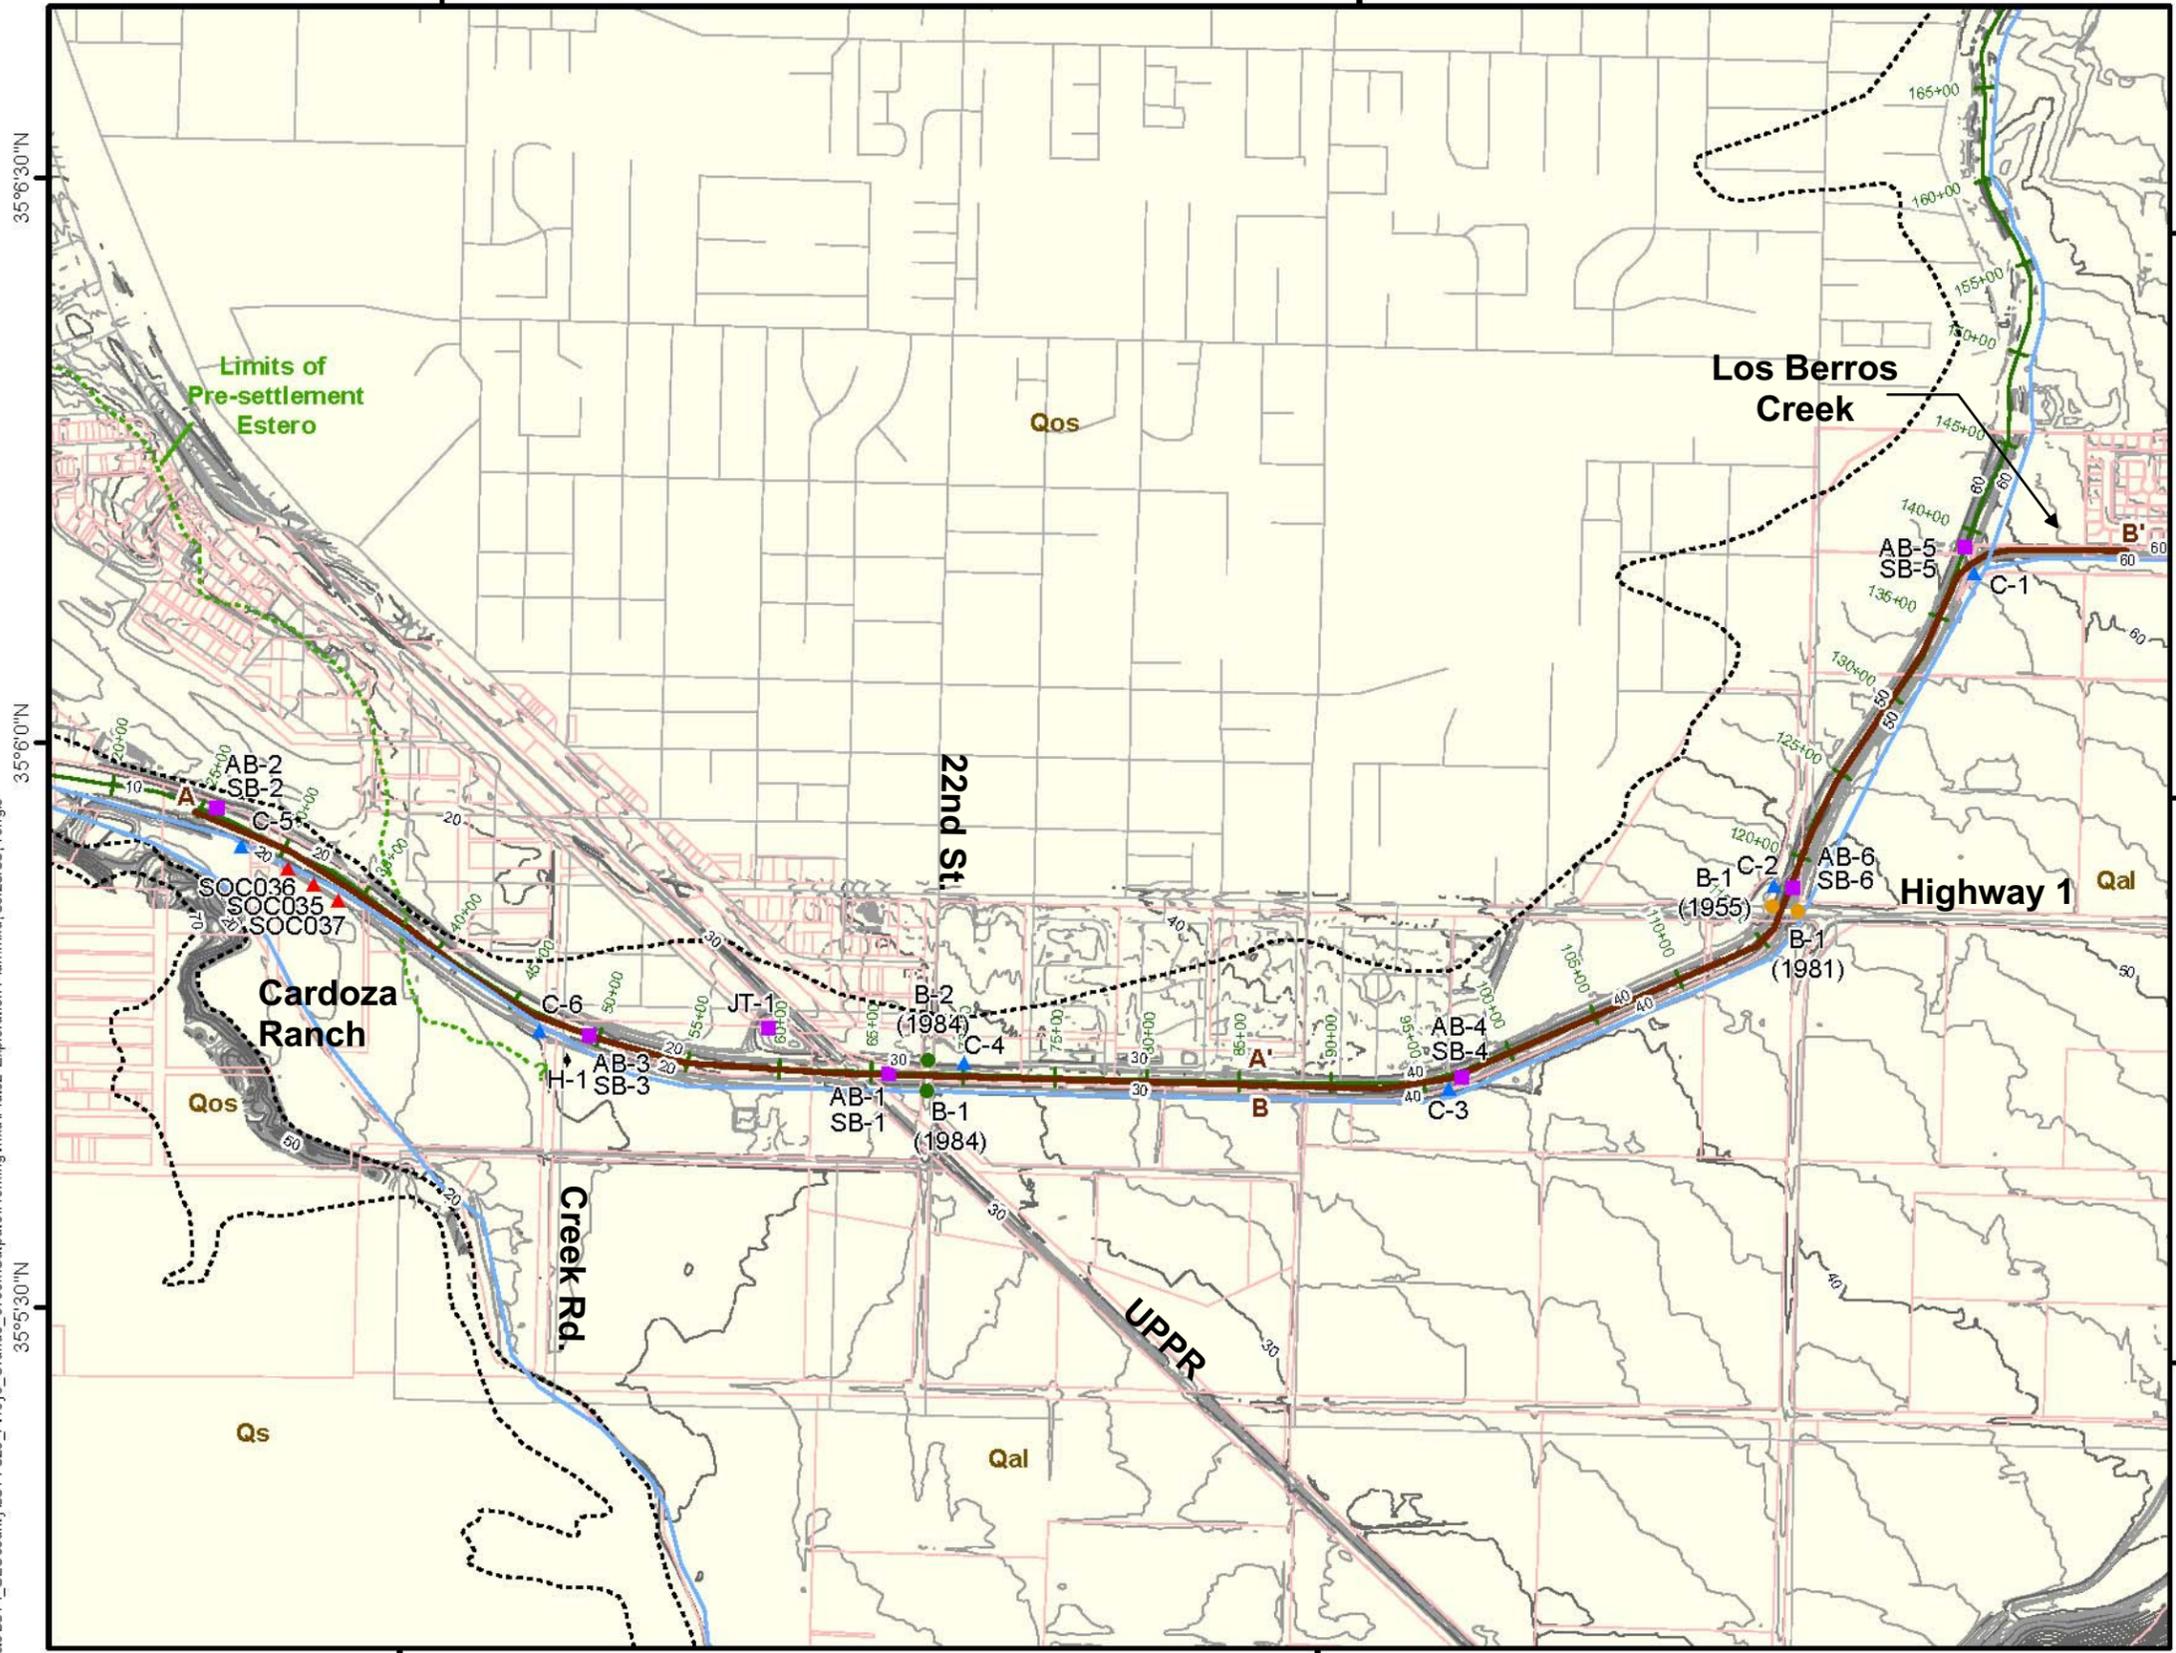
FIELD EXPLORATION PLAN
Arroyo Grande Creek
Waterways Management Plan
San Luis Obispo County, California

- Approximate Exploration Locations**
- ▲ Fugro CPT
 - ▲ USGS SCPT
 - Caltrans Boring (Year of Study)
 - SLO County Boring (Year of Study)
 - ◆ Hand Auger Boring
 - Hand Samples
 - SB Collected from Streambed
 - AB Collected Above Water Surface
 - JT Collected from J. Taylor's Property
- Geology**
- Contact
 - Limits of Pre-settlement Estero
 - Qal Alluvial Deposits
 - Qs Sand Dune Deposits
 - Qos Older Sand Dune Deposits

The U.S. Geological Survey (Holzer et al., 2004) previously performed a geotechnical study in the project vicinity. The study focused on liquefaction and liquefaction-induced lateral spreading that occurred in Oceano in response to the 2003 San Simeon Earthquake. As part of that study, the USGS performed three CPT soundings (SOC 036, 035 and 037) on the Arroyo Grande Creek Levee within the project limits. The soundings were performed in this area of the levee because the USGS observed evidence of instability of the levee and liquefaction within the field adjacent to the levee. The data from those CPT soundings were used to assist in our characterization of the subsurface conditions for this report. The logs of those CPT soundings performed by the USGS are included with the Fugro CPT logs in Appendix A. The approximate locations of the CPT soundings performed by the USGS are also shown on Plate 2.

As shown on Plates 2 and 3, the predominant geologic units mapped in the study area are surficial sediments comprised of dune sand deposits (Qs), older-stabilized dune sand deposits (Qos), and alluvium (Qal). The dune sands (Qs and Qos) mapped by Hall et al. (1973) are referred to as eolian deposits (Qe) by Hanson et al. (1994) on Plate 6. Hall identified older

Also depicted on Plate 2, a portion of the site along the creek was previously occupied by dune sand and an extensive pre-settlement Estero, according to an 1873-1874 map produced by the U.S. Coast Survey (Holzer et al., 2004). According to the USGS (2004) report, this area was subsequently "subdivided and turned into developable lots by leveling dunes and filling in swamp areas with dune sand in March 1927." Presumably, the creek alignment was altered as a consequence of this development. The approximate limits of the Pre-Existing Estero reported by Holzer et al. are noted on Plate 2.

The subsurface conditions encountered generally consisted of artificial fill (Af) materials overlying alluvium deposits (Qal). Logs for this and previous explorations are presented in Appendix A. The locations of the explorations are shown on Plate 2. Subsurface profiles summarizing our interpretation of the soil conditions encountered along the alignment of Arroyo Grande Creek within the project limits are shown on Plates 4a and 4b. A discussion of the geologic units encountered is provided below. Our interpretation of subsurface conditions is based on the CPT correlations developed by Robertson and Campanella (1986) and our hand auger boring log, and is generally supplemented by logs of previous explorations (USGS, 2004; Caltrans, 1956, 1984; San Luis Obispo County, 1984).

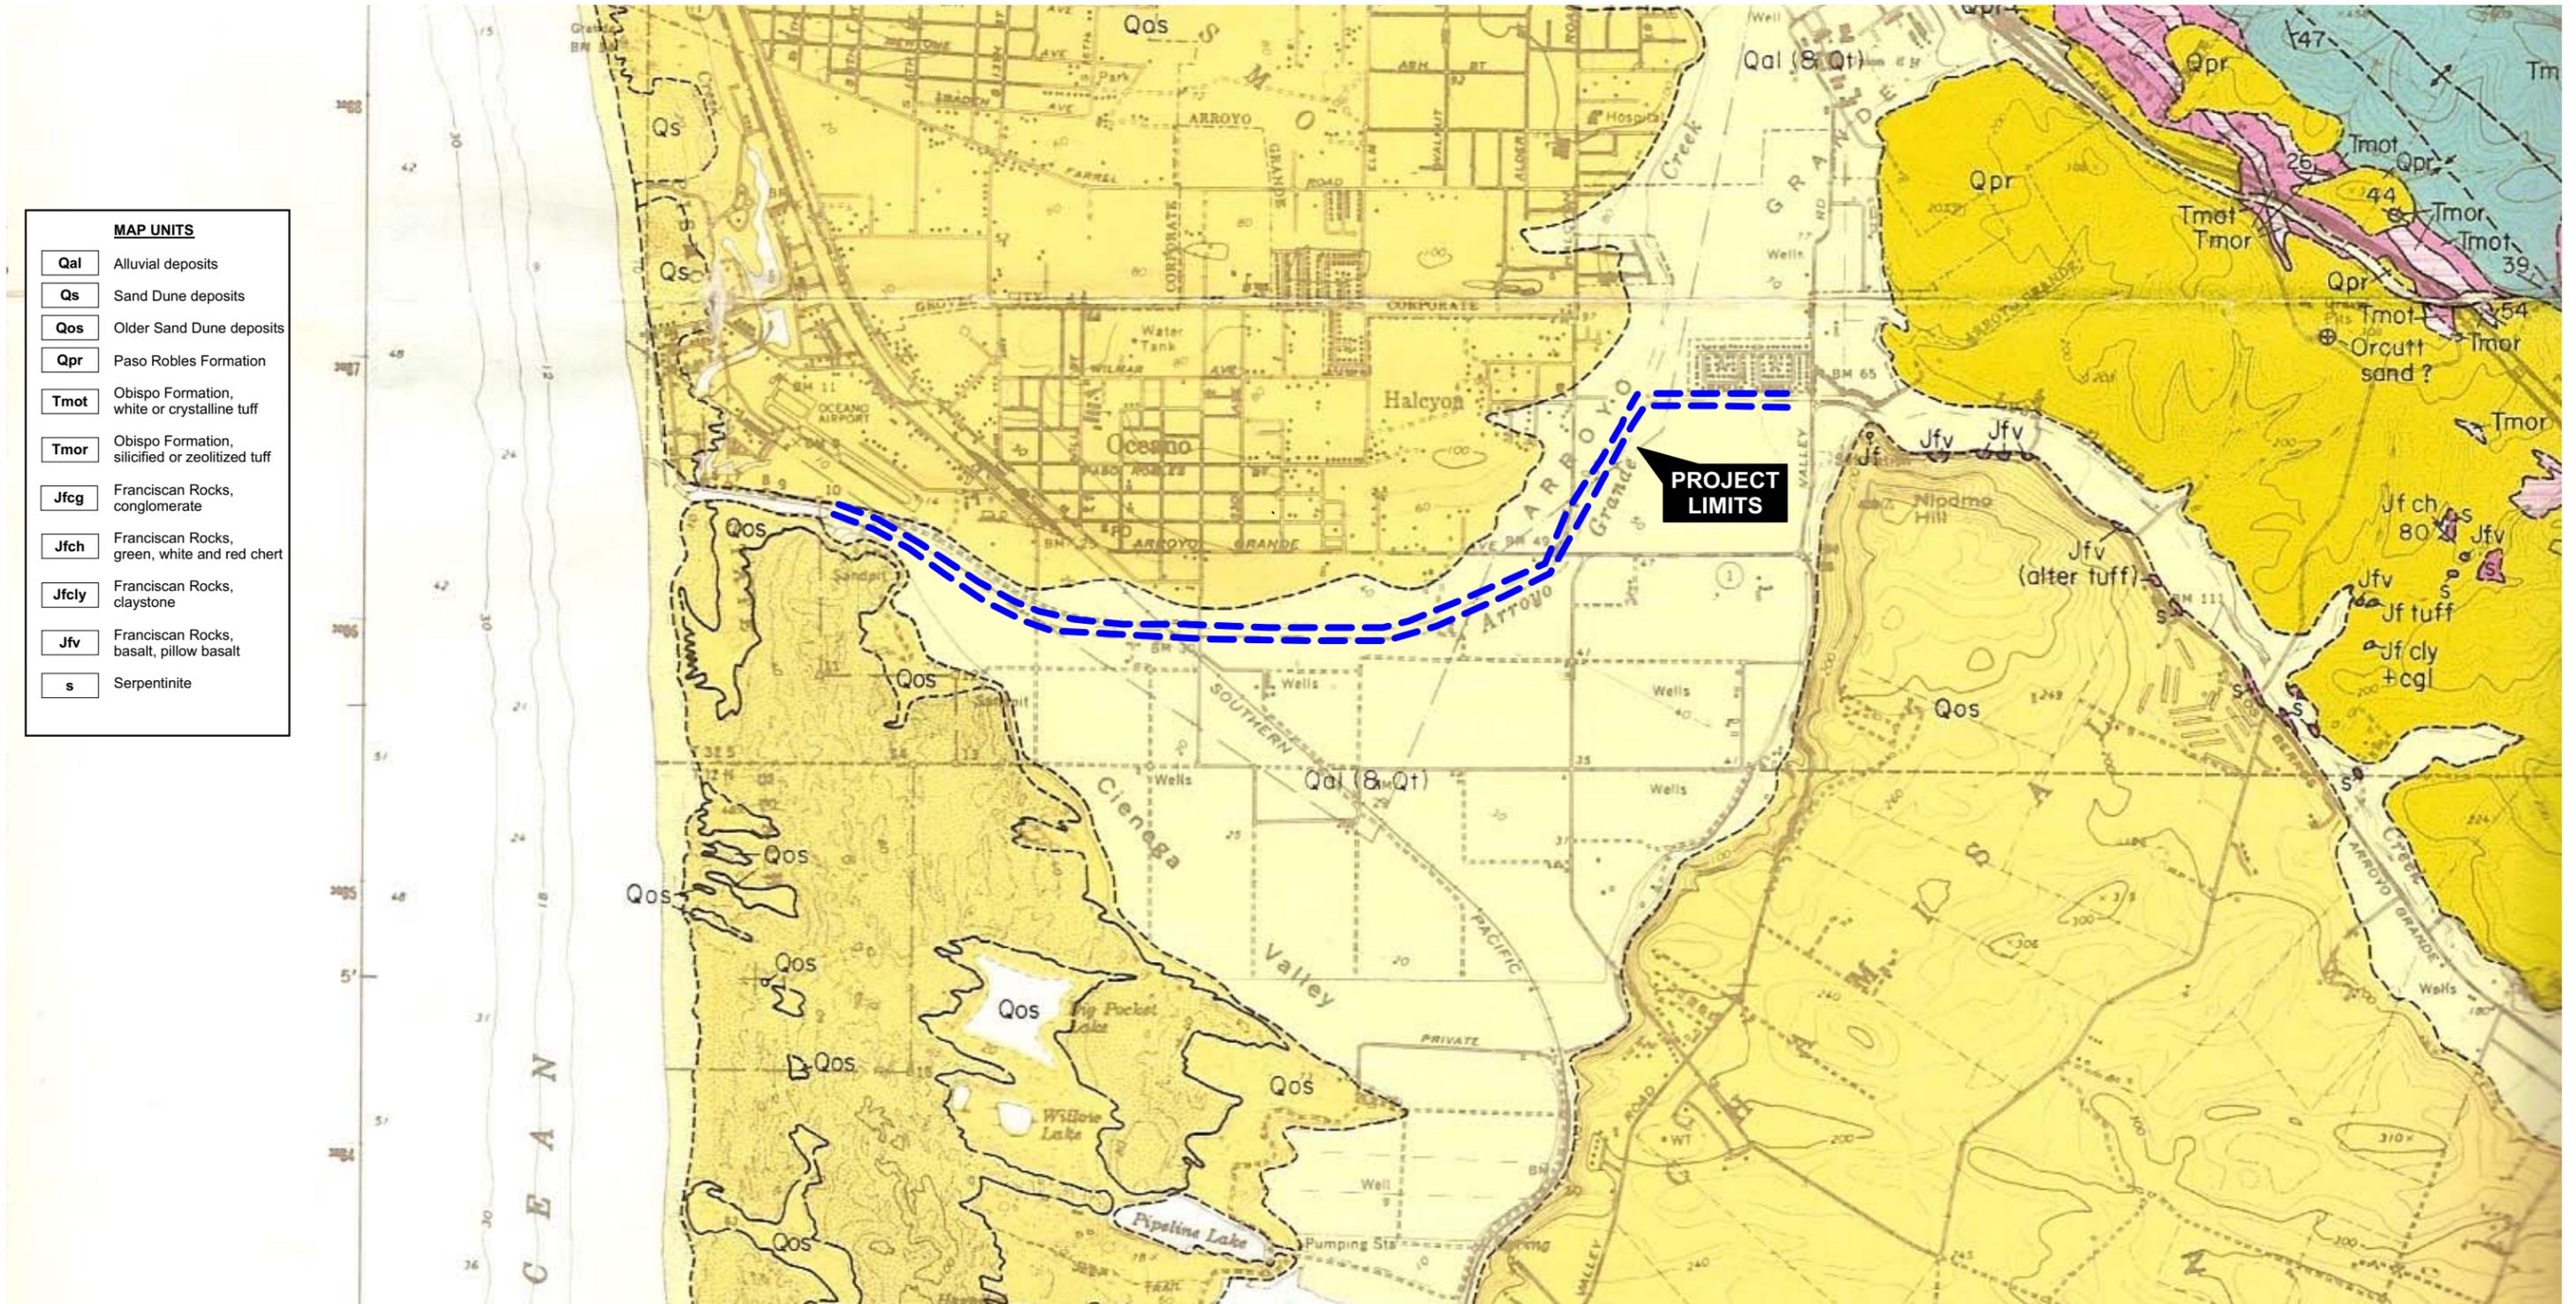
REGIONAL GEOLOGIC MAP
Arroyo Grande Creek
Waterways Management Plan
San Luis Obispo County, California

MAP UNITS	
Qal	Alluvial deposits
Qs	Sand Dune deposits
Qos	Older Sand Dune deposits
Qpr	Paso Robles Formation
Tmot	Obispo Formation, white or crystalline tuff
Tmor	Obispo Formation, silicified or zeolitized tuff
Jfcg	Franciscan Rocks, conglomerate
Jfch	Franciscan Rocks, green, white and red chert
Jfcly	Franciscan Rocks, claystone
Jfv	Franciscan Rocks, basalt, pillow basalt
s	Serpentinite

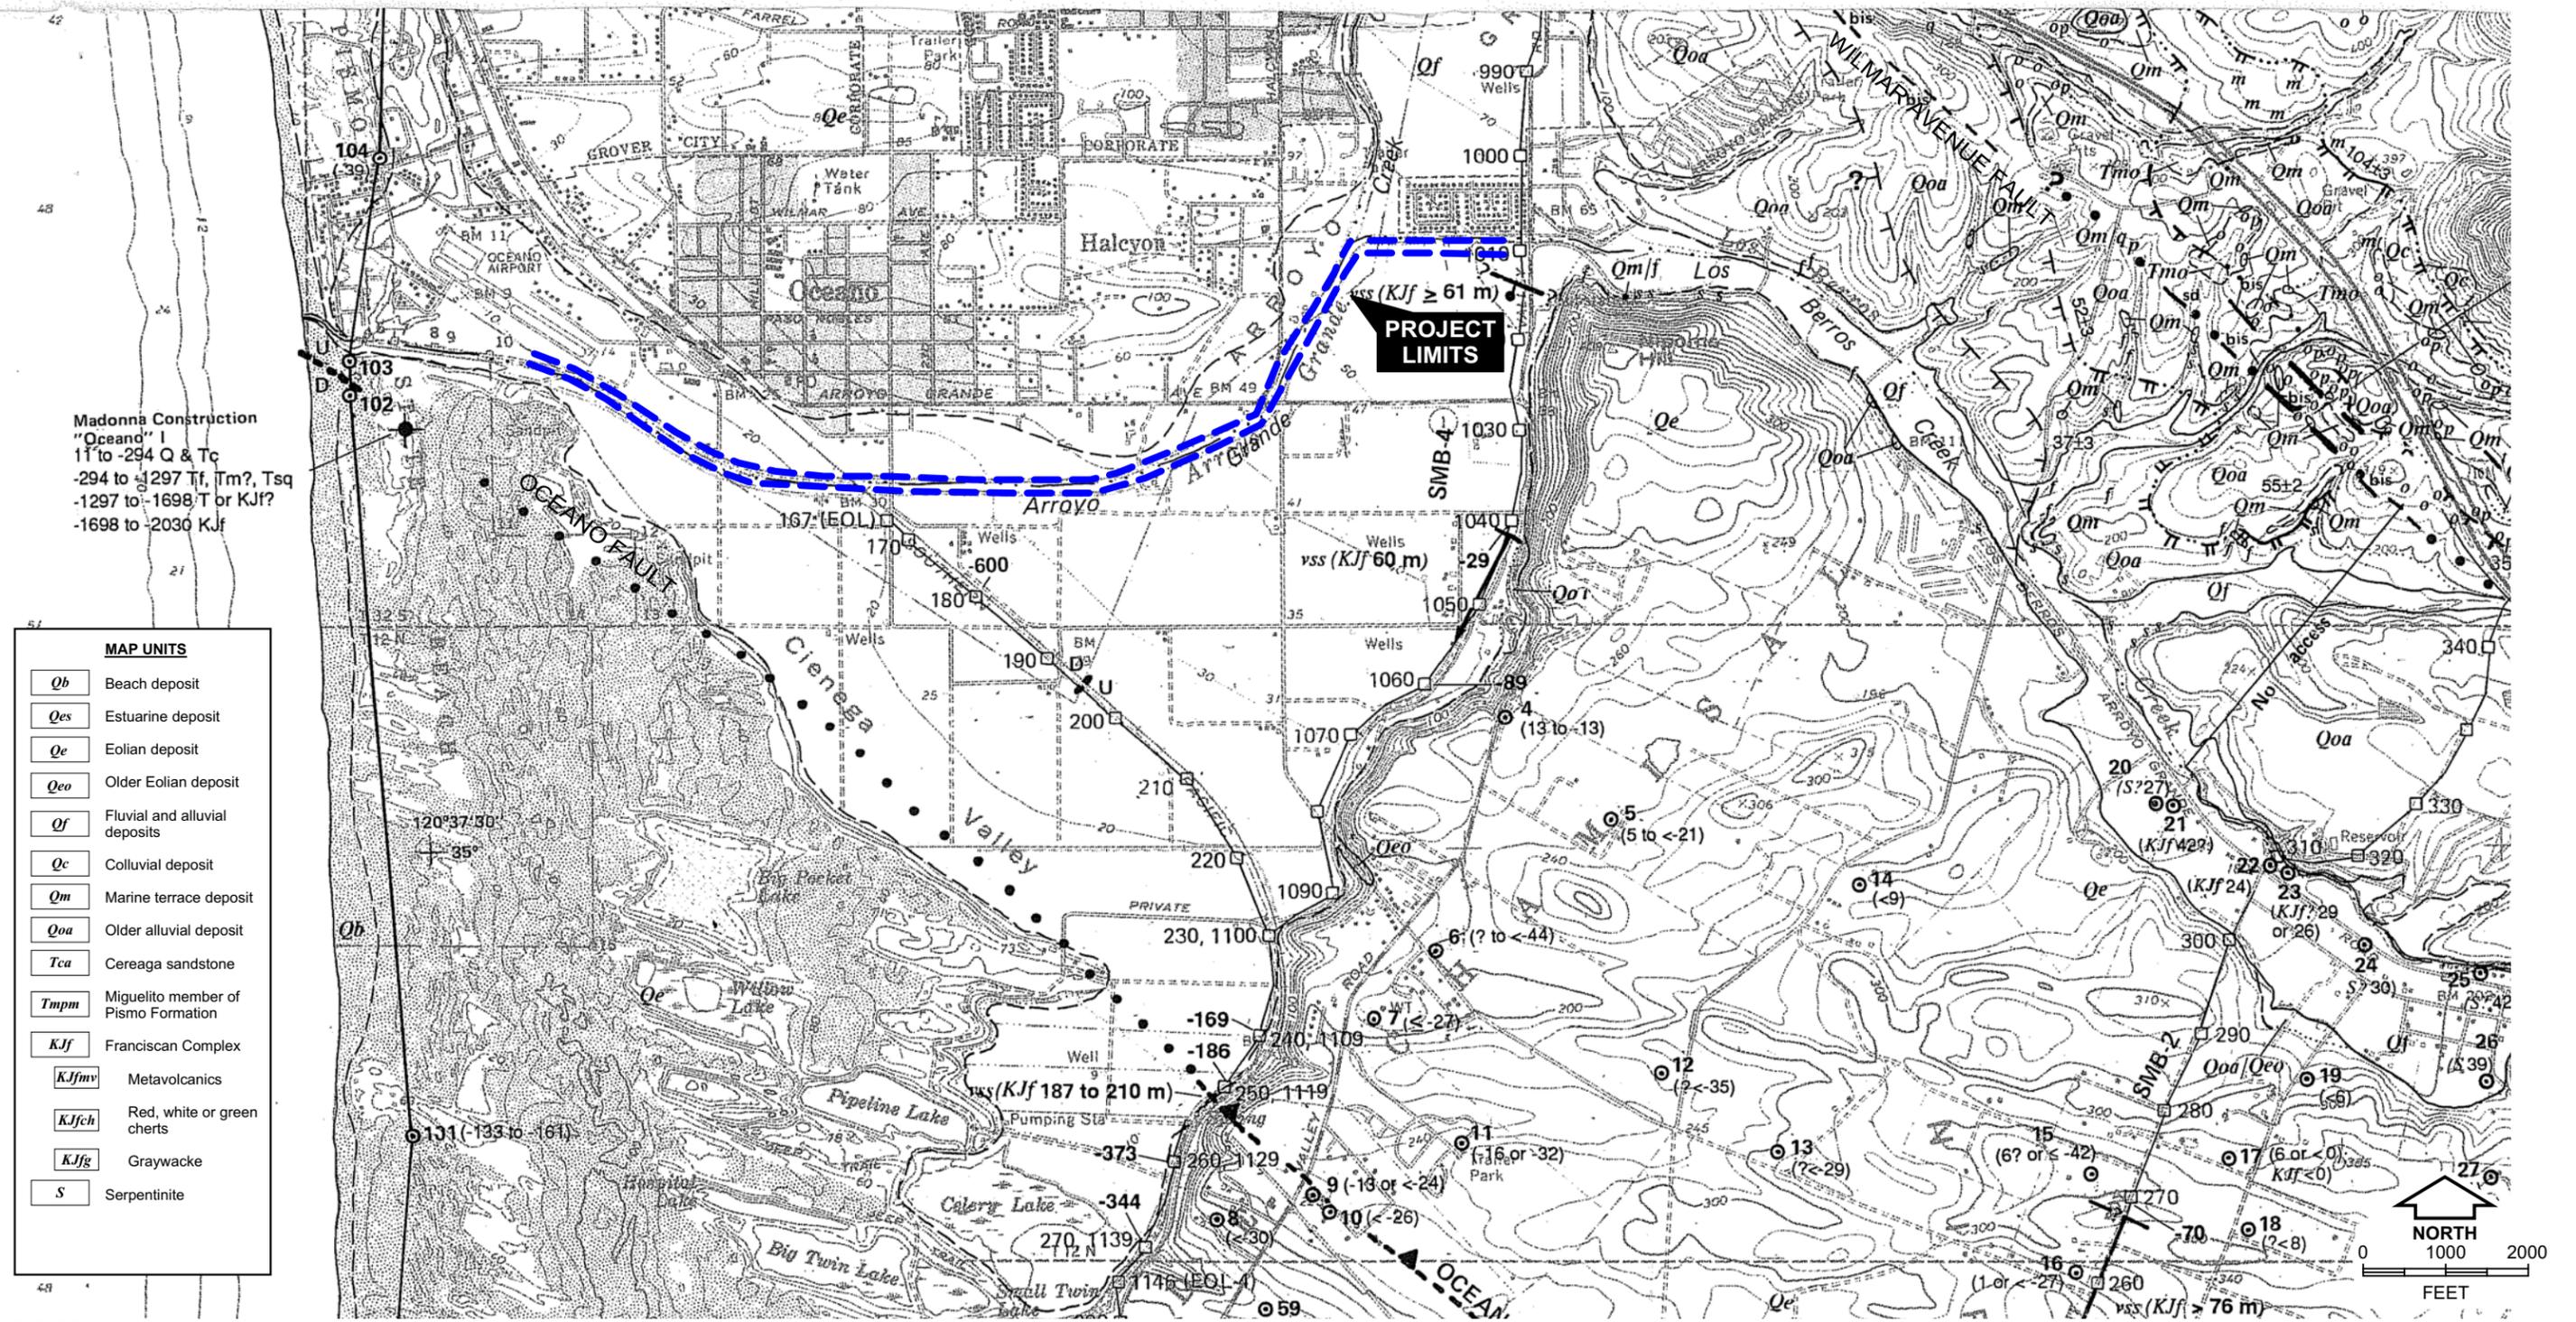
LOCAL FAULT MAP
Arroyo Grande Creek
Waterways Management Plan
San Luis Obispo County, California
PLATE 6

Madonna Construction
"Oceano" 1
11 to -294 Q & Tc
-294 to -1297 Tf, Tm?, Tsq
-1297 to -1698 T or KJf?
-1698 to -2030 KJf

MAP UNITS	
Qb	Beach deposit
Qes	Estuarine deposit
Qe	Eolian deposit
Qeo	Older Eolian deposit
Qf	Fluvial and alluvial deposits
Qc	Colluvial deposit
Qm	Marine terrace deposit
Qoa	Older alluvial deposit
Tca	Cereaga sandstone
Tpm	Miguelito member of Pismo Formation
KJf	Franciscan Complex
KJfmv	Metavolcanics
KJfch	Red, white or green cherts
KJfg	Graywacke
S	Serpentinite

The mapped locations of the Wilmar Avenue and Oceano faults shown on Plate 6 are inferred offsets in well logs and steps in the Franciscan bedrock from geophysical data. Within the Cienega Valley, the inferred locations of the faults are concealed by relatively deep alluvium. It is our opinion that the presence of the faults does not pose a significant fault rupture hazard to the project. However, significant ground motion could impact the site if an earthquake were to occur on the San Luis Range fault system within the life of the project.

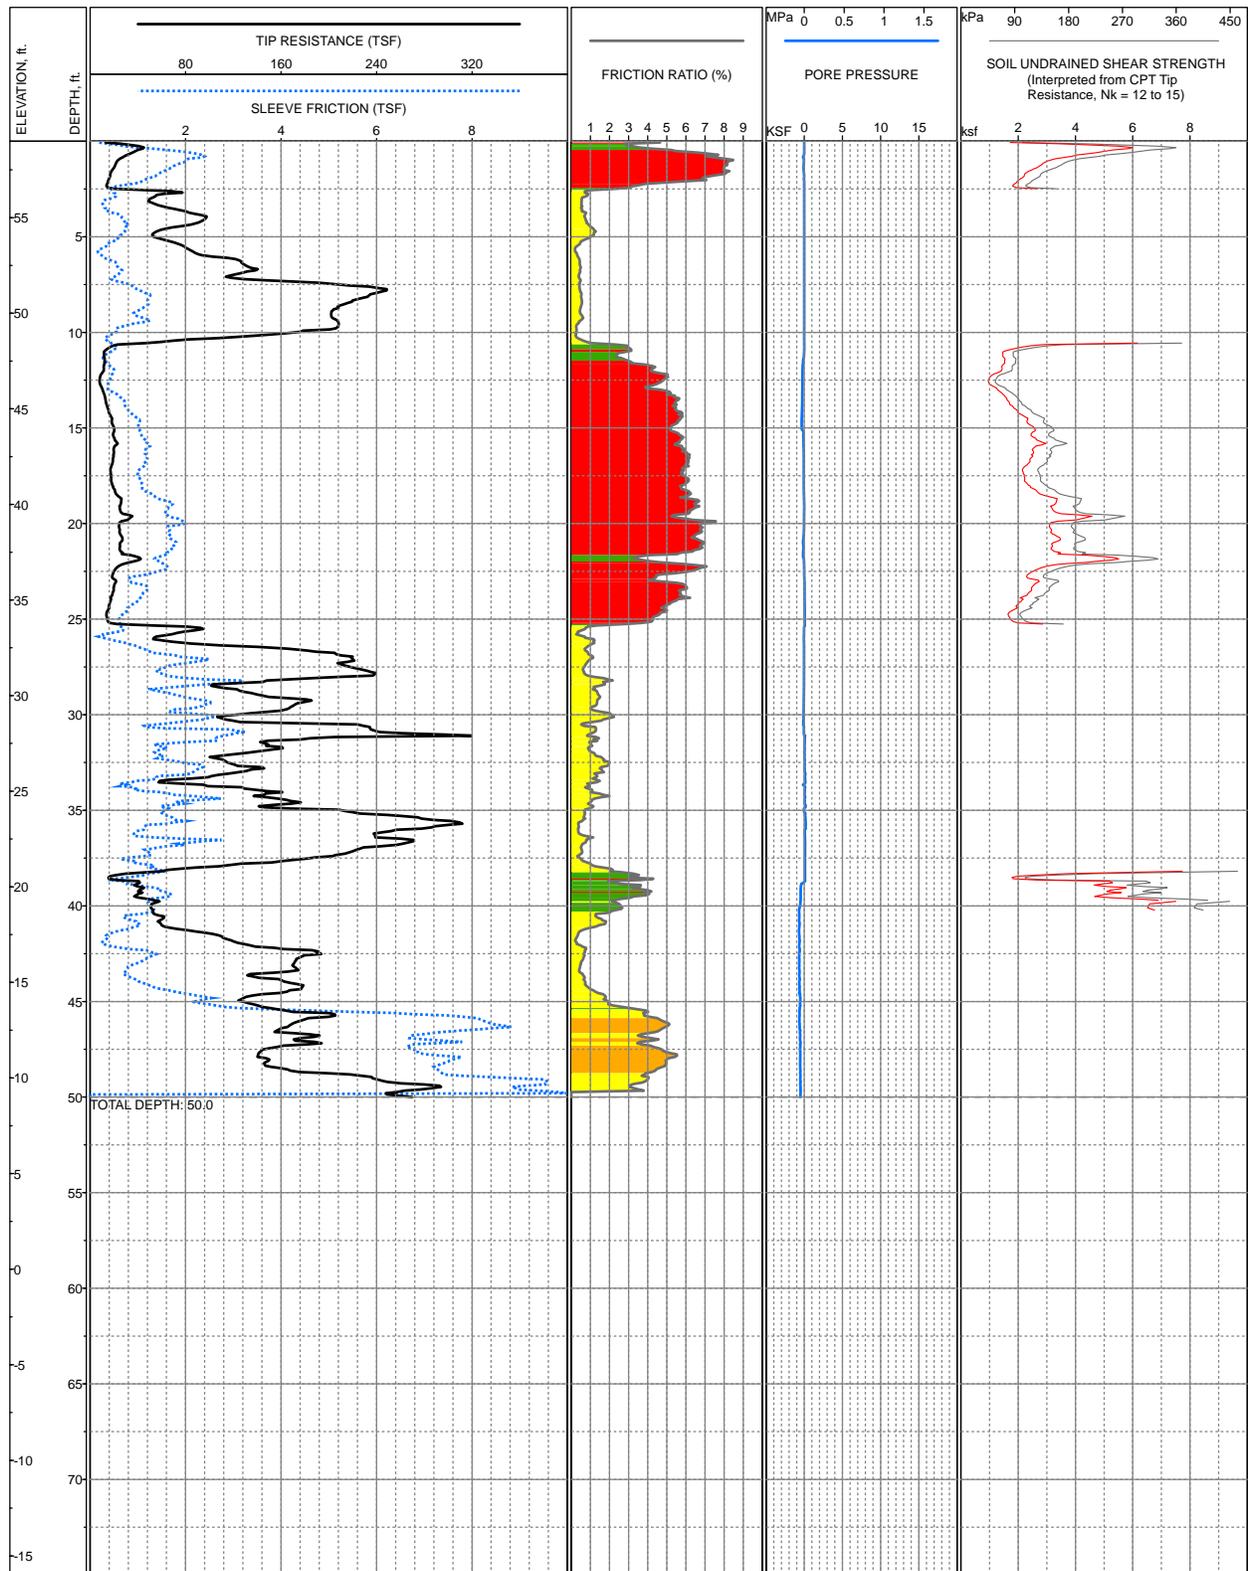
LOG OF C-1
Arroyo Grande Creek Waterways Management Plan
San Luis Obispo, California

COORDINATES: 2,233,857.20N 5,787,490.08W
SURFACE EL: 59.0ft +/- (MSL)
COMPLETION DEPTH: 50.0ft
TESTDATE: 7/22/2008

EXPLORATION METHOD: Cone Penetrometer
PERFORMED BY: Fugro Geosciences
REVIEWED BY: J.Blanchard

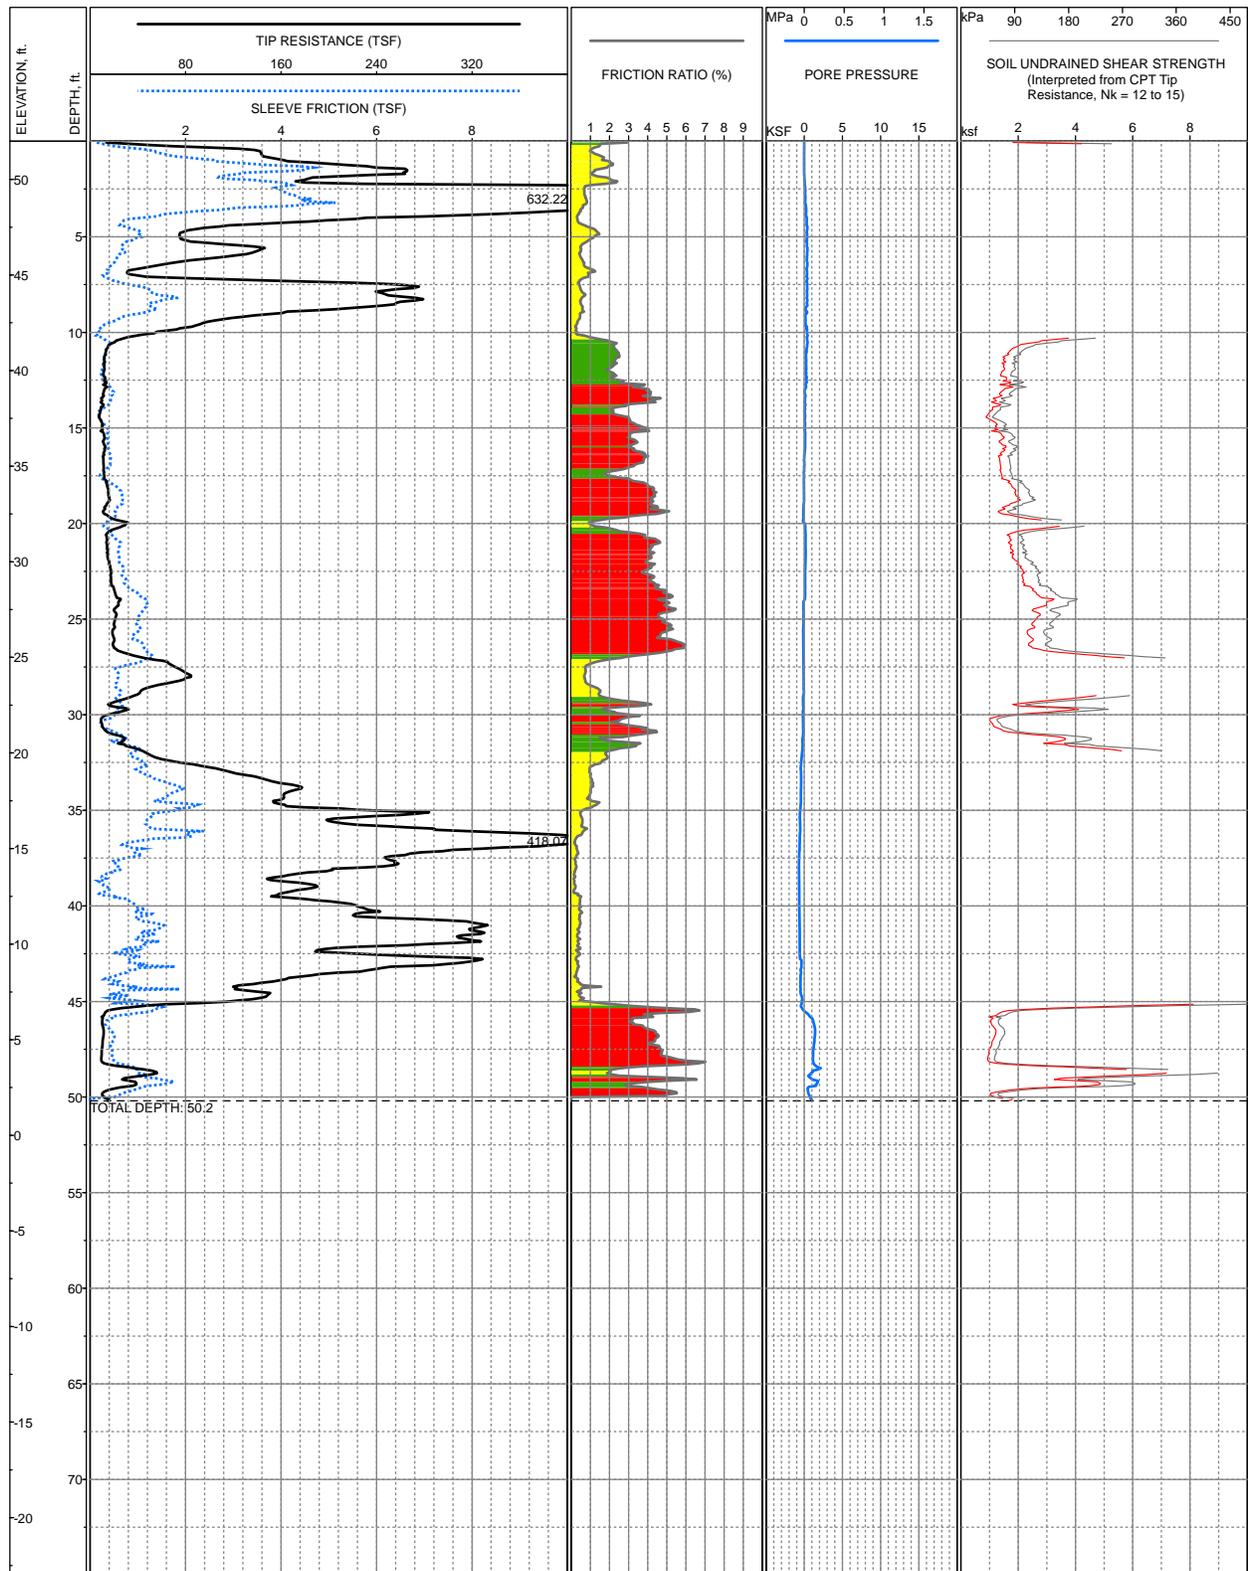
LOG OF C-2
Arroyo Grande Creek Waterways Management Plan
San Luis Obispo, California

COORDINATES: 2,232,173.97N 5,786,405.43W
SURFACE EL: 52.0ft +/- (MSL)
COMPLETION DEPTH: 50.2ft
TESTDATE: 7/22/2008

EXPLORATION METHOD: Cone Penetrometer
PERFORMED BY: Fugro Geosciences
REVIEWED BY: J.Blanchard

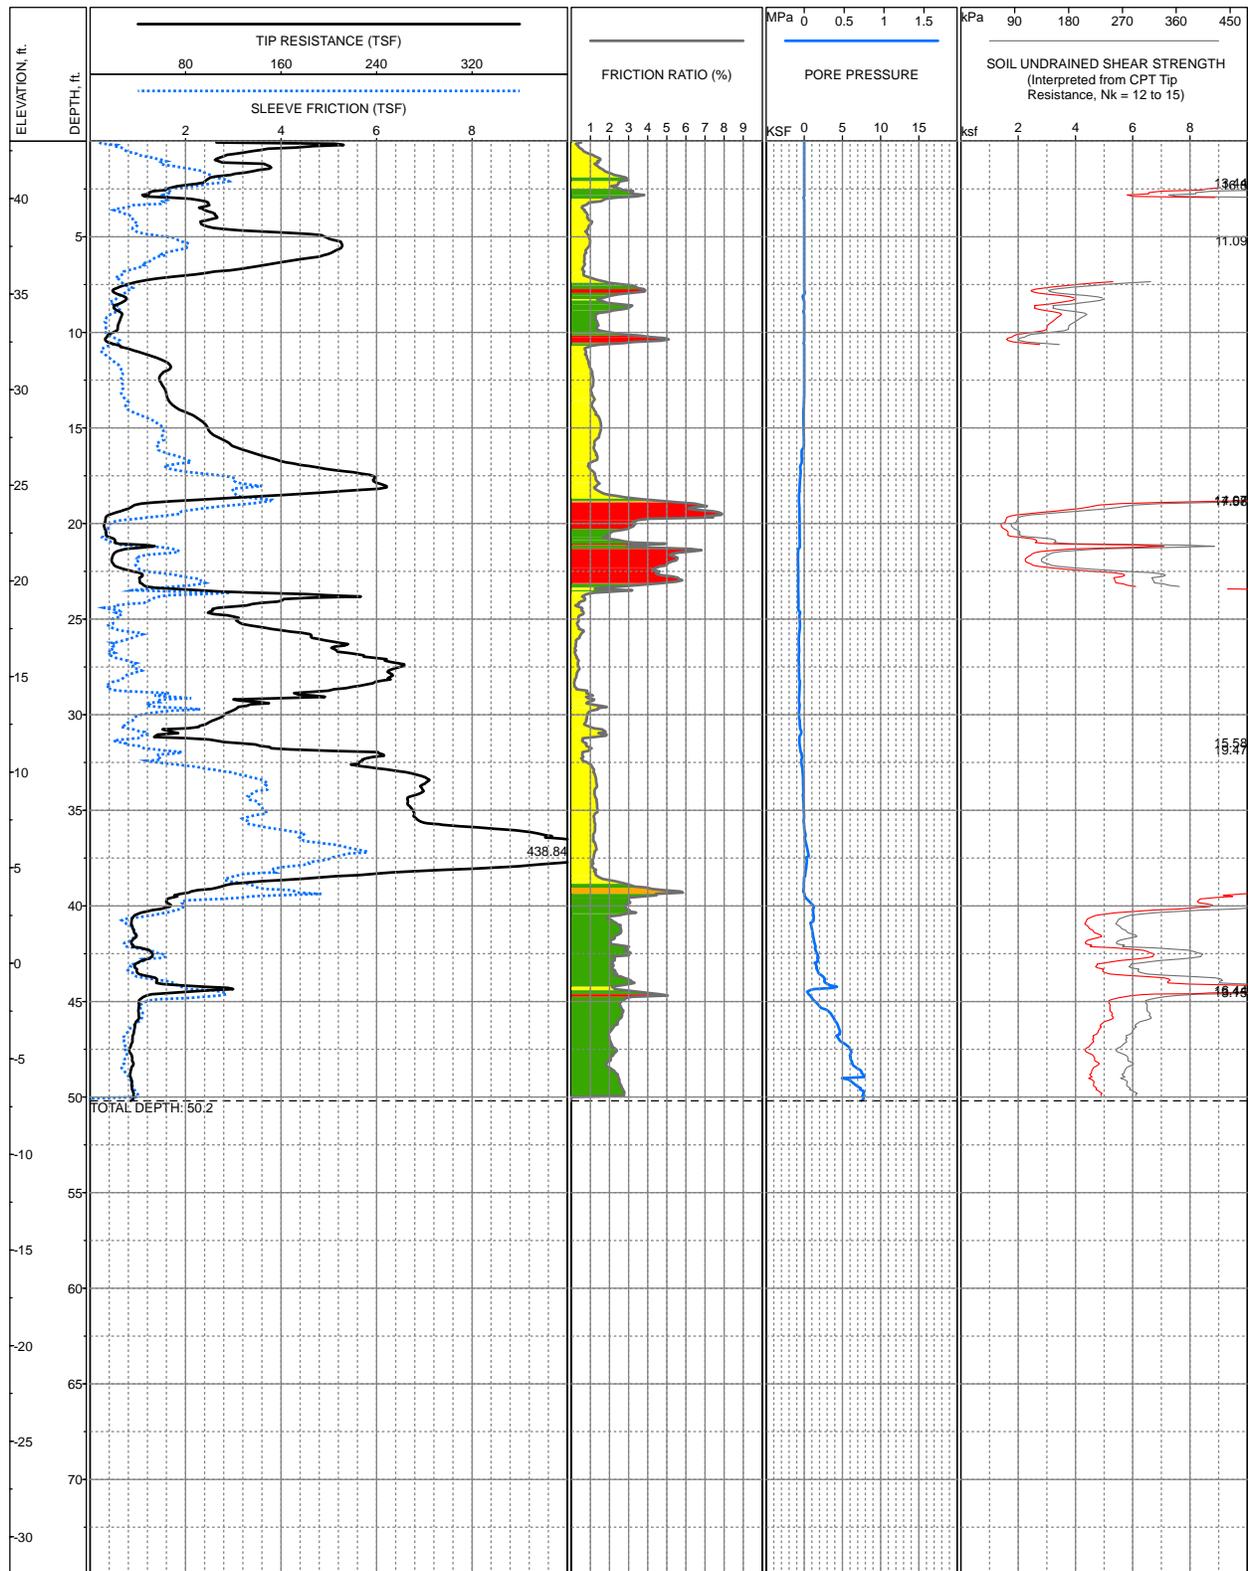
LOG OF C-3
Arroyo Grande Creek Waterways Management Plan
San Luis Obispo, California

COORDINATES: 2,231,087.37N 5,784,635.85W
SURFACE EL: 43.0ft +/- (MSL)
COMPLETION DEPTH: 50.2ft
TESTDATE: 7/22/2008

EXPLORATION METHOD: Cone Penetrometer
PERFORMED BY: Fugro Geosciences
REVIEWED BY: J.Blanchard

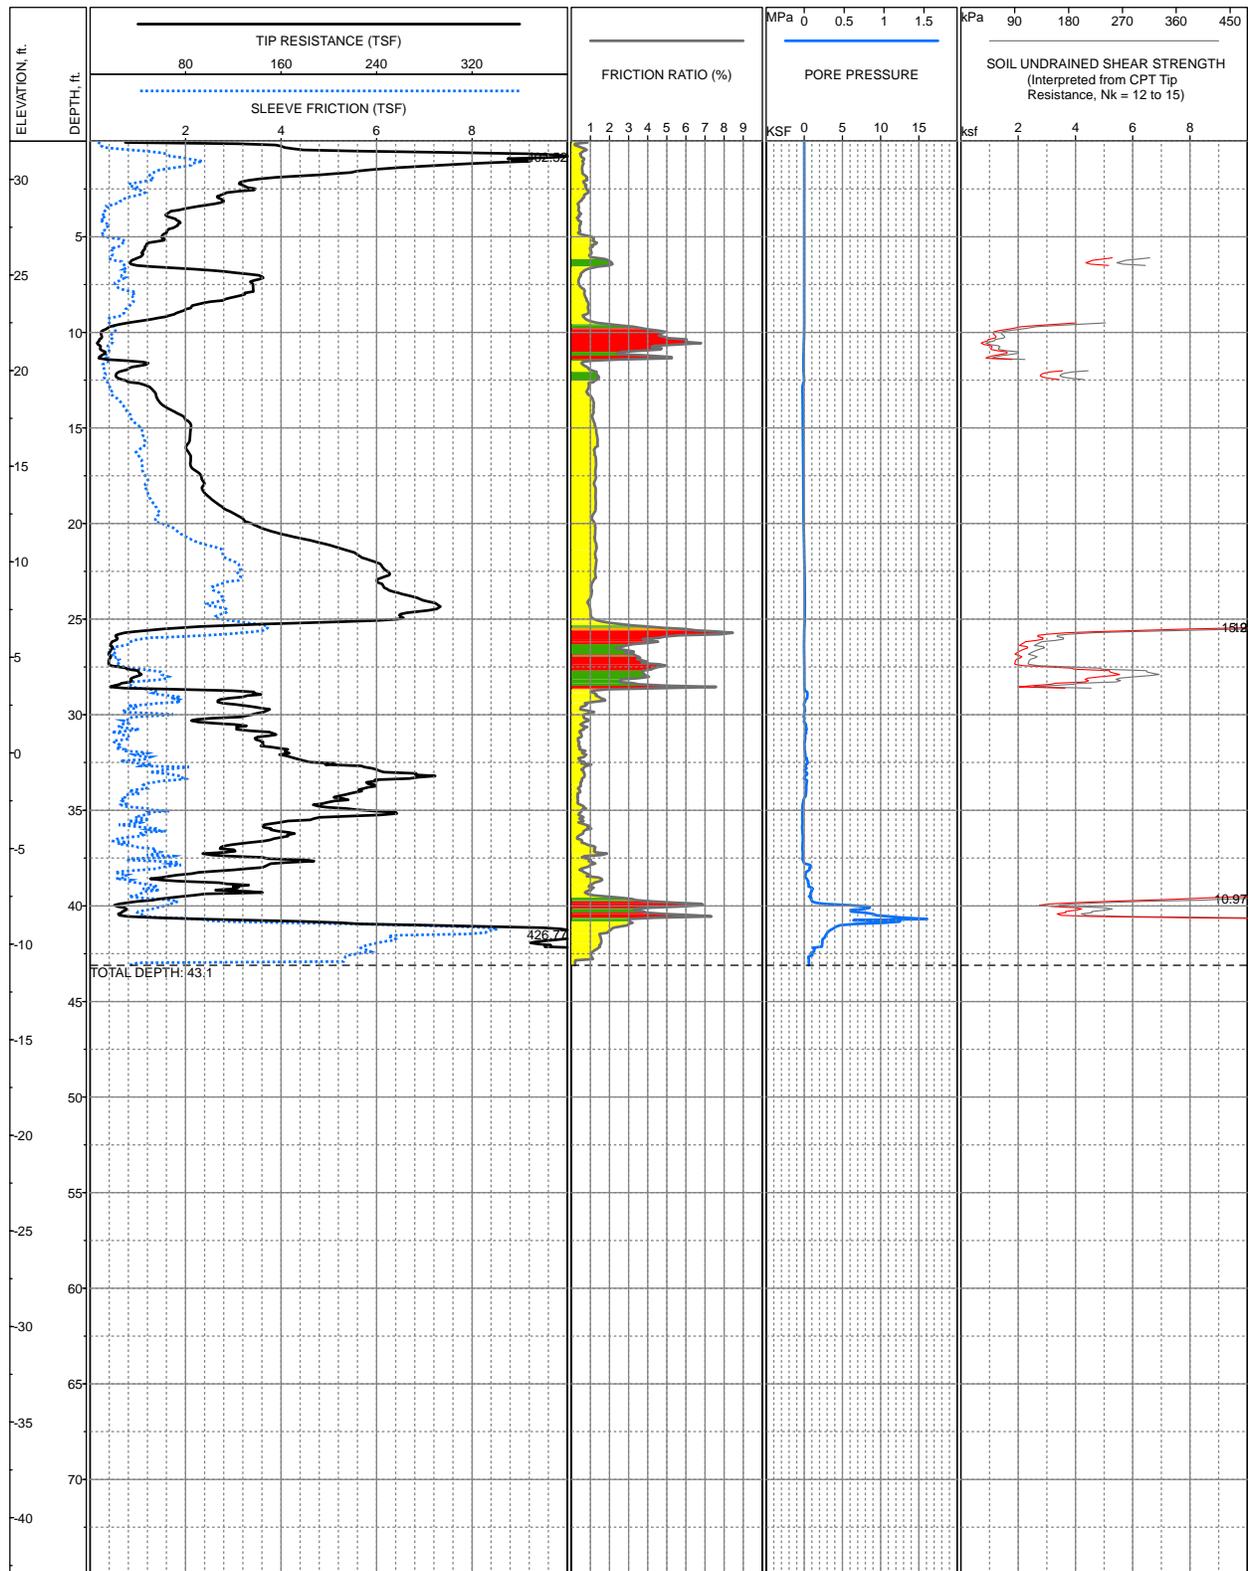
LOG OF C-4
Arroyo Grande Creek Waterways Management Plan
San Luis Obispo, California

COORDINATES: 2,231,221.08N 5,782,003.06W
SURFACE EL: 32.0ft +/- (MSL)
COMPLETION DEPTH: 43.1ft
TESTDATE: 7/22/2008

EXPLORATION METHOD: Cone Penetrometer
PERFORMED BY: Fugro Geosciences
REVIEWED BY: J.Blanchard

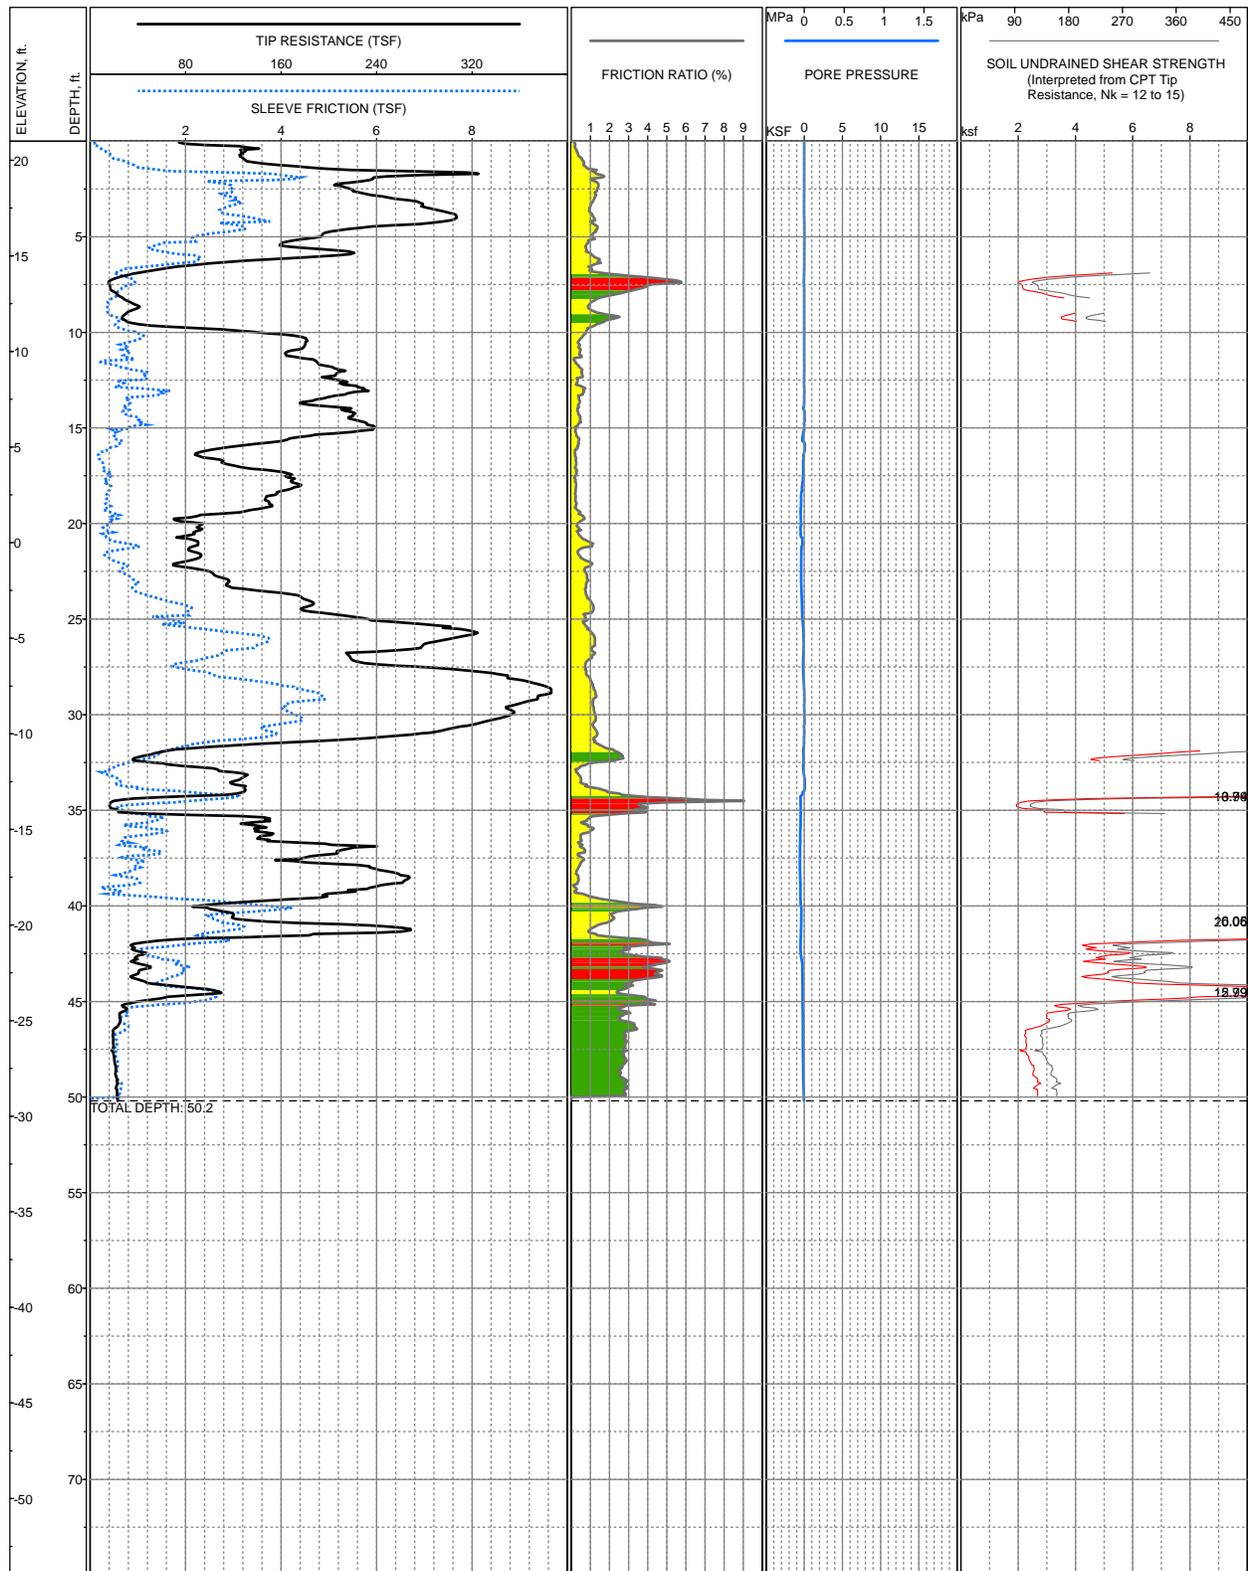
LOG OF C-5
 Arroyo Grande Creek Waterways Management Plan
 San Luis Obispo, California

COORDINATES: 2,232,390.00N 5,778,074.64W
 SURFACE EL: 21.0ft +/- (MSL)
 COMPLETION DEPTH: 50.2ft
 TESTDATE: 7/22/2008

EXPLORATION METHOD: Cone Penetrometer
 PERFORMED BY: Fugro Geosciences
 REVIEWED BY: J.Blanchard
