**PRELIMINARY GEOTECHNICAL REPORT
ARROYO GRANDE CREEK WATERWAYS
MANAGEMENT PLAN
LOS BERROS CREEK TO NEAR OCEANO AIRPORT
SAN LUIS OBISPO COUNTY, CALIFORNIA**

Prepared for:
County of San Luis Obispo
Department of Public Works

April 22, 2009

April 22, 2009
Project No. 3014.029

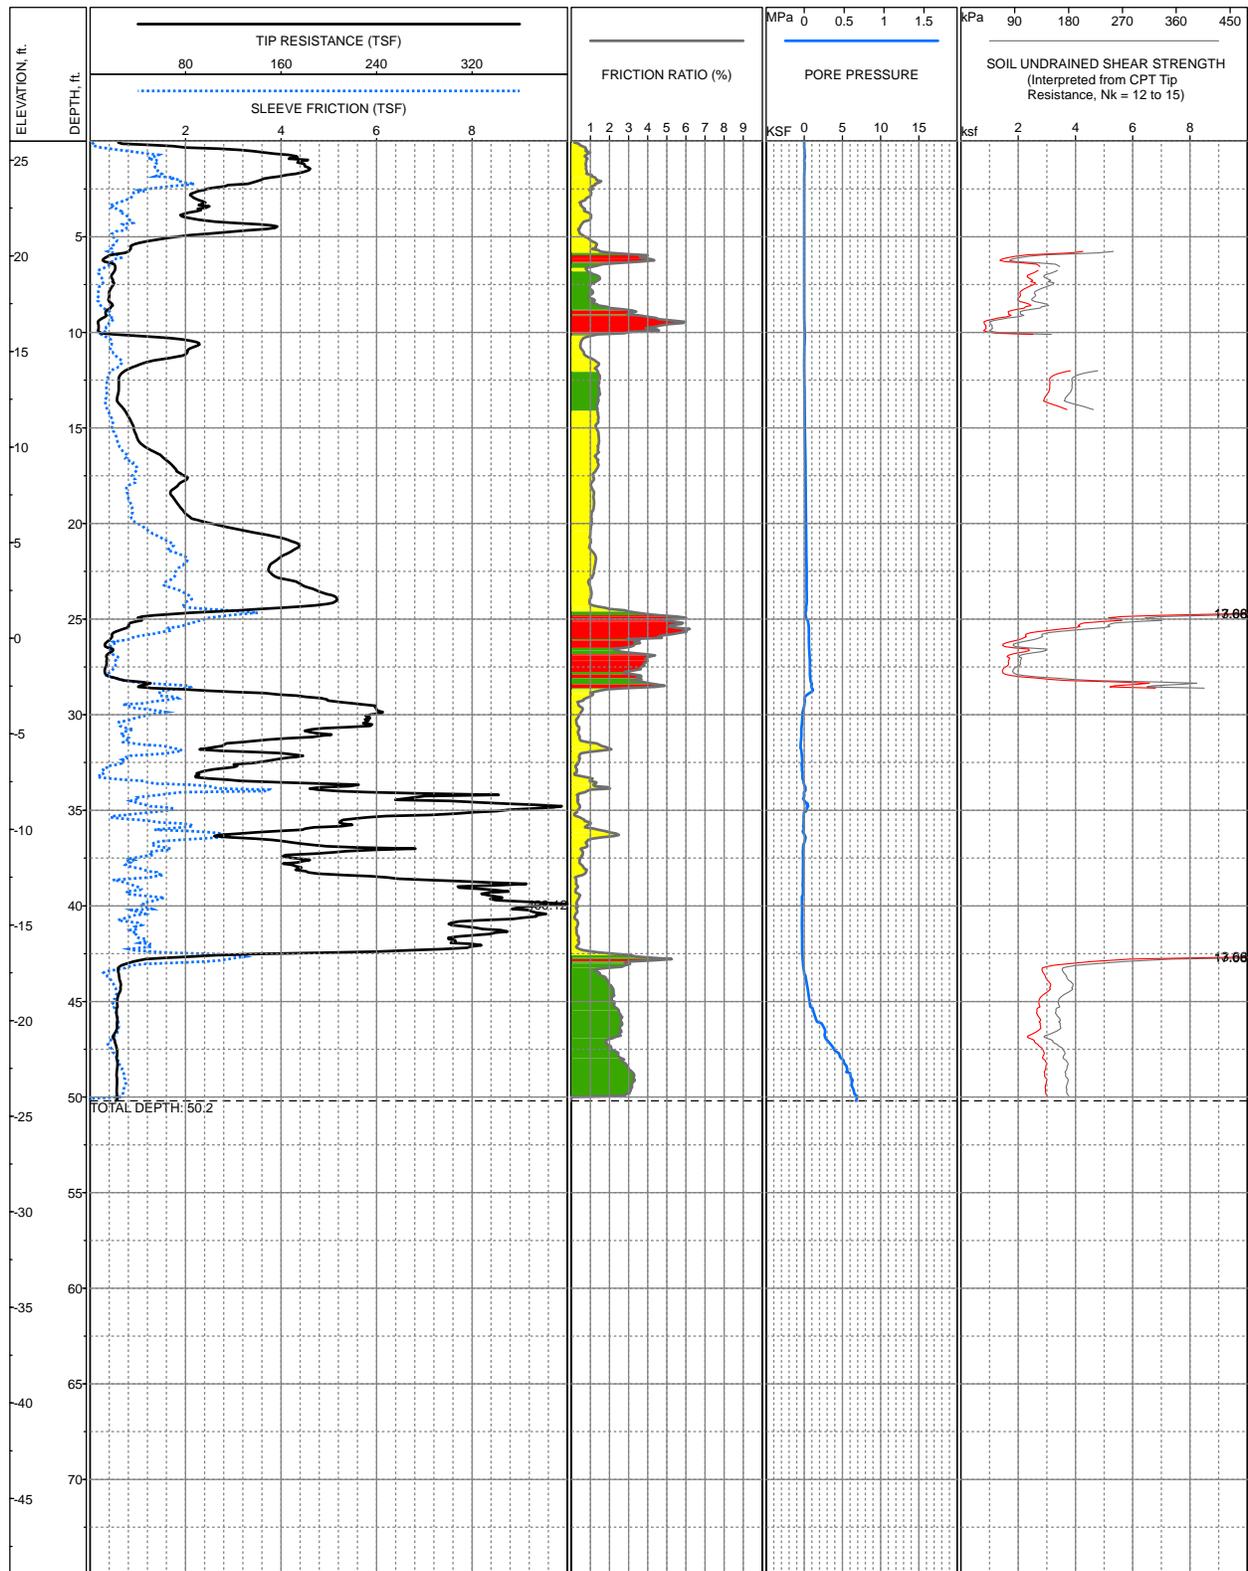
LOG OF C-6
Arroyo Grande Creek Waterways Management Plan
San Luis Obispo, California

COORDINATES: 2,231,397.63N 5,779,691.56W
SURFACE EL: 26.0ft +/- (MSL)
COMPLETION DEPTH: 50.2ft
TESTDATE: 7/22/2008

EXPLORATION METHOD: Cone Penetrometer
PERFORMED BY: Fugro Geosciences
REVIEWED BY: J.Blanchard

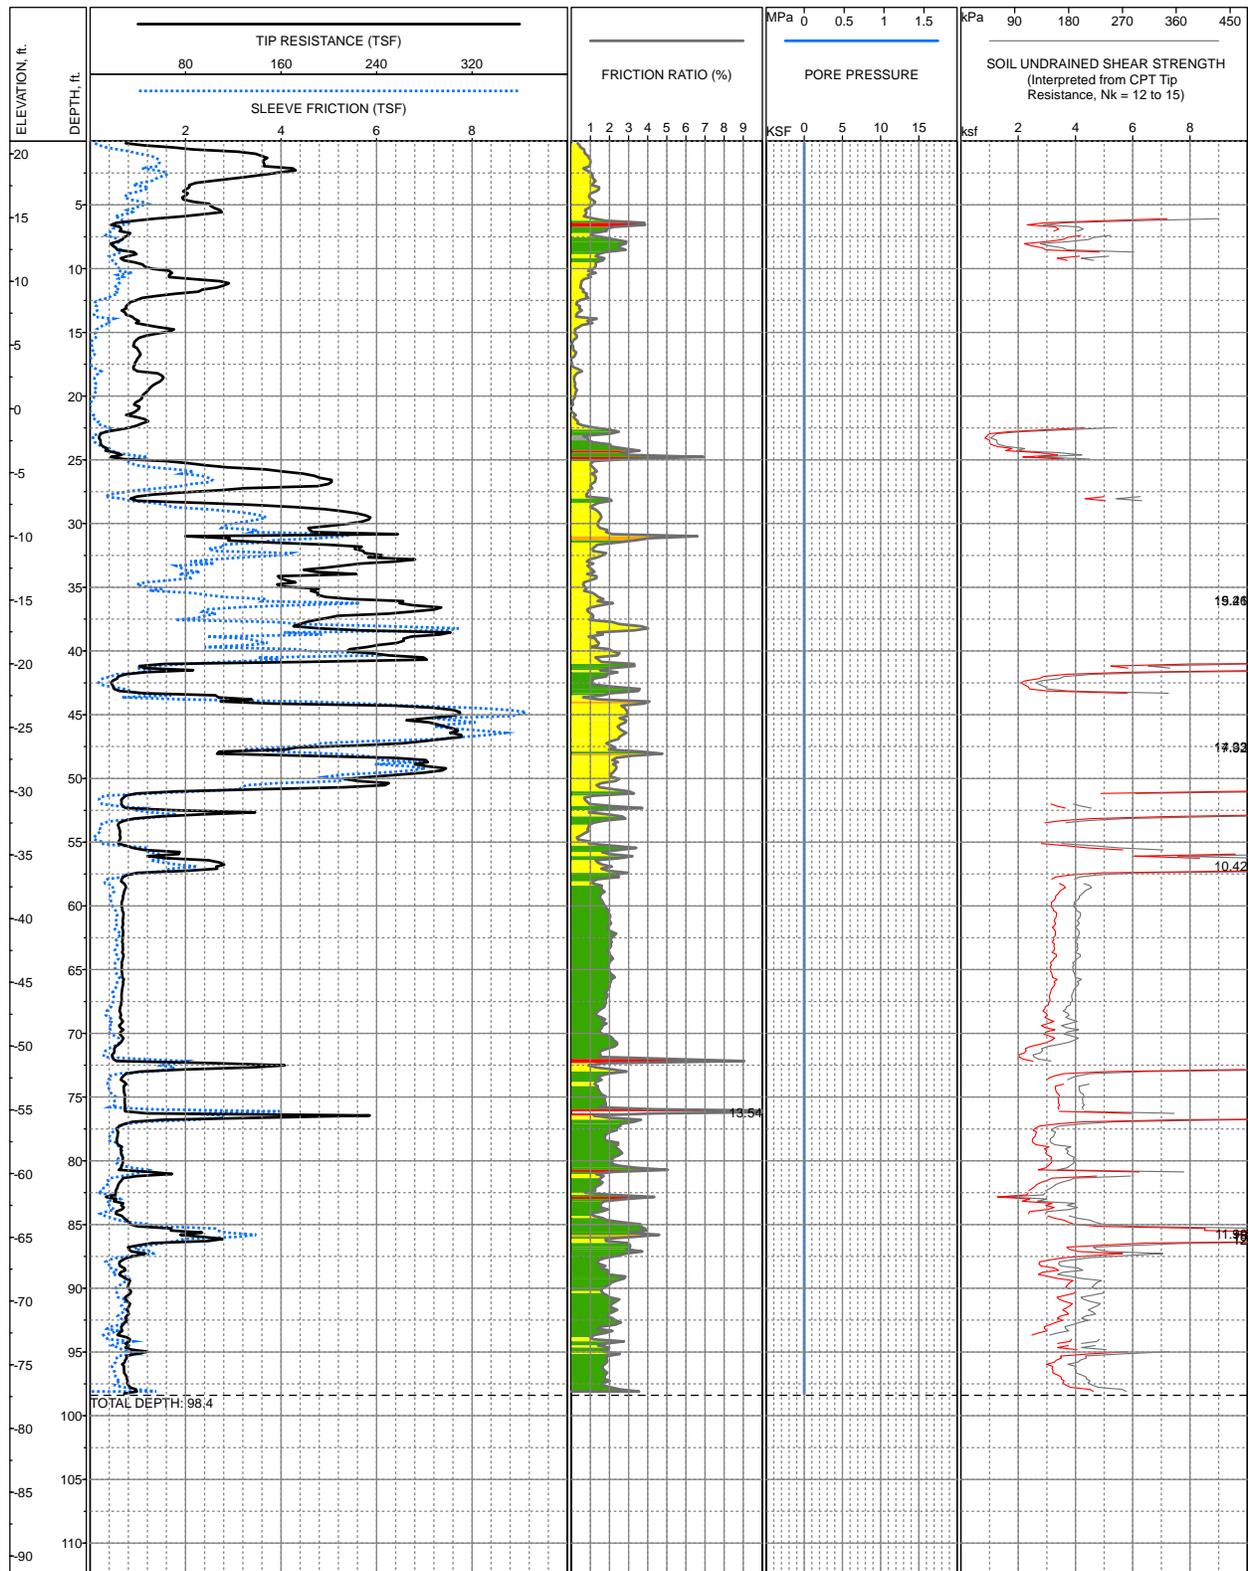
LOG OF SOC035
 Arroyo Grande Creek Waterways Management Plan
 San Luis Obispo, California

LOCATION: South Levee, Approx. 3350 ft northwest of 22nd St. Bridge
 SURFACE EL: 21.0ft +/- (MSL)
 COMPLETION DEPTH: 98.4ft
 TESTDATE: 3/5/2004

EXPLORATION METHOD: Cone Penetrometer
 PERFORMED BY: USGS
 REVIEWED BY: J.Blanchard

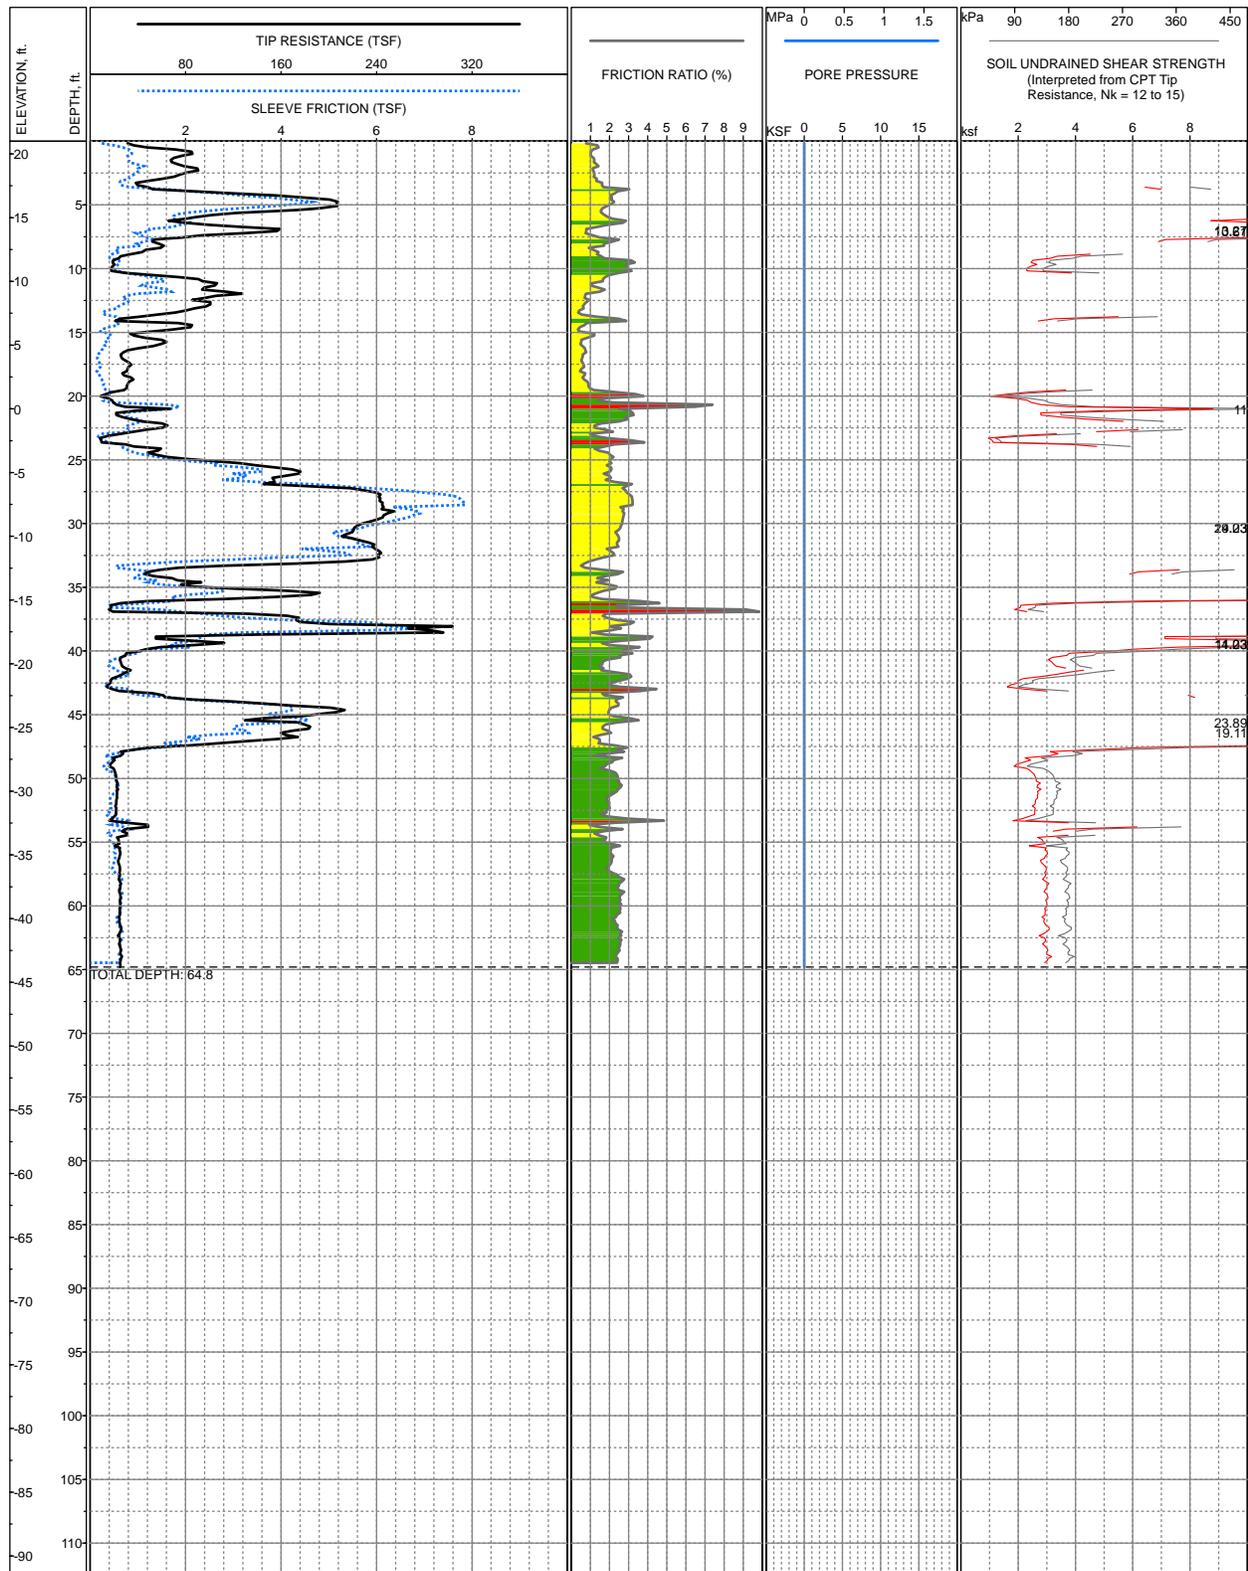
LOG OF SOC036
 Arroyo Grande Creek Waterways Management Plan
 San Luis Obispo, California

LOCATION: South Levee, Approx. 3500 ft northwest of 22nd St. Bridge
 SURFACE EL: 21.0ft +/- (MSL)
 COMPLETION DEPTH: 64.8ft
 TESTDATE: 3/5/2004

EXPLORATION METHOD: Cone Penetrometer
 PERFORMED BY: USGS
 REVIEWED BY: J.Blanchard

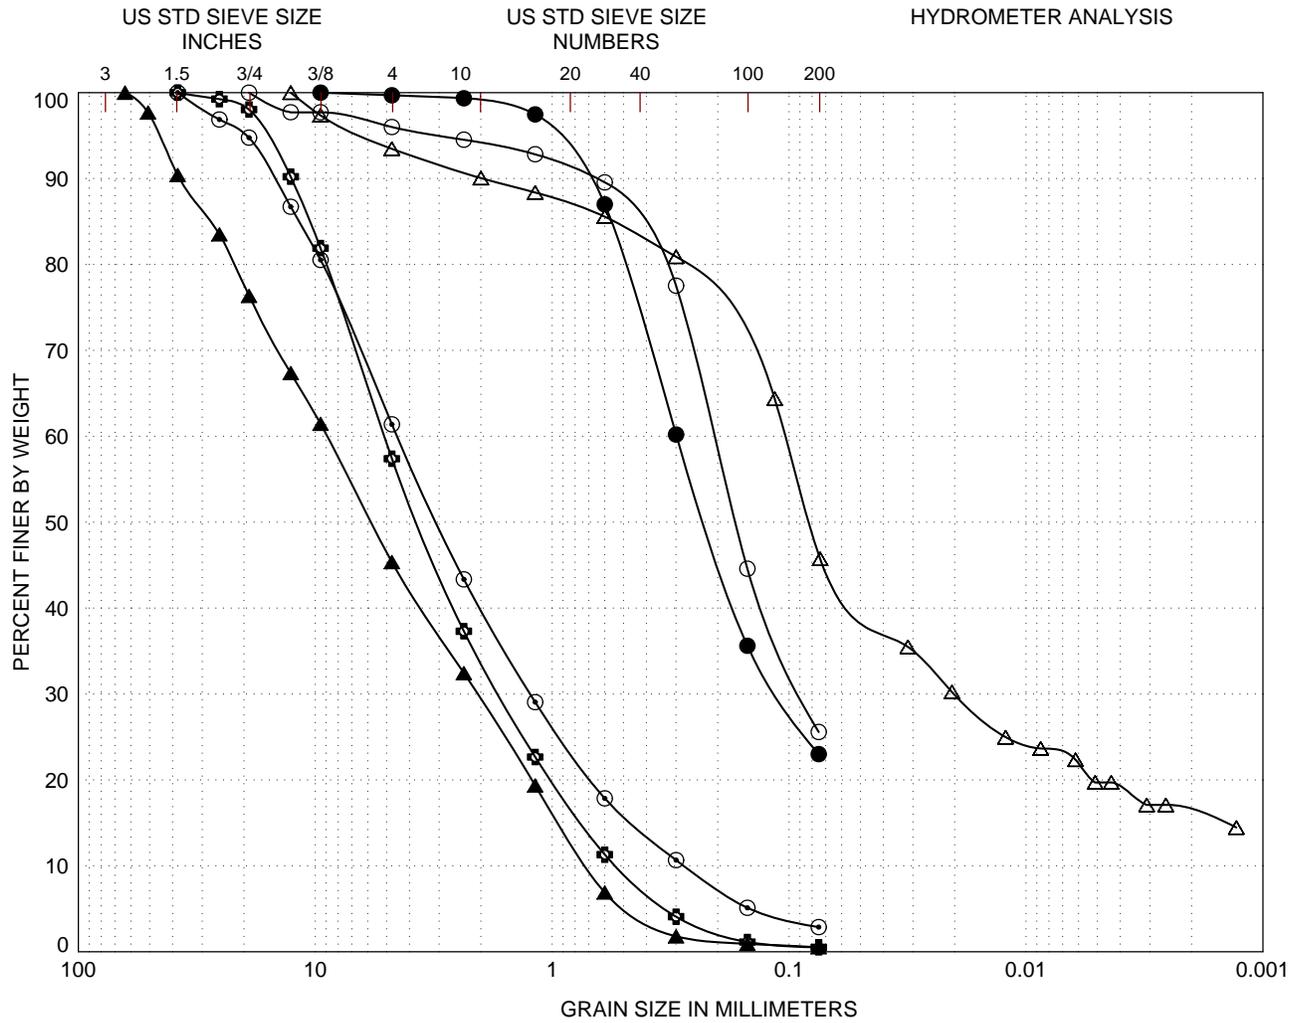
GRAIN SIZE CURVES
Arroyo Grande Creek Waterways Management Plan
San Luis Obispo County, California

GRAVEL		SAND			SILT or CLAY
Coarse	Fine	Coarse	Medium	Fine

LEGEND			CLASSIFICATION	Cc	Cu
(location)	(depth,ft)				
○	AB-1	0.0	Silty SAND (SM)		
●	AB-2	0.0	Silty SAND (SM)		
△	AB-6	0.0	Silty SAND (SM)		
▲	SB-1	0.0	Poorly-graded GRAVEL with sand (GP)	0.7	12.6
⊙	SB-2	0.0	Well-graded SAND with gravel (SW)	1.2	16.3
⊕	SB-6	0.0	Well-graded SAND with gravel (SW)	1.0	9.7

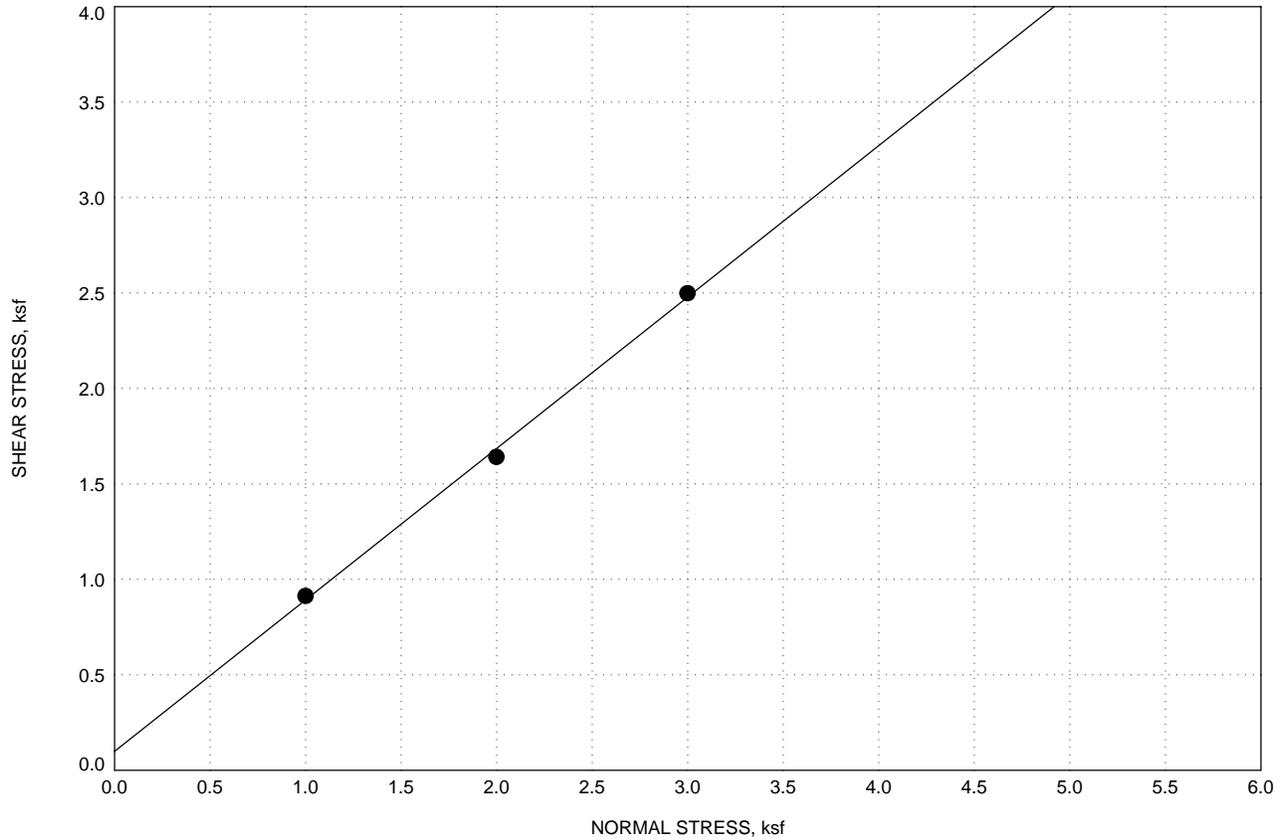
DIRECT SHEAR TEST RESULTS
 Arroyo Grande Creek Waterways Management Plan
 San Luis Obispo County, California

COHESION, ksf	0.1
ANGLE OF INTERNAL FRICTION, deg	38
LOCATION	H-1
DEPTH, ft	1
MOISTURE CONTENT, %	17
UNIT DRY WEIGHT, pcf	92
MATERIAL DESCRIPTION	Clayey SAND (SC)
SAMPLE CONDITION	Ring Sample

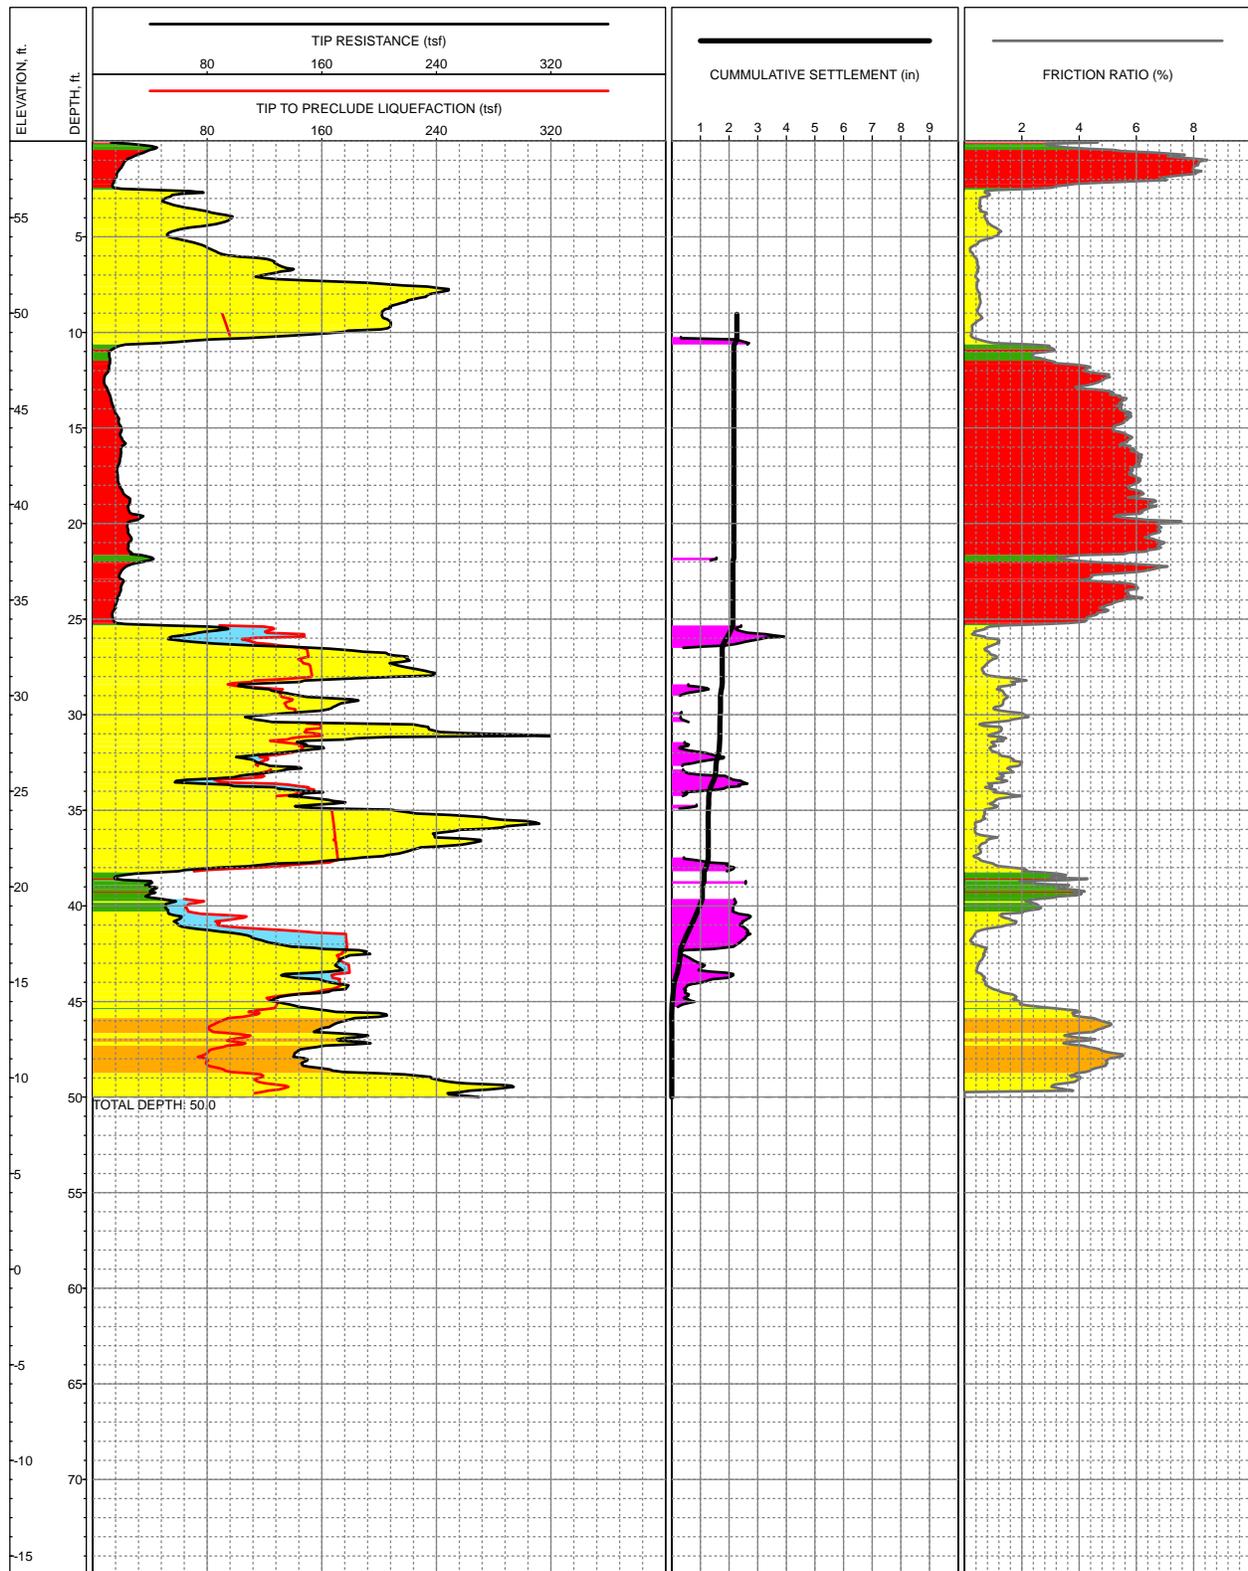
LOG OF CPT C-1, M7.0, a=0.46
Arroyo Grande Creek Waterways Management Plan
San Luis Obispo County, California

COORDINATES: 2,233,857.20N 5,787,490.08W
SURFACE EL: 59.0ft +/- (MSL)
COMPLETION DEPTH: 50.0ft
TESTDATE: 7/22/2008

EXPLORATION METHOD: Cone Penetrometer
PERFORMED BY: Fugro Geosciences
REVIEWED BY: J Blanchard

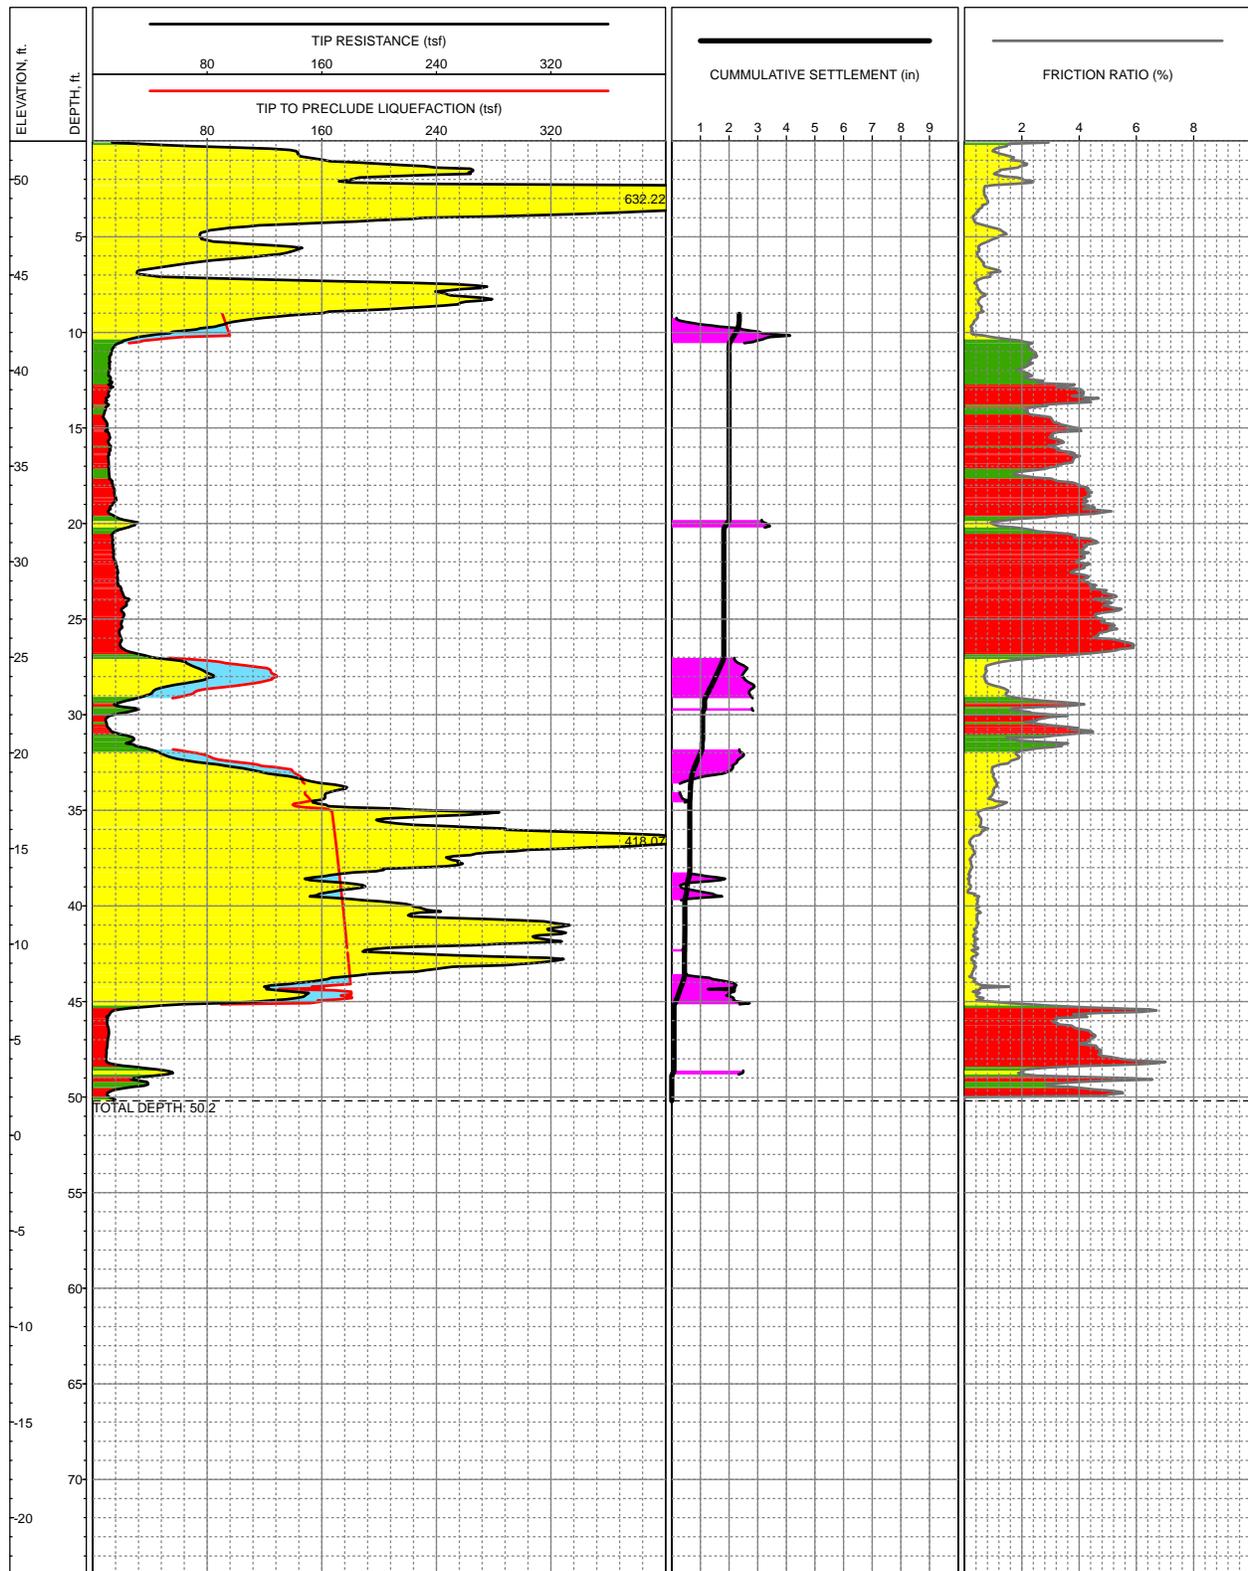
LOG OF CPT C-2, M7.0, a=0.46
Arroyo Grande Creek Waterways Management Plan
San Luis Obispo County, California

COORDINATES: 2,232,173.97N 5,786,405.43W
SURFACE EL: 52.0ft +/- (MSL)
COMPLETION DEPTH: 50.2ft
TESTDATE: 7/22/2008

EXPLORATION METHOD: Cone Penetrometer
PERFORMED BY: Fugro Geosciences
REVIEWED BY: J Blanchard

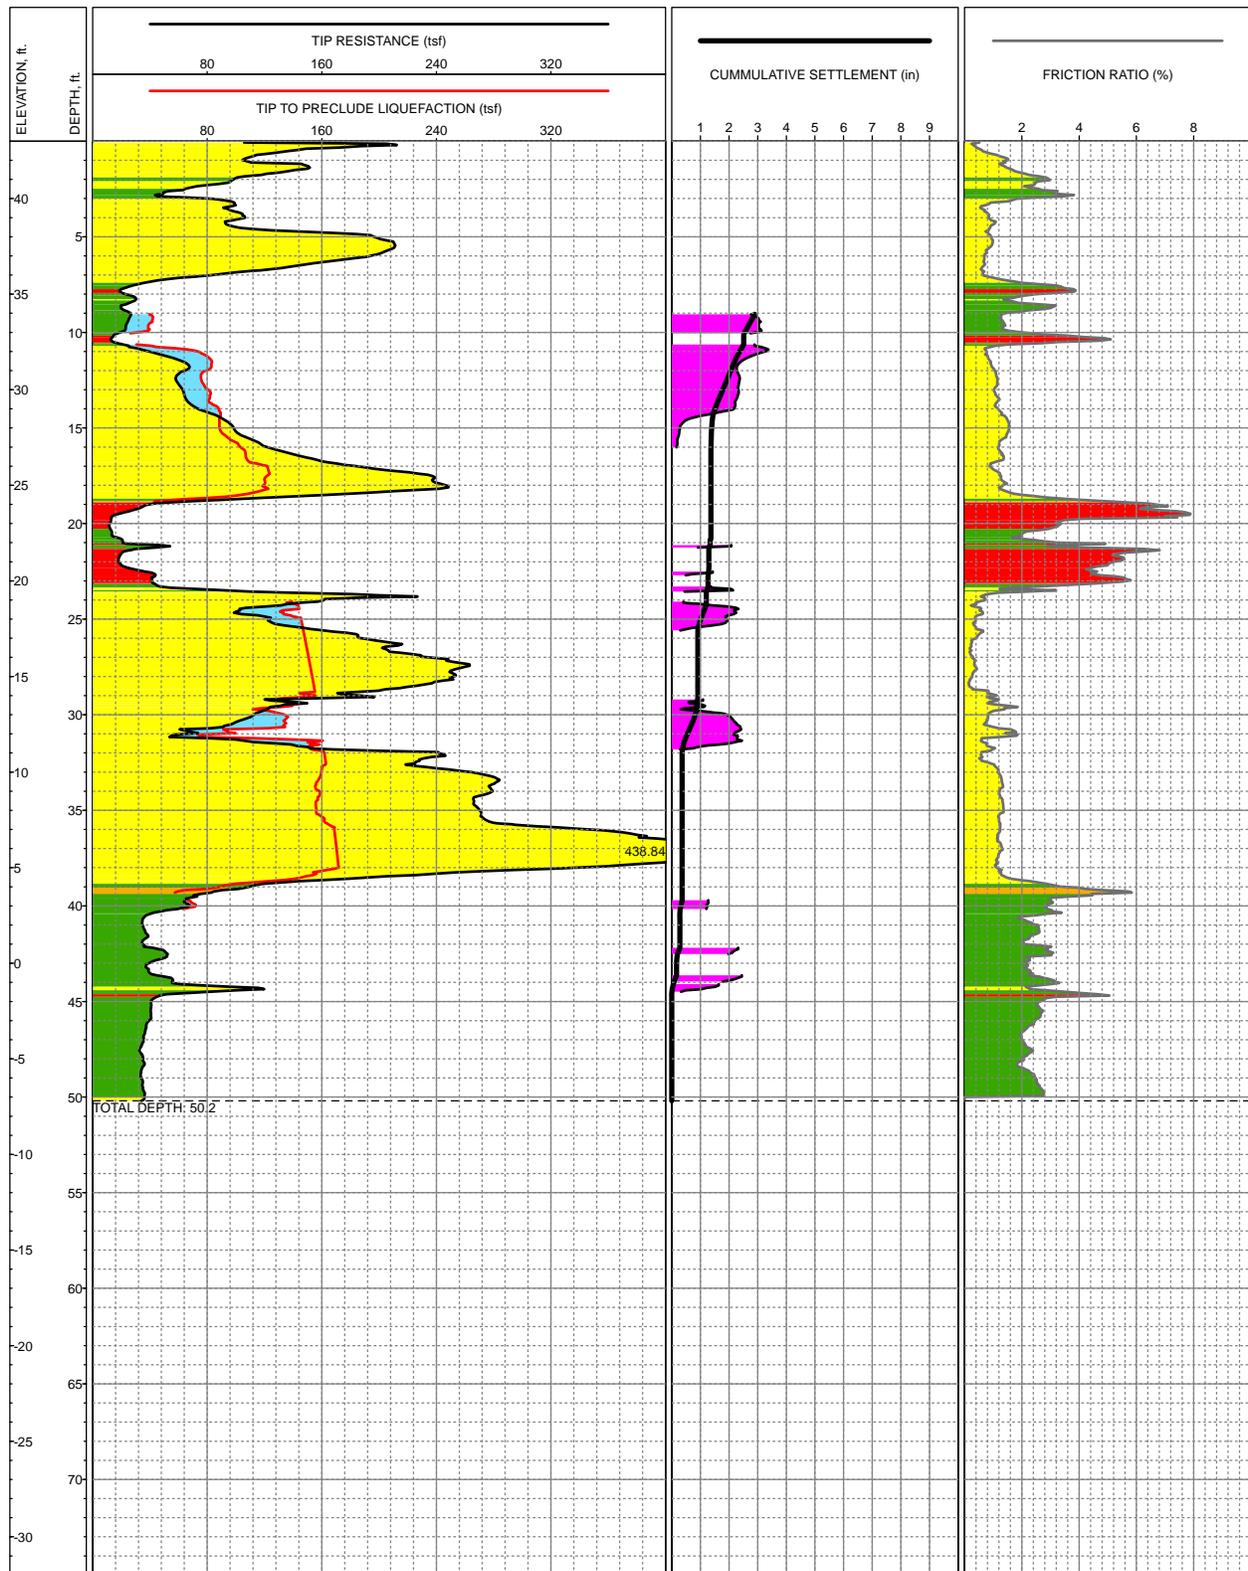
LOG OF CPT C-3, M7.0, a=0.46
Arroyo Grande Creek Waterways Management Plan
San Luis Obispo County, California

COORDINATES: 2,231,087.37N 5,784,635.85W
SURFACE EL: 43.0ft +/- (MSL)
COMPLETION DEPTH: 50.2ft
TESTDATE: 7/22/2008

EXPLORATION METHOD: Cone Penetrometer
PERFORMED BY: Fugro Geosciences
REVIEWED BY: J Blanchard

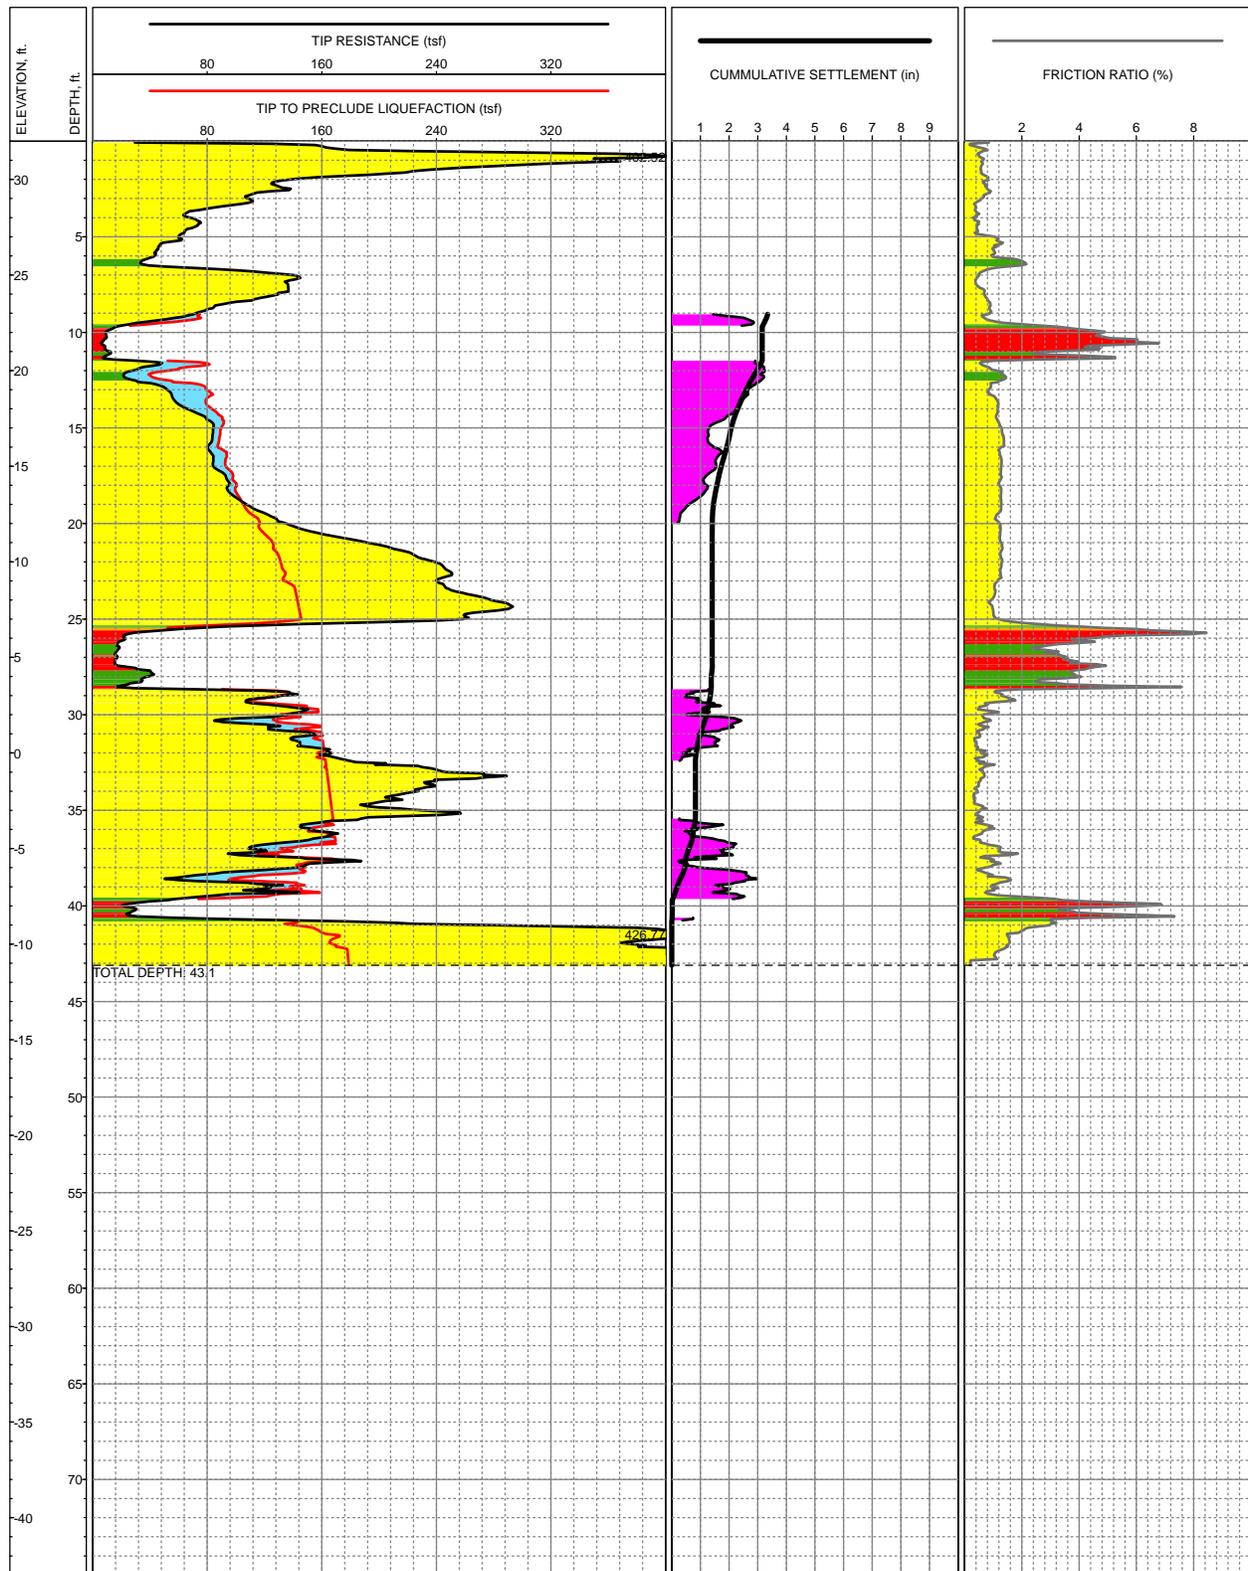
LOG OF CPT C-4, M7.0, a=0.46
 Arroyo Grande Creek Waterways Management Plan
 San Luis Obispo County, California

COORDINATES: 2,231,221.08N 5,782,003.06W
 SURFACE EL: 32.0ft +/- (MSL)
 COMPLETION DEPTH: 43.1ft
 TESTDATE: 7/22/2008

EXPLORATION METHOD: Cone Penetrometer
 PERFORMED BY: Fugro Geosciences
 REVIEWED BY: J Blanchard

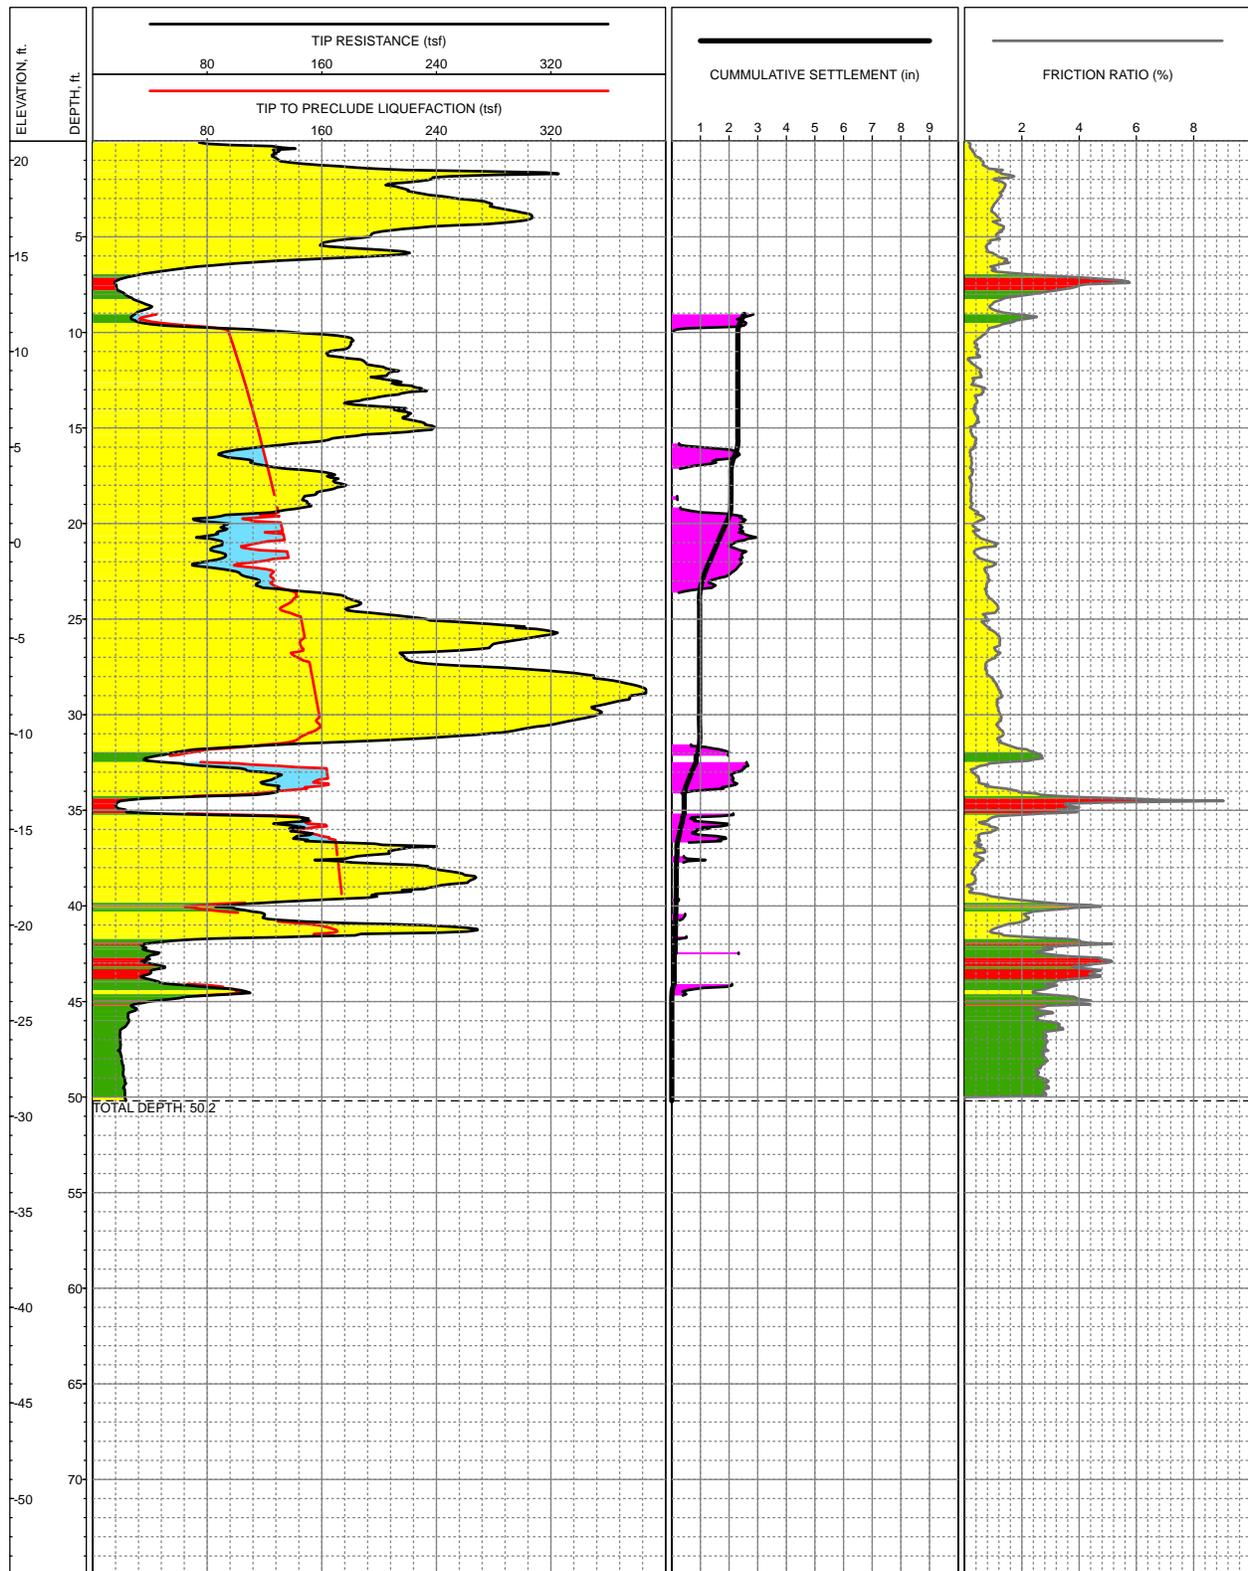
LOG OF CPT C-5, M7.0, a=0.46
 Arroyo Grande Creek Waterways Management Plan
 San Luis Obispo County, California

COORDINATES: 2,232,390.00N 5,778,074.64W
 SURFACE EL: 21.0ft +/- (MSL)
 COMPLETION DEPTH: 50.2ft
 TESTDATE: 7/22/2008

EXPLORATION METHOD: Cone Penetrometer
 PERFORMED BY: Fugro Geosciences
 REVIEWED BY: J Blanchard

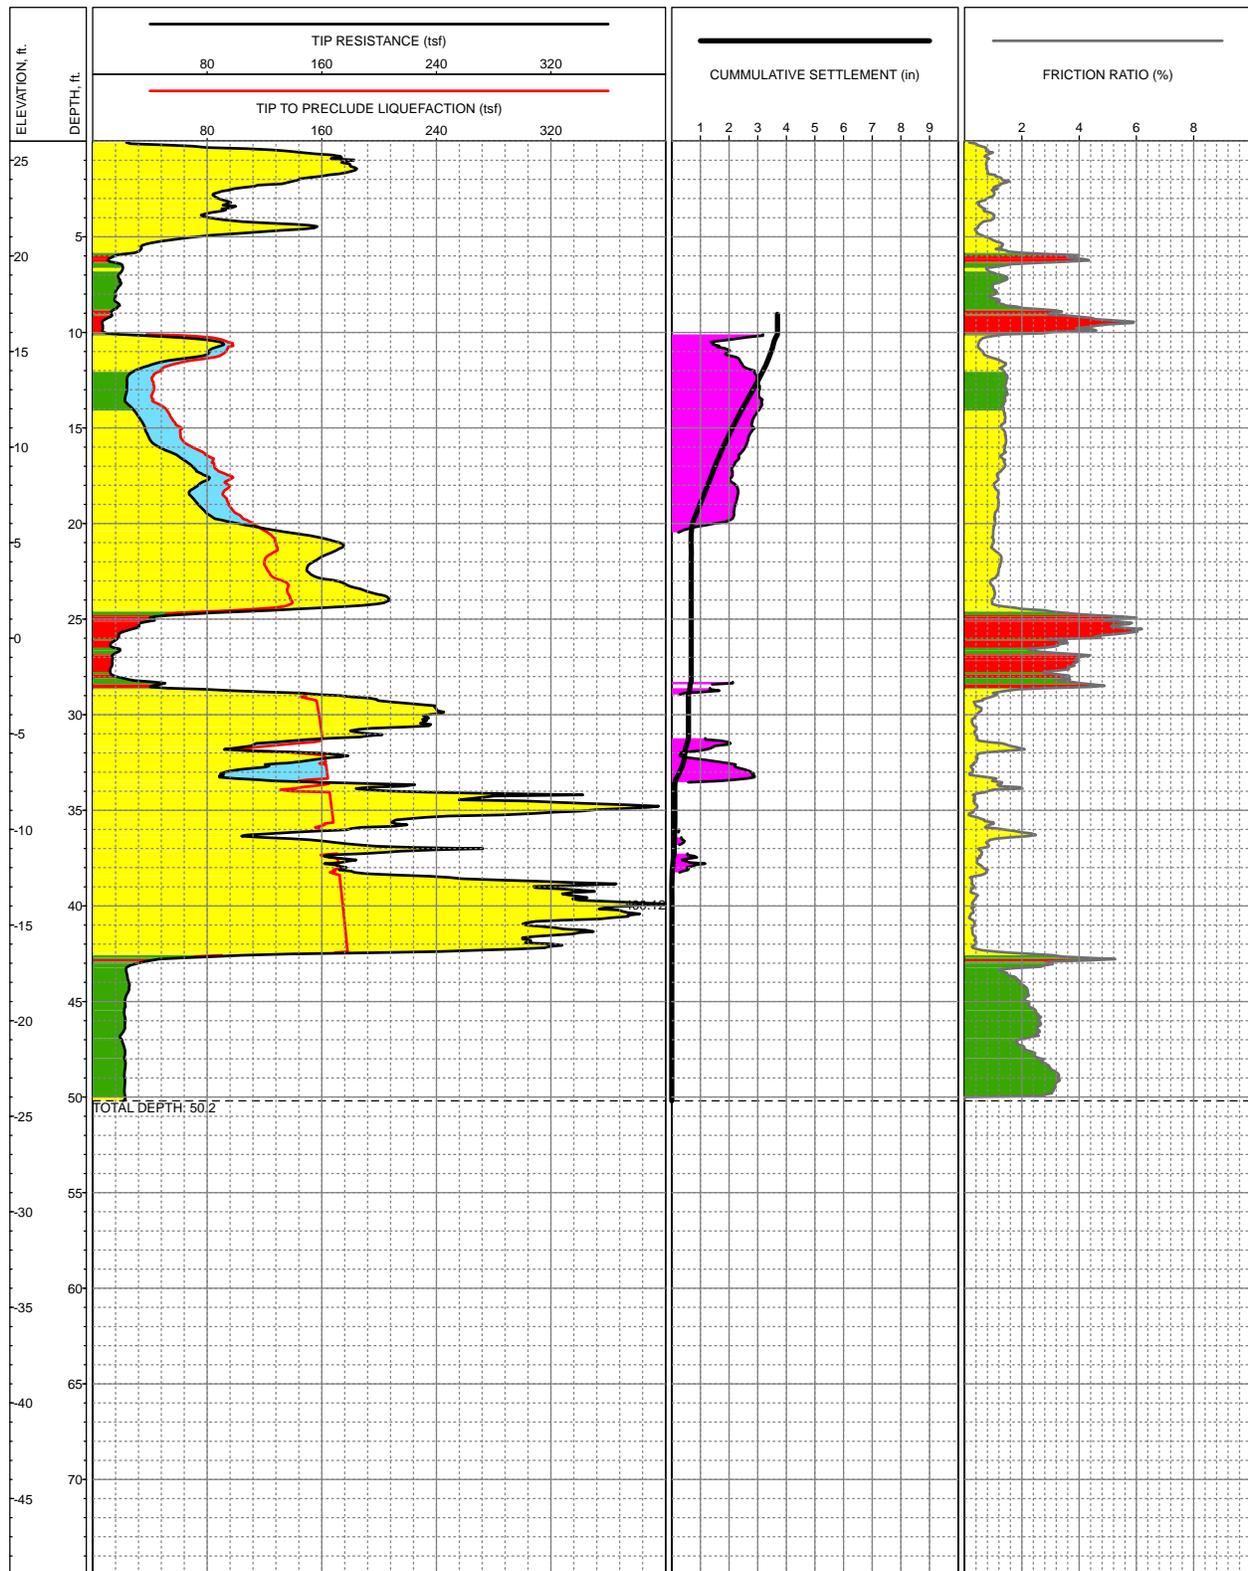
LOG OF CPT C-6, M7.0, a=0.46
 Arroyo Grande Creek Waterways Management Plan
 San Luis Obispo County, California

COORDINATES: 2,231,397.63N 5,779,691.56W
 SURFACE EL: 26.0ft +/- (MSL)
 COMPLETION DEPTH: 50.2ft
 TESTDATE: 7/22/2008

EXPLORATION METHOD: Cone Penetrometer
 PERFORMED BY: Fugro Geosciences
 REVIEWED BY: J Blanchard

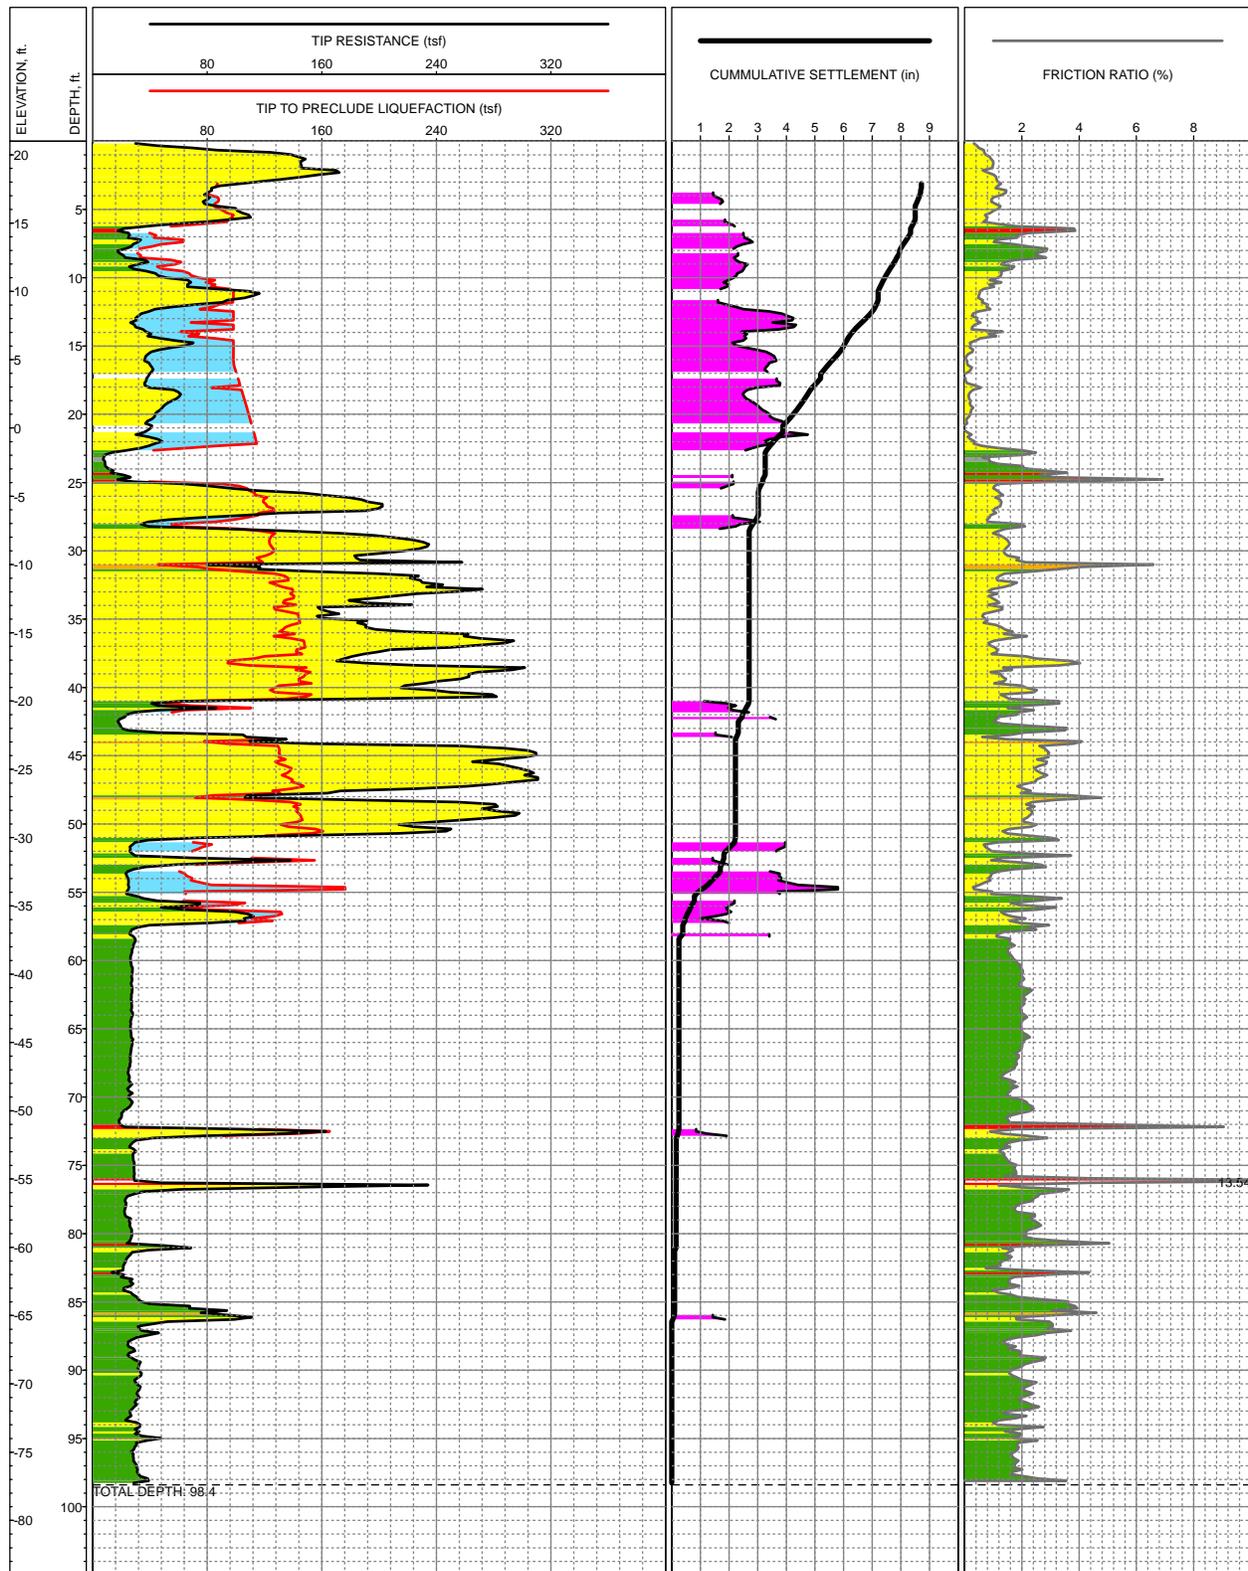
LOG OF CPT SOC035, M=7.0, a=0.46
 Arroyo Grande Creek Waterways Management Plan
 San Luis Obispo County, California

LOCATION: South Levee, Approx. 3350 ft northwest of 22nd St. Bridge
 SURFACE EL: 21.0ft +/- (MSL)
 COMPLETION DEPTH: 98.4ft
 TESTDATE: 3/5/2004

EXPLORATION METHOD: Cone Penetrometer
 PERFORMED BY: USGS
 REVIEWED BY: J Blanchard
