**PRELIMINARY GEOTECHNICAL REPORT
ARROYO GRANDE CREEK WATERWAYS
MANAGEMENT PLAN
LOS BERROS CREEK TO NEAR OCEANO AIRPORT
SAN LUIS OBISPO COUNTY, CALIFORNIA**

Prepared for:
County of San Luis Obispo
Department of Public Works

April 22, 2009

April 22, 2009
Project No. 3014.029

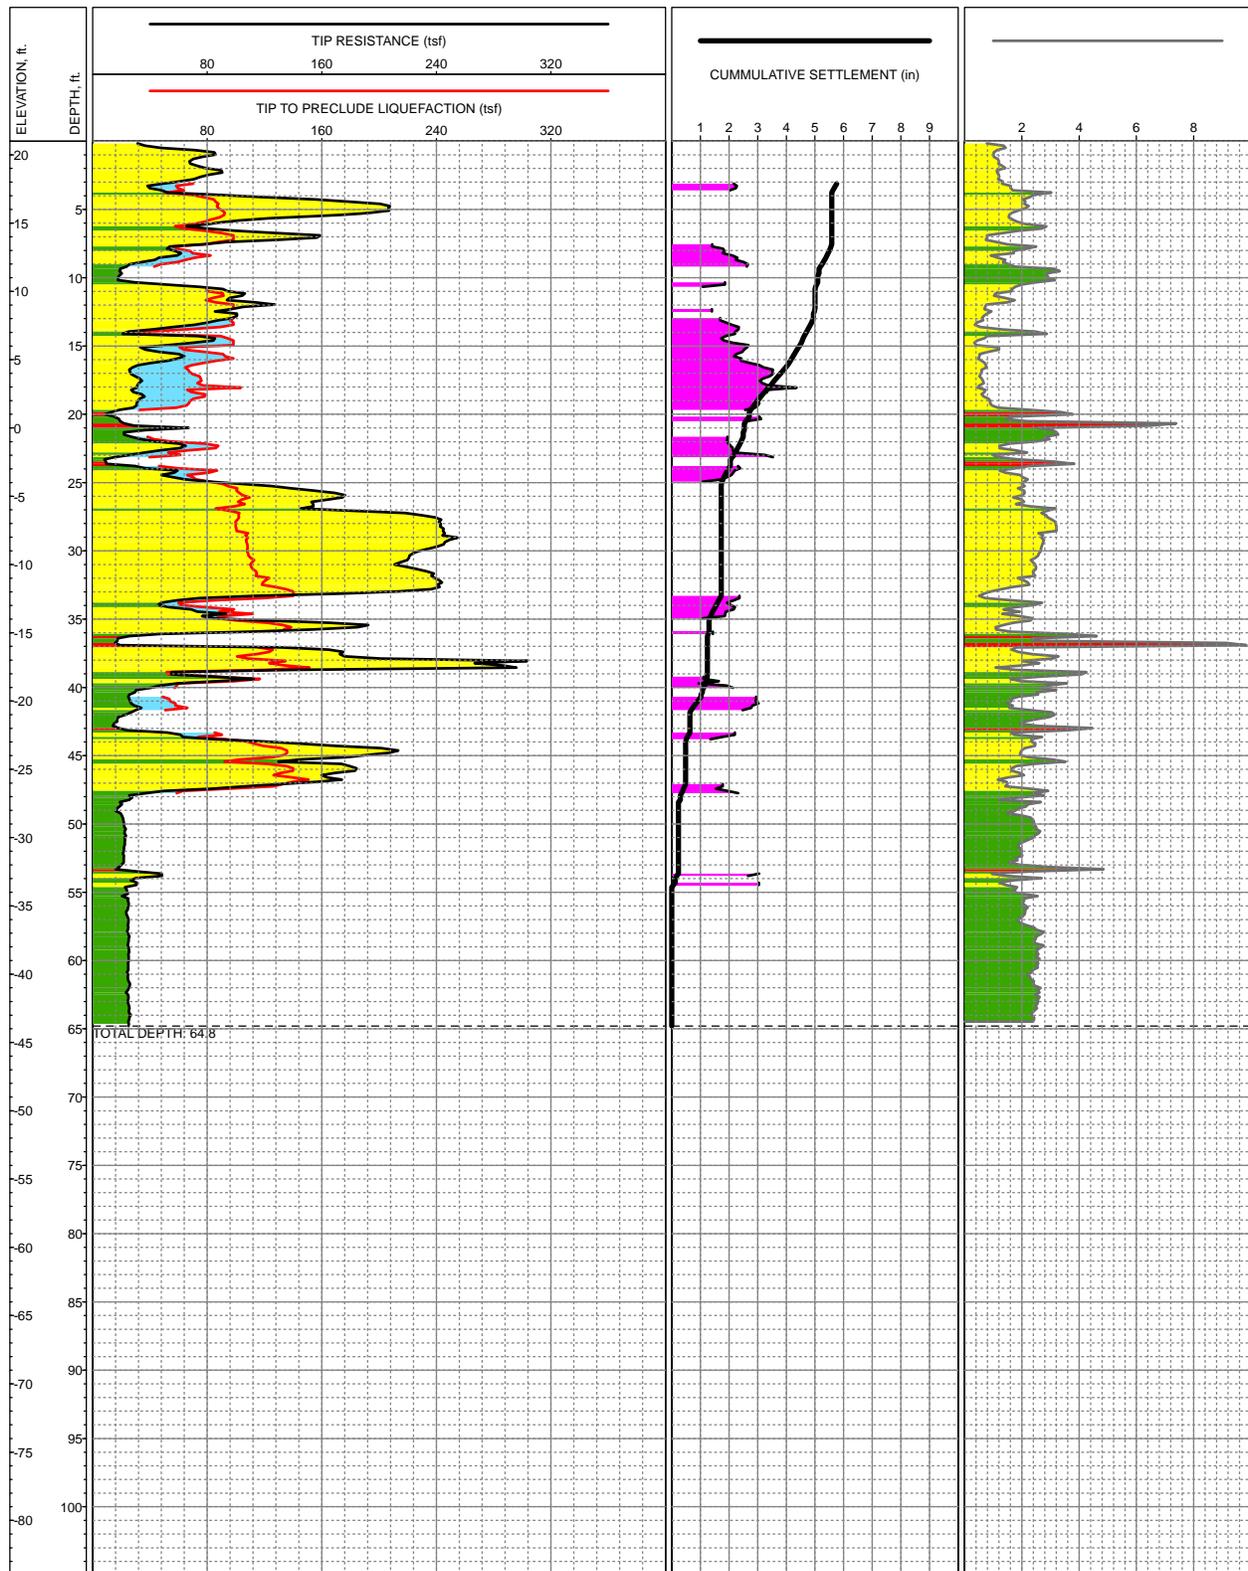
LOG OF CPT SOC036, M=7.0, a=0.46
 Arroyo Grande Creek Waterways Management Plan
 San Luis Obispo County, California

LOCATION: South Levee, Approx. 3500 ft northwest of 22nd St. Bridge
 SURFACE EL: 21.0ft +/- (MSL)
 COMPLETION DEPTH: 64.8ft
 TESTDATE: 3/5/2004

EXPLORATION METHOD: Cone Penetrometer
 PERFORMED BY: USGS
 REVIEWED BY: J Blanchard

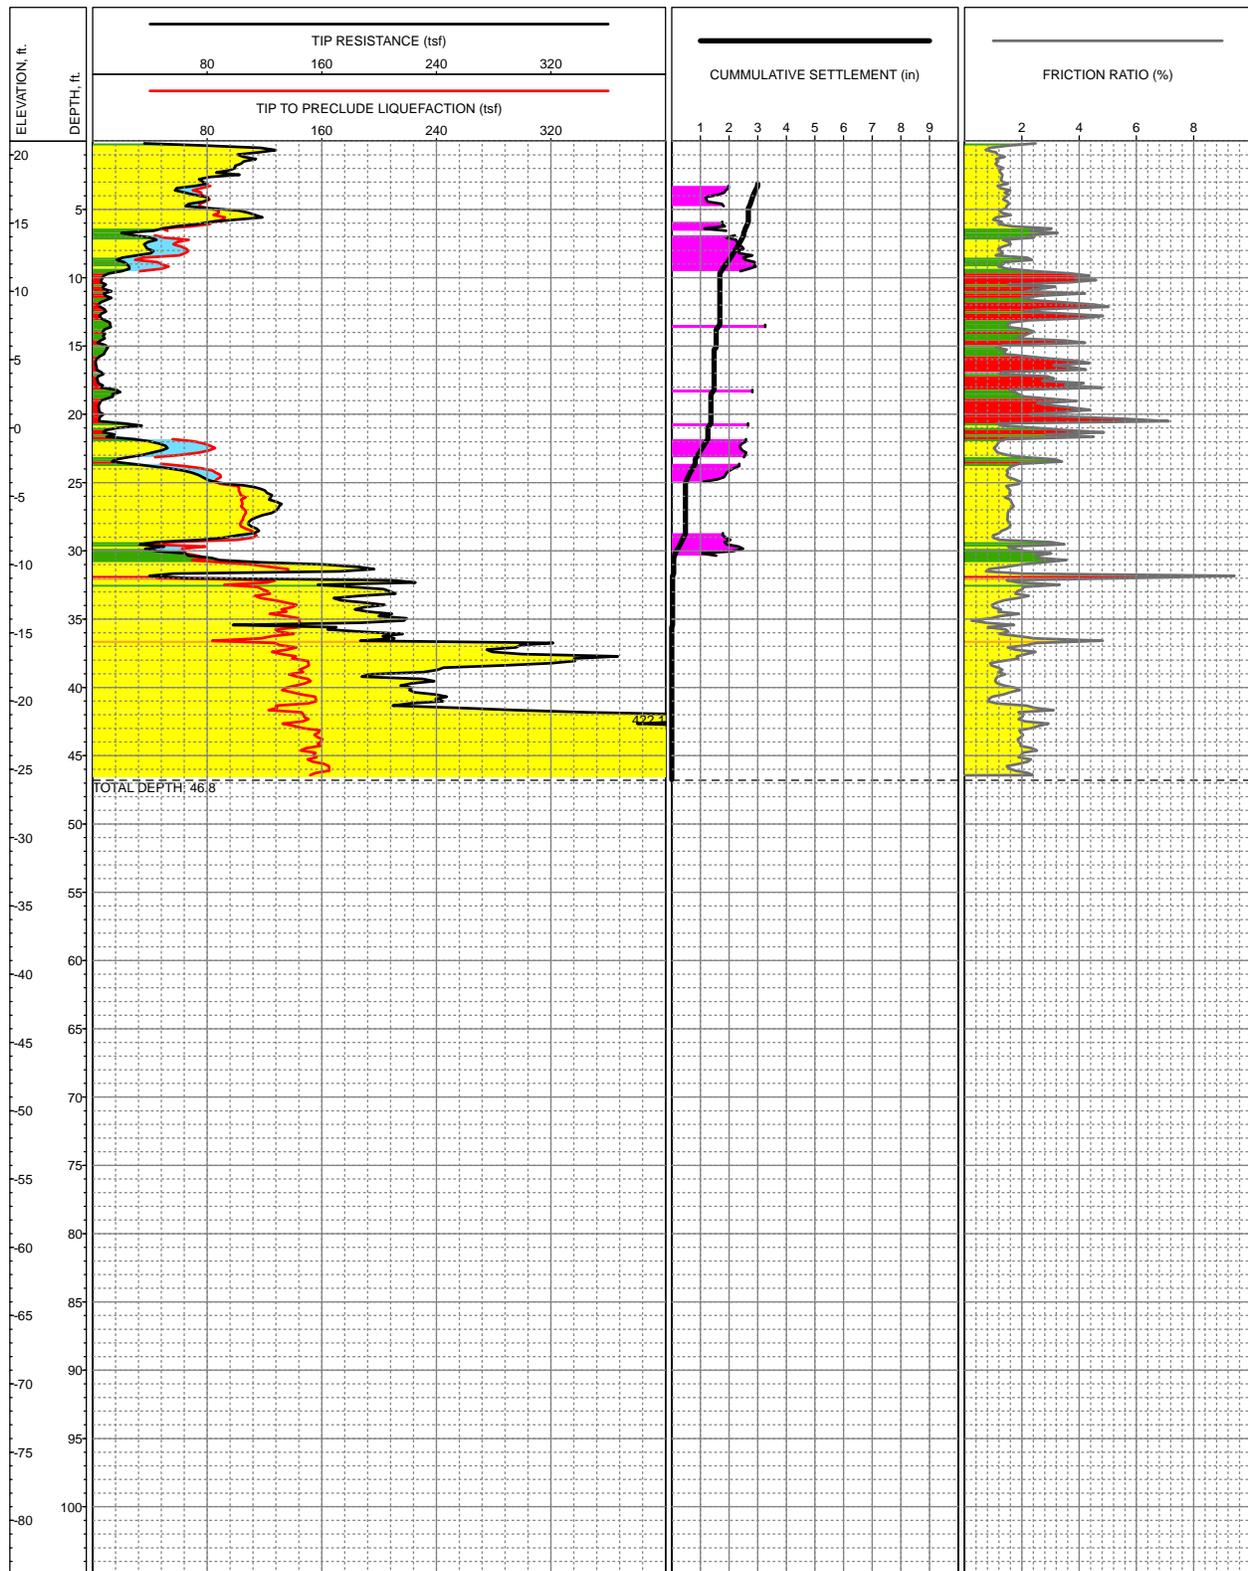
LOG OF CPT SOC037, M=7.0, a=0.46
 Arroyo Grande Creek Waterways Management Plan
 San Luis Obispo County, California

LOCATION: South Levee, Approx. 3250 ft northwest of 22nd St. Bridge
 SURFACE EL: 21.0ft +/- (MSL)
 COMPLETION DEPTH: 46.8ft
 TESTDATE: 3/5/2004

EXPLORATION METHOD: Cone Penetrometer
 PERFORMED BY: USGS
 REVIEWED BY: J Blanchard

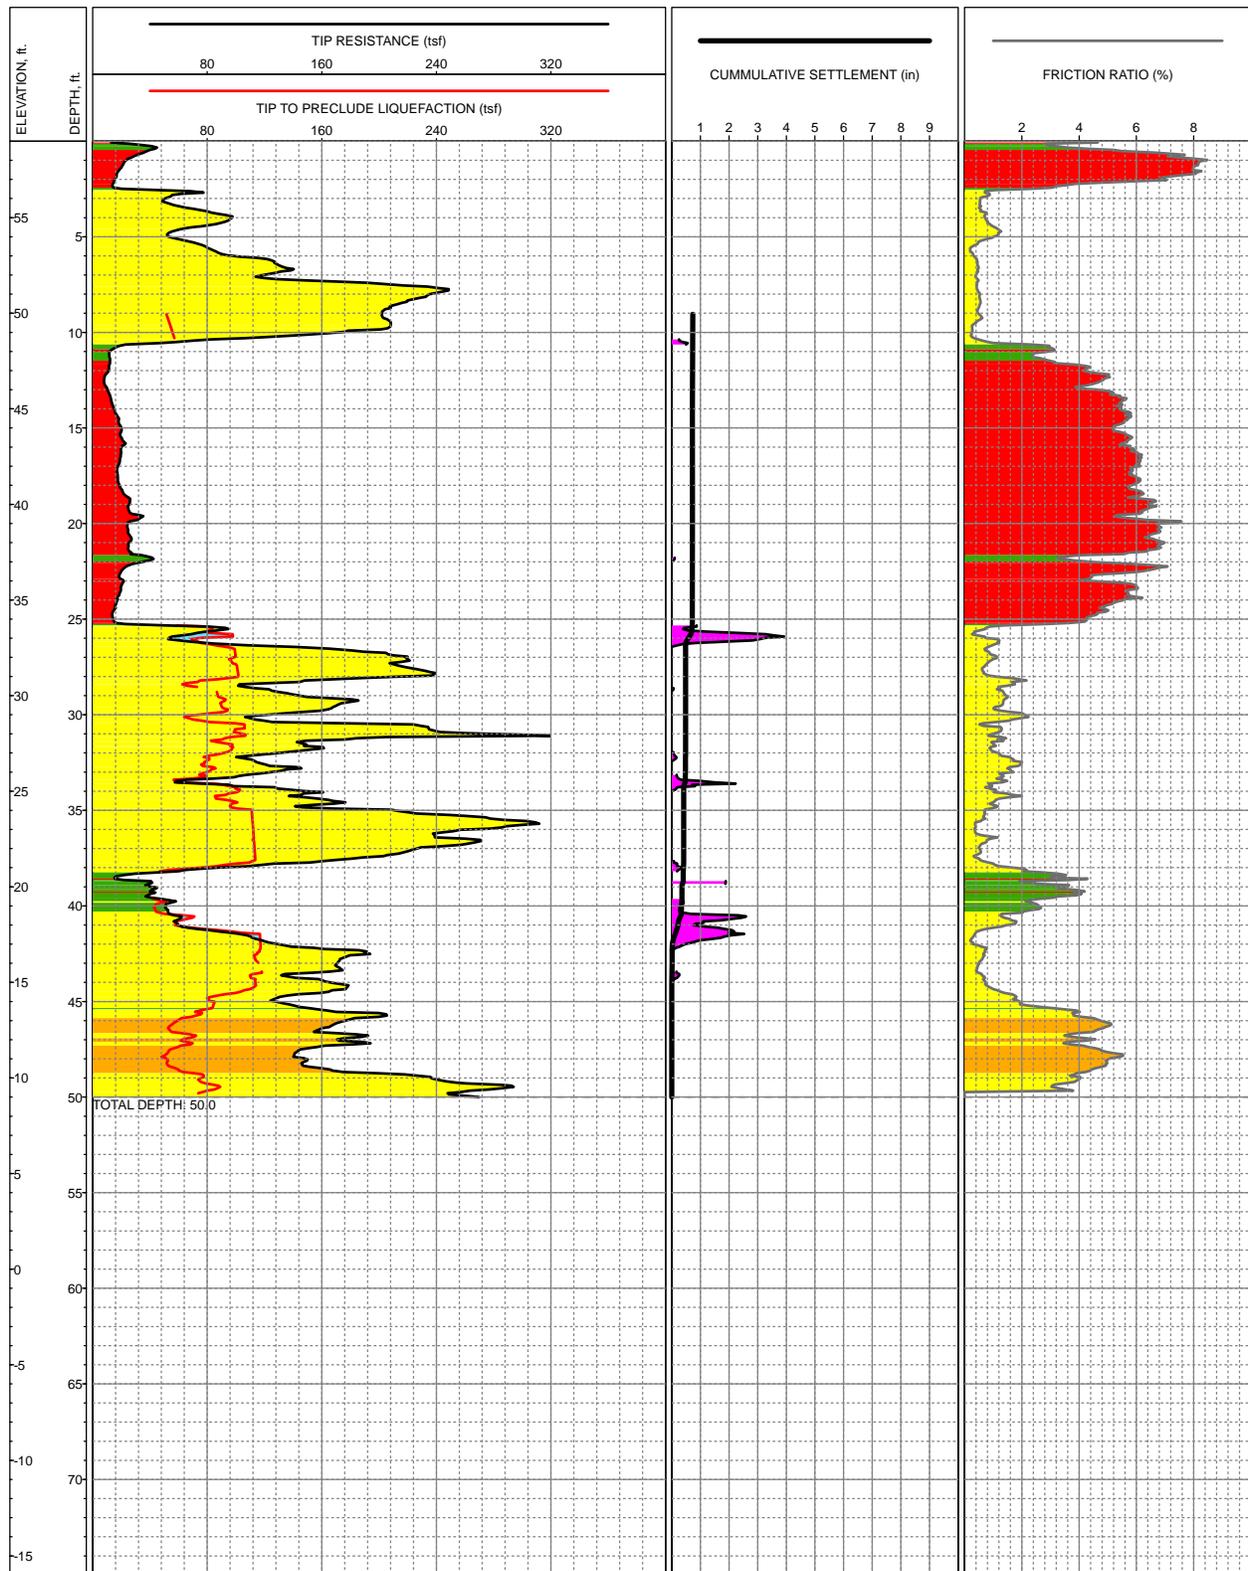
LOG OF CPT C-1, M6.5, a=0.25
Arroyo Grande Creek Waterways Management Plan
San Luis Obispo County, California

COORDINATES: 2,233,857.20N 5,787,490.08W
SURFACE EL: 59.0ft +/- (MSL)
COMPLETION DEPTH: 50.0ft
TESTDATE: 7/22/2008

EXPLORATION METHOD: Cone Penetrometer
PERFORMED BY: Fugro Geosciences
REVIEWED BY: J Blanchard

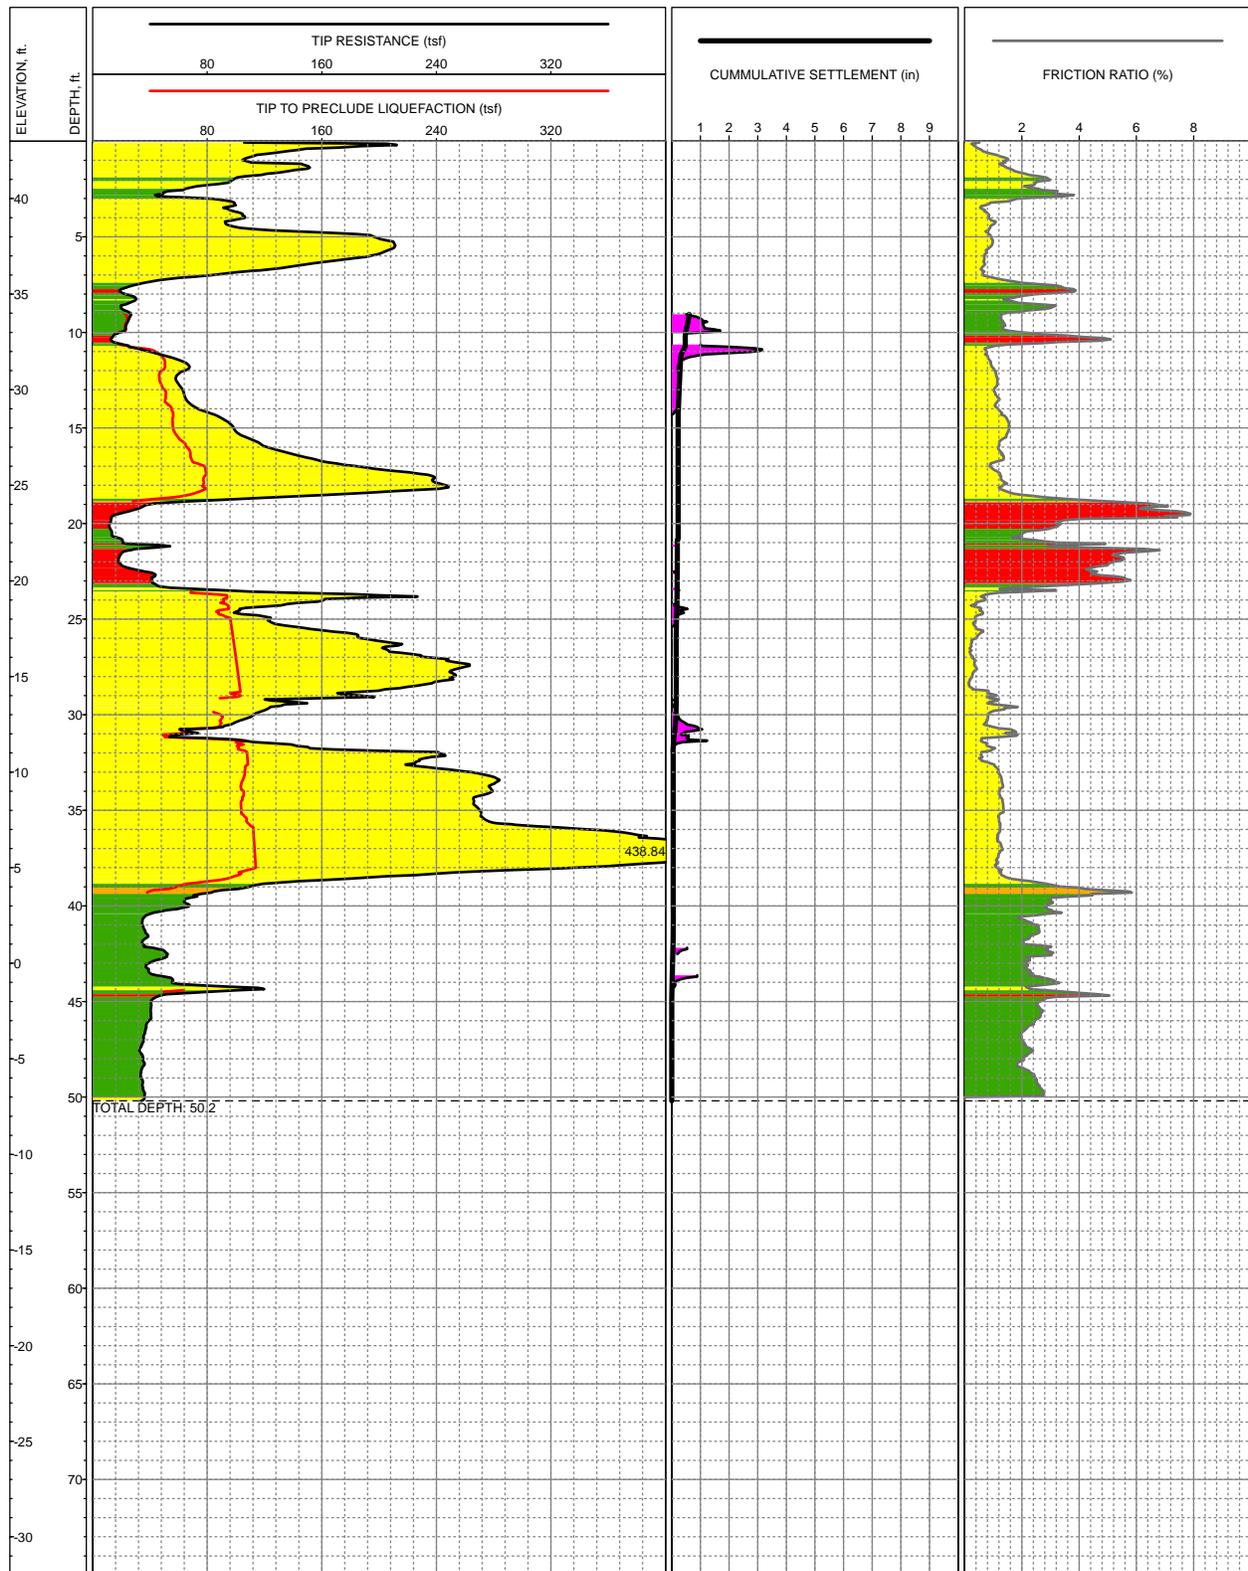
LOG OF CPT C-3, M6.5, a=0.25
Arroyo Grande Creek Waterways Management Plan
San Luis Obispo County, California

COORDINATES: 2,231,087.37N 5,784,635.85W
SURFACE EL: 43.0ft +/- (MSL)
COMPLETION DEPTH: 50.2ft
TESTDATE: 7/22/2008

EXPLORATION METHOD: Cone Penetrometer
PERFORMED BY: Fugro Geosciences
REVIEWED BY: J Blanchard

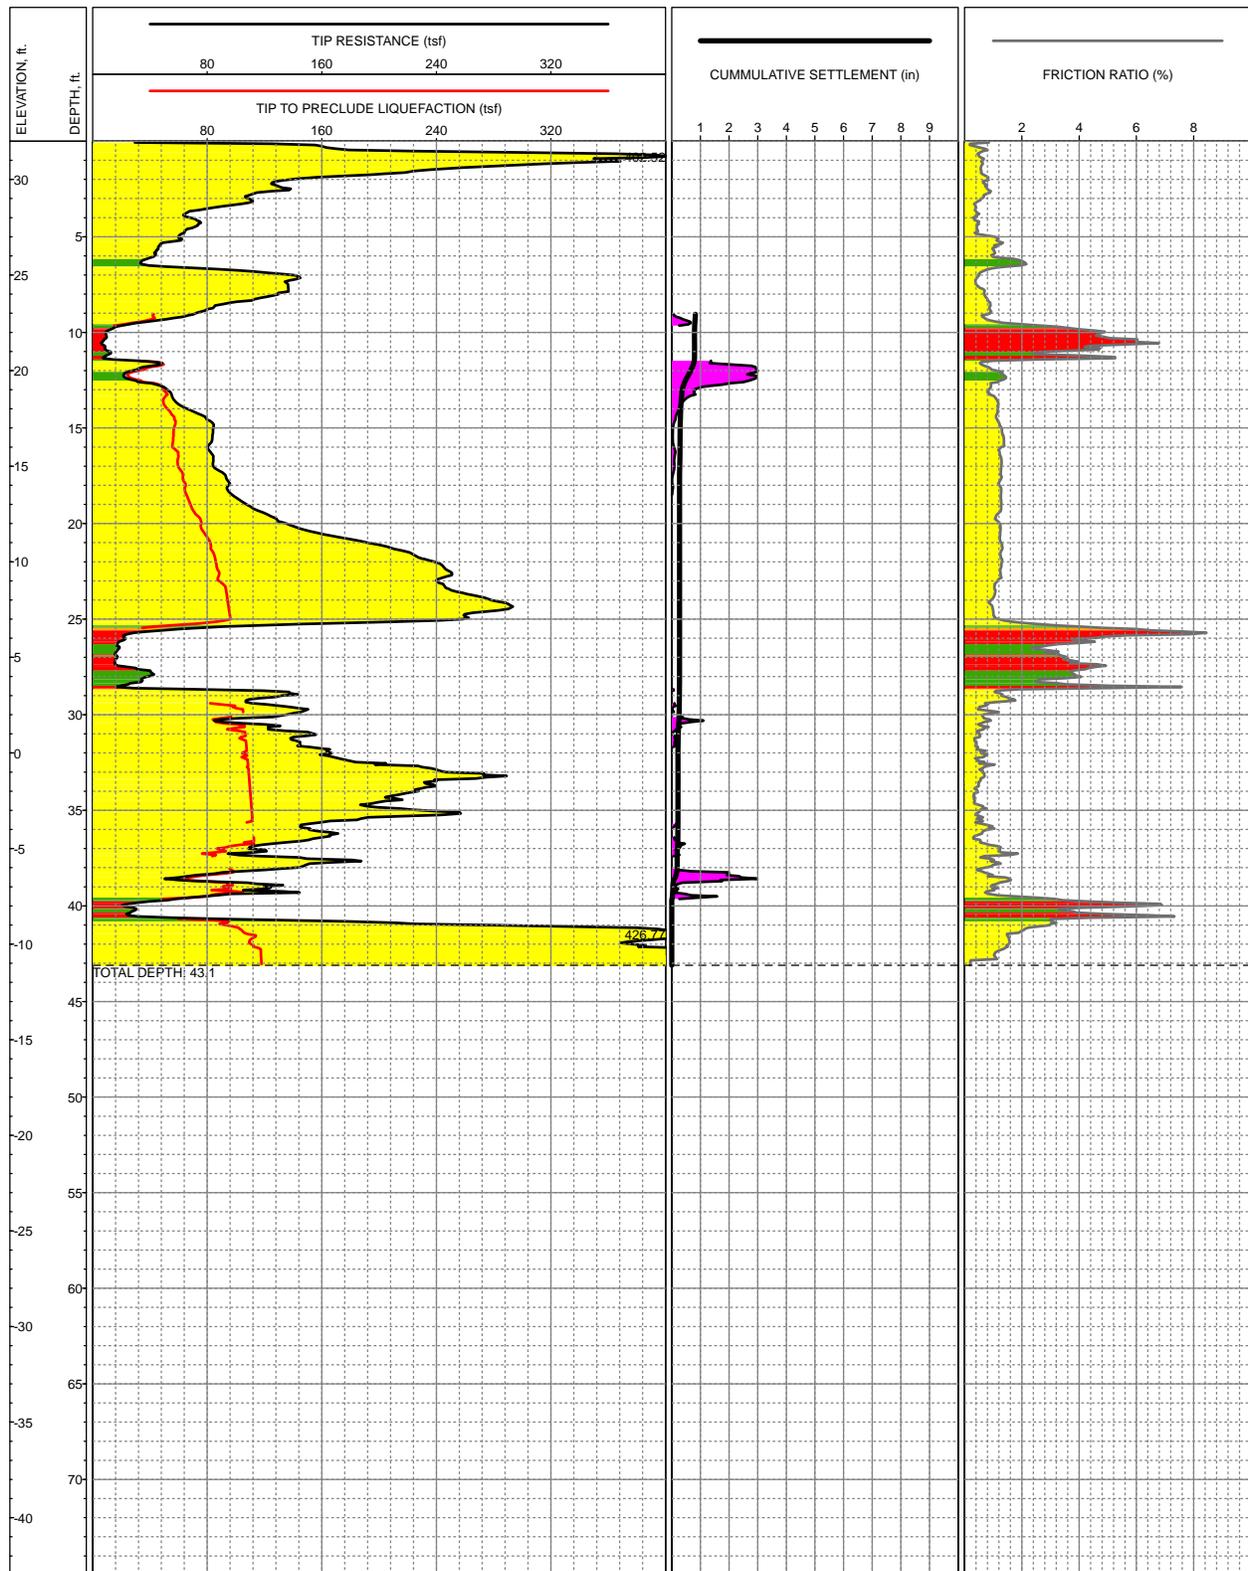
LOG OF CPT C-4, M6.5, a=0.25
Arroyo Grande Creek Waterways Management Plan
San Luis Obispo County, California

COORDINATES: 2,231,221.08N 5,782,003.06W
SURFACE EL: 32.0ft +/- (MSL)
COMPLETION DEPTH: 43.1ft
TESTDATE: 7/22/2008

EXPLORATION METHOD: Cone Penetrometer
PERFORMED BY: Fugro Geosciences
REVIEWED BY: J Blanchard

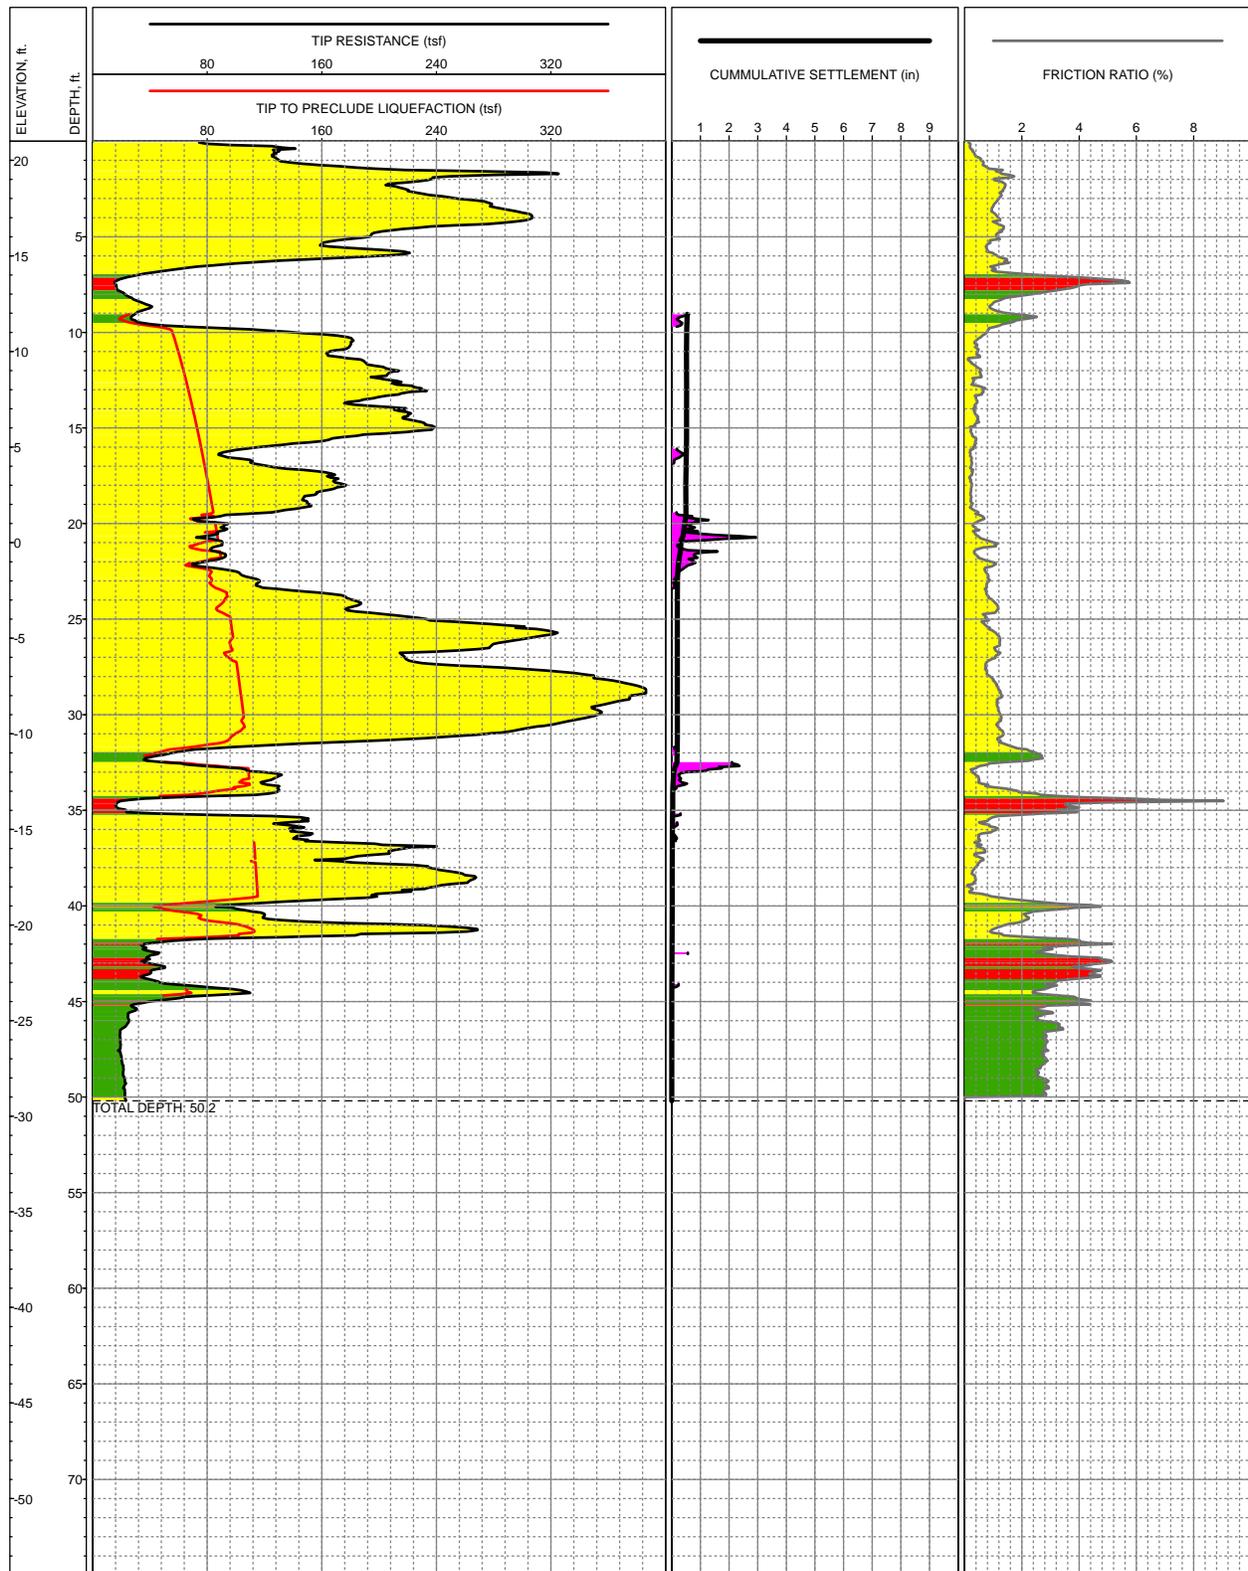
LOG OF CPT C-5, M6.5, a=0.25
Arroyo Grande Creek Waterways Management Plan
San Luis Obispo County, California

COORDINATES: 2,232,390.00N 5,778,074.64W
SURFACE EL: 21.0ft +/- (MSL)
COMPLETION DEPTH: 50.2ft
TESTDATE: 7/22/2008

EXPLORATION METHOD: Cone Penetrometer
PERFORMED BY: Fugro Geosciences
REVIEWED BY: J Blanchard

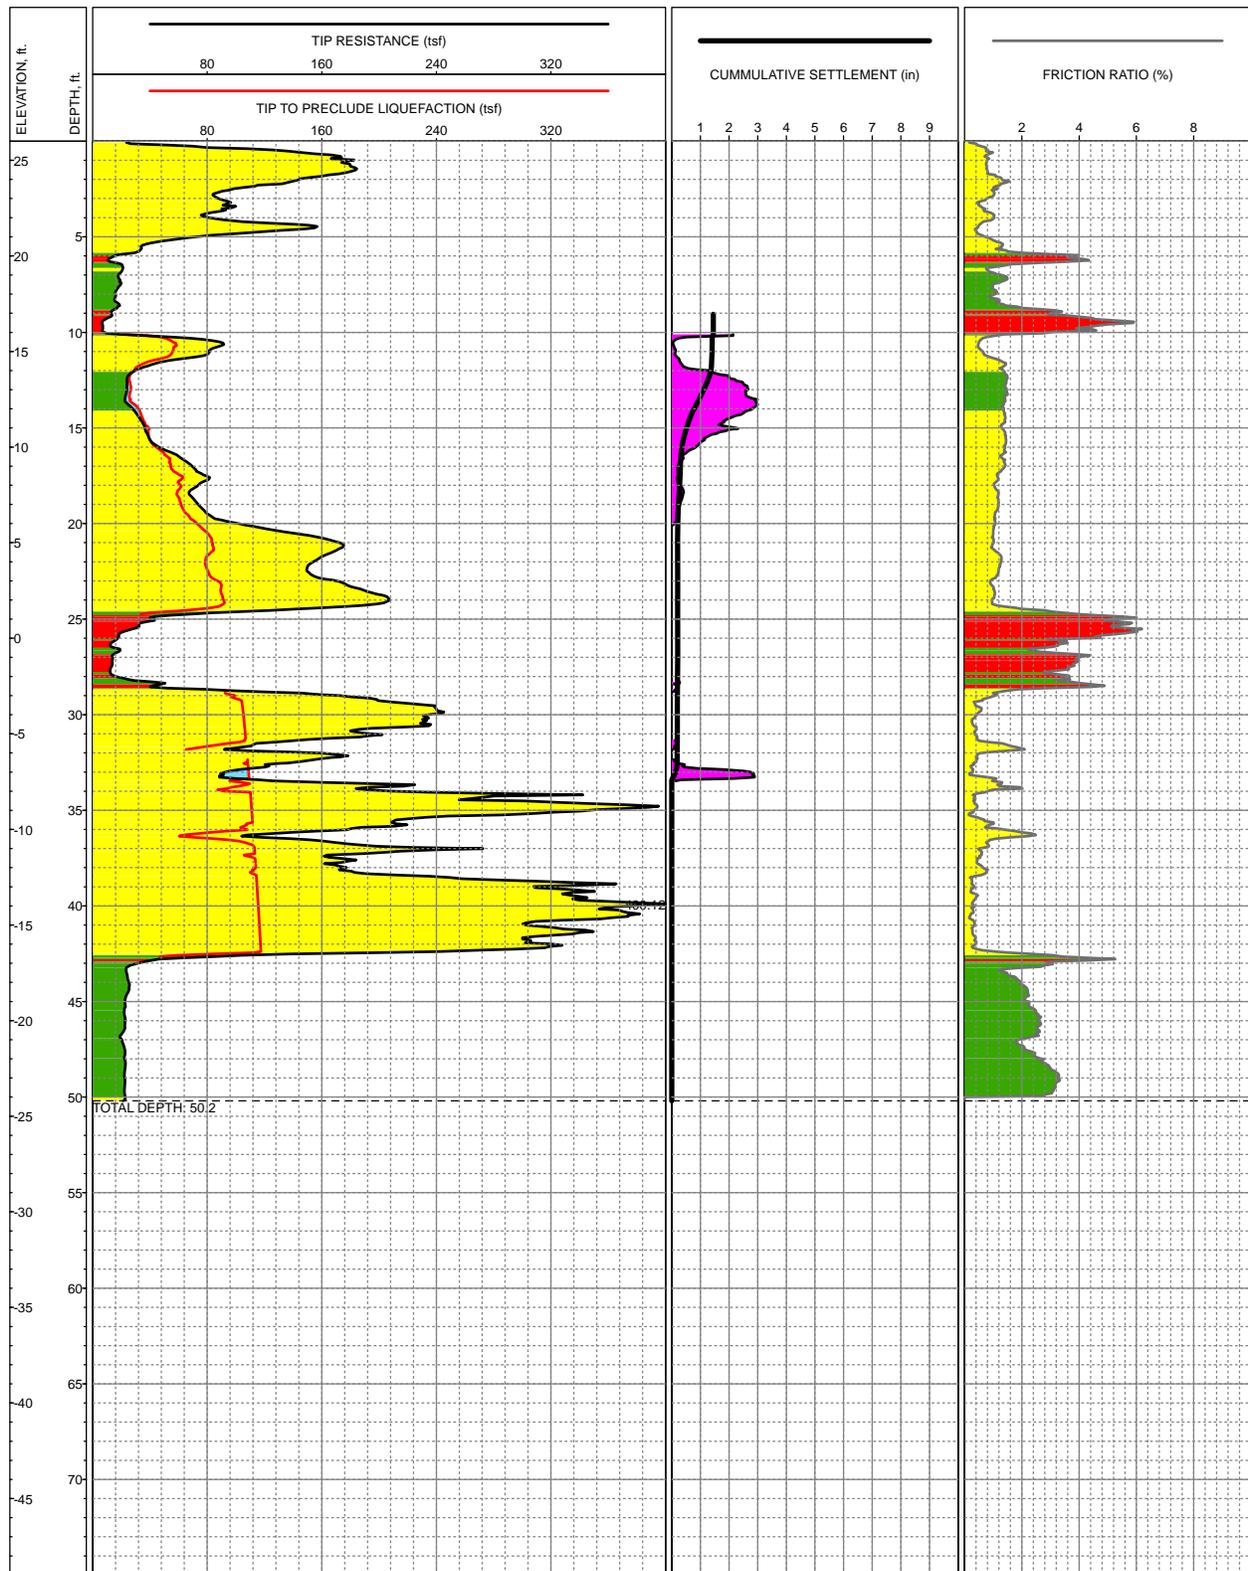
LOG OF CPT C-6, M6.5, a=0.25
 Arroyo Grande Creek Waterways Management Plan
 San Luis Obispo County, California

COORDINATES: 2,231,397.63N 5,779,691.56W
 SURFACE EL: 26.0ft +/- (MSL)
 COMPLETION DEPTH: 50.2ft
 TESTDATE: 7/22/2008

EXPLORATION METHOD: Cone Penetrometer
 PERFORMED BY: Fugro Geosciences
 REVIEWED BY: J Blanchard

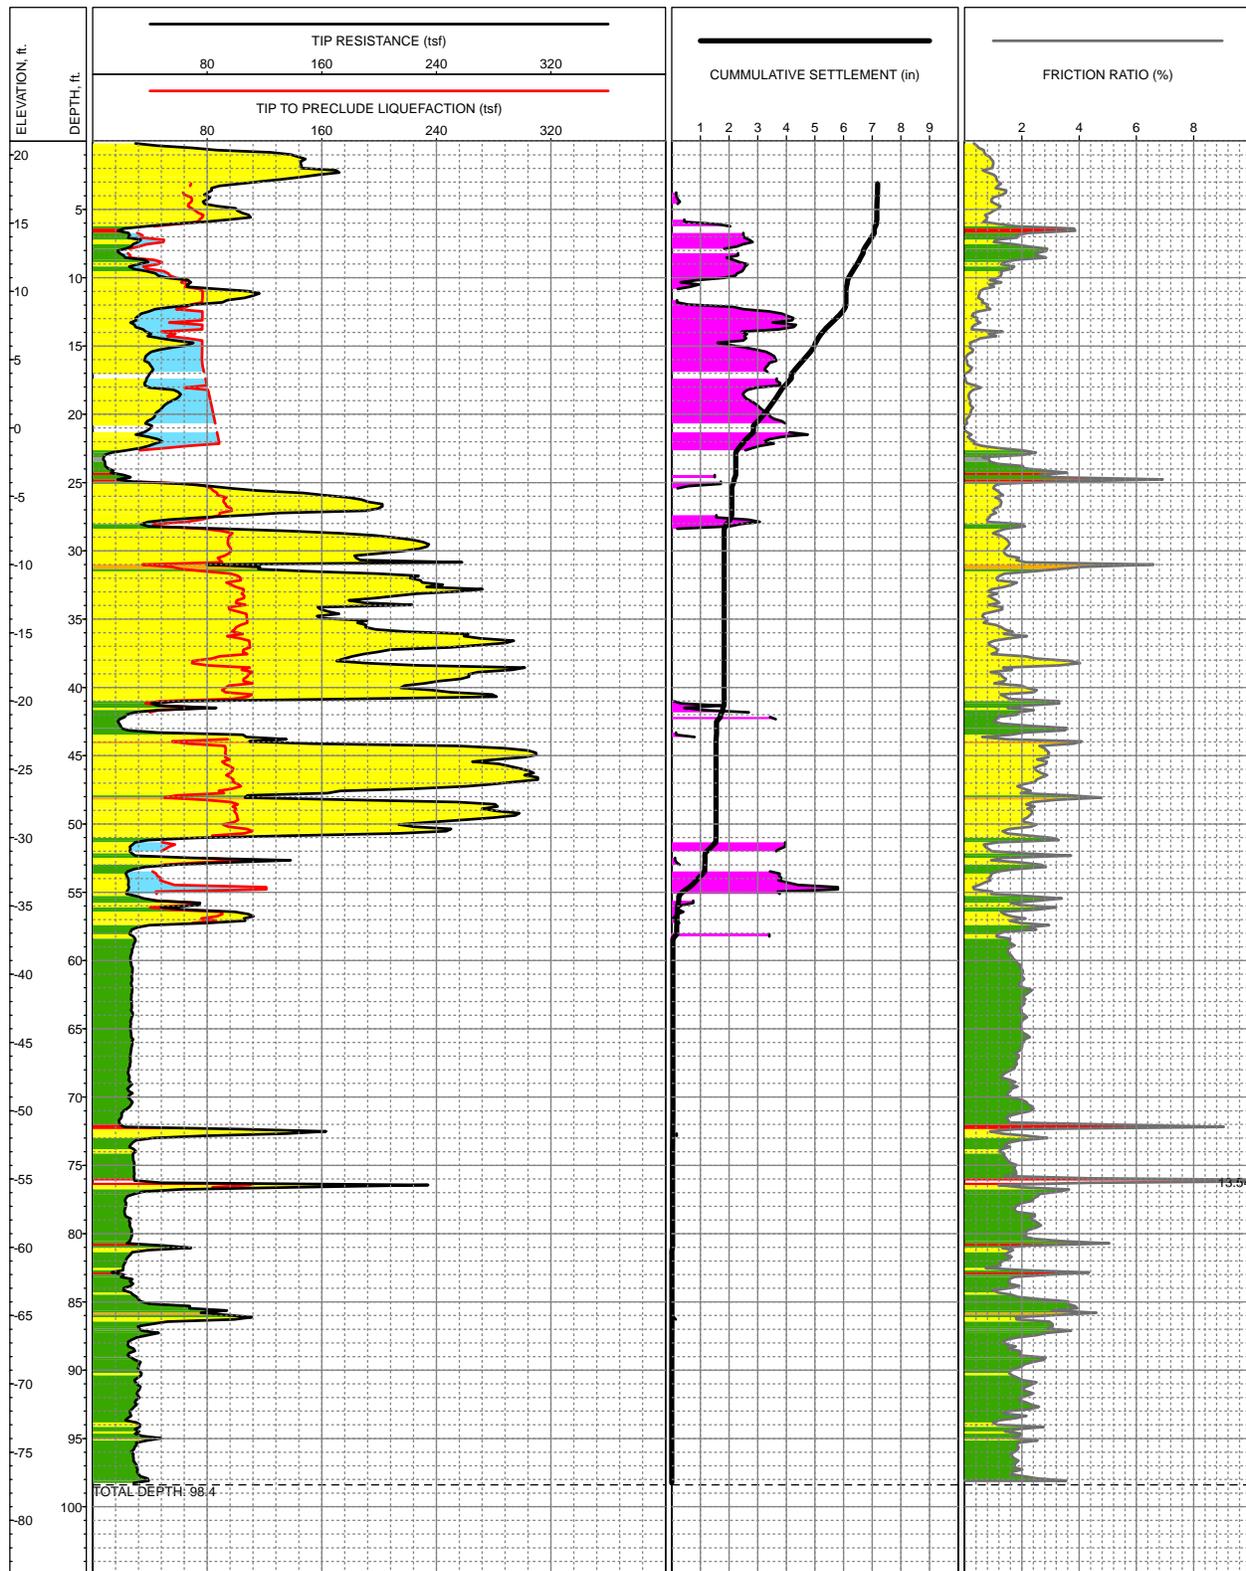
LOG OF CPT SOC035, M=6.5, a=0.25
 Arroyo Grande Creek Waterways Management Plan
 San Luis Obispo County, California

LOCATION: South Levee, Approx. 3350 ft northwest of 22nd St. Bridge
 SURFACE EL: 21.0ft +/- (MSL)
 COMPLETION DEPTH: 98.4ft
 TESTDATE: 3/5/2004

EXPLORATION METHOD: Cone Penetrometer
 PERFORMED BY: USGS
 REVIEWED BY: J Blanchard

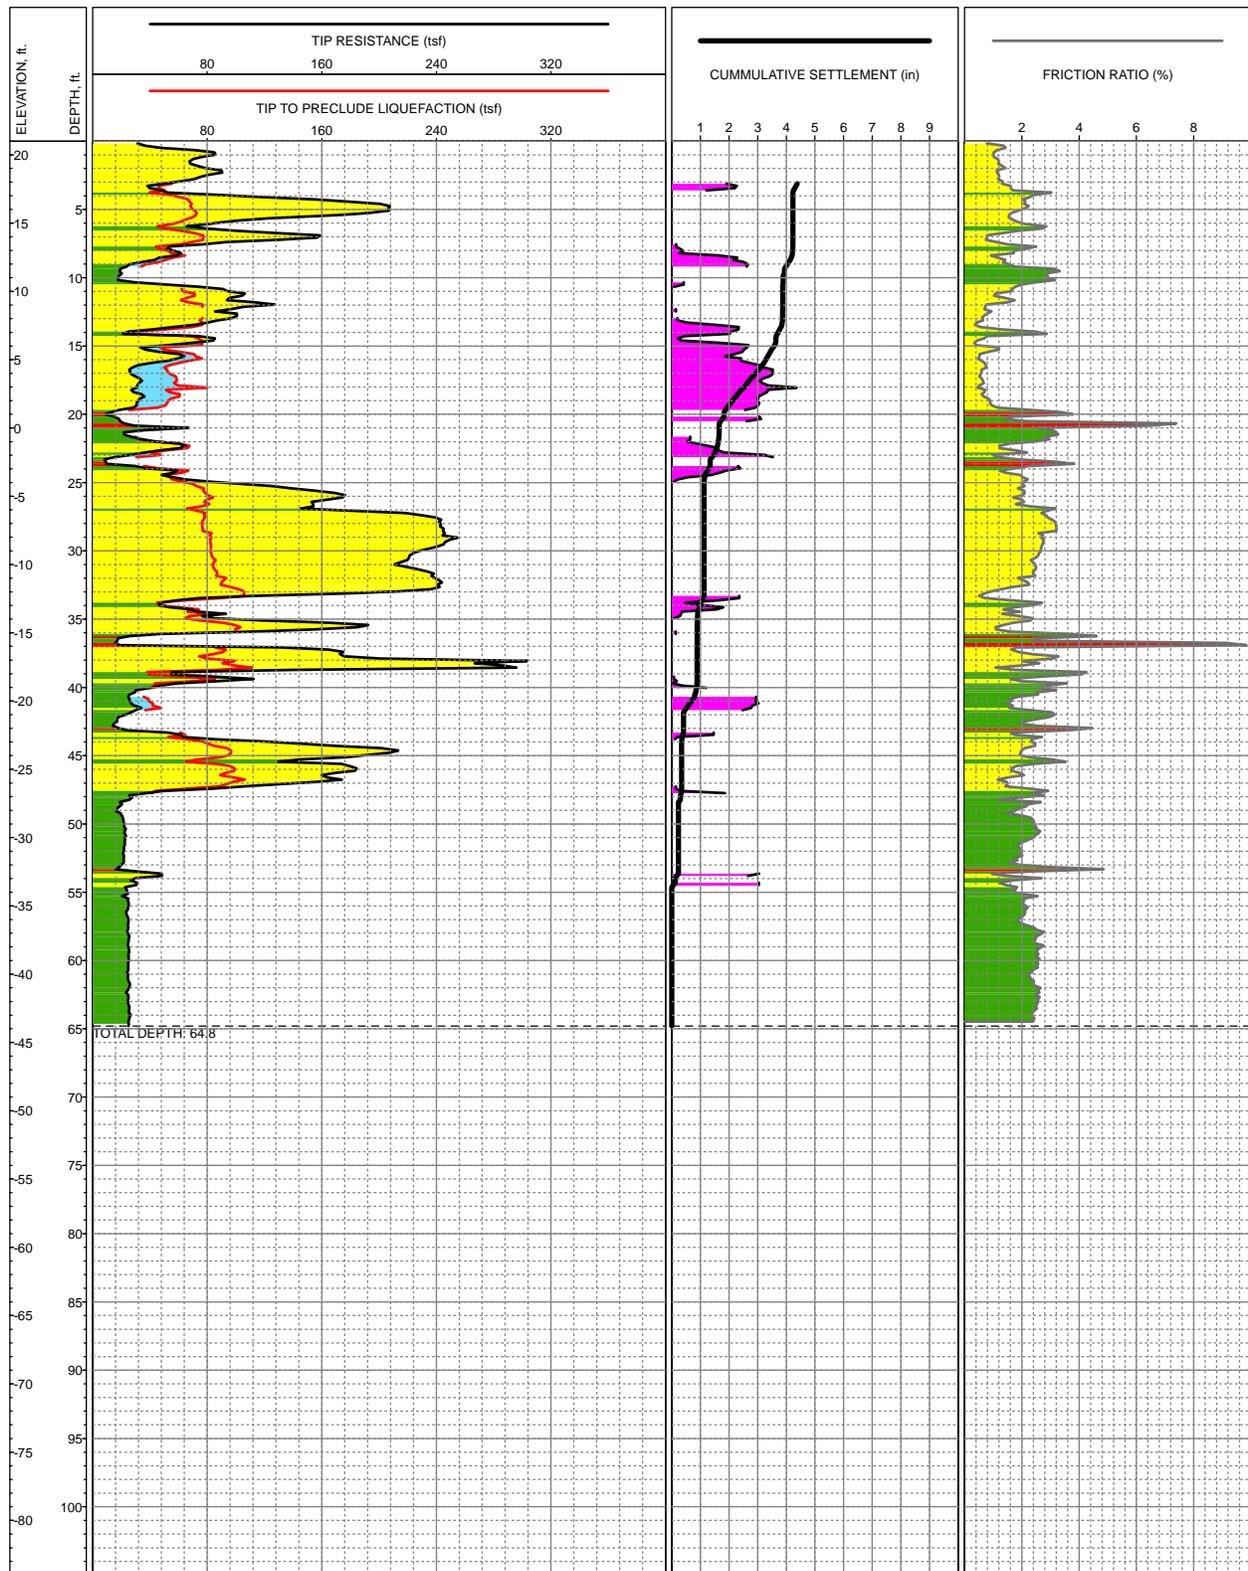
LOG OF CPT SOC036, M=6.5, a=0.25
 Arroyo Grande Creek Waterways Management Plan
 San Luis Obispo County, California

LOCATION: South Levee, Approx. 3500 ft northwest of 22nd St. Bridge
 SURFACE EL: 21.0ft +/- (MSL)
 COMPLETION DEPTH: 64.8ft
 TESTDATE: 3/5/2004

EXPLORATION METHOD: Cone Penetrometer
 PERFORMED BY: USGS
 REVIEWED BY: J Blanchard

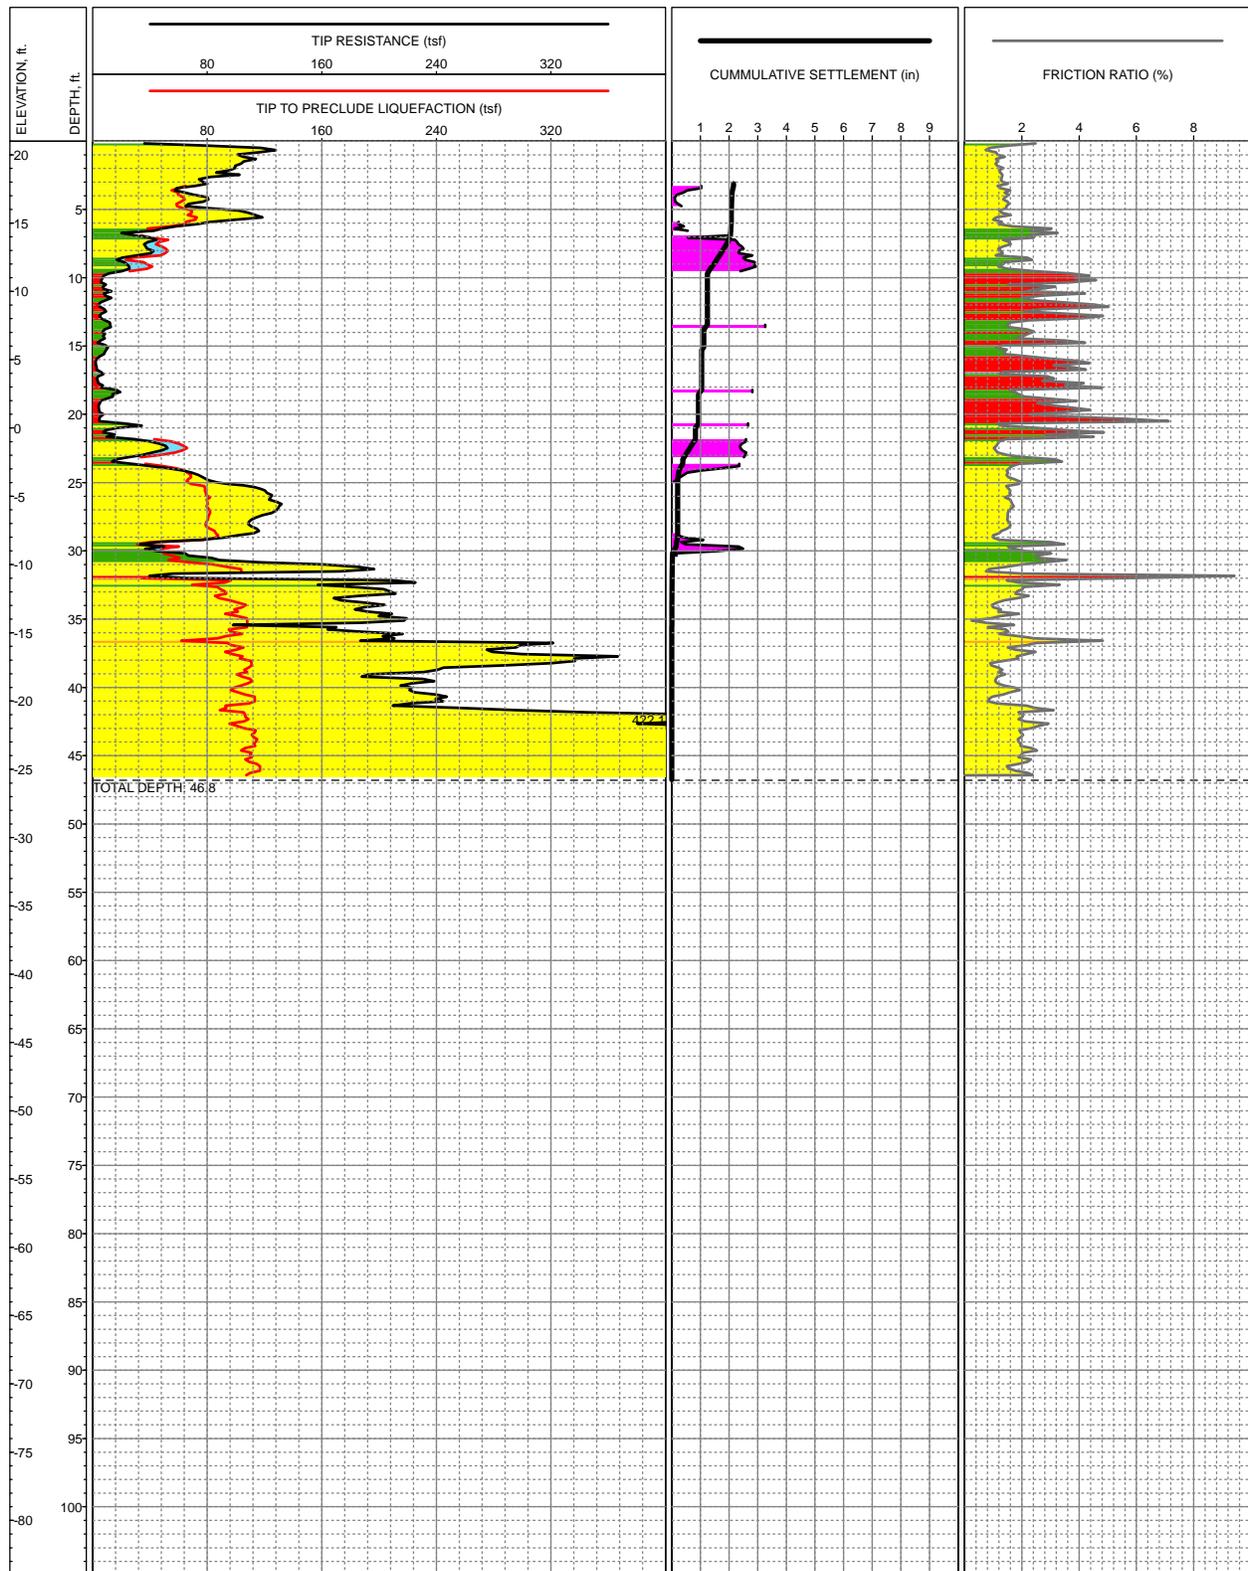
LOG OF CPT SOC037, M=6.5, a=0.25
 Arroyo Grande Creek Waterways Management Plan
 San Luis Obispo County, California

LOCATION: South Levee, Approx. 3250 ft northwest of 22nd St. Bridge
 SURFACE EL: 21.0ft +/- (MSL)
 COMPLETION DEPTH: 46.8ft
 TESTDATE: 3/5/2004

EXPLORATION METHOD: Cone Penetrometer
 PERFORMED BY: USGS
 REVIEWED BY: J Blanchard

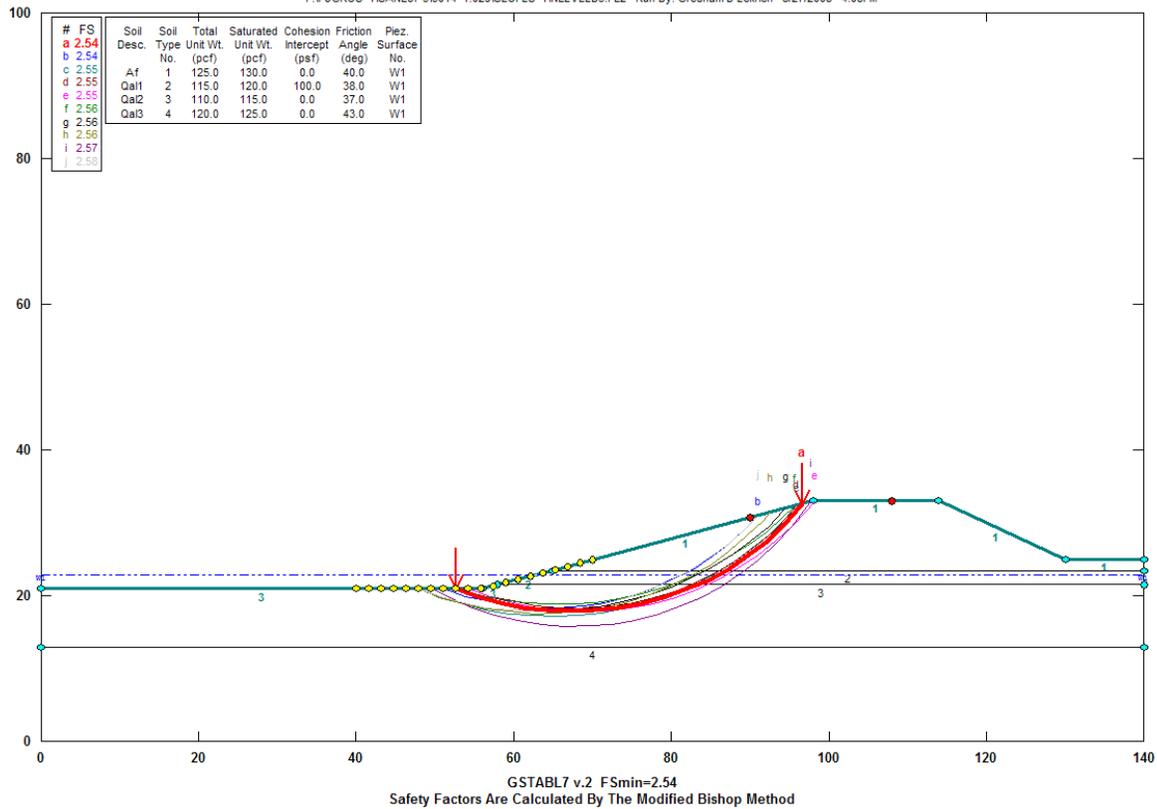
ESTIMATED FACTORS OF SAFETY

Static Loading Condition: 2.5
Pseudostatic Loading Condition: 1.5
Pseudostatic Coefficient: 0.15
Condition: Existing Interior Slope, Static Loading

Arroyo Grande Creek, North Levee - Exterior Slope, Static Strength 2

- ❖ Slope stability analyses of the preliminary levee configurations suggest that the levee can be raised to the conceptual design height and should be stable under static loading and the anticipated flood levels. However, the stability of the levees likely would be compromised by liquefaction of the foundation soil within the Pre-

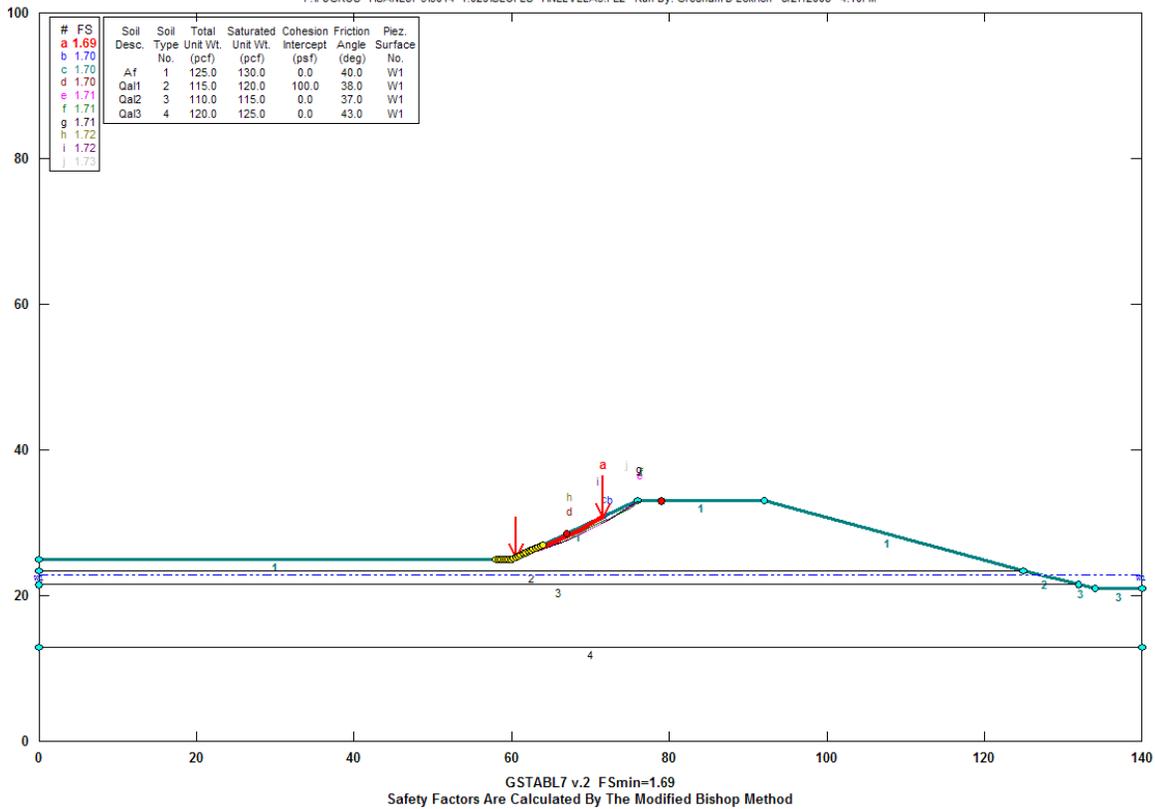
SLOPE STABILITY PLOT FOR NORTH LEVEE EMBANKMENT
 Arroyo Grande Creek Waterways Management Plan
 San Luis Obispo County, California

ESTIMATED FACTORS OF SAFETY

Static Loading Condition: 1.7
Pseudostatic Loading Condition: 1.2
Pseudostatic Coefficient: 0.15
Condition: Existing Exterior Slope, Static Loading
