**PRELIMINARY GEOTECHNICAL REPORT
ARROYO GRANDE CREEK WATERWAYS
MANAGEMENT PLAN
LOS BERROS CREEK TO NEAR OCEANO AIRPORT
SAN LUIS OBISPO COUNTY, CALIFORNIA**

Prepared for:
County of San Luis Obispo
Department of Public Works

April 22, 2009

April 22, 2009
Project No. 3014.029

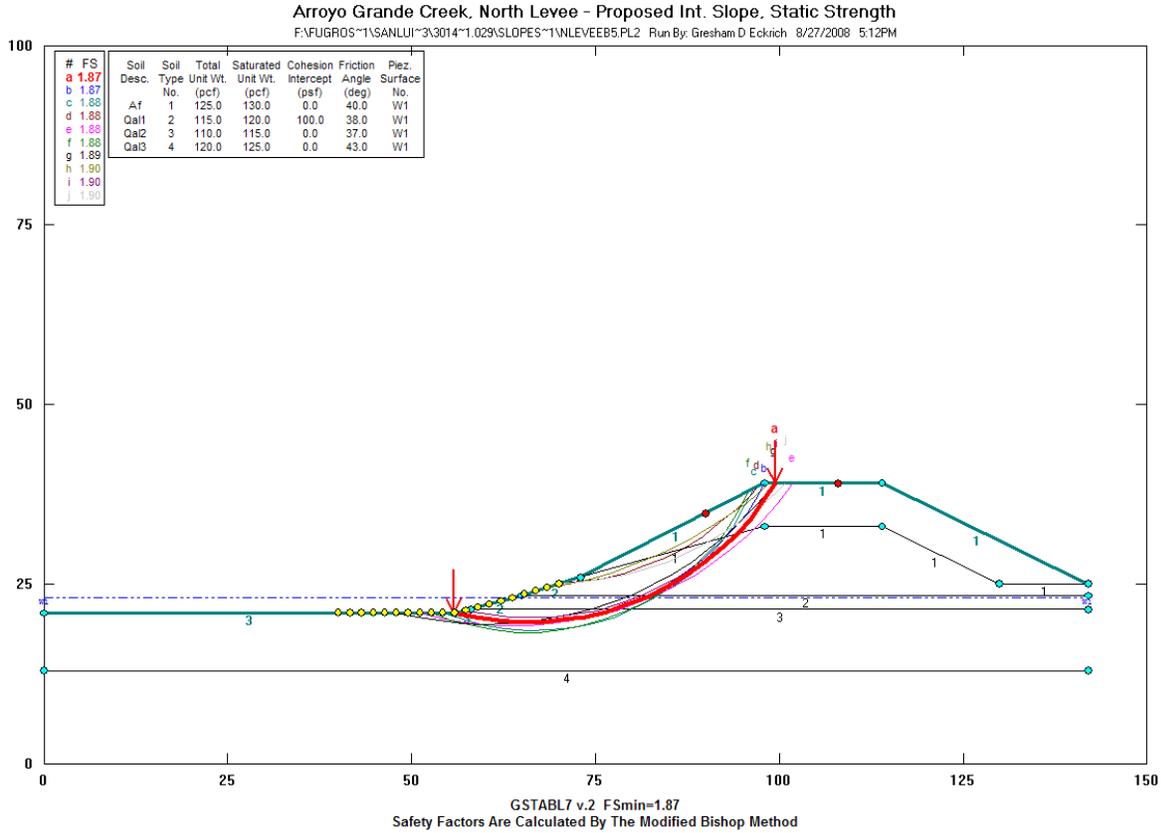
ESTIMATED FACTORS OF SAFETY

Static Loading Condition: 1.9
Pseudostatic Loading Condition: 1.3
Pseudostatic Coefficient: 0.15
Condition: Proposed Interior Slope 1, Static Loading

- ❖ Slope stability analyses of the preliminary levee configurations suggest that the levee can be raised to the conceptual design height and should be stable under static loading and the anticipated flood levels. However, the stability of the levees likely would be compromised by liquefaction of the foundation soil within the Pre-

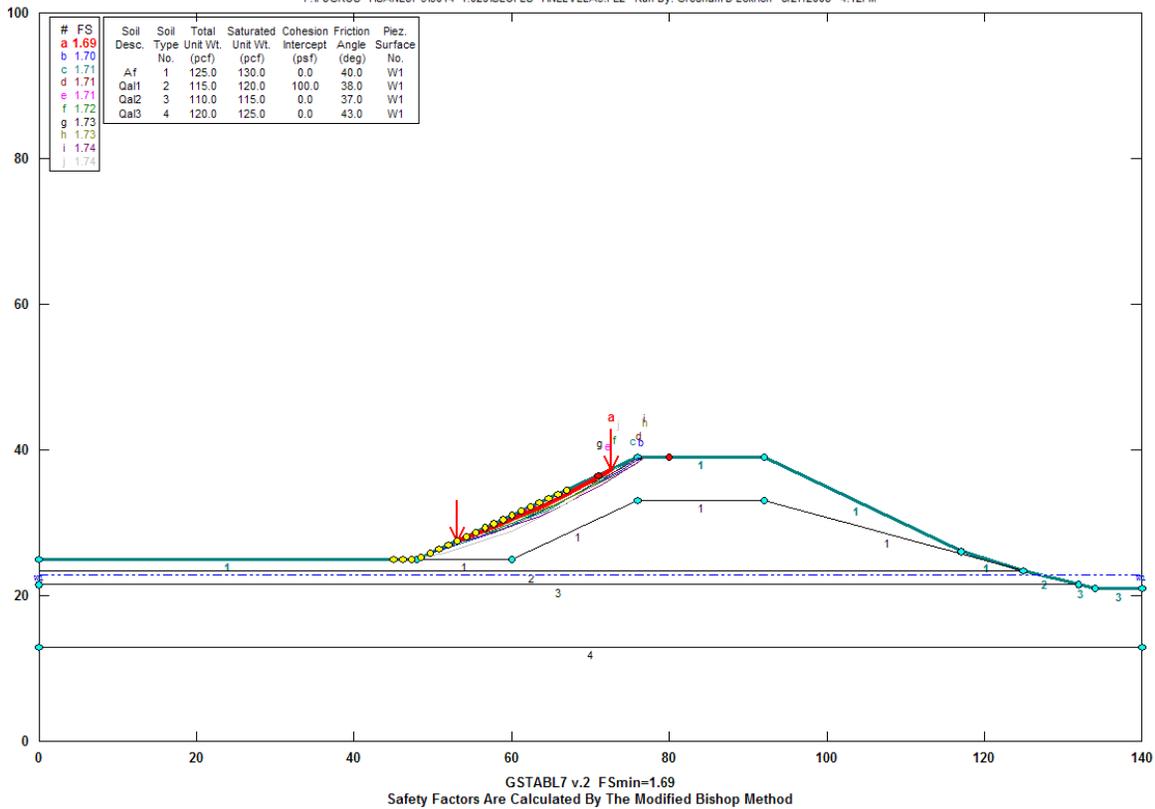
SLOPE STABILITY PLOT FOR NORTH LEVEE EMBANKMENT
 Arroyo Grande Creek Waterways Management Plan
 San Luis Obispo County, California

Arroyo Grande Creek, North Levee - Proposed Ext. Slope, Static Strength

ESTIMATED FACTORS OF SAFETY

Static Loading Condition: 1.7
Pseudostatic Loading Condition: 1.2
Pseudostatic Coefficient: 0.15
Condition: Proposed Exterior Slope 1, Static Loading

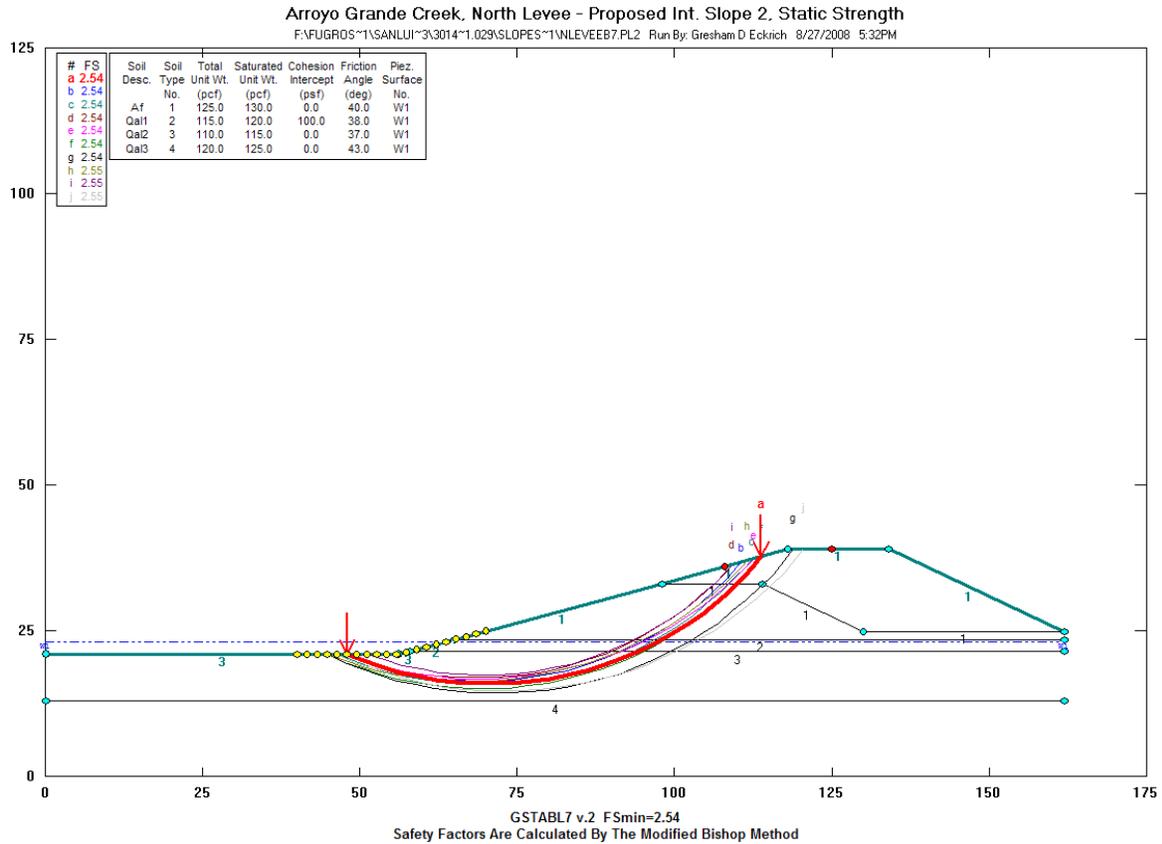
SLOPE STABILITY PLOT FOR NORTH LEVEE EMBANKMENT
 Arroyo Grande Creek Waterways Management Plan
 San Luis Obispo County, California

ESTIMATED FACTORS OF SAFETY

Static Loading Condition: 2.5
Pseudostatic Loading Condition: 1.5
Pseudostatic Coefficient: 0.15
Condition: Proposed Interior Slope 2, Static Loading

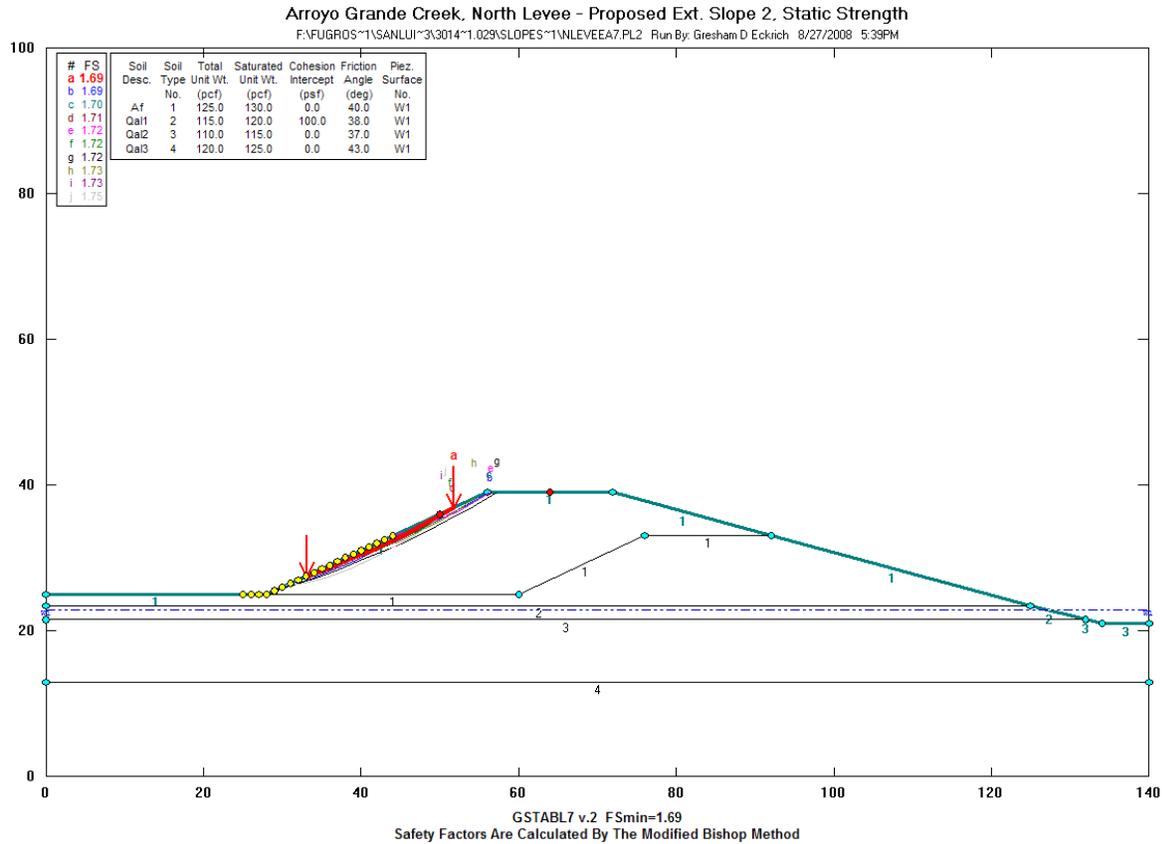
SLOPE STABILITY PLOT FOR NORTH LEVEE EMBANKMENT
 Arroyo Grande Creek Waterways Management Plan
 San Luis Obispo County, California

ESTIMATED FACTORS OF SAFETY

Static Loading Condition: 1.7
Pseudostatic Loading Condition: 1.2
Pseudostatic Coefficient: 0.15
Condition: Proposed Exterior Slope 2, Static Loading

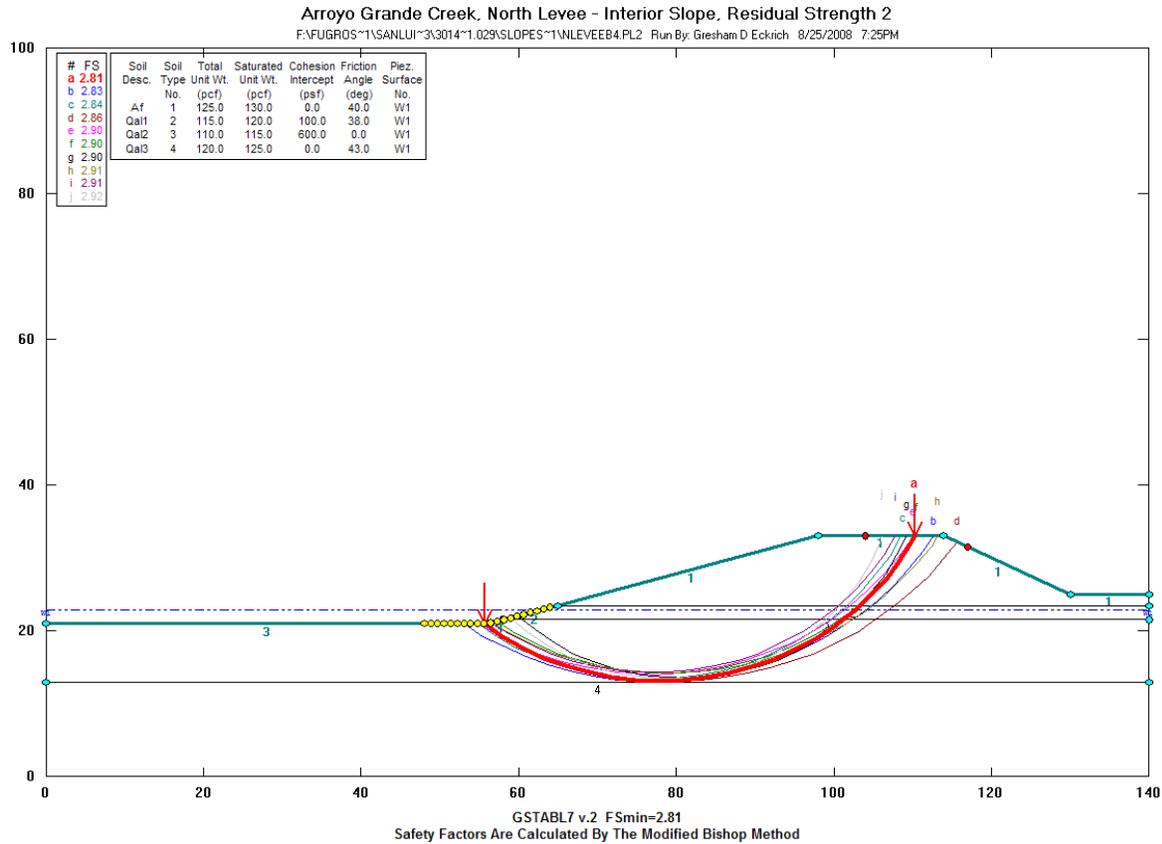
SLOPE STABILITY PLOT FOR NORTH LEVEE EMBANKMENT
 Arroyo Grande Creek Waterways Management Plan
 San Luis Obispo County, California

ESTIMATED FACTOR OF SAFETY

Post-Liquefaction Condition: 2.5

Condition: Existing Interior Slope

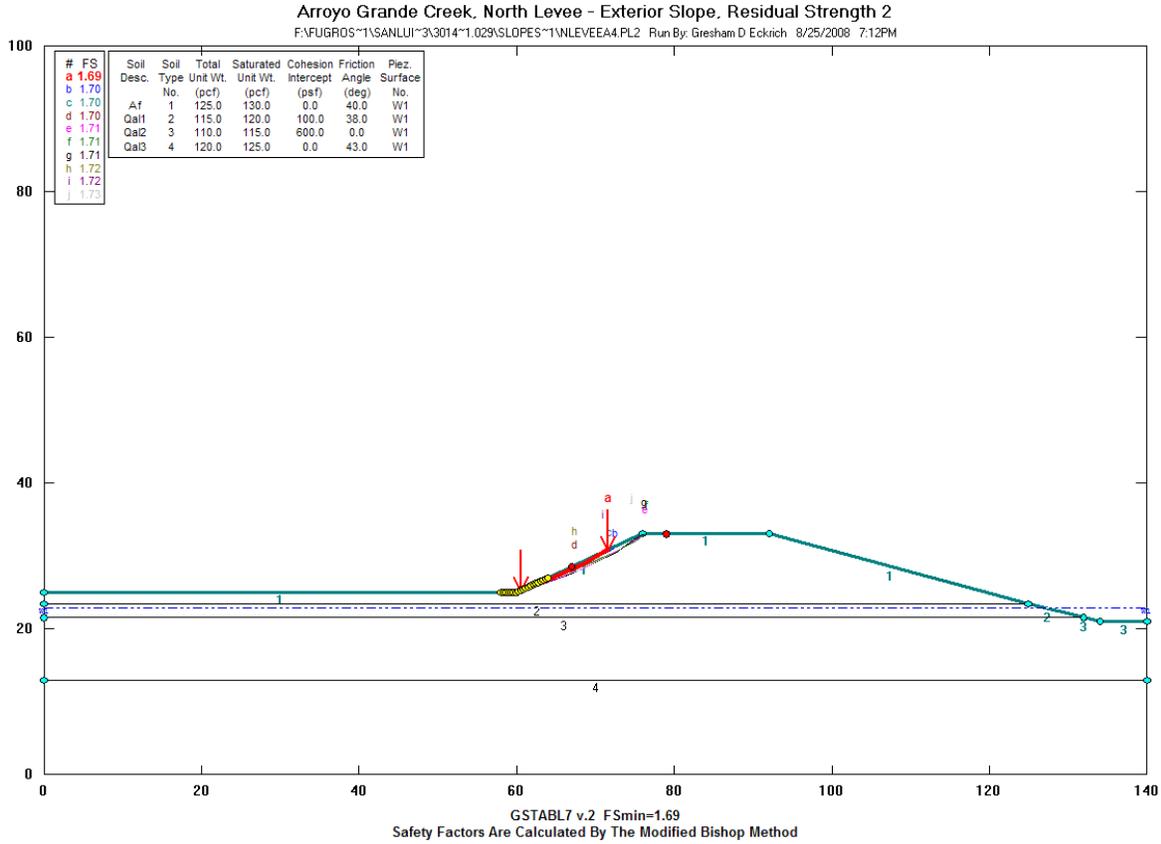
SLOPE STABILITY PLOT FOR NORTH LEVEE EMBANKMENT
 Arroyo Grande Creek Waterways Management Plan
 San Luis Obispo County, California

ESTIMATED FACTOR OF SAFETY

Post-Liquefaction Condition: 1.7

Condition: Existing Exterior Slope

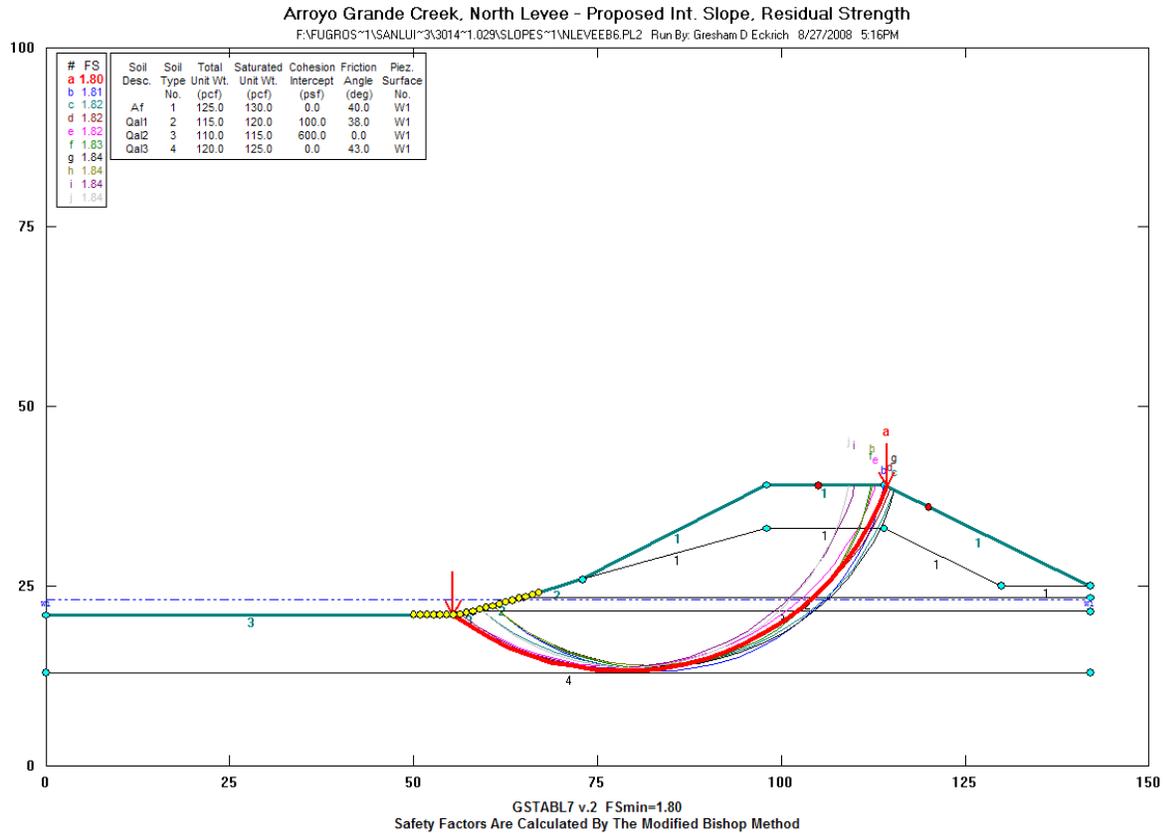
SLOPE STABILITY PLOT FOR NORTH LEVEE EMBANKMENT
Arroyo Grande Creek Waterways Management Plan
San Luis Obispo County, California

ESTIMATED FACTOR OF SAFETY

Post-Liquefaction Condition: 1.8

Condition: Proposed Interior Slope 1

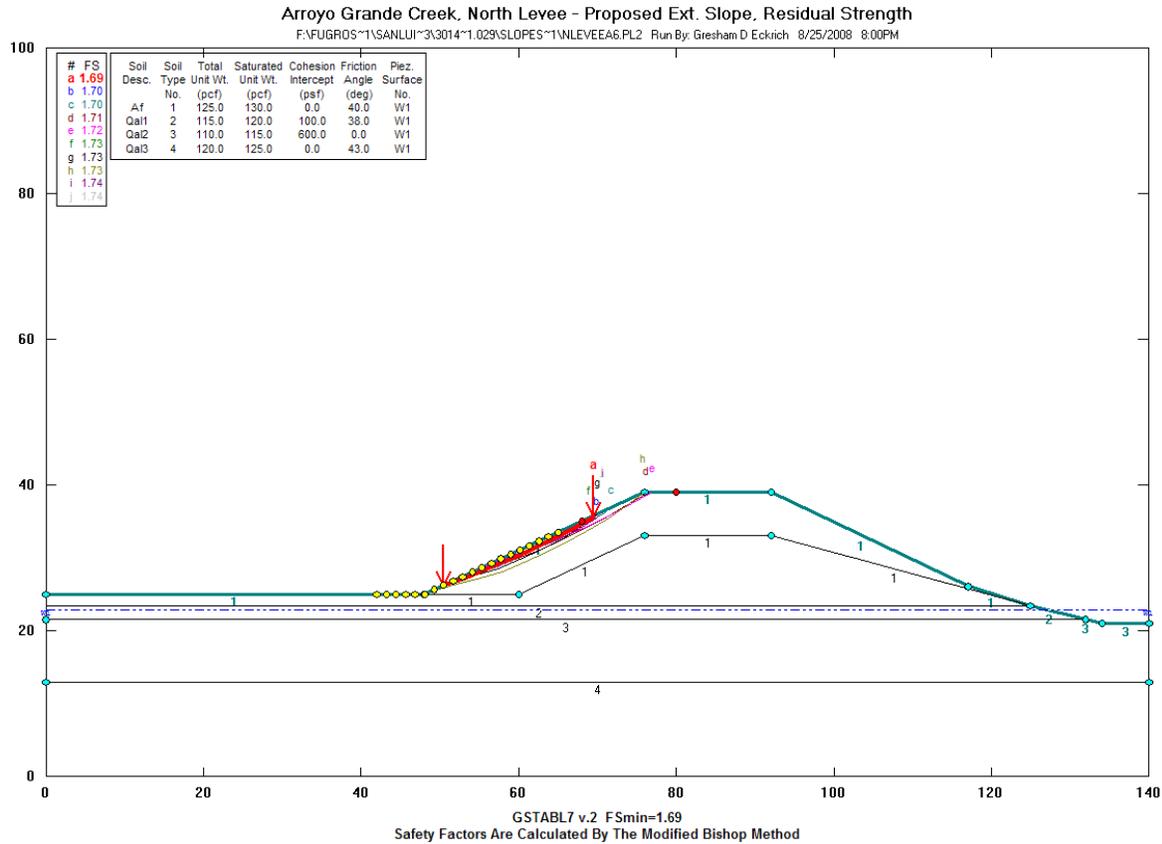
SLOPE STABILITY PLOT FOR NORTH LEVEE EMBANKMENT
 Arroyo Grande Creek Waterways Management Plan
 San Luis Obispo County, California

ESTIMATED FACTOR OF SAFETY

Post-Liquefaction Condition: 1.7

Condition: Proposed Exterior Slope 1

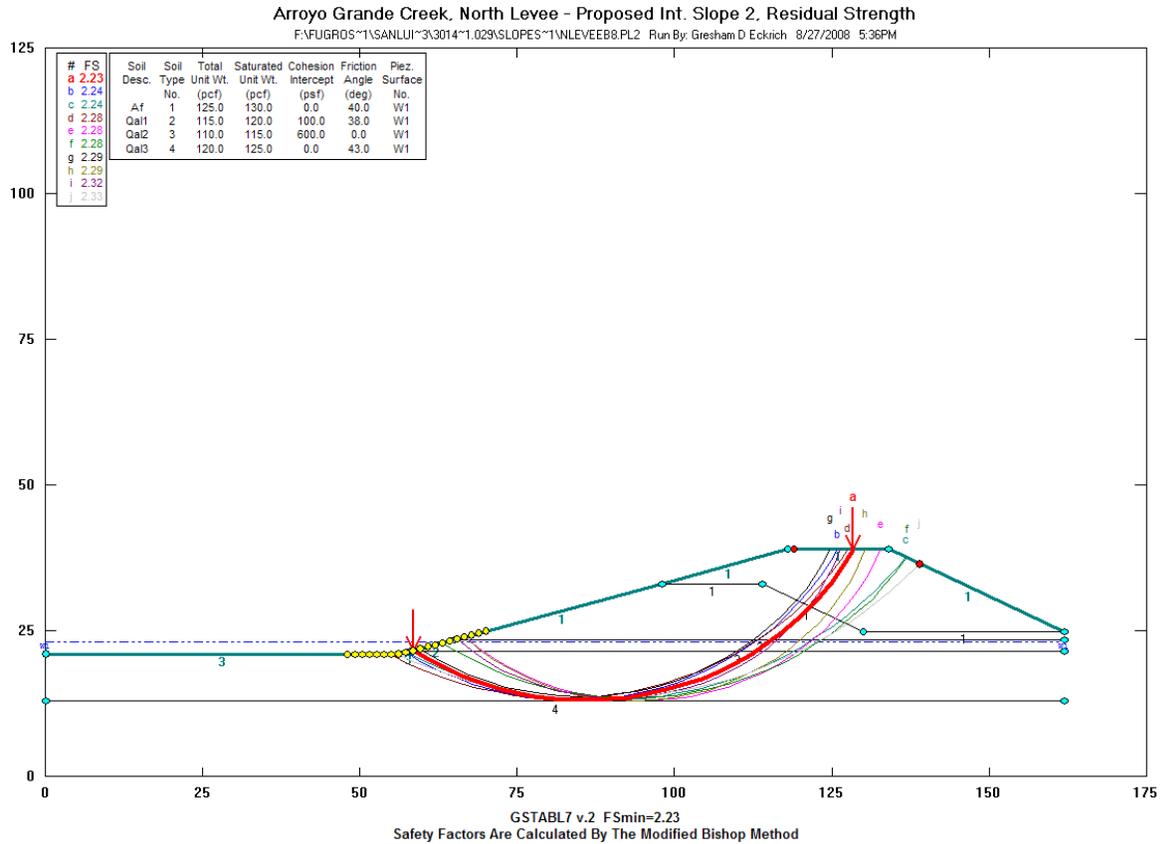
SLOPE STABILITY PLOT FOR NORTH LEVEE EMBANKMENT
 Arroyo Grande Creek Waterways Management Plan
 San Luis Obispo County, California

ESTIMATED FACTOR OF SAFETY

Post-Liquefaction Condition: 2.2

Condition: Proposed Interior Slope 2

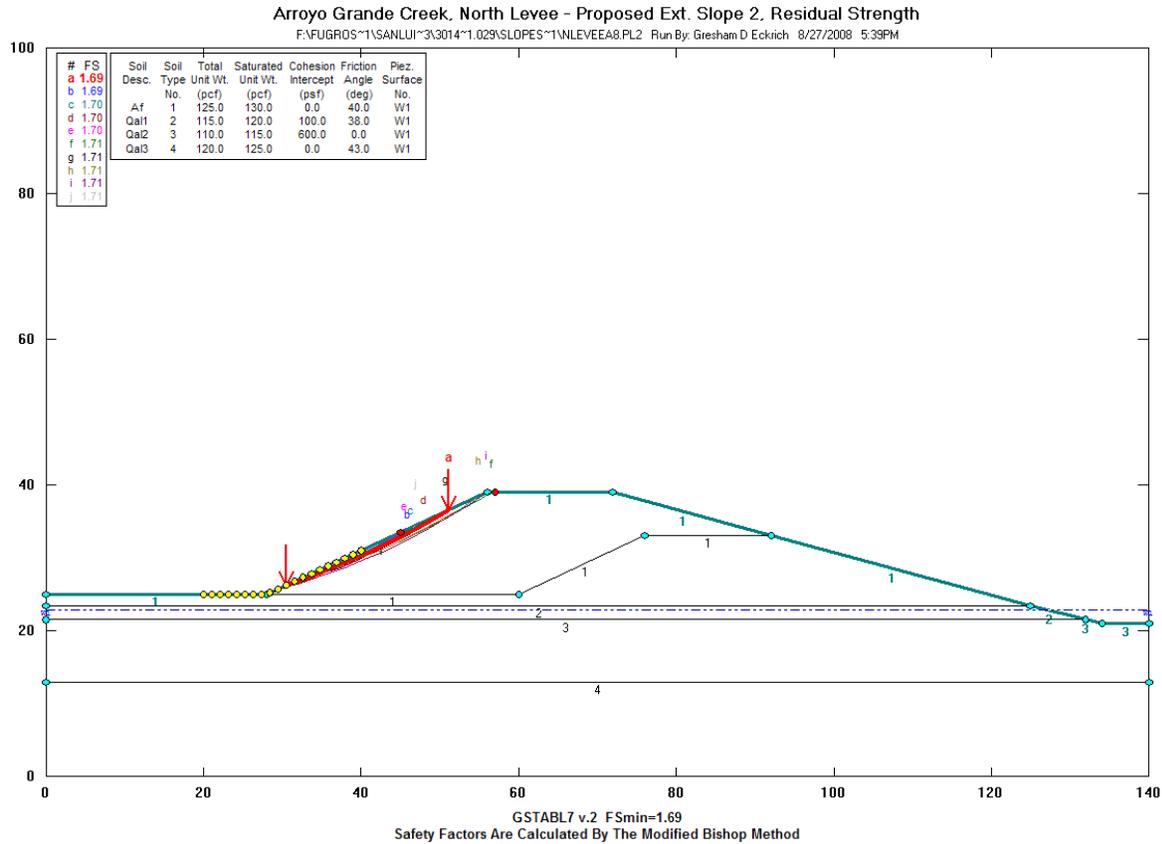
SLOPE STABILITY PLOT FOR NORTH LEVEE EMBANKMENT
 Arroyo Grande Creek Waterways Management Plan
 San Luis Obispo County, California

ESTIMATED FACTOR OF SAFETY

Post-Liquefaction Condition: 1.7

Condition: Proposed Exterior Slope 2

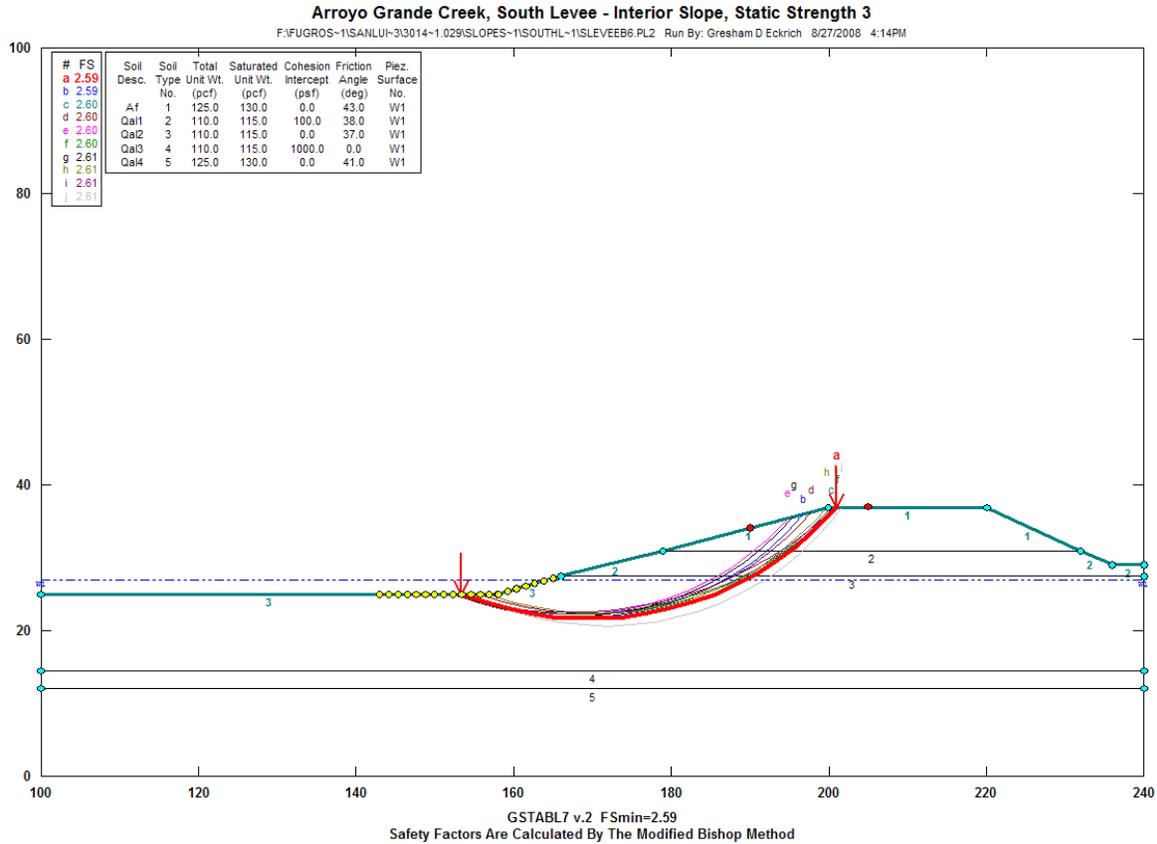
SLOPE STABILITY PLOT FOR SOUTH LEVEE EMBANKMENT
Arroyo Grande Creek Waterways Management Plan
San Luis Obispo County, California

ESTIMATED FACTORS OF SAFETY

Static Loading Condition: 2.6
Pseudostatic Loading Condition: 1.5
Pseudostatic Coefficient: 0.15
Condition: Existing Interior Slope, Static Loading

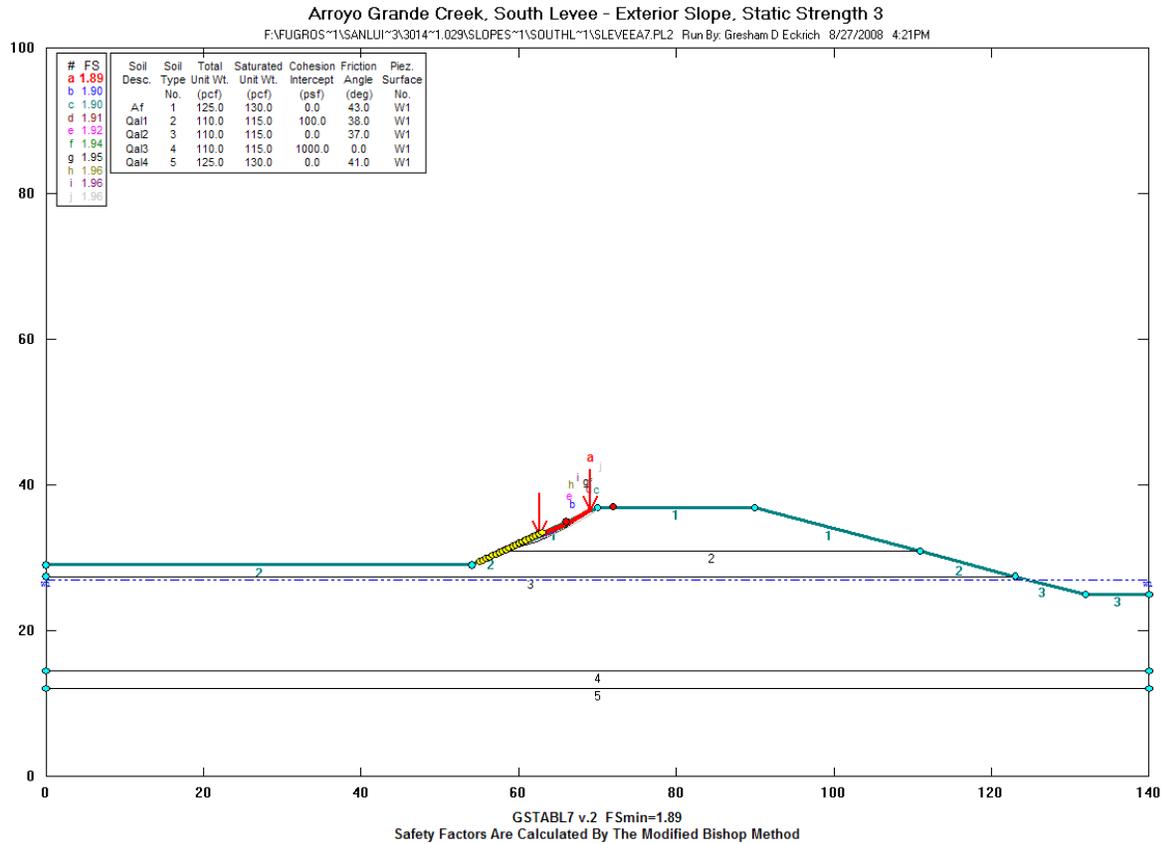
SLOPE STABILITY PLOT FOR SOUTH LEVEE EMBANKMENT
 Arroyo Grande Creek Waterways Management Plan
 San Luis Obispo County, California

ESTIMATED FACTORS OF SAFETY

Static Loading Condition: 1.9
Pseudostatic Loading Condition: 1.3
Pseudostatic Coefficient: 0.15
Condition: Existing Exterior Slope, Static Loading

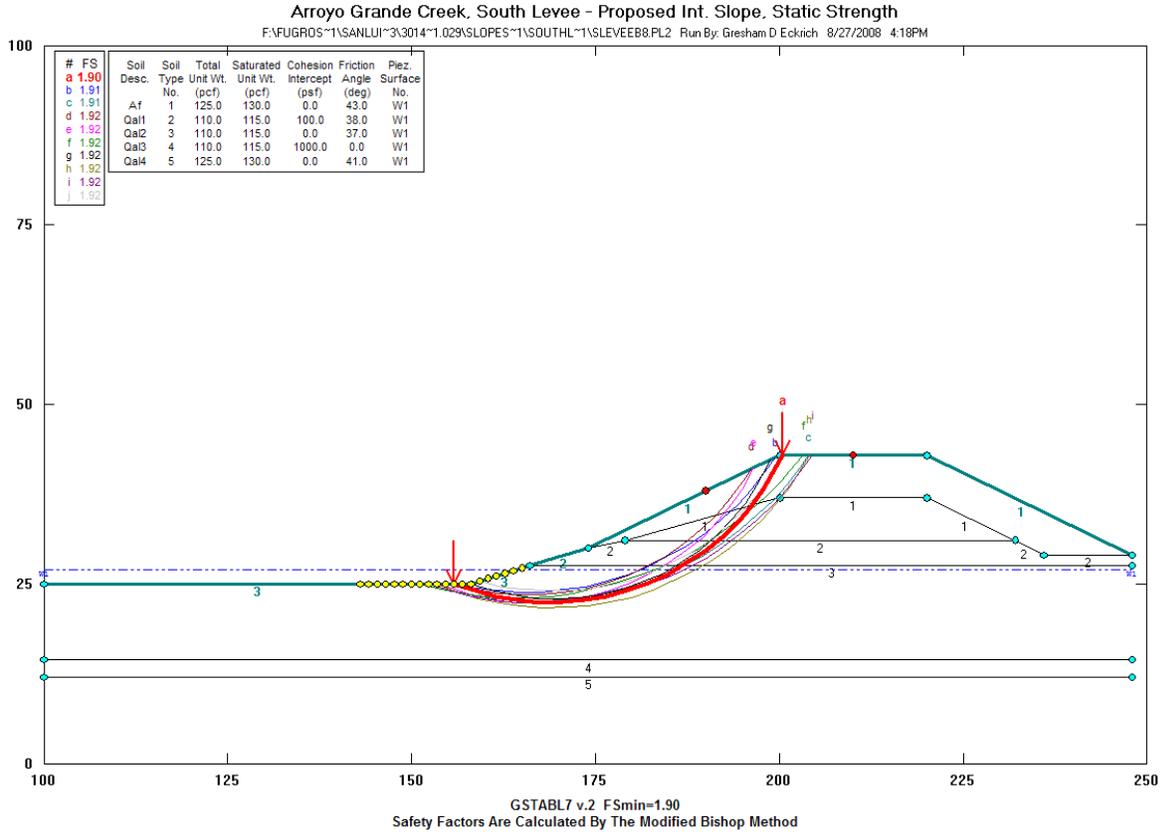
SLOPE STABILITY PLOT FOR SOUTH LEVEE EMBANKMENT
 Arroyo Grande Creek Waterways Management Plan
 San Luis Obispo County, California

ESTIMATED FACTORS OF SAFETY

Static Loading Condition: 1.9
Pseudostatic Loading Condition: 1.3
Pseudostatic Coefficient: 0.15
Condition: Proposed Interior Slope 1, Static Loading

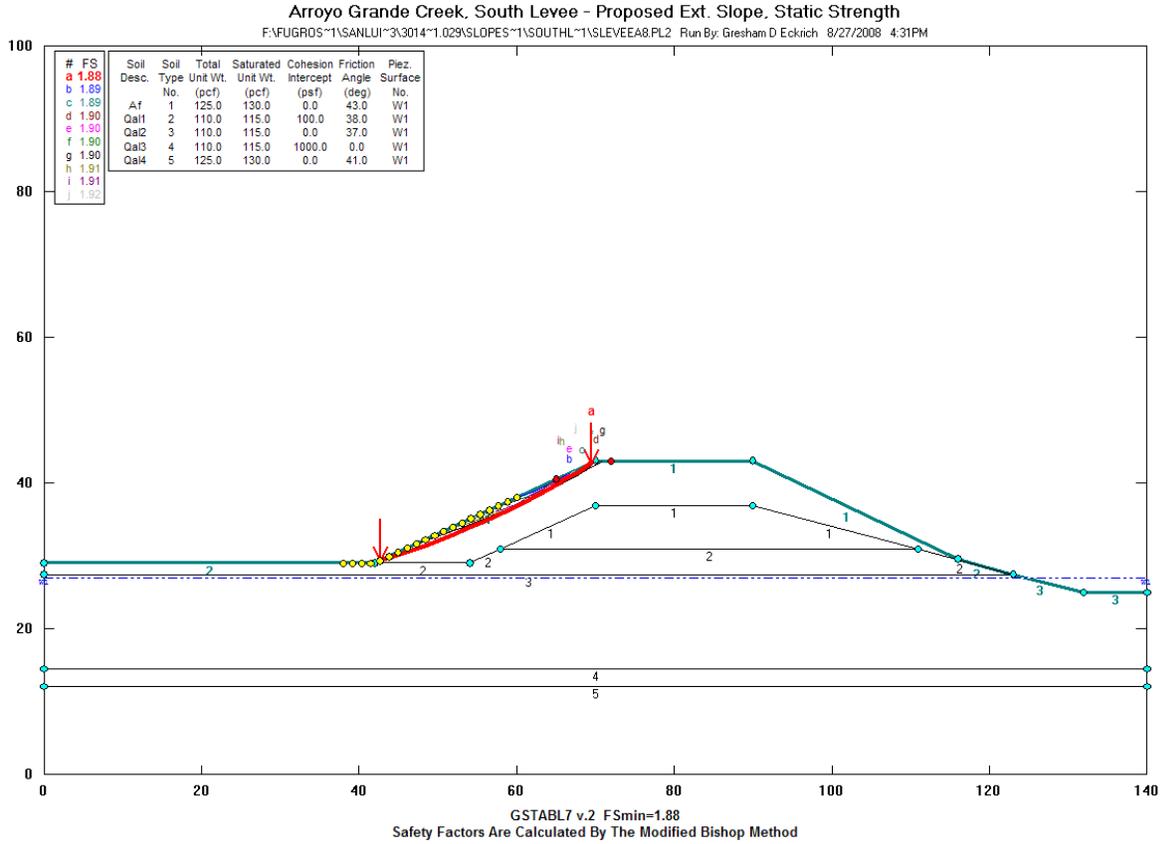
SLOPE STABILITY PLOT FOR SOUTH LEVEE EMBANKMENT
 Arroyo Grande Creek Waterways Management Plan
 San Luis Obispo County, California

ESTIMATED FACTORS OF SAFETY

Static Loading Condition: 1.9
Pseudostatic Loading Condition: 1.3
Pseudostatic Coefficient: 0.15
Condition: Proposed Exterior Slope 1, Static Loading

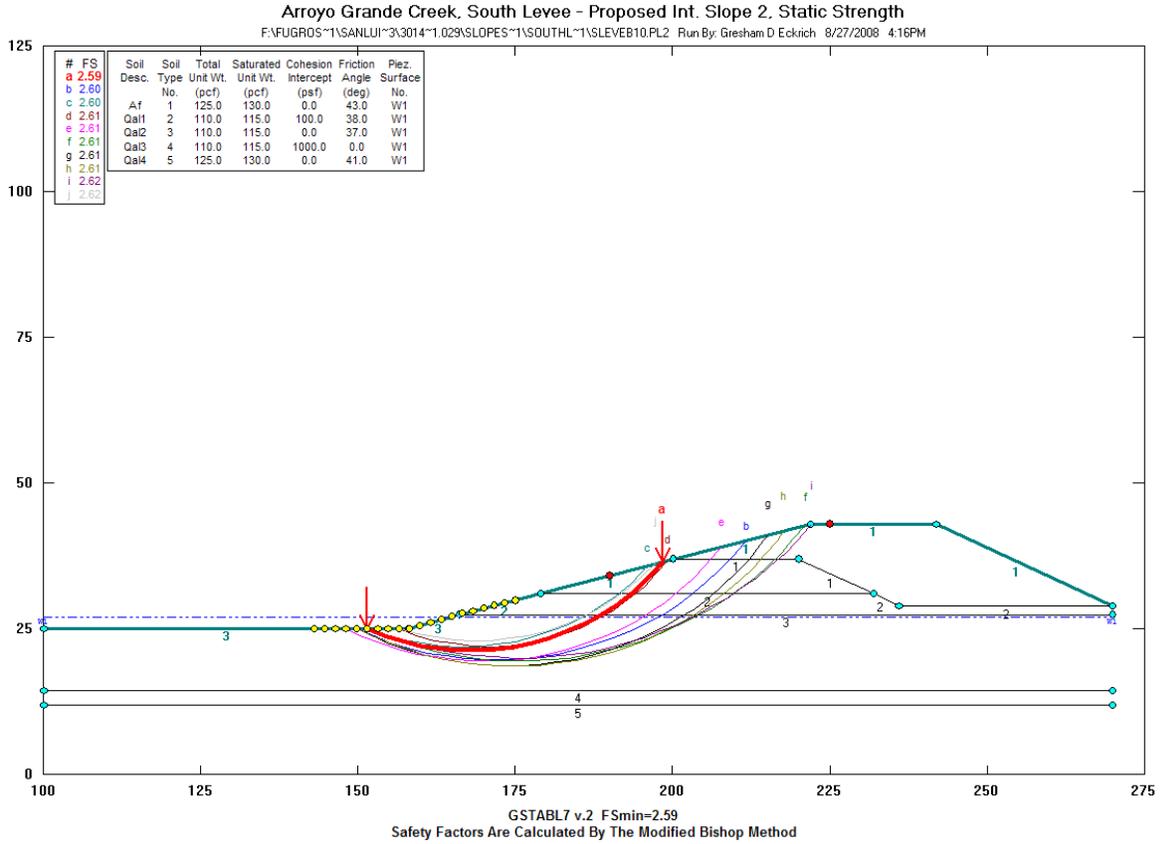
SLOPE STABILITY PLOT FOR SOUTH LEVEE EMBANKMENT
 Arroyo Grande Creek Waterways Management Plan
 San Luis Obispo County, California

ESTIMATED FACTORS OF SAFETY

Static Loading Condition: 2.6
Pseudostatic Loading Condition: 1.5
Pseudostatic Coefficient: 0.15
Condition: Proposed Interior Slope 2, Static Loading

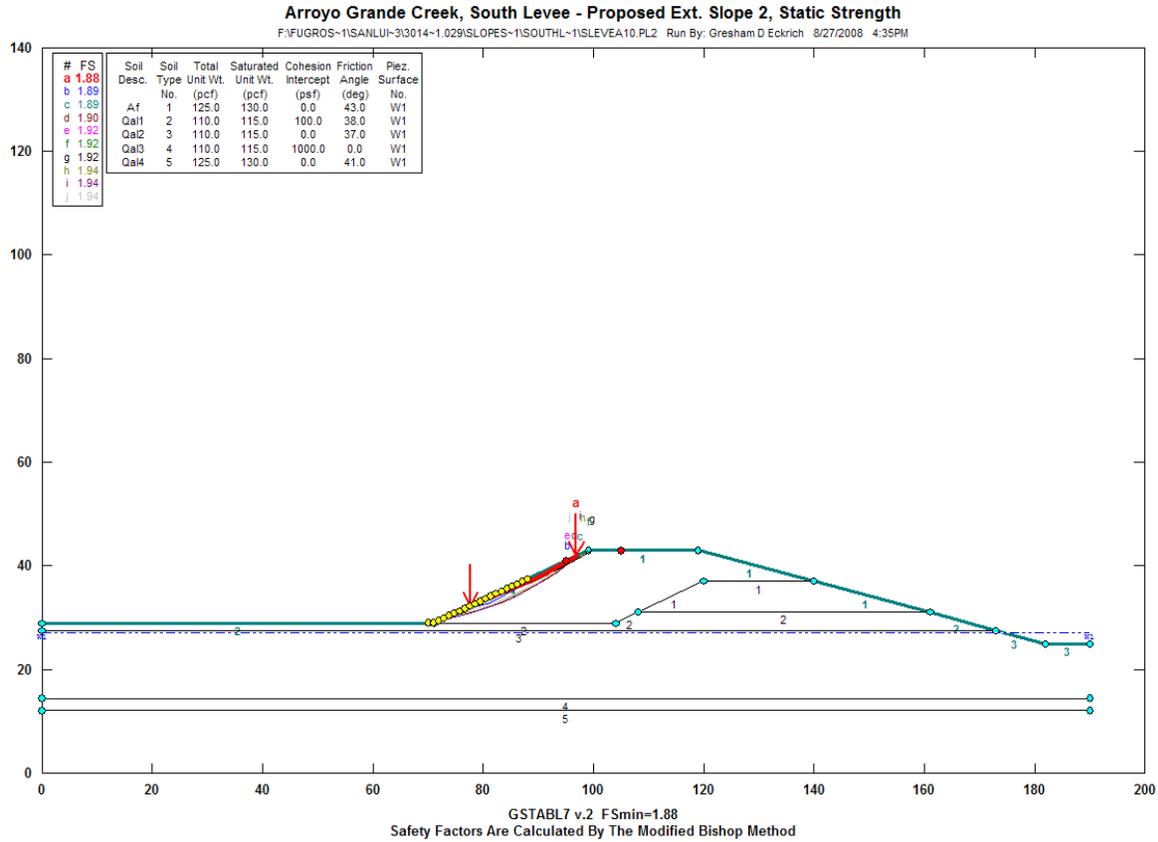
SLOPE STABILITY PLOT FOR SOUTH LEVEE EMBANKMENT
 Arroyo Grande Creek Waterways Management Plan
 San Luis Obispo County, California

ESTIMATED FACTORS OF SAFETY

Static Loading Condition: 1.9
Pseudostatic Loading Condition: 1.3
Pseudostatic Coefficient: 0.15
Condition: Proposed Exterior Slope 2, Static Loading

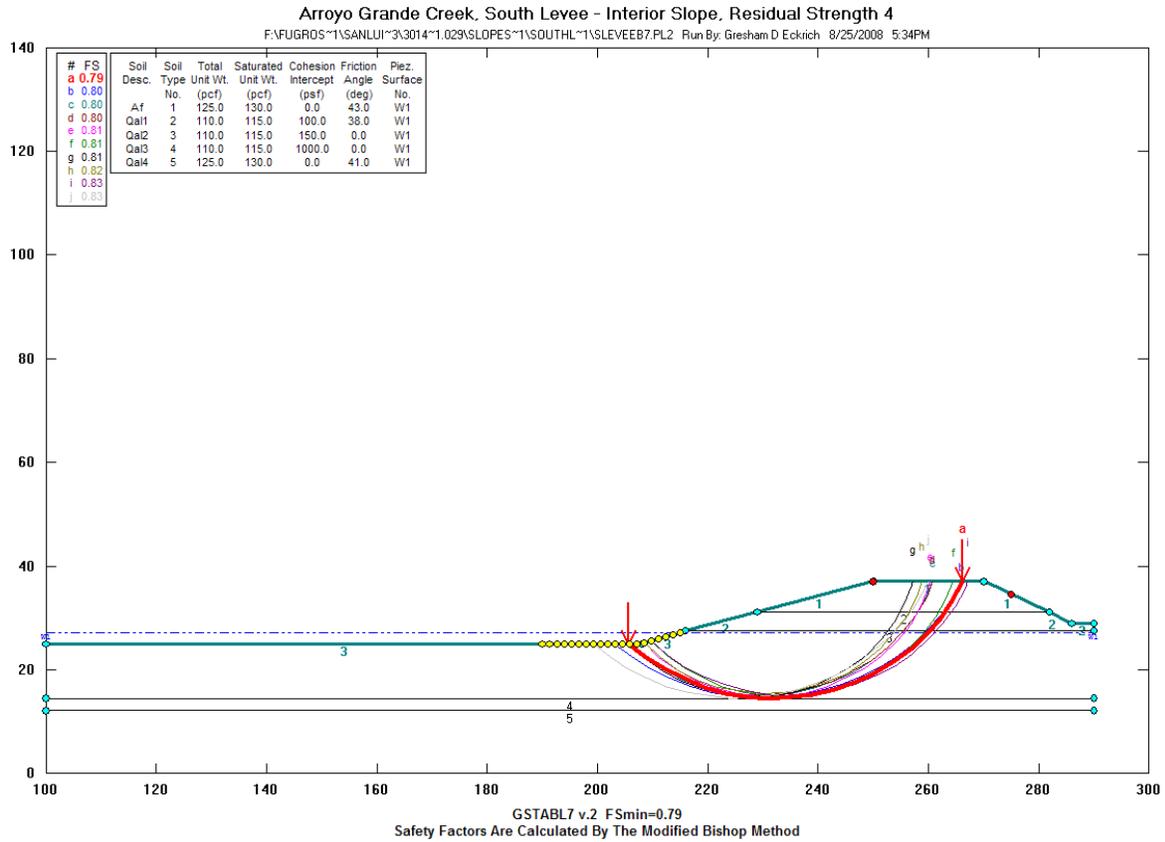
SLOPE STABILITY PLOT FOR SOUTH LEVEE EMBANKMENT
Arroyo Grande Creek Waterways Management Plan
San Luis Obispo County, California

ESTIMATED FACTOR OF SAFETY

Post-Liquefaction Condition: 0.8

Condition: Existing Interior Slope

Settlement Estero area west of about Creek Road. Because it is unlikely that there would be full flows in Arroyo Grande Creek at the same time as a damaging earthquake, the County anticipates that if an earthquake were to occur and damage is realized, they would have the opportunity to make repairs to the levee system before high flows would inundate the channel. The existing levee is vulnerable to this potential hazard whether the height of the levee is raised to improve flood protection or not.

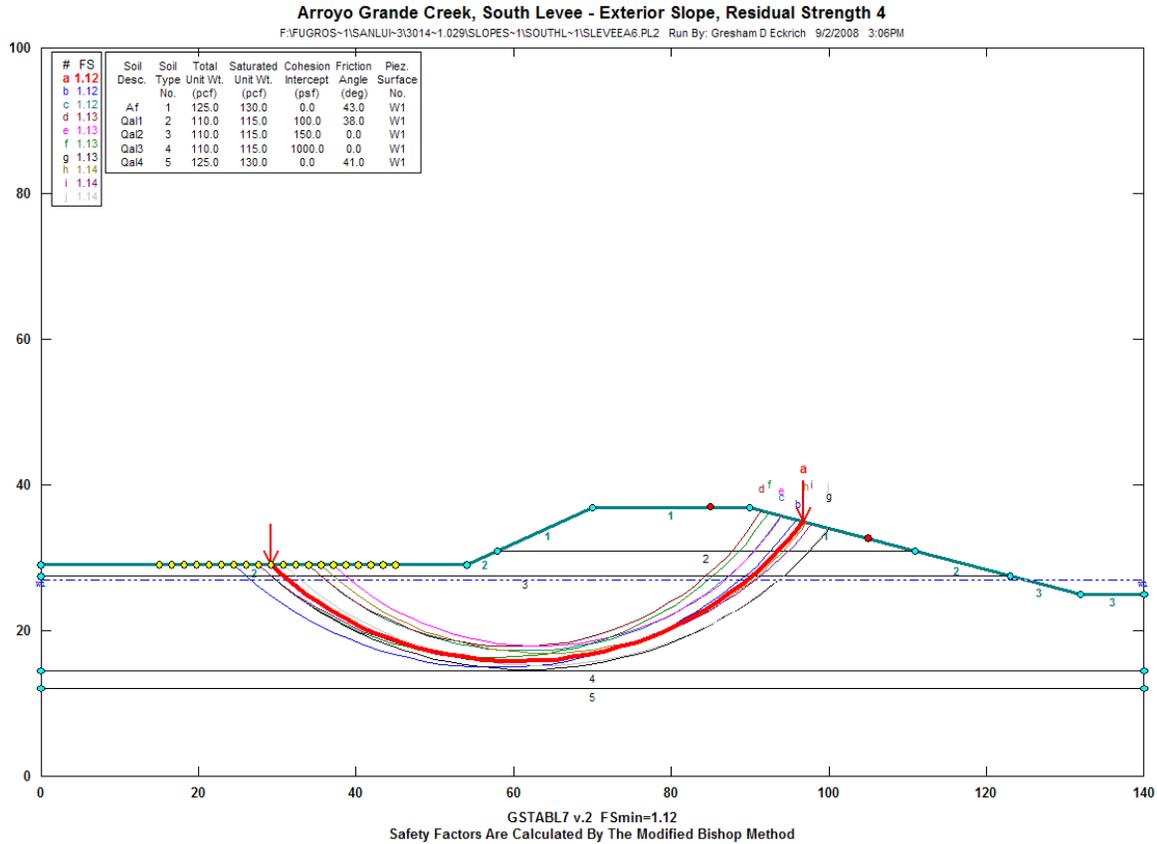
SLOPE STABILITY PLOT FOR SOUTH LEVEE EMBANKMENT
 Arroyo Grande Creek Waterways Management Plan
 San Luis Obispo County, California

ESTIMATED FACTOR OF SAFETY

Post-Liquefaction Condition: 1.1

Condition: Existing Exterior Slope

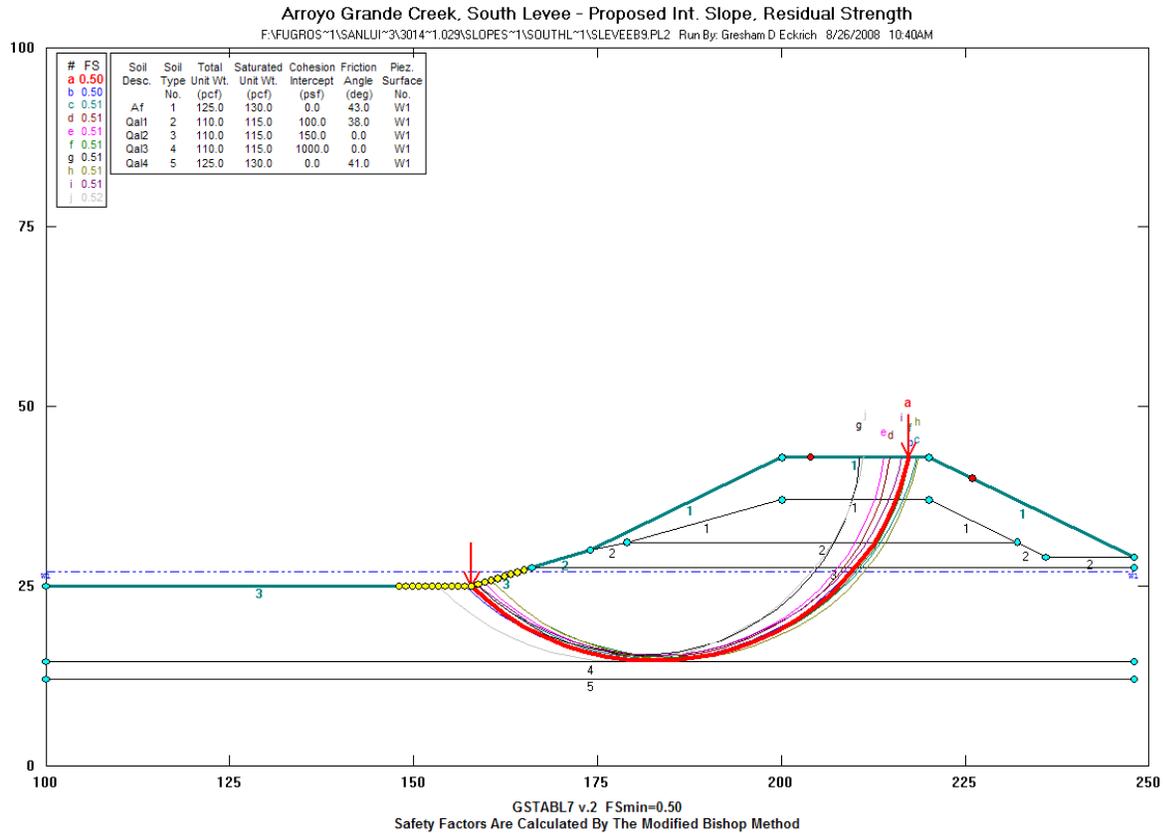
SLOPE STABILITY PLOT FOR SOUTH LEVEE EMBANKMENT
 Arroyo Grande Creek Waterways Management Plan
 San Luis Obispo County, California

ESTIMATED FACTOR OF SAFETY

Post-Liquefaction Condition: 0.5

Condition: Proposed Interior Slope 1

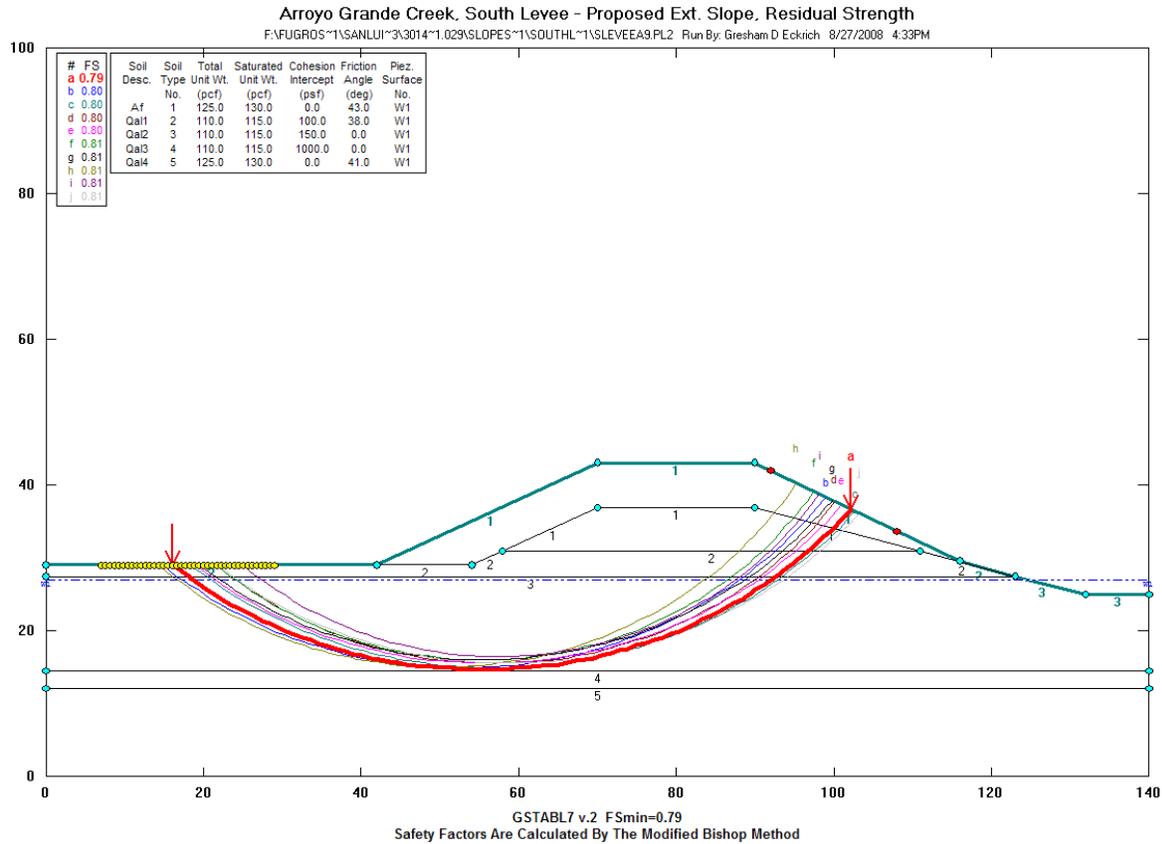
SLOPE STABILITY PLOT FOR SOUTH LEVEE EMBANKMENT
 Arroyo Grande Creek Waterways Management Plan
 San Luis Obispo County, California

ESTIMATED FACTOR OF SAFETY

Post-Liquefaction Condition: 0.8

Condition: Proposed Exterior Slope 1

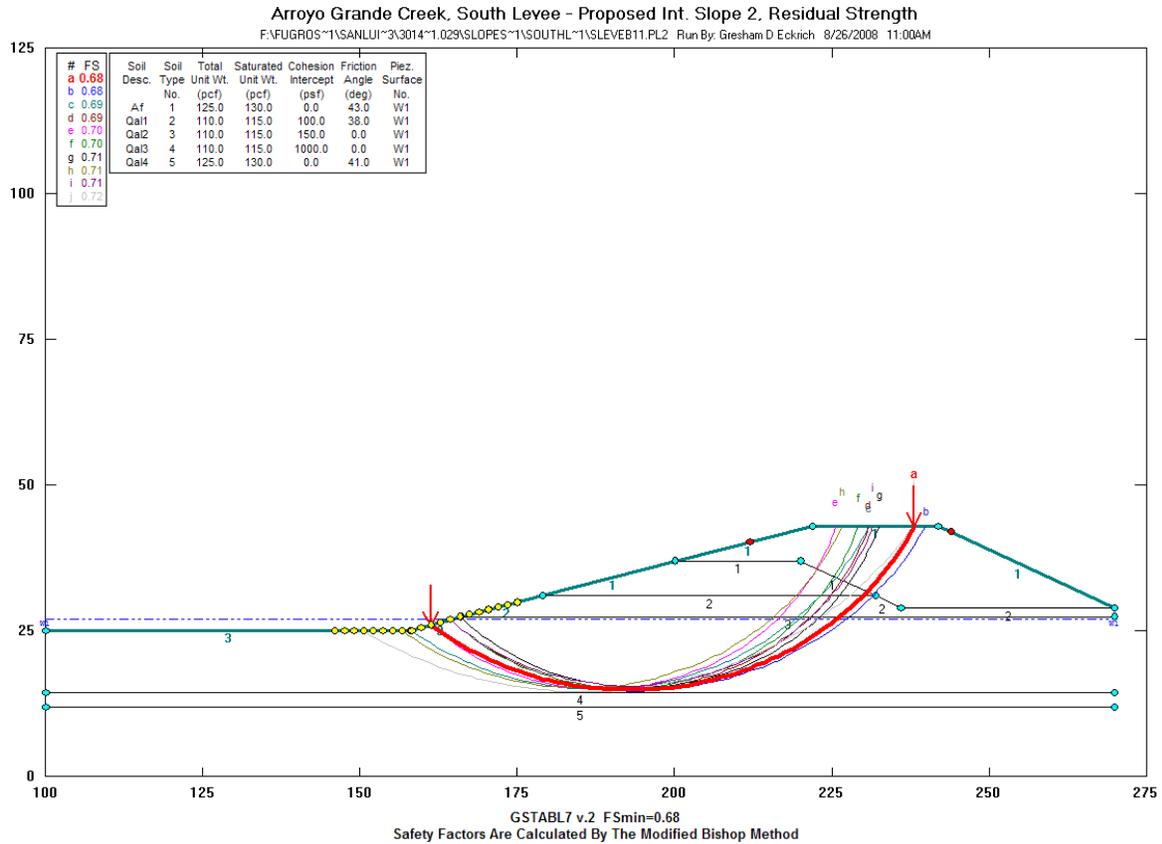
SLOPE STABILITY PLOT FOR SOUTH LEVEE EMBANKMENT
 Arroyo Grande Creek Waterways Management Plan
 San Luis Obispo County, California

ESTIMATED FACTOR OF SAFETY

Post-Liquefaction Condition: 0.7

Condition: Proposed Interior Slope 2
