**PRELIMINARY GEOTECHNICAL REPORT
ARROYO GRANDE CREEK WATERWAYS
MANAGEMENT PLAN
LOS BERROS CREEK TO NEAR OCEANO AIRPORT
SAN LUIS OBISPO COUNTY, CALIFORNIA**

Prepared for:
County of San Luis Obispo
Department of Public Works

April 22, 2009

April 22, 2009
Project No. 3014.029

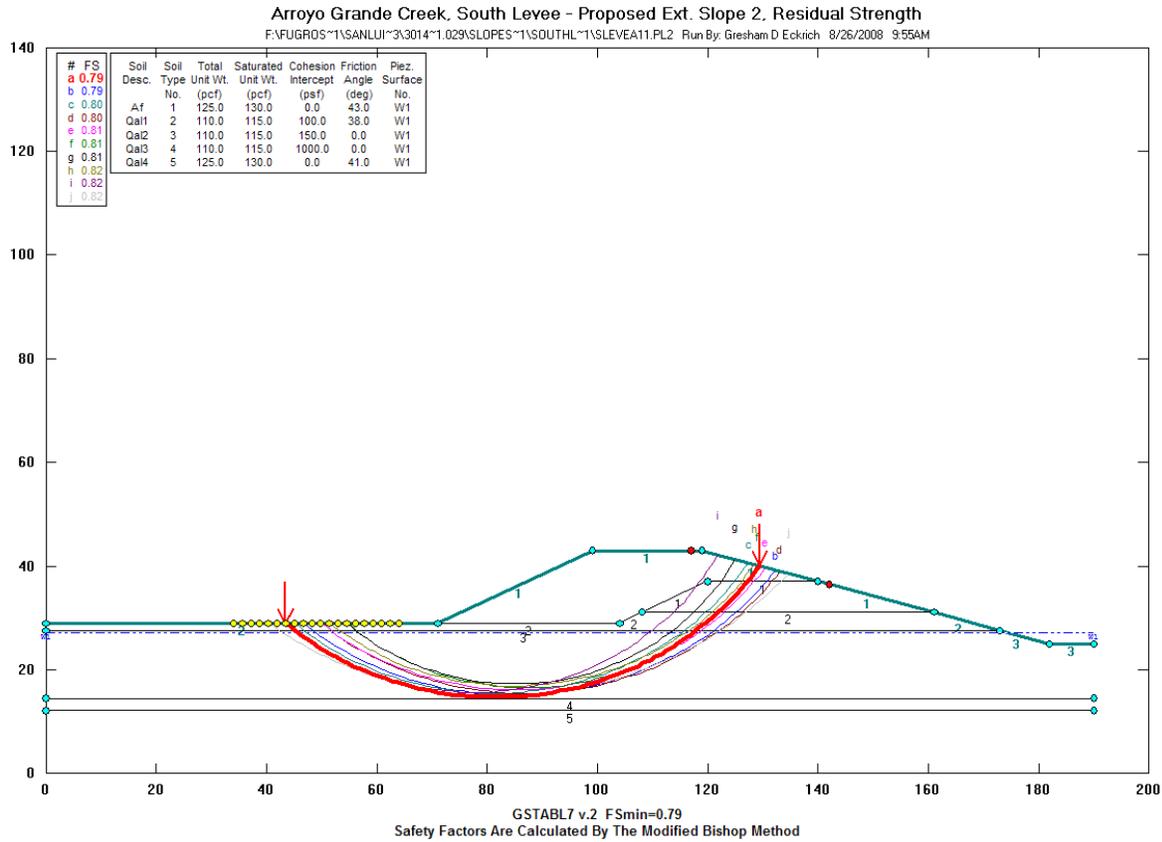
ESTIMATED FACTOR OF SAFETY

Post-Liquefaction Condition: 0.8

Condition: Proposed Exterior Slope 2

- ❖ Slope stability analyses of the preliminary levee configurations suggest that the levee can be raised to the conceptual design height and should be stable under static loading and the anticipated flood levels. However, the stability of the levees likely would be compromised by liquefaction of the foundation soil within the Pre-

Settlement Estero area west of about Creek Road. Because it is unlikely that there would be full flows in Arroyo Grande Creek at the same time as a damaging earthquake, the County anticipates that if an earthquake were to occur and damage is realized, they would have the opportunity to make repairs to the levee system before high flows would inundate the channel. The existing levee is vulnerable to this potential hazard whether the height of the levee is raised to improve flood protection or not.
