CONCEPTUAL HABITAT MITIGATION AND MONITORING PLAN FOR THE EL CAMINO REAL BRIDGE REPLACEMENT

November 2017

County of San Luis Obispo
Department of Public Works
San Luis Obispo, CA 93408

SWCA Environmental Consultants
1422 Monterey Street, Suite C200
San Luis Obispo, CA 93401

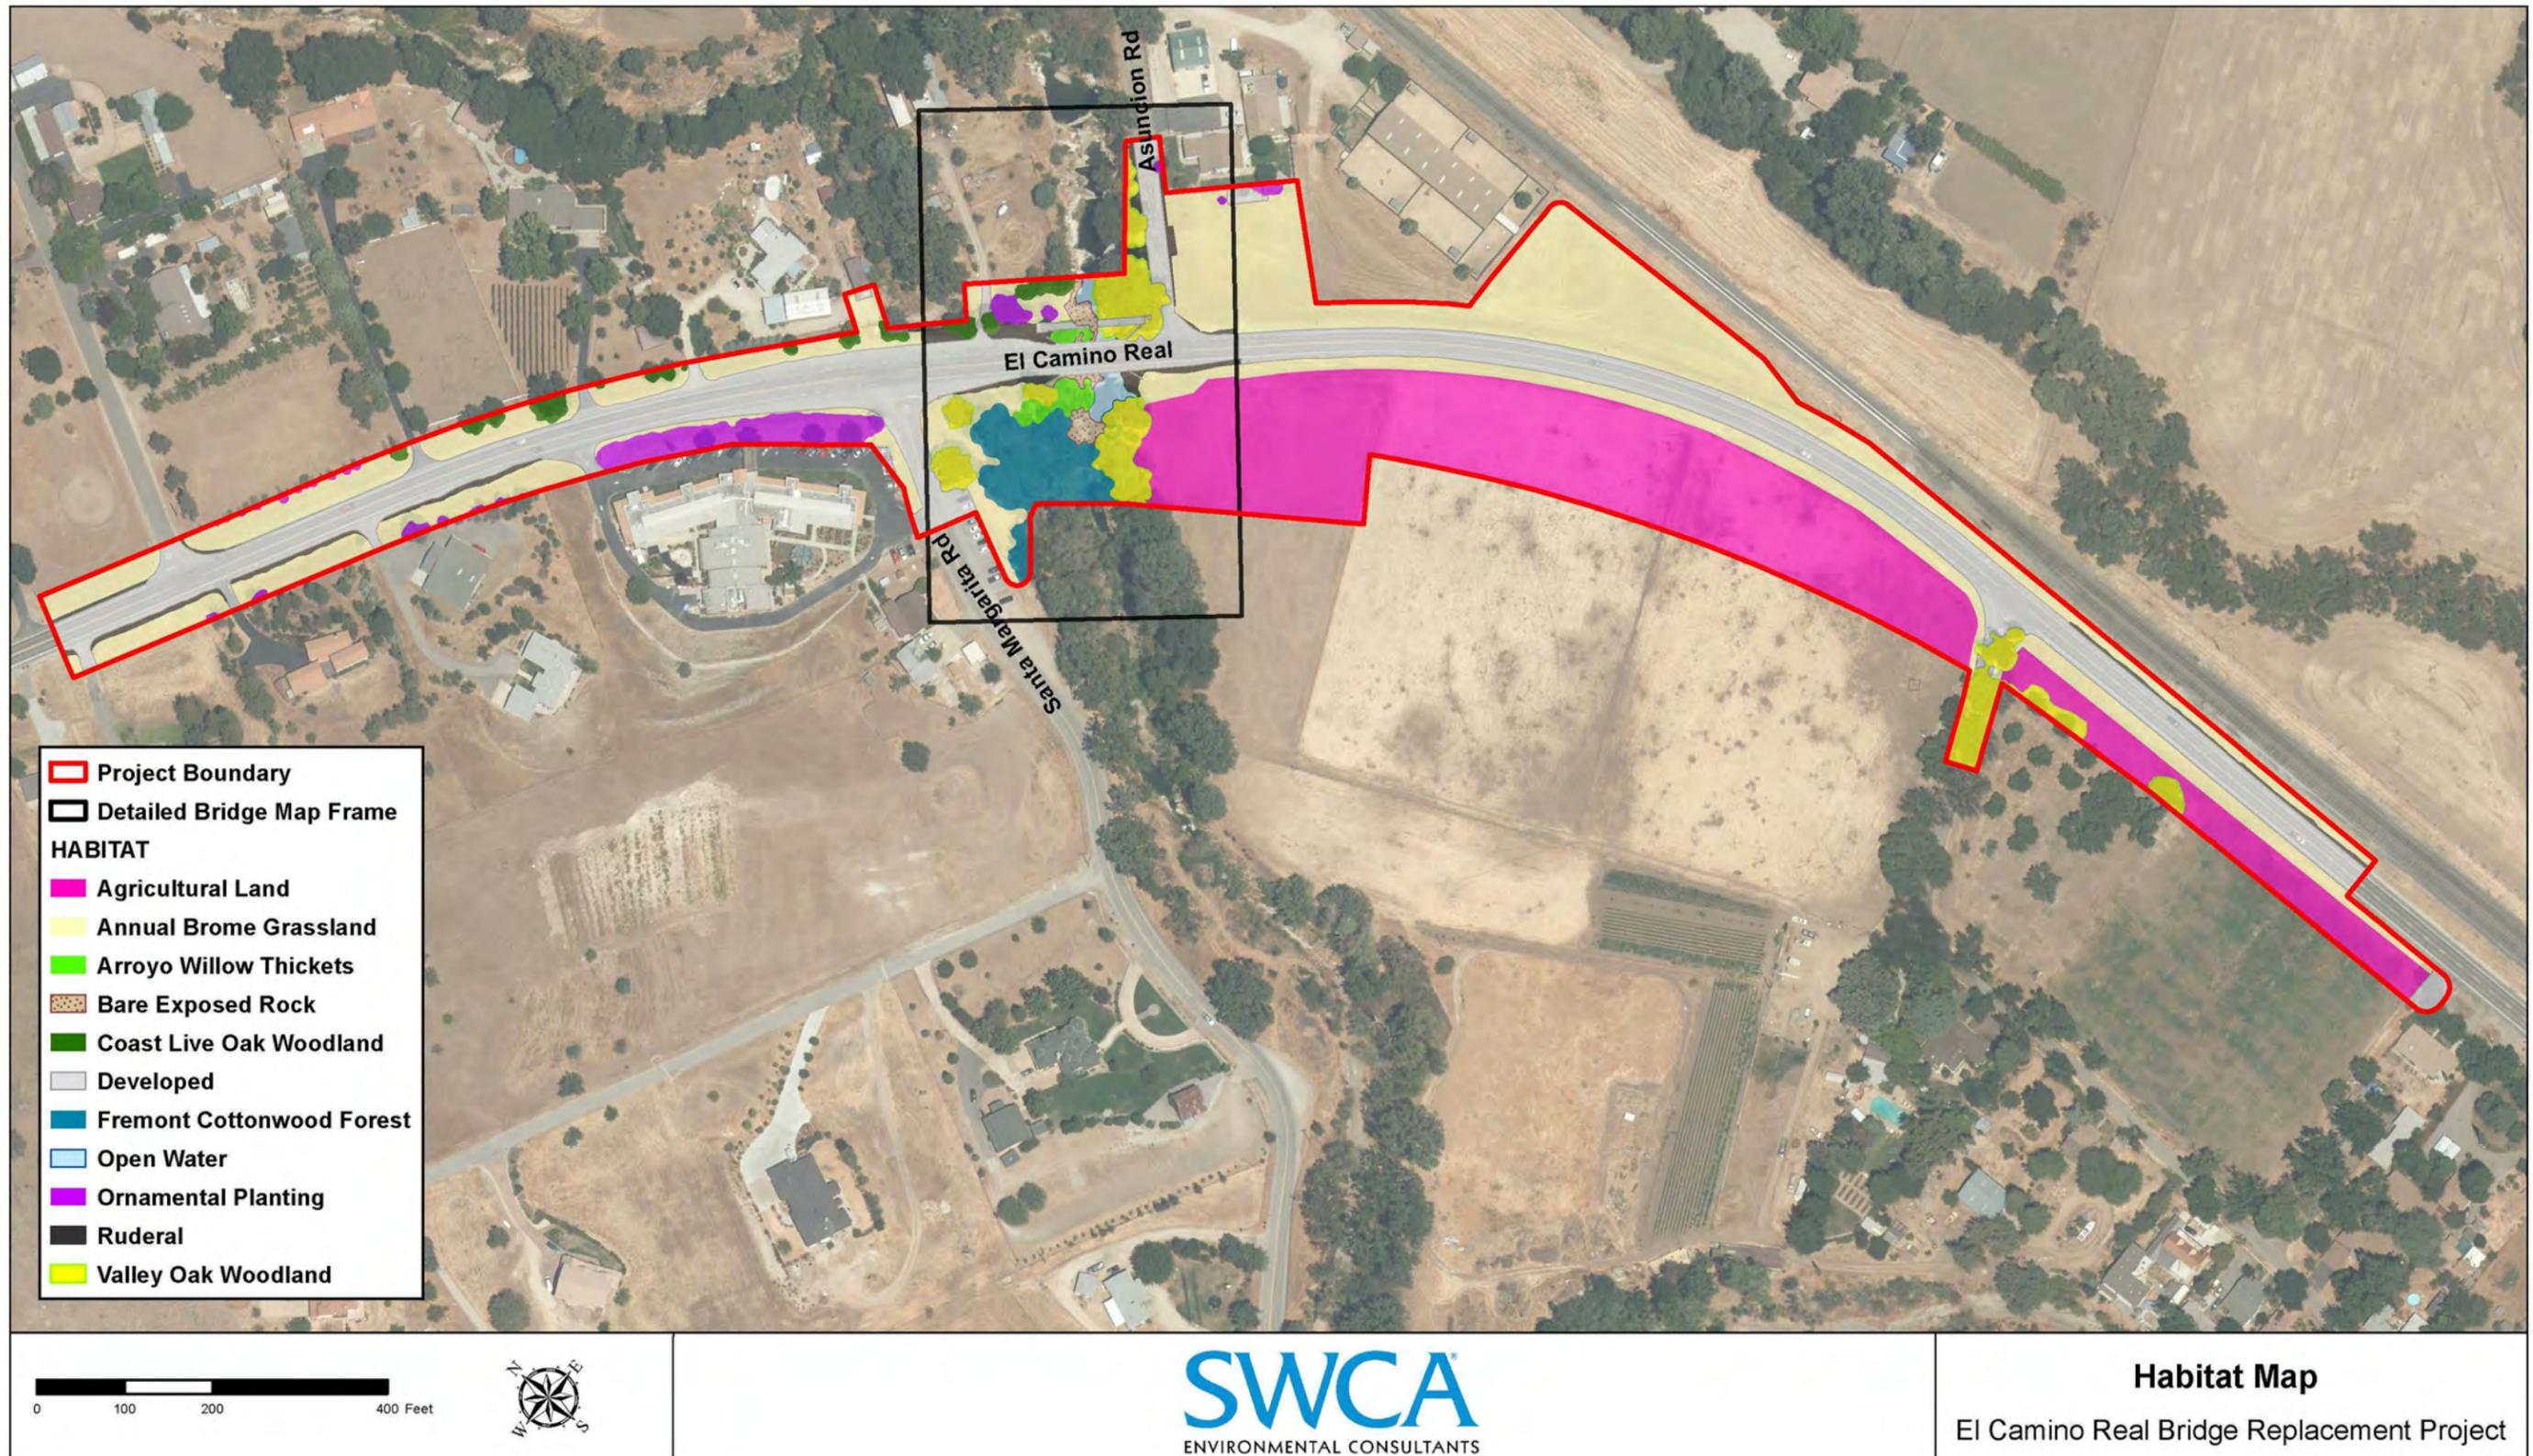
Figure 3. Habitat Map

The vegetation communities observed within the BSA include: ruderal/developed, annual brome grassland, coast live oak woodland, valley oak woodland, arroyo willow thicket, and Fremont cottonwood forest (refer to Figures 3 and 4). Approximately 0.37 acre of riparian habitat (classified as either arroyo willow thicket or Fremont cottonwood forest) and approximately 0.69 acre of oak woodlands (classified as coast live oak woodland and valley oak woodland) adjacent to the riparian areas were mapped within the BSA. Hydrology is controlled by Santa Margarita Creek and, to a lesser extent, runoff from adjacent agricultural areas.

Fremont Cottonwood Forest (*Populus fremontii* Forest Alliance; CDFW CA Code: 61.130.00) is described by Sawyer et al. (2009) as occurring on floodplains, along low-gradient rivers, along perennial or seasonally intermittent streams, in valleys with a dependable subsurface water supply that varies considerably during the year. The Fremont cottonwood forest falls within the Holland (1986) description of southern cottonwood willow riparian forest (CNDDDB CTT61330CA) as it is recognized as a natural community of special concern by the CDFW. The USFWS Wetland Inventory (1996 national list) recognizes Fremont cottonwood as a FACW plant. This alliance generally occurs adjacent to river and creek channels, within seasonally flooded arroyos, and in topographic depressions close to ground water. This community consists of forested stream-side riparian vegetation, varying from open to closed canopies (Holland 1986). Along the Santa Margarita Creek riparian corridor the Fremont cottonwood forest is co-dominant in the tree canopy with boxelder (*Acer negundo*), California black walnut, coast live oak, red willow (*Salix laevigata*), and arroyo willow (*Salix lasiolepis*). Dominant shrubs within the Fremont cottonwood forest community in the BSA consists of American dogwood, poison oak (*Toxicodendron diversilobum*), virgin's bower (*Clematis ligusticifolia*), snowberry (*Symphoricarpos mollis*), and scattered coyote bushes and mulefat. Fremont cottonwood forest intergrades with valley oak woodland along the southwestern banks and with coast live oak woodland along the northeastern banks of Santa Margarita Creek. Within the BSA, approximately 4,737 ft² (0.32 acre) of Fremont cottonwood forest was mapped.

- Herbicide use shall be restricted to application of the glyphosate-based herbicide Aquamaster above the OHWM (refer to Figure 3). All herbicide applications shall be performed by an individual in possession of a Qualified Applicators License and with experience managing invasive weed species in sensitive habitats.
- Following removal of invasive weed cover, all areas to be planted shall be watered repeatedly to stimulate germination of existing weed seeds. Sprouted weeds should be sprayed with an approved herbicide, covered with black plastic for a period of at least 4 weeks, or removed by hand to conclude at least one grow-and-kill cycle prior to planting on the site.
- Invasive weed cover may also be achieved through mechanical means. Equipment will be staged at the top of bank to avoid further impact to the creek channel.

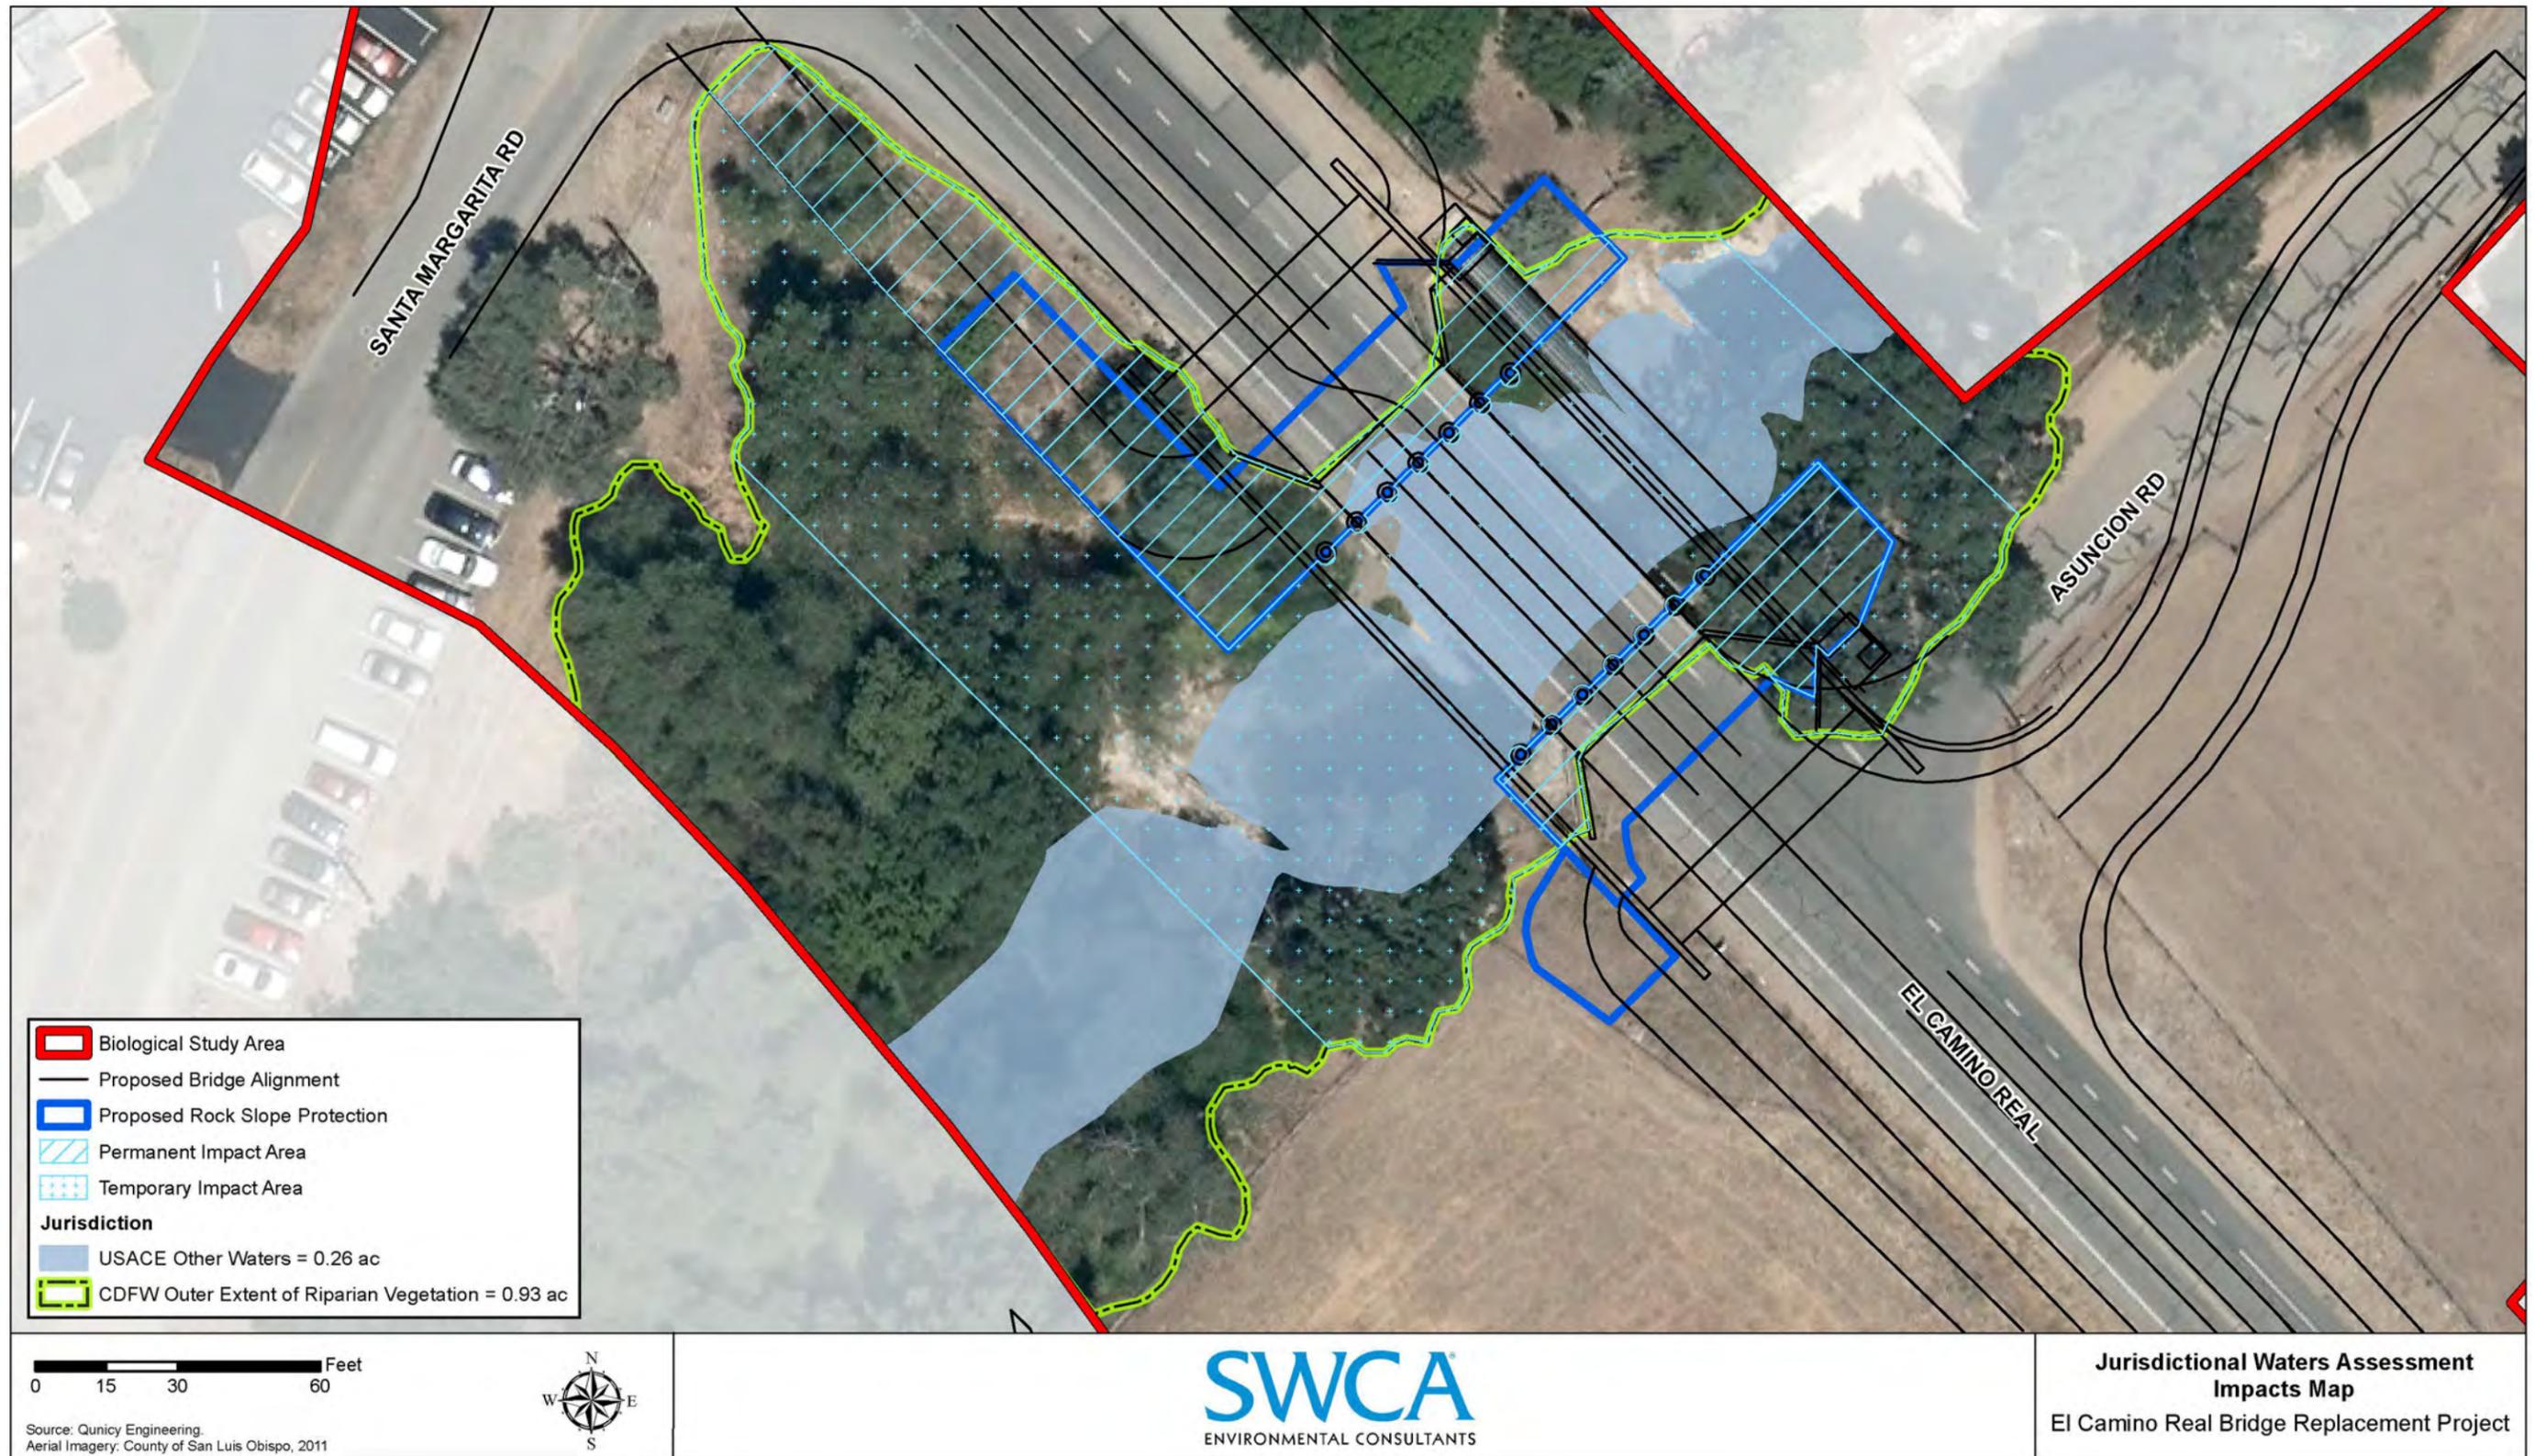
Figure 5. Jurisdictional Features and Impacts Map

Within the BSA, potential USACE jurisdiction was mapped to include areas identified as ‘other waters’. No USACE-defined ‘wetlands’ were present within the BSA. ‘Other waters’ were mapped between the OHWMs observed along the creek banks. In addition, a small ponded area was mapped that is located directly adjacent to the OHWM along the west bank of Santa Margarita Creek. Table 1 quantifies the total area of USACE, CDFW, and RWQCB jurisdictional features mapped within the BSA during the jurisdictional assessment.

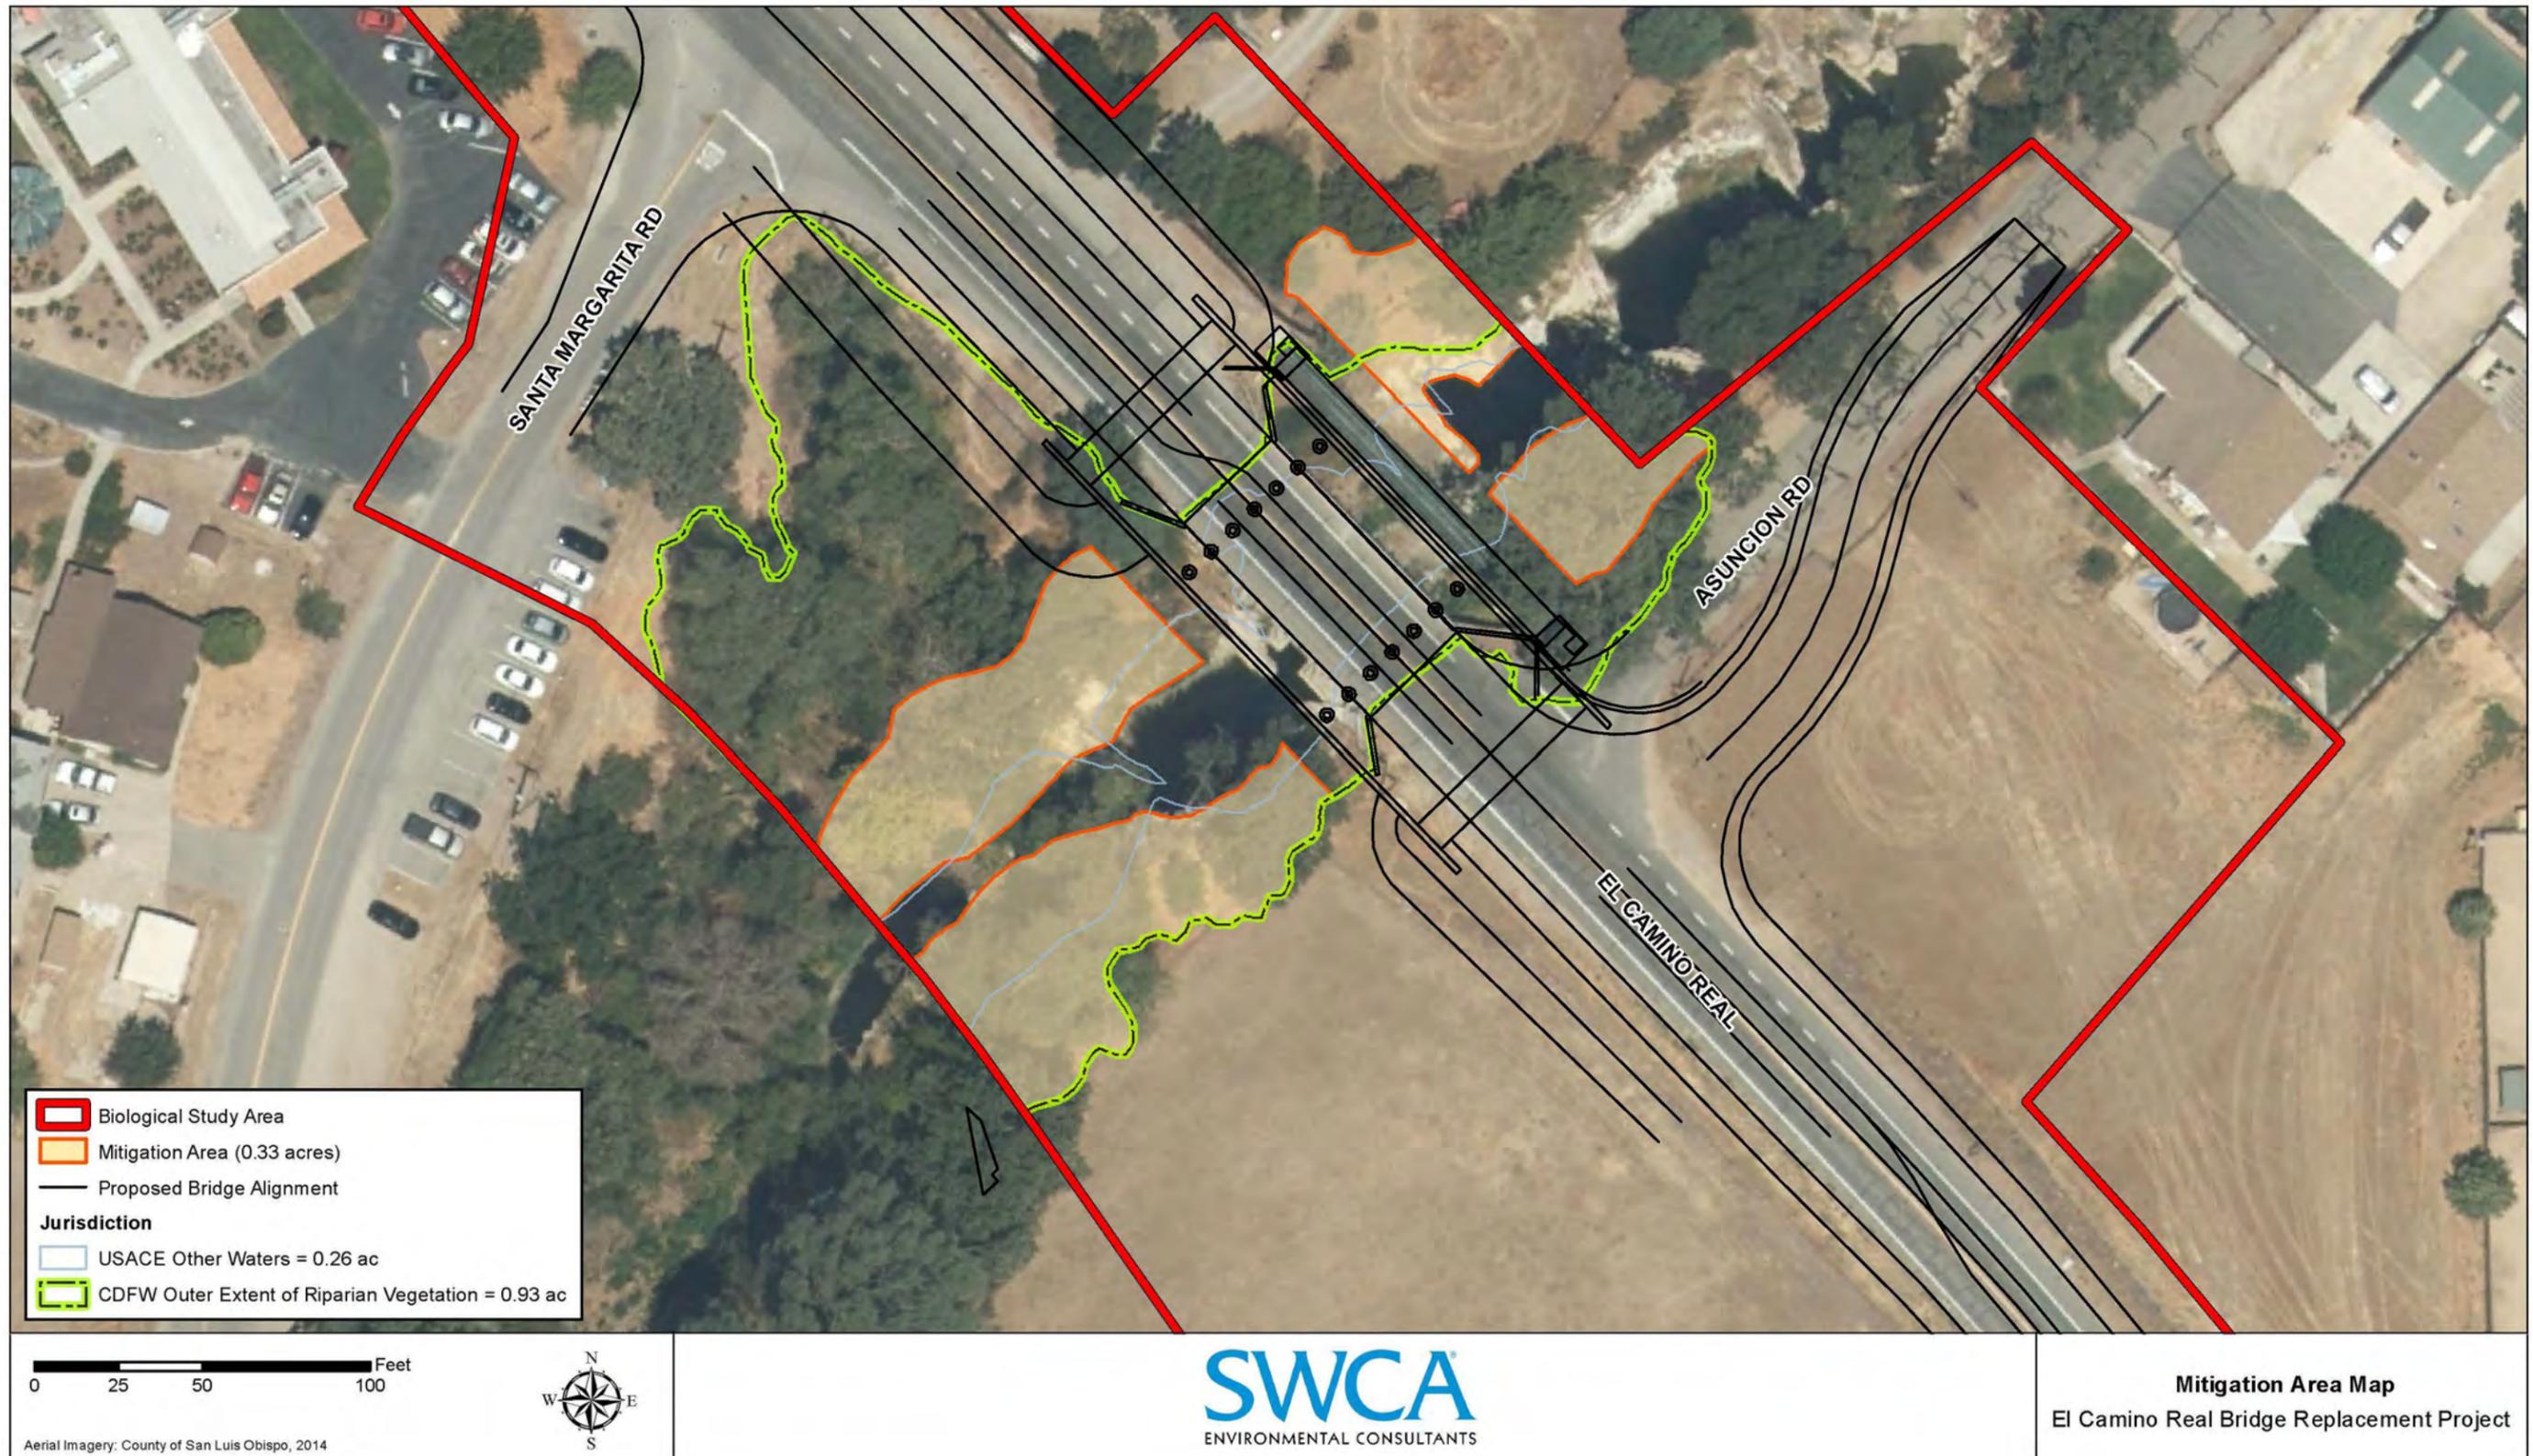
Figure 6. Mitigation Area Map

Permanent impacts will result from installation of the approach abutments, placement of RSP, and construction of the fill slopes. Permanent impacts to jurisdictional areas will be mitigated at a 3:1 ratio. The permanent impact mitigation area will be located within the Santa Margarita Creek corridor immediately downstream and upstream of the project footprint and in areas in and adjacent to the BSA that support exotic species, contain debris, and have erosion. Compensatory mitigation for permanent impacts will focus on enhancing the undisturbed riparian vegetation on the banks of the creek. Habitat enhancement activities will include removing concrete and debris from the channel, removing non-native plant species from the creek banks, and planting riparian scrub species. The locations of proposed mitigation areas are identified on Figure 6.

Temporarily impacted areas are expected to be returned to the pre-construction condition following project completion. Temporary impacts will occur within an estimated 110-foot-wide dewatering and construction corridor that spans approximately 30 feet upstream and downstream of the proposed bridge. The corridor would include the dewatered area, temporary crossing, and associated riparian vegetation removal. Temporary impacts will also occur in the riparian vegetation located within 10 feet of either side of the proposed temporary clear span bridge. Project staging areas have been selected to minimize unnecessary impacts to native riparian vegetation. Temporary impacts to jurisdictional areas on the creek banks will be mitigated at a 1:1 ratio by restoring the topography and vegetation in the temporarily impacted areas. Temporary impact restoration activities will focus on re-contouring the disturbed areas, placing geotextiles or erosion control blankets, applying an appropriate seed mix, and planting willow cuttings and container stock. Temporary impacts within the creek channel will be restored naturally. The removal of the existing concrete from the streambed beneath the bridge will enable habitat conditions to become re-established. The locations of proposed mitigation areas are identified on Figure 6.
