**PRELIMINARY GEOTECHNICAL REPORT
LOS OSOS WASTEWATER PROJECT
LOS OSOS MORTUARY, GIACOMAZZI, AND BRANIN
PROPERTIES
SAN LUIS OBISPO COUNTY, CALIFORNIA**

Prepared for:
COUNTY OF SAN LUIS OBISPO

July 17, 2007

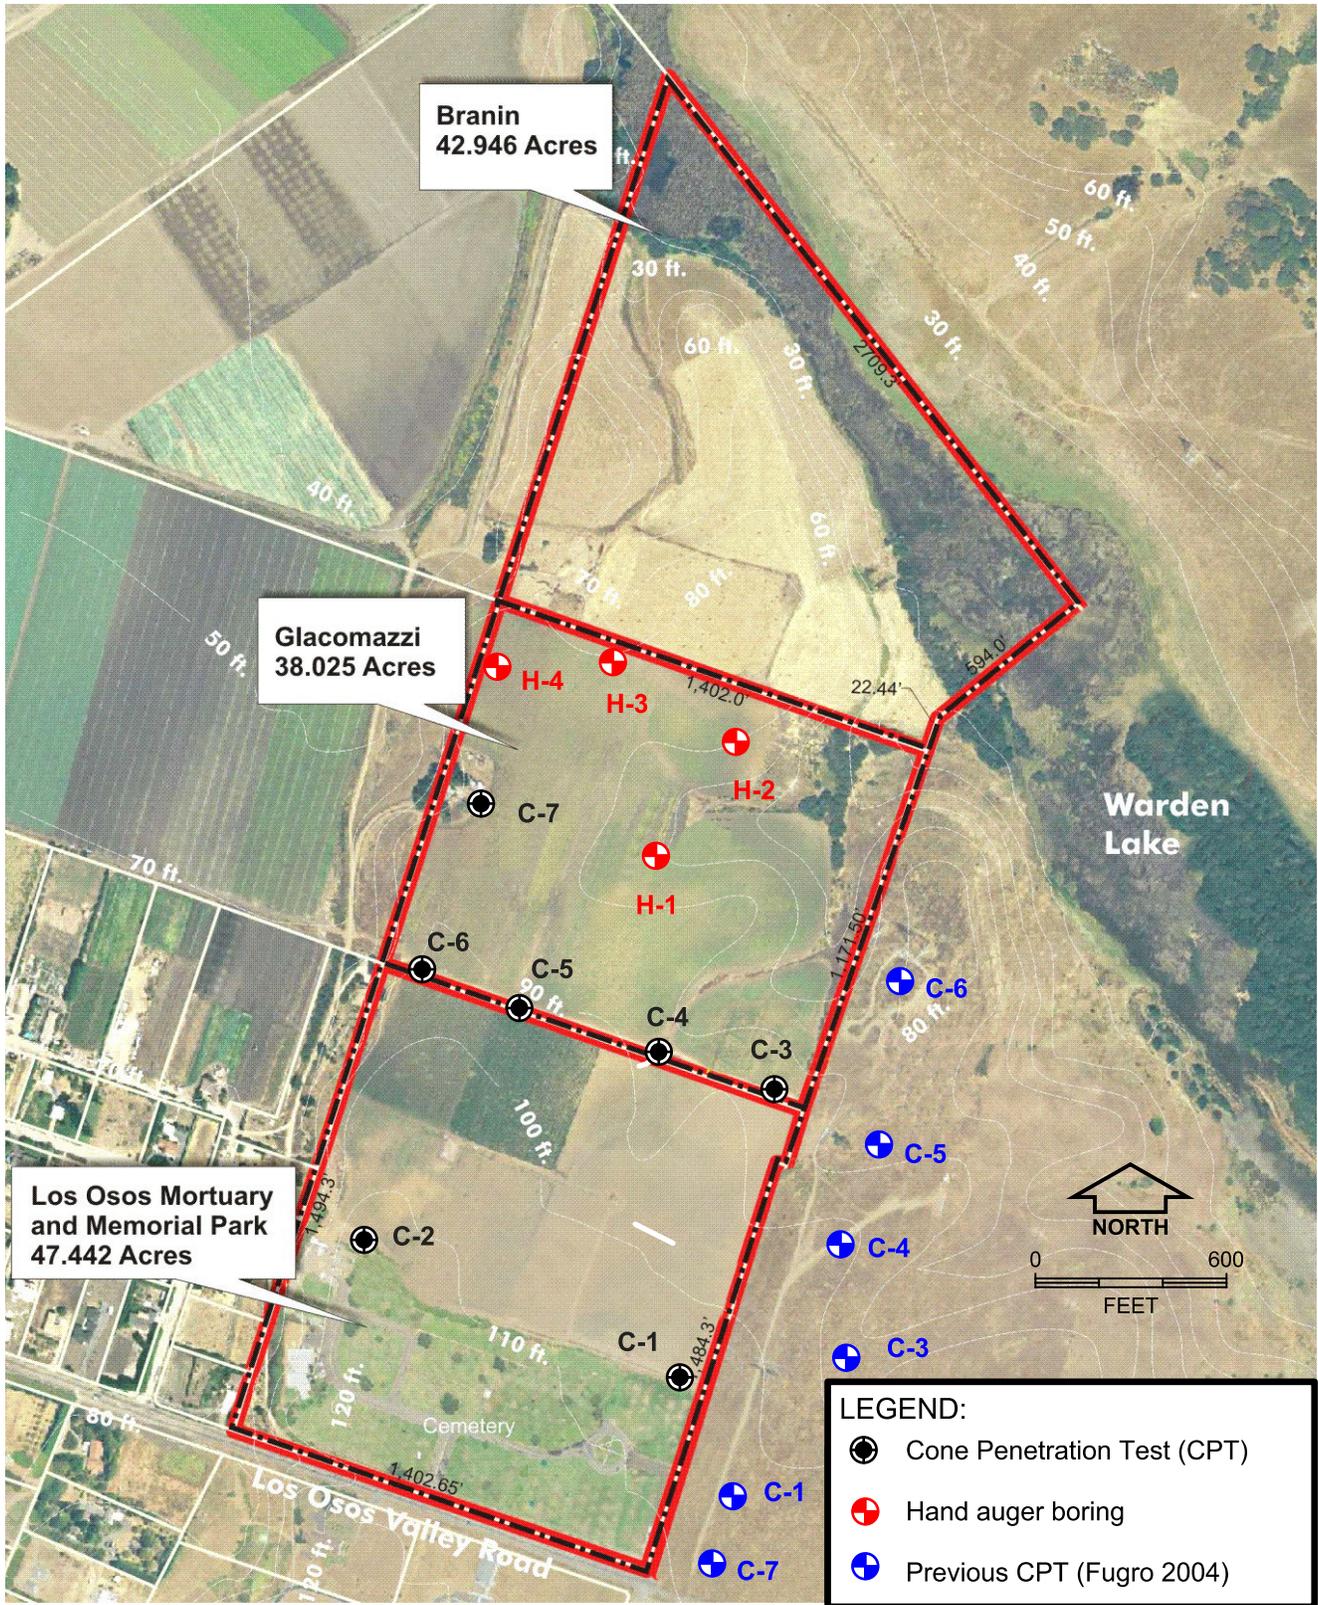
FIELD EXPLORATION PLAN
 Los Osos Wastewater Project
 San Luis Obispo County, California

BASE MAP SOURCE: Crawford Multari Clark Associates (2007). Areas Potentially Suitable for Wastewater Facilities.

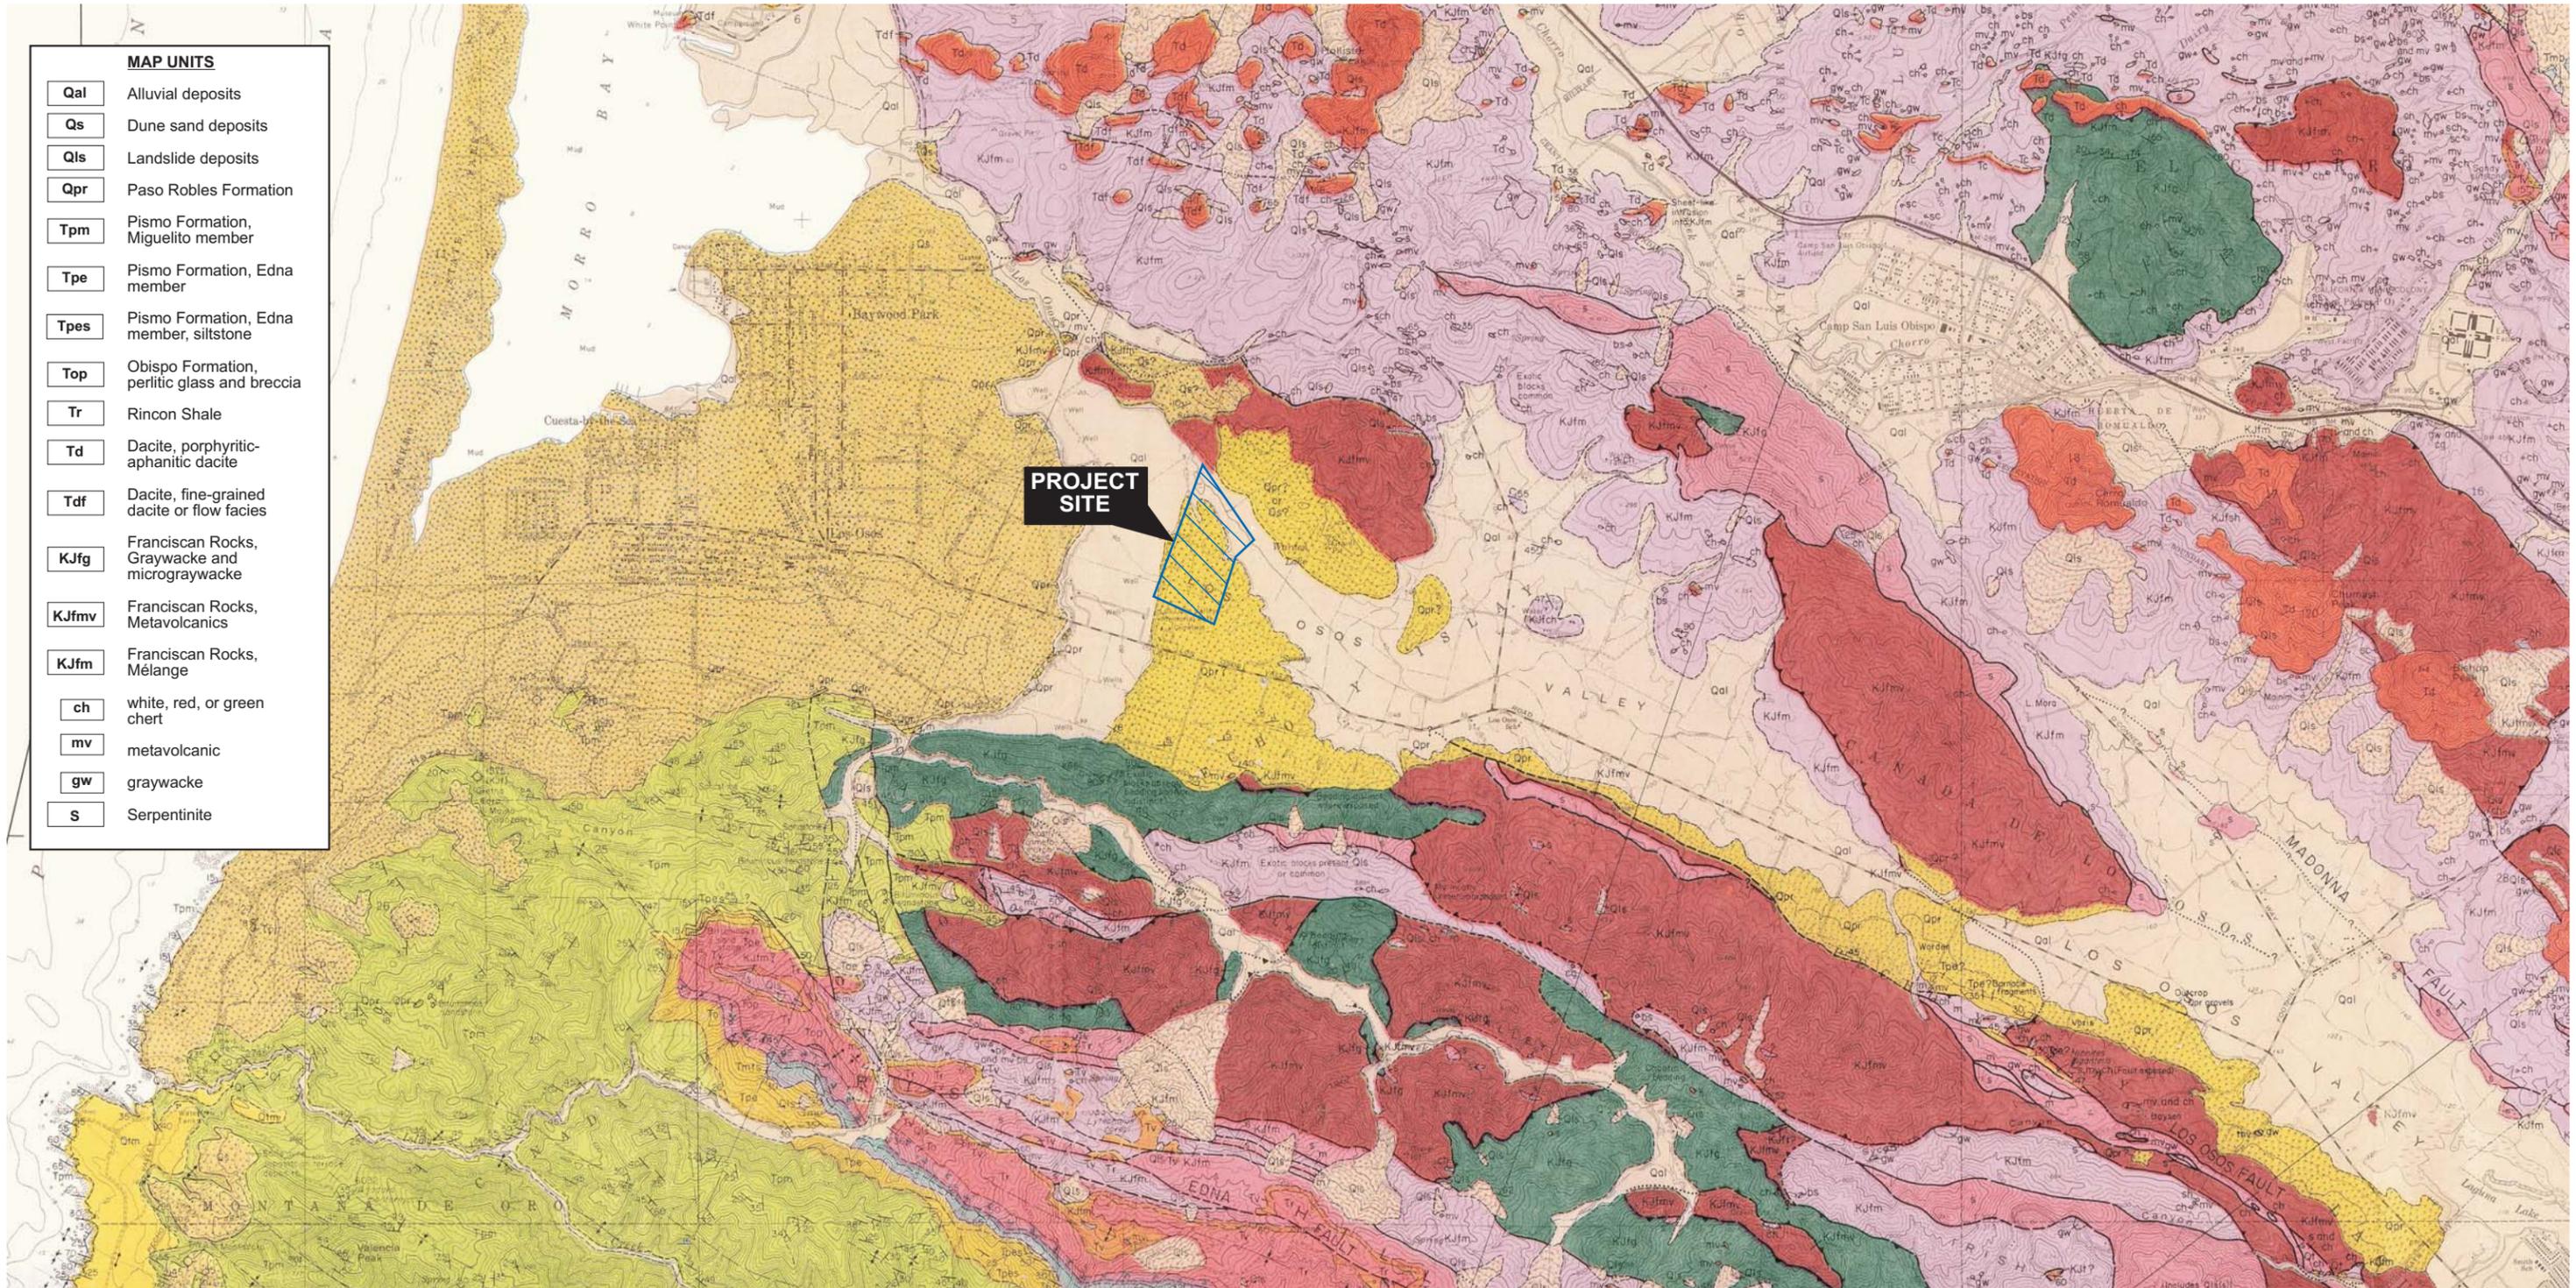
REGIONAL GEOLOGIC MAP
Los Osos Wastewater Project
San Luis Obispo County, California

| MAP UNITS | |
| Qal | Alluvial deposits |

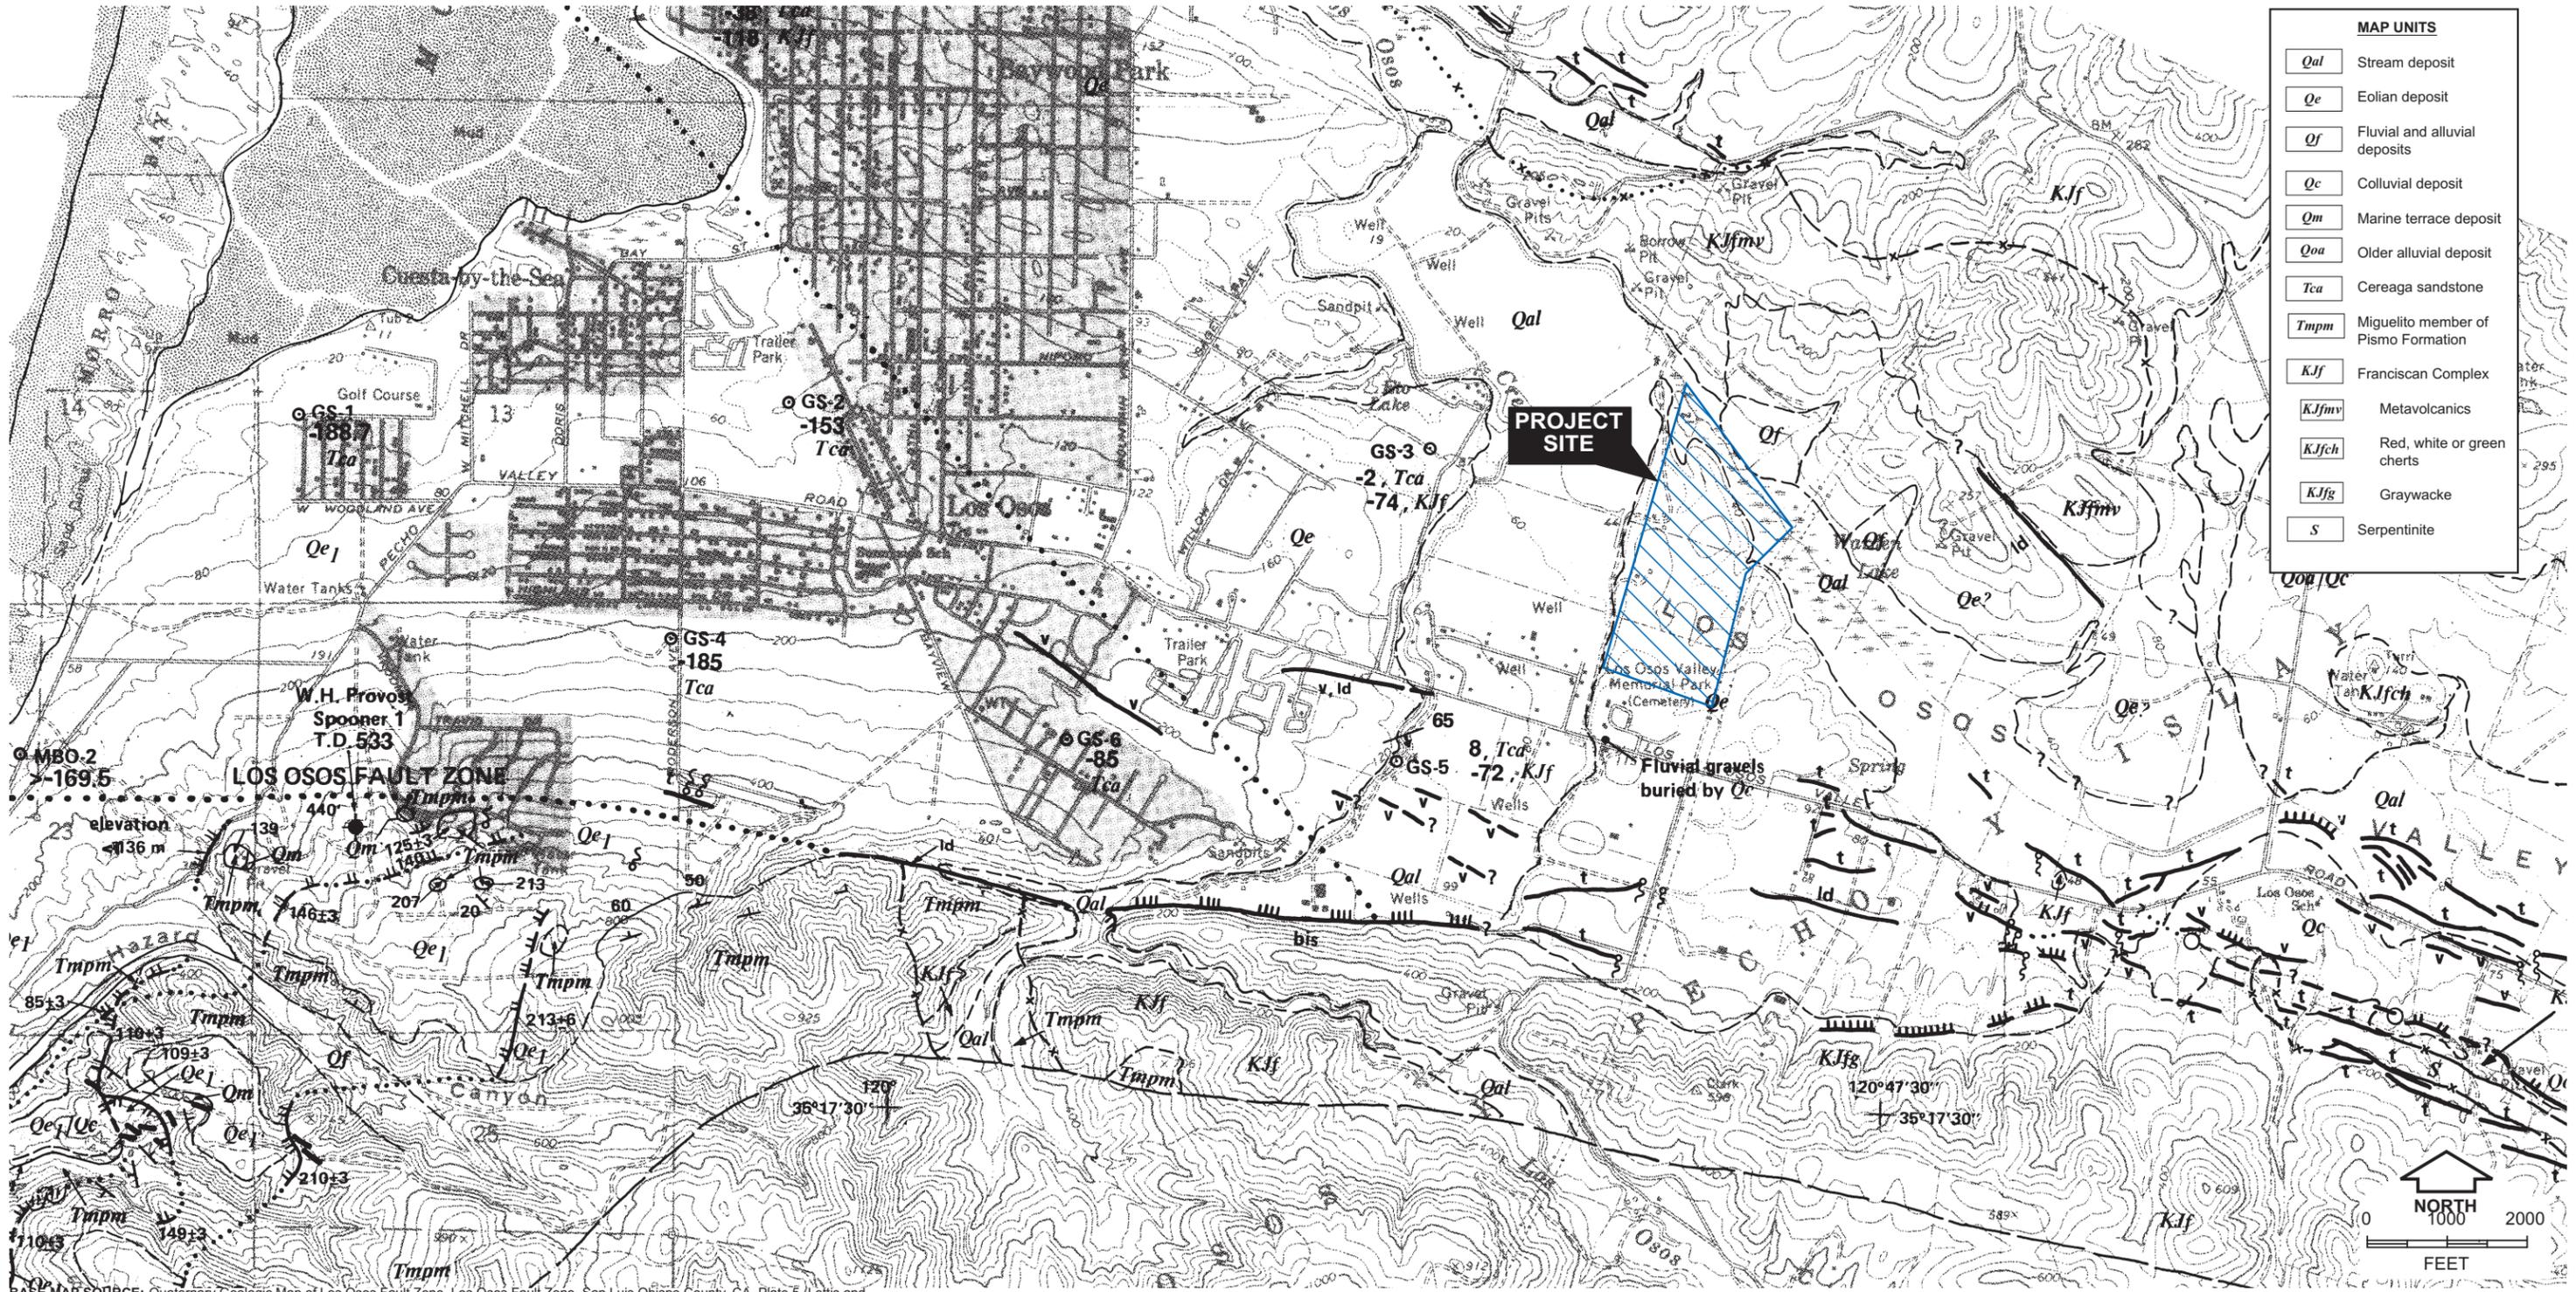
LOS OSOS FAULT ZONE AND LINEAMENTS
Los Osos Wastewater Project
San Luis Obispo County, California

| MAP UNITS | |
| Qal | Stream deposit |

- ✦ Exploratory oil well - Producer, name of well, and depth (meters) are indicated
- Closed depression
- ☺ Spring
- Trench location
- x Bedrock exposure
- Limit of mapping

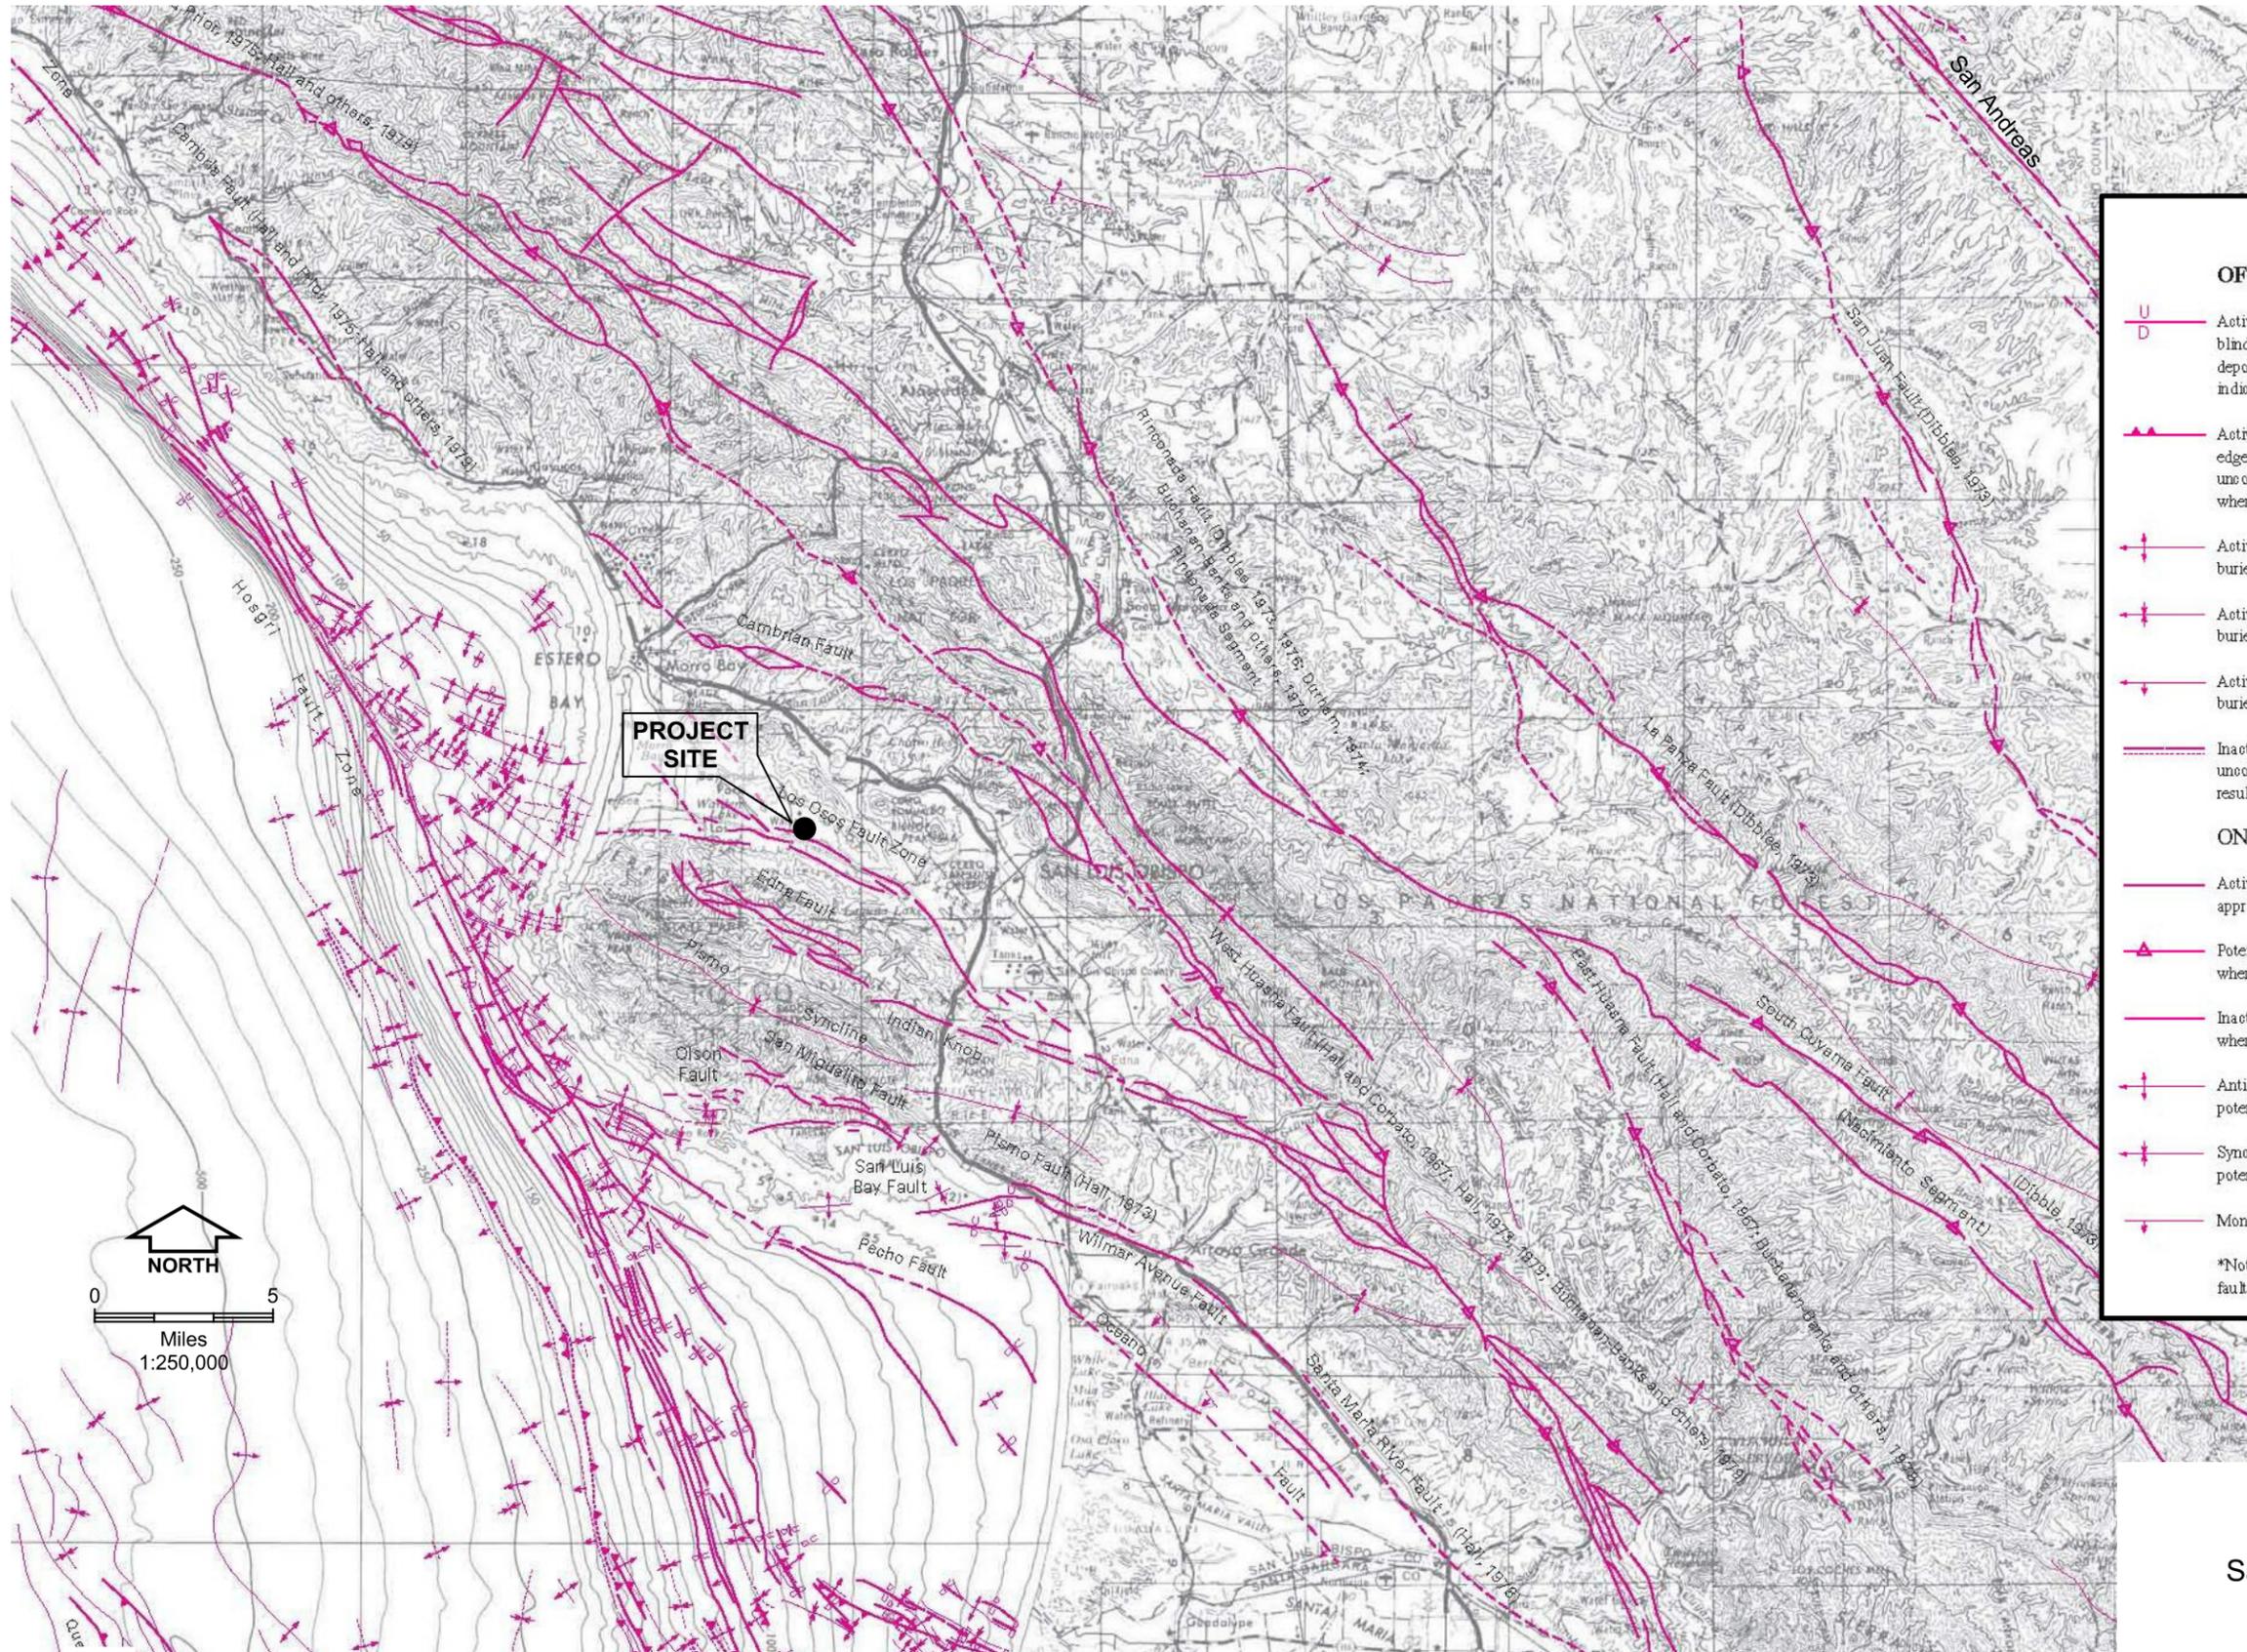
REGIONAL FAULT MAP
Los Osos Wastewater Project
San Luis Obispo County, California

EXPLANATION

OFFSHORE REGION*

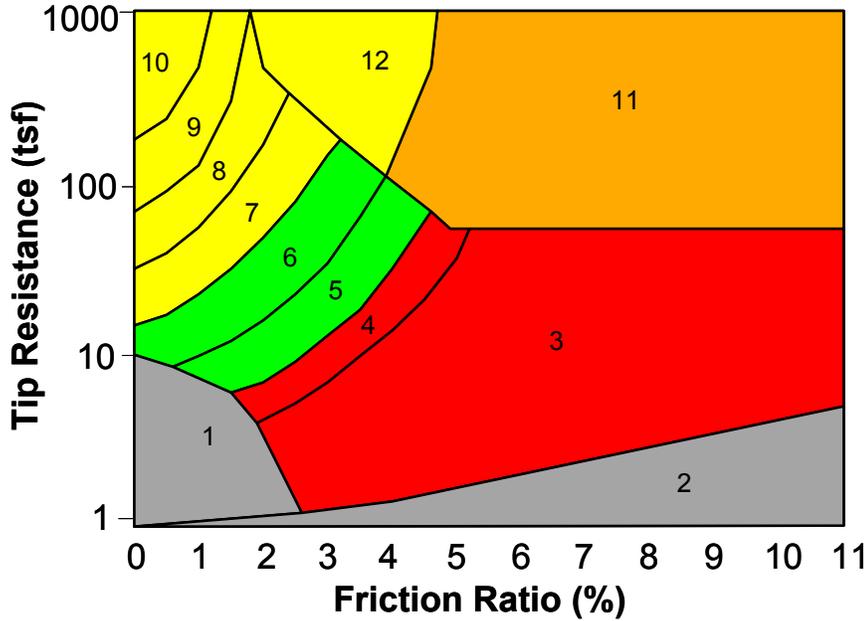
KEY TO CPT LOGS
 Los Osos Wastewater Project
 San Luis Obispo County, California

| Zone | Soil Behavior Type | U.S.C.S. |
| 1 | Sensitive Fine-grained | OL-CH |

CPT CORRELATION CHART
 (Robertson and Campanella, 1984)

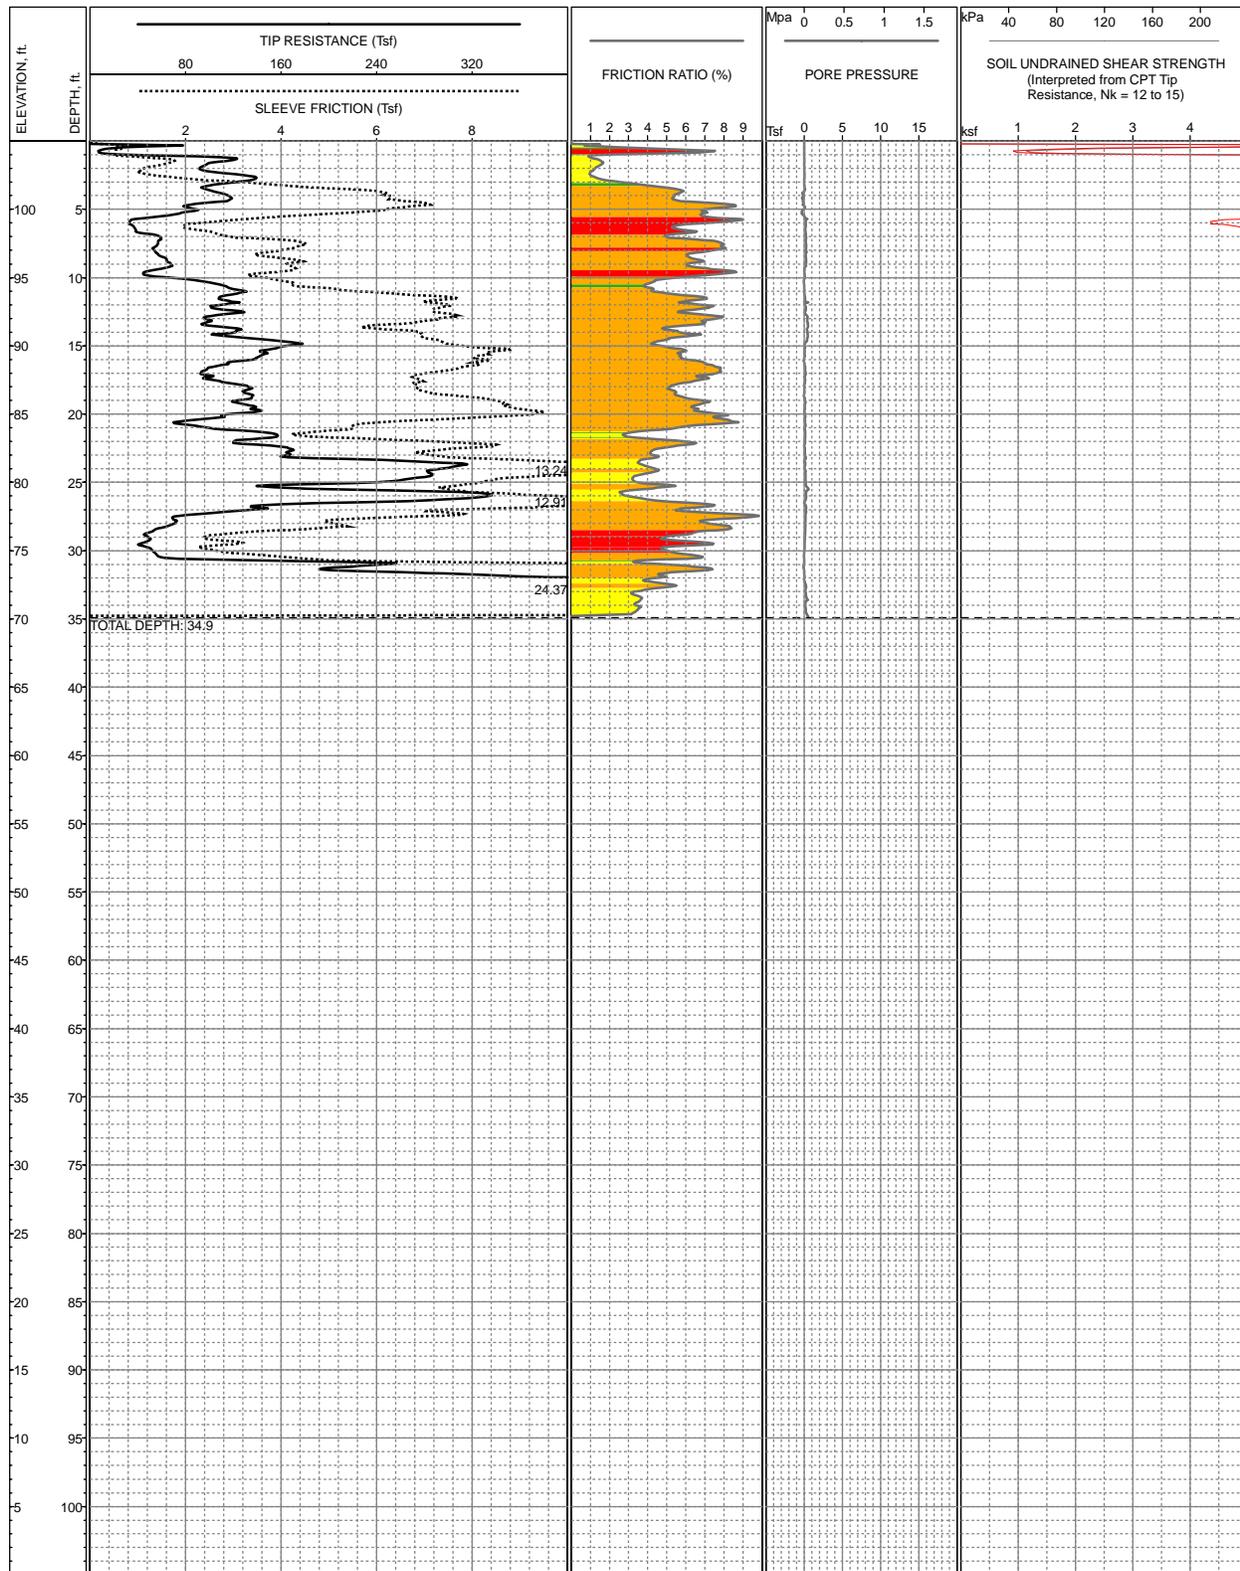
LOG OF C-1
Los Osos Wastewater Project
San Luis Obispo County, California

LOCATION: Southeast corner of Los Osos Mortuary property.
SURFACE EL: 105ft +/- (MSL)
COMPLETION DEPTH: 34.9ft
TESTDATE: 5/8/2007

EXPLORATION METHOD: Cone Penetrometer
PERFORMED BY: Fugro Geosciences
REVIEWED BY: J Blanchard

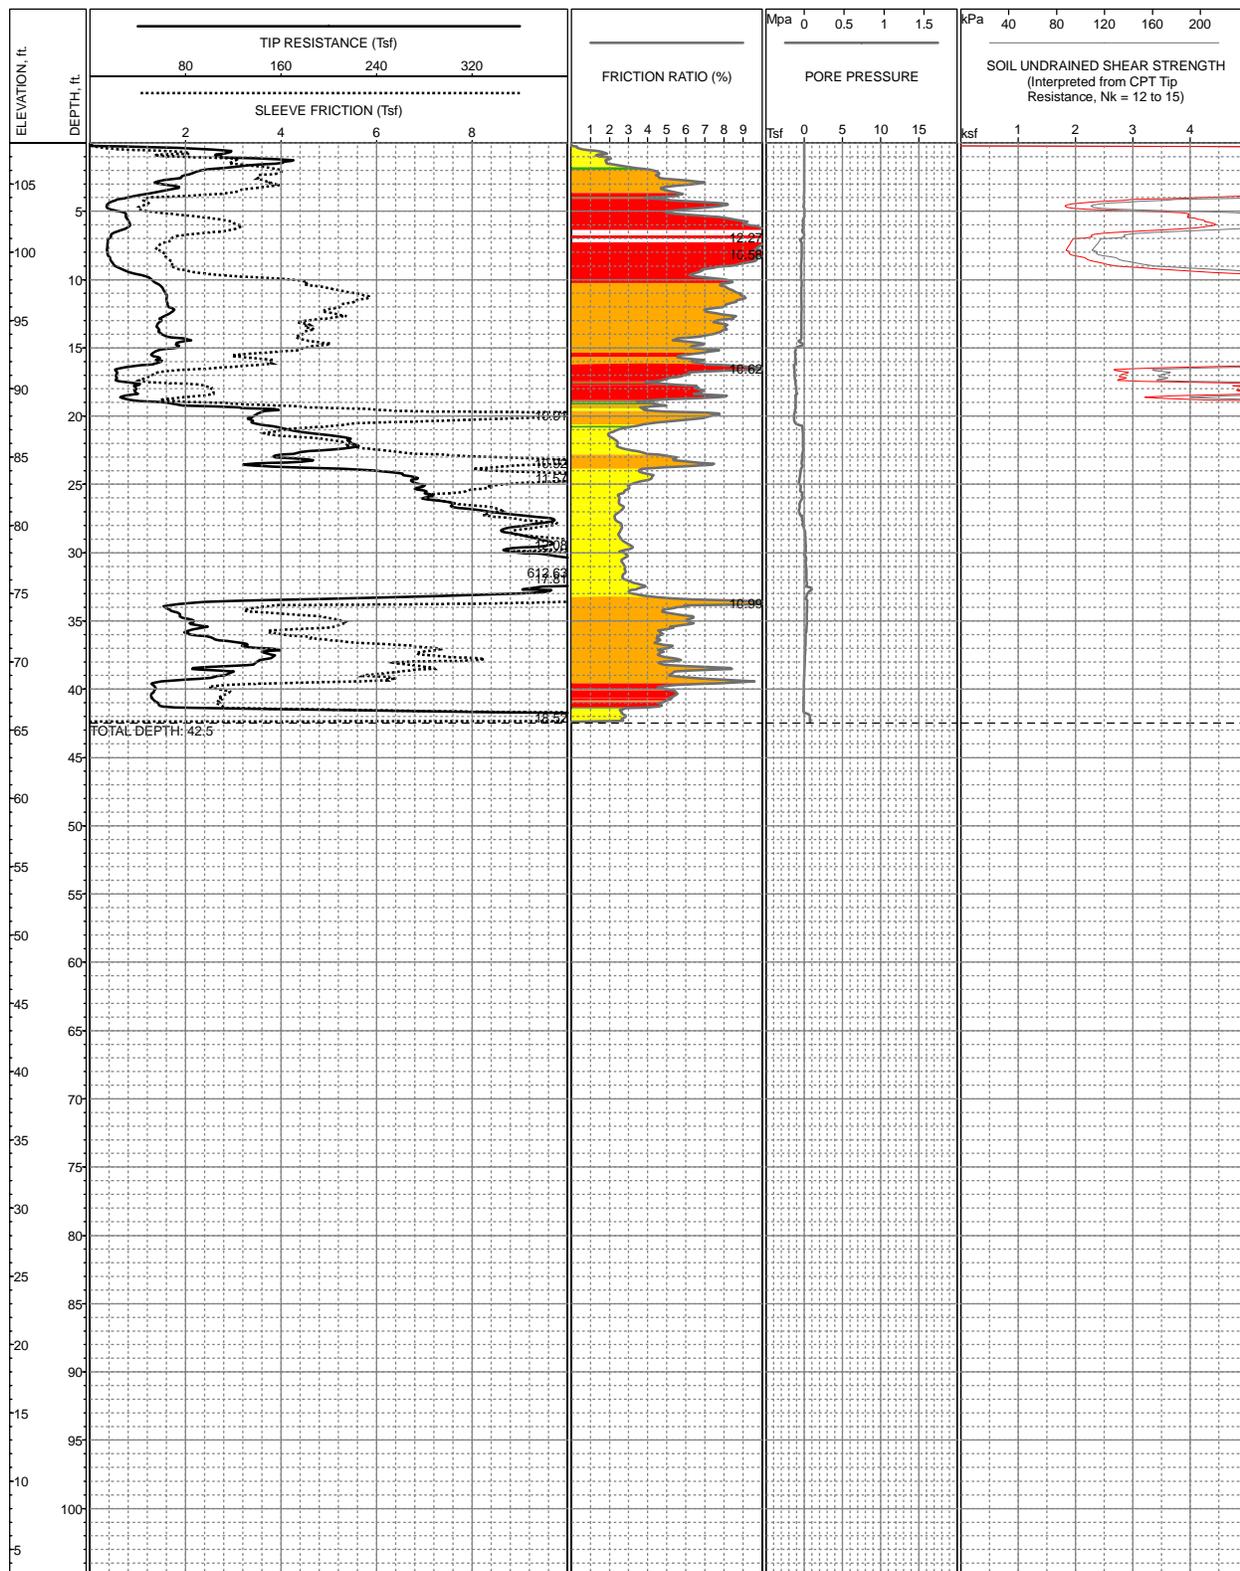
LOG OF C-2
Los Osos Wastewater Project
San Luis Obispo County, California

LOCATION: Southwest corner of Los Osos Mortuary property.
SURFACE EL: 108ft +/- (MSL)
COMPLETION DEPTH: 42.5ft
TESTDATE: 5/8/2007

EXPLORATION METHOD: Cone Penetrometer
PERFORMED BY: Fugro Geosciences
REVIEWED BY: J Blanchard

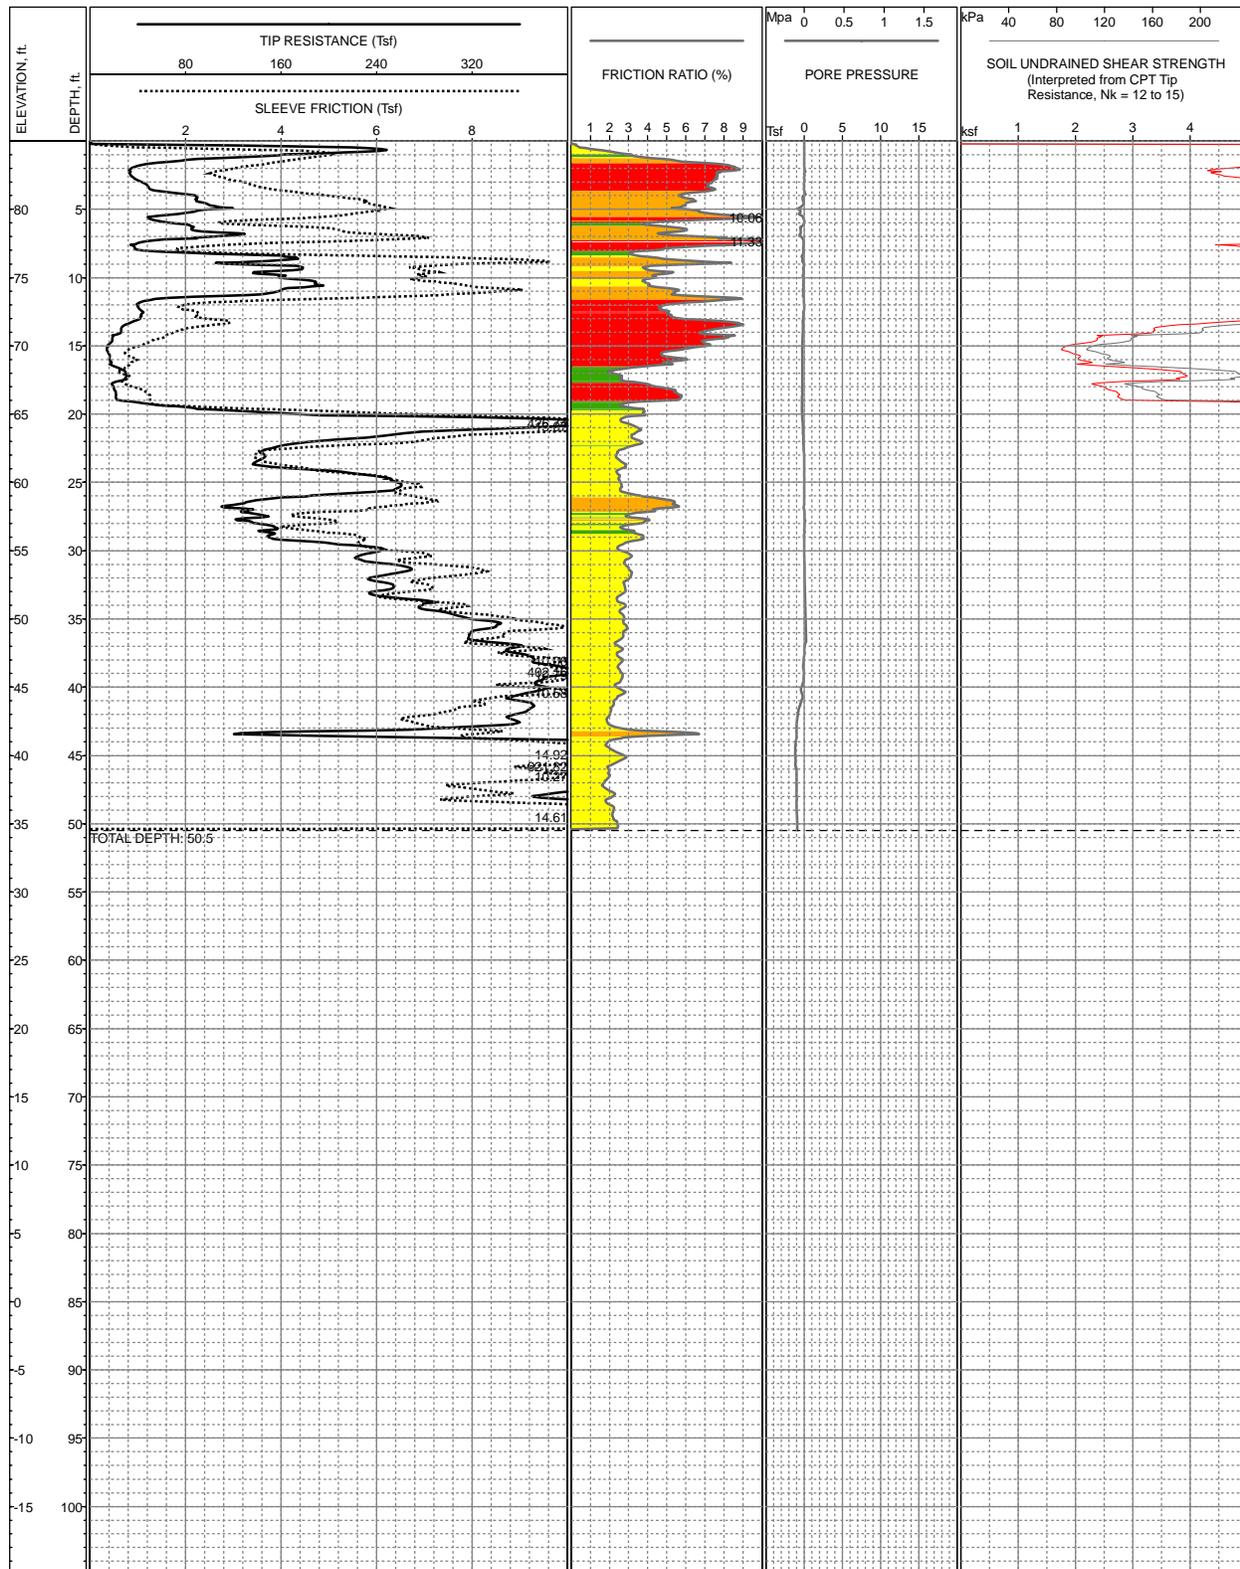
LOG OF C-3
Los Osos Wastewater Project
San Luis Obispo County, California

LOCATION: Southeast corner of Giacomazzi property.
SURFACE EL: 85ft +/- (MSL)
COMPLETION DEPTH: 50.5ft
TESTDATE: 5/8/2007

EXPLORATION METHOD: Cone Penetrometer
PERFORMED BY: Fugro Geosciences
REVIEWED BY: J Blanchard

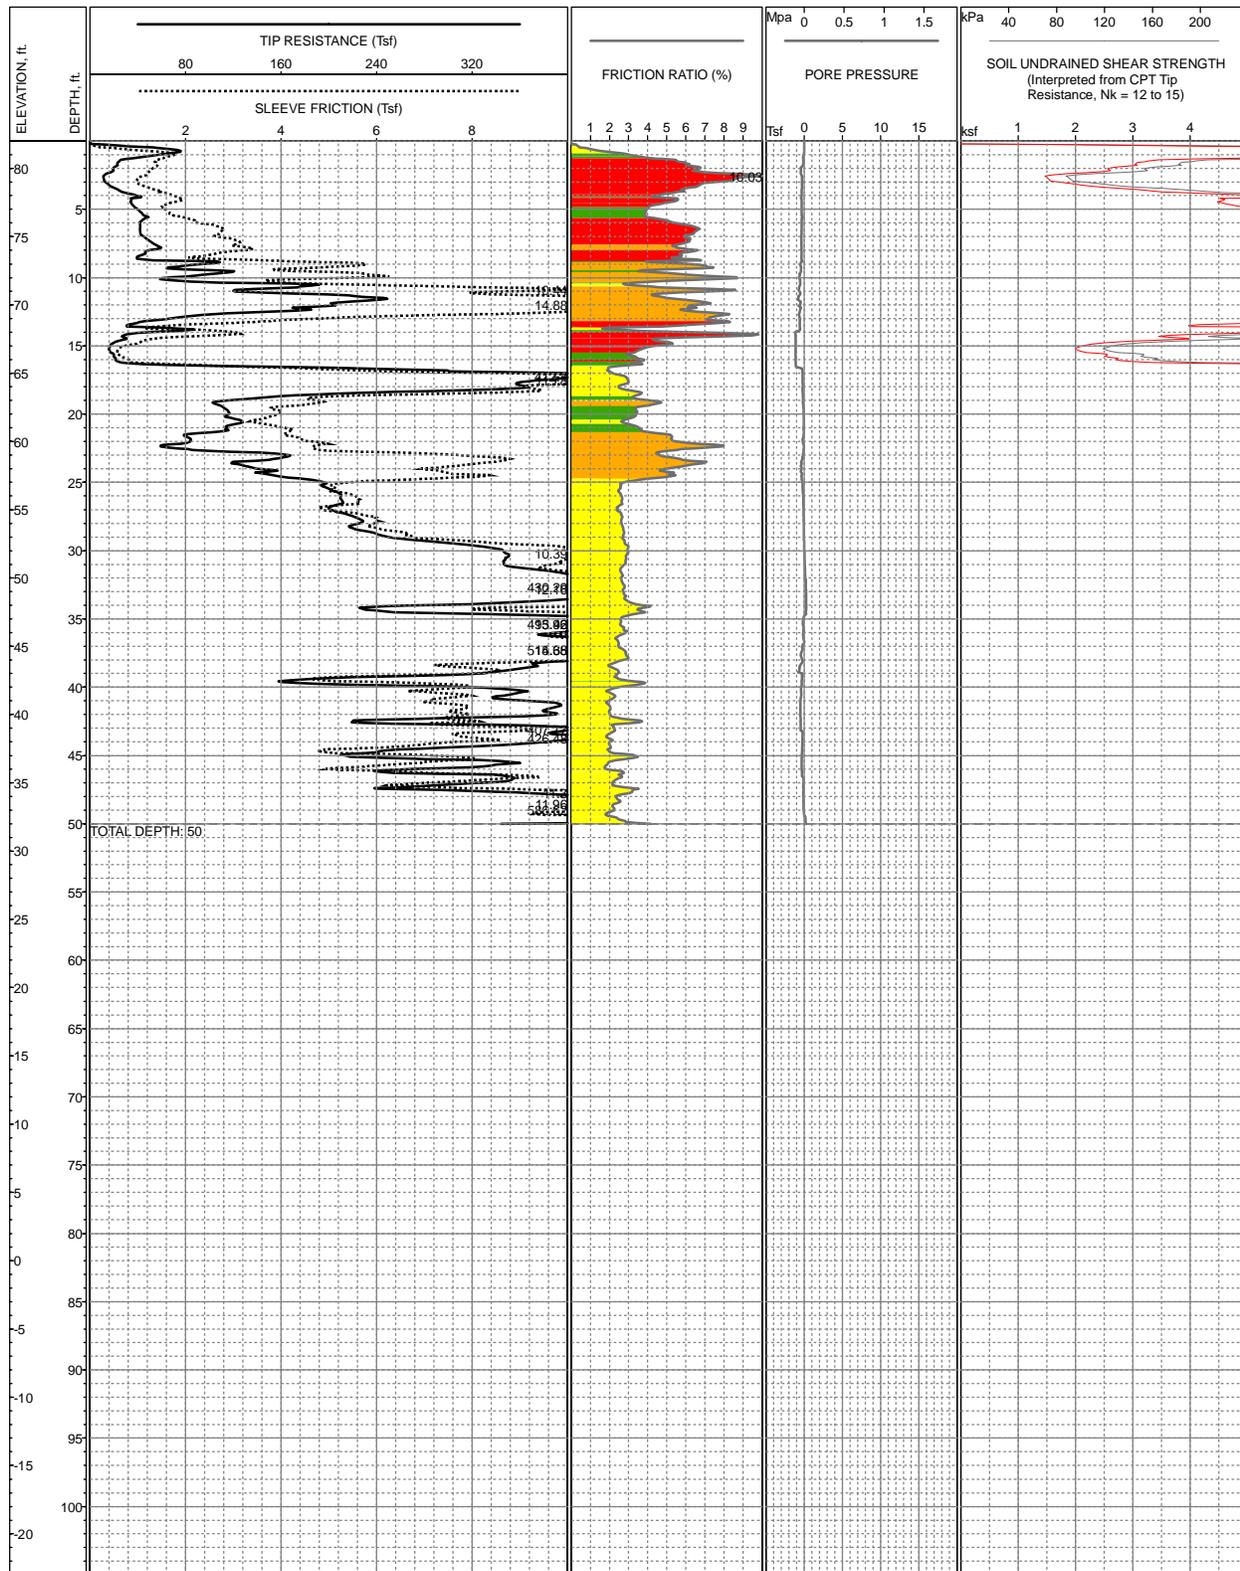
LOG OF C-4
 Los Osos Wastewater Project
 San Luis Obispo County, California

LOCATION: Southern access road of Giacomazzi property, 500 feet west of southeast corner.
 SURFACE EL: 82ft +/- (MSL)
 COMPLETION DEPTH: 50ft
 TESTDATE: 5/8/2007

EXPLORATION METHOD: Cone Penetrometer
 PERFORMED BY: Fugro Geosciences
 REVIEWED BY: J Blanchard
