**PRELIMINARY GEOTECHNICAL REPORT
LOS OSOS WASTEWATER PROJECT
LOS OSOS MORTUARY, GIACOMAZZI, AND BRANIN
PROPERTIES
SAN LUIS OBISPO COUNTY, CALIFORNIA**

Prepared for:
COUNTY OF SAN LUIS OBISPO

July 17, 2007

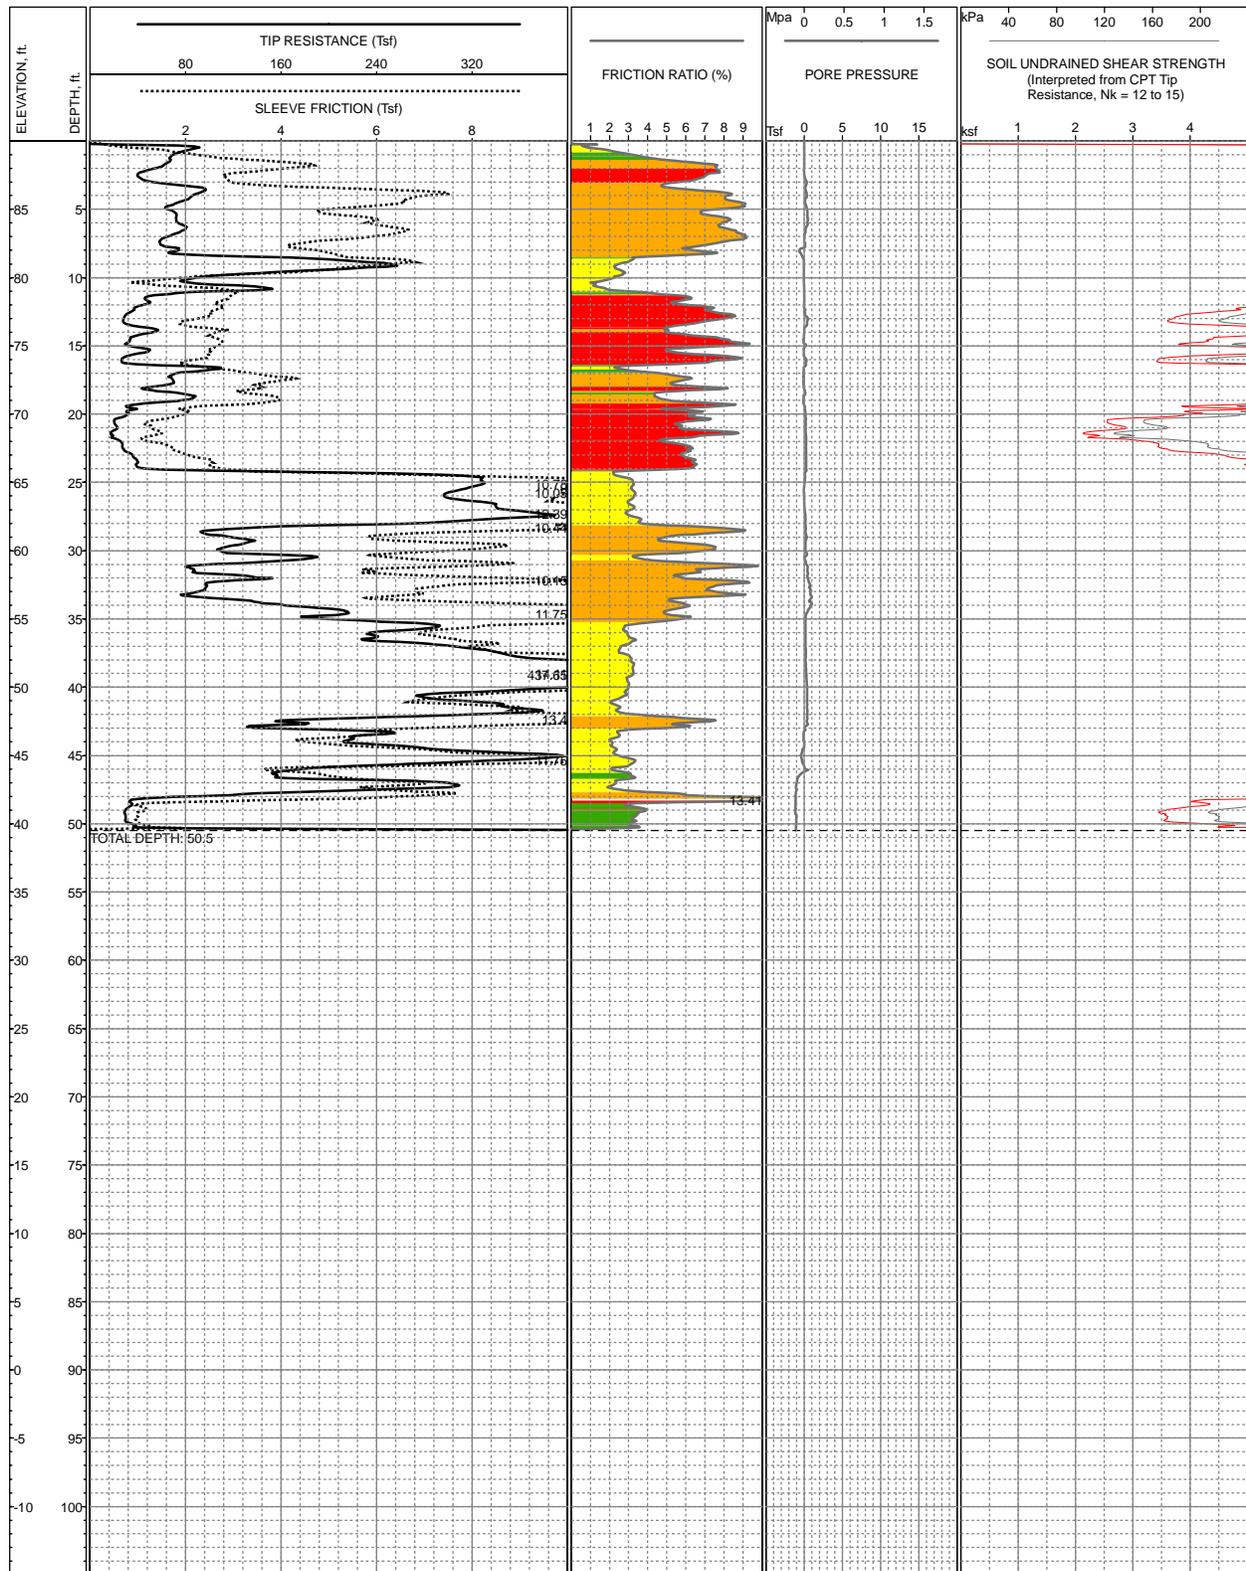
LOG OF C-5
 Los Osos Wastewater Project
 San Luis Obispo County, California

LOCATION: Southern access road of Giacomazzi property, 900 feet west of southeast corner.
 SURFACE EL: 90ft +/- (MSL)
 COMPLETION DEPTH: 50.5ft
 TESTDATE: 5/8/2007

EXPLORATION METHOD: Cone Penetrometer
 PERFORMED BY: Fugro Geosciences
 REVIEWED BY: J Blanchard

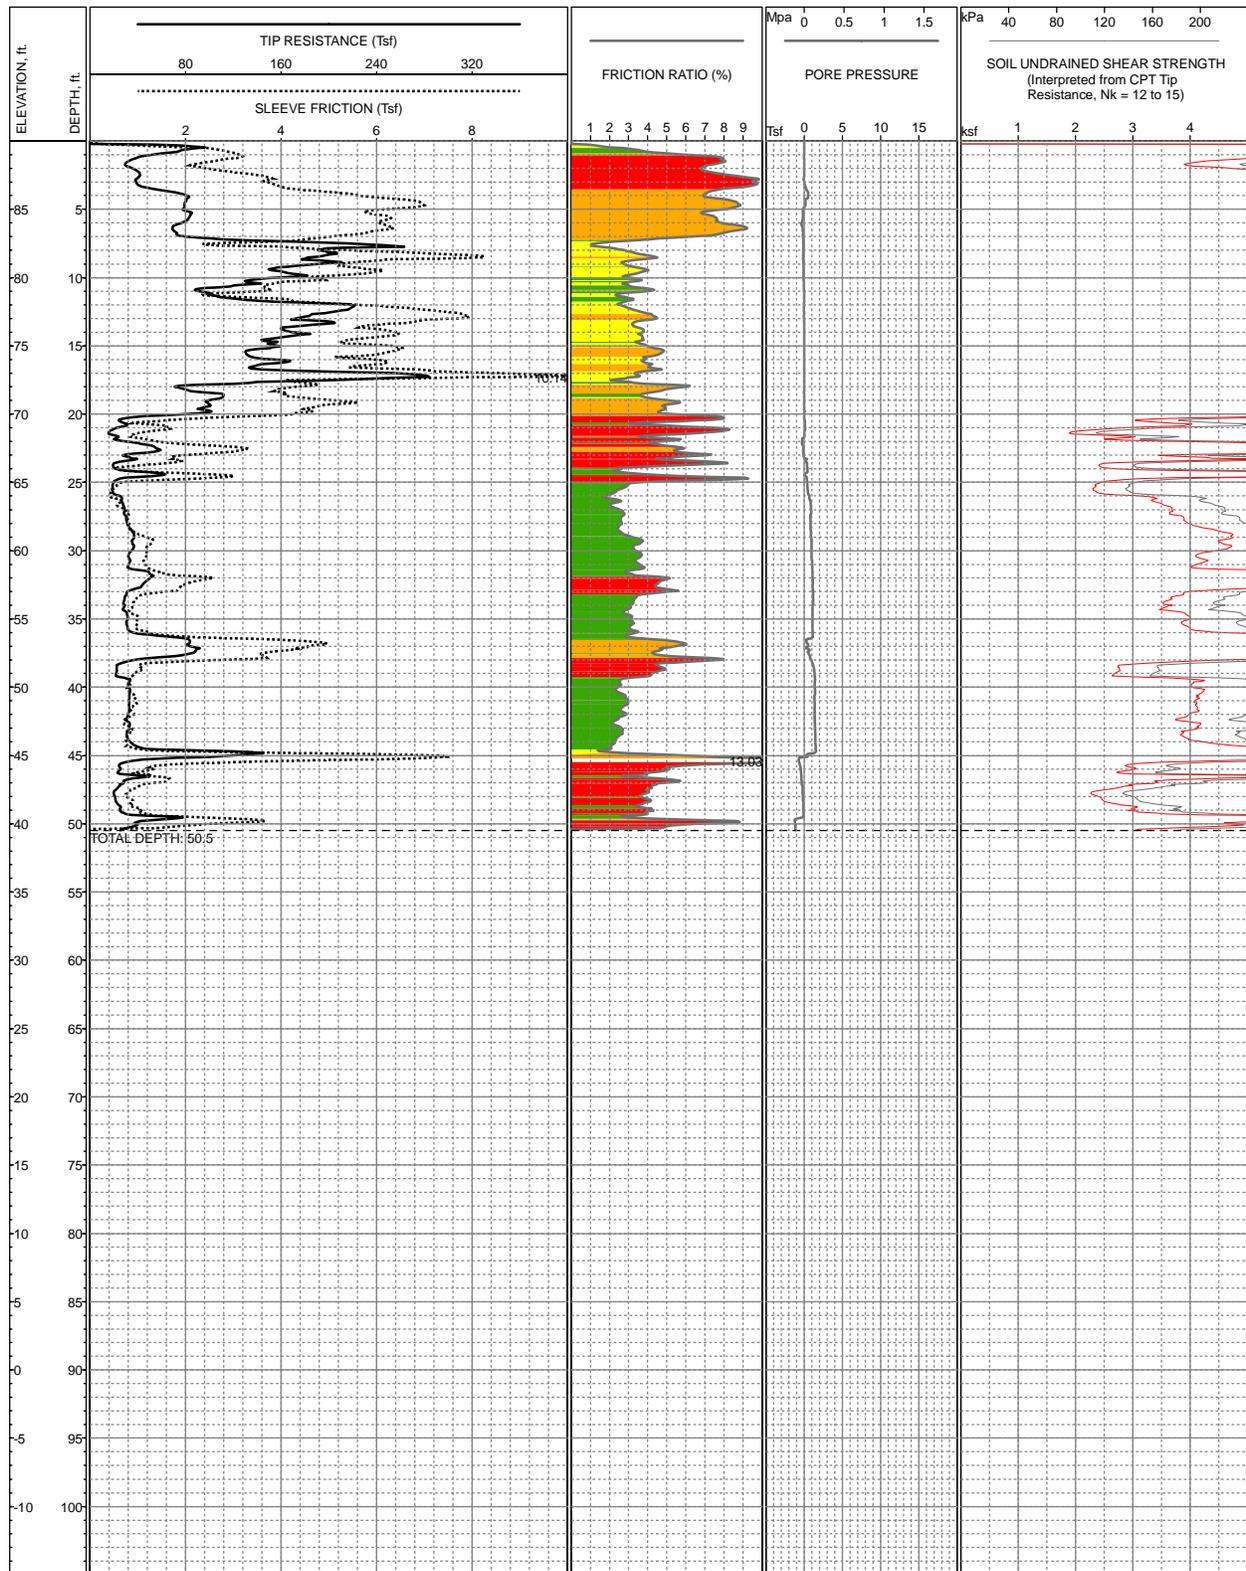
LOG OF C-6
Los Osos Wastewater Project
San Luis Obispo County, California

LOCATION: Southwest corner of Giacomazzi property.
SURFACE EL: 90ft +/- (MSL)
COMPLETION DEPTH: 50.5ft
TESTDATE: 5/8/2007

EXPLORATION METHOD: Cone Penetrometer
PERFORMED BY: Fugro Geosciences
REVIEWED BY: J Blanchard

Typical 1 to 2 story and moderately loaded structures can likely be supported on shallow foundations bearing in compacted fill. Relatively large or heavy structures located along the western edge of the site will need to consider total and differential settlement of the underlying fine grained materials (See CPT C-6 and C-7).

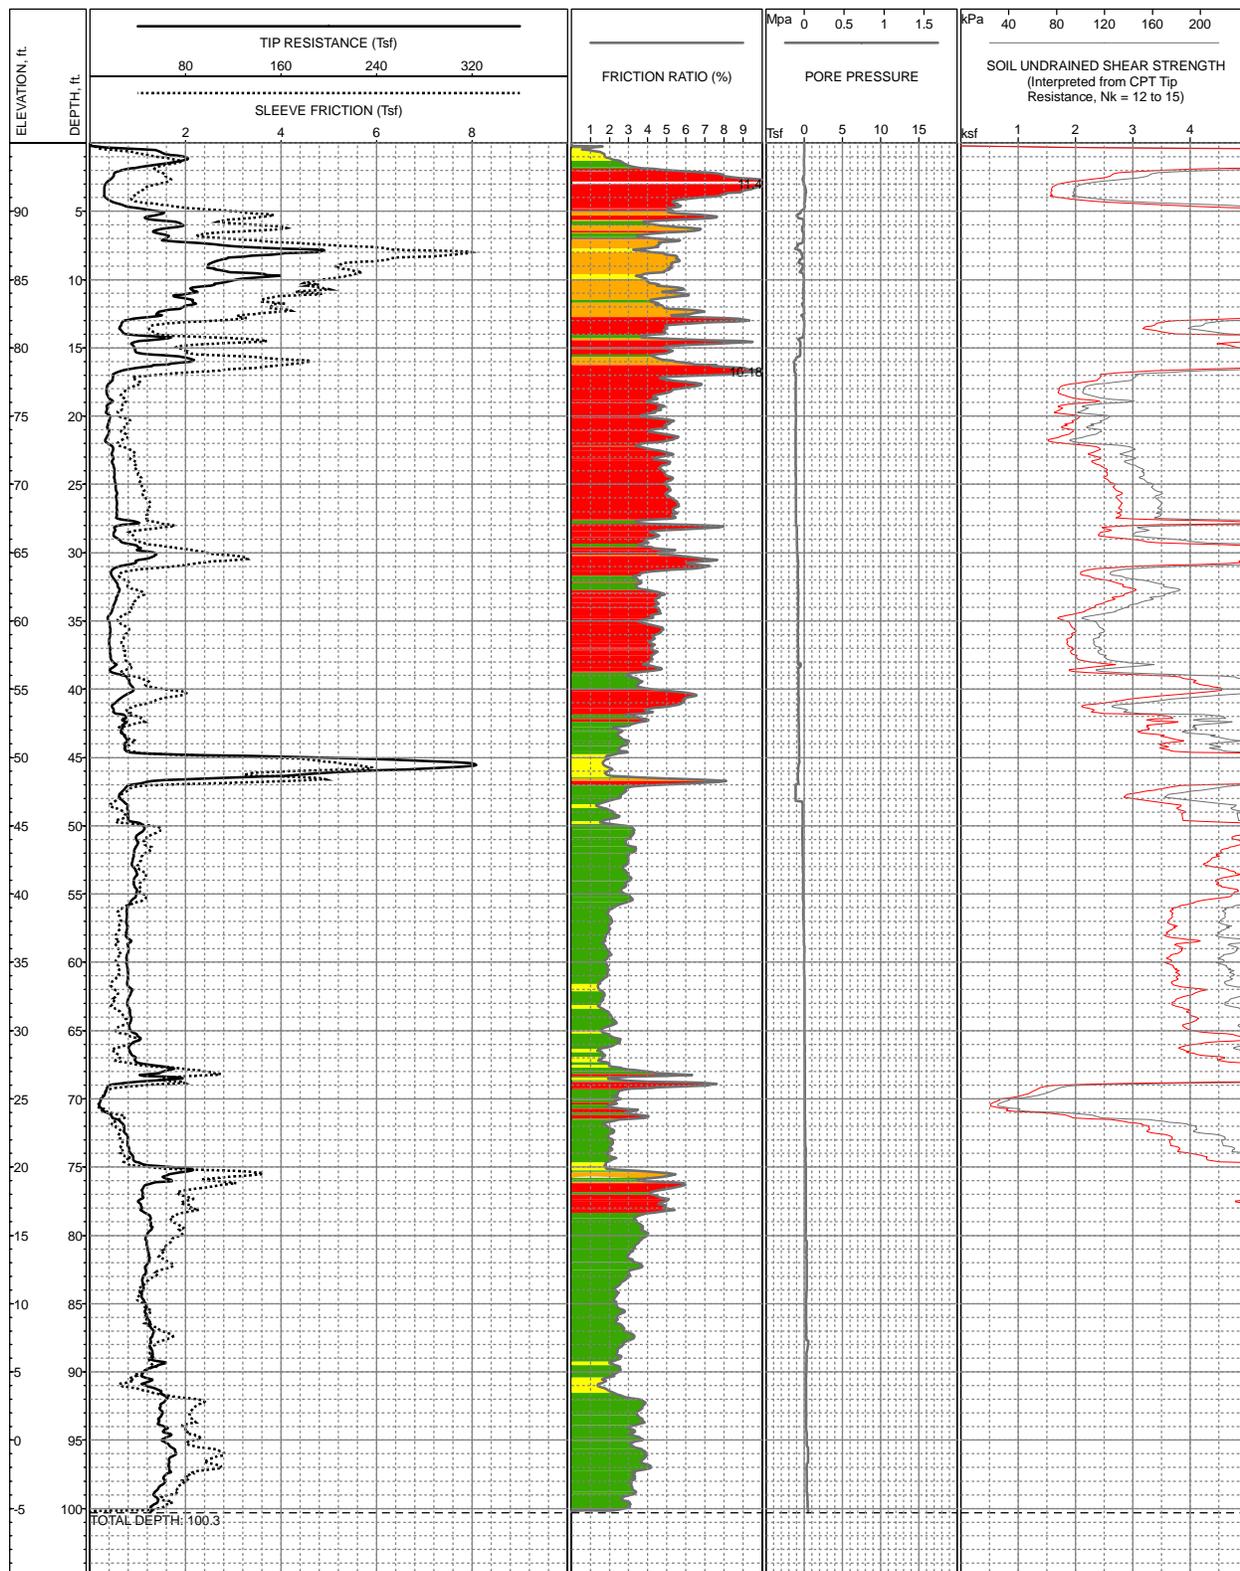
LOCATION: Eastern edge of Giacomazzi property, adjacent to existing garage.
SURFACE EL: 95ft +/- (MSL)
COMPLETION DEPTH: 100.3ft
TESTDATE: 5/8/2007

EXPLORATION METHOD: Cone Penetrometer
PERFORMED BY: Fugro Geosciences
REVIEWED BY: J Blanchard
