V. ENVIRONMENTAL IMPACTS AND MITIGATION MEASURES

A. GEOLOGY AND SOILS

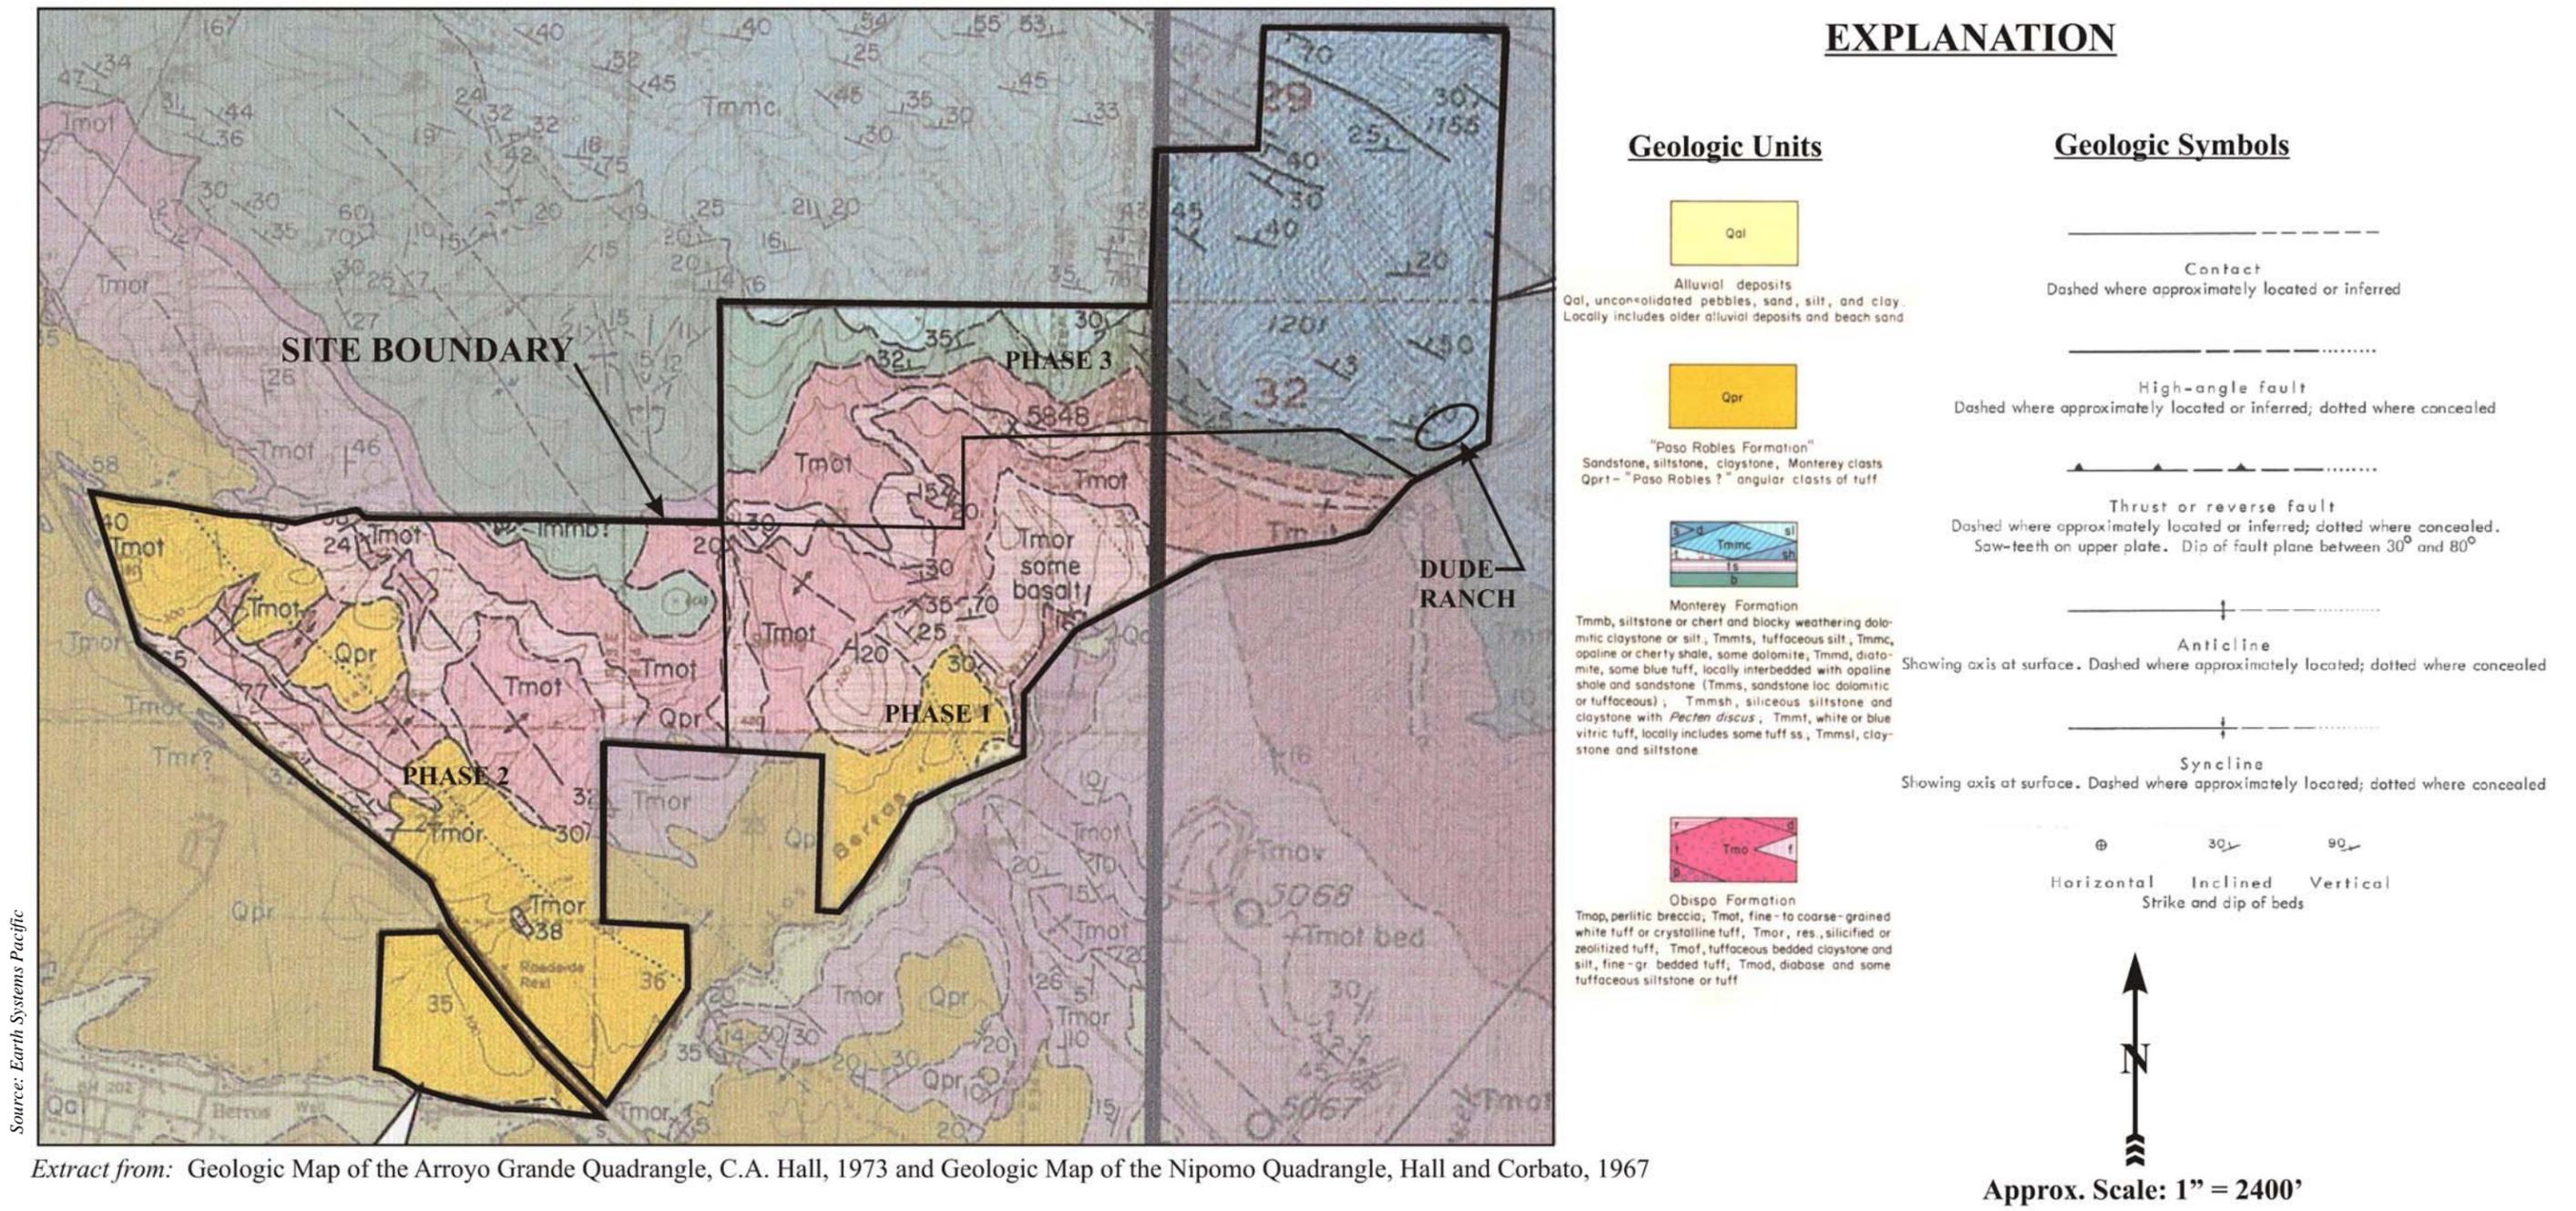
Extract from: Geologic Map of the Arroyo Grande Quadrangle, C.A. Hall, 1973 and Geologic Map of the Nipomo Quadrangle, Hall and Corbato, 1967

The majority of the Phase Two area is underlain by claystone (Tmot), a tuffaceous member of the Obispo formation. This unit is described as very soft to moderately hard, poorly to well-indurated, and generally moderately weathered where exposed. It varies from slightly fractured to intensely fractured. The area is also underlain by the second Obispo formation subunit (Tmor) a zeolitized, very resistant and hard tuff. This unit is described as very hard to moderately hard, moderately to very well-indurated, and generally slightly to moderately weathered where exposed. It is slightly fractured to intensely fractured.

Rock of the Monterey formation forms the upslope areas of the northernmost area of Phase Two. This unit (Tmmb) is a silty shale consisting of bedded, blocky claystone and siltstone that is intensely to very intensely fractured.

Phase Three is underlain by claystone (Tmot), a tuffaceous member of the Obispo formation. This unit is described as very soft to moderately hard, poorly to well-indurated, and generally moderately weathered where exposed. It varies from slightly fractured to intensely fractured. The area is also underlain by the second Obispo formation subunit (Tmor) a zeolitized, very resistant and hard tuff. This unit is described as very hard to moderately hard, moderately to very well-indurated, and generally slightly to moderately weathered where exposed. It is slightly fractured to intensely fractured.

Rock of the Monterey formation forms the upslope areas and the tops of the ridges along the northern and eastern boundaries of Phase Three. This unit is geologically younger than the Obispo formation. It is divided into two sub-units at the site, a silty shale (Tmmb) and a cherty shale (Tmmc). The silty shale consists of bedded, blocky claystone and siltstone that is intensely to very intensely fractured. The cherty shale is dense, brittle, and bedded, and also intensely to very intensely fractured.

The site of the proposed Dude Ranch is underlain by rock of the Monterey formation. This unit is divided into two sub-units at the site, a silty shale (Tmmb) and a cherty shale (Tmmc). The silty shale consists of bedded, blocky claystone and siltstone that is intensely to very intensely fractured. The cherty shale is dense, brittle, and bedded, and also intensely to very intensely fractured.
