REPORT

GEOTECHNICAL INVESTIGATION AND DESIGN RECOMMENDATIONS

Santa Margarita Quarry

Project No. 073-97199

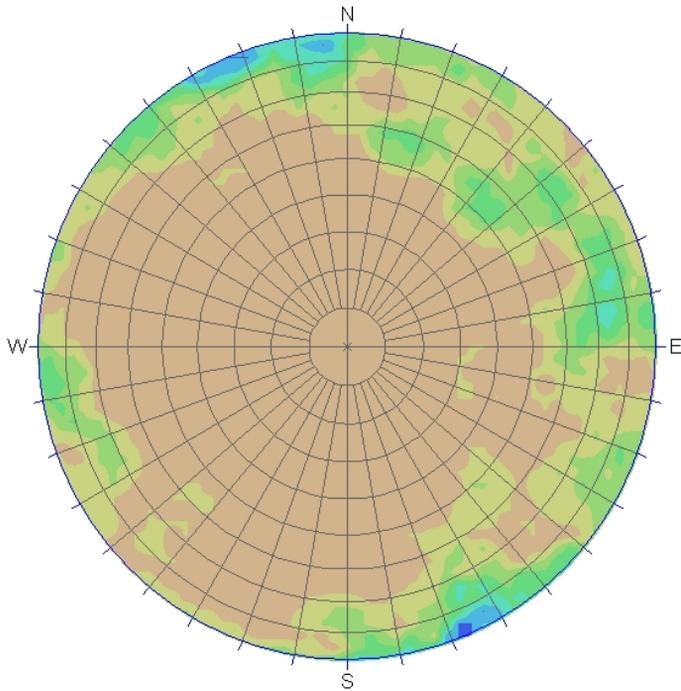
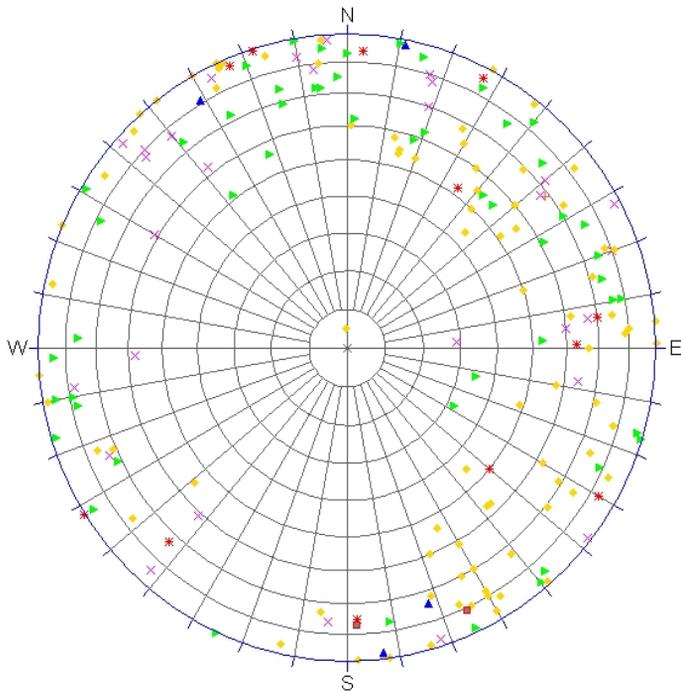
DRAWN	RK	DATE	3/28/08	JOB NO.	073-97199
CHECKED	GM	SCALE	NA	DWG. NO. / REV. NO.	
REVIEWED	GM	FILE NO.			FIGURE 4

Equal Area
Lower Hemisphere
183 Poles
183 Entries

ALL STRUCTURES MAPPED

The structural orientation data collected during mapping was plotted on stereonet using an equal-area, lower hemisphere projection, and contoured with the Schmidt method. Figure 4 is a compilation of all of the structural data, and shows that structures are generally moderately to steeply dipping. Faults, shears, and dikes (Figure 5) generally show the same structural orientations as joints (Figure 6); a concentration of poles striking east-northeast and dipping steeply, a smaller concentration of poles striking north-south and dipping steeply, and moderately to steeply southwest-dipping structures with variable strike. Plots of data collected from the upper benches (Figure 7), the pit bottom (Figure 8), and the exploration roadcut (Figure 9) show that the steep east-northeast-striking trend is present in all three areas. Steep north-south-striking structure is present in the upper benches and the roadcut, but is not well-developed in the pit bottom. Moderately to steeply southwest-dipping structures are present in all areas as well, but are more prominent in the pit bottom. Structural trends from the mapping data are summarized in Table 5 below.

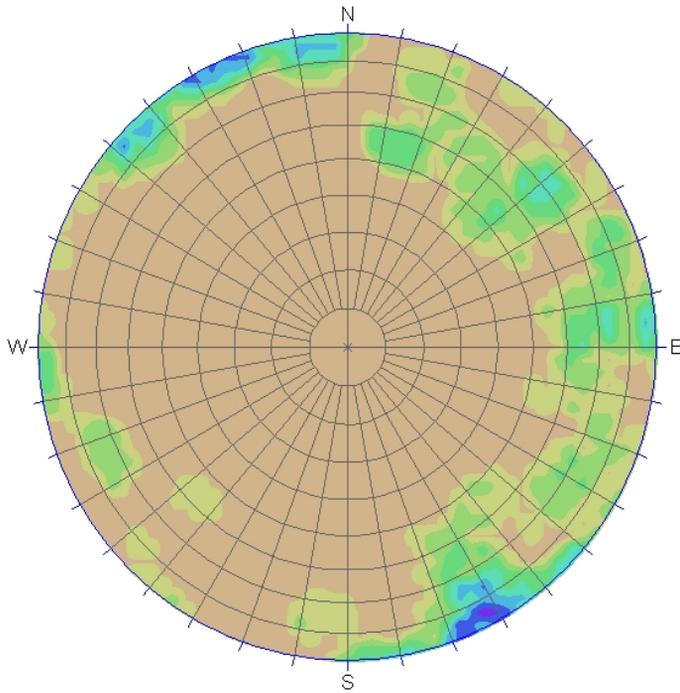
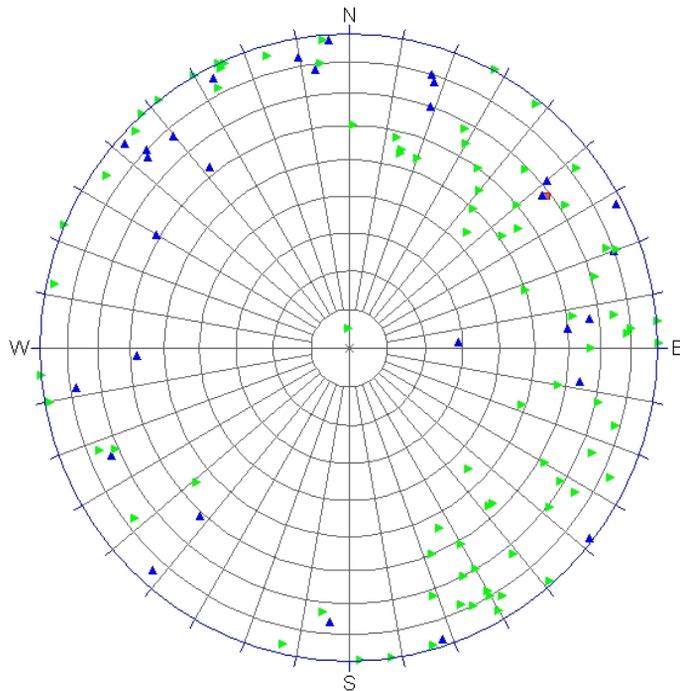
DRAWN	RK	DATE	3/28/08	JOB NO.	073-97199
CHECKED	GM	SCALE	NA	DWG. NO. / REV. NO.	
REVIEWED	GM	FILE NO.		FIGURE 6

Equal Area
Lower Hemisphere
113 Poles
113 Entries

ALL JOINTS MAPPED

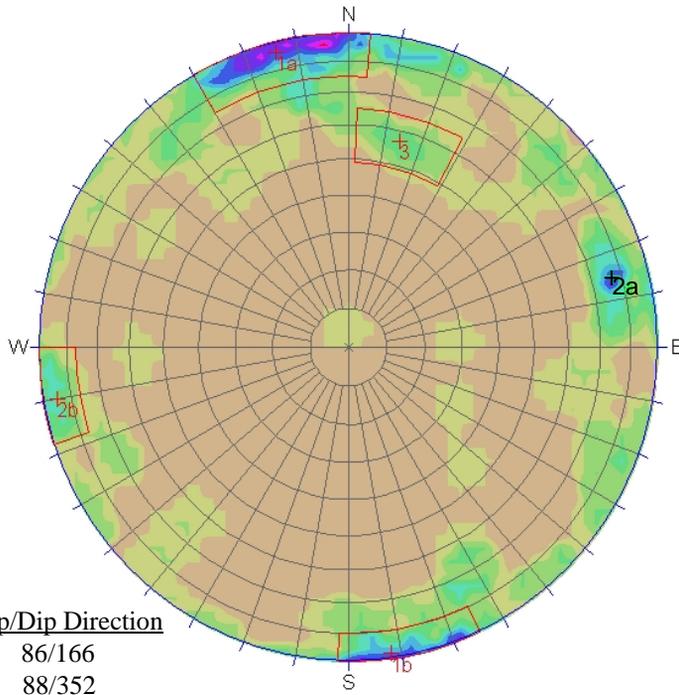
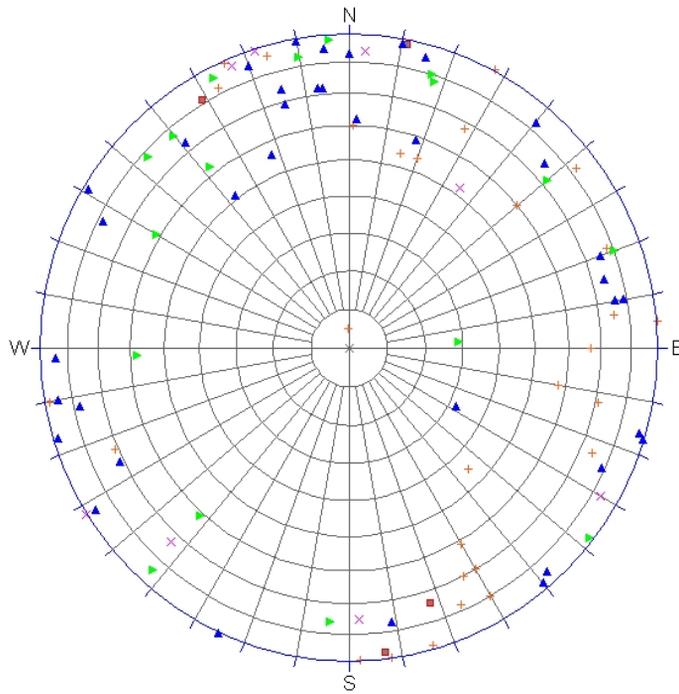
DRAWN	RK	DATE	3/28/08	JOB NO.	073-97199
CHECKED	GM	SCALE	NA	DWG. NO. / REV. NO.	
REVIEWED	GM	FILE NO.			FIGURE 7

Set Dip/Dip Direction

1a	86/166
1b	88/352
2a	77/255
2b	85/080
3	57/194

**ALL STRUCTURES MAPPED
ON UPPER BENCHES**

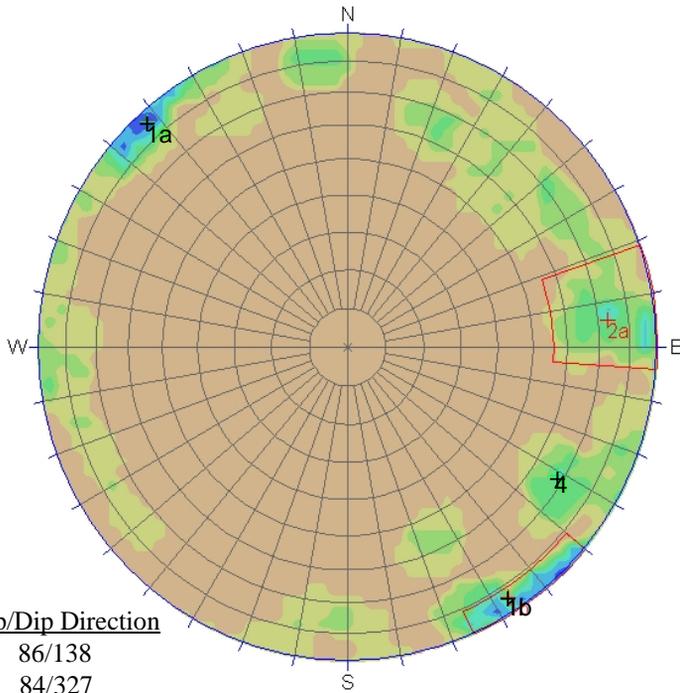
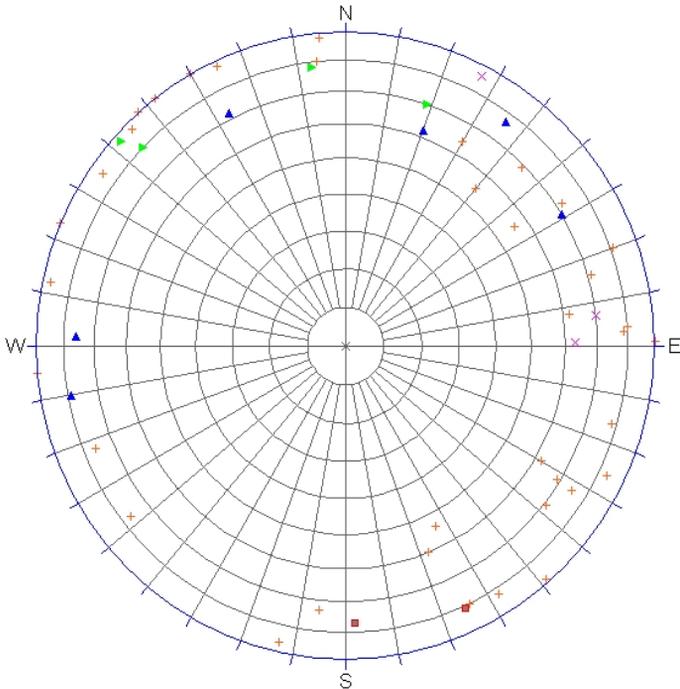
DRAWN	RK	DATE	3/28/08	JOB NO.	073-97199
CHECKED	GM	SCALE	NA	DWG. NO. / REV. NO.	
REVIEWED	GM	FILE NO.		FIGURE 9

Set	Dip/Dip Direction
1a	86/138
1b	84/327
2a	73/264
4	68/301

**ALL STRUCTURES MAPPED
IN EXPLORATION ROADCUT**

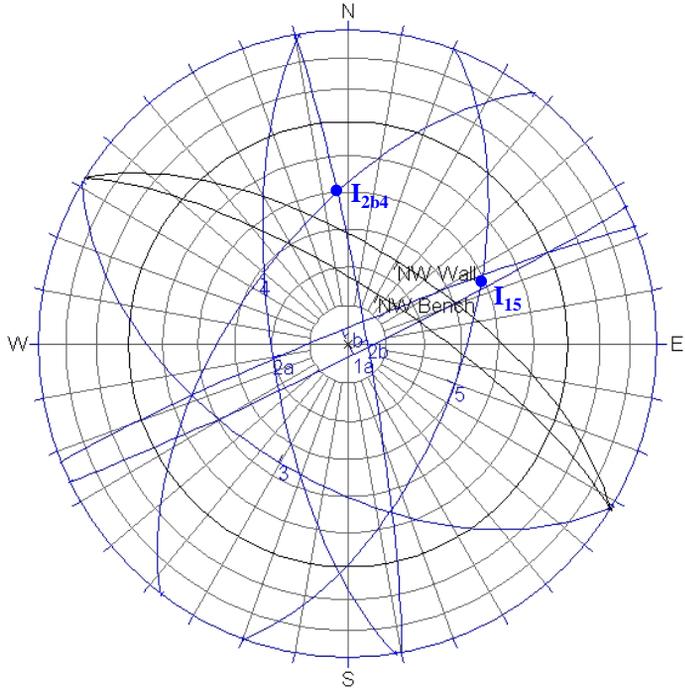
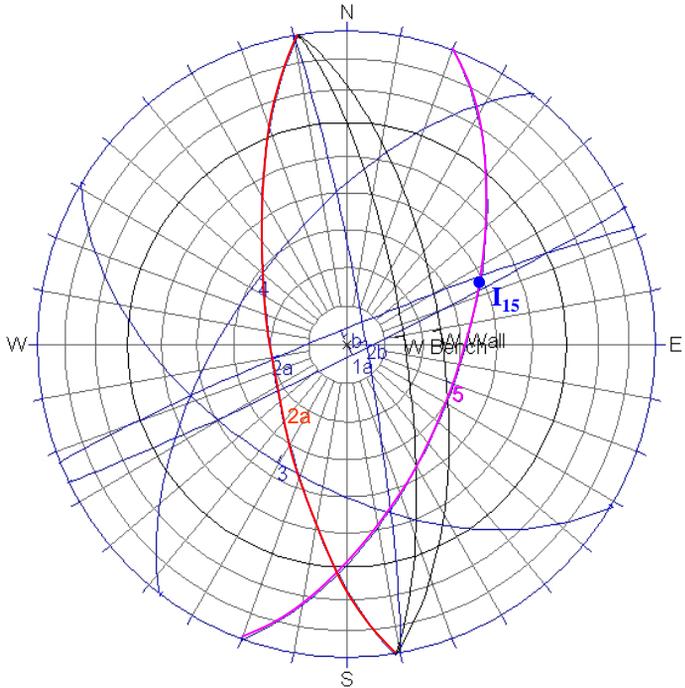
FIGURE 11

NORTHWEST
SECTOR

WEST
SECTOR

The general dip direction of the northwest wall is 032° (Figure 11). Toppling may occur in this slope if closely-spaced structures parallel to the Rinconada splay are present, although no systematic shallow structures to act as base planes are indicated by the mapping data. Wedges may form along the intersection of Sets 1 and 5, with wedge intersections oriented 065°/50° (trend/plunge). Sets 2b and 4 also form potential wedges, with intersections oriented 356°/50°.

The dip direction of the walls in the West sector is 081° (Figure 11). Localized planar failures are possible along Set 5, which has an average dip direction about 30° from that of the slope. These are not expected to be extensive because the difference in dip direction between the slope and Set 5 is greater than 20°, and so the lateral extent of any such failures would be limited. Toppling may occur along steeper than average structures in Set 2a, a prominent set in the current pit, although these failures are not expected to be widespread due to the apparent lack of shallow structures to act as base planes. As in the northwest wall, the intersection of Sets 1 and 5 may form wedges with intersections oriented 065°/50° (trend/plunge).

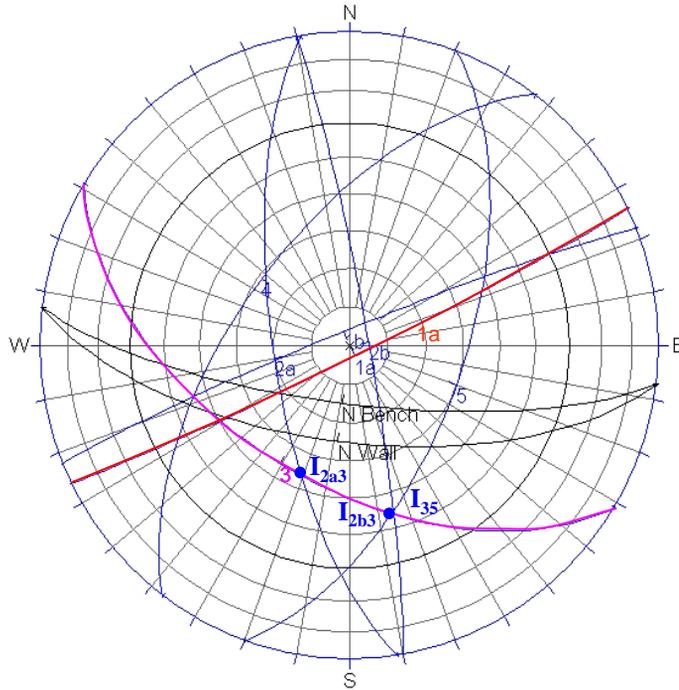
FIGURE 12

NORTH
SECTOR

The general dip direction of the north wall is 187° (Figure 12). The dip direction of Set 3 is 24° from that of the north wall, and undercutting this set could cause planar failures if the set is well-developed in this area. Set 3 is present in all areas that were mapped, and is particularly strong in the north end of the current pit. This set presents a risk of bench-scale and multi-bench failures unless it is considered in the slope design for this sector. Recommended design slope angles are flattened to mitigate this potential (Section 5.2.3.3).

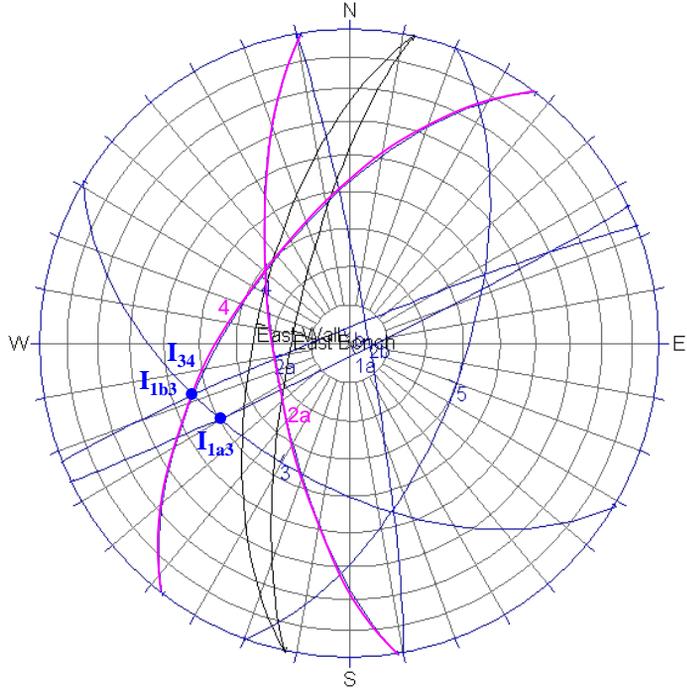
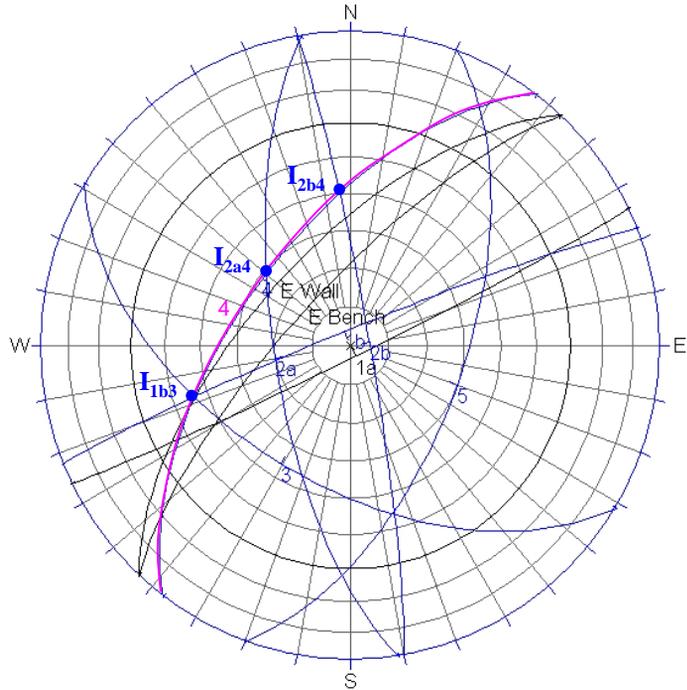
FIGURE 13

NORTHEAST
SECTOR

EAST
SECTOR

Figure 13 Design Stereonets, Northeast and East Sectors

In the Northeast sector, the average dip direction of the slopes is 282° (Figure 13). The average dip direction of Set 2a is 21° from the average dip direction of the wall in this sector. Set 2a is prominent in this area, as evidenced by bench-scale planar failures along it in the current east wall, and therefore presents a potential risk for planar failures in this sector. Recommended design slope angles are flattened to mitigate this potential (Section 5.2.3.3).

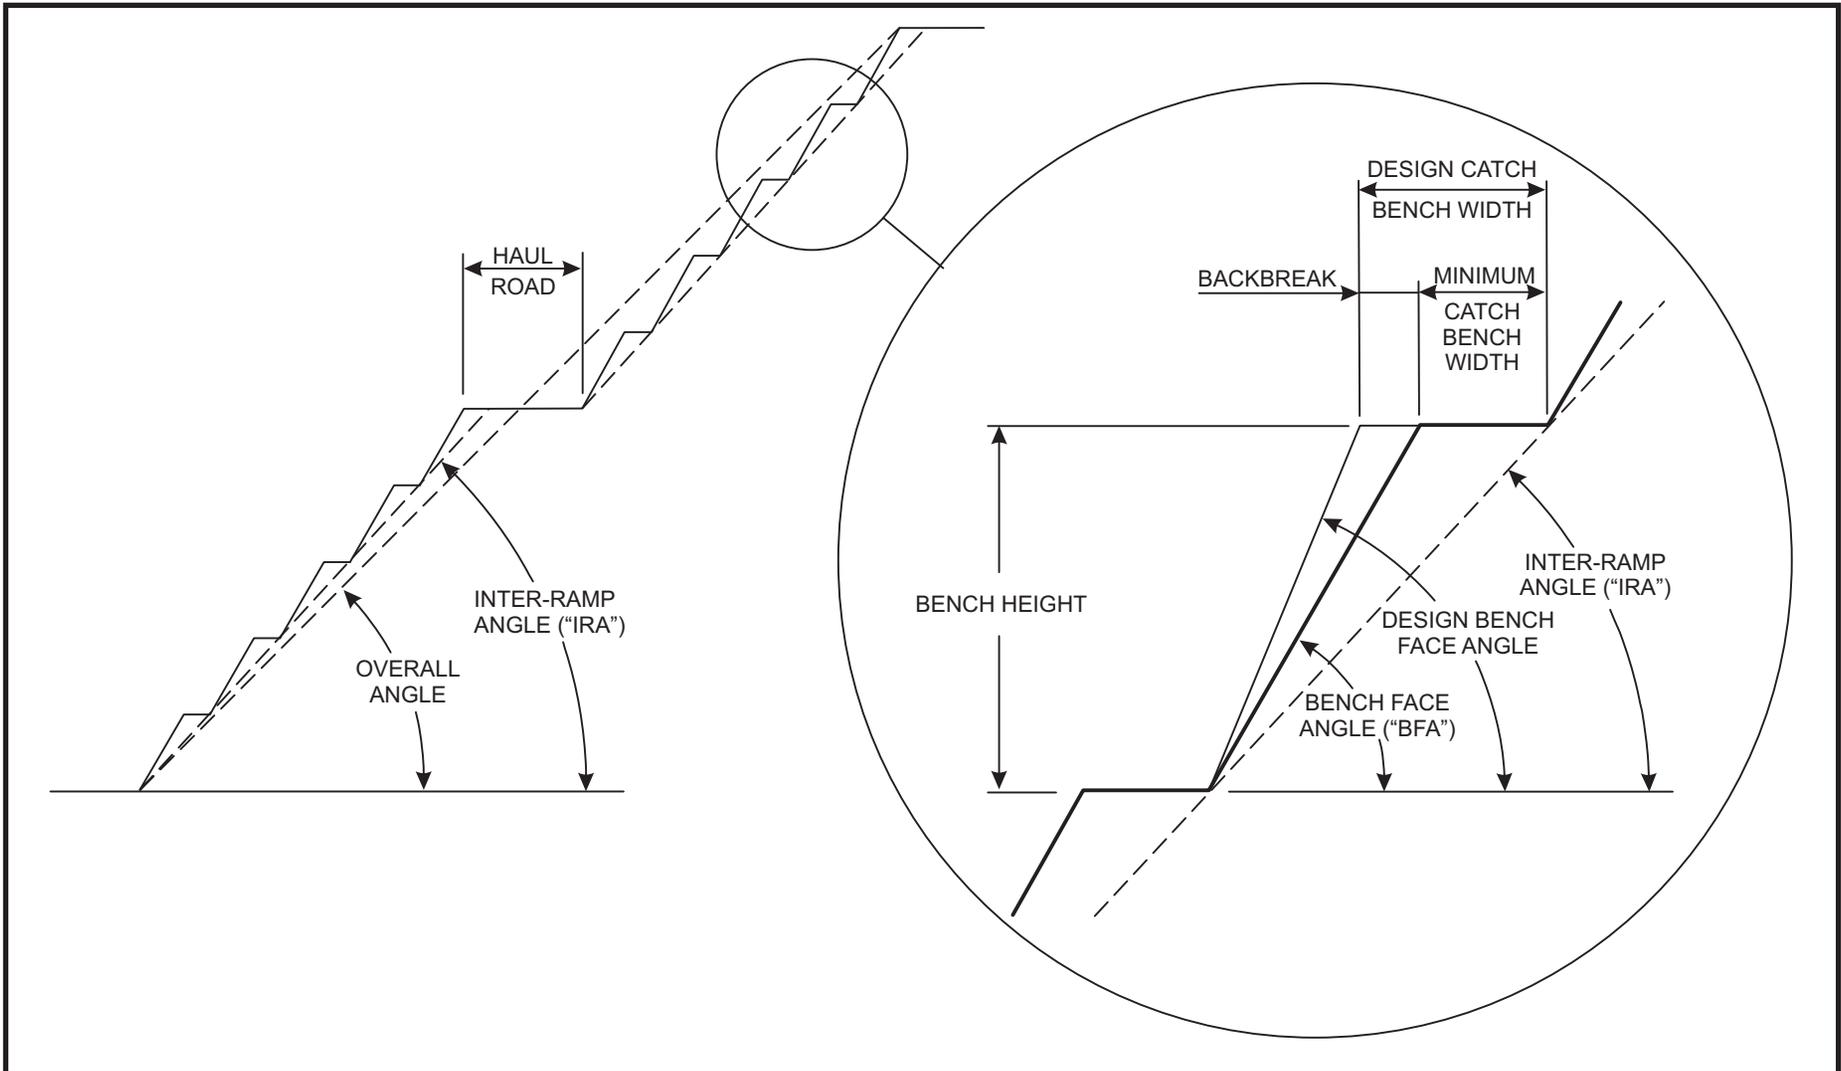
FIGURE 14

Figure 14 Bench and Inter-Ramp Slope Configuration

Since there appears to be little potential for rock mass or structural control of overall or inter-ramp slope angles, achievable pit slope angles will be determined by the bench configurations that can be safely developed and maintained. Bench configurations are defined by production bench height, achievable bench face angle (BFA), and catch bench width, all of which combine to define the inter-ramp angle (IRA) as shown in Figure 14. Our recommended bench configurations are given in terms of these parameters, but include the following assumptions:

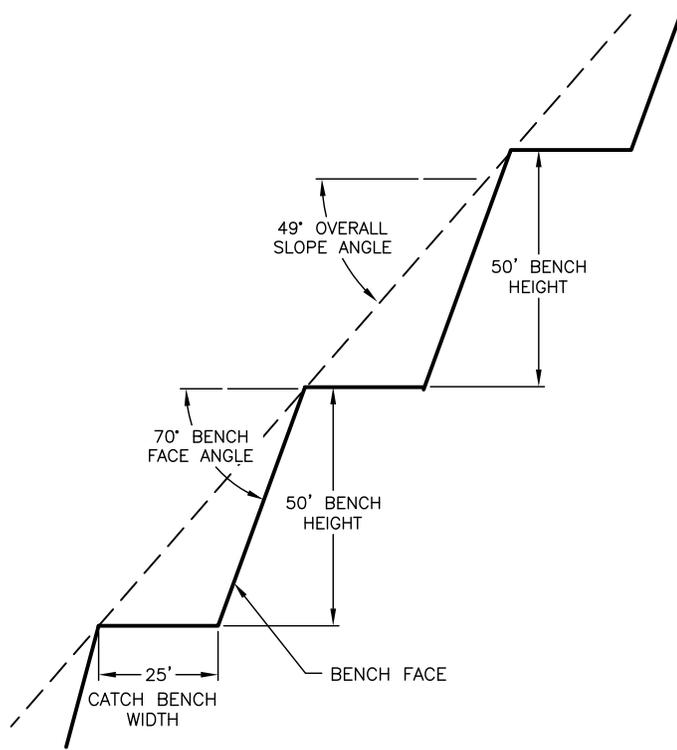
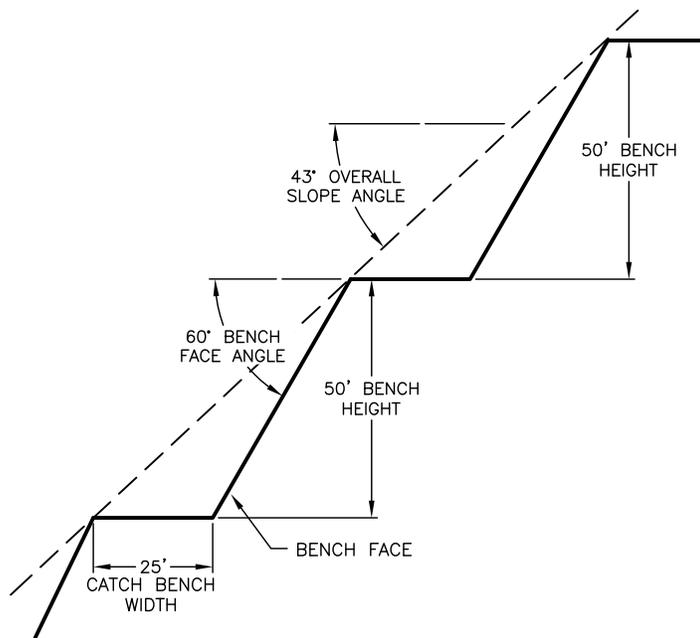
FIGURE 15

WEST AND NORTHWEST SECTORS, WEATHERED AND FRESH ROCK

NORTH, NORTHEAST AND EAST SECTORS WEATHERED AND FRESH ROCK

Fresh Granite should be excavated in a single bench configuration with design 25-ft catch benches at 50-ft vertical intervals. Design bench face angles of 70° appear feasible provided an effective pre-split is implemented at the pit limit, and will result in an inter-ramp slope angle of 49° (Figure 15). Based on the bedrock design in the Northwest and West walls, an effective pre-split blast will be required to develop clean bench faces. Inter-ramp slope angles on the order of 5° lower can be expected without the use of an effective pre-split.

Fresh granite should be single-benched, with 25-ft catch benches at 50-ft vertical intervals, for an inter-ramp slope angle of 43°, as illustrated in Figure 15. It should be possible to develop these moderate bench face angles without pre-split blasting, but effective cushion blasting should be implemented to limit blast damage and back-break.

The recommended design slope configurations illustrated in Figure 15 and summarized below (Table 11) should be safely achievable if an effective pre-split is implemented in the fresh rock in the Northwest and West sectors. Effective cushion blasting should be adequate for the design bench configurations in weathered rock and for the flatter design bench face angles in fresh rock in the North, Northeast, and East sectors. Bench-scale failures may still occur where structural conditions are locally unfavorable.

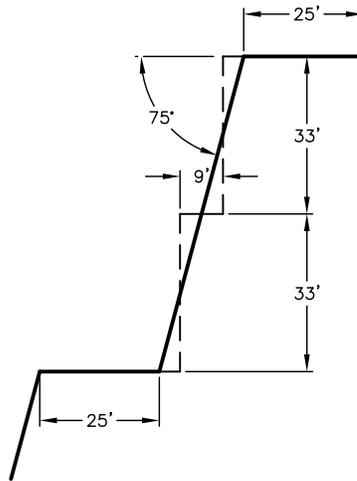
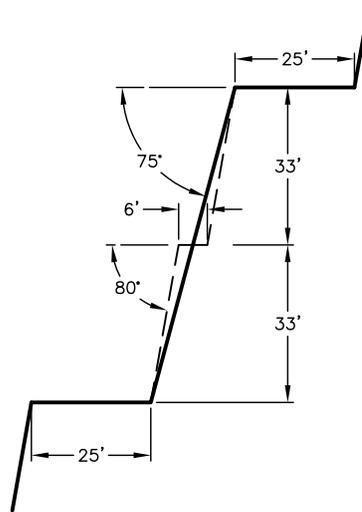
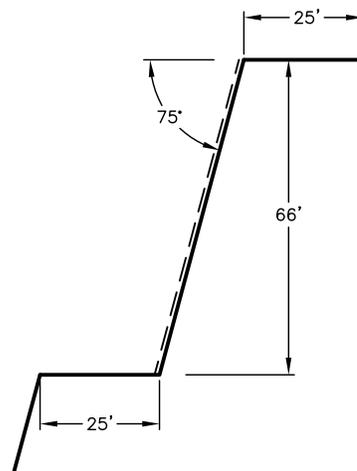
FIGURE 16

VERTICAL PRE-SPLIT DRILLED SINGLE BENCH HEIGHT

DRILL VERTICAL PRE-SPLIT ON APPROXIMATE CENTER OF DESIGN BENCH FACE WITH MINIMUM SAFE STANDOFF DISTANCE (NOMINAL 9 FT) BETWEEN LIFTS.

INCLINED PRESPLIT DRILLED SINGLE BENCH HEIGHT

DRILL PRE-SPLIT AT 80° INCLINATION WITH MINIMUM SAFE STANDOFF DISTANCE (NOMINAL 6 FT) BETWEEN LIFTS

INCLINED PRE-SPLIT DRILLED DOUBLE BENCH HEIGHT

DRILL PRE-SPLIT AT 75° INCLINATION ALONG DESIGN BENCH FACE

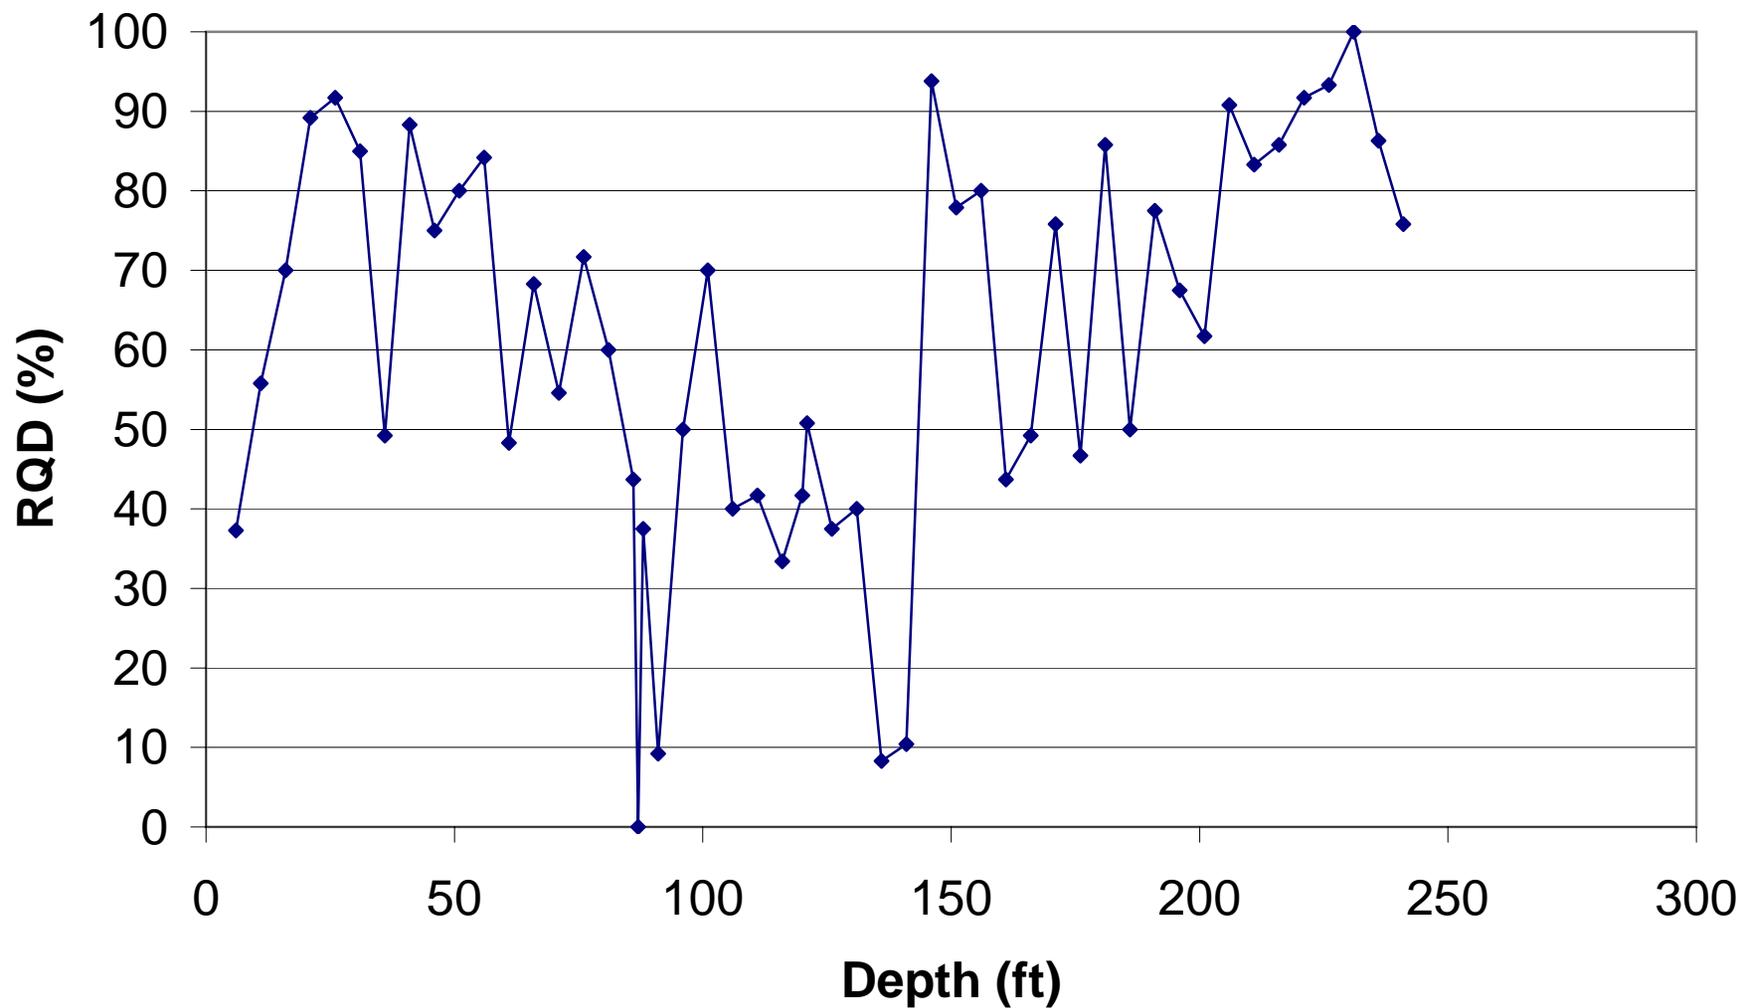
RQD vs. Depth, SM06-1

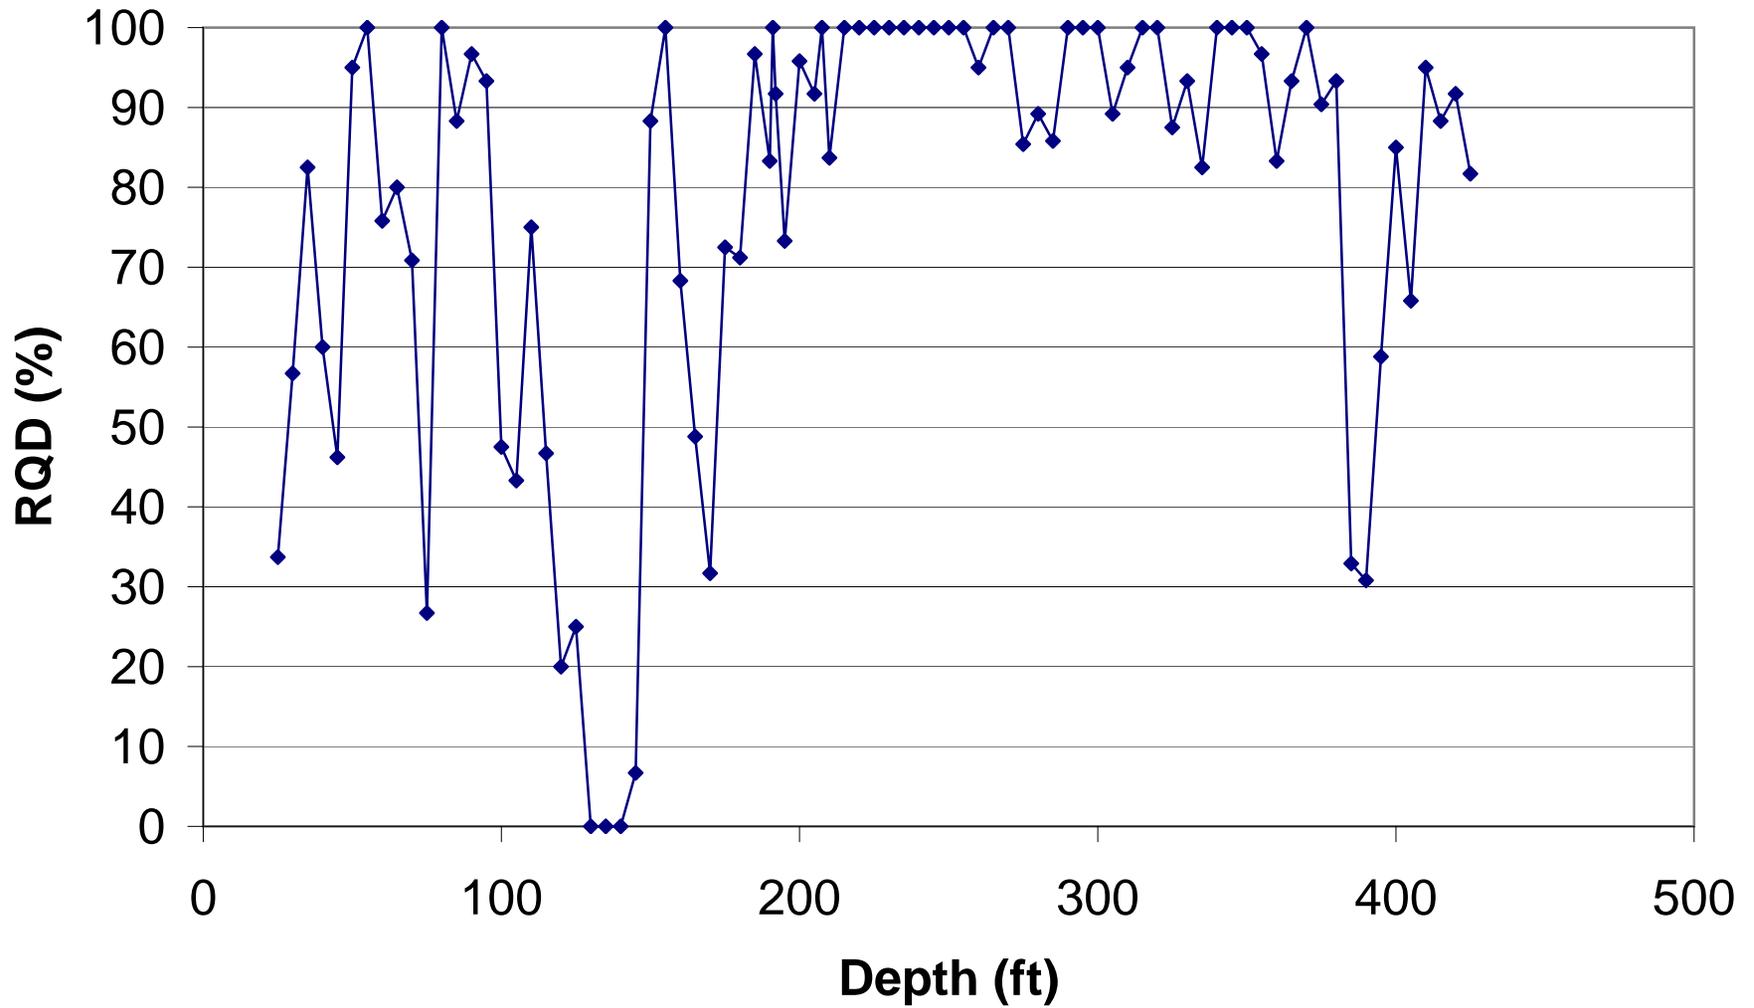
RQD vs. Depth, SM06-2

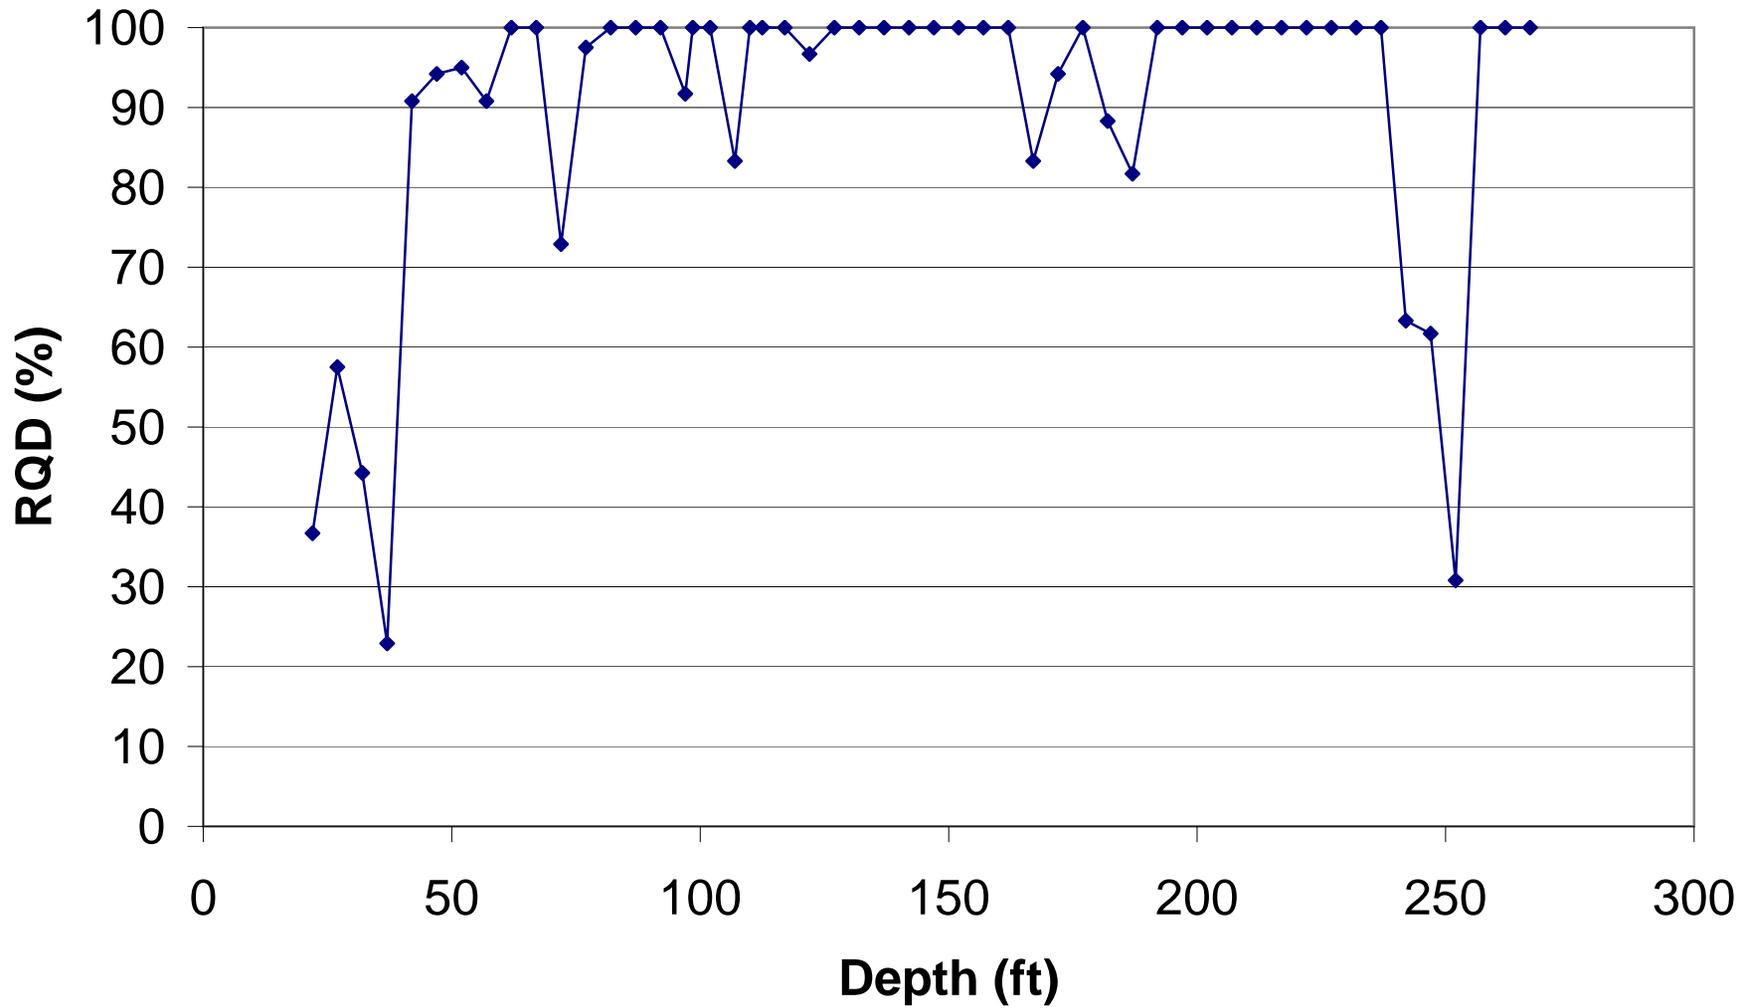
RQD vs. Depth, SM06-3

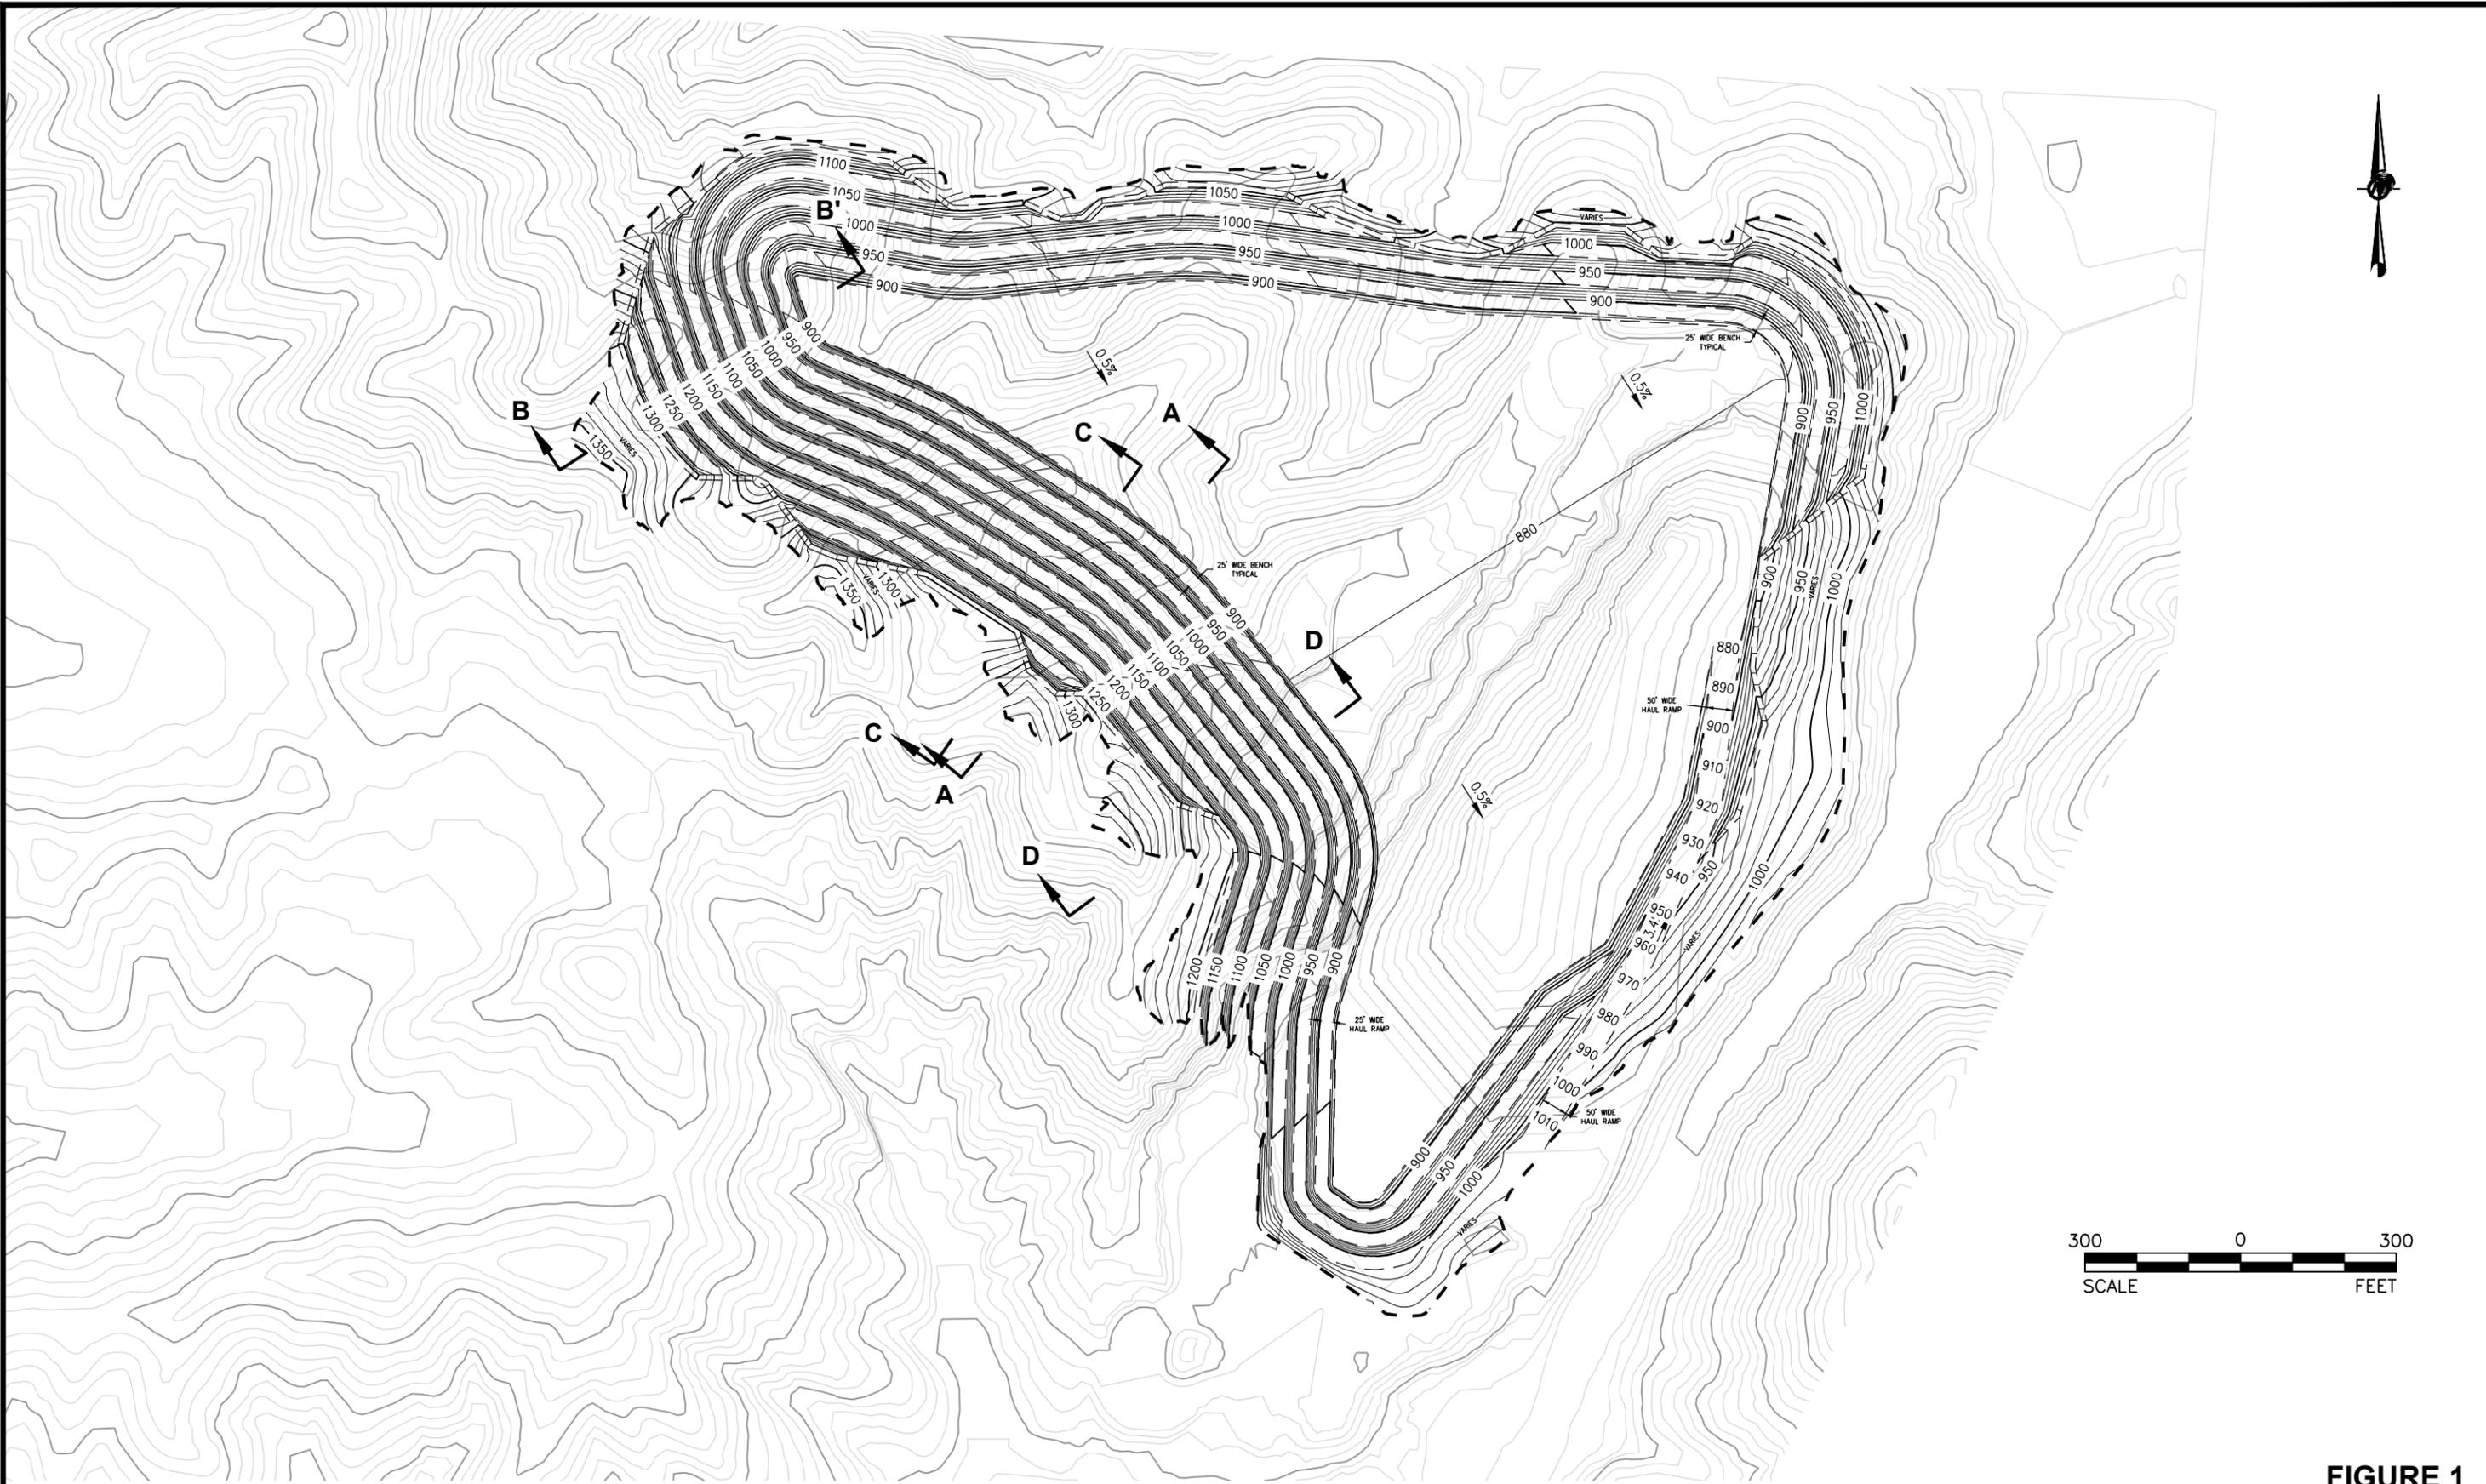
FIGURE 1
LIMIT EQUILIBRIUM STABILITY ANALYSIS
SANTA MARGARITA QUARRY EXPANSION
LEHIGH HANSON
