**PRELIMINARY GEOTECHNICAL REPORT  
LOS OSOS WASTEWATER PROJECT  
LOS OSOS MORTUARY, GIACOMAZZI, AND BRANIN  
PROPERTIES  
SAN LUIS OBISPO COUNTY, CALIFORNIA**

Prepared for:  
COUNTY OF SAN LUIS OBISPO

July 17, 2007

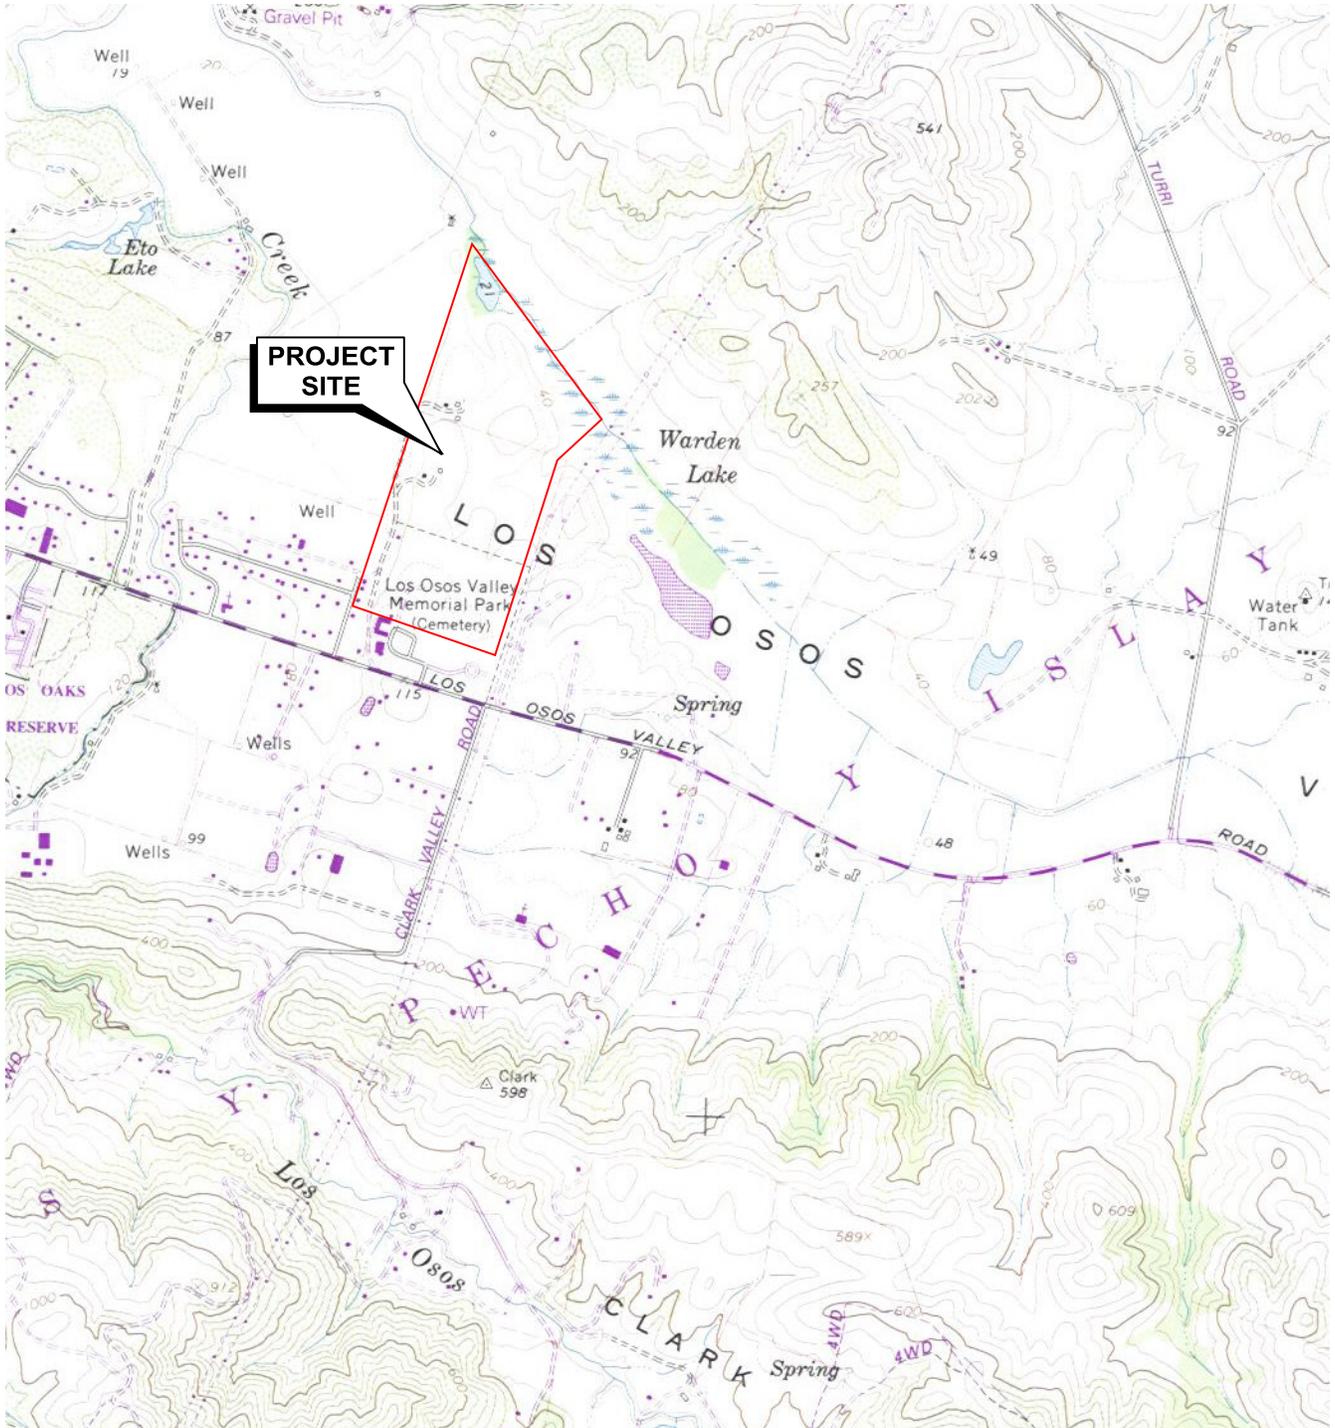
**VICINITY MAP**  
Los Osos Wastewater Project  
San Luis Obispo County, California

BASE MAP SOURCE: USGS Morro Bay South 7.5' Quadrangle, revised 1994.

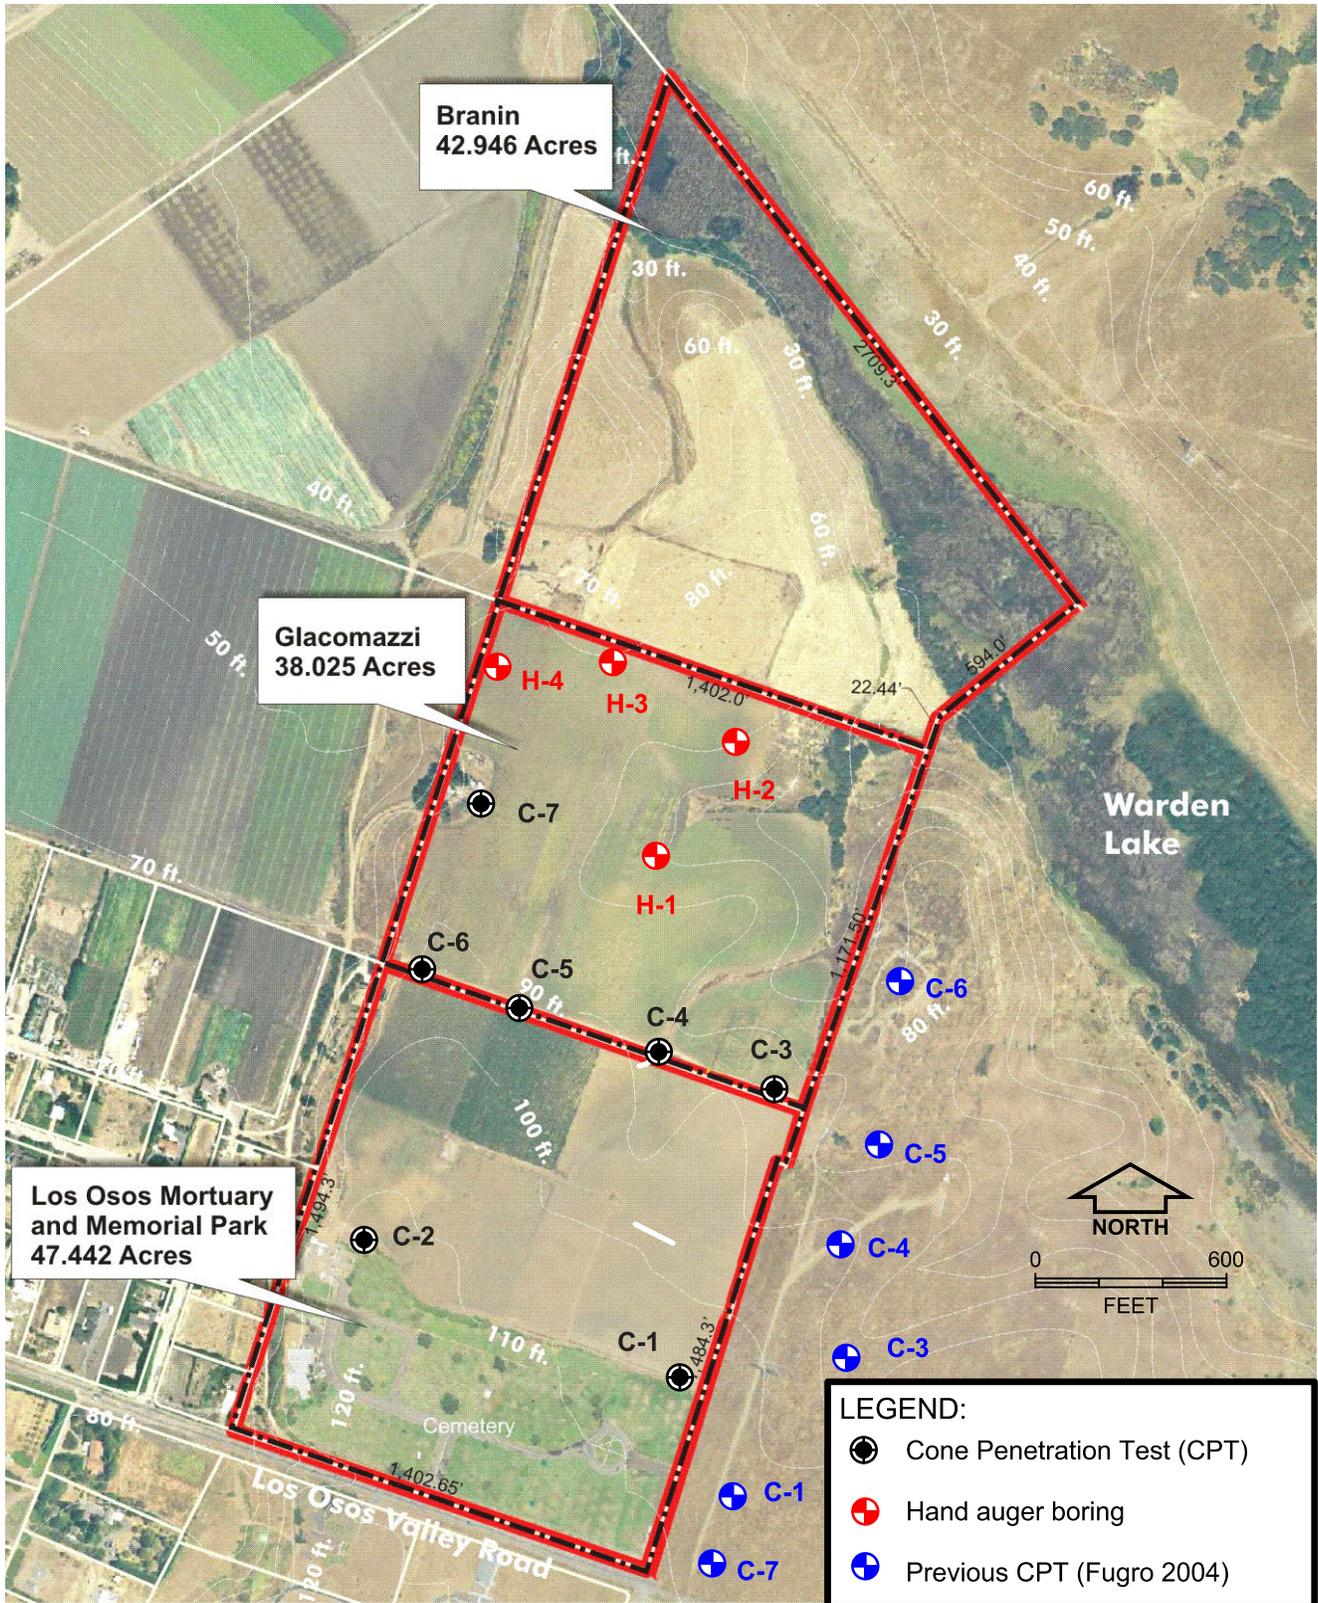
**FIELD EXPLORATION PLAN**  
 Los Osos Wastewater Project  
 San Luis Obispo County, California

**BASE MAP SOURCE:** Crawford Multari Clark Associates (2007). Areas Potentially Suitable for Wastewater Facilities.

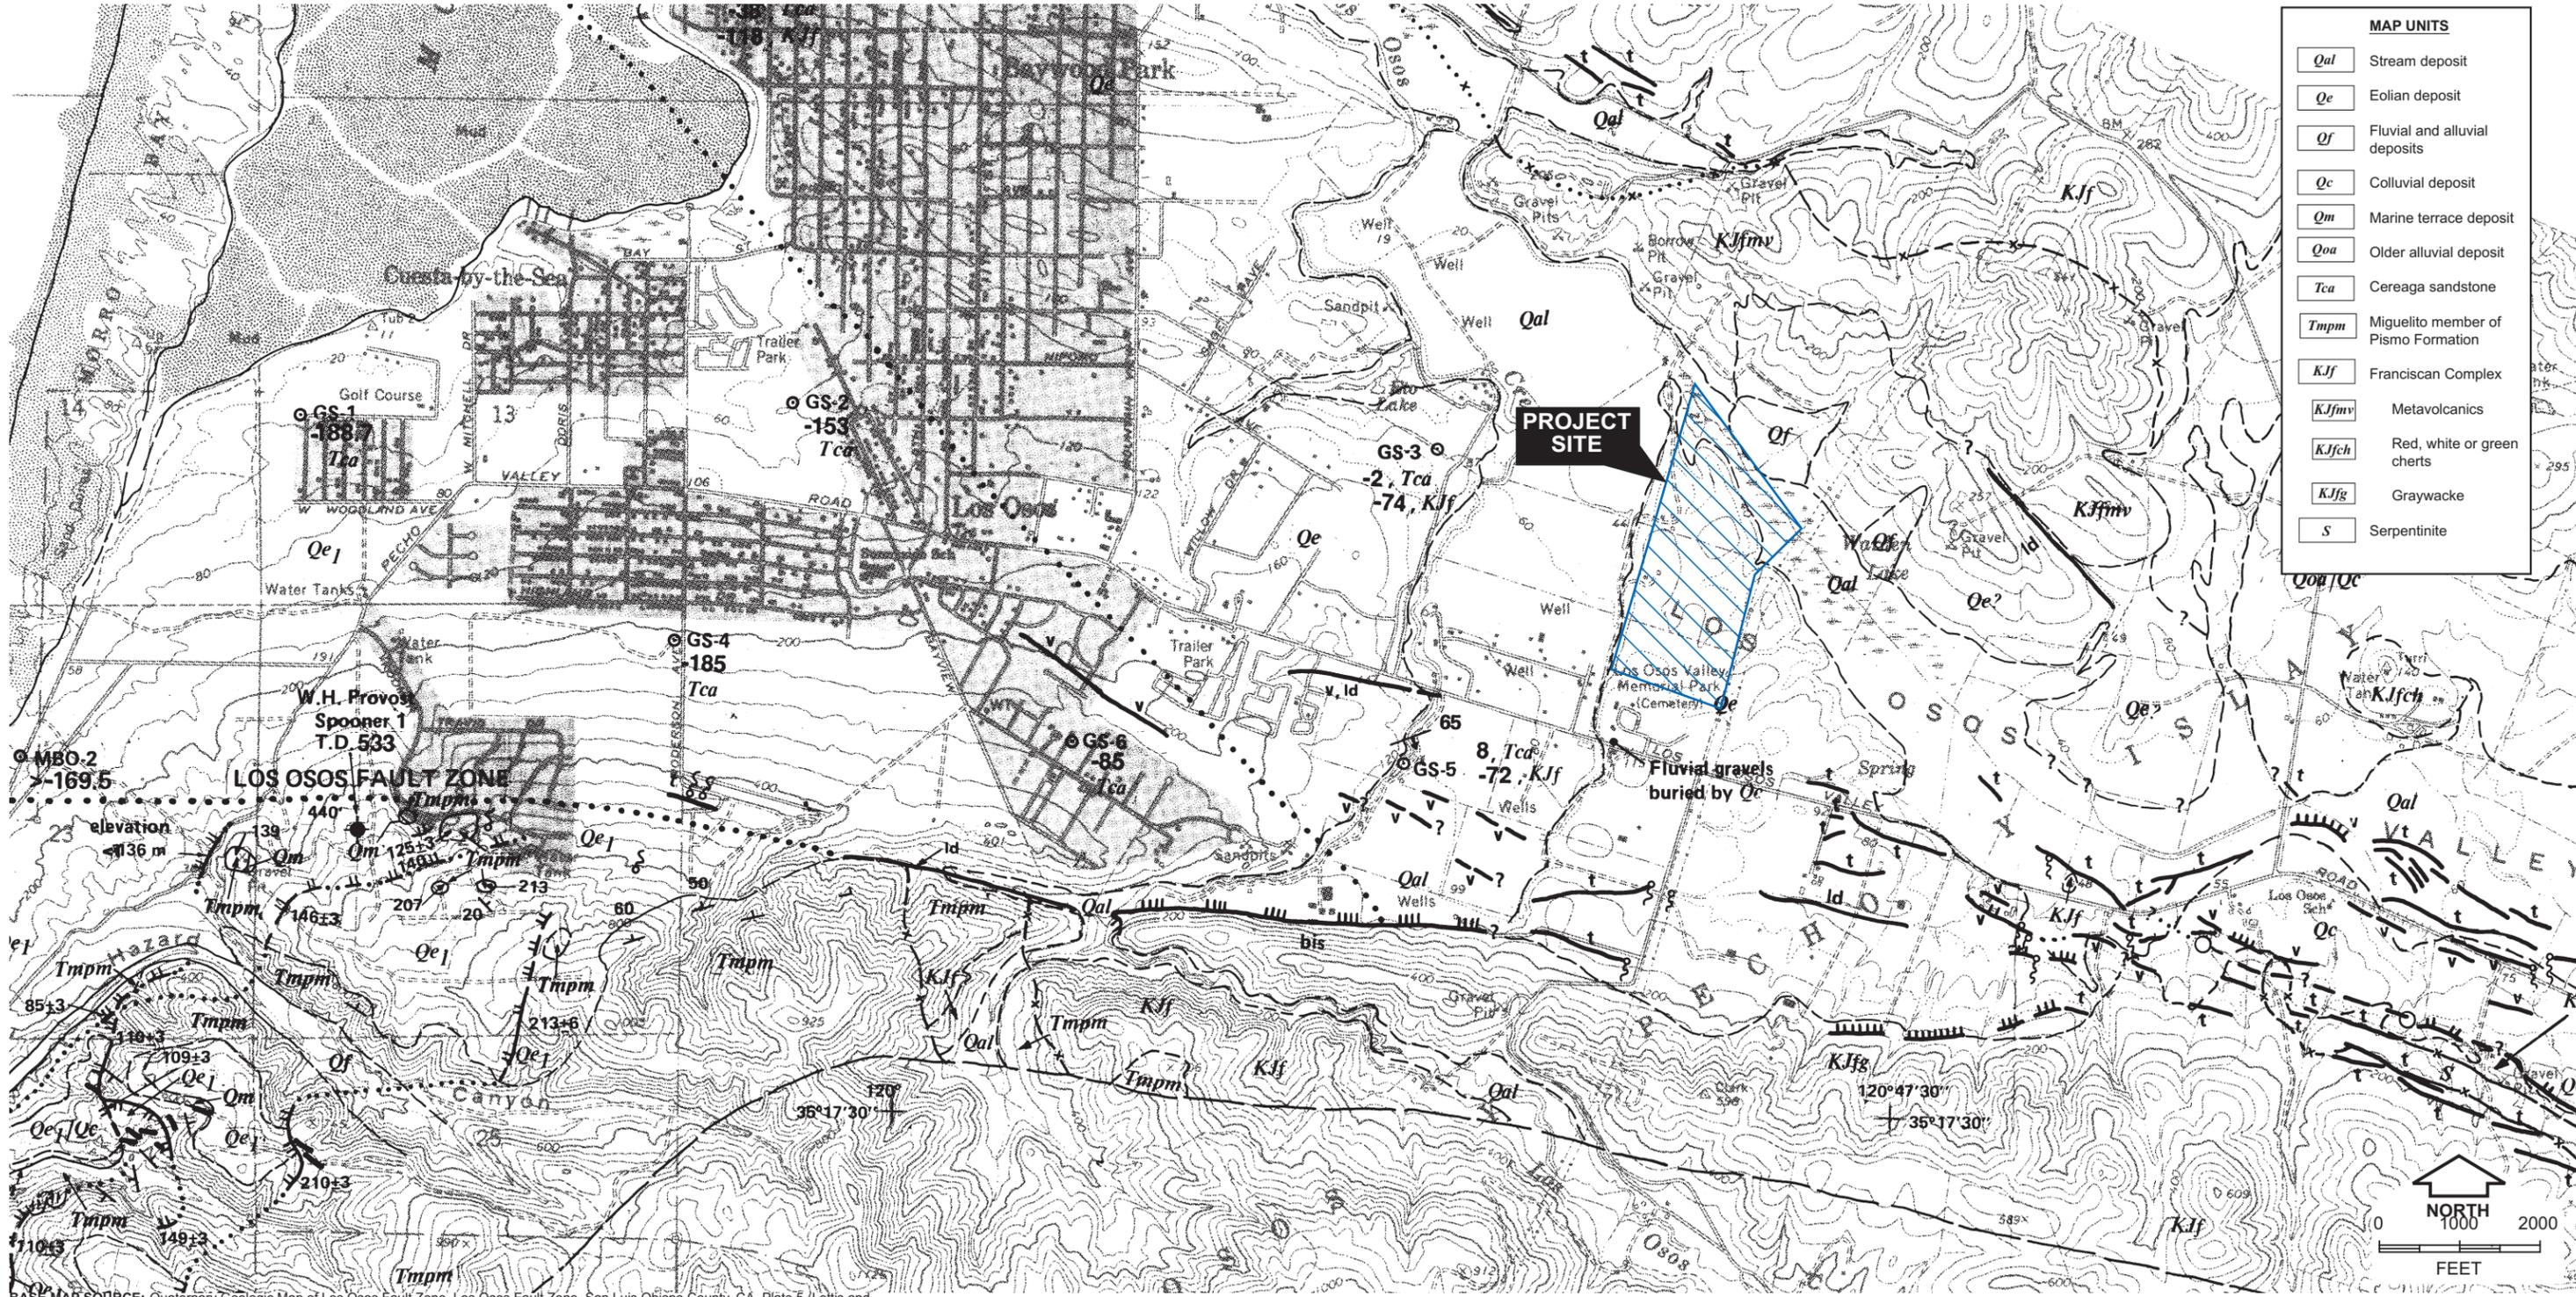
**LOS OSOS FAULT ZONE AND LINEAMENTS**  
Los Osos Wastewater Project  
San Luis Obispo County, California

MAP UNITS	
Qal	Stream deposit
Qe	Eolian deposit
Qf	Fluvial and alluvial deposits
Qc	Colluvial deposit
Qm	Marine terrace deposit
Qoa	Older alluvial deposit
Tca	Cereaga sandstone
Tmpm	Miguelito member of Pismo Formation
KJf	Franciscan Complex
KJfmv	Metavolcanics
KJfch	Red, white or green cherts
KJfg	Graywacke
S	Serpentine

- Trench location
- Bedrock exposure
- Limit of mapping

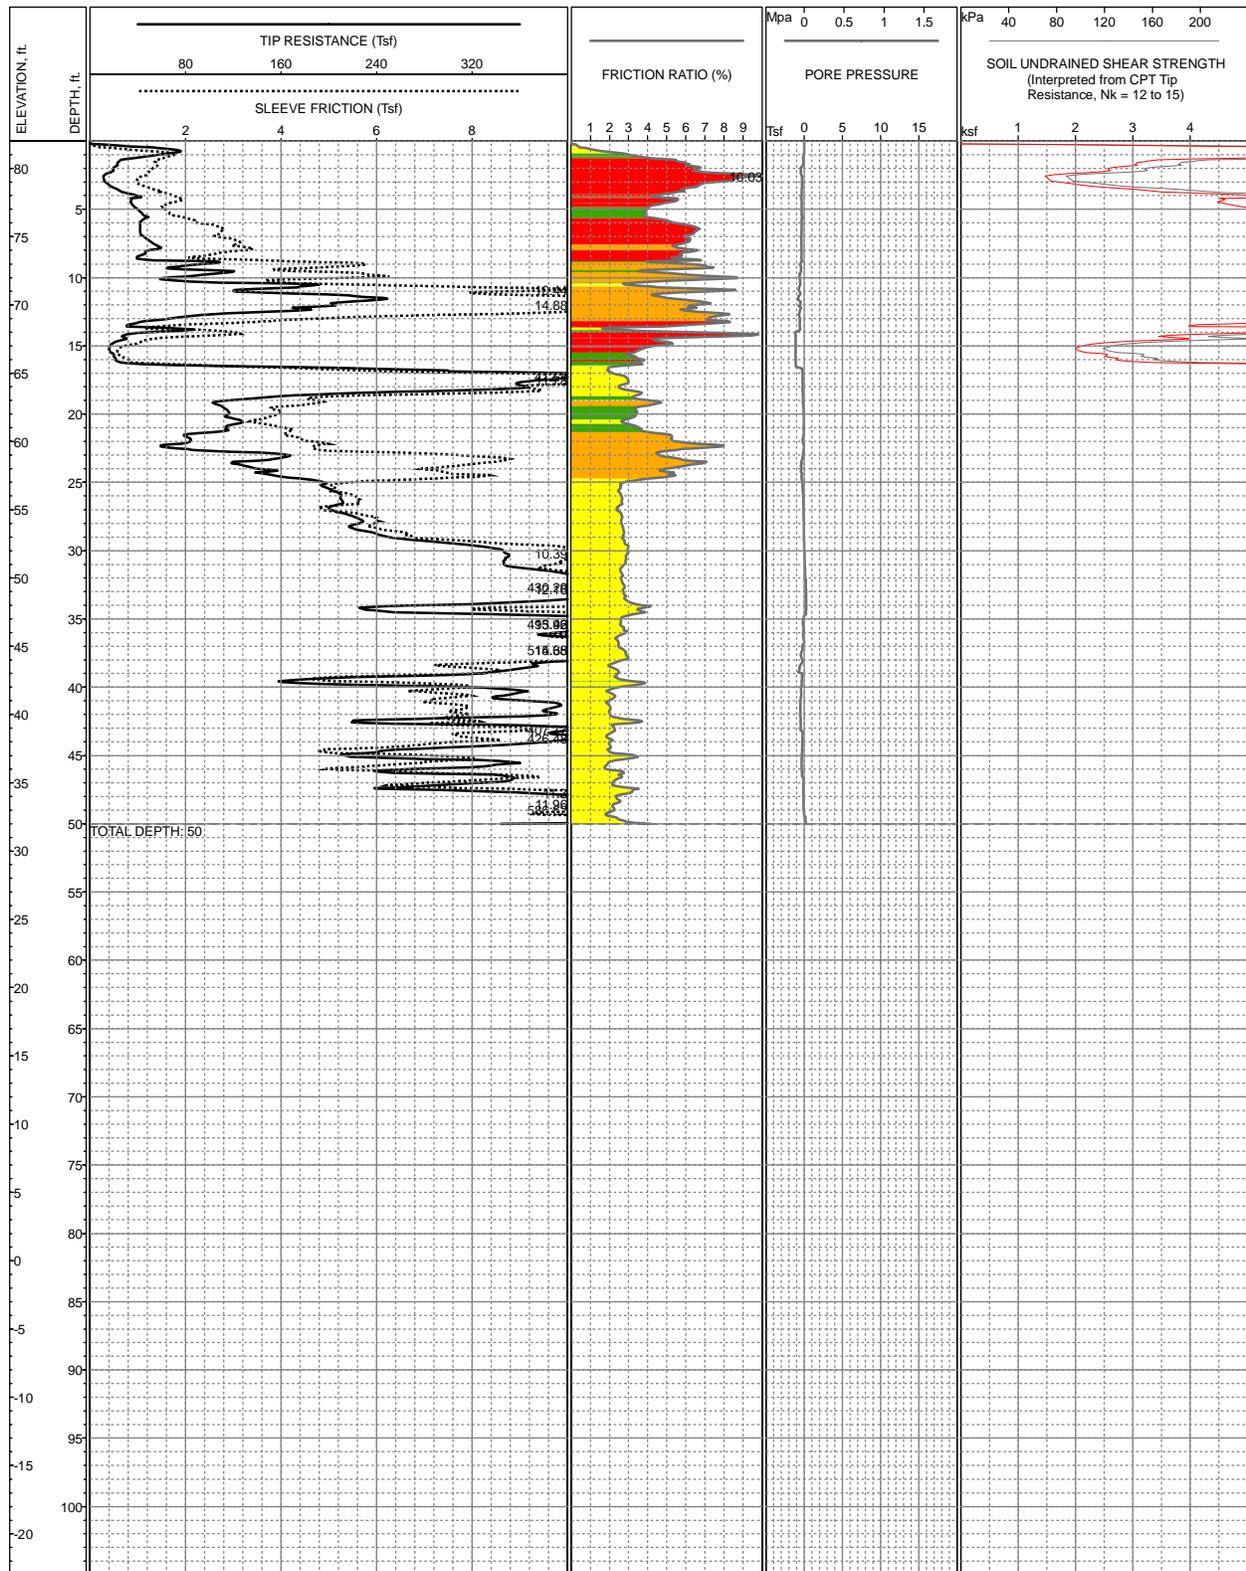
**LOG OF C-4**  
 Los Osos Wastewater Project  
 San Luis Obispo County, California

LOCATION: Southern access road of Giacomazzi property, 500 feet west of southeast corner.  
 SURFACE EL: 82ft +/- (MSL)  
 COMPLETION DEPTH: 50ft  
 TESTDATE: 5/8/2007

EXPLORATION METHOD: Cone Penetrometer  
 PERFORMED BY: Fugro Geosciences  
 REVIEWED BY: J Blanchard
