# Waterway Management Plan

# San Luis Obispo Creek Watershed

#### City of San Luis Obispo

#### **County of San Luis Obispo**

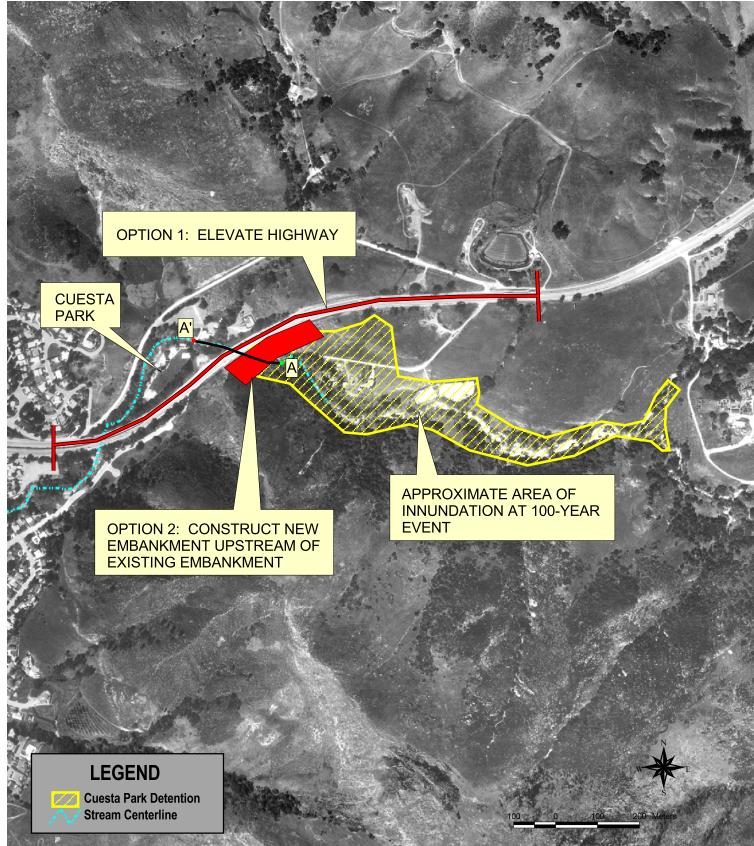
SECTION A-A' **OPTION 2: CONSTRUCT UPSTREAM EMBANKMENT**

Currently, the Highway 101 culvert crossing of San Luis Obispo Creek above Cuesta Park acts as a dam during very large storms, providing an important measure of flood protection storage for the City. This function would be enhanced by elevating the highway shoulder by about 5 meters (16 feet) and modifying the existing culvert (choking down the culvert to reduce flow and increase detention storage-see **Figure 6-5**). The upstream storage area would only fill (greater than it currently does) during rare events, and the flow detention would be temporary, lasting only several hours to at most a day. During most storms and most years, the upstream channel system would be essentially unaffected by the project.
