# San Luis Obispo Valley Basin Characterization and Monitoring Well Installation

January 18, 2018

Prepared for  
San Luis Obispo County Flood Control  
and Water Conservation District

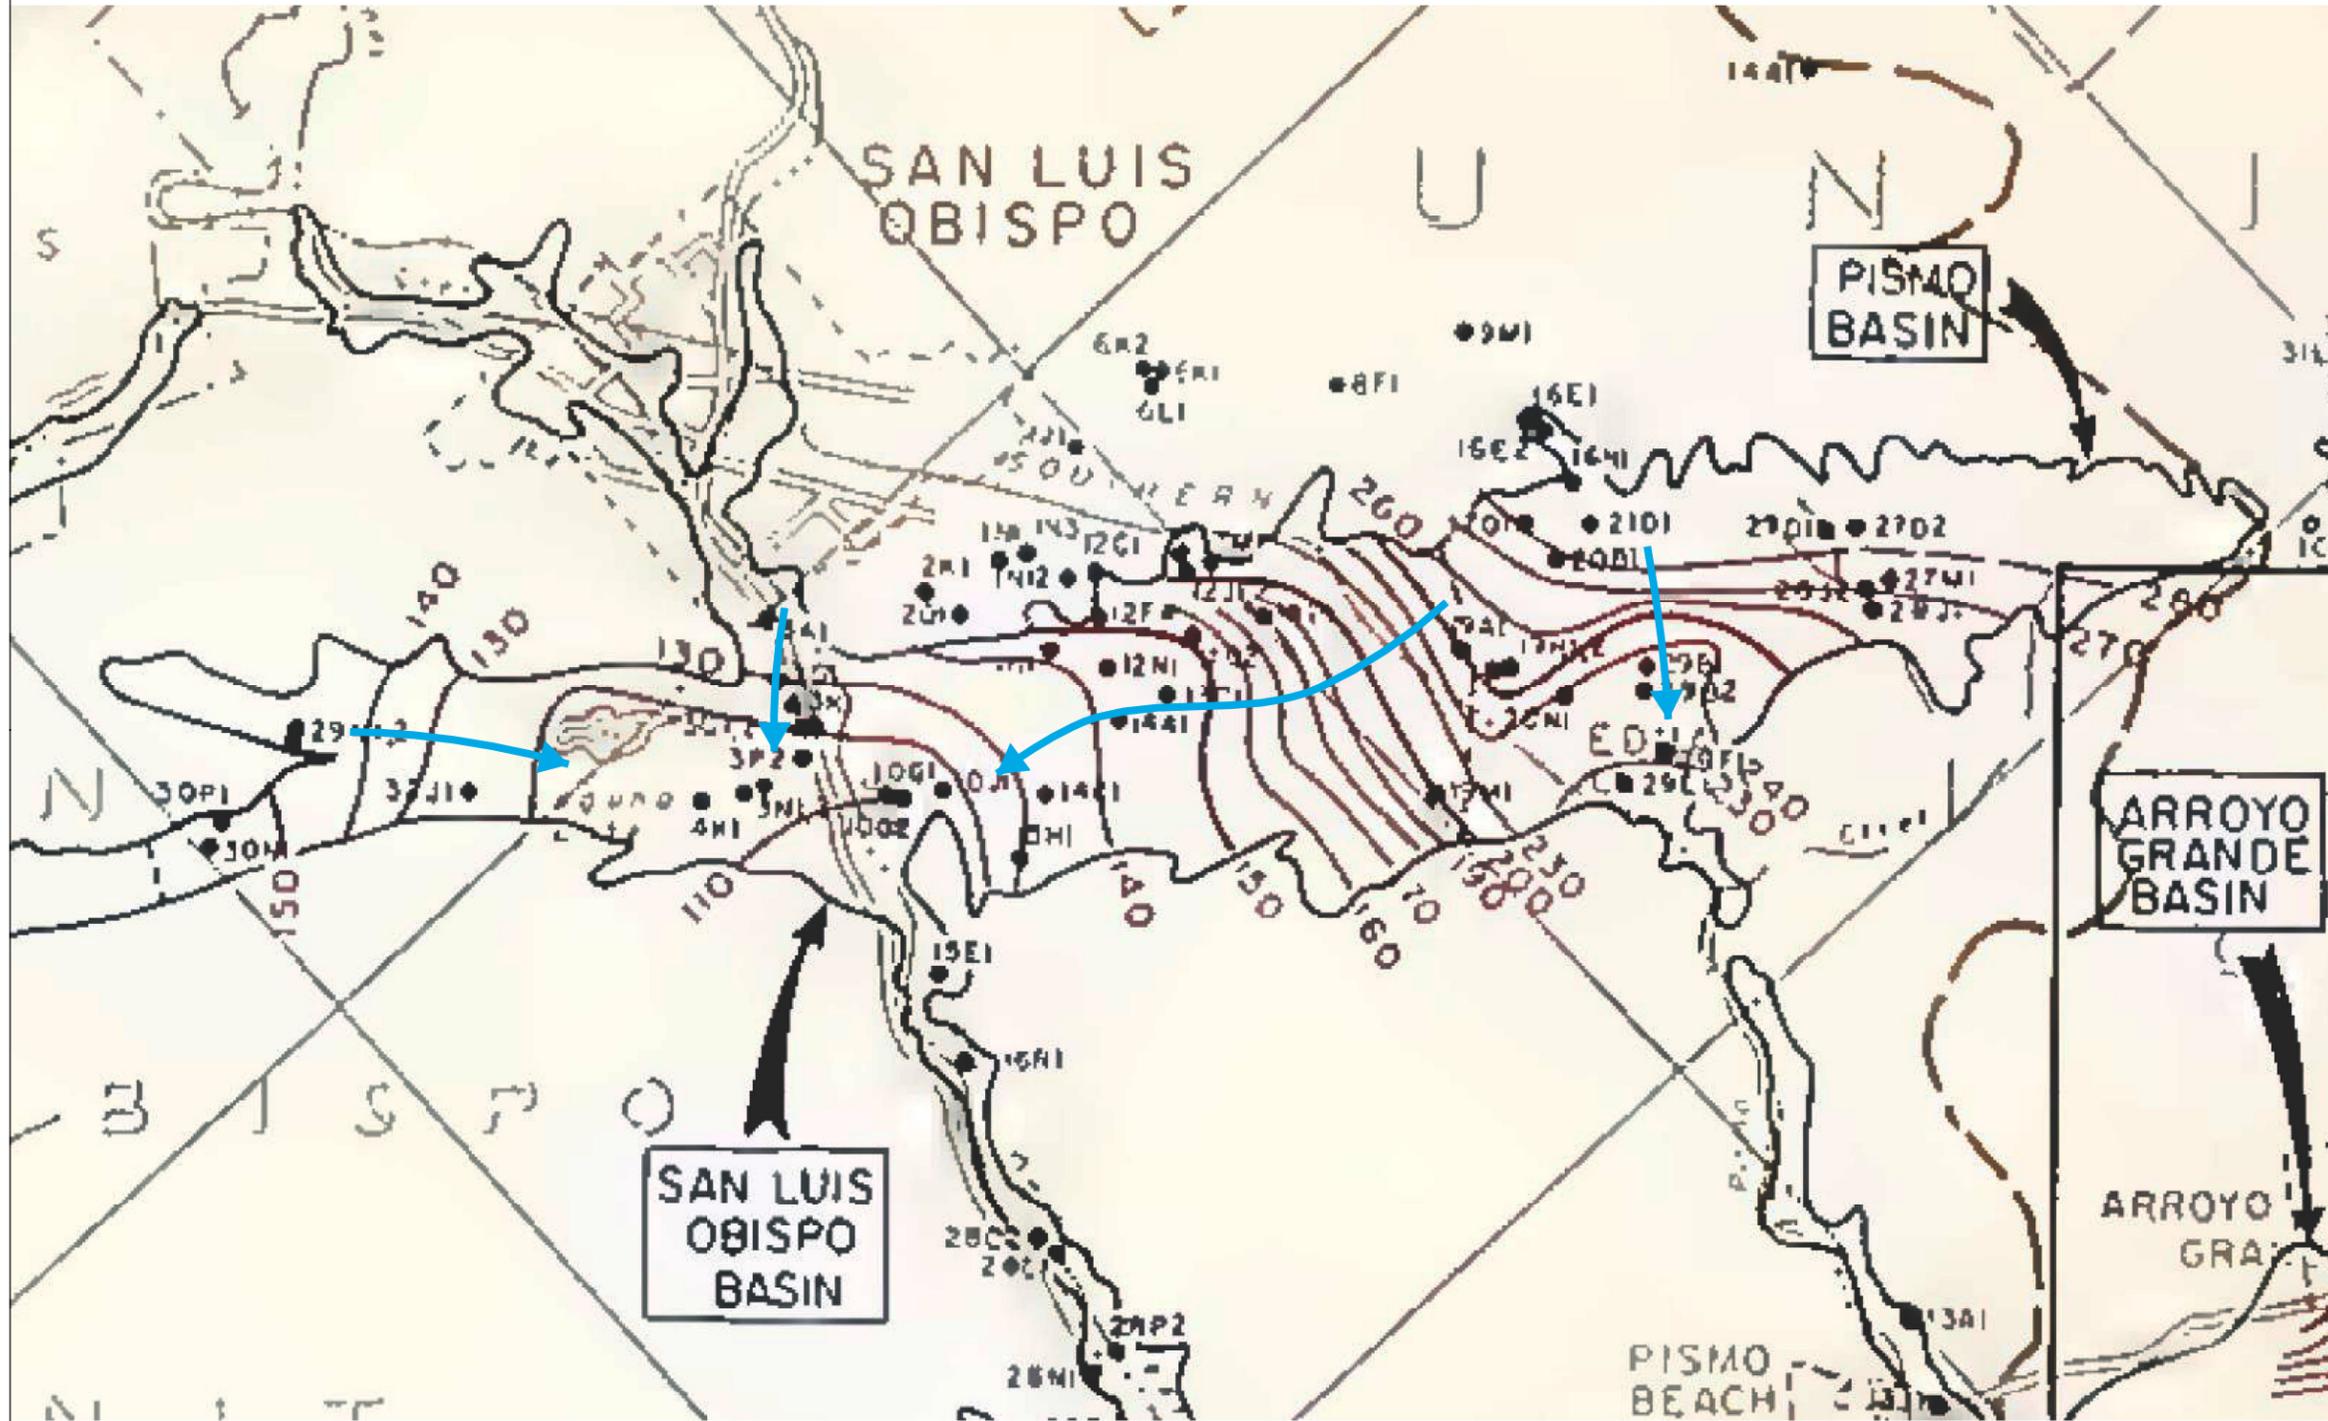
**FIGURE 22**  
**Fall 1954 Groundwater**  
**Level Elevation Map**

**Source**  
 San Luis Obispo County Investigation, State Water  
 Resources Board Bulletin No. 18, Plate 9B, May 1958

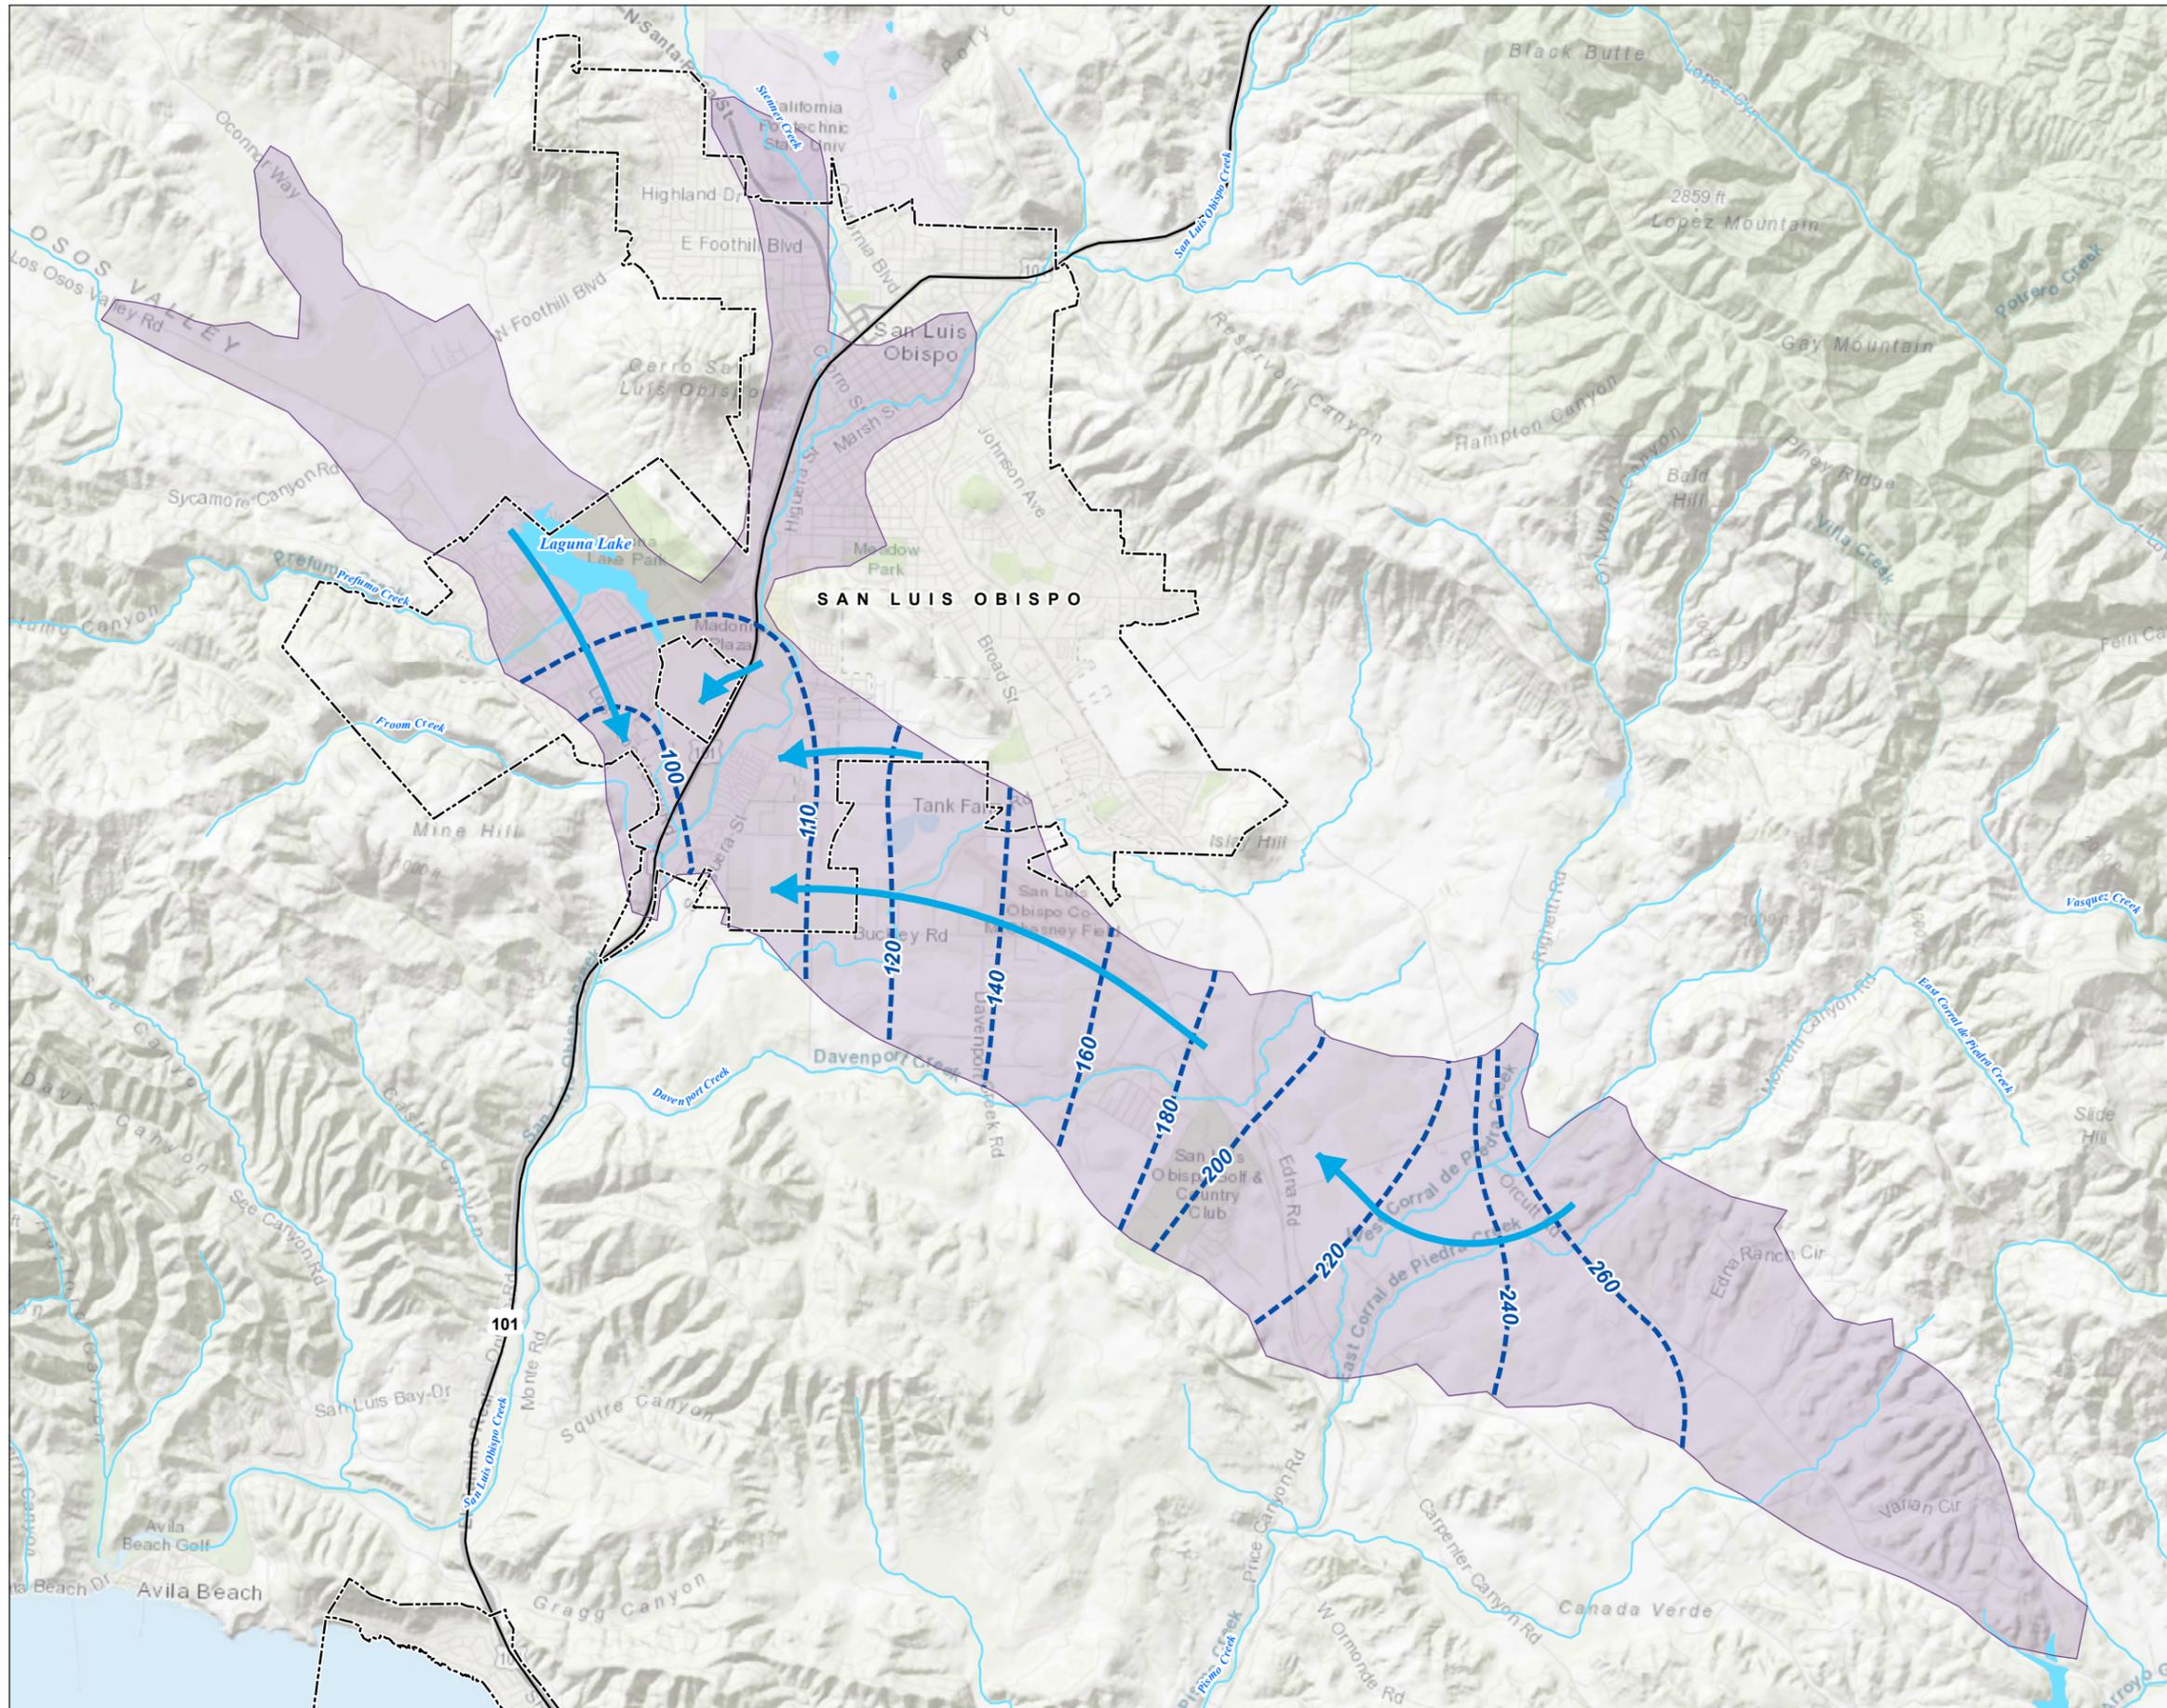
**FIGURE 23**  
**Spring 1990**  
**Groundwater Level**  
**Elevation Map**  
 San Luis Obispo Valley  
 Basin Characterization

**NOTE**  
 1. Contours and flow direction were adapted from 1991 Boyle Groundwater Basin Evaluation, Plate 8

Boyle (1991) presents water level elevation contour maps for the spring of 1986 and 1990, based on water level data collected in the field. A recreation of the Boyle water level contours for spring of 1990 is presented in Figure 23 and displays a pattern of groundwater flow in the Basin very similar to that exhibited in the DWR map. Contours for the spring of 1986 are not presented in this report, but 1986 represents wetter conditions than the 1990 map, and it is noted in Boyle (1991) that there is a difference of approximately 10 feet of elevation between the two maps, representing the variation in water levels that may be observed between wet and dry weather cycles.

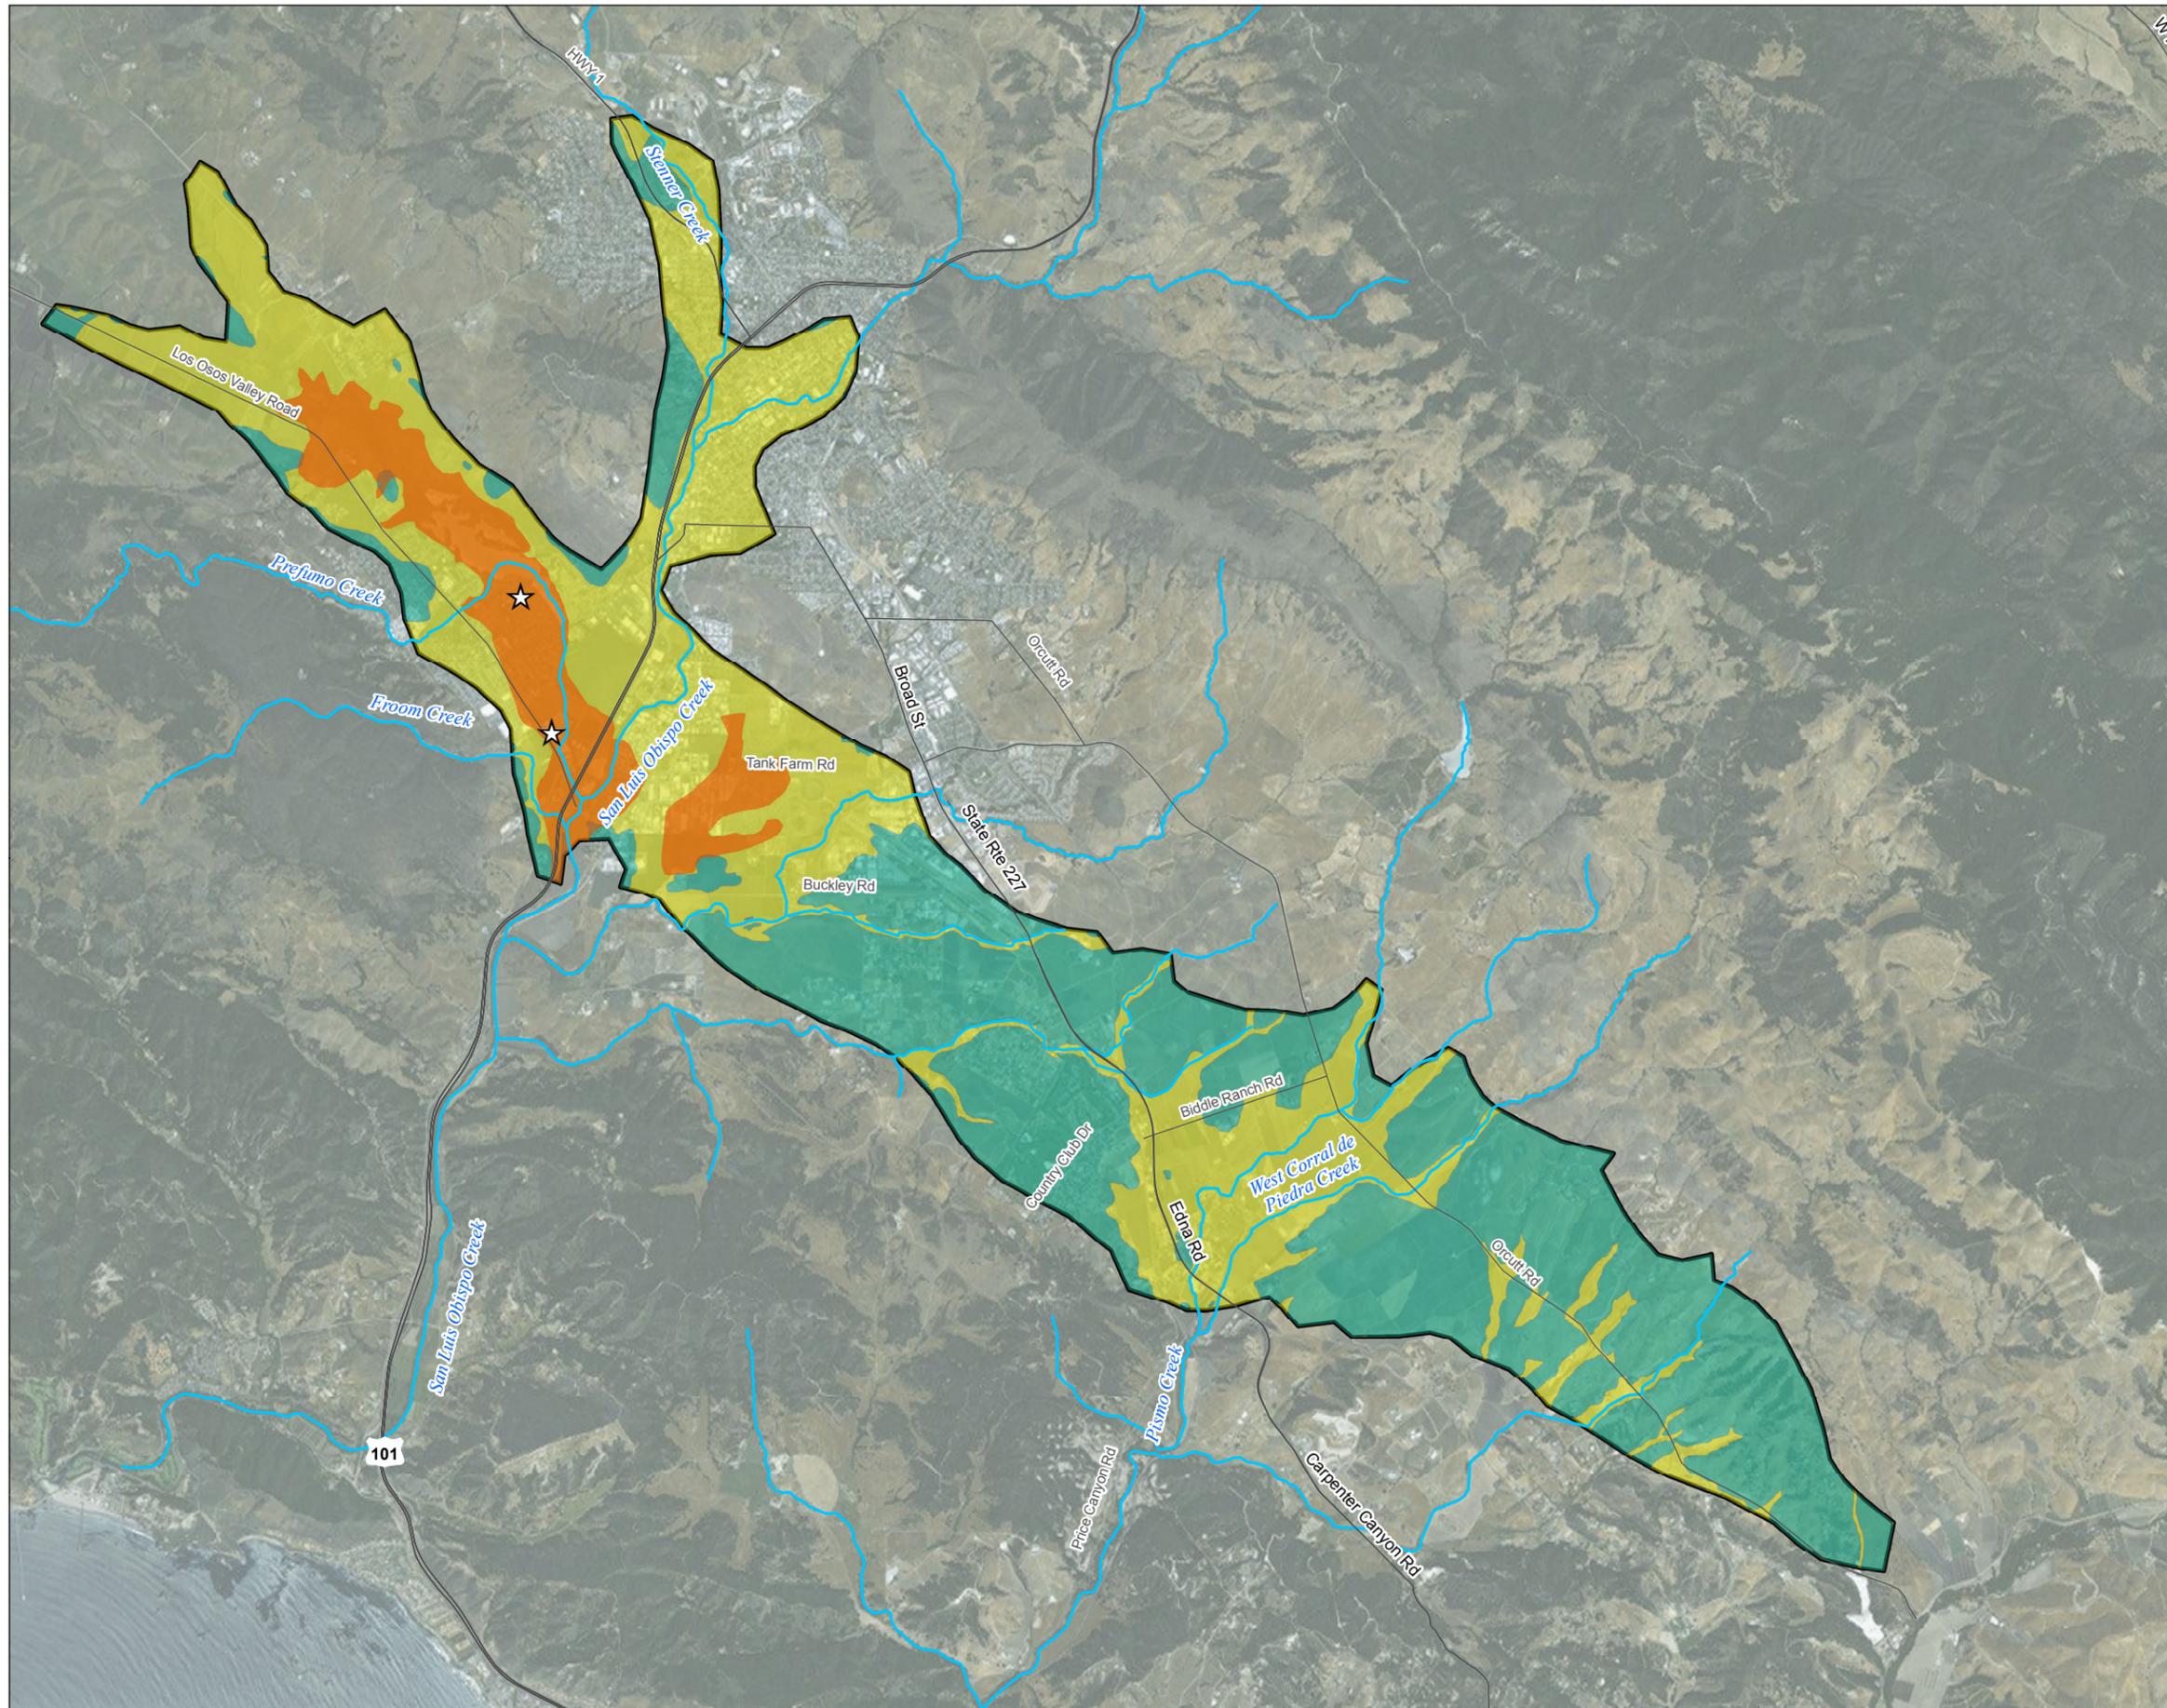
**FIGURE 28**  
**San Luis Obispo Valley Basin**  
**Subsidence Potential**  
 San Luis Obispo Valley  
 Basin Characterization

- ☆ Areas of Historical Subsidence
- Expected Subsidence with Groundwater Removal
- Potential Subsidence with Groundwater Removal
- Low Risk of Subsidence
- Bulletin 118 Basin Boundary

A subsidence study was performed as part of this Study. Subsidence has been observed in the Basin along Los Osos Valley Road west of Highway 101. Subsidence in the area of Auto Mall Parkway is associated with compaction of organic sediments resulting from lowered groundwater levels from groundwater extraction in the vicinity. Subsidence also has been observed in the Lake Laguna area; lowered groundwater

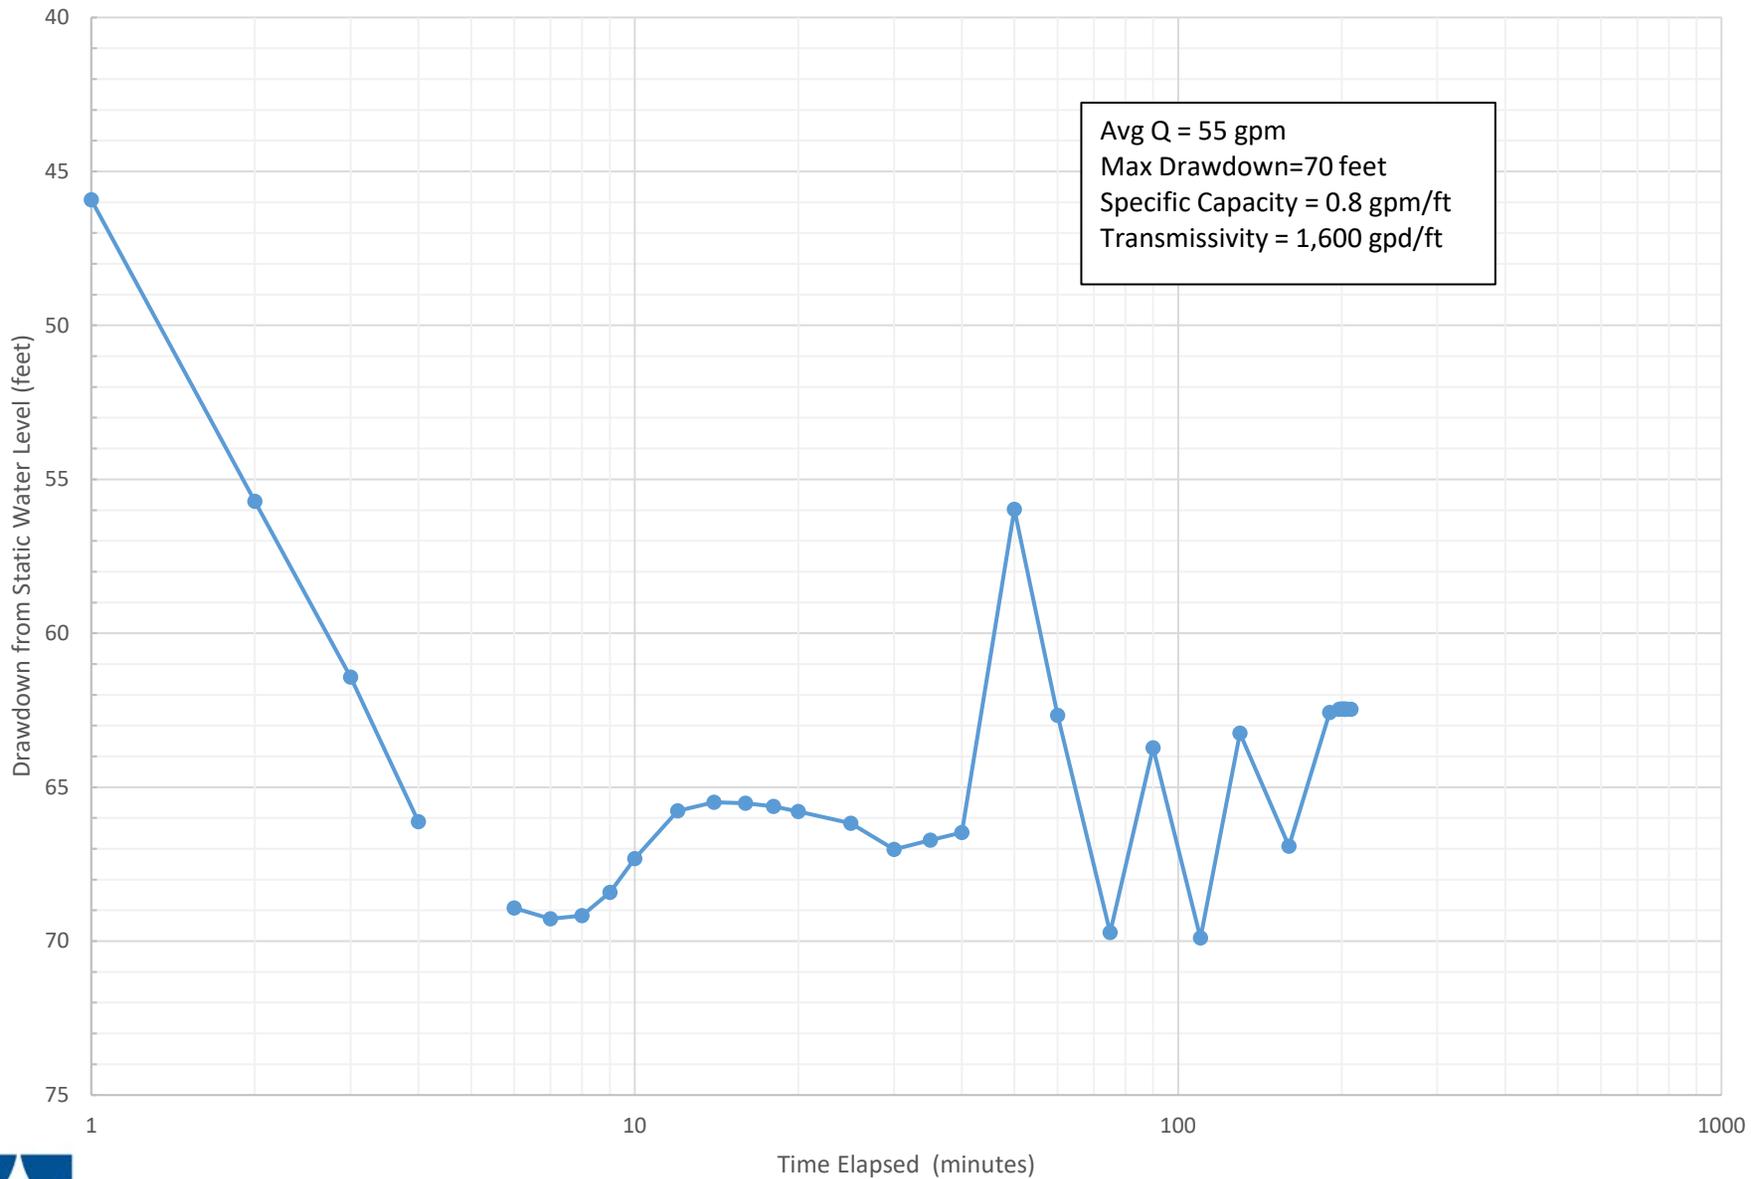
**San Luis Obispo Valley Basin Characterization**  
 Buckley Road Well Constant Rate Test

Avg Q = 55 gpm  
 Max Drawdown=70 feet  
 Specific Capacity = 0.8 gpm/ft  
 Transmissivity = 1,600 gpd/ft

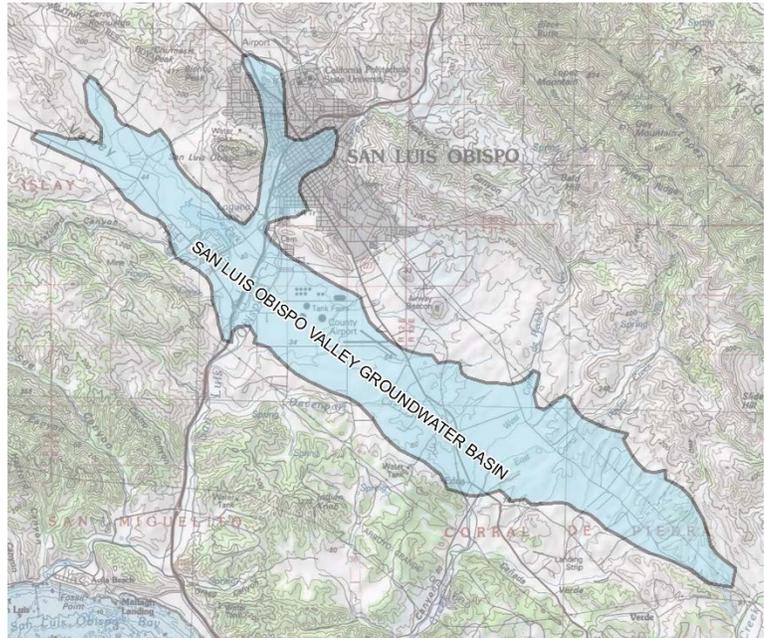
Figure 1: Vicinity Map

Yeh and Associates was retained by GSI Water Solutions, Inc. to provide a preliminary subsidence evaluation as input to the San Luis Obispo Valley Basin Characterization Project in San Luis Obispo County, California. The location of the basin is shown in light blue on Figure 1, and on Plate 1- San Luis Obispo Groundwater Basin Vicinity Map.

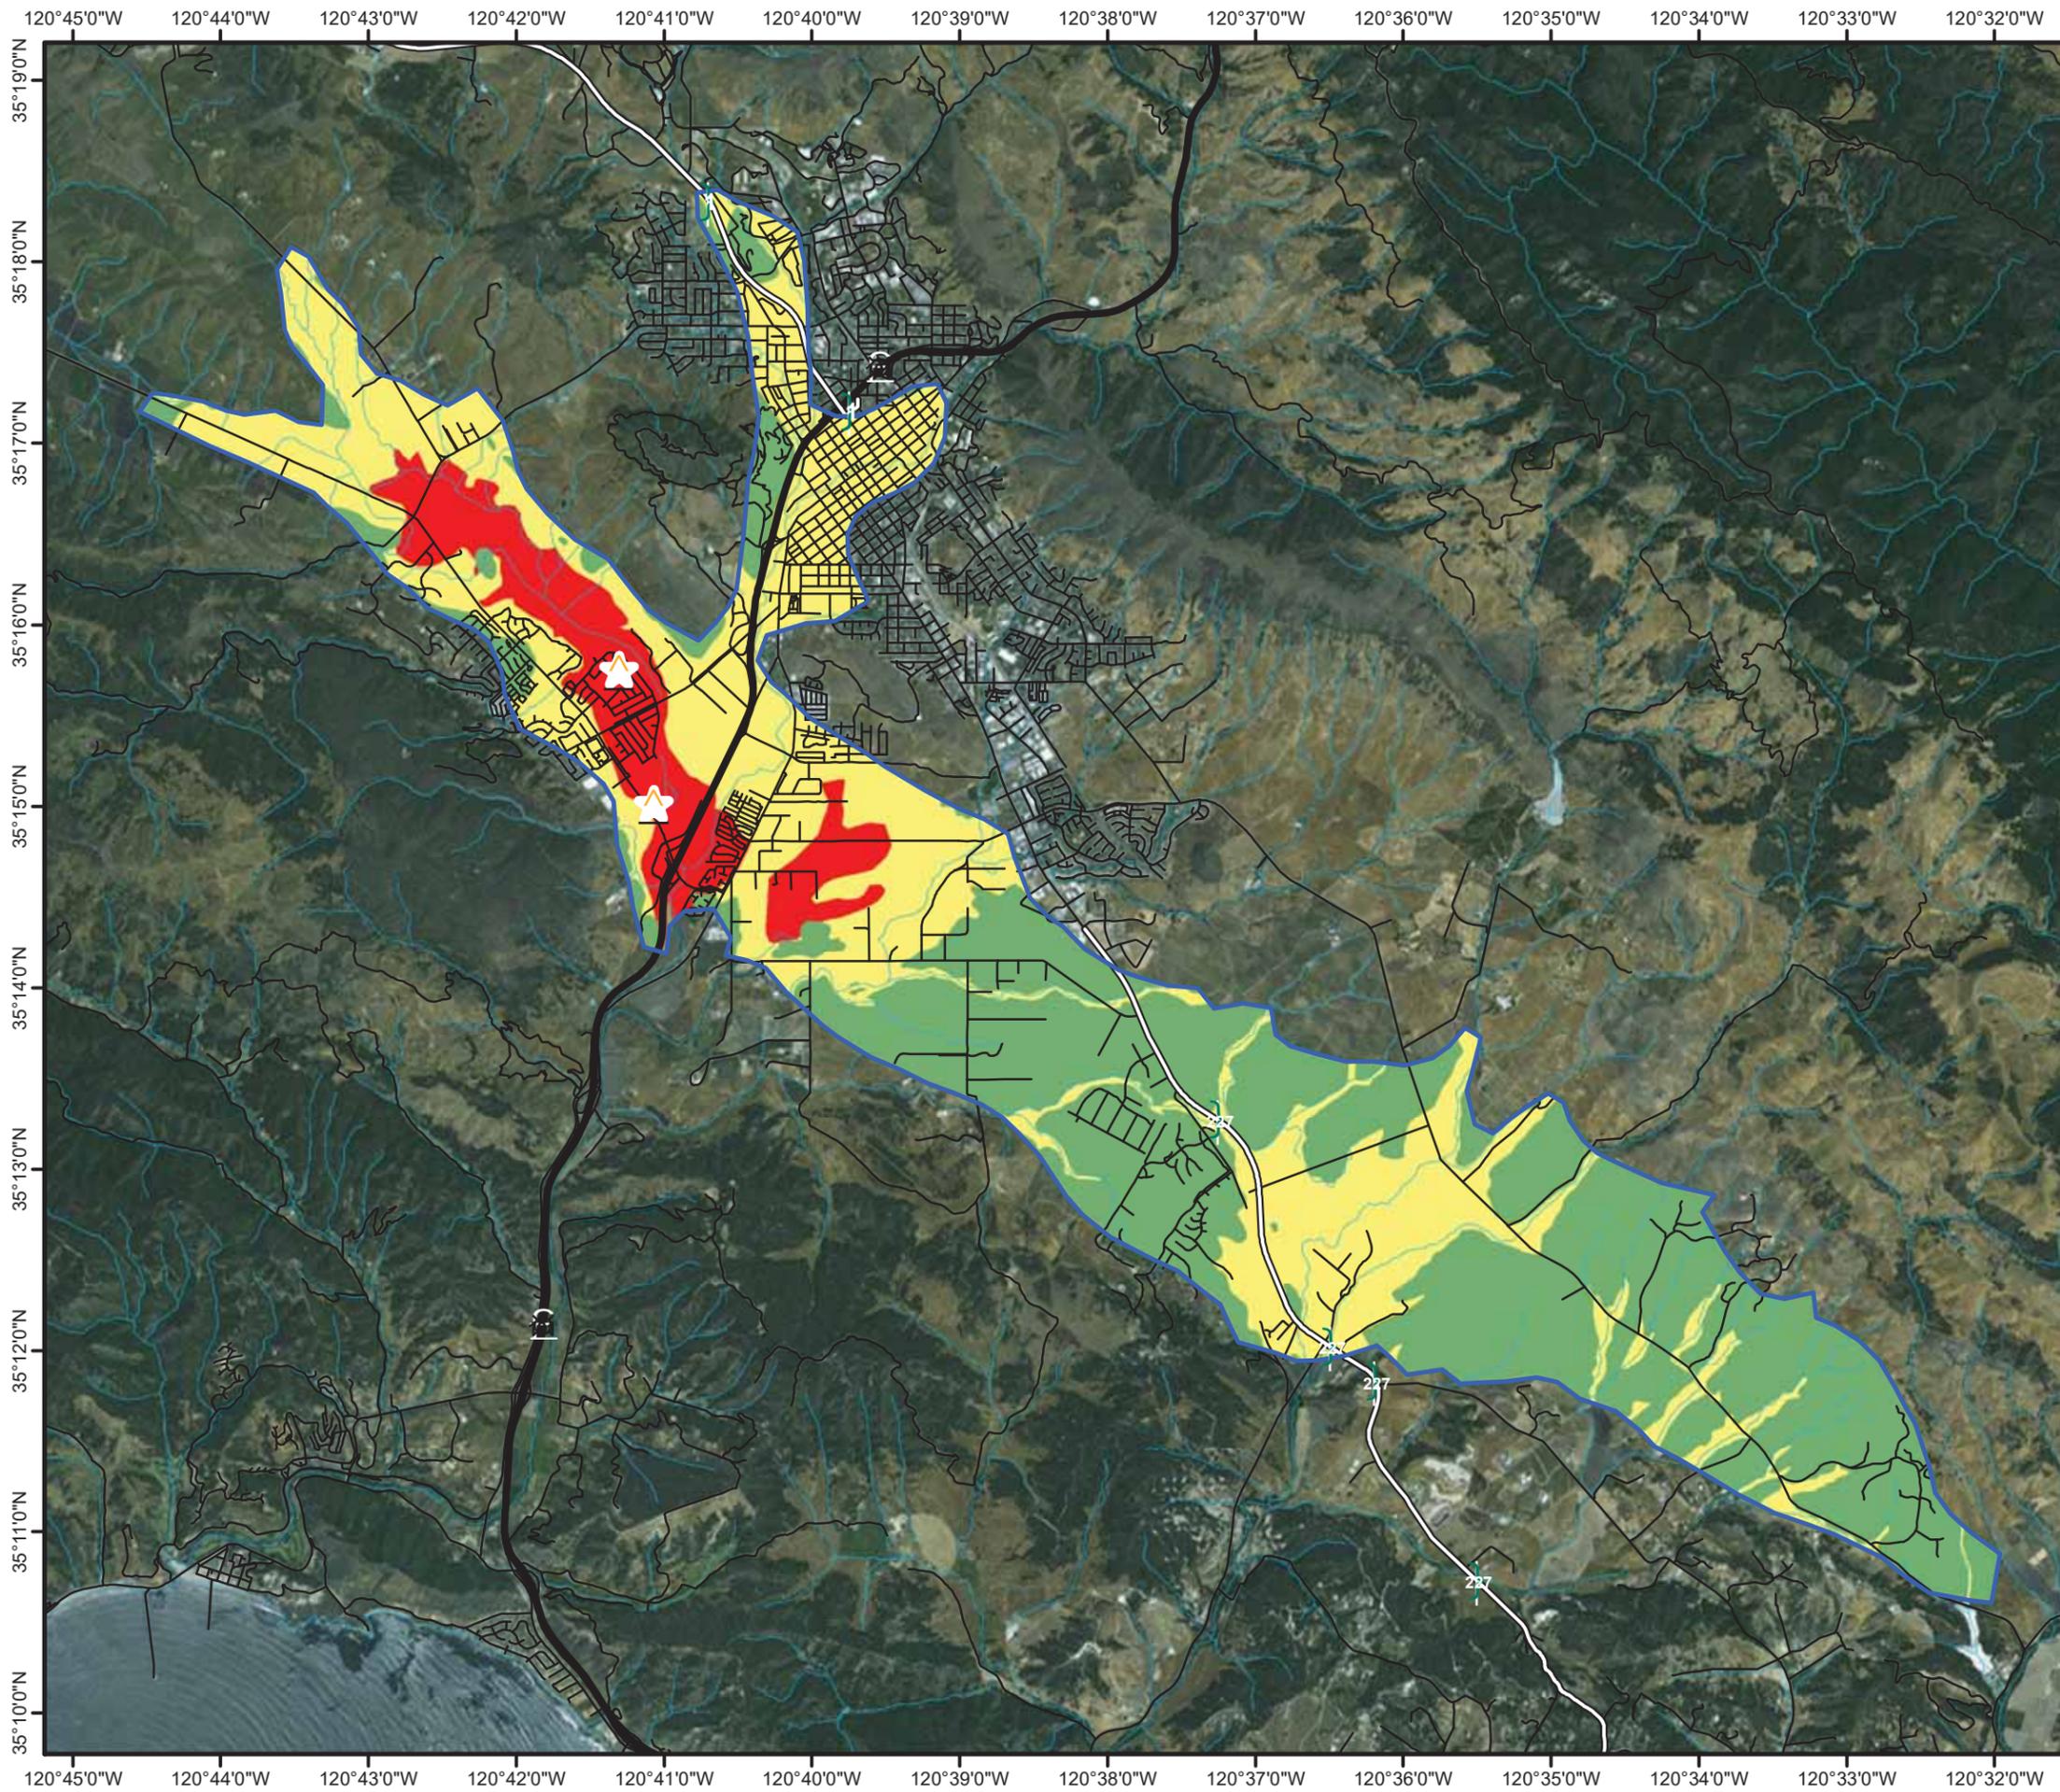
<b>Yeh and Associates, Inc.</b> Consulting Engineers & Scientists	
<b>Historical and Potential Subsidence</b>	
PROJECT NAME: San Luis Obispo Valley Groundwater Basin Subsidence Characterization San Luis Obispo County, CA	PLATE <b>2</b>
PROJECT NUMBER: 216-350	DATE: October 2017

### Subsidence Potential

- **Category 1.** Category 1 has the highest likelihood of future subsidence if subject to lowered groundwater levels in the future. Based on a review of public data and consultant reports, alluvium mapped in these areas contains young organic soil known in areas around Los Osos Valley Road, Laguna Lake, and low-lying wetland areas near Tank Farm Road. These areas are known to have experienced historical subsidence or to contain soft or organic soil, and were identified as having a potential for subsidence in relation to geology and groundwater pumping. These areas are identified as Category 1 in Figure 27, with star symbols marking approximate areas of known historical subsidence. Extraction of groundwater resources in these areas could cause further subsidence.

- **Category 2.** Low-lying topographic areas in the Basin that are mapped as young alluvial soil were identified as potentially containing soft or organic soil layers that may have a potential for subsidence in relation to groundwater pumping, but currently there is no historical or subsurface information to further evaluate those areas. Those areas are mostly located along Prefumo Creek and San Luis Obispo Creek and the main drainages through the west end of the Edna Valley near Price Canyon. These areas are identified as Category 2 in Figure 27. This screening criteria recognizes the unconsolidated nature typical of young alluvium that has been mapped in these areas potentially could subside because of compaction of the aquifer if groundwater levels were lowered.

- **Category 3.** Geographic areas in the Basin that were mapped as bedrock or older surficial sediments, and are not known to be underlain by young organic soil or young alluvium, were identified as Category 3 in Figure 27. These areas were evaluated and characterized as not having factors known to be susceptible to subsidence in relation to groundwater pumping. Generally, these are upland areas where bedrock is shallow or where bedrock is mapped at the ground surface, such as in the areas around the airport and Orcutt Road.

and reduced water levels associated with groundwater pumping. These areas are identified as Category 1 on Plate 2, with star symbols marking approximate areas of known historical subsidence. Extraction of groundwater resources in these areas associated with lowering of water levels could cause further subsidence.
