**An Assessment of Potential Impacts to Public and Worker Health
Posed by the
Cold Canyon Landfill and Composting Facility
San Luis Obispo County, Ca.**

Occupational Safety and Health Audit of the Composting Facility

**Alvin Greenberg, Ph.D., REA, QEP
Risk Science Associates
121 Paul Dr., Suite A
San Rafael, CA 94903**

October 7, 2010

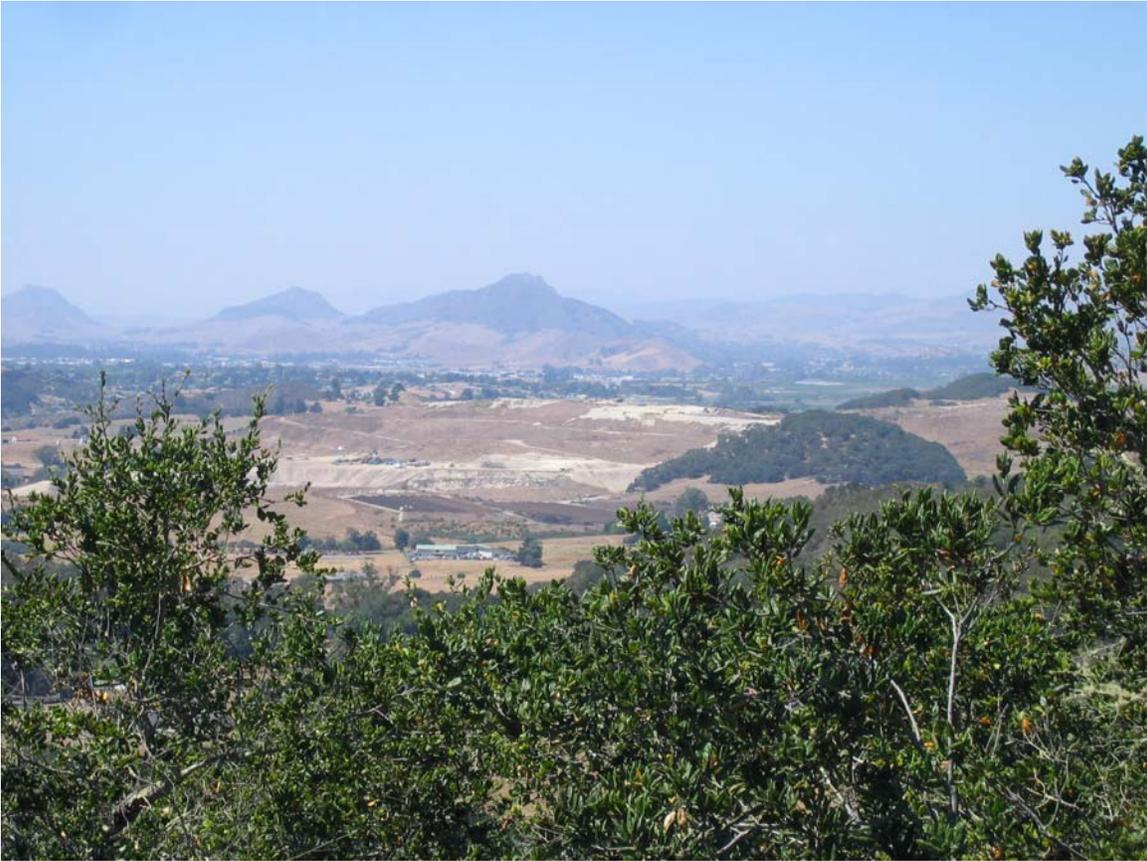
Photo 1

The Cold Canyon Landfill and composting facility (see photo 1) is the subject of community concern regarding human health risks, composting activities, and odors. Two phases of investigations have been initiated in a step-wise approach to ascertain a basis for these concerns. This report constitutes Task 3 of three tasks that are part of Phase 1 designed to document existing conditions at the landfill composting facility. Task 1 consisted of the review and evaluation of obtainable air, surface water, and groundwater monitoring data from the RWQCB, SLO County Air Pollution Control District, SLO County Environmental Health, Cold Canyon Landfill, the California Department of Resources Recycling and Recovery (Cal Recycle), and scientific articles addressing potential hazards from composting activities. Task 2 included the preparation, administration, and evaluation of a questionnaire designed to determine the frequency and spatial location of persons claiming symptoms, the types and frequency of symptoms alleged, and the alleged observable impacts to eco-receptors. The questionnaire has been developed and administered and the responses are now being evaluated. Phase 2 consists of additional environmental monitoring (if appropriate) and the preparation of a human health risk assessment addressing the potential hazard and risk posed by the facility.

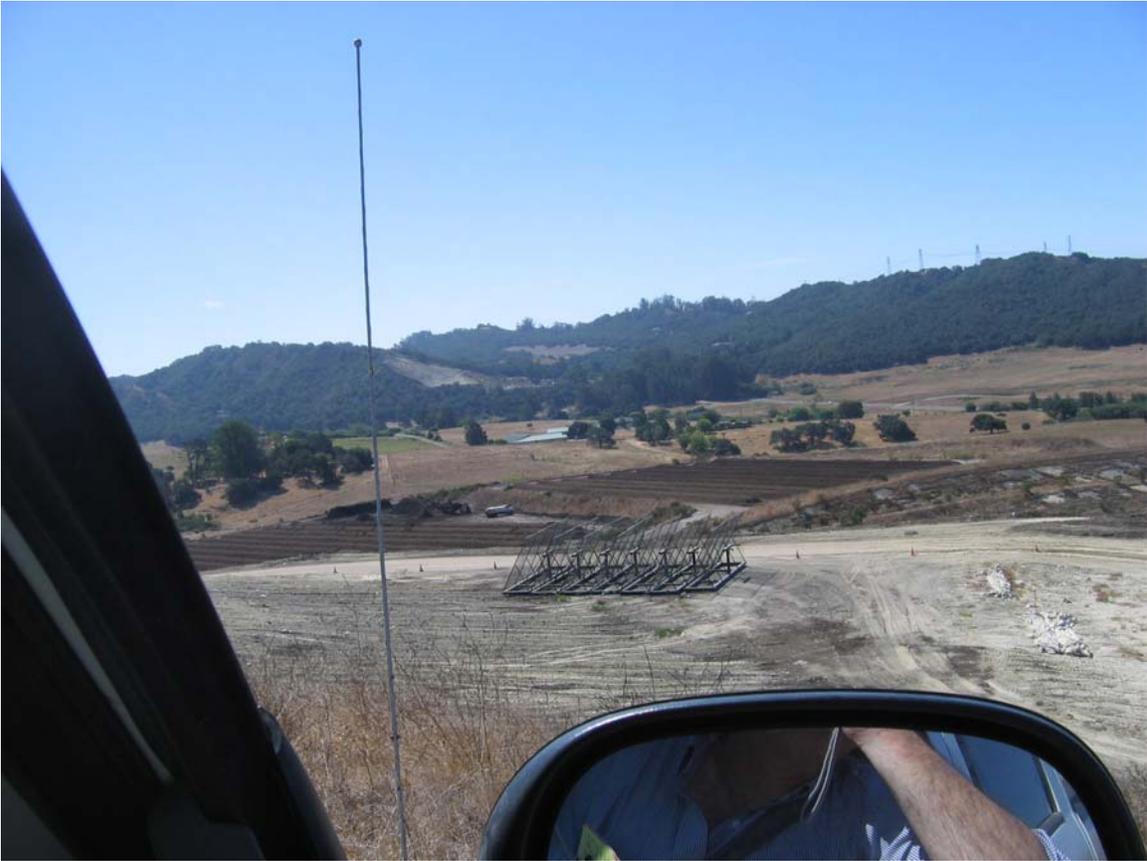
Photo 2

- During the site tour via an enclosed vehicle, it was clear while berms existed on the north, east, and west sides of the composting area (see photo 2; all directions are approximate as the compost area is not laid-out in a direct N-S alignment), no artificial windbreaks or trees were strategically placed to assist in the diminution of odors moving off-site and no berms were located on the south end thus allowing free movement of air onto or from the composting area (see photo 3).

- The windrows, however, were placed at appropriate separation distances and were of appropriate height.
- Recommendations:
In order to better control the off-site migration of bioaerosols, dusts, and odors, any compost facility at the Cold Canyon Landfill should have wind breaks and vegetation on all four sides.

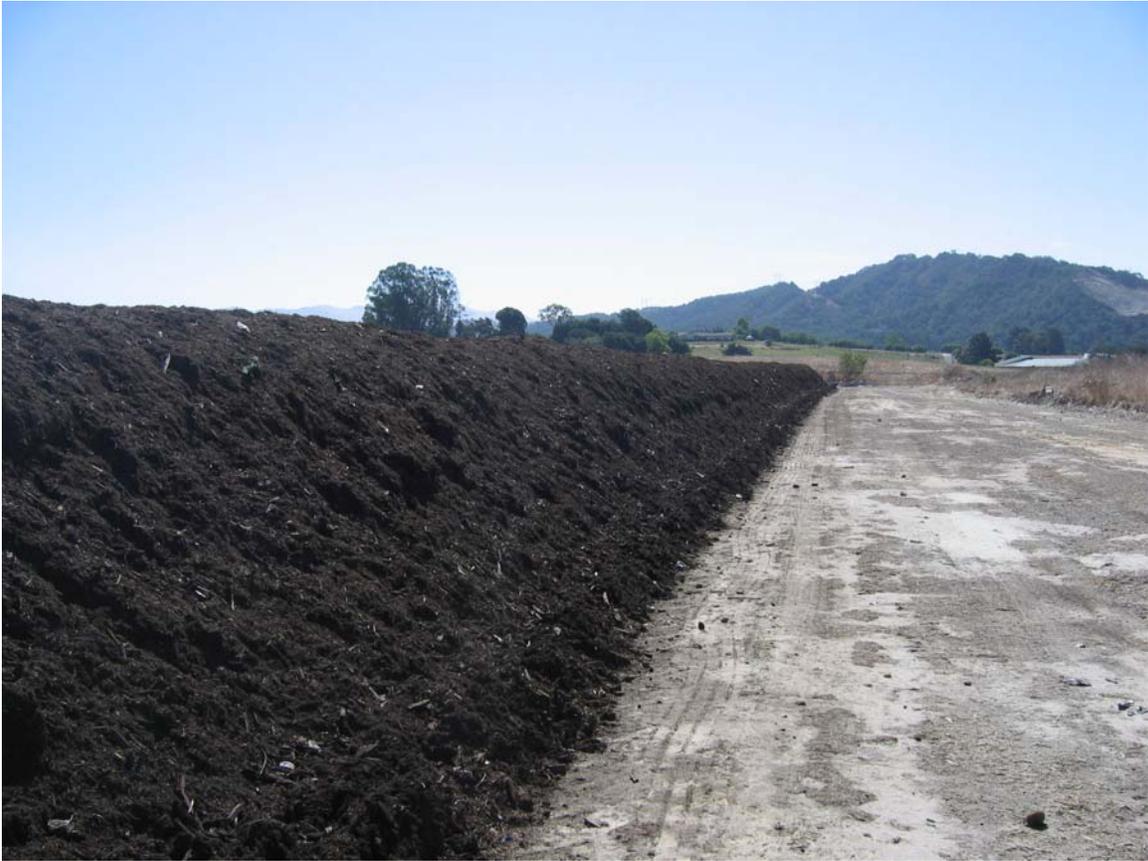
Photo 4

- The facility keeps its windrows at 8 ft. or less (see photo 4) and monitors the temperature during the pathogen cycle so that it is less than 140 °F.

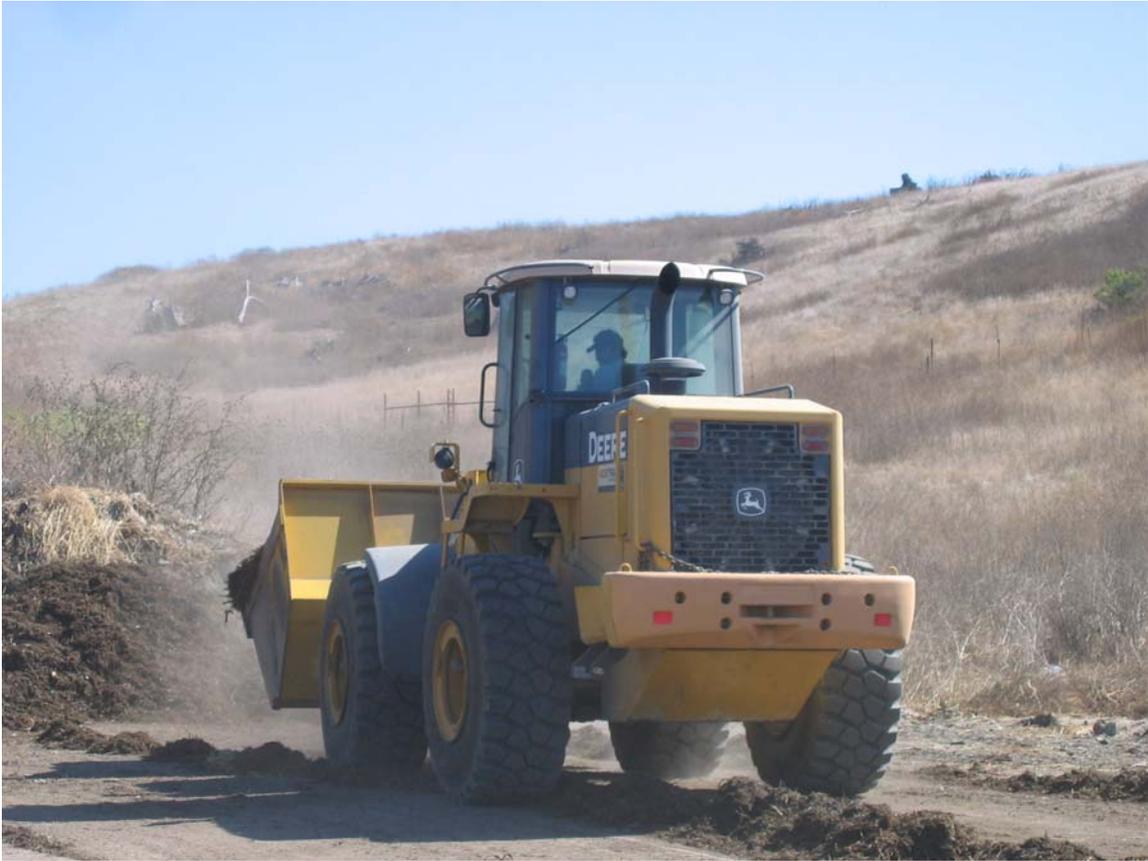
Photo 5

- During the tour of the compost facility, moderately strong odors were noticed downwind close-in (within 50 ft.) of a compost windrow but not upwind. (Wind direction that morning was toward the landfill – N by NW – and wind speed was light, estimated at <3 mph.) The odor was only considered “strong” when observing a front-end loader moving a pile of screened-out waste into a haul vehicle. This waste also was dry and a considerable dust cloud was generated when the pile was disturbed and loaded into the haul vehicle (see photo 5).

- This facility has no environmental cabs but does operate front-end loaders with an operator cab. One cab is newer and is equipped with AC and HEPA filters (photo 5) but not with advanced door seals and there is no seal inspection and replacement program. The other cab is enclosed but it is an older model that lacks AC and HEPA filters. All workers have N95 dust mask respirators available which are approved for use at composting facilities but none of the workers or management seen during the audit wore these respirators. It was stated that the workers are not required to wear them and most workers do not wear them during loading, screening, turning, or while in the cab. They usually wear them when grinding. (The auditor wore a N95 dust mask when stepping outside the vehicle at the compost facility.)

- Recommendations:
- Generation of dust during any movement of compost material or green waste should be kept to an absolute minimum by adding additional moisture via a water spray and establishing a “high wind” shut-down level for activities that generate dust. Visible clouds of dust should be avoided. While the “hand test” for soil moisture is adequate on some days, actual soil moisture should be measured by instrument on most days.

- Recommendations:
- The cabs of heavy equipment should be inspected for poor window and door seals and worn seals replaced. Workers should be required to wear N95 dust masks when not inside a heavy equipment cab, auto, or truck if at the compost

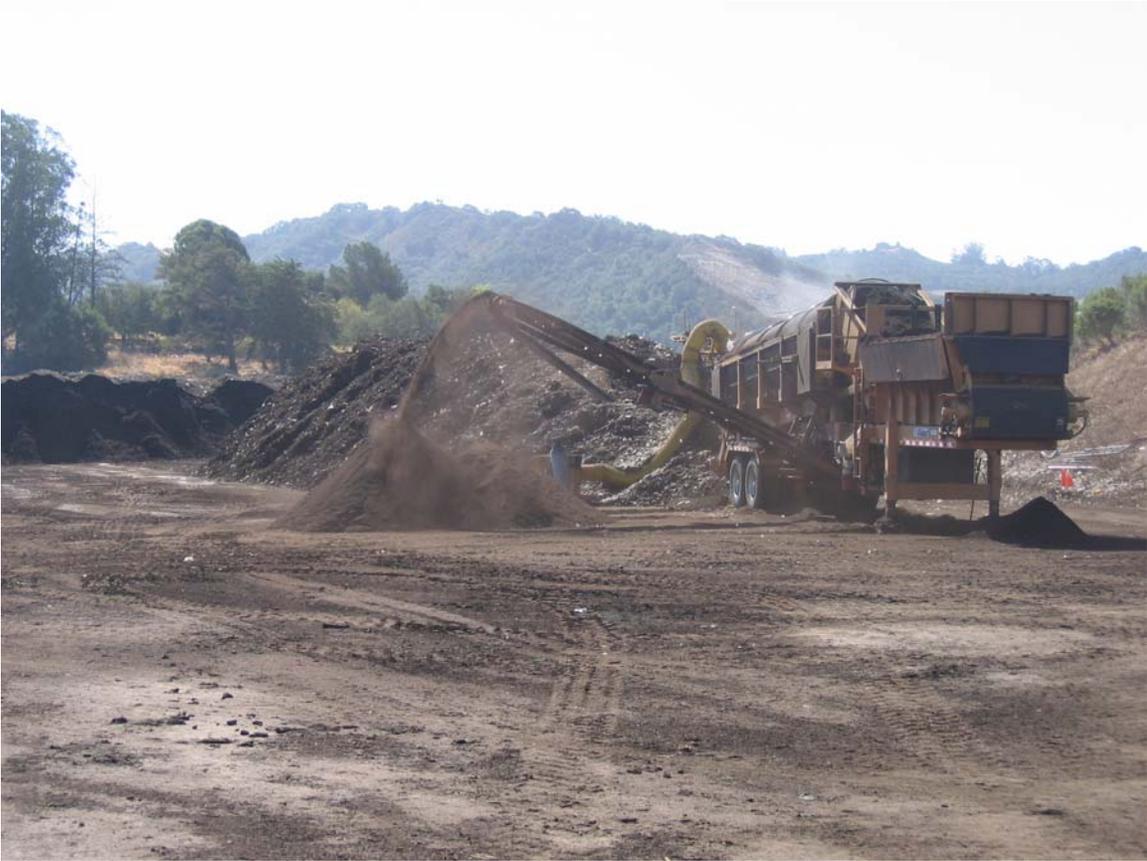
Photo 6

- Dust was also generated during the “screening” procedure when the compostable material was dropped onto the site for movement to the windrows. The material was dry and dust could be seen coming from the pile (see photo 6).
