**Appendix D.**  
**California Red-legged Frog Habitat Site Assessment Data Sheet**

Proposed project name: Bob Jones Pathway

# Appendix I Photo Documentation

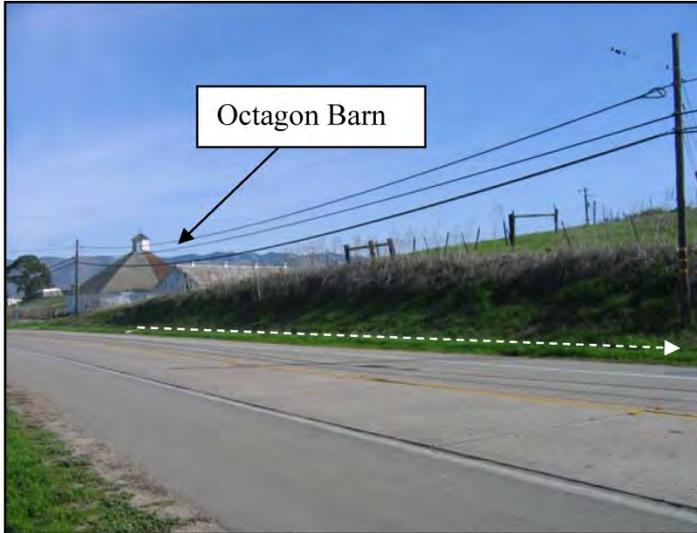
**Photo 1:**

Northeast view of the northernmost section of the proposed new bike path route, beginning along the east side of South Higuera Street in San Luis Obispo. The Octagon Barn is visible in the background. The white dashed line represents the approximate location of the proposed route.

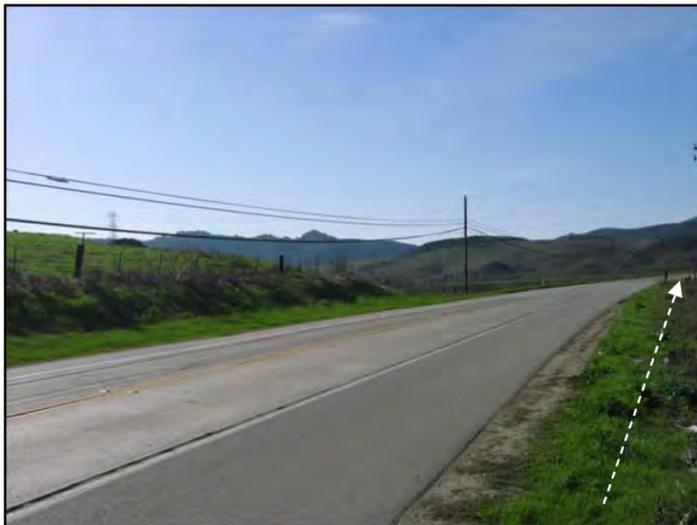
**Photo 2:**

Southwest view of the proposed new bike path route along the west side of South Higuera Street. The white dashed line represents the approximate location of the proposed route.

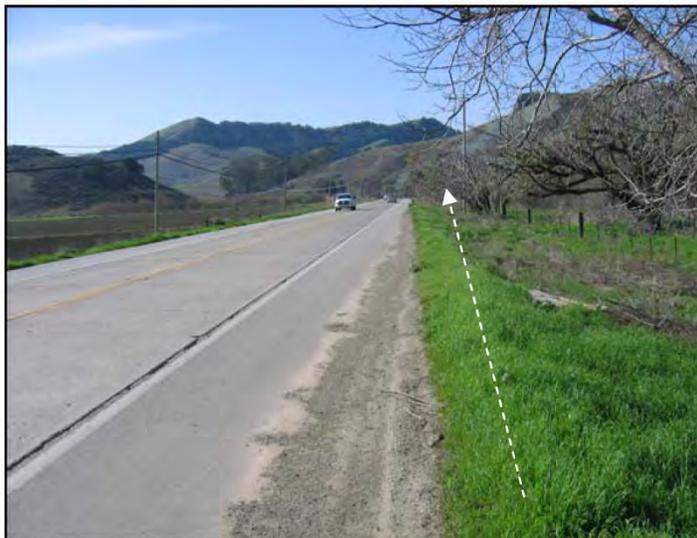
**Photo 3:**

Another view of the proposed new bike path route along the west side of South Higuera Street. The white dashed line represents the approximate location of the proposed route.

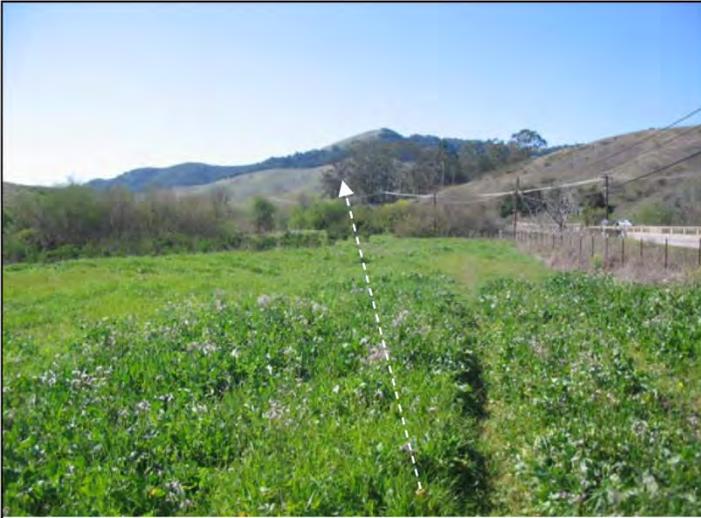
**Photo 4:**

Southwest view of SLO Land Conservancy Property. The white dashed line represents the approximate location of the proposed route.

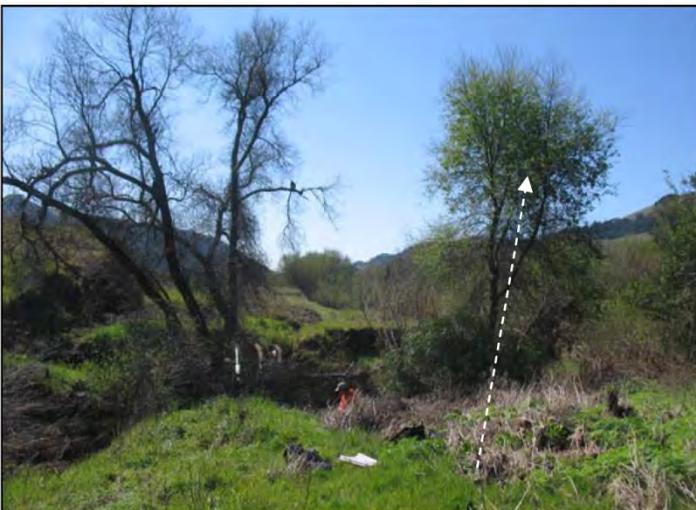
**Photo 5:**

West view of location of proposed South Higuera Bridge (BR-A) crossing of SLO Creek. The white dashed line represents the approximate location of the orientation of the proposed bridge and route.

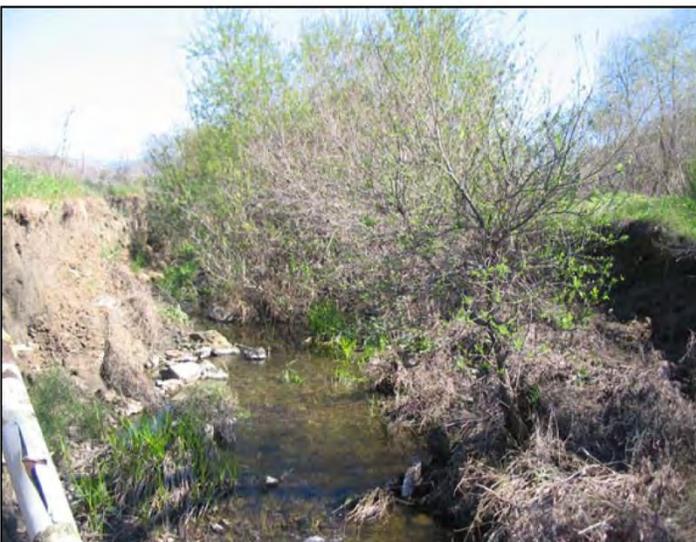
**Photo 6:**

East view of in-stream and vegetative conditions near the proposed South Higuera Bridge (BR-A) crossing of SLO Creek. Note riparian vegetation in the overstory and sparse emergent vegetation in the streambed.

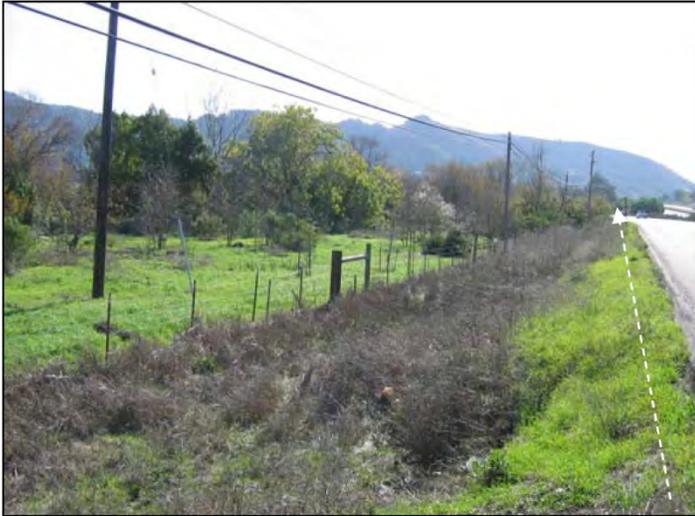
**Photo 7:**

South view of the proposed new bike path route along the east side of South Higuera Street north of Cloverridge Lane. The white dashed line represents the approximate location of the proposed route.

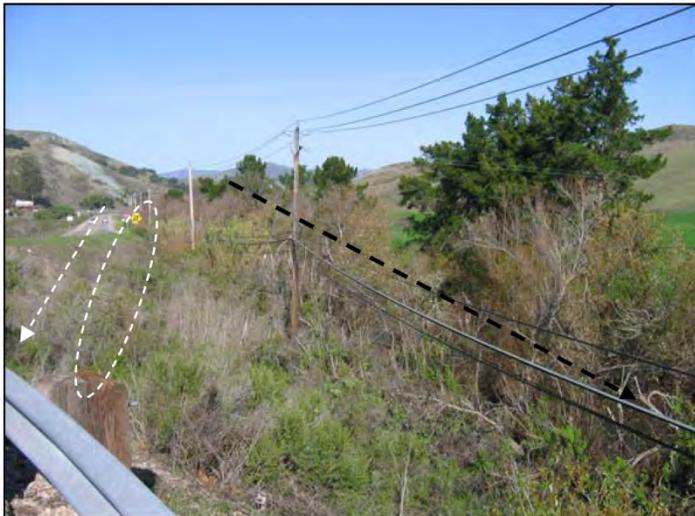
**Photo 8:**

North view of the proposed route along the east side of South Higuera Street north of Cloverridge Lane. The oval represents the approximate location of RSP that would be installed to support the trail. Some riparian vegetation would be impacted along the SLO Creek riparian corridor (orientation of the creek depicted by dark dashed line).

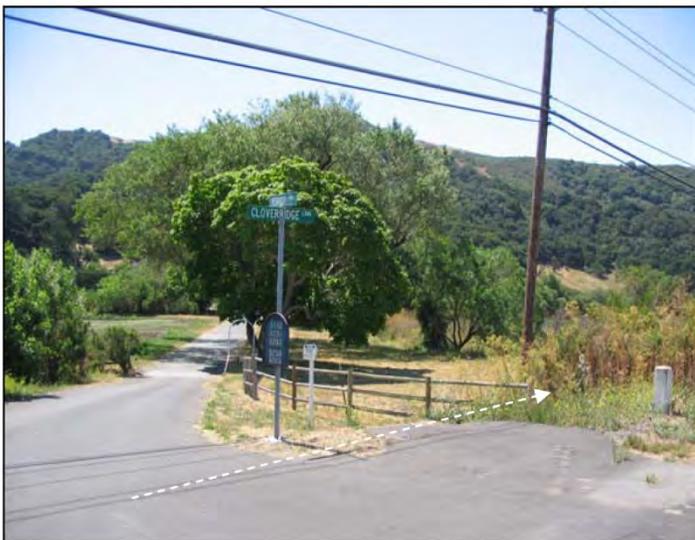
**Photo 9:**

Intersection of Cloverridge Lane and Venado Lane. The white dashed line represents the approximate location of the proposed route.

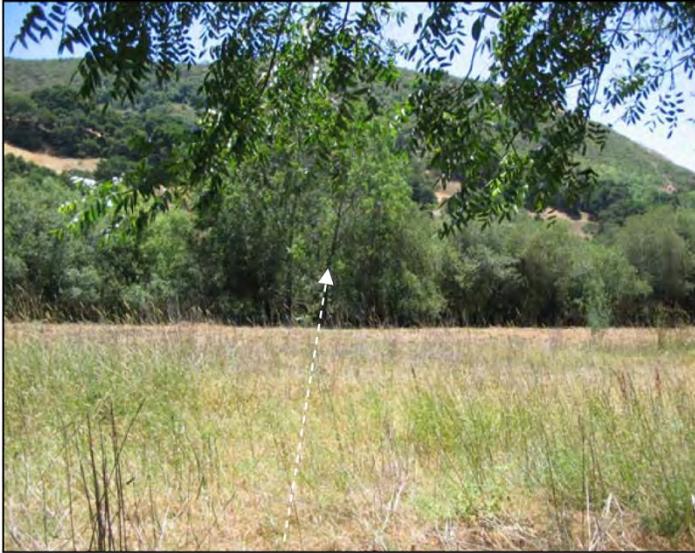
**Photo 10:**

Southeast view of the proposed Bunnell Bridge (BR-B) crossing of SLO Creek. The white dashed line represents the approximate location of the orientation of the proposed bridge and route.

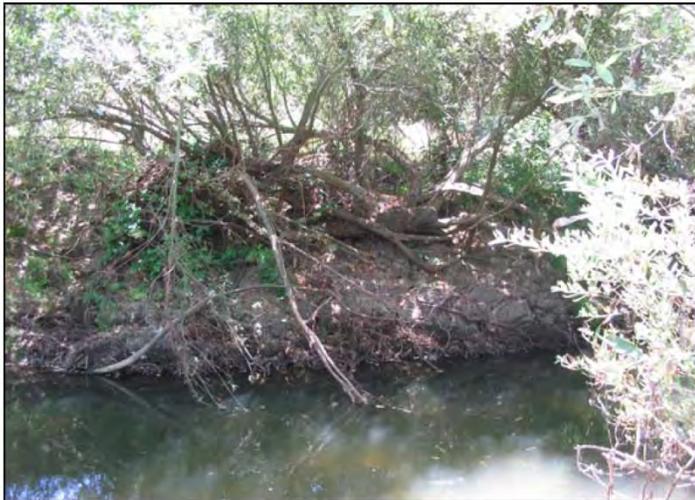
**Photo 11:**

Close-up of conditions of SLO Creek at the location of the proposed Bunnell Bridge (BR-B). The riparian overstory at this location is dense and emergent vegetation is dense to non-existent. Juvenile steelhead were observed in the creek at this location.

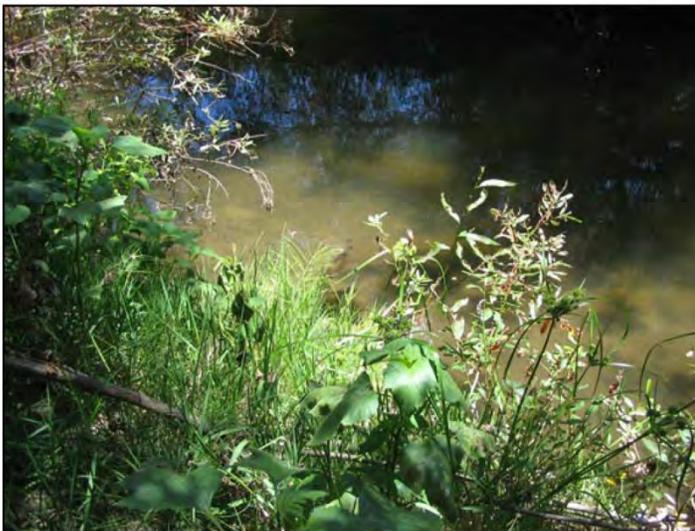
**Photo 12:**

View of bank and emergent vegetation near the proposed Bunnell Bridge (BR-B).
