Appendix D

Baseflow Habitat Evaluation

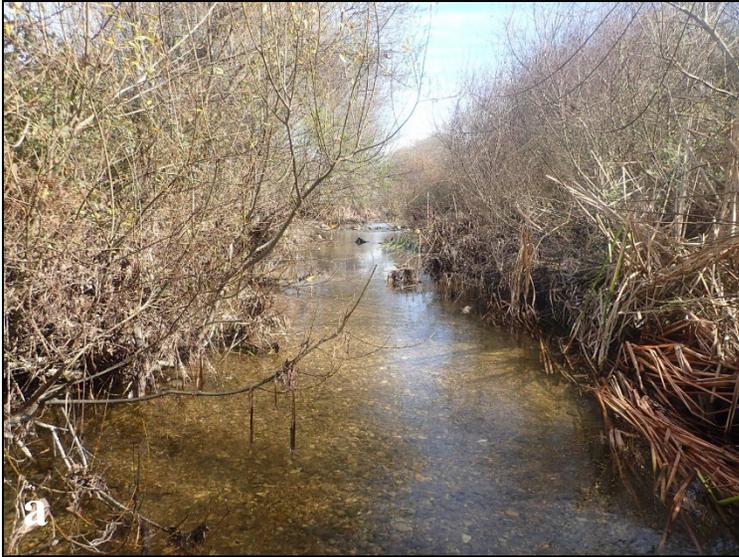
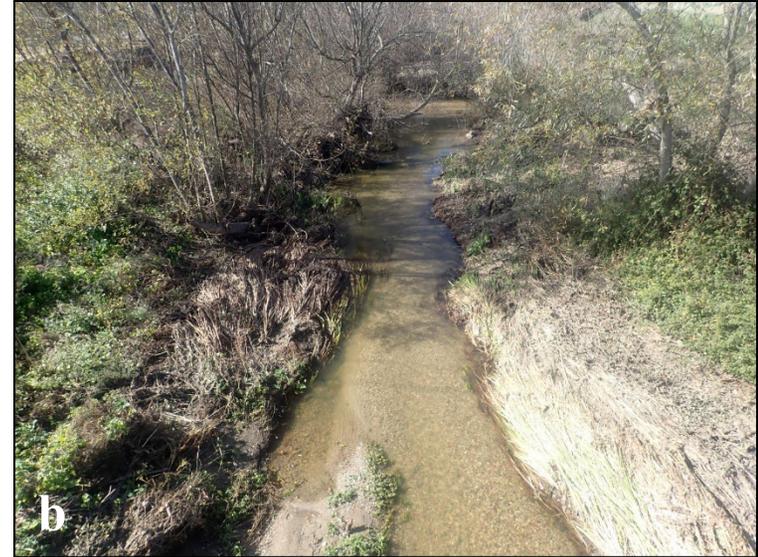
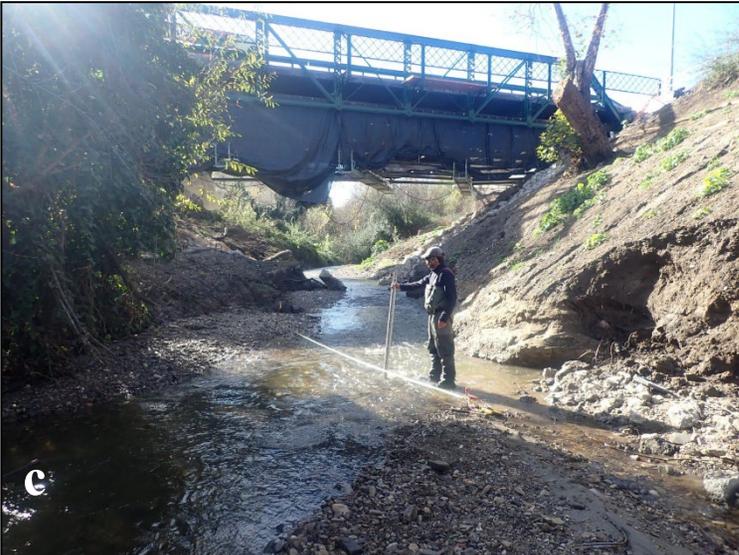
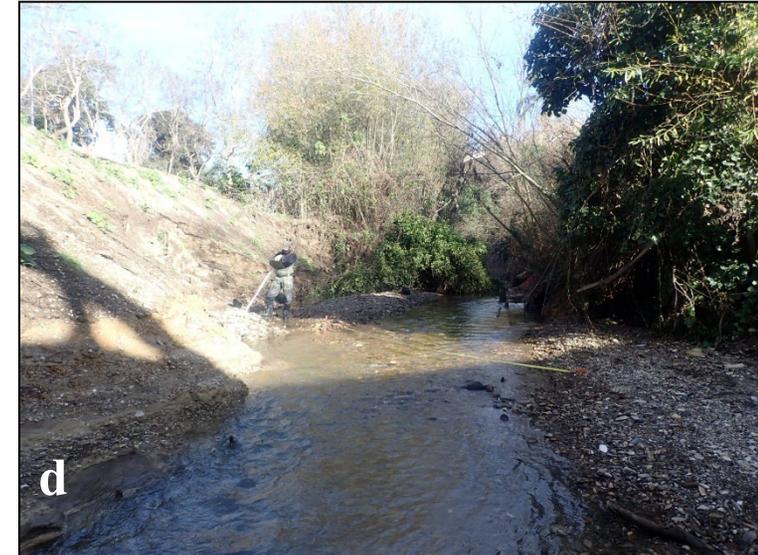
Figure D-1. Lopez Dam release of 3 cfs. At the Lagoon on 2/3/21 (a), 22nd Street Bridge on 2/3/21 (b), and City of Arroyo Grande on 2/1/21 (c-d). No flow measurements available.

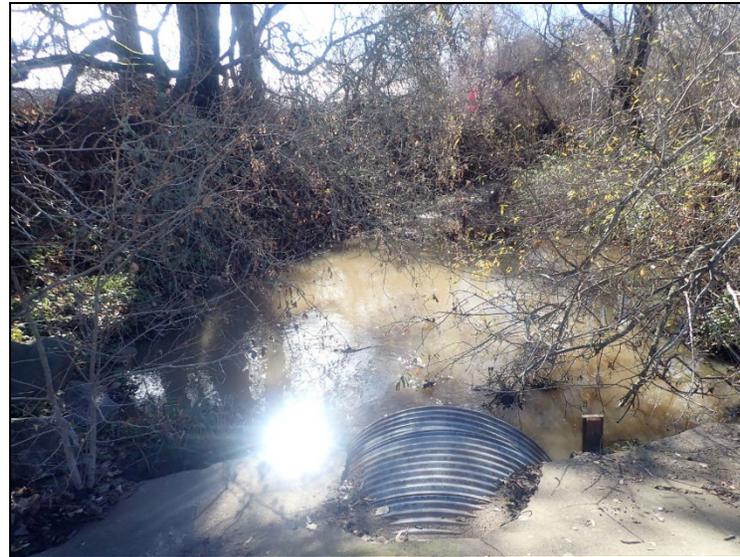
Figure D-2. Lopez Dam release of 3 cfs at Cecchetti Road on 1/29/21. No flow measurements available.

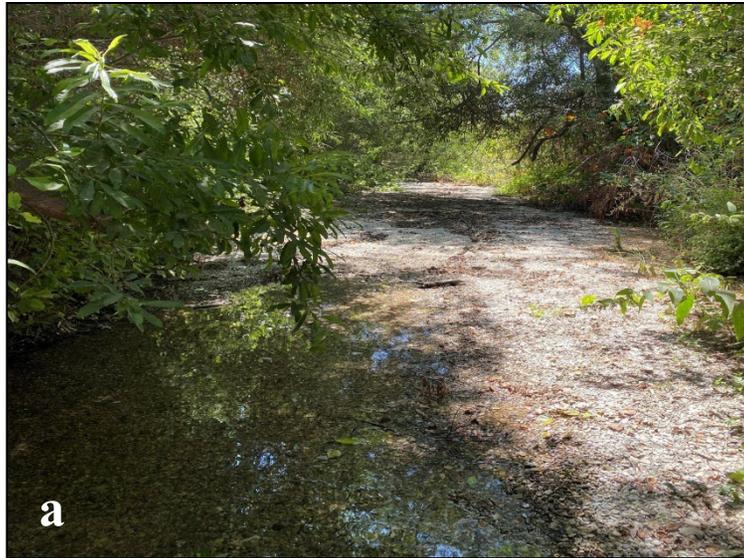
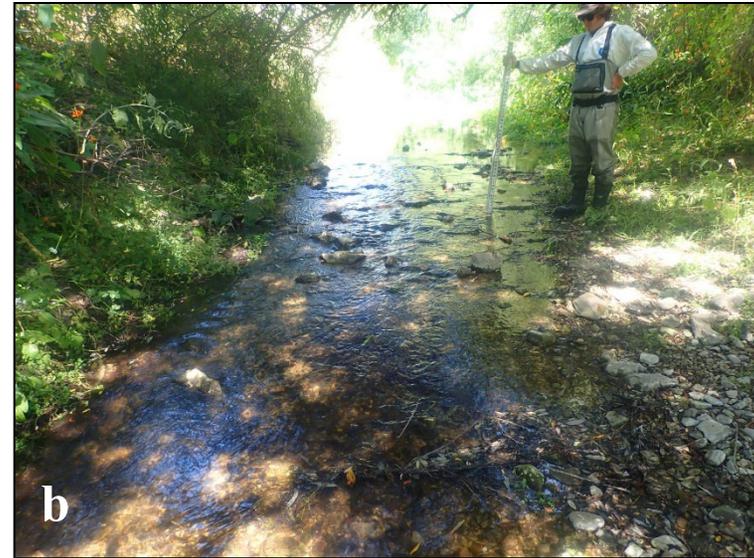
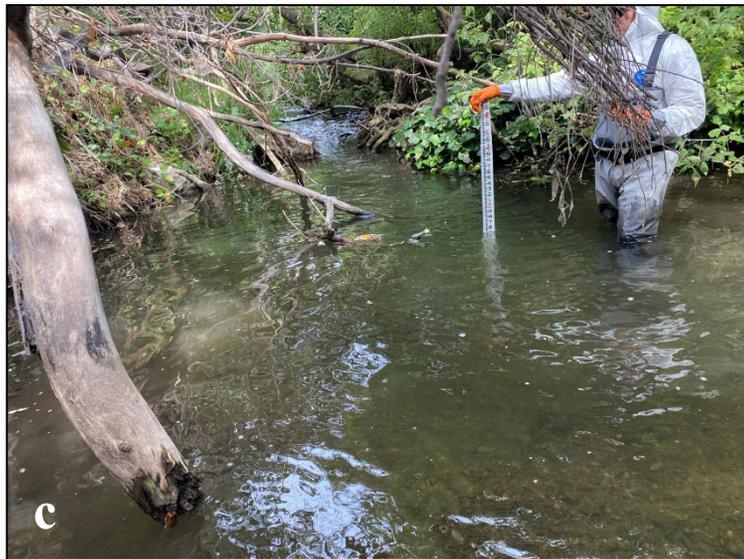
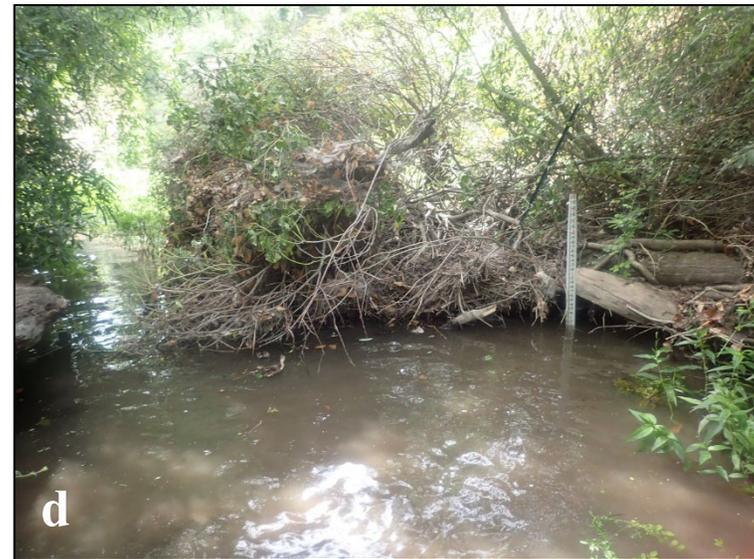
Figure D-3. Lopez Dam release of 5 cfs at the 22nd St. Bridge on 7/21/21 at 0 cfs (a), Upstream of the lagoon on 7/21/21, flow measured at 1.1 cfs (b), and City of Arroyo Grande on 7/22/21, flow measured at 1.9 cfs (c-d).

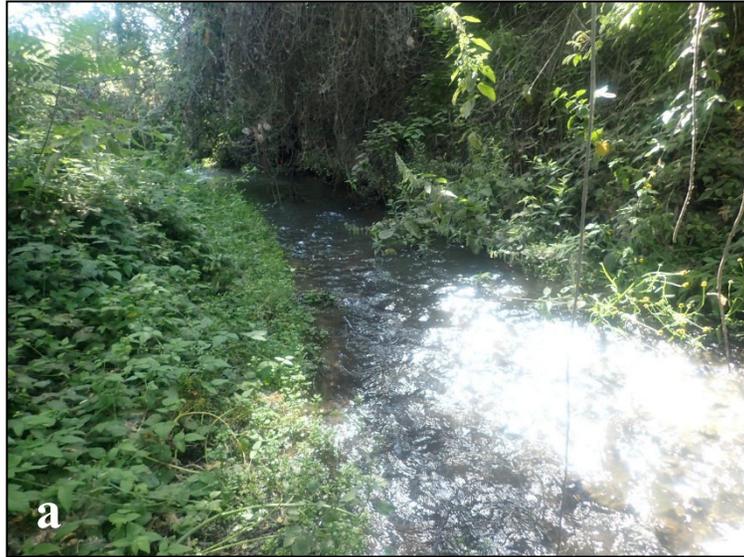
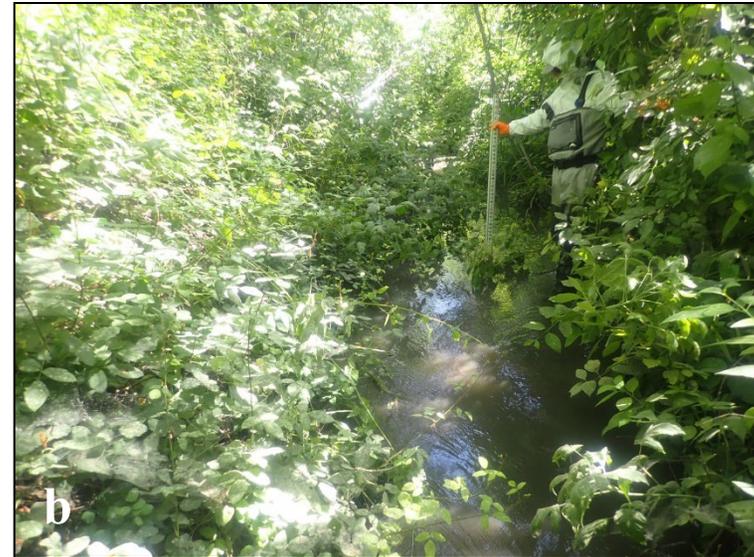
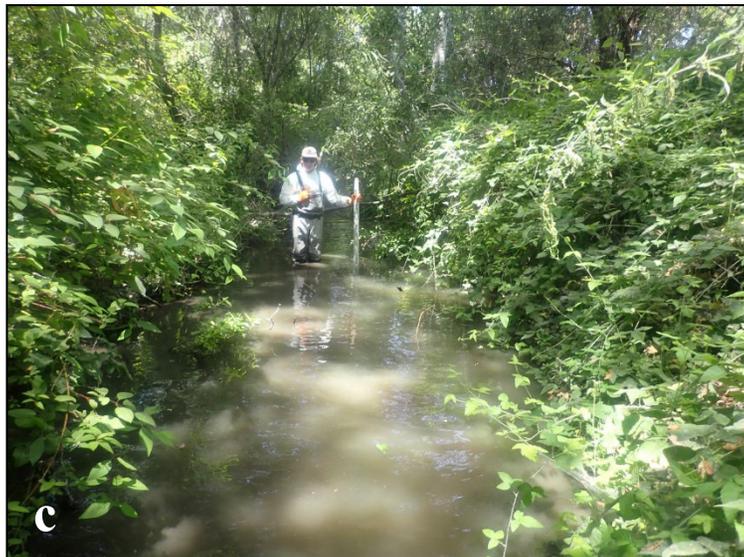
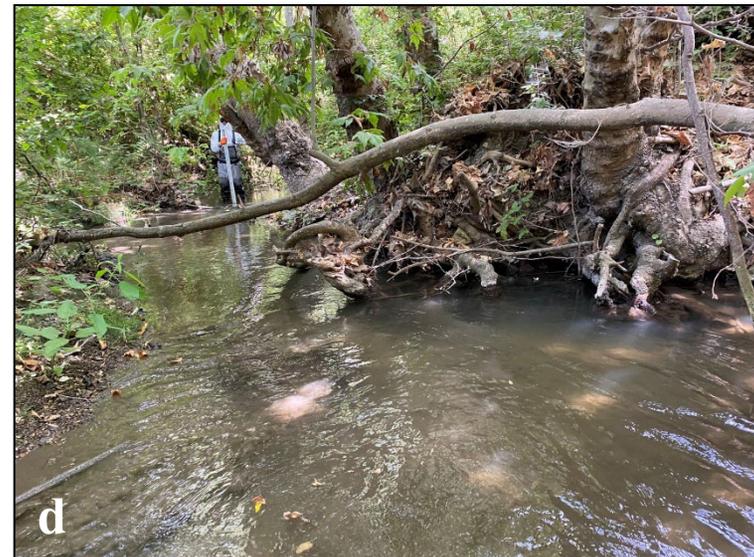
Figure D-4. Lopez Dam release of 5 cfs at Cecchetti Road on 7/21/21, flow measured at 2.7 cfs (a-b), and at Talley Farms Road on 7/22/21, flow measured at 3.5 cfs (c-d).

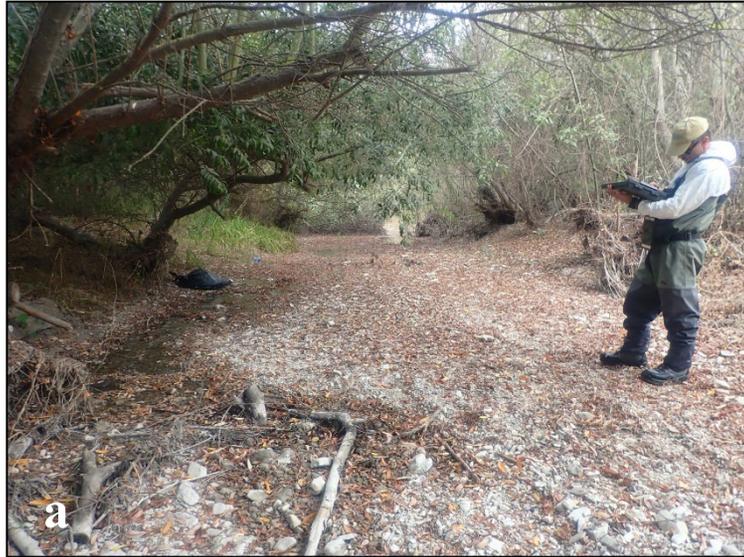
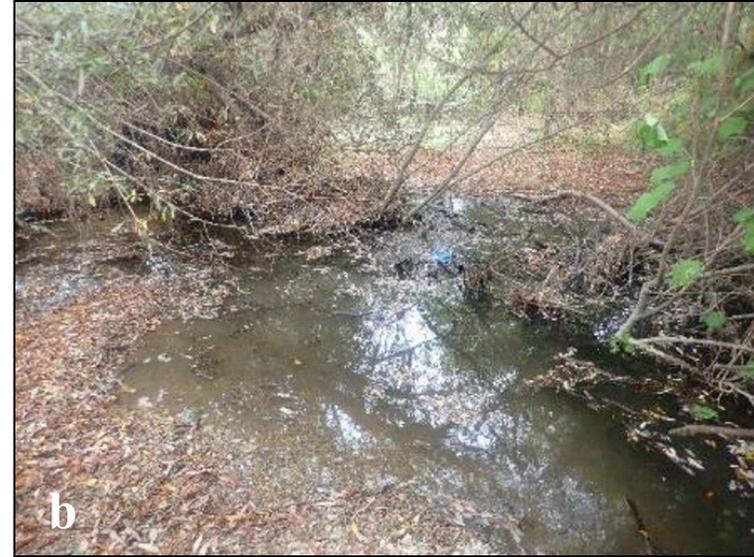
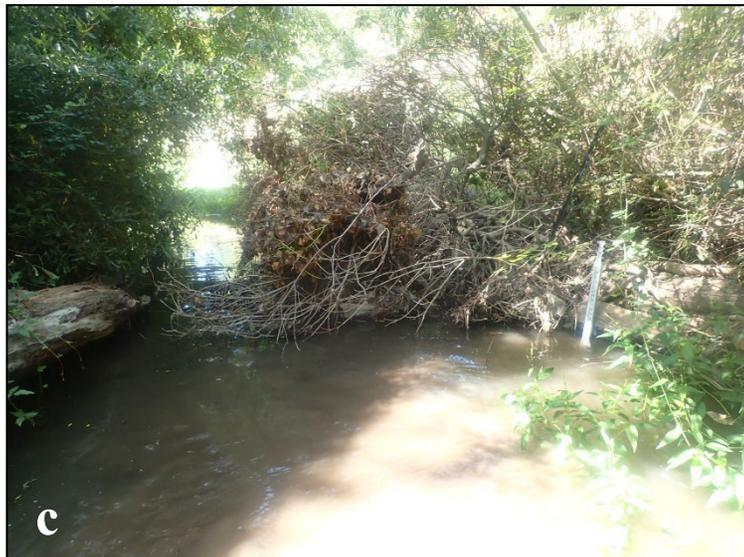
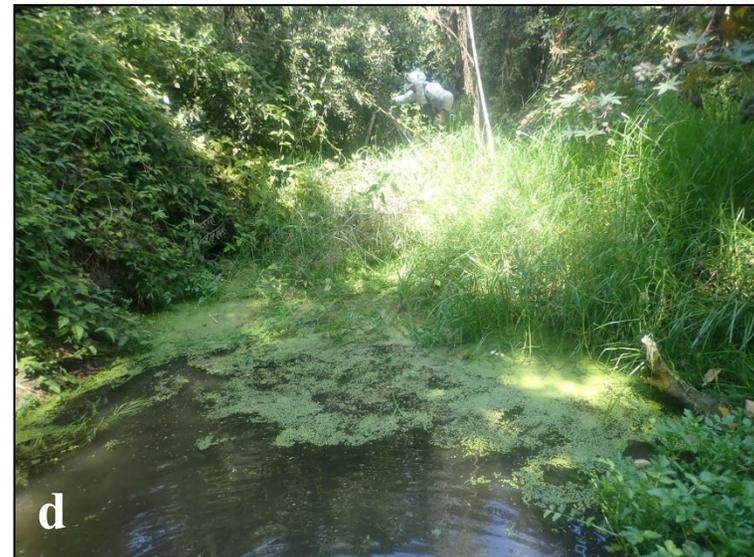
Figure D-5. Lopez Dam release of 7 cfs upstream of the lagoon on 9/6/21 at 0 cfs (a), upstream of the lagoon on 9/6/21, flow measured at 2.2 cfs (b), and City of Arroyo Grande on 9/6/21, flow measured at 3.9 cfs (c-d).

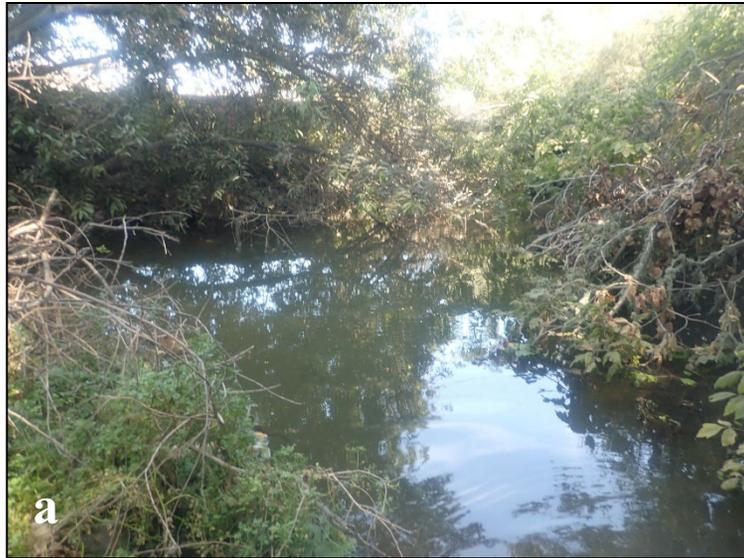
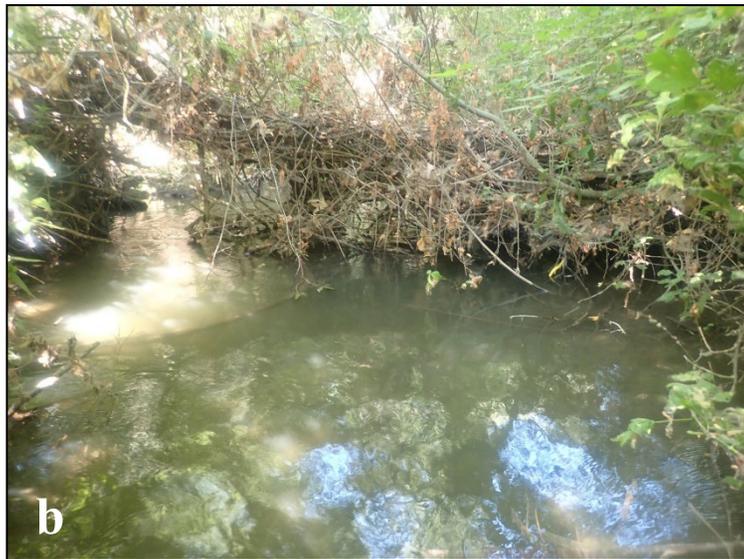
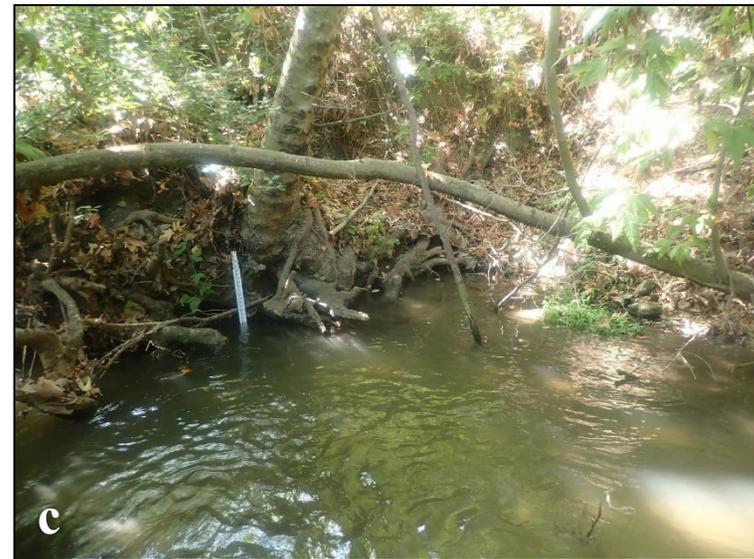
Figure D-6. Lopez Dam release of 7 cfs at Cecchetti Road on 9/6/21, flow measured at 4.5 cfs (a), and at Talley Farms Road on 9/6/21, flow measured at 5.2 cfs (b-c).

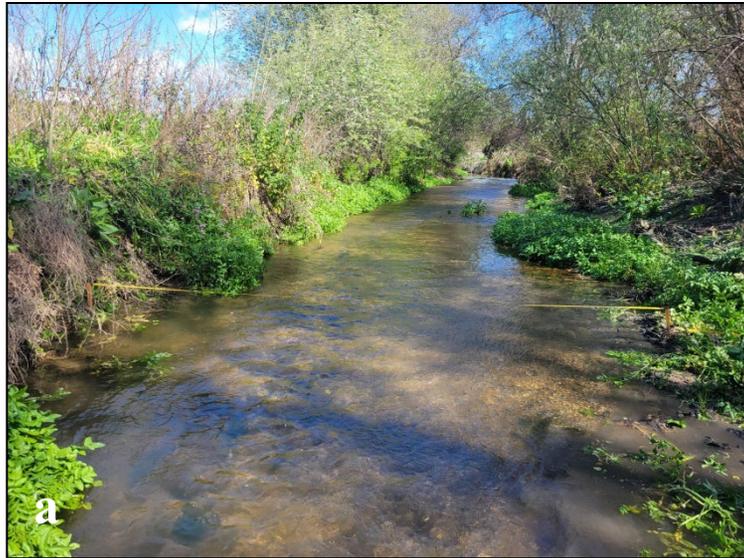
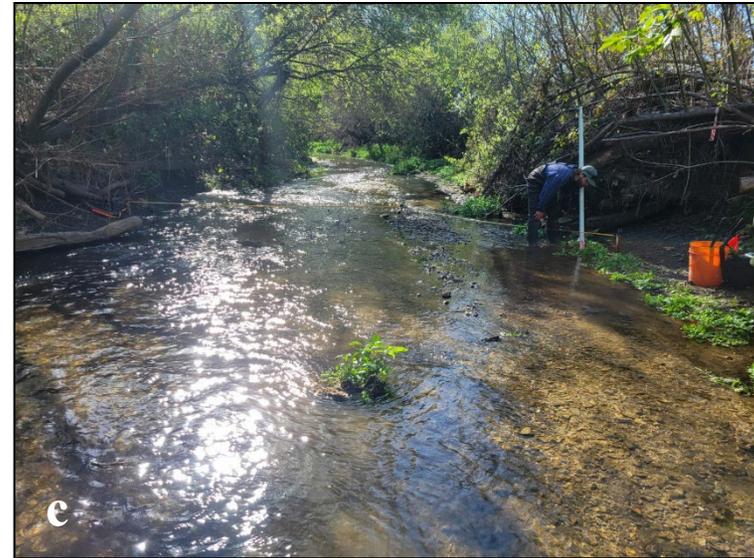
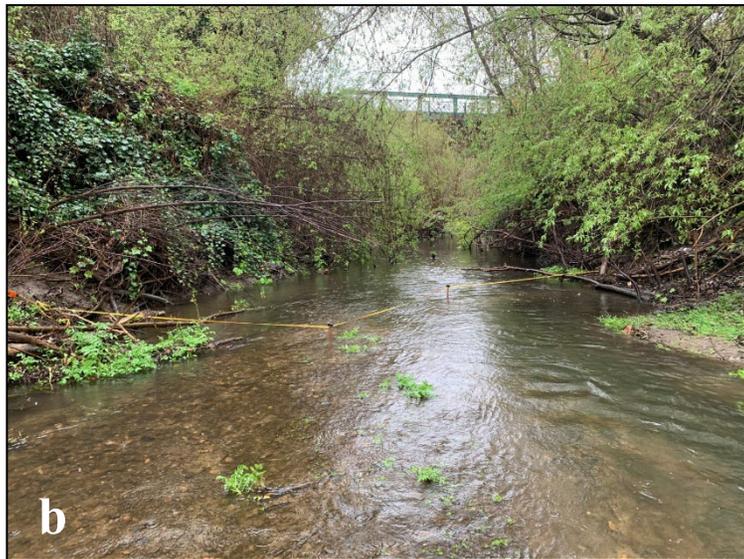
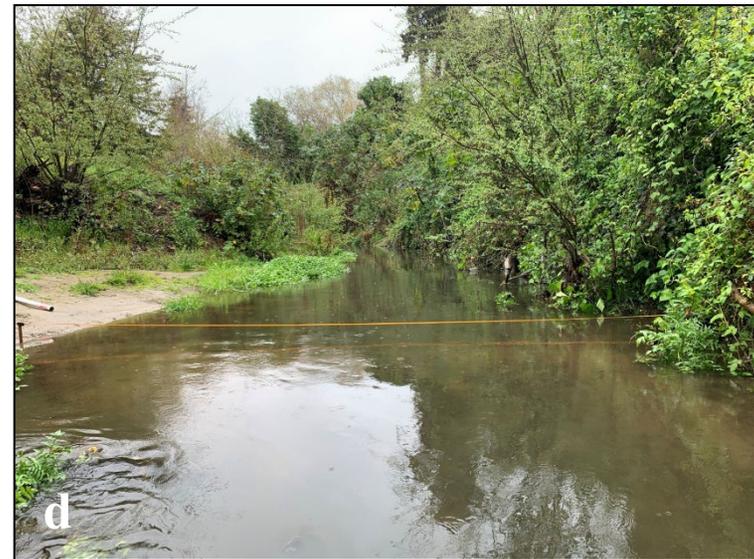
Figure D-7. Lopez Dam release of 8 cfs upstream of the lagoon on 3/3/25 (a-b) and City of Arroyo Grande on 3/5/25 (c-d). No flow measurements available.

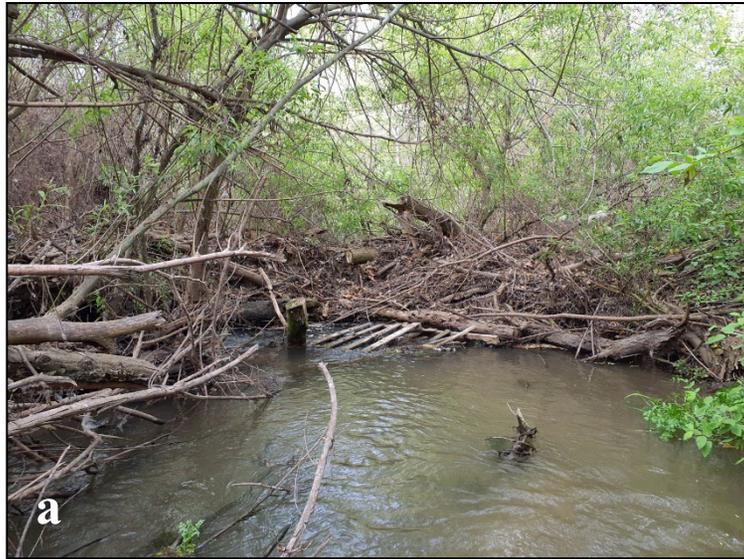
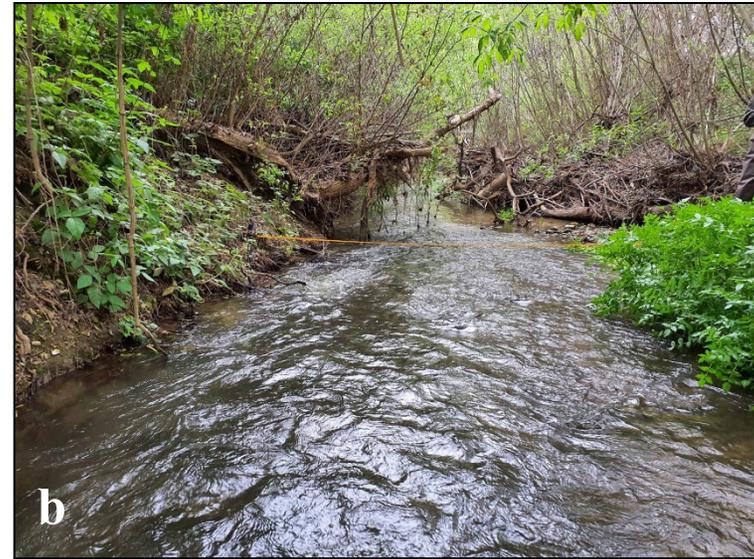
Figure D-8. Lopez Dam release of 8 cfs at Cecchetti Road on 3/27/25 (a-b). No flow measurements available.
