Arroyo Grande Creek Channel Waterway Management Program

National Marine Fisheries Service
Biological Opinion Annual Report

January 2026

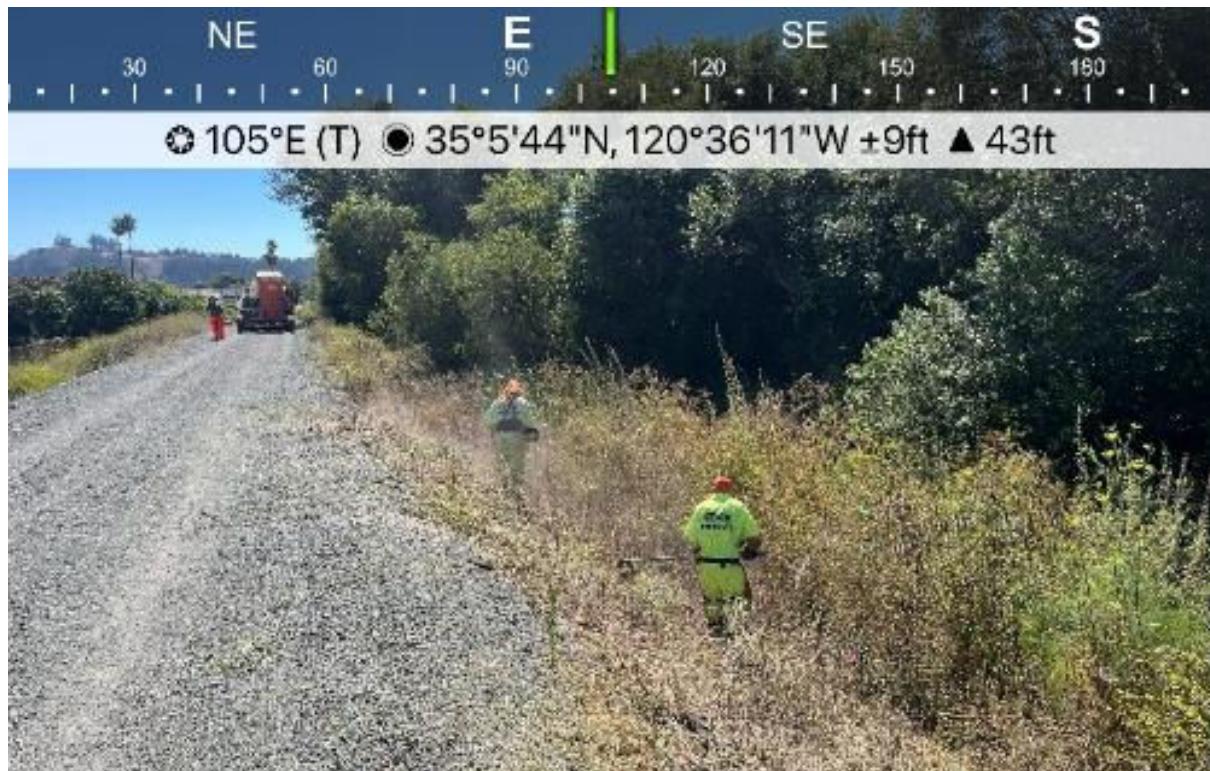
Photograph 1. Vegetation removal at SMZ 12/13, facing east. July 10, 2025.

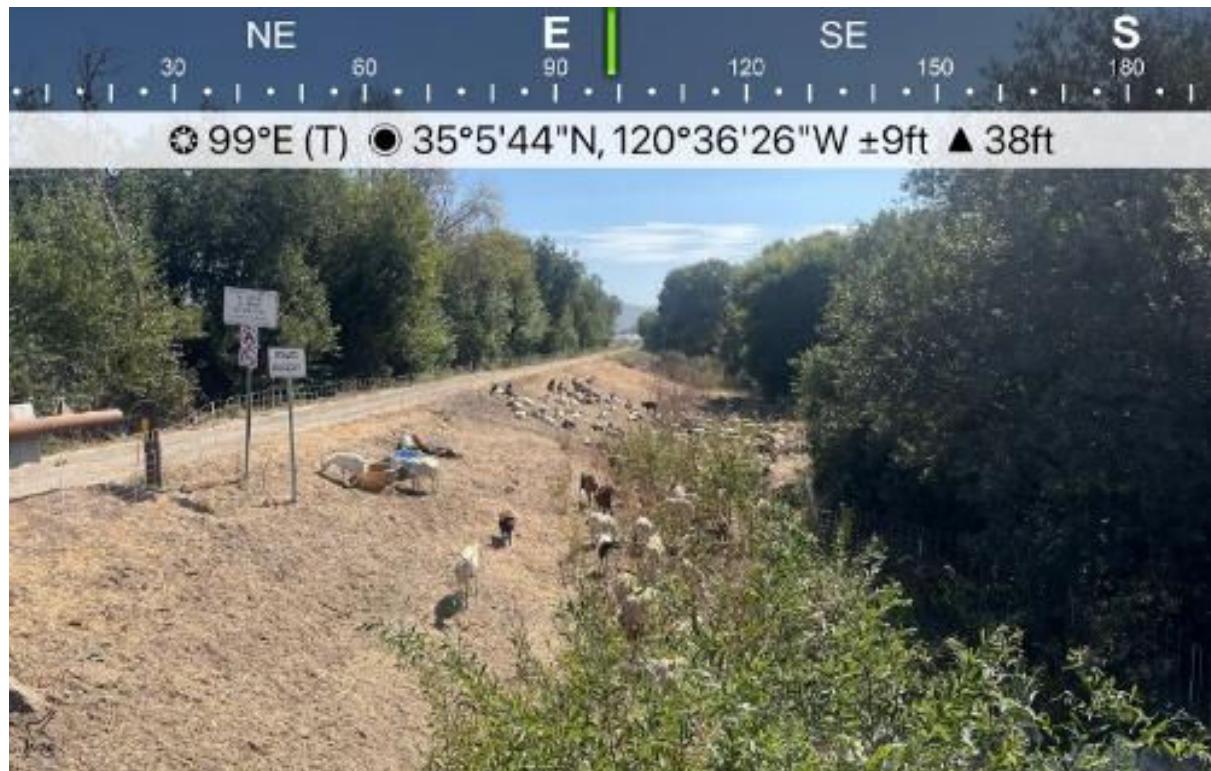
Photograph 3. Goats utilized for vegetation removal downstream on 22nd Street bridge, facing east. August 20, 2025.

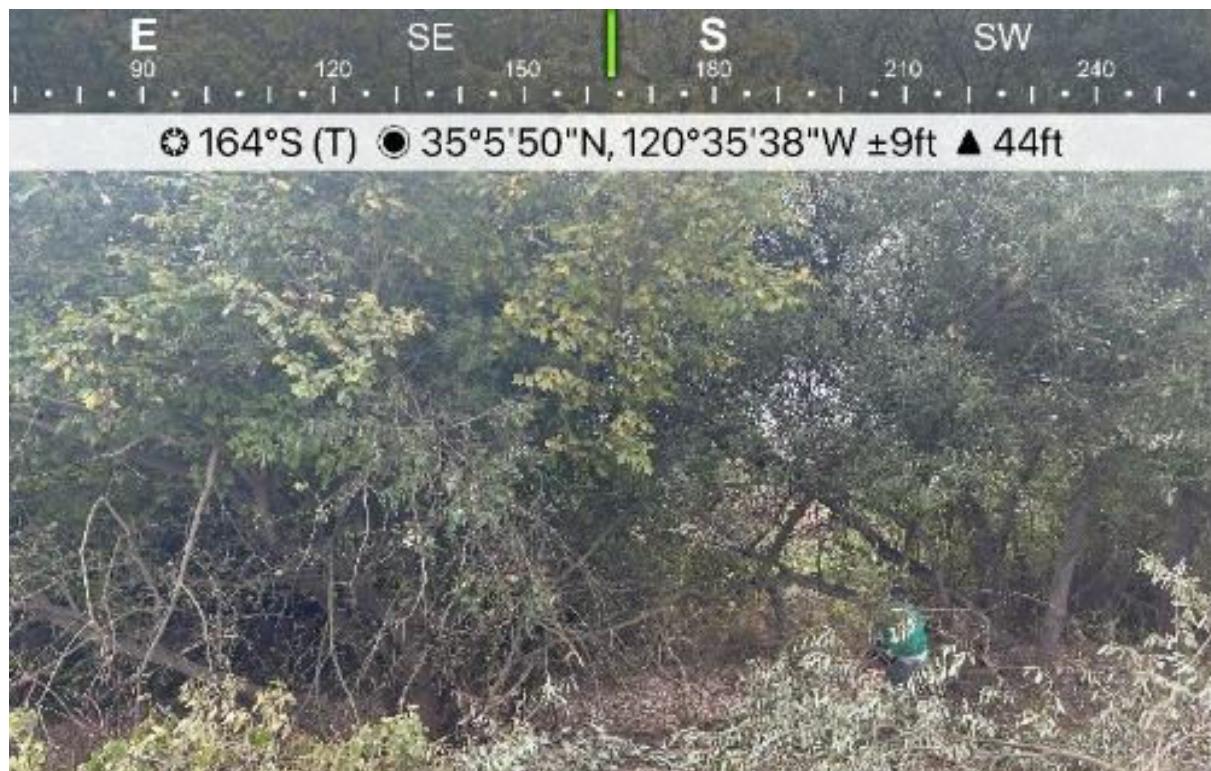
Photograph 4. Vegetation management crew trimming woody vegetation within the secondary channel north of Arroyo Grande Creek, facing south. September 16, 2025.

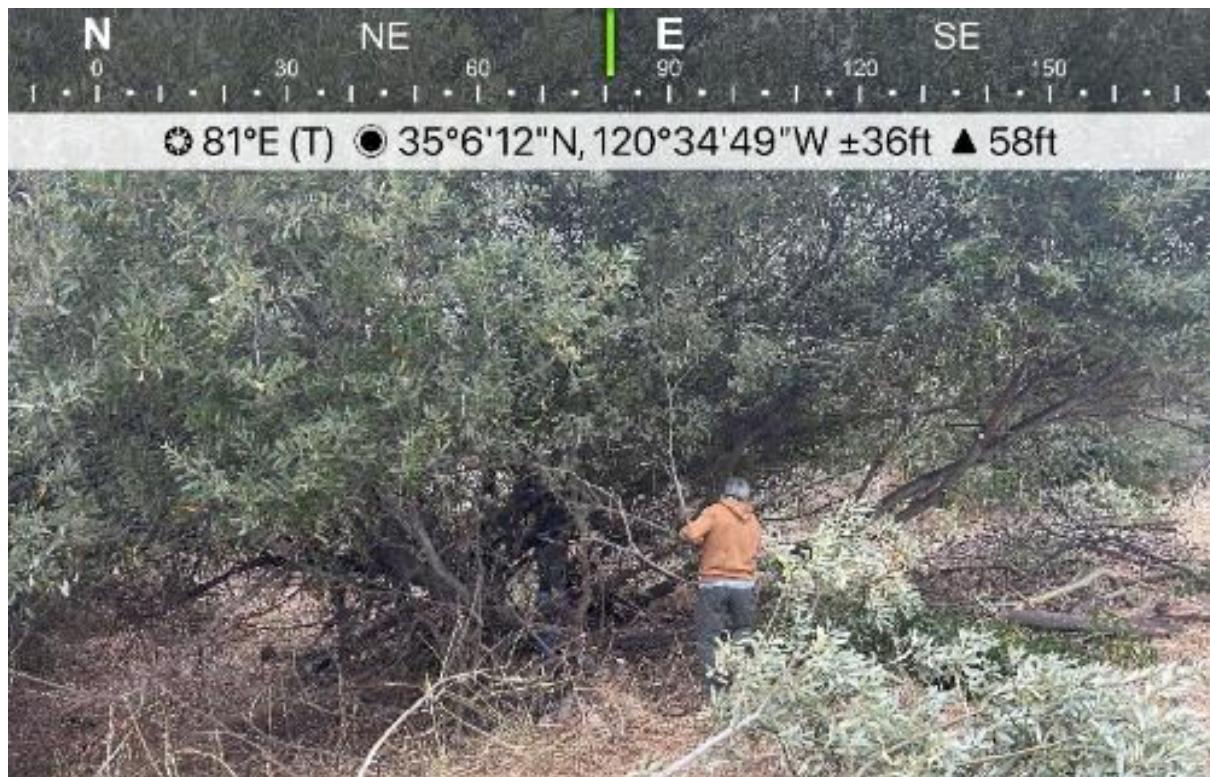
Photograph 5. Crew trimming woody vegetation along levee road south of Los Berros Creek, facing east. September 19, 2025.

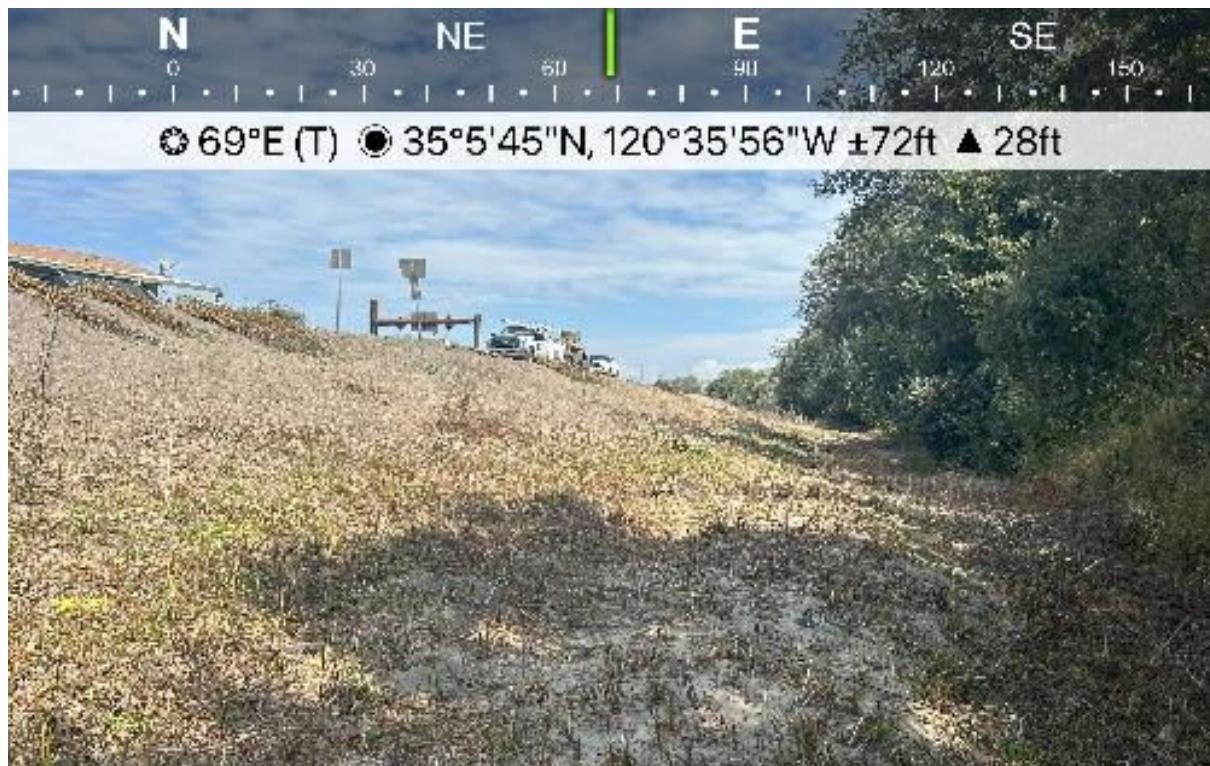
Photograph 6. Levee road north of Arroyo Grande Creek following woody vegetation trimming, facing east. September 16, 2025.

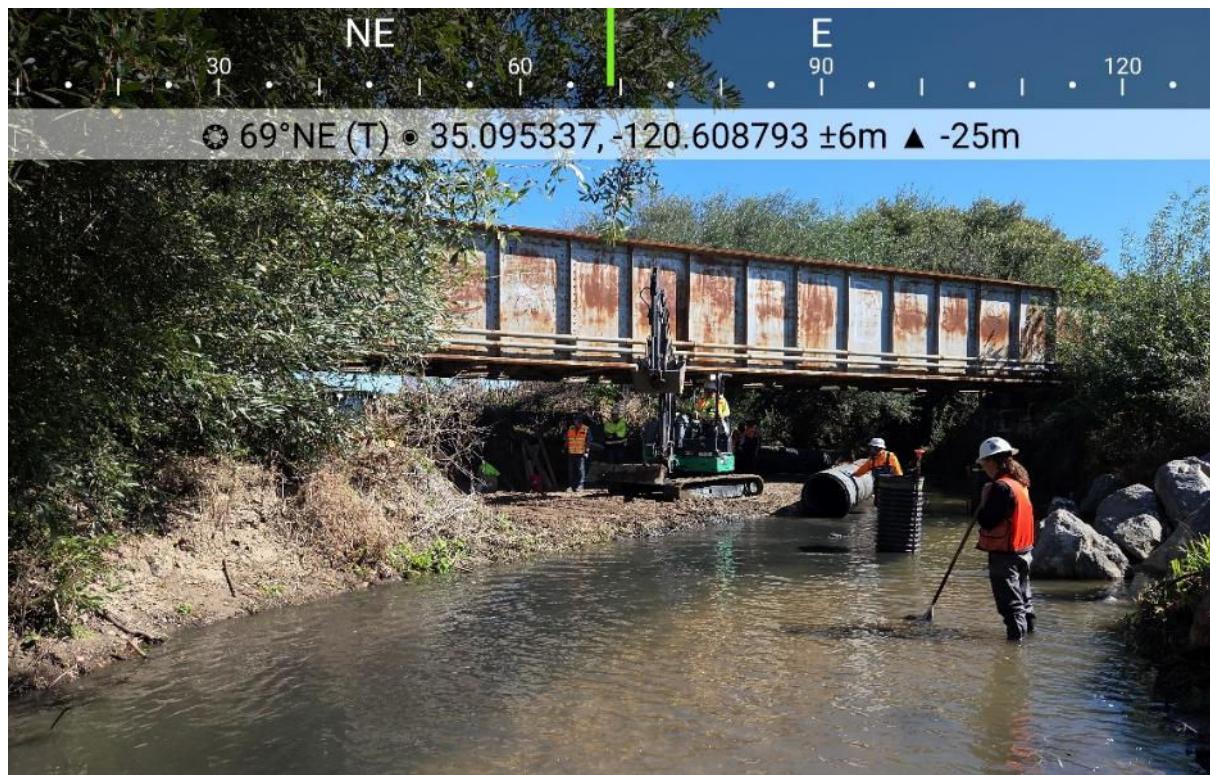
Photograph 8. Fish recovery and relocation during diversion of Arroyo Grande Creek at the Breach Site. October 16, 2025.

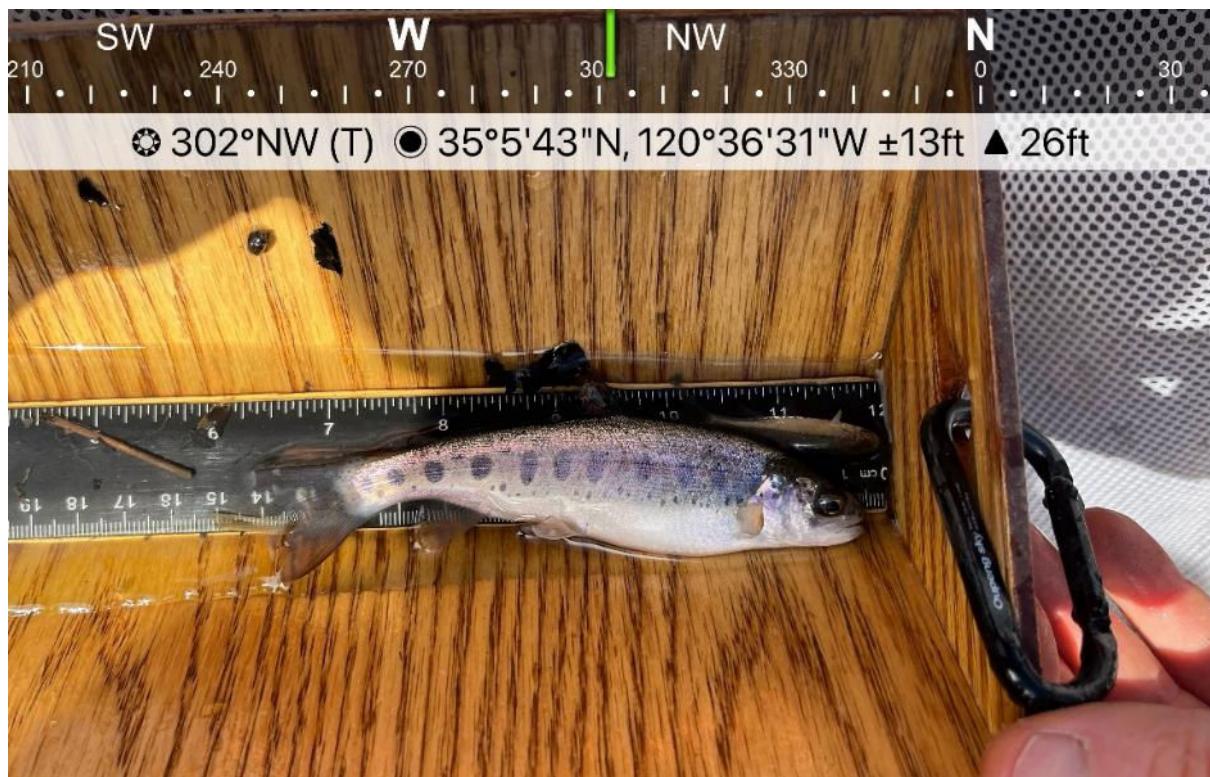
Photograph 9. SCCC steelhead recovered and relocated from the Breach Site. October 15, 2025.

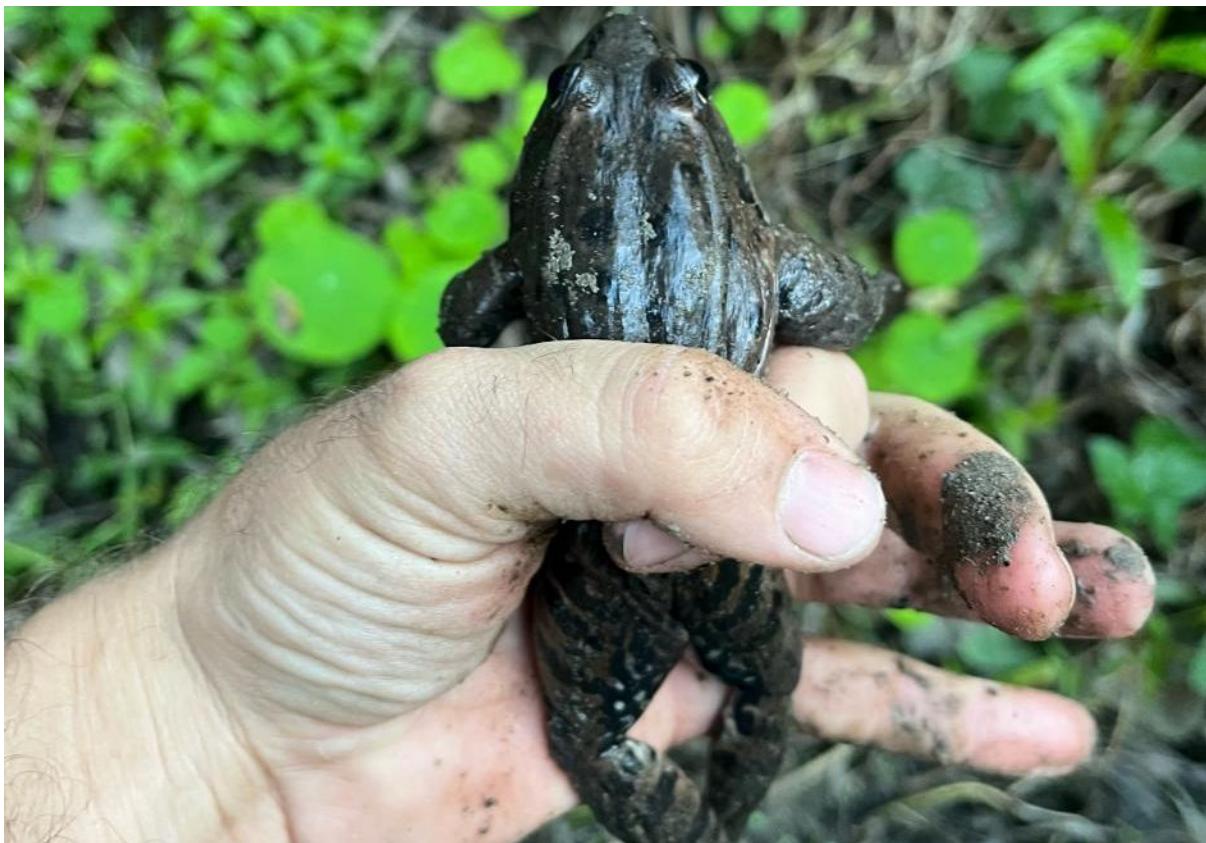
Photograph 13. Adult CRLF captured and relocated. October 22, 2025.

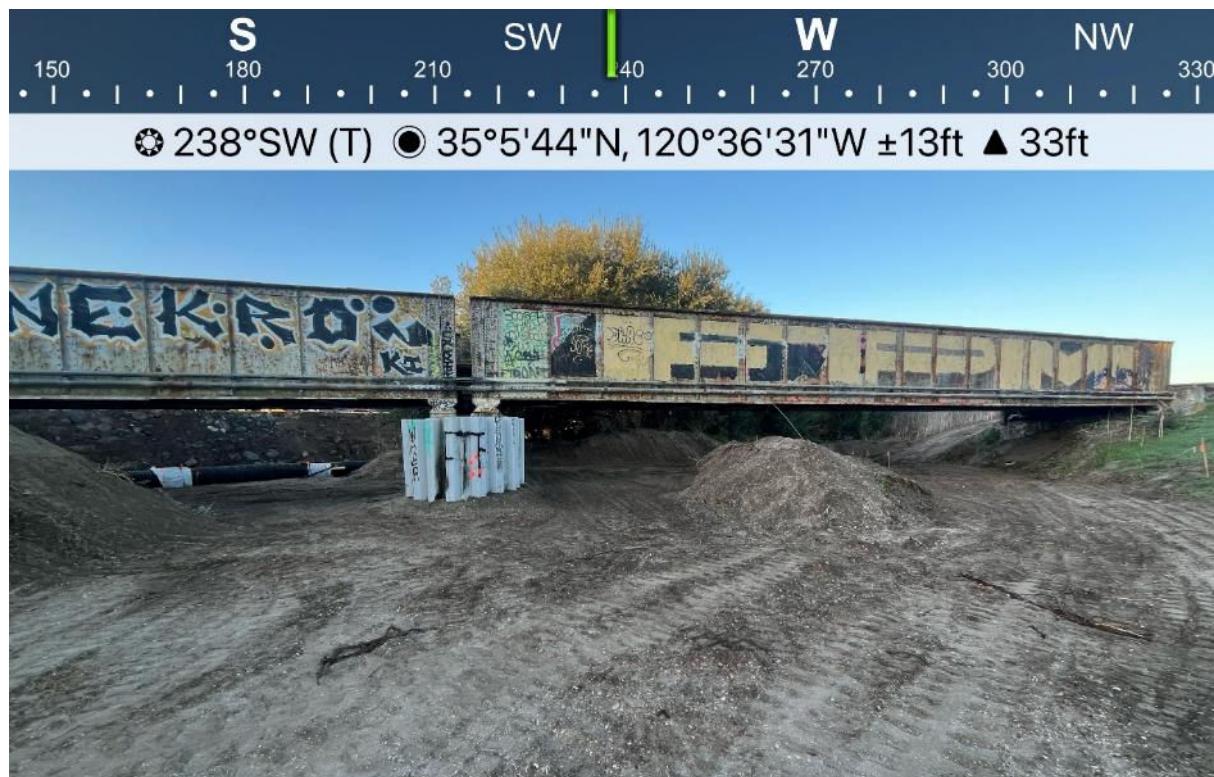
Photograph 15. Looking downstream (southwest) at the UPRR Bridge crossing the SMZ 7 secondary channel; Breach Site work area in background, photo left. October 27, 2025.

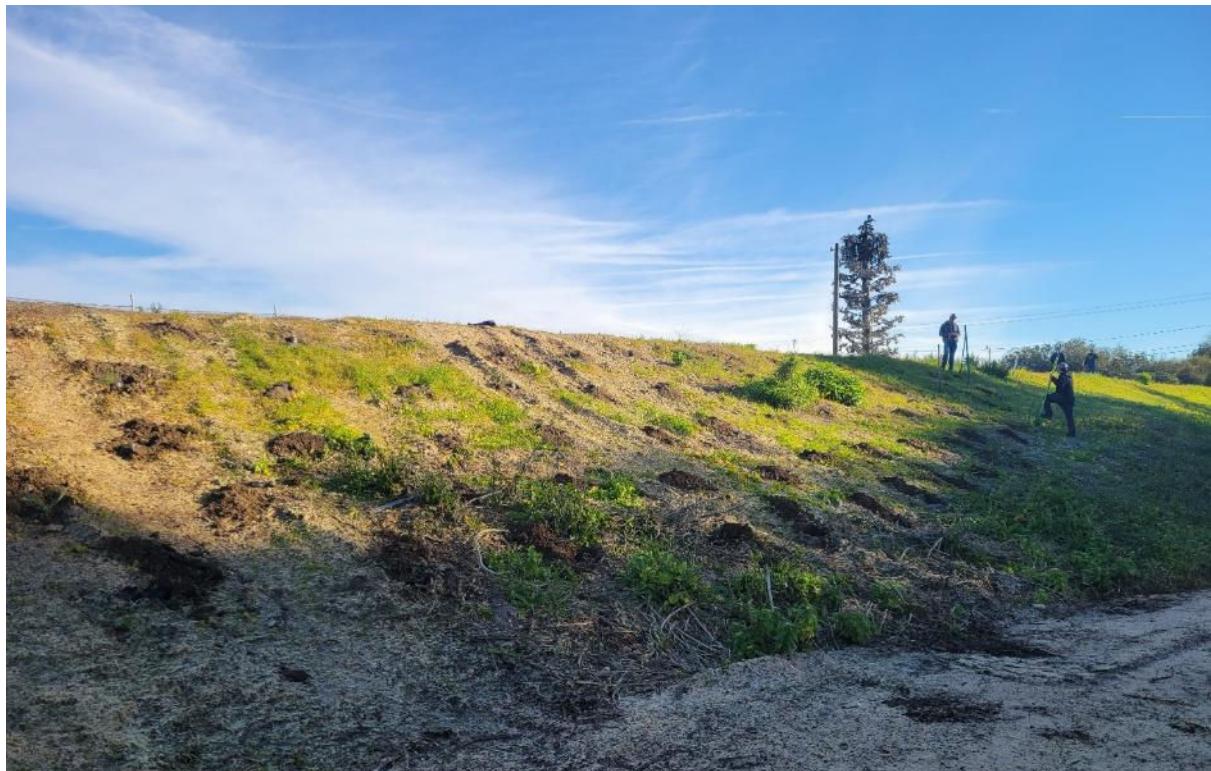
Photograph 17. Planting container plants at SMZ 7. December 2, 2025.

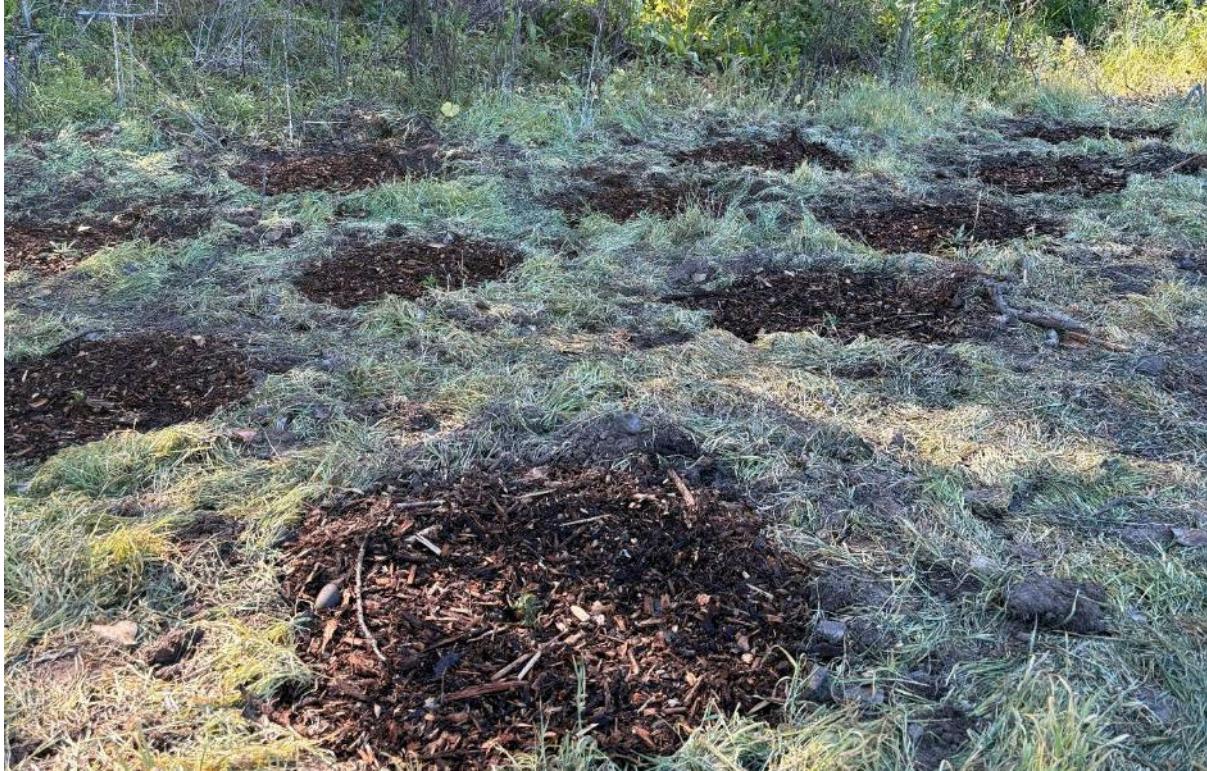
Photograph 19. Newly planted native perennials with mulch topdressing; SMZ 8. December 8, 2025.

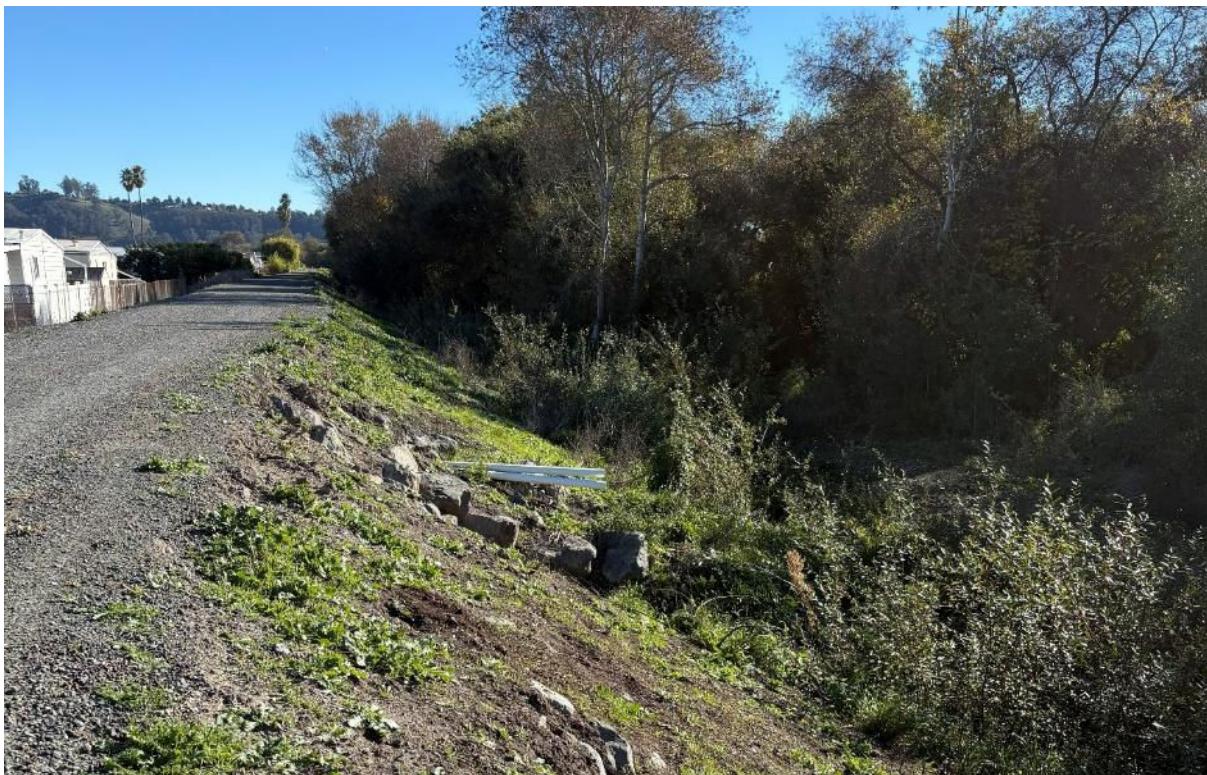
Photograph 20. Site preparation for new container plantings at SMZ 10. December 8, 2025.

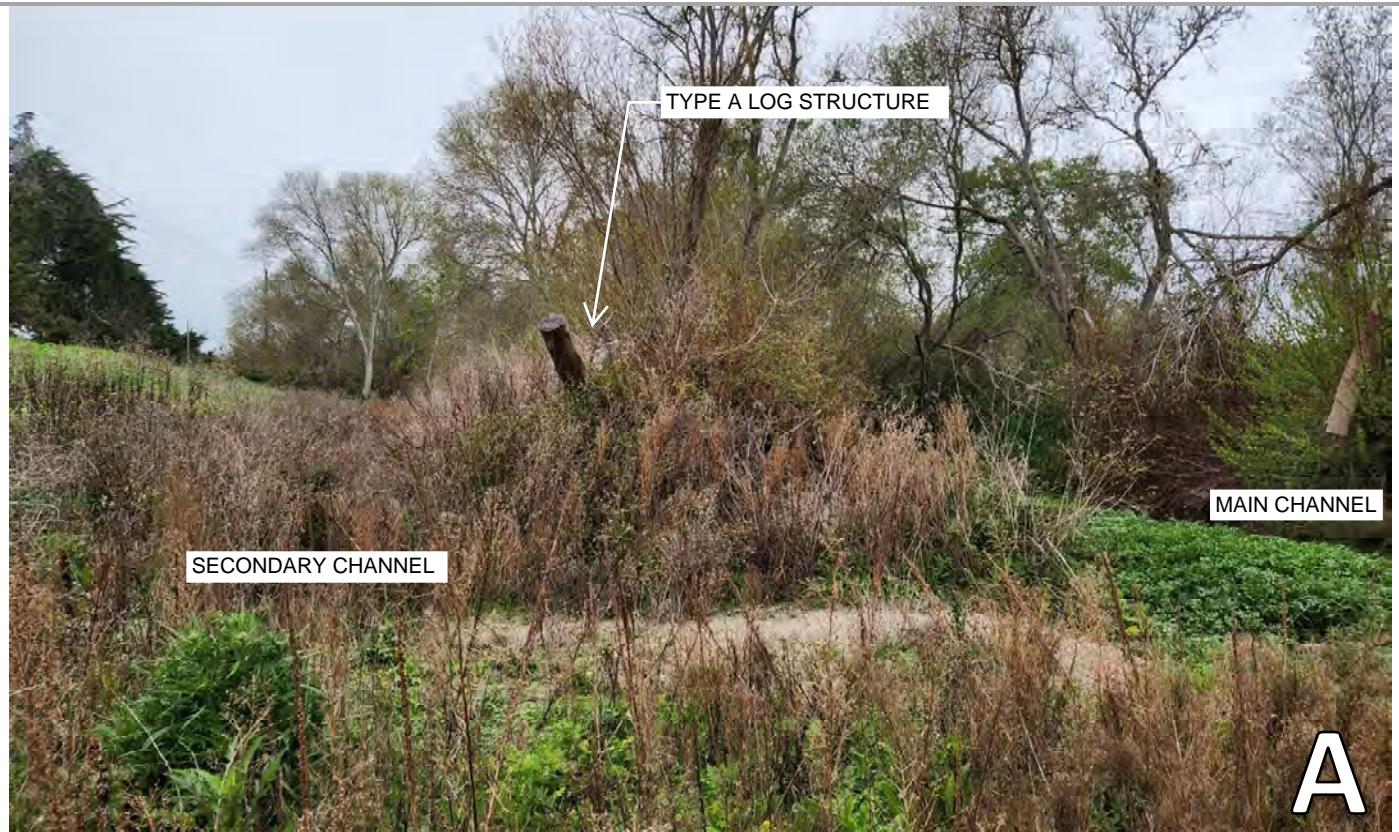
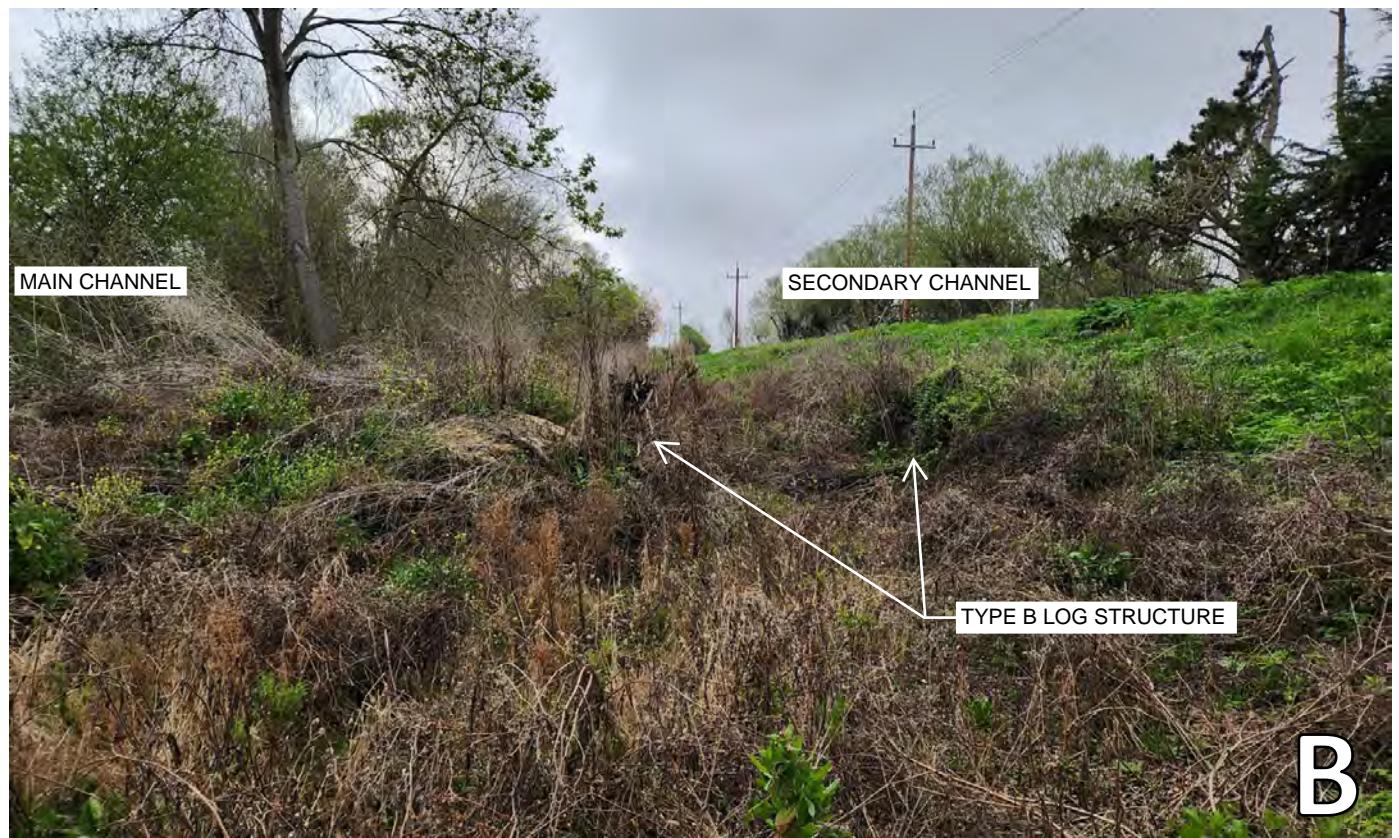
PHOTO A: SITE 1 TYPE A STRUCTURE LOOKING DOWNSTREAM (FEB. 2025)

PHOTO B: SITE 1 TYPE B STRUCTURE LOOKING UPSTREAM (FEB. 2025)

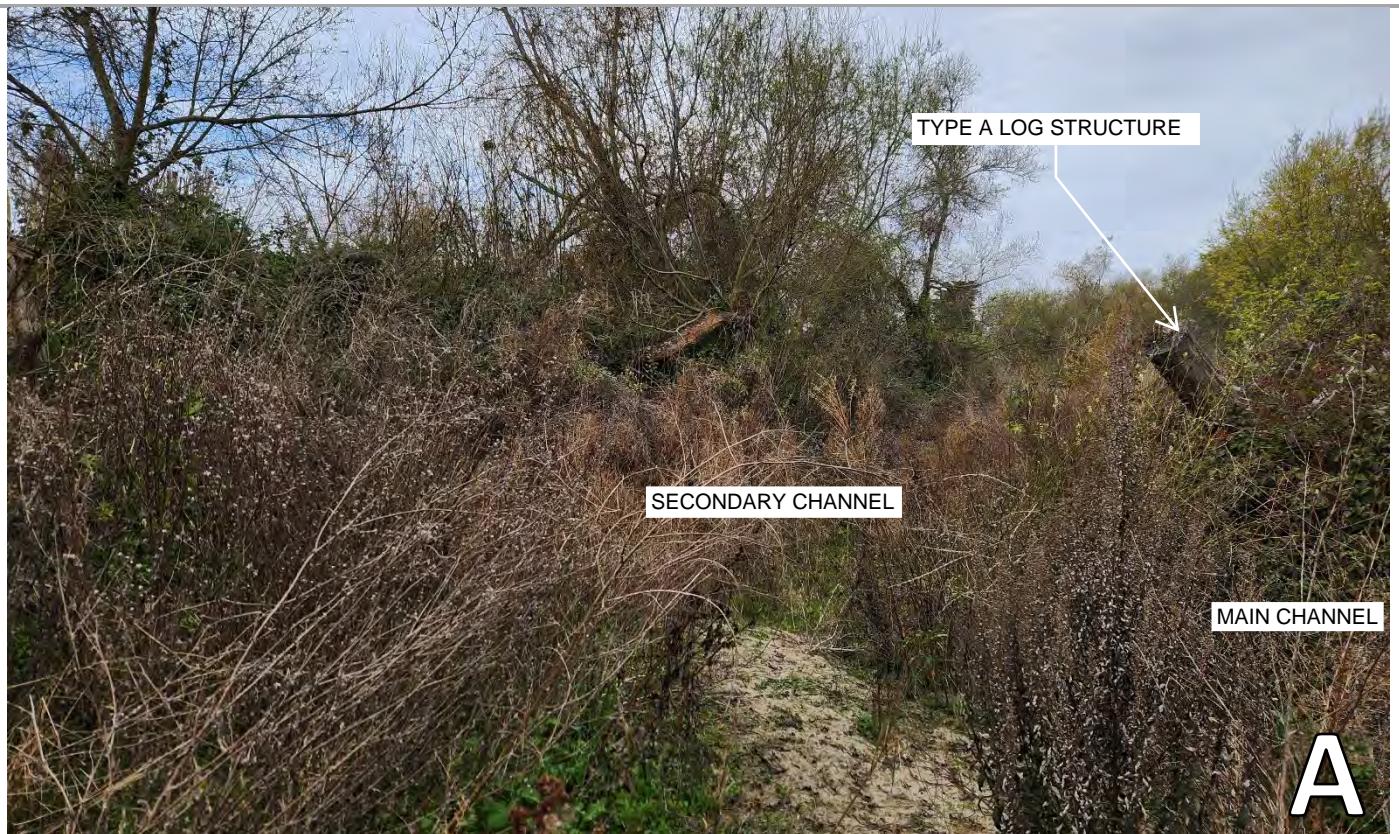
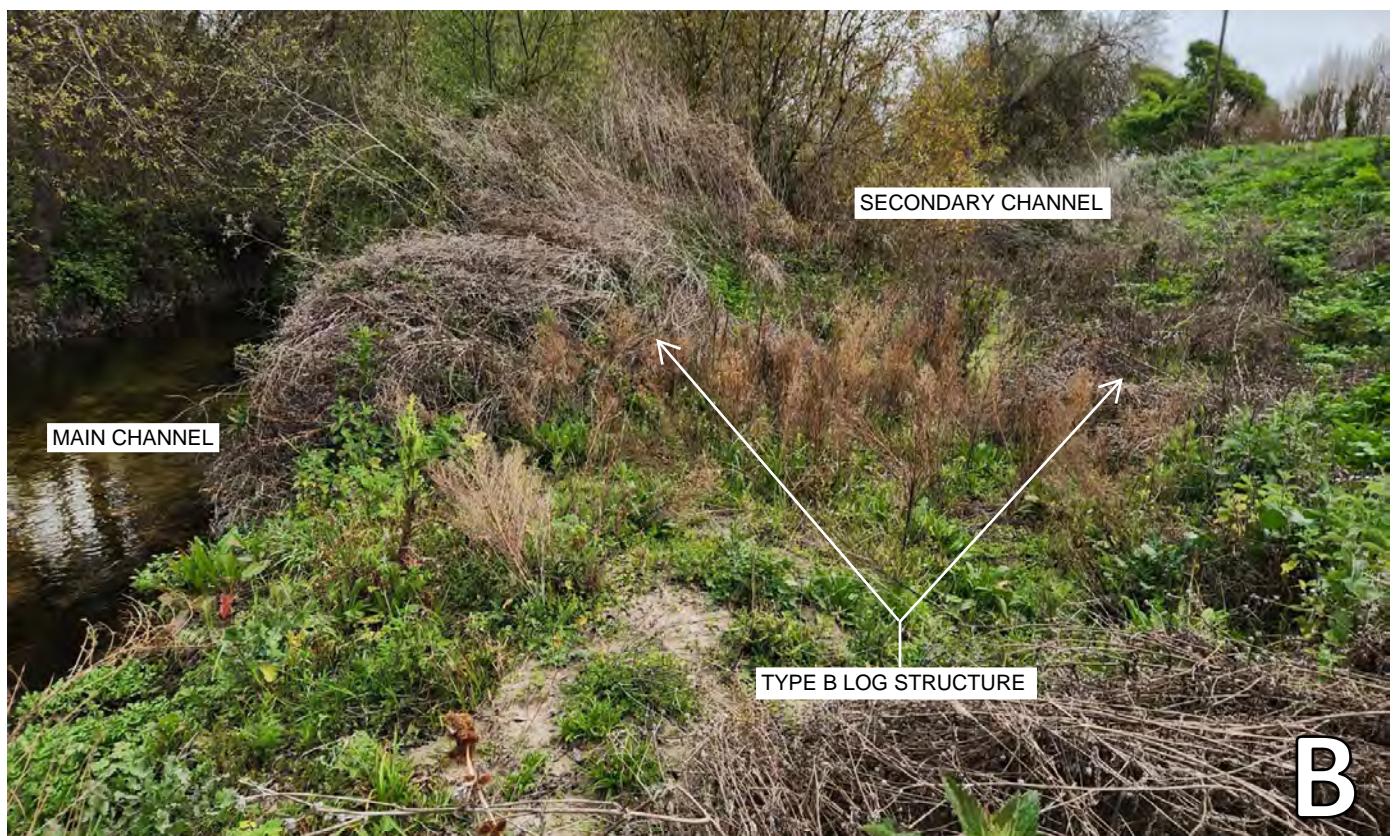
PHOTO A: SITE 2 TYPE A STRUCTURE LOOKING DOWNSTREAM (FEB. 2025)

PHOTO B: SITE 2 TYPE B STRUCTURE LOOKING UPSTREAM (FEB. 2025)

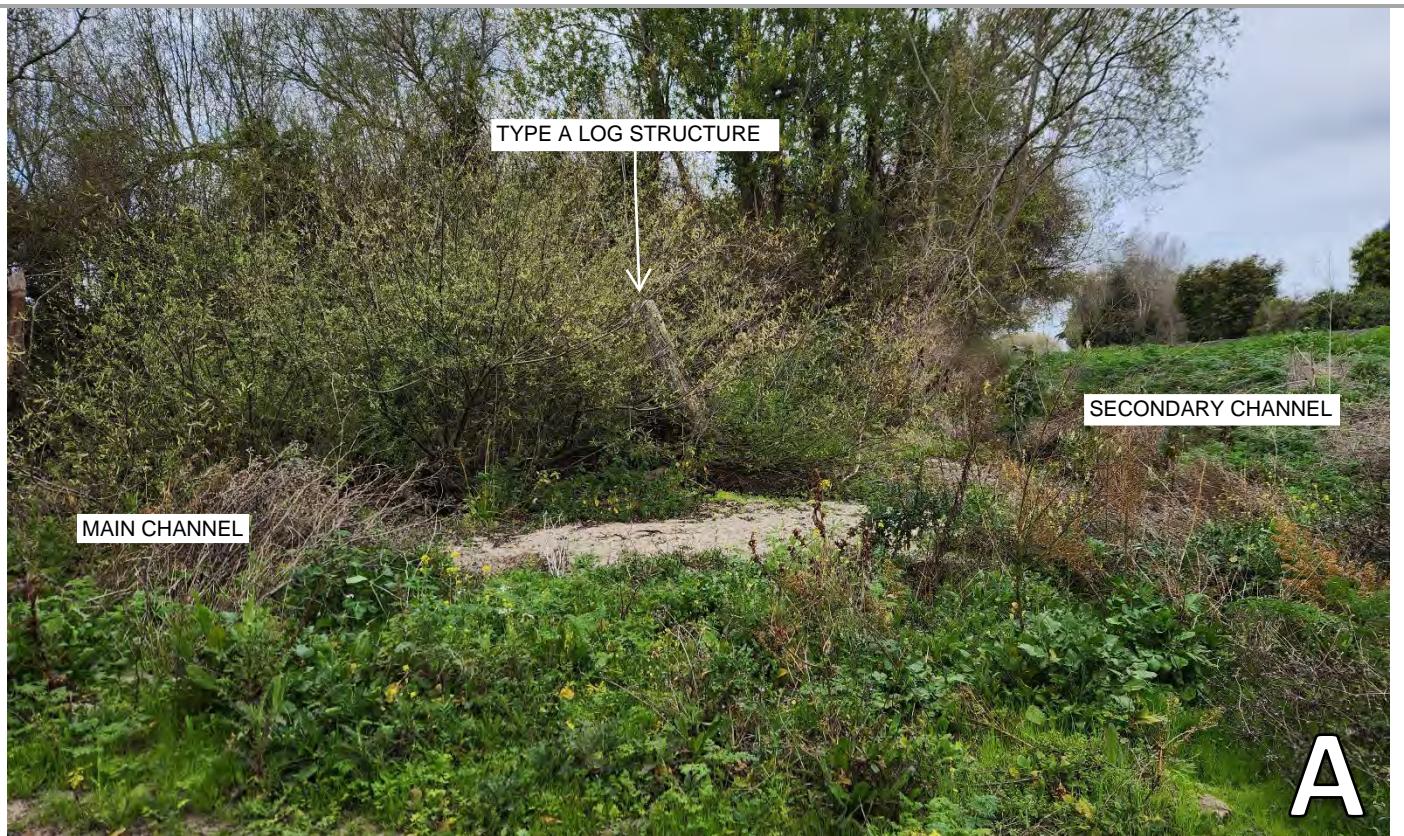
PHOTO A: SITE 3 TYPE A STRUCTURE LOOKING DOWNSTREAM (FEB. 2025)

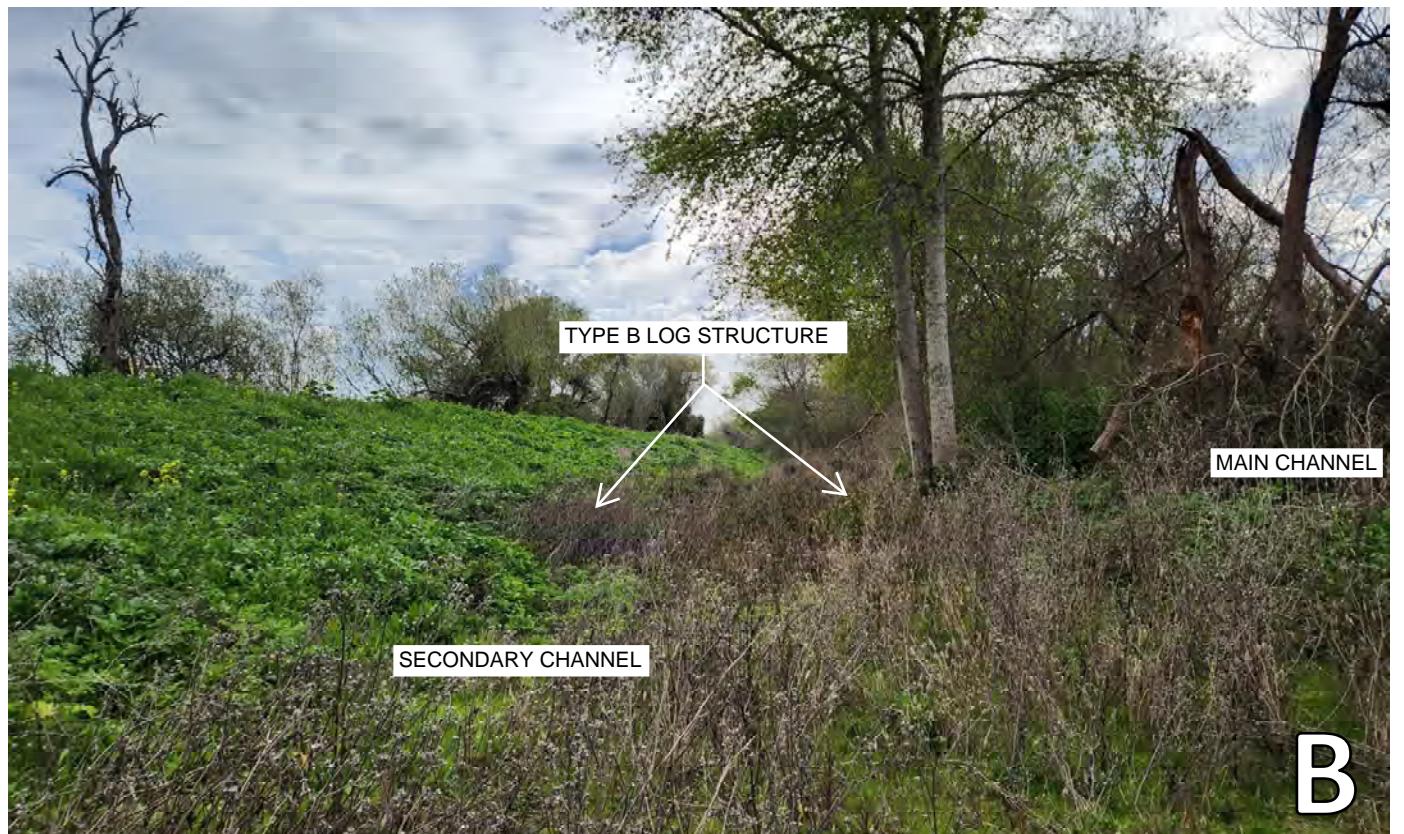
PHOTO B: SITE 3 TYPE B STRUCTURE LOOKING UPSTREAM (FEB. 2025)

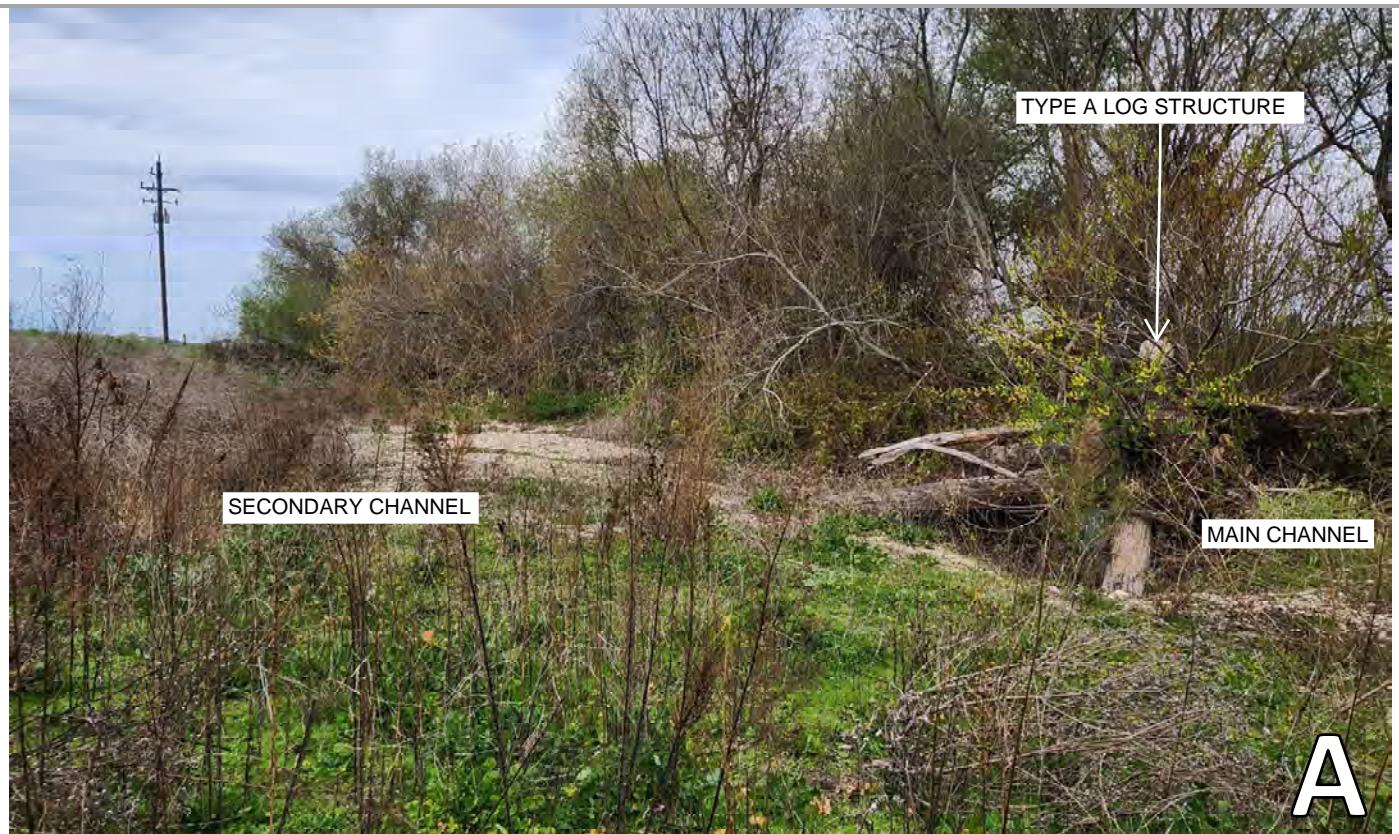
PHOTO A: SITE 4 TYPE A STRUCTURE LOOKING DOWNSTREAM (FEB. 2025)

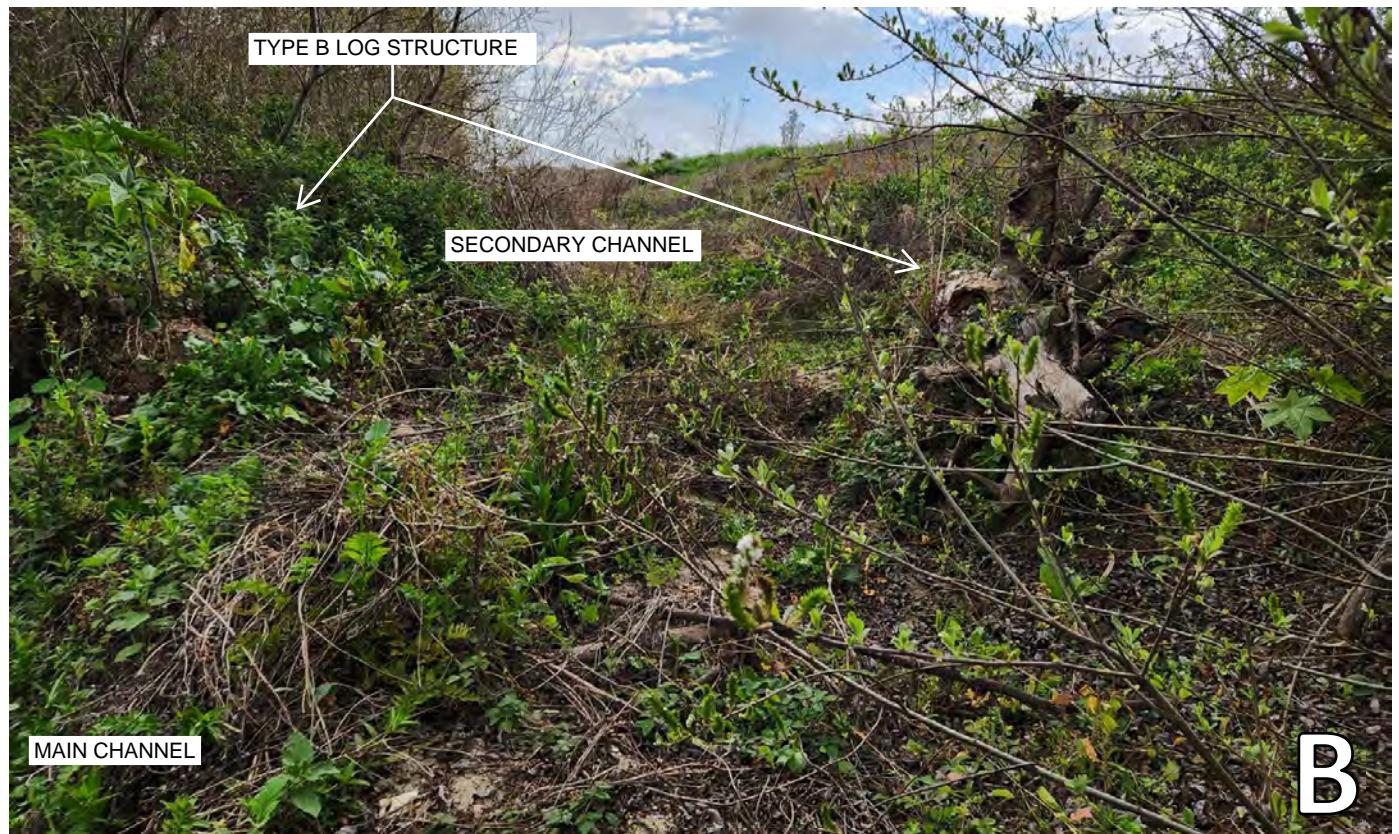
PHOTO B: SITE 4 TYPE B STRUCTURE LOOKING UPSTREAM (FEB. 2025)

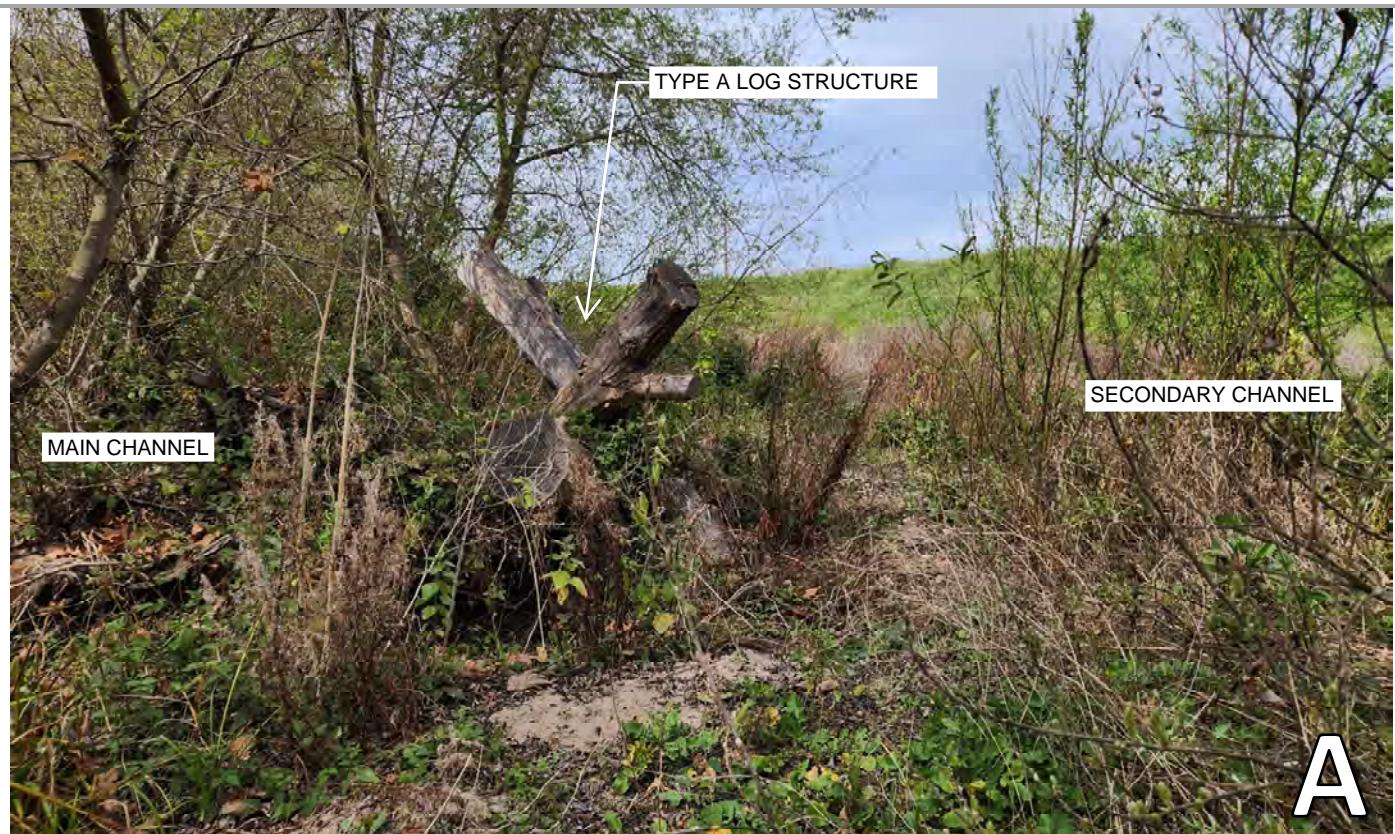
PHOTO A: SITE 6 TYPE A STRUCTURE LOOKING DOWNSTREAM (FEB. 2025)
