Arroyo Grande Creek Channel Waterway Management Program

National Marine Fisheries Service
Biological Opinion Annual Report

January 2026

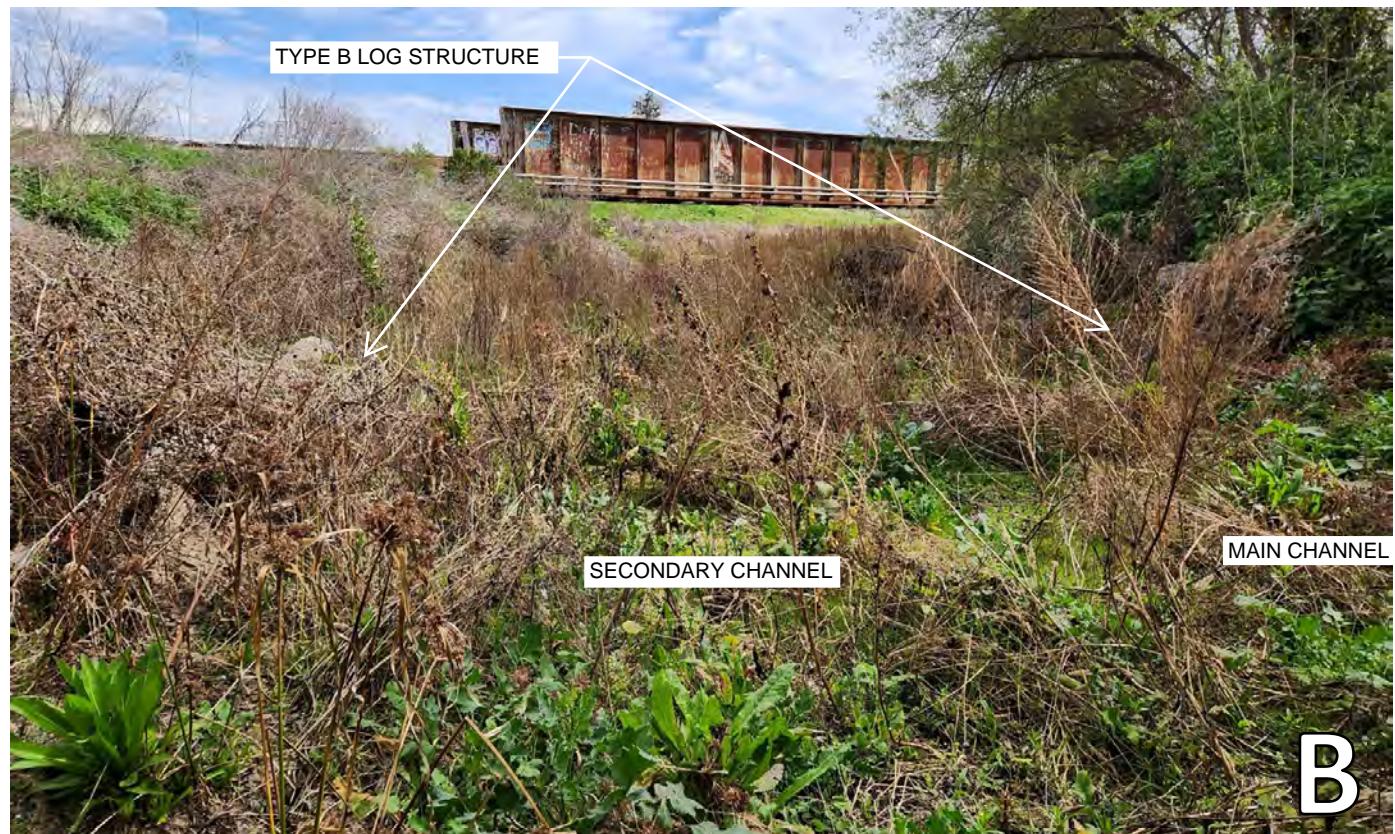
PHOTO B: SITE 6 TYPE B STRUCTURE LOOKING UPSTREAM (FEB. 2025)

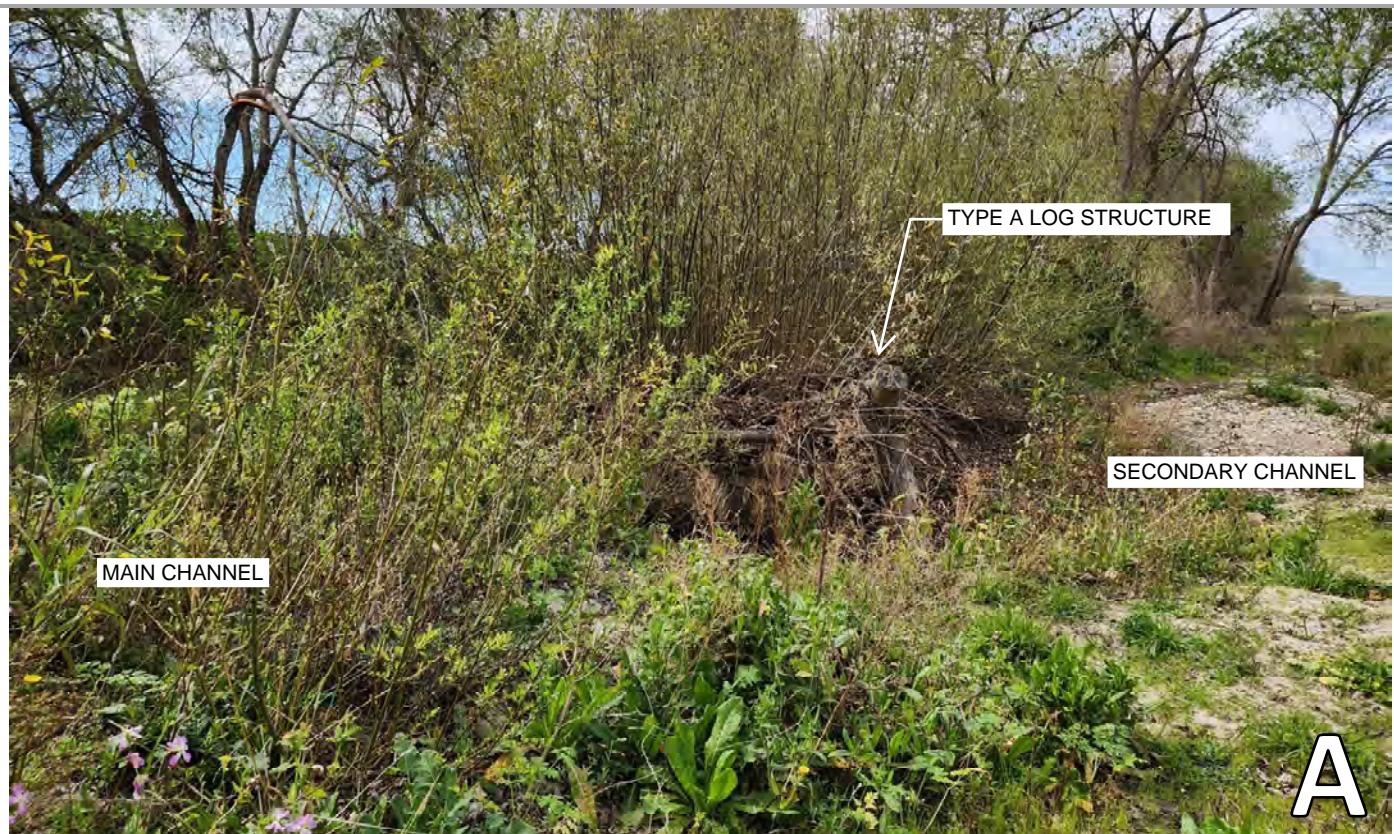
PHOTO A: SITE 7 TYPE A STRUCTURE LOOKING DOWNSTREAM (FEB. 2025)

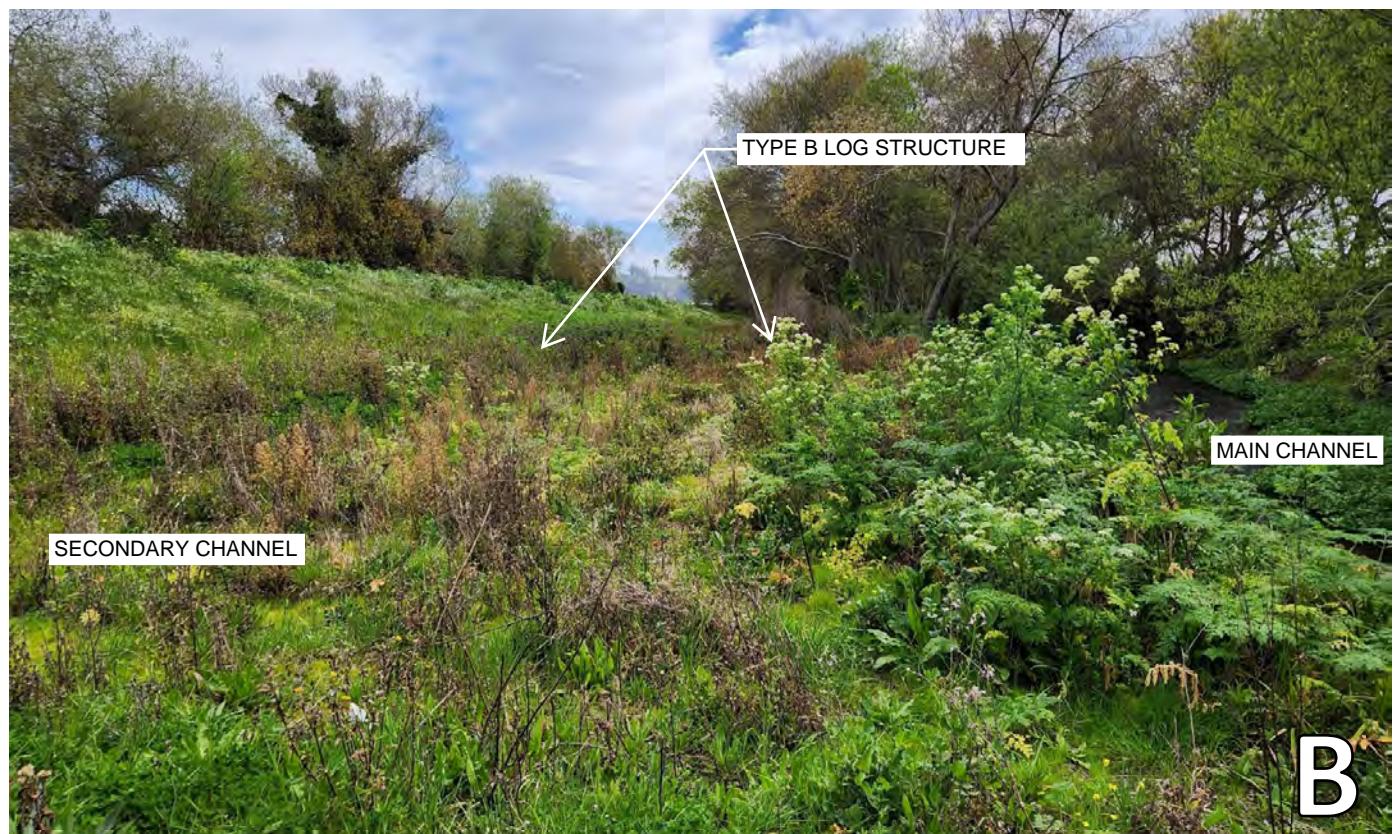
PHOTO B: SITE 7 TYPE B STRUCTURE LOOKING UPSTREAM (FEB. 2025)

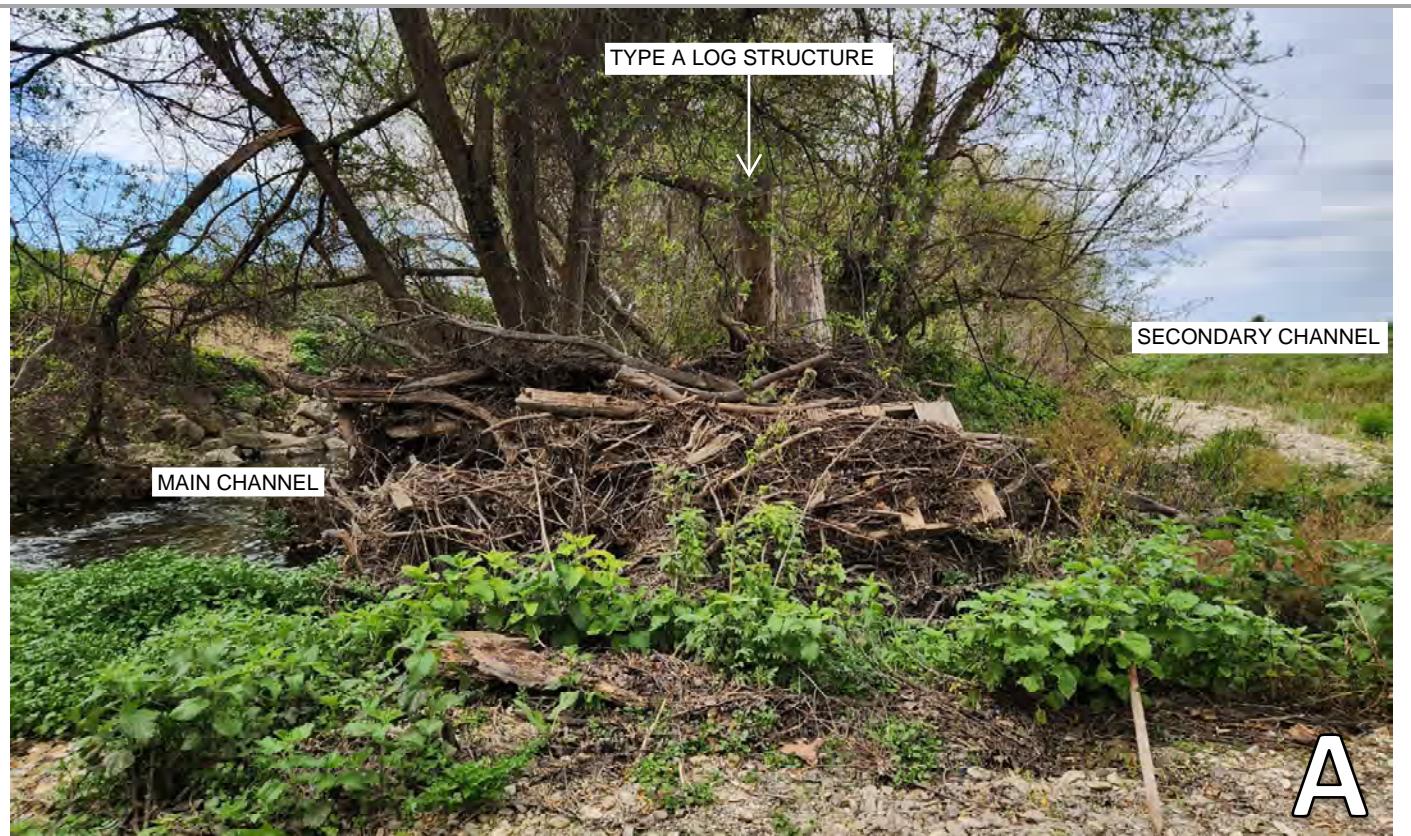
PHOTO A: SITE 9 TYPE A STRUCTURE LOOKING DOWNSTREAM (FEB. 2025)

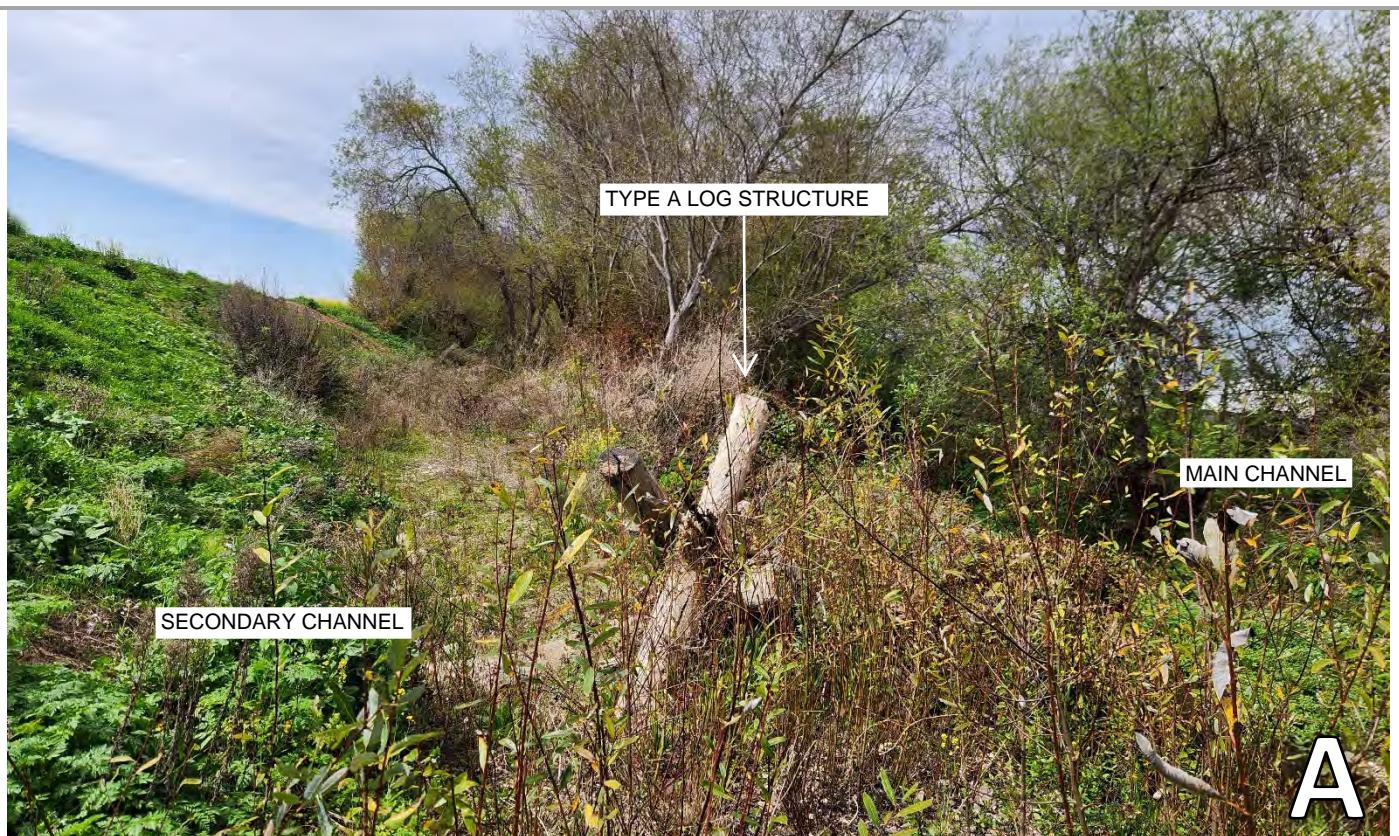
PHOTO A: SITE 10 TYPE A STRUCTURE LOOKING DOWNSTREAM (FEB. 2025)

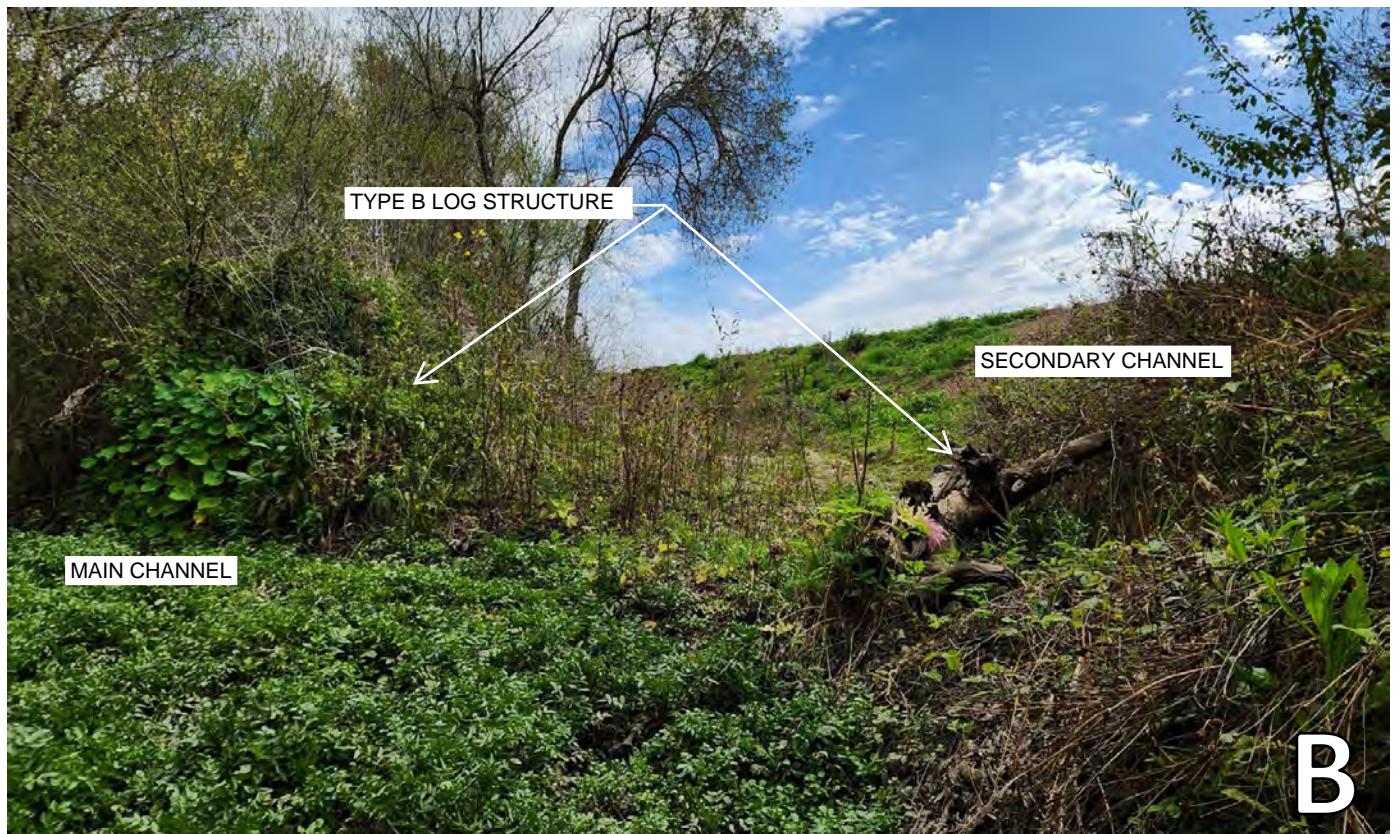
PHOTO B: SITE 10 TYPE B STRUCTURE LOOKING UPSTREAM (FEB. 2025)

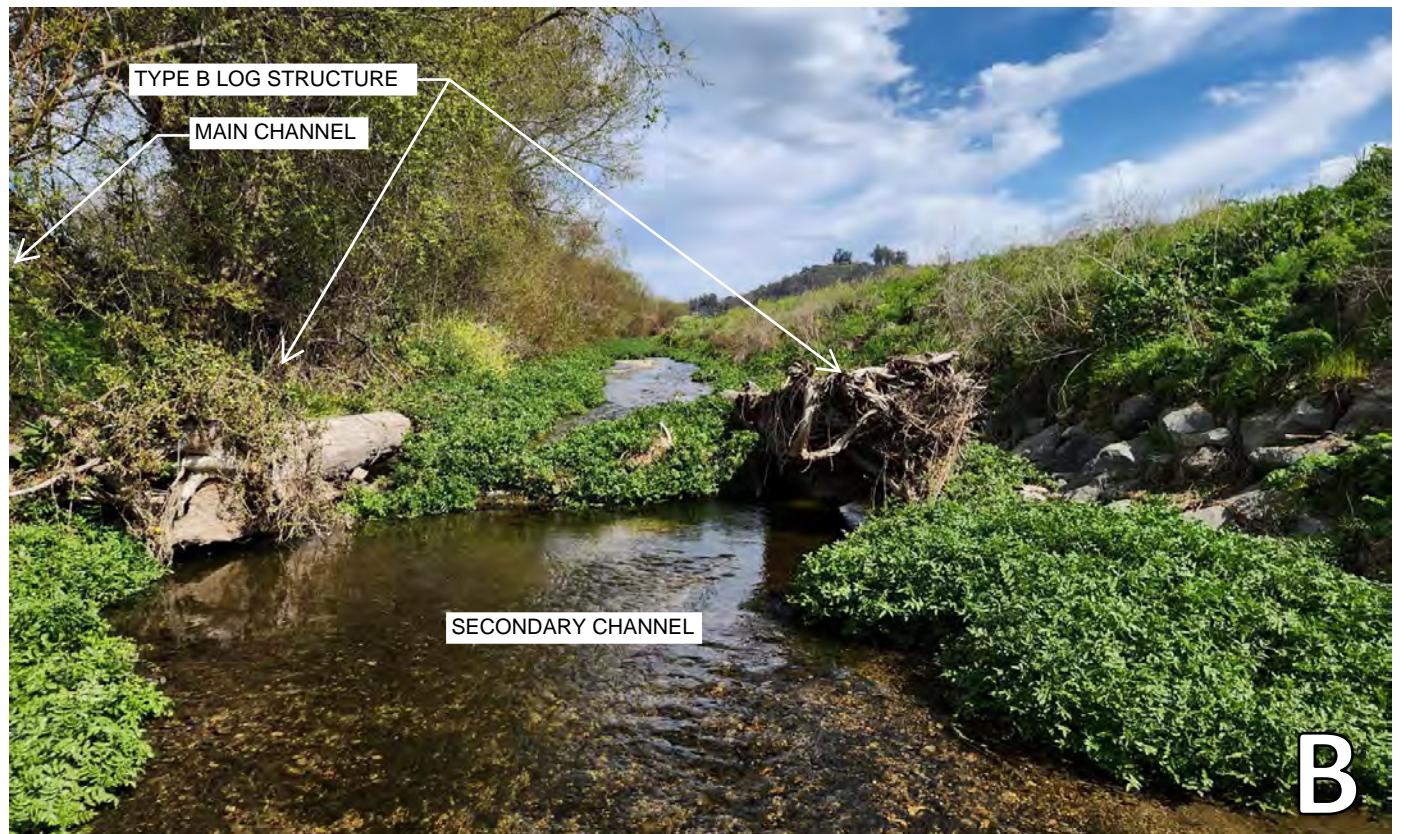
Site #	Log Structure Condition	Alcove/Pool Condition	Notes
12/13A	OK	Good	Structure is perched approx. 3 feet above the main channel. Small scour pool immediately underneath the structure.
12/13B	Good	Good	Log structure operates optimally. Root wads exposed on both sides, shallow pool immediately downstream from structure.
14A	Good	None	Flow in secondary channel only. Unlikely that primary flow will shift back to main channel, bend in thalweg pointing away from log structure.
14B	Poor	OK	Footer logs completely submerged. Root wad logs are both exposed on the side/top, with root wad fully exposed.
15A	OK	Good	Significant bank cutting over river right log (approx. 8ft).
15B	OK	Good	Footer logs were fully submerged in June from apparent backwater. Root wad on river right is exposed. River left root wad log is partially buried. Erosion cut on river right adjacent to root wad, approx. 5 to 6 feet deep.

PHOTO B: SITE 12&13 TYPE B STRUCTURE LOOKING UPSTREAM (FEB. 2025)

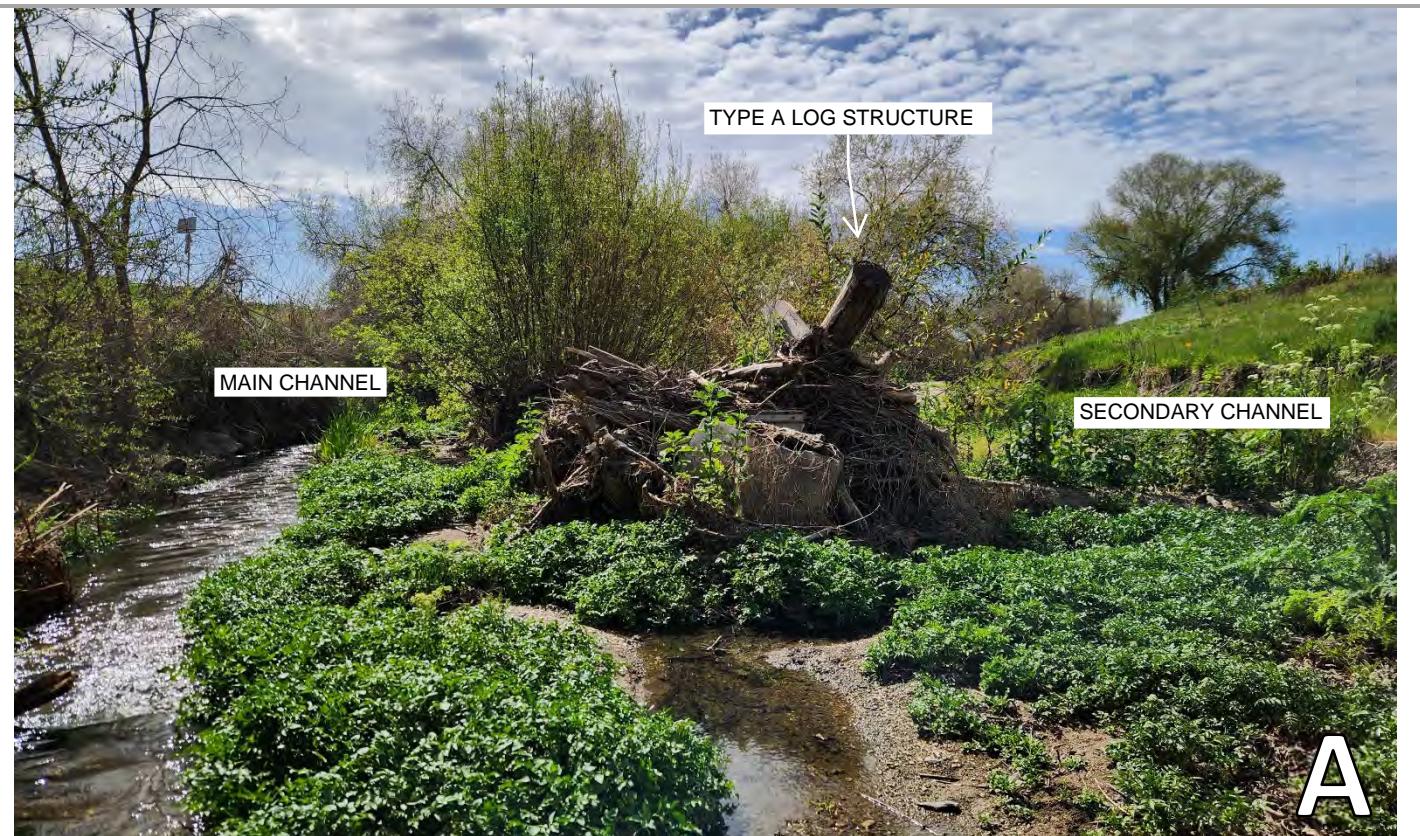
PHOTO A: SITE 14 TYPE A STRUCTURE LOOKING DOWNSTREAM (FEB. 2025)

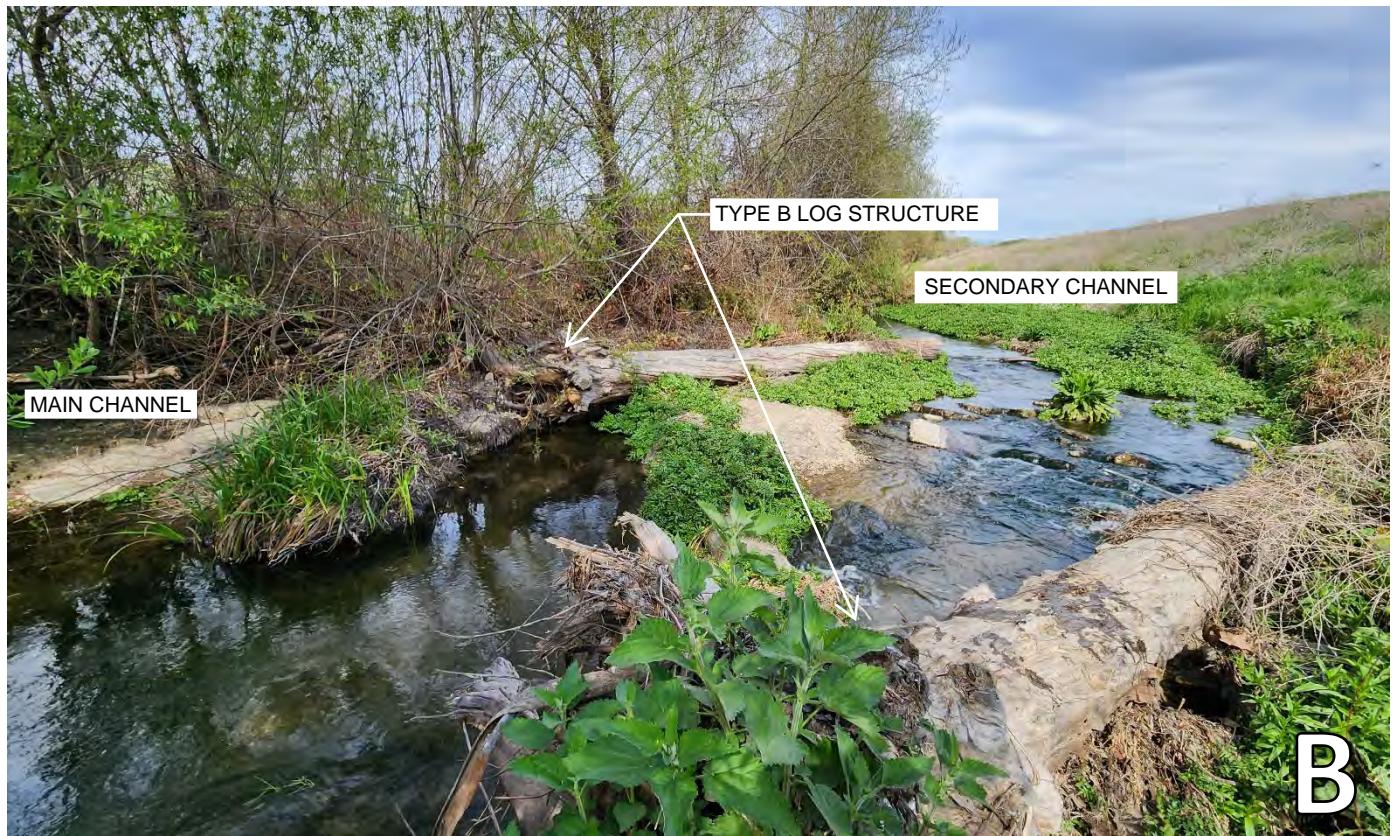
PHOTO B: SITE 15 TYPE B STRUCTURE LOOKING UPSTREAM (FEB. 2025)

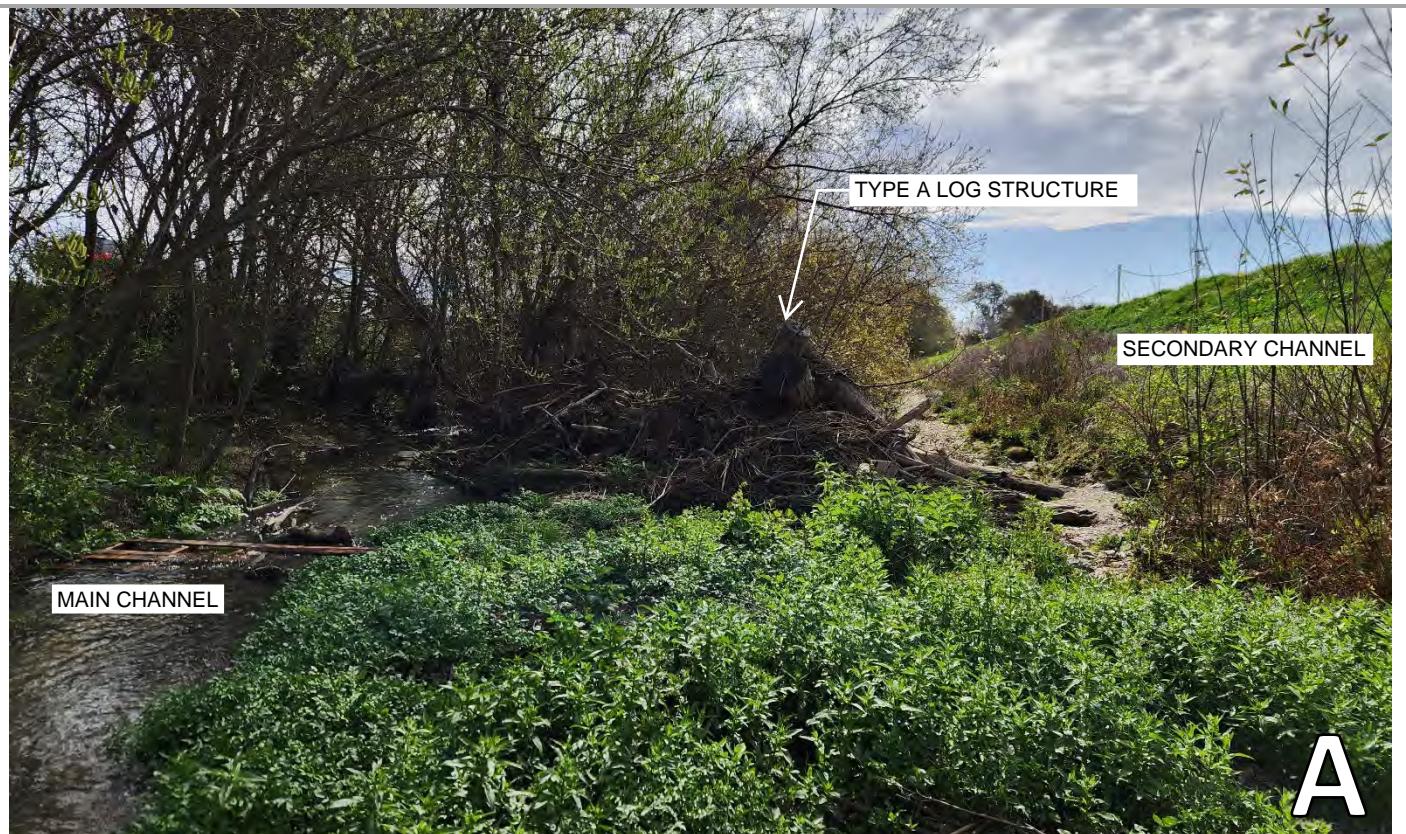
PHOTO A: SITE 16 TYPE A STRUCTURE (FEB. 2025)

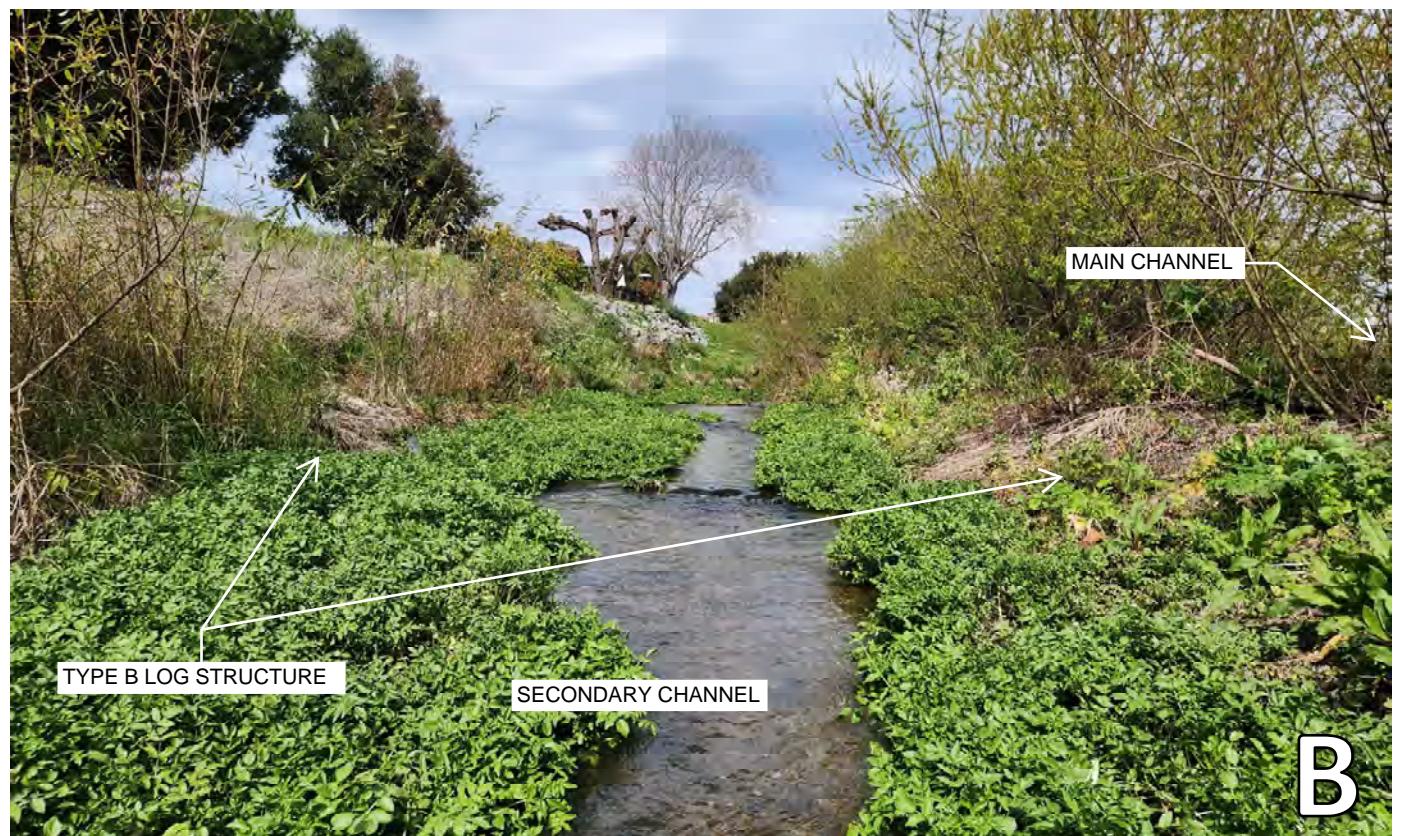
PHOTO B: SITE 16 TYPE B STRUCTURE LOOKING UPSTREAM (FEB. 2025)

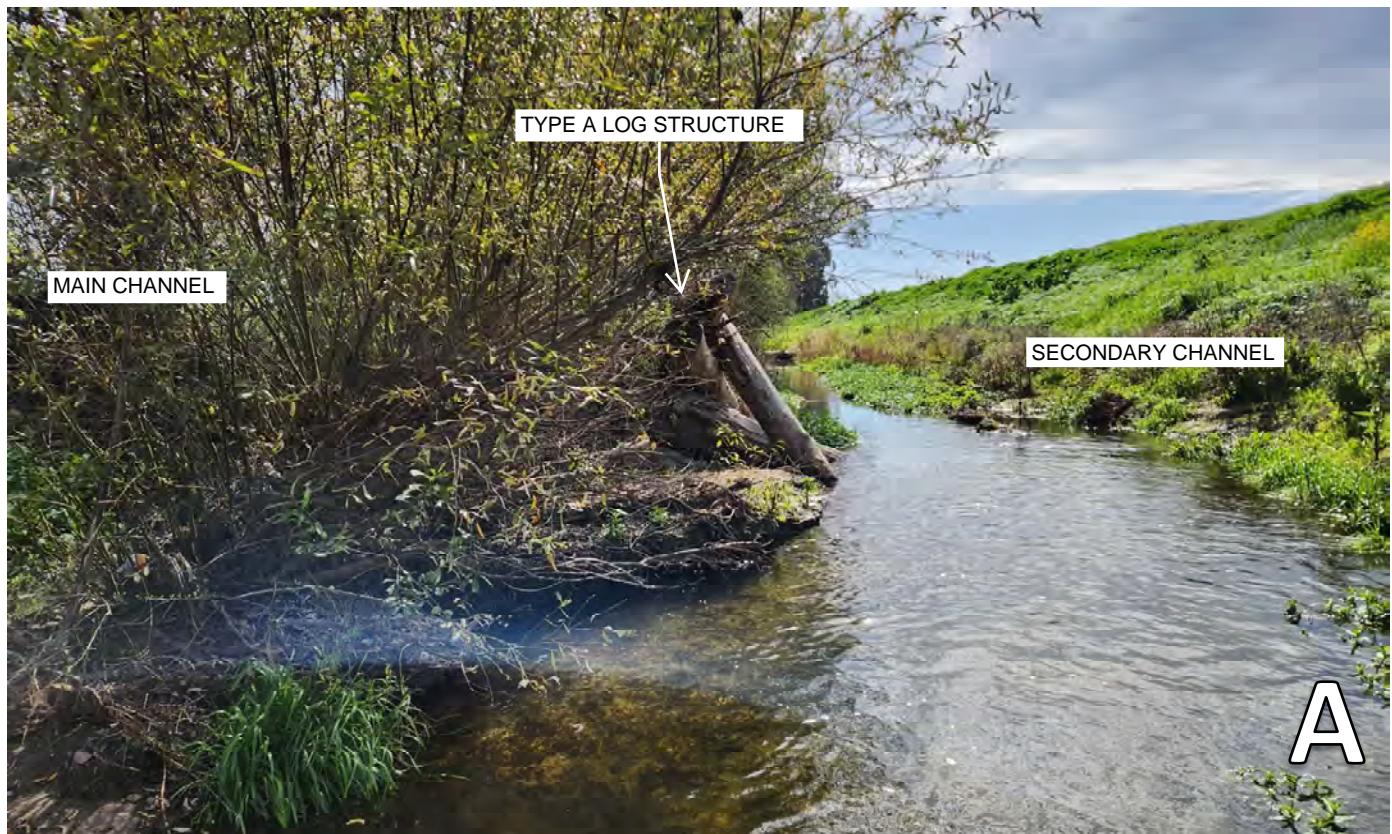
PHOTO A: SITE 18 TYPE A STRUCTURE LOOKING DOWNSTREAM (FEB. 2025)

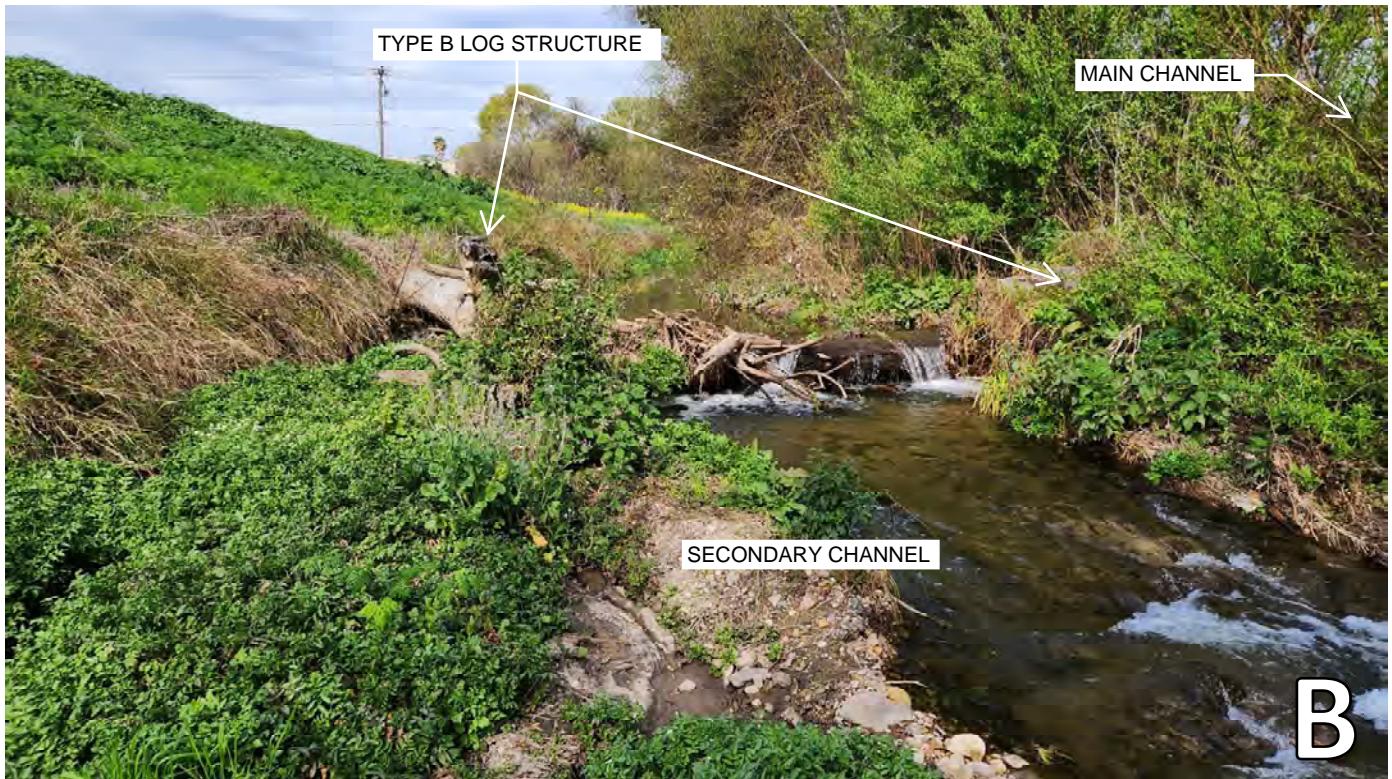
PHOTO B: SITE 18 TYPE B STRUCTURE LOOKING UPSTREAM (FEB. 2025)

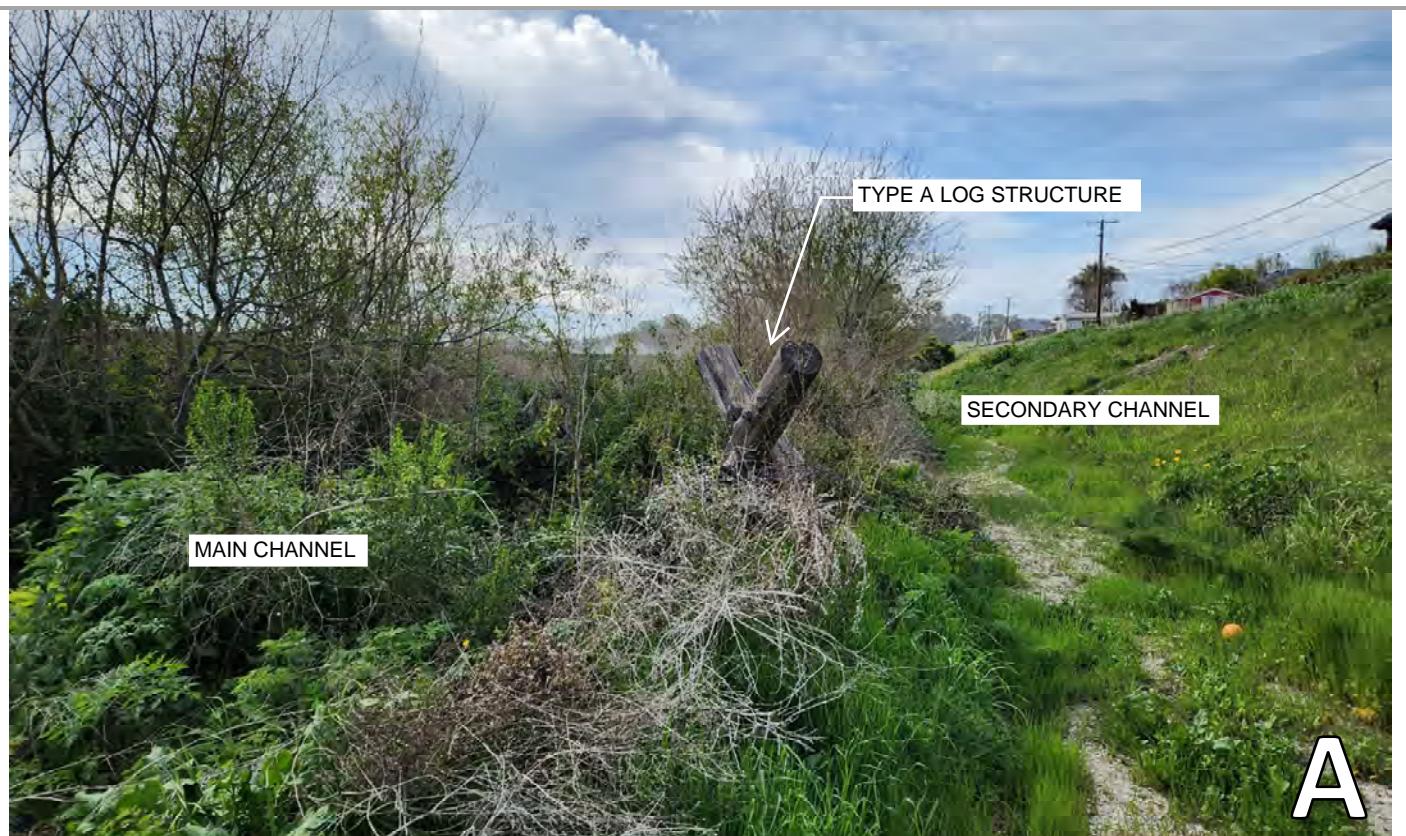
PHOTO A: SITE 19 TYPE A STRUCTURE LOOKING DOWNSTREAM (FEB. 2025)

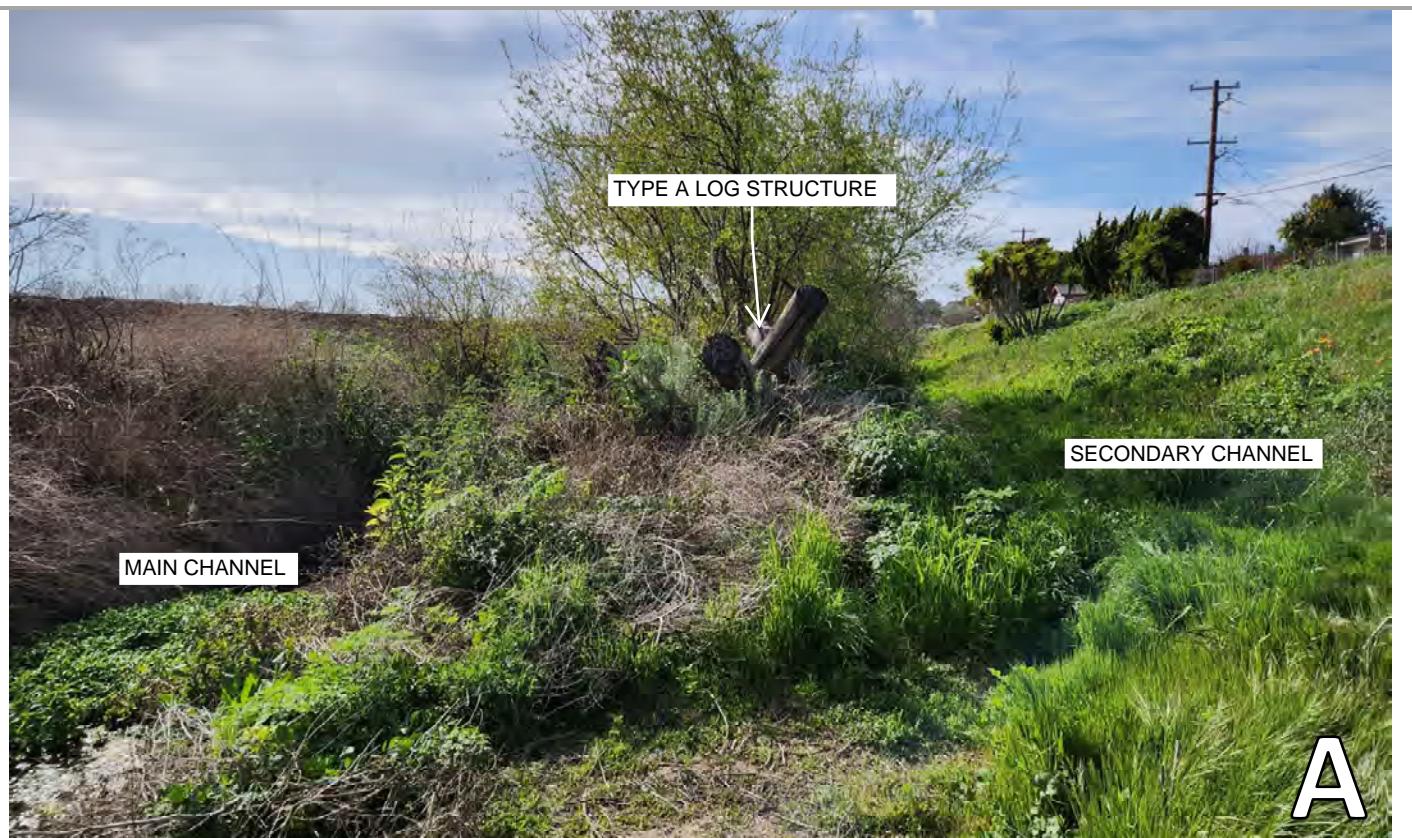
PHOTO A: SITE 20 TYPE A STRUCTURE LOOKING DOWNSTREAM (FEB. 2025)

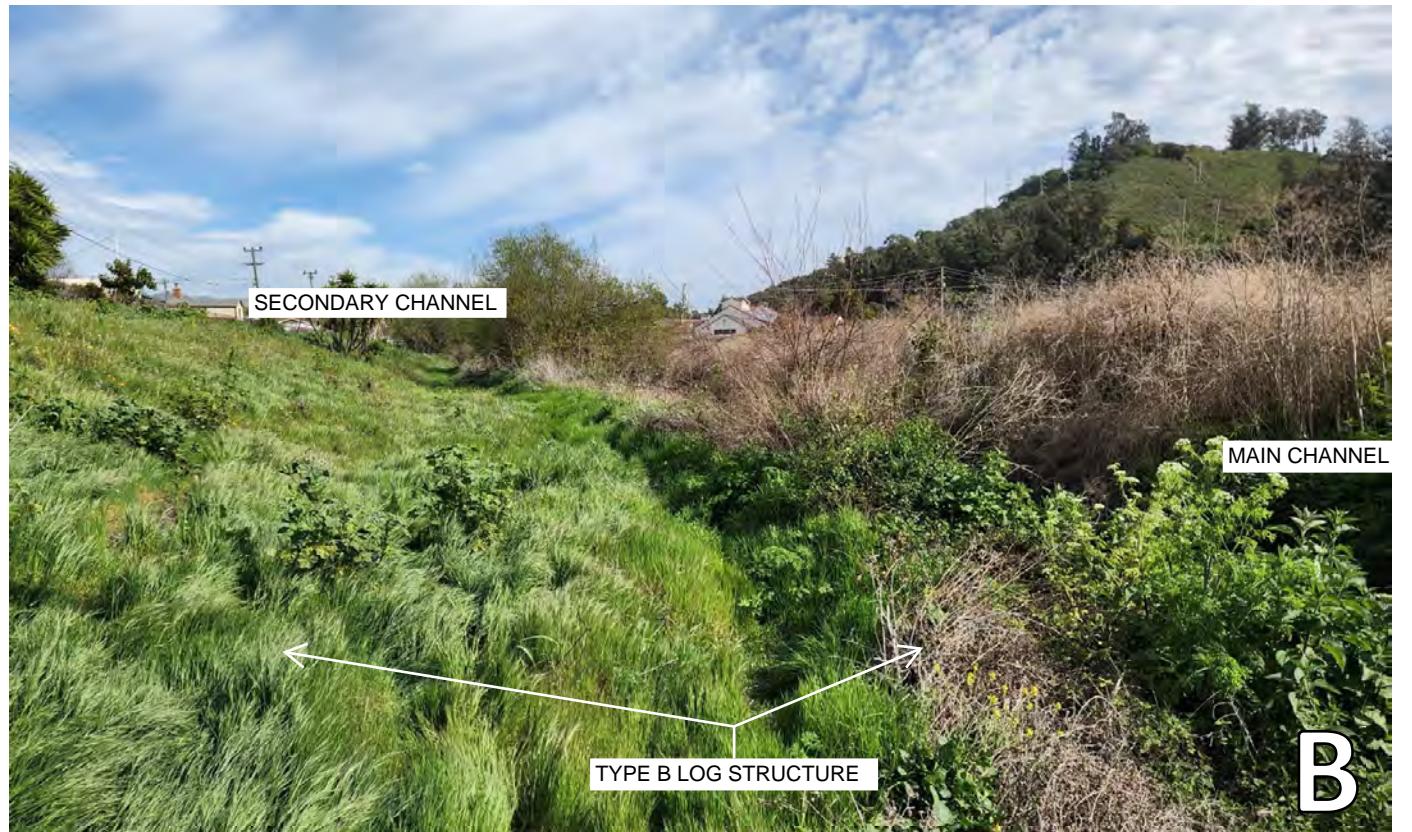
PHOTO B: SITE 20 TYPE B STRUCTURE LOOKING UPSTREAM (FEB. 2025)

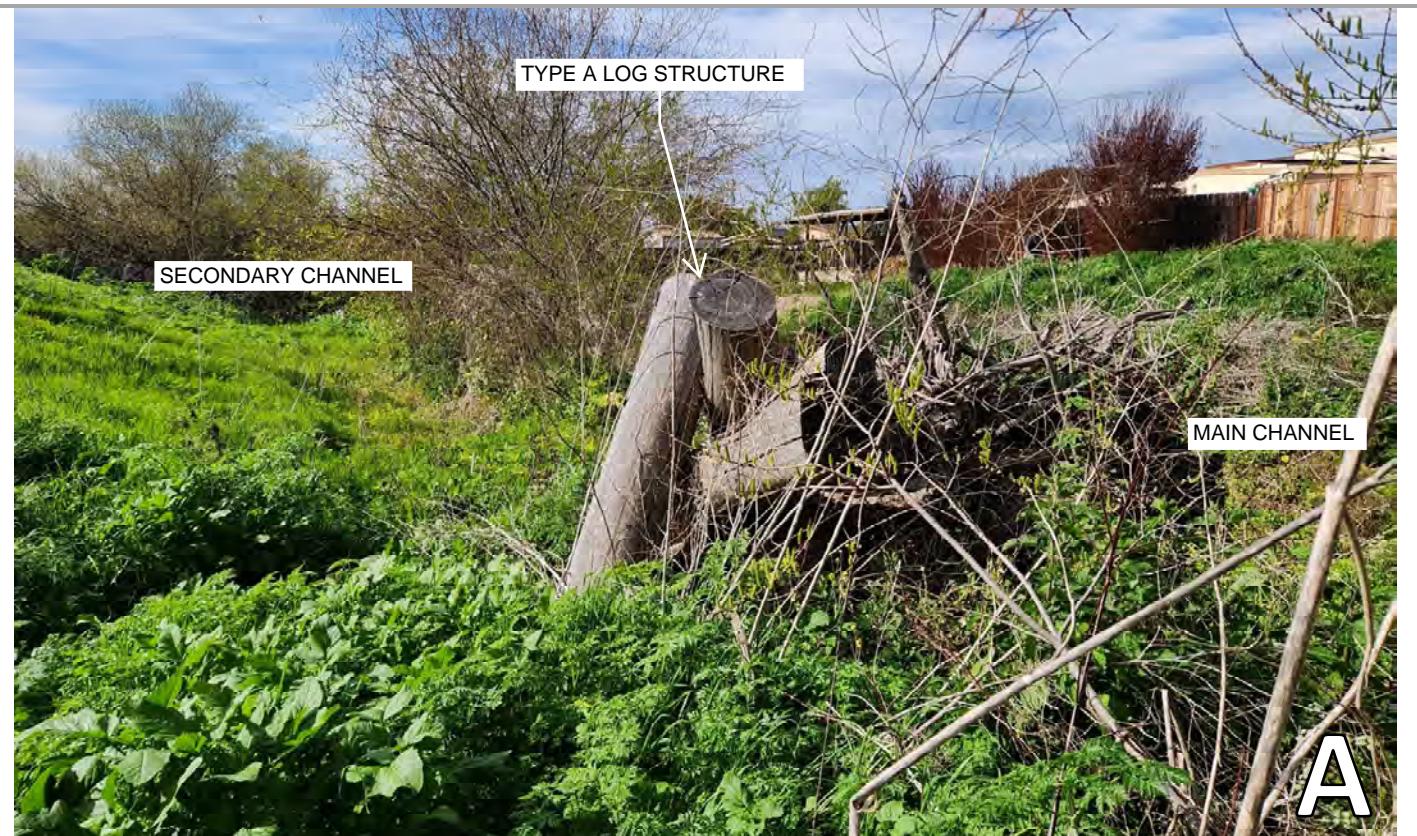
PHOTO A: SITE 21 TYPE A STRUCTURE LOOKING DOWNSTREAM (FEB. 2025)

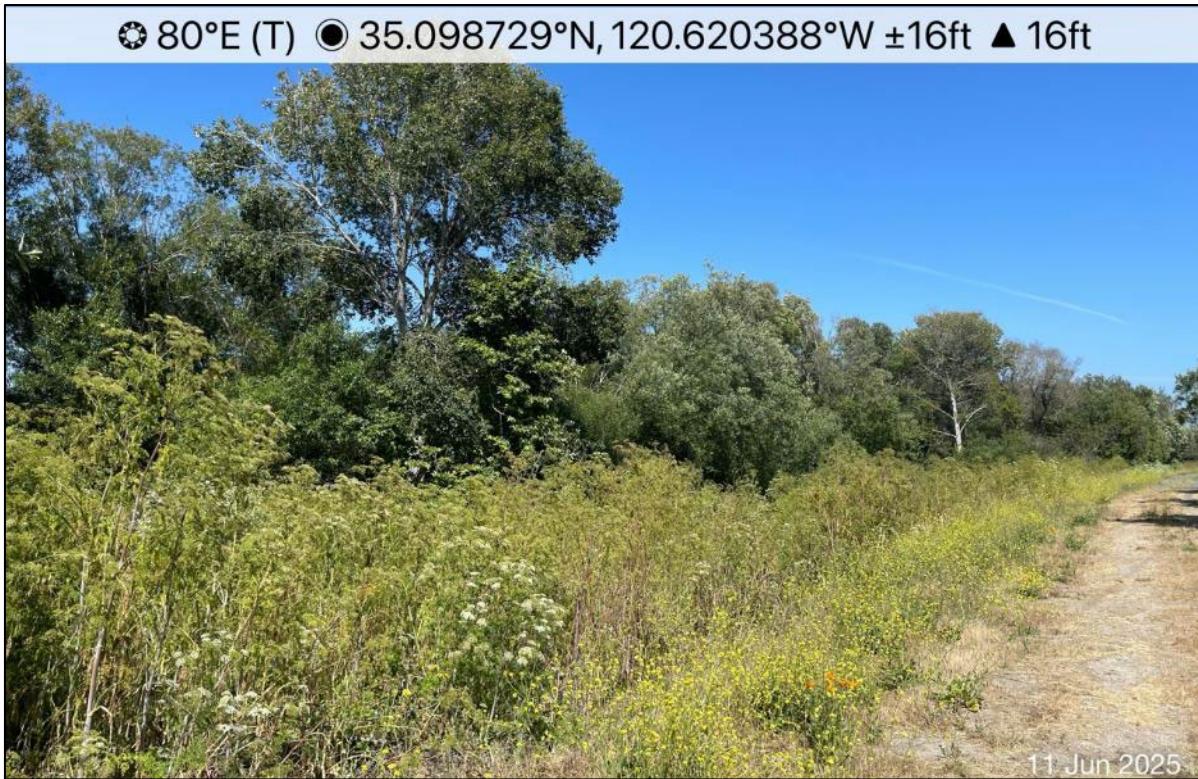
Photograph 1. View of SMZ 1, facing east. June 11, 2025.

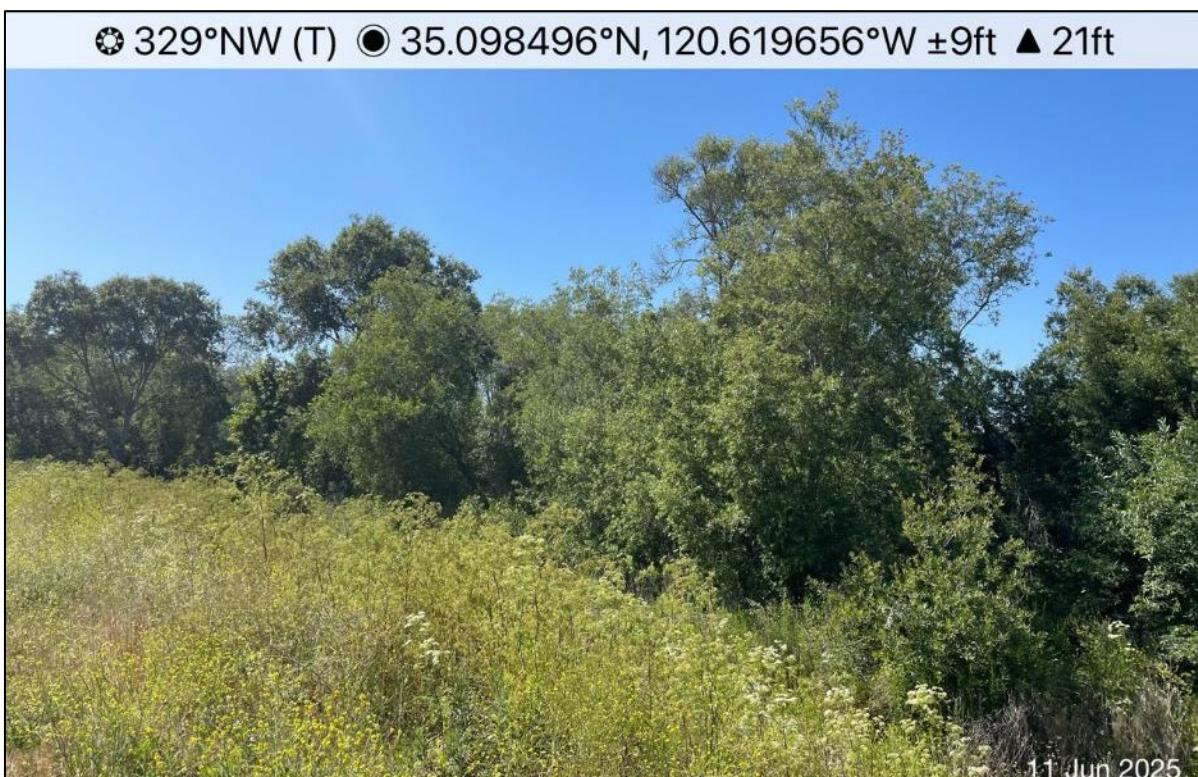
Photograph 2. View of SMZ 1, facing northwest. June 11, 2025.

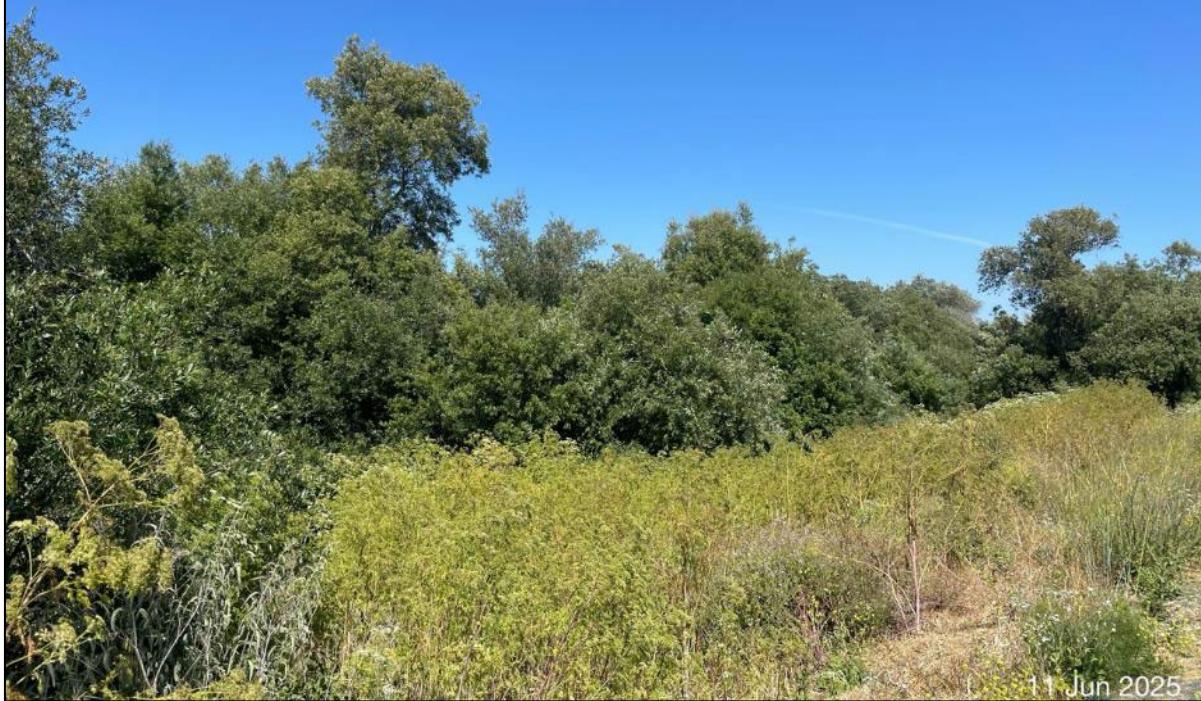
Photograph 3. View of SMZ 2, facing east. June 11, 2025.
